Building and Timber Pest Inspection Report

Inspection Date: Fri, 13 Mar 2026

Property Address: 5B Malcolm Ct, Mount Waverley VIC 3149,
Australia

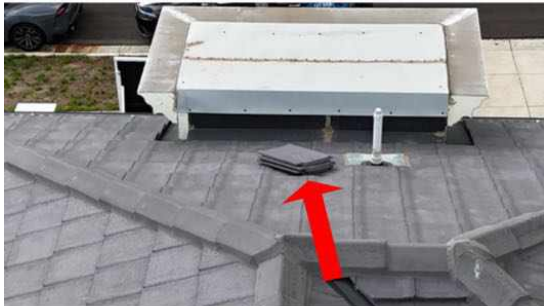
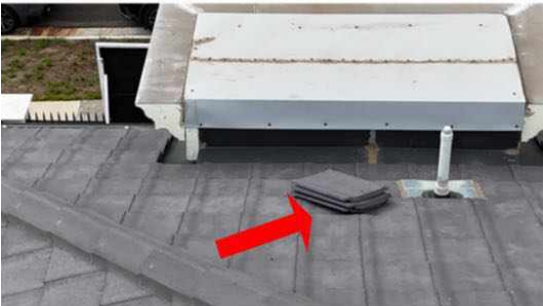
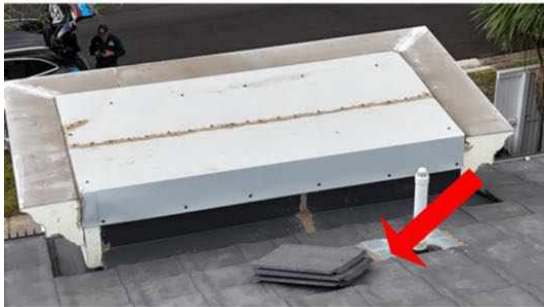
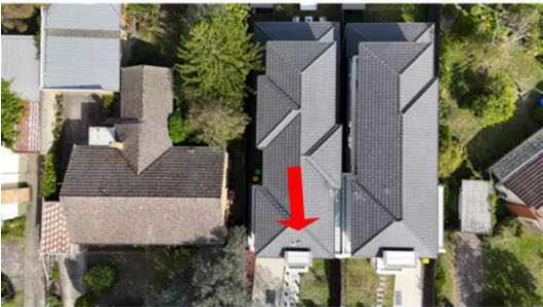
Building: Main Building
Location: Roof Exterior
Finding: Roof Plumbing - Loose Roof Tiles (Safety Hazard)
Information: Loose and displaced roof tiles were observed left on the roof surface at the time of inspection. These tiles present a safety hazard, as they may shift or fall from the roof during adverse weather conditions, potentially causing damage to the roof covering, gutters, or posing a risk of injury to persons below.

The presence of loose tiles may also allow water ingress if underlying tiles become displaced, which can lead to moisture penetration and deterioration of roof components.

It is recommended that a qualified roofing contractor or roof tiler be engaged as a matter of priority to remove or properly secure the loose tiles and ensure the roof covering is reinstated to a safe and serviceable condition. Regular roof maintenance and inspection are advised to prevent recurrence.

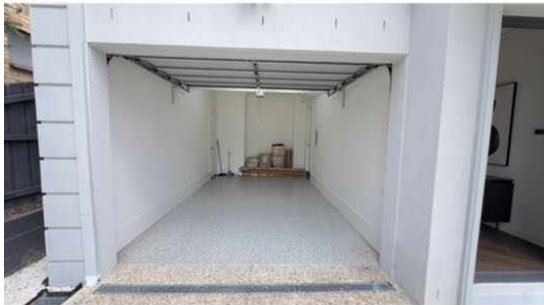
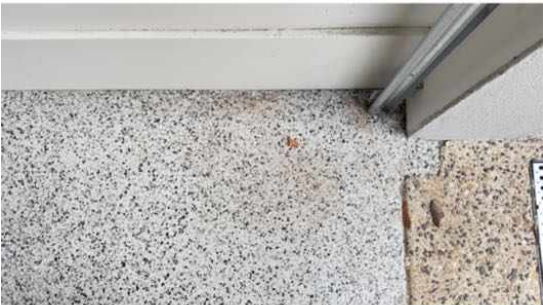
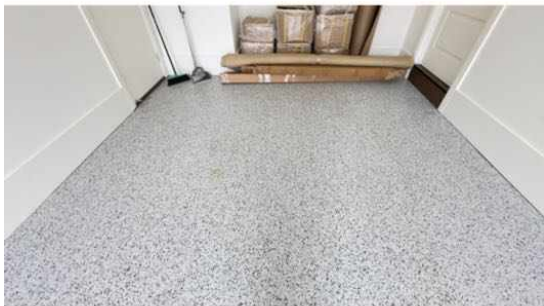
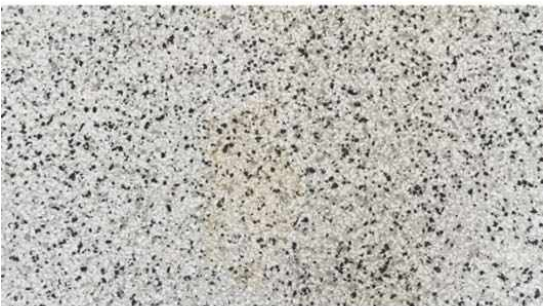
Building: Main Building
Location: Garage
Finding: Garage - Stains To Concrete Slab
Information: The garage floor was observed to have stains in this area. While primarily a cosmetic issue, these stains can reduce slip resistance and may indicate leaks from vehicles or stored equipment.

The staining appears to be caused by spillage or leakage from vehicles, machinery, or general maintenance activities.

When practical, a qualified cleaning or maintenance professional should be engaged to remove the oil stains using appropriate methods. Regular cleaning and monitoring will help maintain the appearance of the floor, reduce slip hazards, and minimise potential long-term damage to the concrete surface.

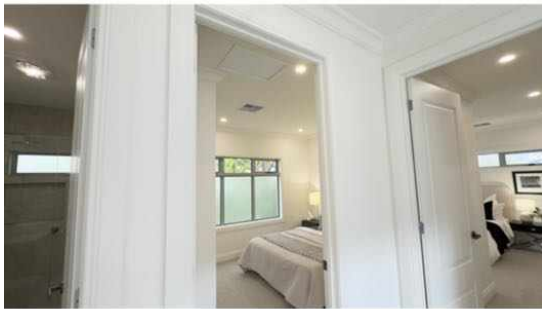
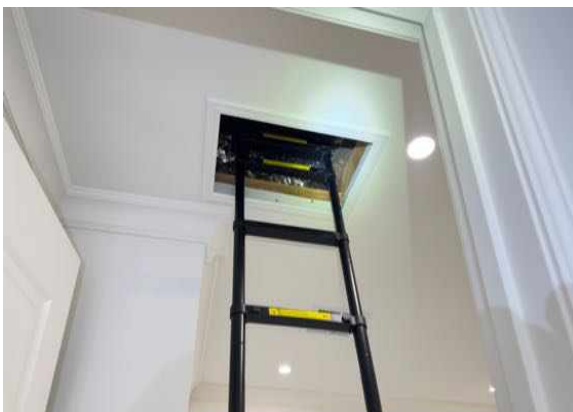
Finding 3.02

Information: Limited access to the roof void was present due to facts including but not limited to, limited access, insulation, Air condition Unit & ducting, obstructions or placement of insulation and or sarking, for this reason complete access to the roof void was not possible.

NOTE: Unless all insulation is removed from the roof space a full inspection is never possible, timber pest or termite activity and/or damage may not be visible.

A visual inspection was carried out from accessible areas only, recommend installing another access hatch in a more accessible area for a re-inspection.

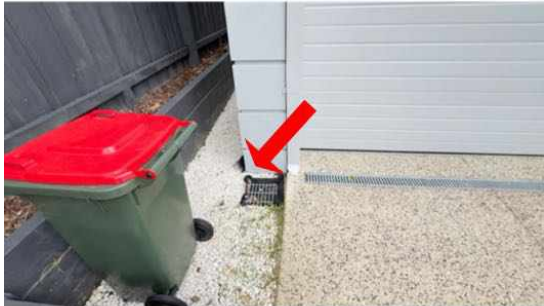
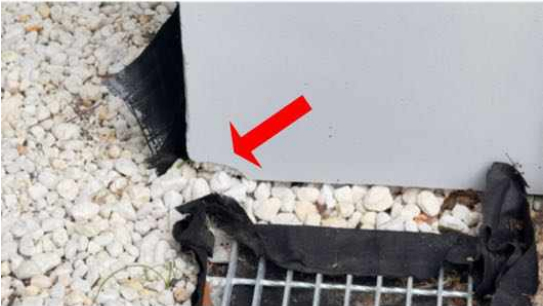
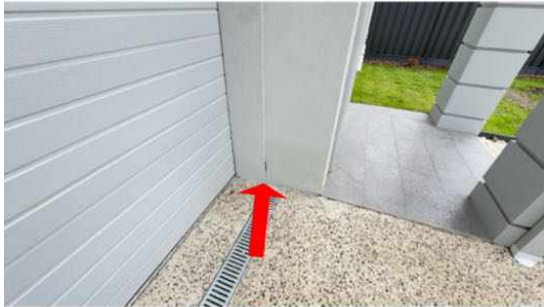
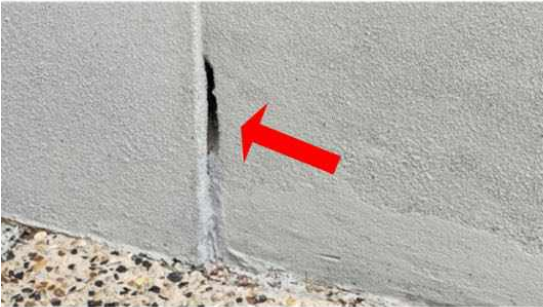
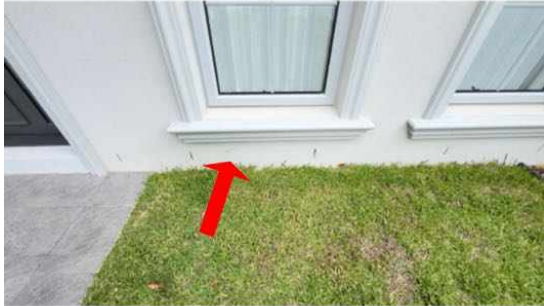
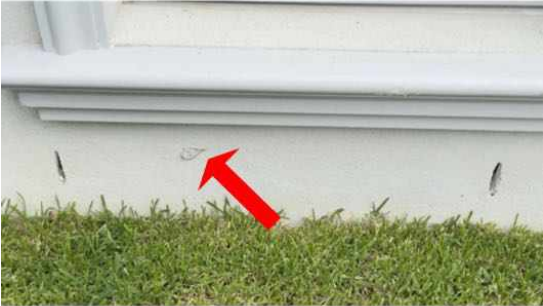
Finding 3.03

Building: Main Building
Location: All External Areas >
Finding: External Walls - Minor Incomplete / Substandard Finishing
Information: Minor areas of incomplete or substandard finishing were observed to sections of the external wall surfaces at the time of inspection. The finishing works appear inconsistent in quality and presentation, which may affect the overall appearance and weather resistance of the wall surface.

Such conditions are commonly associated with workmanship issues, incomplete construction works, or deterioration of surface finishes over time. While generally cosmetic in nature, incomplete or poorly finished external surfaces may allow moisture

Note: No elevated moisture readings were detected in this area at the time of inspection.

It is recommended that a registered builder or suitably qualified contractor be engaged to review the affected areas and undertake appropriate rectification works to complete and improve the external wall finishing, ensuring an acceptable standard of workmanship and adequate weather protection.

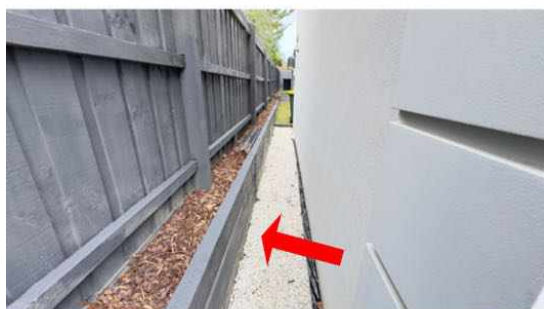
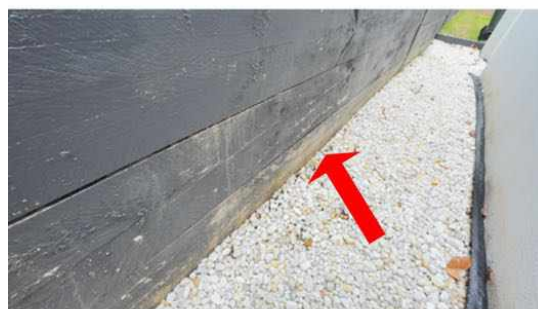
Finding 3.04

Building:	Main Building
Location:	All External Areas >
Finding:	Paint - Poor Paint Finish
Information:	Poor paint finishes were observed in this area. The defects include uneven coverage, brush and roller marks and drips in areas, which affect the visual appearance of the surface.

Poor paint finish can result from inadequate surface preparation, application over damp or unprimed surfaces, use of low-quality paint, or environmental conditions during painting. While primarily cosmetic, these issues may reduce the durability of the painted surfaces if left unaddressed.

A qualified painter should be engaged as soon as possible to prepare and repaint the affected areas. Rectification will restore an even, visually appealing finish and help protect the underlying surfaces from premature deterioration.

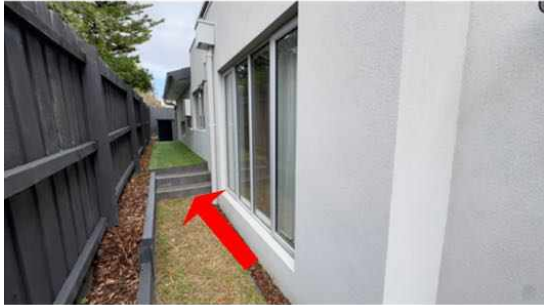
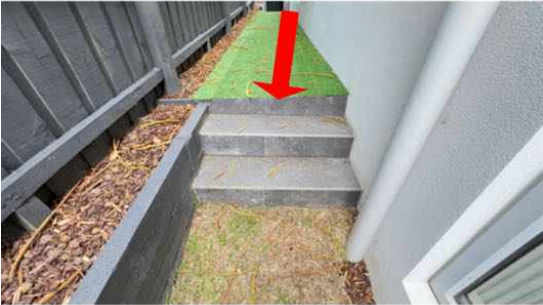
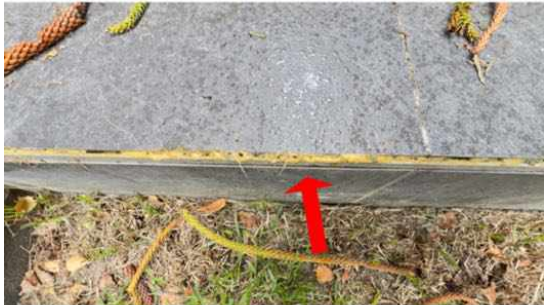
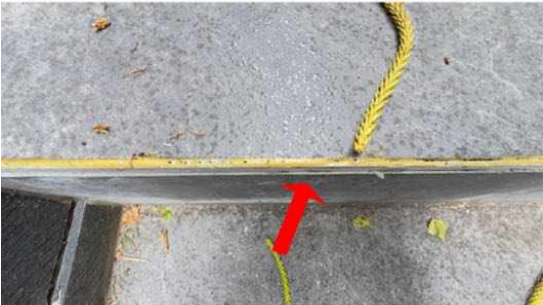
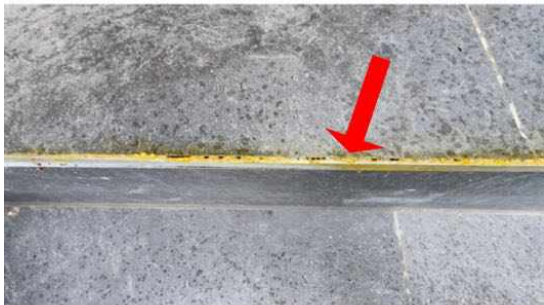
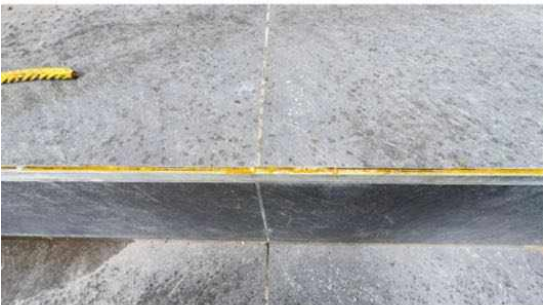
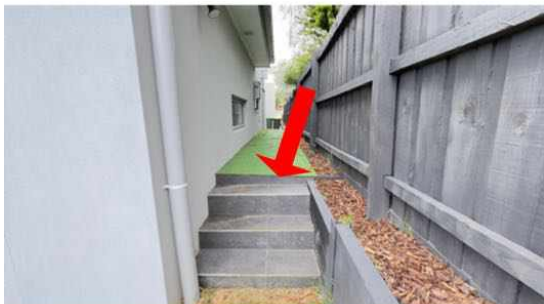
Finding 3.05

Building:	Main Building
Location:	All External Areas
Finding:	Tiling - Discolouration
Information:	Marked discolouration was observed to sections of the tiles at the time of inspection.

Tile discolouration may result from wear, staining, cleaning residues, or ageing of the tile surface or grout. While typically cosmetic in nature, it may indicate areas of inadequate maintenance.

Cleaning, sealing, or replacement of affected tiles may be undertaken as required for aesthetic purposes.

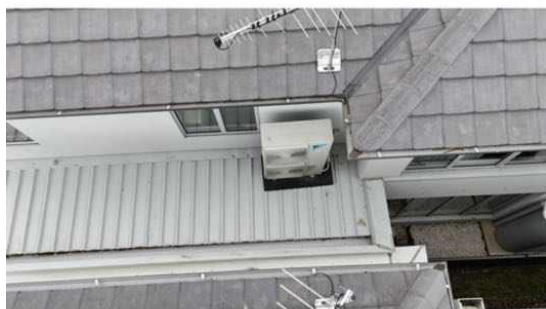
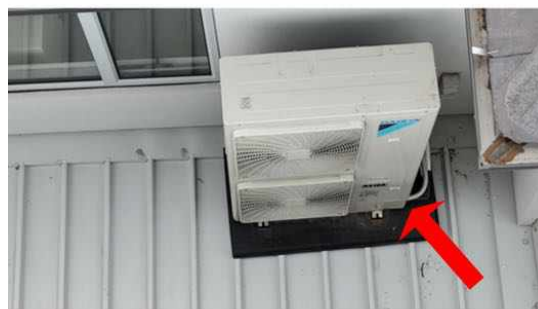
Finding 3.06

Building:	Main Building
Location:	All External Areas >
Finding:	AC Condensate Drain - Not Connected To Storm Water
Information:	The air conditioning condensate drain in this area was observed to be disconnected from stormwater drainage.

When condensate is not properly directed to a stormwater outlet, water can accumulate around the building or air conditioning unit, creating damp conditions that may lead to secondary defects such as timber rot, corrosion of nearby metal components, mould growth, or slippery surfaces. Prolonged pooling of water may also attract termites and contribute to long-term deterioration of surrounding building elements.

A qualified HVAC technician or licensed plumber should be engaged immediately to connect the condensate drain to a suitable stormwater outlet. Prompt rectification will ensure proper drainage, protect the building fabric, and reduce potential health and safety risks.

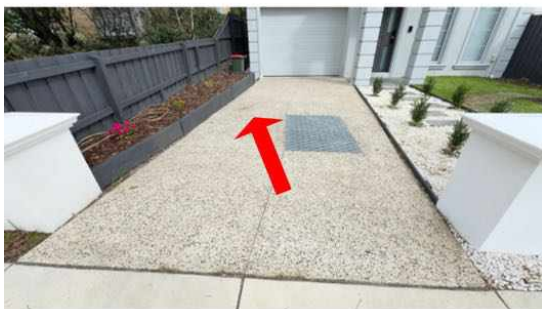
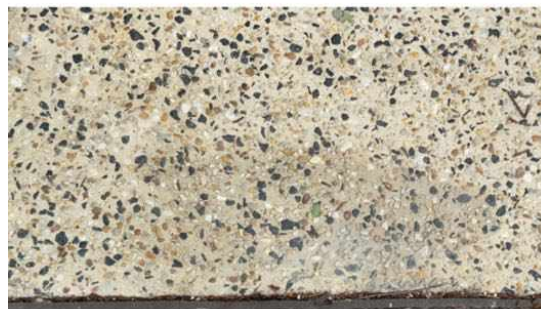
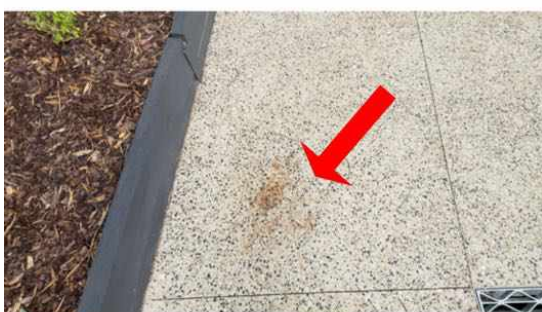
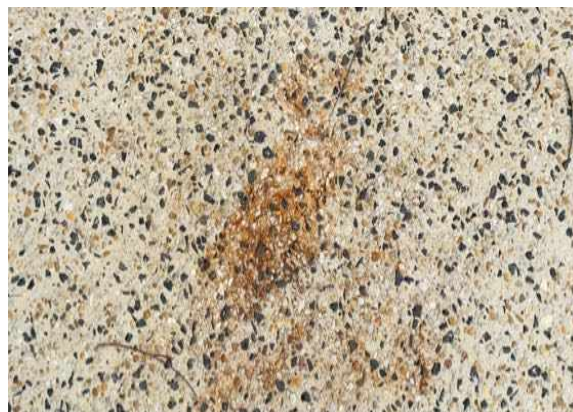
Finding 3.07

Building:	Main Building
Location:	Driveway >
Finding:	Driveway - Discolouration
Information:	The external driveway was visually inspected. Discolouration was observed in this area. Discolouration may affect the aesthetic appearance of the driveway and could indicate exposure to environmental factors, staining, and wear.

Possible causes include weathering, sun exposure, water staining, or contact with chemicals or organic matter.

A qualified cleaning specialist should be engaged when practical to clean or treat the affected areas. Prompt attention will improve appearance and maintain the surface condition.

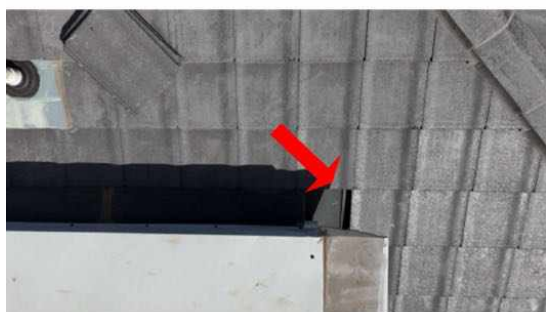
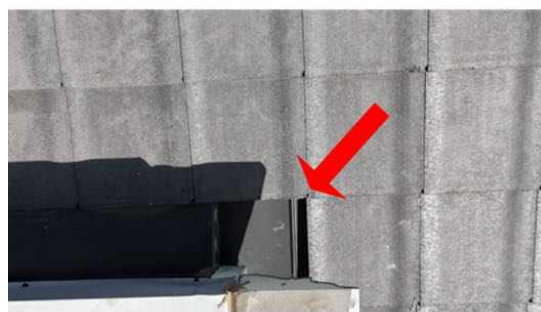
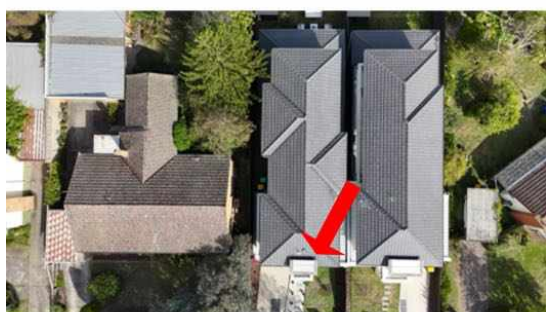
Finding 3.08

Building:	Main Building
Location:	Roof Exterior
Finding:	Roof plumbing - Flashing inadequate
Information:	Some sections of the roof are missing or have inadequate roof flashings. Flashings are metal and other materials which are applied to seals and intersections between roof coverings and building elements. They are designed to aid in weatherproofing of roof joins.

Flashings that are not installed adequately or are missing are likely to result in water penetration to the interior of the property, as well as creating excessively damp conditions against the exterior surfaces and around the base perimeter of the building.

Premature ageing and secondary building defects are imminent where roof plumbing is missing or inadequately installed. Additionally, water pooling also creates an environment that is susceptible to termite and pest infestation.

A roofing plumber should be appointed as soon as possible to install relevant roof plumbing materials, ensuring that no further damage is sustained.

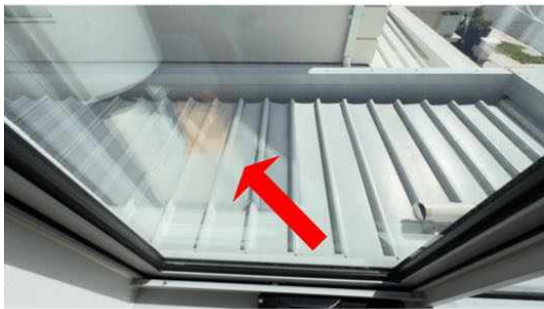
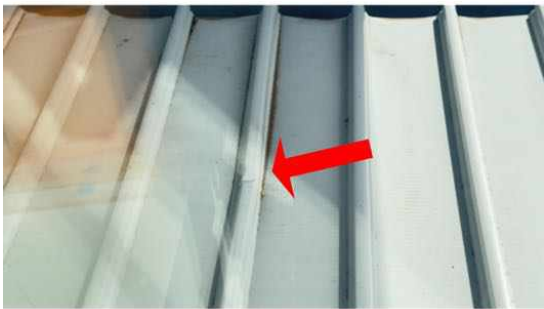
Finding 3.09

Building:	Main Building
Location:	Roof Exterior
Finding:	Roof Plumbing - Metal Sheets Deteriorated
Information:	The inspection identified metal roof sheets that are showing signs of deterioration. Deteriorated metal sheets can compromise the roof's water-tightness, potentially leading to leaks, corrosion, and damage to the underlying structure.

The deterioration may be due to age, prolonged exposure to weather, corrosion, or lack of maintenance.

It is recommended that a licensed plumber or roofing specialist be engaged immediately to assess the condition of the roof sheets and undertake necessary repairs or replacement. Prompt action will help maintain the structural integrity and longevity of the roof.

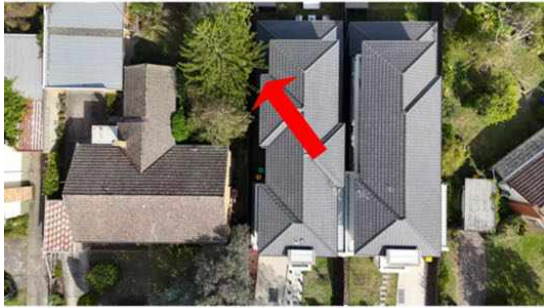
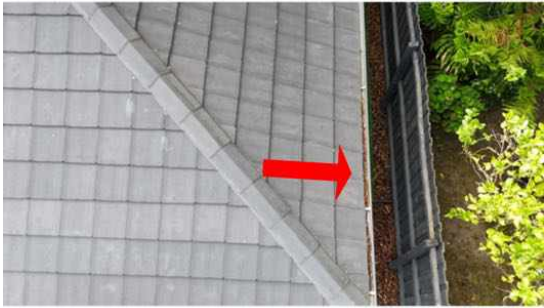
Finding 3.10

Building: Main Building
Location: Roof Exterior
Finding: Roof Plumbing - Gutters Blocked
Information:

Gutters in this area are blocked and not allowing water to flow freely. The issue is observed along the gutter runs where leaves, debris, or other obstructions have accumulated.

This has likely occurred due to lack of maintenance or build-up of debris over time. Blocked gutters may cause water to overflow, damage the roof, walls, or foundations, and increase the risk of erosion or water ingress.

A licensed roof plumber or competent handy man is required to inspect and clear the blocked gutters in this area. This should be rectified immediately to ensure water drains correctly and to prevent potential damage to the building.

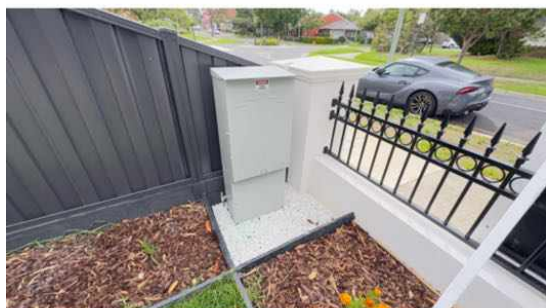
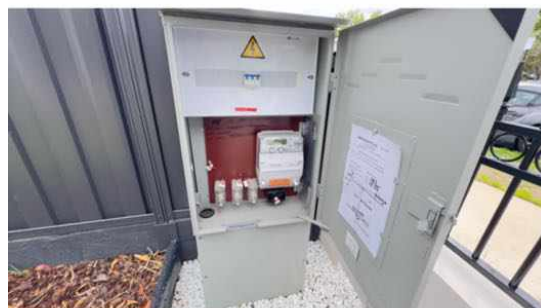
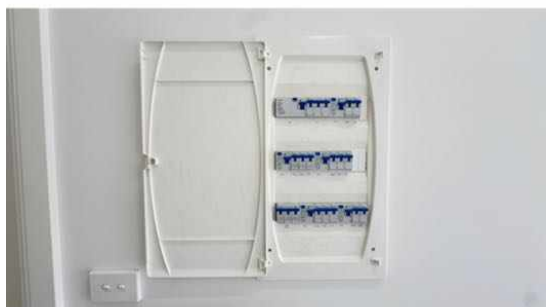
Building:	Main Building
Location:	All External Areas
Finding:	Timber Pests - Durable Notice Not Identified
Information:	During the inspection, no durable notice relating to a termite management system was observed on the property. A durable notice is required to identify the type of termite management system installed, the date of installation, and any ongoing maintenance or inspection requirements. The absence of this notice makes it difficult to confirm the presence, effectiveness, or maintenance status of any termite protection measures.

may not be adequately maintained or may have expired, particularly in the case of chemical barriers that require periodic replenishment. This uncertainty increases the likelihood of undetected termite activity and potential damage to timber elements within the building.

The lack of a durable notice may be due to removal during renovations, age of the property, or the absence of a compliant termite management system at the time of construction. Regardless of the cause, this represents a gap in termite risk management and ongoing building protection.

It is recommended that a licensed pest management technician be engaged immediately to assess whether a termite management system is present and functioning. Where a system exists, the technician should confirm its type, condition, and maintenance requirements and install a compliant durable notice in accordance with current standards.

If no termite management system is identified, it is strongly recommended that an appropriate termite protection system be installed and documented. Regular inspections and maintenance should then be undertaken to reduce the risk of future termite infestation and associated structural damage.

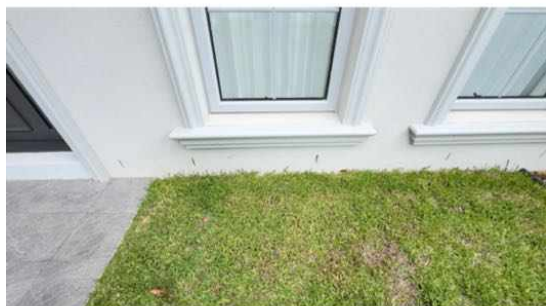
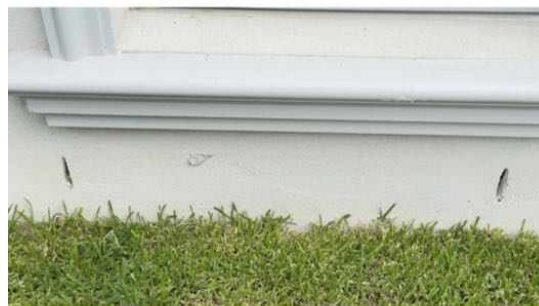
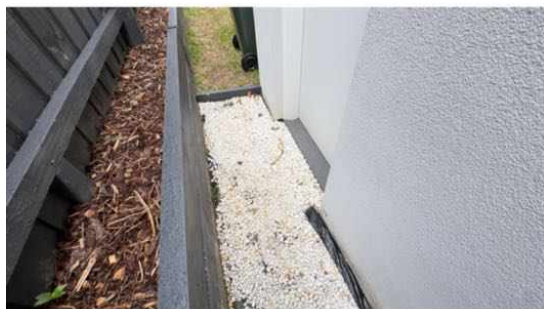
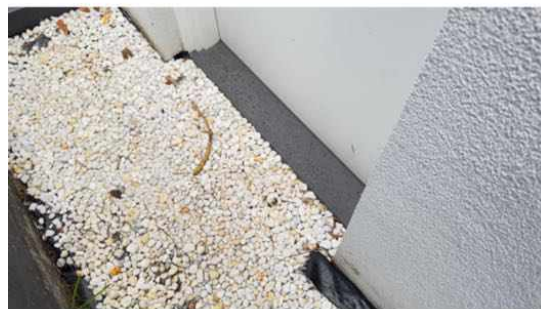
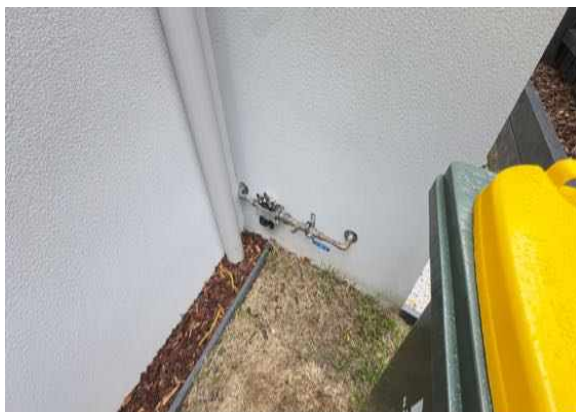
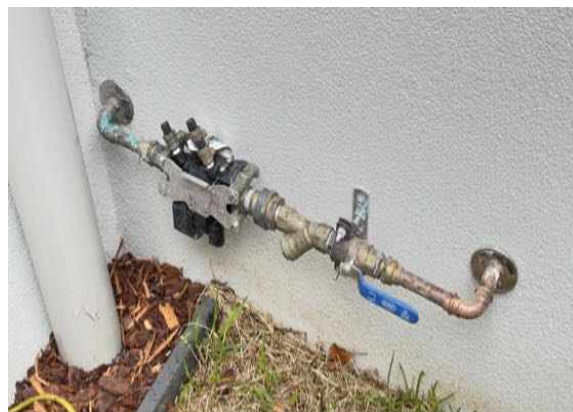
Finding 6.02

Finding: Timber Pests - Bridging Of Termite Barrier Found

Information: During the inspection, bridging of the termite barrier was observed in certain areas. Bridging occurs when external elements, such as soil, vegetation, garden beds, or timber, make direct contact with the termite management system, effectively bypassing the barrier's protective function. This compromises the barrier's ability to prevent termites from accessing the building and can increase the risk of infestation.

The possible causes of bridging include poor landscaping practices, where soil or mulch is piled too high around the perimeter of the building, or growth of plants with roots extending into the barrier area. In some cases, structural movement or settling of the soil may also cause previously effective barriers to become bridged. The presence of bridging provides a direct path for termites to bypass the chemical or physical barrier, potentially leading to hidden infestation.

*Bridging is a significant issue as it negates the effectiveness of termite barriers, leaving the building vulnerable to termite attacks. If left unaddressed, termites can find entry points through the bridged areas, leading to structural damage and potential long-term problems for the property. Since termites can go undetected for extended periods, the damage caused by such infestations can be costly to repair.

It is strongly recommended that a licensed pest management specialist or termite professional be engaged immediately to assess the termite barrier and address the bridging issue. This may involve removal of bridging materials, adjustment or repair of the barrier, and ensuring that the area around the barrier is clear of any materials that could facilitate termite entry.

In addition to addressing the bridging issue, it is also crucial to inspect the property for signs of termite activity immediately and consider replacing or reapplying the termite barrier to ensure it is still effective. Regular maintenance and monitoring of the barrier are recommended to prevent future issues and ensure long-term protection against termites.

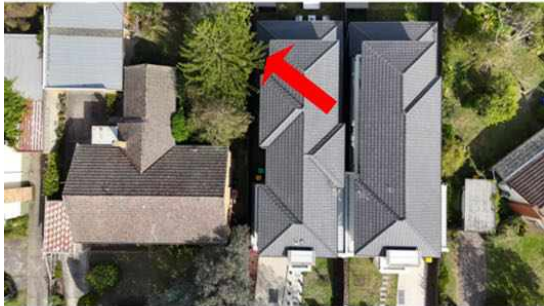
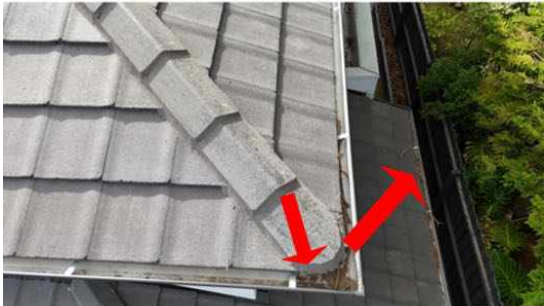
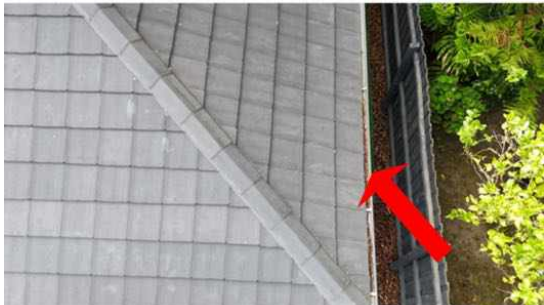
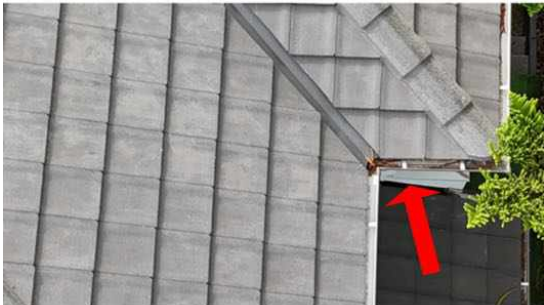
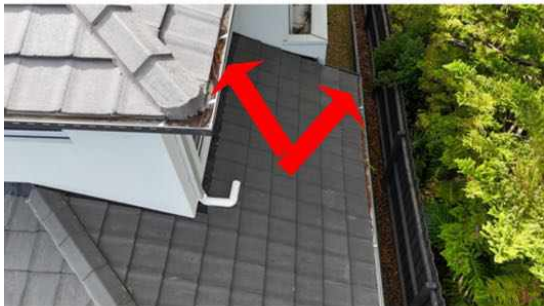
Finding 6.03

Building: Main Building
 Location: All External Areas
 Finding: Timber Pests - Conducive Conditions - Gutters Blocked
 Information: During the inspection, gutters were observed to be blocked, resulting in water overflow and poor roof drainage. Blocked gutters are a significant concern as they can cause moisture to accumulate around roof edges, fascia boards, wall cavities, and subfloor areas. Persistent moisture in these locations creates conditions highly conducive to timber pest activity, including termites, borers, and fungal decay.

The blockage is likely due to the accumulation of debris such as leaves, dirt, and organic matter. When gutters are unable to discharge water effectively, overflow can lead to concealed moisture penetration into building elements, reducing timber durability and increasing vulnerability to pest attack.

Moisture-related conditions of this nature substantially increase the risk of timber pest infestation and can accelerate deterioration of structural timbers if left unaddressed, potentially leading to progressive damage and higher repair costs.

It is recommended that a qualified roofing contractor or competent handyman be engaged promptly to clear and service all gutters and downpipes and ensure effective drainage away from the building. Ongoing gutter maintenance, in conjunction with regular timber pest inspections, is essential to reduce moisture-related risks and

protect the long-term integrity of the structure.

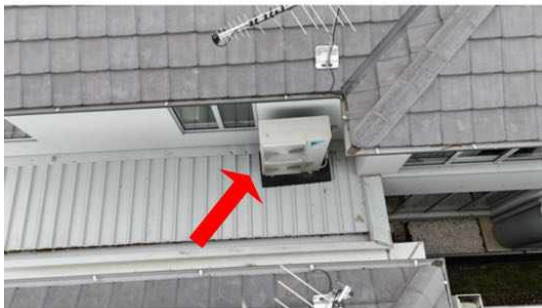
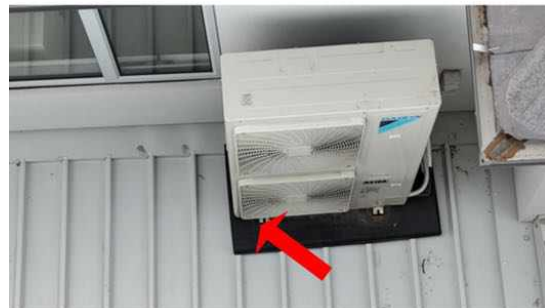
Finding 6.04

Building: Main Building
Location: All External Areas
Finding: AC Condensate Drain - Not Connected To Storm Water
Information: The air conditioning condensate drain in this area was observed to be disconnected from stormwater drainage.

When condensate is not properly directed to a stormwater outlet, water can accumulate around the building or air conditioning unit, creating damp conditions that

may lead to secondary defects such as timber rot, corrosion of nearby metal components, mould growth, or slippery surfaces. Prolonged pooling of water may also attract termites and contribute to long-term deterioration of surrounding building elements.

A qualified HVAC technician or licensed plumber should be engaged immediately to connect the condensate drain to a suitable stormwater outlet. Prompt rectification will ensure proper drainage, protect the building fabric, and reduce potential health and safety risks.

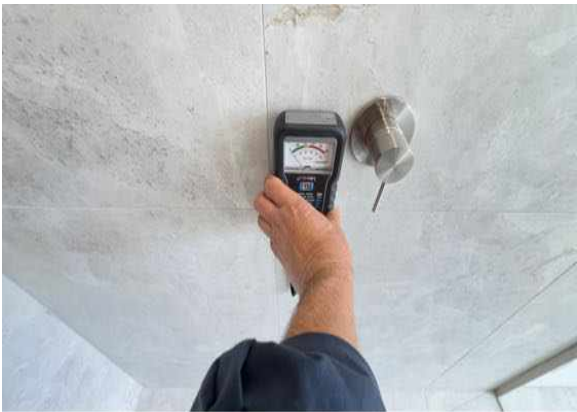
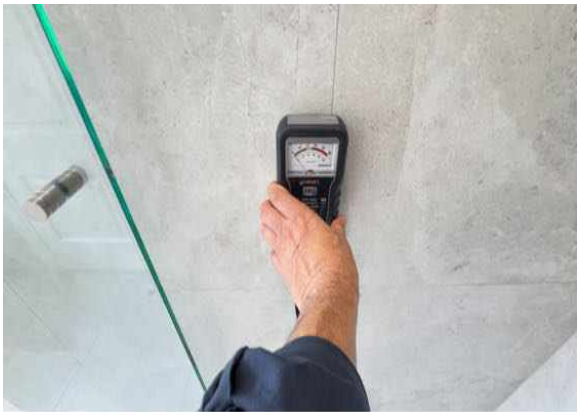
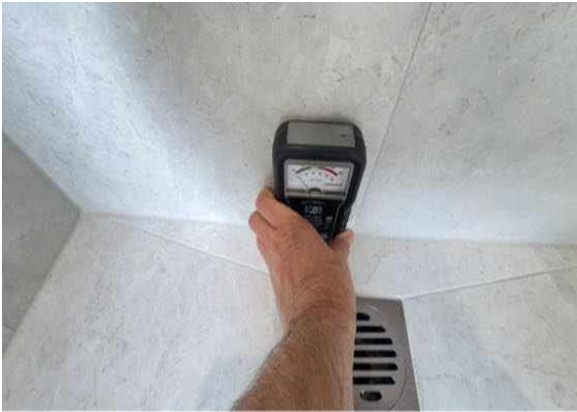
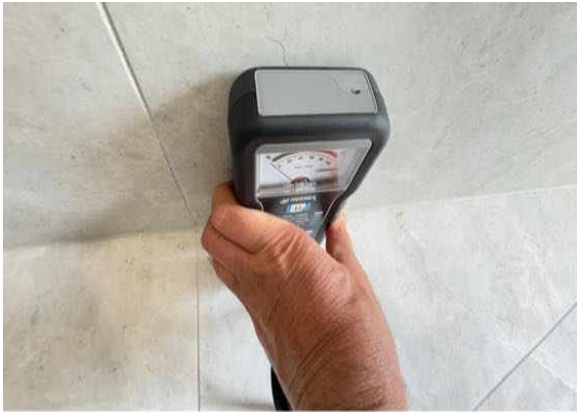
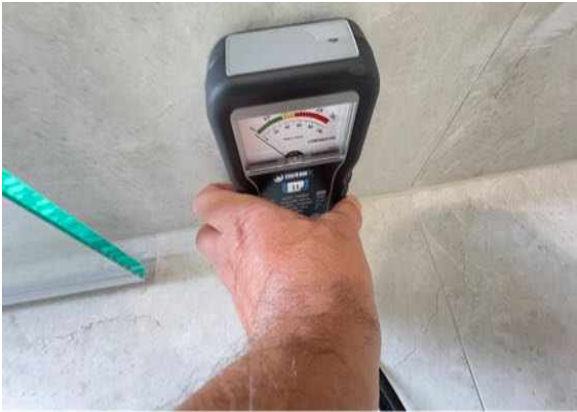
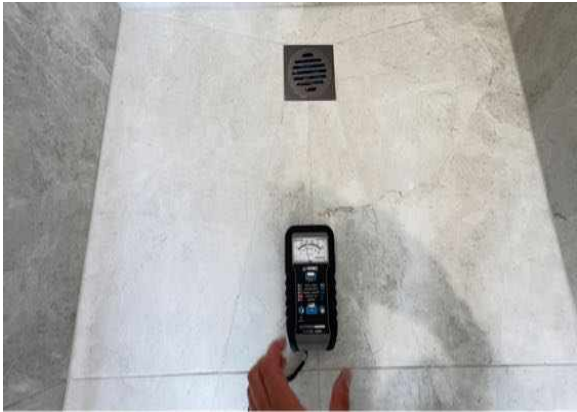
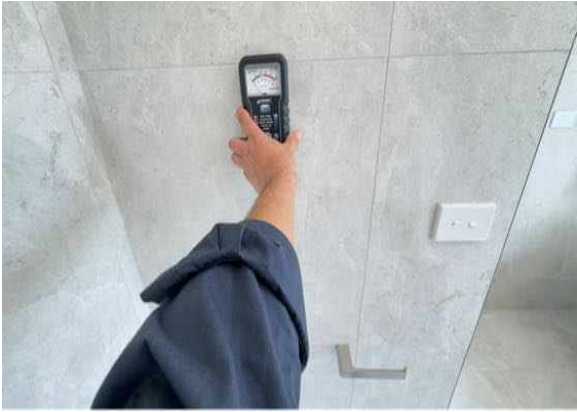
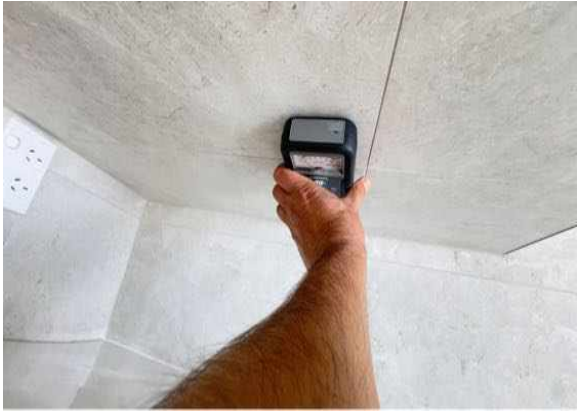
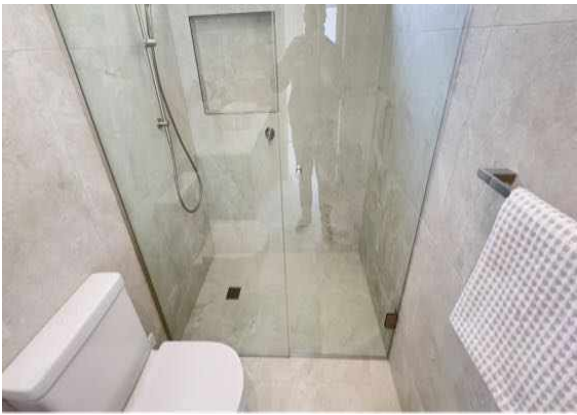
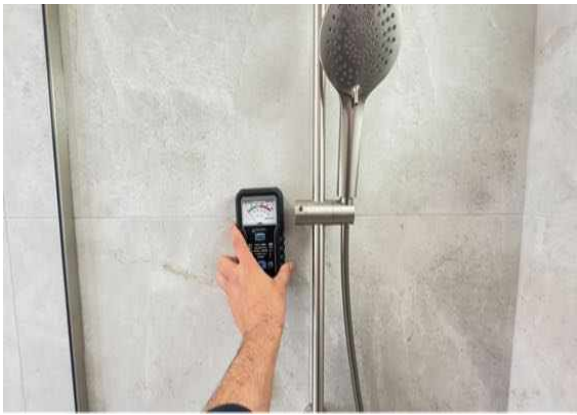
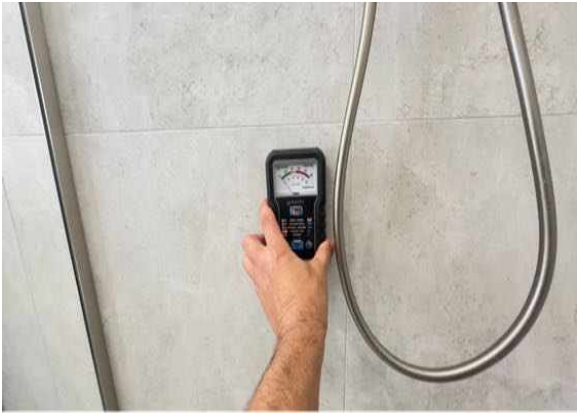
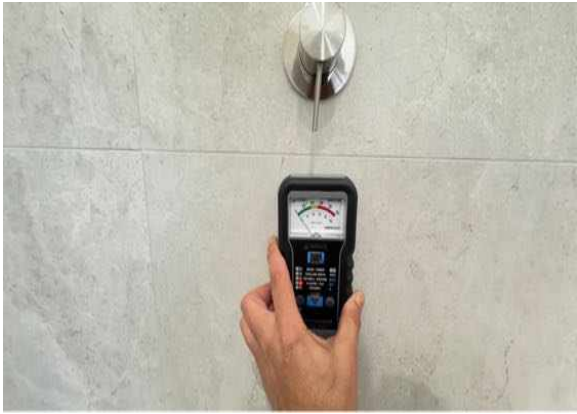
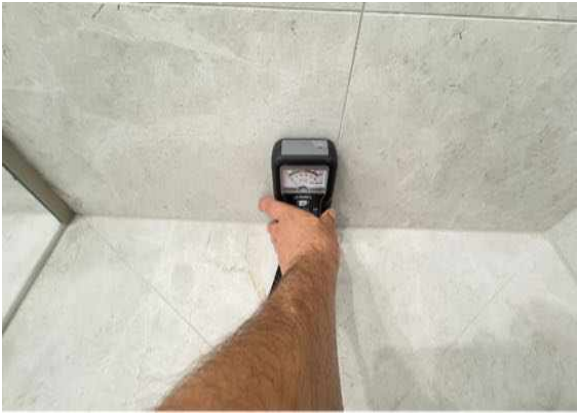
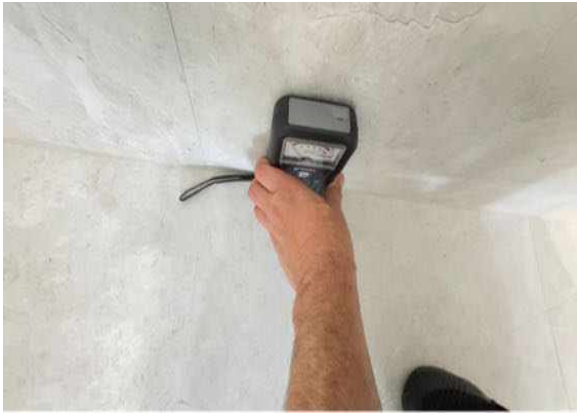
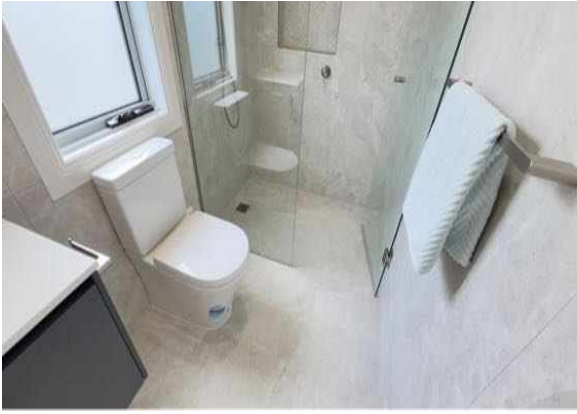
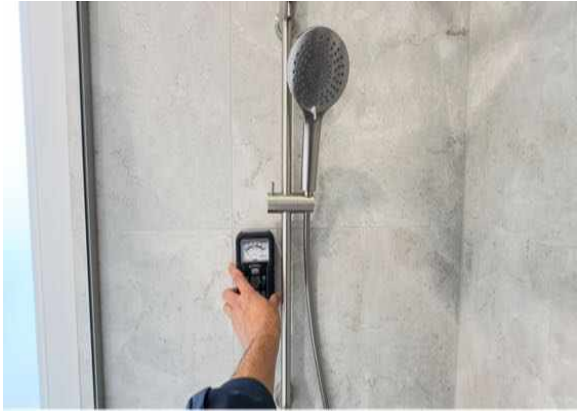
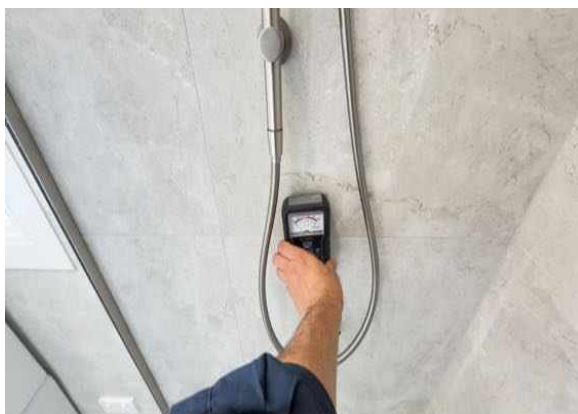
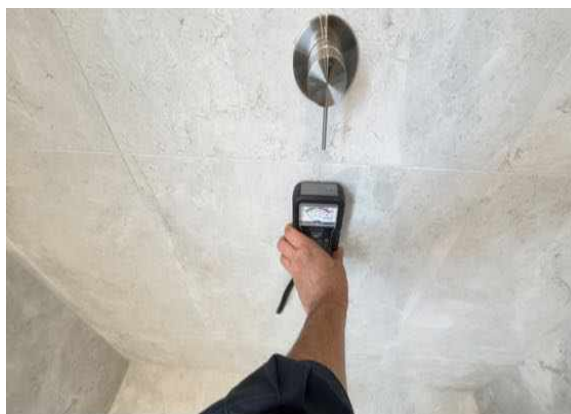
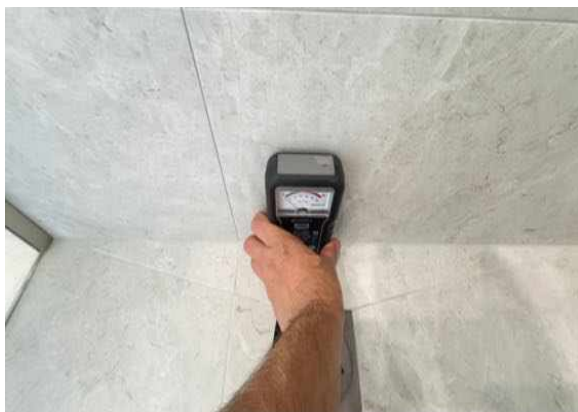
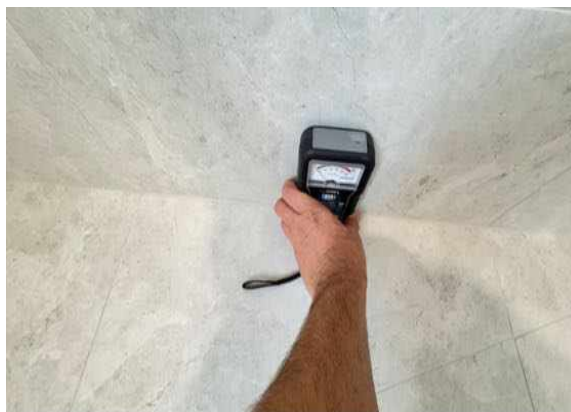
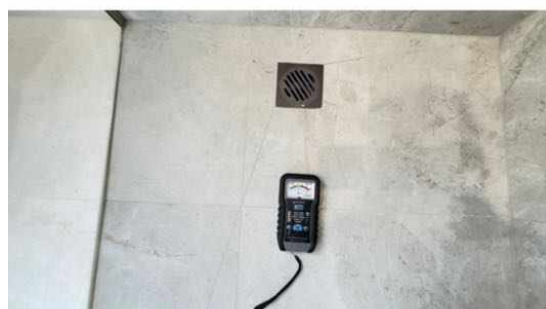
Building: Main Building
 Location: All Areas Interior & Exterior
 Finding: Moisture Levels - Advisory - No Elevated Moisture Levels Present
 Information: At the time of inspection, no elevated moisture levels were detected in these areas. Moisture readings were taken (using a Tramex Moisture Meter) and non-invasive testing methods and reflect conditions present at the time of inspection only. This item is noted for advisory purposes and should not be relied upon as a guarantee that moisture issues are not present elsewhere or may not occur in the future.

It is important to note that moisture levels can fluctuate due to weather conditions, plumbing usage, seasonal changes, or intermittent leaks. Concealed moisture within wall cavities, subfloor areas, or other inaccessible locations may not be detected during a visual or limited moisture assessment.

Ongoing monitoring of the property is recommended, and further investigation by a qualified tradesperson should be considered if signs of water ingress, dampness, staining, mould growth, or material deterioration become apparent.

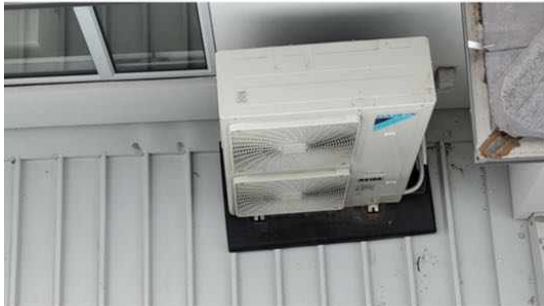
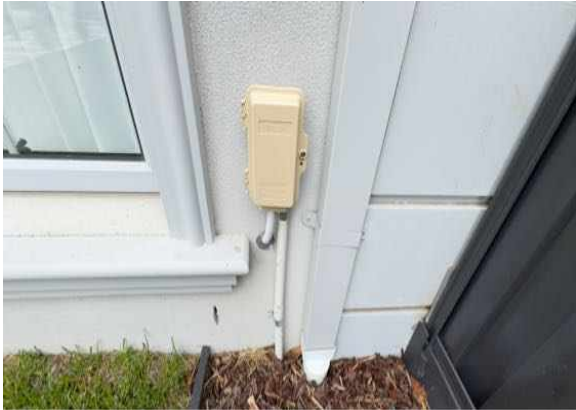
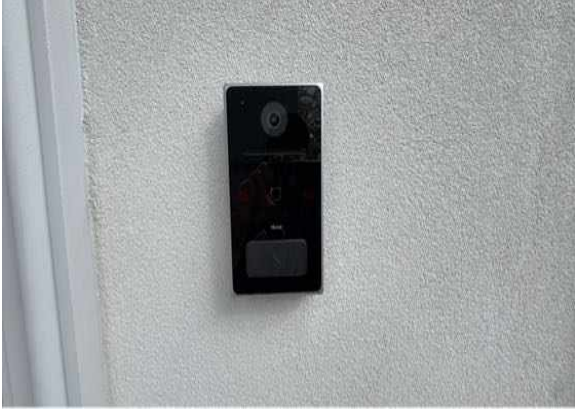
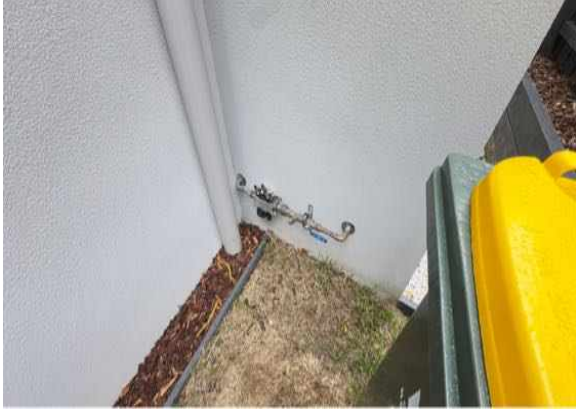
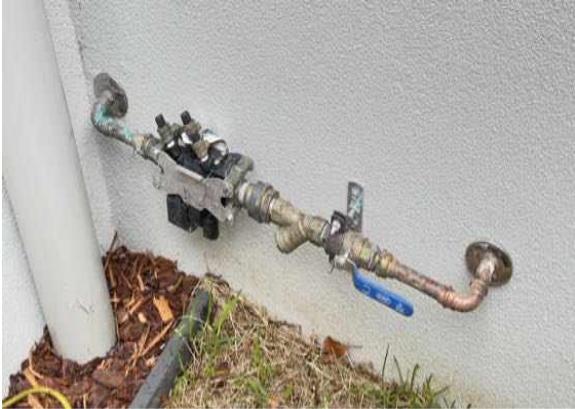
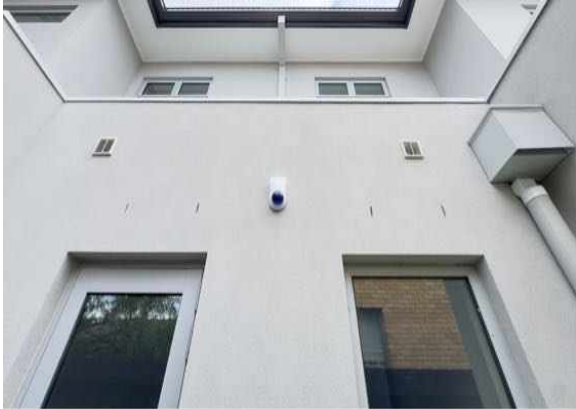
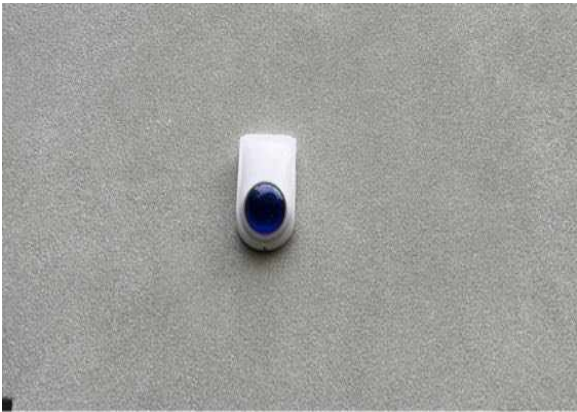
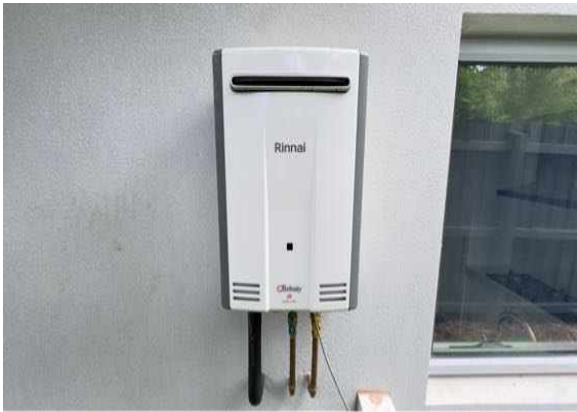
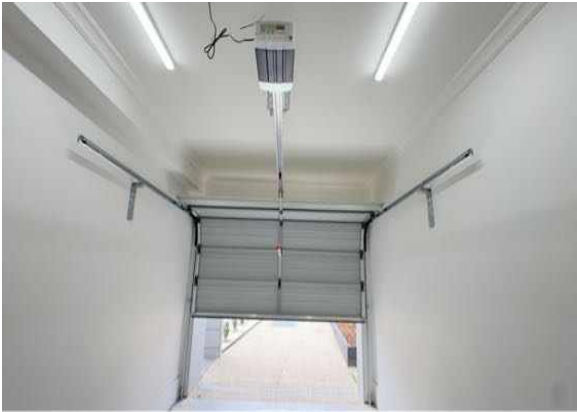
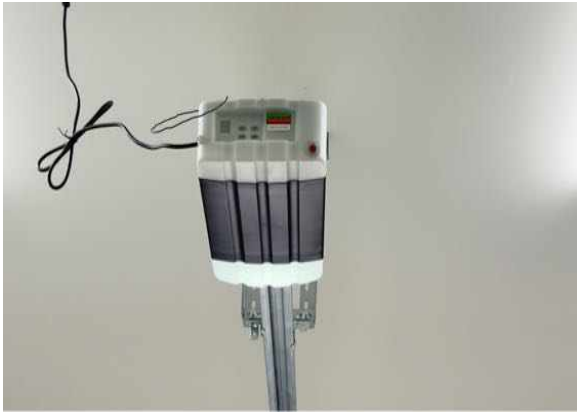
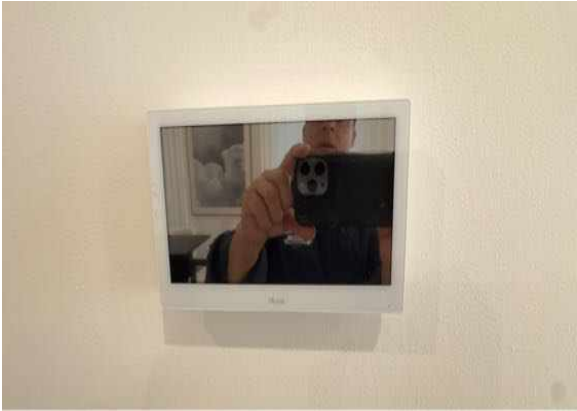
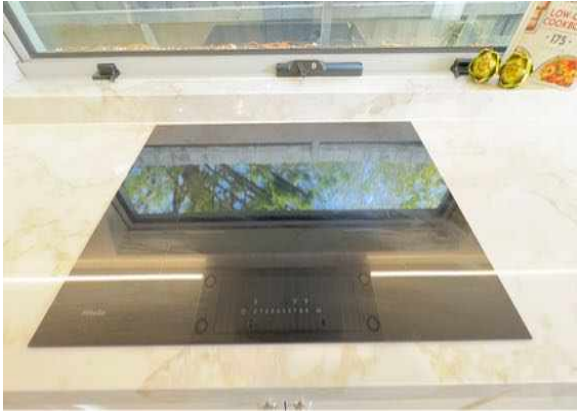
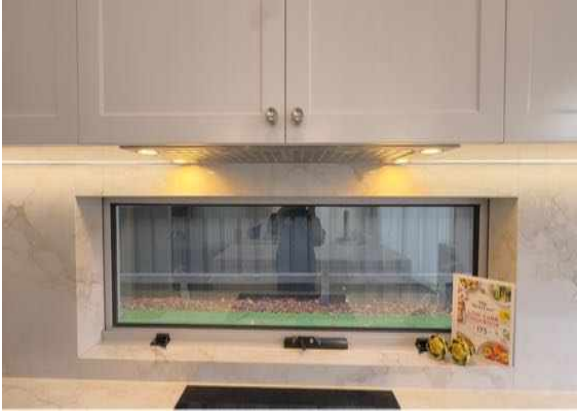
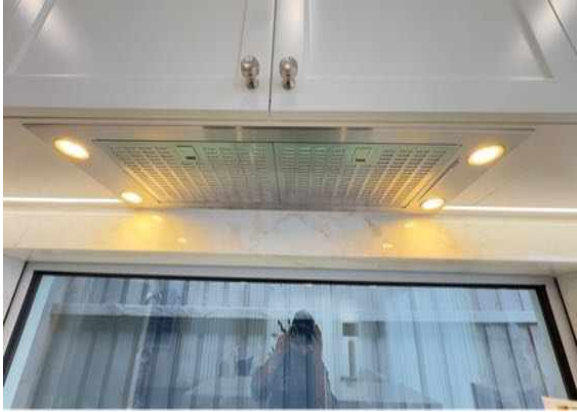
Building:	Main Building
Location:	All Areas, Interior & Exterior
Finding:	Appliances, Heating & Cooling Systems, Mechanical Systems, Plumbing, Electrical, Fireplaces - Advisory
Information:	The inspection did not include testing, operation, safety, or assessment of any installed or portable appliances or mechanical systems. This includes, but is not limited to, ovens, cooktops, microwaves, rangehoods, dishwashers, ducted vacuum systems, air-conditioning units, heating systems, hot water services, ceiling fans, exhaust fans, intercoms, security systems, fireplaces, and solid fuel heaters.

Appliances may be worn, damaged, or malfunctioning. Electrical or gas appliances can pose serious safety hazards if incorrectly installed or maintained.

Service, repair, or replace equipment as necessary, particularly where service history or warranty coverage is unknown.

Inspect any water, gas, or electrical connections associated with appliances to ensure safety and compliance.
