Building and Timber Pest Inspection Report

Inspection Date: Fri, 13 Mar 2026

Property Address: 5B Malcolm Ct, Mount Waverley VIC 3149,
Australia

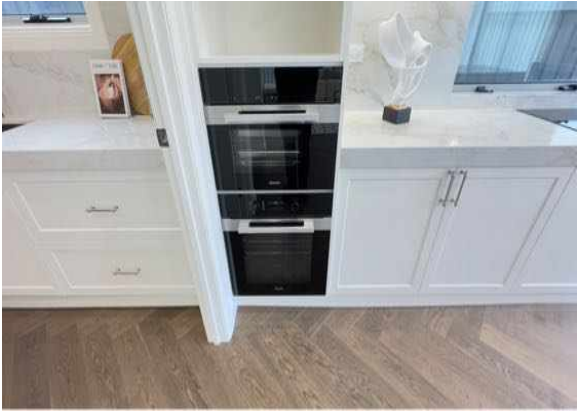
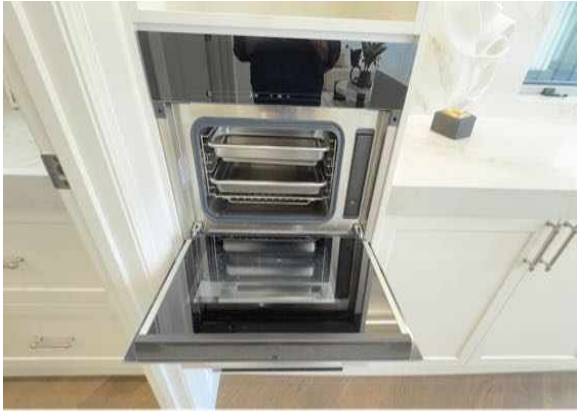
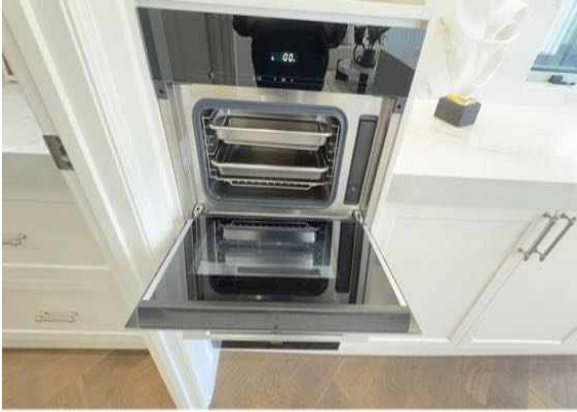
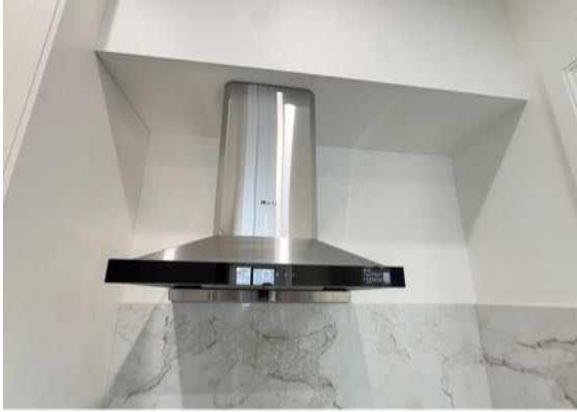
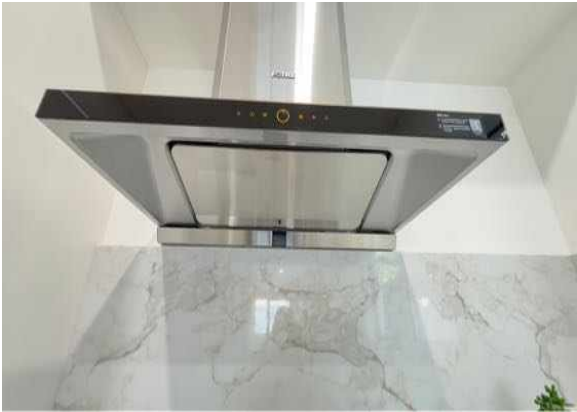
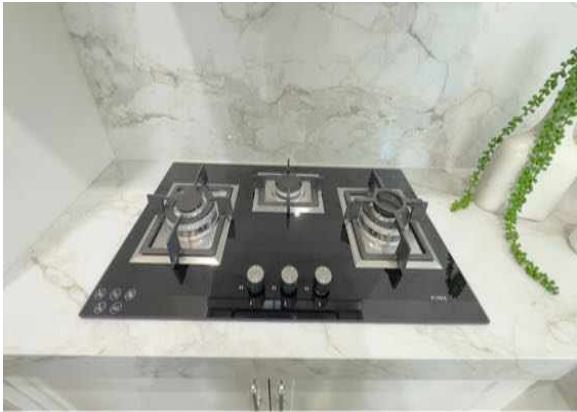
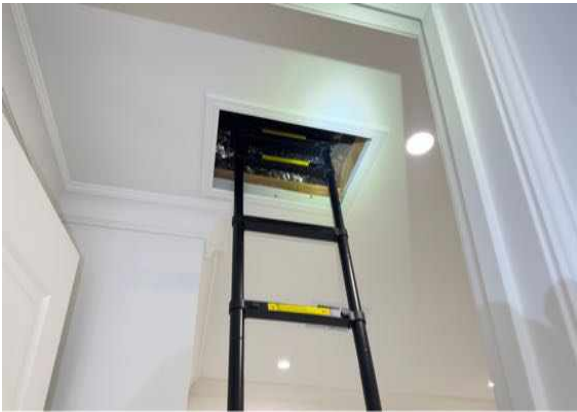
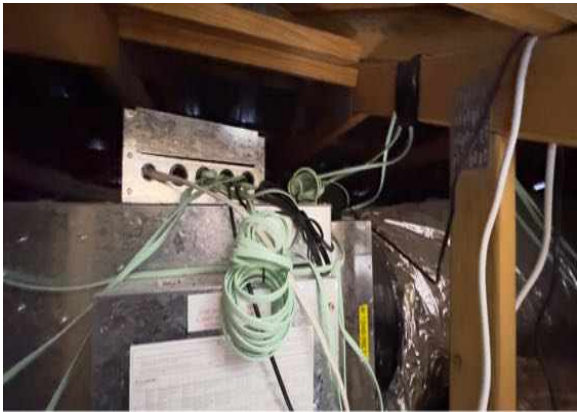
Building:	Main Building
Location:	All Areas, Interior & Exterior
Finding:	Appliances, Heating & Cooling Systems, Mechanical Systems, Plumbing, Electrical, Fireplaces - Advisory
Information:	The inspection did not include testing, operation, safety, or assessment of any installed or portable appliances or mechanical systems. This includes, but is not limited to, ovens, cooktops, microwaves, rangehoods, dishwashers, ducted vacuum systems, air-conditioning units, heating systems, hot water services, ceiling fans, exhaust fans, intercoms, security systems, fireplaces, and solid fuel heaters.

Where appliances are beyond their warranty period, the owner should be prepared for potential costs of repair or replacement at any time. The operation of these appliances cannot be guaranteed, and further inspection by a licensed tradesperson may be required. Many appliances are only covered by limited manufacturer or installer warranties. Confirming warranty status is strongly recommended prior to purchase, as out-of-warranty items may require servicing, replacement, or certification by a qualified technician.

Appliances may be worn, damaged, or malfunctioning. Electrical or gas appliances can pose serious safety hazards if incorrectly installed or maintained.

Service, repair, or replace equipment as necessary, particularly where service history or warranty coverage is unknown.

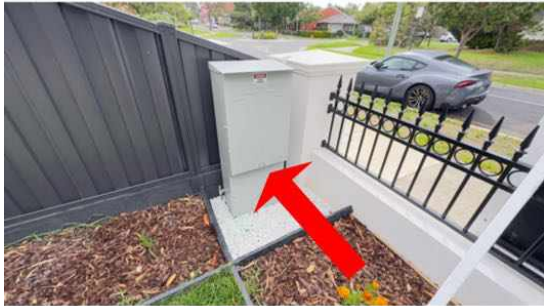
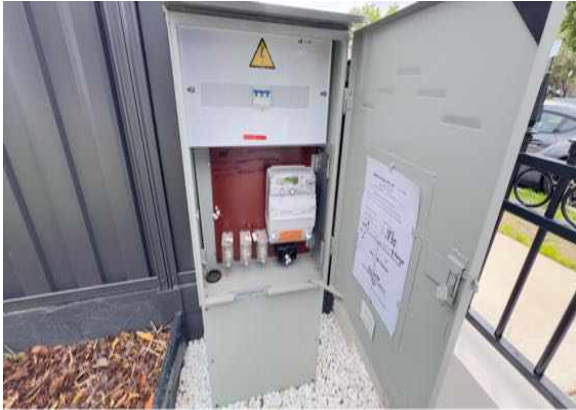
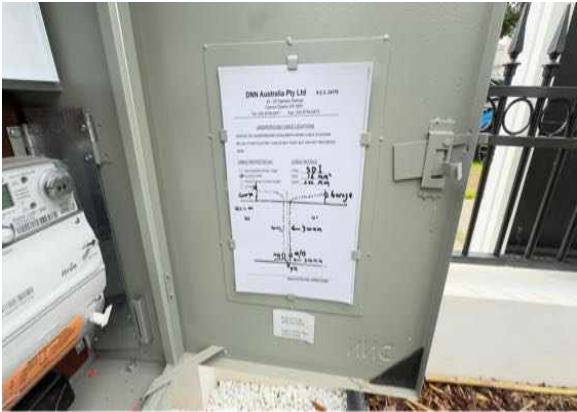
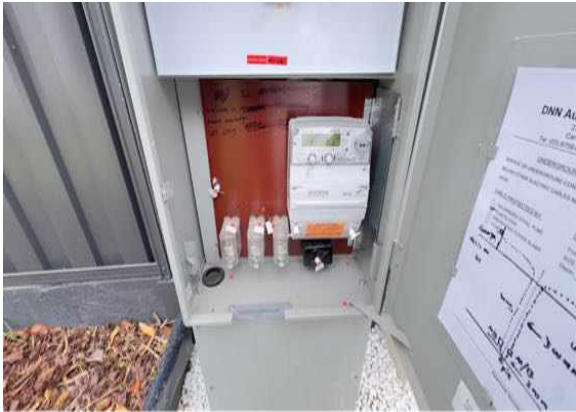
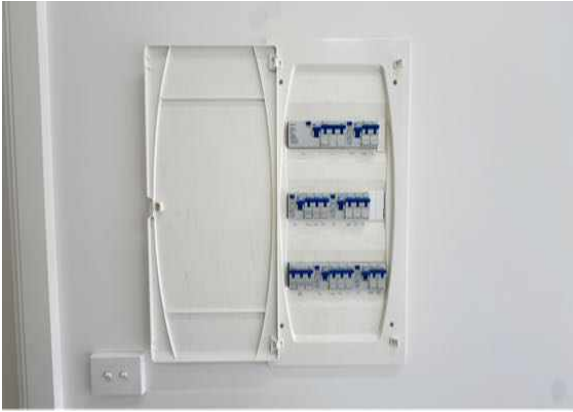
Building: Main Building
Location: All External Areas
Finding: Electrical Switch Board - Location
Information: For your information, the main electrical switchboard was visually inspected. No intrusive testing or detailed electrical assessment was performed as part of this inspection.

For full compliance and safety verification, a licensed electrician should be engaged to inspect the switchboard, test all circuits, and ensure all components are functioning correctly. This will help maintain electrical safety and prevent potential hazards.

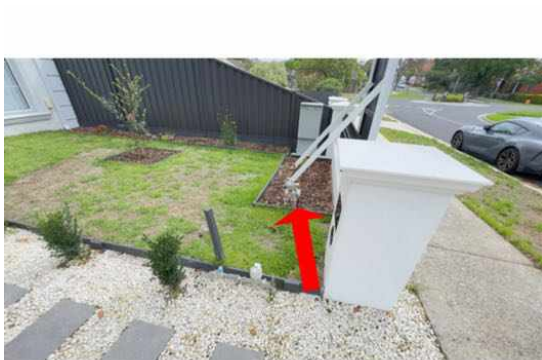
Building: Main Building
 Location: All External Areas
 Finding: Gas Meter - Location For Your Information
 Information: The gas meter was inspected and photographed for reference and location purposes only.

Gas meters can be affected over time by age, environmental exposure, or accidental impact, which may lead to corrosion, physical damage, leakage, or non-compliance with current regulations. Regular checks are recommended to ensure ongoing safe operation.

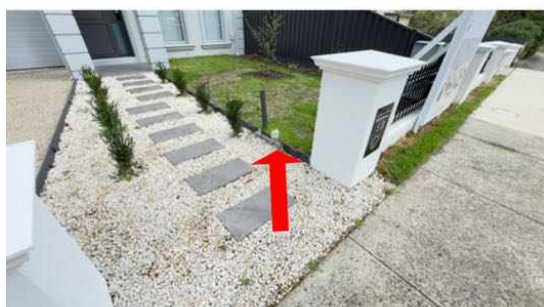
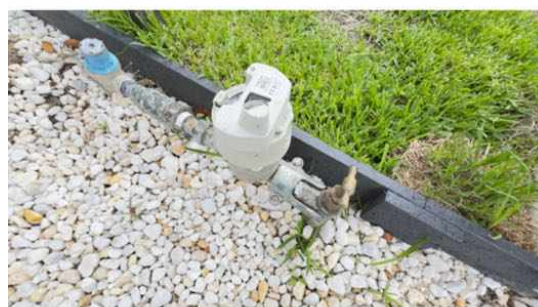
Building: Main Building
 Location: All External Areas
 Finding: Water Meter - Location For Your Information Only
 Information: The water meter was photographed at the time of the inspection. The meter is included for reference & location purposes only.

Water meters can be affected over time by age, environmental exposure, accidental impact, or poor maintenance. Potential issues could include leaks, corrosion, or malfunction that may impact water supply or cause water damage.

It is recommended that a licensed plumber carry out routine inspections and maintenance to ensure continued safe and compliant operation. Observations are for informational purposes only and do not form part of a full safety or compliance inspection.

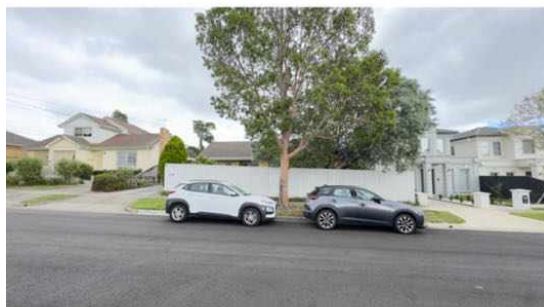
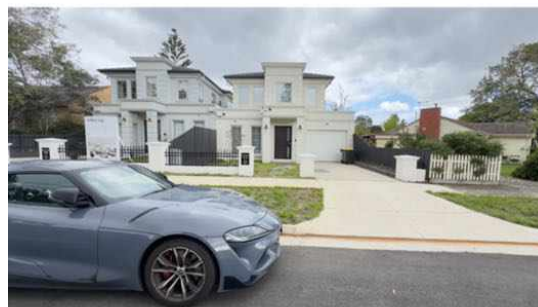
Building:
 Location: Limited Areas
 Finding: Neighbouring Properties - For Your Information
 Information: Neighbouring properties were visually inspected from publicly accessible areas. No detailed structural, noise, or compliance testing was performed as part of this inspection.

Recommendation: For concerns regarding noise, encroachments, or structural issues affecting neighbouring properties, it is recommended to engage relevant specialists (e.g., acoustic consultant, building surveyor, or a registered builder) and/or contact the local council.

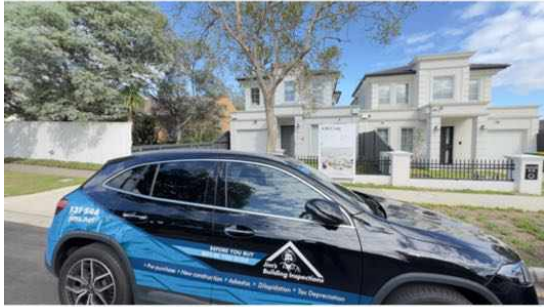
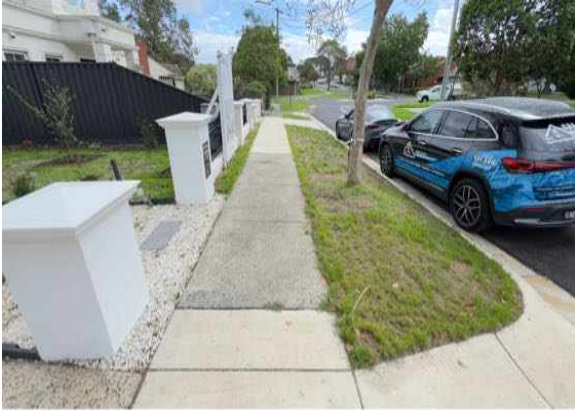
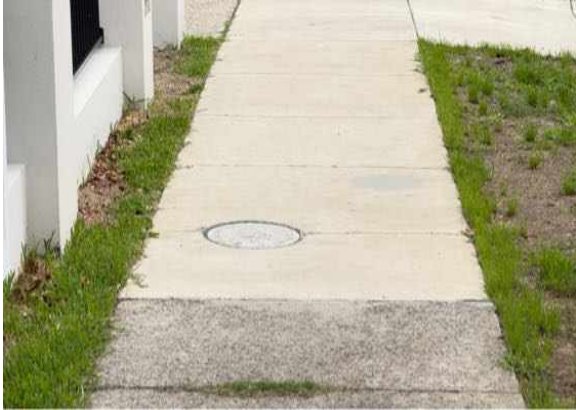
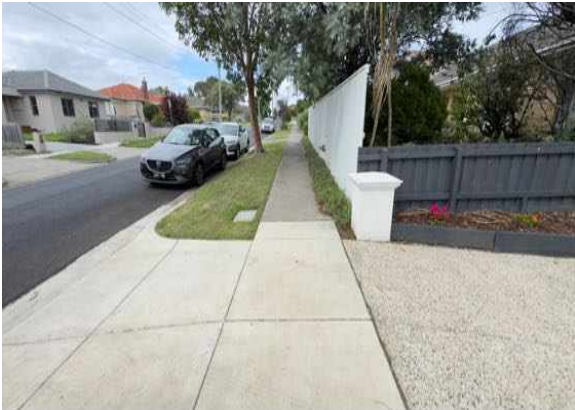
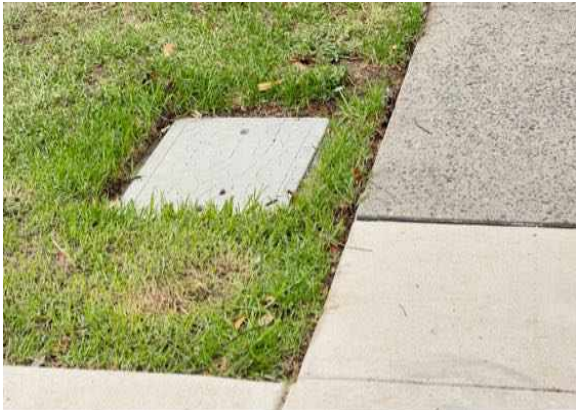
During the inspection, minor cracking, surface wear, or uneven sections were observed on footpaths or crossovers. Some accessible metal components, such as street signage or grates, showed signs of rust or deterioration. Debris accumulation and vegetation encroachment were also noted around council infrastructure. Access or visibility was limited to certain council-owned assets.

These areas should be monitored, and for detailed assessment, maintenance, or compliance verification, the relevant local council authority should be contacted immediately. Regular monitoring of adjacent council assets is recommended to ensure ongoing safety and proper maintenance.

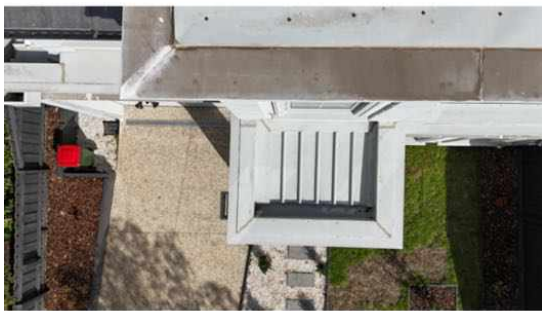
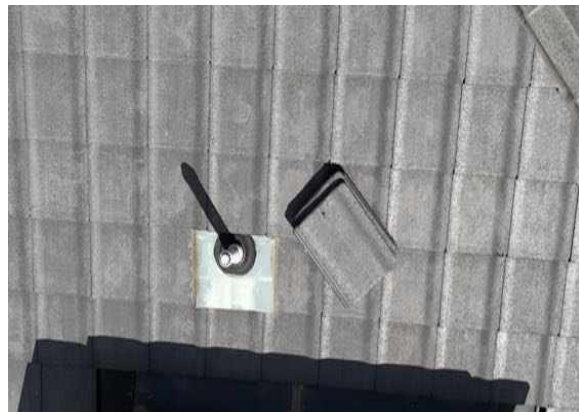
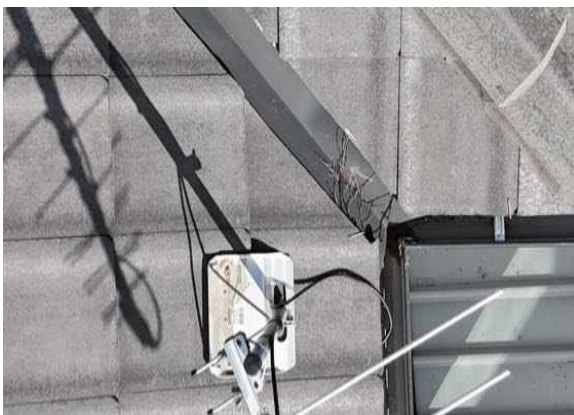
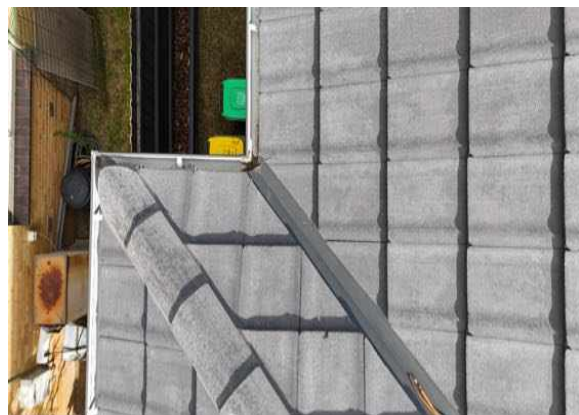
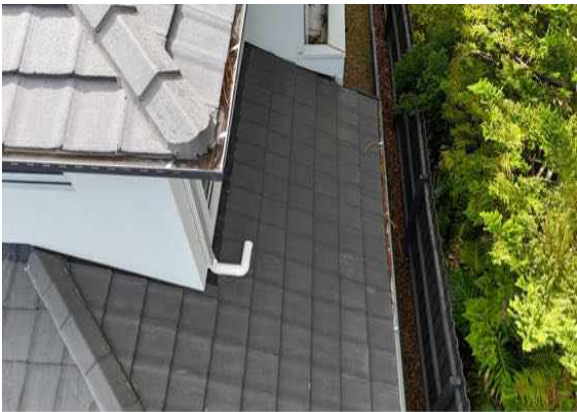
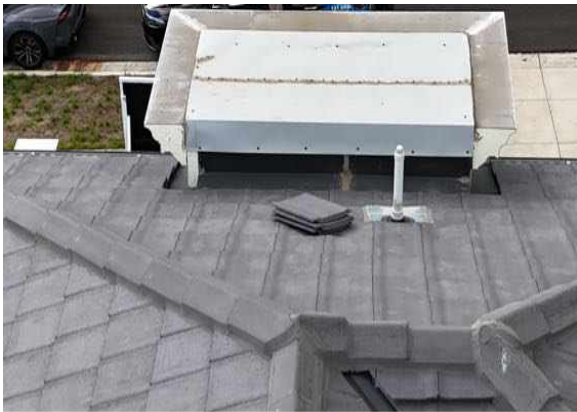
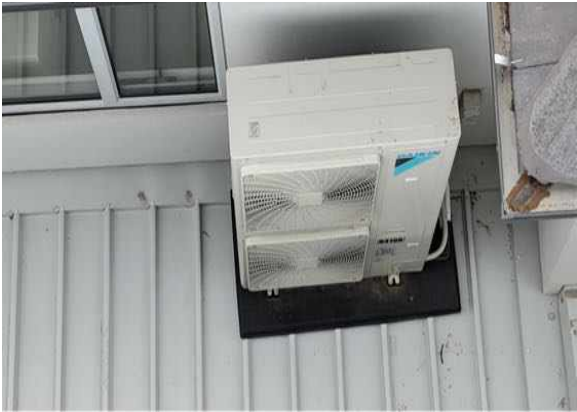
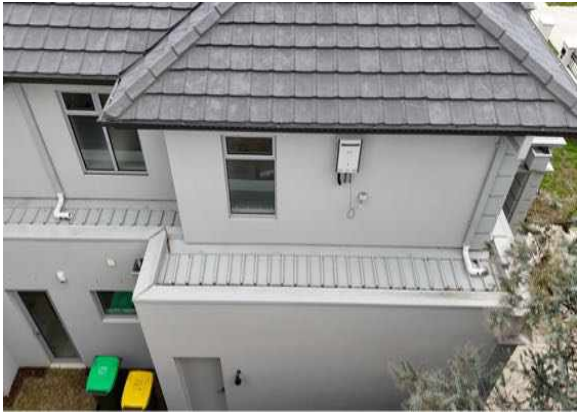
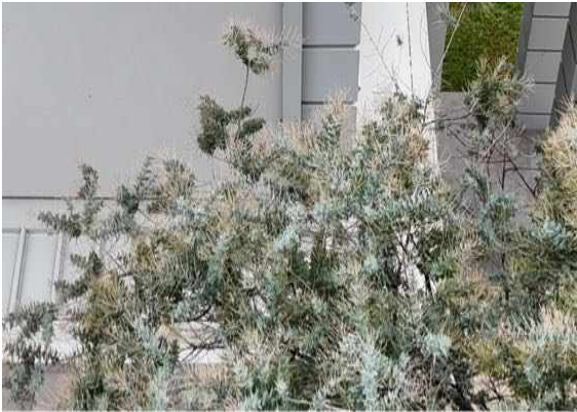
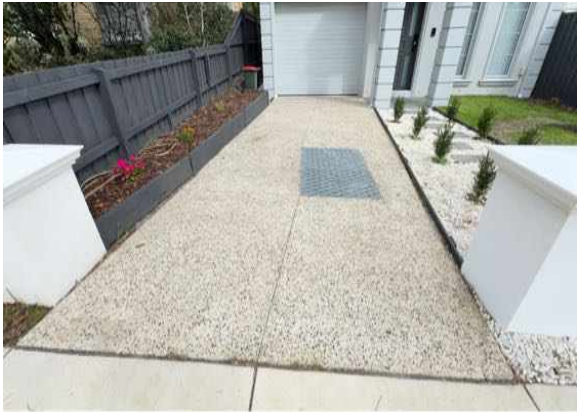
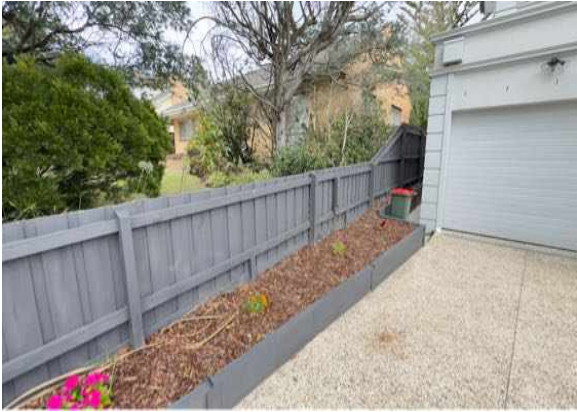
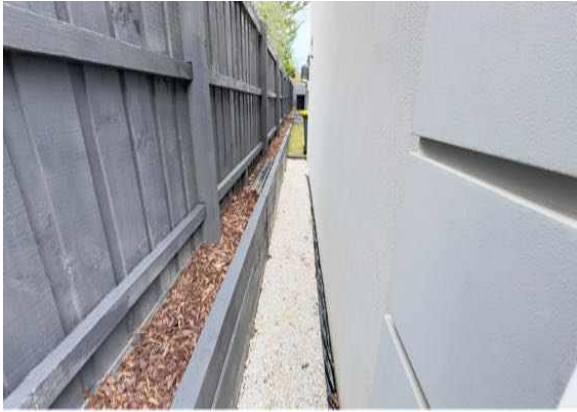
It is important to note that these restrictions can conceal a wide range of building defects, including but not limited to:

Because these areas could not be visually assessed, no comment can be made on their condition within this report.

It is strongly recommended that obstructions be removed and concealed areas made fully accessible immediately. A re-inspection should then be carried out to allow a complete assessment of the property's condition. This is particularly important prior to purchase, as defects in concealed areas can carry significant rectification costs.
