Building and Timber Pest Inspection Report

Inspection Date: Thu, 9 Apr 2026

Property Address: 6/17-19 Norman St, Concord NSW 2137,
Australia

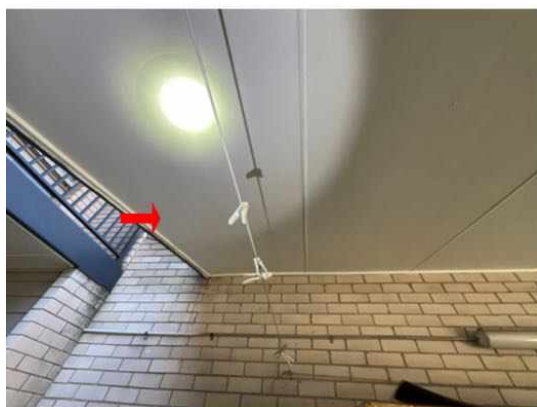
Finding: Additional Photos - Obstructions and Limitations

Information: These photographs are an indication of the obstructions and limitations which impeded full inspection of the property at the time of inspection. These obstructions can hide an array of defects and should be removed to allow full inspection to be carried out. A re-inspection is recommended once the areas are made accessible.

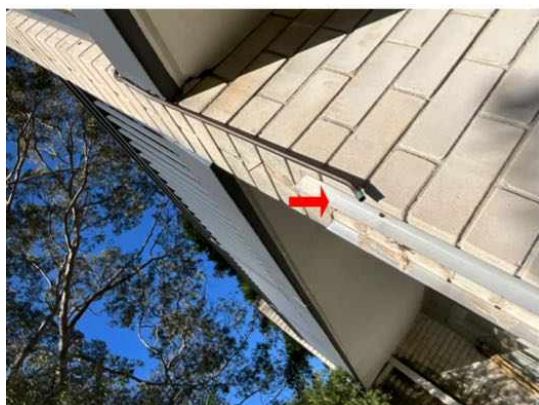
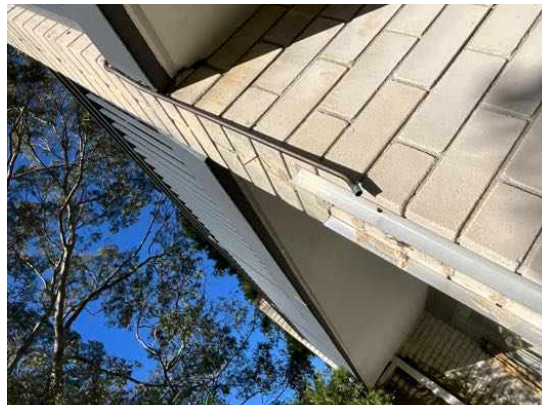
Finding 3.04

Building:	Main Building
Location:	Exterior walls - rear
Finding:	Water staining
Information:	Water staining was evident in this area at the time of inspection. Water staining indicates that surfaces have been exposed to excessive moisture over time. The minerals and other elements in the water lead to staining, which may graduate to corrosion and deterioration if left unmanaged.

While mostly an appearance defect, water staining can be indicative of more serious defects, which may be currently concealed by other building elements.

Where water staining is active, a licensed plumber must be consulted to identify the cause of the staining and to provide advice on any reparation works that may be required. Replacement of any broken or damaged structures is advised.

Conversely, where water staining is old and inactive, affected building materials may be repaired or replaced at client discretion. A qualified carpenter or registered builder may be appointed to perform these works.

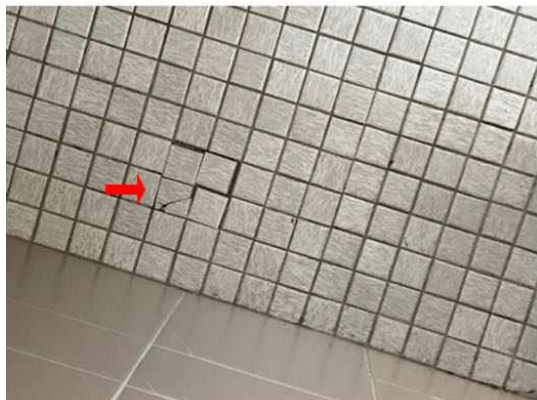
Finding 3.11

Building:	Main Building
Location:	Ensuite
Finding:	Shower - Damp
Information:	Damp is evident to the lower 300mm of wall to the shower alcove. This defect is quite common, and is suspected to have been caused by moisture permeating through the grouting in this area, which shows evidence of deterioration. Leaking pipes within the adjoining wall is also a possible cause.

Damp (or structural damp) refers to the presence of unwanted moisture in the structure of a building, either as the result of intrusion from outside, or condensation from within the structure. In the shower area, internal water leaks or other sources of excessive moisture are generally the cause of damp.

Unmanaged damp in the shower recess is likely to facilitate the formation and development of mould and fungi growth, decaying associated building materials and compromising their structural integrity. It is important to address damp conditions, as the World Health Organisation notes that excess moisture leads - on almost all indoor materials - to growth of microbes such as moulds, fungi and bacteria, which subsequently emit spores and other matter into the indoor air. Exposure to these contaminants is associated with a wide range of respiratory and other health-related problems.

Consultation with a qualified plumber or bathroom specialist is advised immediately to identify the cause of damp and to perform remedial works as required. Where excessive mould growth is present, further inspection by a specialist environmental health inspector should also be considered.

Always ensure that sealant and grout is in good condition to prevent any moisture issues occurring in the future.

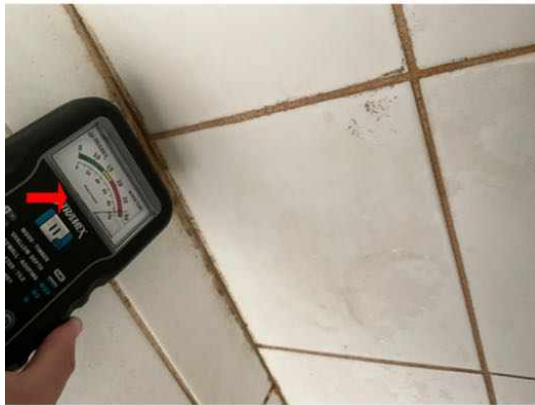
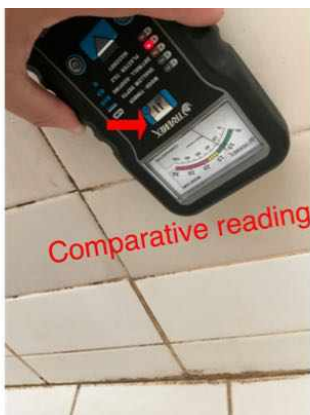
Finding 3.12

Building:	Main Building
Location:	Ensuite
Finding:	Sealant and grouting - Missing or damaged
Information:	It was noted on inspection that sealant or grout is degraded to the tiled shower alcove and or other areas of the bathroom.

There appears to be excessive mould to the sealant and grout which will likely require scraping out and replacement.

Flexible and mould resistant materials should be applied to affected areas to prevent any subsequent water damage that is likely to occur. Regular maintenance and replacement of damage or missing or damaged sealant and grout is highly recommended to the wet areas, as this is a regular wear and tear defect. Sealant and grouting in areas that come into regular contact with water should be maintained for the long term care of your property.

A sealant specialist or tiling contractor should be appointed to complete these works as soon as possible

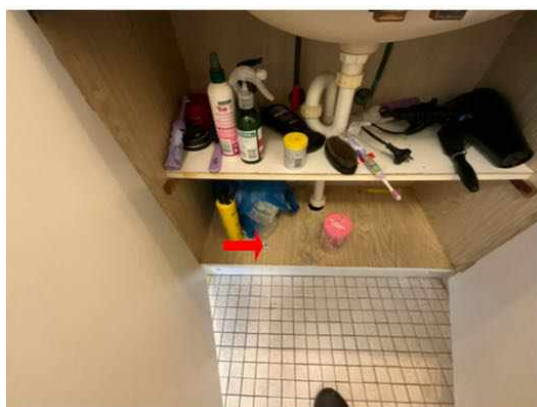
Finding 3.14

Building:	Main Building
Location:	Bathroom
Finding:	Evidence of excessive moisture was present at the time of inspection
Information:	Excessive moisture is present behind the bathroom tiles, indicating a potential water leakage issue within the wall.

The prolonged presence of moisture can lead to mold growth, deteriorate the structure, and create an environment conducive to health hazards. Additionally, it may compromise the adhesive holding the tiles, leading to their detachment.

A licensed plumber or a qualified contractor specializing in water damage remediation should investigate the source of the moisture, fix any leaks, and address the damage. Additionally, replacing affected tiles and ensuring proper waterproofing are crucial to preventing future issues.

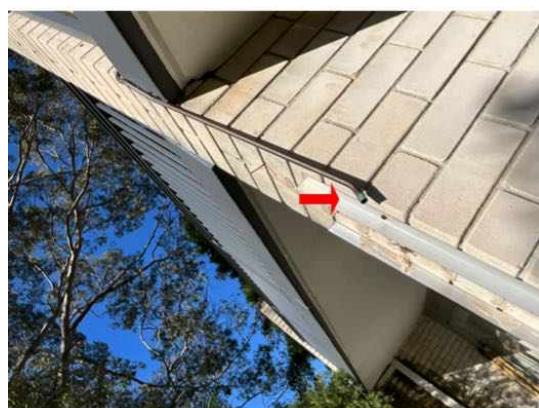
Finding 6.06

Building:	Main Building
Location:	Exterior walls - rear
Finding:	Bridging or Obstruction Conducive environment for Termites
Information:	Bridging of termite barriers occurs when termites bridge (usually by building a mud tunnel) a termite barrier or inspection inspection zone or where termites have a passage, allowing them to bridge the barrier.

Where bridging has occurred full inspection is prevented and termites may enter a property in a concealed or undetected manner.

Recommended moving obstructions away from the external walls for further and future inspections.

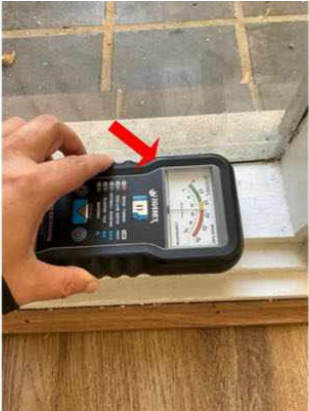
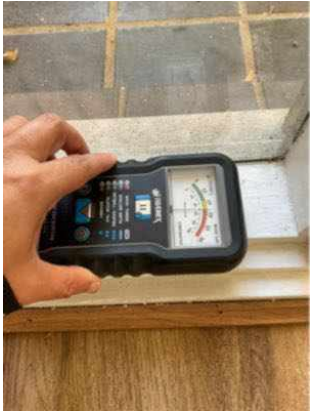
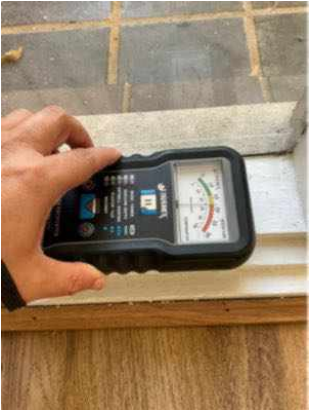
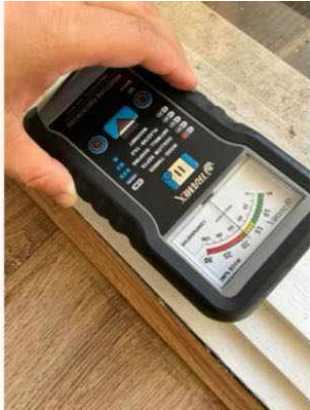
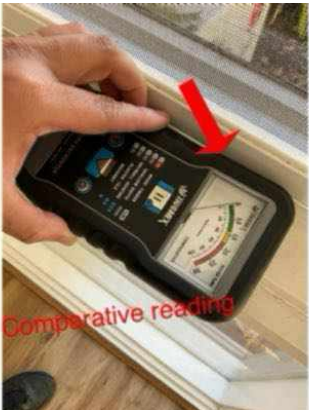
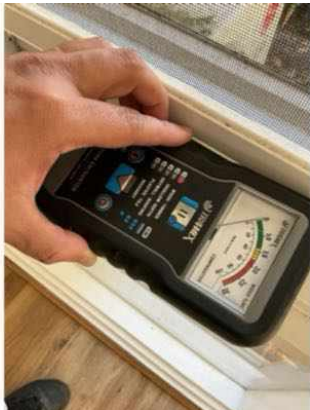
Finding 6.08

Building: Main Building
Location: Ensuite
Finding: Excessive moisture - Conducive to Timber pest
Information: Excessive moisture can attract termites and produce conditions that promote fungal growth and wood decay.

Excessive moisture is generally caused by deteriorated inadequate or missing roof drainage leaking plumbing pipes or fixtures poorly plumbed HWS overflows or condenser units and poor site drainage.

Prior to any remedial works being performed a qualified plumber should be appointed to further inspect the property and to identify the cause of the excessive moisture. Works to remove affected building elements may then be necessary and should be performed by an appropriate tradesperson.

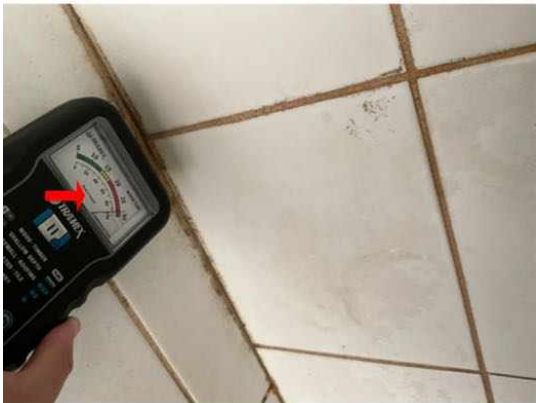
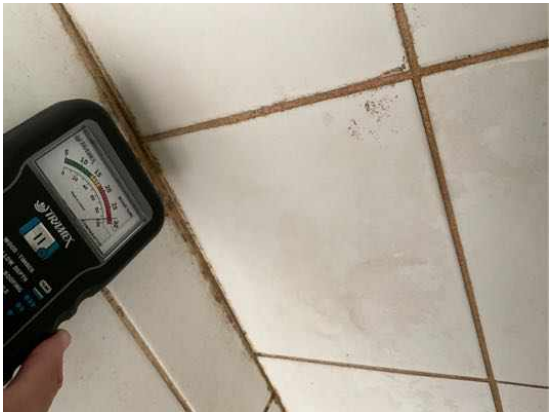
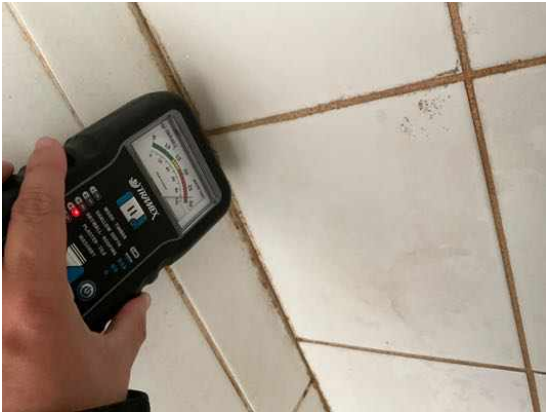
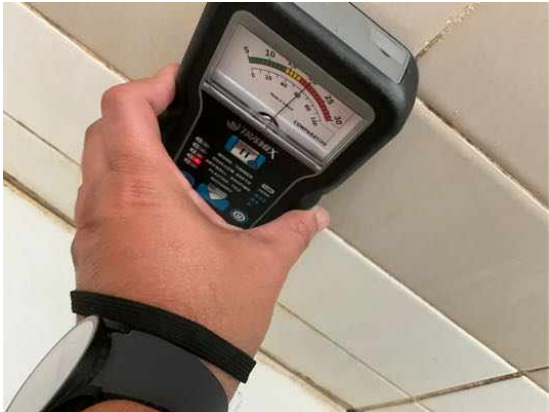
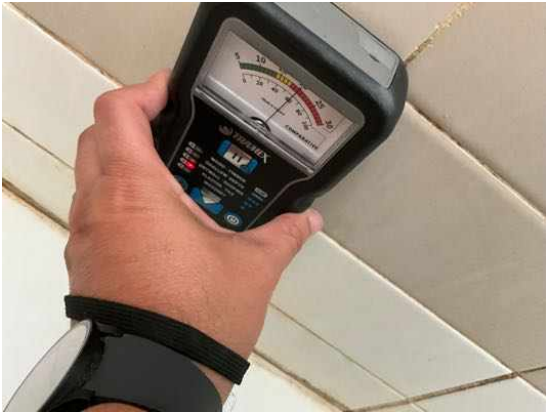
Finding 6.09

Building:	Main Building
Location:	Bathroom
Finding:	Excessive moisture - Conducive to Timber pest
Information:	Excessive moisture can attract termites and produce conditions that promote fungal growth and wood decay.

Excessive moisture is generally caused by deteriorated inadequate or missing roof drainage leaking plumbing pipes or fixtures poorly plumbed HWS overflows or condenser units and poor site drainage.

Prior to any remedial works being performed a qualified plumber should be appointed to further inspect the property and to identify the cause of the excessive moisture. Works to remove affected building elements may then be necessary and should be performed by an appropriate tradesperson.

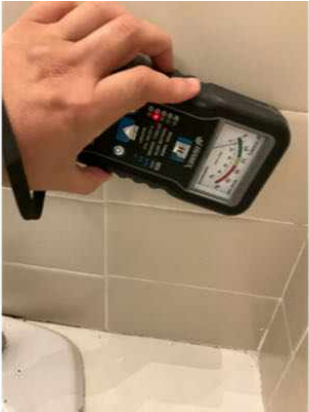
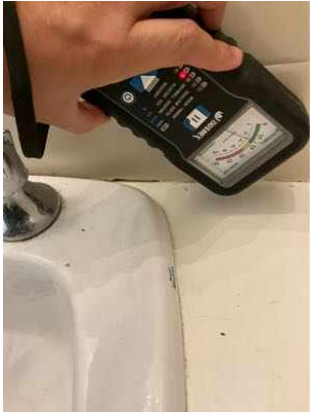
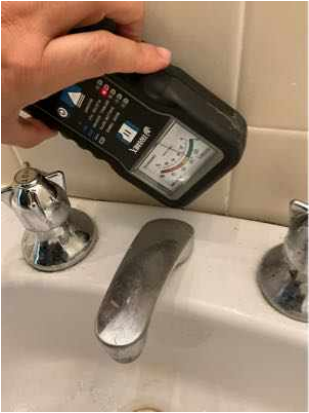
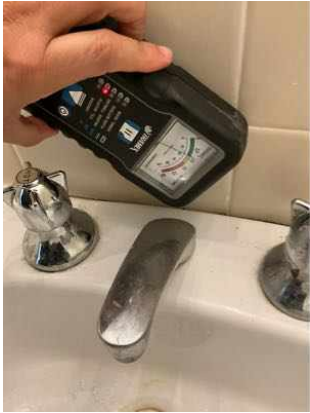
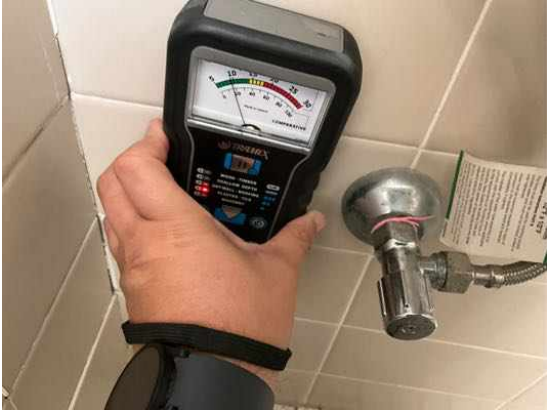
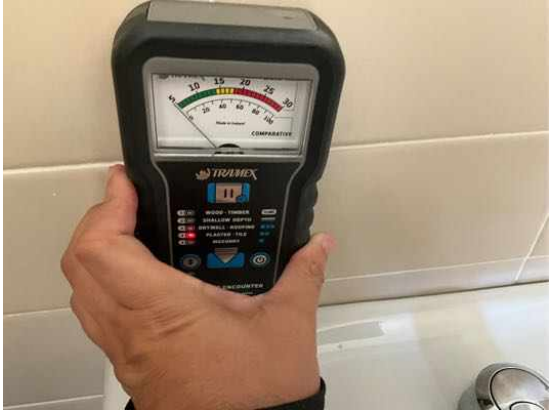
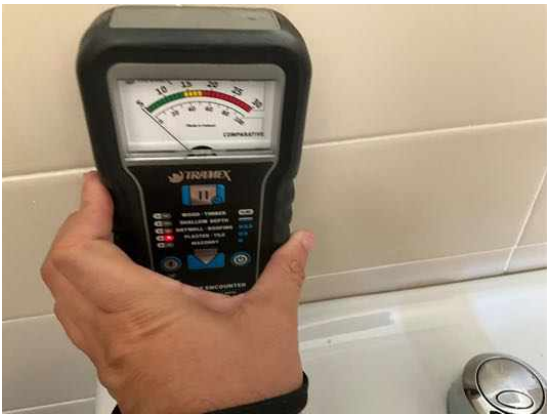
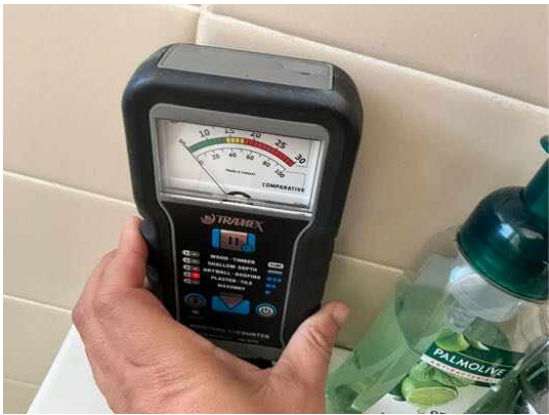
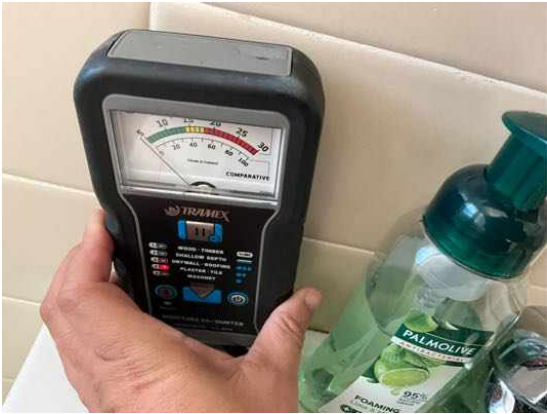
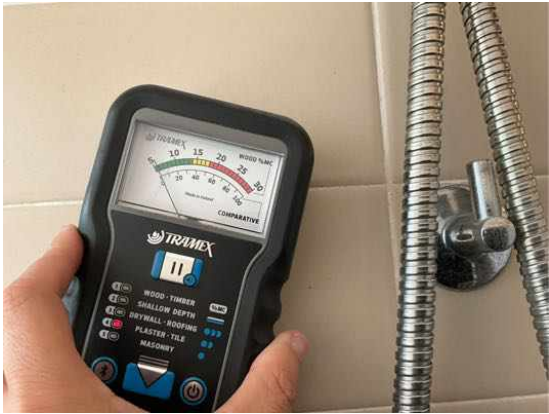
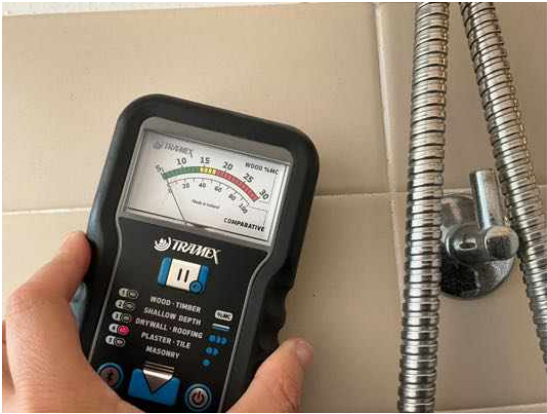
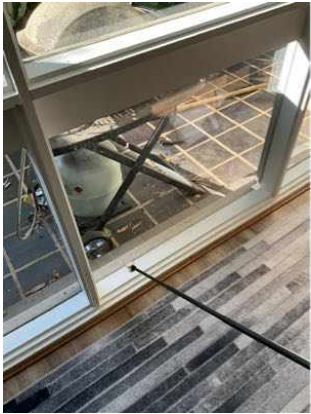
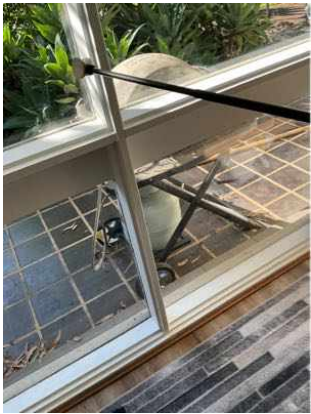
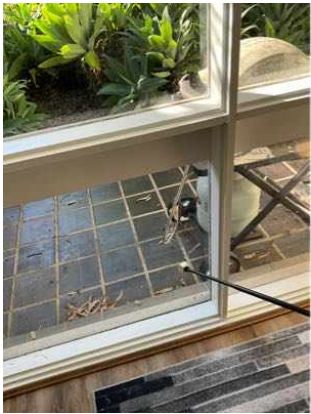
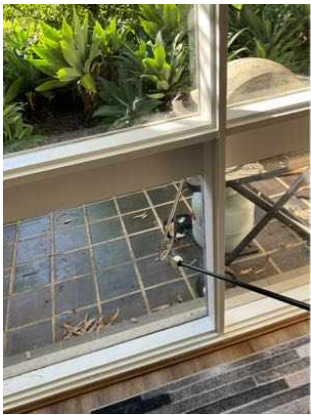
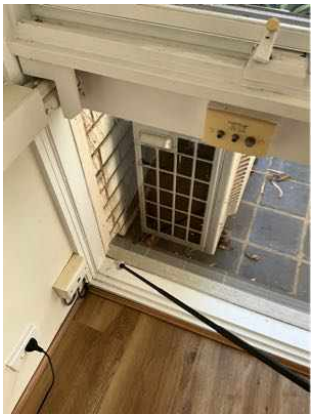
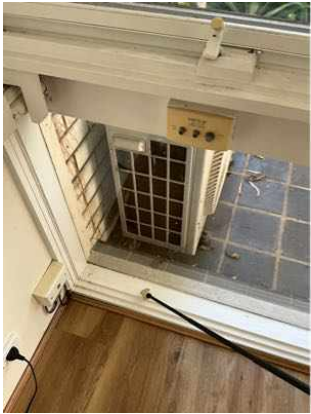
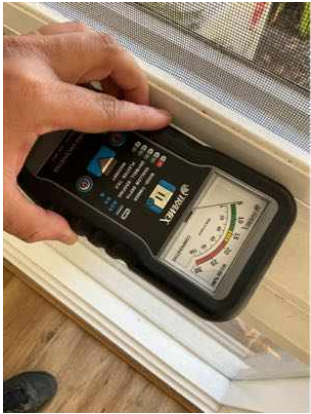
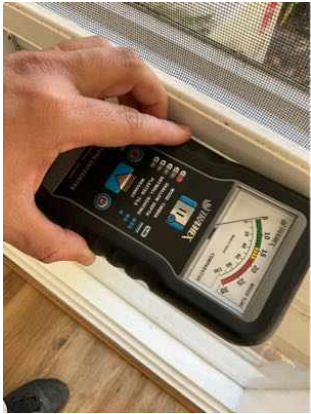
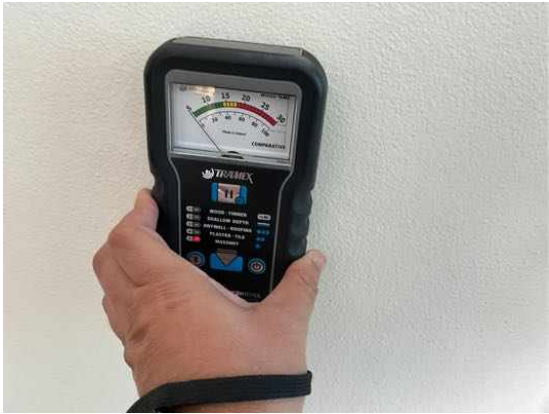
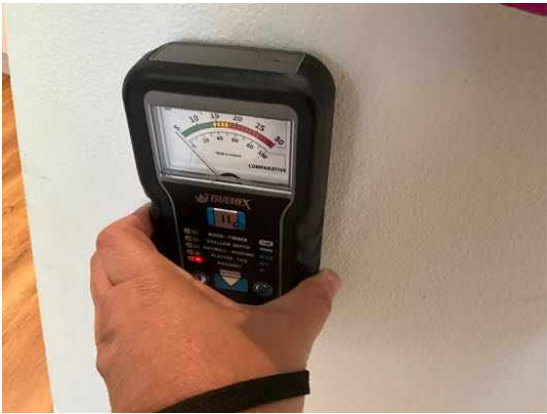
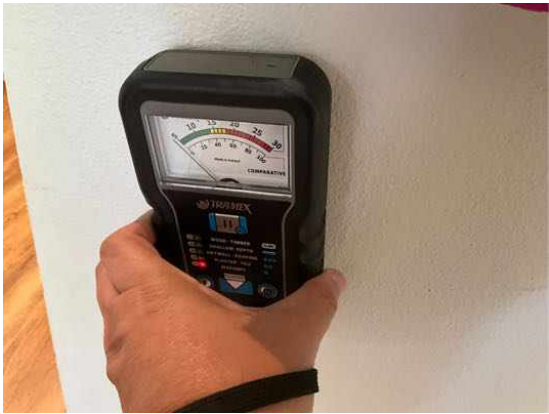
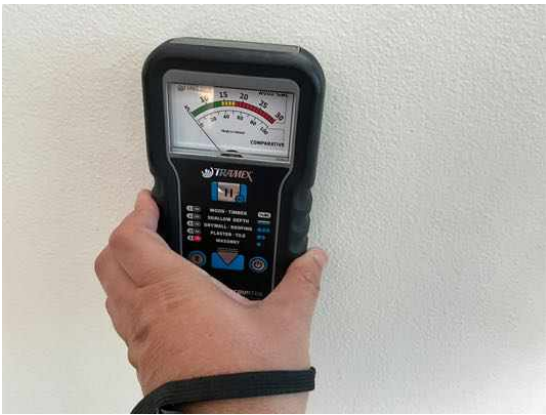
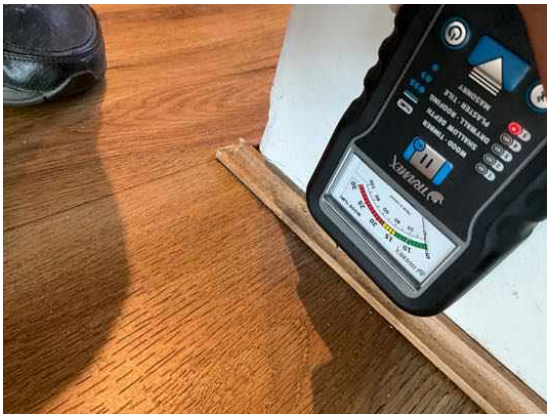
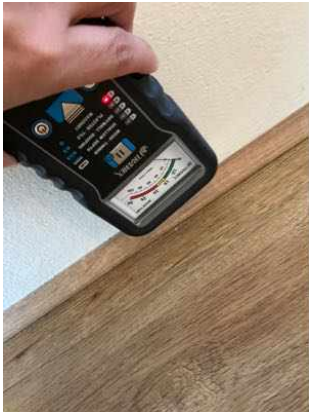
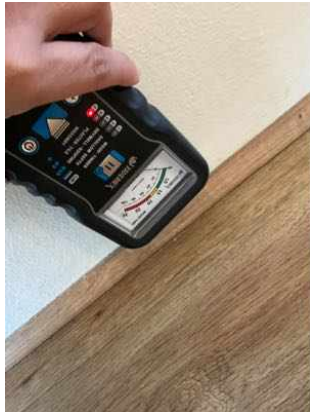
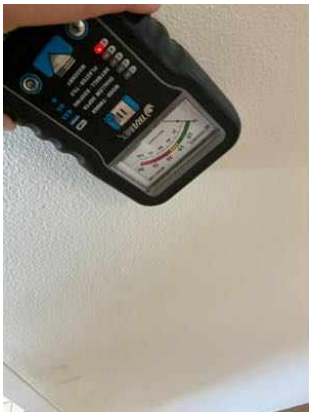
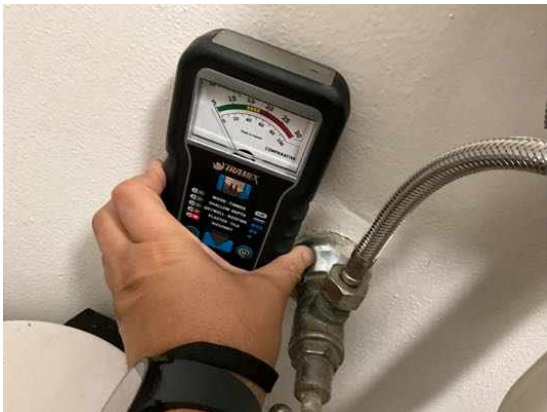
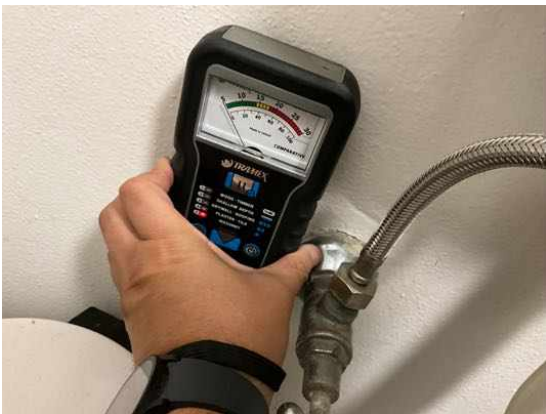
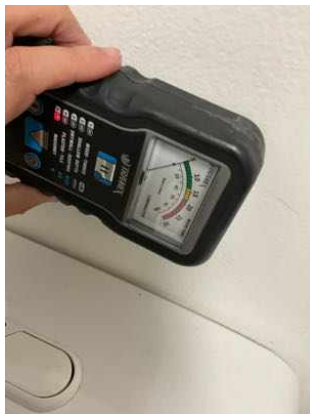
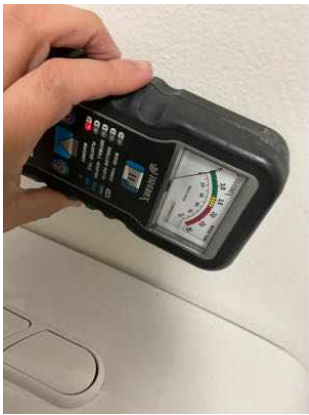
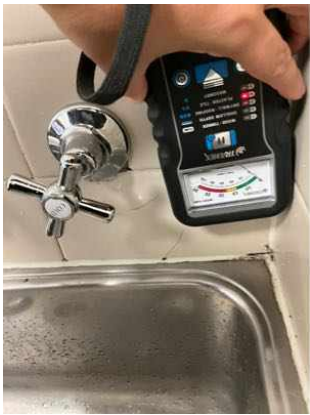
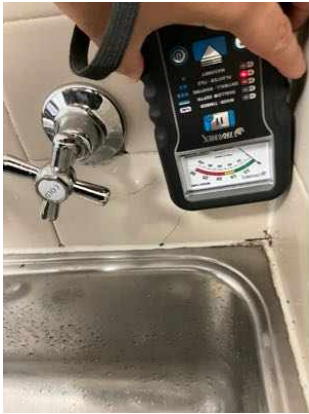
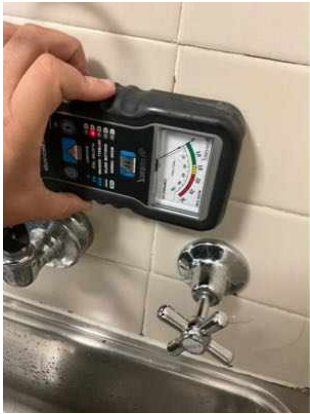
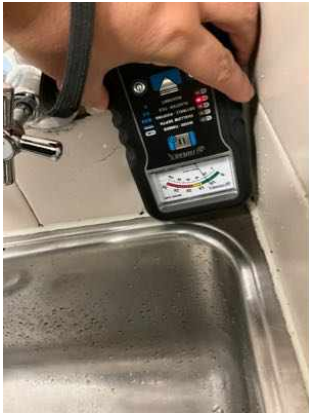
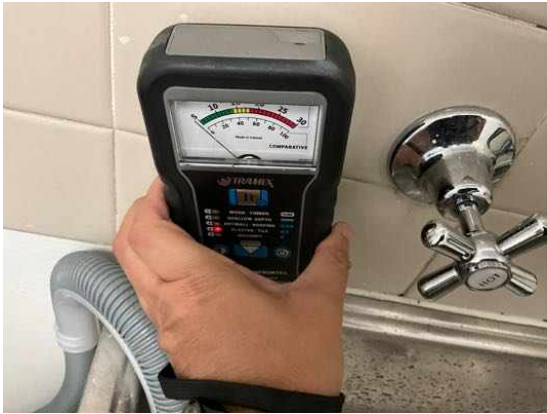
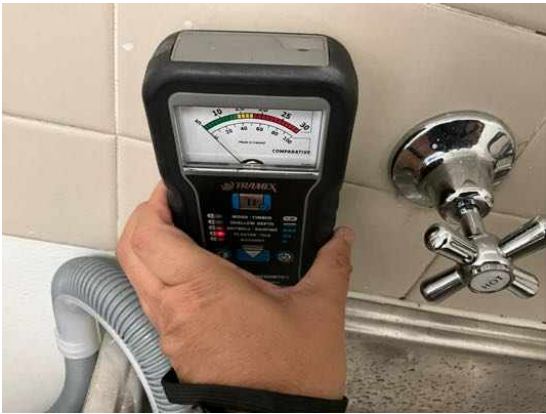
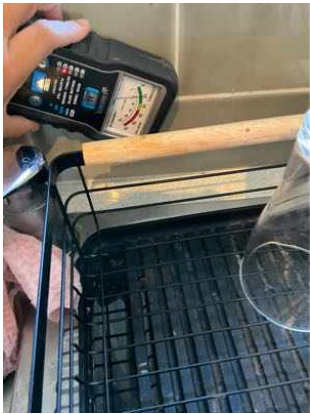
Building: Main Building
Location: All Areas
Finding: Additional Photos
Information: Additional photos are provided for your general reference

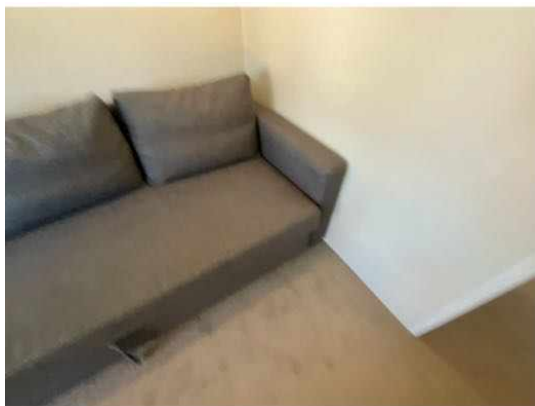
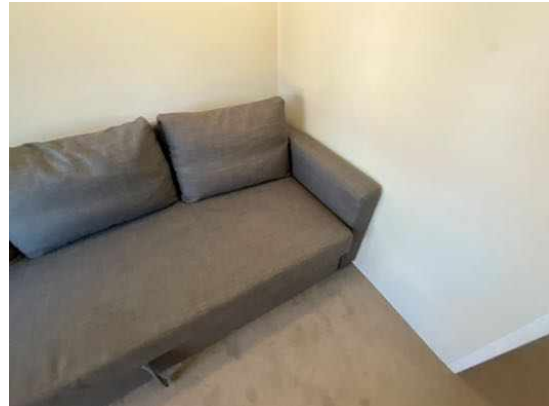
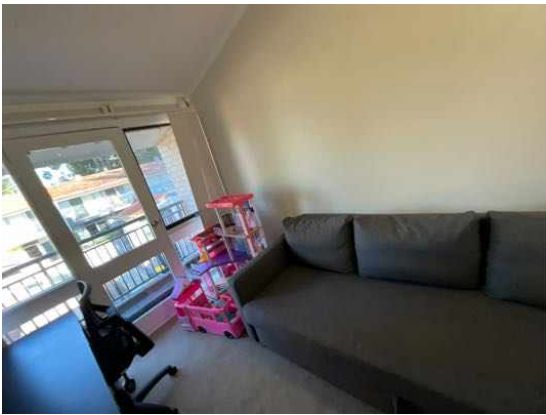
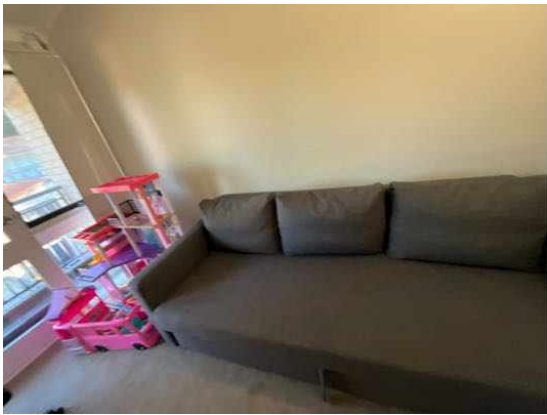
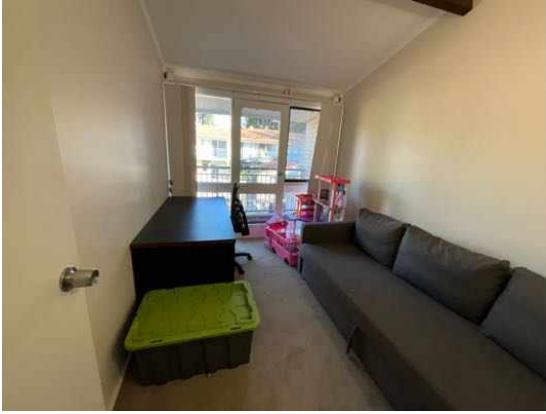
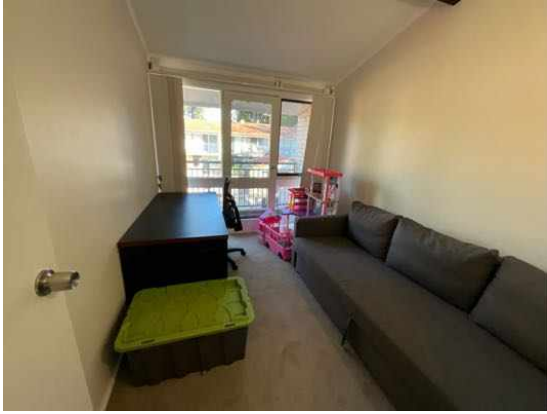
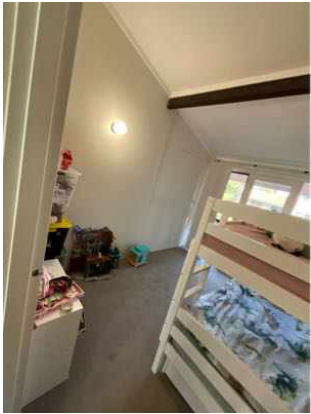
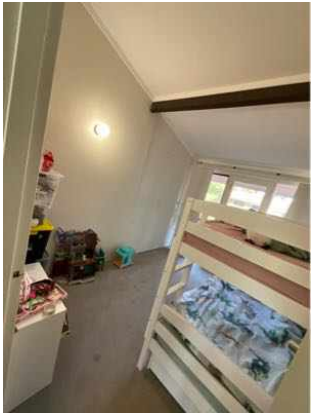
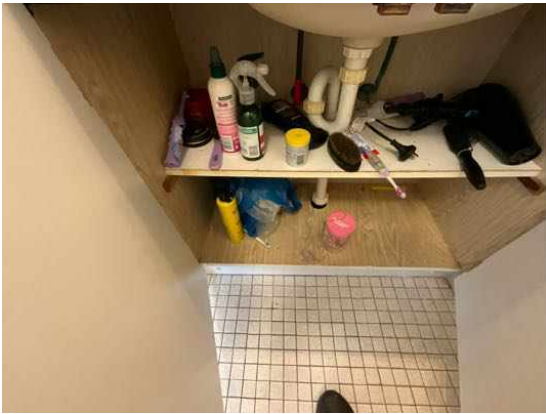
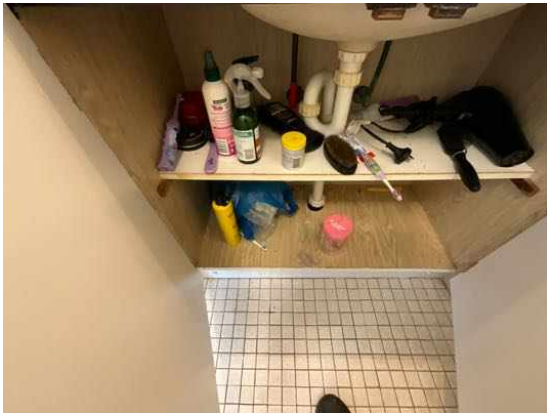
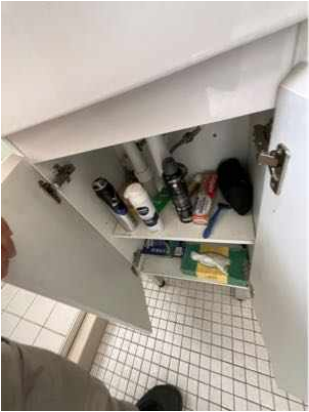
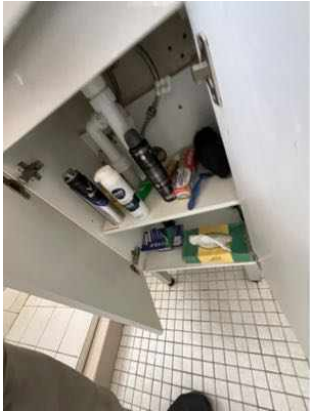
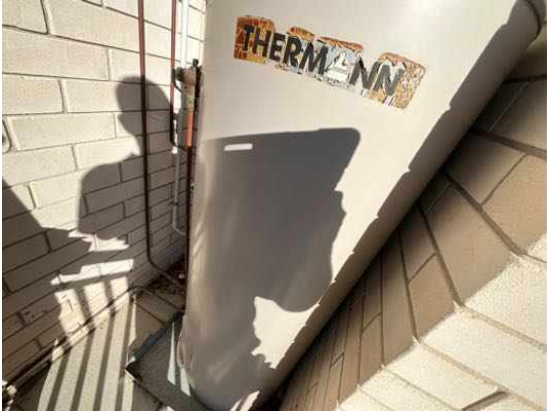
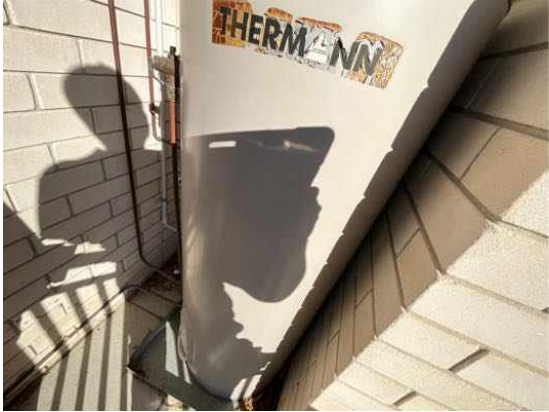
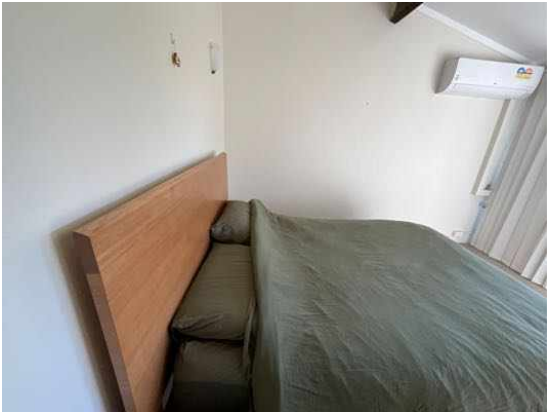
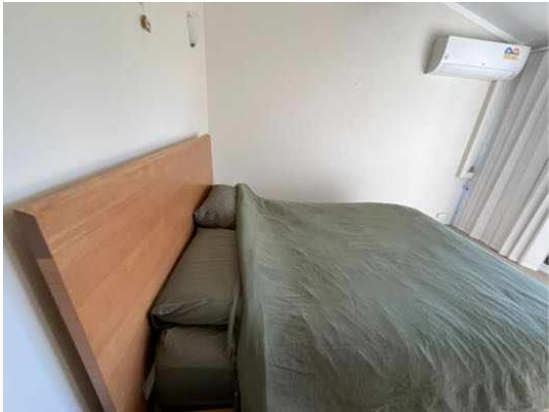
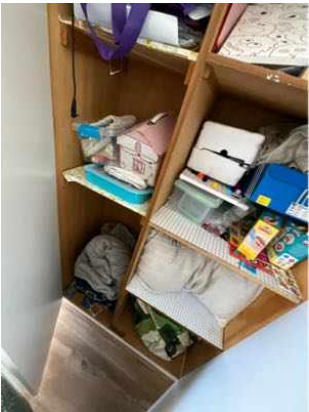
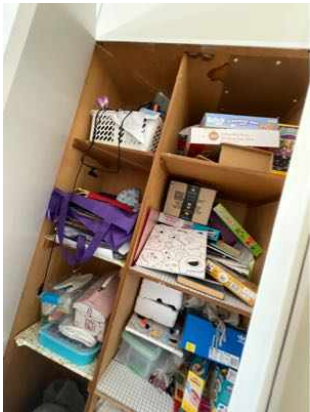
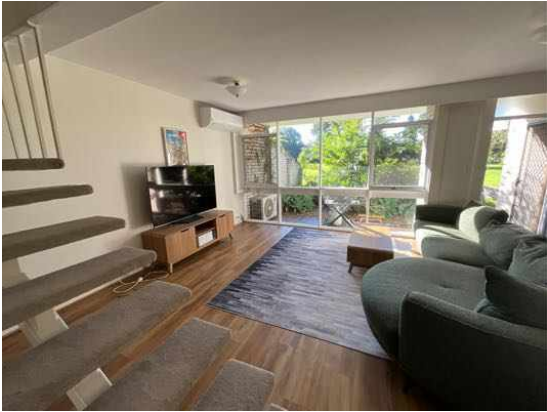
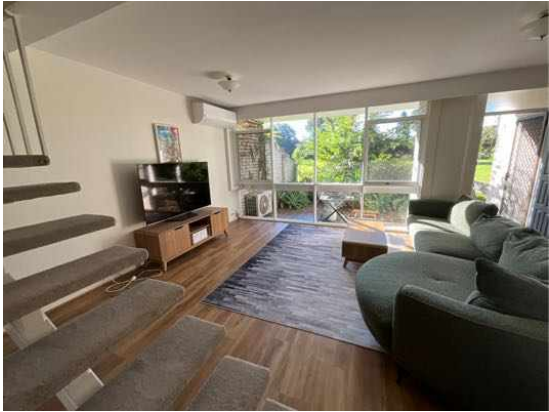
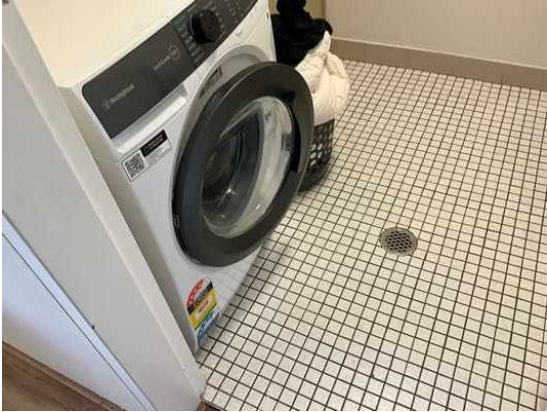
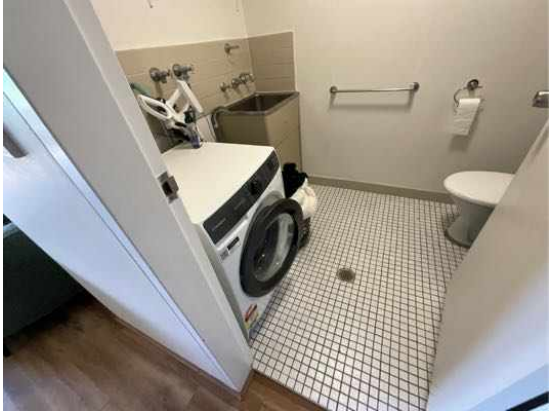
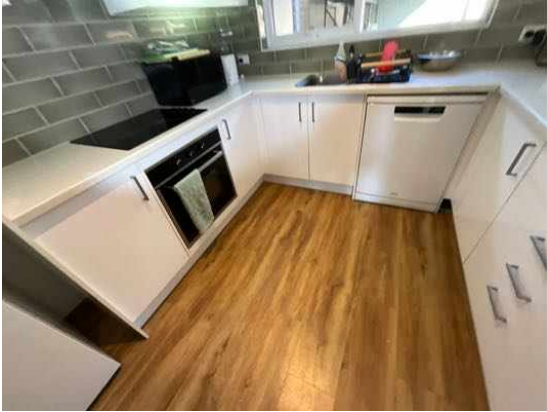
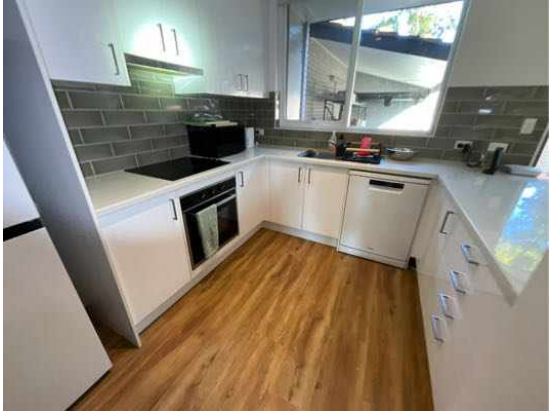
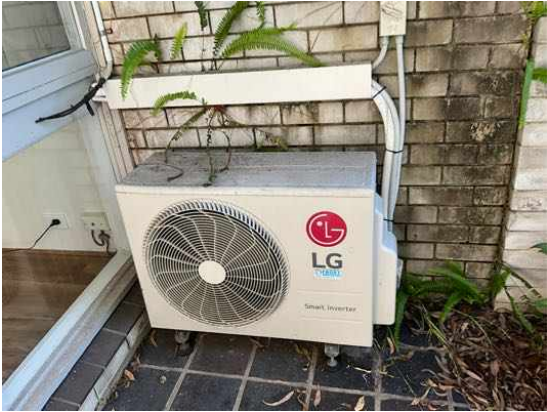
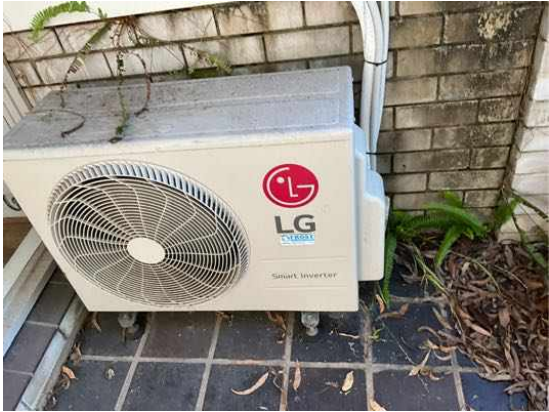
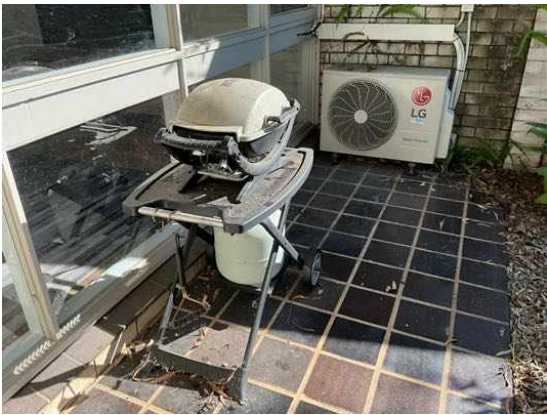
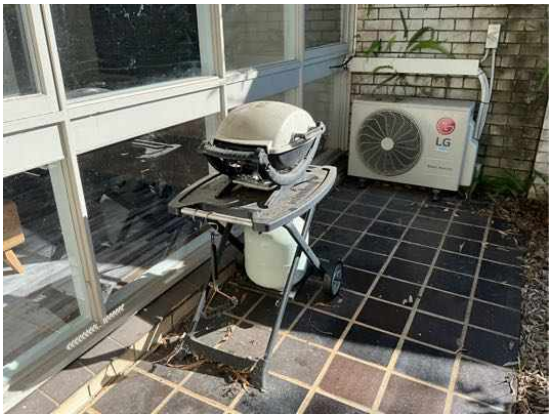
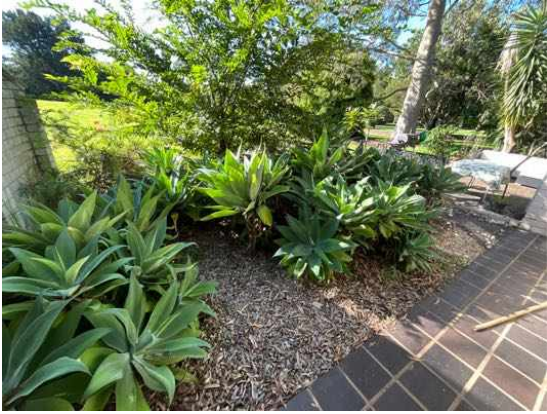
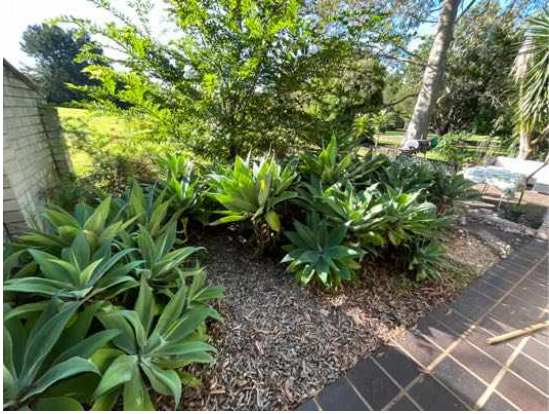
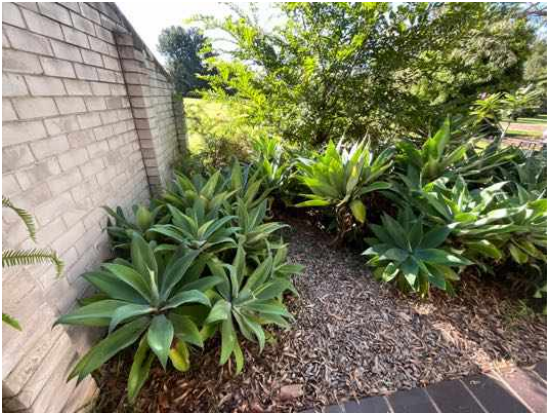
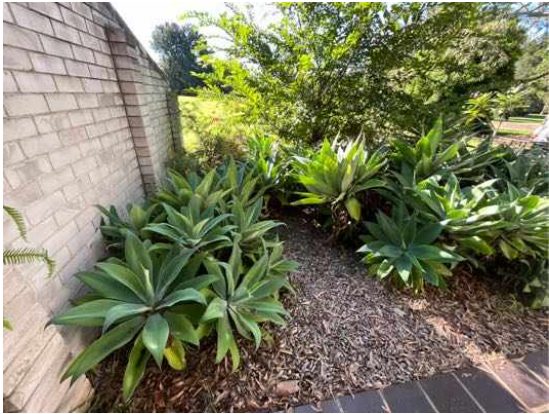
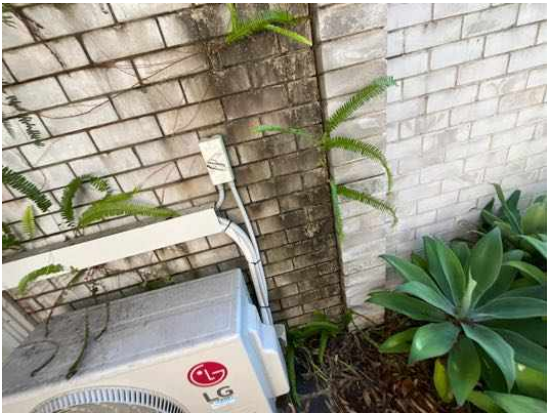
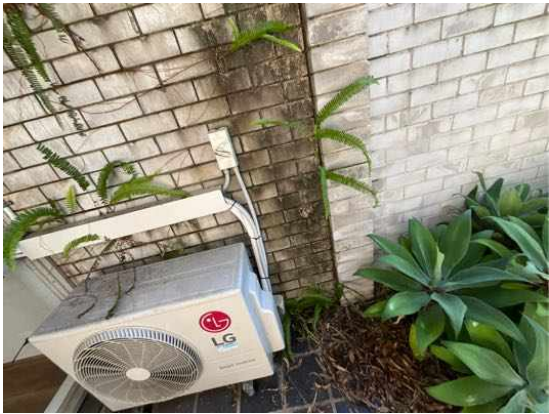
Building: Main Building
Location: All Areas
Finding: Additional Photos - Obstructions and Limitations
Information: These photographs are an indication of the obstructions and limitations which impeded full inspection of the property at the time of inspection. These obstructions can hide an array of defects and should be removed to allow full inspection to be carried out. A re-inspection is recommended once the areas are made accessible.
