# Building and Timber Pest Inspection Report

Inspection Date: Tue, 17 Mar 2026

Property Address: 6A Ledger St, Goulburn NSW 2580,  
Australia

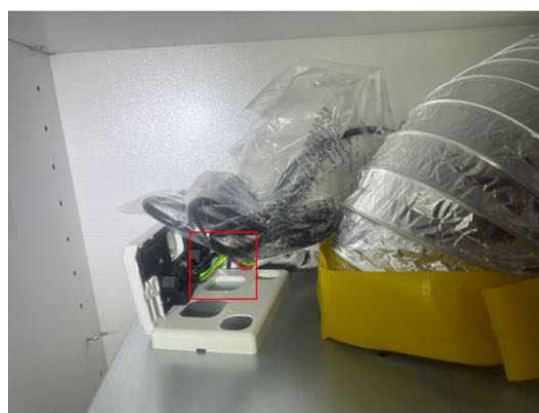
#### Finding 1.01

Building:	Main Building
Location:	Kitchen
Finding:	Electrical wires exposed
Information:	Exposed electrical wiring was identified. Exposed electrical wiring represents a potential safety hazard including for fire and personal contact. Contact a licensed electrician urgently for further inspection investigation and rectification.

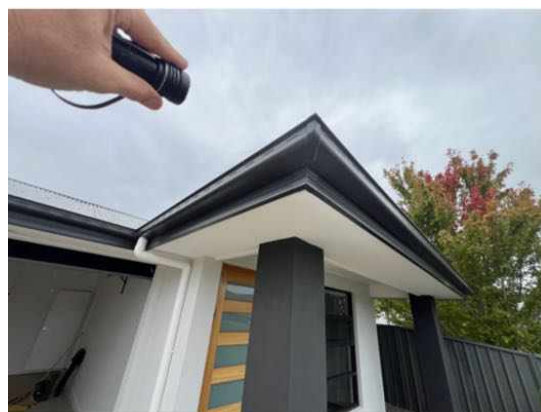
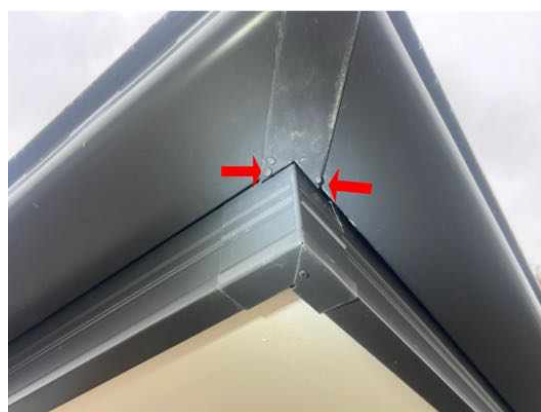
Building:	Main Building
Location:	Exterior walls - front
Finding:	Guttering - Active Leak
Information:	An active leak was identified in the guttering during the inspection. This issue is likely caused by damage, corrosion, or substandard installation. The leak allows water to escape improperly, increasing the risk of water pooling around the building's foundation. Prolonged moisture exposure can create conditions conducive to termite activity and may also lead to soil erosion, water ingress into lower areas, or damage to associated building elements.

A licensed roof plumber should assess the guttering to identify the exact cause of the leak and carry out necessary repairs or replacements as a priority to prevent further

damage and mitigate the risk of termite infestation.

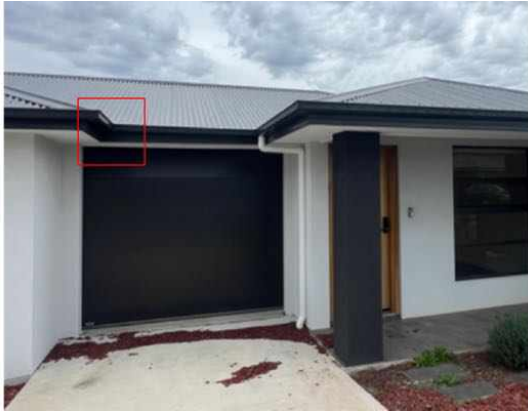
### Finding 3.02

Building:	Main Building
Location:	Garage
Finding:	Fascia internal corner/Installation - substandard or incomplete
Information:	The installation of this fascia corner appears to have been completed to a substandard level of workmanship or is incomplete. Generally substandard repairs or installation are related to poor workmanship, the use of inappropriate materials, or a failure to complete installation to a suitable standard.

Where installation is substandard and/or incomplete, the roof plumber should undertake rectification. Unfinished and substandard building works are likely to degrade more quickly and may create potential for secondary defects to associated building elements.

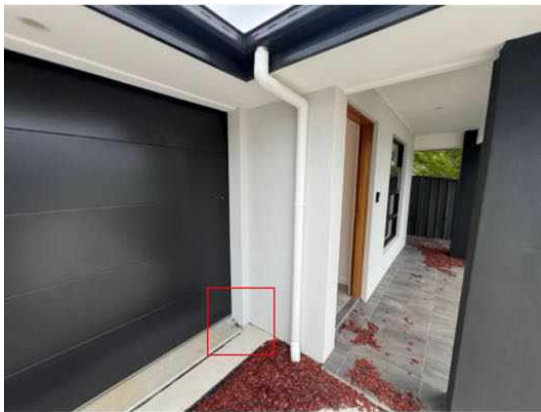
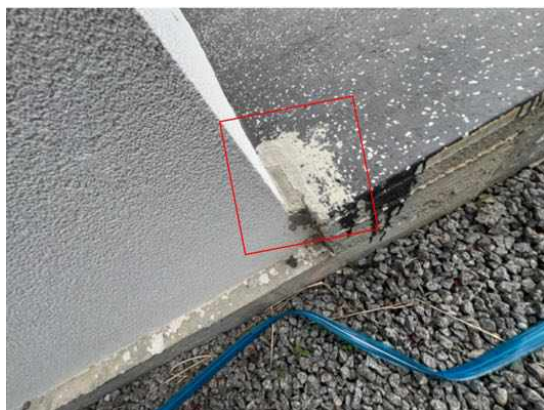
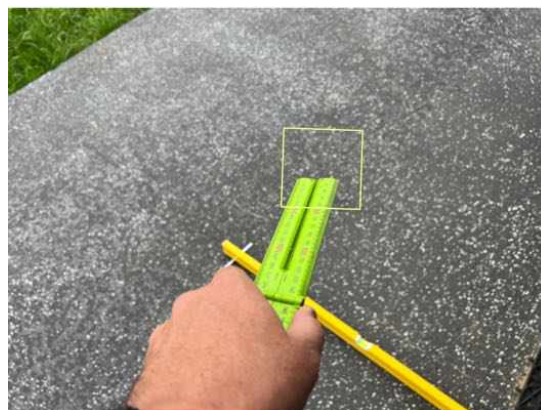
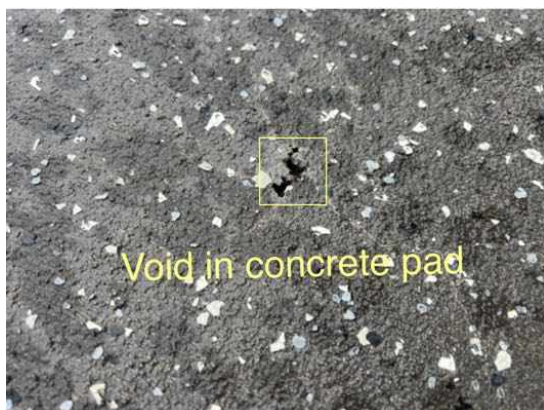
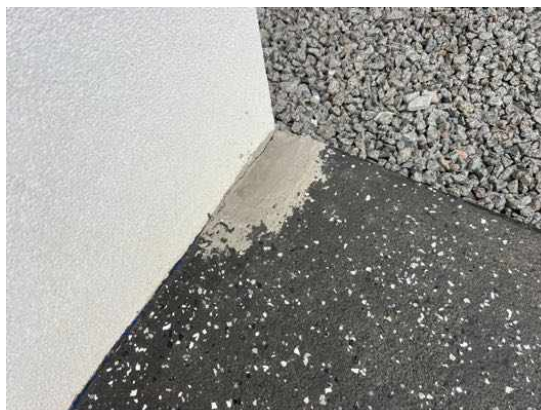
### Finding 3.03

Building:	Main Building
Location:	Garage, Alfresco
Finding:	Concrete finish/Installation - substandard or incomplete
Information:	The installation of concrete finish appears to have been completed to a substandard level of workmanship or is incomplete. Generally substandard repairs or installation are related to poor workmanship, the use of inappropriate materials, or a failure to complete installation to a suitable standard.

Where installation is substandard and/or incomplete, the concrete should undertake rectification. Unfinished and substandard building works are likely to degrade more quickly and may create potential for secondary defects to associated building elements.

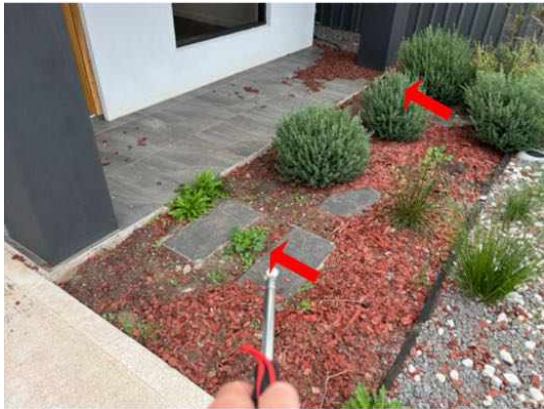
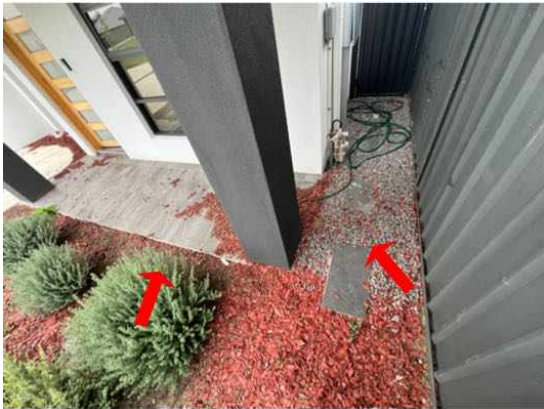
### Finding 3.04

Building:	Yard
Location:	Yard - Front
Finding:	Site drainage - Inadequate
Information:	The site drainage in this area was found to be inadequate at the time of inspection, creating potential for subsequent water damage to associated building elements.

It is important that water does not lie against the base of walls; surrounding paths and ground levels should be sloped to drain water away from walls. Downpipes should not discharge stormwater onto lower walls or plinths. Stormwater should be carried away by large, regularly cleaned drains. Ground levels may need to be lowered to expose a buried DPC.

Where site drainage is inadequate, installation of an Agricultural (Aggie) Drain may be required. A qualified plumber should be appointed to further inspect the property and perform any remedial works as necessary. Water damage and secondary defects are likely to occur if left unmanaged.

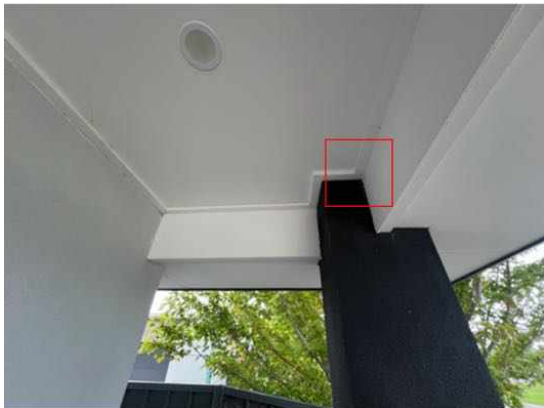
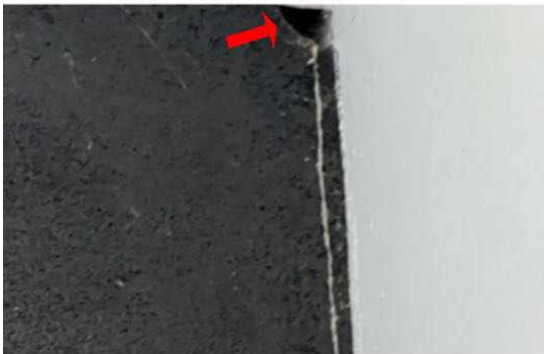
**Finding 3.05**

Building: Main Building  
 Location: Porch  
 Finding: Gaps - general  
 Information: A gap was identified to this area. It is suspected that the installation of this moulding/trim or incomplete brickwork was completed to a substandard level of workmanship or is incomplete.

Gaps and holes makes the area susceptible to insect and vermin ingress, as well as allowing water penetration. As such, associated building elements are likely to deteriorate at an accelerated rate, and major implications are expected if Gaps are left unmanaged.

All excessive holes, gaps or cracks should be adequately filled by a suitable sealant, trimmings or brickwork as soon as possible to prevent any further damage. Such works may be conducted by a general handyman, licensed carpenter or bricklayer.

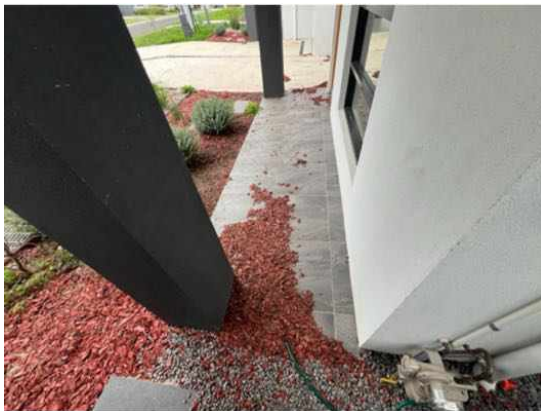
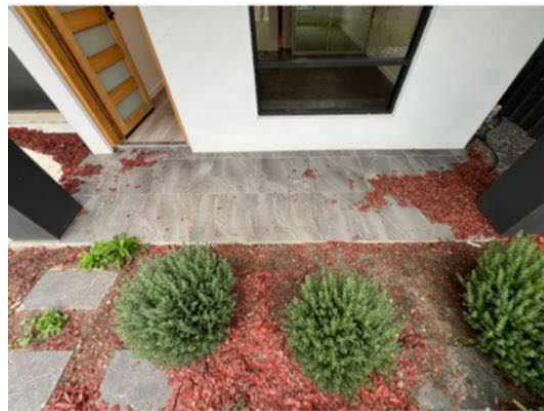
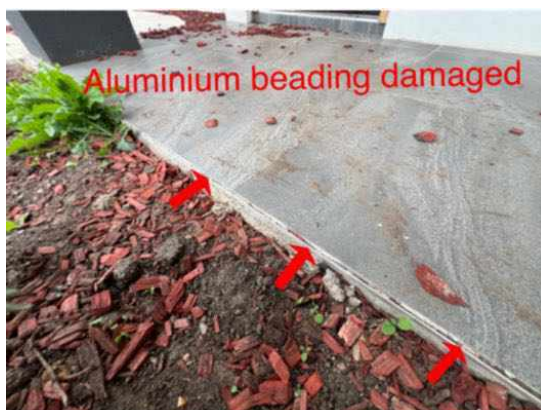
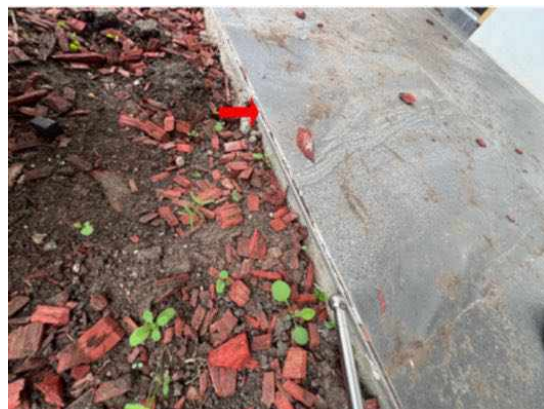
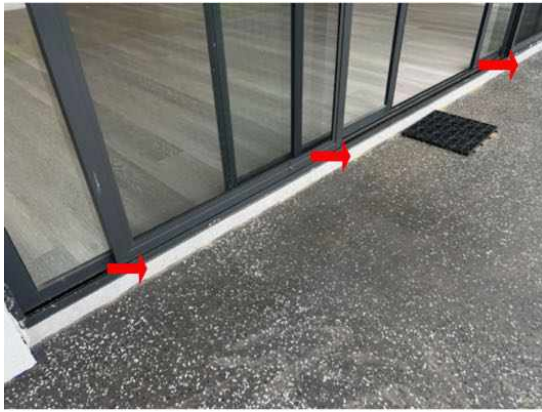
**Finding 3.06**

Building: Main Building  
 Location: Porch, Alfresco  
 Finding: Tiles - Drummy

Information: Drummy tiled areas were identified at the time of inspection. The term 'drummy' refers to tiles that have become detached from their fixing, despite otherwise being in relatively good condition. Such defects are generally caused by physical or moisture damage to the area. Drummy tiled areas may also be a direct result of poor workmanship during the construction process.

Tiled areas may swell and shrink with changes in air humidity if the area has sustained moisture damage. Any exposure to moisture is capable of causing tiled areas to become drummy and/or cracked over a prolonged period of time. Drummy tiled areas generally require removal and replacement of affected tiles, with adequate sealant and grouting.

Specialist trades are available for these types of services. A registered builder may be required to undertake works if damage is extensive or if secondary building defects have resulted. Otherwise, it is advised that a tiling contractor be appointed to perform works as necessary. Immediate action is recommended to ensure that no further damage is sustained in the affected area.

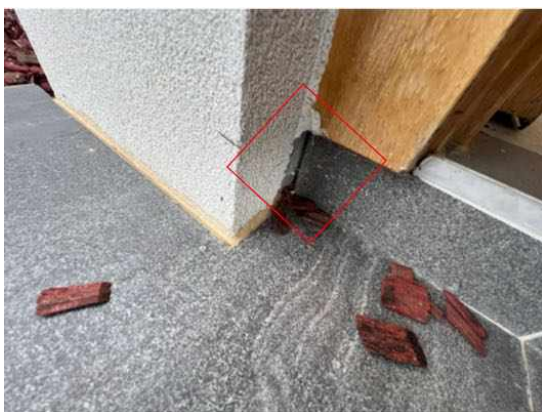
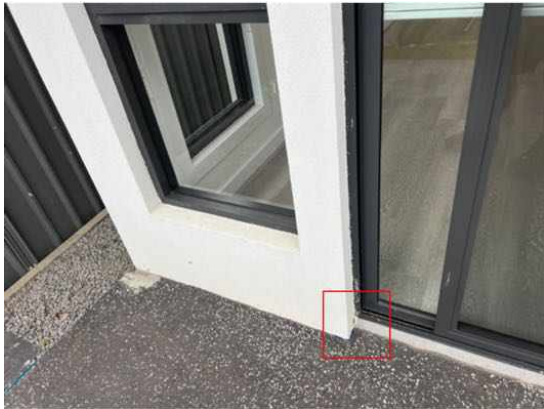
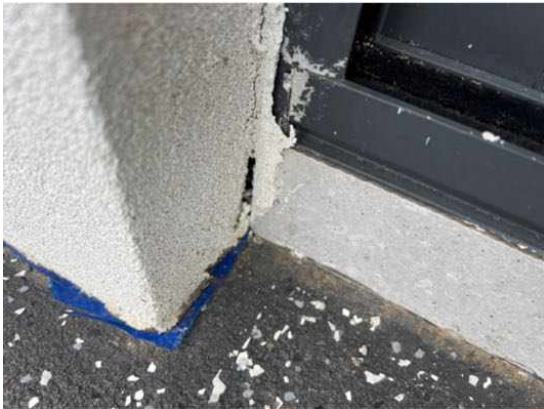
### Finding 3.07

Finding: Porch and Alfresco - Missing Sealant at Tile Junction

Information: It was noted that sealant was not installed along the junction at the porch floor tiles. Junctions between dissimilar materials such as tiles and wall surfaces require flexible sealant to accommodate normal movement and to prevent moisture entering beneath the tiles.

Without a suitable sealant, water may track below the tiled surface during rainfall, leading to drummy or detached tiles and deterioration of underlying materials. The absence of sealant at this junction increases the risk of moisture ingress and tile failure over time.

A flexible, exterior-grade sealant should be installed at the affected area to provide a watertight and durable finish. A tiling contractor or general handyperson should be appointed to carry out the necessary works.

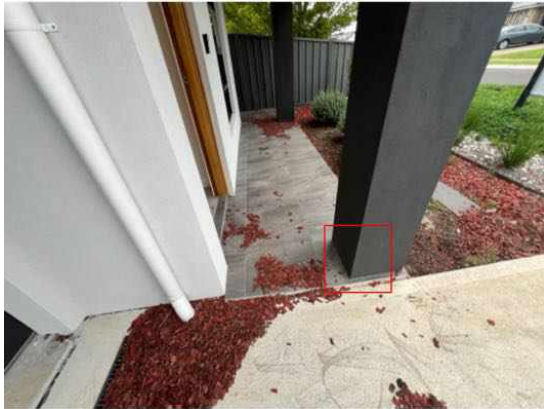
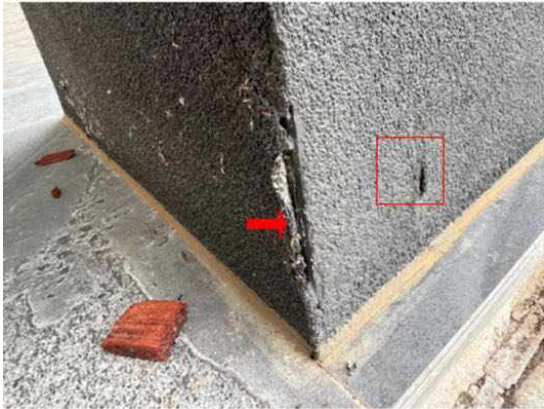
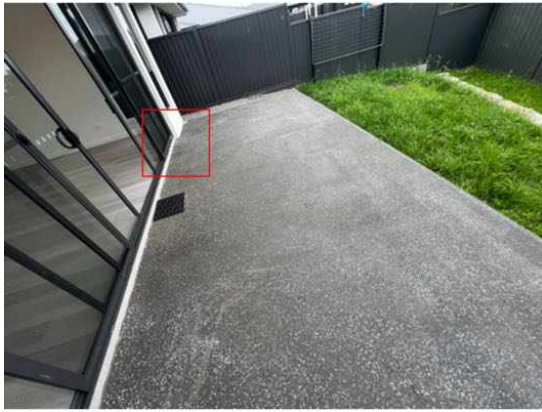
**Finding 3.08**

Building: Main Building  
Location: Porch, Alfresco  
Finding: Render - Damaged  
Information: Breakage occurs generally when the building materials have either aged and decayed, or as a result of damage (accidental or deliberate).

Repair and/or replacement of broken elements is advised to ensure that additional secondary defects do not arise as a consequence. Such works are necessary, as all building elements play a key role in the operation and function of the overall structure and its performance.

A renderer/plasterer should be appointed to repair or replace the affected building element prior to any subsequent damage being caused.

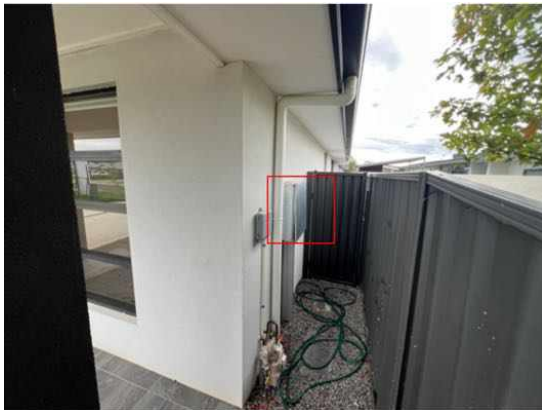
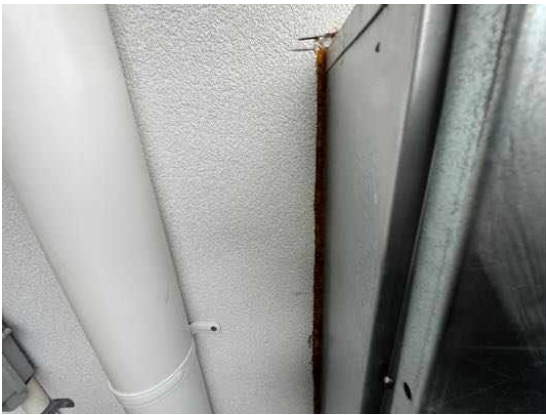
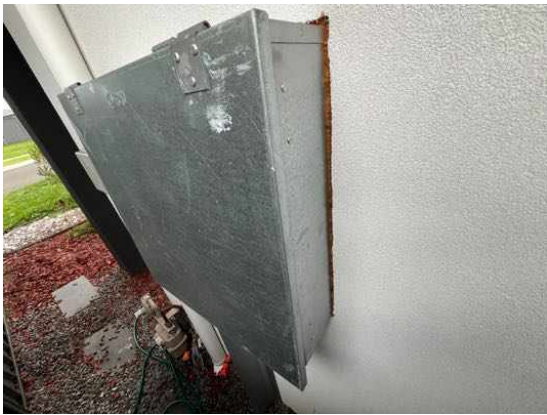
### Finding 3.09

Building: Main Building  
 Location: Meter Box  
 Finding: Meter Box - Unsealed Penetration  
 Information: A gap was observed around the meter box where it interfaces with the surrounding wall lining.

Open penetrations of this nature may allow moisture or water ingress into the wall structure, particularly during rainfall events. Ongoing exposure to moisture in these areas may contribute to deterioration of adjacent building materials over time.

It is recommended that the installation be assessed and the gap appropriately sealed to reduce the risk of moisture ingress into the wall system.

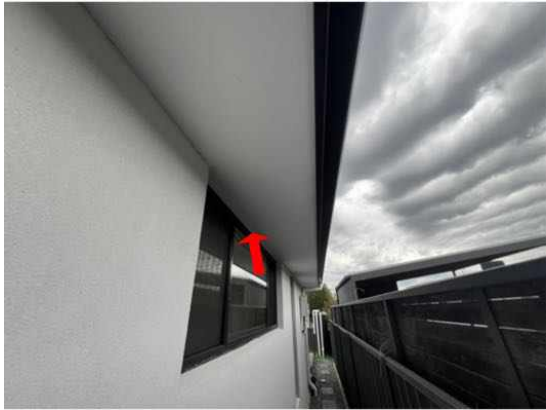
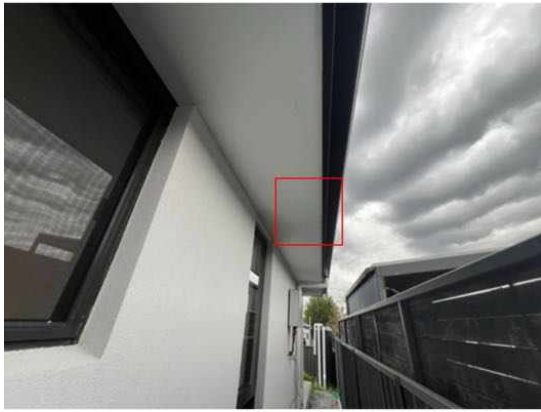
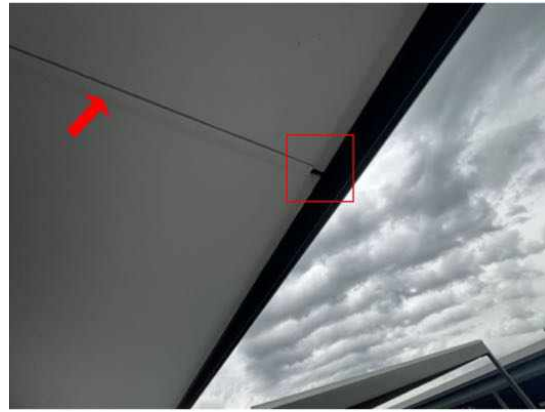
**Finding 3.10**

Building: Main Building  
Location: Exterior walls - right side  
Finding: Eave - Incomplete or substandard works  
Information: The works to this area appear to be incomplete or have been completed to a substandard level.

Works that have not been completed to a satisfactory level create potential for the development of building defects and may impede on the safety and integrity of the overall structure.

It is highly recommended that a carpenter be appointed to complete these works and ensure the safety of the area and the longevity of all associated building elements.

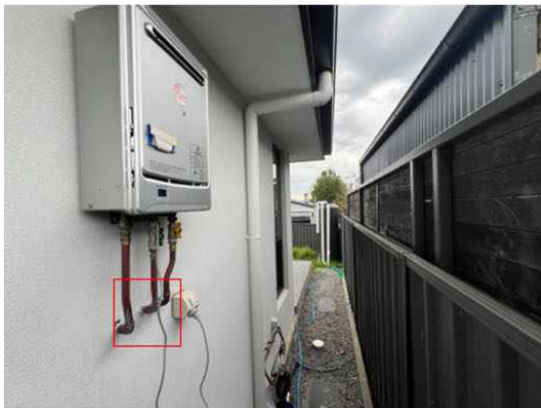
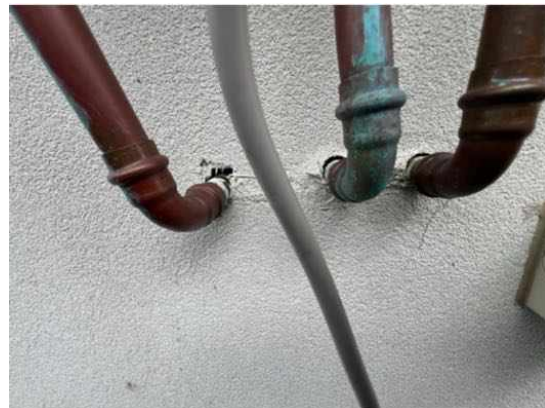
### Finding 3.11

Building:	Main Building
Location:	Exterior walls - right side
Finding:	Pipe wall Penetration – substandard finish
Information:	Pipe/s penetration through the external wall was observed with visible gaps surrounding the pipe. This condition is considered substandard and increases the risk of moisture ingress, pest entry, and deterioration of adjacent building elements.

Gaps around penetrations reduce the effectiveness of the wall's weatherproofing and may allow water to enter concealed areas, particularly during wind-driven rain events.

It is recommended that a licensed plumber or sealant specialist be appointed to properly seal the penetration and ensure the wall remains protected against moisture and environmental exposure.

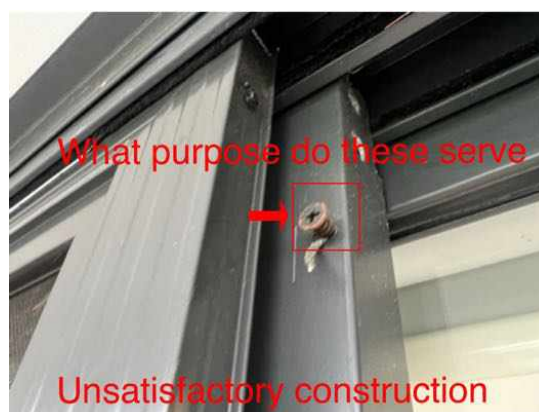
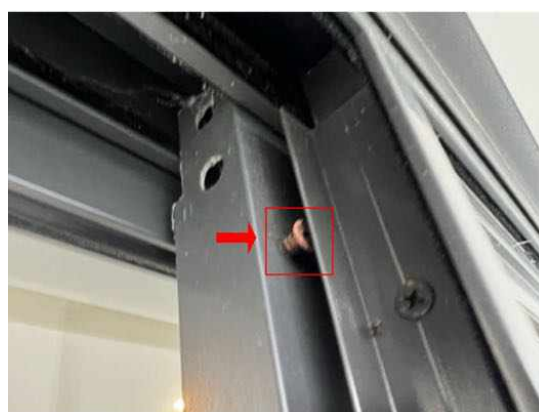
### Finding 3.12

Building:	Main Building
Location:	Alfresco
Finding:	Additional Photos - Minor defects
Information:	Additional photographs have been included for general reference only. Where arrows or annotations are shown, these items may be discussed with the building inspector if

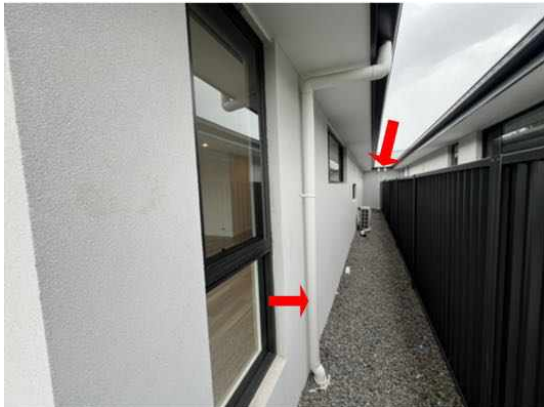
### Finding 3.13

Building:	Main Building
Location:	Exterior walls - left side
Finding:	Downpipe Drainage - Insufficient Capacity
Information:	It is suspected that the roof plumbing system to the exterior roof is insufficient in capacity due to excessive run lengths between downpipes, and may not adequately manage the volume of rainwater it is required to drain. The result is generally that the system may overflow during periods of heavy rainfall, creating damp conditions against external surfaces and the base of the building perimeter.

If left unmanaged, excess moisture in these areas may allow the formation of conditions conducive to deterioration of building elements, including corrosion, rot, and other secondary defects. Damp conditions are also considered conducive to termite and pest activity, further increasing the risk to the structure.

A licensed plumber should be appointed to inspect the roof drainage system and undertake rectification as required in the short term.

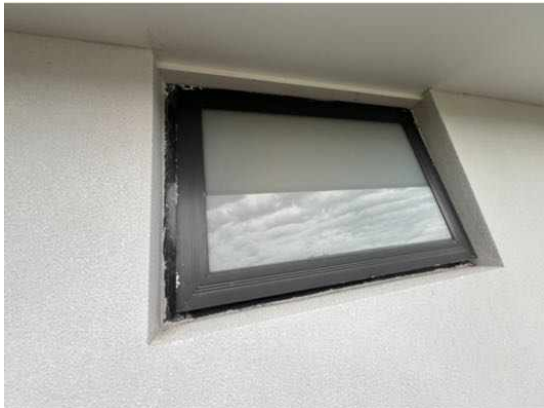
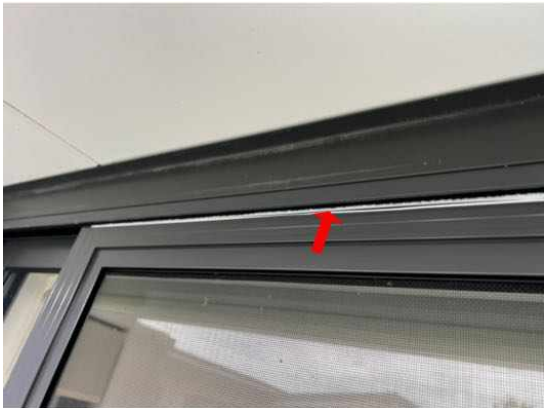
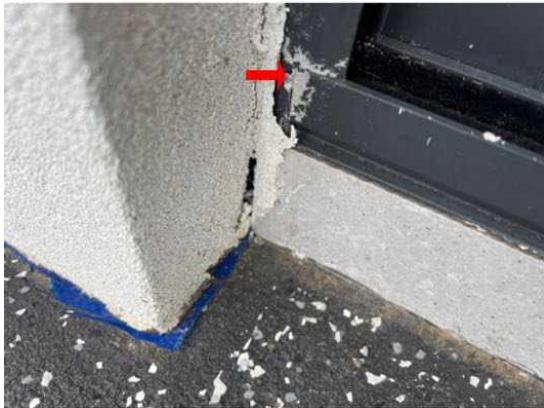
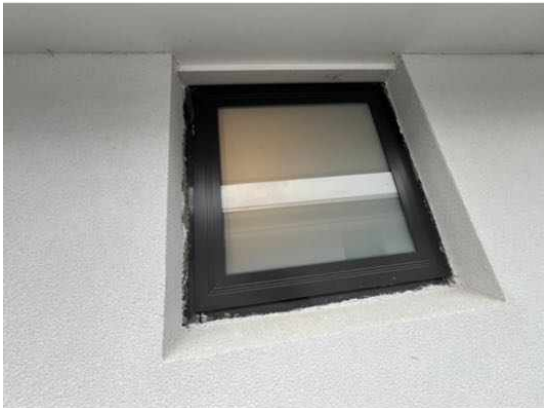
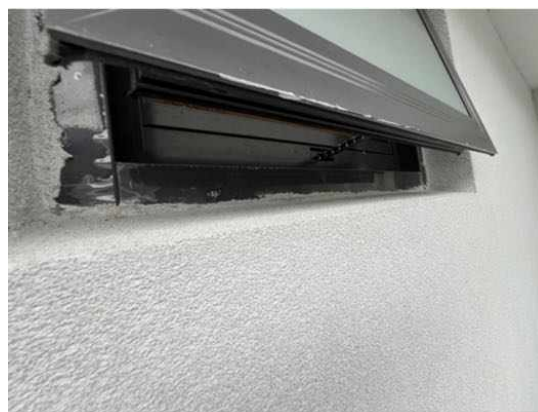
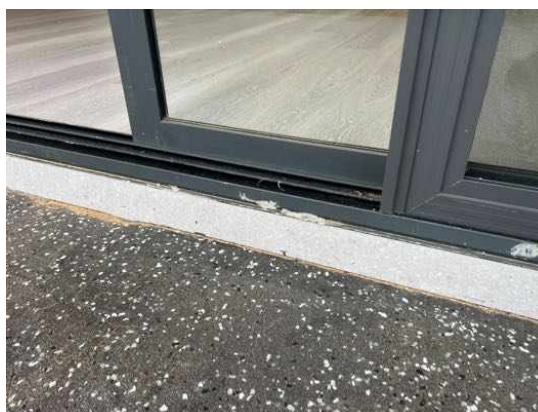
**Finding 3.14**

Building: Main Building  
Location: All External Areas  
Finding: Cleaning - Guide to Standards & Tolerances Part 19.8  
Information: During the inspection, it was observed that general cleaning of the building and site had not been completed to an acceptable presentation standard. The Guide to Standards & Tolerances Part 19.8 states that building works are defective where windows are not clean, floors are not swept, mopped or vacuumed, and fixtures such as tiles, sinks, basins, troughs, and cupboards are not ready for use. The client should consult with the builder to confirm how the cleaning will be completed to meet the minimum standard outlined in the Guide to Standards & Tolerances prior to handover.

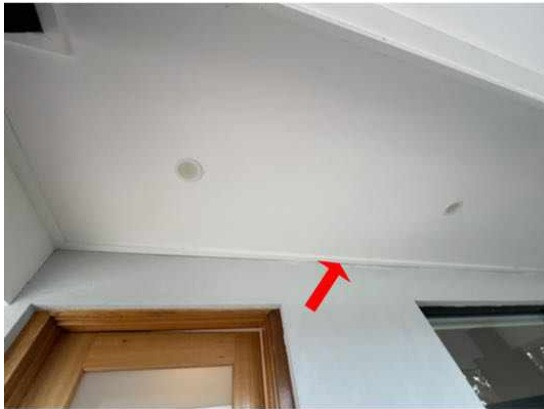
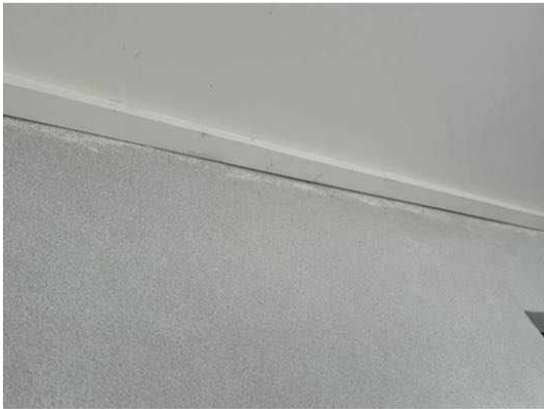
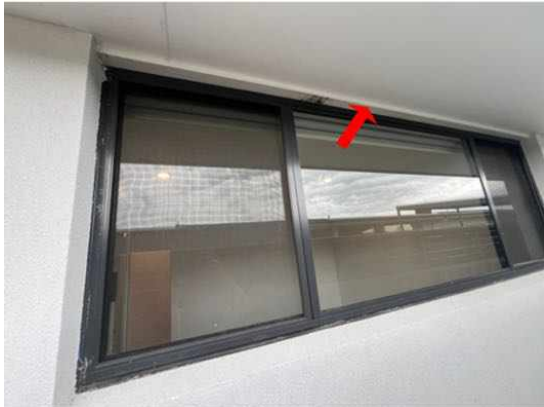
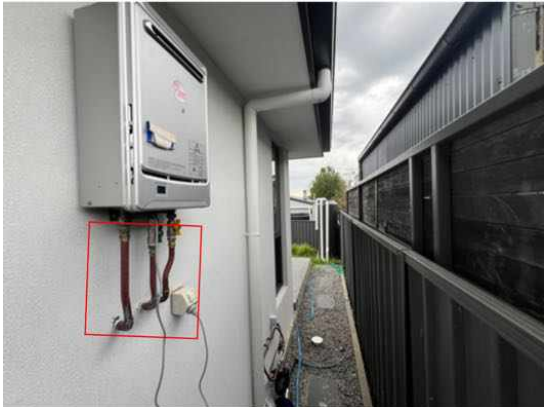
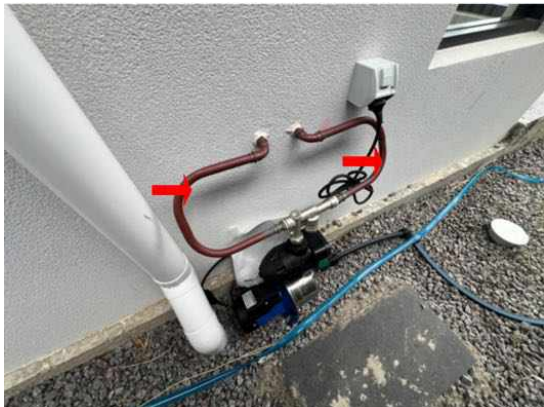
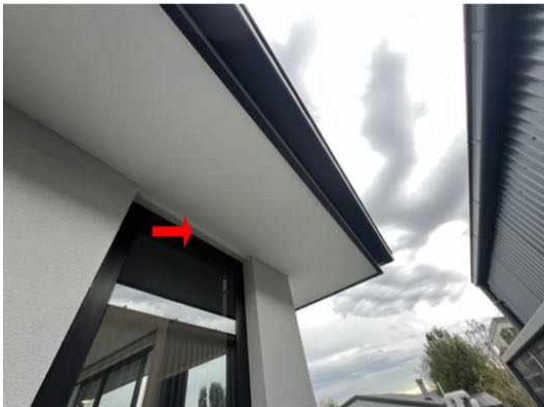
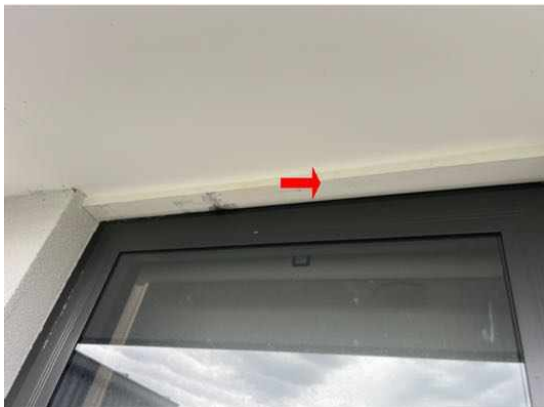
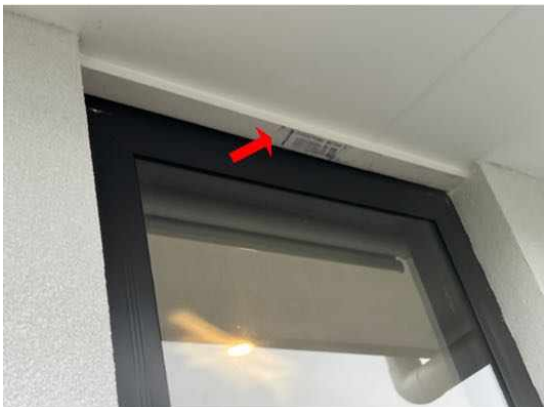
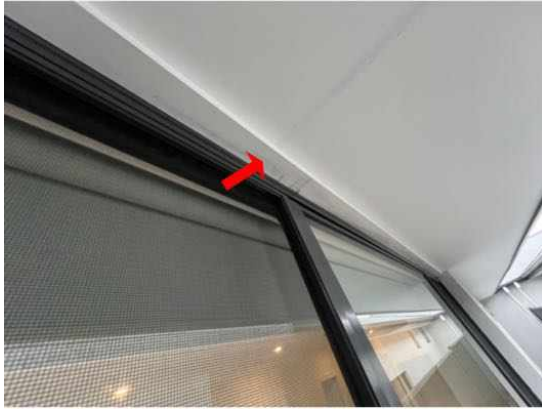
### Finding 3.15

Building:	Main Building
Location:	All External Areas
Finding:	Paint finish - Incomplete
Information:	The paint finish in this area was identified as being incomplete at the time of inspection.

Whilst incomplete or missing paint finish is generally an appearance defect, it can also lead to the development of secondary building defects over time. Incomplete areas of paint finish expose the area to moisture, potentially accelerating the deterioration of underlying building materials.

Incomplete paint finishes should be sanded back, filled, leveled and painted, as applicable. Where inadequate or missing paint protection has led to the deterioration of the associated building element, repair and/or replacement of this building element may be required.

A painting contractor should be appointed as soon as possible to perform necessary works to aid the appearance of the affected area and to ensure the area is protected against further deterioration. Alternatively, the homeowner following manufacturer instructions may perform these works.

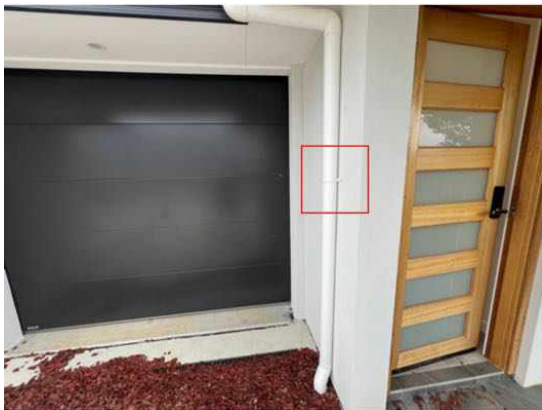
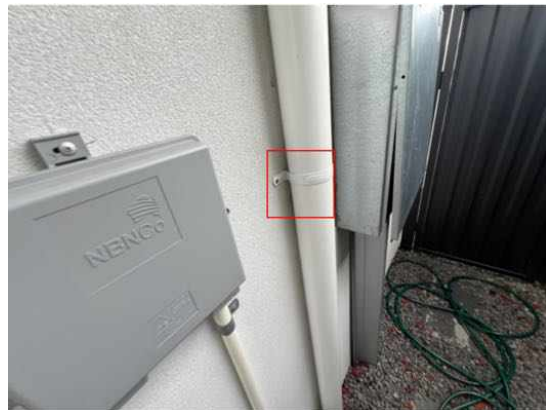
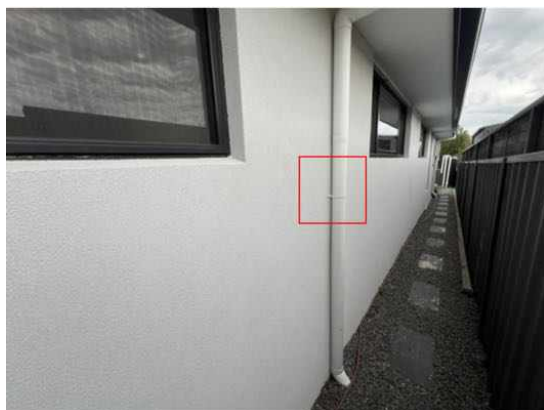
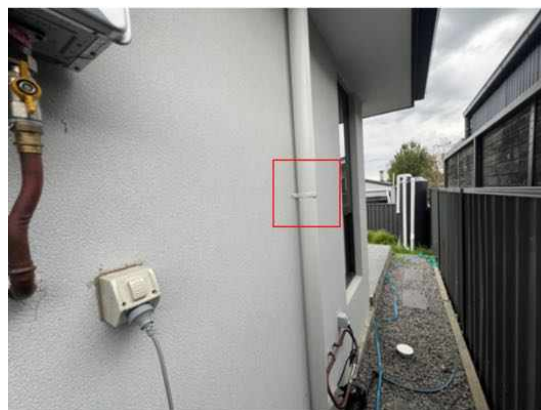
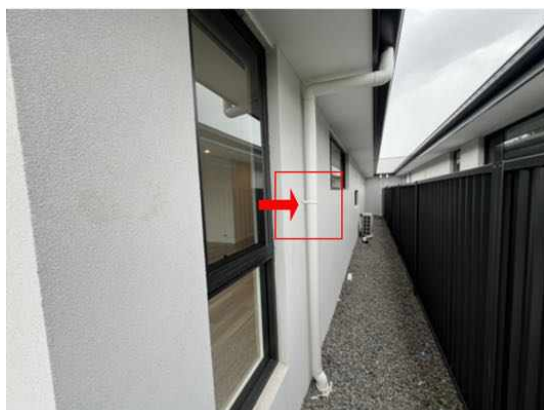
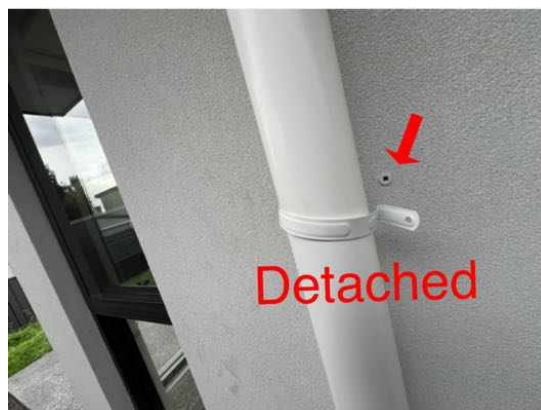
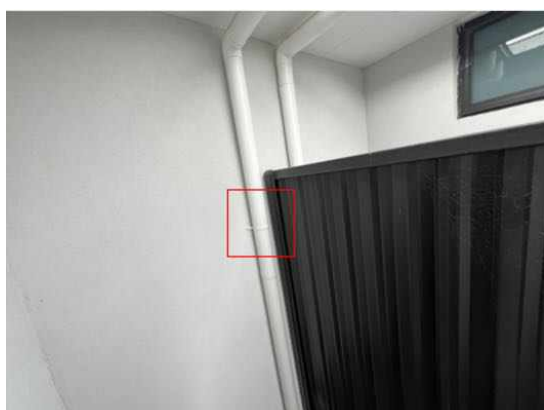
### Finding 3.16

Building:	Main Building
Location:	All Internal Areas
Finding:	Downpipe - Inadequate Fixings
Information:	The downpipe was observed to be secured with only a single clip at the time of inspection. Downpipes require adequate fixing to maintain stability and alignment against the wall structure.

Where insufficient fixings are provided, the downpipe may become loose or displaced over time, which may lead to movement at joints, leakage, or failure of the pipe during stormwater discharge.

A licensed plumber should be appointed to inspect the downpipe and undertake rectification as required in the short term.

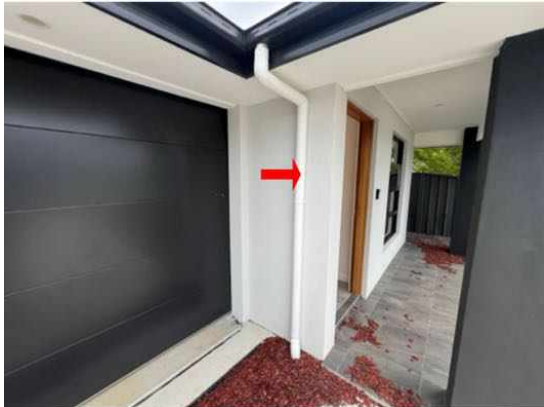
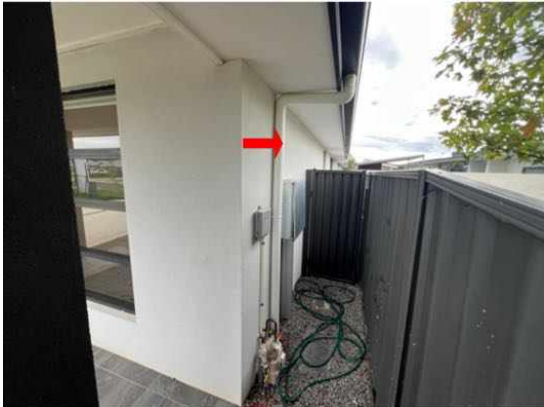
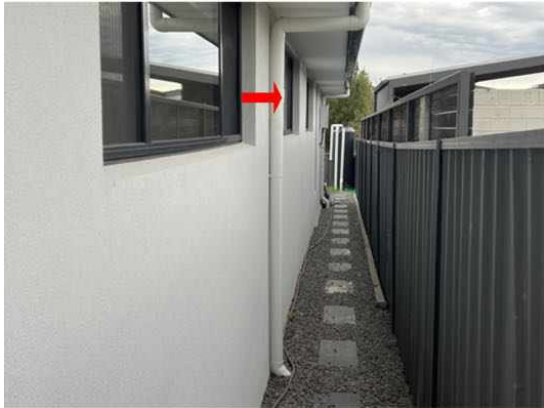
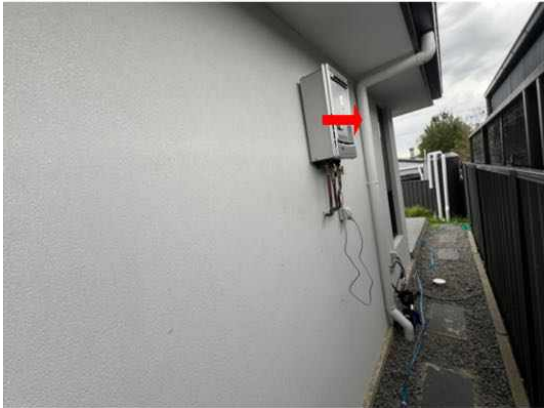
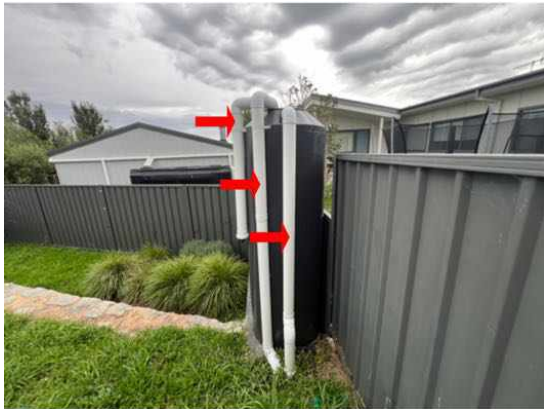
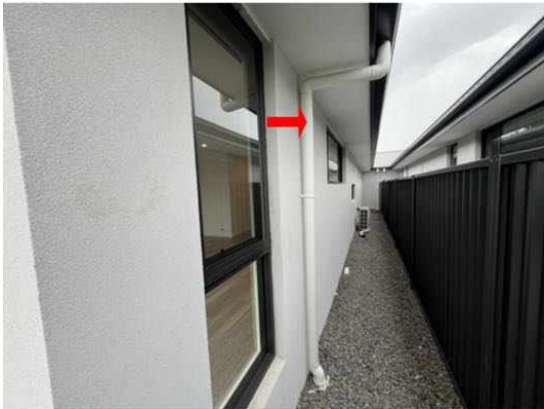
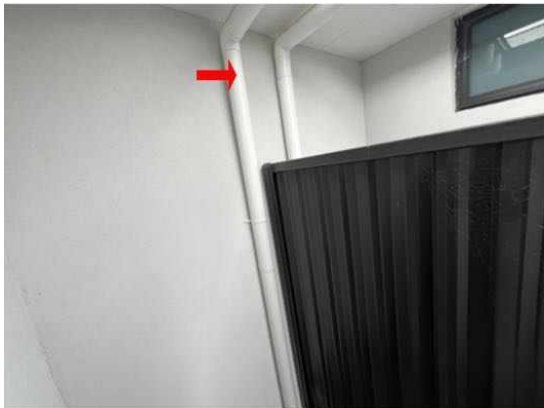
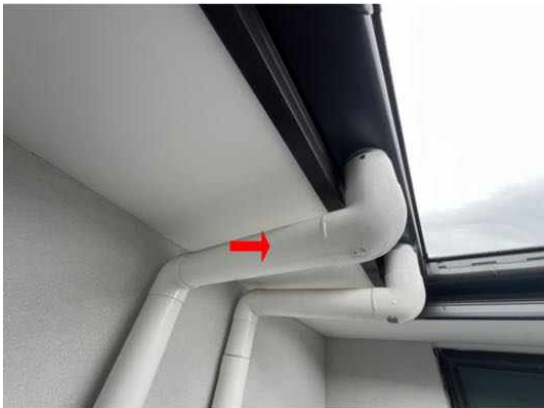
### Finding 3.17

Building:	Main Building
Location:	All External Areas
Finding:	PVC pipes - not UV rated.
Information:	The PVC pipework in this area is not UV rated and therefore not adequately protected from direct sunlight.

In accordance with Australian Standards, PVC pipes and fittings, where exposed to direct sunlight, must have resistance to UV radiation or be alternatively protected.

At the current time, the pipework is non-compliant. Works to rectify this defect is recommended.

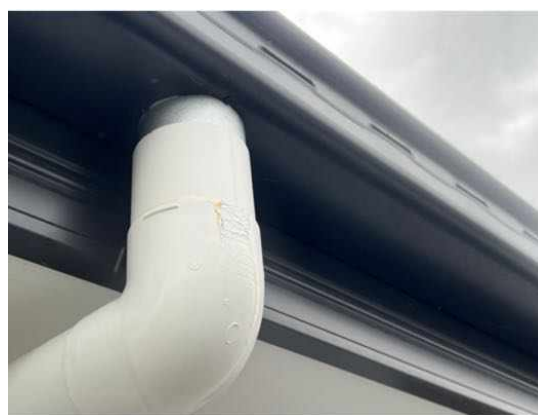
### Finding 3.18

Building:	Main Building
Location:	All External Areas
Finding:	Downpipe - inadequately secured
Information:	The downpipe was noted to be not adequately secured to the adjoining gutter pop. Movement at the joint increases the likelihood of leakage or dislodgement during periods of heavy rainfall.

Inadequate downpipe connection may result in water discharging near the building foundation, increasing the risk of dampness, erosion, or concealed damage to surrounding elements. A licensed plumber should assess the downpipe and ensure it is properly fixed to maintain effective stormwater drainage from the property.

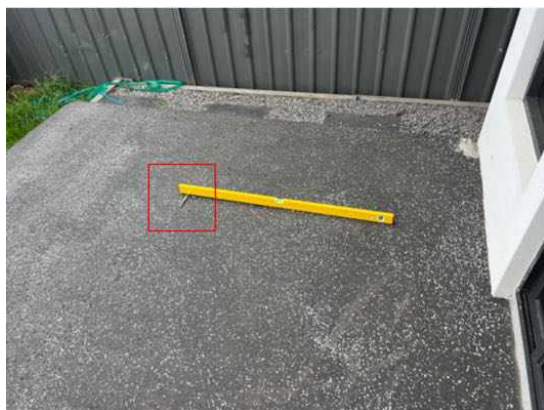
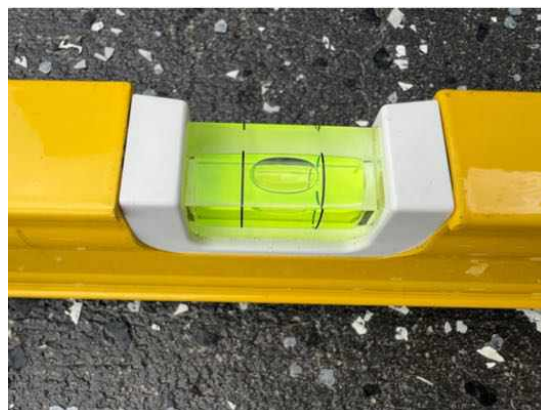
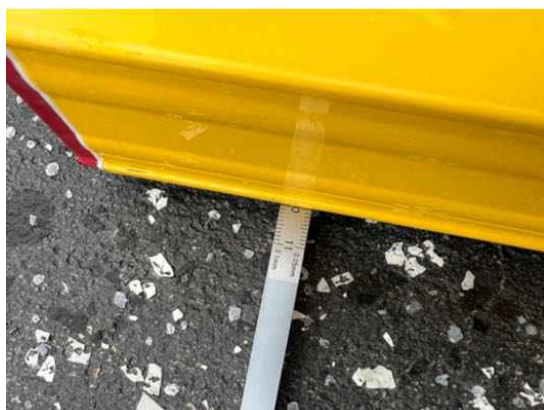
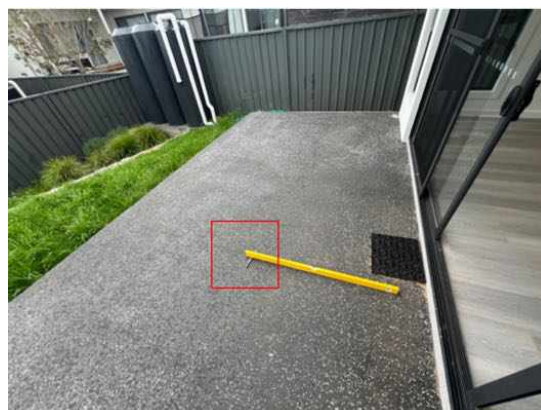
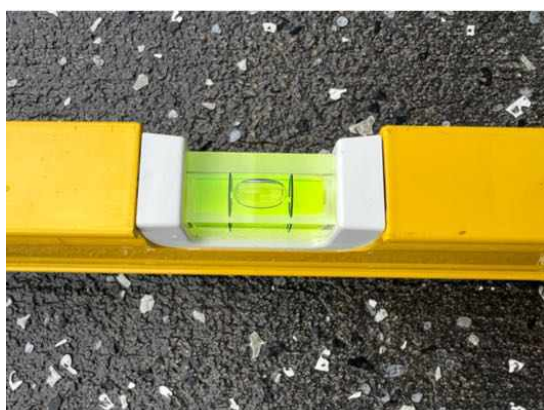
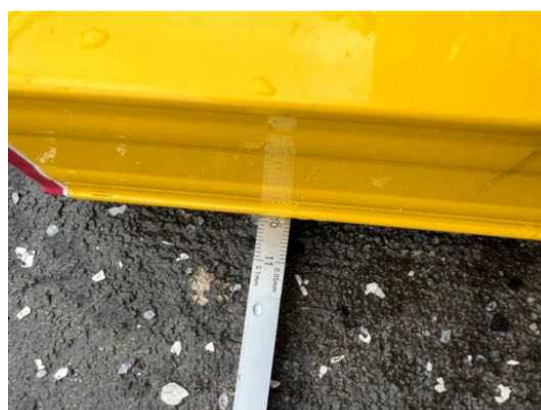
Building:	Main Building
Location:	All External Areas
Finding:	Perimeter Paving - Insufficient Fall
Information:	The perimeter paving or ground levels were found to have an inadequate slope away from the adjoining building structure, creating potential for water pooling in this area.

Perimeter paving is required to fall from the building by a minimum of 25mm in the first metre and bare ground should fall away from the house by 50mm in the first meter. This standard ensures that excessive moisture does not pool around the base of building structures, which creates potential for water and structural damage, as well as making the area susceptible to termite and timber pest activity.

Where paving or ground levels do not have adequate fall, a licensed paving contractor should be appointed to install or remove and re-level pavement.

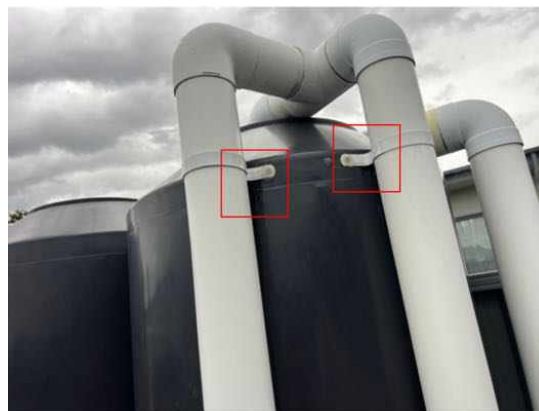
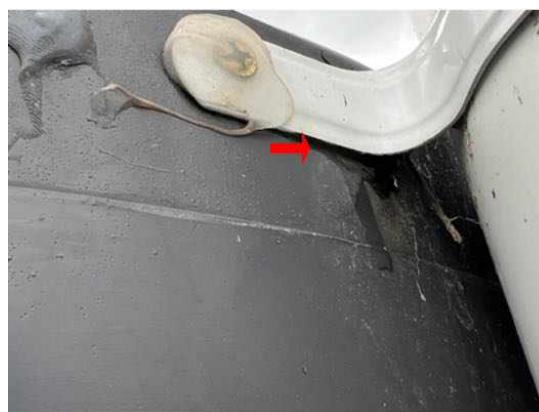
### Finding 3.21

Building: Yard  
 Location: Yard - Back  
 Finding: Water Tank Water leak - External  
 Information: Water leaks were found to be present to exterior plumbing work. Leaks are generally caused by deterioration of the plumbing elements over time, due to exposure to weather conditions, but may have also been caused by minor impact damage.

Such leaking creates damp conditions in the affected area, causing potential for water pooling and subsequent water damage if left unattended. These conditions may also attract termite attack, particularly if the area is subject to minimal levels of sun throughout daylight hours.

It is highly advised that a licensed plumber be appointed to rectify any water leaks that may be present. Areas of repair and replacement of plumbing fittings and fixtures may be required and, as such, a quotation should be sought.

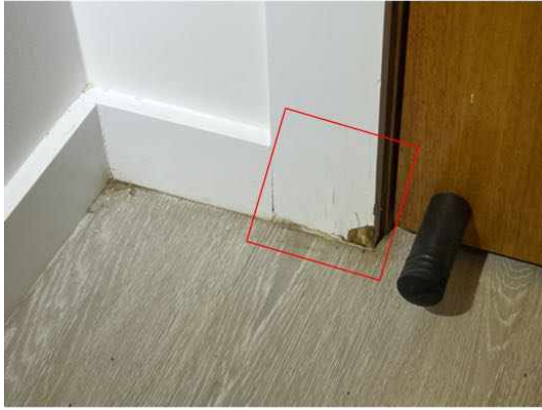
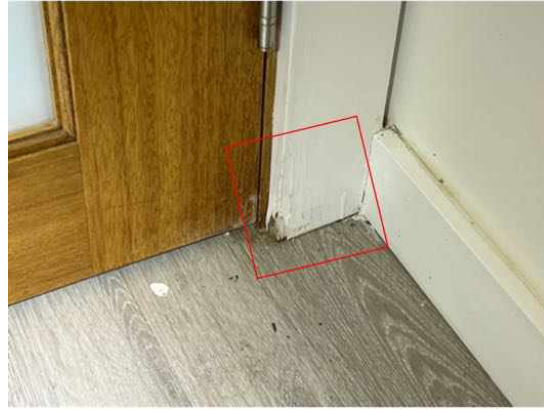
Building:	Main Building
Location:	Entry
Finding:	Timber Element - Moisture Damage
Information:	Moisture-related damage was observed to the architrave at the base of the door frame. Deterioration of timber in this location is commonly associated with prolonged exposure to moisture or water ingress at the threshold.

If left unmanaged, continued moisture exposure may result in further deterioration of the timber elements and adjacent building materials. Moisture-affected timber is also considered a conducive condition for termite activity.

A licensed carpenter should be appointed to inspect the affected area and undertake rectification as required in the short term.

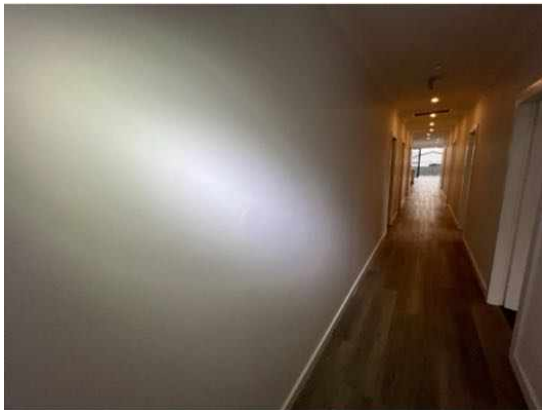
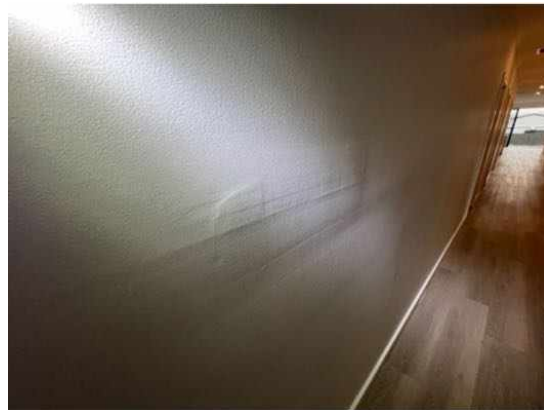
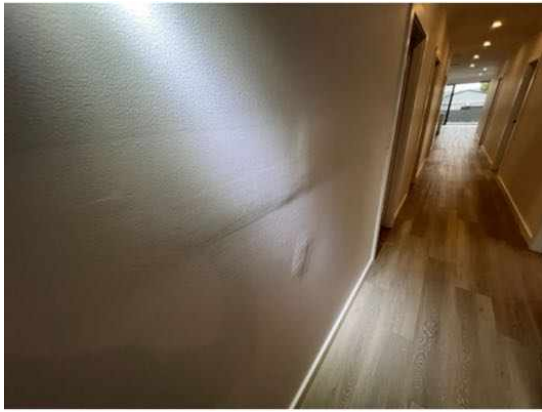
### Finding 3.23

Building:	Main Building
Location:	Entry
Finding:	Wall - Incomplete or substandard works
Information:	The plasterboard finishing to this area appear to be incomplete or have been completed to a substandard level.

Works that have not been completed to a satisfactory level create potential for the development of building defects and may impede on the safety and integrity of the overall structure.

It is highly recommended that a licensed plasterboard contractor or painter should be appointed to finish the wall.
