# Building and Timber Pest Inspection Report

Inspection Date: Tue, 17 Mar 2026

Property Address: 6A Ledger St, Goulburn NSW 2580,  
Australia

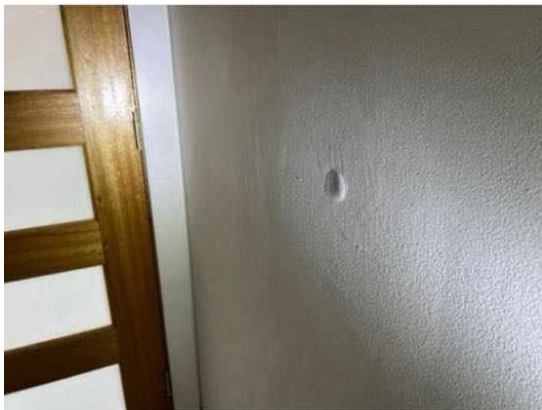
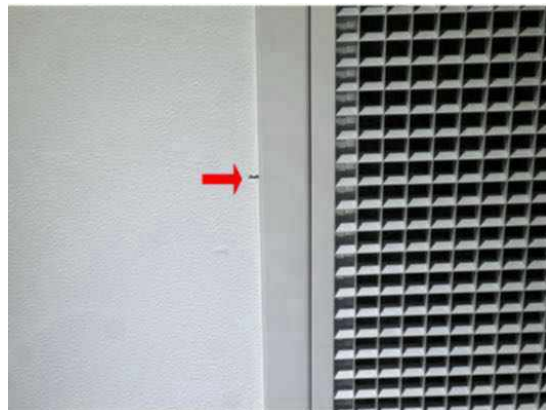
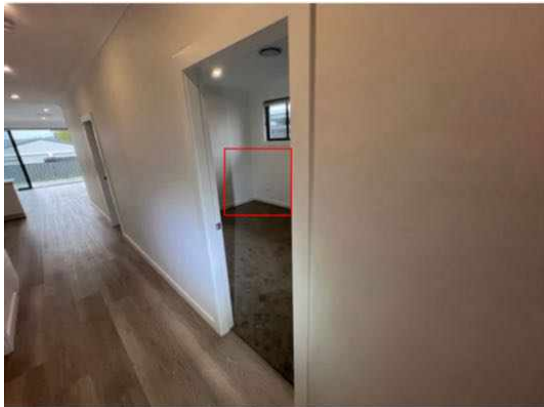
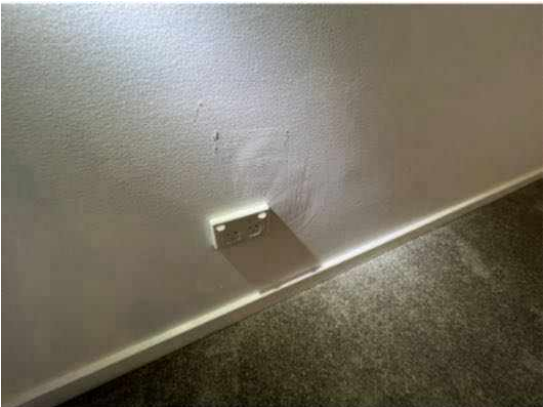
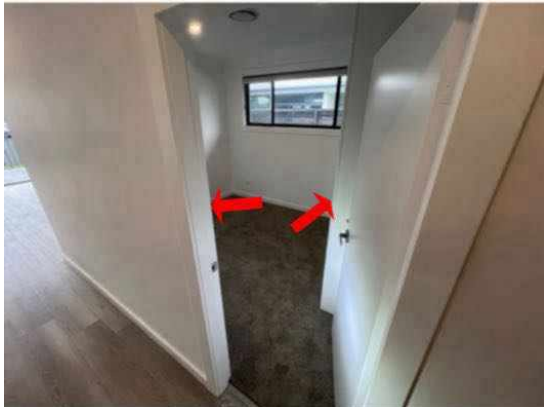
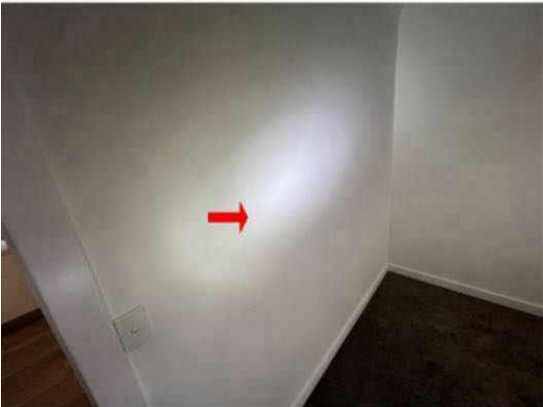
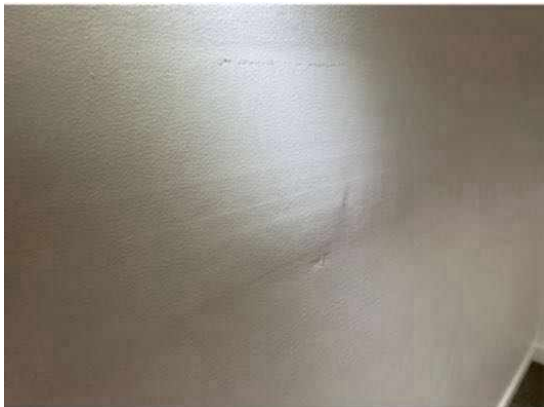
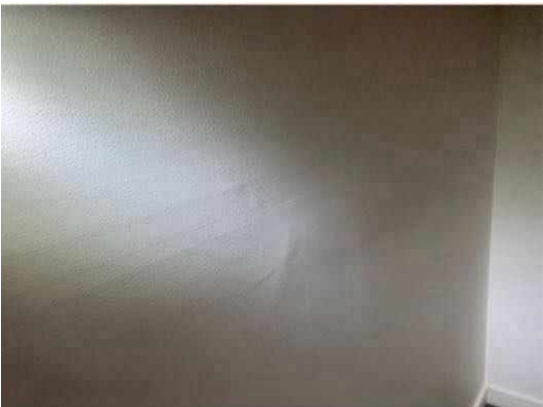
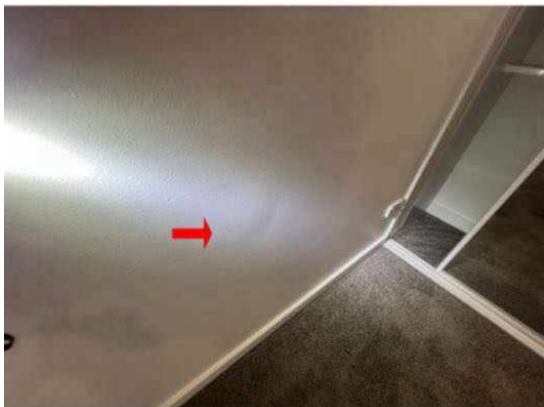
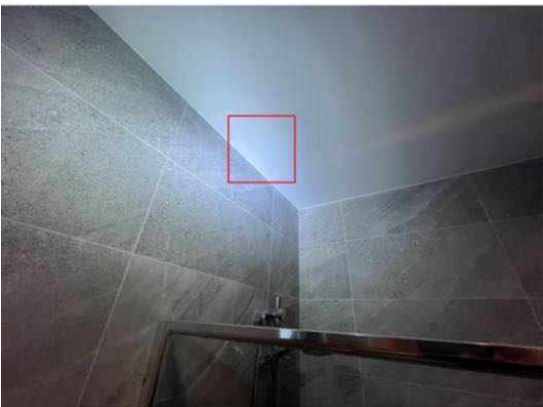
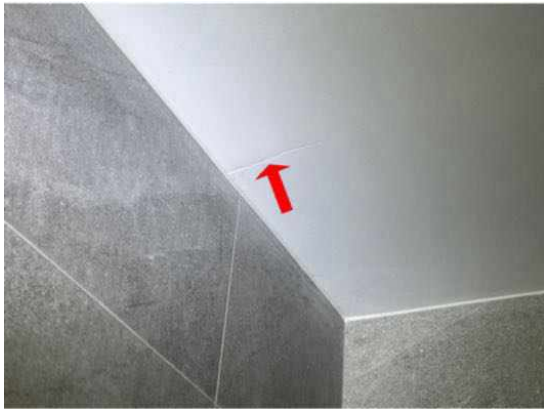
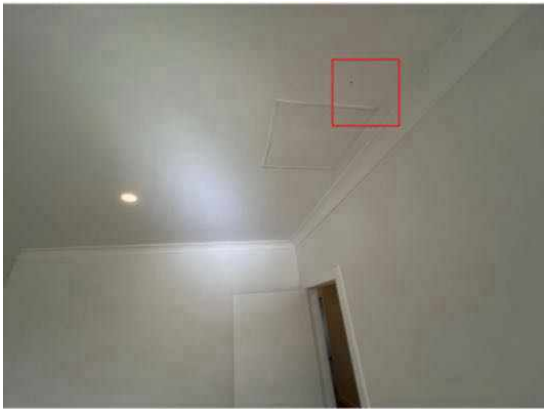
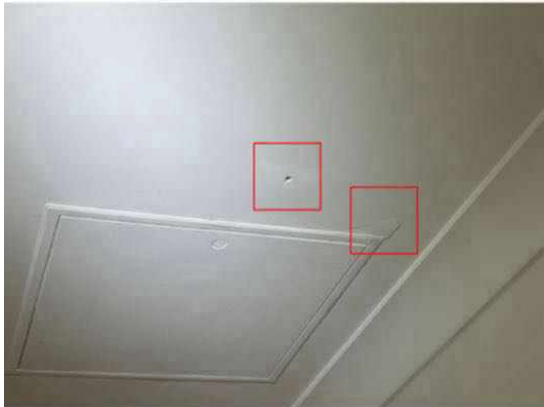
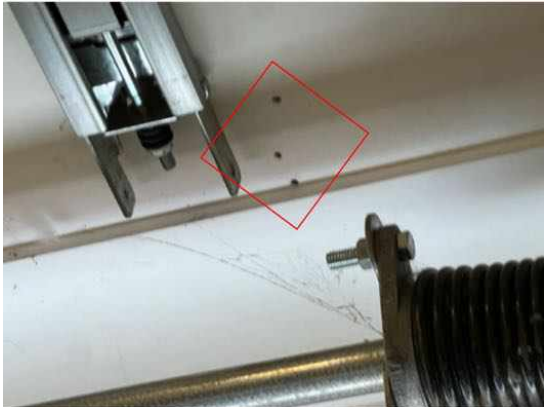
### Finding 3.24

Building:	Main Building
Location:	All Internal Areas
Finding:	Plasterboard - Incomplete or substandard works
Information:	The works to this area appear to be incomplete or have been completed to a substandard level.

Works that have not been completed to a satisfactory level create potential for the development of building defects and may impede on the safety and integrity of the overall structure.

It is highly recommended that a plasterer or painter be appointed to complete these works and ensure the safety of the area and the longevity of all associated building elements.

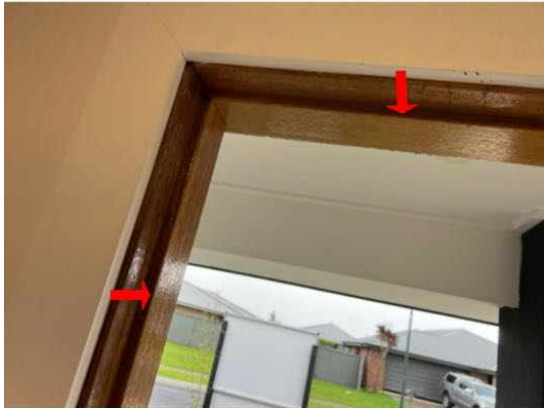
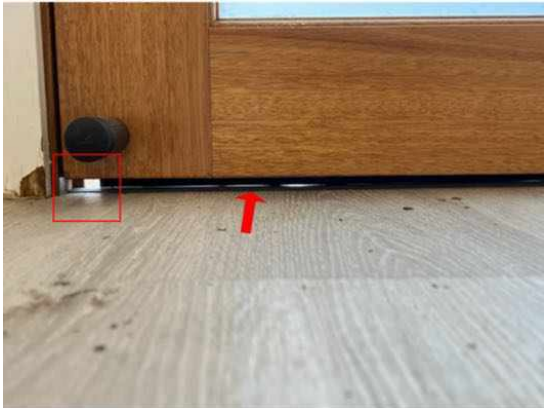
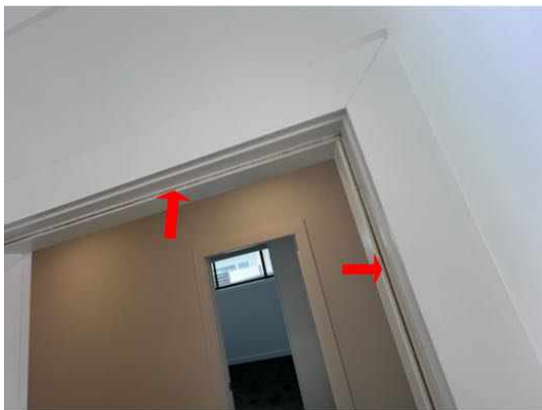
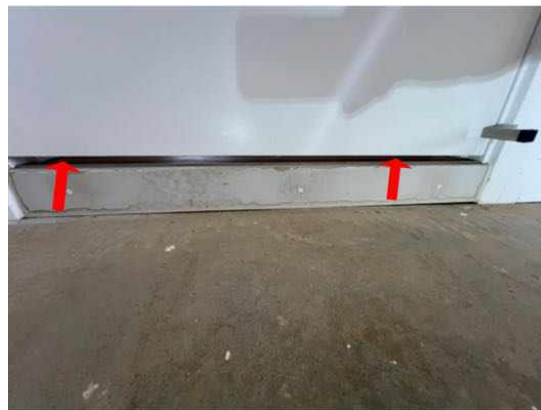
**Finding 3.25**

Building: Main Building  
Location: Entry, Garage  
Finding: Doors (External) – Gaps and/or Seals Defective (NCC 3.12.3.3)  
Information: External doors were identified as not fully sealed to all edges, including the main entry and garage-to-house access doors. All external doors, including those leading from garages, must be fitted with compliant weather seals in accordance with NCC 3.12.3.3 to prevent air and moisture ingress. The client should bring this matter to the certifier’s attention to seek clarification on whether the installation meets compliance with the NCC.

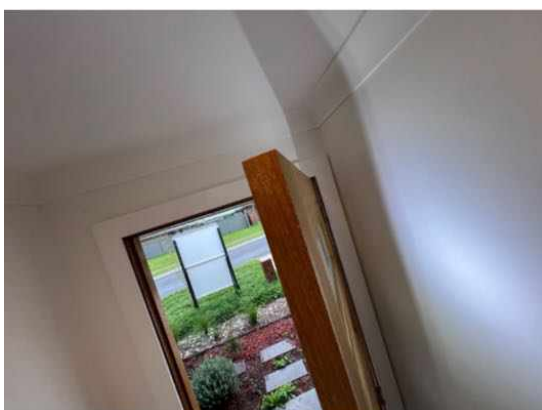
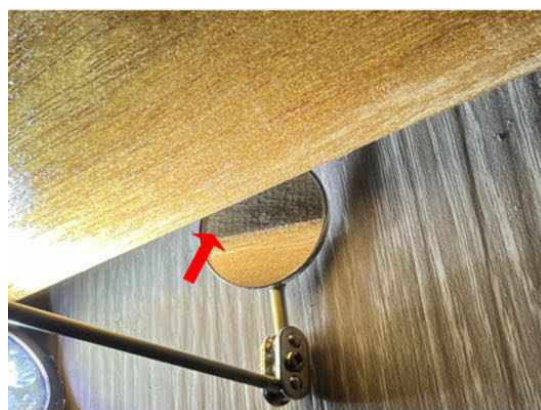
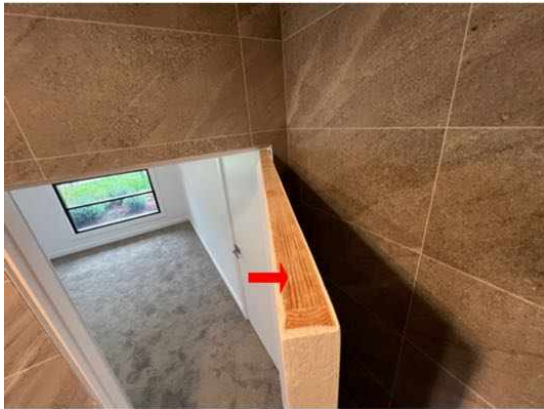
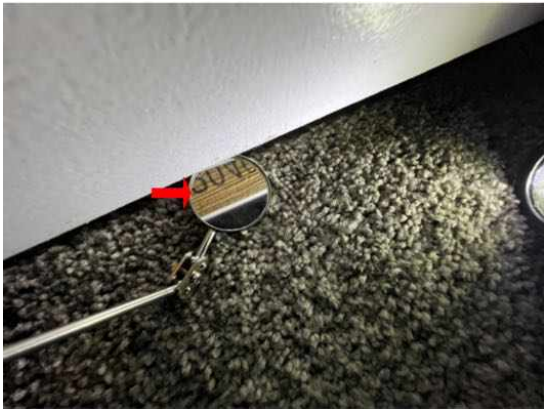
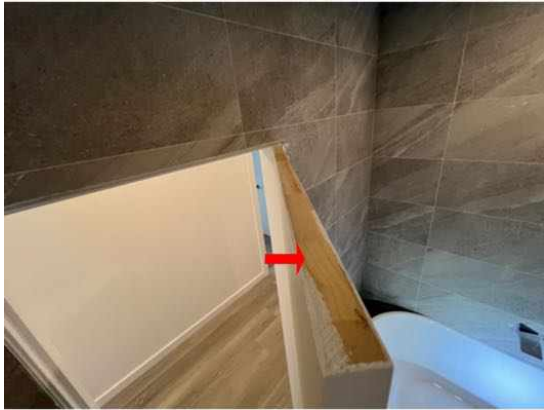
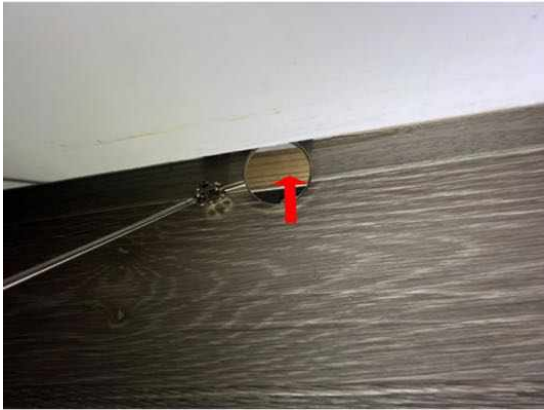
### Finding 3.26

Building:	Main Building
Location:	All Internal Areas
Finding:	Door Edges Not Sealed - Guide to Standards & Tolerances Part 9.6
Information:	It was observed during the inspection that the tops and bottoms of several timber doors have not been sealed or painted. While this may appear minor, unsealed edges expose the timber to potential moisture ingress, which can cause swelling, distortion, and premature deterioration.

The Guide to Standards & Tolerances Part 9.6 states that door leaves are defective if they do not have all sides, top and bottom edges sealed or painted in accordance with the manufacturer's specifications. In accordance with AS 2311 Guide to the Painting of Buildings, all exposed timber surfaces should be properly sealed or coated to protect against moisture absorption and decay.

The client should clarify with the builder whether not sealing the door edges affects the manufacturer's warranty and how the installation complies with the requirements of the Guide to Standards & Tolerances and AS 2311.

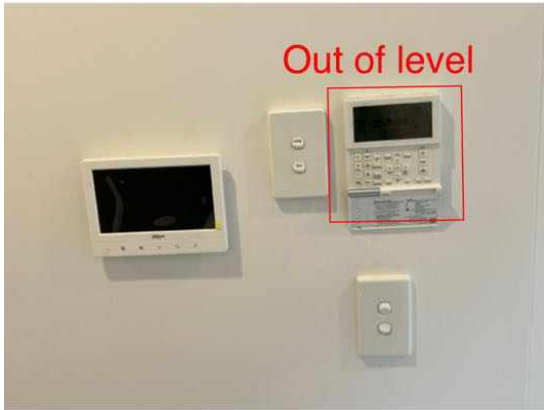
**Finding 3.27**

Building: Main Building  
Location: Hallway  
Finding: Additional Photos - Minor defects  
Information: Additional photographs have been included for general reference only. Where arrows or annotations are shown, these items may be discussed with the building inspector if further clarification is required.

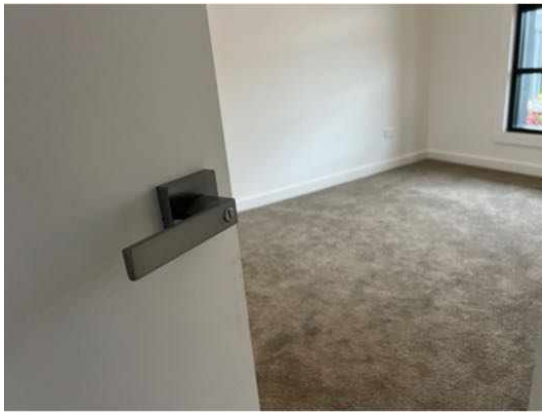
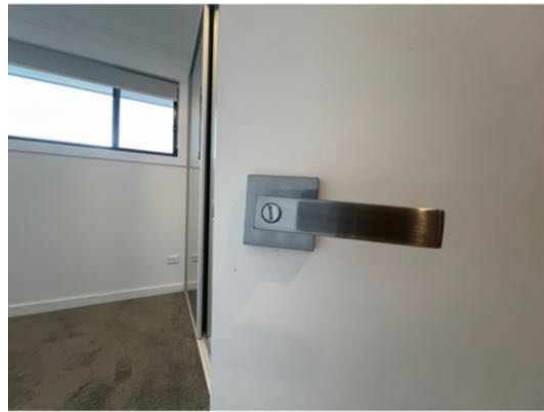
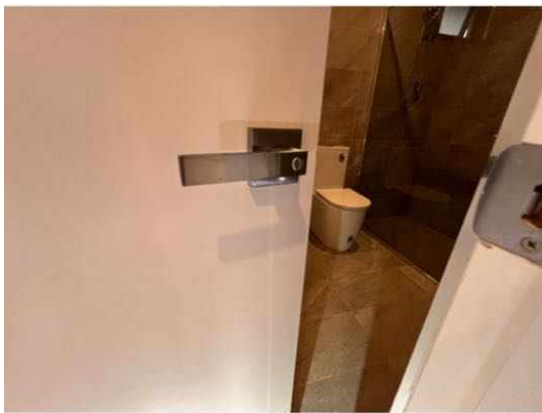
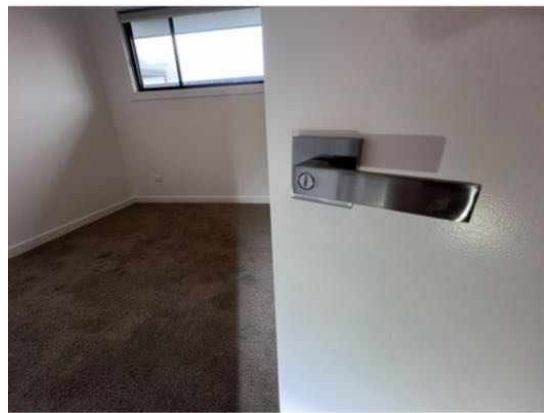
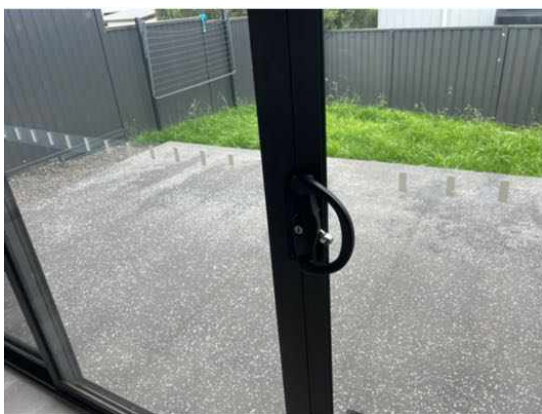
**Finding 3.28**

Location: All Internal Areas  
Finding: Door Handle - Loose  
Information: The door handle in this area was identified as loose at the time of inspection. A loose door handle can impede the proper operation of the door and, if left unattended, may lead to further deterioration or damage to the associated door structure.

This defect is typically caused by wear and tear, insufficient fixing, or deterioration of the handle's components.

It is recommended that a qualified carpenter or general handyperson be appointed to secure or replace the handle to restore its functionality and ensure proper operation.

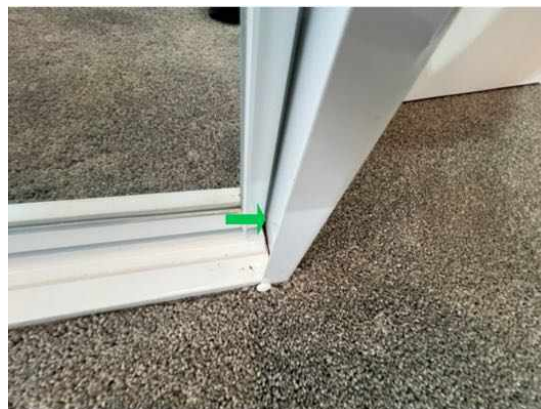
### Finding 3.29

Building:	Main Building
Location:	All Bedrooms
Finding:	Robe Sliding door - not plumb
Information:	The sliding robe doors are not plumb with the wall when closed, resulting in visible misalignment. This issue is generally caused by improper track installation, frame movement, or an out-of-square opening. Misaligned robe doors can affect operation, closing functionality, and the overall finish. The responsible carpenter or installer should assess the issue and undertake corrective work as required to ensure the doors align properly within the opening.

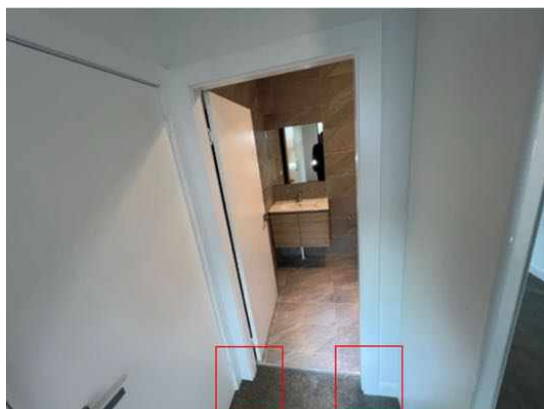
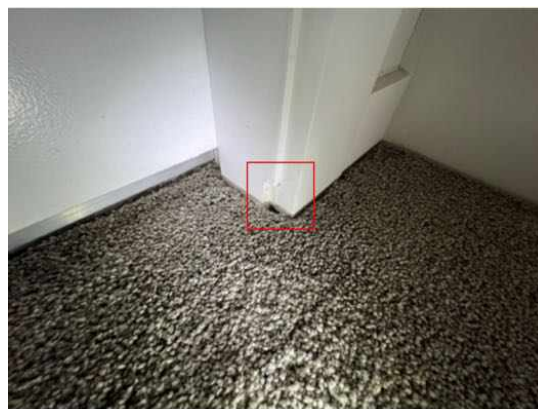
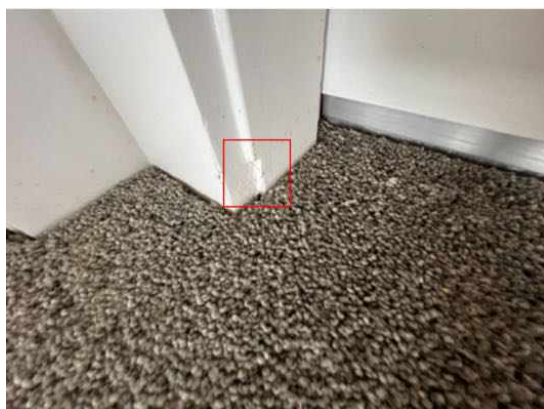
### Finding 3.30

Building:	Main Building
Location:	Ensuite
Finding:	Door Installation - substandard or incomplete
Information:	The installation of the door jamb appears to have been completed to a substandard level of workmanship or is incomplete. Generally substandard repairs or installation are related to poor workmanship, the use of inappropriate materials, or a failure to complete installation to a suitable standard.

undertake rectification. Unfinished and substandard building works are likely to degrade more quickly and may create potential for secondary defects to associated building elements.

Where installation is substandard and/or incomplete, the carpenter or painter should

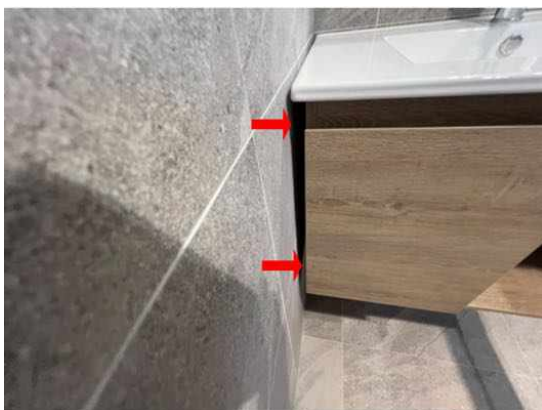
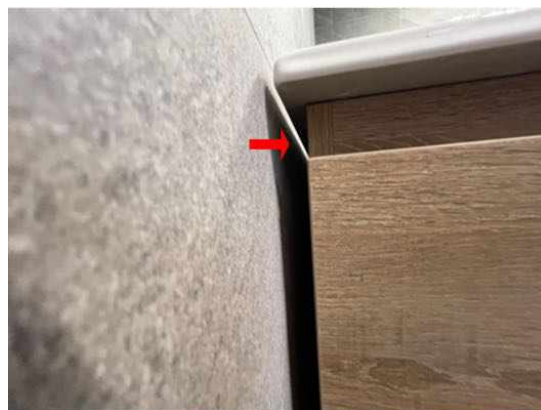
Building:	Main Building
Location:	Ensuite
Finding:	Joinery - Missing Filler (wall)
Information:	No filler has been installed between the joinery doors/drawers and the adjoining surface at the time of inspection. This component is typically included to provide a buffer, preventing direct contact between moving parts and adjacent surfaces while also concealing gaps for a more seamless finish.

The absence of a filler may lead to doors or drawers rubbing against the adjoining surface, potentially causing wear and impacting functionality over time. Additionally, the visible gap detracts from the overall aesthetic appeal of the installation.

It is recommended that a qualified cabinet maker or joiner be engaged to install an appropriate filler to improve both the functionality and appearance of the joinery.

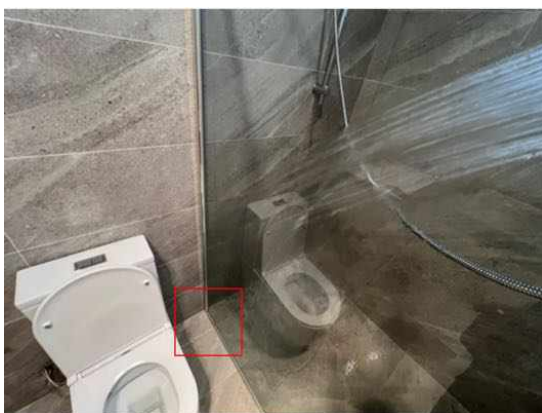
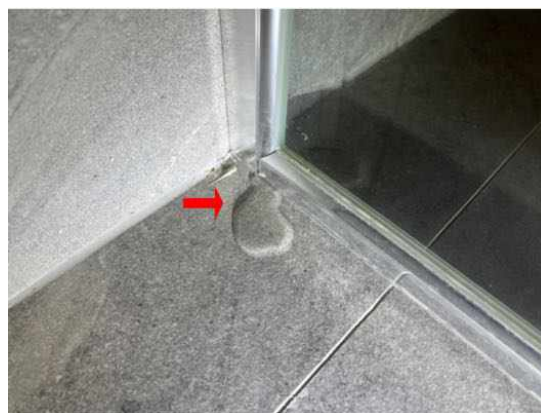
### Finding 3.32

Building:	Main Building
Location:	Ensuite
Finding:	Shower screen - active leak
Information:	A active leak was identified to the shower screen, likely due to deteriorated or inadequate sealant. If left unmanaged, water ingress may lead to damage to adjacent walls and flooring, as well as creating conditions conducive to mould growth.
	Resealing is recommended to restore a watertight seal and prevent further deterioration.

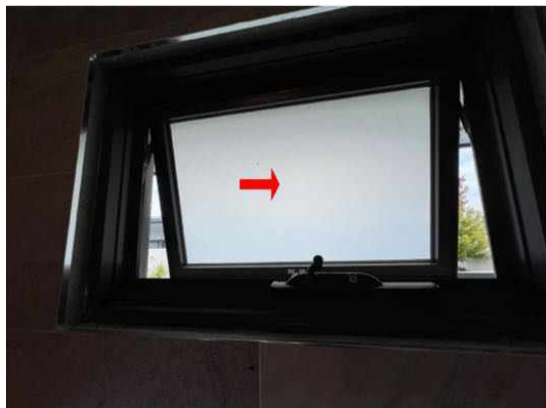
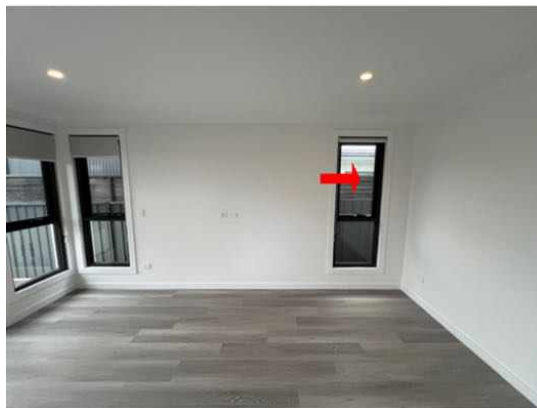
### Finding 3.33

Building:	Main Building
Location:	Ensuite, Living Room
Finding:	Flyscreens - Missing
Information:	Flyscreens were found to be missing to the windows in this area at the time of inspection. Whether the flyscreens have not been installed or have been removed post-installation, this missing building element detracts from the operational state of the window.

Where not replaced, missing flyscreens allow pest and insect ingress into the

adjoining room/s. It is advised that all missing building elements be replaced in order to ensure the full function of all building structures.

A general handyman may be appointed to replace flyscreens at the discretion of the client.

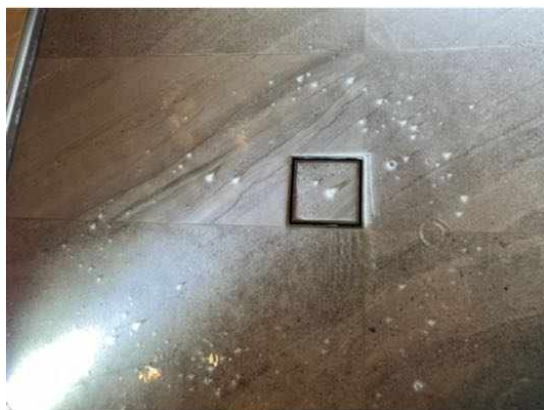
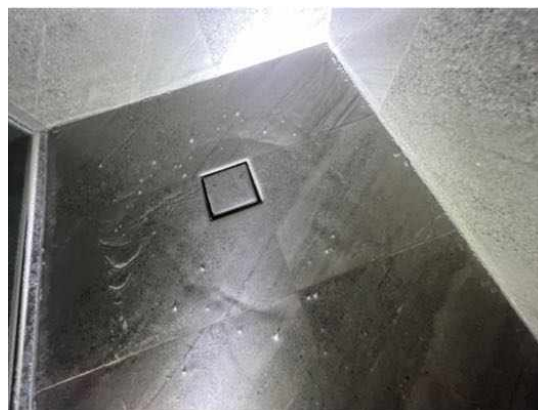
### Finding 3.34

Building:	Main Building
Location:	Ensuite, Bathroom
Finding:	Shower base - Water pooling
Information:	Evidence of water pooling around the floor waste in the shower recess was noticed at the time of inspection. It is suspected that this excessive moisture is attributed to insufficient fall in the shower floor tiles.

This pooling is minor overall but is still considered unsatisfactory, as standard tiling practices would not permit this situation to occur. Pooling water around floor wastes can create a slip hazard in extreme cases and create conditions that are conducive to mould growth over time. Where left unmanaged, the degradation of sealant and grouting is also likely to occur, possibly necessitating further repair works.

Remedial works may involve some sections of tiling and flooring repair and replacement. A tiling contractor or bathroom specialist should be appointed to provide further advice on reparation options and to perform works as necessary.

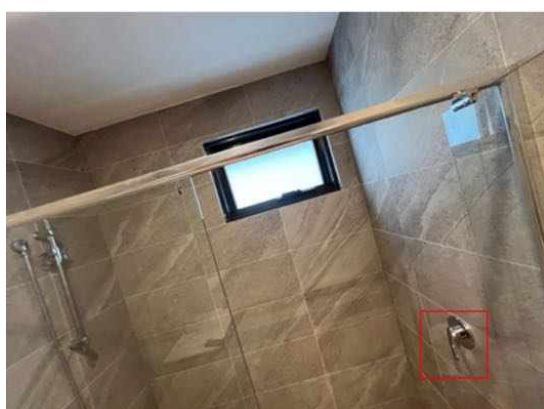
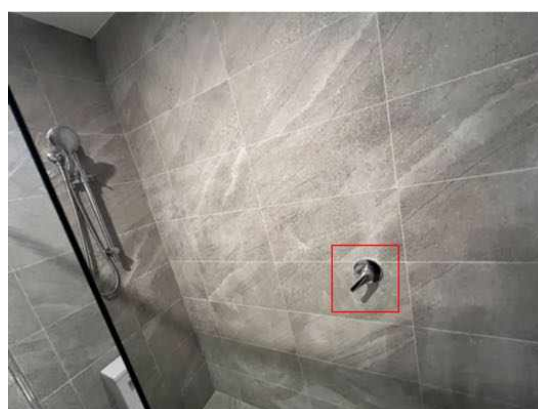
### Finding 3.35

Building:	Main Building
Location:	Ensuite, Bathroom
Finding:	Tap - Water hammer
Information:	This tap shows evidence of water hammer being present. Water hammer, a pressure surge resulting when a fluid is forced to suddenly change direction, is a common defect in plumbing fittings, particularly those that are aged and not frequently maintained. Water hammer is generally caused by factors that create high water pressure in the affected plumbing fixture, usually evidenced by a faint banging noise during operation of the affected tap.

Although water hammer is generally considered to be a minor defect, subsequent damage such as erosion of tap hardware and/or water damage to associated building elements is likely to occur if left unmanaged.

A licensed plumber should be appointed as soon as possible to replace any affected tap hardware and perform any remedial works as necessary. Please be advised that the appointment of a cabinet maker or qualified carpenter may be necessary if water damage to associated building elements has occurred.

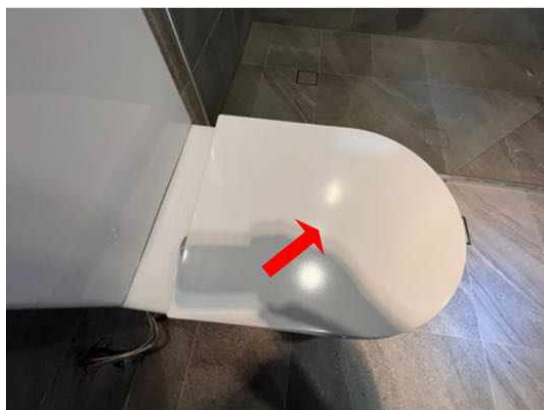
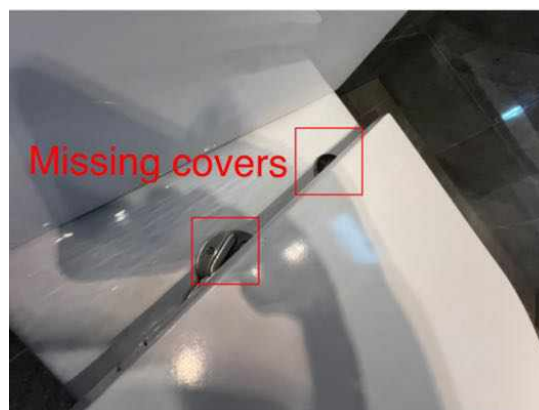
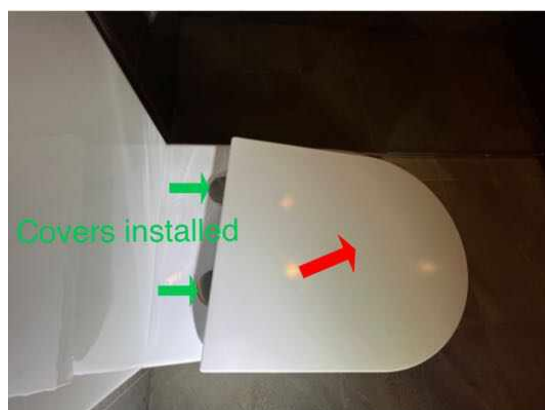
### Finding 3.36

Location: Ensuite, Bathroom  
 Finding: Toilet seat - Loose  
 Information: The toilet seat in this area is loose and requires adjustment to tighten.

If left unmanaged, the fitting may further deteriorate, causing potential for the development of other minor secondary defects.

A handy person or plumber should be appointed to perform these rectification works at discretion of the client.

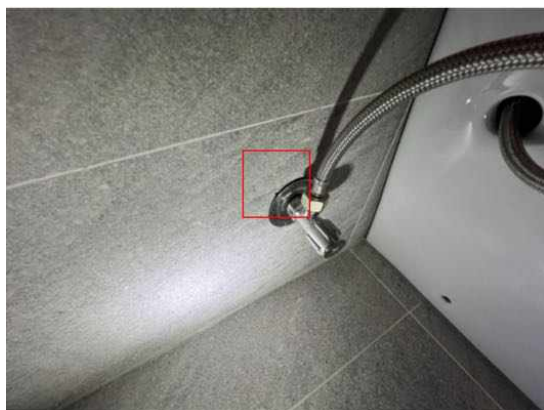
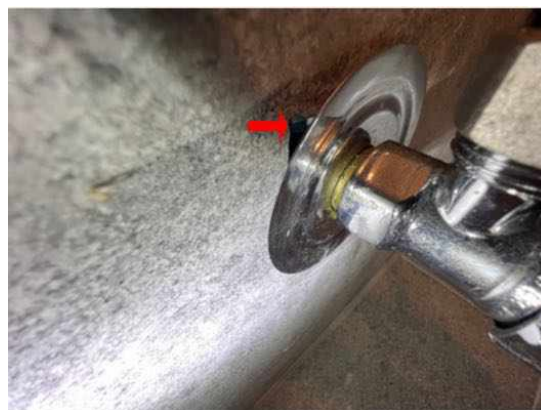
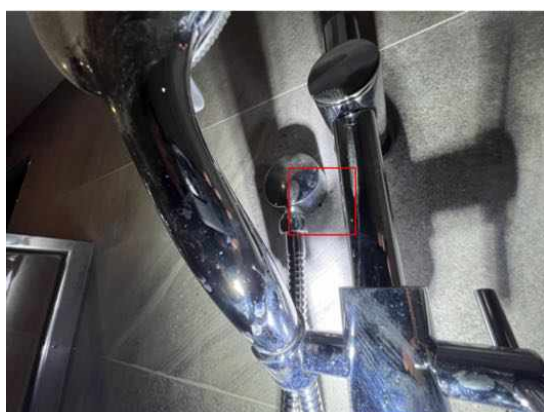
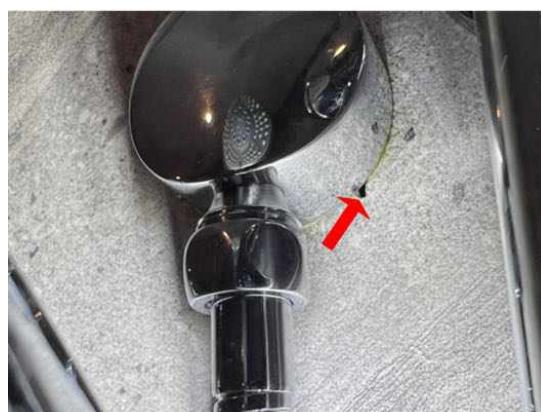
### Finding 3.37

Building: Main Building  
 Location: Ensuite, Bathroom  
 Finding: Tiles - penetration gaps  
 Information: Over sized cutout for pipe penetration was evident to the tiling in this area at the time of inspection. While the opening appears to be minor, this area is frequently exposed to water, allowing potential for water penetration into adjoining sections of walls or flooring.

If left unmanaged, water penetration to these areas may lead to subsequent water damage, which is likely necessitate repair work to affected building elements.

A tiling contractor should be appointed to ensure that no further water damage occurs. The re-application of silicone and grouting throughout remaining tile work is also advised, to further protect the area against water penetration.

Where water penetration has led to water damage, appointment of a relevant tradesperson may be required to repair damaged building elements.

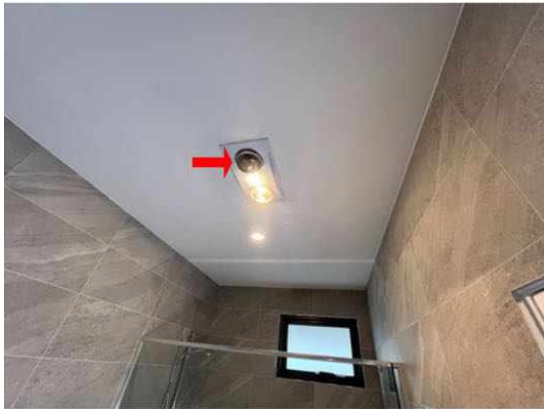
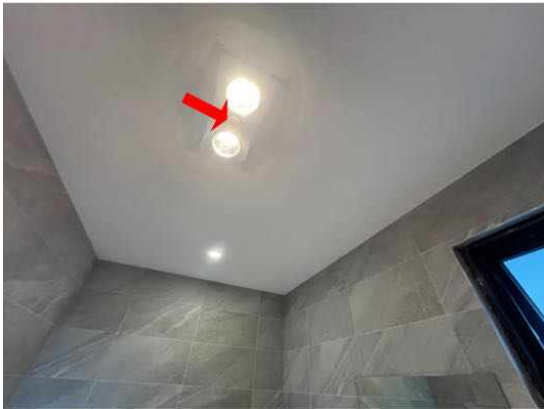
### Finding 3.38

Building:	Main Building
Location:	Ensuite, Bathroom
Finding:	Light bulb for heating not working
Information:	During the inspection, it was noted that the light bulbs for the heat light are not working. This could be due to a variety of reasons such as a blown bulb or faulty wiring.

As a remedial action, it is suggested to replace the light bulbs and if the issue persists, further investigation into the wiring and electrical system may be necessary to resolve the problem.

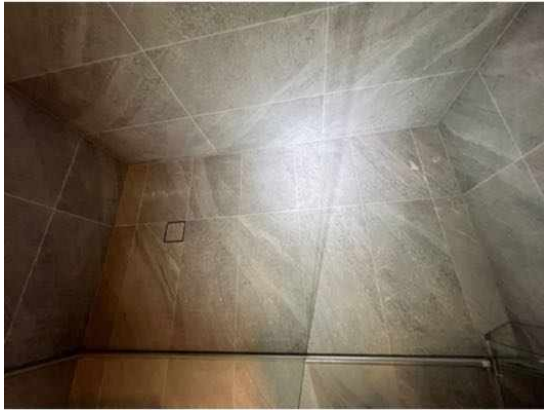
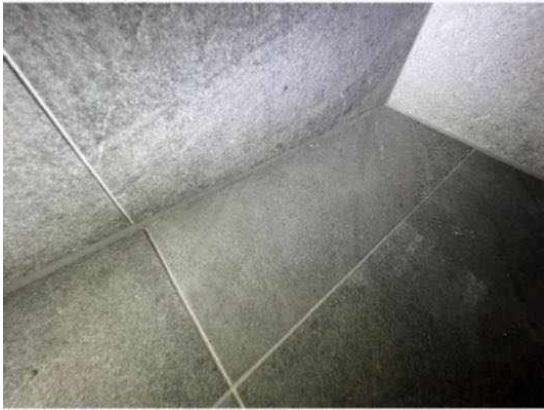
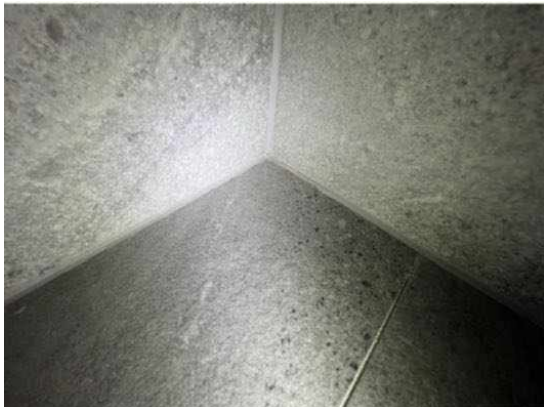
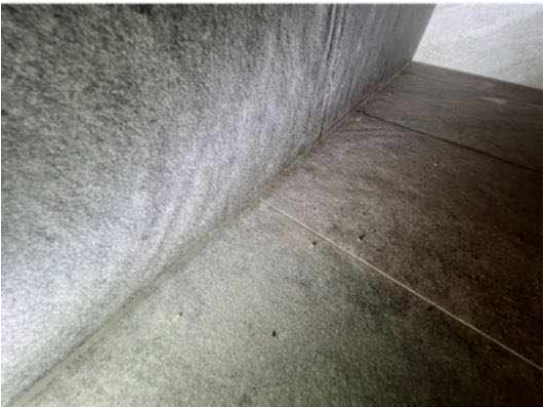
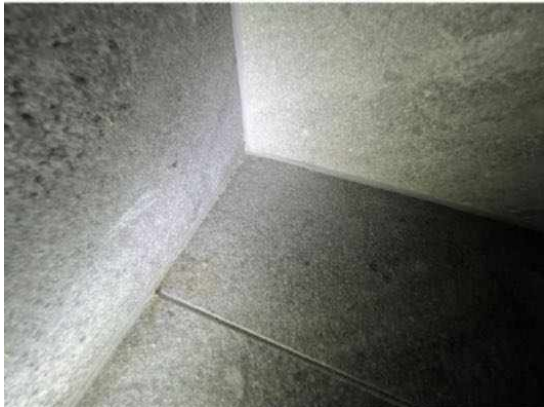
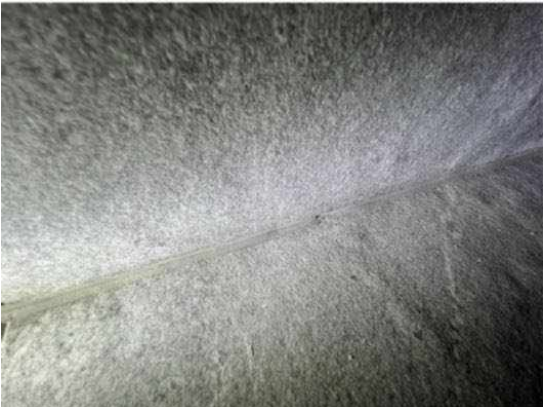
**Finding 3.39**

Building: Main Building  
Location: Ensuite, Bathroom, Laundry  
Finding: Flexible sealants to junctions - poorly applied (AS 3958.1)  
Information: Sealant was observed to be poorly applied to tiled areas, presenting as uneven, smeared, or incomplete.

Flexible sealant is required at junctions to allow for movement while maintaining a watertight finish. As outlined in NSW Standards and Tolerances 12.7, flexible or waterproof sealants are defective if not installed where required by the NCC, AS 3958.1, or the manufacturer’s installation requirements.

All affected areas must be properly sealed prior to handover.

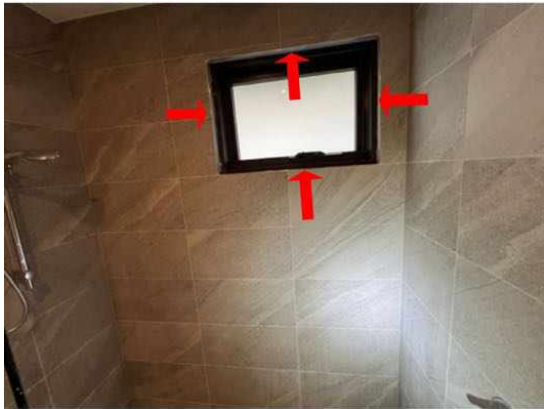
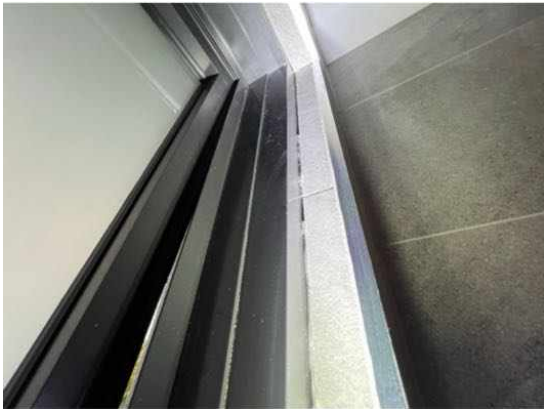
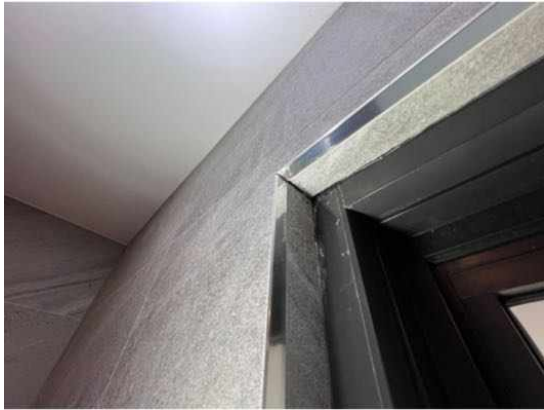
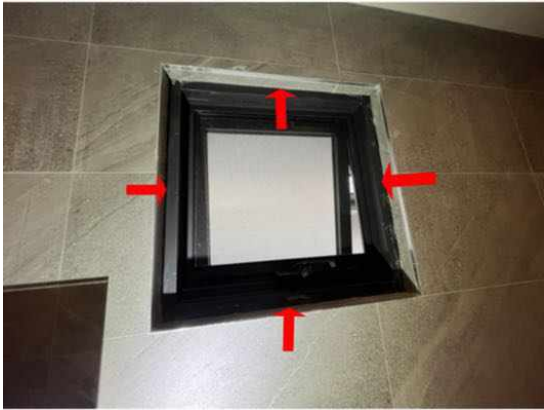
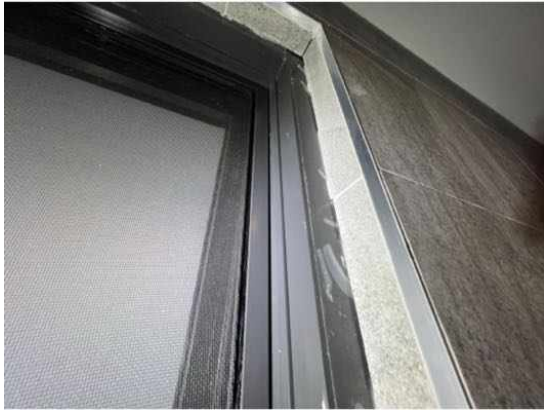
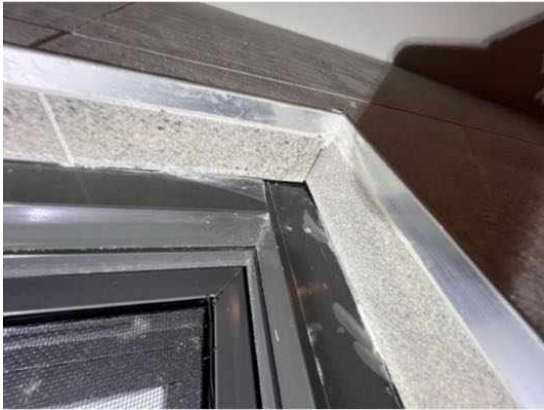
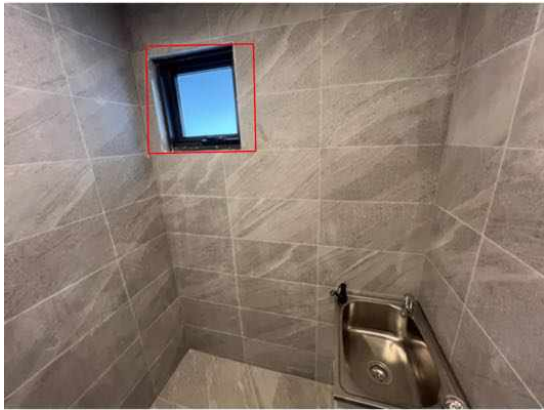
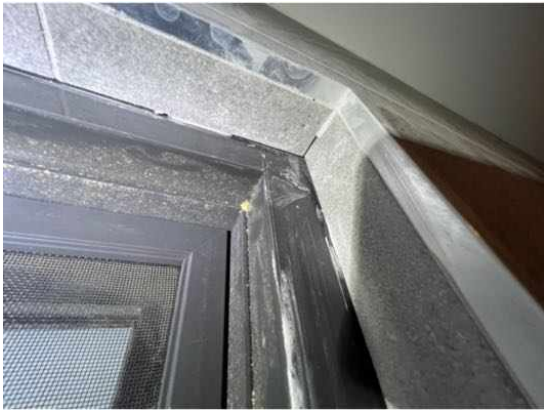
### Finding 3.40

Building:	Main Building
Location:	Ensuite, Bathroom, Laundry
Finding:	Flexible sealants to junctions - not installed (AS 3958.1)
Information:	Sealant was incomplete at junctions within wet areas. As outlined in NSW Standards and Tolerances 12.7, flexible or waterproof sealants are defective if not installed where required by the NCC, AS 3958.1, or the manufacturer's installation instructions.

All required wet area junctions must be fully sealed with compliant materials prior to handover.

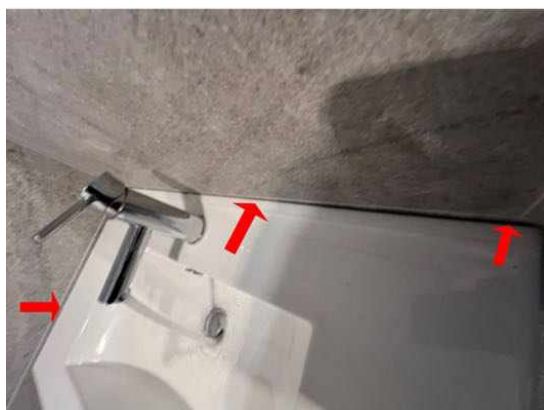
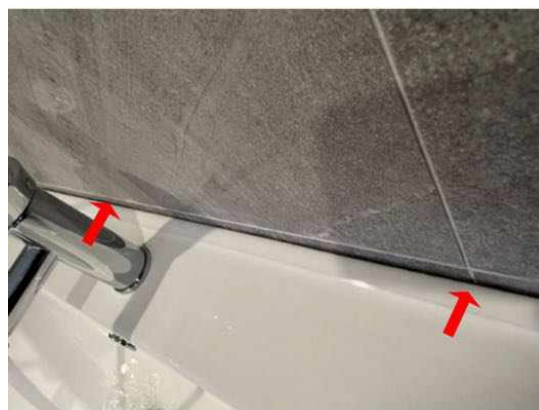
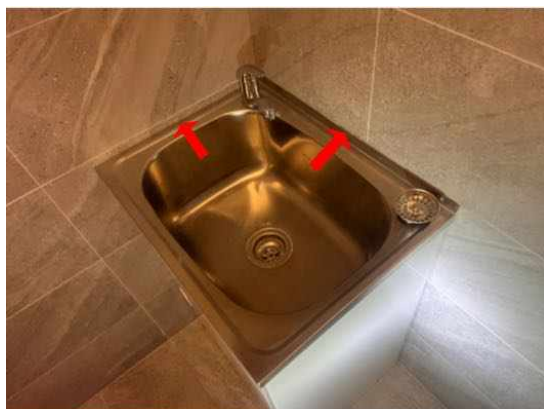
Finding 3.41

Building:	Main Building
Location:	Ensuite, Bathroom, Laundry
Finding:	Sealant - missing
Information:	It was noted on inspection that sealant is missing to this area.

Different materials move at different rates, generally causing cracking to grout or sealant at this point. A flexible sealant is required to allow for expected expansion and contraction, while keeping the joint water tight and protective of all associated building materials.

Flexible and mould resistant materials should be applied to affected areas to prevent any subsequent water damage that is likely to occur. Regular maintenance and replacement of damage or missing or damaged sealant and grout is highly recommended to the wet areas, as this is a regular wear and tear defect. Sealant and grouting in areas that come into regular contact with water should be maintained for the long term care of your property.

A sealant specialist or tiling contractor should be appointed to complete these works as soon as possible

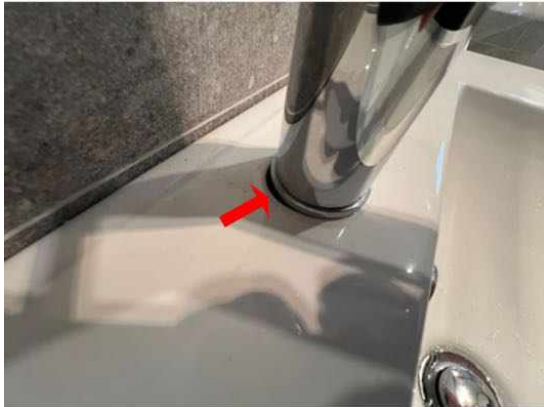
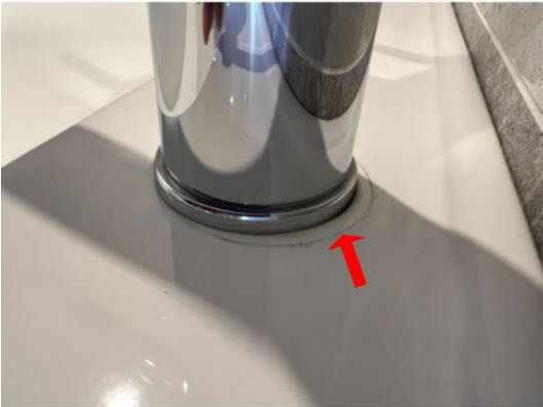
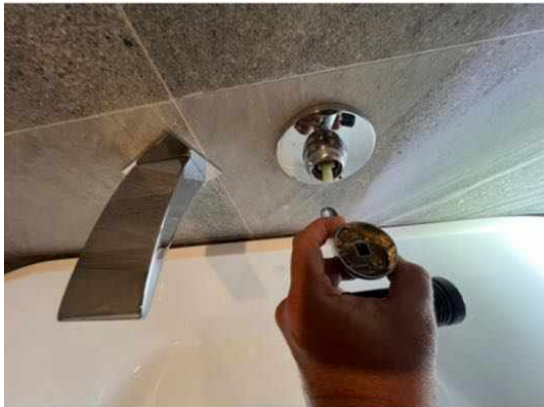
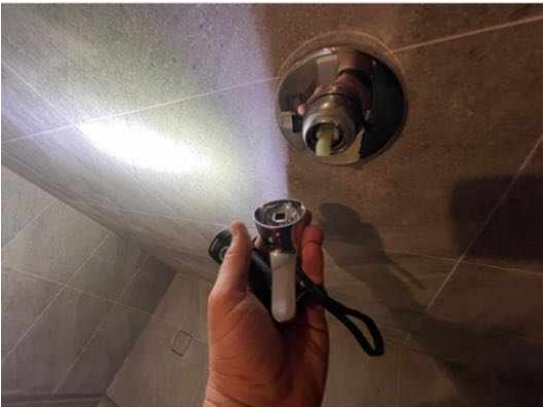
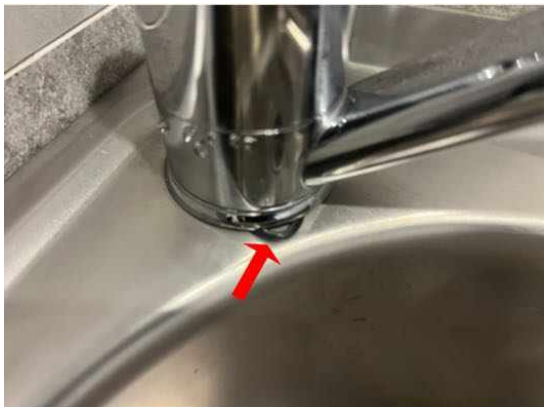
### Finding 3.42

Location: Ensuite, Bathroom. Laundry  
Finding: Tap - Loose  
Information: The tap in this area has not been installed correctly, or has deteriorated with age, and is consequently loose. This tap being loose creates potential for water leaks and subsequent water damage to the surrounding area.

Where taps or spouts are loose, a qualified plumber should be appointed to re-fix the plumbing fitting.

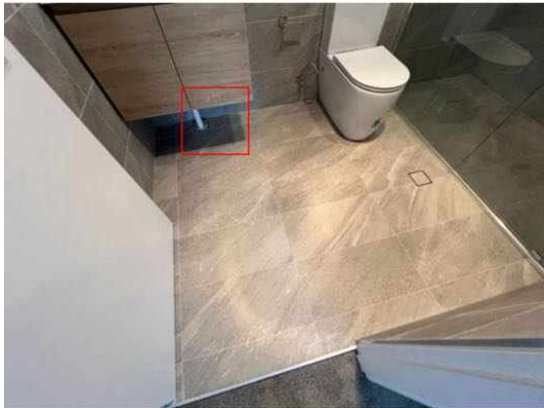
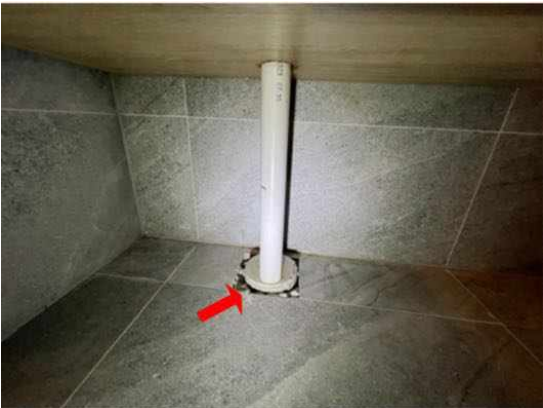
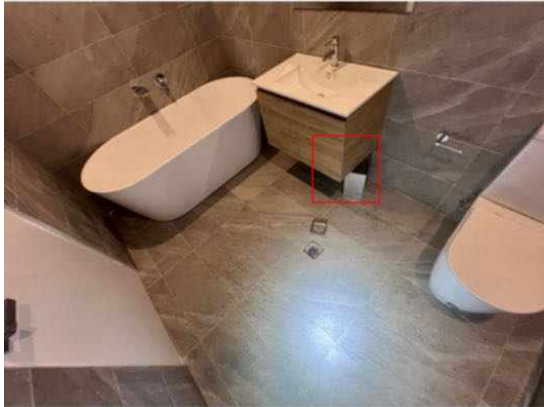
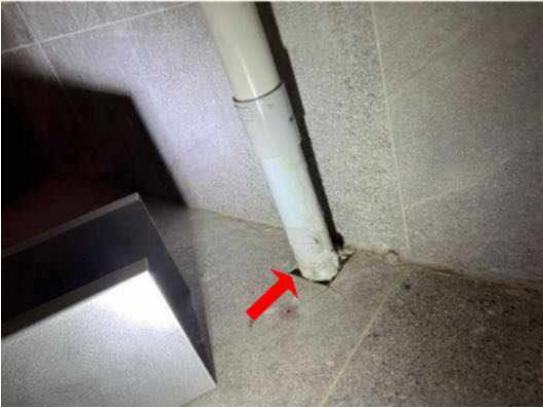
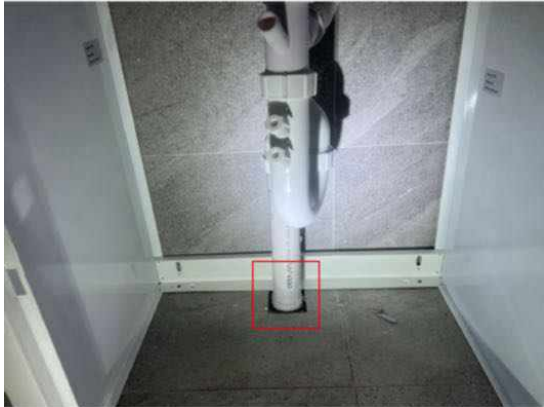
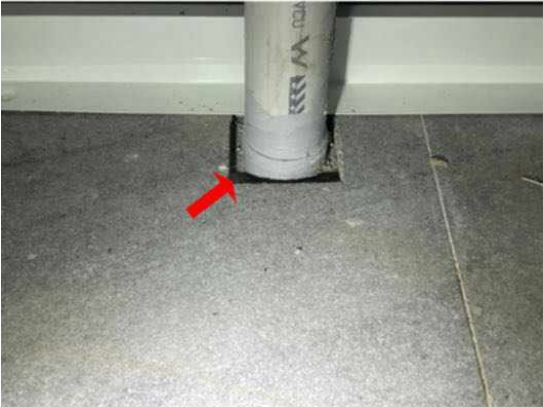
**Finding 3.43**

Works that have not been completed to a satisfactory level create potential for the development of building defects and may impede on the safety and integrity of the overall structure.

It is highly recommended that a qualified floor and wall tiler to be appointed to complete these works and ensure the safety of the area and the longevity of all associated building elements.

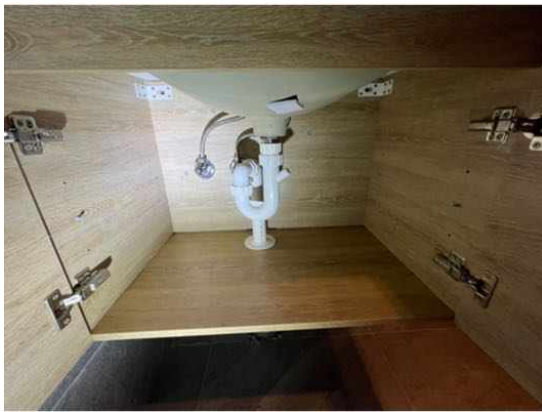
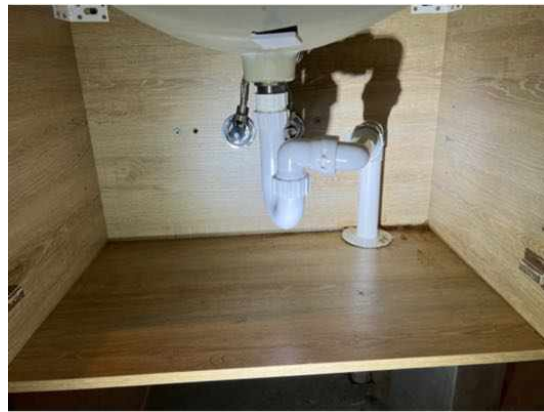
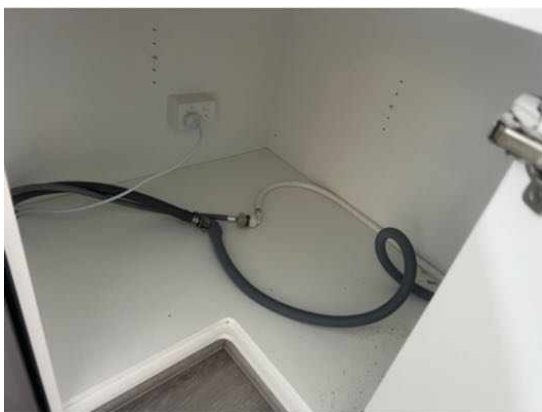
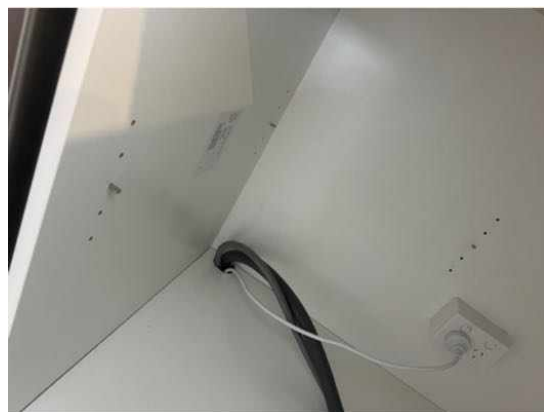
### Finding 3.44

Building: Main Building  
 Location: Ensuite, Bathroom, Kitchen  
 Finding: Shelving - Missing  
 Information: Although some building elements may seem irrelevant or unnecessary, all building elements play a key role in the operation and function of the overall structure and its performance.

Replacement of any missing building element should be conducted as soon as possible to ensure that no damage or functional issues occur to associated building materials.

A carpenter or cabinet maker should be appointed as soon as possible to replace the missing building element.
