# Building and Timber Pest Inspection Report

Inspection Date: Tue, 17 Mar 2026

Property Address: 6A Ledger St, Goulburn NSW 2580,  
Australia

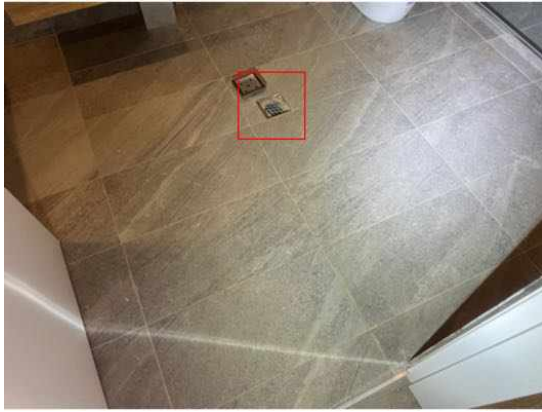
### Finding 3.45

Building: Main Building  
 Location: Bathroom  
 Finding: Tiled insert (waste) - Missing  
 Information: Although some building elements may seem irrelevant or unnecessary, all building elements play a key role in the operation and function of the overall structure and its

Replacement of any missing building element should be conducted as soon as possible to ensure that no damage or functional issues occur to associated building materials.

A Tiler should be appointed as soon as possible to install a tile insert to the waste.

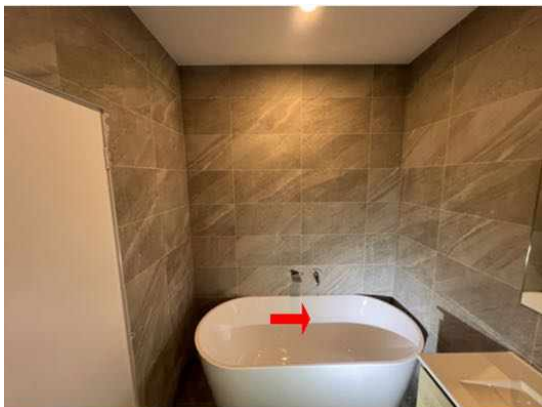
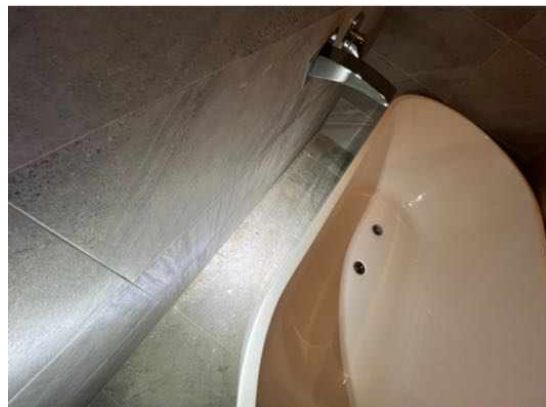
### Finding 3.46

Building:	Main Building
Location:	Bathroom
Finding:	Freestanding Bath - not secure
Information:	The freestanding bath was identified as not being securely fixed to the floor at the time of inspection, allowing noticeable movement. This condition may result from improper installation or inadequate fixing materials.

If left unmanaged, the movement of the bath could lead to damage to associated plumbing, tiles, or surrounding building elements, as well as reducing its usability.

It is recommended that a licensed plumber be engaged to secure the bath to the floor to prevent further movement and ensure its long-term stability.

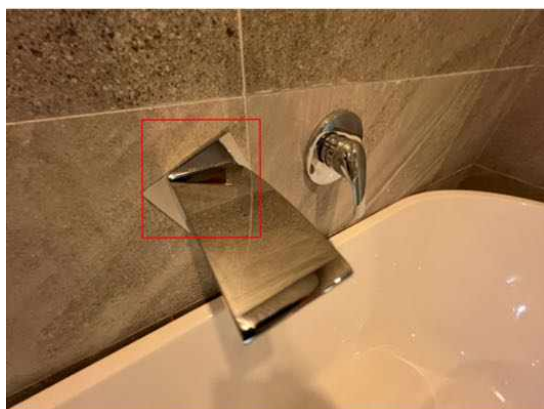
### Finding 3.47

Building:	Main Building
Location:	Bathroom
Finding:	Bath spout - Loose
Information:	The bath spout was observed to be loose at its connection point at the time of inspection. This condition is commonly caused by poor installation, deterioration of sealant, or movement in the fixture over time.

A bath spout may lead to water leakage behind the wall/floor, potentially causing moisture damage and deterioration of associated building elements if left unmanaged.

It is recommended that a licensed plumber be engaged to assess and properly secure the spout to prevent further movement and potential water ingress.

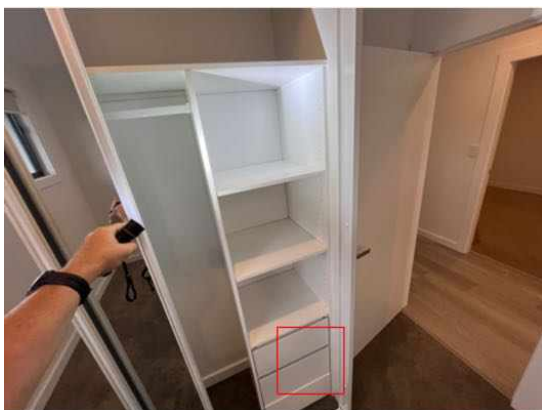
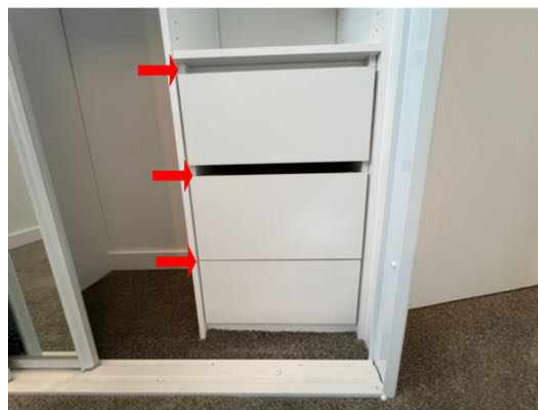
### Finding 3.48

Building:	Main Building
Location:	Bedroom 2
Finding:	Joinery - substandard install (AS 4386.1)
Information:	Misalignment and visible gaps were identified to sections of fixed joinery. These defects impact the overall finish and do not reflect an acceptable standard of installation.

AS4386, Domestic kitchen assemblies – Kitchen units and the NSW Guide to Standards and Tolerances 11.4, joinery components must be installed square, flush, and plumb, with tight-fitting junctions and consistent alignment. Visible gaps or irregularities are defective where they detract from the intended appearance or function.

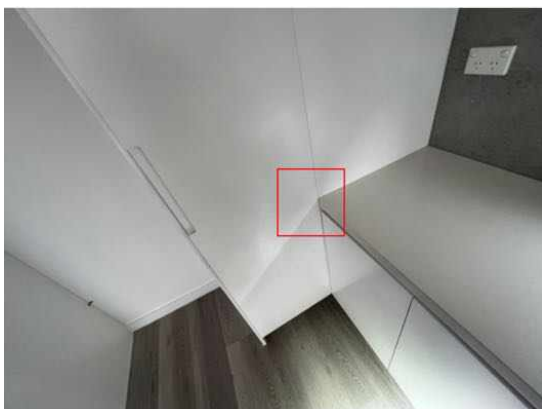
### Finding 3.49

Building:	Main Building
Location:	Kitchen
Finding:	Joinery Doors - Binding
Information:	Binding of joinery doors is evident during standard operation. This defect inhibits the functionality of the affected door as well as creating potential for secondary defects to associated building elements, such as damage to the adjacent joinery.

A door that binds may have several causes, ranging from minor defects, such as poor installation of the door or deteriorated hinges.

Recommend a qualified carpenter or general handyperson should be appointed to perform minor rectification works at client discretion.

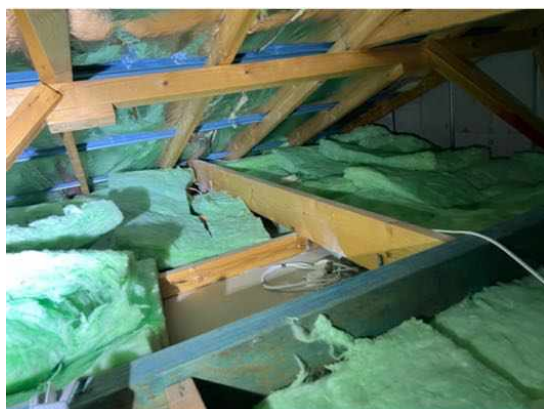
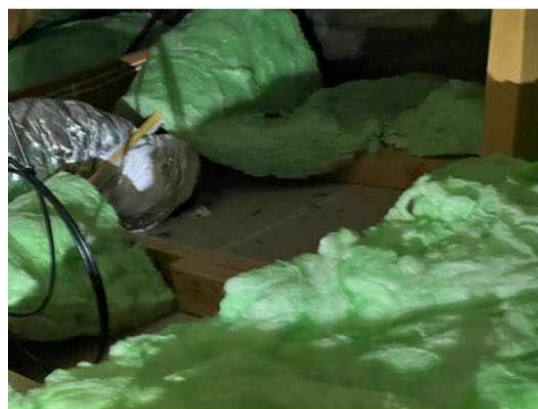
### Finding 3.57

Building:	Main Building
Location:	Roof Void
Finding:	Ceiling - glue Cracking / Minor Detachment
Information:	Cracking was observed along glue at joist, with slight detachment noted at the adhesive/fixing lines to the ceiling lining.

This condition is commonly associated with minor separation between the ceiling lining and supporting joists or inadequate bonding at installation. In new construction, this may indicate that the installation does not meet expected workmanship standards.

If left unmanaged, the affected areas may progress, resulting in further separation or visible surface irregularities.

The builder should be requested to assess the affected area and confirm that the ceiling installation complies with acceptable construction standards prior to handover.

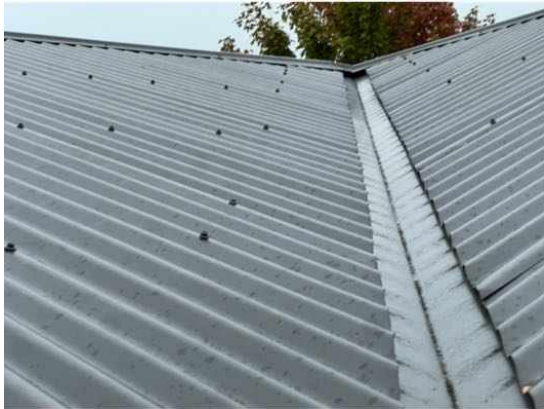
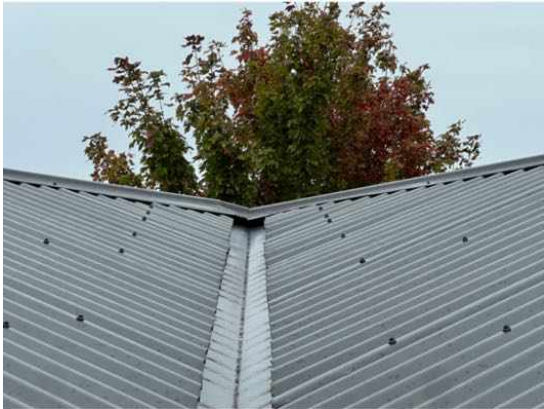
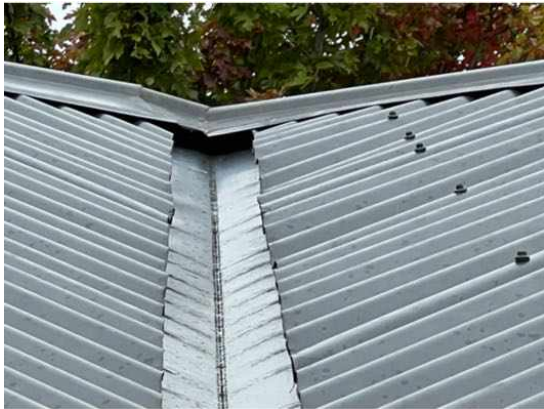
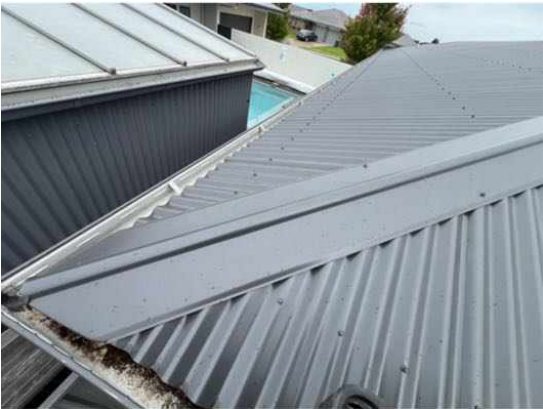
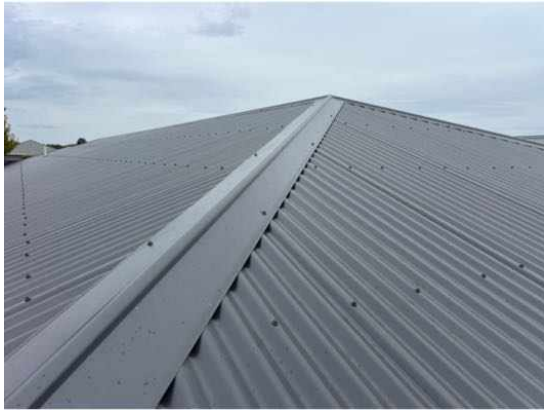
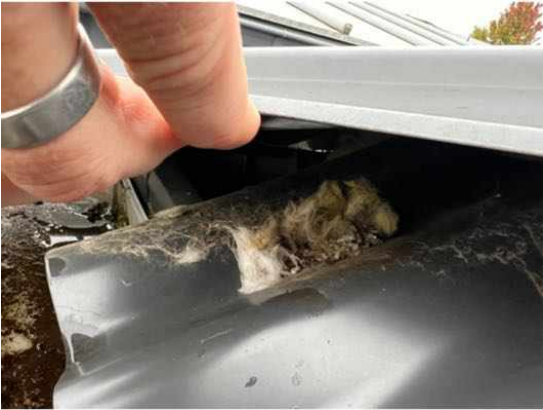
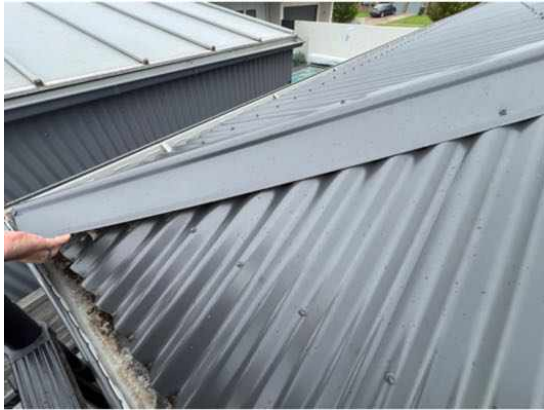
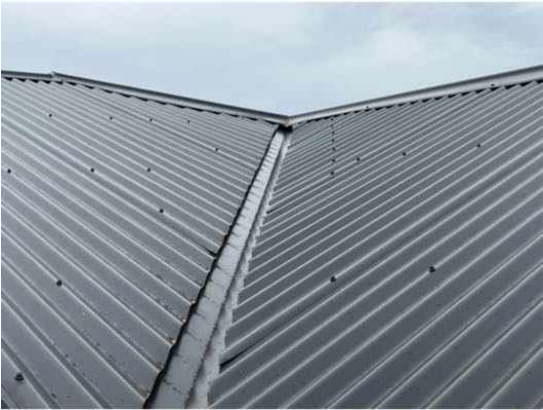
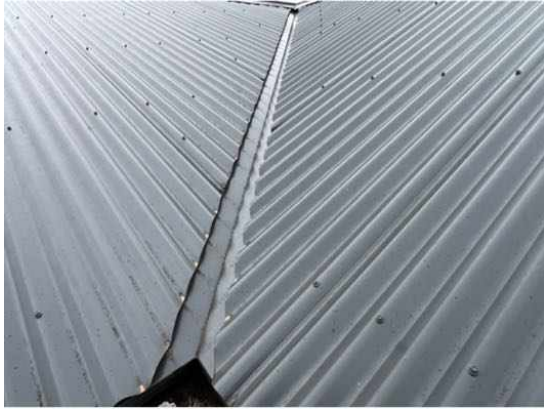
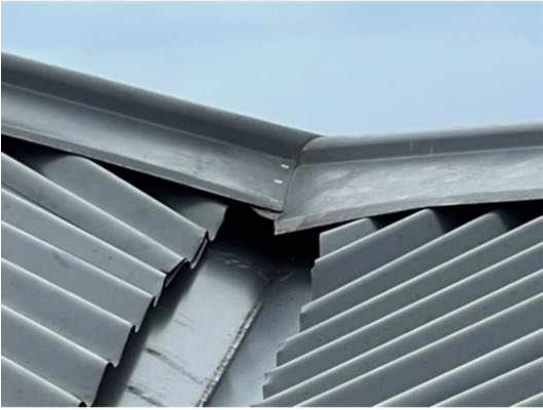
Finding 3.59

Building:	Main Building
Location:	Roof Exterior
Finding:	Roof Fixing Spacing - AS 1562.1-1992
Information:	During the inspection, corrugated roof sheeting fixings were observed to be installed at irregular and widely spaced intervals across several sheet spans. In some areas, the spacing between screws appears inconsistent with standard fixing patterns for corrugated metal roofing.

AS 1562.1-1992 requires metal roof cladding to be securely fixed in accordance with the design requirements and manufacturer specifications to ensure structural adequacy and weatherproof performance. Fixings must be installed at appropriate spacing to resist wind uplift and maintain sheet stability. Excessive or inconsistent screw spans may reduce the sheet's resistance to wind loading and contribute to movement, noise, or premature fastening failure.

The observed fixing pattern may not meet the requirements of AS 1562.1-1992 or the relevant manufacturer installation guide. The builder should confirm that the fixing layout complies with the applicable Australian Standard and manufacturer specifications prior to final acceptance of the works.

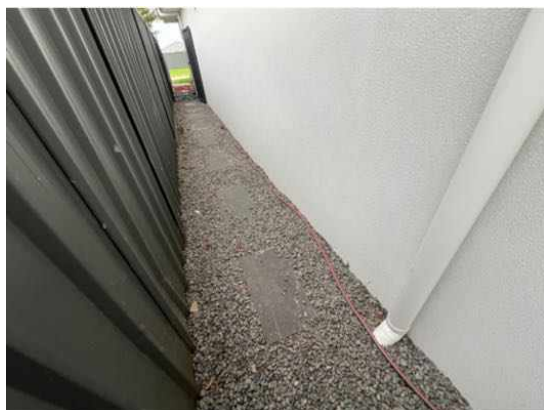
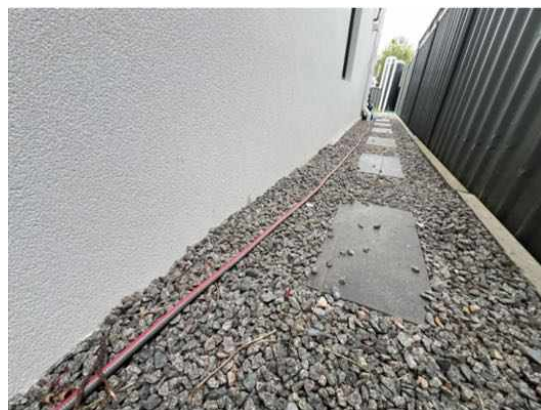
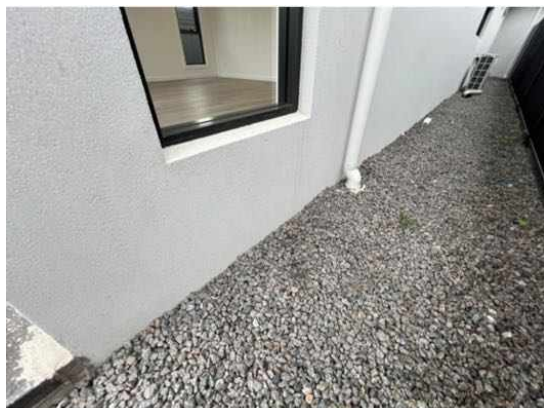
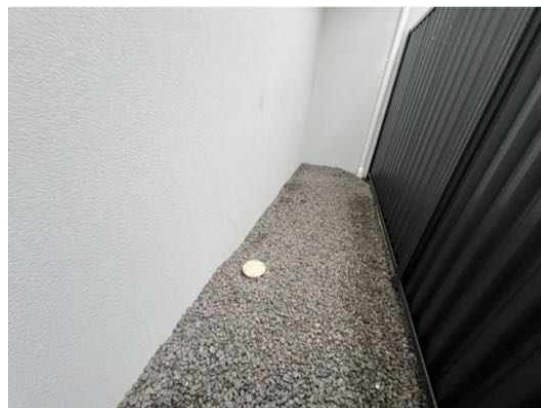
Note: A certificate of compliant installation of the termite barrier may have been issued when the barrier was initially installed to the slab early in the construction process.

However the following trades have not installed the barrier as required and now an avenue for termites to gain undetected access into the building has been created, where termites can gain undetected access to the building & attack all timber building components.

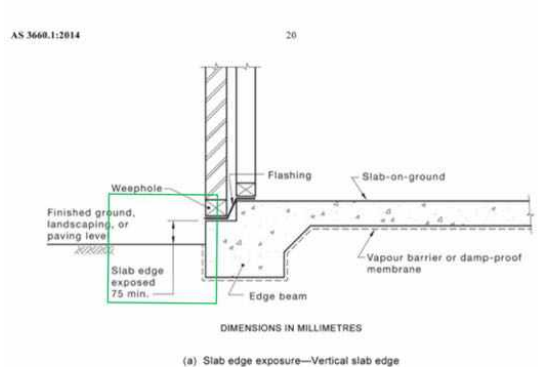
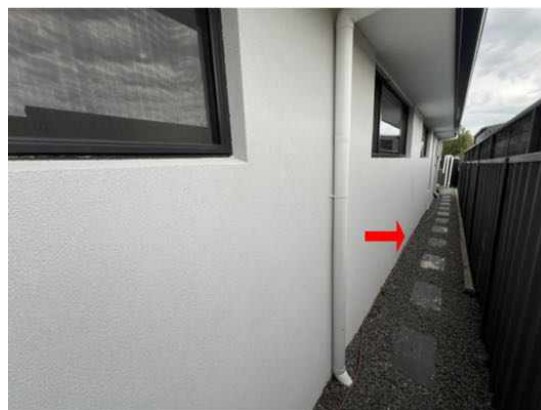
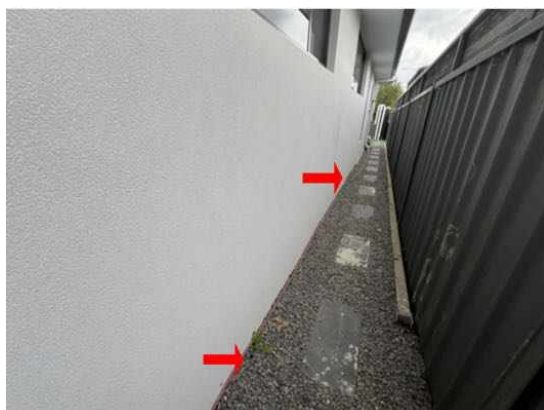
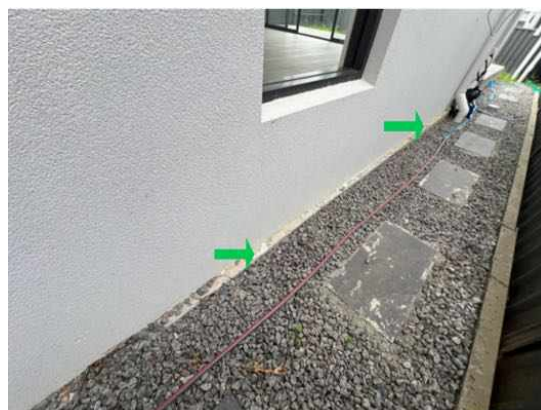
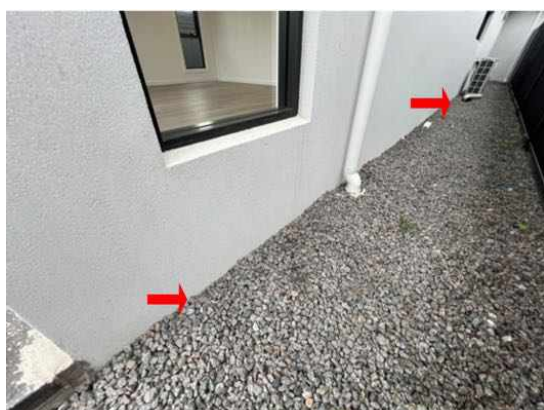
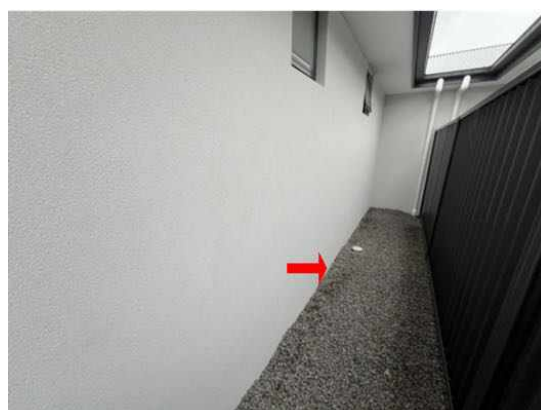
### Finding 6.03

Building:	Main Building
Location:	All External Areas
Finding:	Slab Edge - Exposure
Information:	An inspection zone of at least 75mm in relation to the exposed slab edge, between the bottom brick and the perimeter pavement, is required. This inspection zone should be maintained in order to force termites into the open where they can be detected more readily during regular inspections. The slab edge should not be concealed by anything that may prevent inspection of the area, including render, landscaping, soil, turf, paving, concrete cladding or other structures.

If the slab edge is not properly exposed there is a high risk of termite attack. Sometimes, in order to determine the type of slab, a suitably qualified person such as an architect or builder may be required to consult the construction plans.

Where the slab edge cannot be properly inspected, it is highly recommended that termite or timber pest inspections be carried out every 6-12 months to aid protection of the property against infestation.

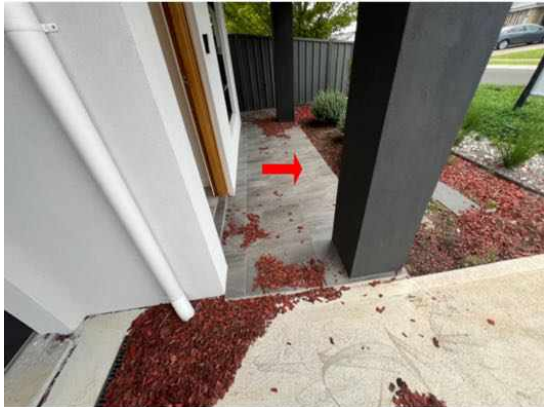
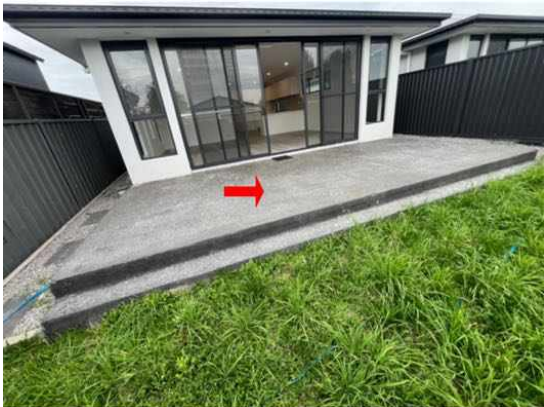
**Finding 6.04**

Building: Main Building  
 Location: Porch, Alfresco  
 Finding: Bridging of physical termite barriers - Concrete Patio  
 Information: The tiled concrete pad to the patio and alfresco including other areas directly abuts dwelling causing bridging. Bridging is the span of a physical termite barrier or inspection zone so that subterranean termites have an entry point over or around that barrier.

Where a concrete patio is retrospectively installed against an external wall, this provides a concealed entry point for termites.

The client should consider obtaining further advice from a timber pest technician regarding treatments required in this area. It is recommended that obtaining such advice be a short-term priority.

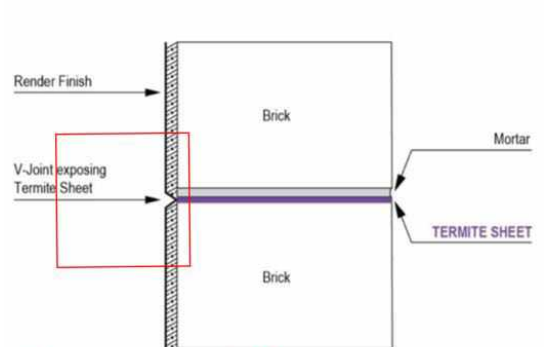
**Finding 6.05**

- Building: Main Building
- Location: Porch, Alfresco
- Finding: Bridging of termite barrier - Piers
- Information: Piers that are attached from ground to structure without a visible inspection zone (barrier 75mm AFL) causes a bridging point. Bridging of termite barriers occurs when termites bridge (usually by building a mud tunnel) a termite barrier or inspection zone or where termites have a passage allowing them to bridge the barrier.

Generally this takes the form of finished ground levels external paving or concrete being retrospectively installed above the damp course level the adjacent internal floor level or weep and ventilation holes.

Where bridging has occurred full inspection is prevented and termites may enter a property in a concealed or undetectable manner.

**V-joint not visible**

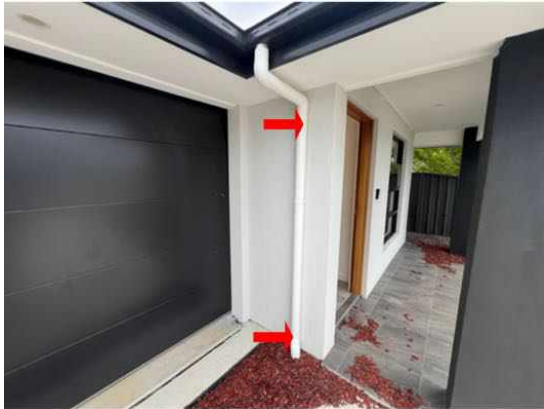
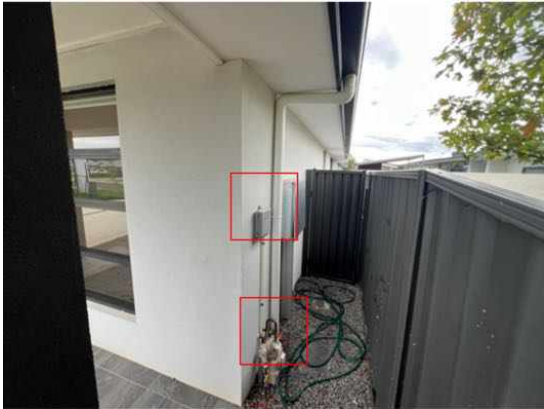
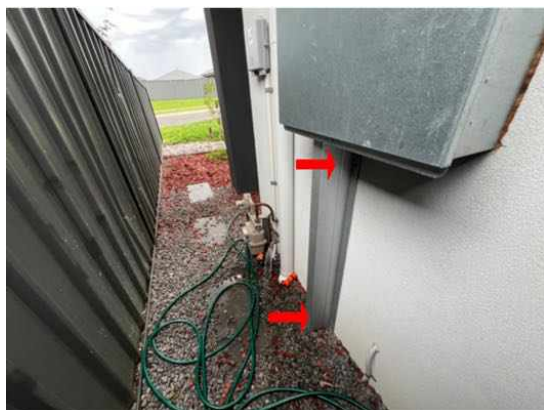
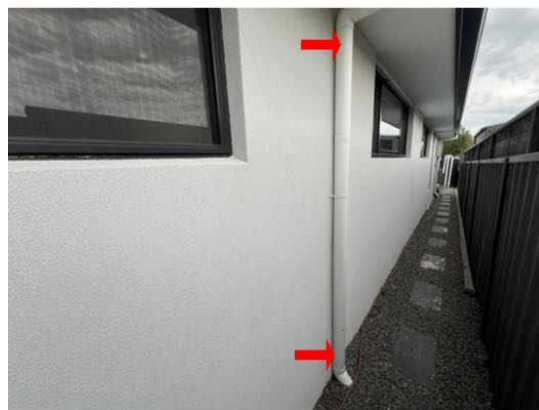
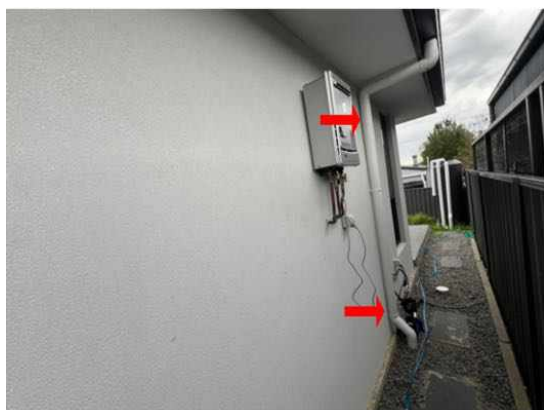
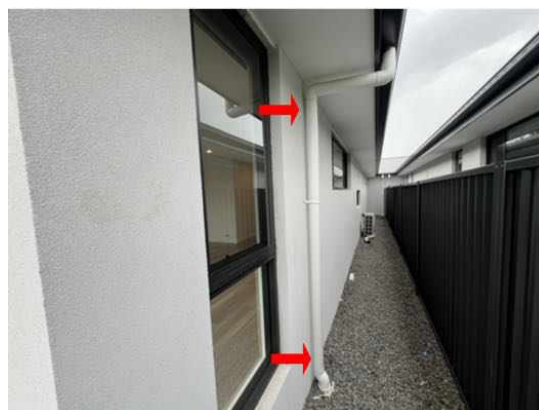
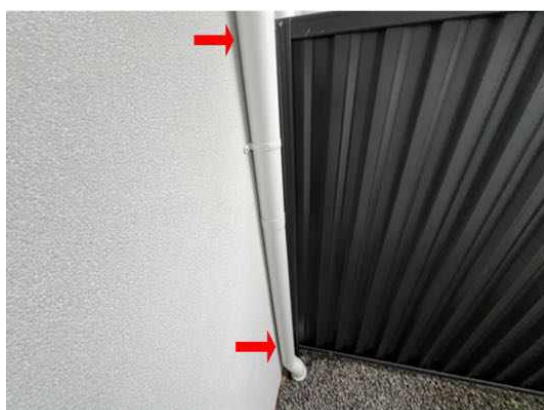
**Finding 6.06**

Building: Main Building  
Location: All External Areas  
Finding: Bridging - Attachments to Buildings.  
Information: Bridging occurs when items against a building provide a concealed entry point for termites into the building or by passing around a termite management system.

Where any part of an attachment to a building is not isolated and is not provided with a clear gap of not less than 25mm from the building, bridging occurs. Attachments to buildings such as hot water services, downpipes, verandahs, decks, steps, fences, service conduits and the like provide the opportunity for concealed entry.

Building attachments of this nature need to be frequently inspected for termite activity by a qualified inspector

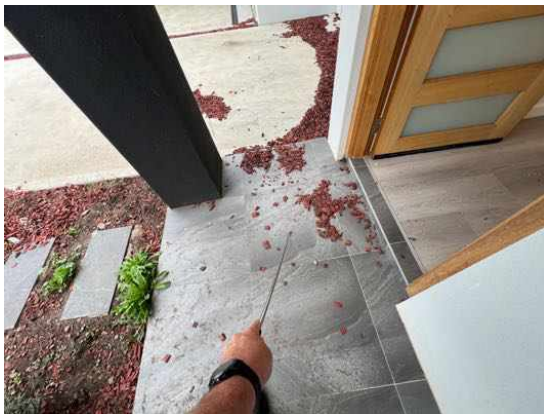
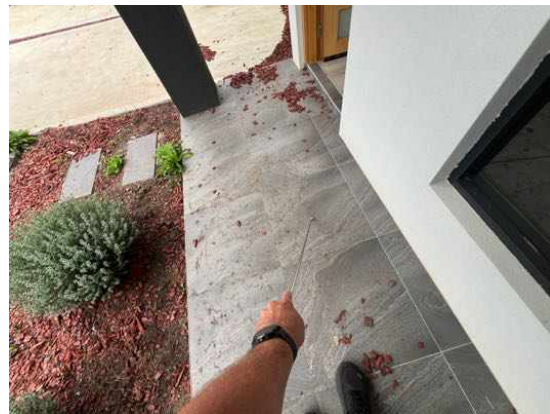
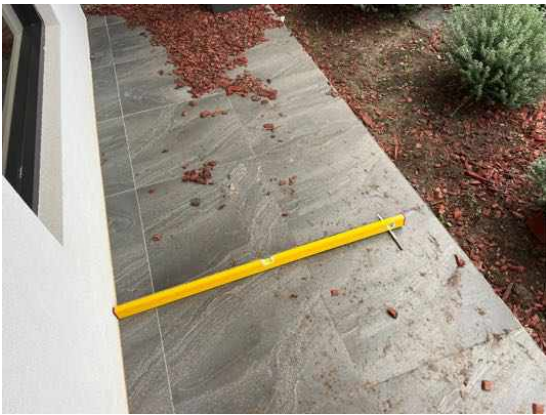
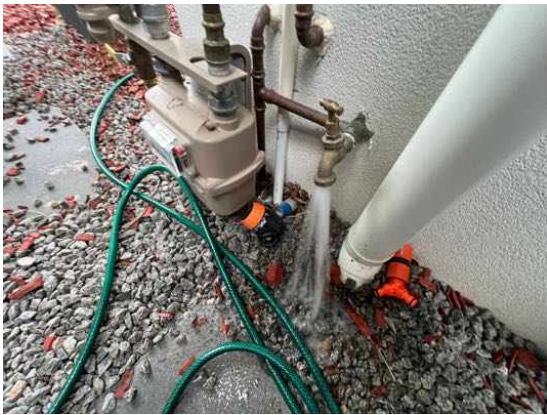
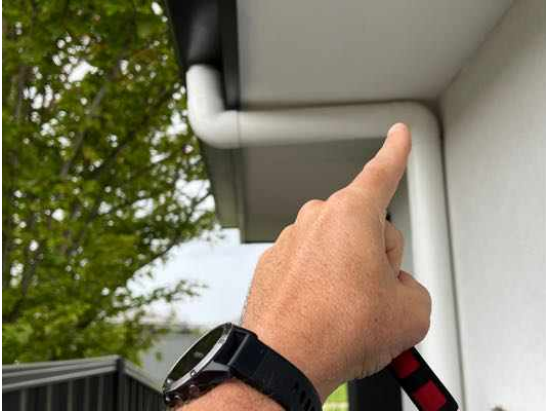
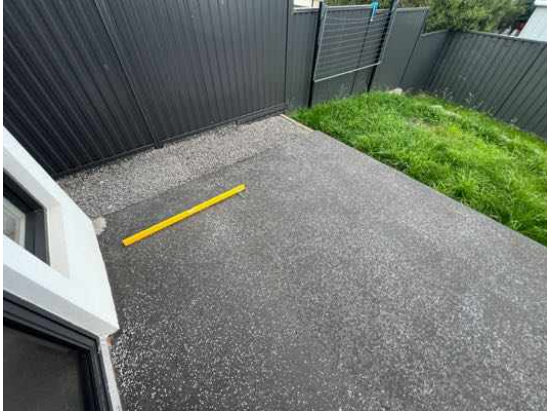
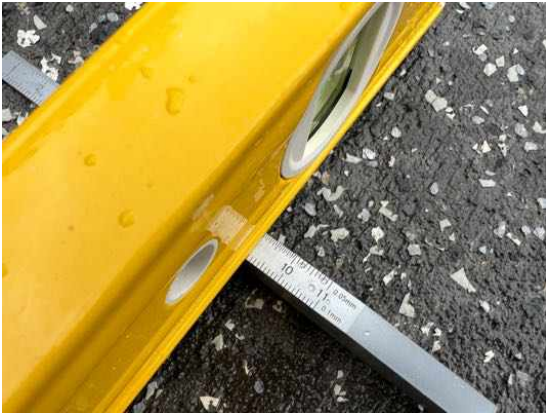
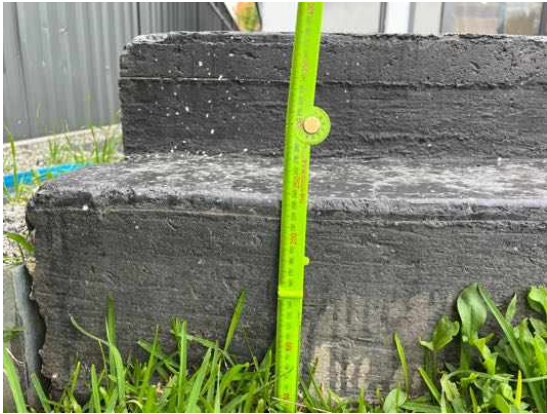
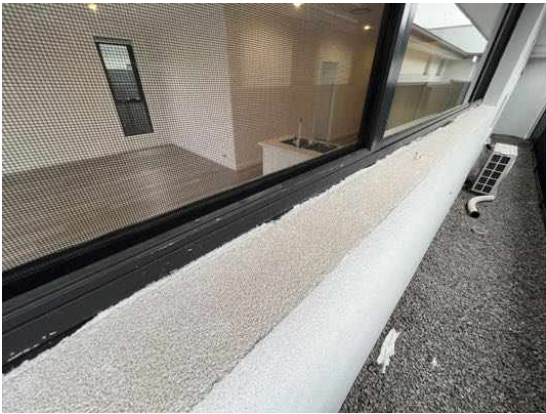
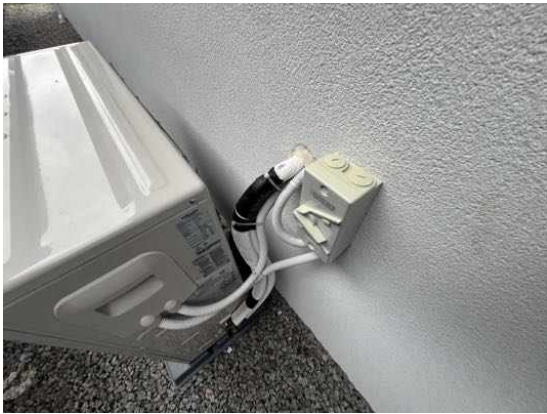
### Noted Item

Finding: FYI - Additional Photos

Information: Additional photos are provided for your general reference and may include obstructions, testing of water & windows, moisture readings or minor maintenance items.

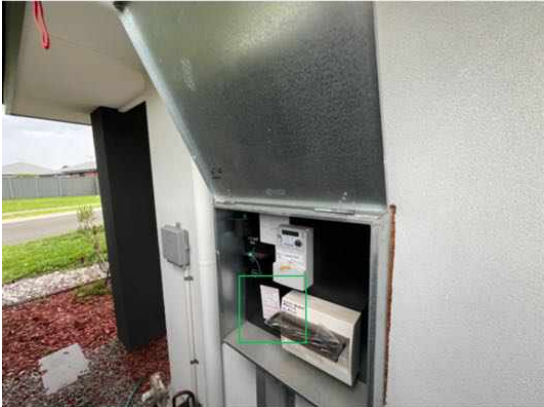
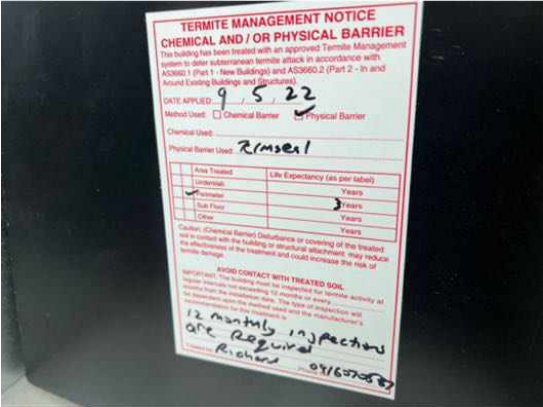
## The following items were noted as - Evidence of a previous termite management program

Where a Termite Management System has been identified you should refer to the type of barrier date of installation warranty conditions and any documentation provided by a builder or past owner. Consult the company who installed the barrier to confirm whether the system is still under warranty.

Most chemical termite management systems expire and require replenishment and all physical systems are primarily designed to prevent concealed entry.
