# Building and Timber Pest Inspection Report

Inspection Date: Thu, 29 Jan 2026

Property Address: 30 Yengo Ct, Holsworthy NSW 2173,  
Australia

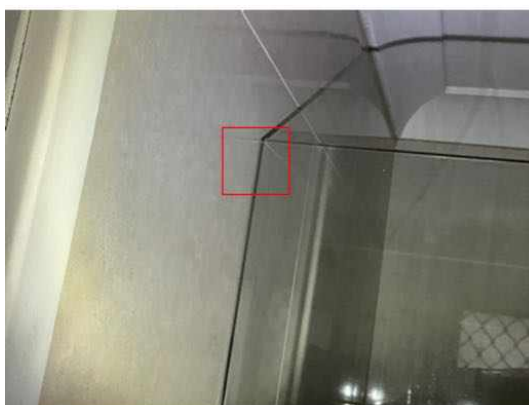
Binding and/or jamming of shower doors were evident during standard operation at the time of inspection. This defect is a potential safety hazard if the shower screen breaks due to impact or jamming force.

It appears this is due to poor initial installation of the shower components.

A licensed glazier is required immediately for repairs and to ensure the safety of the area.

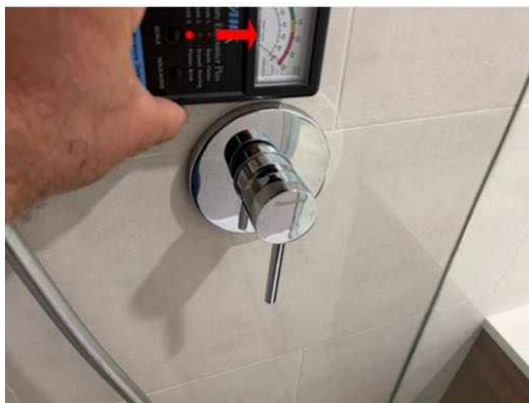
#### Finding 2.01

Building: Main Building  
 Location: Ensuite  
 Finding: Water leak - Suspected  
 Information:

A water leak is suspected in this area as excessive moisture was detected at the time of inspection. Another potential cause maybe moisture ingress behind the tiles from around the wall fittings and penetrations.

In extreme cases, structural damage may develop due to a prolonged water leak. It is highly advised that internal water leaks be addressed by a licensed plumber as a matter of relative urgency.

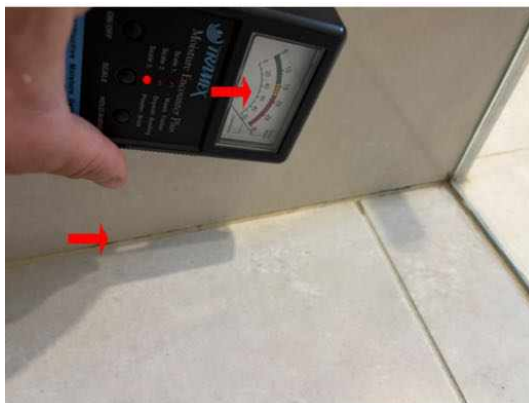
### Finding 3.01

Building:	Main Building
Location:	Bathroom
Finding:	Shower damp - Sealant and grout
Information:	Damp is evident to the lower 400mm of wall to the shower alcove. This defect is quite common, and is suspected to have been caused by moisture permeating or leaching through the grouting and sealant in this area, which shows evidence of deterioration. Leaking pipes within the wall is also a possible cause however this seems unlikely in this instance as there is no moisture build up around the taps or transferring to the other side of the wall. There appears to be no sealant around the tap spindles which may be a small contributing factor.

Consultation with a bathroom sealant specialist is advised immediately to identify the cause of damp and to perform remedial works as required.

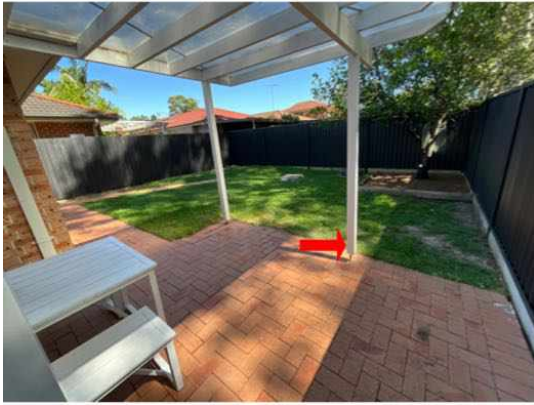
### Finding 3.02

Building:	Main Building
Location:	Alfresco
Finding:	Post anchor - Damaged
Information:	This post anchor in this area shows evidence of damage or movement at the time of inspection. This has likely occurred due to substandard workmanship at the time of construction or otherwise subsidence caused by weather elements.

The deteriorating condition is likely to worsen if not addressed in the short-term future.

A licensed builder should be appointed urgently for replacement or repair, ensuring the integrity of the structure is preserved.

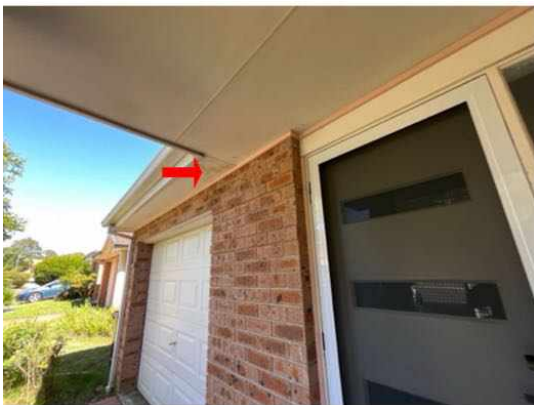
### Finding 3.03

Finding: Eaves/Roof plumbing -- water damages

Information: Water damage is generally an indication of excessive moisture being present, usually via a leak. It is suspected that gutter blockages causing stormwater to backflow into the eaves causing water damages. This is additionally conducive to termite activity due to the damp conditions.

Where water damage is evident, the primary requirement is to identify and rectify the source of the leak. Gutters must be kept clear of any blockages moving forward. A roofing plumber should be appointed for further assessment if the problem persists.

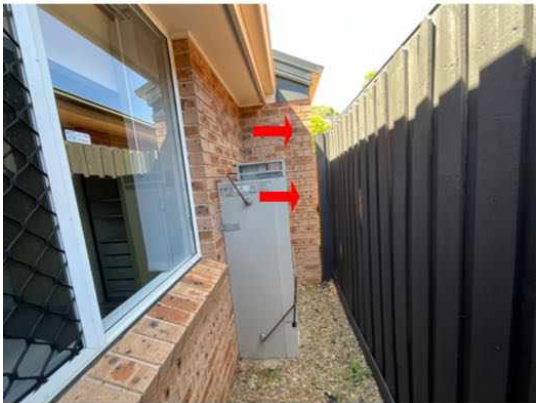
### Finding 3.04

Building:	Main Building
Location:	Behind garage
Finding:	Damage to Masonry Walls (Cracks)- Category 2
Information:	It has been observed that damage to masonry walls caused by movement of slabs, footings, or other causes, has occurred. The degree of damage falls within Category 2, described as noticeable cracks which are easily filled. Such cracking may cause doors and/or windows to stick slightly, and are generally less than 5mm in width.

Damage of this category is required to be monitored for a period of 12 months, after which time a crack rated at Category 2 or above is considered a defect requiring rectification, such as minor repairs and repointing. Always contact your building inspector should cracks widen, lengthen, or grow more numerous.

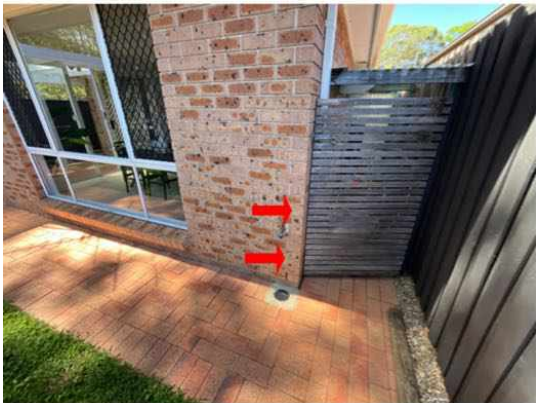
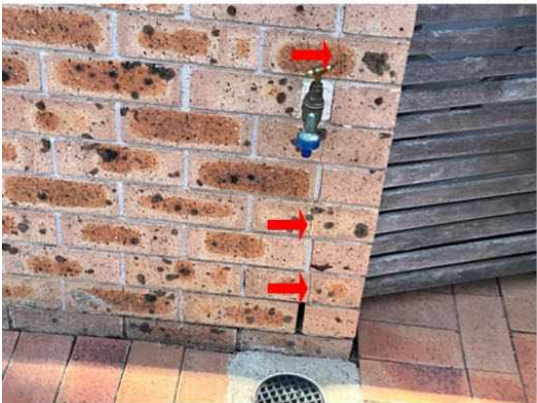
**Finding 3.05**

Building: Main Building  
Location: Multiple areas  
Finding: Damage to Masonry Walls (Cracks) - Category 0  
Information: It has been observed that damage to masonry walls caused by movement of slabs, footings, or other causes, has occurred. The degree of damage falls within Category 0, described as hairline cracks, which are less than 0.1mm in width limit.

Damage of this category is not considered a defect for rectification. Always contact your building ins

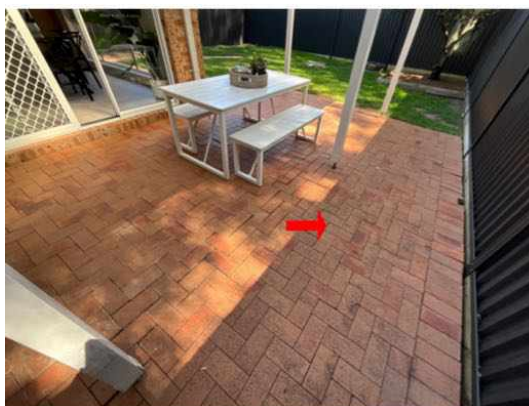
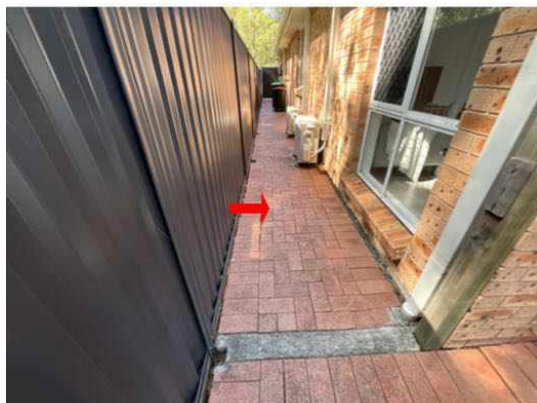
Building:	Main Building
Location:	All Areas
Finding:	Paving — Uneven
Information:	Sections of the external paved area are uneven, which may develop into a trip hazard. It appears as though the area has been subject to rough installation, or that paving sections have lifted due to movements in the foundation.

Left unmanaged, the May develop into a safety hazard due to trip and fall.

Re-paving of the area is required to remedy this situation. Further consultation with a specialist concreter is advised.

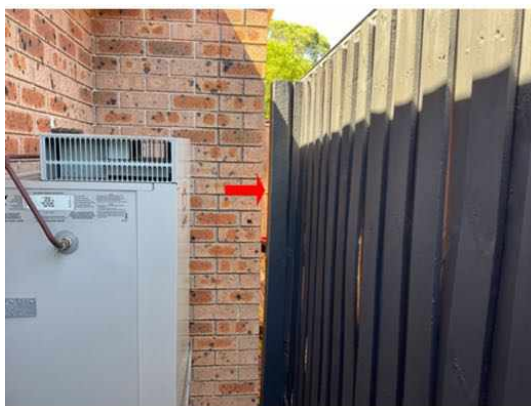
### Finding 3.08

Finding: Fencing - Deteriorated

Information: It was noted at the time of inspection that sections of the fencing in this area has deteriorated. Typically fencing deteriorates due to age and or wear, rot and or rust which is generally expected for a structure of this age, due to prolonged exposure to weather conditions. Sometimes inadequate installation or maintenance can be to blame.

A licensed fencing contractor should be appointed to provide further advice and perform rectification works as necessary.

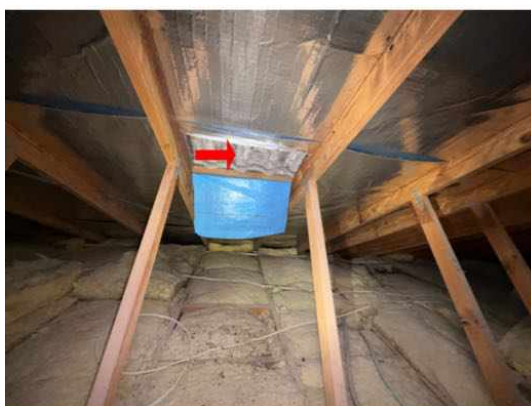
### Finding 3.09

Building:	Main Building
Location:	Roof Void
Finding:	Sarking - Damaged
Information:	Sarking, a laminated aluminium foil applied to the interior of the roof covering, assists in insulating the property and acting as a vapour-barrier to the roof void and, subsequently, to the household.

Where sarking is damaged, both insulation and moisture protection of the property are inhibited. This creates a loss of energy and thus negatively impacts the energy efficiency of the property, allowing potential for moisture ingress from condensation or leaking roof tiles.

It is important to repair any holes or damaged sections of sarking to ensure that the building material is fully functional. A registered builder or qualified carpenter should be consulted to provide further advice on this defect and to perform rectification works at client discretion.

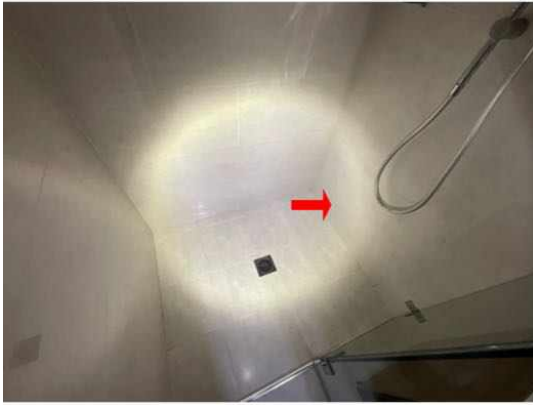
Building:	Main Building
Location:	Ensuite
Finding:	Wet area tiles - Cracked or damaged
Information:	Cracking was evident to the tiling in this area at the time of inspection. While the cracking appears to be minor, this area is frequently exposed to water, allowing potential for water penetration into adjoining sections of walls or flooring.

If left unmanaged, water penetration to these areas may lead to subsequent water damage, which is likely necessitate repair work to affected building elements.

A bathroom specialist should be appointed to determine the integrity of the bathroom waterproofing membrane. If the membrane was found to be intact then relatively minor works to replace the cracked tiles should be carried out to ensure no further damage occurs. The re-application of silicone and grouting throughout remaining tile work is also advised, to further protect the area against water penetration.

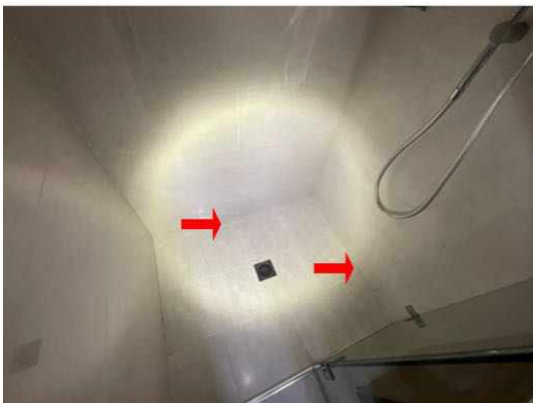
### Finding 3.14

Building:	Main Building
Location:	All Wet Areas
Finding:	Sealant and grouting - Missing or damaged
Information:

It was noted on inspection that sealant or grout is degraded to this area.

Flexible and mould resistant materials should be applied to affected areas to prevent any subsequent water damage that is likely to occur. Regular maintenance and replacement of damage or missing or damaged sealant and grout is highly recommended to the wet areas, as this is a regular wear and tear defect. Sealant and grouting in areas that come into regular contact with water should be maintained for the long term care of your property.

A sealant specialist should be appointed to complete these works as soon as possible.

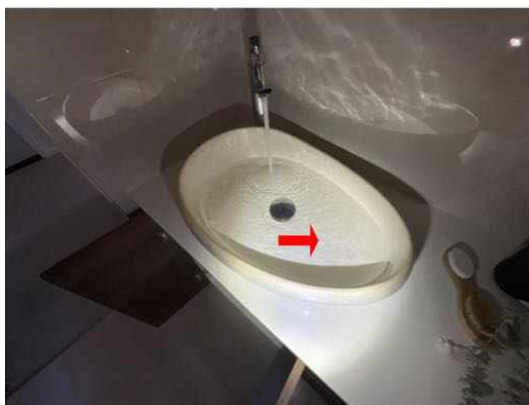
### Finding 3.15

Building: Main Building  
 Location: Ensuite, bathroom  
 Finding: Sink/basin - slow draining  
 Information:

The sink/basin drain appeared to be partially blocked at the time of inspection. Blockages here are usually caused by hair and other debris. If left unmanaged, a lack of general maintenance may lead to the development of more significant defects, such as water damage to surrounding building materials.

A licensed plumber should be appointed to remove the blockage at the client discretion.

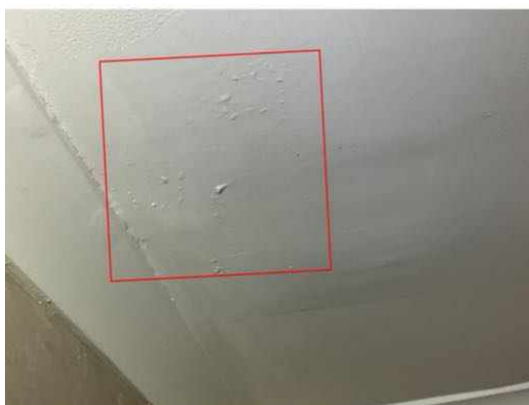
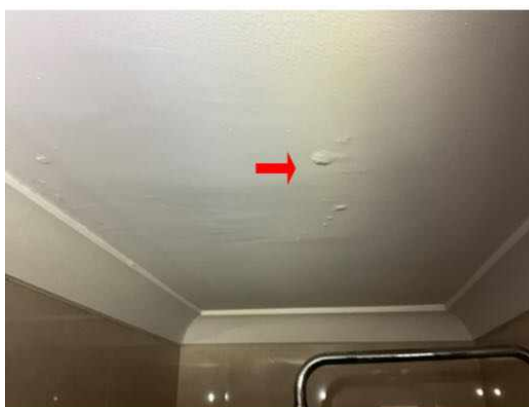
### Finding 3.16

Building: Main Building  
 Location: Ensuite, bathroom  
 Finding: Paint cracking and peeling  
 Information:

Cracking and ultimately flaking of paint can occur for a variety of reasons. Often these failures are due to the fact that the paint has inadequate adhesion and flexibility, both common problems with lower quality exterior flat paints.

Inadequate surface preparation can also cause these failures, especially when paint is applied to bare wood or a very porous surface without first applying a primer.

A qualified painter should be appointed to rectify the problem.

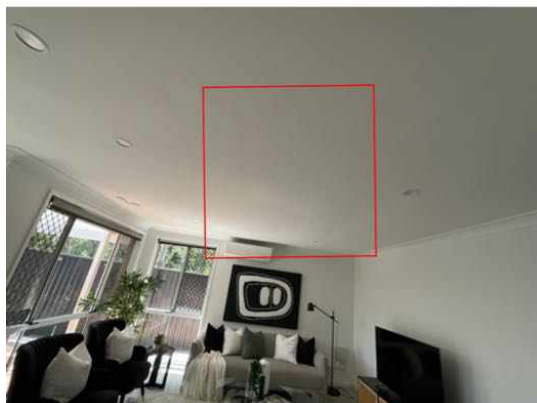
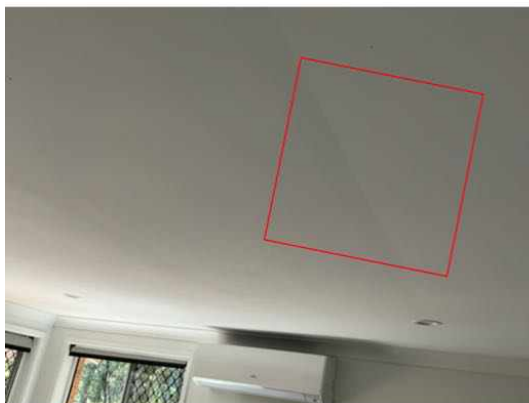
### Finding 3.17

ceiling sheets, may be required. Such works may be performed by relevant tradespeople, such as plasterers and painters. Where excessive moisture has caused the roofing structure to swell and sag, the source of the water leak should primarily be identified prior to any remedial works being performed.

The appropriate action should be taken by the client as soon as possible to ensure that any potential further damage is limited.

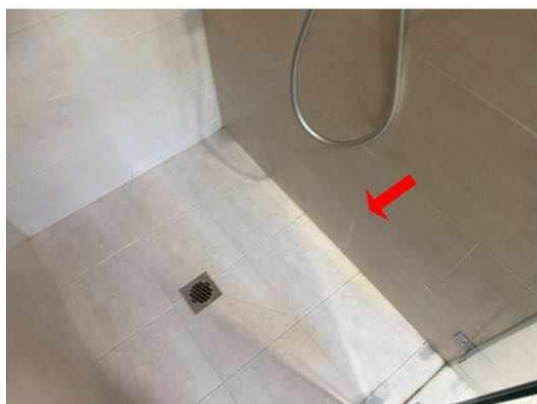
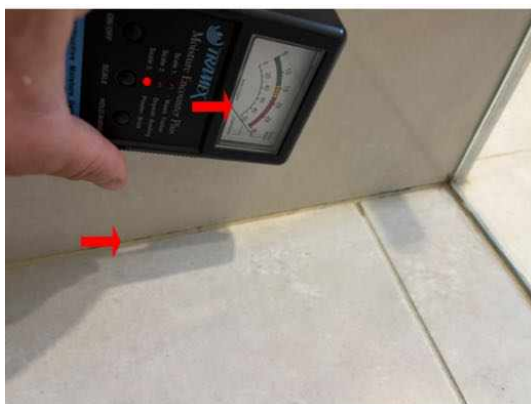
### Finding 6.02

Building:	Main Building
Location:	Bathroom
Finding:	Shower damp - Sealant and grout
Information:	Damp is evident to the lower 400mm of wall to the shower alcove. This defect is quite common, and is suspected to have been caused by moisture permeating or leaching through the grouting and sealant in this area, which shows evidence of deterioration. Leaking pipes within the wall is also a possible cause however this seems unlikely in this instance as there is no moisture build up around the taps or transferring to the other side of the wall. There appears to be no sealant around the tap spindles which may be a small contributing factor.

cause of damp and to perform remedial works as required.

Always ensure that sealant and grout is in good condition to prevent any moisture issues occurring in the future.

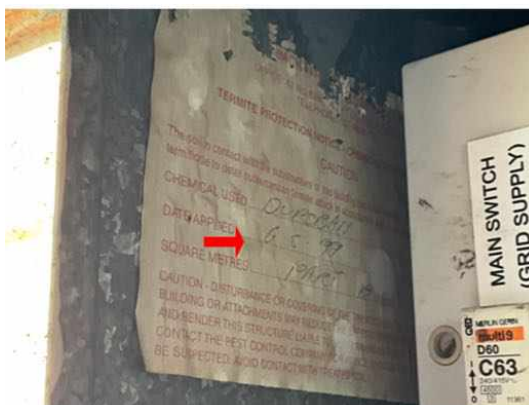
Building:	Main Building
Location:	All Areas
Finding:	Re-application of chemical termite barrier - required
Information:	Chemical treated barriers deteriorate over time necessitating the need for re-application of a barrier every 6-10 years depending on the product type environment etc. Due to this deterioration chemical barriers decline in their effectiveness exponentially if not replenished.

Consult the record of installation to identify the type of chemical and date of application. It is then advised to consult a licensed pest controller regarding reapplication intervals. Annual inspections are almost always required for all system types.

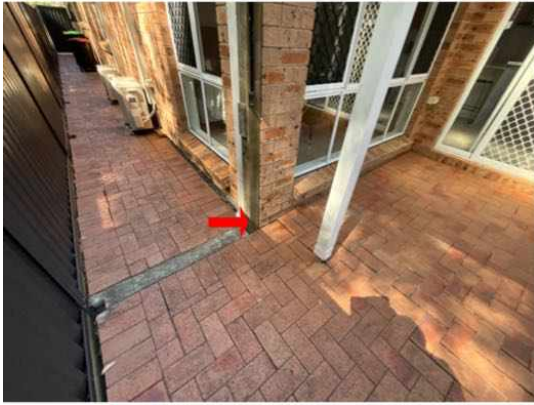
### Finding 6.08

Building:	Main Building
Location:	Alfresco
Finding:	Bridging of termite barrier
Information:	Bridging of termite barriers occurs when termites bridge (usually by building a mud tunnel) a termite barrier or inspection zone or where termites have a passage allowing them to bridge the barrier.

Generally this takes the form of finished ground levels external paving or concrete being retrospectively installed above the damp course level the adjacent internal floor level or weep and ventilation holes.

Where bridging has occurred full inspection is prevented and termites may enter a property in a concealed or undetectable manner.

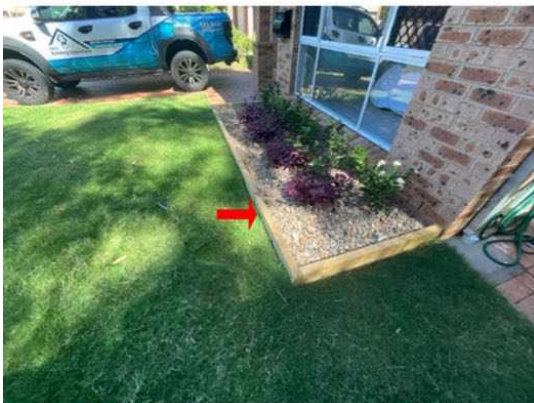
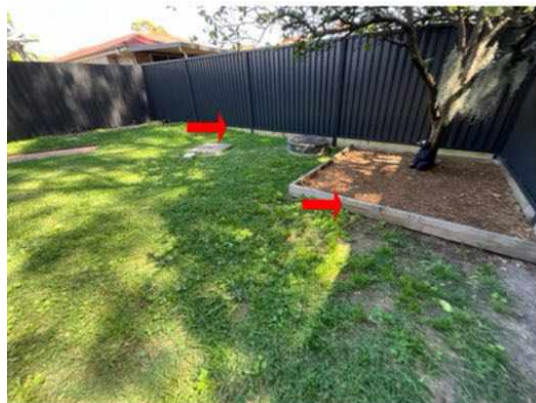
### Finding 6.09

Building:	Main Building
Location:	Fencing & Landscaping
Finding:	Building materials in direct ground contact - conducive to termites
Information:	Where timber elements are in direct contact with the ground and consequently moisture or dampness they become conducive to termite activity. Whether timber is used as a building element part of a fencing structure or stored as an unused item they can provide an environment that is attractive to termite infestation.

When met with excessive moisture timber begins to decay and develop wood rot. Any timbers that are in direct contact with external grounds especially if left untreated or non-durable also provide ingress for subterranean termites into that particular element.

The removal of any such materials that may be conducive to termite activity should be removed as soon as possible to minimise the risk of termite attack.

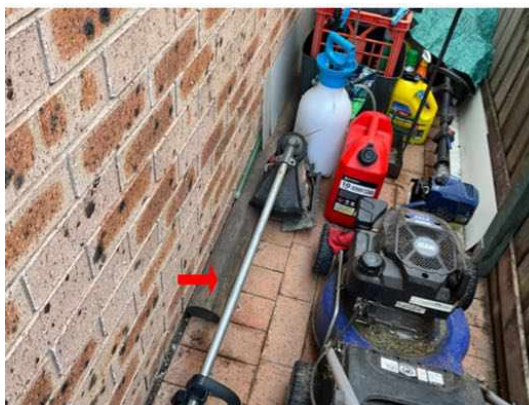
### Finding 6.10

Building:	Main Building
Location:	Yard
Finding:	Stored timbers - subfloor space or external area
Information:	The storing of timbers in the subfloor space or around the external property increases the risk of termite activity being present. As they are likely to come into contact with weather conditions or excessive moisture wood rot is likely to develop on timbers that are not treated.

It is highly recommended that any stored timbers be immediately removed from areas in which they may attract any termite / timber pest attack. Minimisation of risk / prevention of termite attack is far more adequate than dealing with the presence of termite activity.

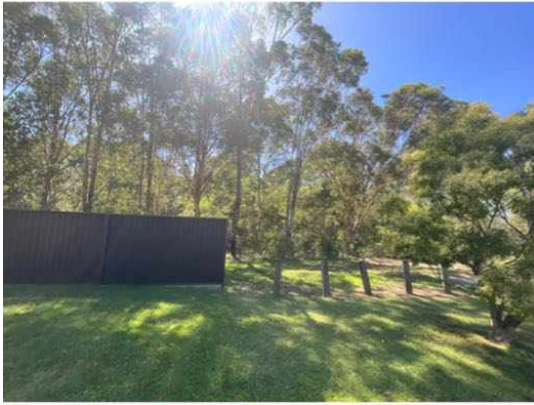
### Finding 6.11

Building:	Main Building
Location:	
Finding:	Surrounding bushland - Conducive
Information:	Home and or building is situated in a high risk area for termite activity, due to close proximity to surrounding bushland.

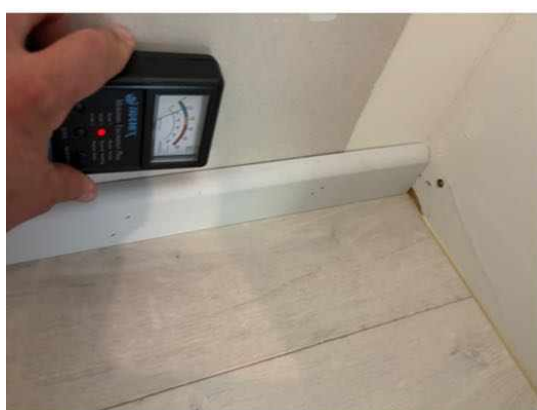
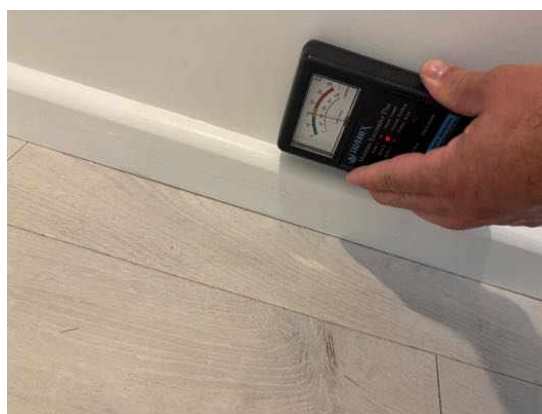
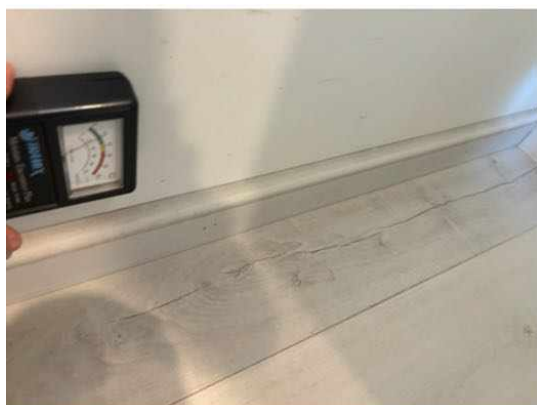
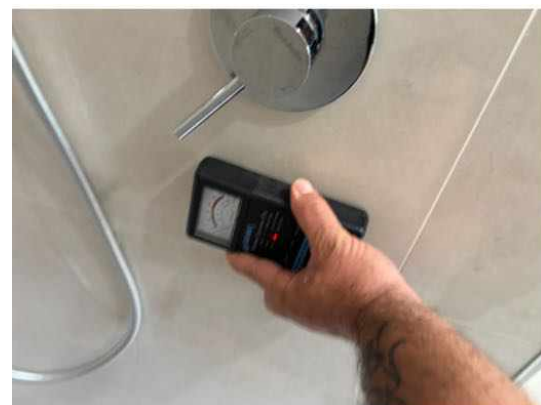
#### Noted Item

Building: Main Building  
 Location: All Areas  
 Finding: Moisture metre  
 Information: During the inspection the property was checked for moisture using a moisture metre.

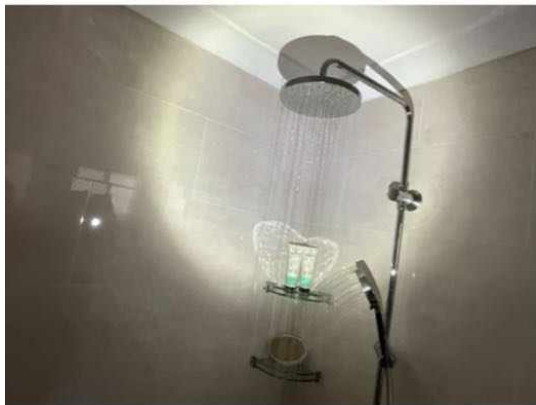
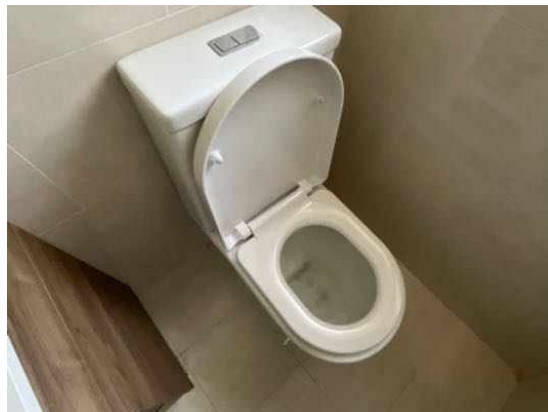
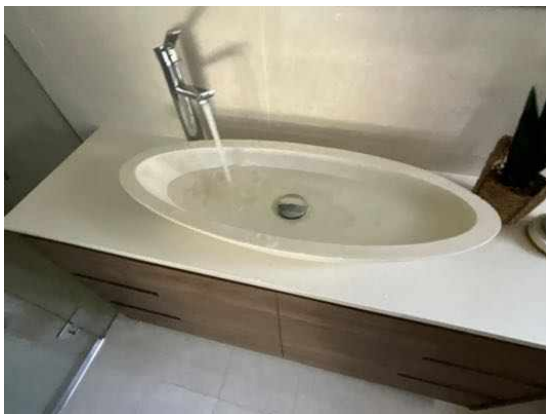
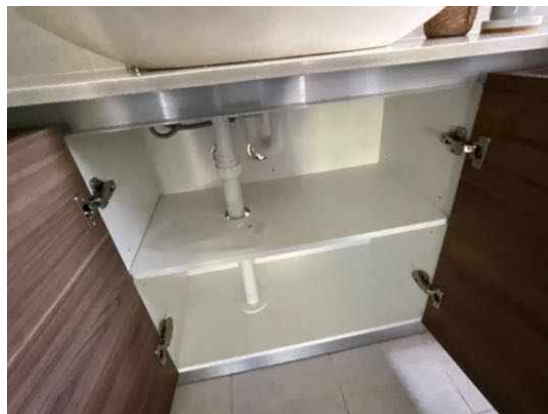
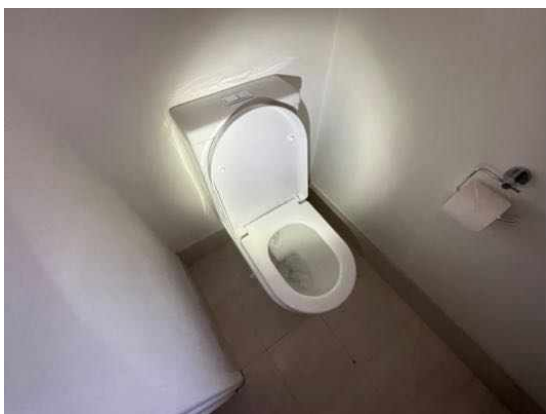
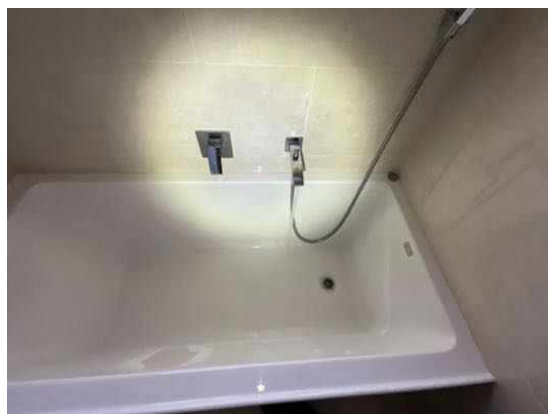
#### Noted Item

Building: Main Building  
 Location: All Wet Areas  
 Finding: Waterproofing  
 Information:

All taps, mixers and toilets were tested for operation, except for those obstructed. The waterproofing to the shower recess was assessed by checking the walls in and around the shower recess for varying moisture content. There were no significant variations across the tested areas. No sign of recent water damage was evident upon

a visual inspection of the surrounding walls, where the visual nature of the inspection was possible.

Consequently, there is no conclusive evidence of any current shower recess leakage other than those which may have already been mentioned earlier in this report. It is reasonable to assume the shower waterproofing is sound. Note that if the shower is not used, or has not been used for some time, moisture readings would not vary significantly and this can lead to erroneous results. It is not possible under the visual inspection criteria (under which a prepurchase inspection is carried out) to categorically determine if there are leaks. If a more accurate assessment is required, a special purpose inspection should be requested. Alternatively, the assumption should be made that the shower may leak.

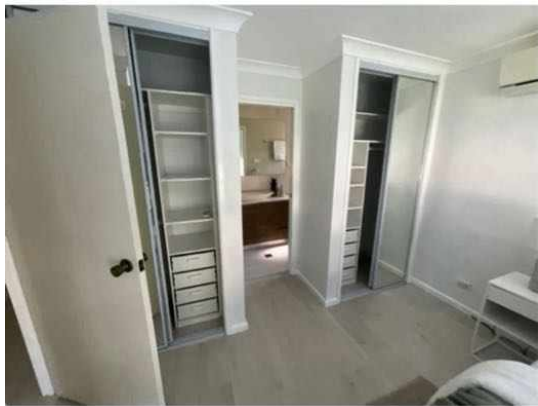
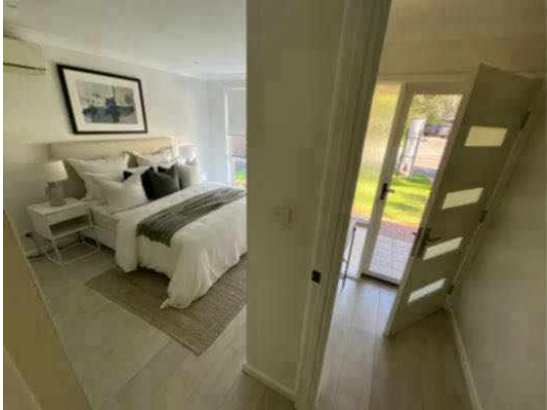
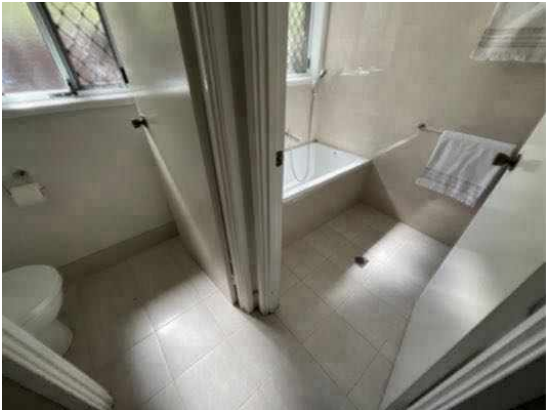
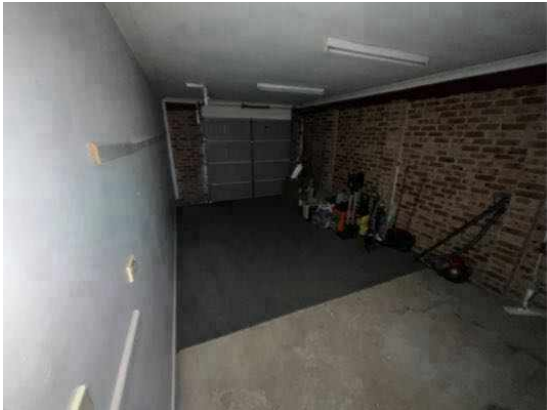
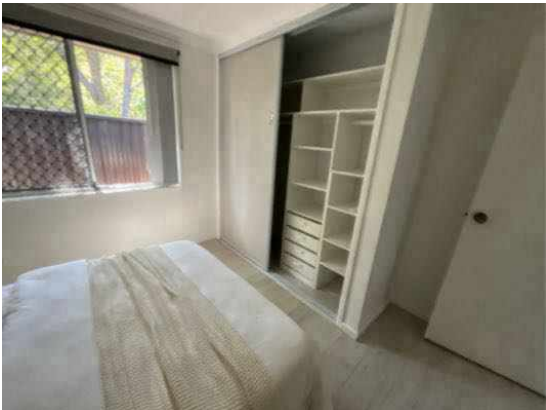
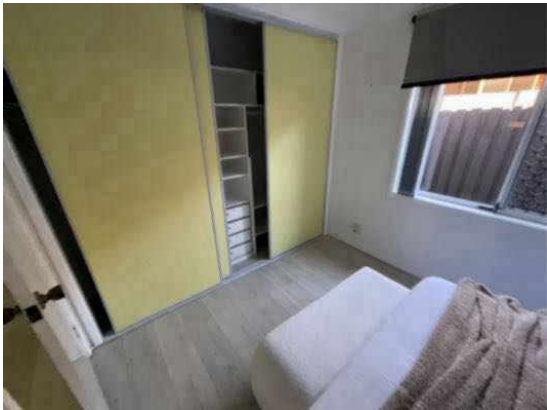
### Noted Item

Building: Main Building  
Location: All Areas  
Finding: Additional Photos - Obstructions and Limitations  
Information:

These photographs are an indication of the obstructions and limitations which impeded full inspection of the property at the time of inspection. These obstructions can hide an array of defects and should be removed to allow full inspection to be carried out. A re-inspection is recommended once the areas are made accessible.

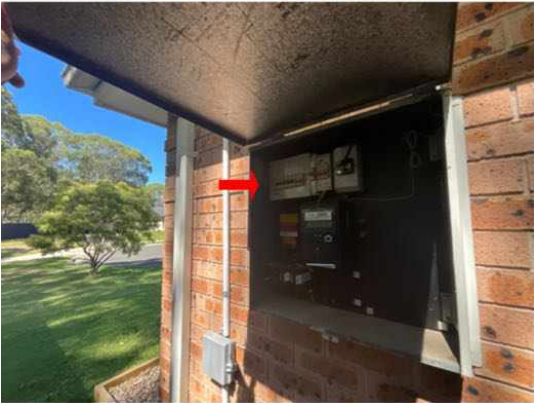
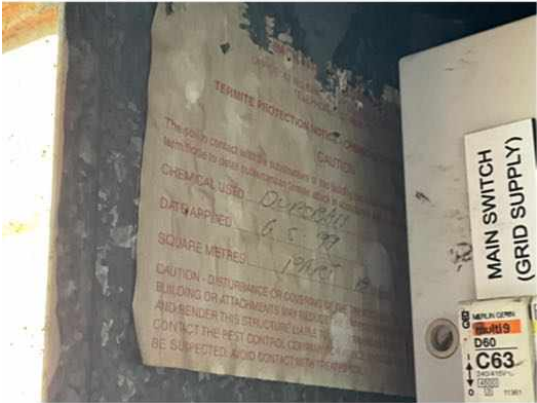
Where a Termite Management System has been identified you should refer to the type of barrier date of installation warranty conditions and any documentation provided by a builder or past owner. Consult the company who installed the barrier to confirm whether the system is still under warranty.

Most chemical termite management systems expire and require replenishment and all physical systems are primarily designed to prevent concealed entry.
