Building and Timber Pest Inspection Report

Inspection Date: Tue, 17 Feb 2026

Property Address: 24/6-8 Price St, Ryde NSW 2112, Australia

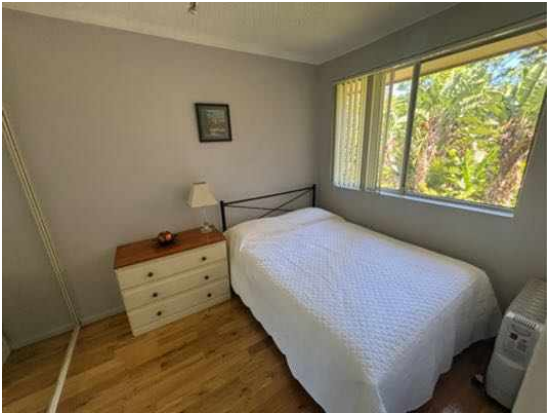
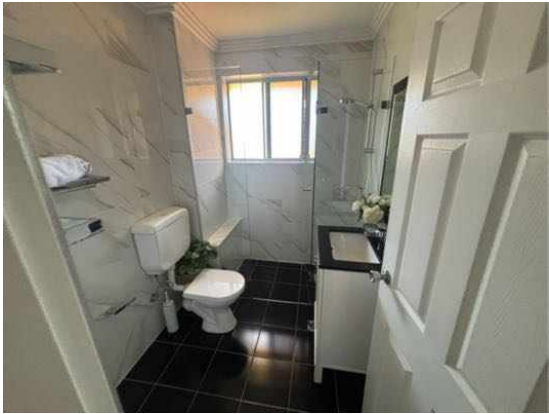
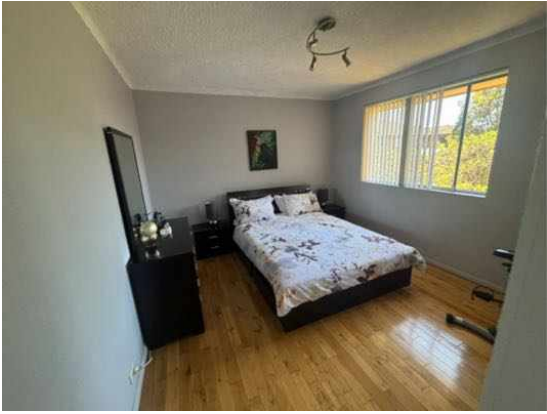
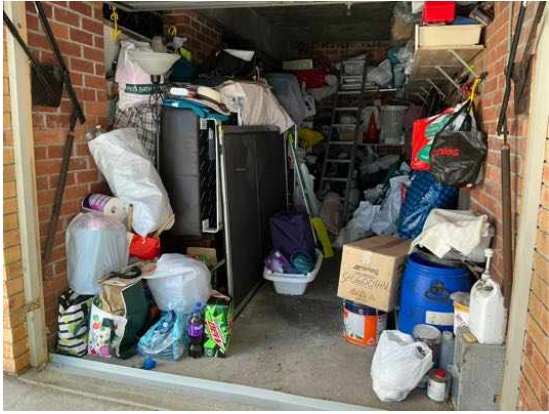
Building: Main Building
 Location: All Areas
 Finding: FYI - Windows and Doors were tested for Operation
 Information: During the inspection, all accessible windows and doors were tested to assess their functionality. Some windows and doors, however, were locked or obstructed by furniture, personal belongings, or other impediments, which prevented a complete evaluation of these specific units. For those windows and doors that could be tested, they appeared to operate as intended at the time of the inspection, with no immediate concerns noted regarding their opening, closing, or locking mechanisms.

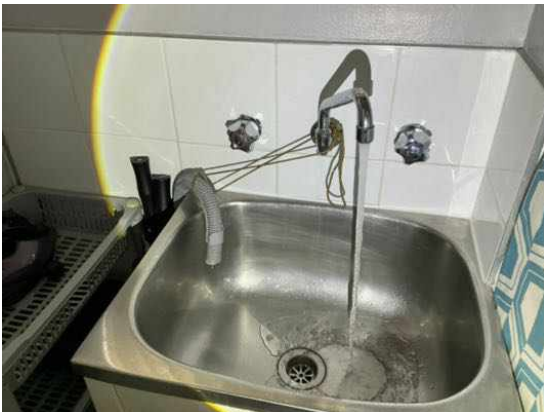
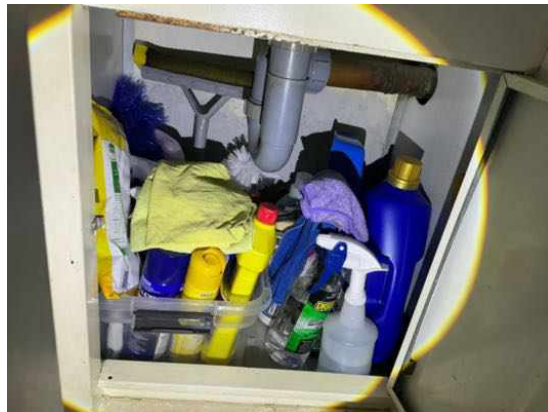
Given this, a re-inspection is recommended after all obstructions have been cleared to allow for a comprehensive assessment of these areas. Regular maintenance and monitoring of plumbing and drainage systems is also advised to ensure ongoing functionality and early detection of potential issues.

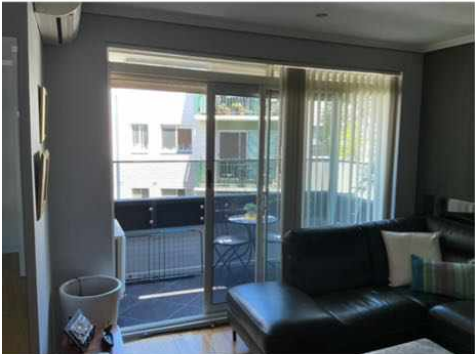
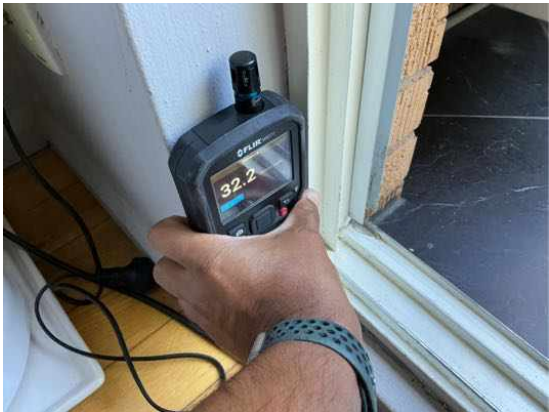
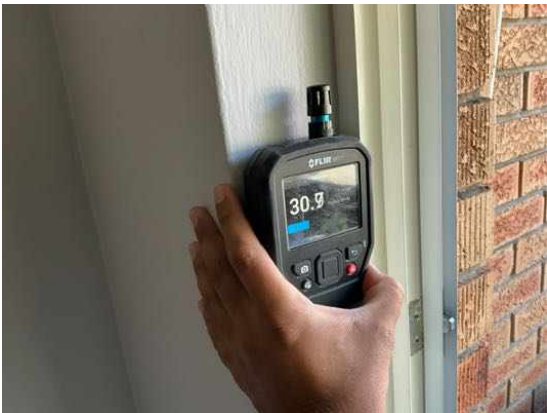
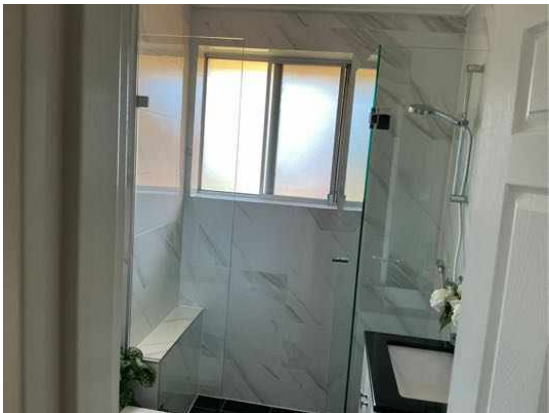
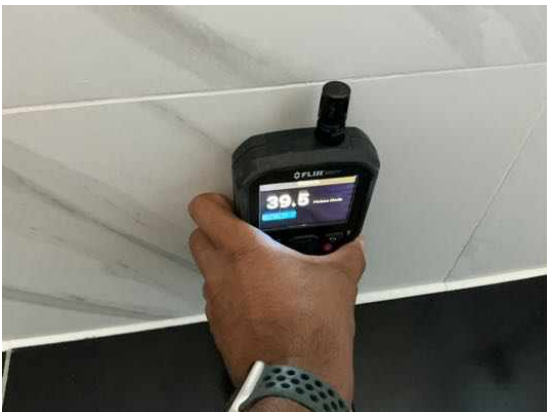
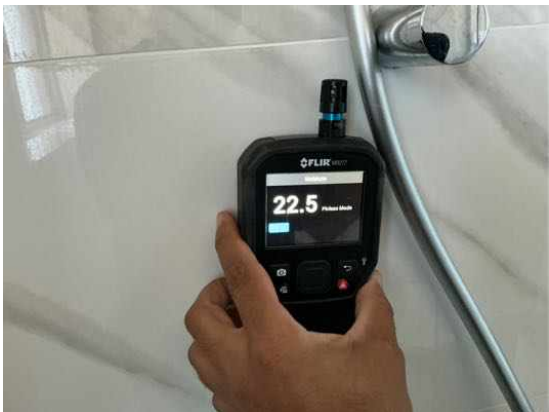
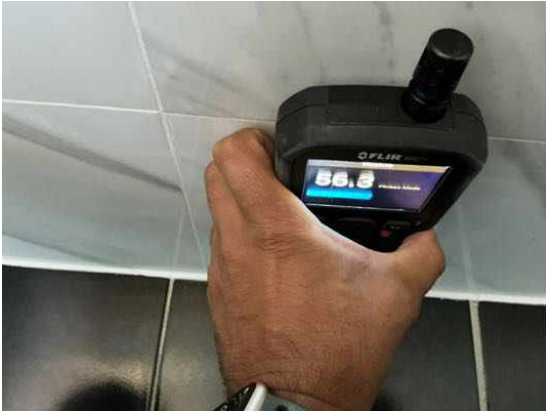
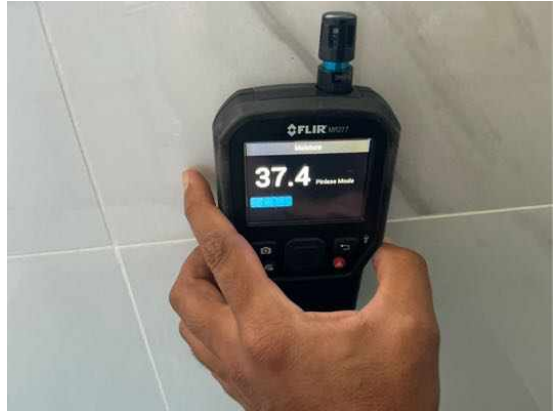
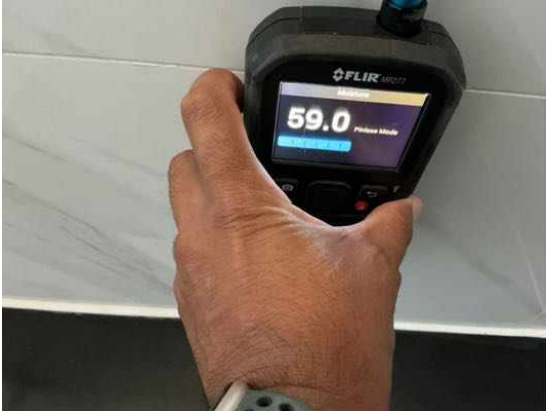
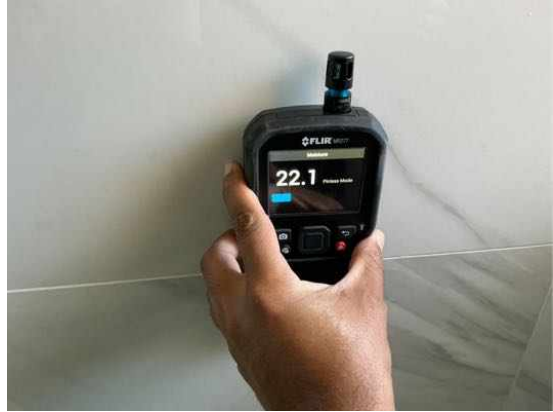
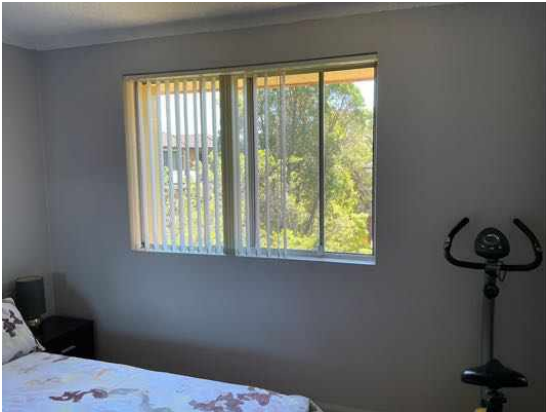
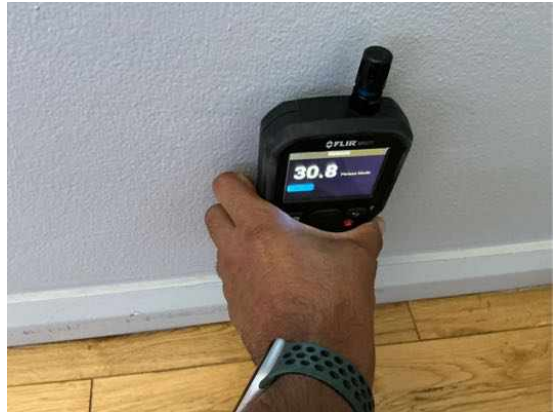
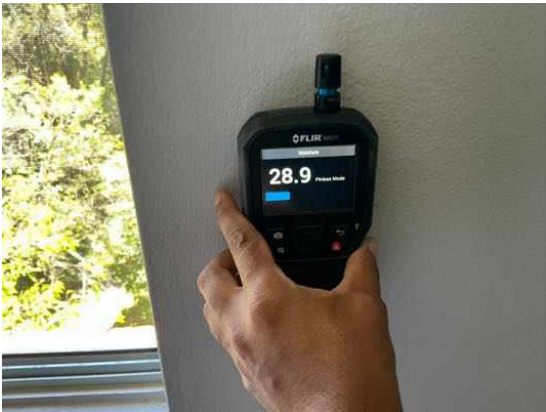
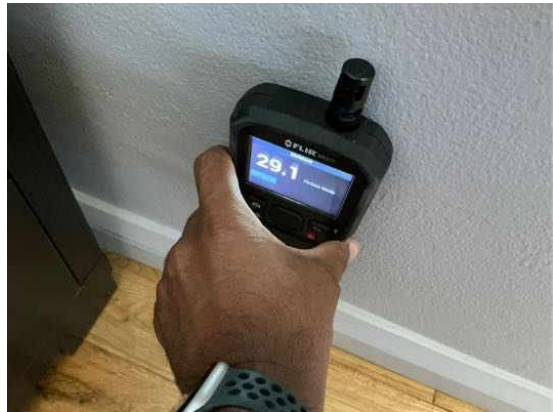
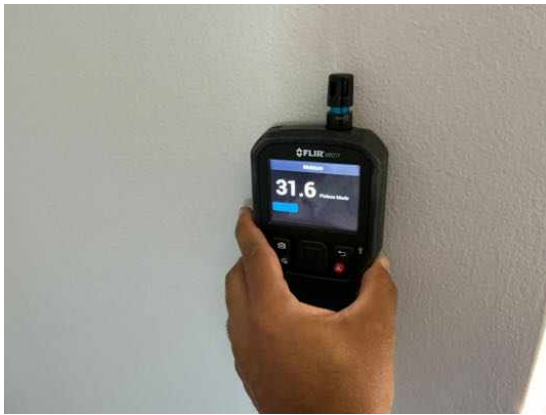
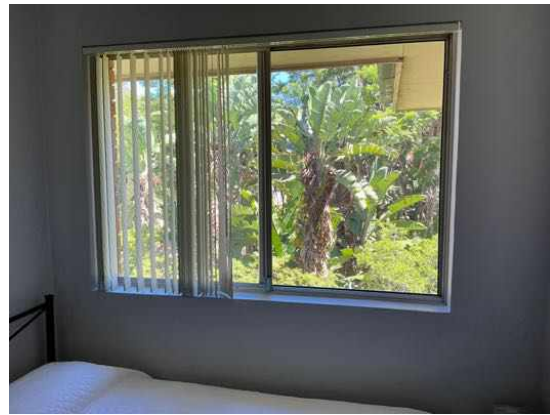
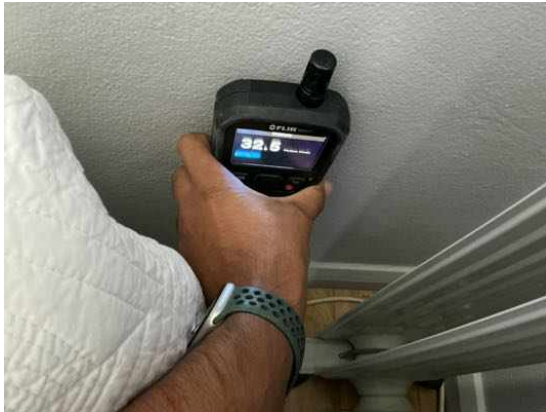
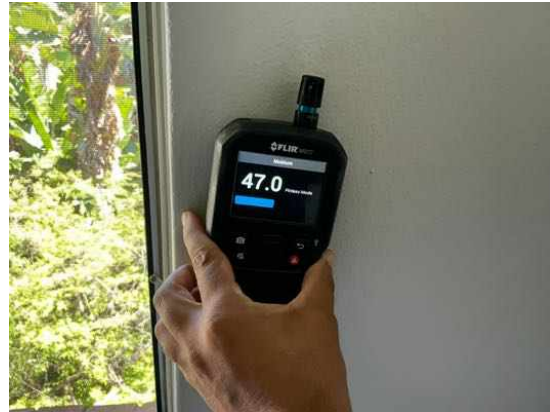
It is important for the client to understand that moisture levels can fluctuate over time due to various factors, including changes in weather, humidity, and environmental conditions. While the readings reflect the property's moisture levels during the inspection, they may not represent future conditions, and increased moisture could lead to issues such as dampness, mould growth, or deterioration of building materials if left unmonitored.

For further clarification or additional information regarding the moisture readings, the client is encouraged to contact the building inspector directly. Regular monitoring of moisture-prone areas is recommended to ensure any emerging concerns are addressed promptly, particularly during wetter seasons or in high-humidity conditions.

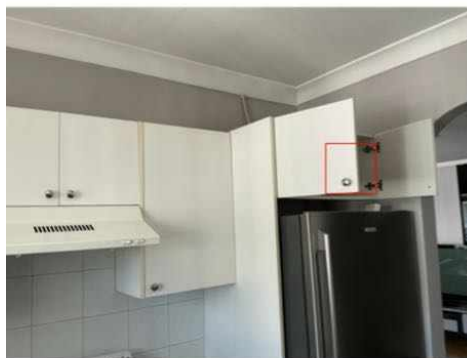
Building: Main Building
Location: Kitchen
Finding: Electrical Meter Box
Information: Electrical meter box is located in kitchen cabinets

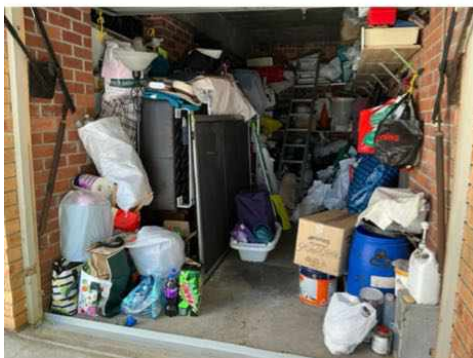
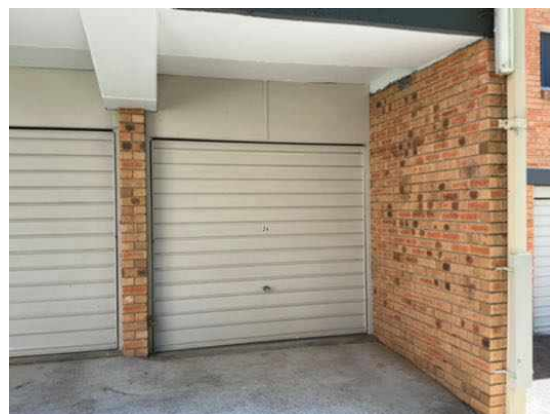
Finding: Allocated Car Spaces

Information: The accompanying photos are provided for your general reference, showcasing the current condition of the car parking spots and storage rooms as observed at the time of inspection. It is important to note that these images are meant to serve as a visual snapshot of the property's features at the time of the assessment. However, the client is strongly advised to confirm all allocations, such as car parking spots, storage rooms, and any associated rights or access, within the terms of the contract. Verifying these allocations through the contract ensures clarity and avoids potential disputes regarding ownership or usage. The photos included are intended to give an overview of the designated areas, but the final details should always be cross-referenced with the contractual agreements for accuracy and completeness.

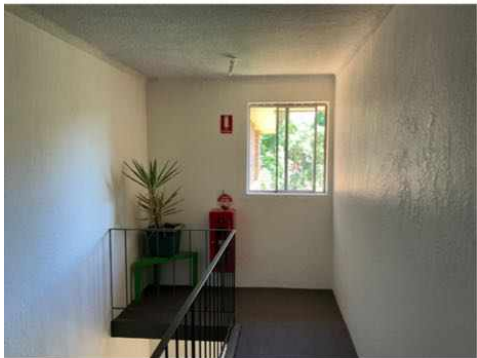
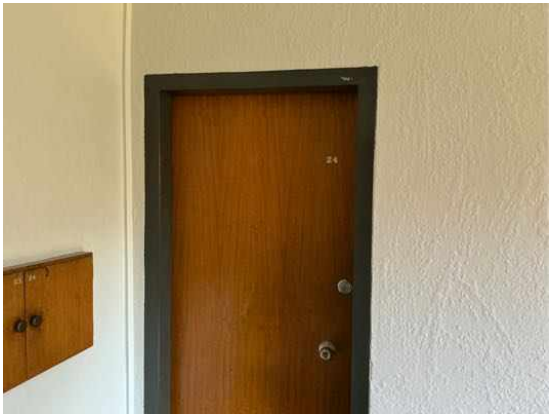
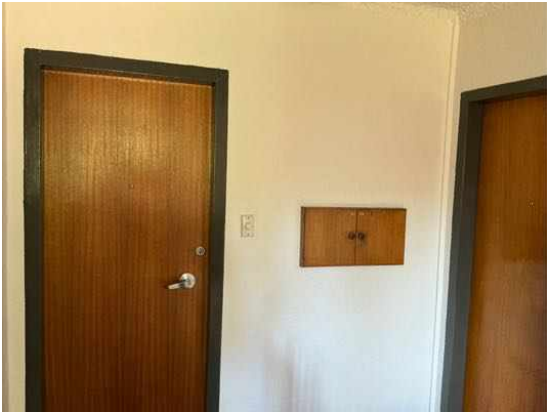
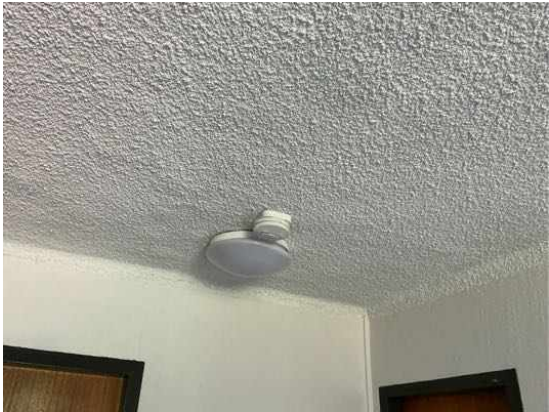
Building: Main Building
Location: All Areas
Finding: Additional Photos of Common Areas
Information: Additional photos have been provided for your general reference. These images serve as visual documentation of the current condition of the common areas within the building complex at the time of inspection. It is recommended that the client consult with strata management regarding any necessary repairs or maintenance required throughout the complex. These photographs are intended to illustrate the present state of the common areas and should be used as a basis for discussing and prioritizing any needed remedial works with the relevant parties.
