Building and Timber Pest Inspection Report

Inspection Date: Wed, 11 Feb 2026

Property Address: 60 Park Rd, Sydenham NSW 2044, Australia

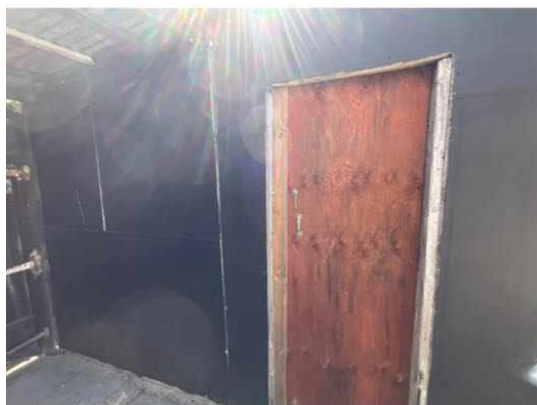
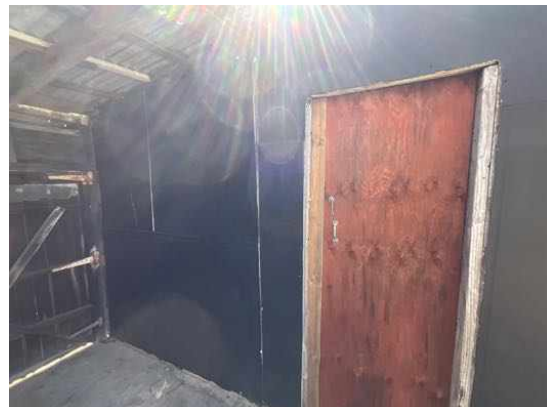
Information: Reporting on Asbestos is outside the Scope of this Report. This suspected defect is highlighted as a caution only. We suspect, based on our experience in the building industry, that there is a higher risk of the identified building element containing asbestos.

As Asbestos Reporting is outside the scope of this report, we advise that you consider a separate Asbestos Inspection and Condition Audit, which can include the taking of samples for definitive confirmation of the presence of Asbestos.

In the interim, the client is advised to act with caution, especially when considering any damage to building materials general wear and tear renovations extensions demolition and general maintenance activities due to the suspected presence of Asbestos.

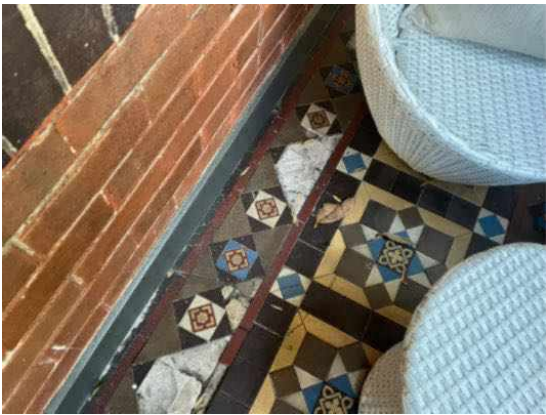
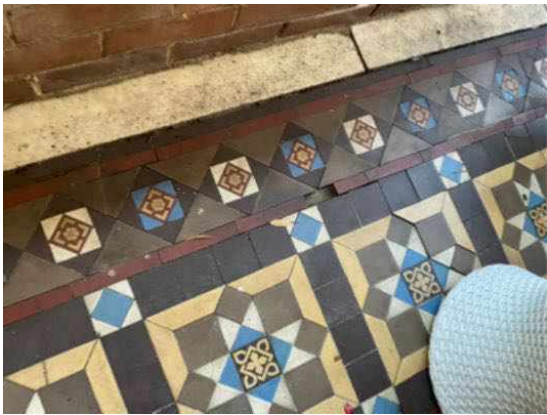
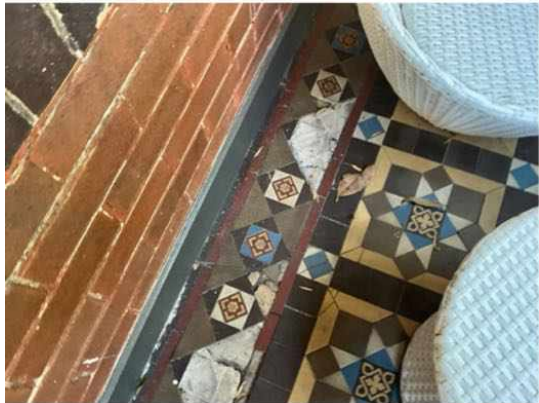
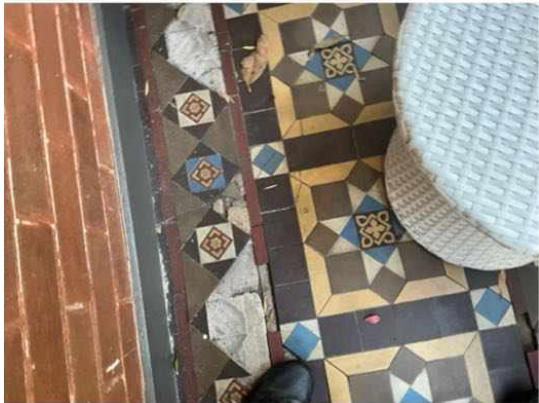
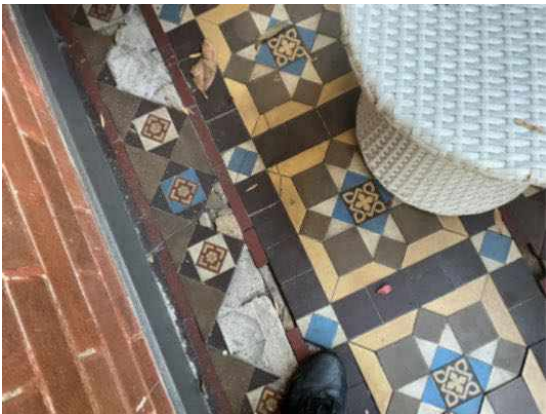
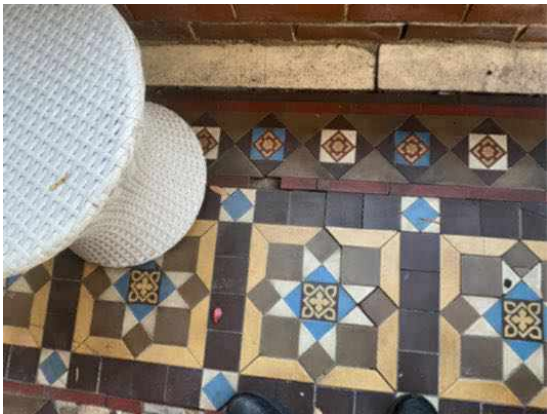
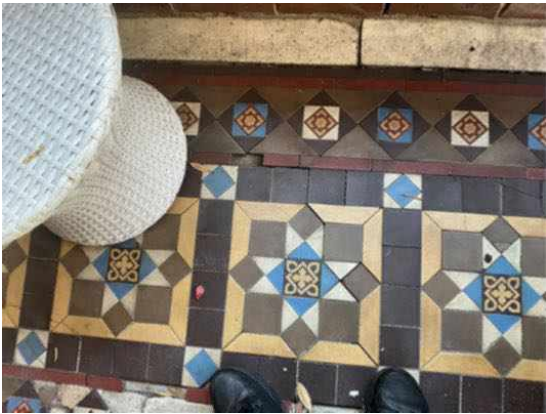
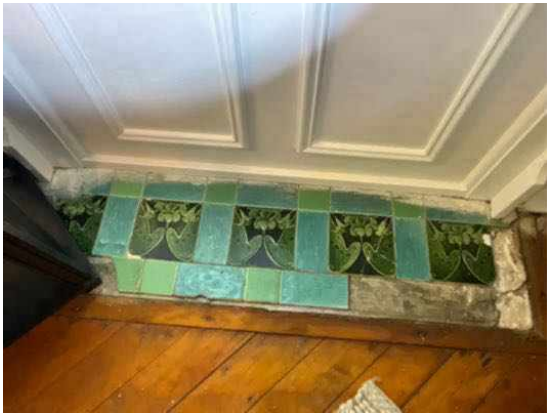
Building: Main Building
Location: All Areas
Finding: Uneven & damaged floor tiles
Information: Uneven & damaged floor tiles were observed on the tiled surface.

Uneven tiles present a trip hazard, particularly in high-traffic or outdoor areas, and can lead to personal injury. They may also contribute to water pooling and long-term deterioration of the tile adhesive or substrate.

A licensed tiler or builder should be engaged to assess and rectify the affected tiles, which may involve lifting and re-laying the tiles or re-levelling the substrate to meet current building tolerances.

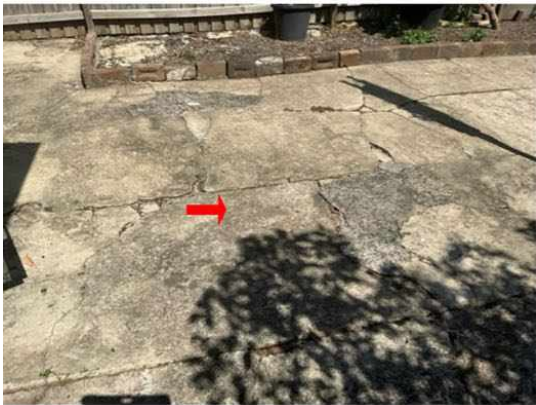
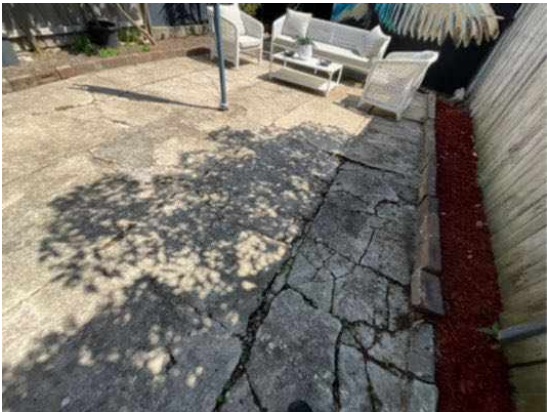
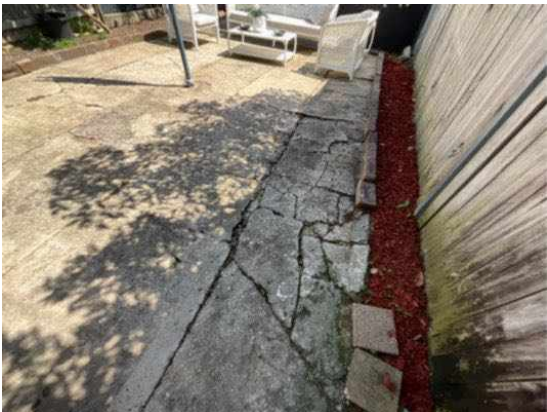
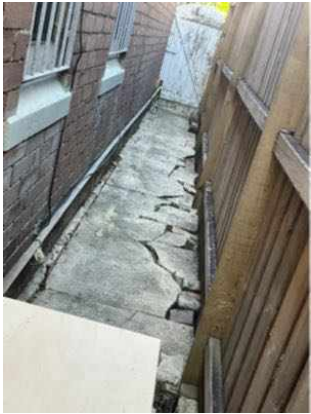
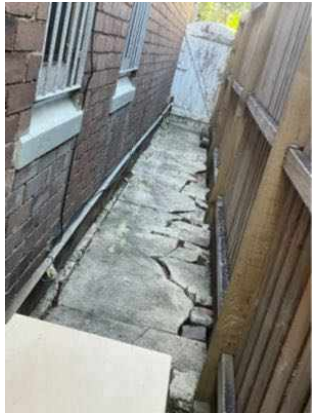
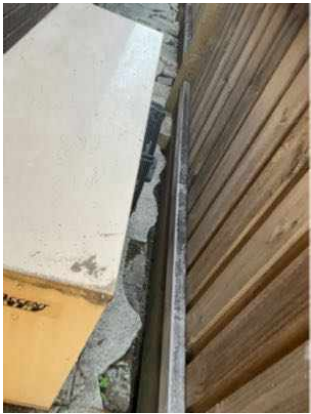
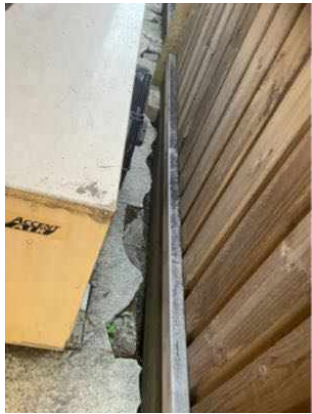
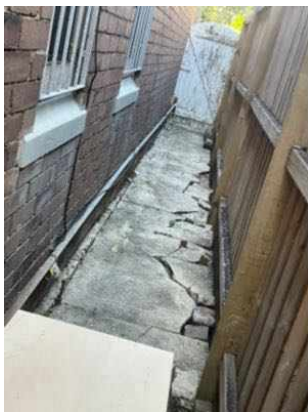
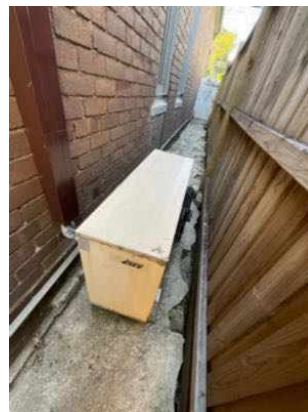
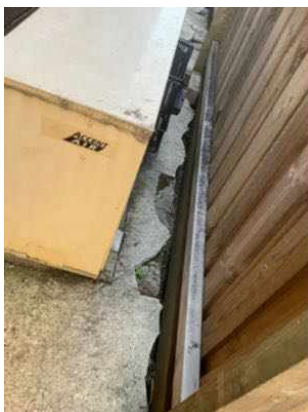
Finding 2.03

Building:	Main Building
Location:	All Areas
Finding:	Noticeable Cracking in Concrete Slab
Information:	Noticeable cracking has been observed in the concrete slab, failing to meet the required construction and quality standards.

- Cracks are visible on the surface and may extend through the depth of the slab.
- Evidence of improper curing or inadequate reinforcement leading to cracking.

- Compromised structural integrity of the slab, potentially leading to failure under load.
- Water ingress through cracks, causing corrosion of reinforcement and further weakening the structure.
- Potential trip hazards and aesthetic issues, reducing the overall value and safety of the property.
- Increased maintenance and repair costs due to ongoing deterioration.

- A structural engineer should be engaged to assess the extent of the cracking and recommend appropriate repair methods.
- A licensed contractor or concrete repair specialist should carry out the recommended repairs under the guidance of the structural engineer.

A detailed inspection should be conducted post-repair to confirm compliance with the required standards and to ensure that the structural integrity of the concrete slab has been restored.

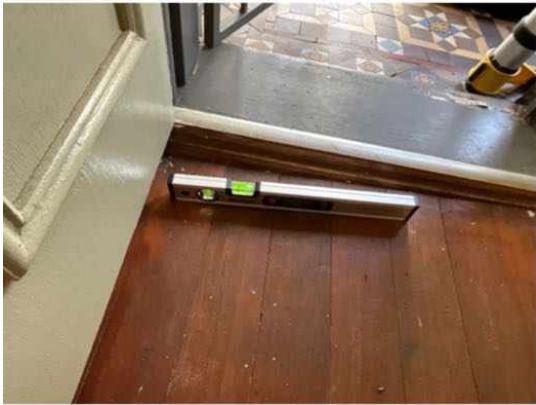
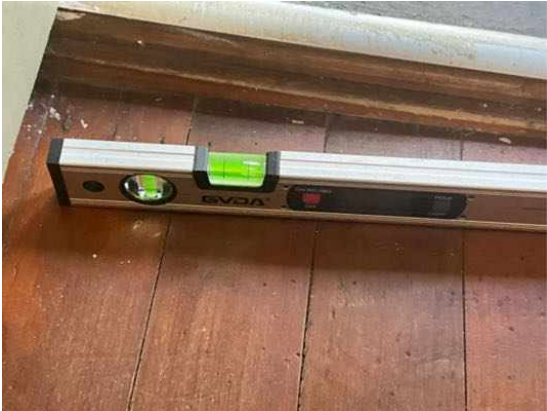
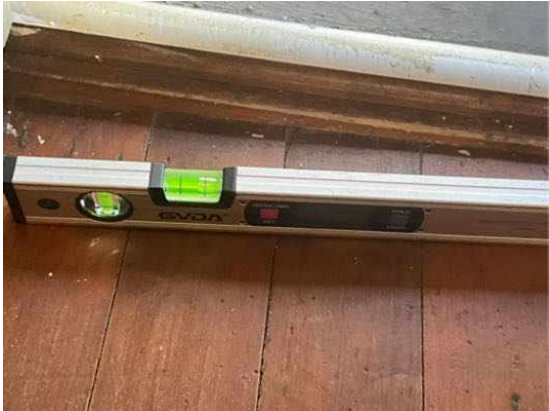
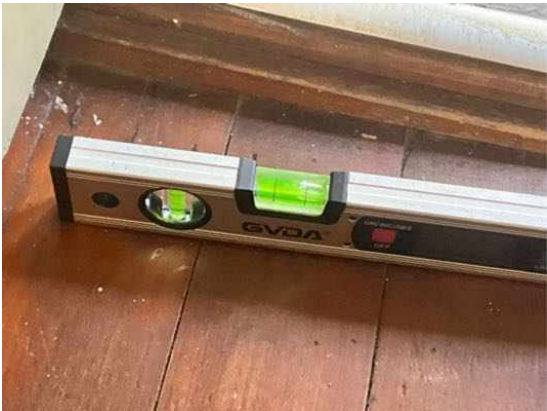
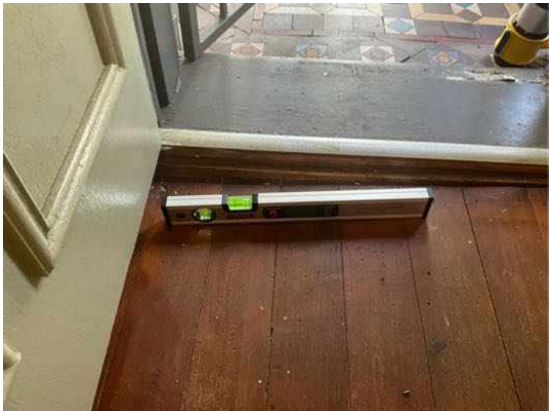
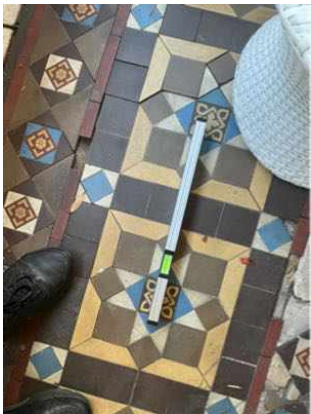
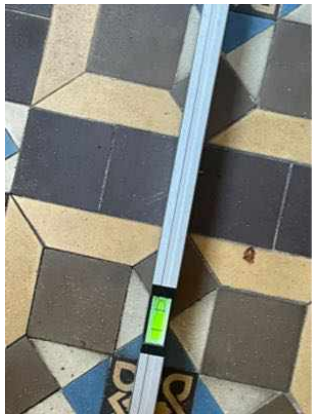
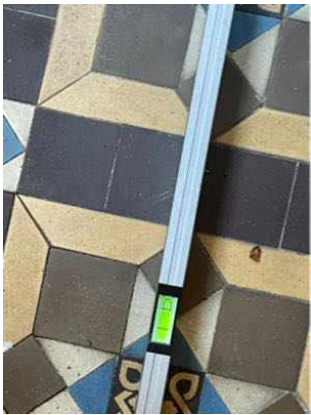
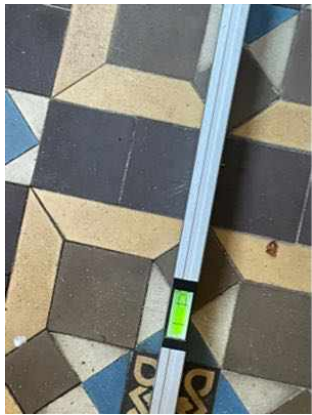
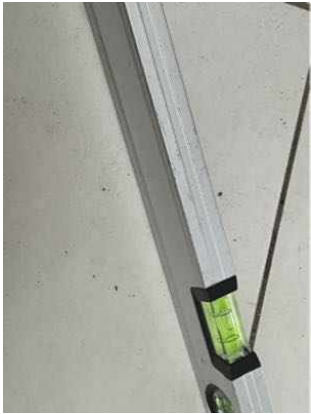
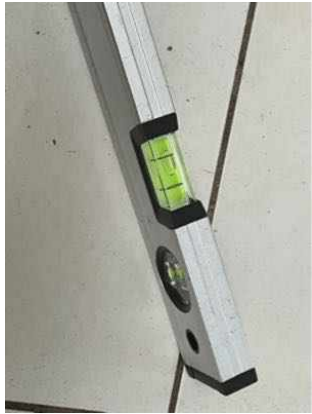
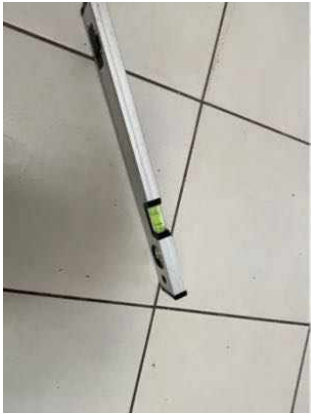
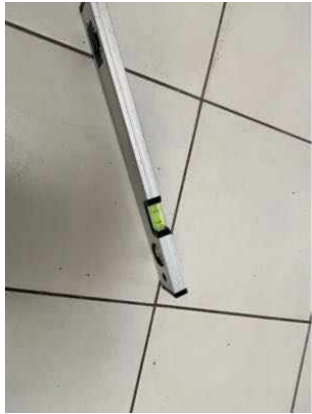
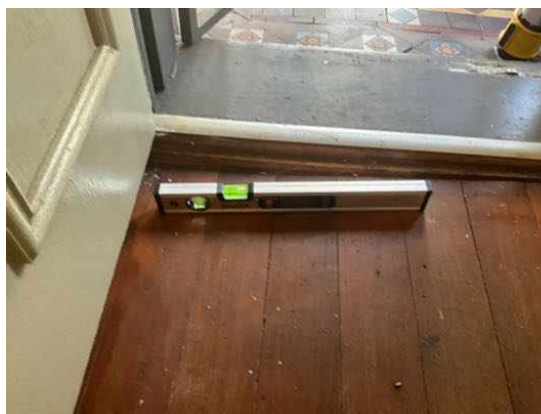
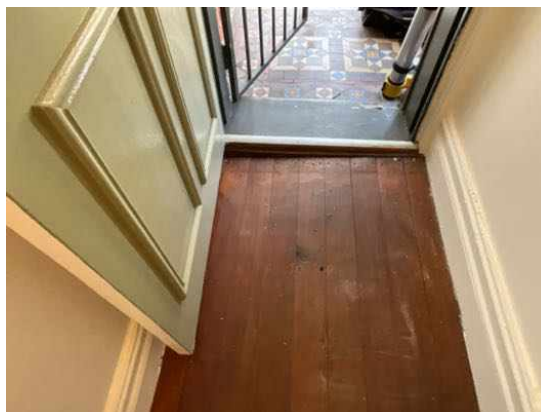
Finding 2.04

Building:	Main Building
Location:	All Areas
Finding:	Uneven / Out-of-Level Internal Flooring
Information:	The internal flooring within the inspected area was observed to be out of level and uneven underfoot. Variations in floor levels can indicate structural movement, which may be associated with foundation settlement, reactive soil movement, or deterioration and/or subsidence of supporting subfloor stumps and bearers.

Given the nature of this defect, a further invasive inspection of the subfloor area is strongly recommended to assess the condition of stumps, bearers, joists, and footings. Access limitations during a visual, non-invasive inspection may prevent full assessment of structural elements.

Repairs, if required, would typically involve re-levelling and/or re-stumping works and should be carried out by a suitably qualified and registered builder experienced in structural rectification works. In some cases, structural engineer assessment may also be required to determine the extent and cause of movement prior to rectification.

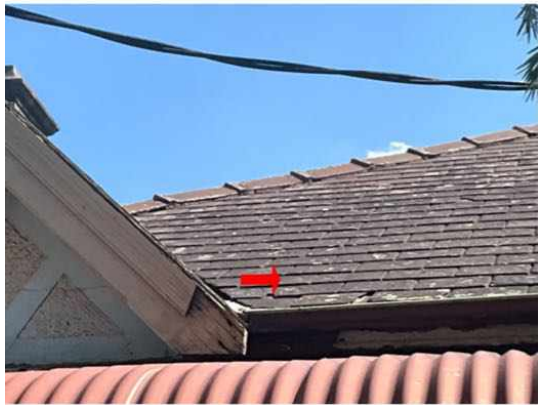
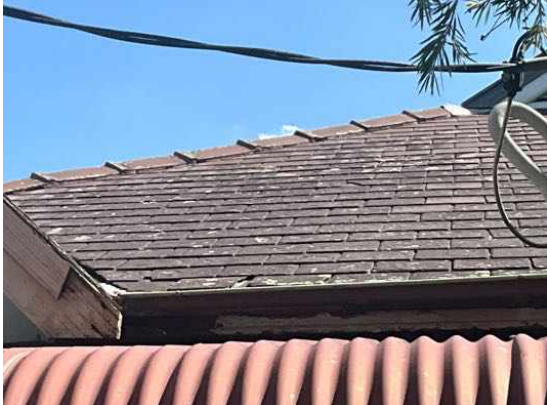
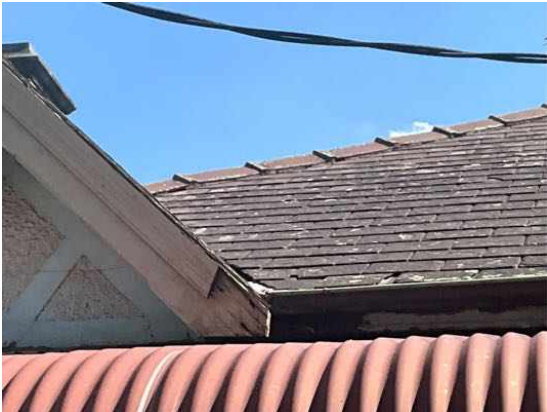
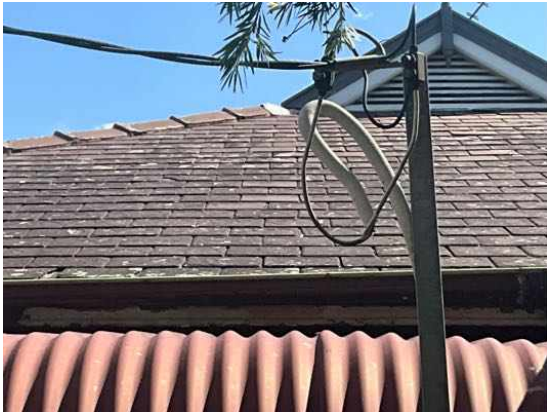
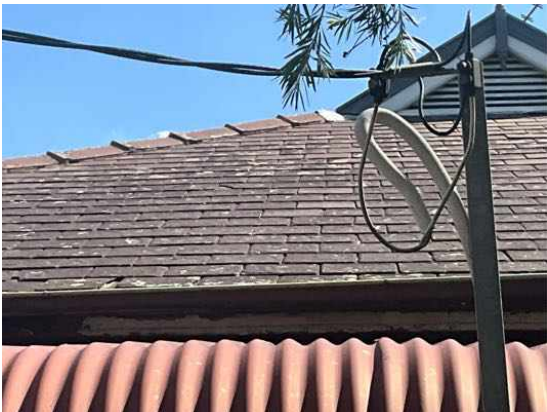
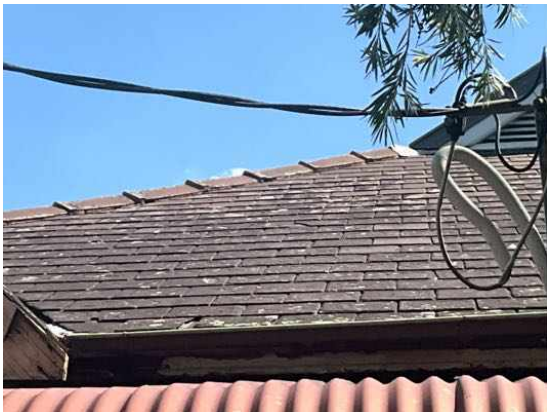
Finding 2.05

Building:	Main Building
Location:	All Areas
Finding:	Roof Weathered
Information:	Upon inspection of the exterior roofing, the majority of roof was not in a fair condition. While weathering of the roof is consistent with the age of the property, maintenance works are required.

Isolated areas of mortar have come loose in the valleys and minor cracking is also present. Re-pointing and re-sealing the may be considered as an interim solution by the client to help preserve and extend the life span of the tiles.

Where left unmanaged, deteriorating roof are likely to lead to a number of secondary defects, including minor water leaks and weather exposure to internal roofing structures.

Consultation with a roofing contractor is highly advised to gain advice on cost of remedial works that may be required in the short to medium term. Remedial works are likely to increase the longevity of the exterior roofing structure.

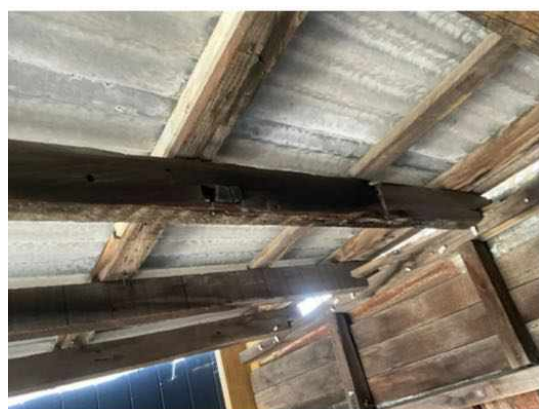
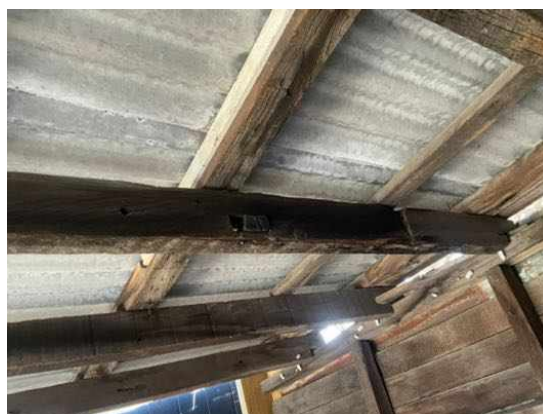
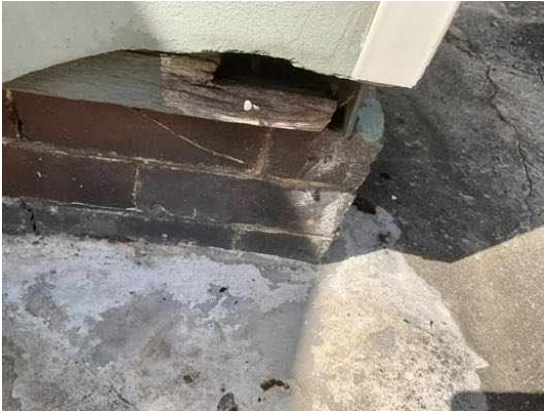
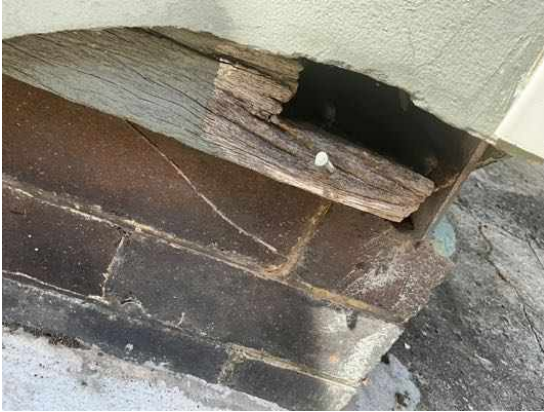
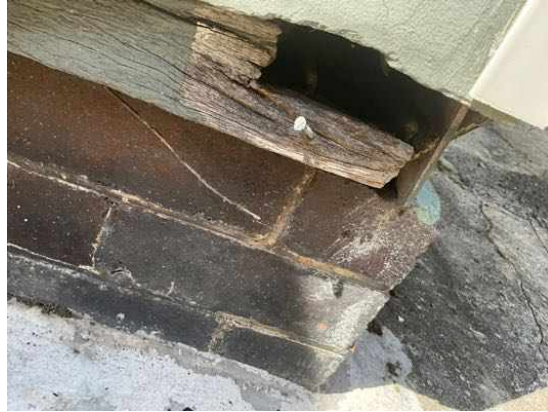
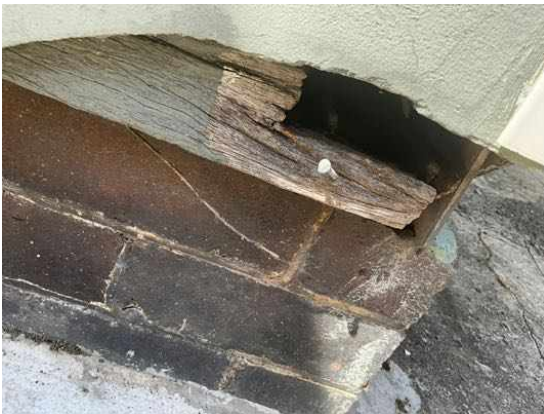
Building: Main Building
Location: All Areas
Finding: Rot weakening the timber structure
Information: Cracks and signs of wood rot have been observed, weakening the timber structure. The deterioration could be due to moisture exposure, aging, or insect infestation, compromising the structural integrity of the timber.

- ****Structural Instability:**** The cracks and wood rot can compromise the load-bearing capacity of the timber, potentially leading to structural failure or collapse, especially in

- **Safety Hazard:** Weakening of the timber structure increases the risk of accidents, such as falling debris or collapse, posing a danger to occupants.

- **Progressive Damage:** If left unaddressed, wood rot can spread, further degrading the timber and accelerating the risk of structural failure.

- **Pest Infestation:** Wood rot can attract pests such as termites, which may cause additional damage.

A structural engineer or professional carpenter should be contacted to assess the extent of the damage. Depending on the severity, repairs may involve replacing the affected timber sections, treating the wood with preservatives, or reinforcing the structure. If there is extensive rot, a specialist in wood restoration or pest control may also be required to prevent further decay or infestation.

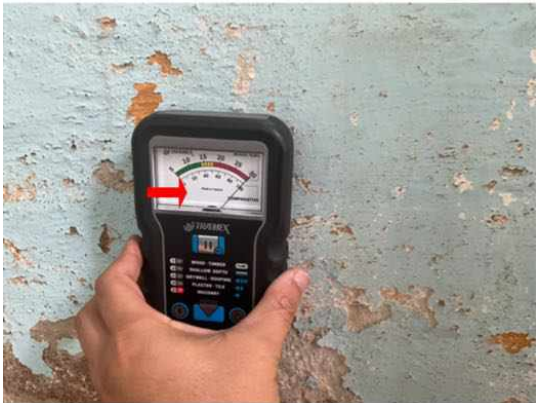
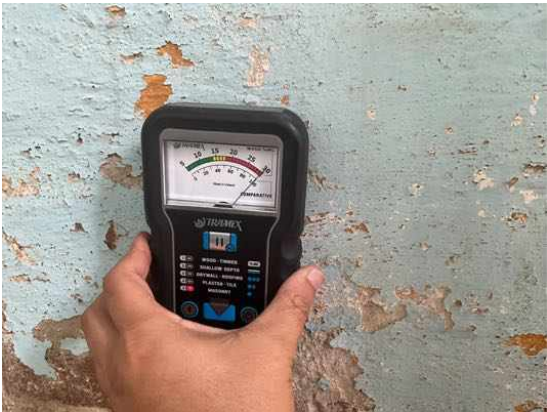
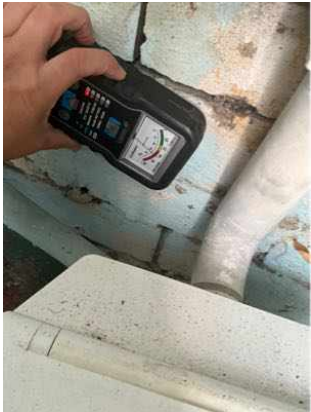
Finding 2.07

Building:	Main Building
Location:	Toilet (WC)
Finding:	Evidence of excessive moisture was present at the time of inspection
Information:	Excessive moisture is present behind the bathroom tiles, indicating a potential water leakage issue within the wall.

The prolonged presence of moisture can lead to mold growth, deteriorate the structure, and create an environment conducive to health hazards. Additionally, it may compromise the adhesive holding the tiles, leading to their detachment.

A licensed plumber or a qualified contractor specializing in water damage remediation

should investigate the source of the moisture, fix any leaks, and address the damage. Additionally, replacing affected tiles and ensuring proper waterproofing are crucial to preventing future issues.

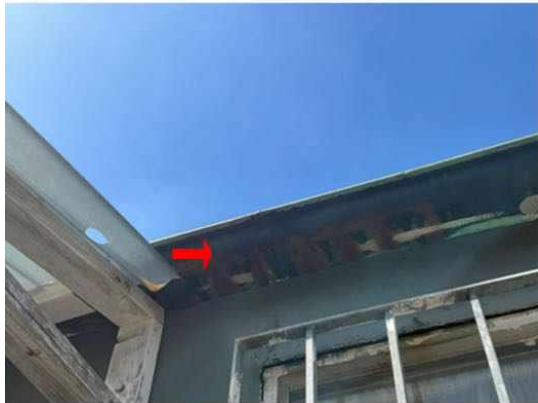
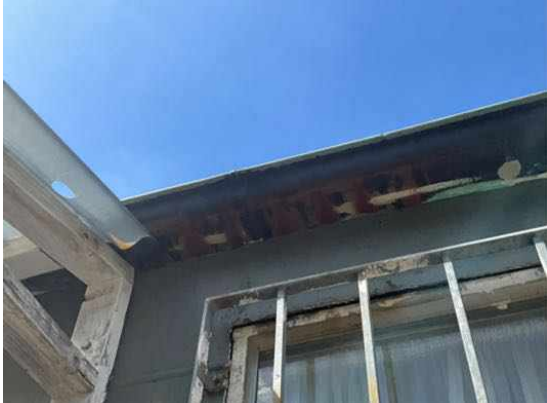
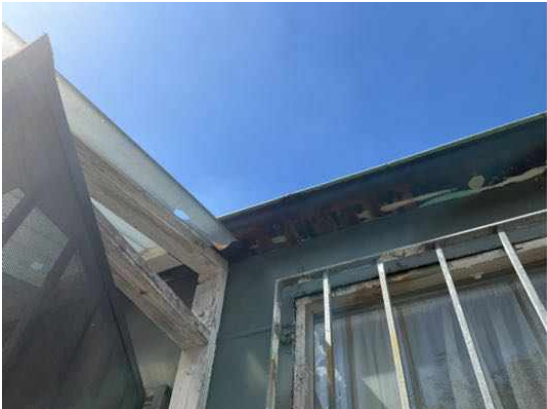
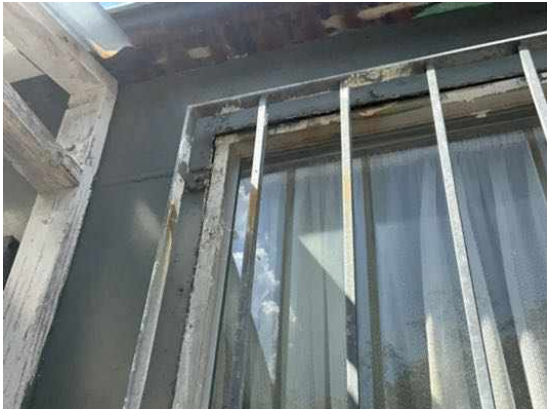
Finding 2.08

Building: Main Building
Location: All Areas
Finding: Rusty Gutters
Information: The gutters exhibit signs of rust, including corrosion and discoloration, compromising their functionality and aesthetics.

Risk: Rusty gutters pose several risks, including reduced water drainage efficiency, potential water damage to the building’s exterior and foundation, and aesthetic degradation. Corrosion weakens the structural integrity of the gutters, making them prone to leaks, cracks, and eventual failure. Inadequate water drainage can lead to water pooling around the foundation, causing erosion, moisture infiltration, and potential structural damage over time. Additionally, rust stains may detract from the curb appeal of the property, impacting its overall appearance and value.

A qualified gutter repair or maintenance professional should be engaged to address the issue. They can assess the extent of rust damage, recommend appropriate repair or replacement options, and perform necessary repairs to restore the functionality and integrity of the gutters. Depending on the severity of the rust, repairs may involve cleaning, sanding, patching, or replacing corroded sections of the gutters. Additionally, they may apply protective coatings or install gutter guards to prevent future rust formation and prolong the lifespan of the gutters. Regular gutter maintenance, including cleaning and inspection, can also help prevent rust and ensure optimal performance.

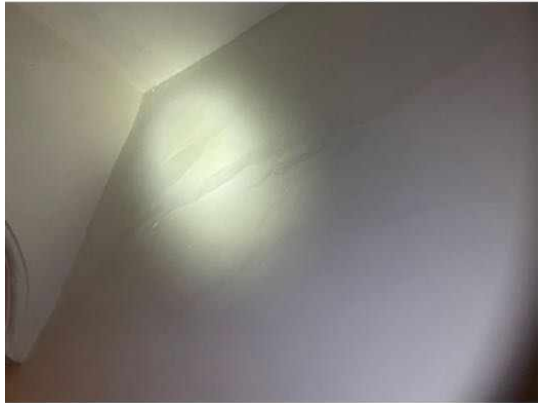
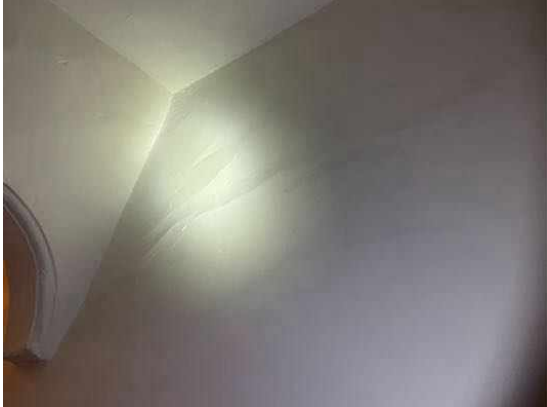
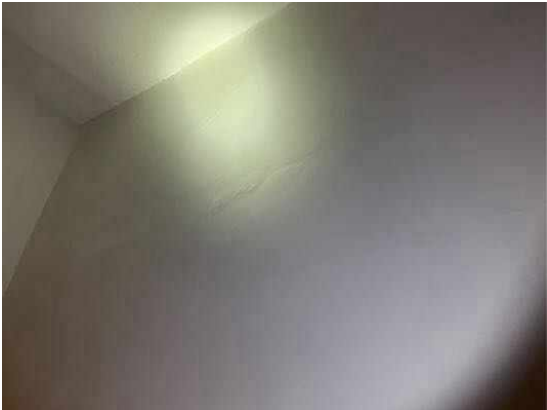
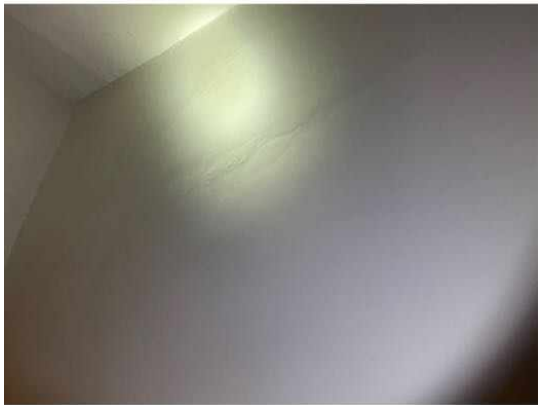
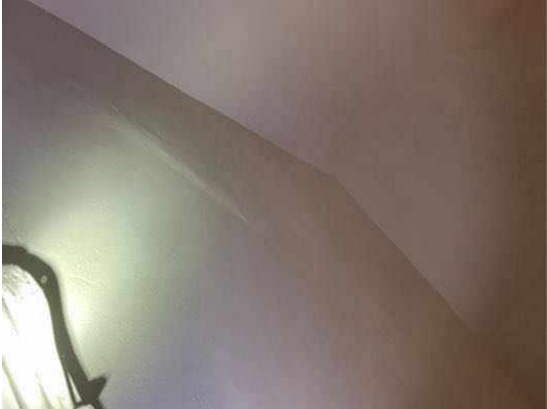
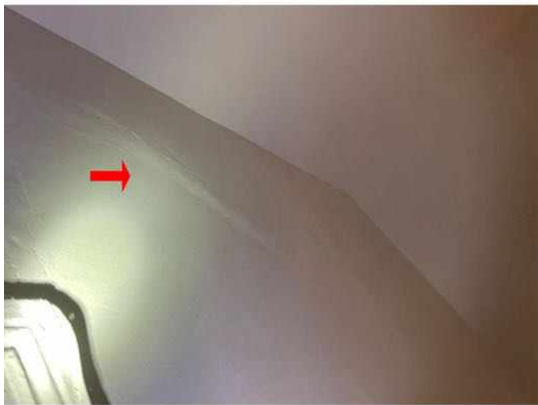
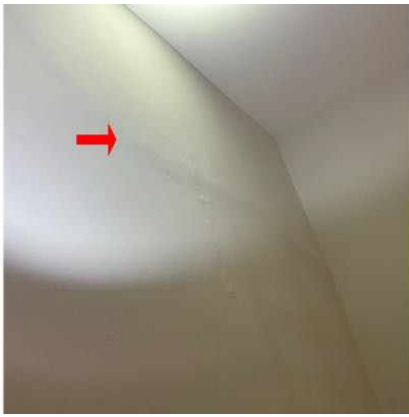
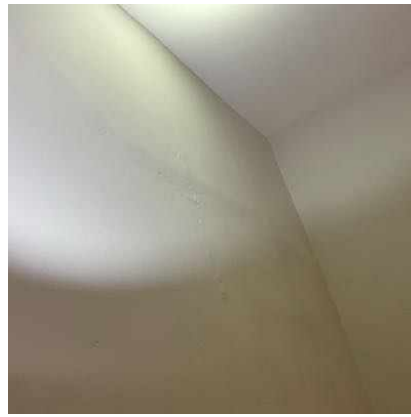
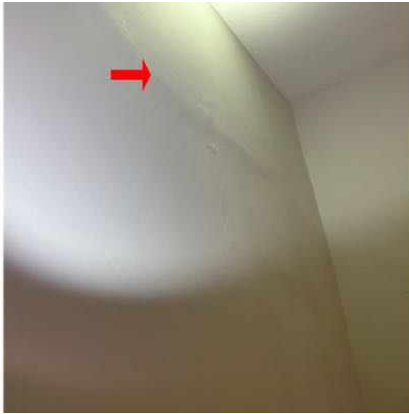
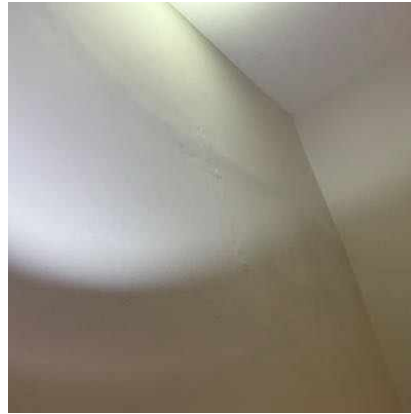
Finding 2.09

Building: Main Building
Location: All Areas
Finding: Poor workmen ship

Risk: Poor workmanship poses a range of risks, including compromised structural integrity, potential safety hazards, and a decreased lifespan of the structure. It may also lead to aesthetic and functional issues.

Resolution: A qualified contractor or construction professional should be consulted to assess and address the poor workmanship. They can implement corrective measures to ensure structural soundness, safety, and overall quality of the construction.

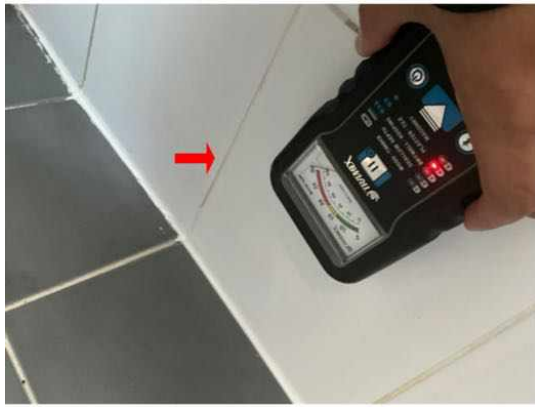
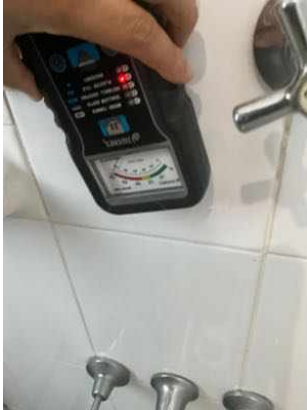
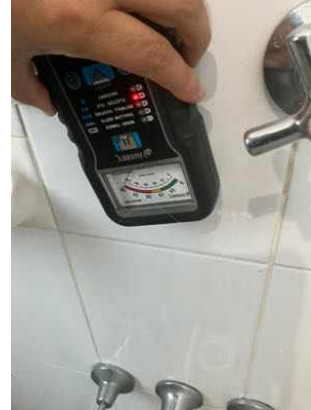
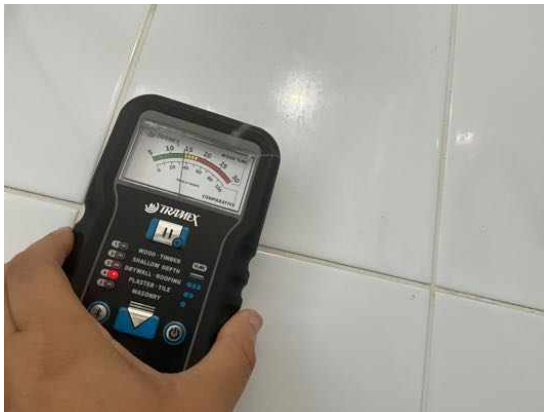
Finding 2.10

Building:	Main Building
Location:	Bathroom
Finding:	Evidence of excessive moisture was present at the time of inspection
Information:	Excessive moisture is present behind the bathroom tiles, indicating a potential water leakage issue within the wall.

The prolonged presence of moisture can lead to mold growth, deteriorate the structure, and create an environment conducive to health hazards. Additionally, it may compromise the adhesive holding the tiles, leading to their detachment.

A licensed plumber or a qualified contractor specializing in water damage remediation should investigate the source of the moisture, fix any leaks, and address the damage. Additionally, replacing affected tiles and ensuring proper waterproofing are crucial to preventing future issues.

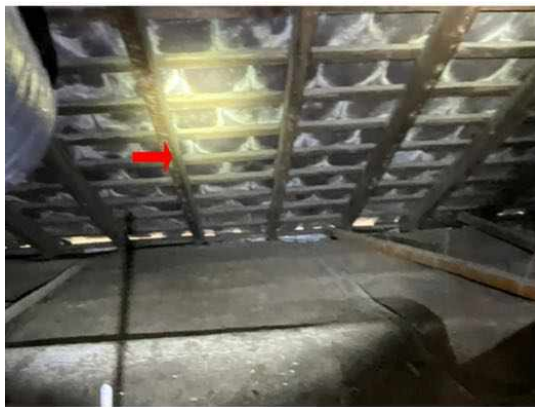
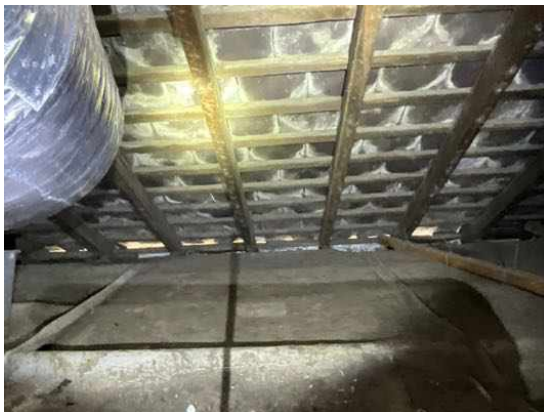
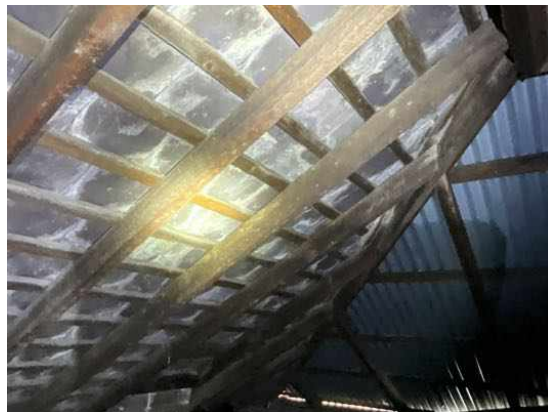
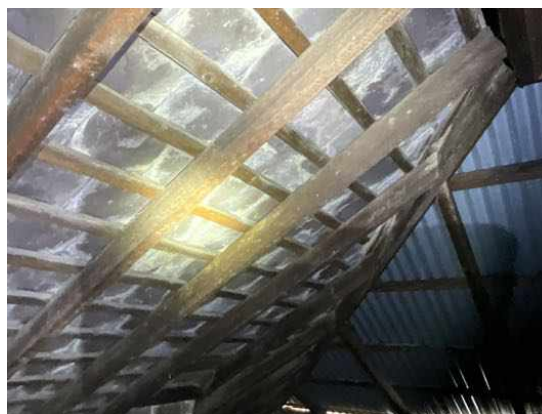
Finding 2.11

Building:	Main Building
Location:	Roof Void
Finding:	Roof void - Suspected water leak
Information:	Suspected water leak in the roof void, as evidenced by the presence of water stains, indicating potential gaps or holes.
Risk:	<ul style="list-style-type: none"> • Structural Damage: Continuous water leakage can weaken the structural integrity of the roof and ceiling, leading to potential collapse.

- Mold and Mildew: Persistent moisture can promote the growth of mold and mildew, posing health risks such as respiratory problems and allergic reactions.
- Electrical Hazard: Water intrusion near electrical wiring can create a risk of short circuits, fires, or electrical shocks.
- Insulation Damage: Prolonged exposure to moisture can damage insulation, reducing its effectiveness and increasing energy costs.

A licensed roofing contractor should be contacted immediately to inspect, diagnose, and repair the source of the leak to prevent further damage.

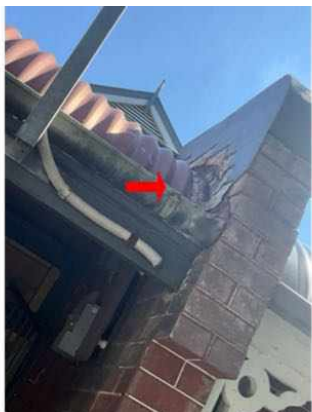
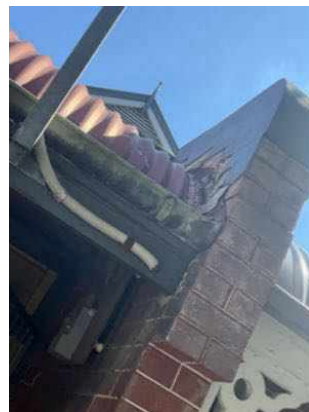
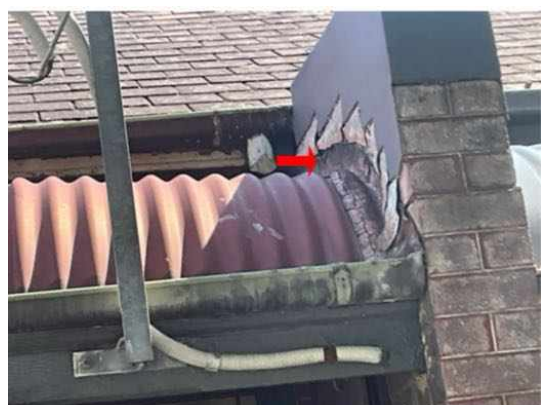
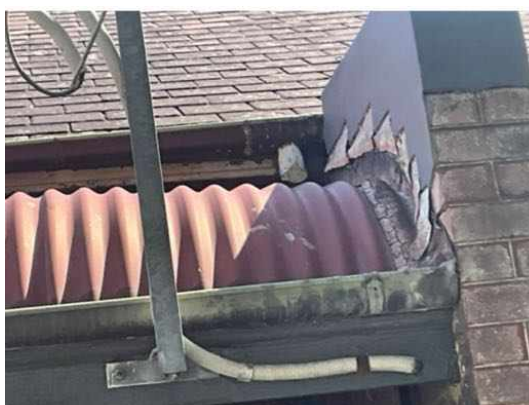
Finding 3.01

Building:	Main Building
Location:	Roof Exterior
Finding:	Flashing deteriorated
Information:	The flashing installed between the timber frameworks and the panels of the building is deteriorated. This deterioration includes visible corrosion, gaps, and cracks, which compromise the effectiveness of the flashing in preventing water ingress.

1. Water Ingress: Compromised flashing can lead to water penetration causing moisture to infiltrate the building envelope.
2. Structural Damage: Continuous exposure to moisture can lead to timber rot, weakening the structural integrity of the timber framework and surrounding materials.
3. Mold and Mildew Growth: Moist conditions promote mold and mildew growth, which can cause health issues for occupants and further damage building materials.
4. Insulation Damage: Water ingress can damage insulation, reducing the building's energy efficiency and increasing heating and cooling costs.
5. Aesthetic Issues: Water staining and damage can affect the building's appearance, potentially lowering property value and requiring costly repairs.

A licensed and qualified roofer with experience in flashing installation and repair should be engaged to address this issue. The contractor will:

1. Assess the extent of the deterioration.

2. Remove the damaged flashing.
3. Install new, properly sealed flashing to ensure water tightness.
4. Inspect adjacent areas for any signs of water damage and repair as needed.

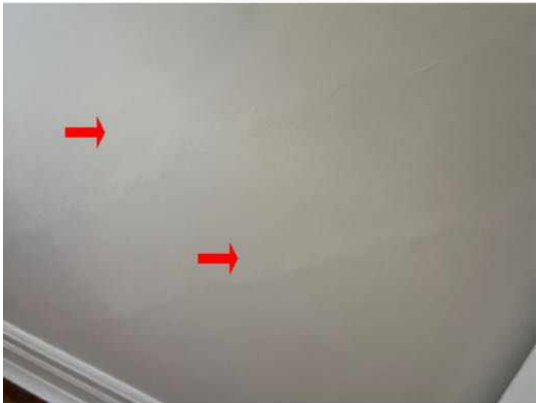
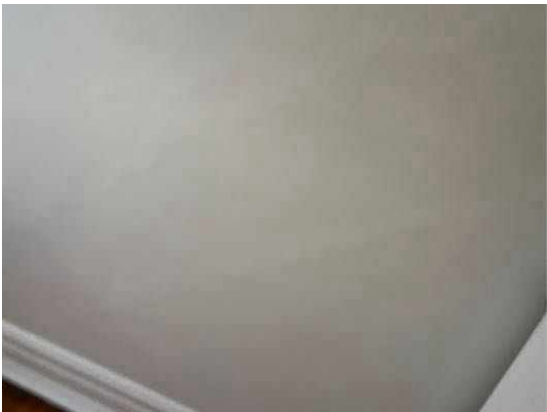
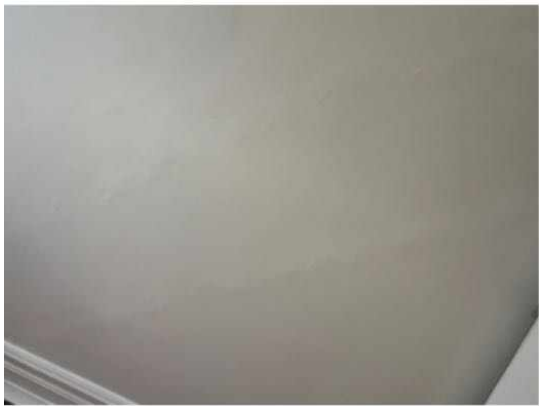
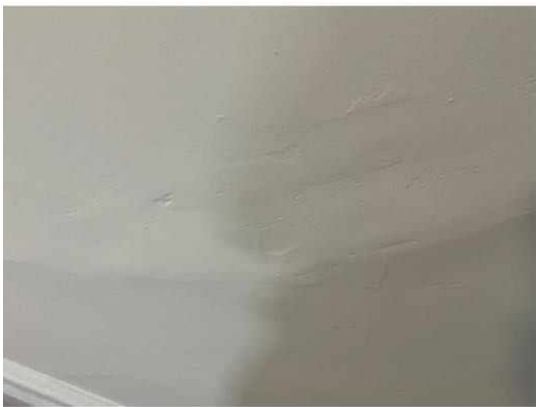
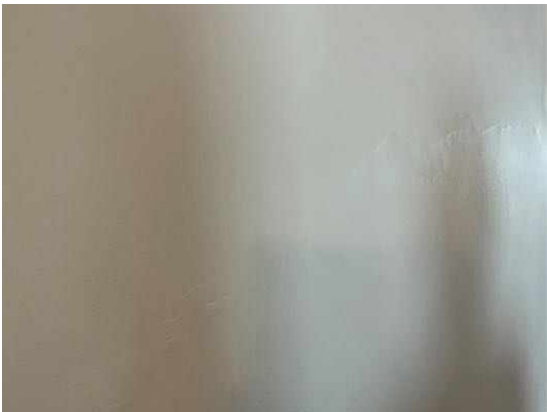
Finding 3.02

Building:	Main Building
Location:	All Areas
Finding:	Poor workmanship
Information:	The structure exhibits signs of poor workmanship, evident in various aspects of construction and finishing.

Risk: Poor workmanship poses a range of risks, including compromised structural integrity, potential safety hazards, and a decreased lifespan of the structure. It may also lead to aesthetic and functional issues.

Resolution: A qualified contractor or construction professional should be consulted to assess and address the poor workmanship. They can implement corrective measures to ensure structural soundness, safety, and overall quality of the construction.

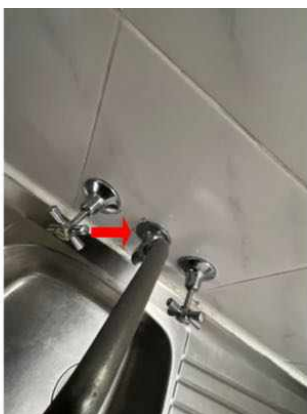
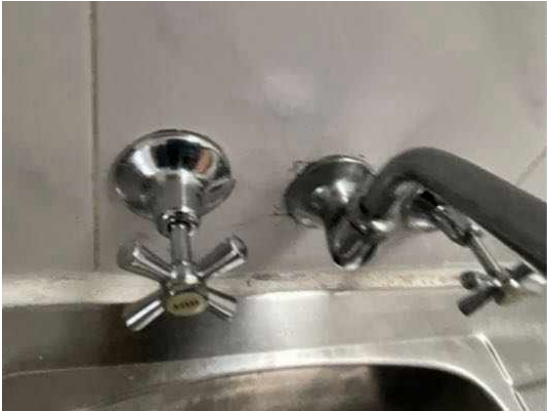
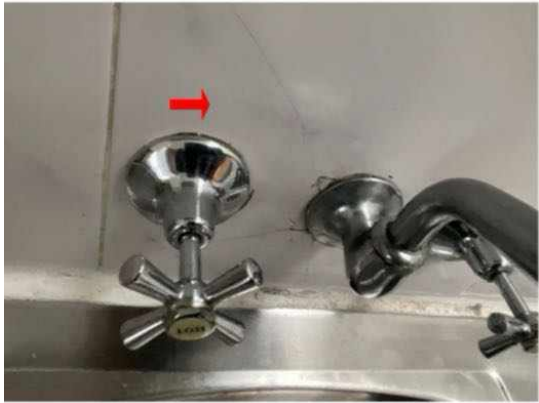
Finding 3.06

Building: Main Building
Location: Kitchen
Finding: Evidence of excessive moisture was present at the time of inspection
Information: Excessive moisture is present behind the bathroom tiles, indicating a potential water leakage issue within the wall.

The prolonged presence of moisture can lead to mold growth, deteriorate the structure, and create an environment conducive to health hazards. Additionally, it may compromise the adhesive holding the tiles, leading to their detachment.

A licensed plumber or a qualified contractor specializing in water damage remediation should investigate the source of the moisture, fix any leaks, and address the damage. Additionally, replacing affected tiles and ensuring proper waterproofing are crucial to preventing future issues.

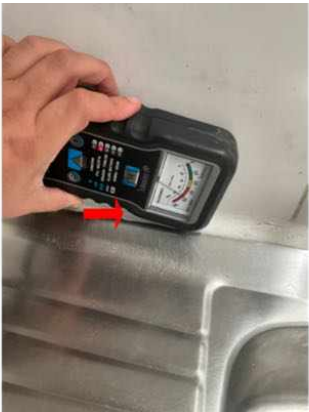
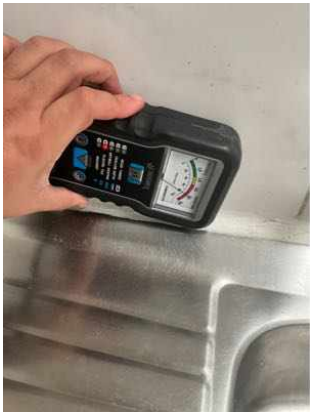
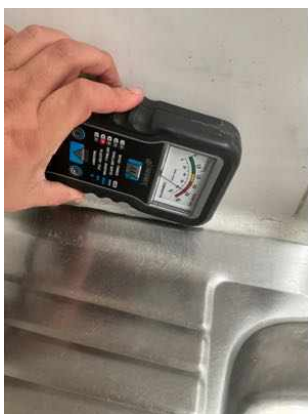
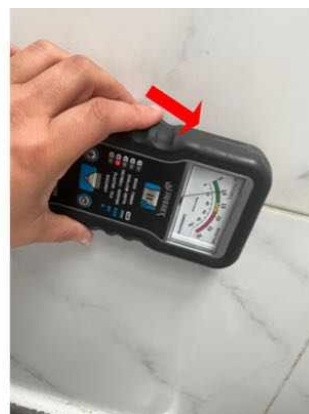
Finding 3.07

Building:	Main Building
Location:	All Areas
Finding:	Excessive Moisture – Skirting Boards
Information:	At the time of inspection, excessive moisture readings were detected to the skirting boards. This condition is inconsistent with normal dry internal conditions and indicates ongoing or intermittent moisture exposure to the wall base and adjoining building elements.

- Rising damp due to an ineffective or bridged damp-proof course (DPC)
- Moisture ingress from external ground levels, inadequate falls, or poor drainage
- Plumbing leaks within walls or adjacent wet areas
- Prolonged condensation or poor ventilation

- Deterioration of skirting boards and wall linings
- Potential mould growth affecting indoor air quality
- Concealed damage to framing and finishes if left unaddressed

Further investigation by a licensed builder and/or plumber is recommended to determine the source of moisture. Rectification may include improving drainage, addressing damp-proofing, repairing leaks, and replacing affected materials once moisture issues are resolved.

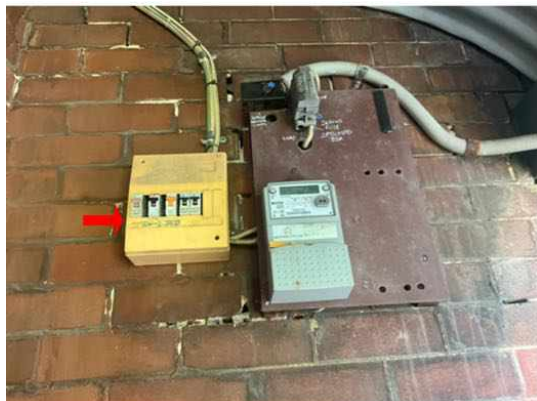
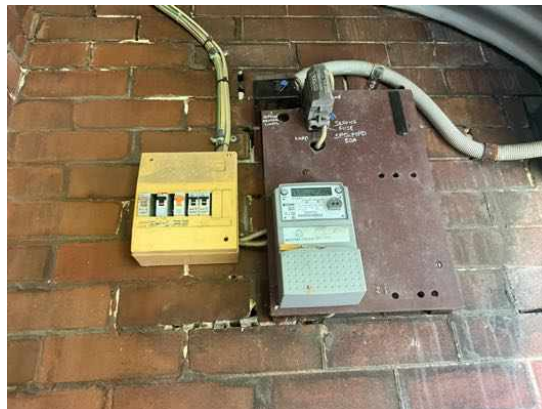
Finding 6.01

Building:	Main Building
Location:	Front porch
Finding:	No Evidence of Termite Management System - Durable notice / Legible Sticker
Information:	The application of a pre & post-construction chemical termite barrier is highly recommended for all properties. Such barriers are highly effective in preventing termite attack on any timber building elements throughout the property.

A durable notice was not placed in the switchboard unit to indicate current termite barriers is legible at the time of inspection.

Client must seek further information from the vendor or real estate agent if the conditions of termite management systems were maintained.

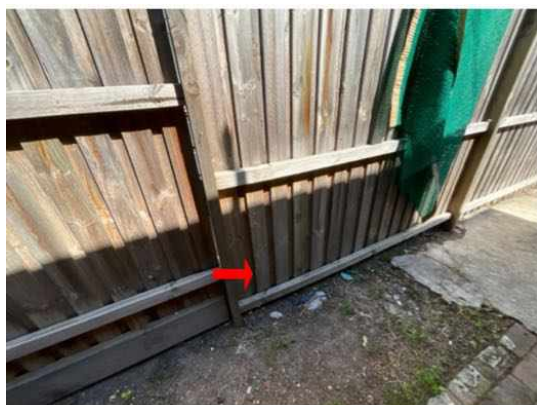
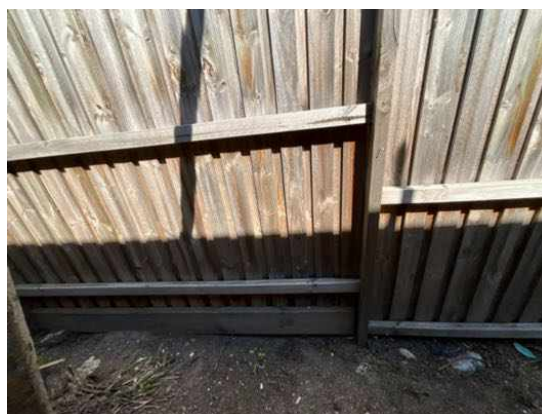
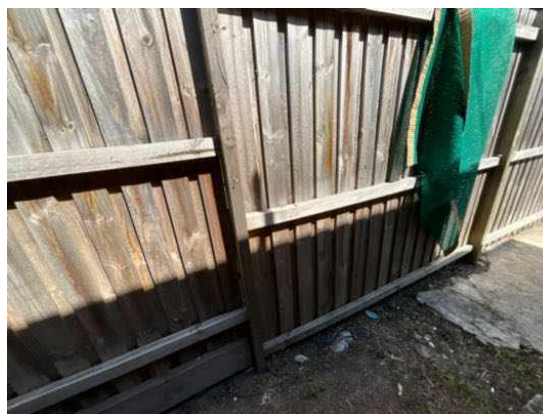
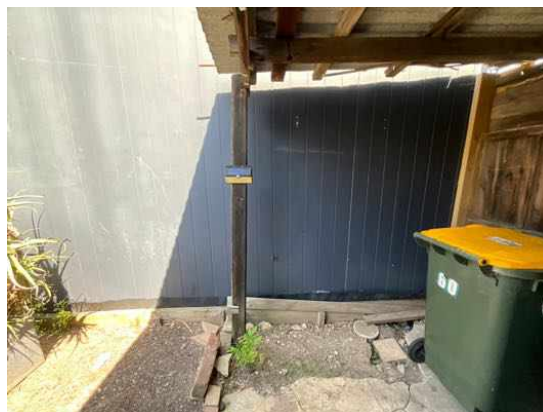
Finding 6.02

Building:	Main Building
Location:	All Areas
Finding:	Timber on ground / conducive conditions to termite damage
Information:	Timber on the ground is indeed conducive to termite damage. Termites are known to thrive in moist environments, and wood in contact with soil or moisture is more susceptible to infestation.

To prevent this, it's important to keep timber elevated and away from direct ground contact. Regular inspections and proper termite control measures are also essential to protect your wooden structures from termite damage.
