Building and Timber Pest Inspection Report

Inspection Date: Wed, 11 Feb 2026

Property Address: 60 Park Rd, Sydenham NSW 2044, Australia

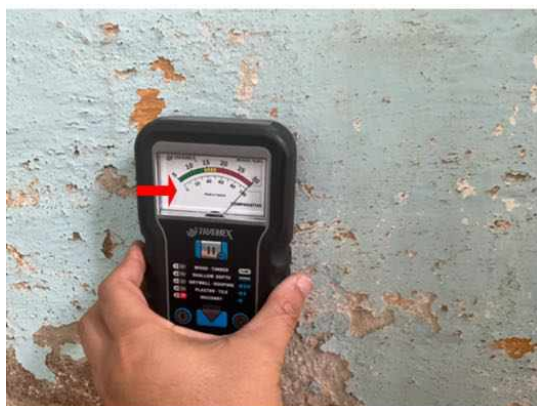
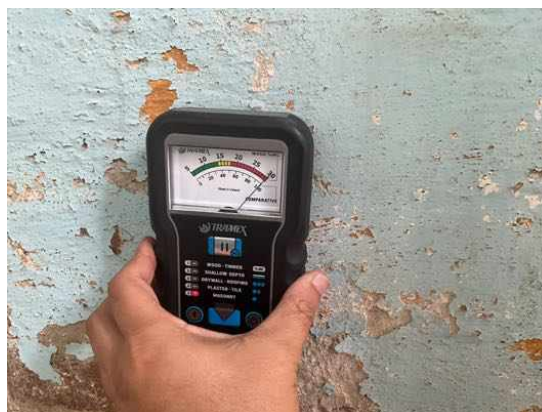
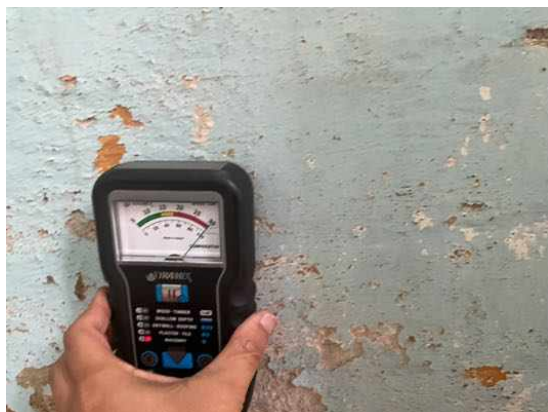
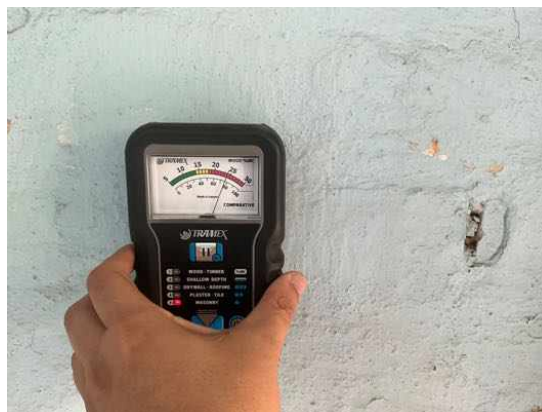
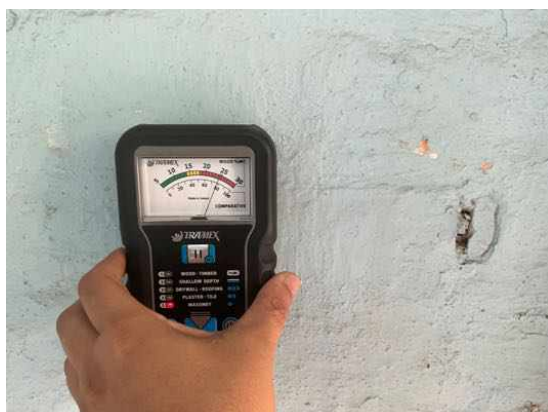
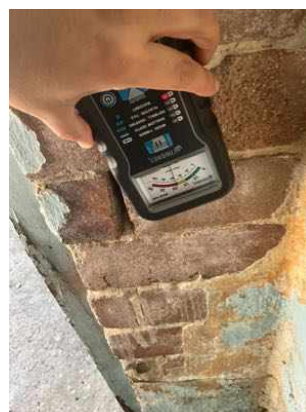
Finding 6.03

Building:	Main Building
Location:	Toilet (WC)
Finding:	Excessive moisture - Conducive to Timber pest
Information:	Excessive moisture can attract termites and produce conditions that promote fungal growth and wood decay.

Excessive moisture is generally caused by deteriorated inadequate or missing roof drainage leaking plumbing pipes or fixtures poorly plumbed HWS overflows or condenser units and poor site drainage.

Prior to any remedial works being performed a qualified plumber should be appointed to further inspect the property and to identify the cause of the excessive moisture. Works to remove affected building elements may then be necessary and should be performed by an appropriate tradesperson.

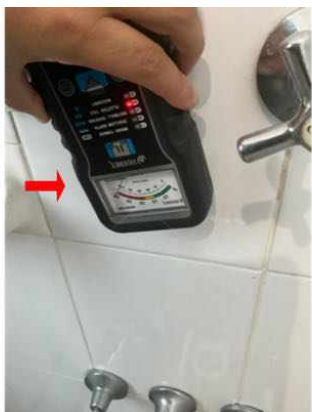
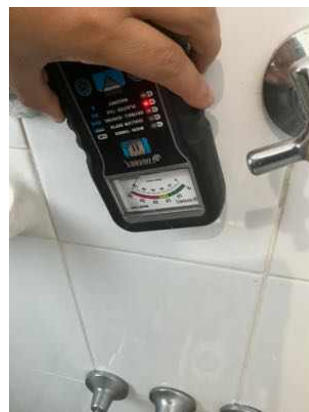
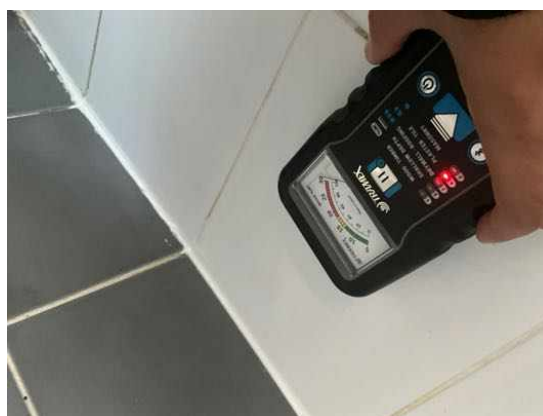
Finding 6.04

Building:	Main Building
Location:	Bathroom
Finding:	Excessive moisture - Conducive to Timber pest
Information:	Excessive moisture can attract termites and produce conditions that promote fungal growth and wood decay.

Excessive moisture is generally caused by deteriorated inadequate or missing roof drainage leaking plumbing pipes or fixtures poorly plumbed HWS overflows or condenser units and poor site drainage.

Prior to any remedial works being performed a qualified plumber should be appointed to further inspect the property and to identify the cause of the excessive moisture. Works to remove affected building elements may then be necessary and should be performed by an appropriate tradesperson.

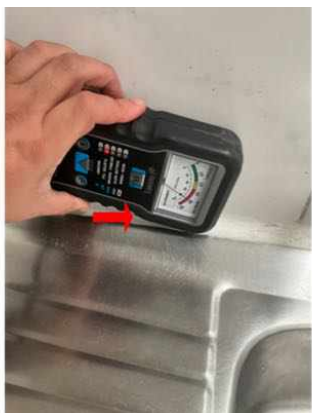
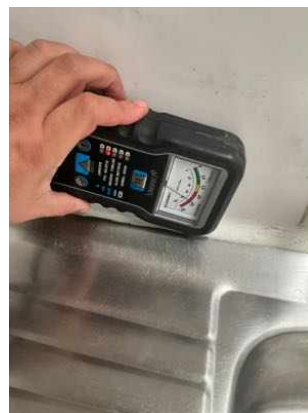
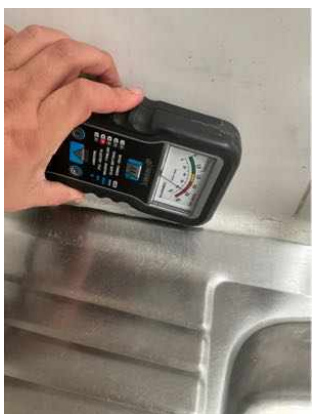
Finding 6.05

Building:	Main Building
Location:	Kitchen
Finding:	Excessive moisture - Conducive to Timber pest
Information:	Excessive moisture can attract termites and produce conditions that promote fungal growth and wood decay.

Excessive moisture is generally caused by deteriorated inadequate or missing roof drainage leaking plumbing pipes or fixtures poorly plumbed HWS overflows or condenser units and poor site drainage.

Prior to any remedial works being performed a qualified plumber should be appointed to further inspect the property and to identify the cause of the excessive moisture. Works to remove affected building elements may then be necessary and should be performed by an appropriate tradesperson.

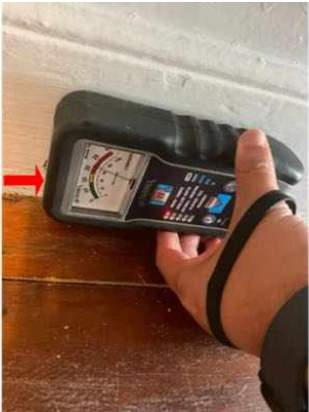
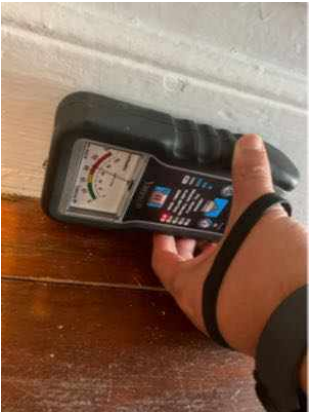
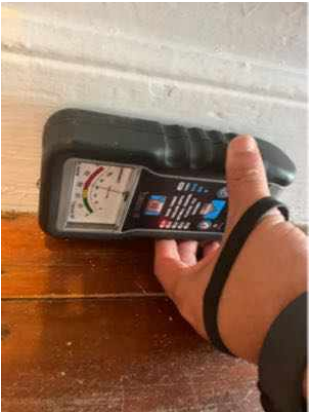
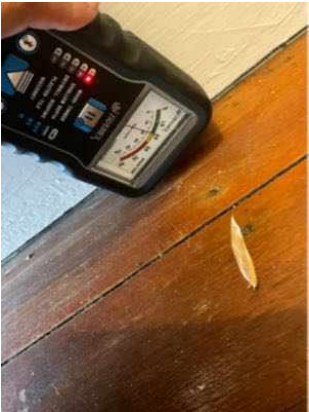
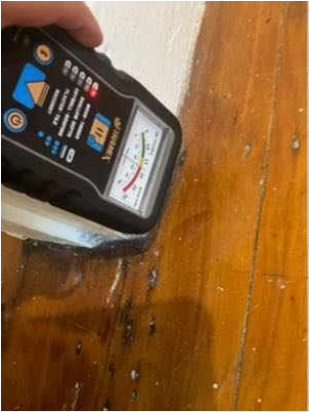
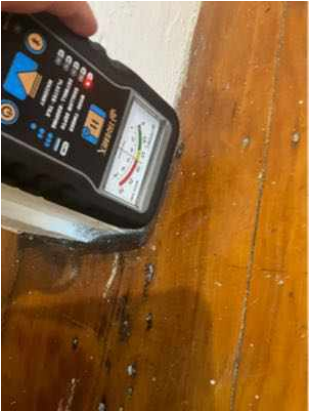
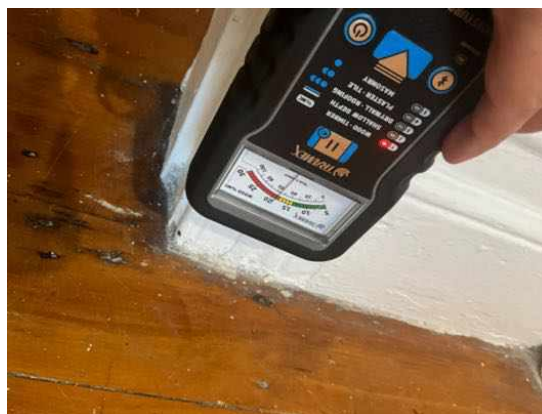
Finding 6.06

Building:	Main Building
Location:	All Areas
Finding:	Excessive moisture - Conducive to Timber pest
Information:	Excessive moisture can attract termites and produce conditions that promote fungal growth and wood decay.

Excessive moisture is generally caused by deteriorated inadequate or missing roof drainage leaking plumbing pipes or fixtures poorly plumbed HWS overflows or condenser units and poor site drainage.

Prior to any remedial works being performed a qualified plumber should be appointed to further inspect the property and to identify the cause of the excessive moisture. Works to remove affected building elements may then be necessary and should be

performed by an appropriate tradesperson.

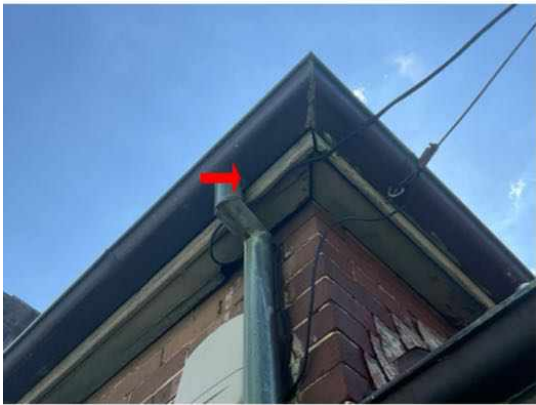
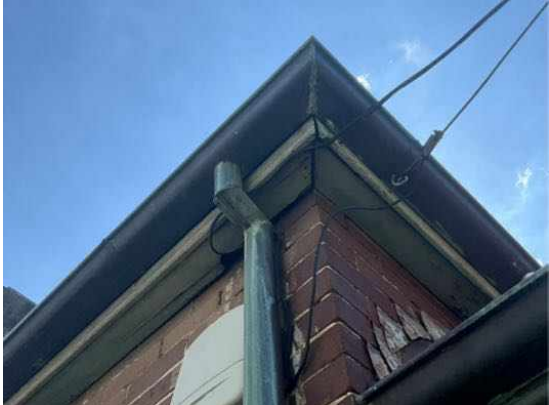
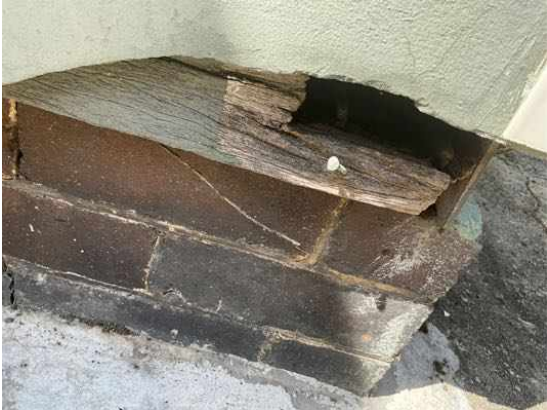
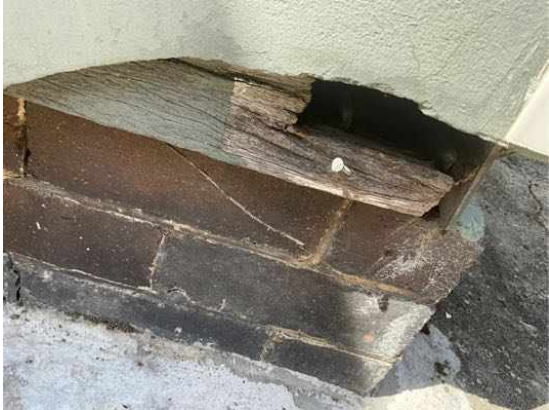
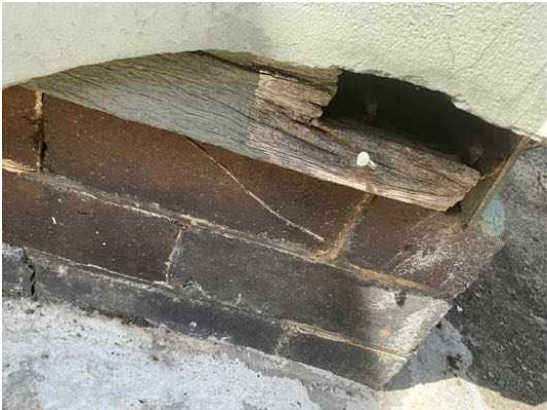
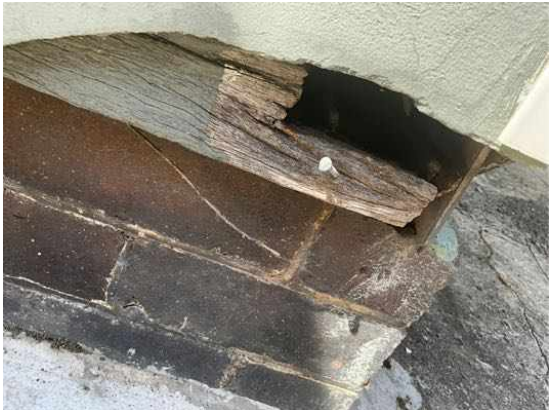
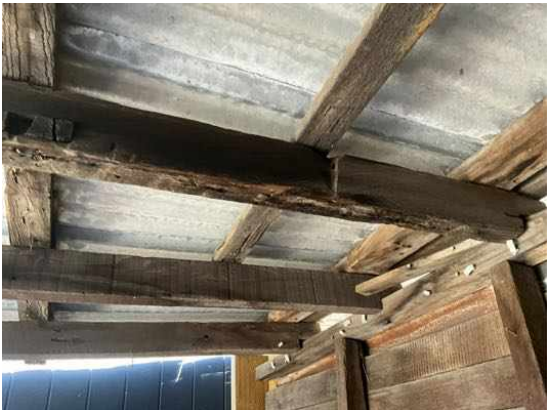
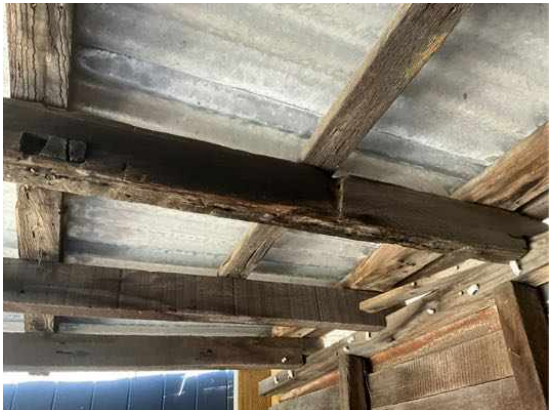
Finding 7.01

Finding: Wood rot

Information: This building element shows evidence of wood rot. Wood rot, also known as Fungal Decay, occurs when timbers and other cellulose building materials are exposed to damp conditions on an ongoing basis. This could be the result of exposure to weathering over a prolonged period of time, or the attraction of excessive moisture from other abutting building materials. Contributing factors also include poor air ventilation in the area.

Wood rot is often associated with general damp problems and is evidenced by a 'musty' smell or mould and mildew occurring on surfaces. If left unmanaged, damp conditions can lead to further health problems and the decay of timbers will continue.

Early intervention and regular maintenance, particularly of exterior timbers, will prolong the useful life of these building elements. Prior to any works being performed, the cause of the moisture that has created the visible wood rot should be identified and addressed in a suitable manner. Replacement of affected timbers may then be a necessary step in protecting surrounding building elements from such deterioration.

A qualified plumber may be appointed to assess the cause of excessive moisture and to provide advice on any remedial works as required. A qualified carpenter or registered builder may also be required to replace affected building materials.

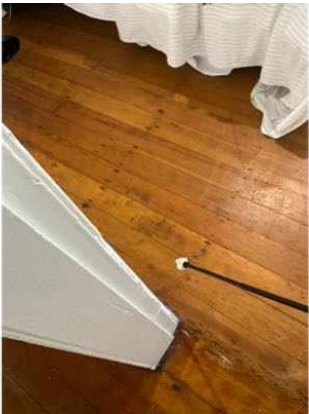
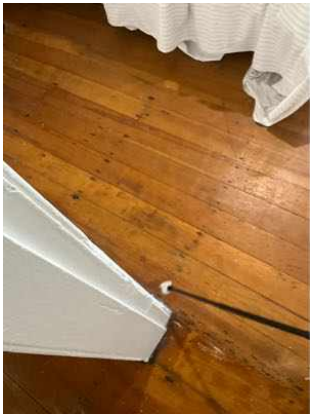
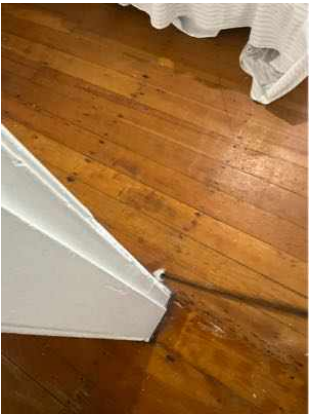
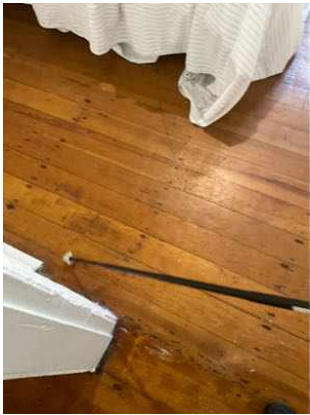
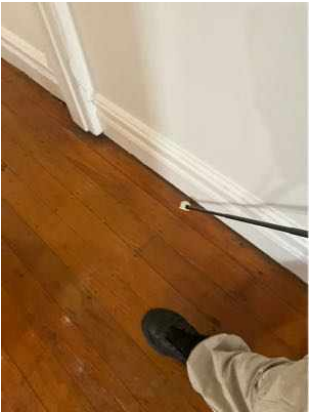
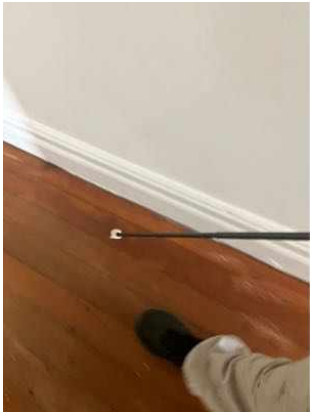
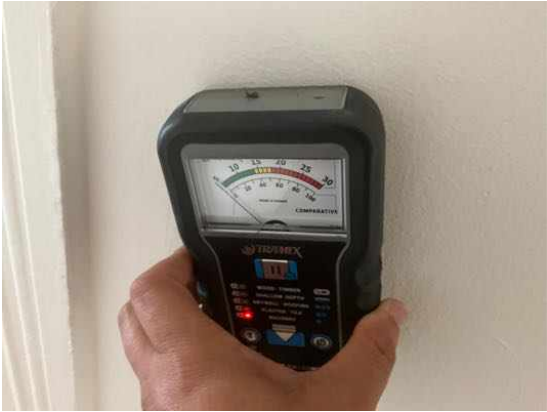
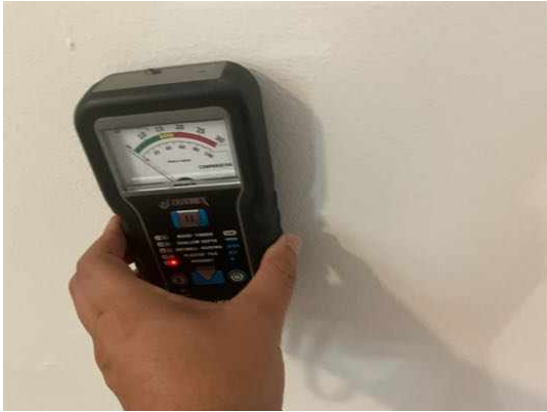
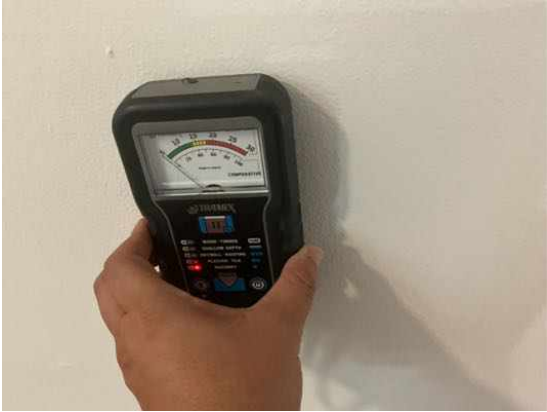
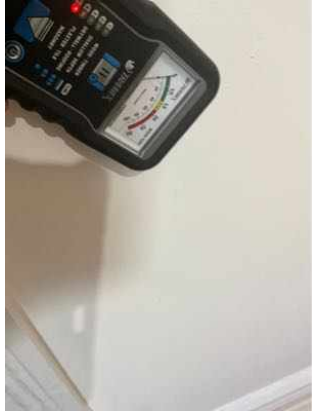
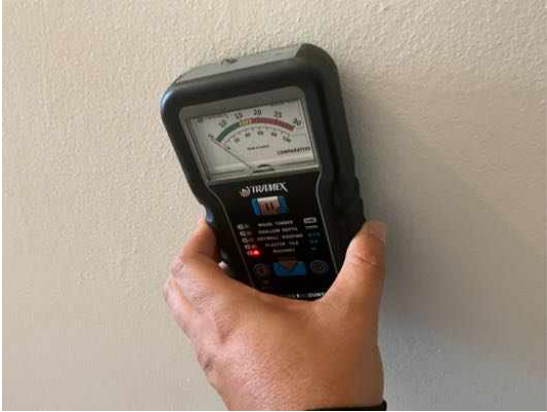
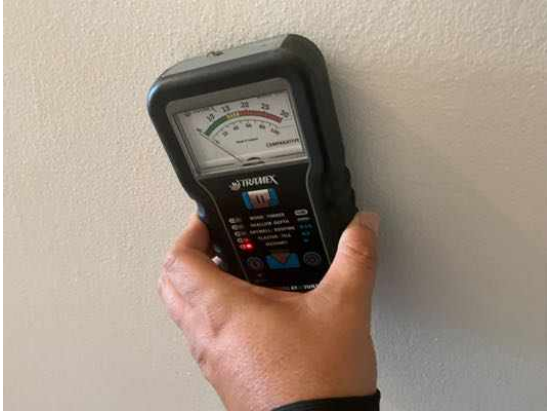
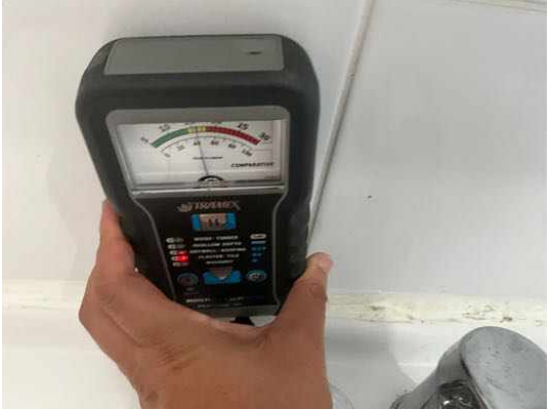
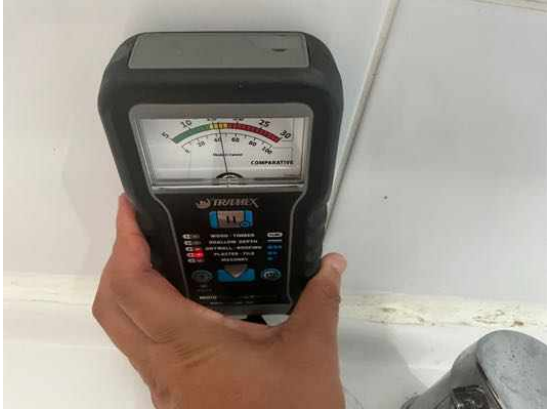
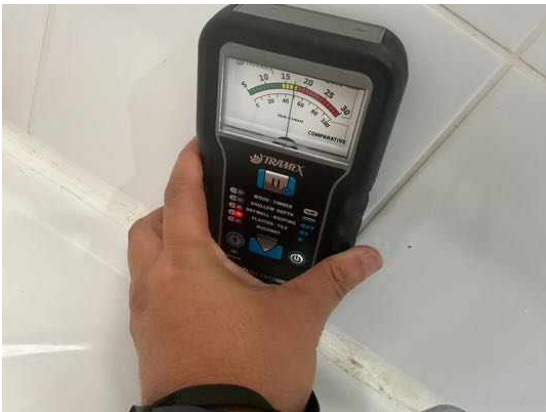
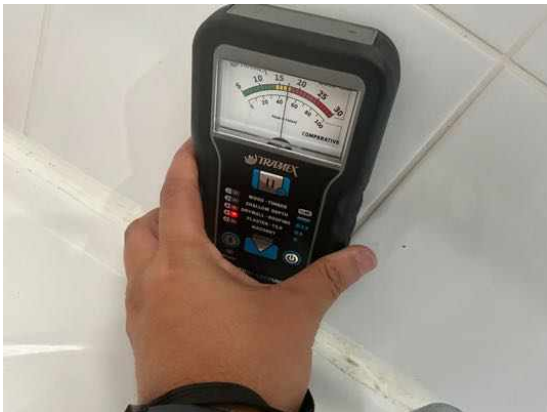
Building: Main Building
Location: All Areas
Finding: Additional Photos
Information: Additional photos are provided for your general reference

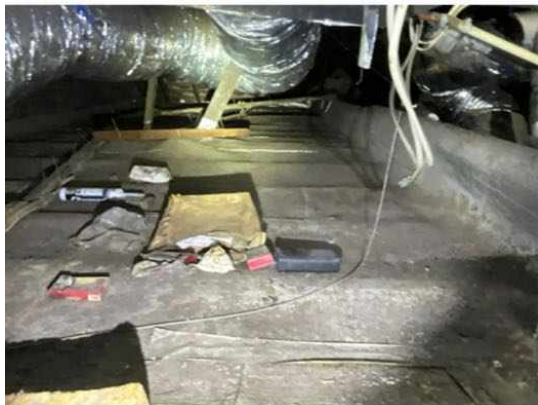
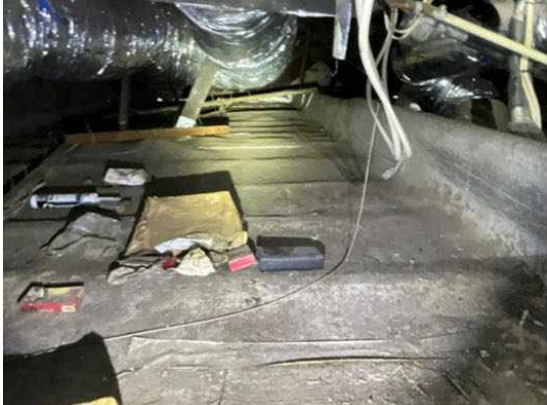
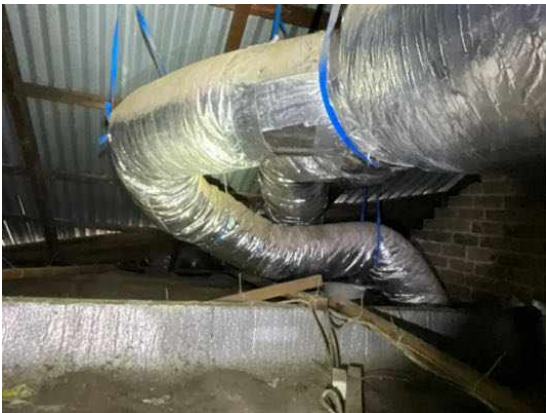
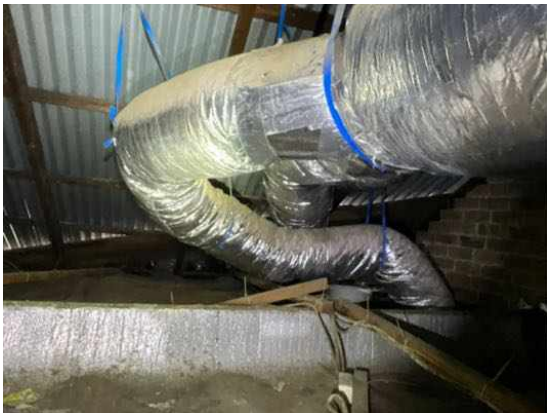
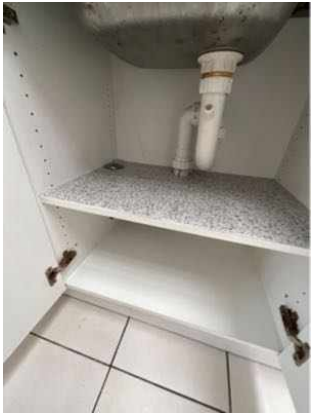
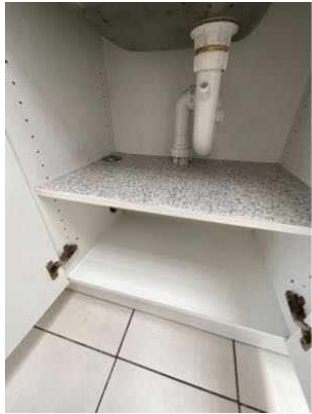
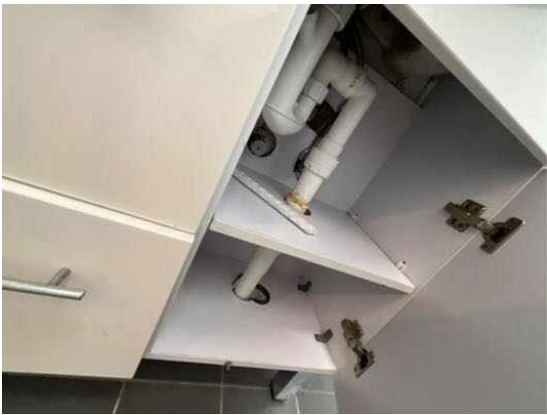
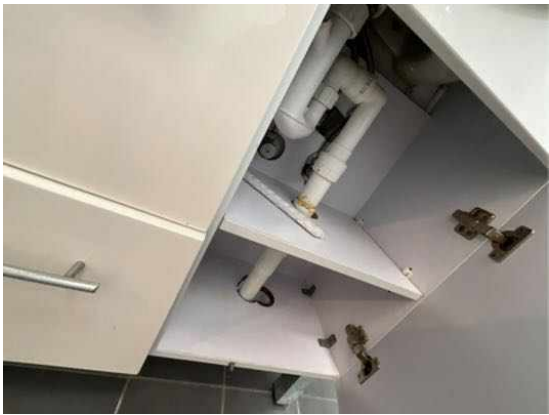
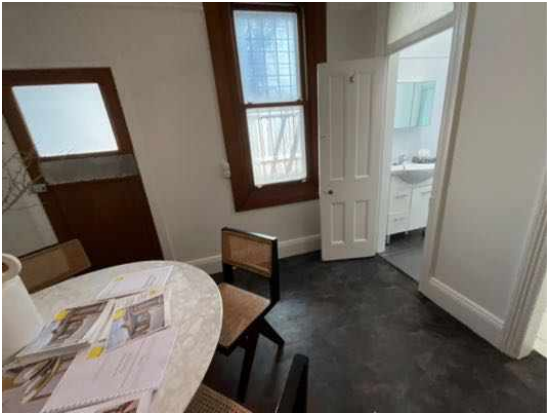
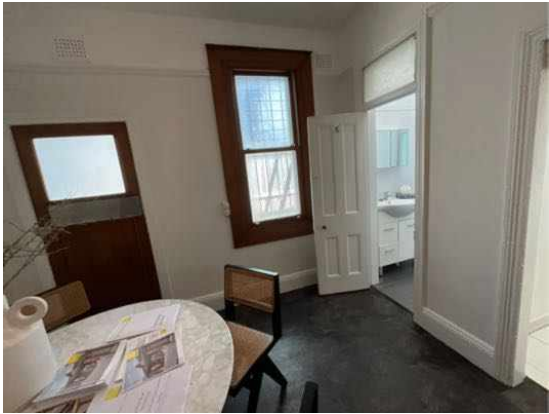
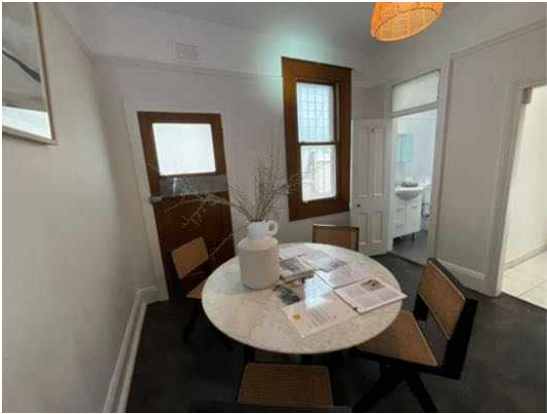
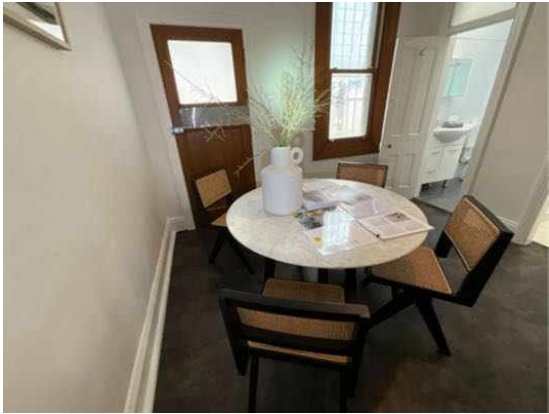
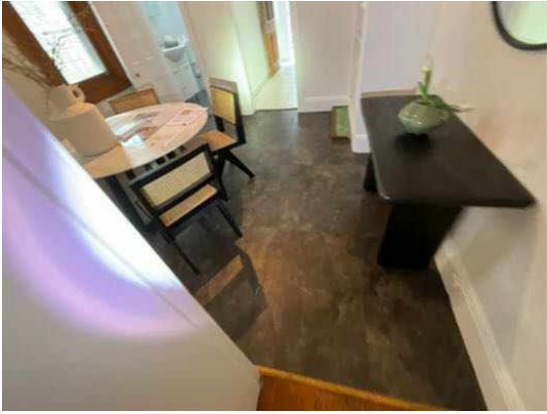
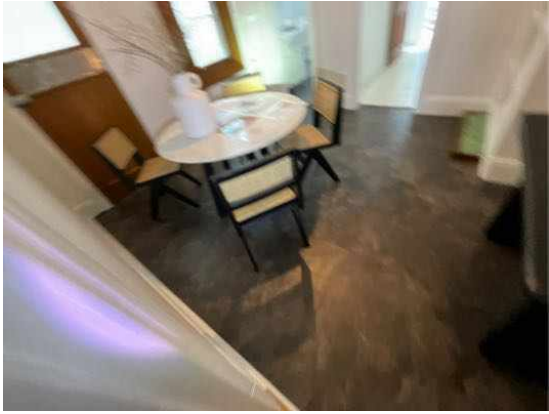
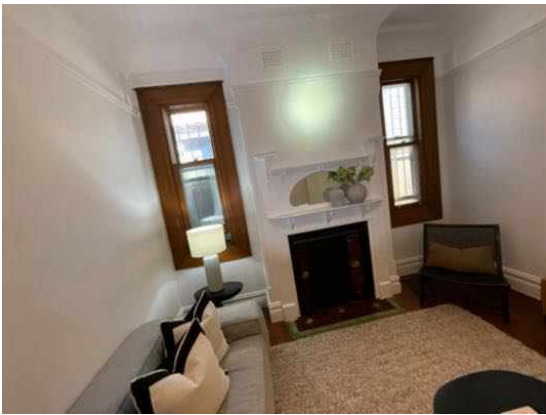
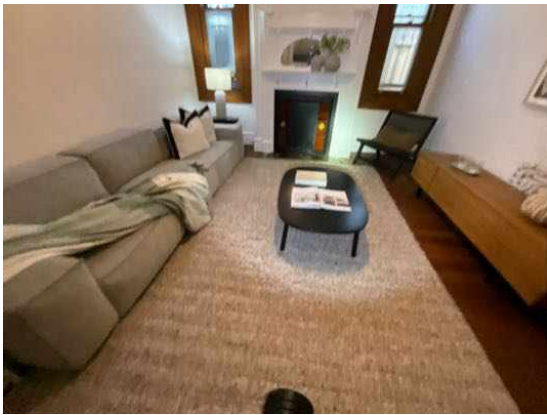
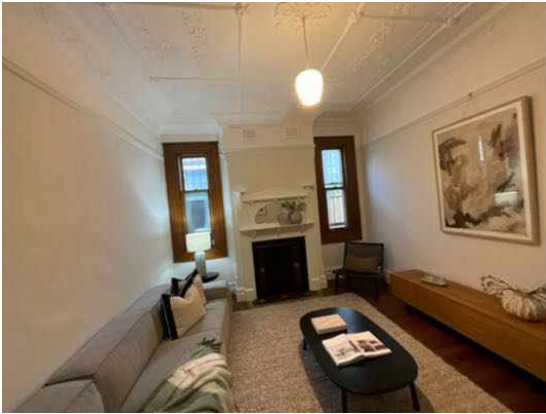
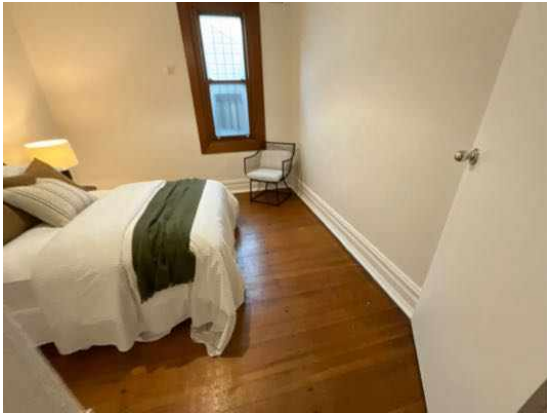
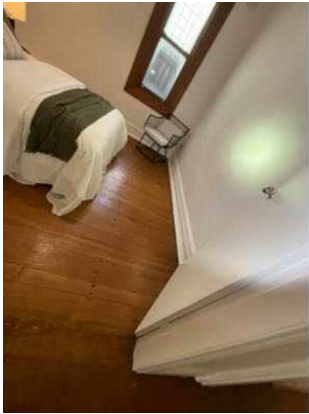
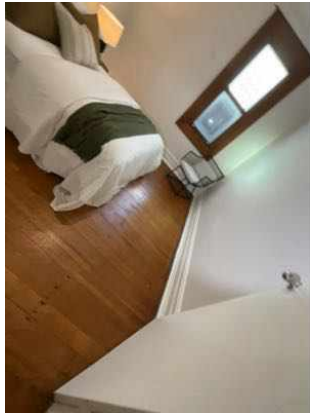
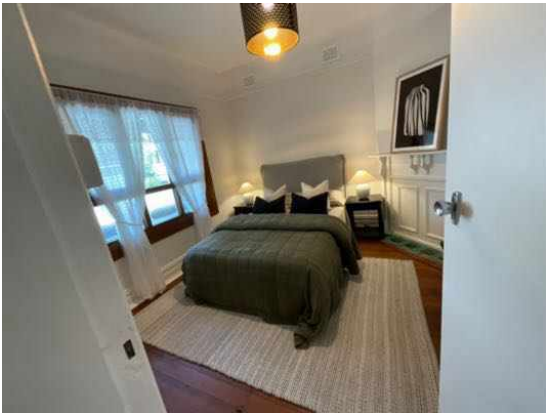
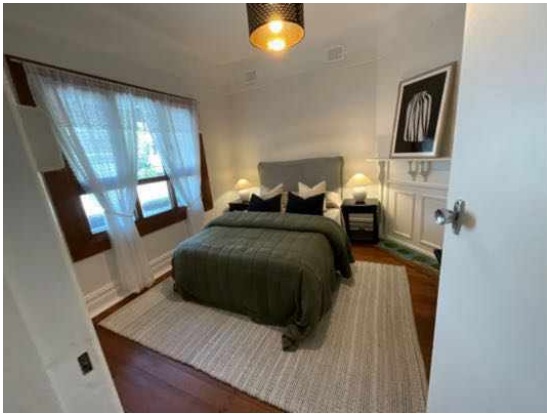
Building: Main Building
Location: All Areas
Finding: Additional Photos - Obstructions and Limitations
Information: These photographs are an indication of the obstructions and limitations which impeded full inspection of the property at the time of inspection. These obstructions can hide an array of defects and should be removed to allow full inspection to be carried out. A re-inspection is recommended once the areas are made accessible.
