Building and Timber Pest Inspection Report

Inspection Date: Wed, 25 Mar 2026

Property Address: 6 Kirkwood Cres, Colebee NSW 2761,
Australia

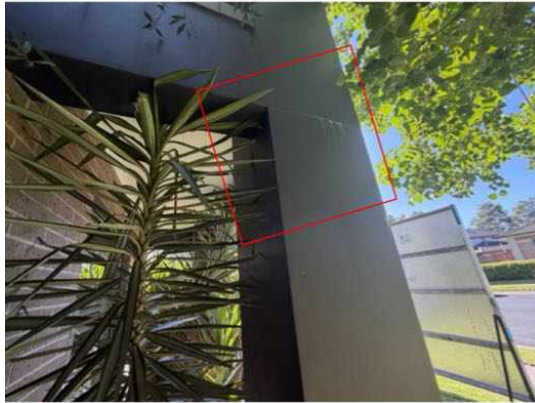
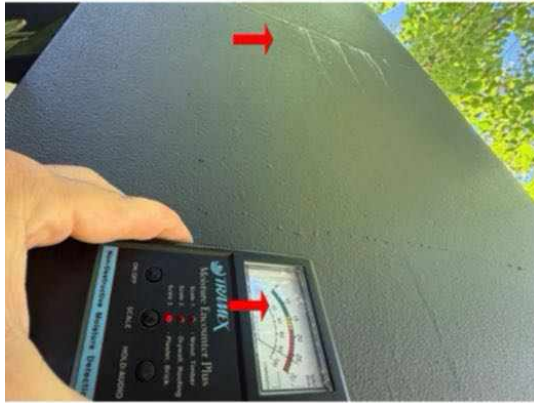
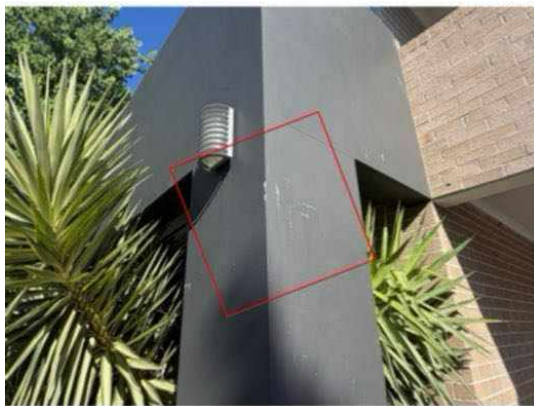
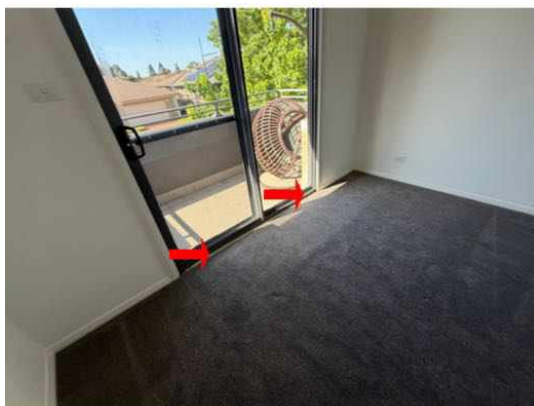
Building:	Main Building
Location:	Balcony
Finding:	Water leak - Internal
Information:	A water leak is expected in this area at the time of inspection due to the balcony floor waterproofing failure. Internal water leaks can be detrimental to surrounding building elements.

Rust, corrosion, decay and water damage are potential outcomes where a minor water leak is left unattended. More serious defects may also result, such as electrical hazards, or water damage to structural building elements.

Balcony waterproofing is suspected to have failed, hence allowing moisture penetration to the adjacent surfaces. A licensed plumber must be appointed urgently for further assessment. Major works should be expected and must be completed by a licensed builder.

In extreme cases, structural damage may develop due to a prolonged water leak. It is highly advised a licensed plumber be advised for further investigation. Major works should be expected and must be carried out by licensed builder.

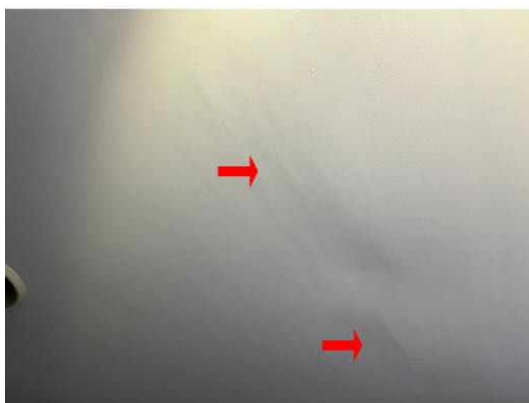
Building:	Main Building
Location:	Bedroom - Master
Finding:	Ceiling - Sagging
Information:	Sections of the ceiling were found to be sagging at the time of inspection. Sagging to the fixed ceiling structure generally indicates that the building materials have swollen, due to contact with water, or that fixings (e.g. nails or glue) have become loose and require reattachment.

Where minor sagging is evident, comparatively minor works, such as re-gluing of ceiling sheets, may be required. Such works may be performed by relevant tradespeople, such as plasterers and painters. Where excessive moisture has caused the roofing structure to swell and sag, the source of the water leak should primarily be identified prior to any remedial works being performed. A licensed roof plumber must be appointed for this work.

The appropriate action should be taken by the client as soon as possible to ensure that any potential further damage is limited.

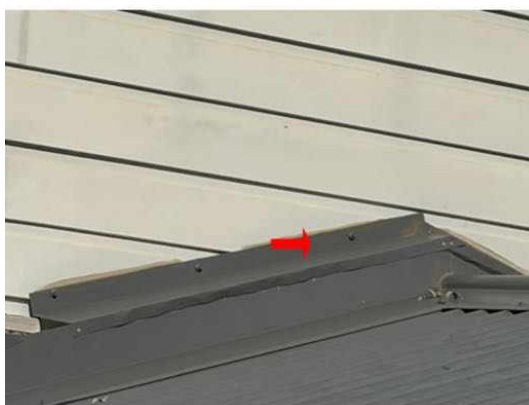
Finding 3.02

Building: Main Building
 Location: Garage
 Finding: Roof plumbing - Flashing inadequate
 Information: Some sections of the roof are missing or have inadequate roof flashings. Flashings are metal and other materials which are applied to seals and intersections between roof coverings and building elements. They are designed to aid in weatherproofing of roof joins.

Flashings that are not installed adequately or are missing are likely to result in water penetration to the interior of the property, as well as creating excessively damp conditions against the exterior surfaces and around the base perimeter of the building.

Premature ageing and secondary building defects are imminent where roof plumbing is missing or inadequately installed. Additionally, water pooling also creates an environment that is susceptible to termite and pest infestation.

A licensed roofing plumber should be appointed as soon as possible to install relevant roof plumbing materials, ensuring that no further damage is sustained.

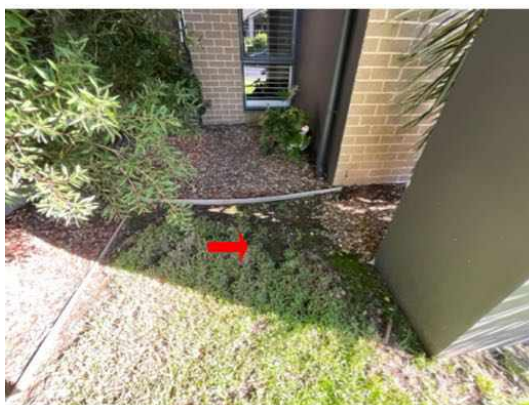
Finding 3.03

Building: Main Building
 Location: Yard
 Finding: Site drainage— Inadequate
 Information: The site drainage in this area was found to be inadequate at the time of inspection, creating potential for subsequent water damage to associated building elements. This is additionally conducive to termite activity.

Where site drainage is inadequate, installation of an Agricultural (Aggie) Drain may be required. A licensed plumber should be appointed to further inspect the property and perform any remedial works as necessary. Water damage and secondary defects are likely to occur if left unmanaged.

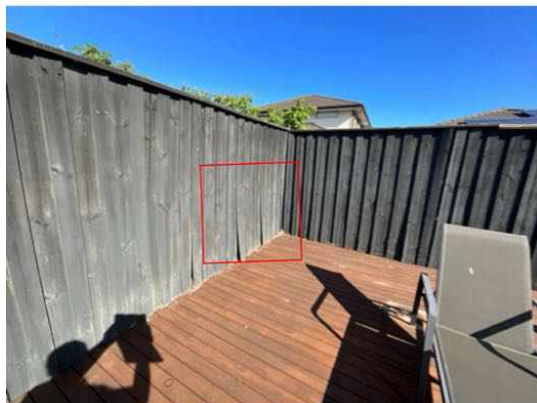
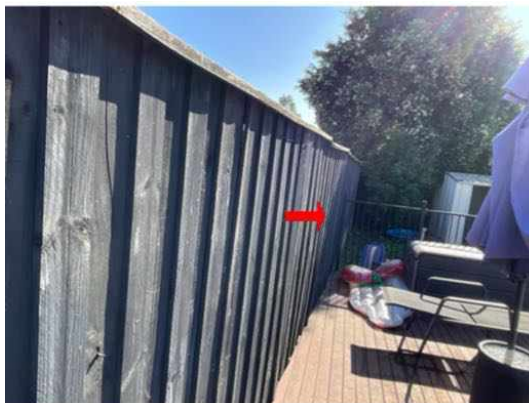
Finding 3.04

Building: Main Building

Finding: Fencing - Deteriorated

Information: It was noted at the time of inspection that sections of the fencing in this area has deteriorated. Typically fencing deteriorates due to age and or wear, rot and or rust which is generally expected for a structure of this age, due to prolonged exposure to weather conditions. Sometimes inadequate installation or maintenance can be to blame.

If left unattended, it is likely that further damage will occur. It is suspected that repair of several elements of the fencing may be required however replacement may be a consideration of the client also.

A licensed fencing contractor should be appointed to provide further advice and perform rectification works as necessary.

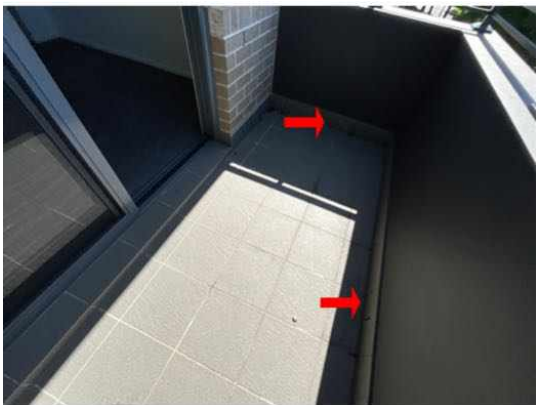
Finding 3.05

Building:	Main Building
Location:	All Wet Areas
Finding:	Sealant and grouting - Missing or damaged
Information:

It was noted on inspection that sealant or grout is degraded to this area.

Different materials and floor areas move at different rates, generally causing cracking to grout or sealant at this point. A flexible sealant is required to allow for expected expansion and contraction, while keeping the joint water tight and protective of all associated building materials.

Flexible and mould resistant materials should be applied to affected areas to prevent any subsequent water damage that is likely to occur. Regular maintenance and replacement of damage or missing or damaged sealant and grout is highly recommended to the wet areas, as this is a regular wear and tear defect. Sealant and grouting in areas that come into regular contact with water should be maintained for the long term care of your property.

A sealant specialist should be appointed to complete these works as soon as possible.

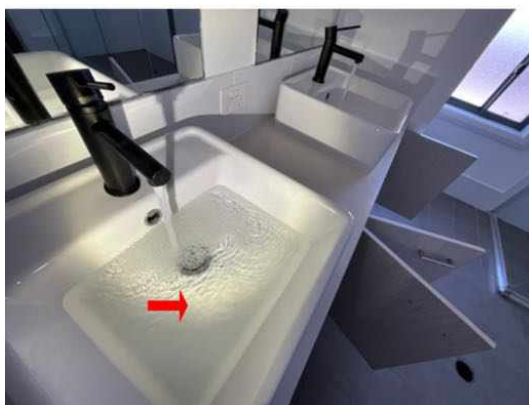
Finding 3.06

Building: Main Building
 Location: Ensuite 1 & 2
 Finding: Sink/basin - slow draining
 Information:

The sink/basin drain appeared to be partially blocked at the time of inspection. Blockages here are usually caused by hair and other debris. If left unmanaged, a lack of general maintenance may lead to the development of more significant defects, such as water damage to surrounding building materials.

A licensed plumber should be appointed to remove the blockage at the client discretion.

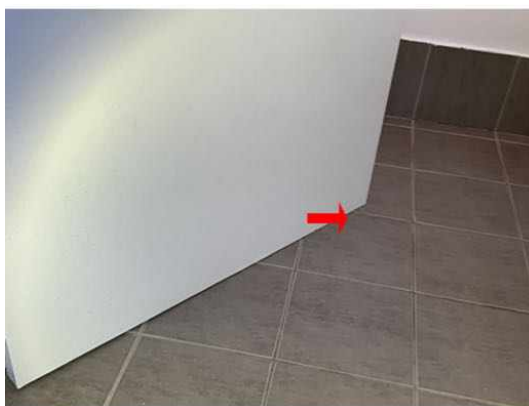
Finding 3.07

Building: Main Building
 Location: Ensuite 1
 Finding: Door - Binding/jamming
 Information:

Binding and/or jamming of this door is evident during standard operation. This defect inhibits the functionality of the affected door as well as creating potential for secondary defects to associated building elements, such as damage to the floor covering or adjacent frame.

A door that binds to flooring or to the associated door frame may have several causes, ranging from minor defects, such as poor installation of the door or deteriorated hinges.

A licensed carpenter should be appointed to perform minor rectification works at client discretion.

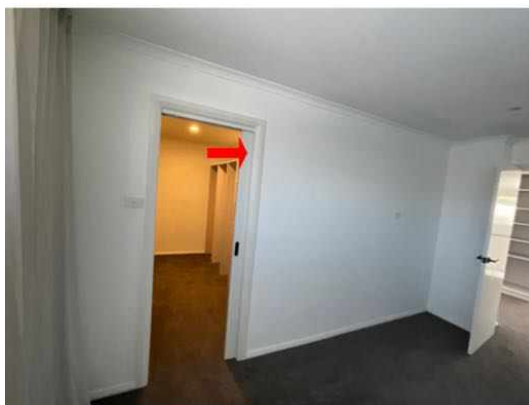
Building:	Main Building
Location:	Bedroom - Master
Finding:	Door - Stiff to slide
Information:	<p>The door in this area was jammed and difficult to slide along the associated tracks at the time of the inspection. Restricted function of the affected door may pose as a potential safety hazard if required for emergency egress from the building.</p> <p>Generally, factors such as general age of the building element and a lack of maintenance are the usual causes for this type of defect.</p>

Replacement of door hardware or tracks may be required, as well as minor repairs and cleaning. A registered builder will be required to repair the affected doors.

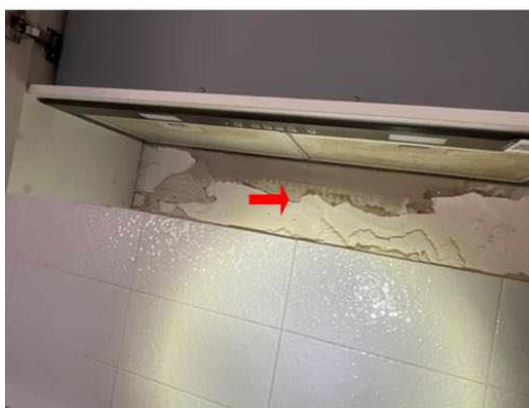
Building:	Main Building
Location:	Kitchen
Finding:	Tiles - Missing
Information:	Tiles were found to be missing in this tiled area. It appears as though broken tiles have been removed and not replaced, or have come loose from their original fixing through general deterioration.

Where tiles are missing, water penetration is likely to occur to exposed walls and flooring, creating potential for subsequent water damage.

Any tiles that are missing should be replaced immediately by a tiling contractor or general handyman. If left unmanaged over a prolonged period of time, water damage is likely to necessitate repair works to surrounding building elements.

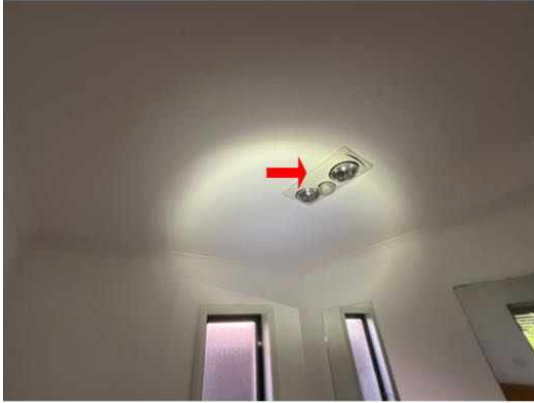
Finding 3.12

Building:	Main Building
Location:	Ensuite 1
Finding:	Exhaust fan - Not operating
Information:	The exhaust fan in this area appears to be damaged or blocked and is not operating as intended. If left unmanaged, a lack of general maintenance is likely to lead to the development of more significant defects, such as water damage to surrounding building materials from inadequate ventilation. If left unattended for a prolonged period of time, poor ventilation in this area may also be conducive to the development of mould.

Where no secondary damage has developed, the Homeowner may undertake minor cleaning of the area and consider replacement of the exhaust fan. Alternatively, consultation with a Licensed Electrician is required to check for any secondary or concealed damage and consider repair or replacement.

Please be advised that a cabinet maker or qualified carpenter may also be required if water damage has occurred and that an additional specialist mould inspection may be required if severe mould has resulted.

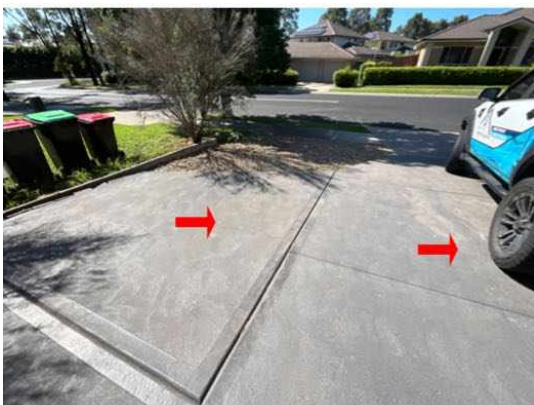
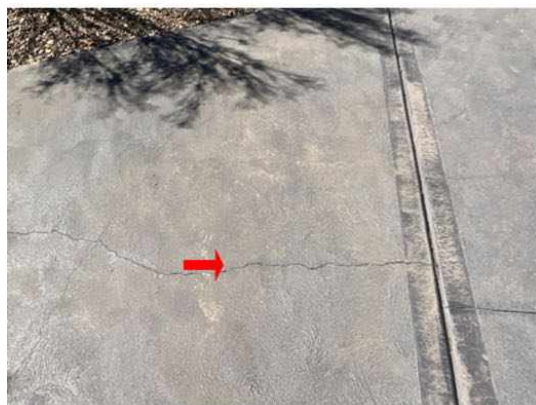
Finding 3.13

Building:	Main Building
Location:	Driveway
Finding:	Cracking - External Concrete Paving Damage Category 1 - Fine (less than 2mm)
Information:	Fine cracks were identified in external concrete paving. Although fine cracks are quite noticeable, they are often only considered to be an appearance defect, and usually do not indicate any structural damage. To be considered a Category 1 or fine crack, the crack is found to be less than 2mm in width.

Generally the cause of a hairline crack in existing concrete paving such as driveways and pathways is indicative of the expansion and contraction of the concrete. Such causes are generally due to environmental factors, such as moisture levels, weather conditions, root systems of nearby trees or the soil types on which they are laid.

Fine cracks may also be due to poor original installation of the concrete. Factors such as poor compaction of the sub surface and/or inadequate reinforcing of the slab may create cracking and other secondary defects.

Monitoring of all cracking should be conducted frequently. Always contact a building inspector should cracks widen, lengthen, or become more numerous.

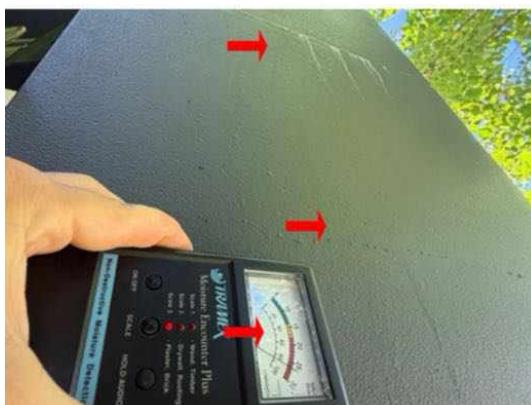
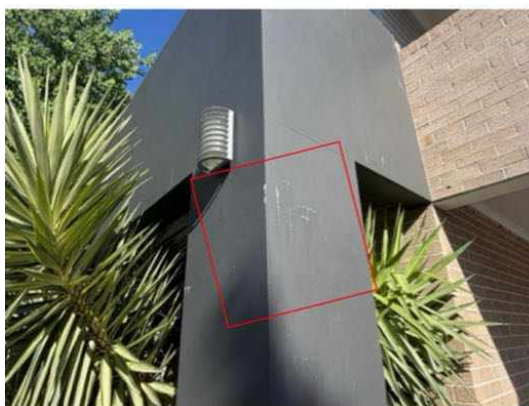
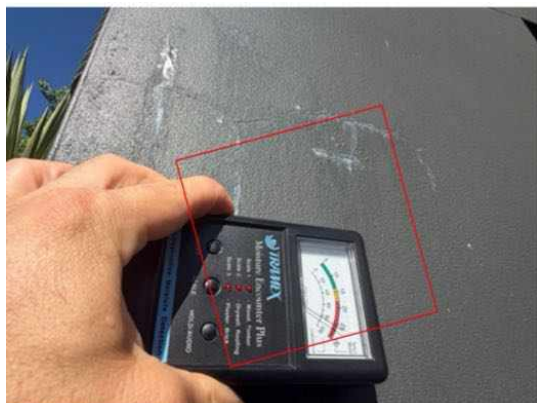
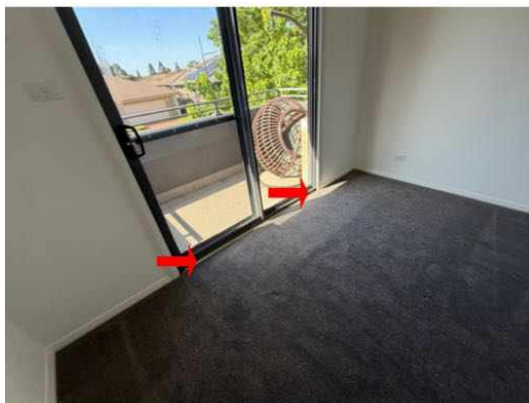
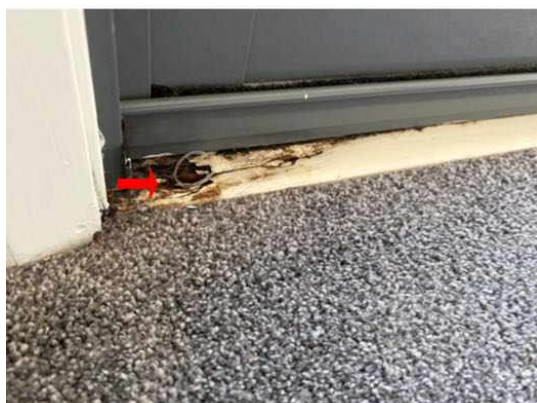
Building: Main Building
Location: Balcony
Finding: Water leak - Internal
Information: A water leak is expected in this area at the time of inspection due to the balcony floor waterproofing failure. Internal water leaks can be detrimental to surrounding building elements.

Rust, corrosion, decay and water damage are potential outcomes where a minor water leak is left unattended. More serious defects may also result, such as electrical hazards, or water damage to structural building elements.

In extreme cases, structural damage may develop due to a prolonged water leak. It is highly advised a licensed plumber be advised for further investigation. Major works should be expected and must be carried out by licensed builder.

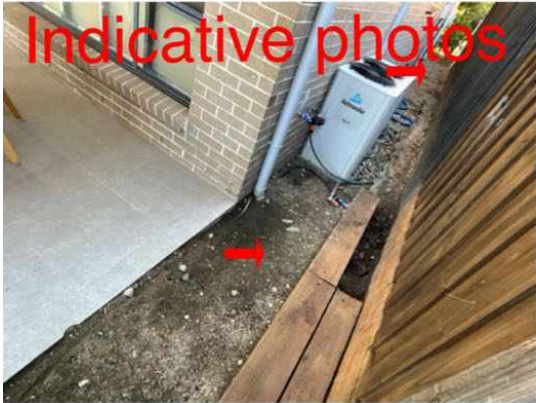
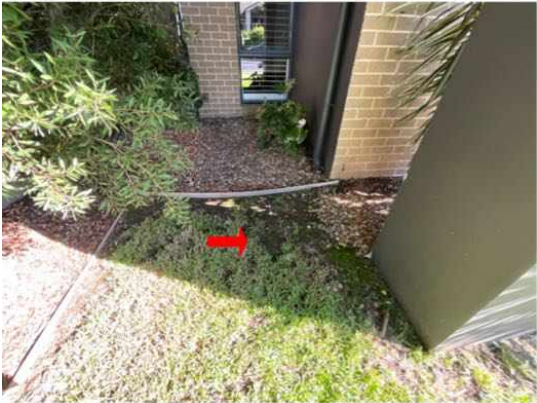
Finding 6.02

Building:	Main Building
Location:	Yard
Finding:	Site drainage— Inadequate
Information:	The site drainage in this area was found to be inadequate at the time of inspection, creating potential for subsequent water damage to associated building elements. This is additionally conducive to termite activity.

Where site drainage is inadequate, installation of an Agricultural (Aggie) Drain may be required. A licensed plumber should be appointed to further inspect the property and perform any remedial works as necessary. Water damage and secondary defects are likely to occur if left unmanaged.

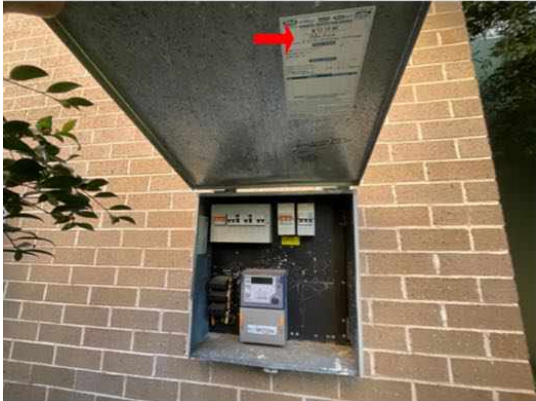
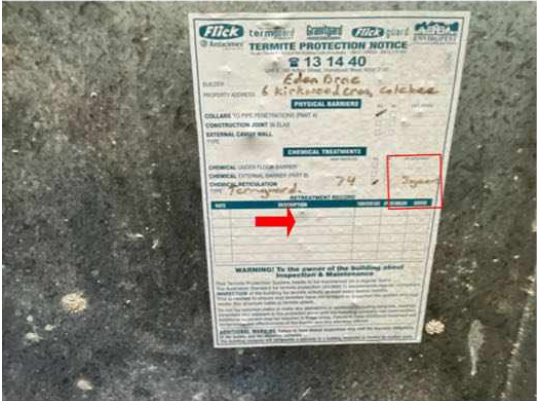
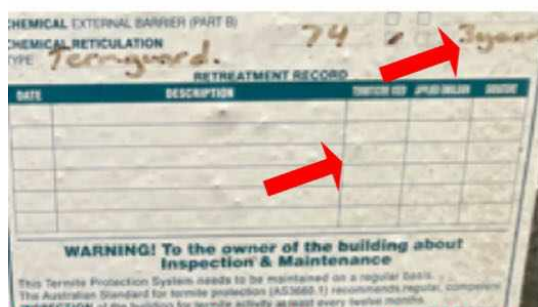
Finding 6.03

Building: Main Building
 Location: All Areas
 Finding: Re-application of chemical termite barrier - required
 Information: Chemical treated barriers deteriorate over time necessitating the need for re-application of a barrier every 6-10 years depending on the product type environment etc. Due to this deterioration chemical barriers decline in their effectiveness exponentially if not replenished.

Information has faded

Consult the record of installation to identify the type of chemical and date of application. It is then advised to consult a licensed pest controller regarding reapplication intervals. Annual inspections are almost always required for all system types.

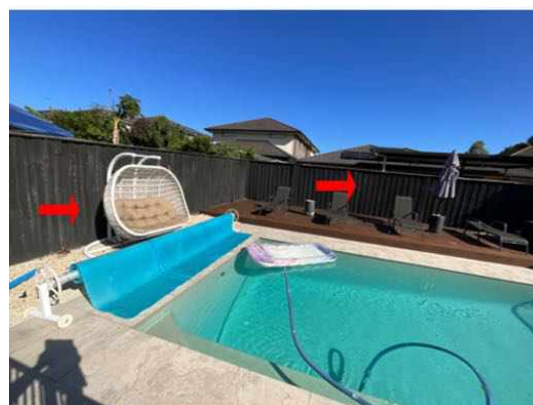
Finding 6.04

Building:	Main Building
Location:	Fencing & Landscaping
Finding:	Building materials in direct ground contact - conducive to termites
Information:	Where timber elements are in direct contact with the ground and consequently moisture or dampness they become conducive to termite activity. Whether timber is used as a building element part of a fencing structure or stored as an unused item they can provide an environment that is attractive to termite infestation.

When met with excessive moisture timber begins to decay and develop wood rot. Any timbers that are in direct contact with external grounds especially if left untreated or non-durable also provide ingress for subterranean termites into that particular element.

The removal of any such materials that may be conducive to termite activity should be removed as soon as possible to minimise the risk of termite attack.

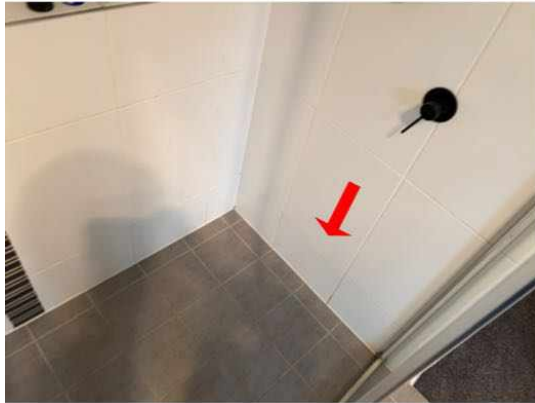
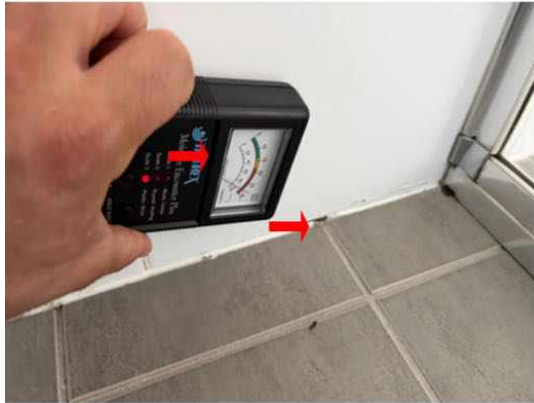
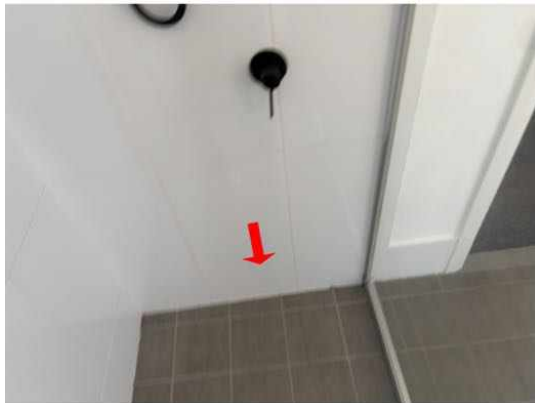
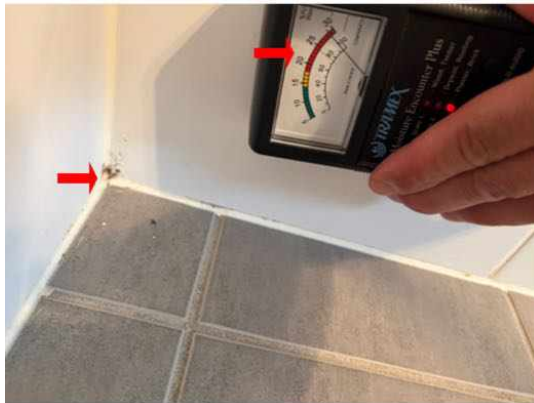
Building:	Main Building
Location:	Ensuite 1 & 2
Finding:	Shower damp - Sealant and grout
Information:	Damp is evident to the lower 400mm of wall to the shower alcove. This defect is quite common, and is suspected to have been caused by moisture permeating or leaching through the grouting and sealant in this area, which shows evidence of deterioration. Leaking pipes within the wall is also a possible cause however this seems unlikely in this instance as there is no moisture build up around the taps or transferring to the other side of the wall. There appears to be no sealant around the tap spindles which may be a small contributing factor.

Damp (or structural damp) refers to the presence of unwanted moisture in the structure of a building, either as the result of intrusion from outside, or condensation from within the structure. In the shower area, internal water leaks, degraded materials or other sources of excessive moisture are generally the cause of damp.

Unmanaged damp in the shower recess is likely to facilitate the formation and development of mould and fungi growth, decaying associated building materials and compromising their structural integrity of associated elements. It is important to address damp conditions, as the World Health Organisation notes that excess moisture leads - on almost all indoor materials - to growth of microbes such as moulds, fungi and bacteria, which subsequently emit spores and other matter into the indoor air. Exposure to these contaminants is associated with a wide range of respiratory and other health-related problems. Damp conditions also create a conducive environment for termite infestation.

Consultation with a bathroom sealant specialist is advised immediately to identify the cause of damp and to perform remedial works as required.

Always ensure that sealant and grout is in good condition to prevent any moisture issues occurring in the future.

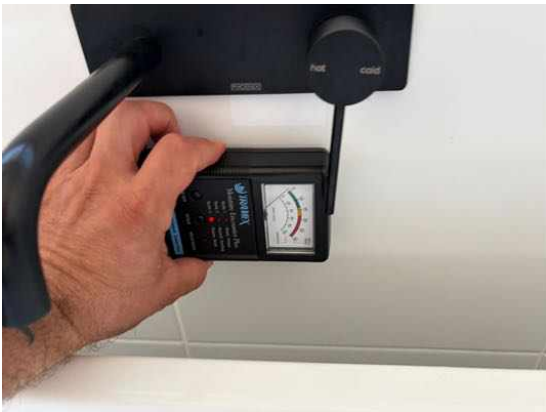
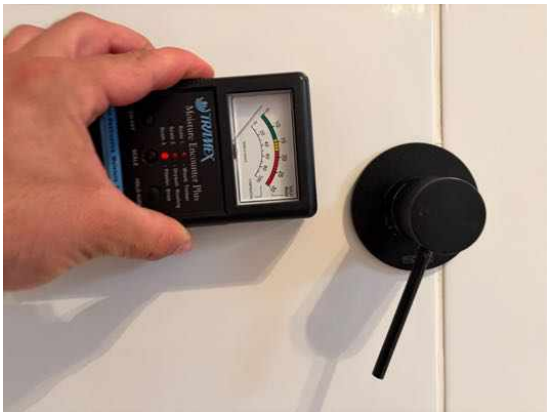
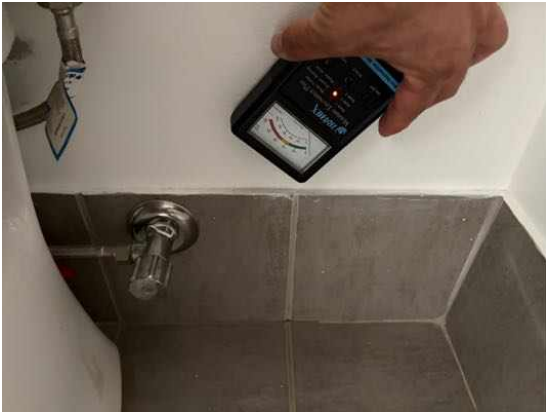
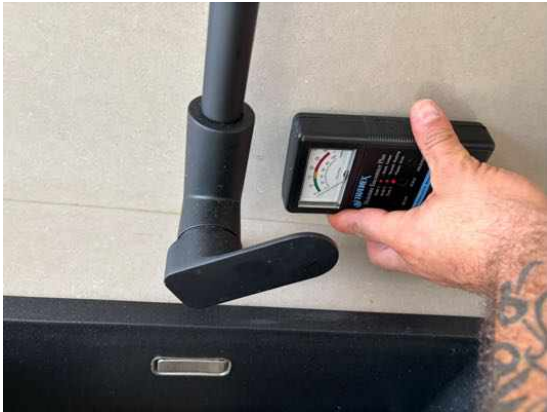
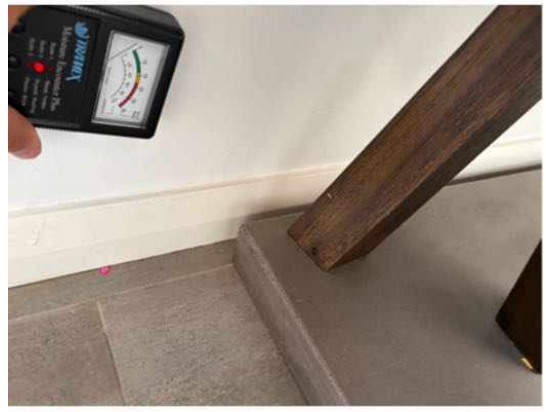
Building: Main Building
Location: All Areas
Finding: Moisture metre
Information: During the inspection the property was checked for moisture using a moisture metre.

This is for information only.

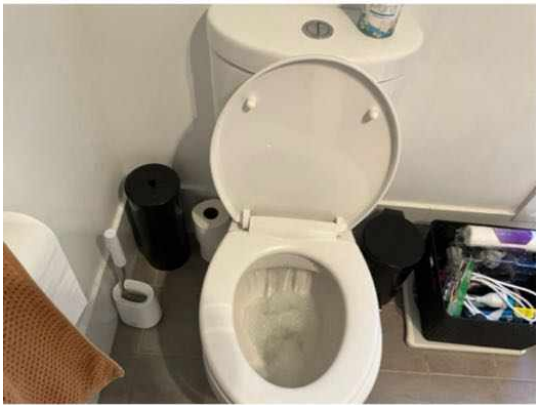
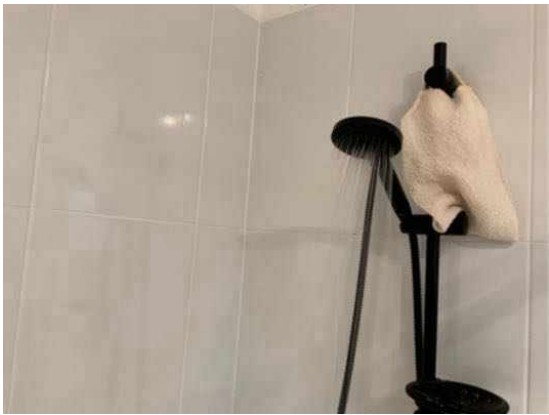
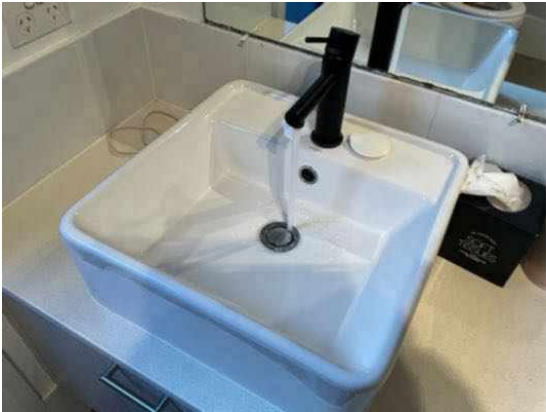
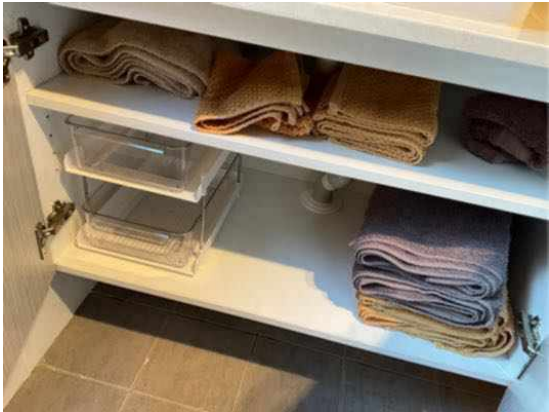
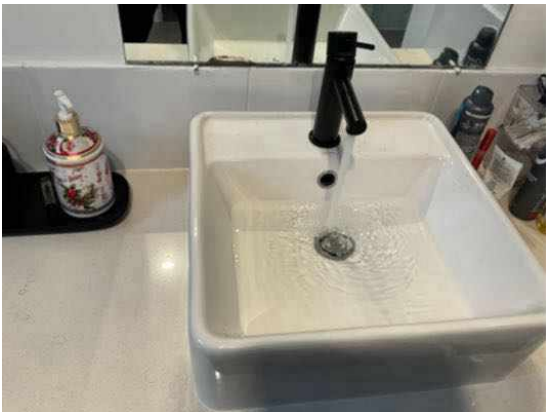
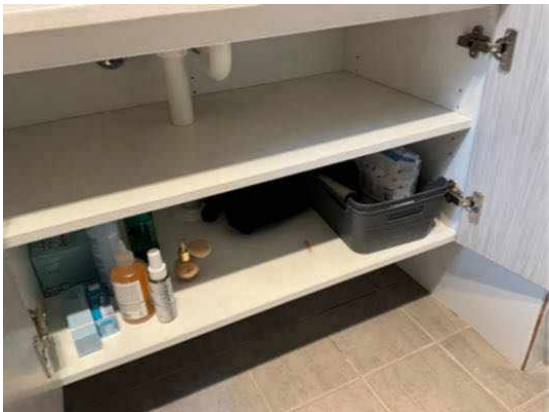
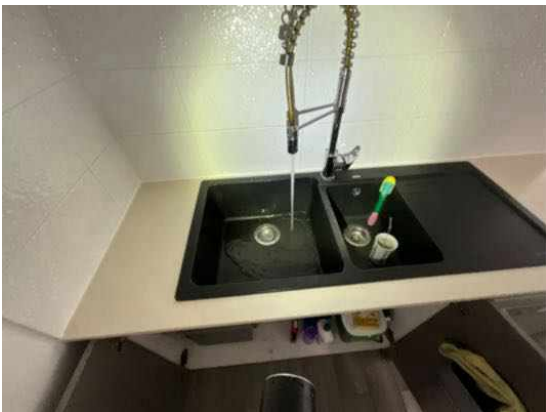
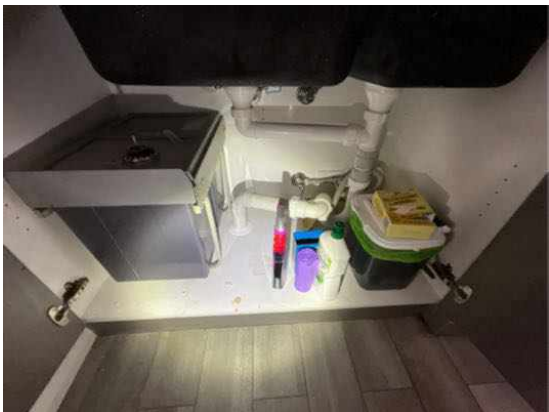
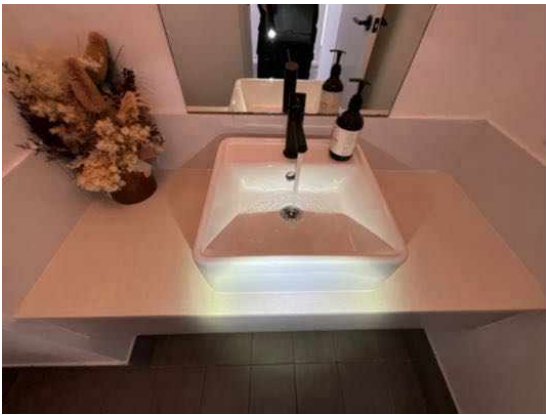
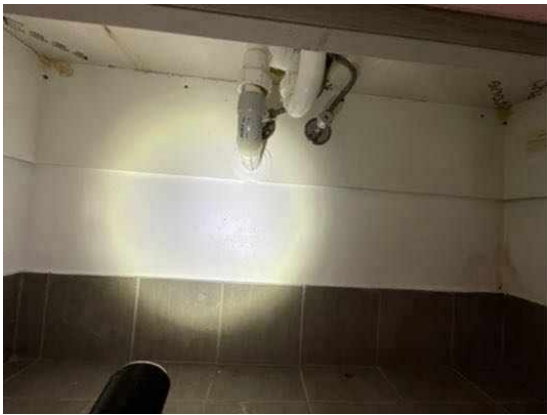
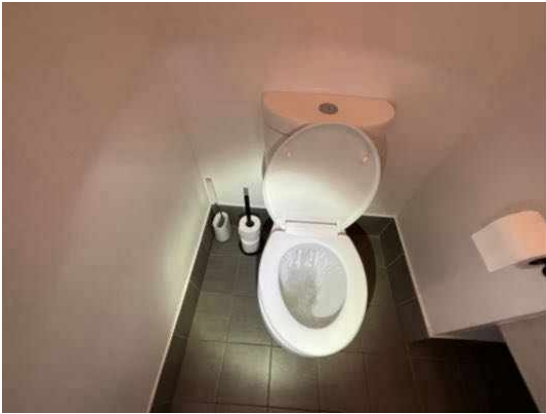
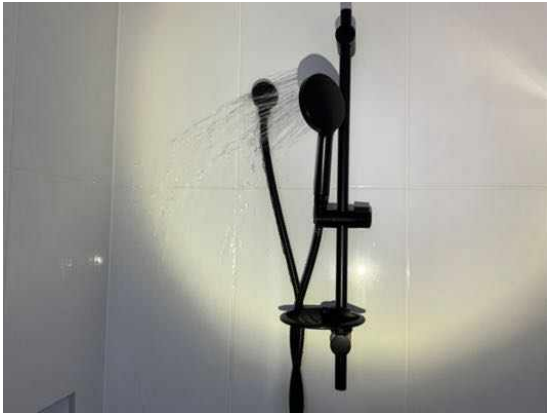
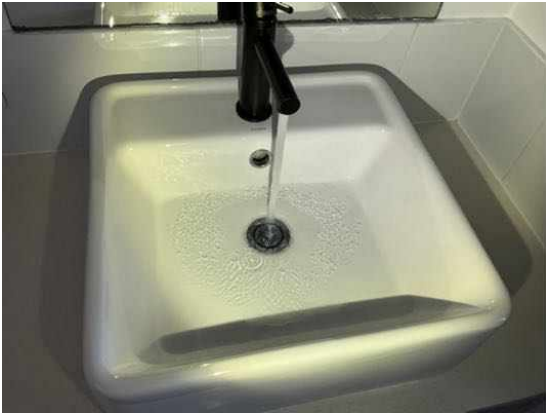
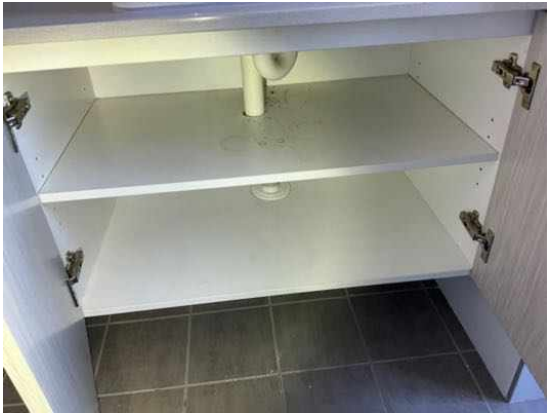
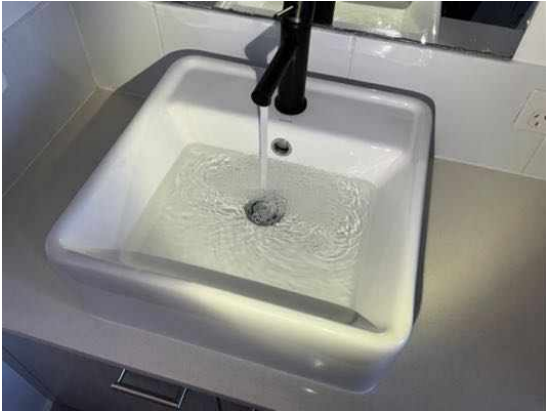
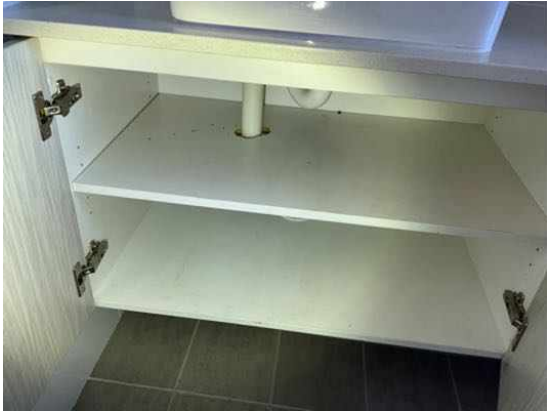
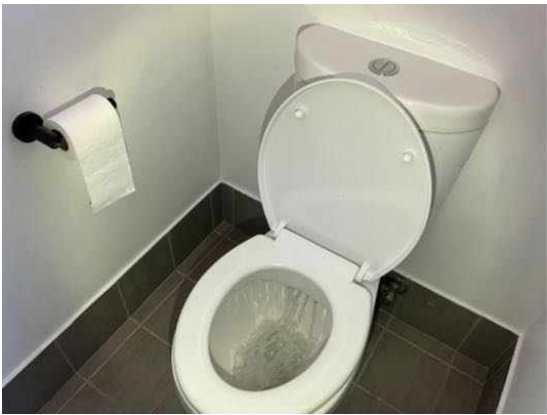
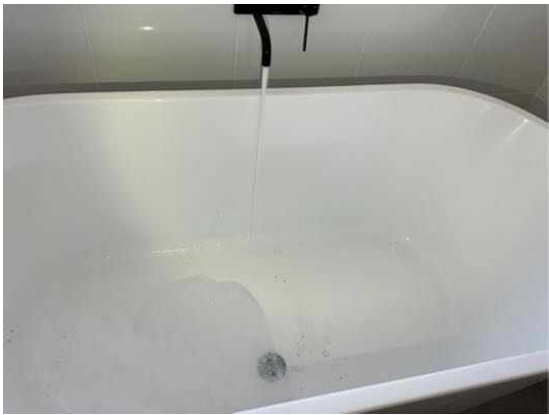
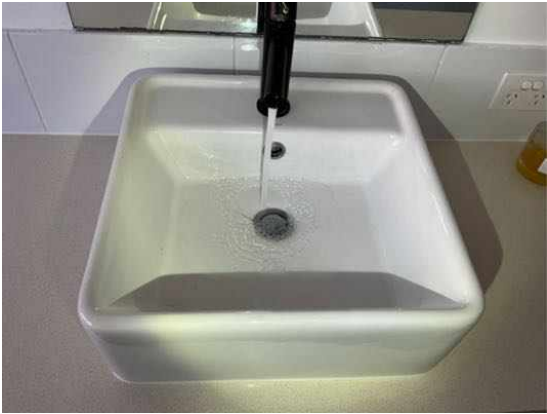
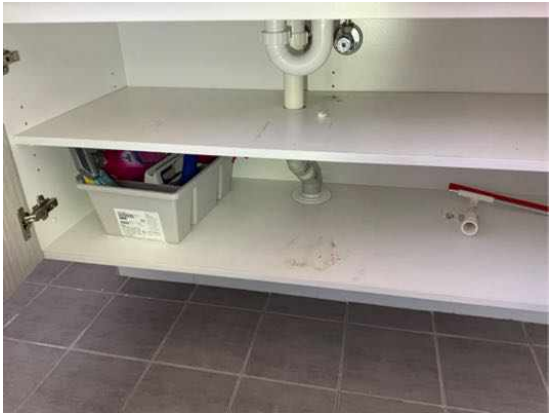
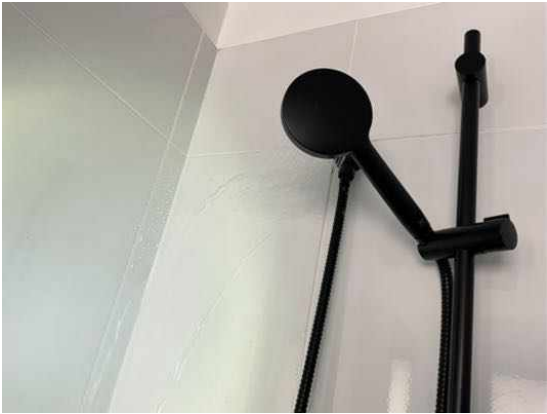
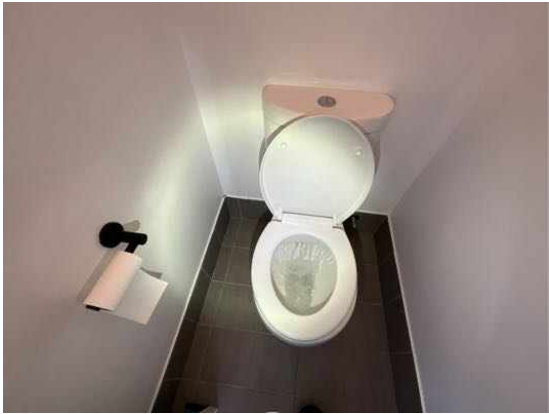
Building: Main Building
Location: All Wet Areas
Finding: Additional Photos
Information:

Additional photos are provided for your general reference.

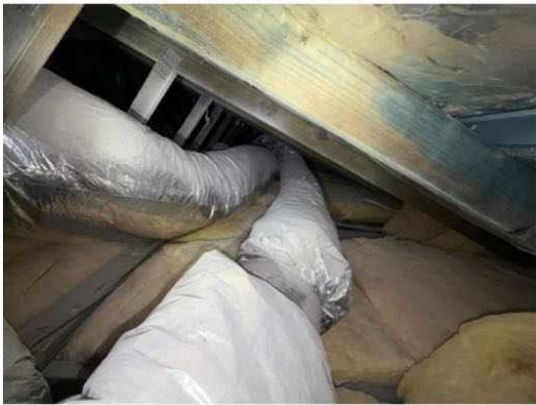
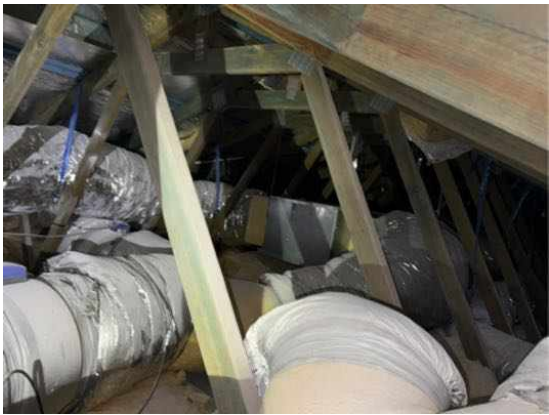
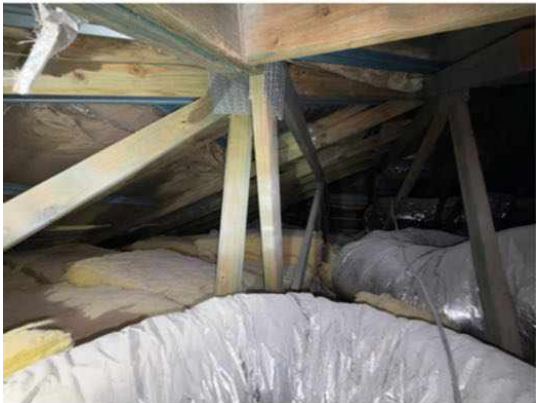
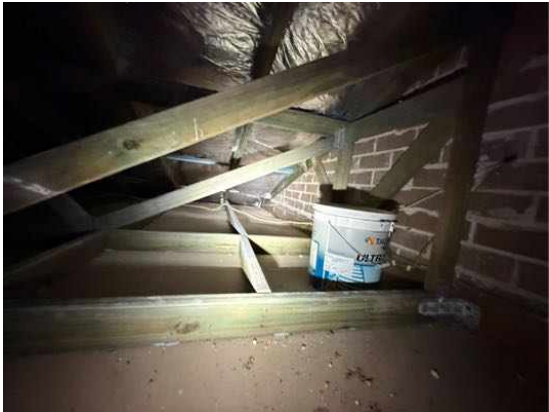
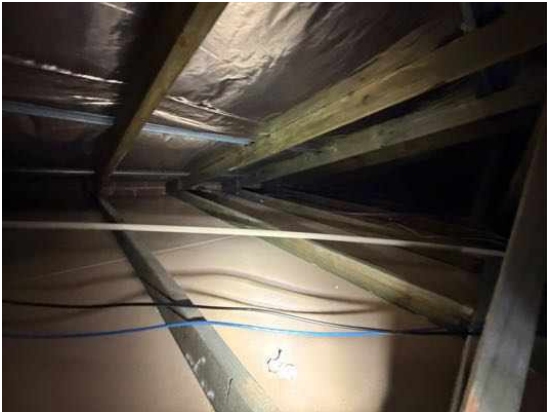
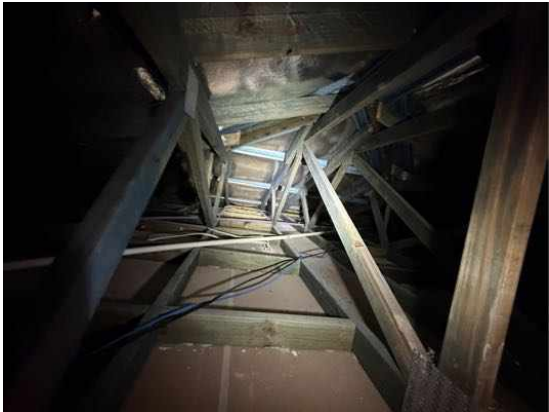
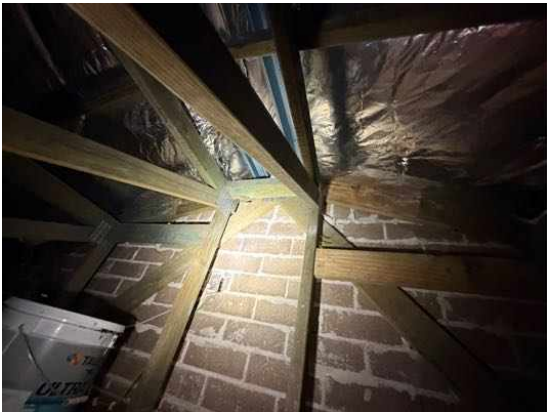
Building: Main Building
Location: Roof Void
Finding: Additional Photos
Information:

Additional photos are provided for your general reference.

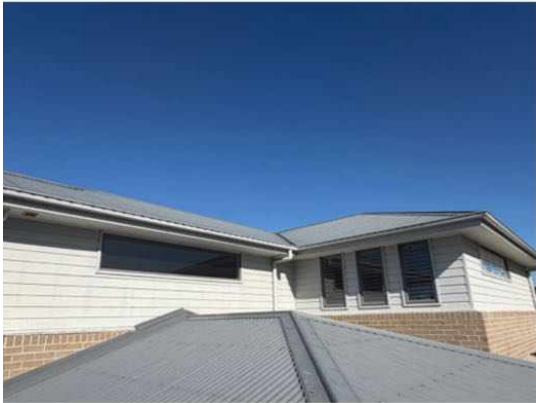
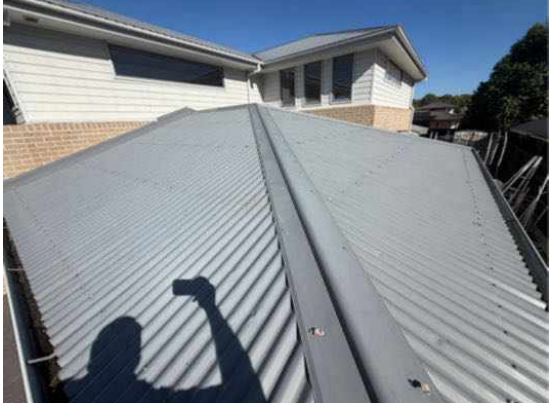
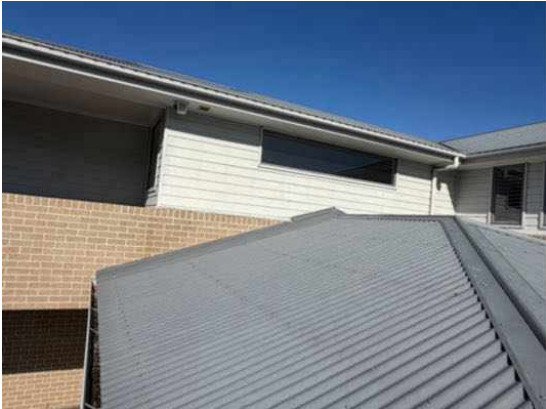
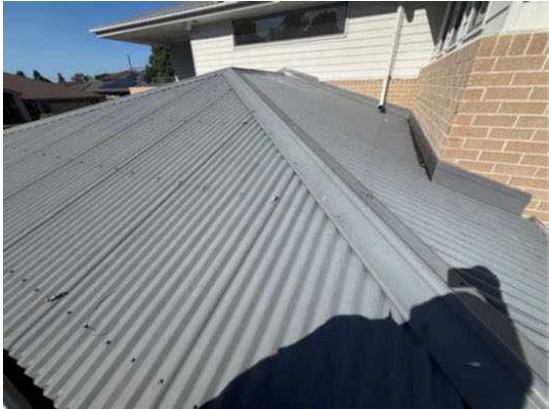
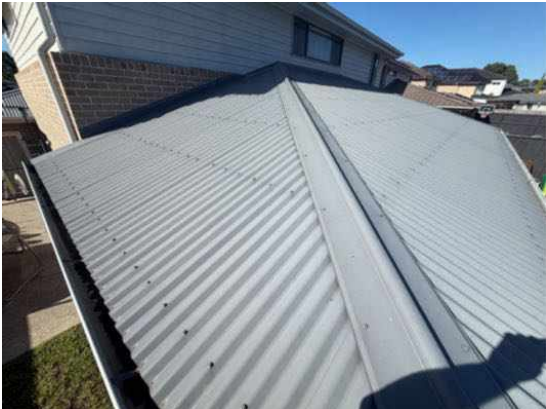
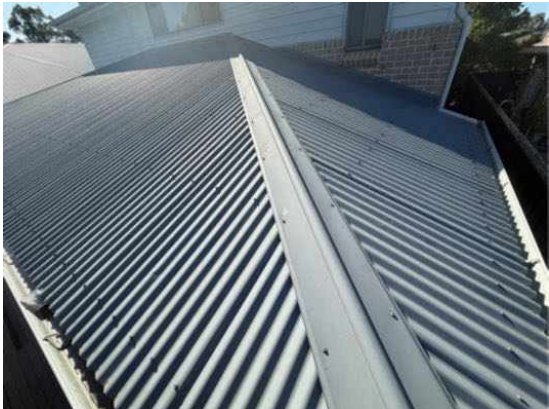
Building: Main Building
Location: Roof Exterior
Finding: Additional Photos
Information:

Additional photos are provided for your general reference.

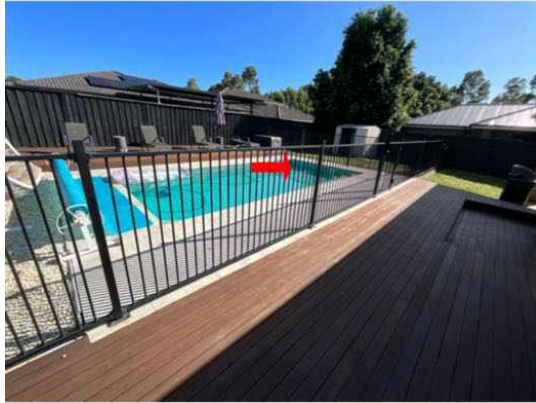
Building:	Main Building
Location:	Pool area
Finding:	Pool inspection
Information:	This inspection specifically excludes any inspection of the pool, associated pool equipment and pool surrounds. An inspection should be made by a specialist pool inspector to determine the condition of the pool, pool equipment and surrounds. A pool safety inspection is not included as part of a standard building inspection and must be commissioned separately as a specialist report.
