Building and Timber Pest Inspection Report

Inspection Date: Wed, 25 Mar 2026

Property Address: 6 Kirkwood Cres, Colebee NSW 2761,
Australia

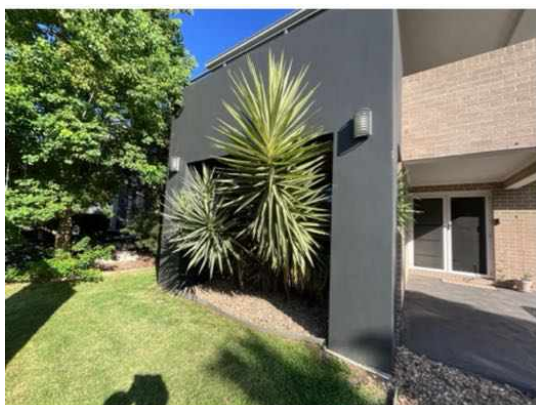
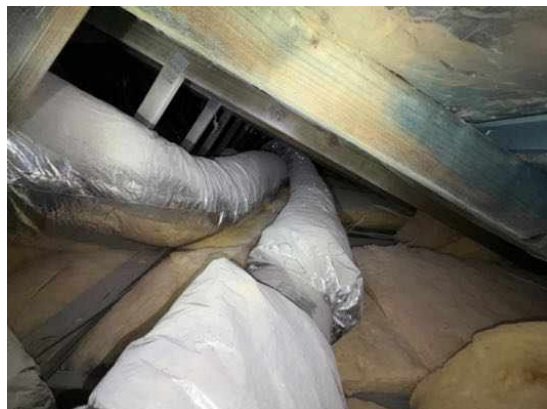
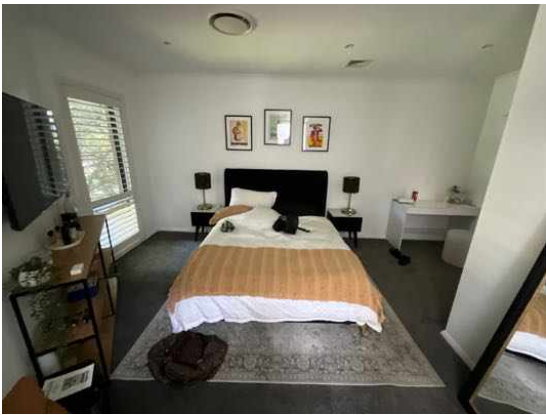
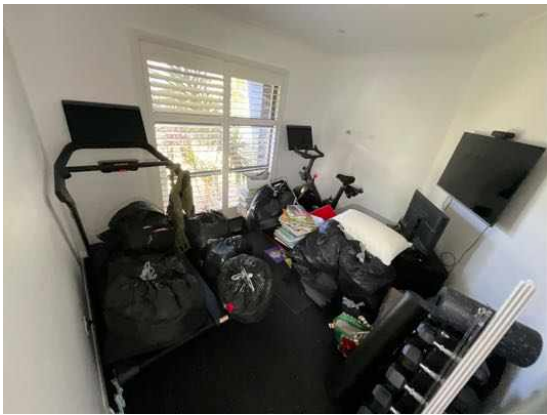
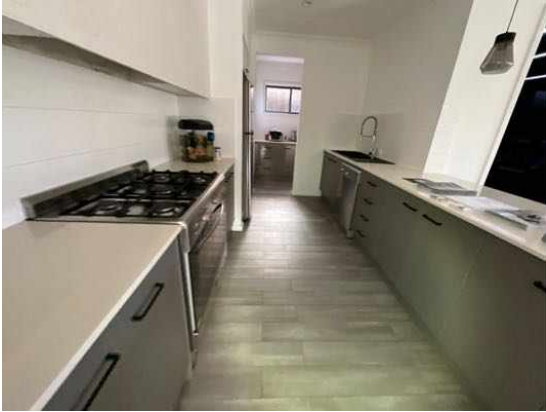
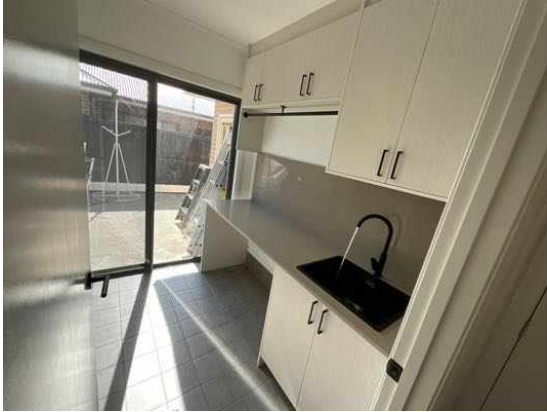
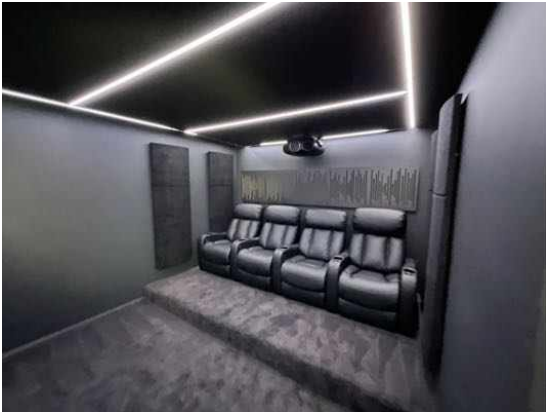
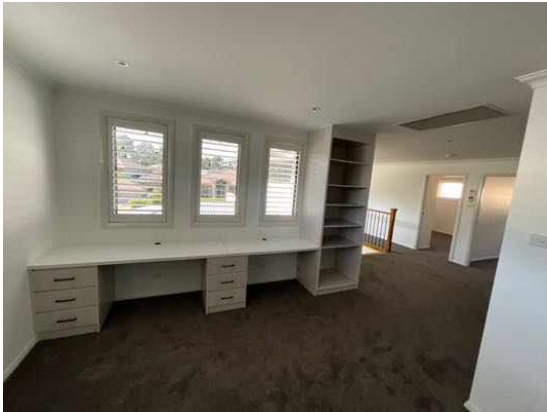
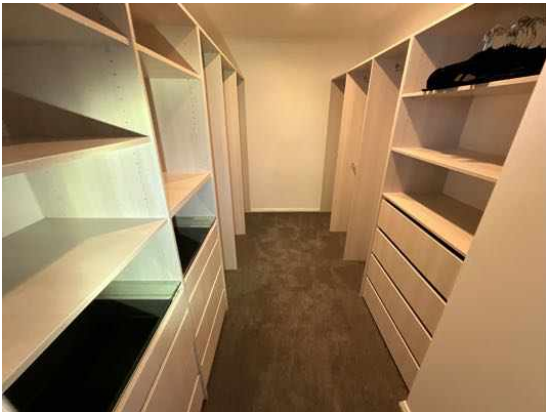
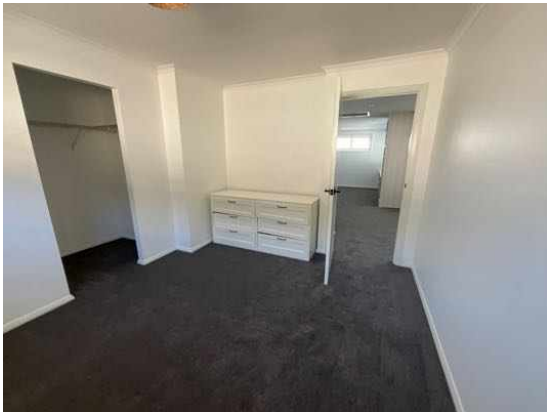
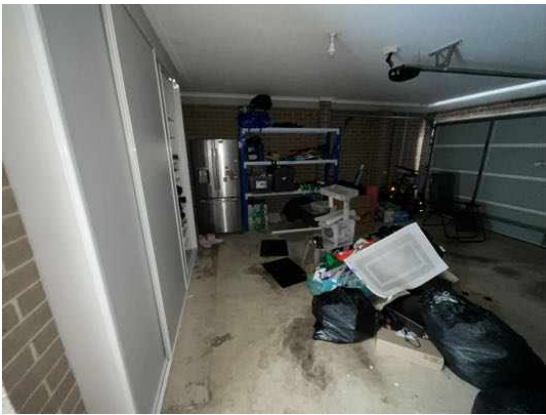
Building:	Main Building
Location:	All Areas
Finding:	Additional Photos - Obstructions and Limitations
Information:

These photographs are an indication of the obstructions and limitations which impeded full inspection of the property at the time of inspection. These obstructions can hide an array of defects and should be removed to allow full inspection to be carried out. A re-inspection is recommended once the areas are made accessible.

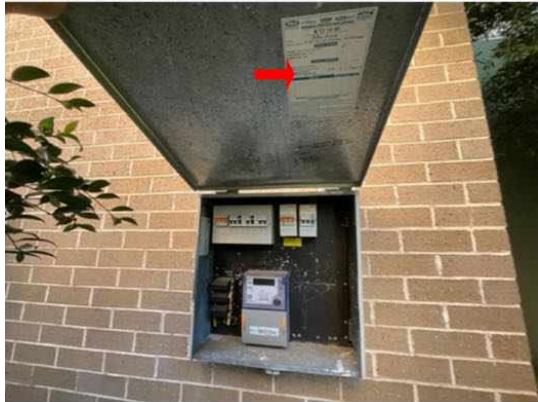
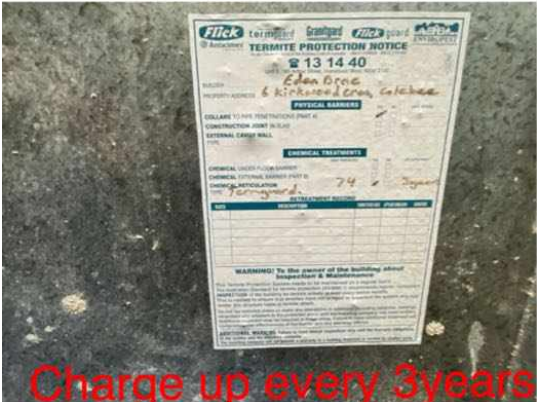
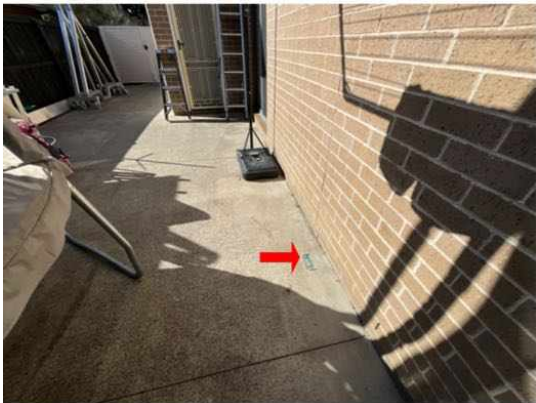
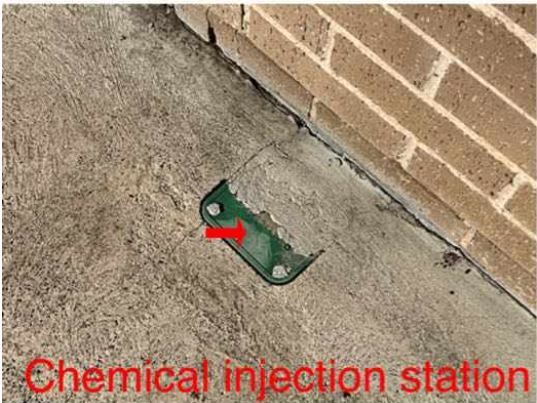
Where a Termite Management System has been identified you should refer to the type of barrier date of installation warranty conditions and any documentation provided by a builder or past owner. Consult the company who installed the barrier to confirm whether the system is still under warranty.

Most chemical termite management systems expire and require replenishment and all physical systems are primarily designed to prevent concealed entry.
