# Building and Timber Pest Inspection Report

Inspection Date: Thu, 12 Feb 2026

Property Address: 125 Pound Creek Rd, Tumbarumba NSW  
2653, Australia

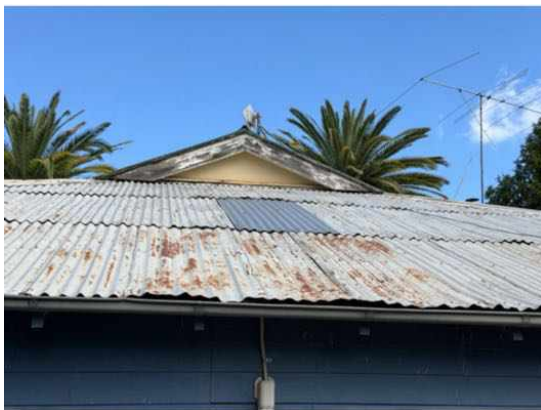
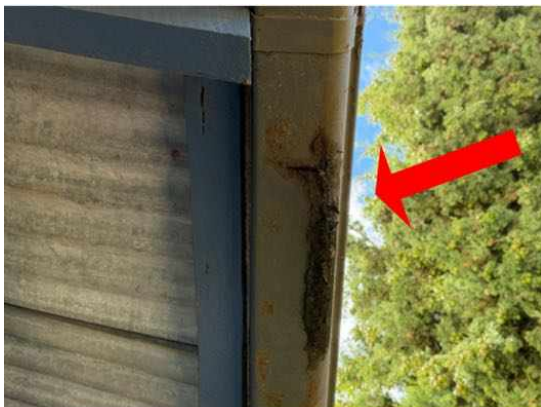
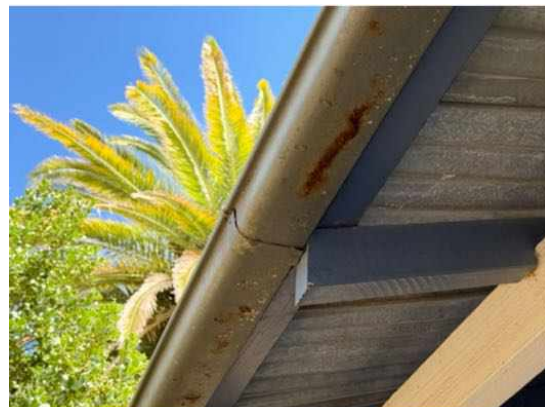
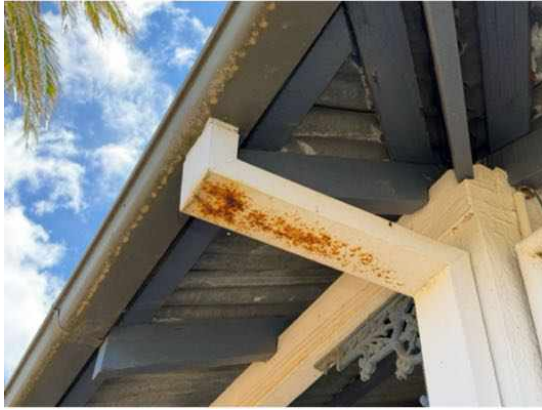
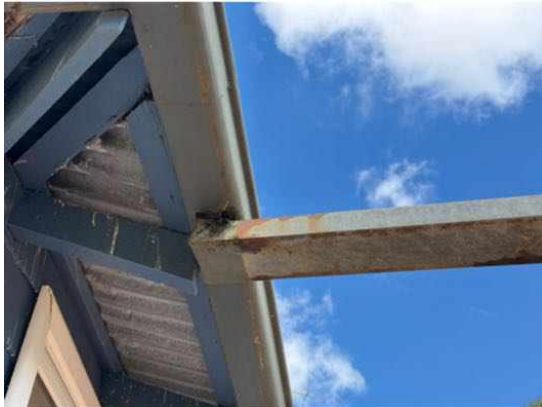
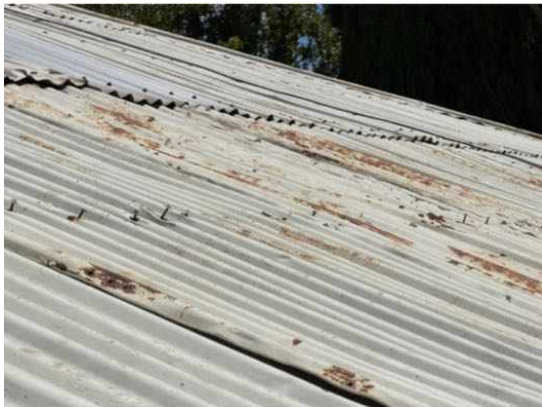
Building: Main Building  
Location: Gutters, Down-pipes, Roof Sheeting  
Finding: Roof plumbing & sheeting - Rusted, Loose, Disconnected  
Information: Several areas of rust were identified to the roof plumbing and roof sheeting, & several roof sheets were found to be loose. It appears the rust has lead to the development of holes at the bottom of the gutters and leaking of the downpipes. Some down-pipes were also found to be disconnected.

Consultation with a licensed roof plumber and roofing contractor is required promptly, to provide further advice on replacement works needed to prevent any potential further damage or deterioration that may occur.

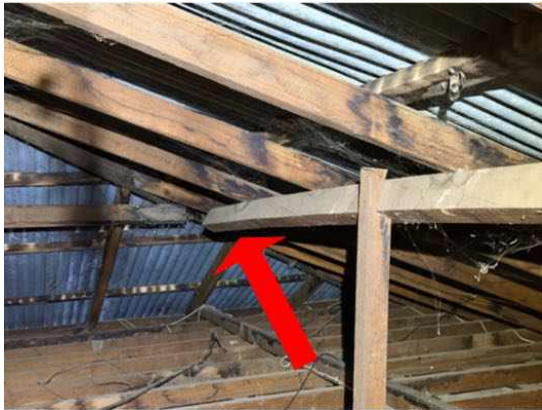
### Finding 3.01

Building:	Main Building
Location:	Roof Void
Finding:	Roof Framing - Additional Fixings / Support Required
Information:	It appears that a rafter in the roof void has been cut and requires additional support. A small strut also appears to require additional fixings, and an under-purlin was found to be slightly sagging.

Recommend engaging a licensed carpenter in the short term, to provide remedial works where necessary.

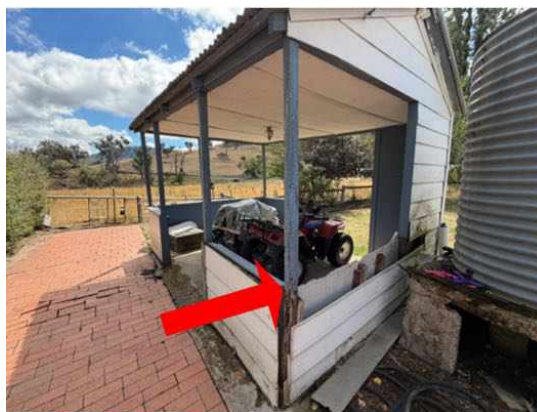
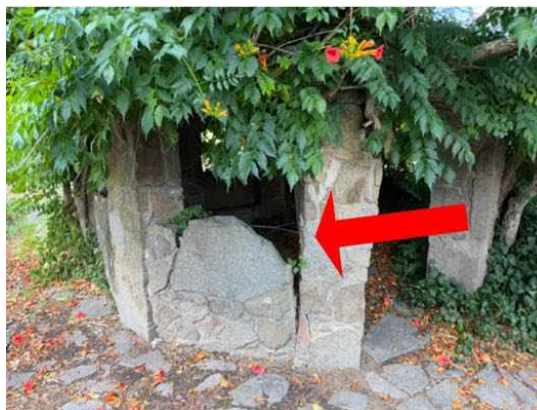
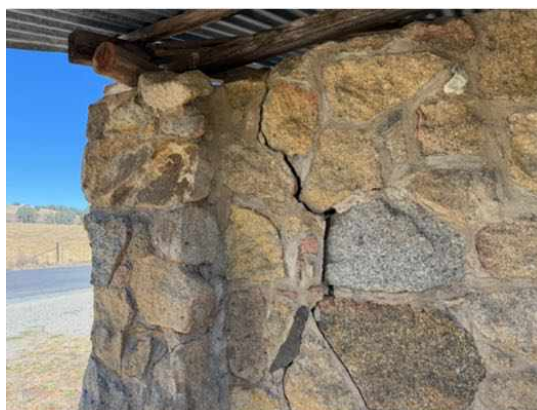
### Finding 3.02

Building:	Main Building
Location:	Sheds & Outbuildings
Finding:	Outbuildings & Sheds - Unstable & Deteriorated
Information:	It appears that areas of the outbuildings and sheds were unstable and deteriorated and evidence of movement was identified in the masonry. It is advised that the client engage a registered builder to either remove the structures or provide remedial works to ensure they are sufficiently reinforced and secure. Further movement & deterioration will occur if neglected.

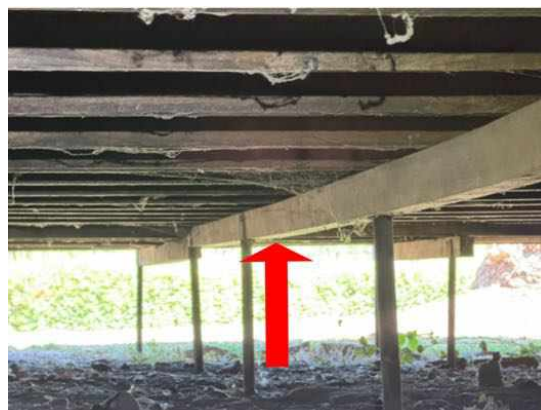
### Finding 3.03

Building:	Main Building
Location:	All Areas
Finding:	Flooring - Uneven
Information:	Some areas, of the flooring & bearers, throughout the building & subfloor appear to be uneven. It is advised that the client monitor the flooring to identify any further movement. Where flooring remains relatively unchanged for an extended period of time, it is likely that this defect has been caused by general movement of the foundations of the property.

However, where further movement and unevenness occurs, a structural engineer should be engaged promptly for further evaluation.

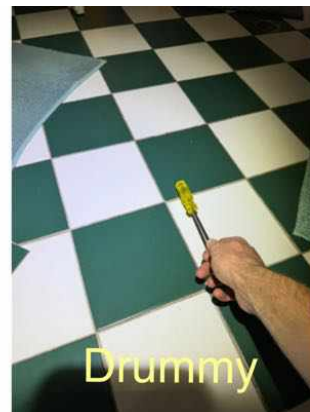
Finding: Sealant / grouting - deteriorated or missing & Cracked Tiles

Information: It appears that the sealant and grout has deteriorated in some tiled areas, a common defect in buildings of a similar age. Areas of cracked & drummy tiles were also noted, which can allow for moisture ingress behind the tiles, if neglected.

Drummy

Recommend engaging a licensed tiling contractor in the short term, to provide maintenance works where necessary.

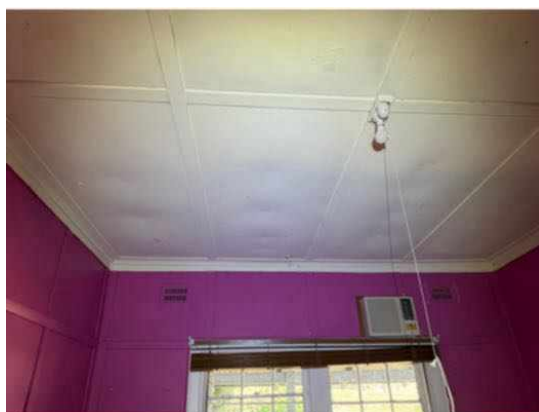
### Finding 3.06

Building:	Main Building
Location:	All Internal Areas
Finding:	Ceilings Sagging & Drummy / Loose Plaster
Information:	Sections of the ceilings throughout the building, appeared to be sagging at the time of inspection. Several plaster walls were also found to be loose and drummy. Causes of ceiling sagging & drummy plaster include fixings (e.g. nails or glue) that have become loose and require re-fixing, or movement of the building overtime.

Where sagging & drumminess has occurred, works such as re-gluing & re-fixings of plaster sheets, may be required. Such works may be performed by relevant tradespeople, such as plasterers or licensed carpenters.

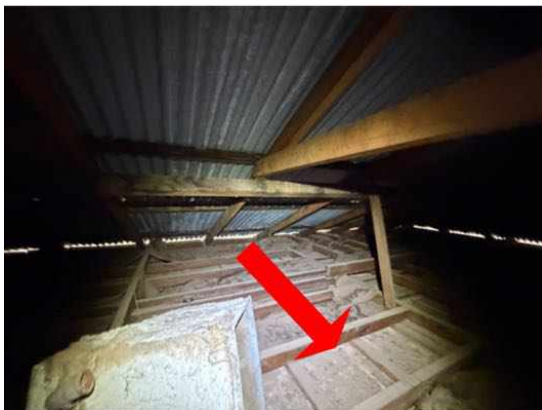
Finding: Insulation - Missing

Information: It was noted that insulation is not present in the roof void. Insufficient or missing insulation is likely to reduce the energy efficiency of the home.

Installation of adequate insulation is advised and can be conducted by an insulation contractor at clients discretion.

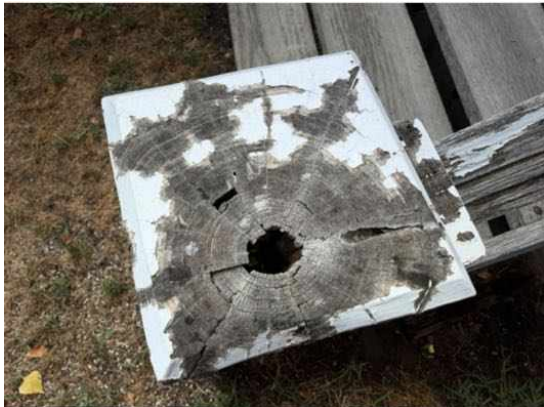
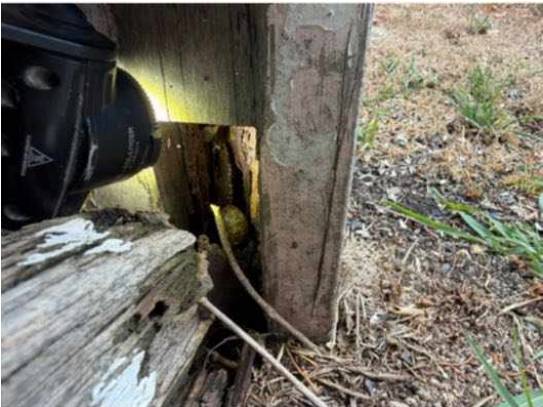
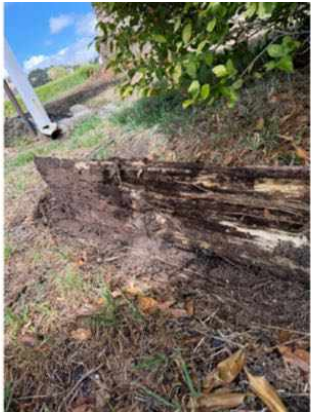
Building: Main Building  
Location: Shed Framing, Verandah Stair Post, Landscaping Timbers  
Finding: Evidence of termite workings & damage  
Information: Termite damage & workings were identified at, but not limited to, areas throughout the external shed framing, veranda stair posts, external timbers and trees.

The client should engage a licensed pest controller promptly to provide further advice regarding installation of a termite treatment.

6 monthly ongoing termite inspections, conducted by a qualified termite inspector, are also recommended

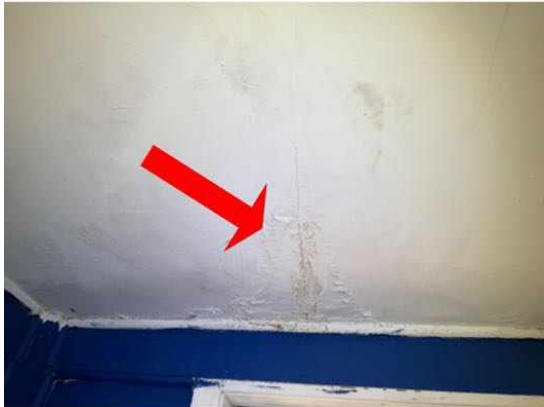
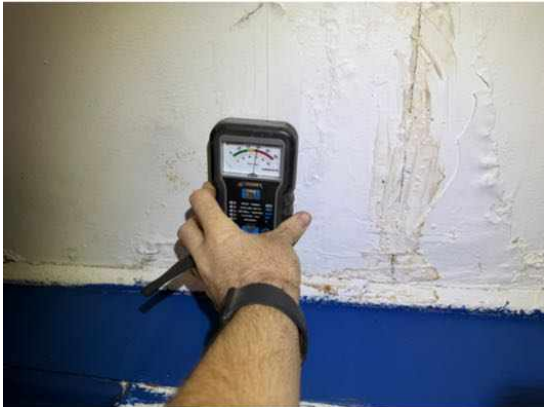
Building:	Main Building
Location:	Dining Room Ceiling, Laundry Ceiling
Finding:	Ceiling Leaks
Information:	High moisture was identified at, but not limited to the dining room and laundry ceilings. Potential causes of leaking include damaged plumbing fittings and fixtures, or deterioration of the roof plumbing.

This creates an environment conducive to termite activity and water damage to surrounding materials.

Recommend engaging a licensed roof plumber or roofing contractor promptly to provide remedial works.

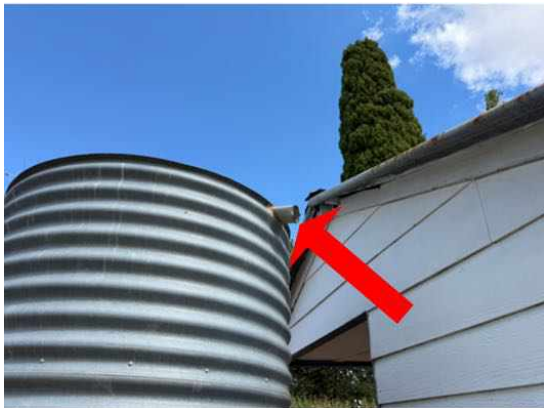
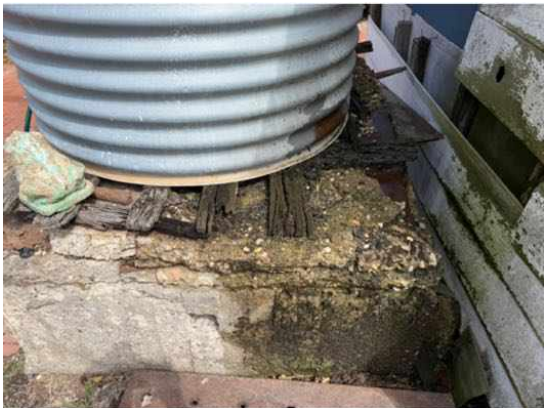
**Finding 6.03**

Building: Main Building  
 Location: Rear Elevation  
 Finding: Water Tank - Leaking  
 Information: It appears that the rear water tank was leaking and the overflow was not connected to stormwater drainage. Leaking water tanks create water pooling at the base, creating areas conducive to timber pest activity, and damage to surrounding building elements.

Recommend engaging a licensed plumber at clients earliest convenience to provide remedial works where necessary.

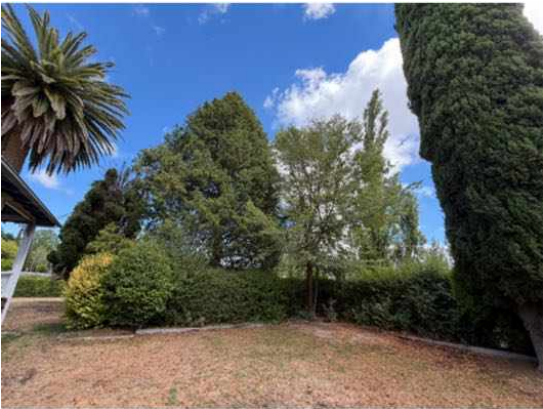
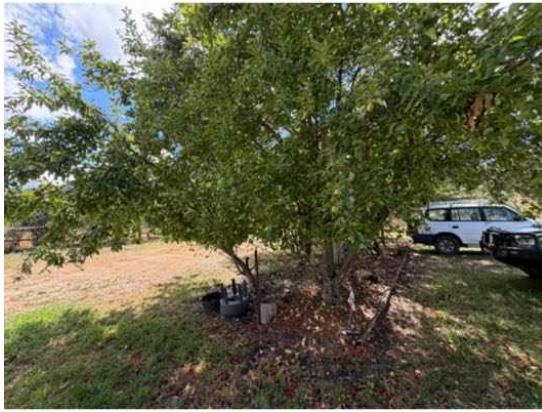
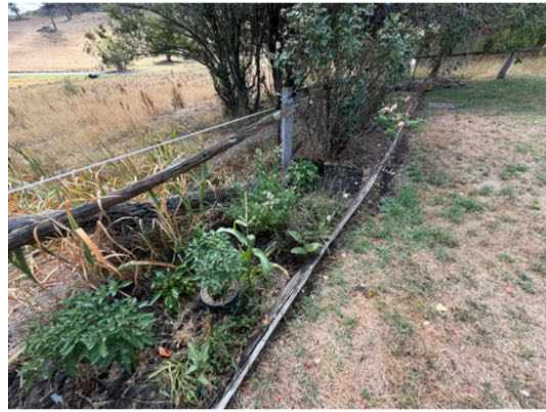
**Finding 6.04**

Building: Main Building  
Location: All External Areas  
Finding: Timber in direct ground contact & trees - conducive to termites  
Information: Where timber materials are in direct contact with the ground and consequently moisture, they become conducive to termite activity. The tree stumps, landscaping timbers, timber debris in the subfloor, and trees surrounding the building create an environment conducive to termite infestation.

Where feasible, any timbers in direct contact with the ground should be removed and any trees in close proximity to the building should be removed or test drilled (inspected) at least annually to reduce the risk of termite infestation & detect any early signs of termite activity.

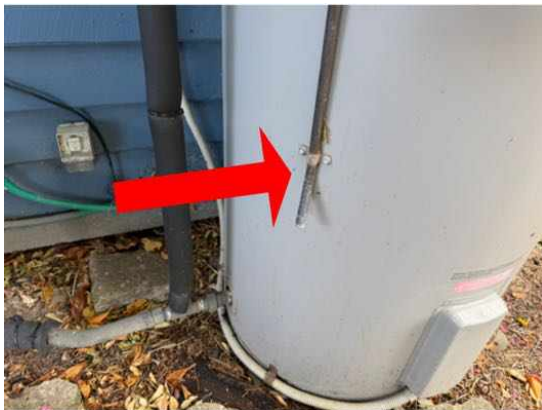
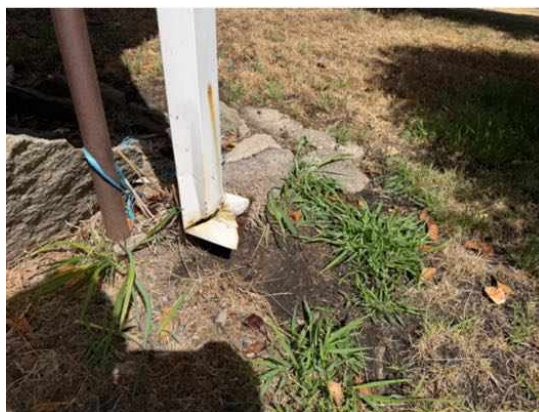
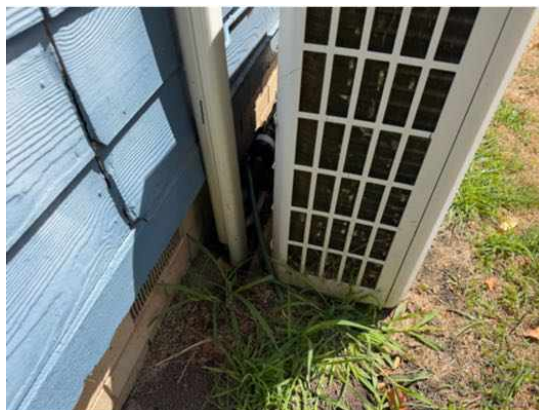
### Finding 6.05

Building: Main Building  
Location: All external areas  
Finding: Potential Water pooling - against property  
Information: It appears that there are potential areas around the perimeter of the property that could be susceptible to water pooling.

Where insufficient drainage of taps, hot water system & aircon overflows, and garden beds against the house are present, water pooling is likely to occur, and can create areas conducive to timber pests and potential damage to the subfloor structure overtime, if neglected.

Recommend consulting with a licensed plumber in the short term to further assess and provide remedial advice.

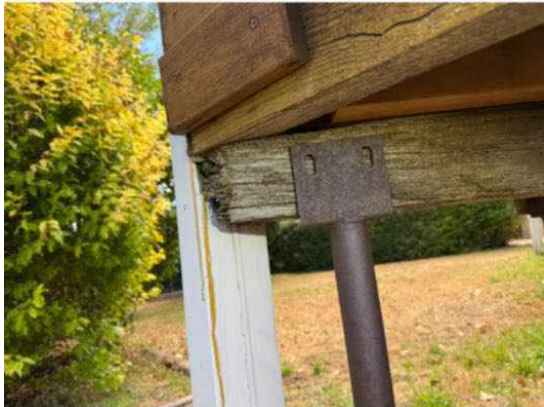
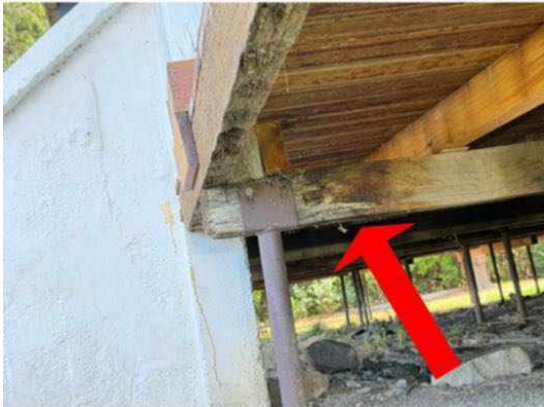
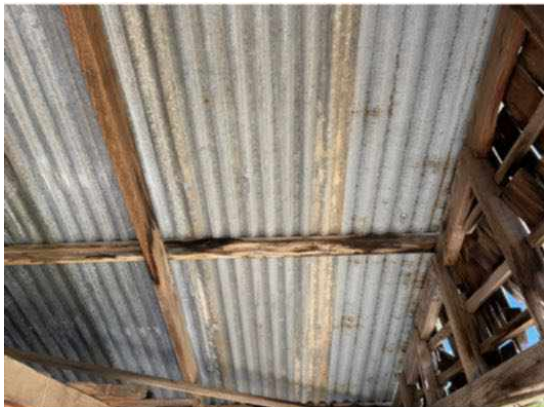
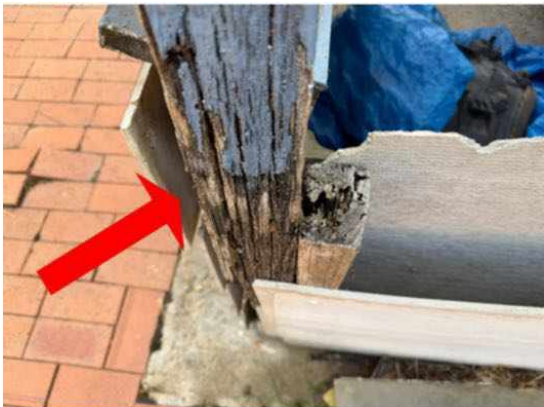
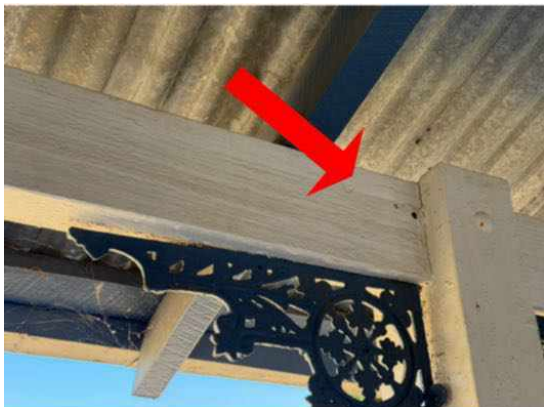
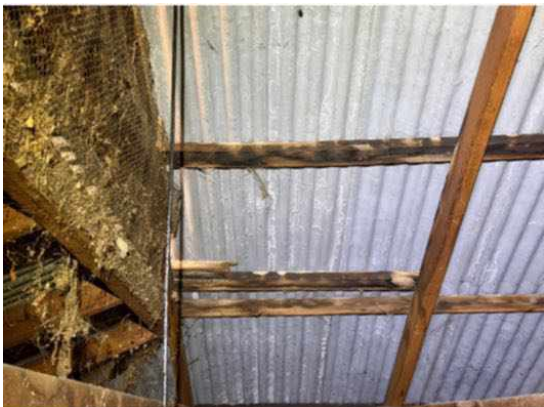
### Finding 7.01

Building:	Main Building
Location:	Roof Framing, Deck Framing, Balustrade, Fascias, Shed Framing, External Trims
Finding:	Fungal decay & weathering
Information:	Areas of fungal decay (wood rot) & weathering were identified at but not limited to some window frames, roof framing, deck framing, balustrade, fascias, shed framing & external trims.

For areas where structural timbers are affected by wood rot (deck, shed & roof framing) a registered builder should be engaged promptly to replace affected materials where necessary.

For areas where fungal decay is superficial, the client can engage a licensed carpenter at their discretion to replace affected materials.

For areas of general weathering, it is advised the client engage a licensed painter to apply protective sealant or coating to areas of weathered external timbers.

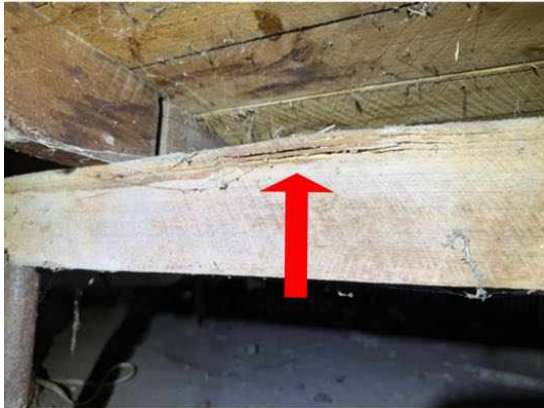
### Finding 8.01

Building:	Main Building
Location:	Subfloor
Finding:	Evidence of wood borer damage identified (powder-post)
Information:	Evidence of previous Lyctus Borer (powder-post beetle) damage was identified at but not limited to a bearer in the subfloor. Wood borer damage is generally considered superficial damage to the affected timber. As no live wood borer activity was identified treatment is not required.

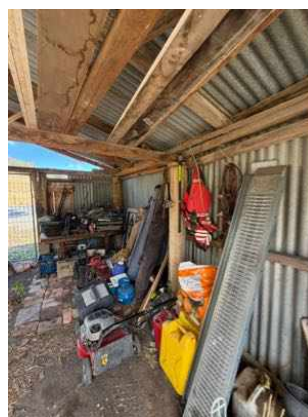
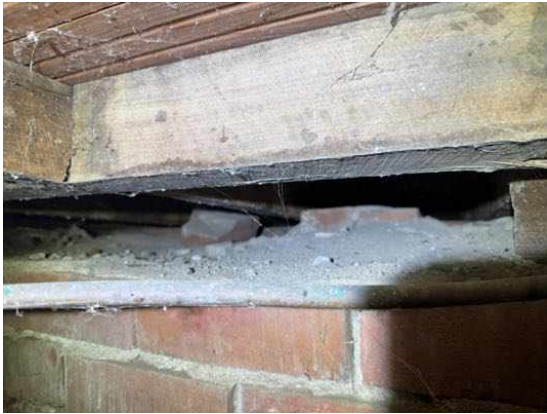
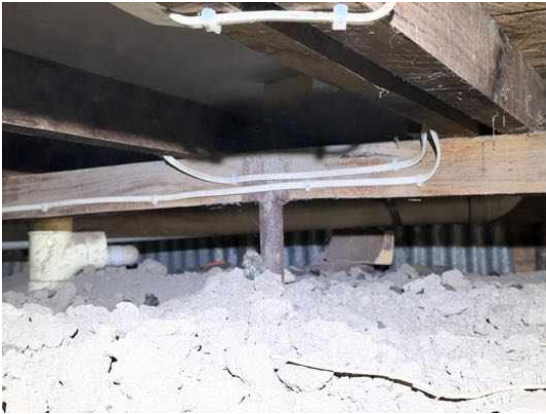
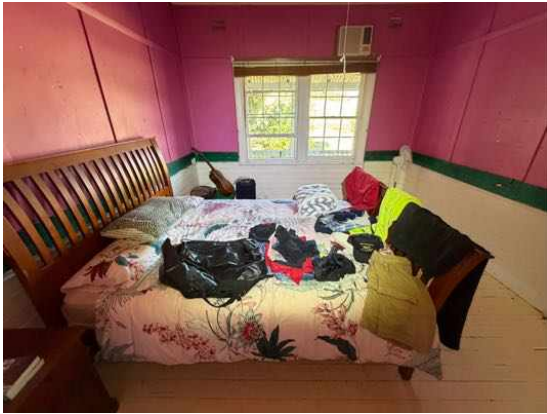
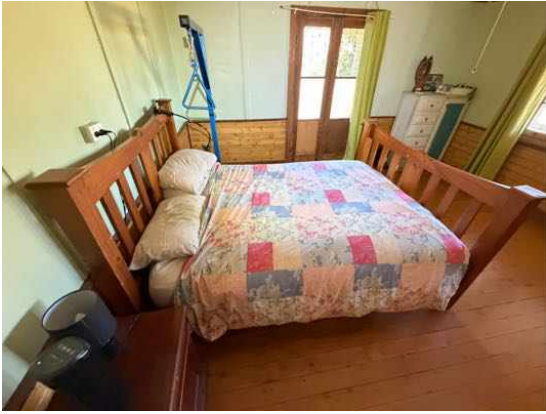
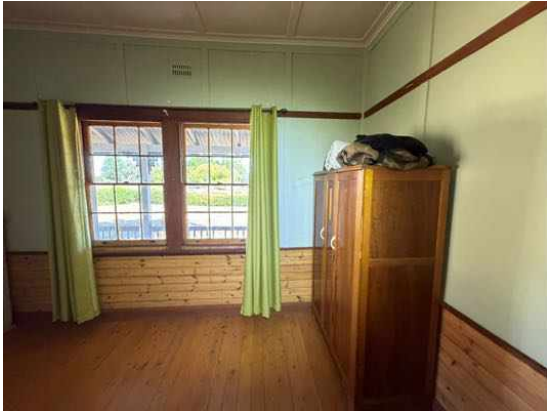
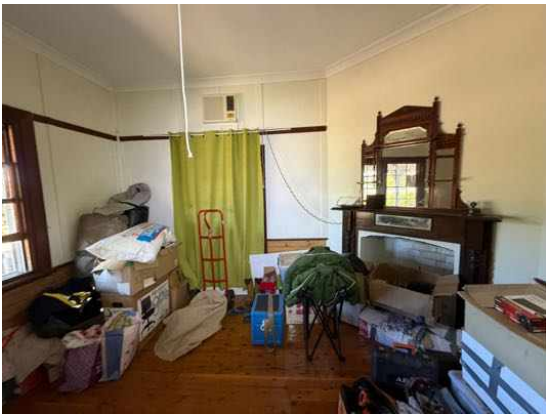
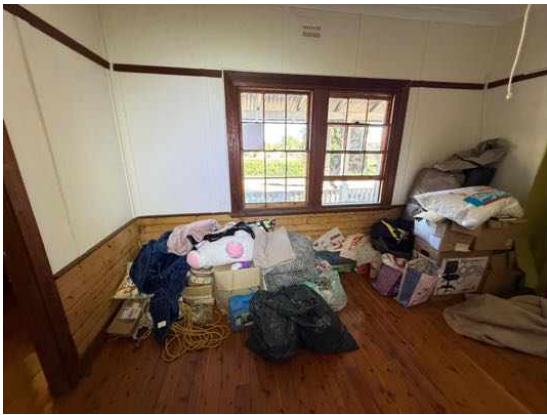
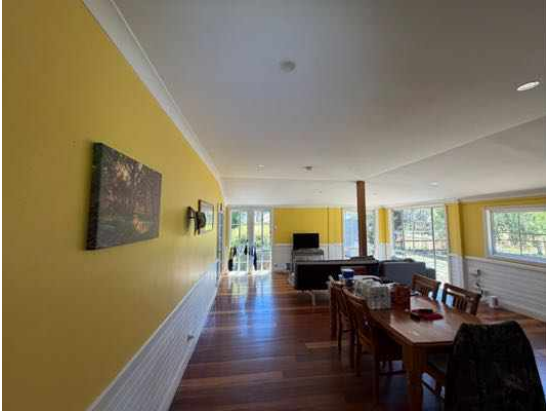
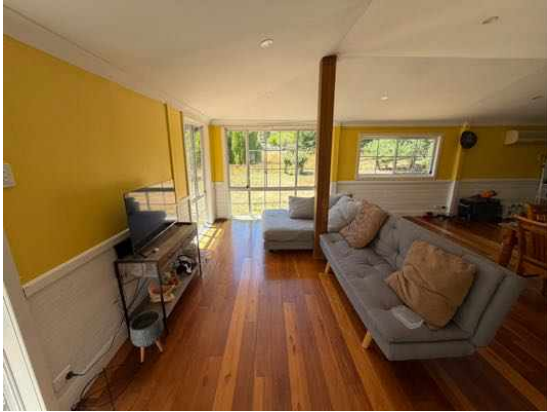
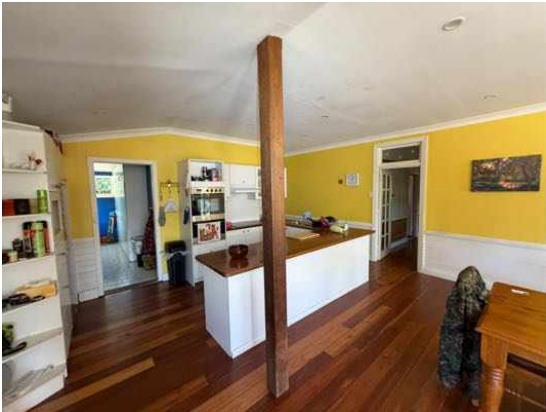
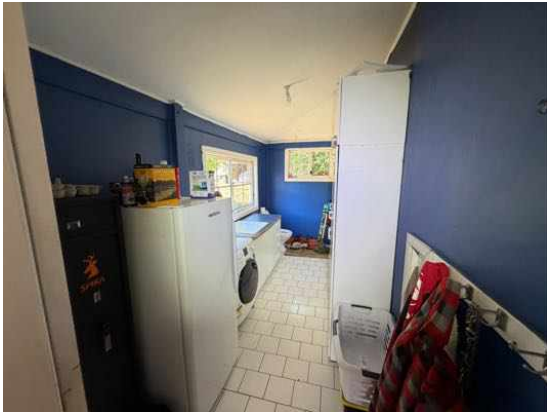
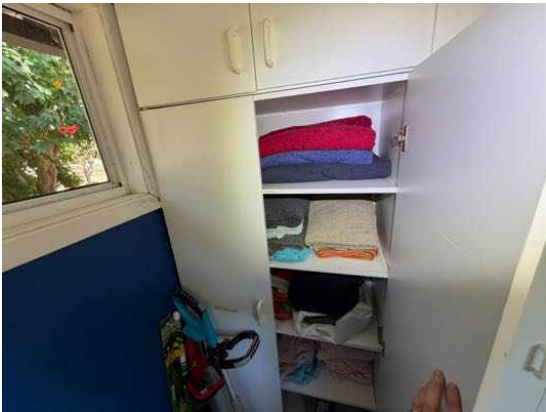
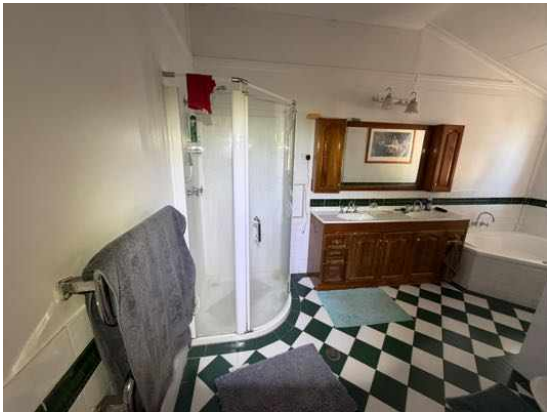
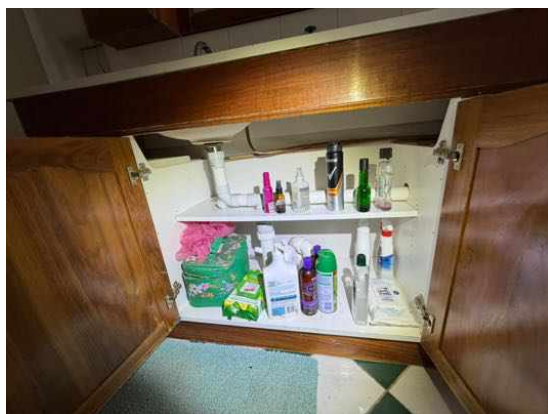
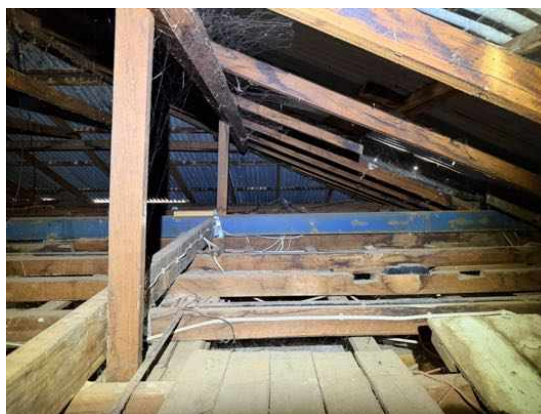
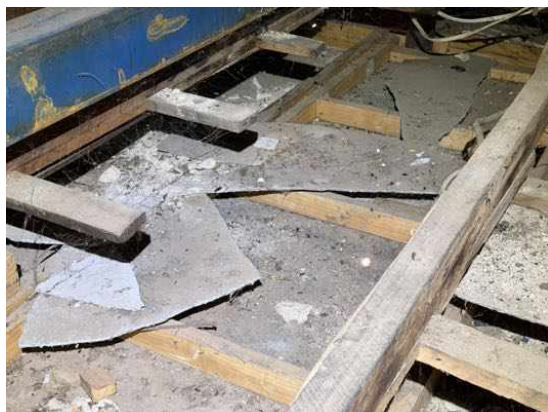
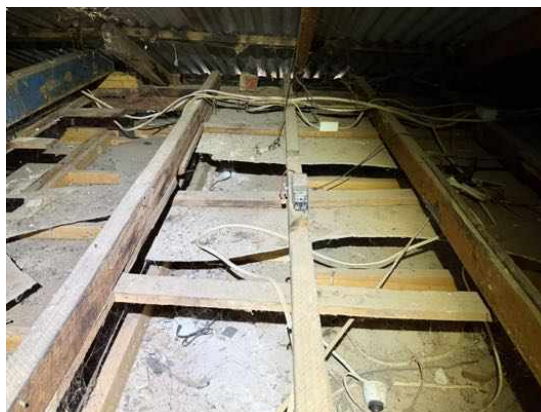
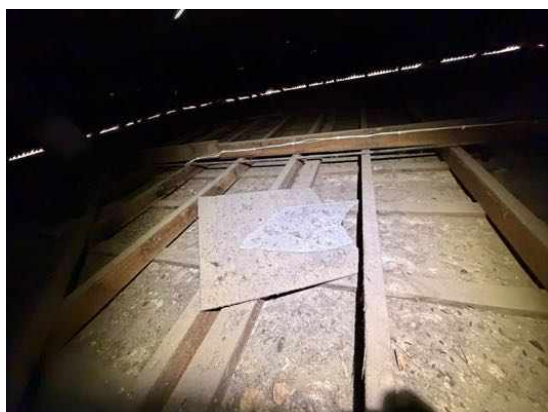
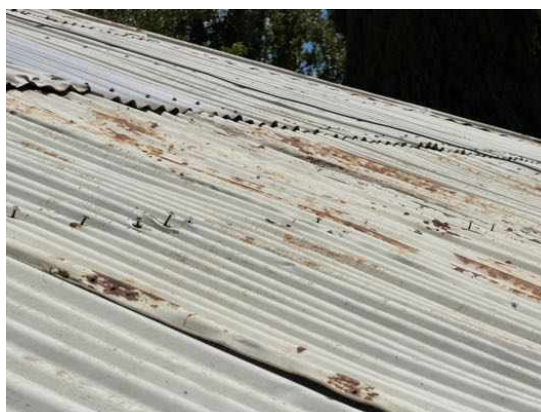
Several limitations and obstructions impeded the inspection and, if feasible, should be removed, and a further inspection should be performed. The subfloor and roof void was unable to be fully inspected due to low clearance, obstructions and damaged asbestos debris. Indicative images below depict some of the obstructions encountered.

Building: Main Building  
Location: All Areas  
Finding: Additional Photos - Obstructions and Limitations  
Information: These photographs are an indication of the obstructions and limitations which impeded full inspection of the property at the time of inspection. These obstructions can hide an array of defects and should be removed to allow full inspection to be carried out. A re-inspection is recommended once the areas are made accessible.

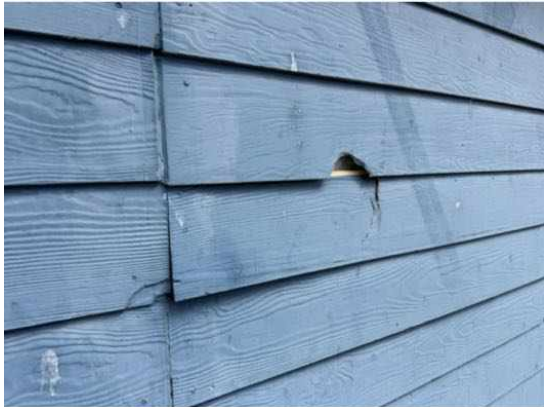
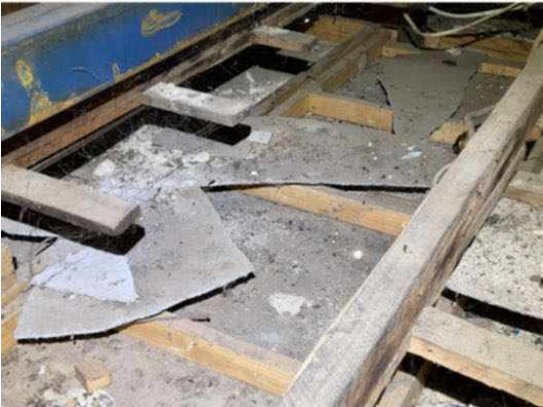
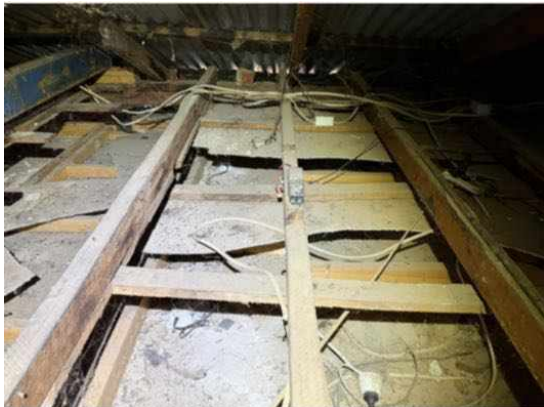
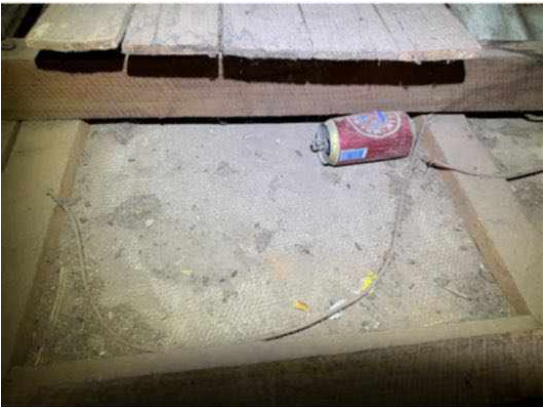
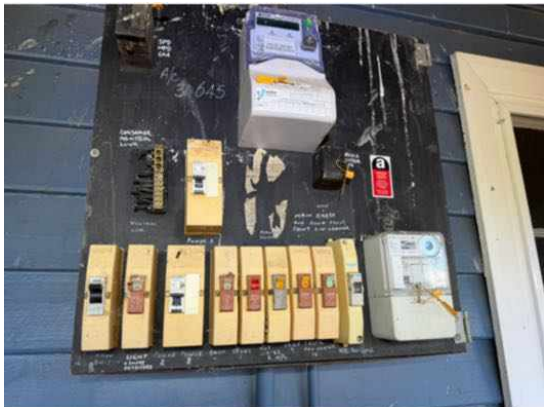
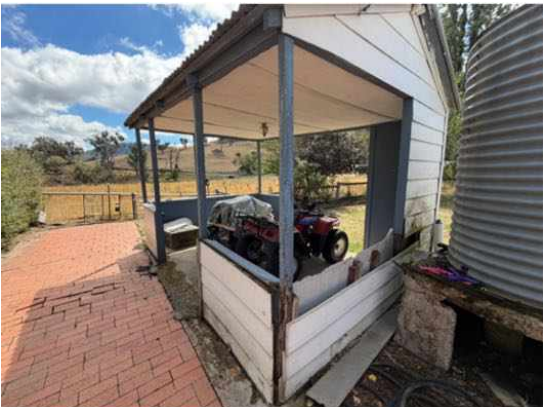
Building: Main Building  
 Location: Weatherboard, Roof Void, Switchboard, Shed Linings  
 Finding: Asbestos - Suspected ACM Identified on Site  
 Information: This suspected defect is highlighted as a caution only as reporting on asbestos is outside the scope of this report. It is suspected that the materials including but not limited to the Weatherboards, Roof Void original ceiling, Switchboard & Shed Linings may be an ACM's (Asbestos containing material)

It is advised that the client consider a separate Asbestos Inspection and Condition Audit, which can include the taking of samples for definitive confirmation of the presence of Asbestos, carried out by a licensed Asbestos Inspector.

In the interim, no works should be conducted to these areas without further specialist advice.

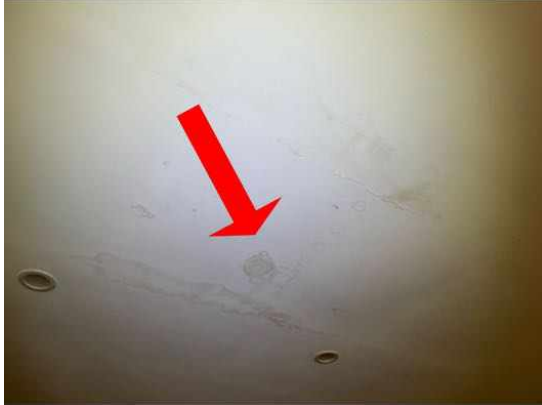
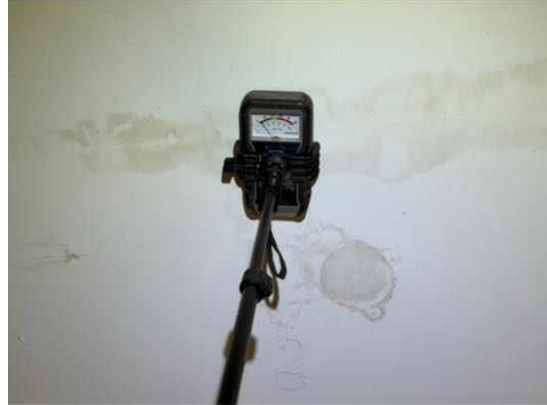
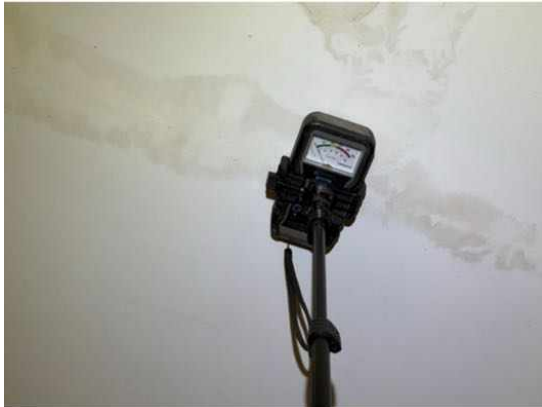
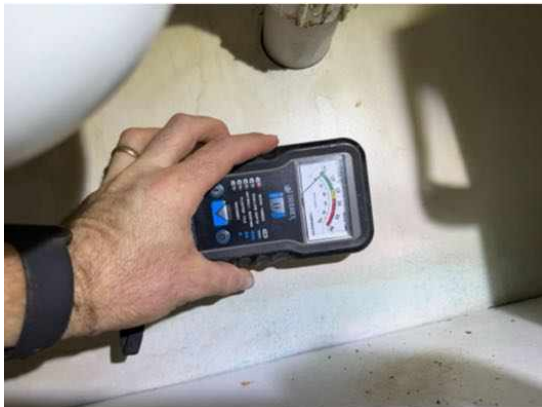
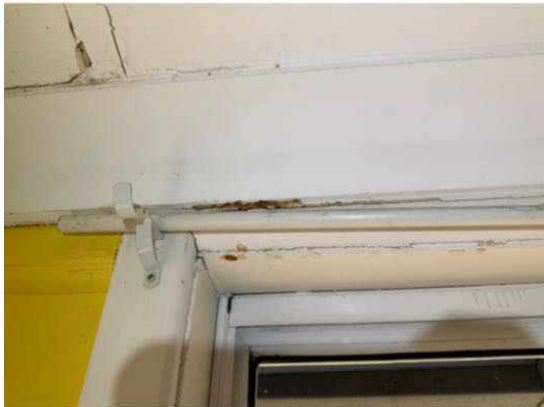
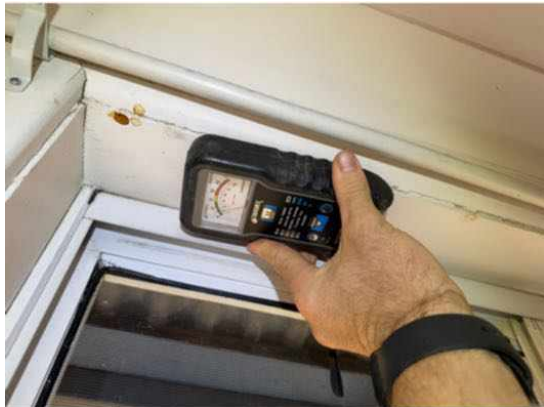
Building: Main Building  
Location: Kitchen ceiling, dining room window, laundry sink, bathroom window.  
Finding: Water Staining Present  
Information: It appears that water staining was present including but not limited to the Kitchen ceiling, dining room window, laundry sink, bathroom window. Potential causes of leaking include deteriorated roof cladding or damaged plumbing fittings and fixtures.

No high moisture was evident in these areas at the time of inspection.

Recommend that the client closely monitor these areas and engage a licensed plumber promptly, should the leak persist or return. A more invasive inspection may reveal secondary building defects.
