Building and Timber Pest Inspection Report

Inspection Date: Mon, 9 Feb 2026

Property Address: 26 Olivedale St, Birdwood SA 5234,
Australia

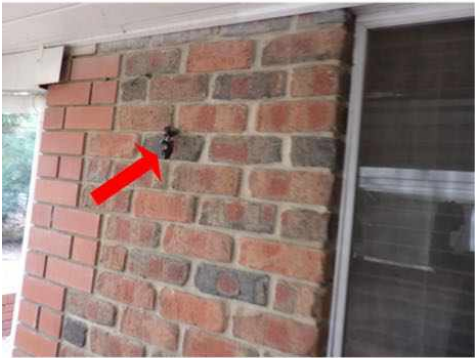
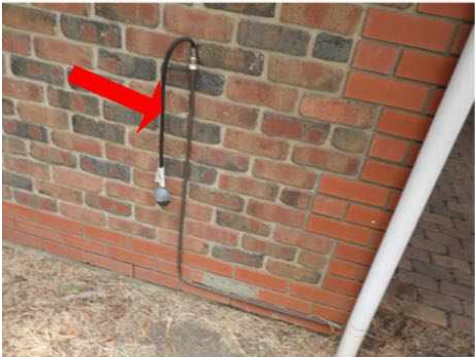
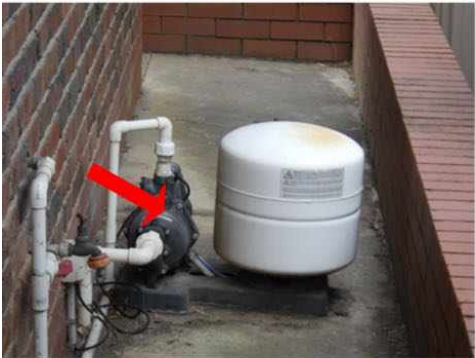
Building:	Building 1
Location:	All Areas
Finding:	Plumbing and electrical, aged / degraded
Information:	Commenting on plumbing and electrical issues is done to draw attention to potential issues throughout the dwelling. As we are not licensed plumbers or electricians follow-up advice is recommended.

Several issues were noted, including the pump Setup not switching off, damage to the solar hot water service on the roof, questionable gas bottle connection at the time of inspection.

Several issues were noted to the electrical including exposed blue points, a damaged power outlet at the time of inspection

These are common defects that is consistent with general ageing of the building element. However, it may be indicative of substandard plumbing or electrical workmanship in some cases.

While this defect only seems minor, if left unmanaged, it is likely to result in the development of rust, water damage, extensive water usage and safety hazards being created. .

It is advised that a licensed electricians and plumbers be appointed to perform remedial works on the affected areas.

Such works should be performed prior to the development of secondary defects to ensure adequate functionality of all associated building elements.

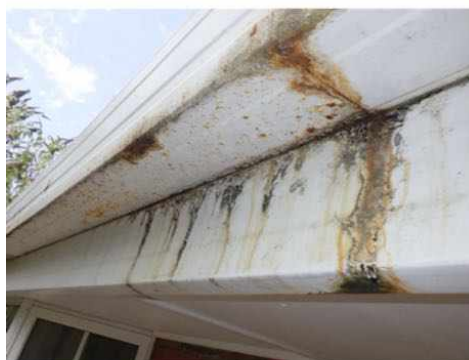
Finding 2.02

Blocked gutters are likely to lead to high levels of moisture in the affected areas. Such moisture will not only cause rust and decay of the associated building materials, but can also provide conditions that are conducive to termite and timber pest activity. Blockages in gutters should therefore be removed immediately to ensure dry conditions are maintained.

Removal of debris may expose currently concealed defects.

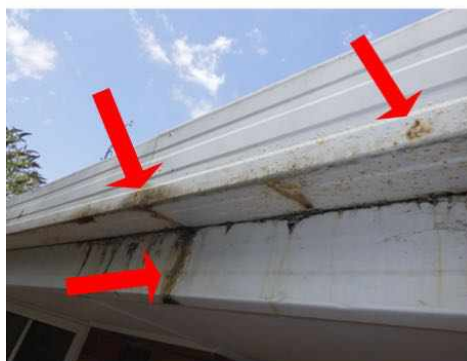
Finding 2.03

Building:	Building 1
Location:	Roof Exterior
Finding:	Roof plumbing - Rusted or corroded
Information:	The roof plumbing has areas of rust and corrosion. It is suspected that this has been caused by blockages, resulting in pooling or standing water, that have prematurely rusted elements of the roof plumbing.

Rusted roof plumbing will generally develop holes and leaks that can affect other building elements with poor drainage of storm water.

Poorly drained roof areas will also lead to damp conditions surrounding the base perimeter of the building which, if left unmanaged, can lead to a range of secondary building defects.

Repair and/or replacement of rusted roof plumbing is highly required in order to reinstate the roof drainage system to a fully operational level.

A licensed plumber or specialist roof restoration company should be appointed to undertake these works. It is advised that such works be completed as soon as

possible to prevent any further damage and deterioration.

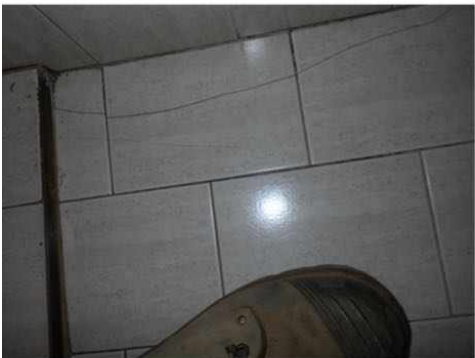
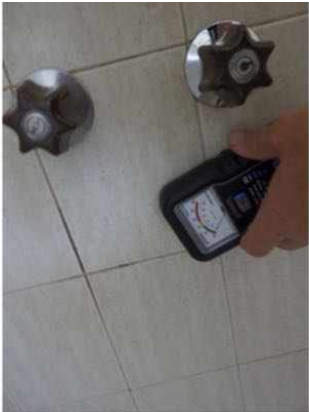
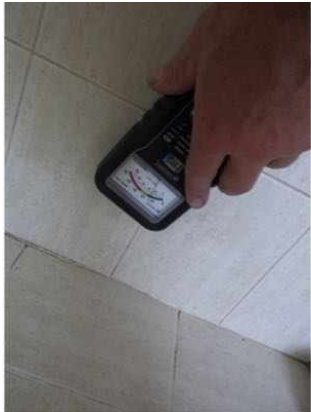
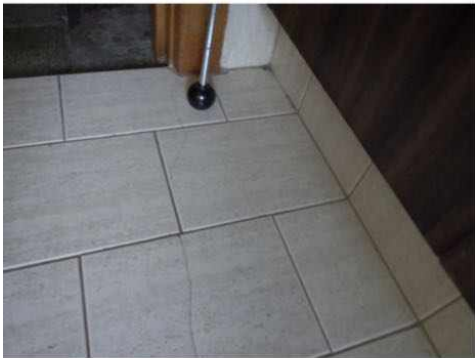
Finding 2.04

Building:	Building 1
Location:	Both bathrooms
Finding:	Deteriorated Tiling, sealant and grout
Information:	It was noted on inspection that tiling, sealant or grout to both bathrooms is showing signs of deterioration with cracked tiles and deteriorated grout throughout.

Flexible and mould resistant materials should be applied to any damaged areas to prevent any subsequent water damage that is likely to occur. Regular maintenance and replacement of damage or missing or damaged sealant and grout is highly recommended to the wet areas, as this is a regular wear and tear defect.

Deteriorated sealant and grouting in areas that come into regular contact with water should be maintained for the long term care of your property. A sealant specialist or tiling contractor should be appointed to complete these works as soon as possible. Full bathroom renovation will likely be required.

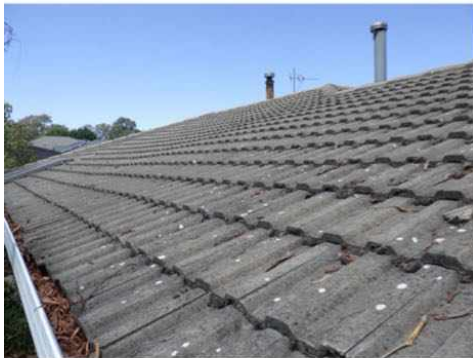
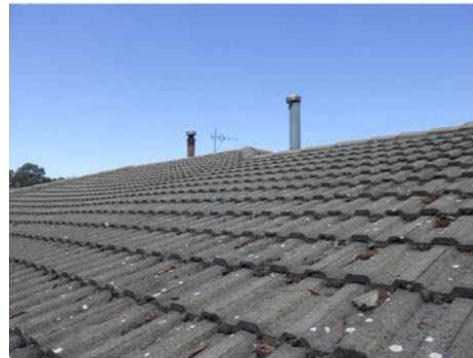
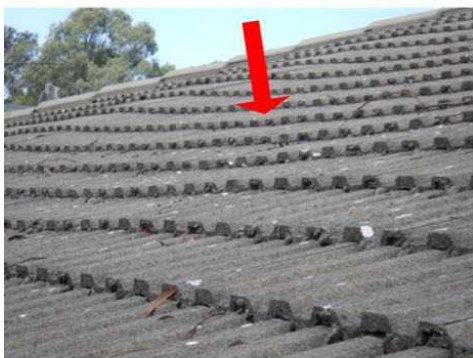
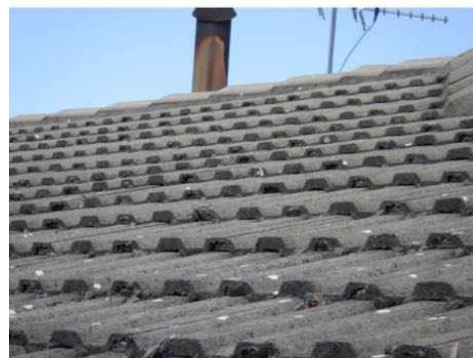
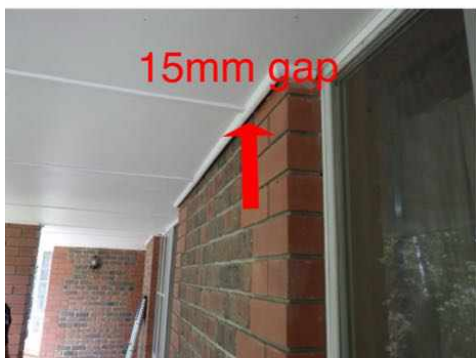
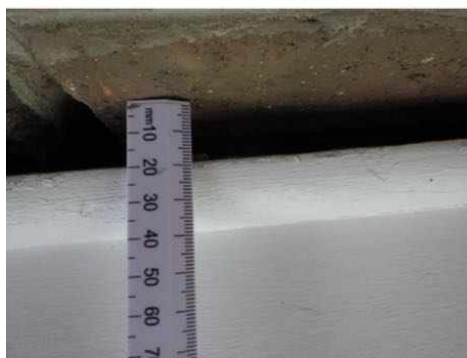
Information: The roofing structure was found to be sagging at the time of inspection. This is evidenced by gaps in the eaves linings/ quads of approximately 10mm at several areas of the roof at the time of inspection. The sag is quite visible on the front roof line.

This defect is a common defect with tiled pitched roofs and should be addressed to prevent damage to associated building materials.

This level of movement requires structural repairs and should be carried out by a licensed builder in association with advice from a structural engineer in the short term.

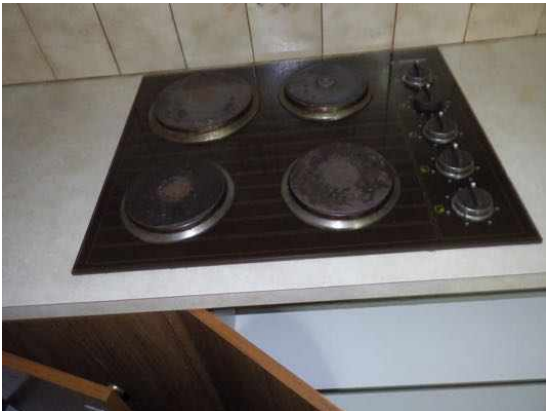
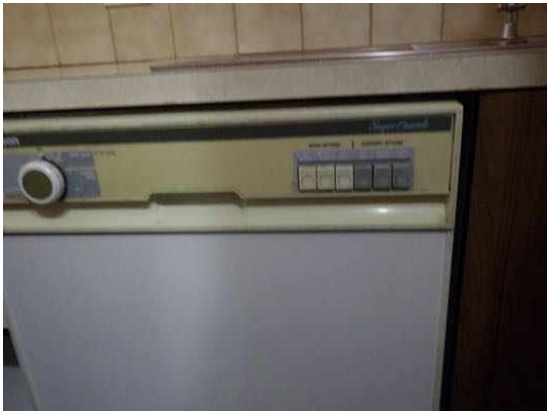
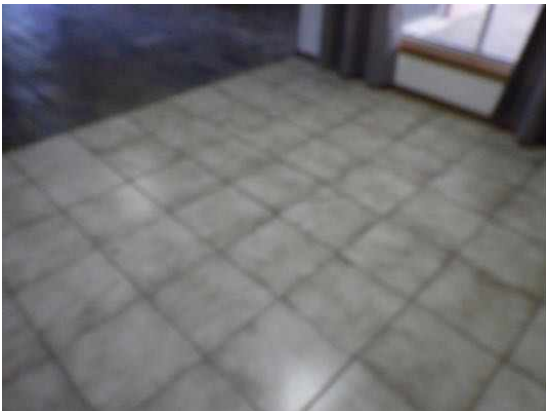
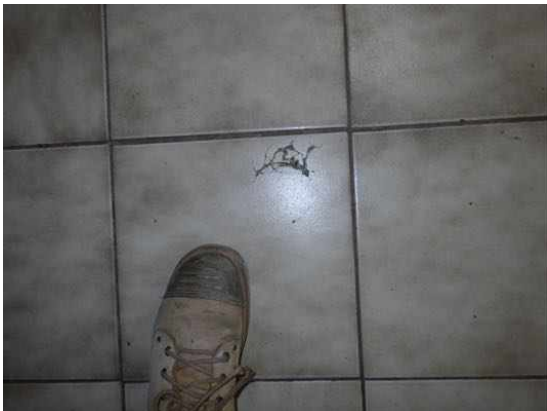
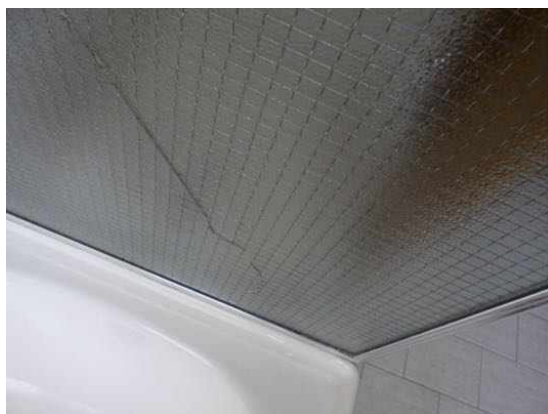
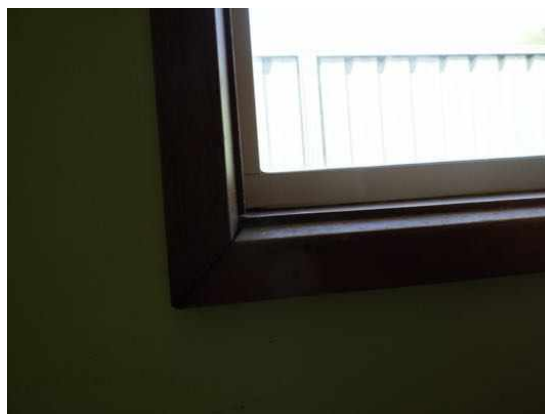
Finding 3.03

Building:	Building 1
Location:	All Areas
Finding:	Minor defects present
Information:	There were several age and maintenance related defects evident to the dwelling at the time of inspection. These defects include but are not limited to

- damage seal tiles to base of sliding doors
- Damage to plastic skylight on roof
- Appliances and Rangehood old and deteriorated
- Cracked or damaged tiles to living area
- Damaged shower screen
- Loose timber sill to bedroom three
- Air-conditioner requires service

Appropriate licensed trades people could be appointed to make repairs at the discretion of the client.

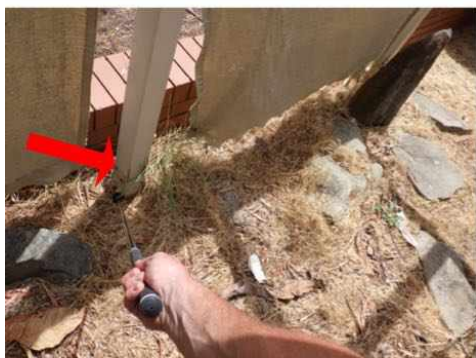
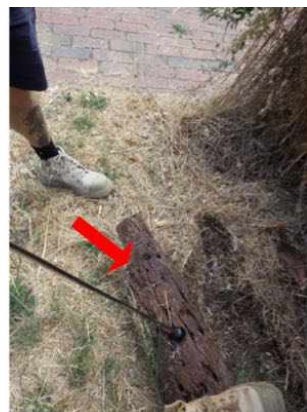
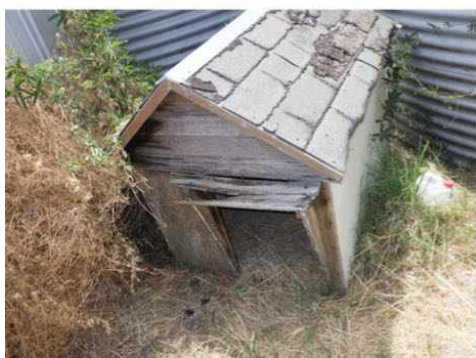
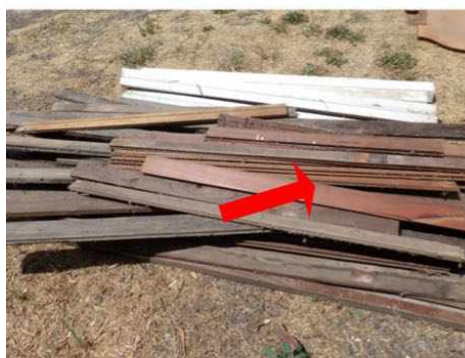
Untreated timbers in direct contact with the ground are likely to develop severe wood rot and/or fungal decay if left unattended creating attraction for subterranean termites to infest the timbers from surrounding areas.

If untreated or non-durable timbers are found to be in a hazardous environment it is highly advised that replacement of these building elements be performed as soon as possible to aid the protection of the property against termite / timber pest attack. Failing this close monitoring is recommended in an attempt to identify termite infestation at an early stage.

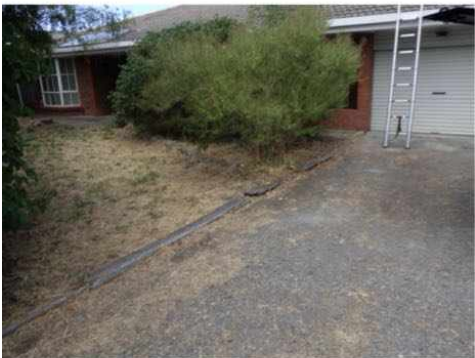
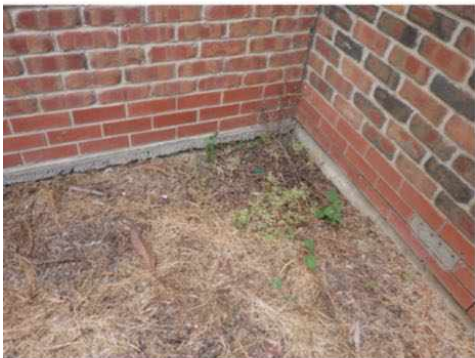
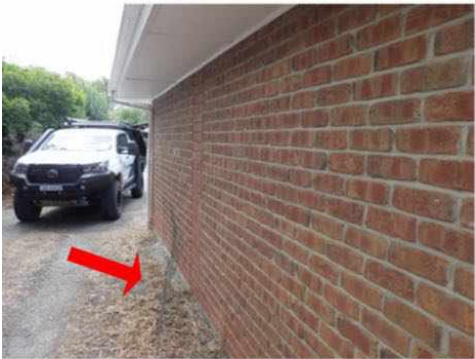
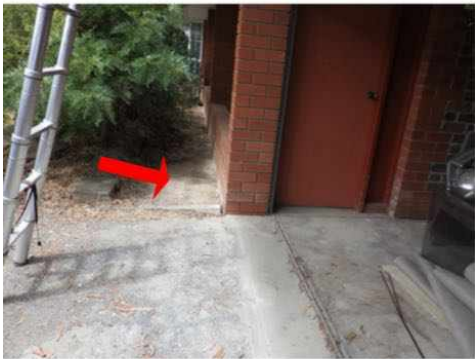
Perimeter paving is required to fall from the building by a minimum of 25mm in the first metre and bare ground should fall away from the house by 50mm in the first meter. This standard ensures that excessive moisture does not pool around the base of building structures, which creates potential for water and structural damage, as well as making the area susceptible to termite and timber pest activity.

Where paving or ground levels do not have adequate fall, a licensed paving contractor should be appointed to install perimeter pavement to ensure a dry environment beneath the house. It is recommended that these works are carried out in the short-term.

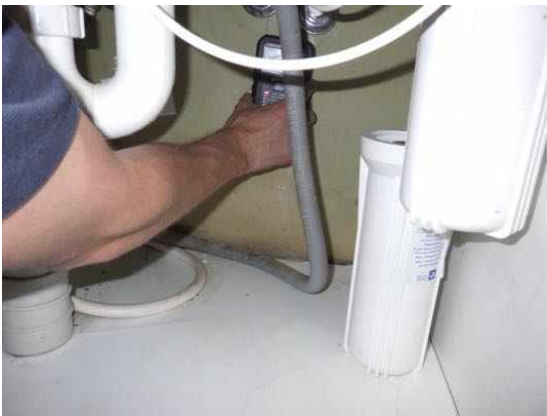
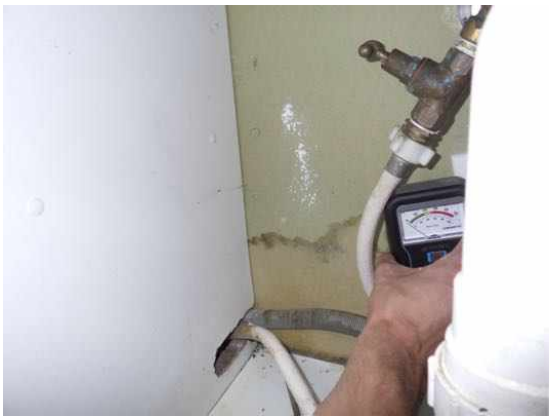
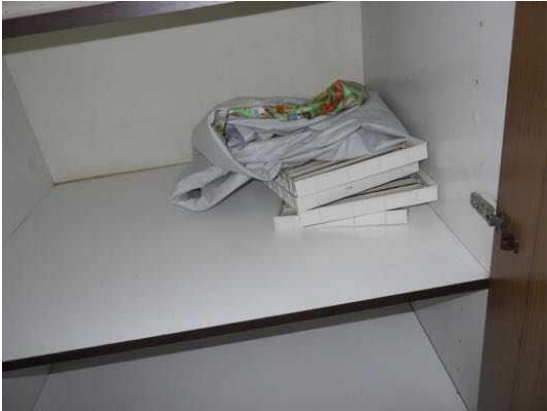
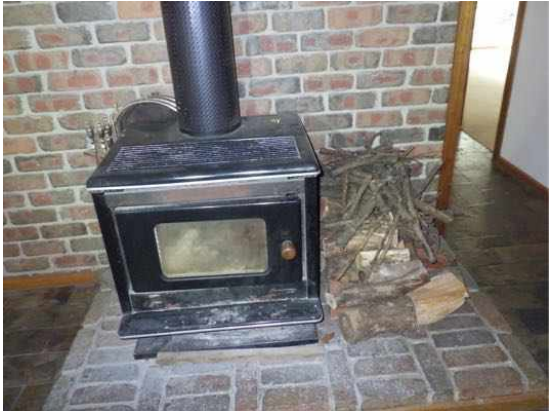
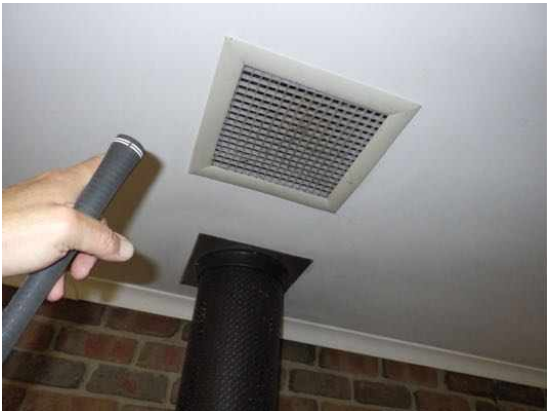
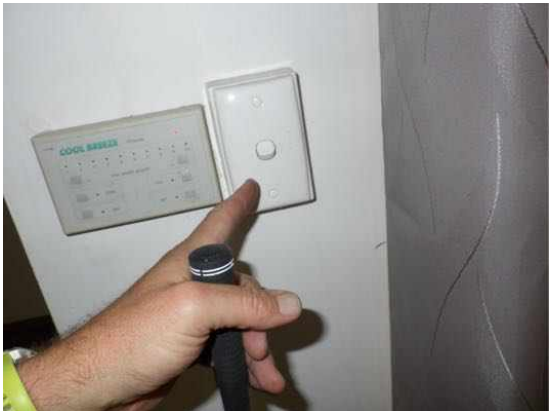
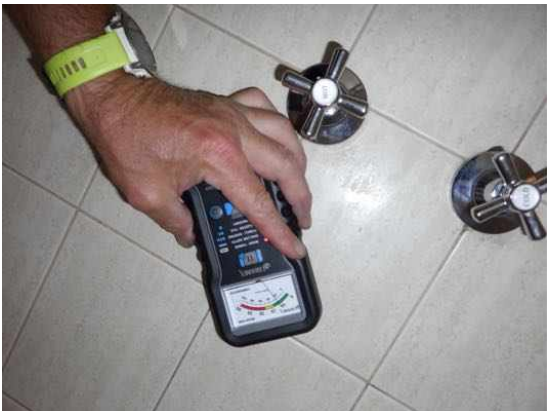
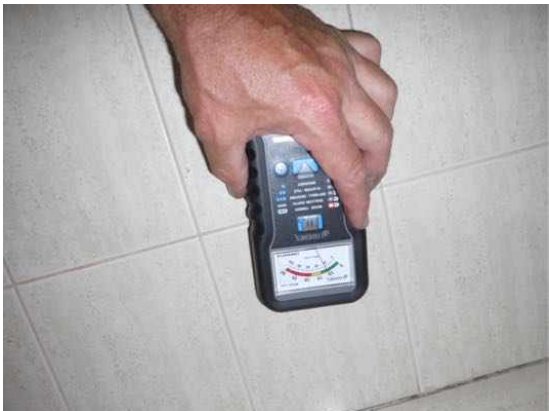
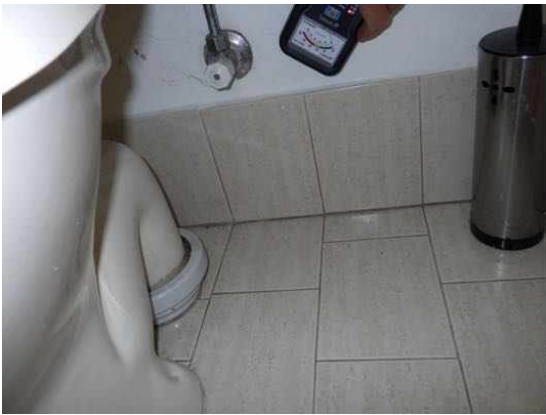
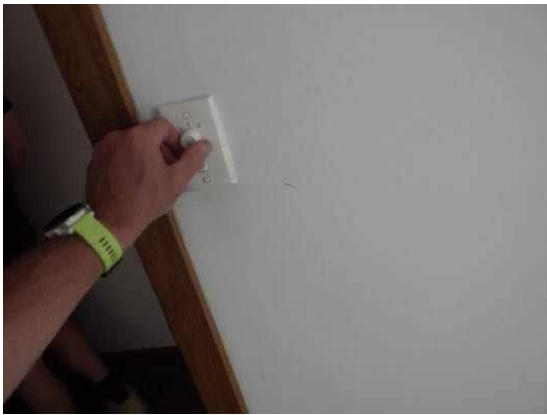
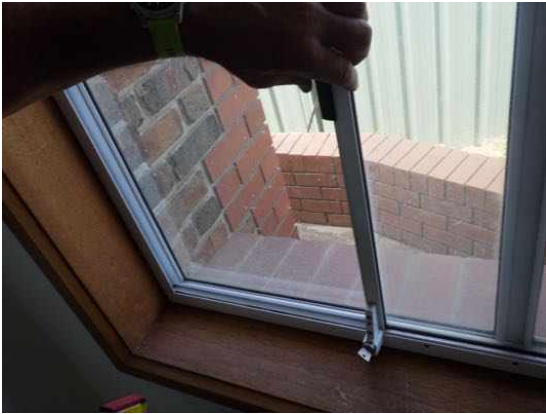
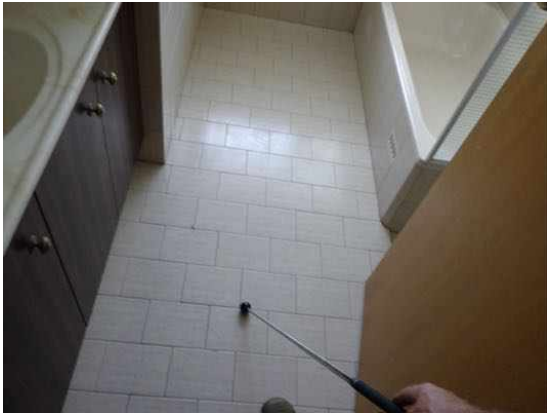
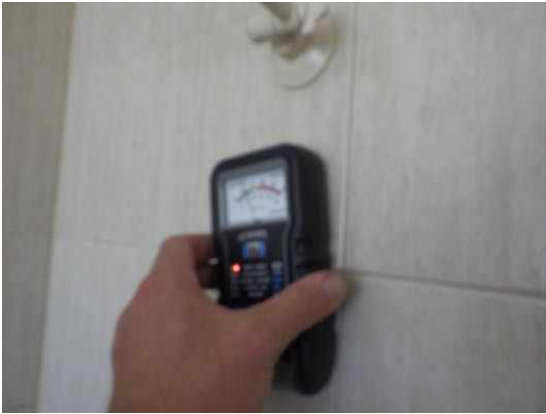
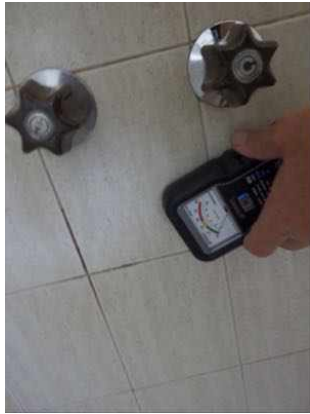
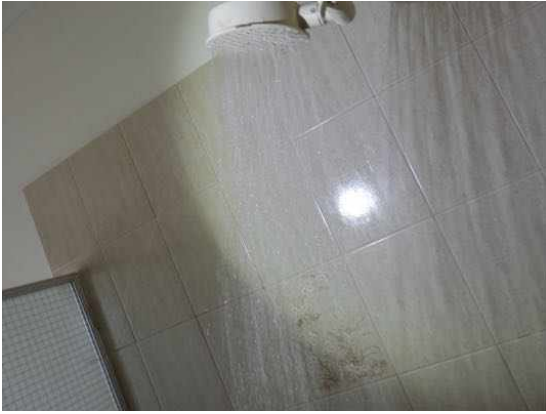
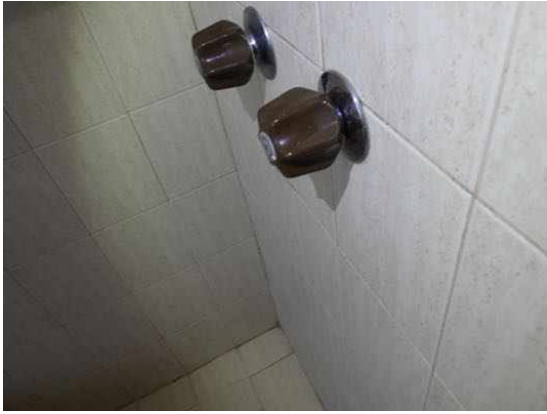
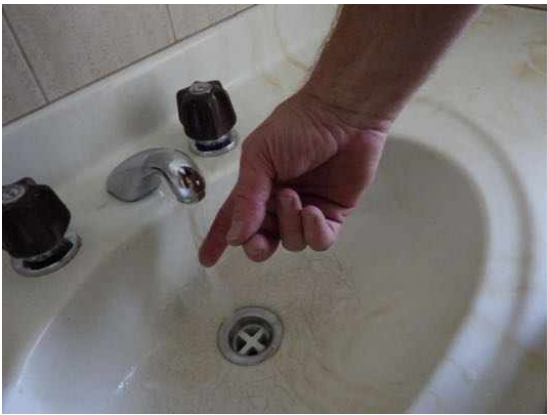
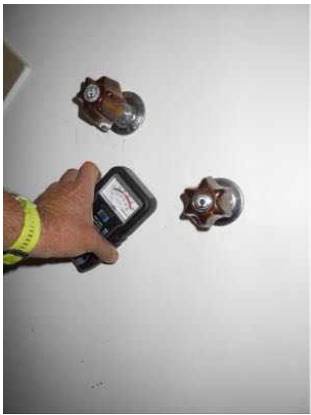
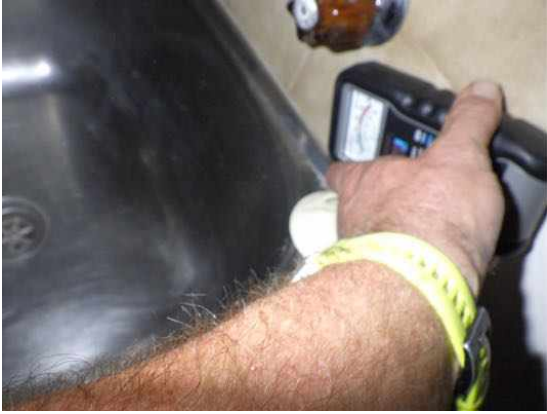
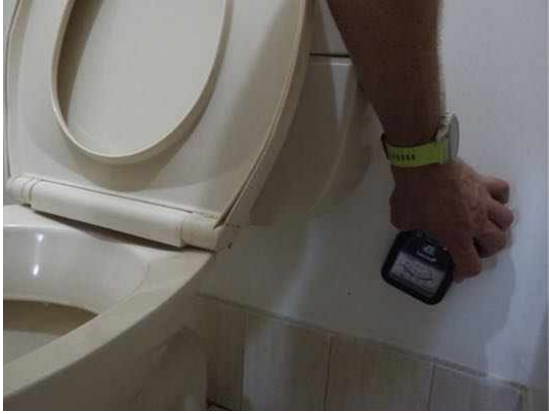
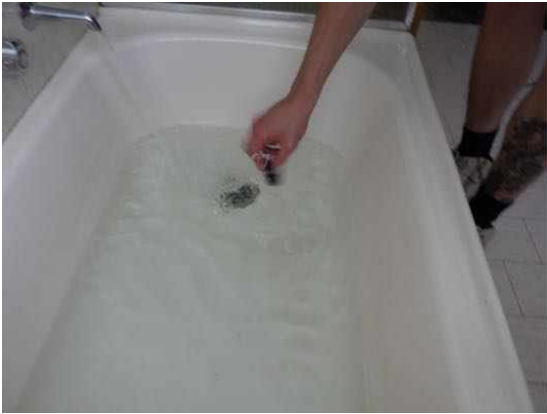
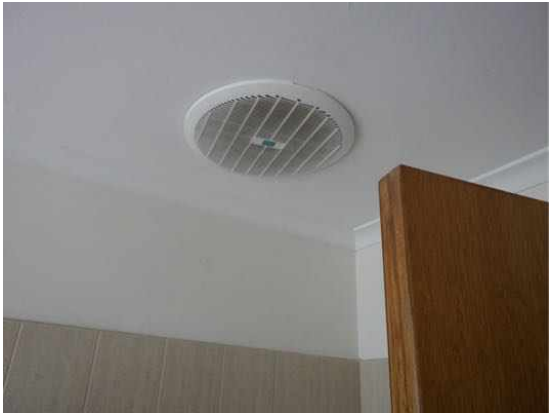
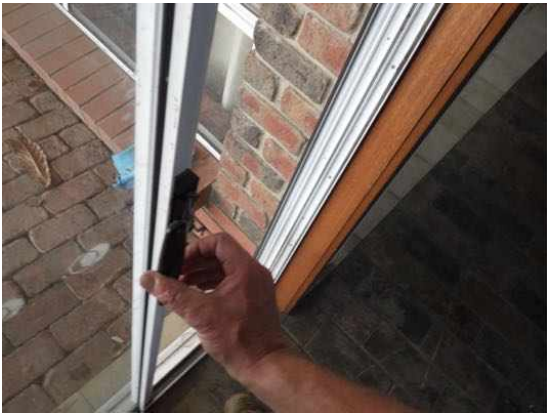
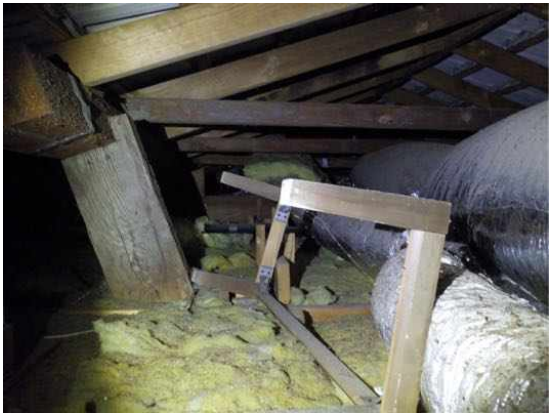
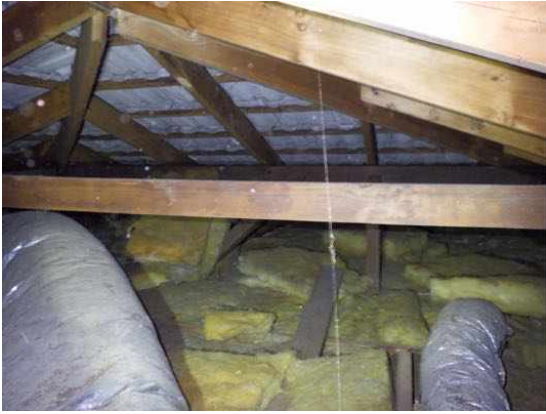
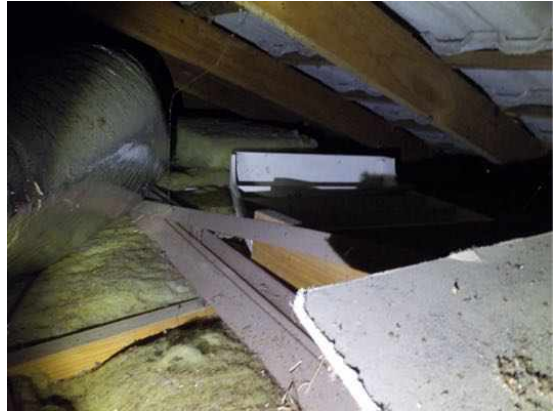
Building: Building 1
Location: All Areas
Finding: Additional Photos
Information: Additional photos are provided for your general reference.

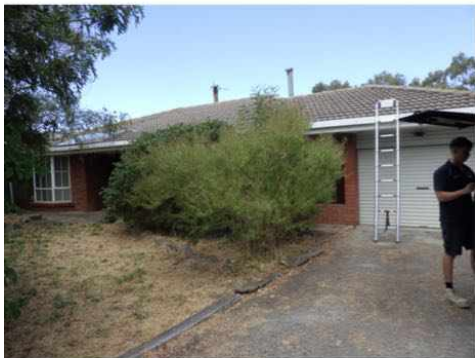
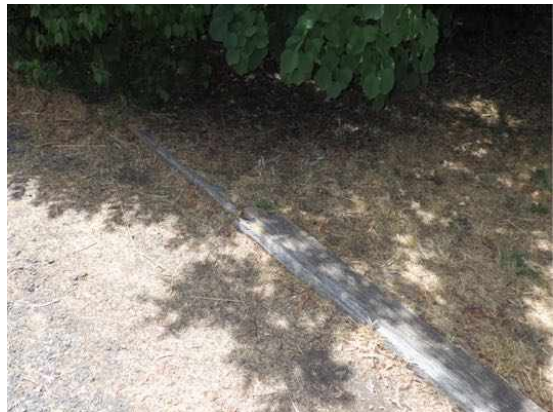
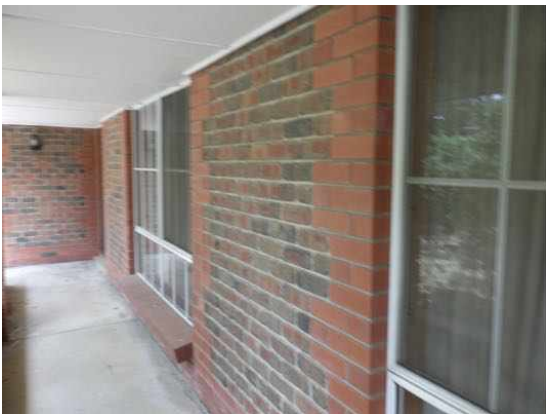
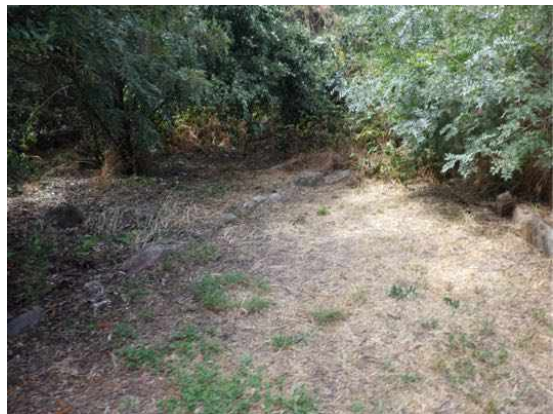
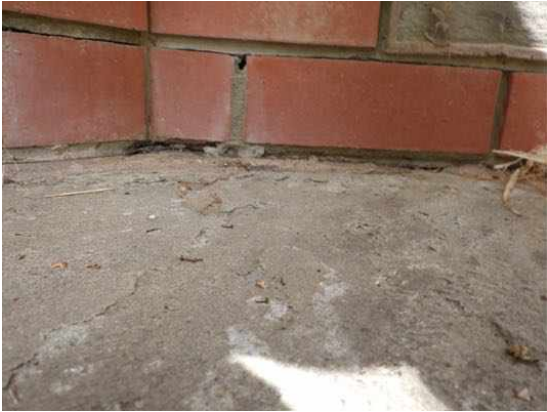
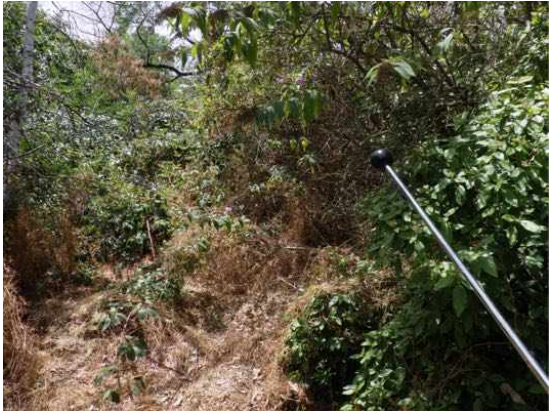
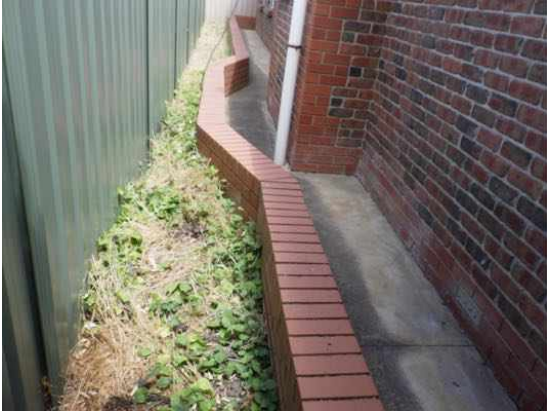
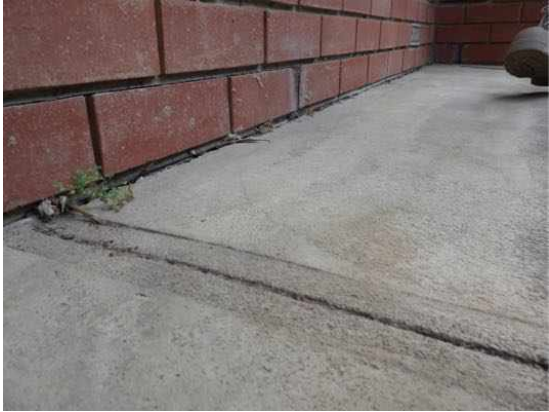
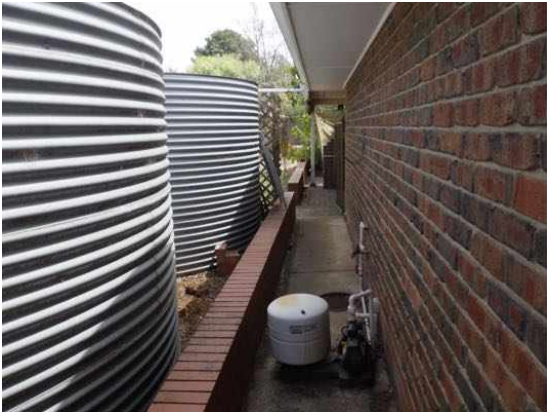
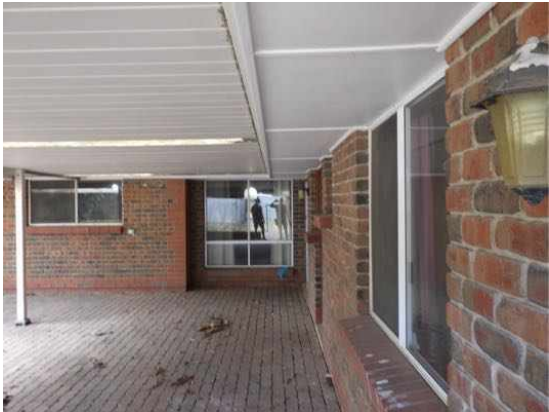
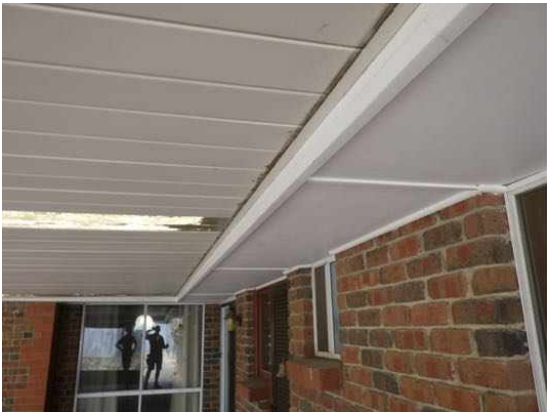
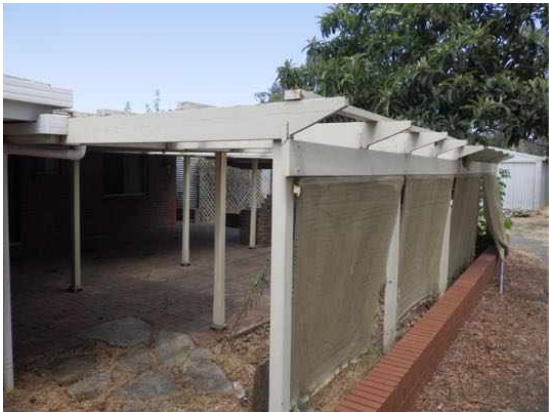
Building: Building 1
Location: All Areas
Finding: Additional Photos - Obstructions and Limitations
Information:

These photographs are an indication of the obstructions and limitations which impeded full inspection of the property at the time of inspection. These obstructions can hide an array of defects and should be removed to allow full inspection to be carried out.
