Building and Timber Pest Inspection Report

Inspection Date: Mon, 9 Feb 2026

Property Address: 26 Olivedale St, Birdwood SA 5234,
Australia

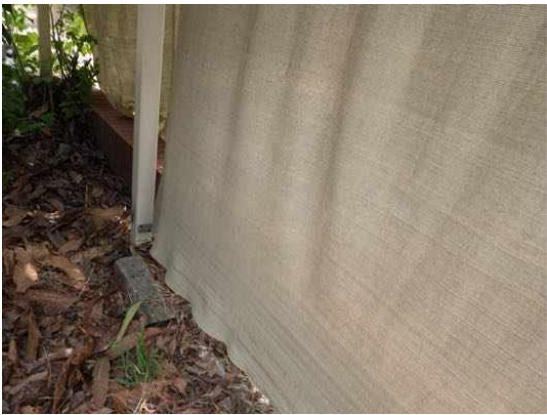
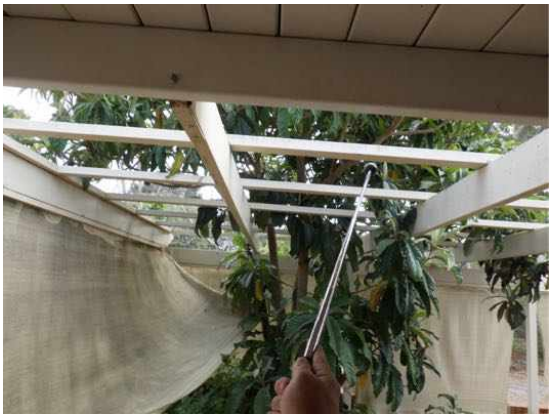
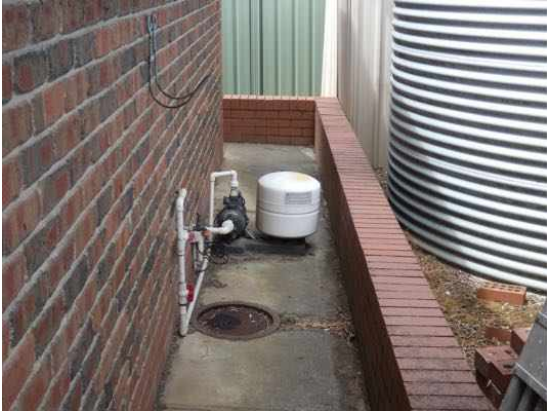
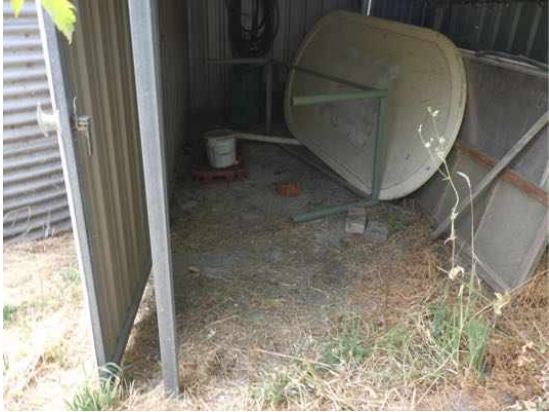
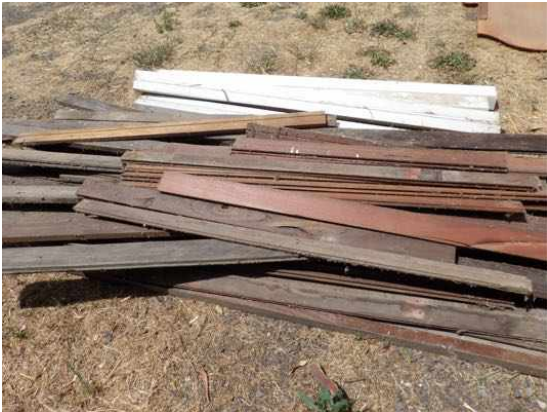
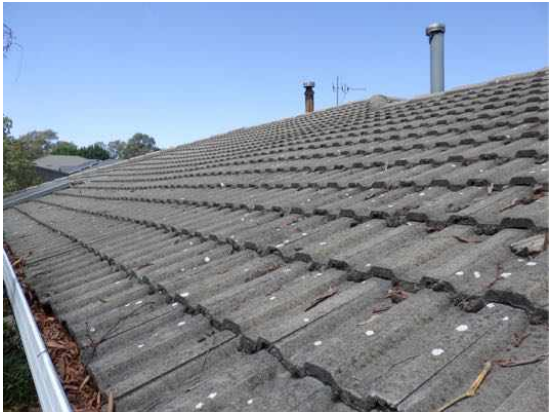
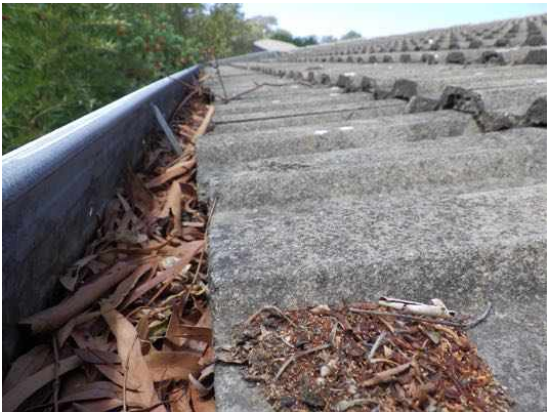
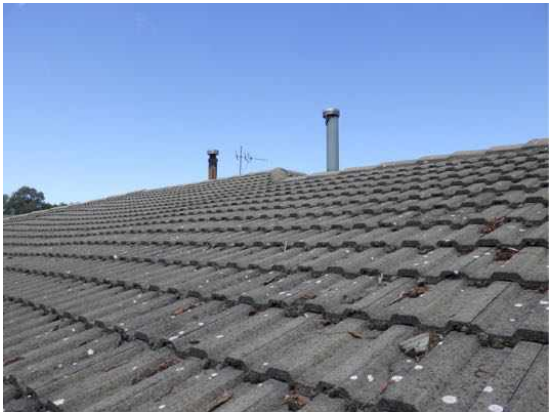
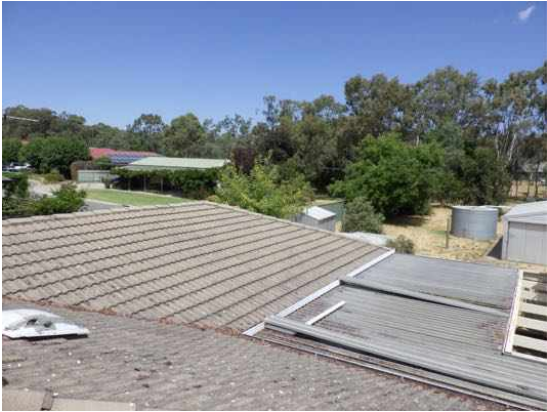
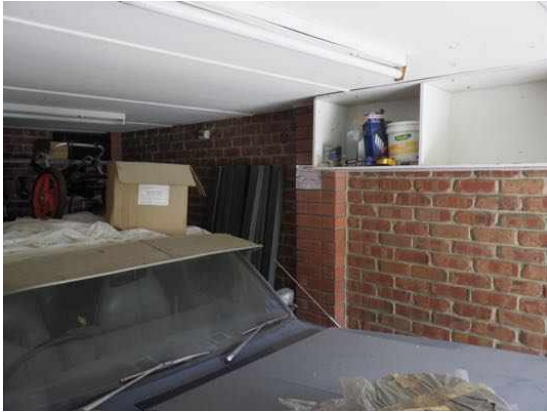
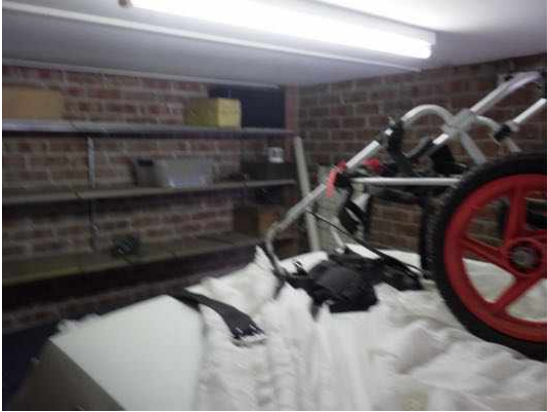
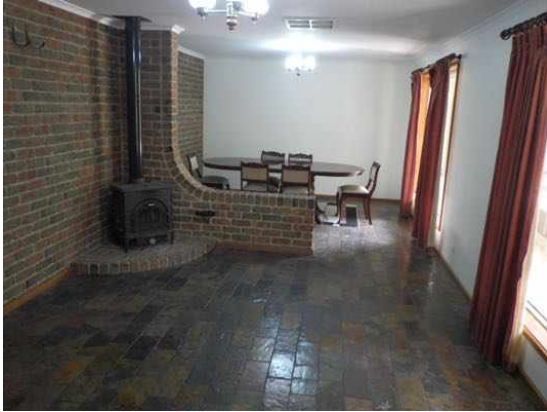
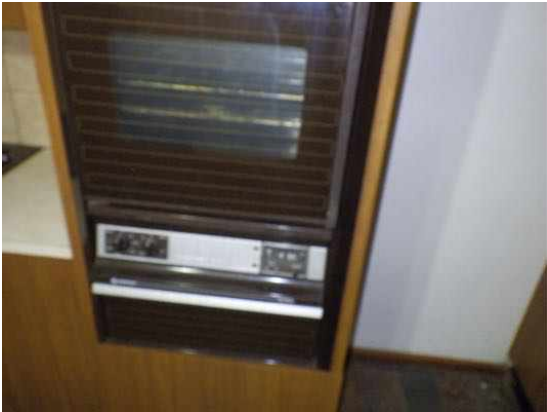
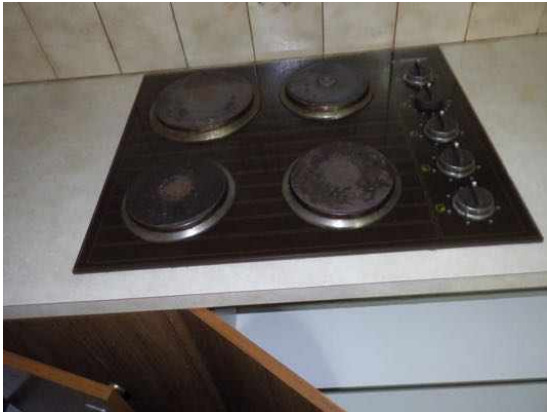
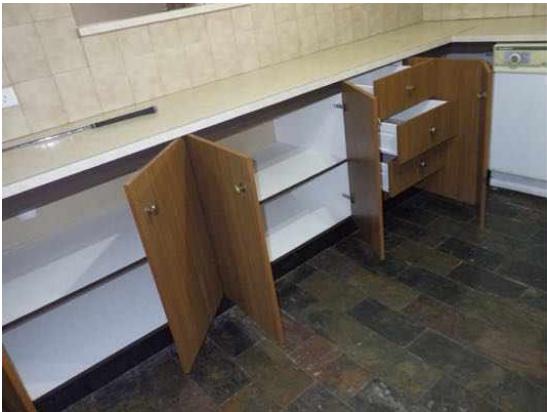
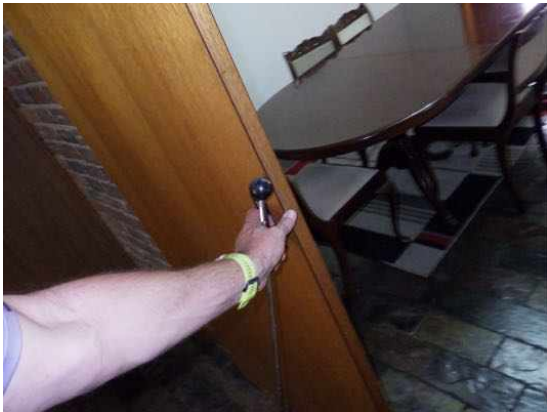
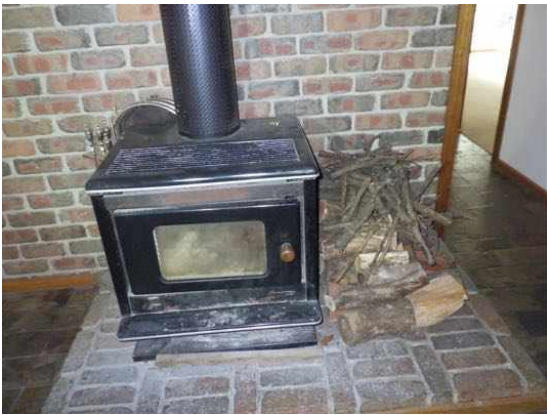
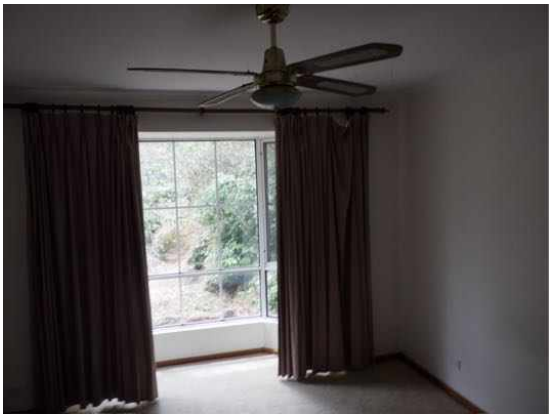
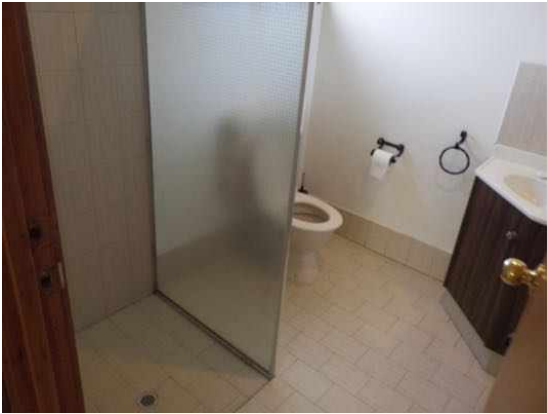
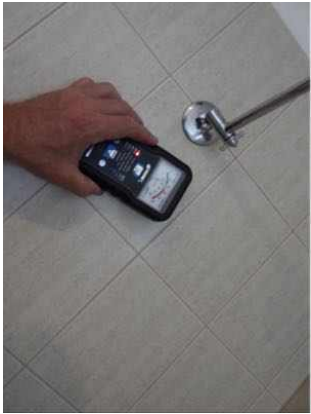
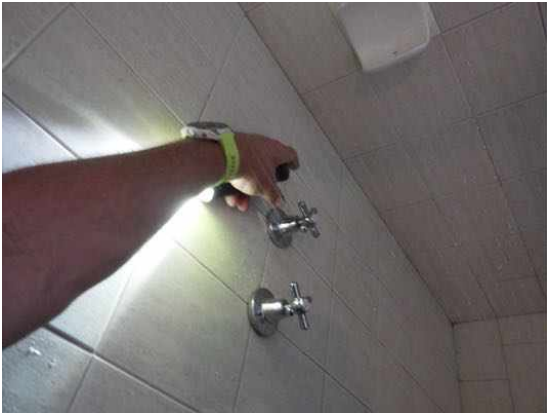
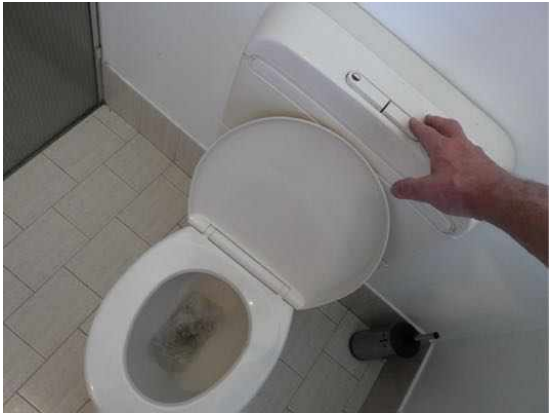
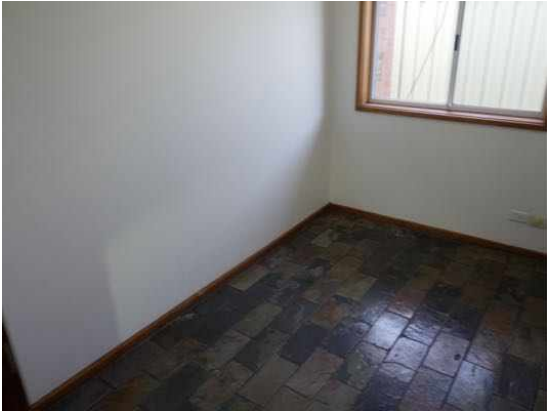
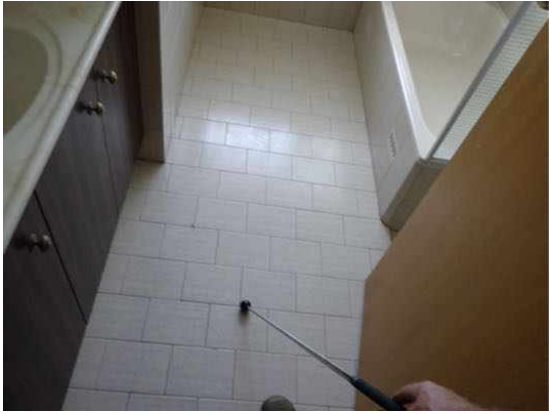
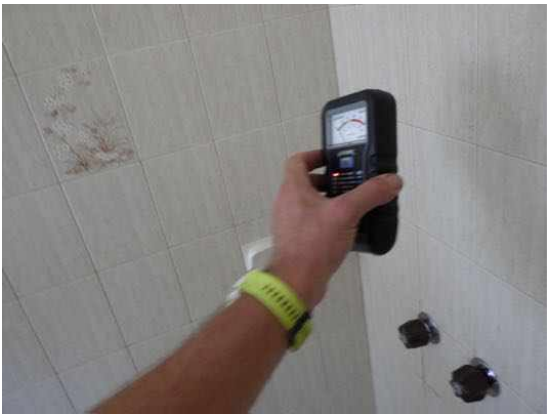
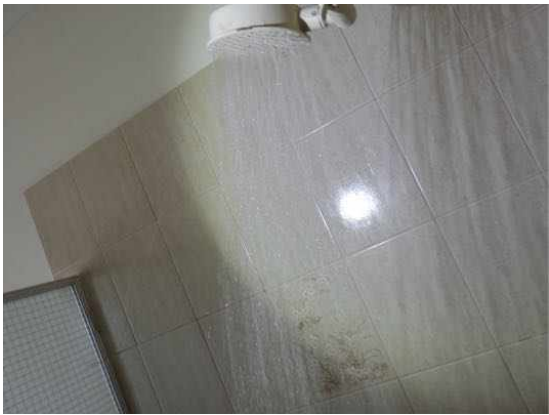
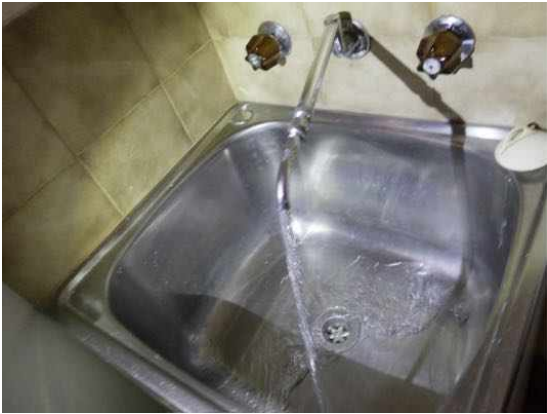
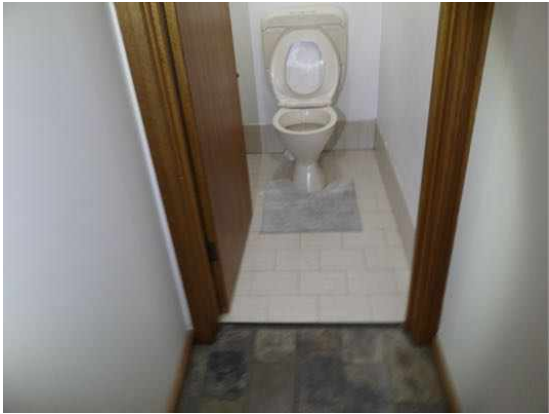
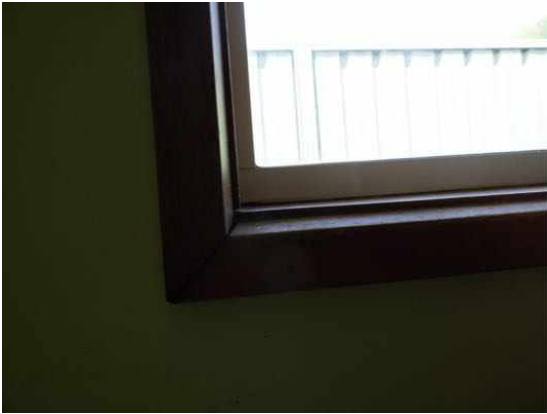
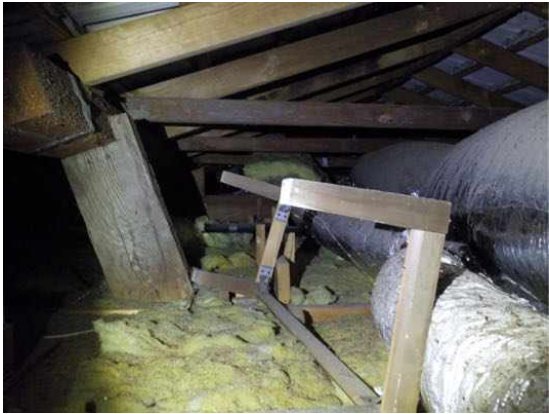
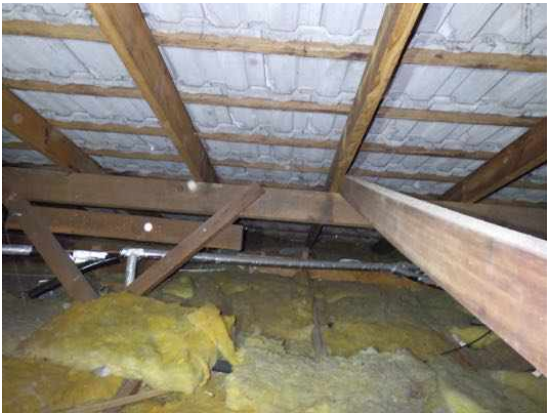
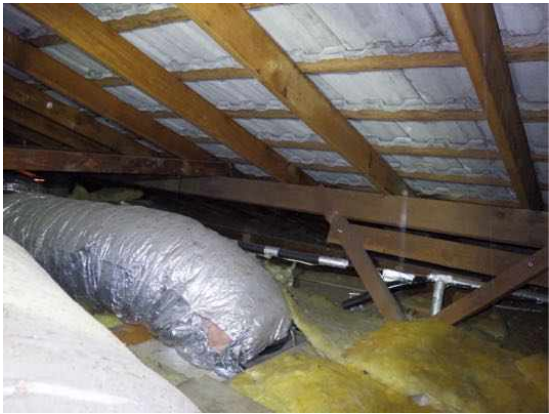
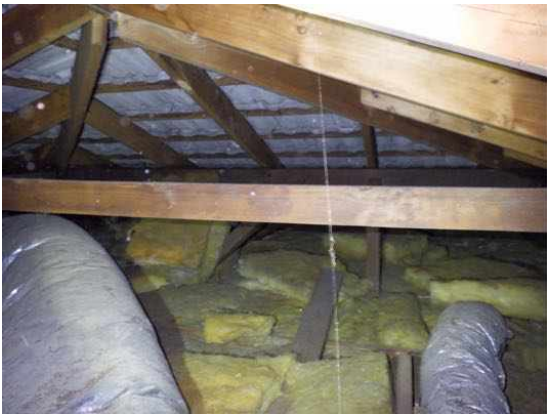
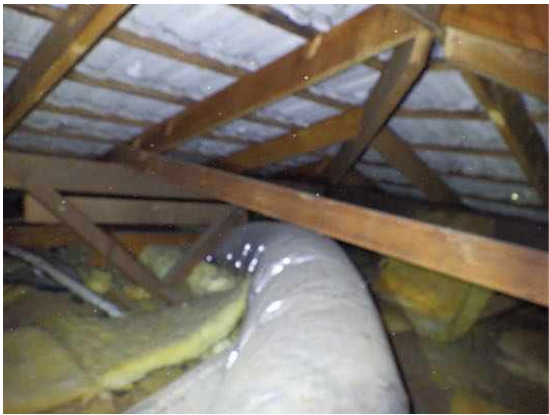
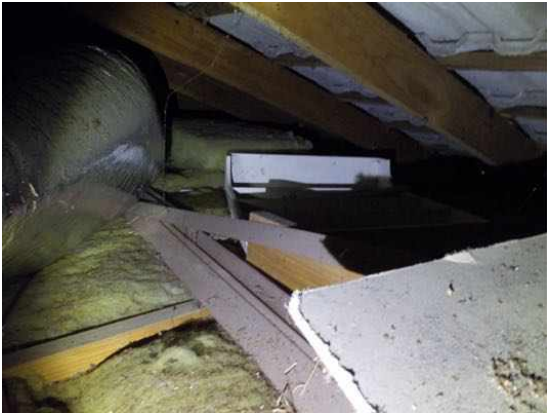
These photographs are an indication of the obstructions and limitations which impeded full inspection of the property at the time of inspection. These obstructions can hide an array of defects and should be removed to allow full inspection to be carried out.
