# Building and Timber Pest Inspection Report

Inspection Date: Wed, 28 Jan 2026

Property Address: 26 Banksia St, Grafton NSW 2460, Australia

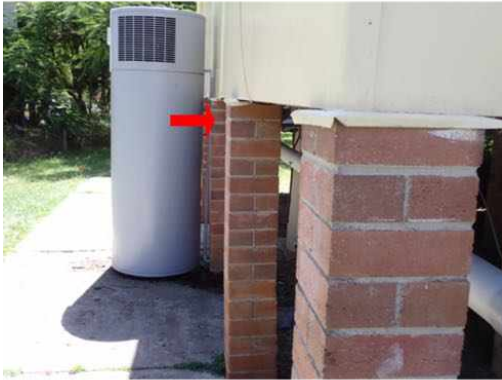
Building: Main Building  
Location: Subfloor  
Finding: Brick Piers – Out of Level  
Information: Several brick piers were observed to be leaning and out of level. This condition is a common defect, often associated with ground movement, footing settlement, or age-related deterioration. While the extent noted at the time of inspection may not be critical, further movement may occur if left unaddressed. Ongoing monitoring and further assessment as required is recommended. Rectification works should be

carried out by a licensed builder or structural engineer.

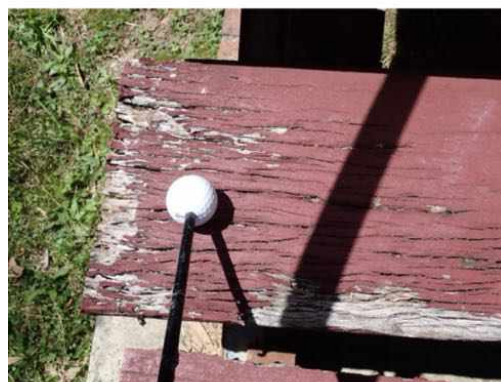
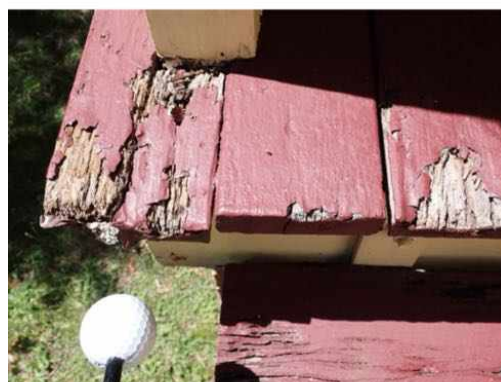
### Finding 2.03

Building:	Main Building
Location:	Entry stairs and porch
Finding:	Entry Stairs and Porch – Wood Rot
Information:	Wood rot was identified to the entry stairs and porch decking and associated framing. This condition is typically caused by prolonged moisture exposure and, if left unaddressed, may worsen and affect the durability and safety of these elements. Repair or replacement of affected timbers is recommended to prevent further deterioration. Works should be carried out by a suitably qualified carpenter or licensed builder.

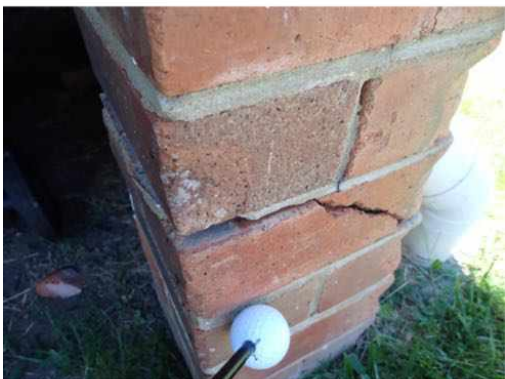
Building: Main Building  
Location: Base brick work wall  
Finding: Base Brickwork – Large Cracking  
Information: Several large cracks were identified in the base brickwork. This condition may be associated with ground movement, footing settlement, or age-related deterioration. Ongoing monitoring and further assessment are recommended, and rectification works should be carried out as required by a licensed builder or bricklayer in consultation with a structural engineer.

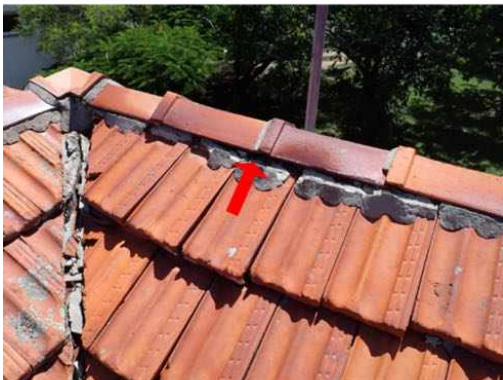
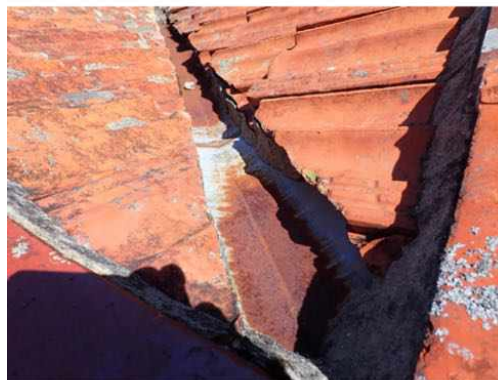
Finding 2.06

Building: Main Building  
Location: Roof  
Finding: Roof Tiles – Poor Condition  
Information: Roof Tiles – Poor Condition

The roof tiles were observed to be in poor condition, with several cracked tiles, missing or deteriorated bedding, misaligned tiles, and lichen growth identified. Surface rust was also noted to the metal roof valleys. These defects may compromise the roof's weatherproof performance and increase the risk of water ingress if left unaddressed. Repair or replacement of affected tiles, bedding, and corroded metal components, along with cleaning of lichen growth, is recommended. Works should be carried out by a licensed roofing contractor or suitably qualified roof tiler.

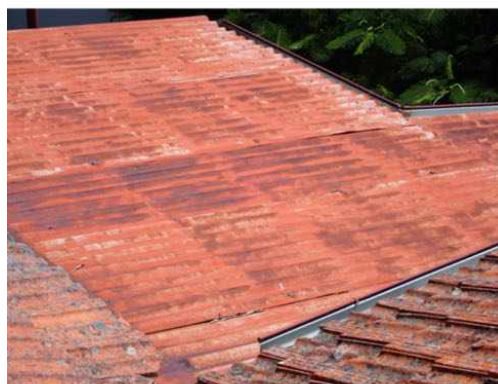
### Finding 2.07

Building:	Main Building
Location:	Roof
Finding:	Entry Tin Roof – Rusting
Information:	Rust was identified to the entry tin roof. This condition is typically associated with age and weather exposure and may worsen over time, potentially leading to corrosion-related perforation and water ingress if left unaddressed. Maintenance, including rust treatment, protective coating, or replacement of affected sheets as required, is recommended. Works should be carried out by a licensed roofing contractor or suitably qualified roof plumber.

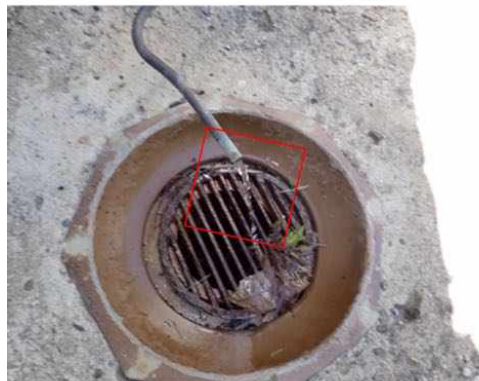
### Finding 2.08

Building:	Main Building
Location:	Right hand side of building
Finding:	Hot Water Unit – Overflow Pipe Constantly Discharging
Information:	The overflow pipe to the hot water unit was observed to be constantly running at the time of inspection. This condition may indicate a faulty pressure relief valve, excessive system pressure, or a defect with the hot water unit. Ongoing discharge can lead to increased water usage and potential damage to surrounding areas if left unaddressed. Further investigation and rectification are recommended. Works should be carried out by a licensed plumber.

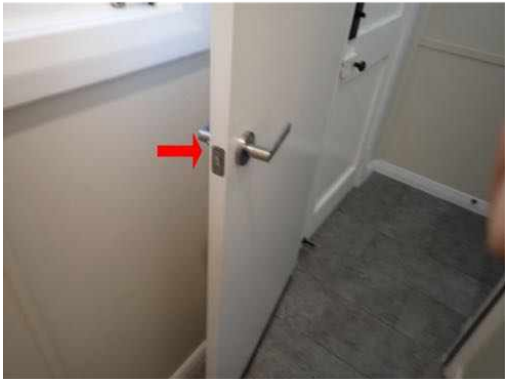
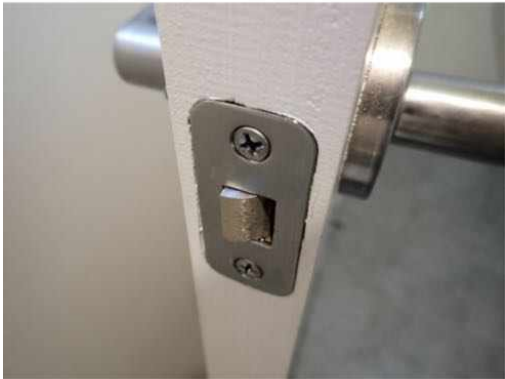
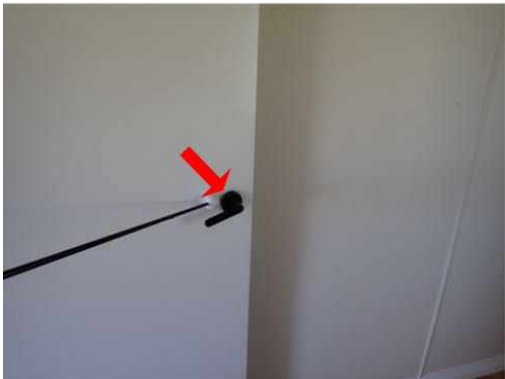
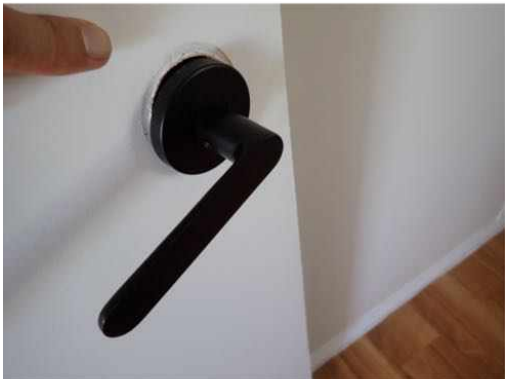
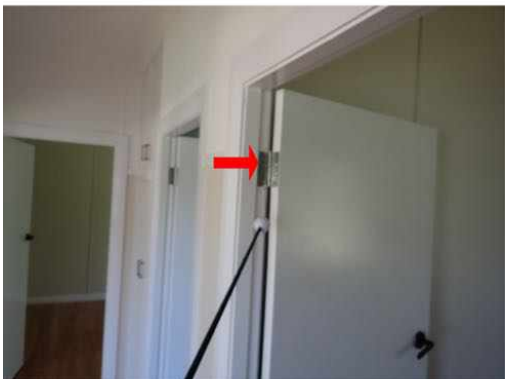
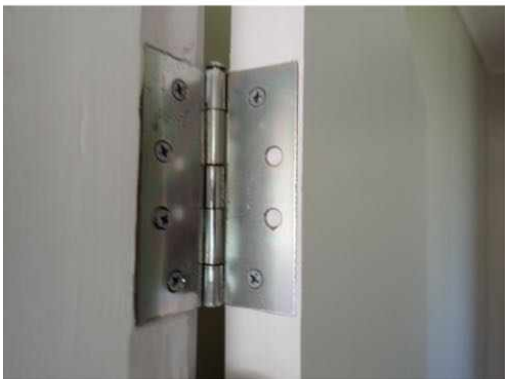
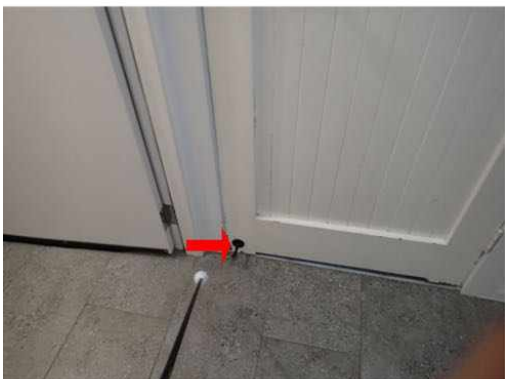
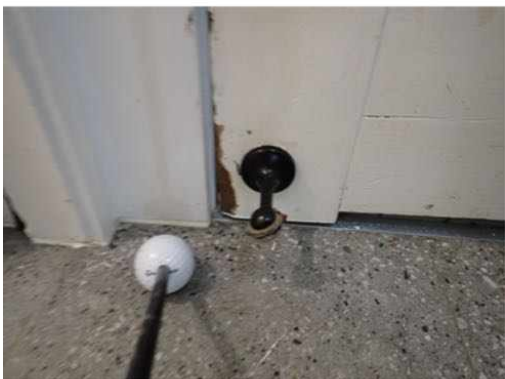
### Finding 3.01

Building:	Main Building
Location:	All Areas
Finding:	Door Hardware – Poor Installation and Loose Fixings
Information:	Poorly fitted door hardware was identified, including loose door handles and stops, along with missing screws to some hinges. These issues may affect the proper operation and durability of the doors if left unaddressed. Adjustment and refixing or replacement of the affected hardware is recommended as required. Works can be carried out by a carpenter or suitably qualified handyman.

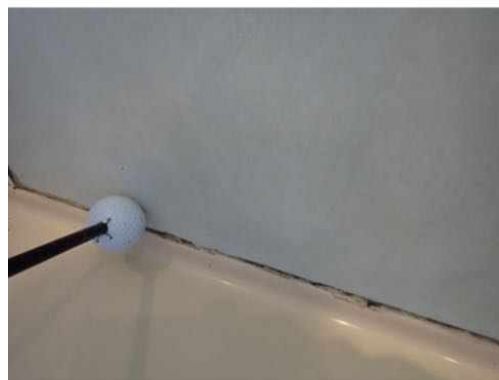
Finding 3.02

Building:	Main Building
Location:	Bathroom
Finding:	Bathroom – Deteriorated Silicone
Information:	Deteriorated silicone sealant was identified within the bathroom. This condition may allow moisture to penetrate behind tiled surfaces, increasing the risk of damage to underlying materials over time. Removal and replacement of failed silicone is recommended to maintain adequate water resistance. Works should be carried out by a licensed tiler or suitably qualified tradesperson.

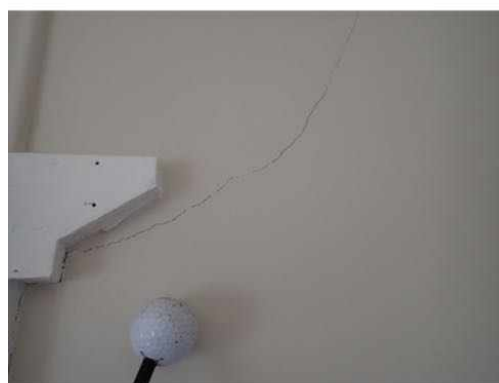
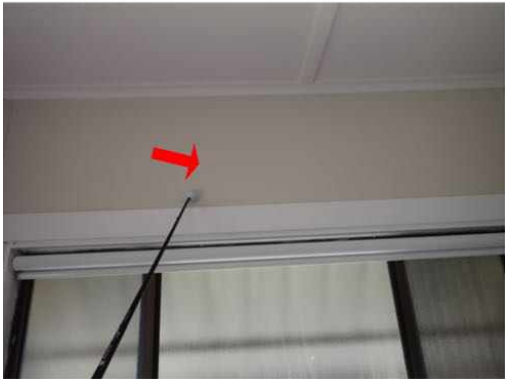
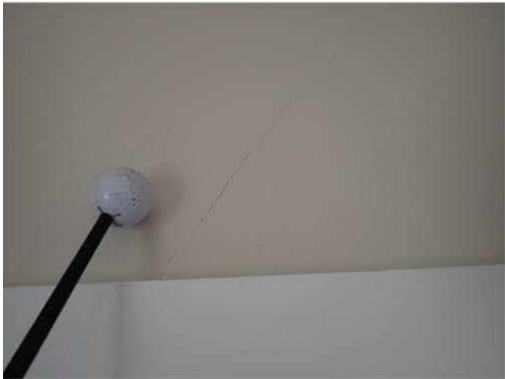
### Finding 3.03

Building:	Main Building
Location:	Bedroom
Finding:	Internal Wall Cladding – Bedroom Cracking
Information:	Cracking was identified in the internal wall cladding within the bedroom. This appears to be a minor defect, commonly associated with shrinkage, age-related wear, or possible structural movement. Cracks may worsen over time if left unaddressed. Monitoring and repair as required is recommended. Works can be carried out by a carpenter or suitably qualified tradesperson.

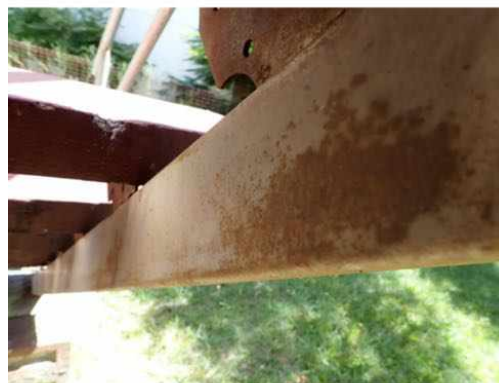
**Finding 3.05**

Building:	Main Building
Location:	Front entry stairs
Finding:	Entry Stairs – Surface Rust to Steel Stringers
Information:	Surface rust was identified to the steel stringers of the entry stairs. This condition is typically associated with weather exposure and age. While minor at the time of inspection, ongoing corrosion may occur if left untreated. Cleaning, rust treatment, and protective coating are recommended to help prevent further deterioration. Works should be carried out by a suitably qualified metal tradesperson or general handyman.

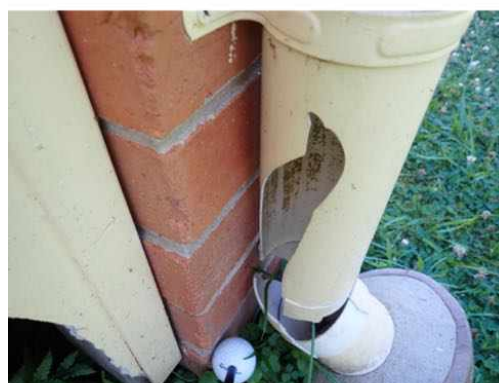
### Finding 3.06

Building:	Main Building
Location:	Back right hand corner
Finding:	Downpipe – Back Right-Hand Corner Damage
Information:	Damage was identified to the downpipe located at the back right-hand corner of the building. This condition may affect effective stormwater discharge and could lead to water overflow and moisture issues to adjacent building elements if left unaddressed. Repair or replacement of the damaged downpipe is recommended. Works should be carried out by a licensed plumber or suitably qualified handyman.

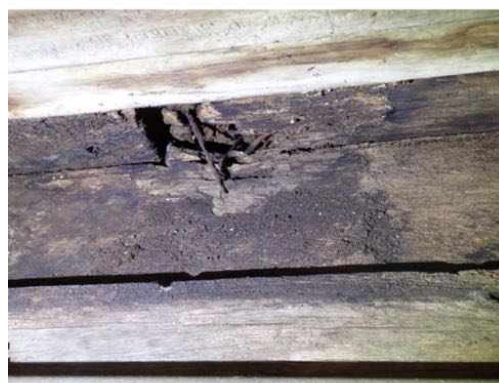
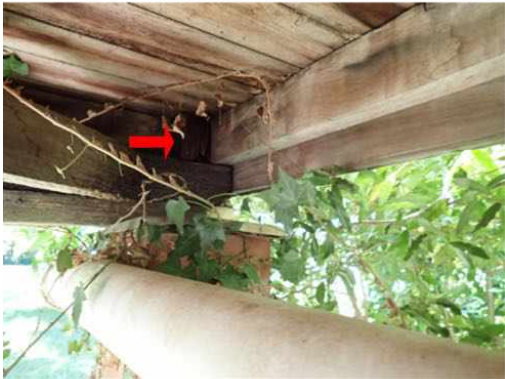
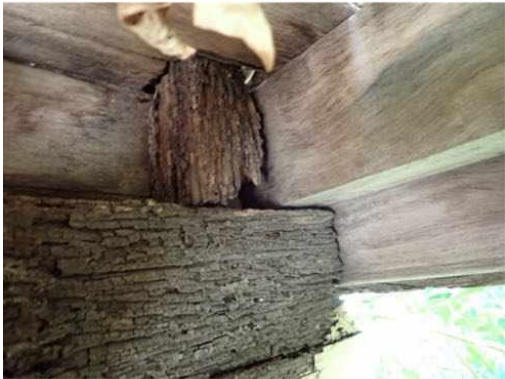
### Finding 7.01

Building:	Main Building
Location:	Subfloor
Finding:	Subfloor Timbers – Minor Wood Rot
Information:	Minor wood rot was identified to subfloor timbers at several locations. This condition is commonly associated with properties of this age and is typically related to prolonged moisture exposure or inadequate ventilation. While minor at the time of inspection, ongoing deterioration may occur if moisture issues persist. Monitoring and repair or replacement of affected timbers as required is recommended. Works should be carried out by a suitably qualified carpenter or licensed builder.

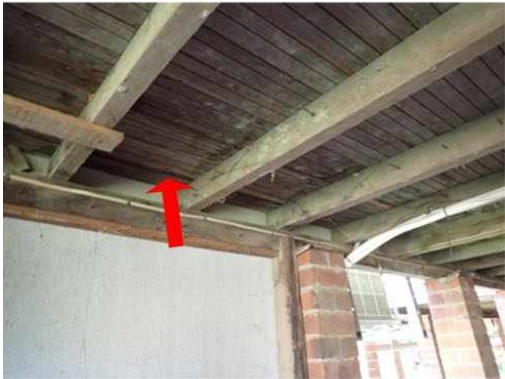
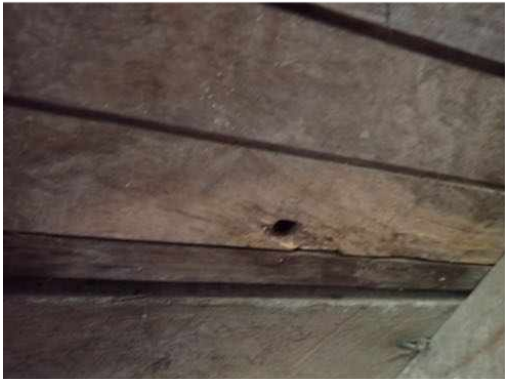
**Finding 8.01**

Building: Main Building  
Location: Subfloor  
Finding: Flooring – Isolated Borer Damage  
Information: Borer damage was identified to the flooring at several isolated locations. This indicates timber pest activity, which may affect the condition and durability of the timber if ongoing. While the damage appeared limited at the time of inspection, further activity cannot be ruled out. Monitoring and assessment are recommended, with treatment or repairs carried out as required. Works should be undertaken by a licensed timber pest technician and/or suitably qualified carpenter.
