# Building and Timber Pest Inspection Report

Inspection Date: Wed, 25 Feb 2026

Property Address: 8 Barbarrosa Rd, Edmondson Park NSW  
2174, Australia

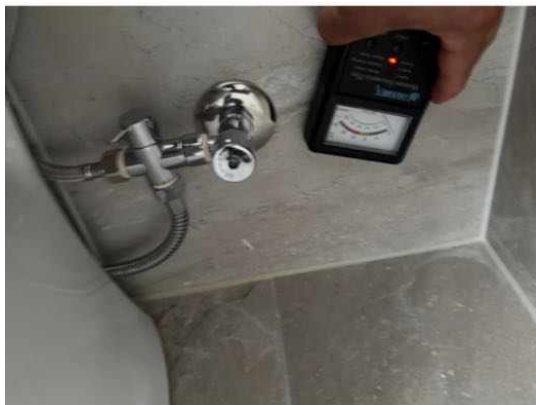
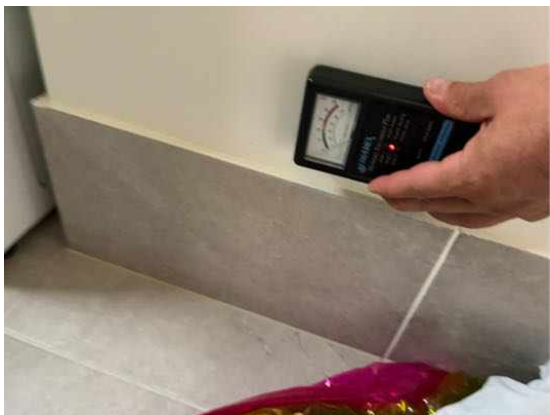
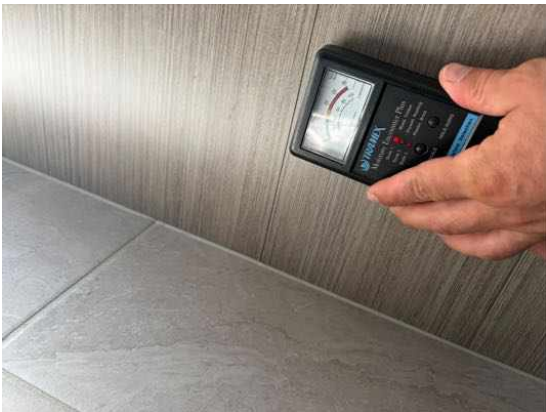
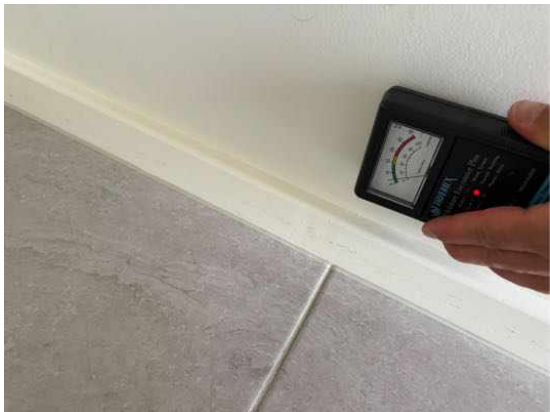
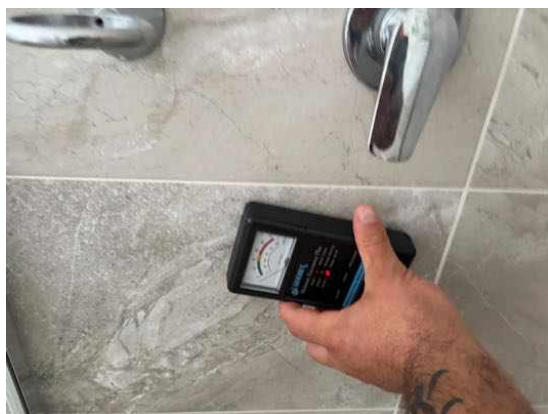
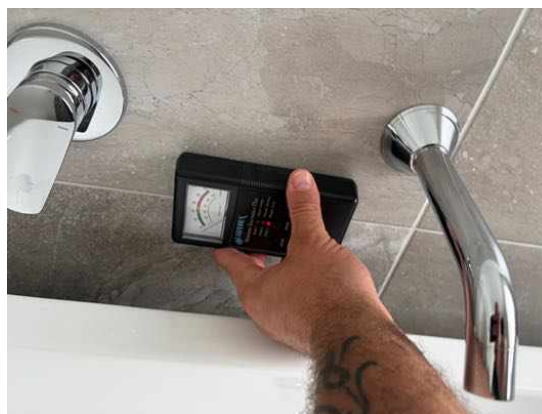
Building: Main Building  
Location: All Areas  
Finding: Moisture metre  
Information: During the inspection the property was checked for moisture using a moisture metre.

This is for information only.

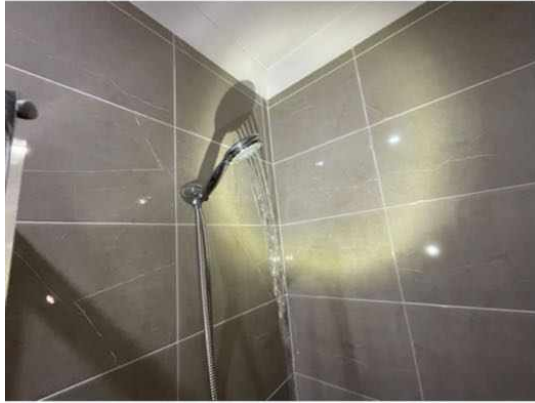
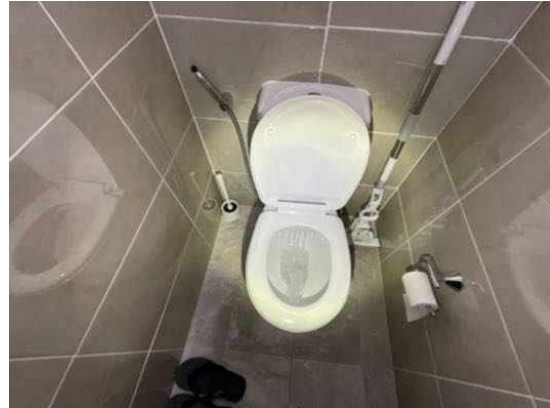
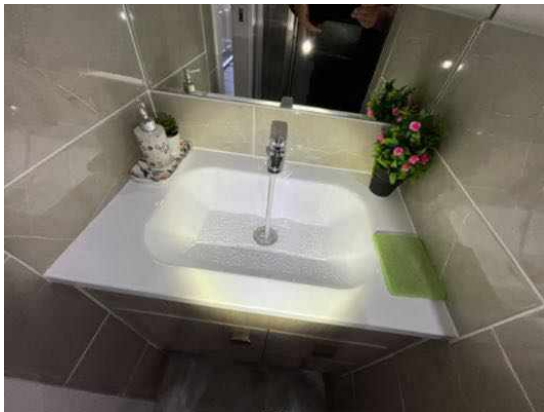
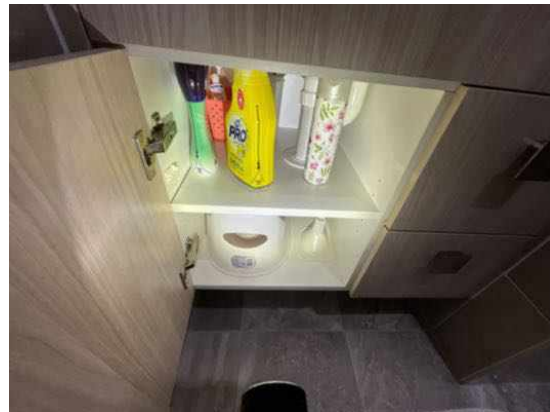
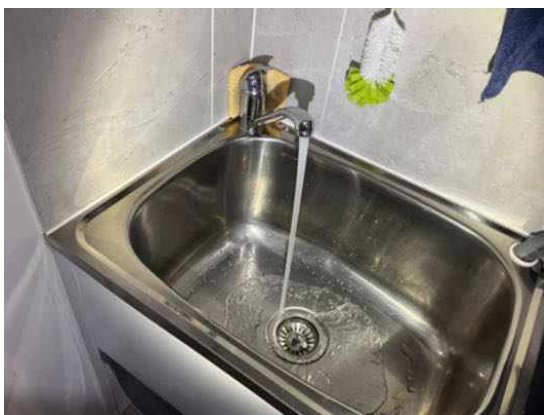
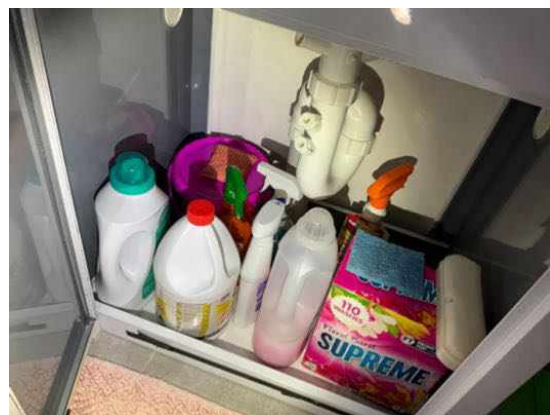
### Noted Item

Building: Main Building  
 Location: All Wet Areas  
 Finding: Waterproofing  
 Information:

All taps, mixers and toilets were tested for operation, except for those obstructed. The waterproofing to the shower recess was assessed by checking the walls in and around the shower recess for varying moisture content. There were no significant variations across the tested areas. No sign of recent water damage was evident upon a visual inspection of the surrounding walls, where the visual nature of the inspection was possible.

Consequently, there is no conclusive evidence of any current shower recess leakage other than those which may have already been mentioned earlier in this report. It is reasonable to assume the shower waterproofing is sound. Note that if the shower is not used, or has not been used for some time, moisture readings would not vary significantly and this can lead to erroneous results. It is not possible under the visual inspection criteria (under which a prepurchase inspection is carried out) to categorically determine if there are leaks. If a more accurate assessment is required, a special purpose inspection should be requested. Alternatively, the assumption should be made that the shower may leak.

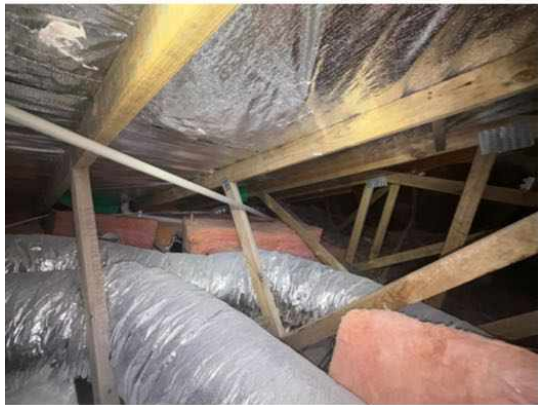
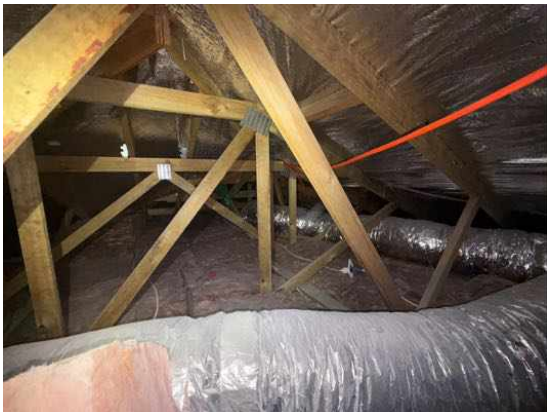
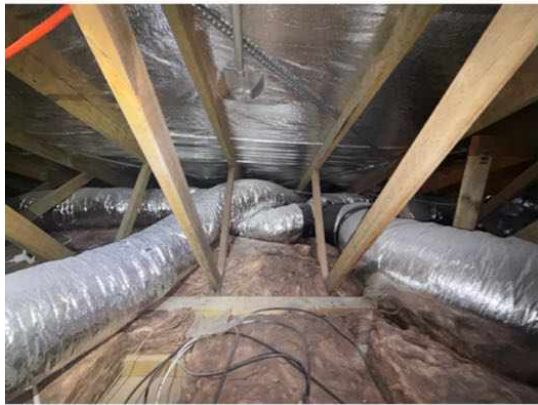
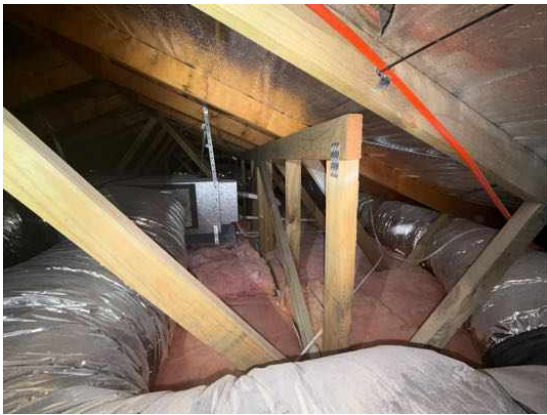
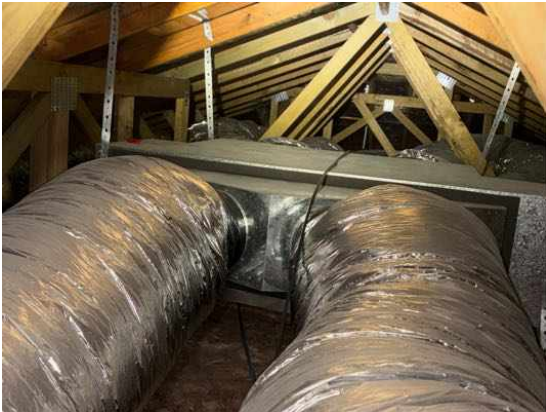
**Noted Item**

Building: Main Building  
Location: Roof Void  
Finding: Additional Photos  
Information:

Additional photos are provided for your general reference.

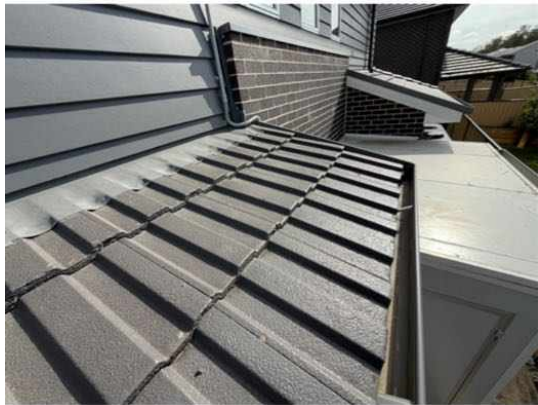
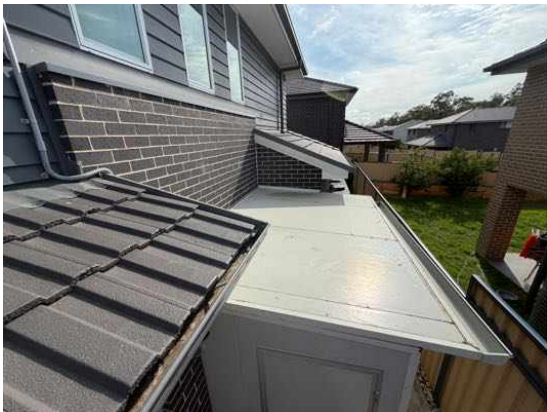
**Noted Item**

Building: Main Building  
Location: Roof Exterior  
Finding: Additional Photos  
Information:

Additional photos are provided for your general reference.

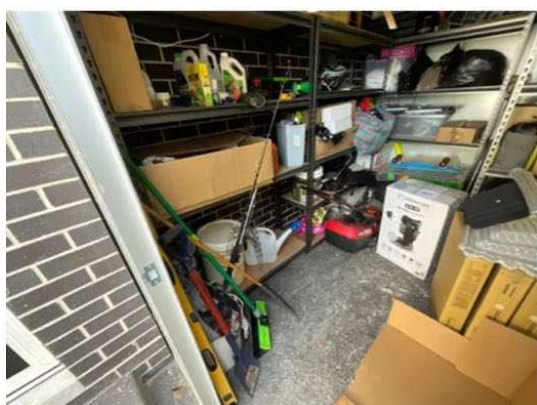
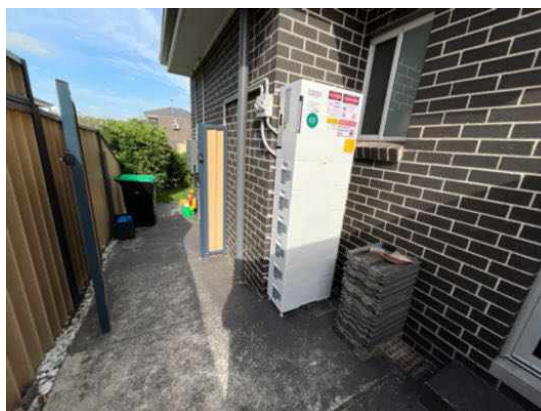
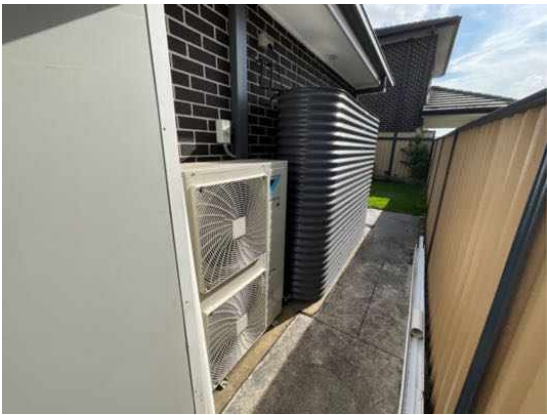
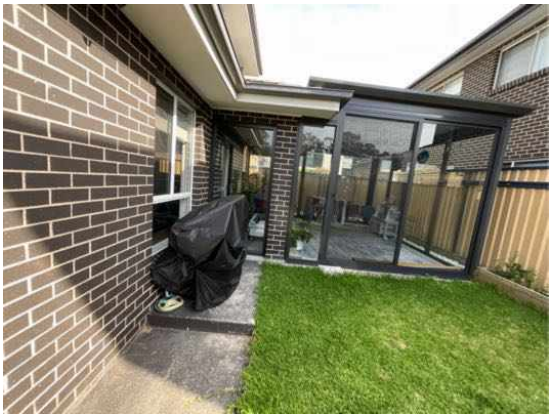
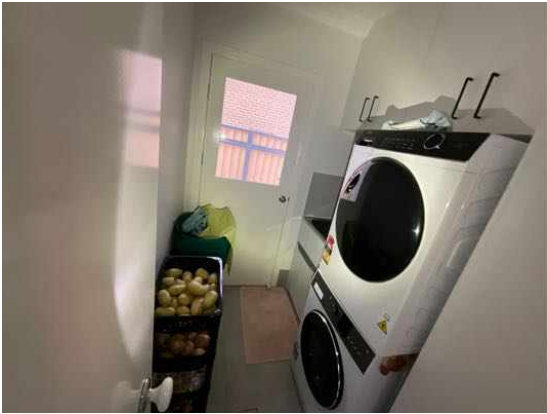
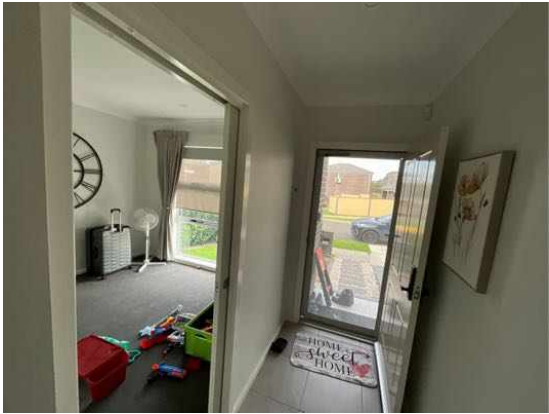
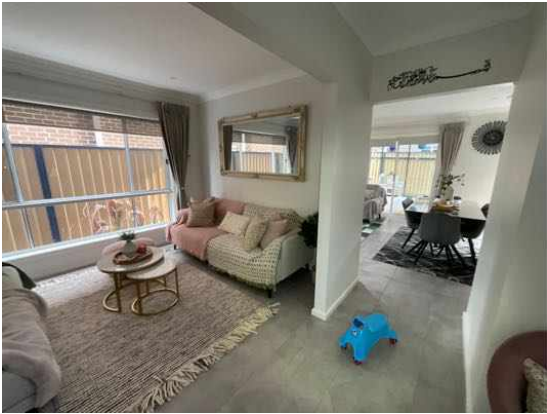
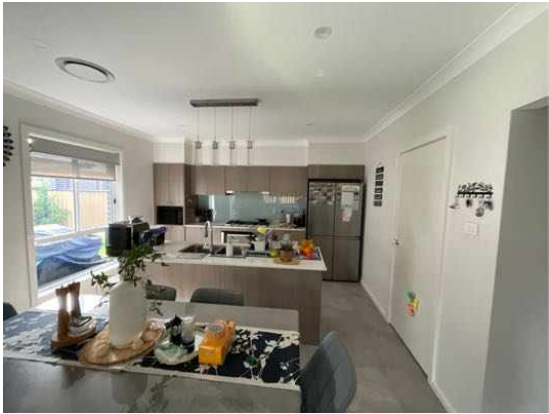
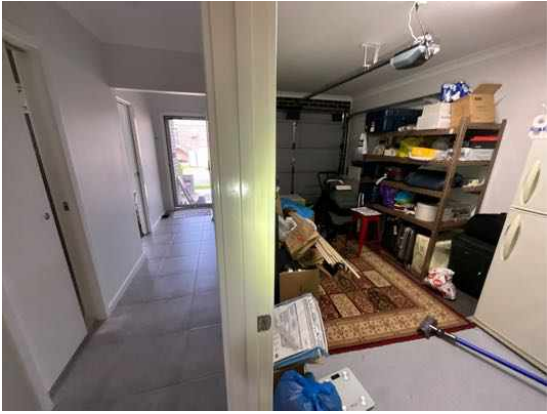
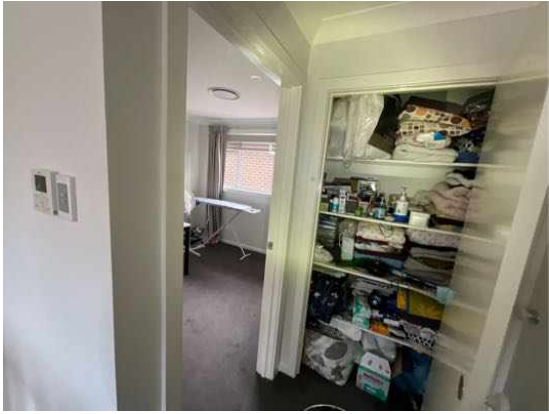
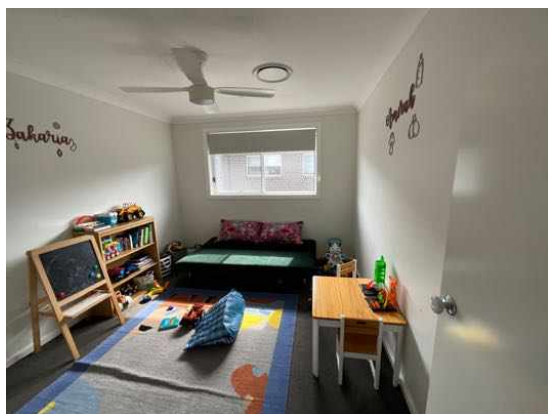
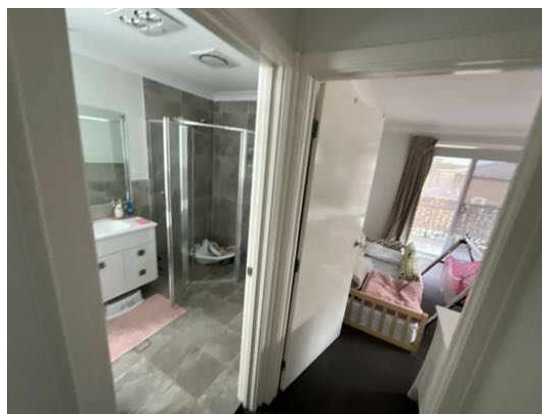
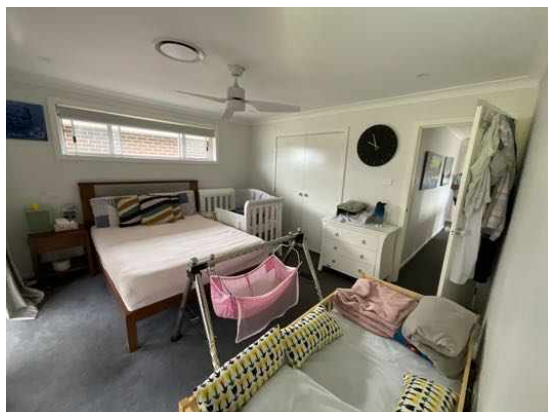
Building:	Main Building
Location:	All Areas
Finding:	Additional Photos - Obstructions and Limitations
Information:	These photographs are an indication of the obstructions and limitations which impeded full inspection of the property at the time of inspection. These obstructions can hide an array of defects and should be removed to allow full inspection to be carried out. A re-inspection is recommended once the areas are made accessible.

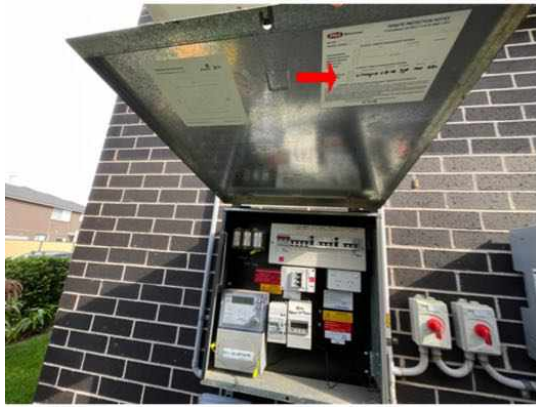
Where a Termite Management System has been identified you should refer to the type of barrier date of installation warranty conditions and any documentation provided by a builder or past owner. Consult the company who installed the barrier to confirm whether the system is still under warranty.

Most chemical termite management systems expire and require replenishment and all physical systems are primarily designed to prevent concealed entry.
