Building and Timber Pest Inspection Report

Inspection Date: Thu, 9 Apr 2026

Property Address: 4104/31 Bourton Rd, Merrimac QLD 4226,
Australia

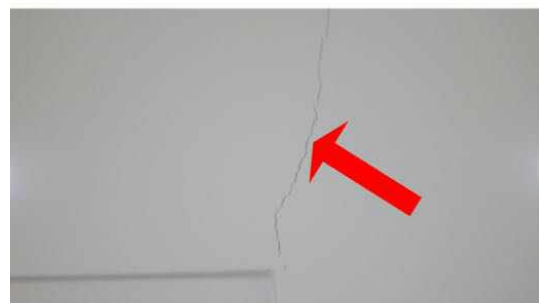
Building: Main Building
Location: Entry > Front Right
Finding: Cracking - Wall
Information: There is fine cracking to an area of the exterior wall in the entry area.

The cracking appears minor in nature and is generally only ever an appearance defect. While such cracking may be noticeable in some cases, it is quite common and does not indicate any structural damage.

Cracking of this nature can generally be repaired with minor sanding, filling and/or repainting. Such works should be performed by a qualified painter or a general handyman.

Note - External area wall repairs and/or maintenance will likely be the responsibility of the buildings body corporate managers.

Monitoring of all cracking should be conducted frequently. Always contact a building inspector should cracks widen, lengthen, or become more numerous.

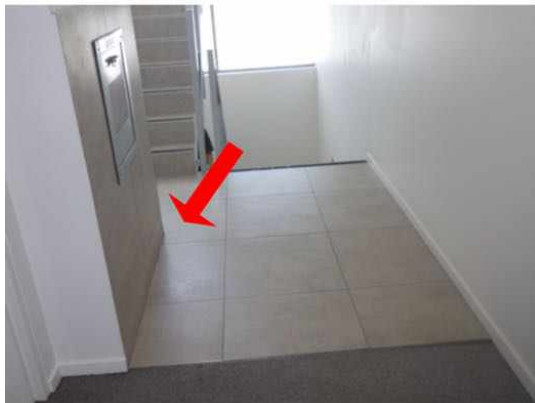
Finding 3.02

Building: Main Building
 Location: Entry > Centre Right
 Finding: Tile - Cracked
 Information: Cracked tiles to the entry area floor were identified at the time of inspection. Such defects are generally caused by impact. Cracked or broken tiled areas may also be a direct result of poor workmanship during the construction process.

A tiling contractor could be appointed to perform repair works at the clients discretion.

Note - External area floor repairs and/or maintenance will likely be the responsibility of the buildings body corporate managers.

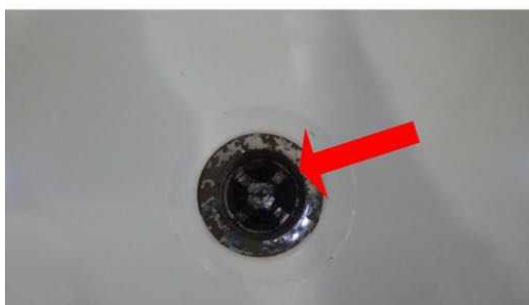
Building: Main Building
 Location: Bathroom > Rear Left
 Finding: Surface Rust
 Information: At the time of inspection the bath drain grate in the bathroom showed evidence of surface rust.

As surface rust provides no protection to the underlying iron, the deteriorating condition is likely to worsen if not addressed.

Rust formation can be controlled with coatings, such as paint, that isolate the iron from the environment.

Alternatively a qualified plumber could be engaged to replace the bath drain grate at the clients discretion.

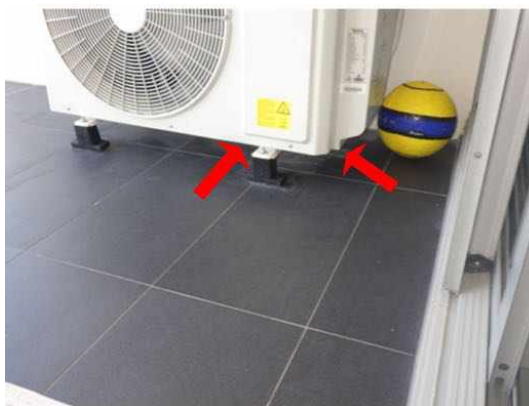
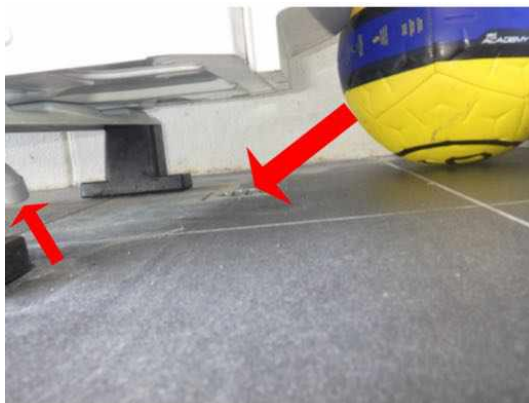
Finding 3.05

Building: Main Building
 Location: Balcony > Centre Right
 Finding: Overflow - Not plumbed for drainage
 Information: The air conditioning unit overflow is not plumbed or connected to suitable drainage, which can result in the surrounding area becoming excessively damp. These damp conditions can lead to secondary defects such as rot, rust or corrosion of associated building elements, the formation of fungal decay, or even the creation of potential slip hazards. When coupled with poor site drainage, pooling of water may also attract termite activity to this area. It is highly recommended that a qualified plumber or general handyman be appointed to extend the overflow pipe to the drainage grate provided. These works will ensure that the area remains dry and free of any secondary defects.

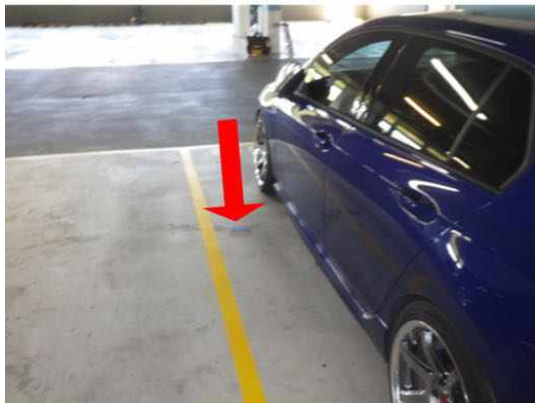
Finding 3.06

| Finding: | Cracking in concrete slab - Category 1 |
| Information: | Cracking coded as Category 1 was identified in the vehicle parking space area concrete slab (as per example photos). A Category 1 crack is described as a fine but noticeable crack, with the slab at an otherwise reasonable level. |

To be considered Category 1, the approximate width of the crack is less than 1.0mm, or a less than 10mm change in offset when a 3m straight edge is placed over the defect.

Category 1 cracks should be monitored for a period of 12 months. At the end of the monitoring period, identified cracks that are rated greater than Category 2 are considered defects, and require rectification.

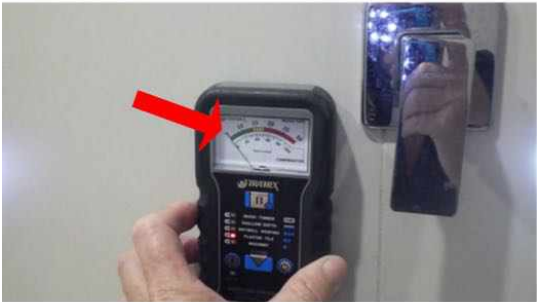
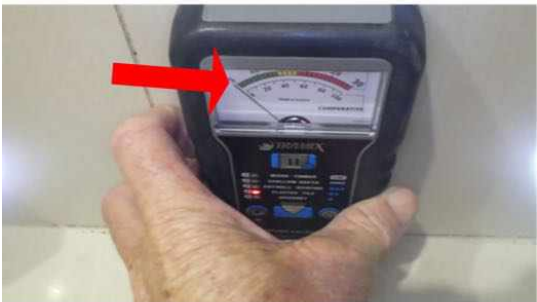
Building: Main Building
Location: Ensuite > Rear
Finding: Moisture Level Readings
Information: At the time of inspection the ensuite shower cubicle areas checked with the Tramex Moisture Meter returned low moisture level readings.

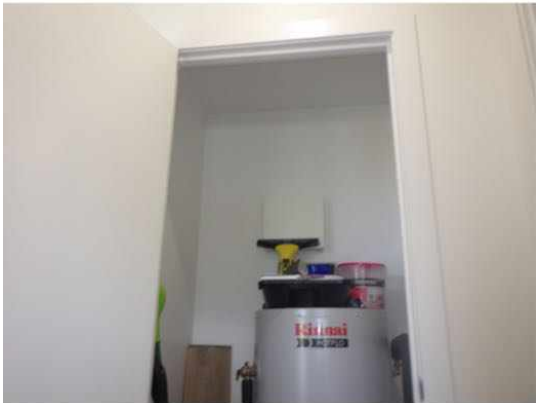
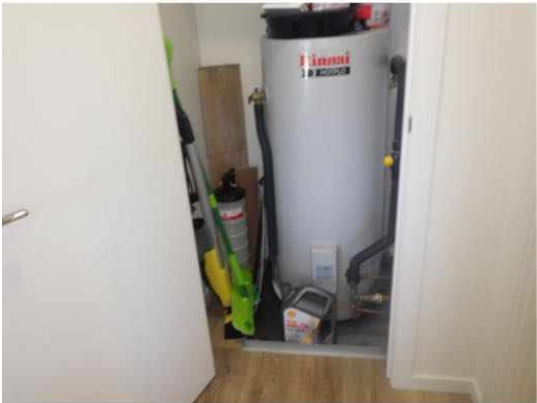
Building: Main Building
 Location: Linen Cupboard > Existing
 Finding: No obvious defect
 Information: No obvious defects found at the time of inspection.

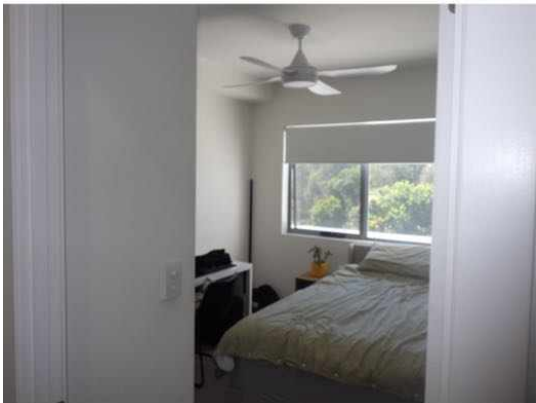
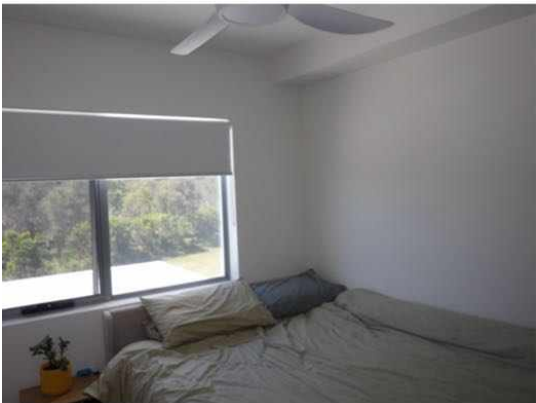
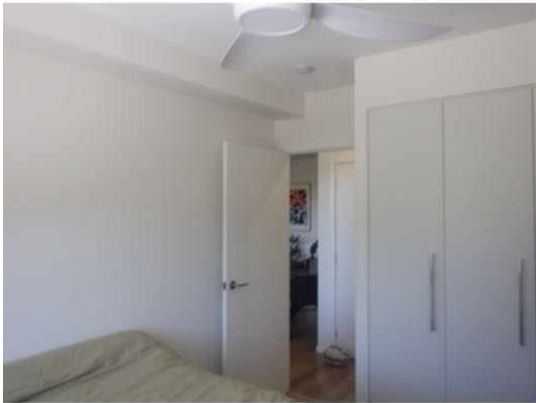
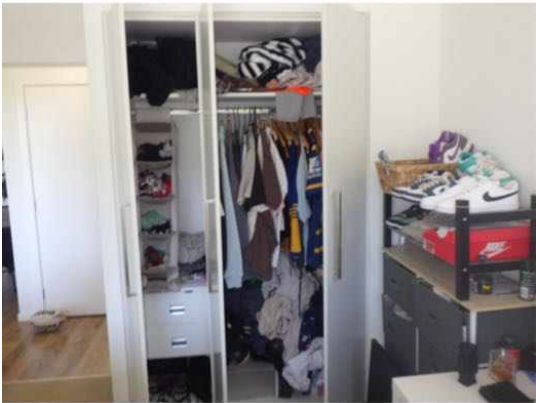
Building: Main Building
 Location: Bedroom 2 > Existing
 Finding: No obvious defect

Information: No obvious defects found at the time of inspection.

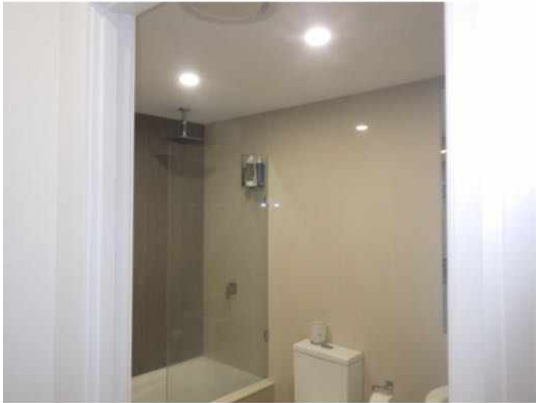
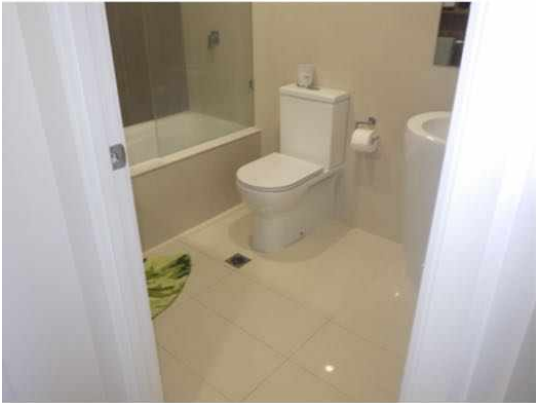
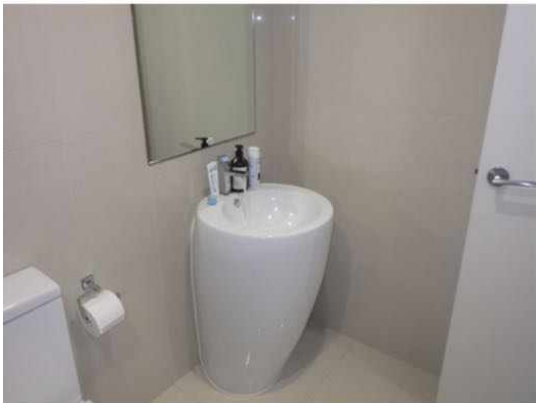
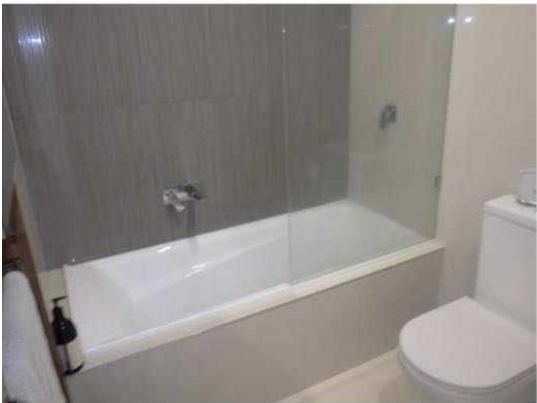
Building: Main Building
Location: Bathroom > Existing
Finding: No obvious defect
Information: No obvious defects found at the time of inspection.

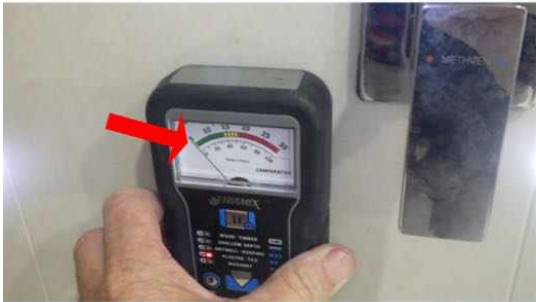
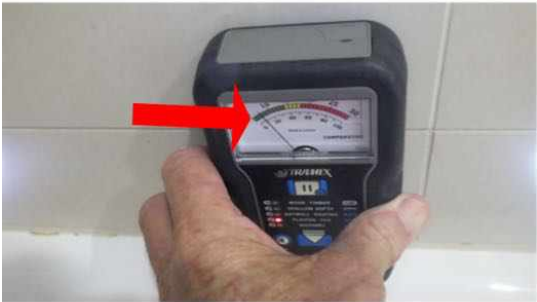
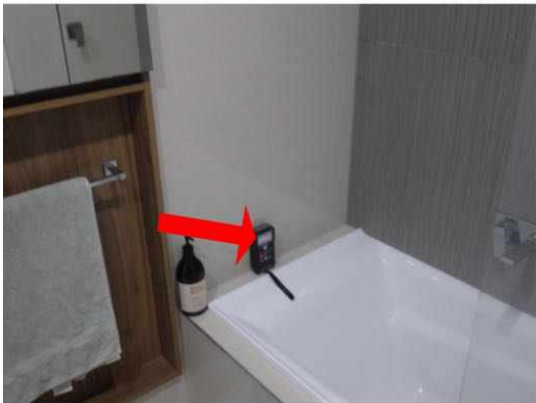
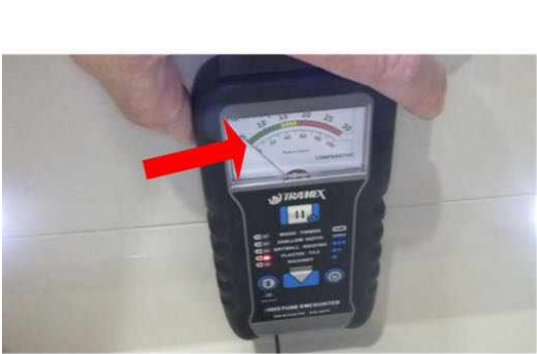
Building: Main Building
Location: Bathroom > Centre Left
Finding: Moisture Level Readings
Information: At the time of inspection the bathroom shower cubicle areas checked with the Tramex Moisture Meter returned low moisture level readings.

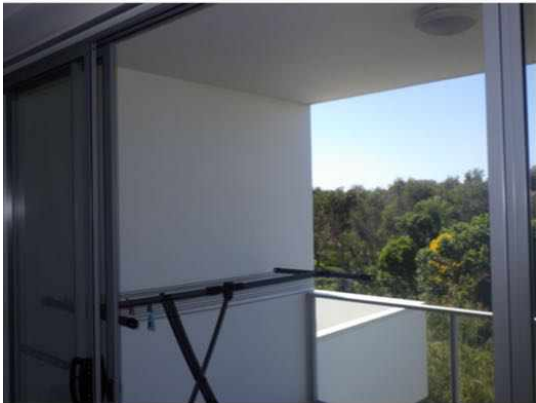
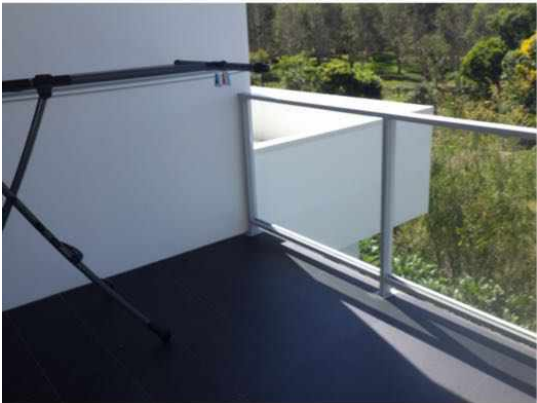
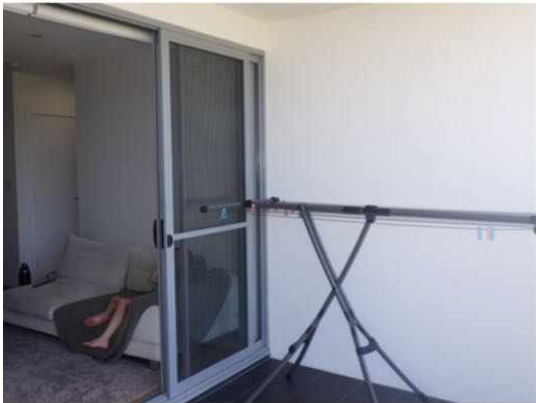
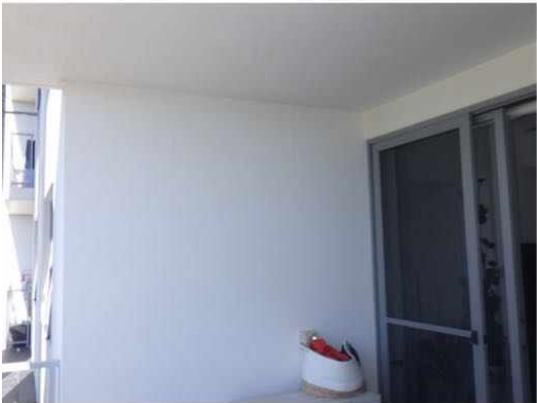
Building: Main Building
 Location: Balcony > Existing
 Finding: Additional Photos
 Information: Additional photos are provided for your general reference

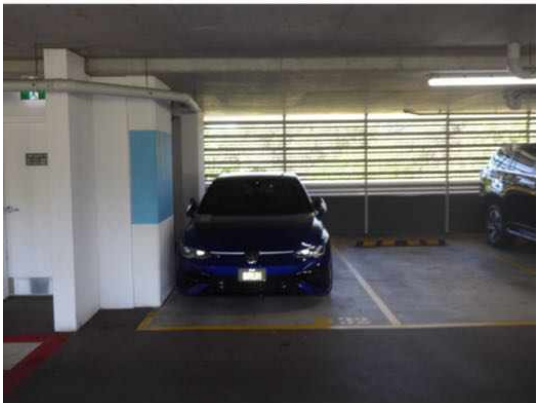
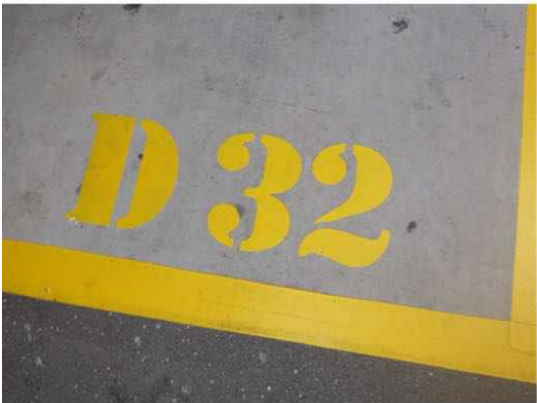
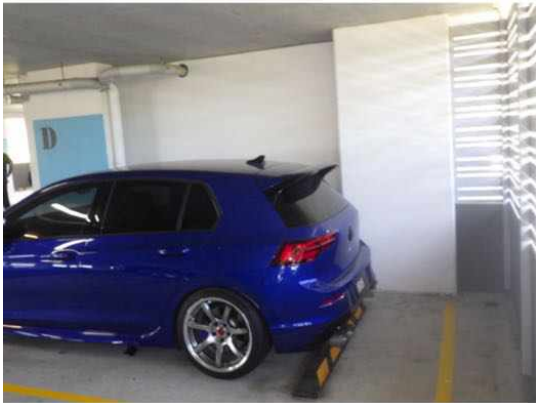
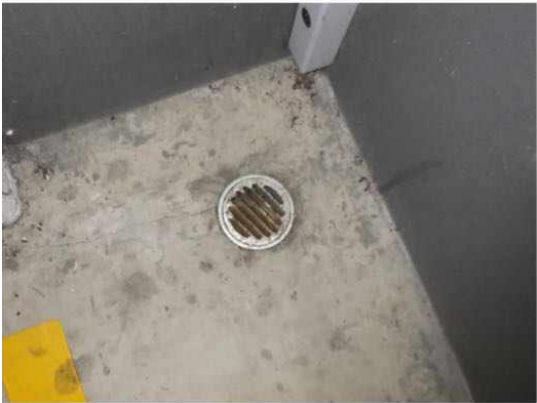
Building: Main Building
 Location: Carpark > Existing
 Finding: Additional Photos

Information: Additional photos are provided for your general reference

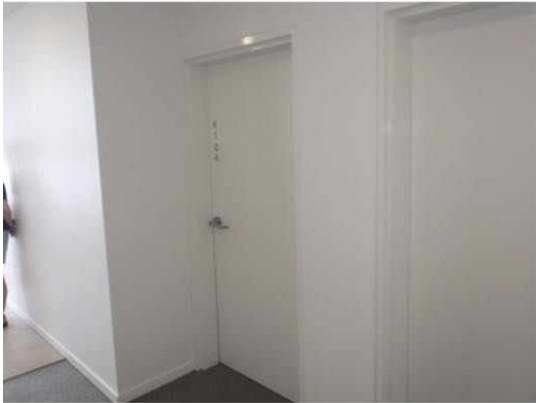
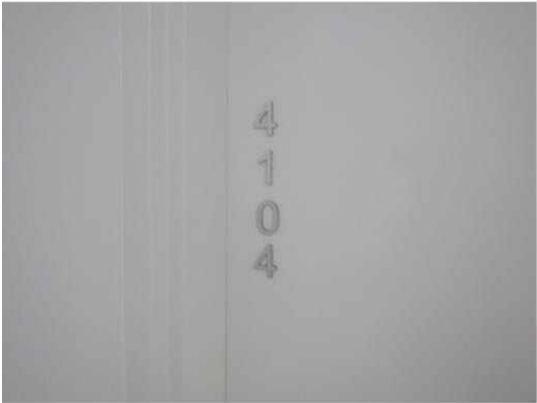
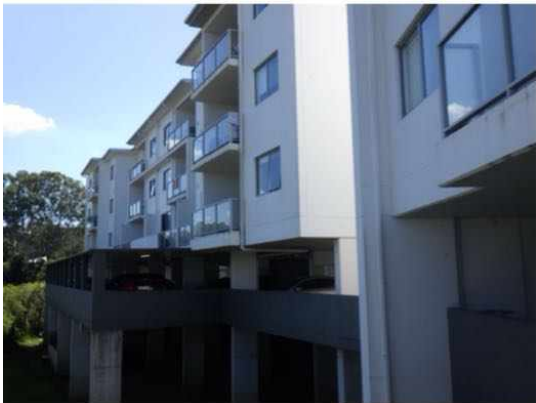
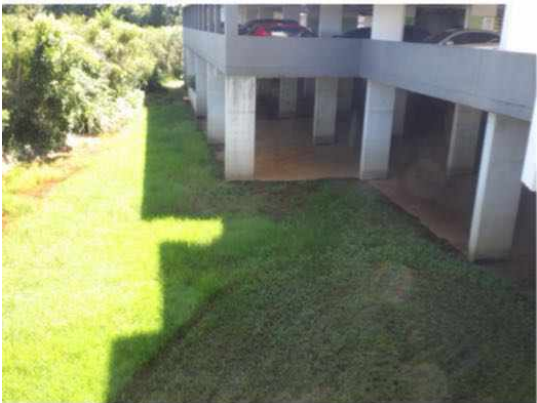
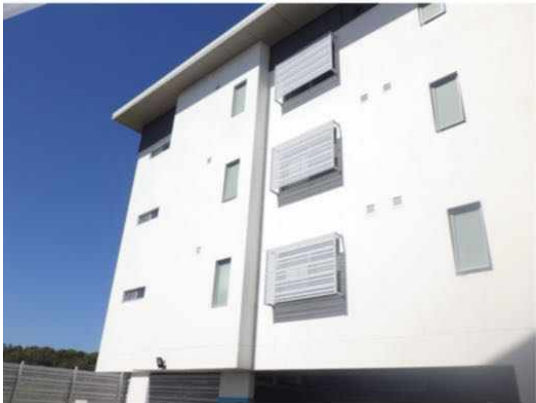
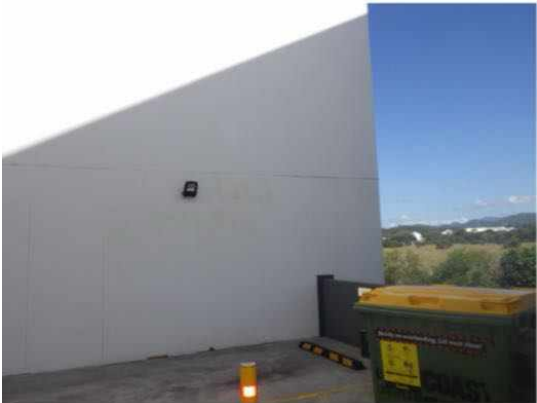
Building: Main Building
Location: External Areas > Existing
Finding: Additional Photos
Information: Additional photos are provided for your general reference

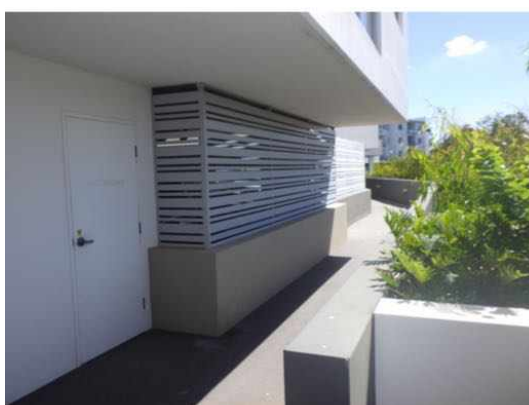
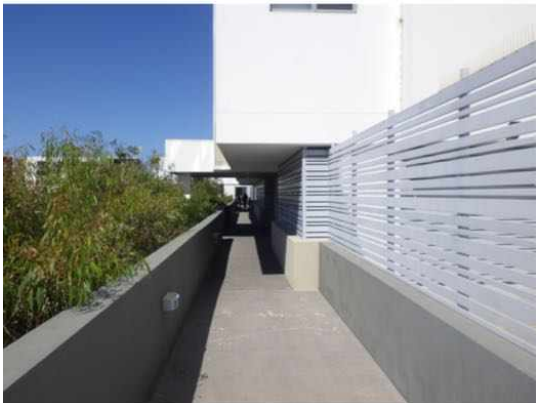
In this instance a visual inspection zone was observed. This system requires regular annual inspections.
