Building and Timber Pest Inspection Report

Inspection Date: Tue, 20 Jan 2026

Property Address: 64 Andrew Lloyd Dr, Doonside NSW 2767,
Australia

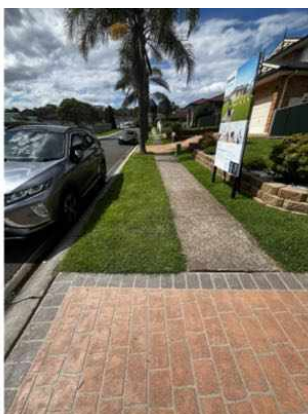
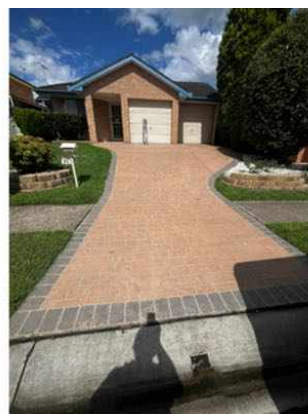
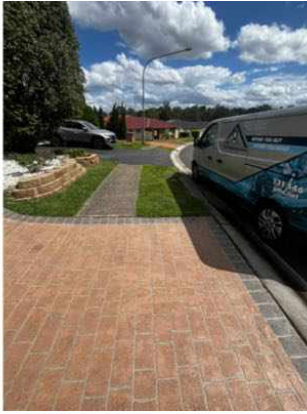
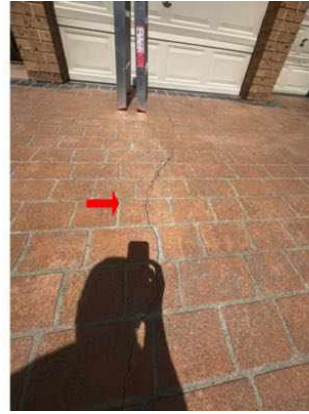
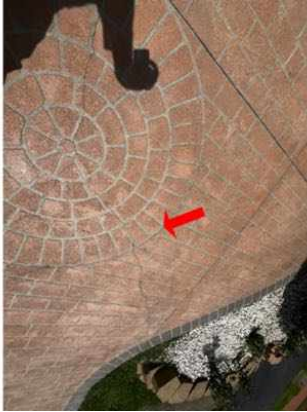
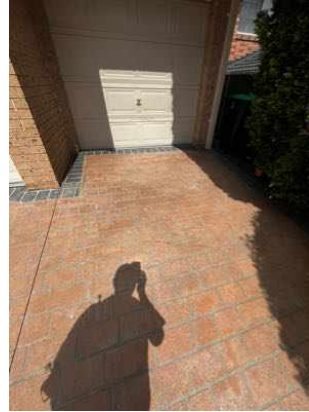
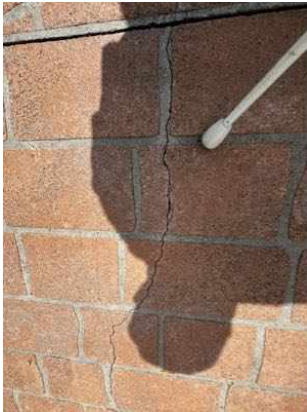
Building: Main Building
Location: Driveway
Finding: Crack in concrete slab - Category 1
Information: A crack coded as Category 1 was identified in the slab. A Category 1 crack is described as a fine but noticeable crack, with the slab at an otherwise reasonable level.

To be considered Category 1, the approximate width of the crack is less than 1.0mm, or a less than 10mm change in offset when a 3m straight edge is placed over the defect.

Category 1 cracks should be monitored for a period of 12 months. At the end of the monitoring period, identified cracks that are rated greater than Category 2 are considered defects, and require rectification.

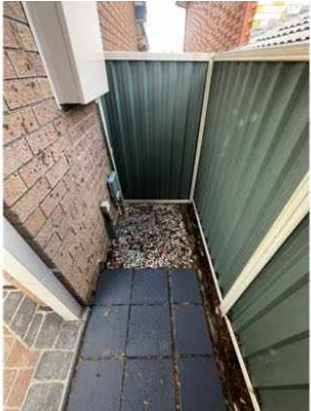
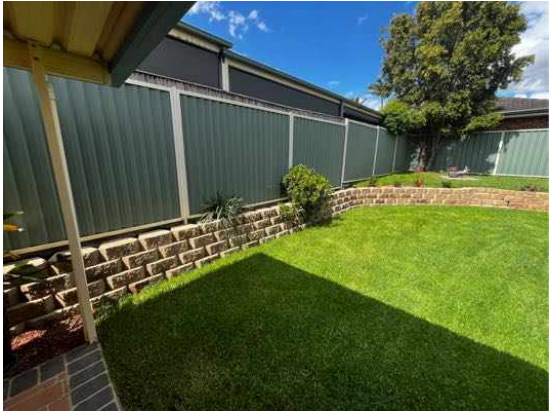
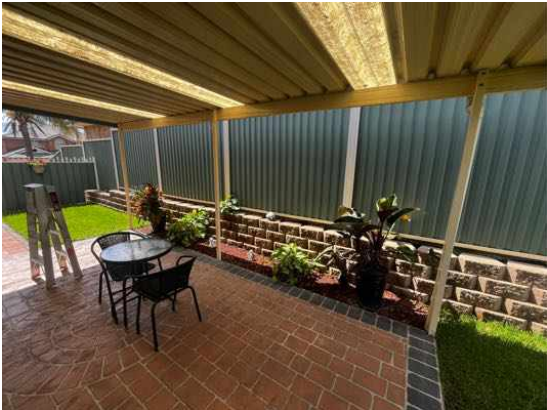
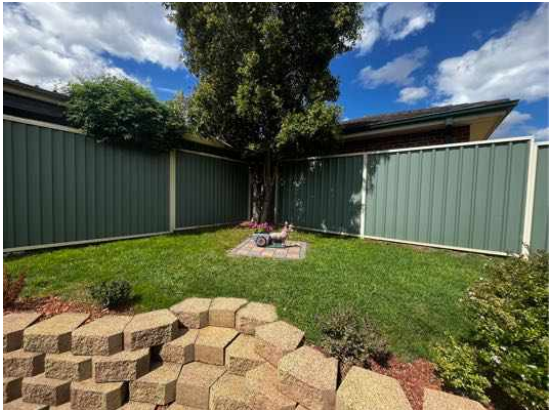
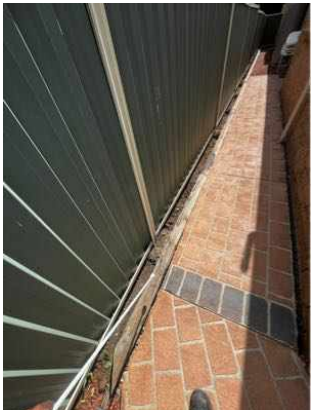
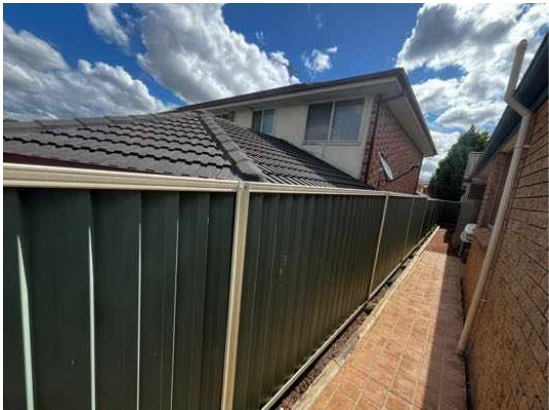
Finding 3.02

Building: Main Building
 Location: Yard
 Finding: Fencing - Deteriorated
 Information:

It was noted at the time of inspection that sections of the fencing throughout the property have deteriorated. Typically fencing deteriorates due to age and or wear, rot and or rust which is generally expected for a structure of this age, due to prolonged exposure to weather conditions. Sometimes inadequate installation or maintenance can be to blame.

If left unattended, it is likely that further damage will occur. It is suspected that repair of several elements of the fencing may be required however replacement may be a

consideration of the client also.

A licensed fencing contractor should be appointed to provide further advice and perform rectification works as necessary.

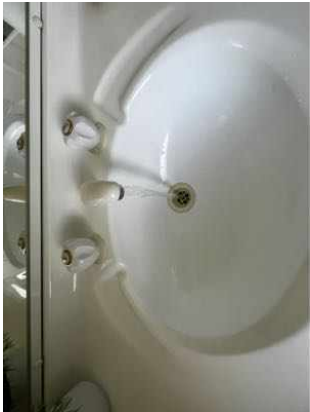
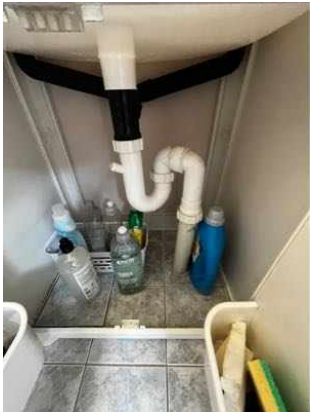
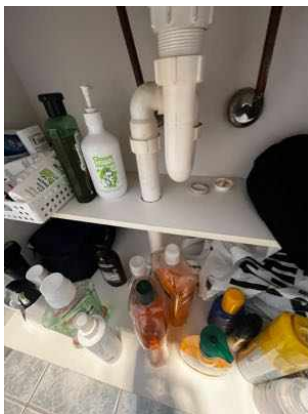
Finding 3.03

Building:	Main Building
Location:	Kitchen/ Laundry Bathroom/Ensuite
Finding:	Cabinetry Plumbing - Kitchen/ Laundry/Bathroom
Information:	All cupboards where sinks and basins with drainage plumbing were inspected and no evidence of leaks were present at the time of inspection.

For your information only no remedial works are required at the time of inspection.

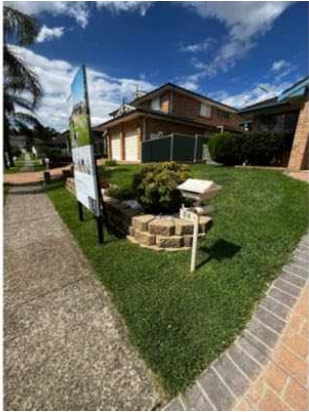
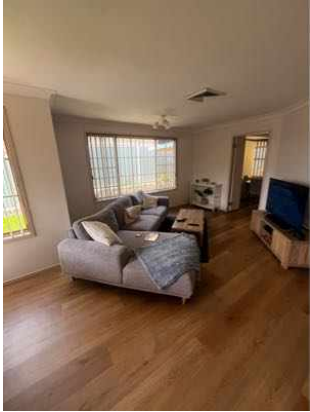
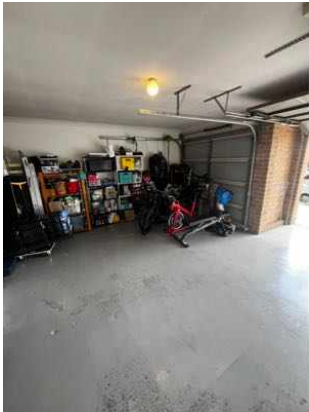
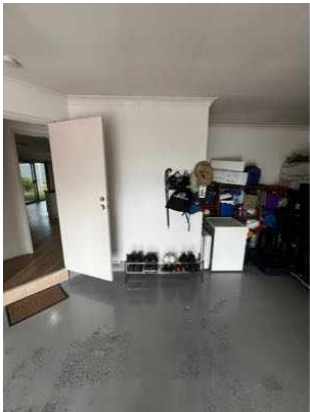
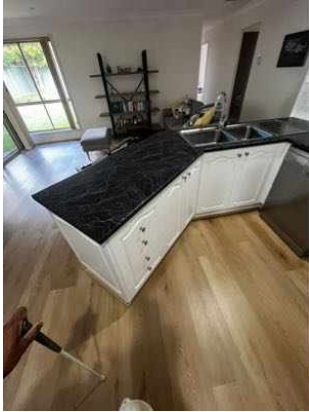
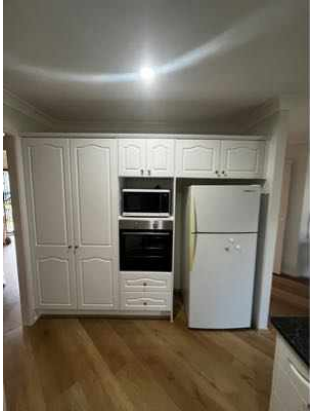
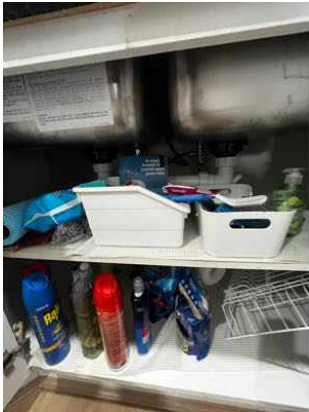
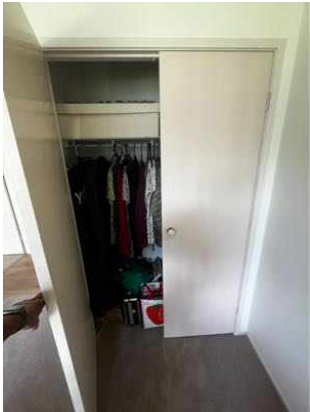
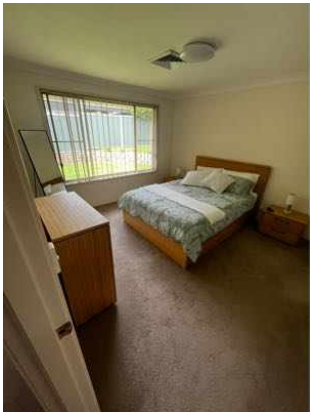
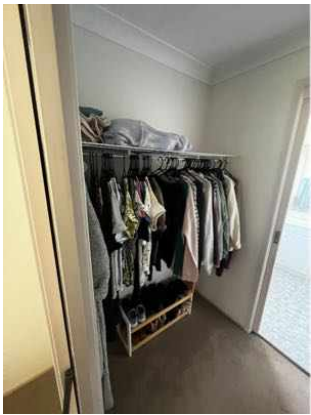
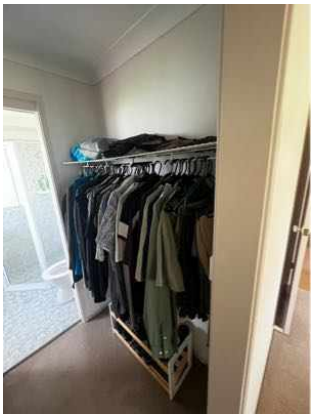
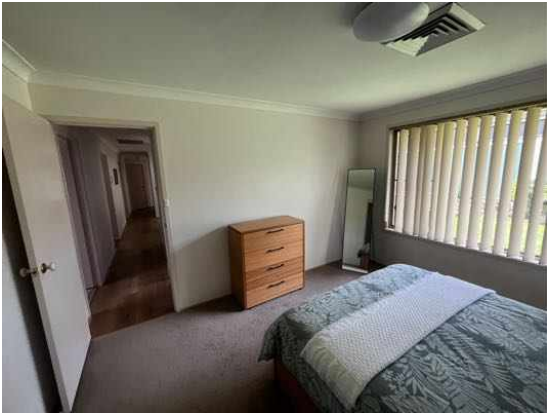
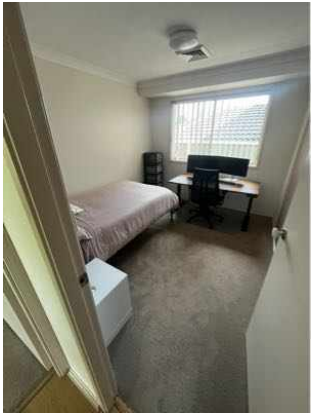
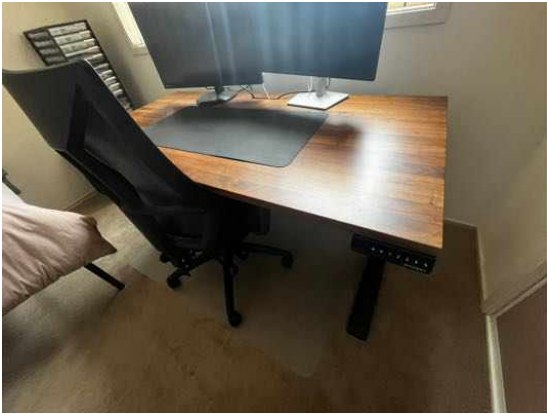
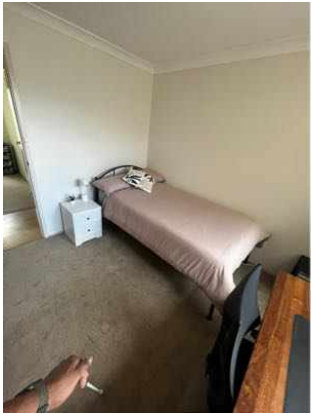
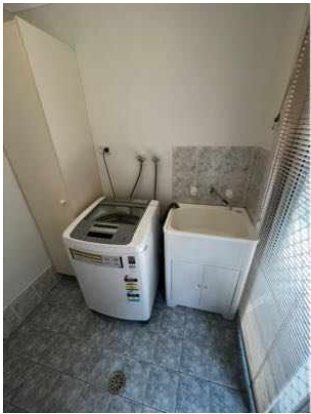
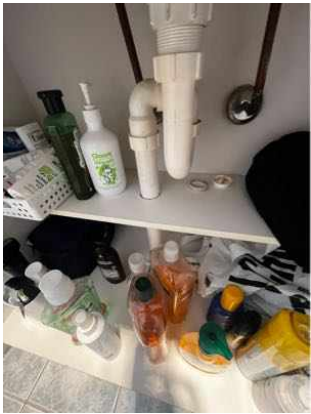
Finding: Additional Photos - Obstructions and Limitations

Information: These photographs are an indication of the obstructions and limitations which impeded full inspection of the property at the time of inspection. These obstructions can hide an array of defects and should be removed to allow full inspection to be carried out. A re-inspection is recommended once the areas are made accessible.

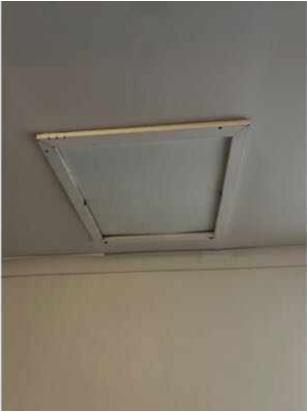
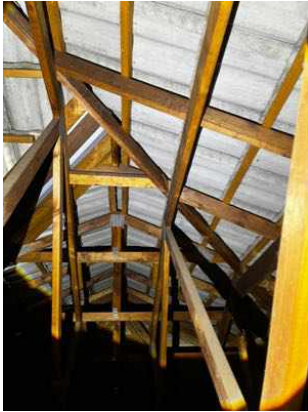
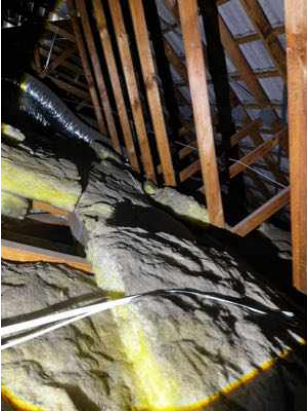
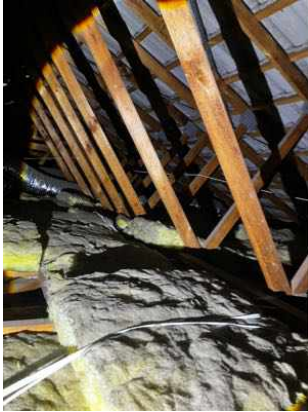
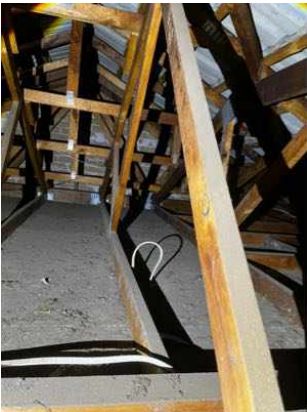
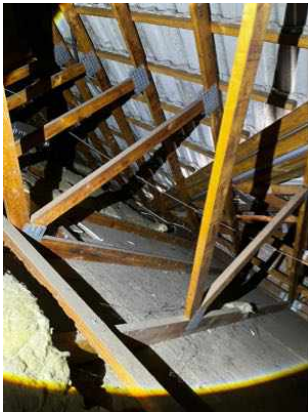
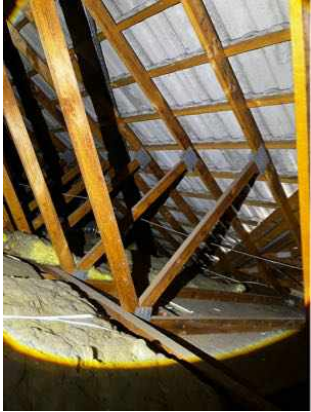
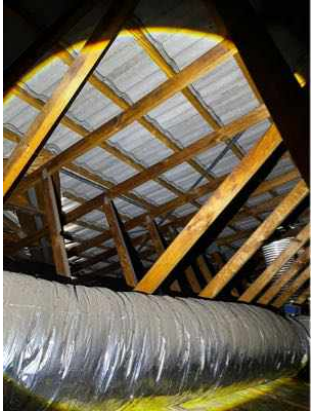
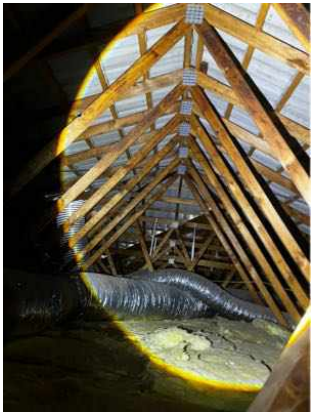
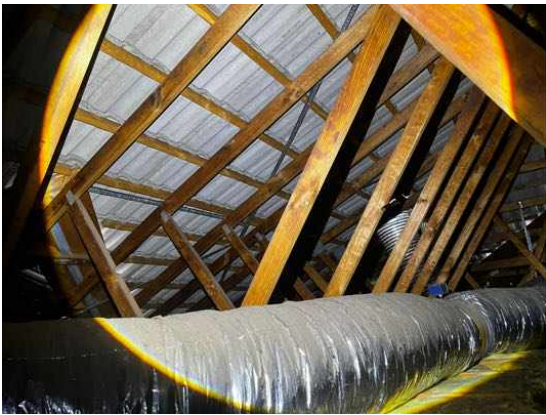
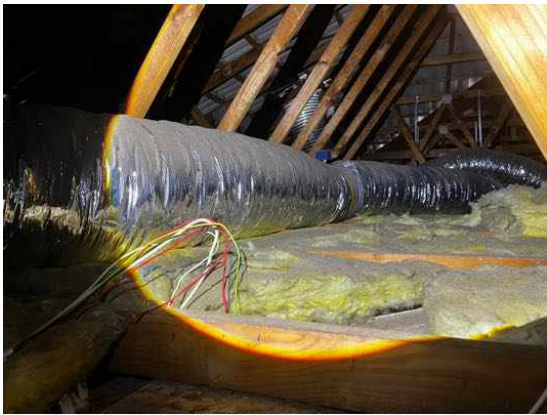
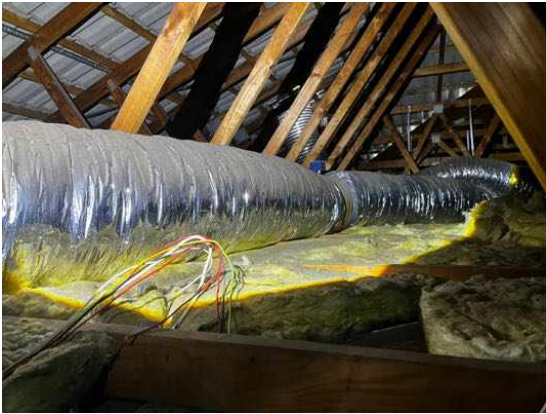
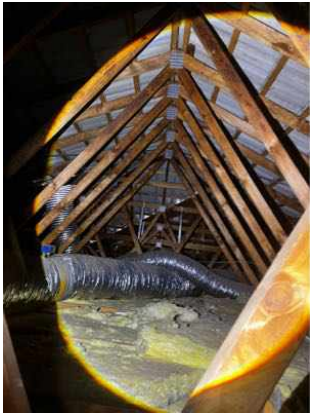
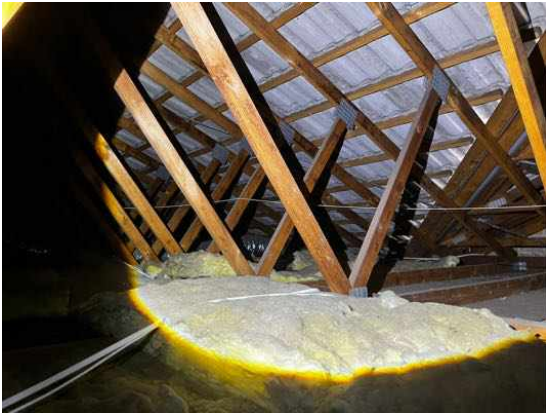
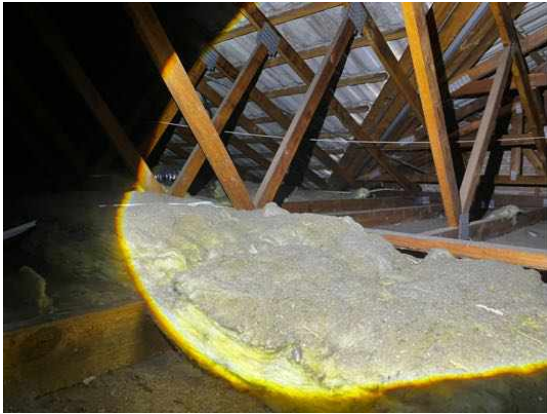
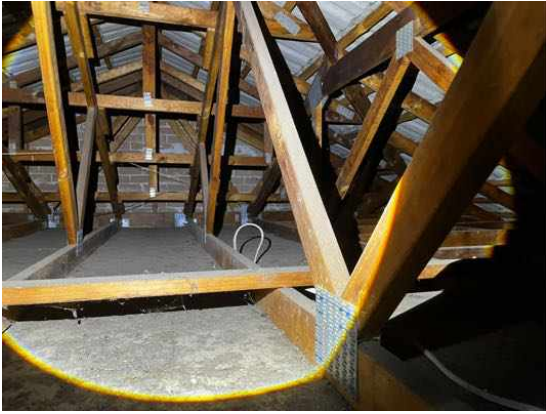
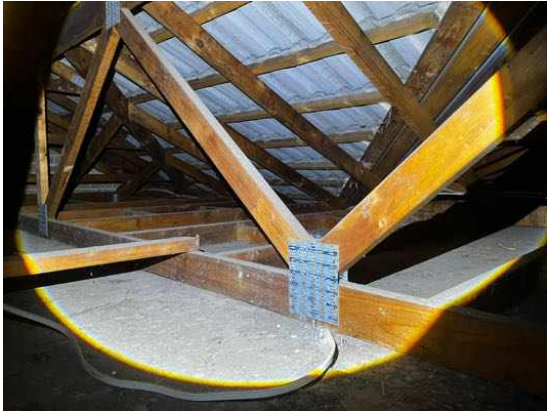
Finding 6.02

Building:	Main Building
Location:	Roof Void
Finding:	Obstructions and Limitations - Roof space
Information:	<p>The Roof Void was inspected up to the safe point of access possible - These photographs are an indication of the obstructions and limitations which impeded full inspection of the Roof Space/Void at the time of inspection such as Stored items, Ducting, Aircon ducting, Skylight tubes, Electrical wires, insulation and cross beams, rafters, low clearance as of the pitch in the roof. These obstructions can hide an array of defects and should be removed to allow full inspection to be carried out.</p>

A re-inspection is recommended once the areas are made accessible.

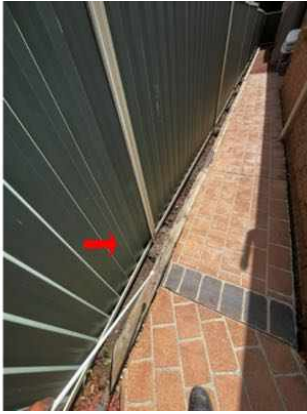
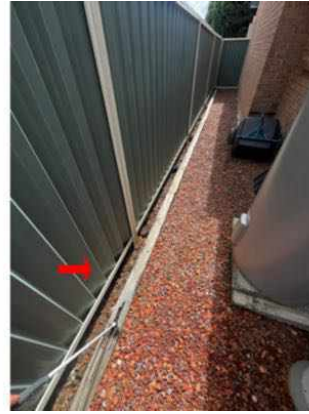
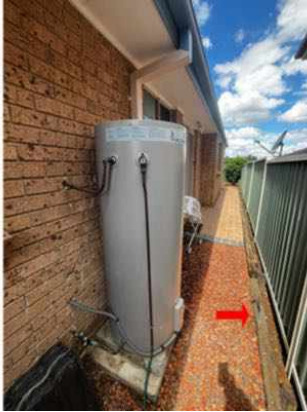
Finding 6.03

Building:	Main Building
Location:	All Areas
Finding:	Building materials in direct ground contact - conducive to termites
Information:	Where timber elements are in direct contact with the ground and consequently moisture or dampness they become conducive to termite activity. Whether timber is used as a building element part of a fencing structure or stored as an unused item they can provide an environment that is attractive to termite infestation.

When met with excessive moisture timber begins to decay and develop wood rot. Any timbers that are in direct contact with external grounds especially if left untreated or non-durable also provide ingress for subterranean termites into that particular element.

The removal of any such materials that may be conducive to termite activity should be removed as soon as possible to minimise the risk of termite attack.

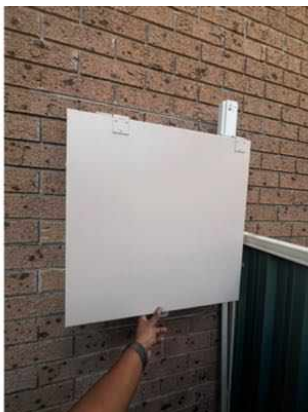
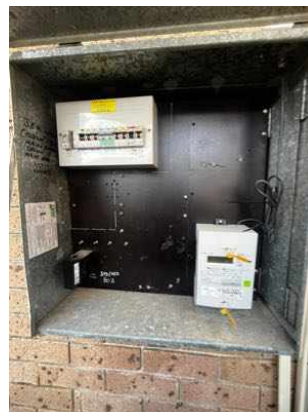
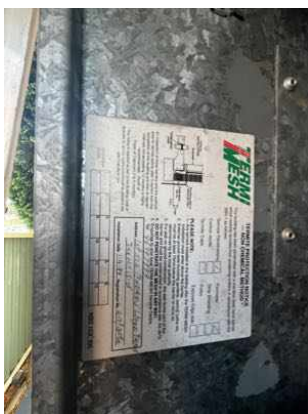
Building:	Main Building
Location:	Electrical Switchboard
Finding:	Evidence of a previous termite management system was identified
Information:	Upon Inspection There was a Durable Notice of Termite treatment identified but the date and the information in the notice was not readable/ identifiable - So It is highly recommended to have a termite treatment organised and to follow a termite treatment proposal and keep note of the system every 12 months in duration.

Where a Termite Management System has been identified you should refer to the type of barrier date of installation warranty conditions and any documentation provided by a builder or past owner. Consult the company who installed the barrier to confirm whether the system is still under warranty.

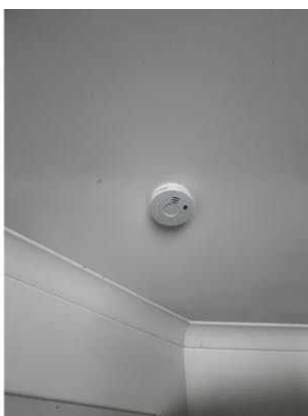
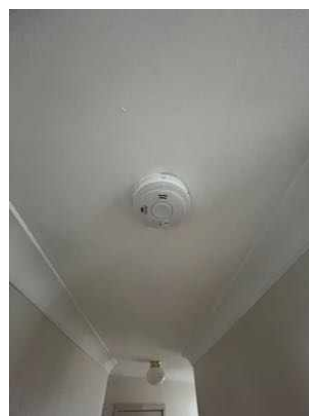
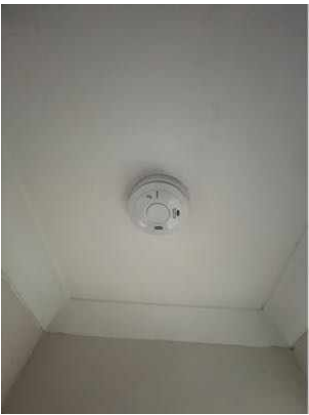
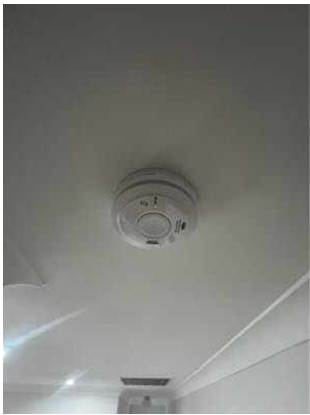
Building: Main Building
 Location: All Internal Areas
 Finding: Smoke Detector and Alarms
 Information: Reporting on Smoke Detectors or Alarms, including hard wired smoke detection systems and their legislative requirements, is outside the Scope of this Report.

Additionally, it is advised that all smoke detectors be tested by the homeowner on a monthly basis.

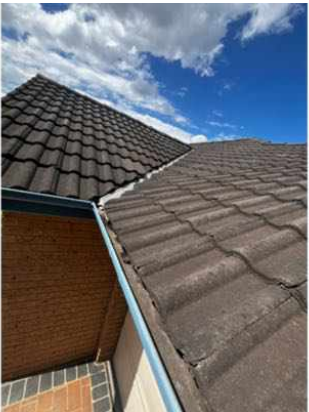
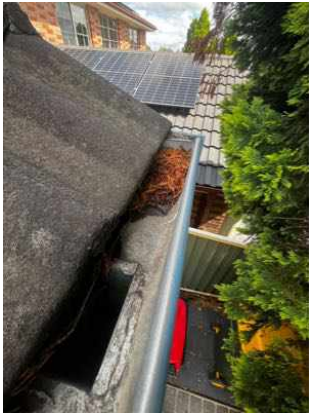
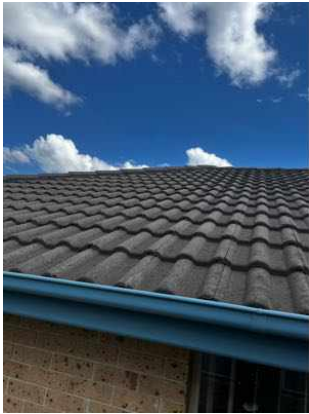
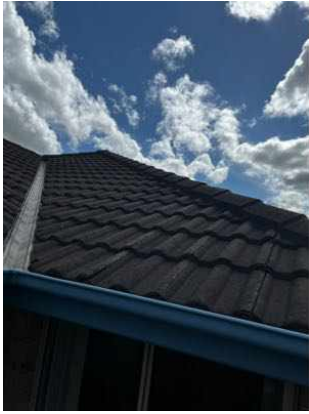
Building: Main Building
Location: Roof Exterior
Finding: Roof tiles - Weathered
Information: Upon inspection of the exterior roofing, the majority of roof tiles were considered to be in a fair condition. While weathering of the tiles is consistent with the age of the property, maintenance works are required.

Where left unmanaged, deteriorating roof tiles are likely to lead to a number of secondary defects, including minor water leaks and weather exposure to internal roofing structures.

Consultation with a roofing contractor is highly advised to gain advice on cost of remedial works that may be required in the short to medium term. Remedial works are likely to increase the longevity of the exterior roofing structure.

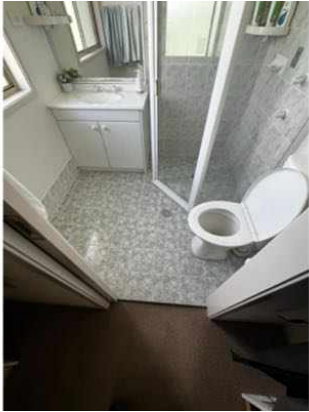
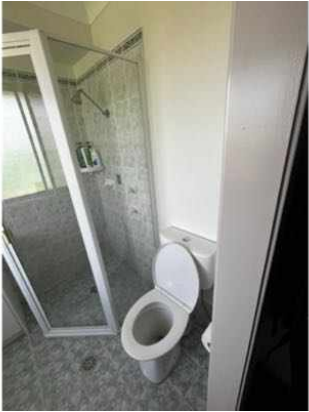
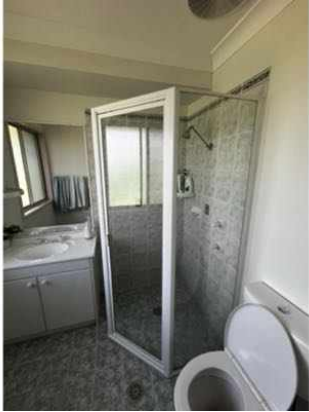
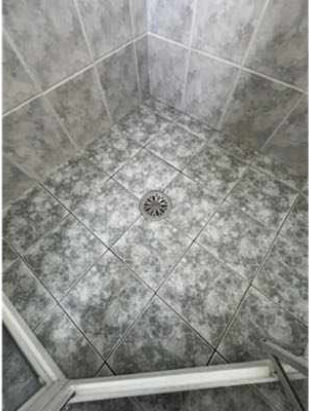
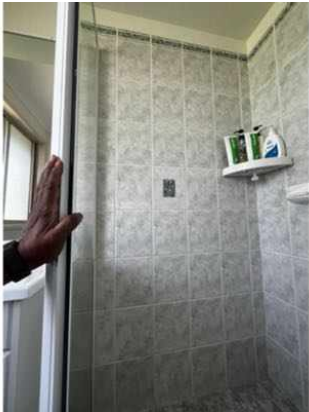
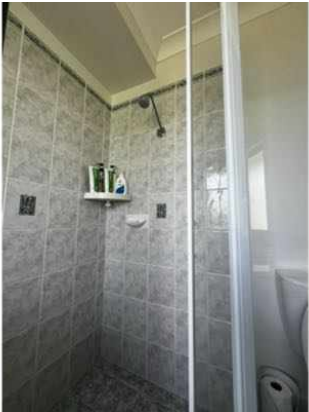
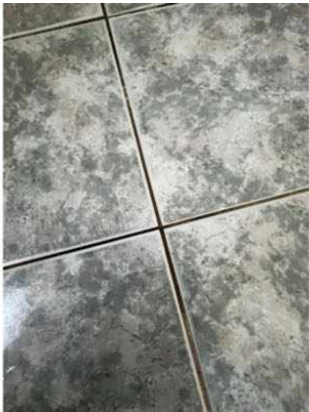
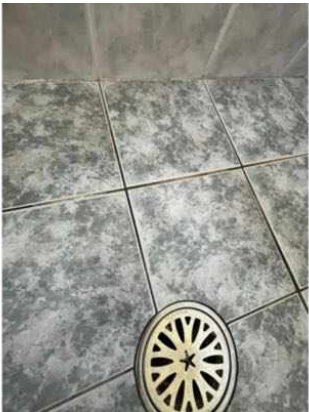
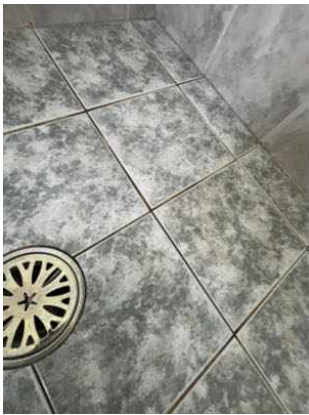
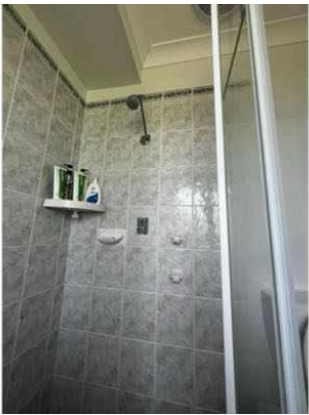
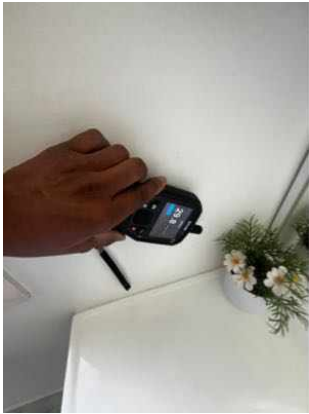
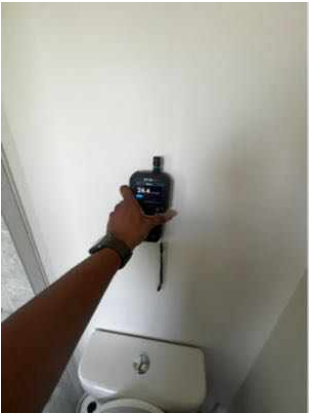
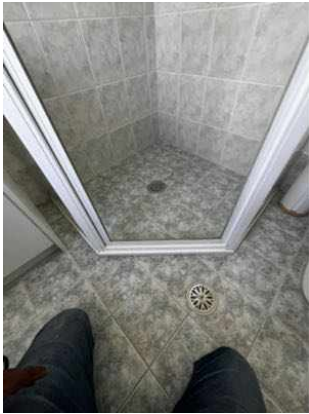
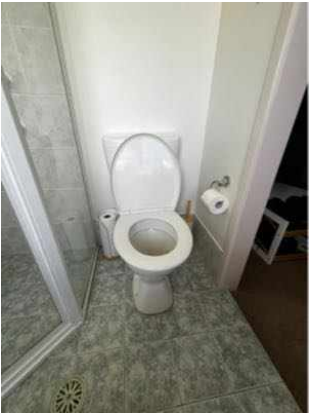
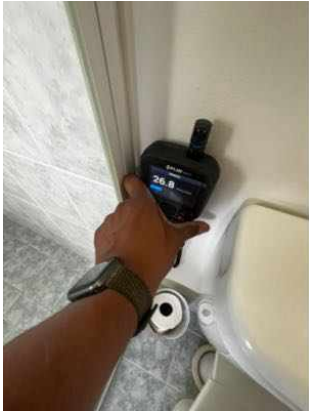
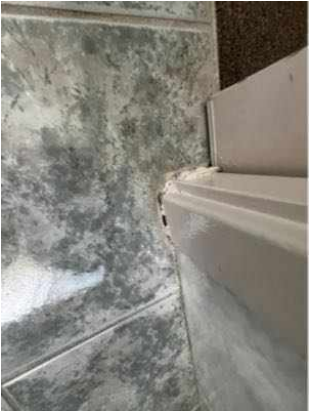
Building: Main Building
Location: Ensuite
Finding: For information only
Information: A Cluster of Photos taken at the time of inspection.

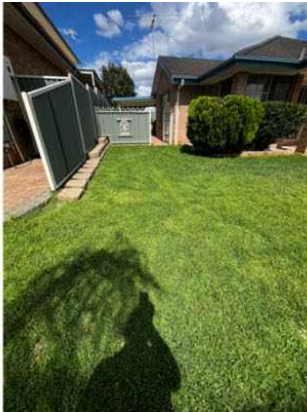
The general adequacy of site drainage is not included in the standard property inspection report. Comments on surface water drainage are limited as where there may have been either little or no rainfall for the period of time, Surface water drainage may appear to be adequate during the inspection but then during periods of heavy rain, may be found to be inadequate.

Any comments made in the section are relevant only in light of the conditions present

at the time of inspection. It is recommended that a smoke test be obtained to determine any illegal connections, blocked or broken drains.

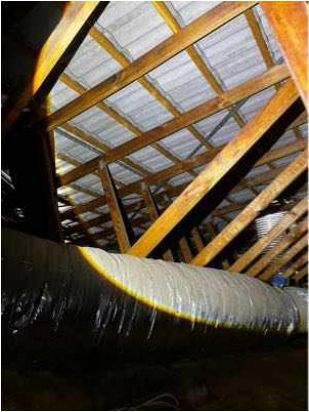
Building:	Main Building
Location:	Roof Void
Finding:	Sarking - Missing
Information:	Sarking is missing under the roof sheeting. Sarking acts as an insulator that helps with noise reduction and protects against water penetration. Sarking plays a key role in the operation and function of the overall roofing structure and its performance.

Although not a requirement at the time of construction, replacement of any missing building element is advisable (although this can be quite expensive to do after the time of construction). Where sarking is missing, regular inspections of the roof tiles for cracking and potential moisture penetration is required.

Sarking may be retrospectively fitted by a registered builder at the discretion of the client.
