# Building and Timber Pest Inspection Report

Inspection Date: Tue, 3 Feb 2026

Property Address: 6/3 Parkside Parade, Toronto NSW 2283,  
Australia

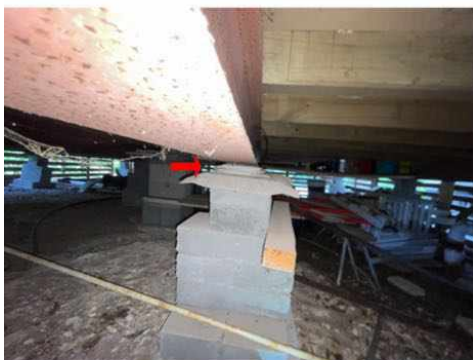
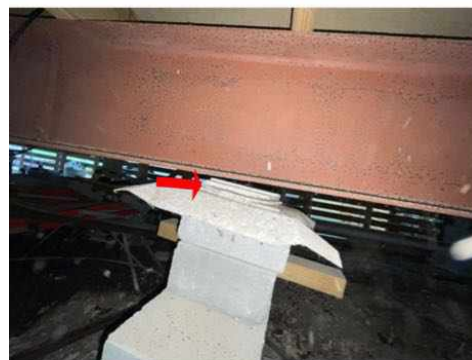
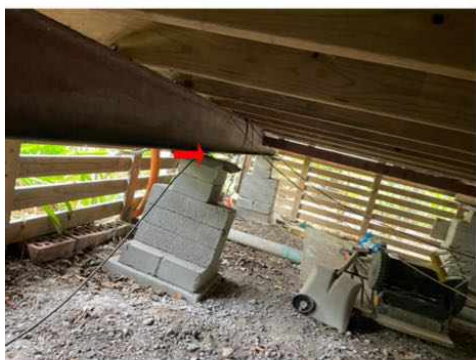
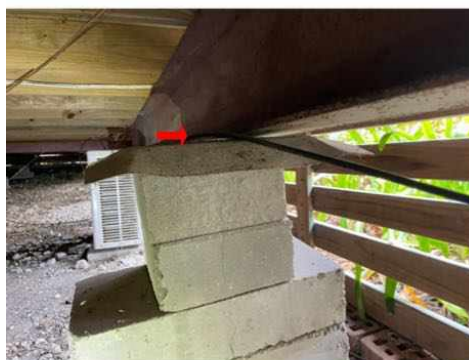
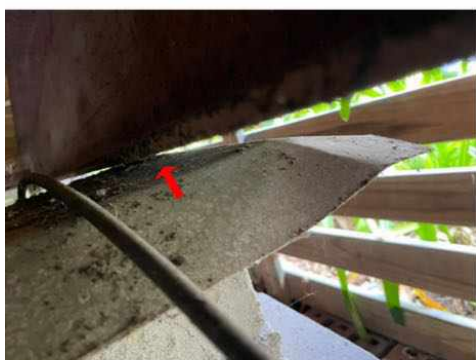
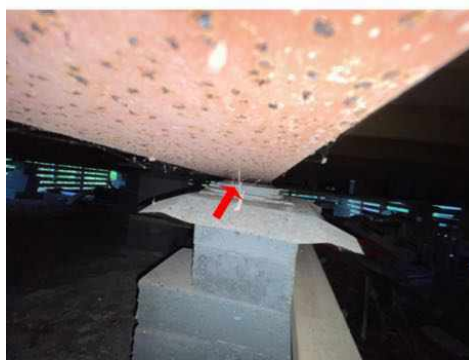
Building: Main Building  
 Location: Subfloor > All Areas  
 Finding: Subfloor Blockwork Stumps – Subsidence, Loss of Contact  
 Information: Several blockwork stumps within the subfloor space appear to have subsided and are no longer providing adequate support to the floor framing above. At least two stumps were observed to have lost contact with the bearers or joists, and one stump is noticeably out of vertical alignment. Packing to some stumps appears inconsistent, and overall support to the structure in these locations is compromised.

The loss of effective load transfer from the structure to the ground can result in uneven floor levels, increased movement, cracking to walls and finishes above, and progressive structural deterioration if left unaddressed. Continued settlement or misalignment of stumps may place additional stress on adjacent structural members, potentially leading to further displacement, service damage, or long-term structural issues.

It is recommended that a licensed builder or structural engineer be engaged to assess the adequacy of the subfloor support system and determine the extent of rectification required. Remedial works may include re-levelling, replacement or underpinning of affected stumps, and ensuring all stumps are correctly founded, aligned, and in full bearing contact with the supporting structure. Rectification should be carried out promptly to reduce the risk of further movement and associated damage.

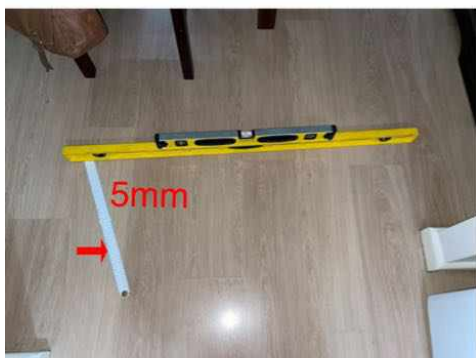
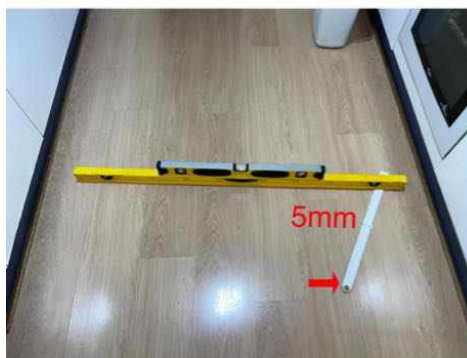
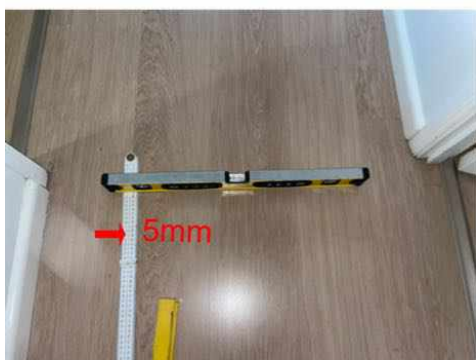
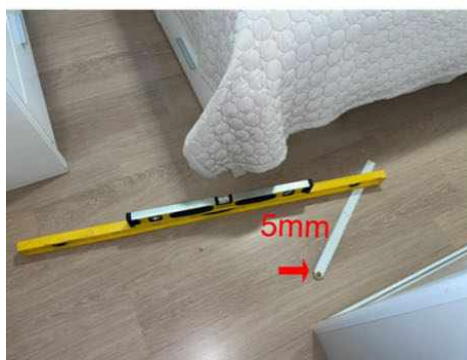
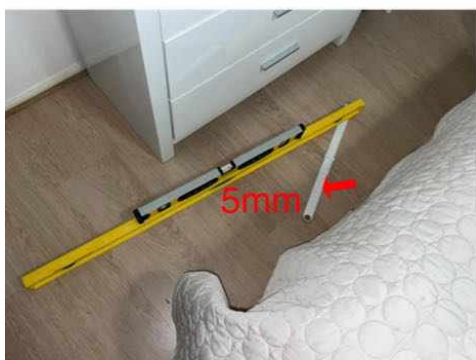
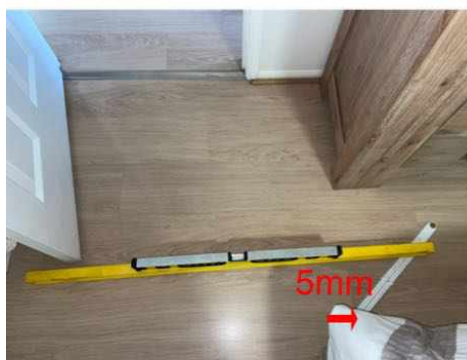
### Finding 3.01

Building:	Main Building
Location:	All Internal Areas > All Areas
Finding:	Flooring - Uneven
Information:	The internal flooring in this area is out of level and uneven by about 5mm to a number of areas. Uneven flooring is likely to indicate minor defects such as expected movement of the foundations of the property, but may also indicate subsidence of the associated subfloor stumps.

It is advised that the flooring be closely monitored to identify any further movement. Where flooring remains relatively unchanged for an extended period of time (i.e. several months), it is likely that this defect has been caused by expected movement of the foundations of the property.

However, where flooring is uneven further, potentially invasive inspection of the subfloor structures and stumps in this area is required. In this case, works to repair are likely to be required, and would be carried out by a registered builder specialising in re-stumping.

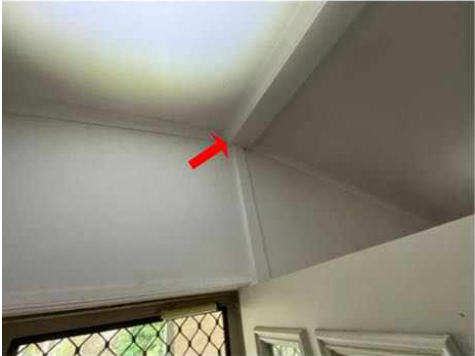
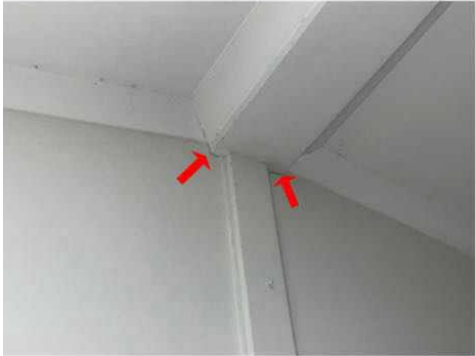
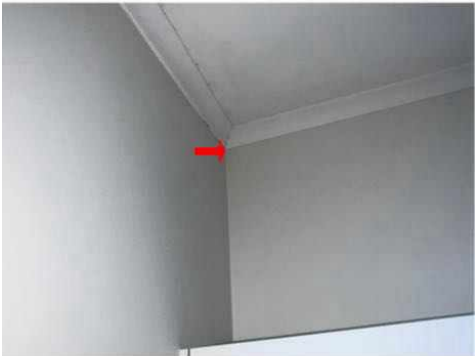
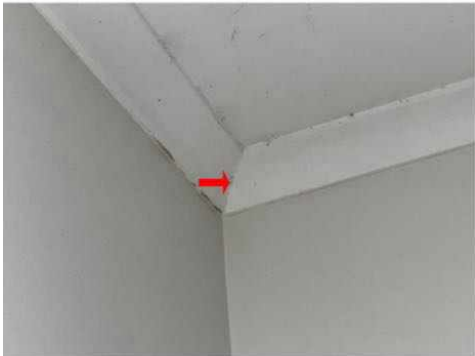
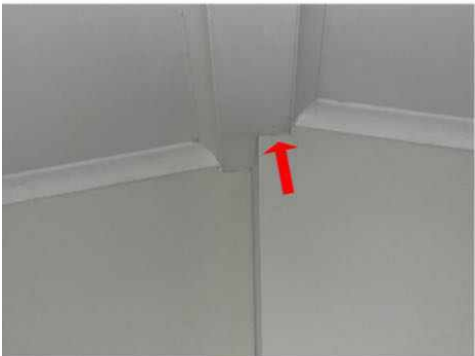
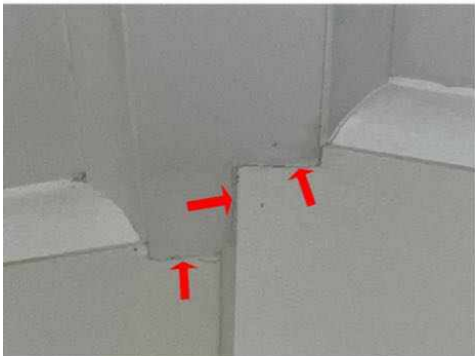
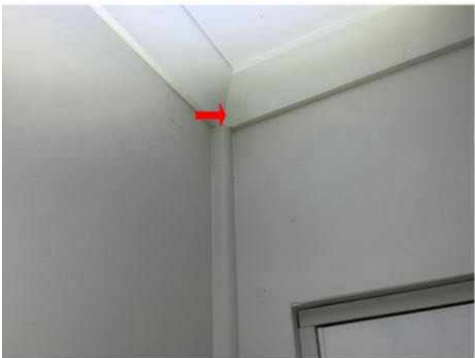
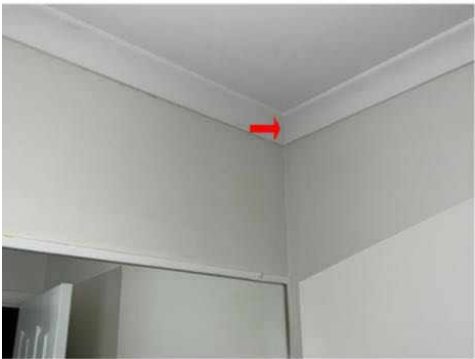
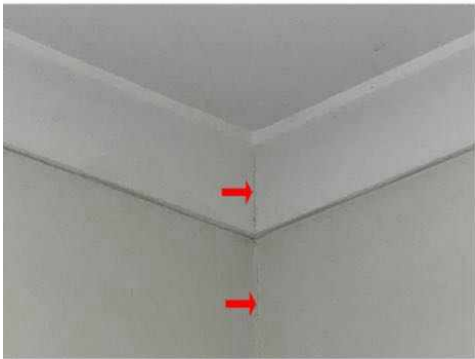
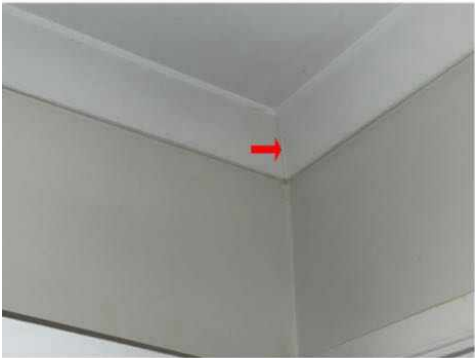
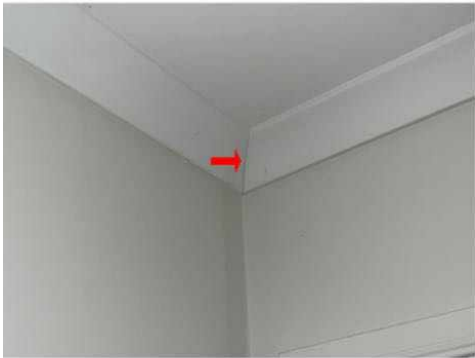
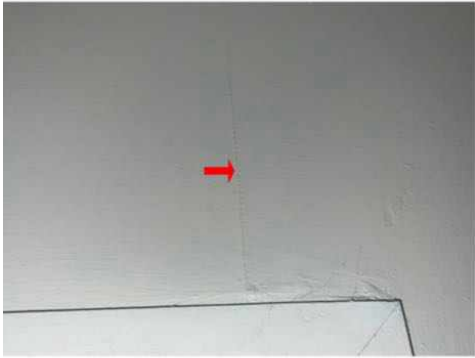
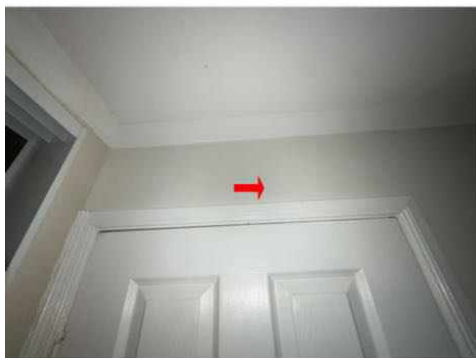
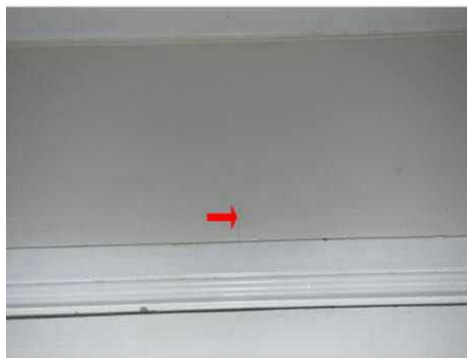
### Finding 3.02

Building:	Main Building
Location:	All Internal Areas > All Areas
Finding:	Cracking - Damage Category 1 - Fine (up to 1mm)
Information:	Cracks were evident to the plasterboard above several doors and to the corner of some of the cornice. Although fine cracks are quite noticeable, they are often only considered to be an appearance defect, and usually do not indicate any structural damage. Generally, the cause of a fine crack is indicative of a separation between building materials and finishes (e.g. paint, plaster, etc.) along joins.

Cracking of this nature can generally be repaired with minor sanding, filling and/or repainting. Such works should be performed by a qualified painter or a general

handyman.

Monitoring of all cracking should be conducted frequently. Always contact a building inspector should cracks widen, lengthen, or become more numerous.

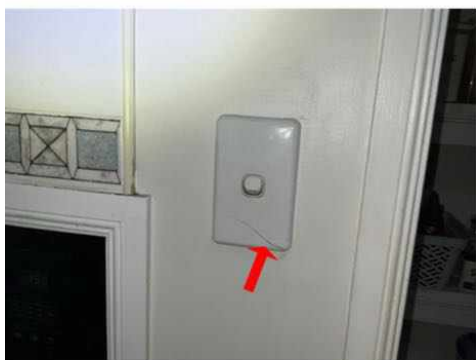
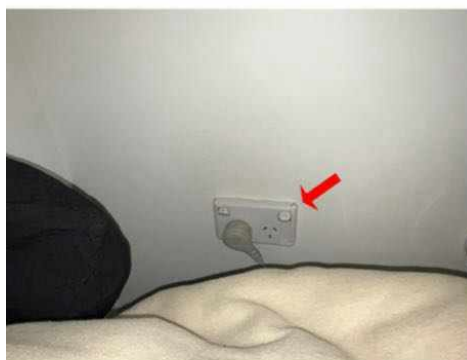
### Finding 3.03

Building:	Main Building
Location:	Bedroom, Kitchen > Front Left, Centre Right
Finding:	Electrical fitting - Broken
Information:	Two electrical fittings were observed to have broken covers, likely as a result of impact damage.

Damaged or missing covers may expose internal components to moisture, dust, or accidental contact, increasing the risk of electrical faults or safety hazards.

It is recommended that the affected fittings be inspected and repaired or replaced by a licensed electrician to ensure they are safe and compliant.

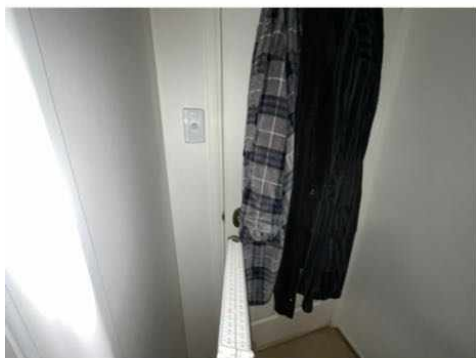
### Finding 3.04

Building:	Main Building
Location:	Bedroom 2 > Centre Right
Finding:	Door handle - Not latching
Information:	It was noted that the door in this area was not latching during operation at the time of inspection. Whilst detracting from the functionality of this building element, this minor defect may also be a security risk, and may therefore have serious implications if left unattended.

It is suspected that this defect has occurred due to minor issues with the associated hinges. Such damage is identified as general wear and tear, which is expected for building elements of this age.

A qualified carpenter or general handyperson may be appointed to perform rectification works as necessary, at client discretion. If left unattended, further functional impairment is likely to occur.

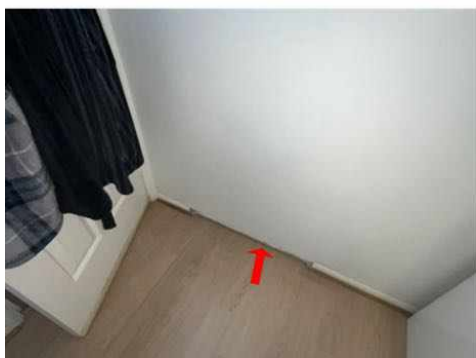
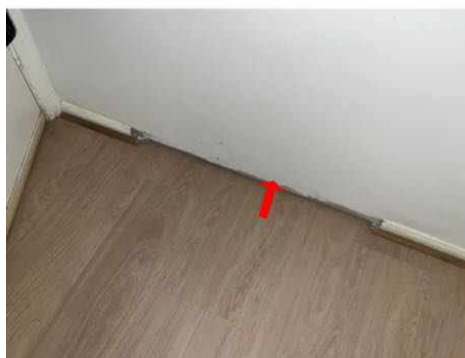
### Finding 3.05

Building:	Main Building
Location:	Bedroom 2 > Centre Right
Finding:	Skirting - Missing
Information:	Skirting acts to cover the intersection or joins between flooring and walls. It was noted at the time of inspection that skirting to the centre left bedroom is missing, most likely due to works in which a door was removed and an infill wall has been constructed.

Skirting works to protect the joins between these building elements and the incomplete skirting also detracts from the overall appearance of the area.

Installation of the skirting is advised to ensure the protection and longevity of any associated building elements. Such works may be performed by a general handyperson or qualified carpenter.

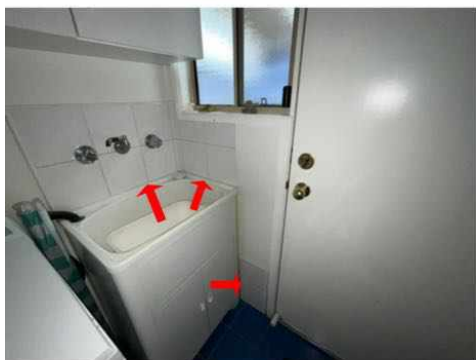
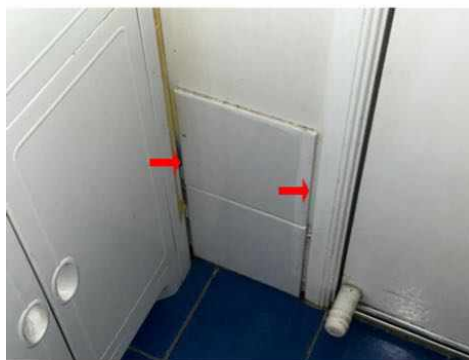
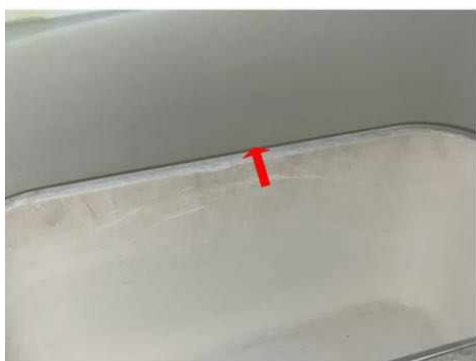
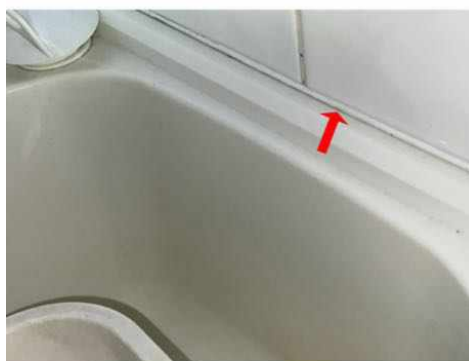
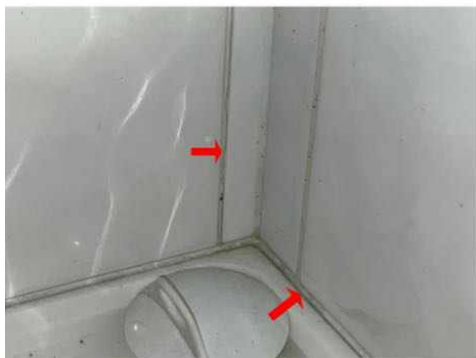
### Finding 3.06

Building:	Main Building
Location:	Laundry > Centre Left
Finding:	Sealant and grouting - Missing or damaged
Information:	It was noted on inspection that sealant or grout is cracking to laundry tub splashback and missing from skirting tiles.

Different materials and floor areas move at different rates, generally causing cracking to grout or sealant at this point. A flexible sealant is required to allow for expected expansion and contraction, while keeping the joint water tight and protective of all associated building materials.

Flexible and mould resistant materials should be applied to affected areas to prevent any subsequent water damage that is likely to occur. Regular maintenance and replacement of damage or missing or damaged sealant and grout is highly recommended to the wet areas, as this is a regular wear and tear defect. Sealant and grouting in areas that come into regular contact with water should be maintained for the long term care of your property.

A sealant specialist or tiling contractor should be appointed to complete these works as soon as possible

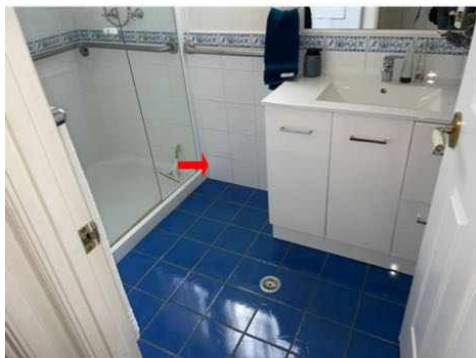
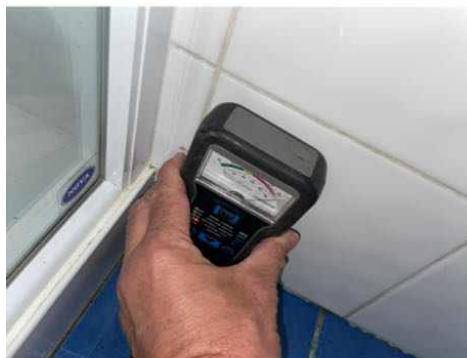
### Finding 3.07

Building:	Main Building
Location:	Bathroom > Rear
Finding:	Moisture Located Externally to the shower screen
Information:	Damp is evident to the tiling adjacent to the shower screen on the exterior side. The moisture meter showed high levels of moisture. This defect is suspected to have been caused by moisture permeating through the tiling in this area or an inadequate or worn shower screen seal. Also it is evident that a tile has been replaced in this area.

Damp (or structural damp) refers to the presence of unwanted moisture in the structure of a building, either as the result of intrusion from outside, or condensation from within the structure. In the shower area, internal water leaks or other sources of excessive moisture are generally the cause of damp.

Unmanaged damp in the shower recess is likely to facilitate the formation and development of mould and fungi growth, decaying associated building materials and compromising their structural integrity. It is important to address damp conditions, as the World Health Organisation notes that excess moisture leads - on almost all indoor materials - to growth of microbes such as moulds, fungi and bacteria, which subsequently emit spores and other matter into the indoor air. Exposure to these contaminants is associated with a wide range of respiratory and other health-related problems.

Consultation with a qualified plumber or bathroom specialist is advised to identify the cause of damp and to perform remedial works as required.

Always ensure that sealant and grout is in good condition to prevent any moisture

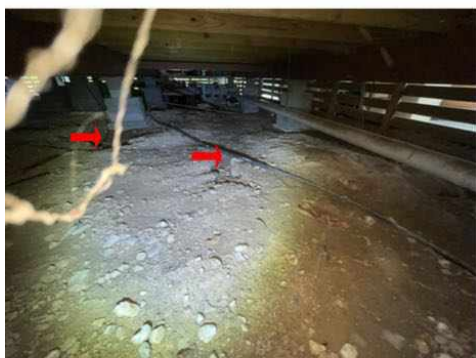
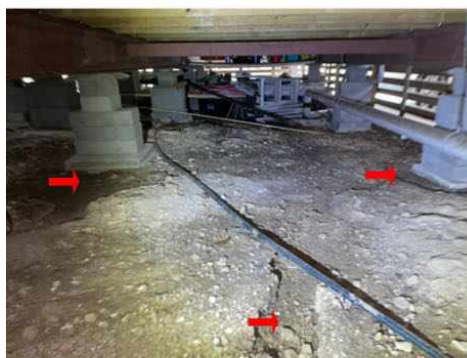
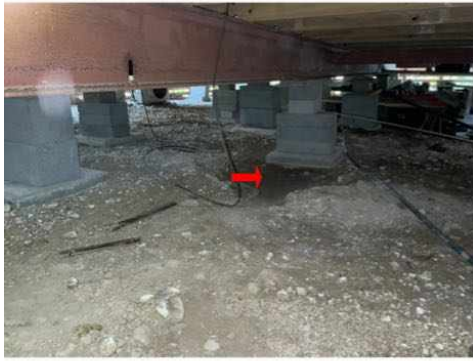
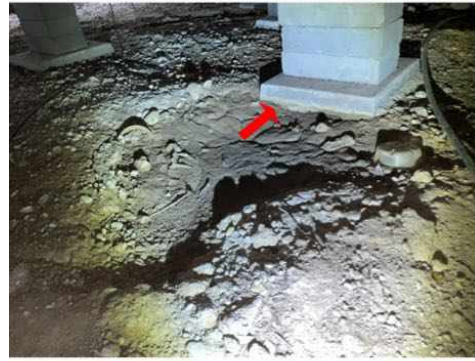
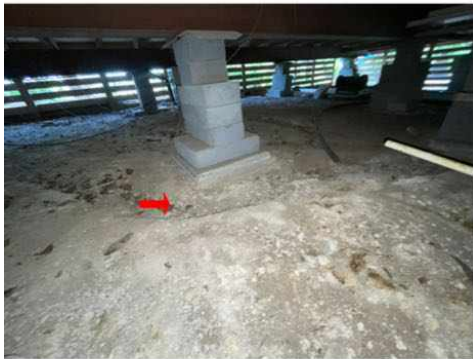
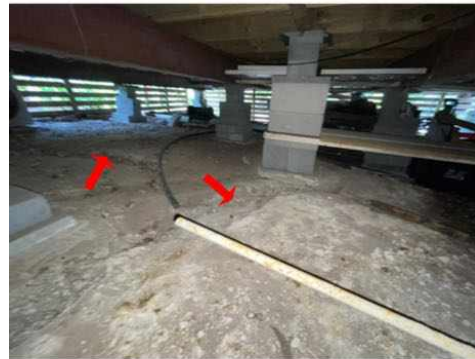
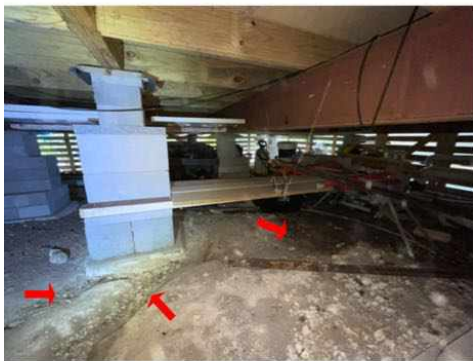
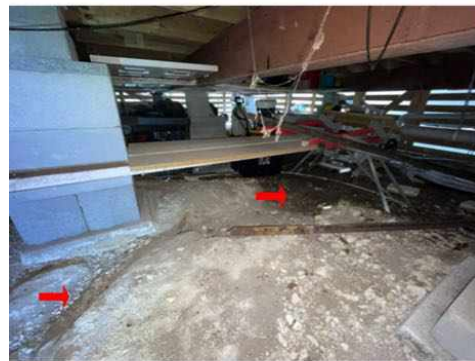
Building: Main Building  
 Location: Subfloor > All Areas  
 Finding: Subfloor Site Drainage - Inadequate  
 Information:

The site drainage within the subfloor area was found to be inadequate at the time of inspection. It was evident that areas within the subfloor space were moist, creating potential for subsequent water damage to associated building elements. This is also apparent as there appears to be some subsidence to the soils within the subfloor space. Poor site drainage can also lead to subsidence of the stumps.

It is important that water does not lie against the base of walls; surrounding paths and ground levels should be sloped to drain water away from walls. Stormwater should be carried away by large, regularly cleaned drains. Ground levels may need to be lowered to expose a buried DPC.

Where site drainage is inadequate, installation of an Agricultural (Aggie) Drain may be required. A qualified plumber should be appointed to further inspect the property and perform any remedial works as necessary. Water damage and secondary defects are likely to occur if left unmanaged.

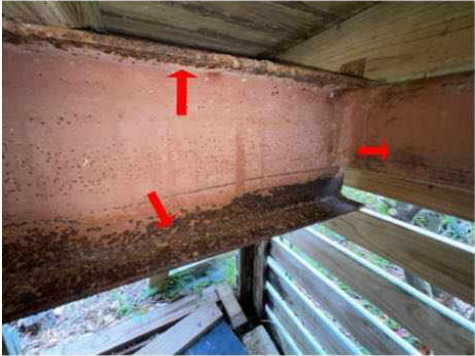
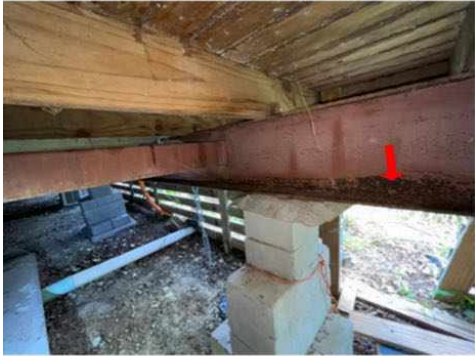
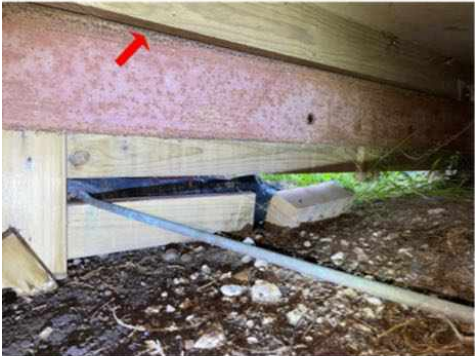
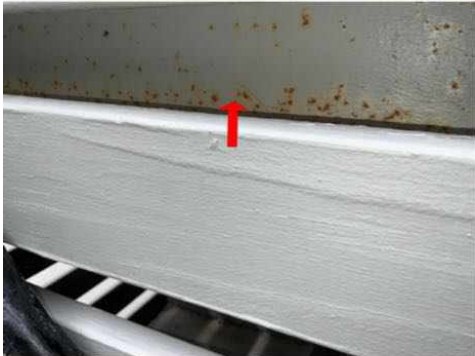
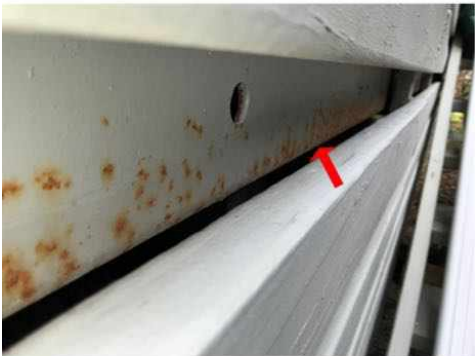
### Finding 3.09

Building:	Main Building
Location:	Subfloor > All Areas
Finding:	Steel Beams - Rusted or corroded
Information:	The steel beams supporting the dwelling are beginning to show evidence of surface rust, which is likely to have developed as a result of exposure to moisture and or inadequate coatings.

As surface rust provides no protection to the underlying iron, the deteriorating condition is likely to worsen if not addressed in the short-term future.

in rust prevention, as does regular general maintenance. Rust formation can be controlled with coatings, such as paint, that isolate the iron from the environment.

Rusting and corrosion should be managed by ideally removing or limiting the affected surface from exposure to moisture. A builder may be appointed to replace any building elements that have been severely affected by rust or water damage.

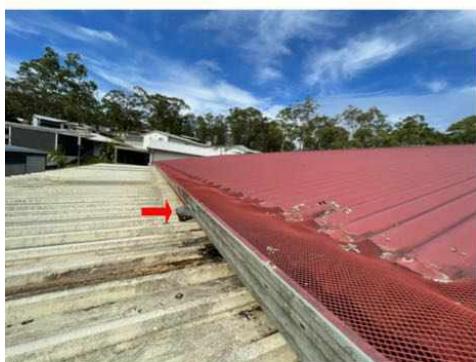
**Finding 3.10**

Building: Main Building  
Location: Roof Exterior > Centre Left  
Finding: Downpipe outlet - Rusted

Information: The downpipe outlet does not have a spreader installed and shows signs of rusting at the outlet.

The absence of a spreader may result in concentrated discharge of rainwater, increasing the risk of erosion, splashing against building elements, or overloading of the receiving surface. Ongoing corrosion may further reduce the serviceability of the downpipe.

It is recommended that a suitable spreader be installed and the rusted sections assessed and repaired or replaced as required by a qualified contractor as soon as possible to prevent further damage.

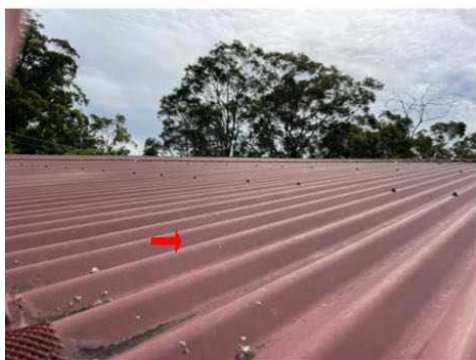
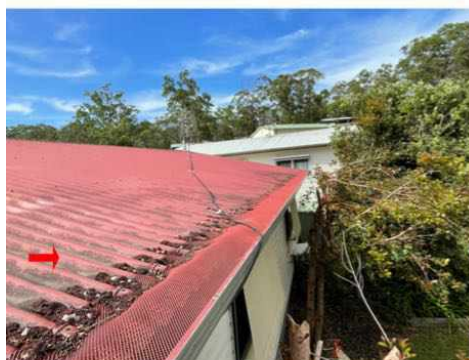
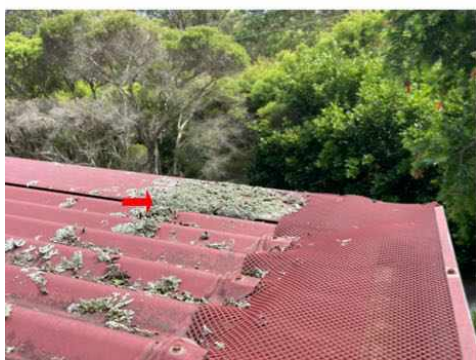
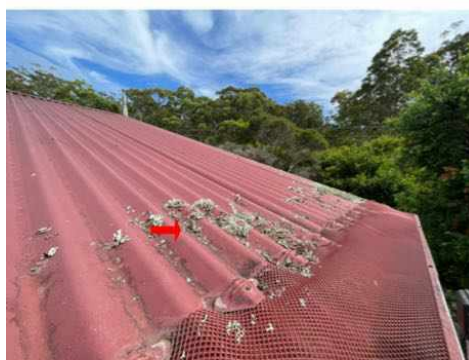
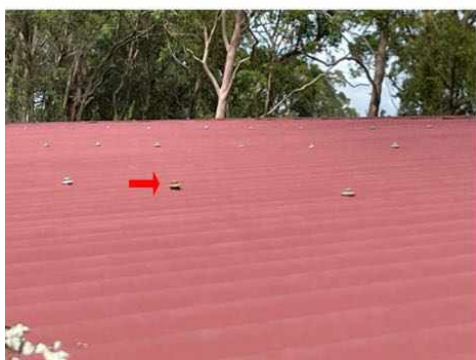
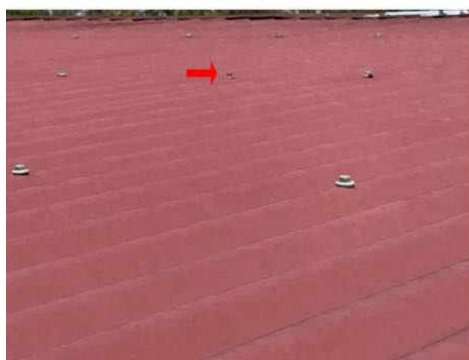
### Finding 3.11

Building: Main Building  
 Location: Roof Exterior > All Areas  
 Finding: Roof sheeting - Defects  
 Information: The roof sheeting shows minor defects including general fading, areas of lichen growth, and some roofing screws showing early signs of rusting with rubber seals beginning to deteriorate.

While these issues are considered minor at the time of inspection, deteriorated screw seals and corrosion may allow water ingress over time, potentially leading to leaks, moisture damage to roof framing, and accelerated deterioration of the roofing materials.

It is recommended that the roof be cleaned to remove lichen, and that affected screws and deteriorated rubber seals be monitored and replaced as required as part of routine roof maintenance by a suitably qualified contractor.

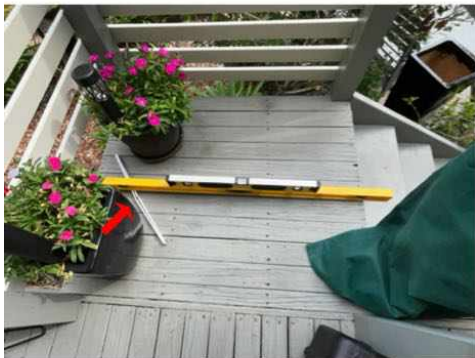
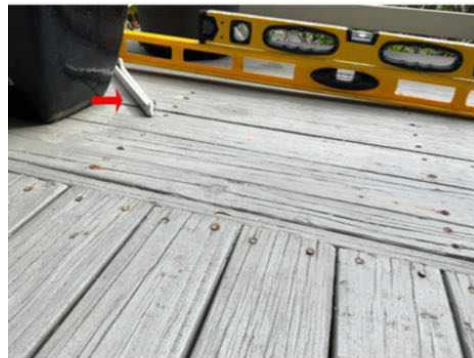
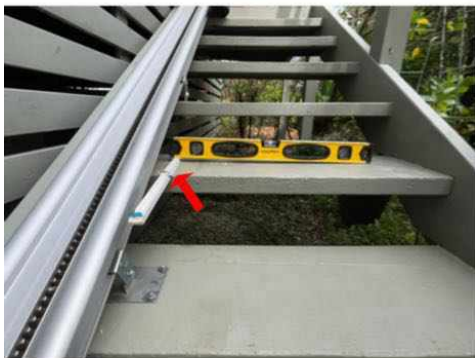
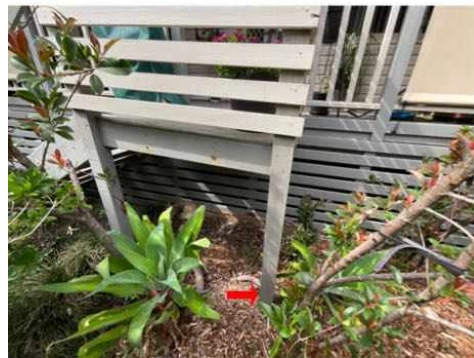
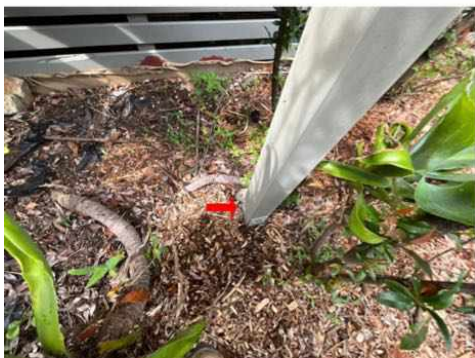
### Finding 3.12

Building:	Main Building
Location:	Deck > Front
Finding:	Entry Stairs and Landing - Uneven
Information:	The timber entry stairs and the associated landing were observed to be out of level at the time of inspection. Measurements taken across the treads and landing indicate unevenness, with visual and physical evidence suggesting that one or more supporting posts may have subsided slightly. No immediate failure was observed; however, the misalignment is noticeable and exceeds what would typically be considered normal settlement or construction tolerance.

Uneven stairs and landings can present a trip hazard and may indicate movement or

inadequate support at the footing or post level. Continued subsidence or movement may lead to increased structural stress on the stair framing, loosening of fixings, accelerated wear to the timber elements, and potential safety concerns for occupants and visitors using the entry stairs.

It is recommended that the timber stairs, landing, and supporting posts be assessed by a licensed builder or carpenter. Further investigation of the post footings may be required to confirm adequacy and stability. Rectification may include re-levelling, packing, post or footing repair, or replacement as necessary to restore the stairs and landing to a safe and level condition.

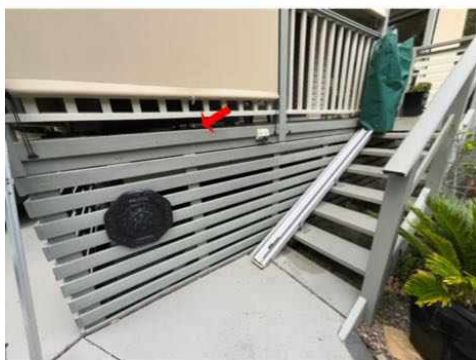
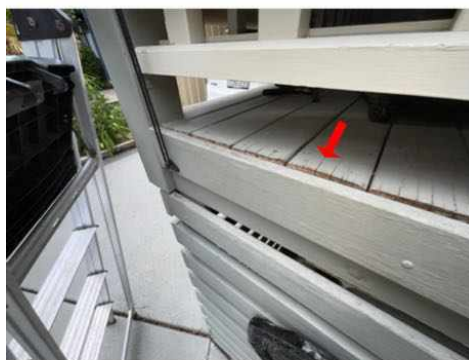
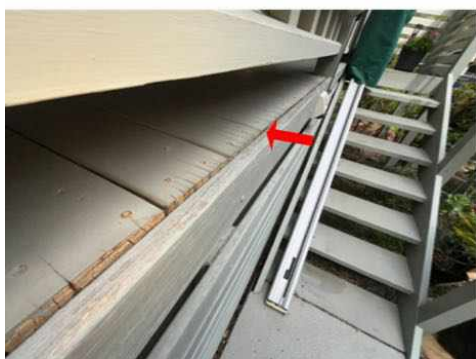
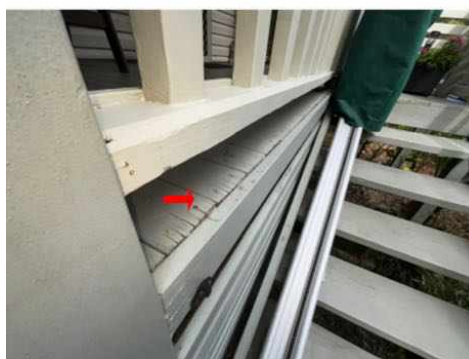
### Finding 3.13

Building:	Main Building
Location:	Deck > Front
Finding:	Decking boards - Weathered
Information:	The ends of several external decking boards were observed to be cracked and splitting, particularly to the exposed end grain. These areas show signs consistent with prolonged weather exposure and possible early-stage timber deterioration. The damage appears more pronounced at unsealed board ends, where moisture ingress is most likely to occur.

Cracking and deterioration to decking boards can allow moisture penetration into the timber, accelerating decay and potentially leading to wood rot over time. If left unaddressed, this may result in further weakening of the decking boards, increased maintenance requirements, and potential safety concerns where boards may become loose, unstable, or fail prematurely.

It is recommended that the affected decking boards be assessed by a licensed carpenter or builder. Remedial works may include sealing exposed end grain, repairing or replacing deteriorated boards, and ensuring ongoing protection through appropriate coatings or finishes. Timely maintenance will help extend the service life of the deck and reduce the risk of further deterioration.

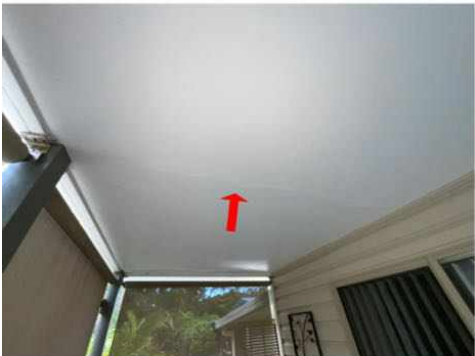
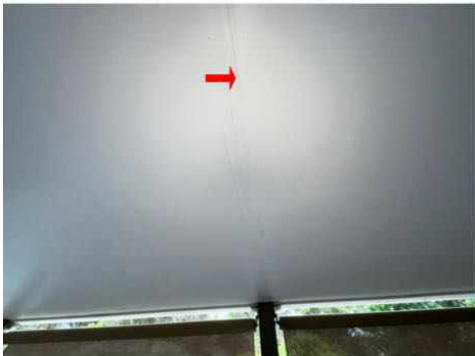
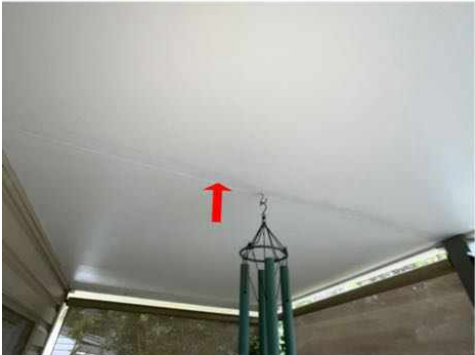
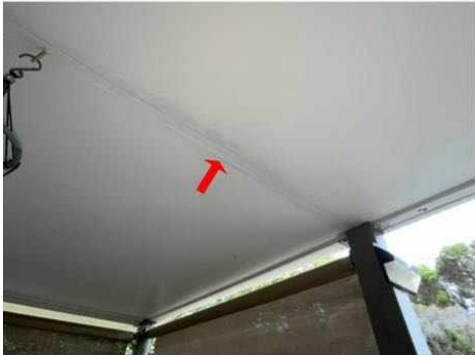
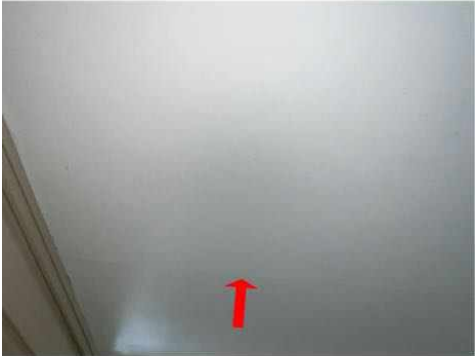
### Finding 3.14

Building: Main Building  
Location: Porch > Front  
Finding: Soffit Lining Joins - Incomplete  
Information: The joins to the soffit linings above the front entry porch show evidence of cracking, likely due to the linings not being sealed or joined adequately at the time of installation.

Cracking to these joints may allow moisture ingress over time, which can lead to further deterioration of the soffit linings and associated finishes if not addressed.

It is recommended that the soffit joints be properly sealed and finished by a suitably qualified tradesperson.

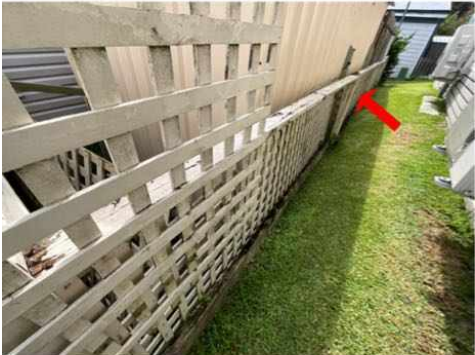
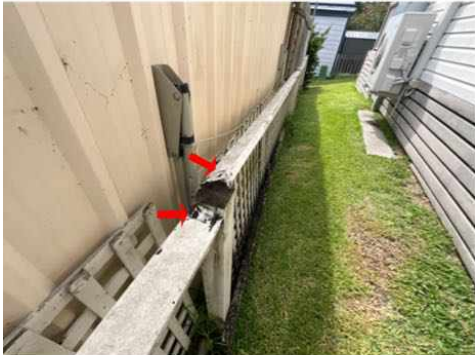
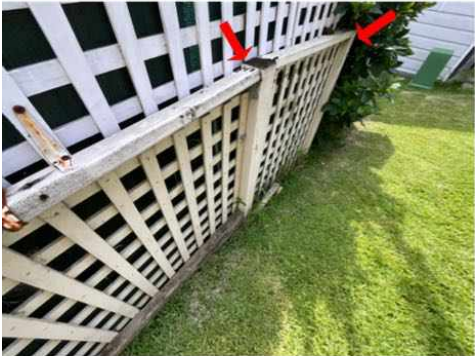
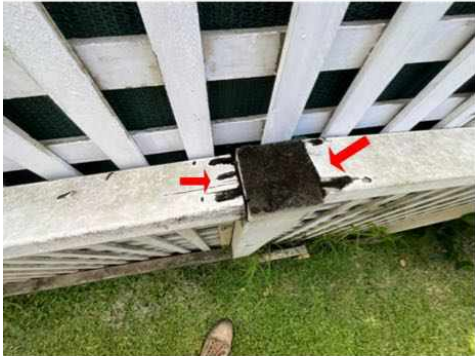
**Finding 3.15**

Building: Main Building  
Location: Yard - Back > Rear  
Finding: Rear Fence - deteriorating  
Information: The rear boundary fence was observed to be in poor condition, with several sections showing timber deterioration, including wood rot to posts, rails and capping members, splitting of timber, loose fixings and areas of leaning or misalignment. Vegetation is growing against and through parts of the fence, contributing to ongoing moisture exposure and accelerated decay.

The condition of the fence reduces its structural stability and may lead to further movement or failure of sections over time. Decayed timber and leaning sections may also present a safety risk and allow unintended access between properties if not addressed.

It is recommended that the fence be assessed by a suitably qualified fencing contractor. Repairs or replacement of deteriorated sections should be carried out as required, with vegetation cleared away from the fence line. In some areas, full replacement may be more appropriate than localised repairs, subject to boundary responsibilities.

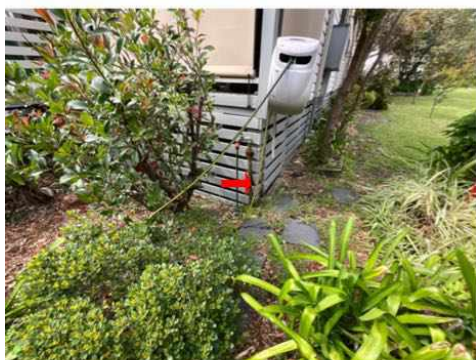
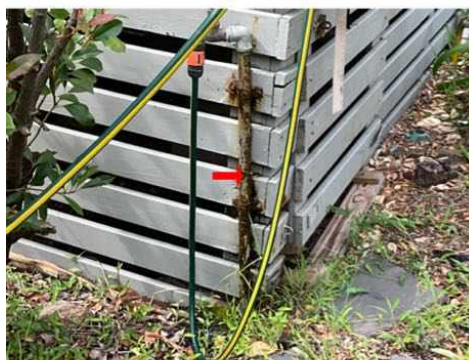
### Finding 3.16

Building:	Main Building
Location:	Yard - Front > Front Right
Finding:	Tap - Leak
Information:	The external tap shows evidence of active leaking, with visible water staining and corrosion to the pipework below.

Ongoing leakage may lead to persistent moisture at ground and wall level, which can contribute to deterioration of adjacent materials and may increase the risk of termite attraction.

It is recommended that the tap and associated pipework be repaired or replaced by a licensed plumber and the surrounding area monitored for moisture-related issues.

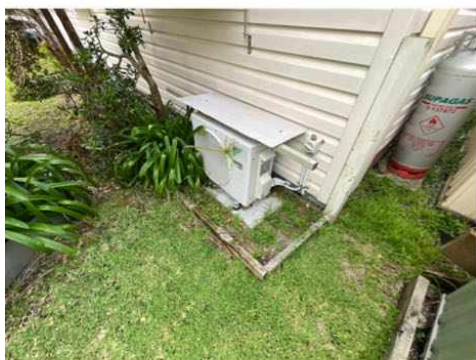
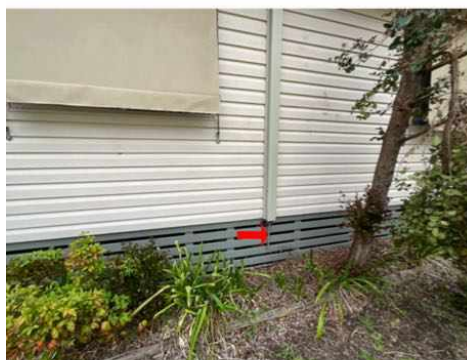
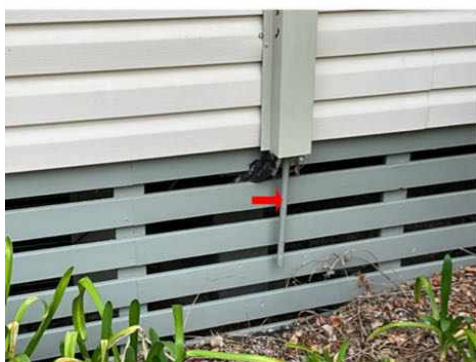
Building:	Main Building
Location:	Exterior walls - right side > Centre Right
Finding:	Air Conditioning not connected to the stormwater
Information:	The Air Conditioner (A/C) overflows were found to be disconnected from storm water drainage which can result in the surrounding area becoming excessively damp. These damp conditions can lead to secondary defects such as rot, rust or corrosion of associated building elements, the formation of fungal decay, or even the creation of potential slip hazards.

Such leaking creates an environment which is conducive to an array of defects, including water damage to associated building elements and the attraction of termite or timber pest infestation.

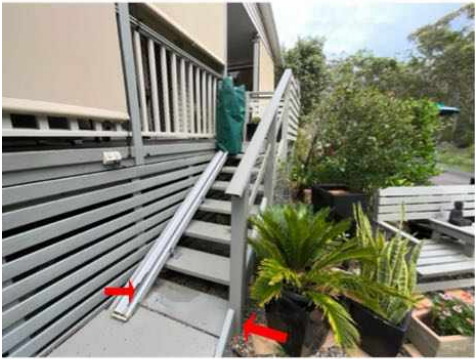
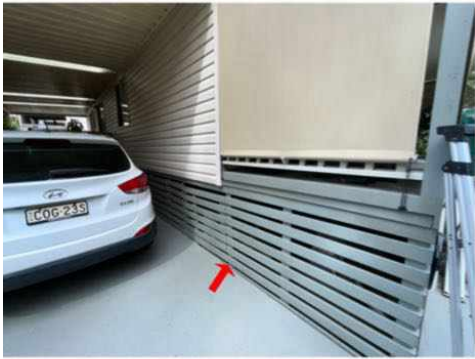
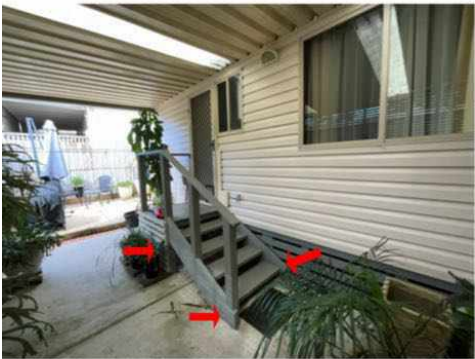
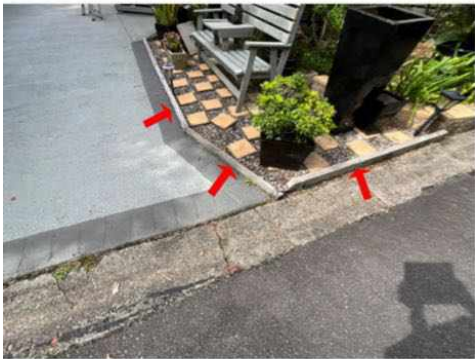
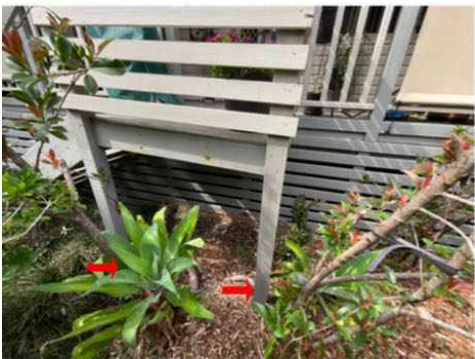
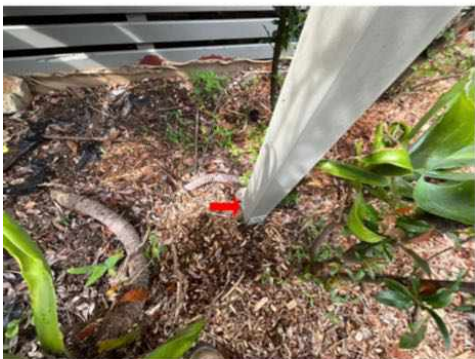
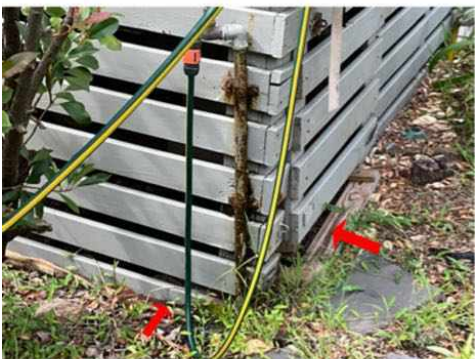
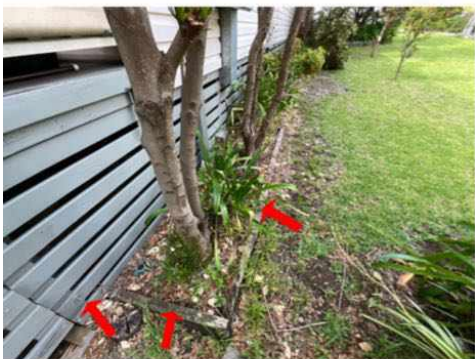
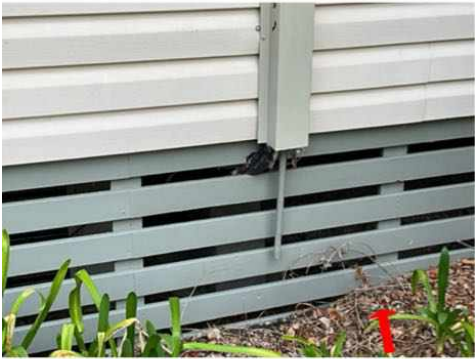
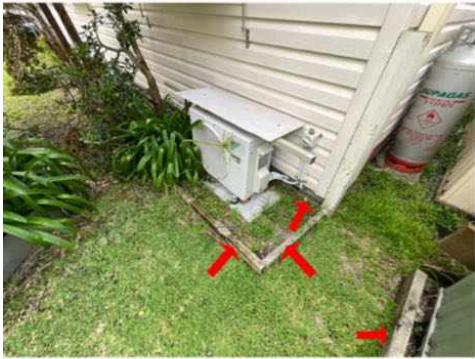
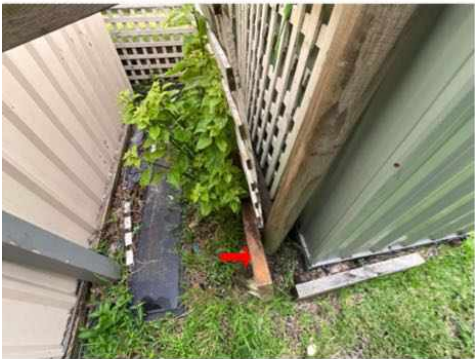
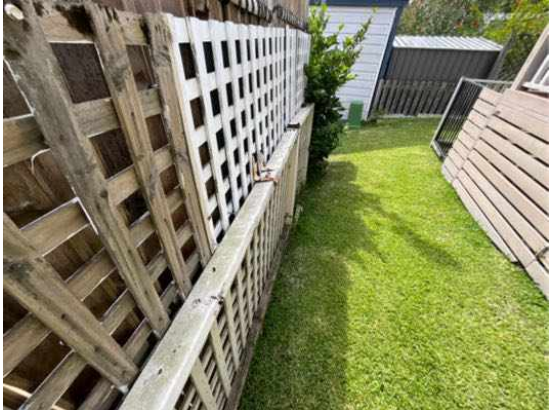
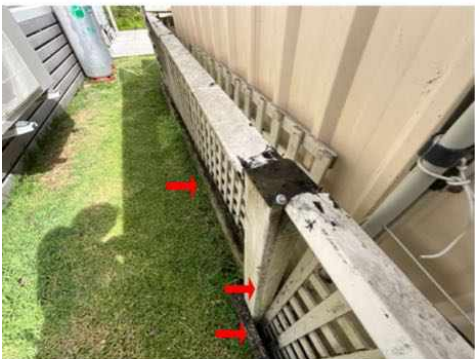
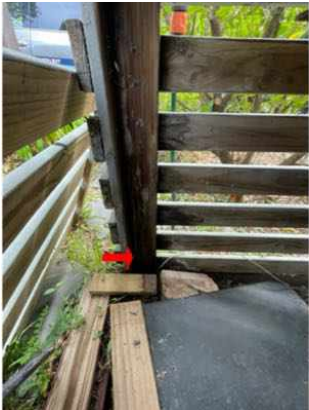
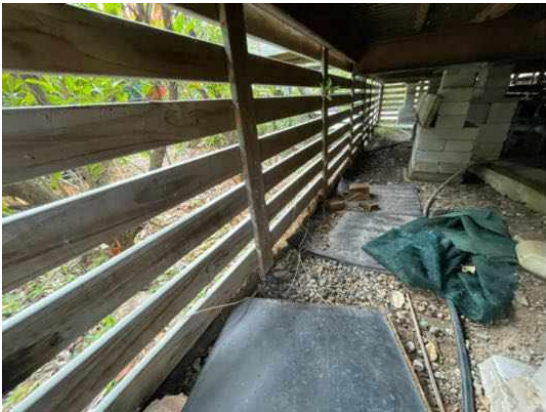
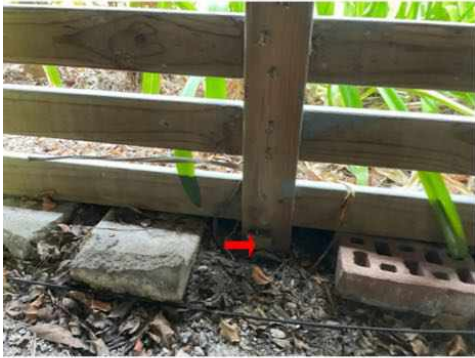
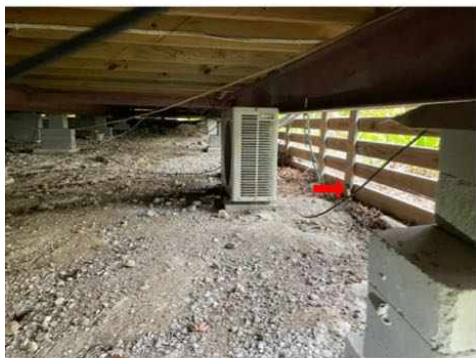
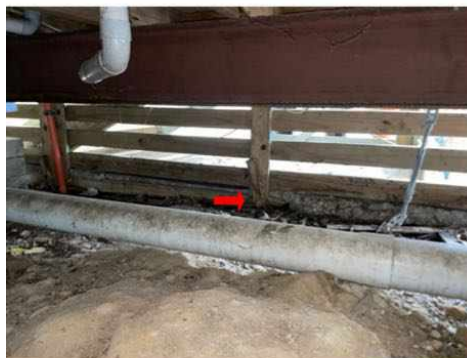
### Finding 6.02

Building:	Main Building
Location:	All Areas > All Areas
Finding:	Building materials in direct ground contact - conducive to termites
Information:	There are a number of areas including the front deck and steps, the timber fence and numerous timber plinths that were in touch with the ground. Where timber elements are in direct contact with the ground and consequently moisture or dampness they become conducive to termite activity. Whether timber is used as a building element part of a fencing structure or stored as an unused item they can provide an environment that is attractive to termite infestation.

When met with excessive moisture timber begins to decay and develop wood rot. Any timbers that are in direct contact with external grounds especially if left untreated or non-durable also provide ingress for subterranean termites into that particular element.

The removal of any such materials that may be conducive to termite activity should be removed as soon as possible to minimise the risk of termite attack.

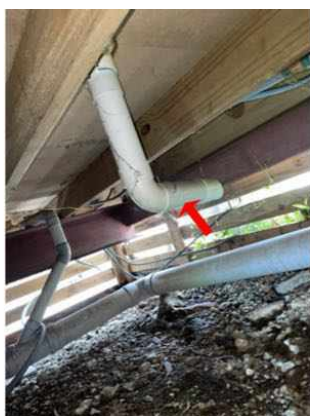
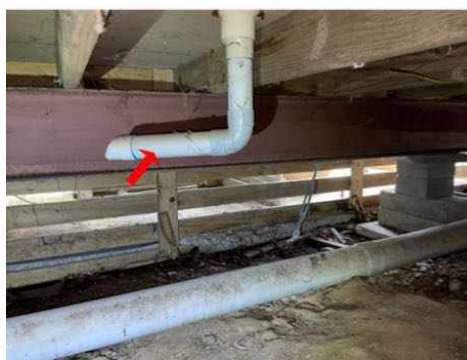
### Finding 6.03

Building:	Main Building
Location:	Subfloor > Rear Right
Finding:	Floor Wastes - Not plumbed for drainage
Information:	The floor waste to the bathroom and laundry is not plumbed or connected to suitable drainage and opens directly into the subfloor space, which can result in the surrounding area becoming damp. When coupled with poor site drainage, pooling of water may attract termite activity to this area.

It is highly recommended that a qualified plumber be appointed to install adequate drainage to the overflow. These works will ensure that the area remains dry and free of any secondary defects.
