# Building and Timber Pest Inspection Report

Inspection Date: Tue, 3 Feb 2026

Property Address: 6/3 Parkside Parade, Toronto NSW 2283,  
Australia

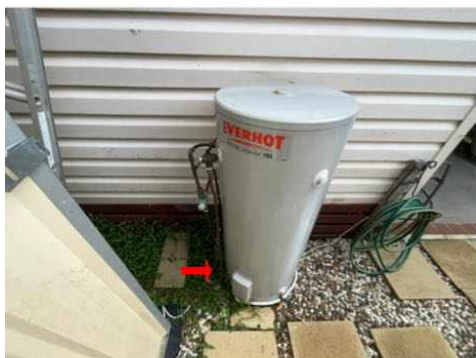
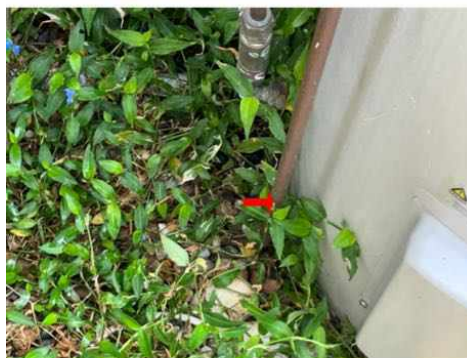
### Finding 6.04

Building:	Main Building
Location:	Yard - Back > Rear
Finding:	HWS Overflow - Not Connected
Information:	The Hot Water System (HWS) overflow was found to be disconnected from storm water drainage and is creating excessive moisture in the surrounding area.

These damp conditions can lead to secondary defects such as rot, rust or corrosion

of associated building elements, the formation of fungal decay, or even the creation of potential slip hazards. When coupled with poor site drainage, pooling of water may also attract termite activity to this area.

It is highly recommended that a licensed plumber be appointed to connect the HWS overflow in order to prevent such an environment from being created. These minor works should be carried out as soon as possible.

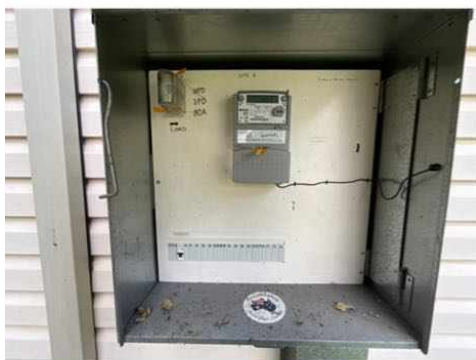
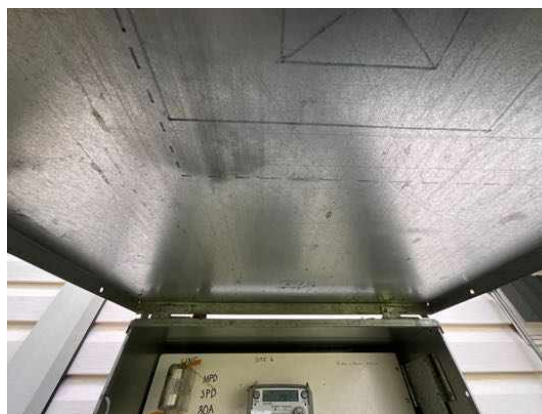
### Finding 6.05

Building:	Main Building
Location:	Meter Box > Front Right
Finding:	Termite Management System - no evidence of a chemical installation
Information:	The application of a post-construction chemical termite barrier is highly recommended for all properties, particularly if live termite activity has been found on the site previously. Such barriers are highly effective in preventing termite attack on any timber building elements throughout the property.

A durable notice should be placed in the switchboard unit to indicate current termite barriers. At the time of inspection, it appeared as though no termite management system has been installed, with no evidence to suggest preventative works taking place.

The client may consider gaining further advice from a pest controller as to the costs and procedures involved with this application. It is recommended that obtaining such advice be a short-term priority.

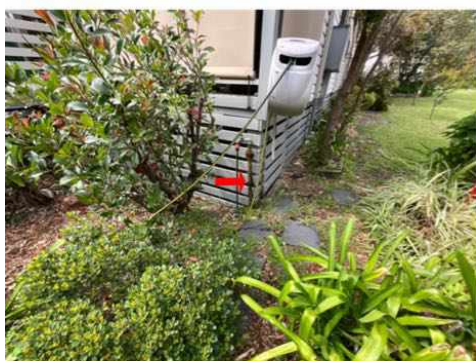
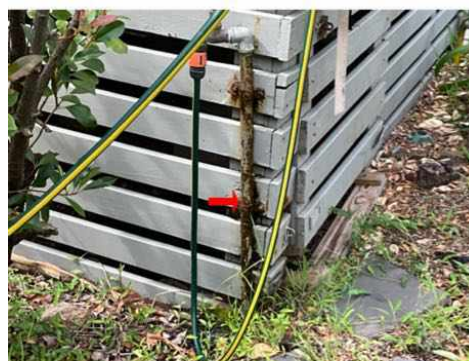
### Finding 6.06

Building:	Main Building
Location:	Yard - Front > Front Right
Finding:	Tap- Leak
Information:	The external tap shows evidence of active leaking, with visible water staining and corrosion to the pipework below.

Ongoing leakage may lead to persistent moisture at ground and wall level, which can contribute to deterioration of adjacent materials and may increase the risk of termite attraction.

It is recommended that the tap and associated pipework be repaired or replaced by a licensed plumber and the surrounding area monitored for moisture-related issues.

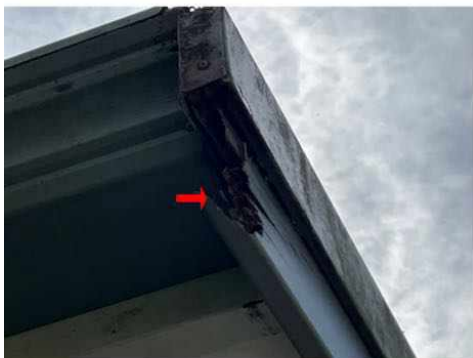
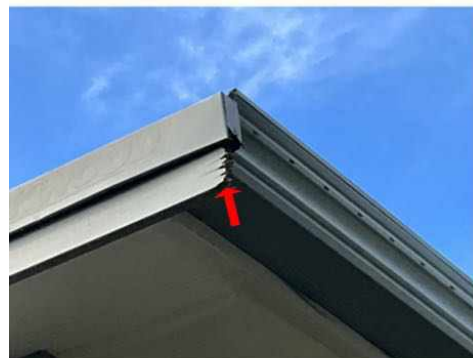
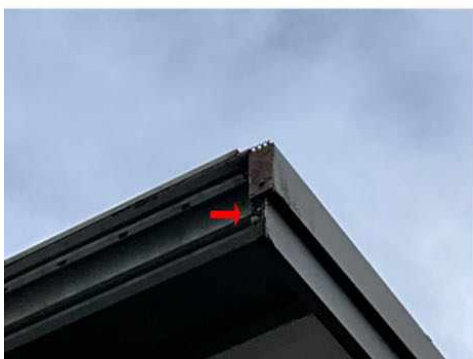
### Finding 7.01

Building:	Main Building
Location:	Roof Exterior > All Areas
Finding:	Fascias - Wood rot

Information: Wood rot was found to be affecting fascias and barges in this area, evidenced by the presence of mould on the surface in some areas. Wood rot, also known as Fungal Decay, occurs when timbers and other cellulose building materials are exposed to damp conditions on an ongoing basis.

It is likely that this wood rot has developed as a result of faults in the roof plumbing, creating excessive moisture in this areas. Frequent exposure to rain and other weather conditions also make fascias and barges susceptible to accelerated deterioration.

Early intervention and regular maintenance will prolong the useful life of these building elements. Prior to any works being performed, the cause of the moisture that has created the visible wood rot should be identified and addressed in a suitable manner.

It is advised that a roof plumber be appointed to inspect all roof plumbing and subsequently identify the cause of the wood rot. Replacement of affected fascias and barges may then be a necessary step in protecting surrounding building elements from such deterioration.

A qualified plumber may be appointed to assess the cause of excessive moisture and to provide advice on any remedial works as required. A qualified carpenter or registered builder may also be required to replace affected building materials.

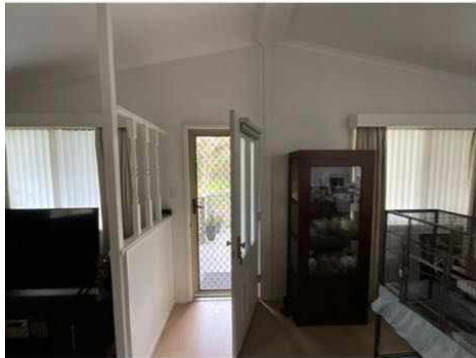
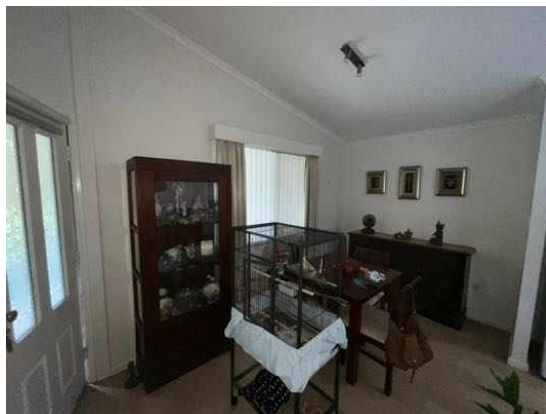
Building: Main Building  
Location: All Areas > All Areas  
Finding: Additional Photos - Obstructions and Limitations - Interior Areas  
Information: These photographs are an indication of the obstructions and limitations which impeded full inspection of the property at the time of inspection. These obstructions can hide an array of defects and should be removed to allow full inspection to be carried out. A re-inspection is recommended once the areas are made accessible.

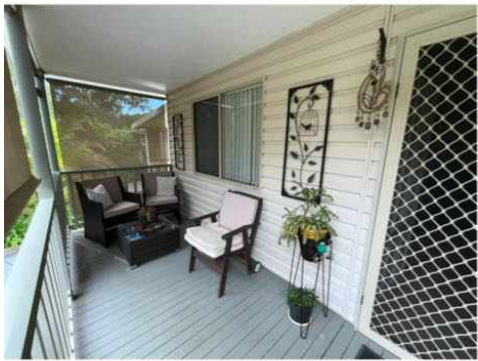
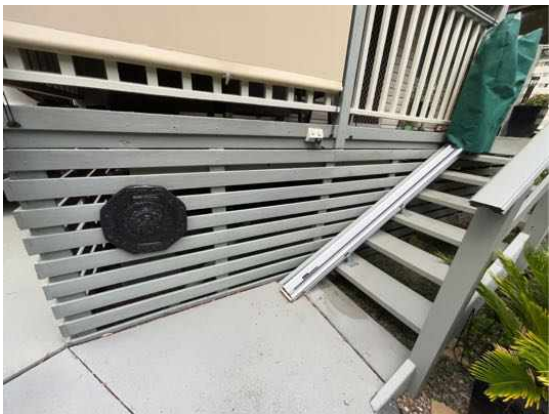
Building: Main Building  
 Location: All External Areas > All Areas  
 Finding: Additional Photos - Obstructions and Limitations - External Areas  
 Information: These photographs are an indication of the obstructions and limitations which impeded full inspection of the property at the time of inspection. These obstructions can hide an array of defects and should be removed to allow full inspection to be carried out. A re-inspection is recommended once the areas are made accessible.

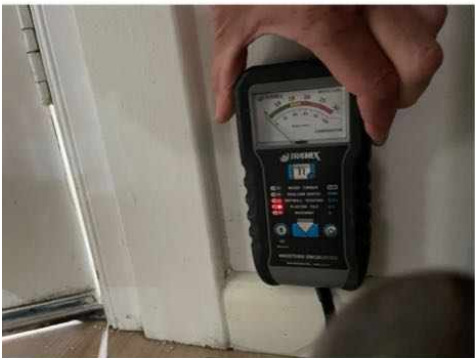
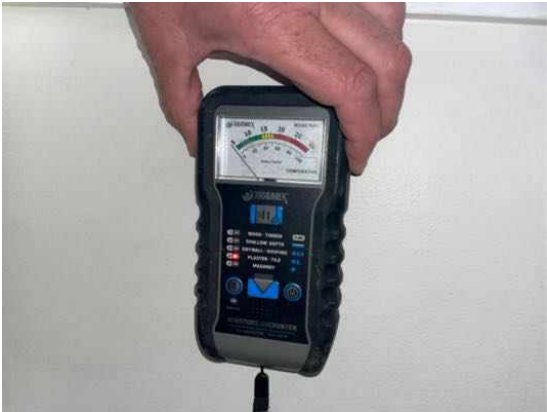
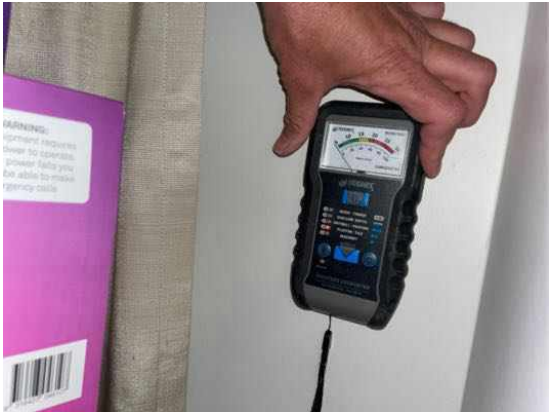
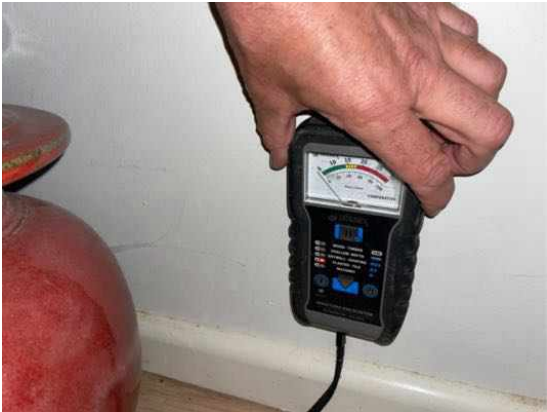
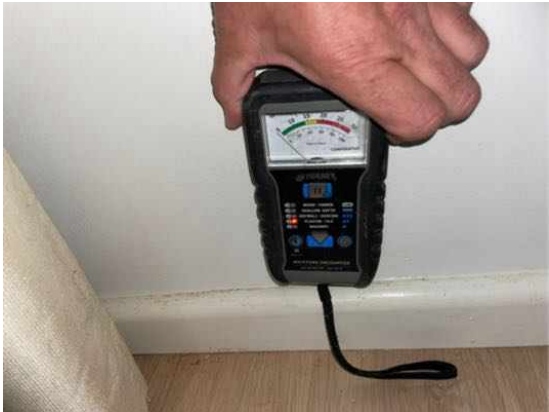
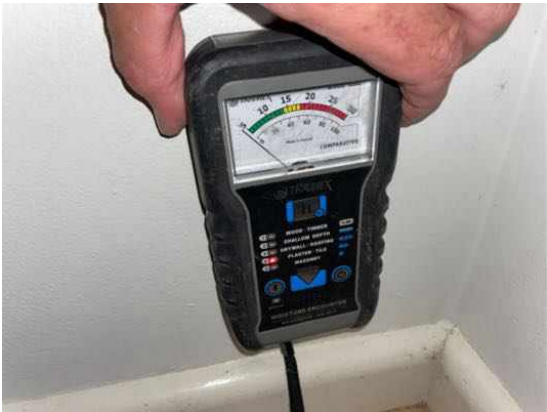
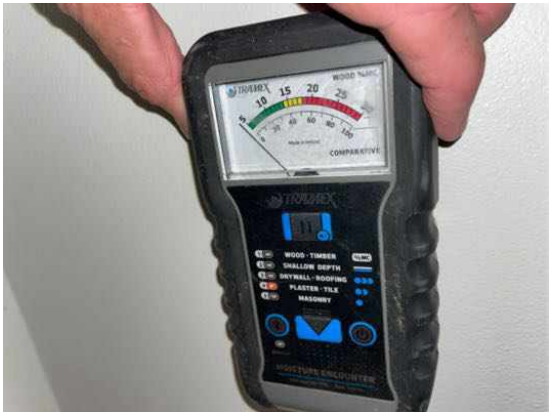
Building: Main Building  
 Location: All Areas > All Areas  
 Finding: Moisture Readings  
 Information: Moisture readings were taken to the wet areas and below and beside windows. There was elevated moisture levels located to the Walk in Robe and beside the shower.

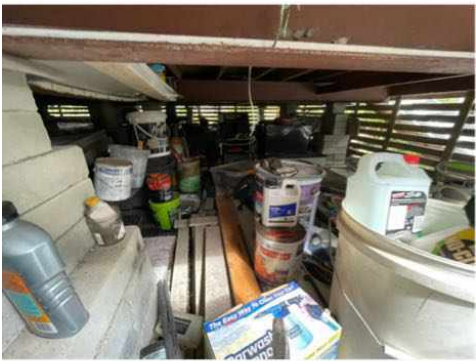
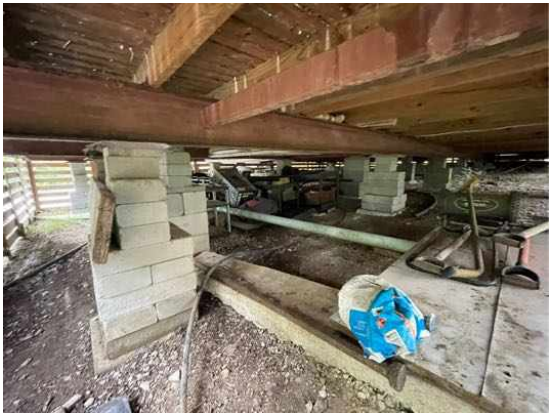
Building:	Main Building
Location:	Subfloor > All Areas
Finding:	Obstructions and Limitations Subfloor
Information:	These photographs are an indication of the obstructions and limitations which impeded full inspection of the Subfloor at the time of inspection. These obstructions can hide an array of defects and should be removed to allow full inspection to be carried out. A re-inspection is recommended once the areas are made accessible.
