Building and Timber Pest Inspection Report

Inspection Date: Thu, 9 Apr 2026

Property Address: 36 Moss St, Numurkah VIC 3636, Australia

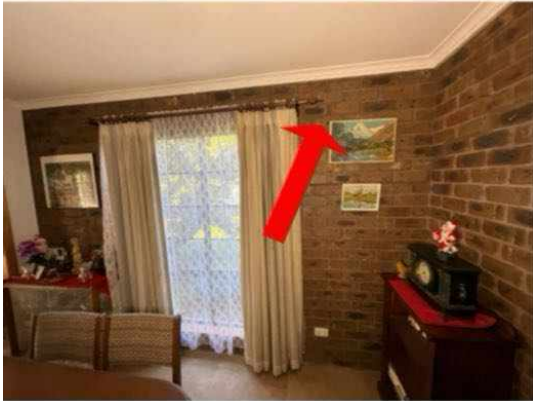
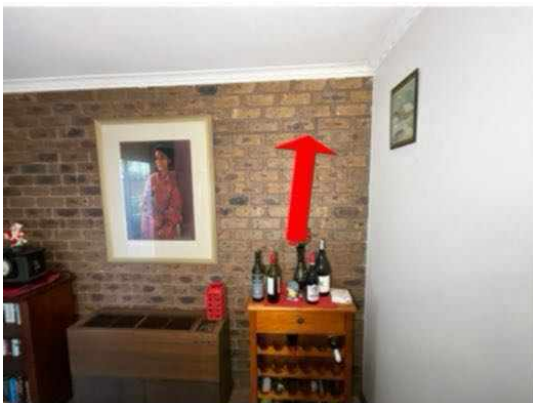
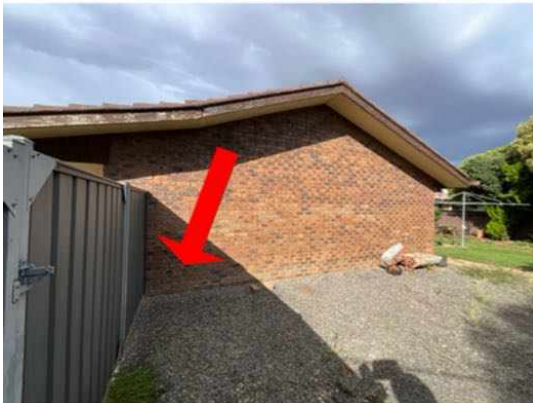
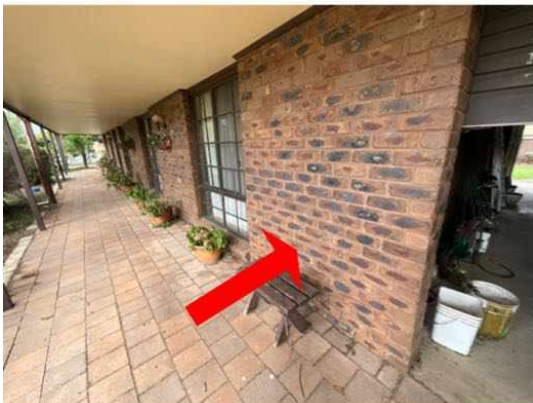
Building: Building 1
Location: Living Room, dining, alfresco, end and front wall
Finding: Brickwork - Step cracking
Information: Step cracking was identified to the brickwork in this area at the time of inspection. Step cracking, which is similar to other forms of cracking, has a variety of possible causes. However, the most common is the subsidence of adjacent footings.

Step cracking is a relatively common defect, and is most likely to occur adjacent to windows, doors and other openings. Mortar failure in the gaps between affected bricks indicates the stresses and tensions affecting the wall.

Where step cracking is extensive or severe, the client is advised to consult a structural engineer. Minor step cracking can be used as a warning sign to address factors causing stress to the wall, which can include the effect of surrounding trees, water leaks, soil erosion, or even the presence of reactive soils in the surrounding area.

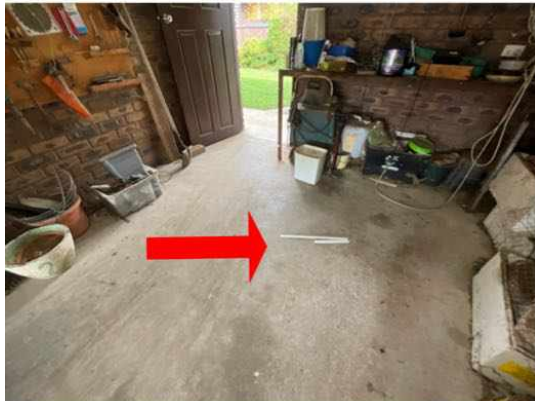
Fine cracks may also be due to poor original installation of the concrete. Factors such as poor compaction of the sub surface and/or inadequate reinforcing of the slab may create cracking and other secondary defects.

Monitoring of all cracking should be conducted frequently. Always contact a building inspector should cracks widen, lengthen, or become more numerous.
