Building and Timber Pest Inspection Report

Inspection Date: Wed, 11 Feb 2026

Property Address: 9/133 Bringelly Road, Kingswood NSW
2747

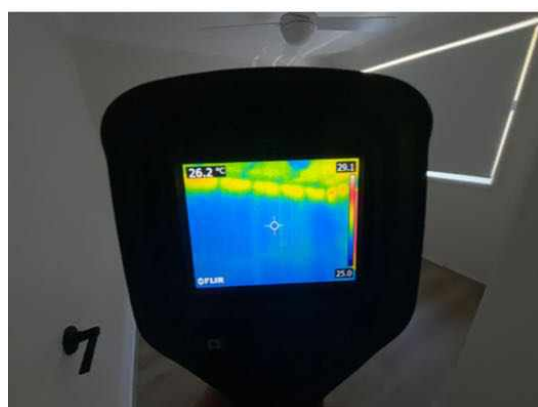
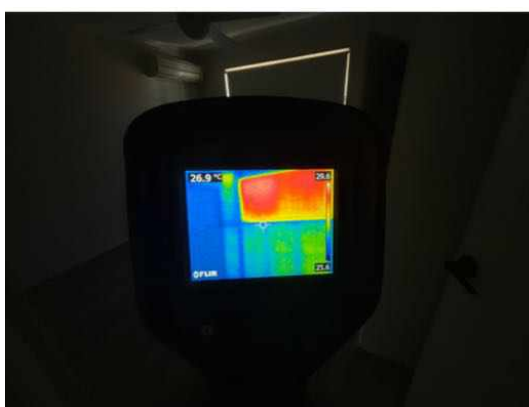
Termites release heat in the form of carbon dioxide and build mud tubes with high moisture content, which can create irregular heat patterns on surfaces such as walls, ceilings, and floors.

At the time of the inspection, no abnormalities indicating live termite activity were observed. However, it's important to note that various factors—such as obstructions, ambient temperature, and wall material/thickness—can impact the accuracy of thermal readings. In cases where surfaces are visually restricted or obstructed, a comprehensive thermal scan may not always be feasible.

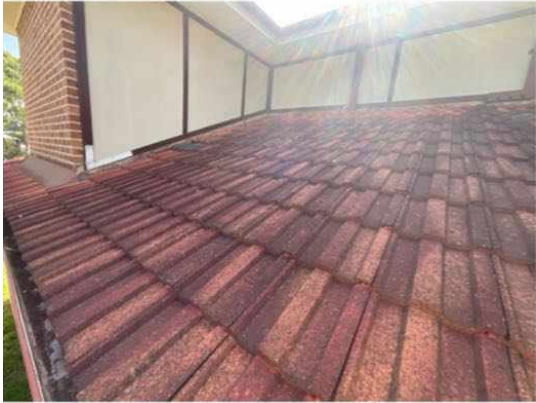
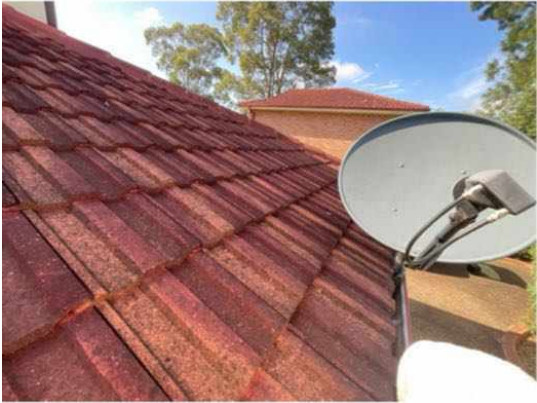
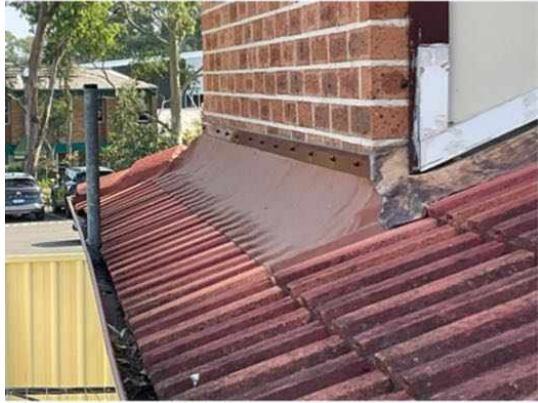
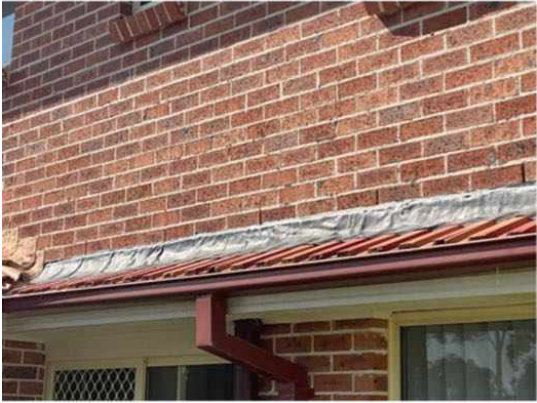
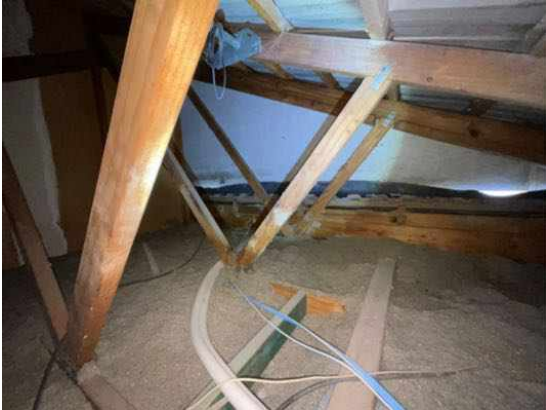
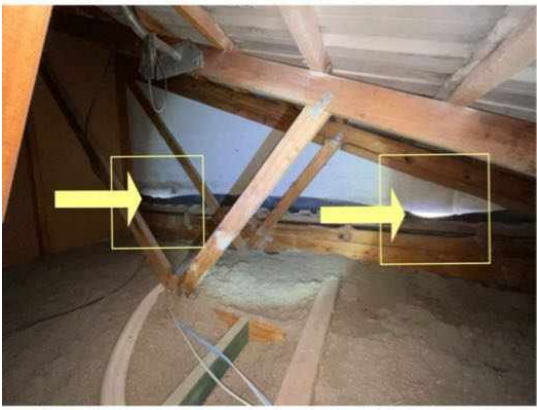
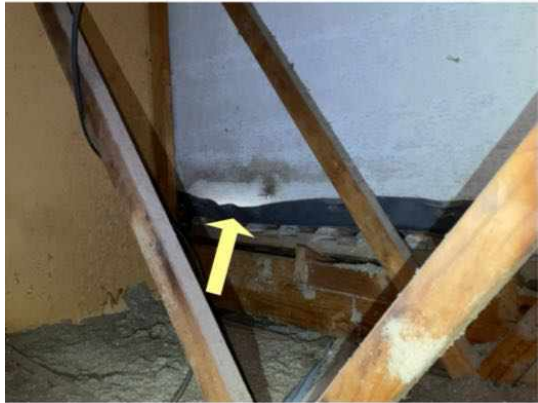
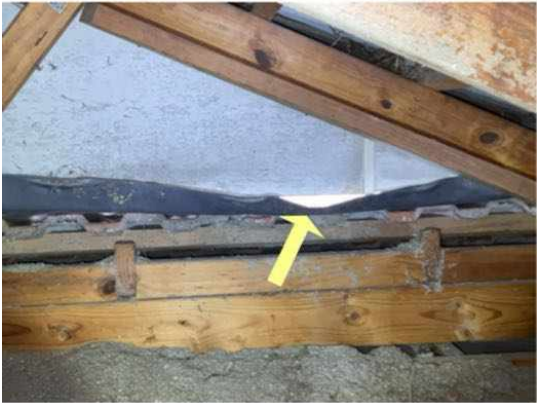
The concrete tiled roof was observed to be in generally sound condition at the time of inspection; however, minor leakage evidence and loose flashing were identified. Access was restricted due to height and safety considerations, and not all roof areas were physically inspected.

Regular maintenance, including inspection of ridge pointing, cleaning of gutters and valleys, and timely repair of loose flashing, is recommended to minimise the risk of future water ingress.

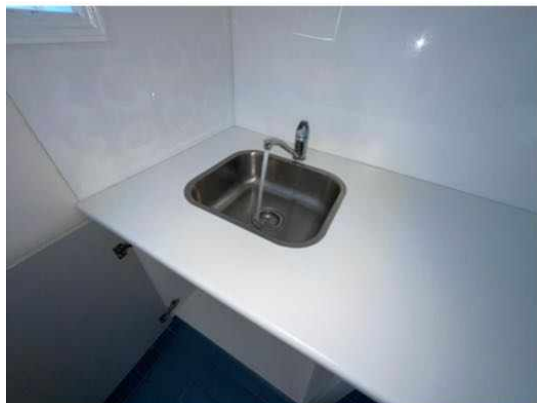
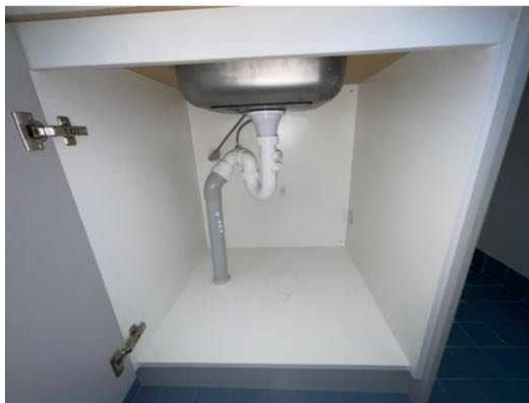
Building: Main Building
 Location: Laundry
 Finding: Laundry - Taps/Plumbing/Drainage.
 Information: Observation: Laundry Tub – Taps, Plumbing, and Cabinetry

- Further monitoring or testing is recommended once the taps are placed into regular

use, to ensure no leaks develop over time and that the drainage system continues to perform adequately.

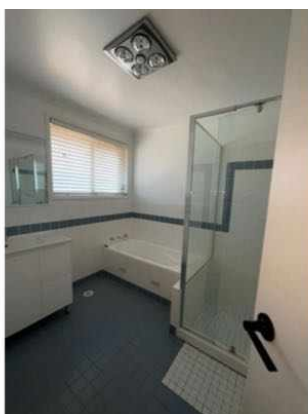
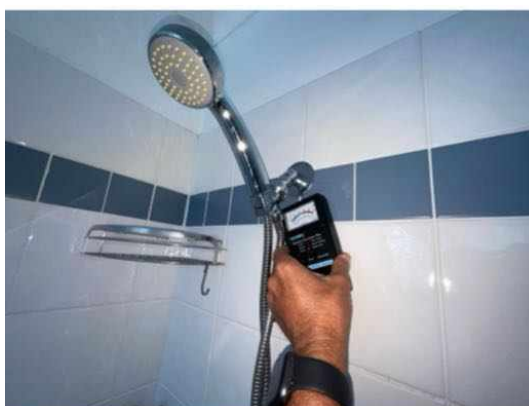
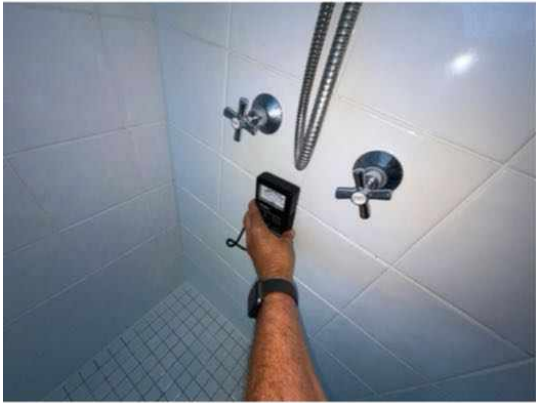
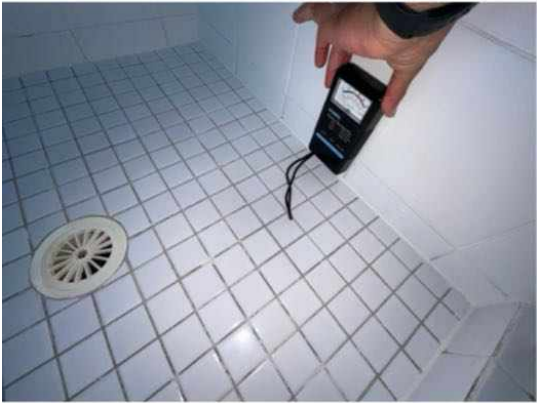
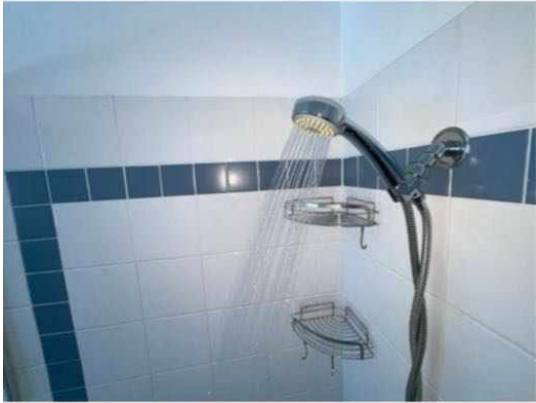
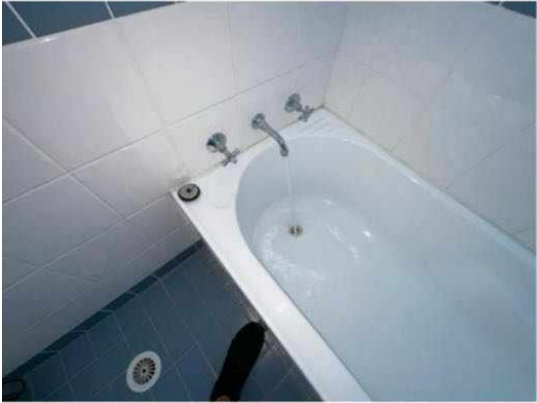
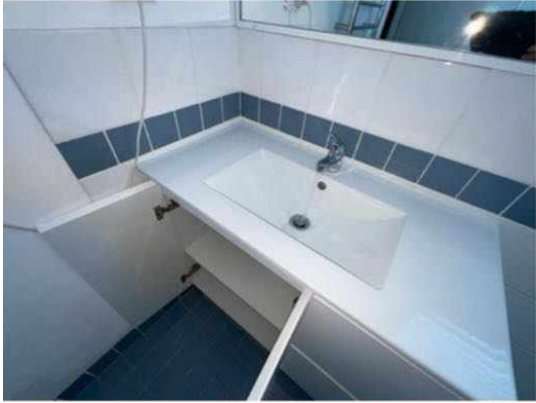
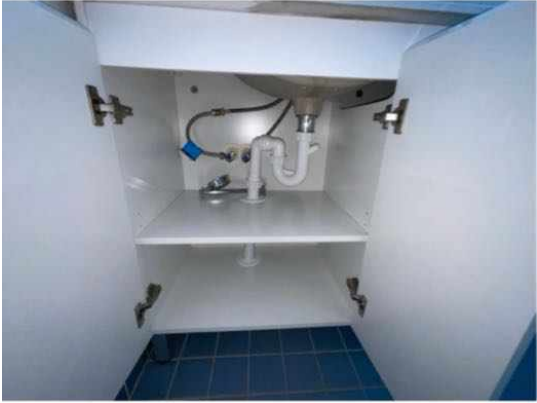
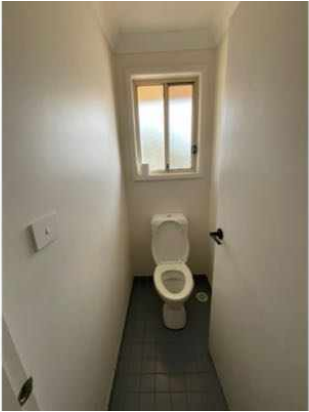
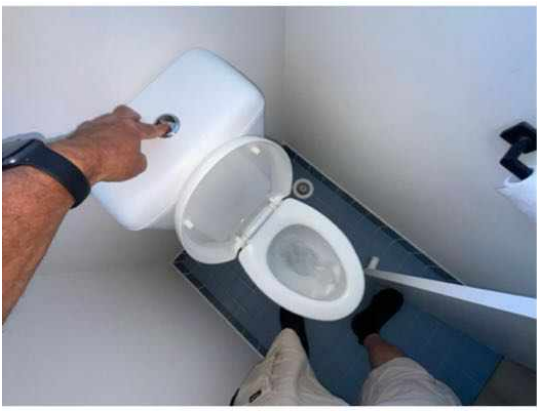
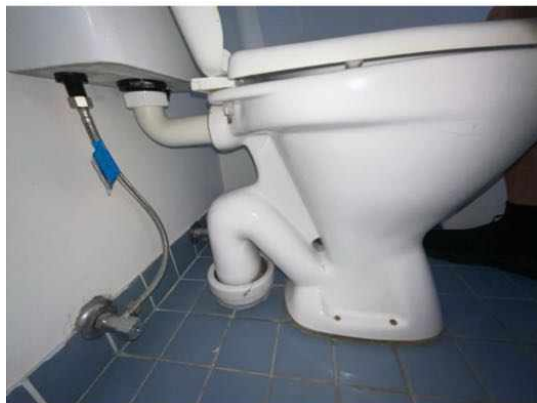
Building: Main Building
 Location: Bathroom
 Finding: Wet Areas - Bathroom(s) - Overall Condition & Recommendations.
 Information: Overall Condition & Recommendations

It is not possible under the visual inspection criteria of a standard pre-purchase report to categorically determine if leaks are present. If a more detailed or accurate assessment is required, a special-purpose inspection should be undertaken.

Alternatively, the assumption should be made that leakage may occur, particularly where historical or environmental conditions are conducive. The visual nature of this inspection cannot detect issues concealed behind wall/floor linings or cabinetry, and invasive investigation may be necessary to confirm the true condition of adjacent or hidden structures.
