Building and Timber Pest Inspection Report

Inspection Date: Wed, 18 Mar 2026

Property Address: 14 Burge Pl, Warilla NSW 2528, Australia

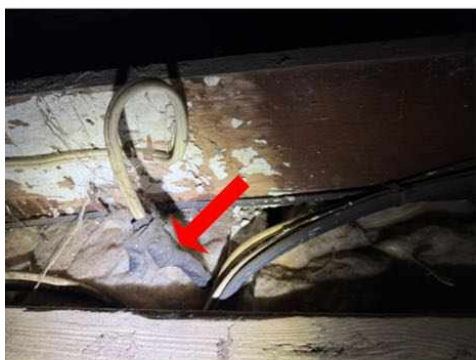
Building:	Building 1
Location:	Roof Cavity
Finding:	Electrical cables missing a junction box
Information:	This electrical fitting in this roof area was found to be missing a junction box at the time of inspection.

This missing fitting and loose cables does expose electrical works, and may create a safety hazard if there is potential contact with persons in the area.

A Licensed electrician should be appointed to rectify these areas immediately.

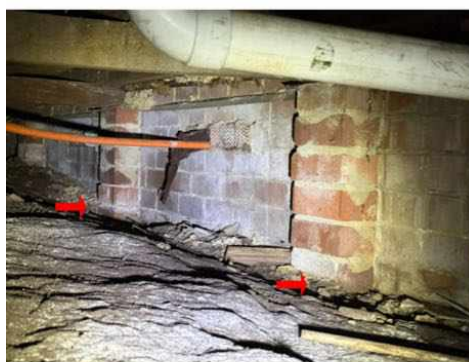
Finding 3.02

Building:	Building 1
Location:	Pictured areas
Finding:	Flooring - Uneven
Information:	The internal flooring in many areas is out of level and uneven. Uneven flooring is likely to indicate minor defects such as expected movement of the foundations of the property, but may also indicate subsidence of the associated subfloor stumps.

It is advised that the flooring be closely monitored to identify any further movement. Where flooring remains relatively unchanged for an extended period of time (i.e. several months), it is likely that this defect has been caused by expected movement of the foundations of the property.

However, where flooring is uneven further, potentially invasive inspection of the subfloor structures and stumps in this area is required. In this case, works to repair are likely to be required, and would be carried out by a registered builder specialising in re-stumping. Installing front drainage will also assist in stopping subfloor movement.

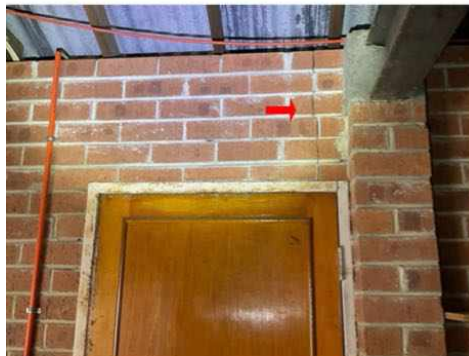
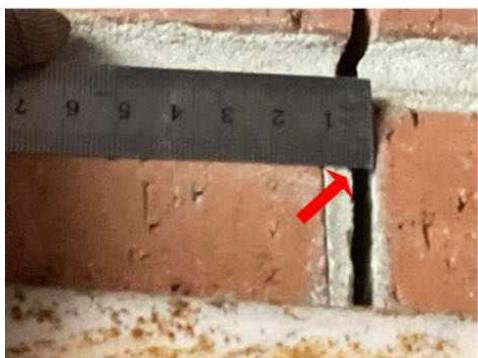
Building:	Building 2
Location:	Garage wall & fence
Finding:	Step cracking to brickwork (minor)
Information:	Minor step cracking was identified to the brickwork in this area at the time of inspection. Step cracking, which is similar to other forms of cracking, has a variety of possible causes. However, the most common is the subsidence of adjacent footings.

Step cracking is a relatively common defect, and is most likely to occur adjacent to windows, doors and other openings. Mortar failure in the gaps between affected bricks indicates the stresses and tensions affecting the wall.

Where step cracking is extensive or severe, the client is advised to consult a structural engineer. This minor step cracking can be used as a warning sign to address factors causing stress to the wall, which can include the effect of surrounding trees, water leaks, soil erosion, or even the presence of reactive soils in the surrounding area.

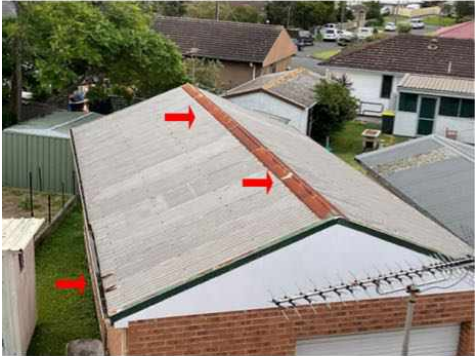
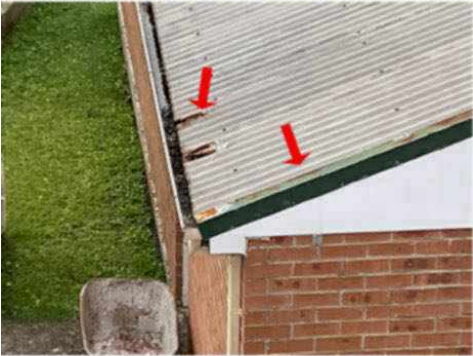
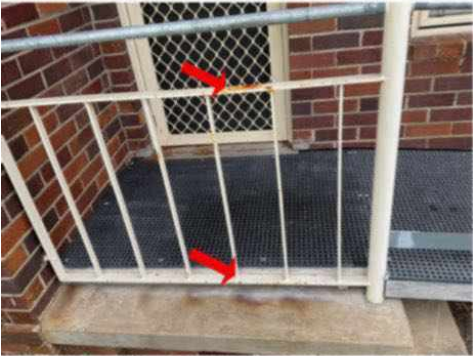
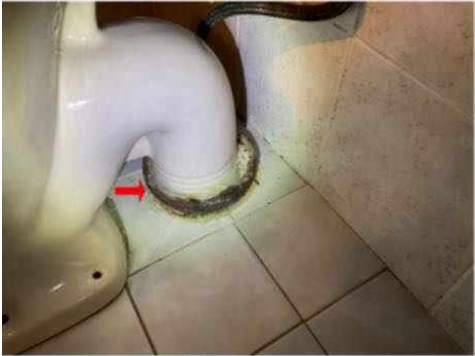
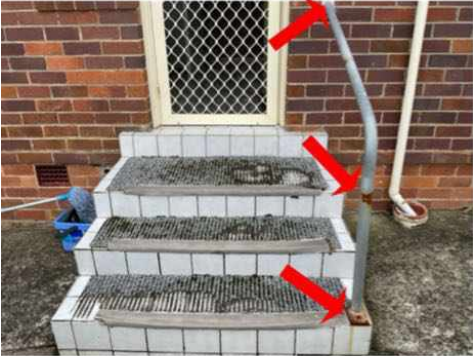
Finding 3.04

Building:	Building 1
Location:	Pictured areas of both buildings
Finding:	Building elements - Rusted or corroded
Information:	This areas of both buildings shows evidence of rusting and corrosion, which is likely to have developed as a result of excessive exposure to moisture and or inadequate

As surface rust provides no protection to the underlying iron, the deteriorating condition is likely to worsen if not addressed in the short-term future.

Where possible, the use of galvanized (treated) metals or aluminium coated metals aid in rust prevention, as does regular general maintenance. Rust formation can be controlled with coatings, such as paint, that isolate the iron from the environment.

Rusting and corrosion should be managed by ideally removing or limiting the affected surface from exposure to moisture. A registered builder may be appointed to replace any building elements that have been severely affected by rust or water damage.

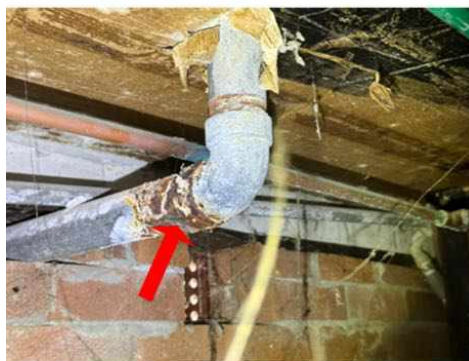
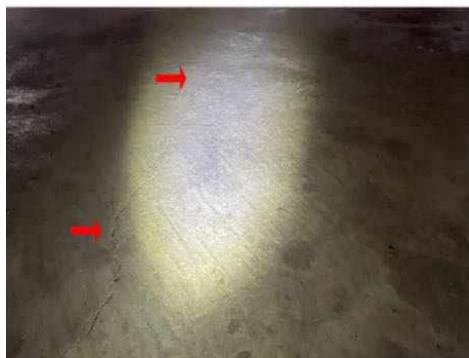
Finding 3.05

Building:	Building 1
Location:	Driveway & garage
Finding:	Crack in concrete slabs - Category 1
Information:	Cracks coded as Category 1 was identified in these pictured slabs. A Category 1 crack is described as a fine but noticeable crack, with the slab at an otherwise reasonable level. To be considered Category 1, the approximate width of the crack is less than 1.0mm, or a less than 10mm change in offset when a 3m straight edge is placed over the defect.

Category 1 cracks should be monitored for a period of 12 months. At the end of the monitoring period, identified cracks that are rated greater than Category 2 are considered defects, and require rectification.

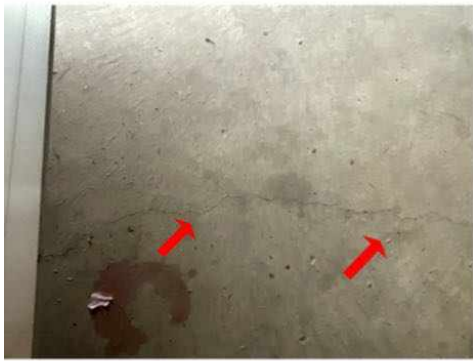
Finding 3.06

Building:	Building 1
Location:	Some rooms
Finding:	Cracking - Damage Category 1 - Fine (up to 1mm)
Information:	Although fine cracks are quite noticeable, they are often only considered to be an appearance defect, and usually do not indicate any structural damage. Generally, the cause of a fine crack is indicative of a separation between building materials and finishes (e.g. paint, plaster, etc.) along joints. Some of these appear to just be paint cracks.

Cracking of this nature can generally be repaired with minor sanding, filling and/or repainting. Such works should be performed by a qualified painter or a general handyman.

Monitoring of all cracking should be conducted frequently. Always contact a building inspector should cracks widen, lengthen, or become more numerous.

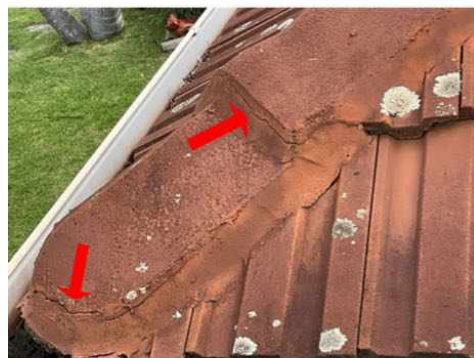
Building:	Building 1
Location:	Roof Exterior
Finding:	Roof areas (tiles, mortar, sealant)- weathered
Information:	Upon inspection of the exterior roofing, the majority of roof tiles and mortar were considered to be in a good condition. While weathering of the roofing areas is consistent with the age of the property, maintenance works are required.

Isolated areas of mortar and tiles show minor cracking is present. Re-pointing and re-sealing the may be considered as an interim solution by the client to help preserve and extend the life span of the tiles. Where left unmanaged, deteriorating roof mortar and tiles are likely to lead to a number of secondary defects, including minor water leaks and weather exposure to internal roofing structures.

Consultation with a roofing contractor is highly advised to gain advice on cost of remedial works that may be required in the short to medium term. Remedial works are likely to increase the longevity of the exterior roofing structure.

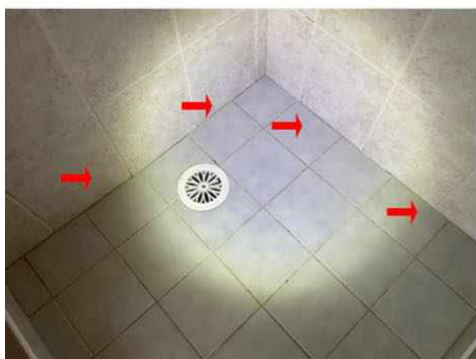
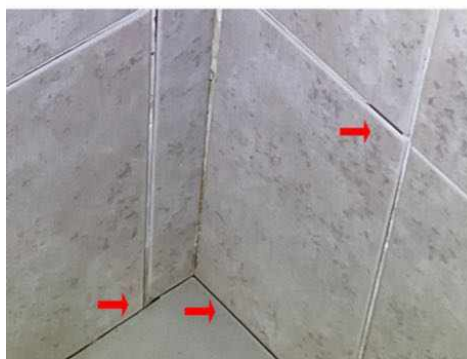
Finding 3.09

Building:	Building 1
Location:	Bathroom
Finding:	Sealant and grouting - Missing or damaged
Information:	It was noted on inspection that sealant or grout is degraded to these pictured areas.

Different materials and floor areas move at different rates, generally causing cracking to grout or sealant at this point. A flexible sealant is required to allow for expected expansion and contraction, while keeping the joint water tight and protective of all associated building materials.

Flexible and mould resistant materials should be applied to affected areas to prevent any subsequent water damage that is likely to occur. Regular maintenance and replacement of damage or missing or damaged sealant and grout is highly recommended to the wet areas, as this is a regular wear and tear defect. Sealant and grouting in areas that come into regular contact with water should be maintained for the long term care of your property.

A sealant specialist or tiling contractor should be appointed to complete these works as soon as possible

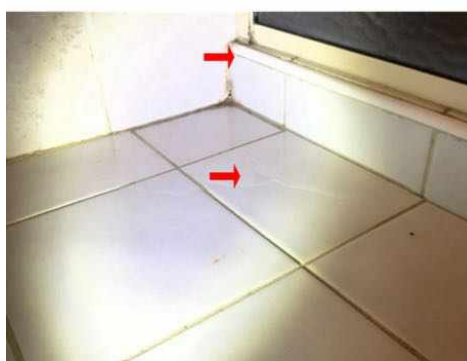
Finding 3.10

Building:	Building 1
Location:	Bathroom
Finding:	Shower screen - Leaking
Information:	Leaking was evident to the shower screening at the time of inspection. It is suspected that the leaking has occurred as a result missing sealant. Leaking from the shower , where left unattended, is likely to lead to water damage to adjoining flooring and walls. Such damage can lead to water damage and necessitate extensive remedial works being required. Active water leaks may also create an environment that is susceptible to the formation and development of mould.

Appointment of a sealant expert is required to repair or replace this missing sealant. Such works should be performed as soon as possible to ensure that no further damage occurs.

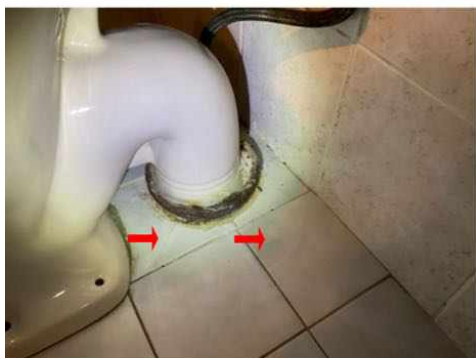
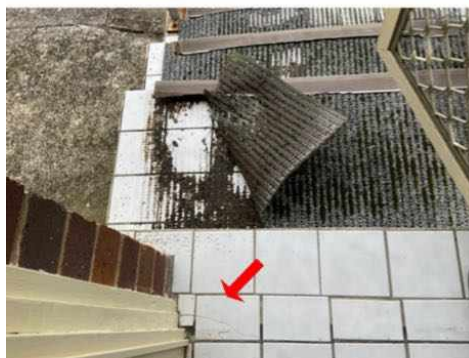
Finding 3.11

Building:	Building 1
Location:	Bathroom, laundry step,
Finding:	Tiles cracked
Information:	Cracked tiles were evident in these pictured areas at the time of inspection. It is suspected that this cracking has occurred as a result of both minor settlement or

impact damage. Cracked tiles throughout the household detract from the overall appearance of the affected areas. In wet areas of kitchens and bathrooms, it can lead to water damage of adjoining walls and floors.

Replacement of cracked tiles is recommended as soon as possible. A tiling contractor may be appointed to perform these works. Where cracks become more numerous, contact a licensed building inspector for further investigation.

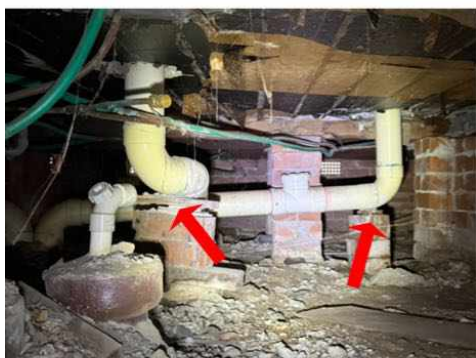
Finding 3.12

Building: Building 1
 Location: Subfloor plumbing
 Finding: Incomplete or substandard works
 Information: The works to this subfloor area appear to have been completed to a substandard level. These pipes are sitting on loose bricks.

Works that have not been completed to a satisfactory level create potential for the development of building defects and may impede on the safety and integrity of the overall structure.

It is highly recommended that the relevant trades be appointed to complete these works and ensure the safety of the area and the longevity of all associated building elements.

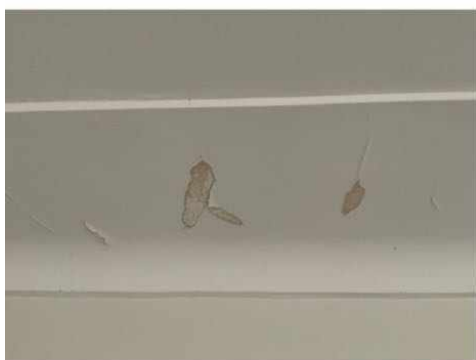
Finding: Paint damaged

e.g. external areas or wet areas, could lead to deterioration of underlying building materials. Damaged paint finishes should be sanded back, filled, leveled and repainted, as applicable.

A painting contractor should be appointed as soon as possible to perform necessary works to aid the appearance of the affected area and to ensure that the area is protected against further deterioration. Alternatively, the homeowner following manufacturer instructions may be able to provide this service.

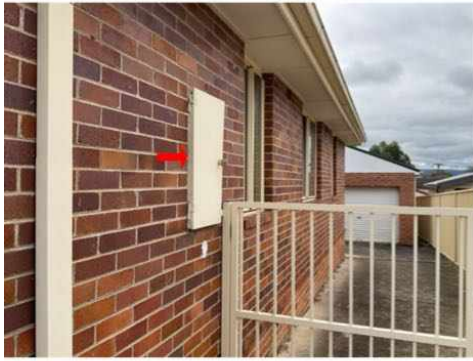
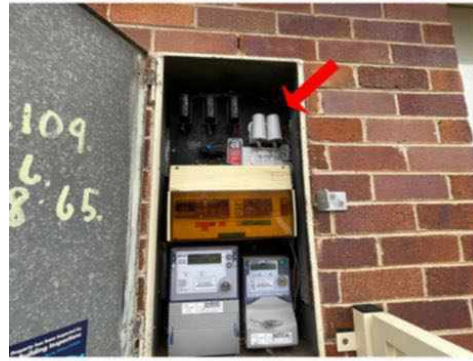
A durable notice should be placed in the switchboard unit to indicate current termite barriers. At the time of inspection, no durable notice was evident and it appeared as though no chemical termite management system has been installed, with no evidence to suggest preventative works taking place since the property was built.

The client may consider gaining further advice from a pest controller as to the costs and procedures involved with a 'chemical' application. It is recommended that obtaining such advice be a short-term priority.

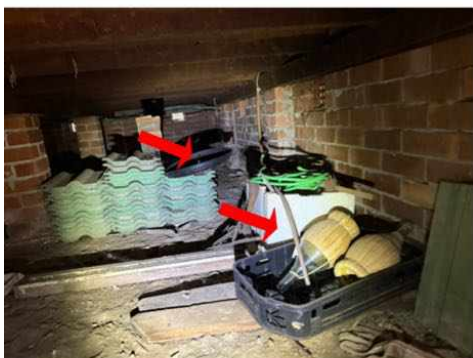
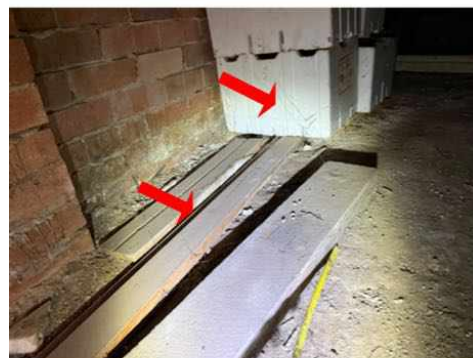
Finding 6.02

Building: Building 1
 Location: Subfloor Areas
 Finding: Subfloor - Debris
 Information:

A clear and empty subfloor will be better ventilated and easier to maintain in a dry condition. The removal of any timber debris is vital in minimising the risk of termite or wood borer activity.

Debris in the subfloor should be removed as soon as possible. Depending on the location and amount of debris and stored items, the homeowner may elect to undertake this task. Alternatively there are a large number of rubbish removal subcontractors that could undertake these works.

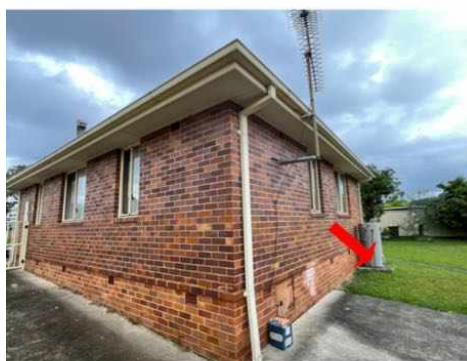
Finding 6.05

Building: Building 1
 Location: Yard areas
 Finding: Timber in contact with the ground
 Information: Any timbers in direct ground contact provide opportunity for concealed termite entry and are likely to be subject to premature rot and decay as the soil retains moisture or damp conditions against the timbers.

Removal of all waste timber that is in direct contact with ground is highly advised. This timber is promoting mould and wood rot and is very attractive to termites.

Frequent pest inspections are advised to readily identify any termite activity in these areas.

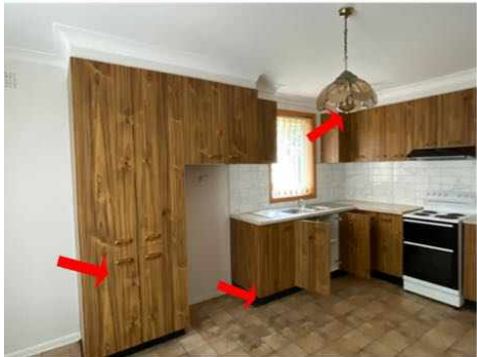
Building: Building 1
Location: All Internal Areas
Finding: Additional Photos - Obstructions and Limitations of INTERNAL AREAS
Information: These photographs are an indication of the obstructions and limitations which impeded full inspection of Internal areas at the time of inspection. These obstructions can hide an array of defects and should be removed to allow full inspection to be carried out. A re-inspection is recommended once the areas are made accessible.

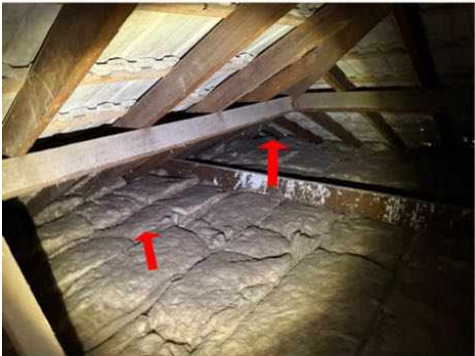
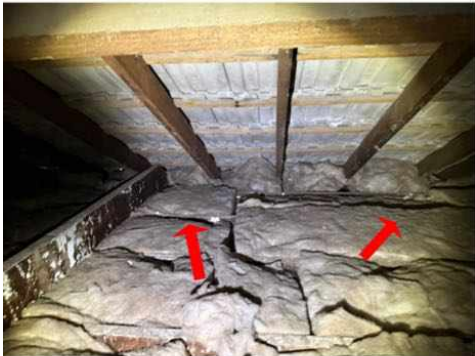
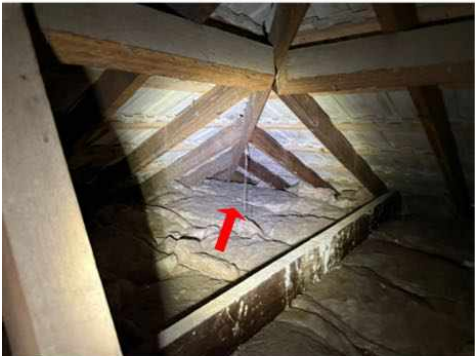
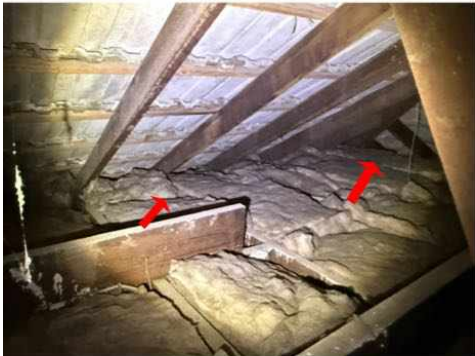
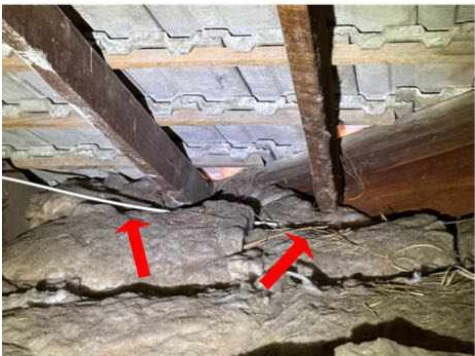
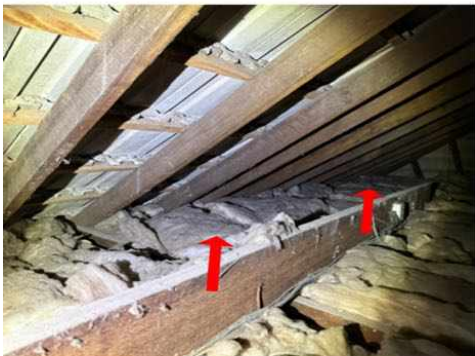
Building: Building 1
Location: All Roof cavity areas
Finding: Additional Photos - Obstructions and Limitations of the ROOF CAVITY
Information: These photographs are an indication of the obstructions and limitations which impeded full inspection of roof cavity areas at the time of inspection. These obstructions can hide an array of defects and should be removed to allow full inspection to be carried out if applicable. A re-inspection is recommended once the areas are made accessible.

The inspection was also limited to areas with an allowable crawl space of 600mm x 600mm, in particular towards the external walls where the roof line diminishes, these areas were not accessible.

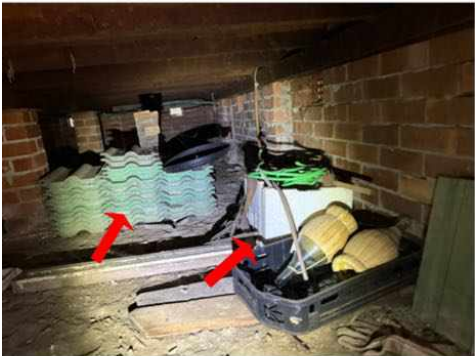
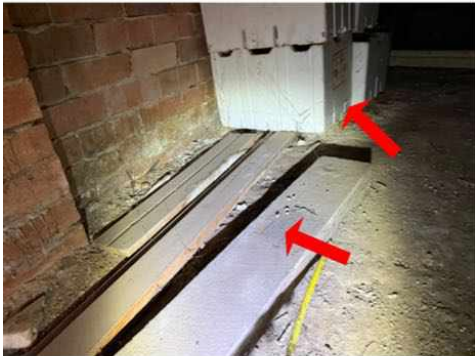
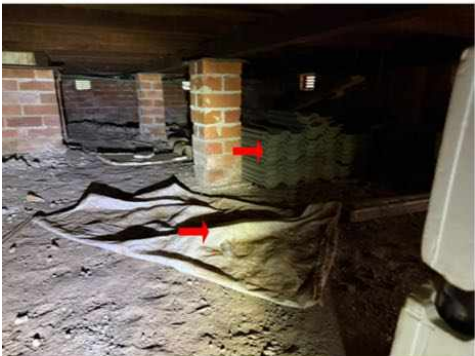
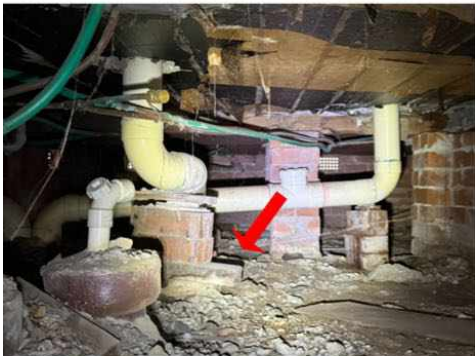
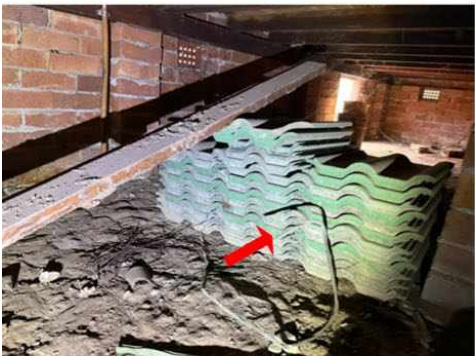
Building: Building 1
Location: All Subfloor Areas
Finding: Additional Photos - Obstructions and Limitations of SUBFLOOR AREAS
Information: These photographs are an indication of the obstructions and limitations which impeded full inspection of subfloor areas at the time of inspection. These obstructions can hide an array of defects and should be removed to allow full inspection to be carried out. A re-inspection is recommended once the areas are made accessible.
