## Building Inspection Report

Inspection Date: Mon, 12 Jan 2026

Property Address: 46 Bonogin Rd, Mudgeeraba QLD 4213,  
Australia

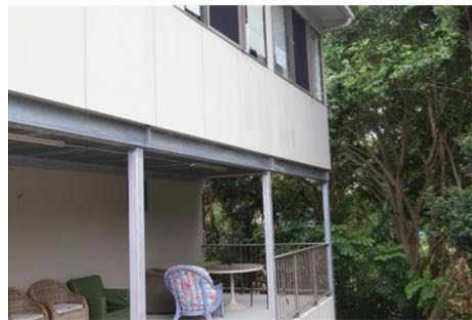
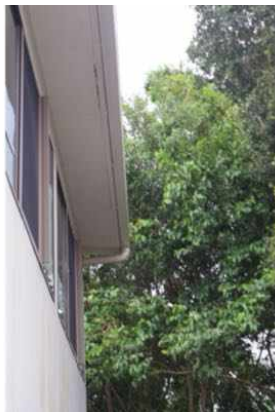
#### Defects 1.01

Information: Where evidence of mould growth was noted, there may be environmental, biological or health issues associated with the report. A specialist inspection by a suitably qualified environmental health inspector is warranted, where mould is extensive or where any queries regarding air quality spores or other related issues apply.

Generally, the client is advised to ensure that the general environment is free of moisture and humidity to aid in the prevention of mould formation and development. Any mould found during the inspection should be cleaned immediately by a cleaning contractor or the homeowner as applicable.

Please note that severely affected building elements may require replacement by a registered builder or qualified carpenter.

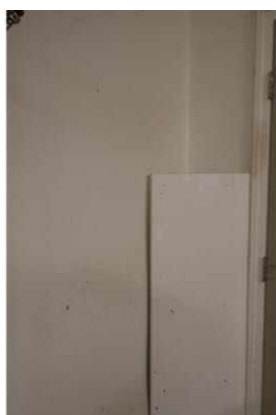
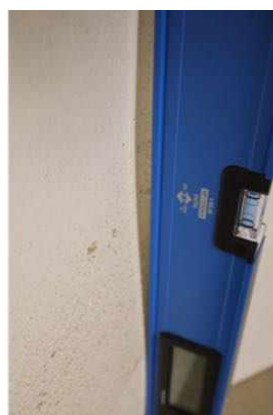
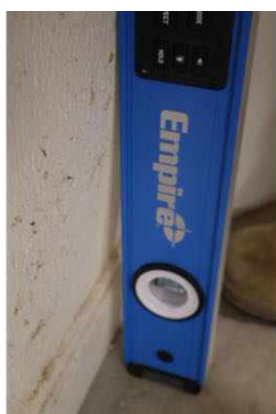
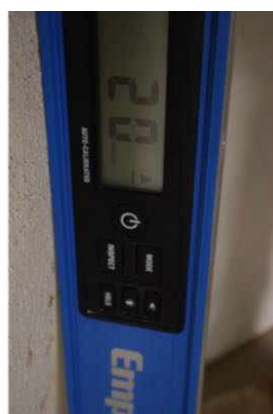
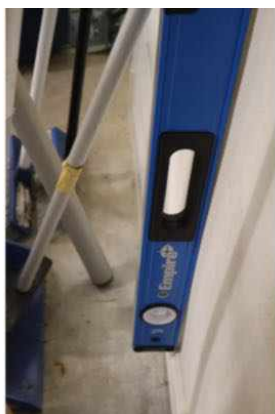
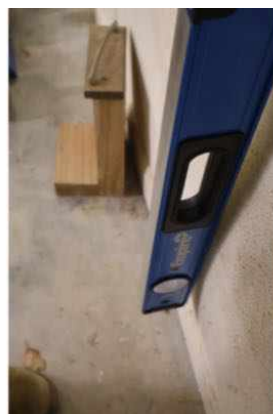
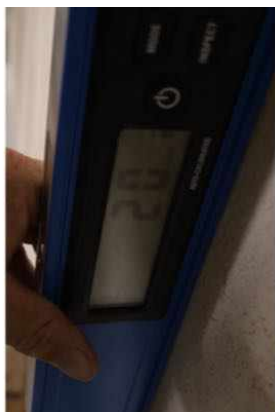
### Defects 2.01

Building:	Main Building
Location:	Workshop/garage > Rear Right
Finding:	Walls - Bowed
Information:	Vertical bowing and horizontal bending is caused by lack of resistance to vertical pressures from foundations, upper floors or roofs, or horizontal pressures from a range of causes e.g. environmental conditions.

Quotations for building works required to fix bowing building elements should be sought prior to purchase. It is suspected that extensive works, including works to roof structures, floor structures, walls and associated finishes, is likely to be required.

A structural engineer may provide advice prior to seeking quotations on the required scope of works to prevent structural failure. Where bowing is less severe, a registered builder, in association with qualified trades, should be appointed to perform remedial works.

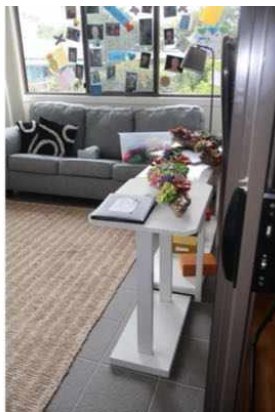
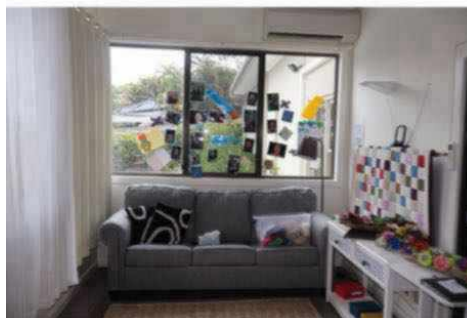
### Defects 3.01

Building:	Main Building
Location:	Quite room > Rear
Finding:	Painted surface - Bubbling
Information:	Sections of paint in this area was found to have bubbled and deteriorated. Paint bubbling is generally an indication of excessive moisture in the area, that is currently hidden by the painted surface.

The presence of excessive moisture can have major implications on associated building elements if left unattended. While only seemingly minor at this stage, the damage cannot be determined due to the paint obstructing any further inspection of the damage.

It is highly advised that the affected paint be cleaned to allow a further, more invasive inspection by a licensed plumber. Failure to act on this defect may necessitate major works in the future.

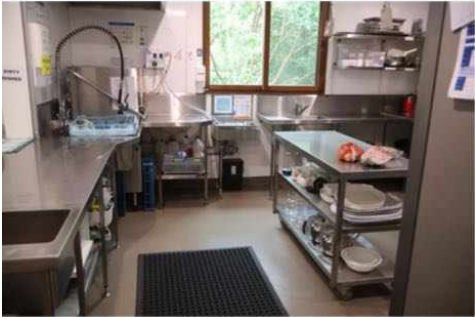
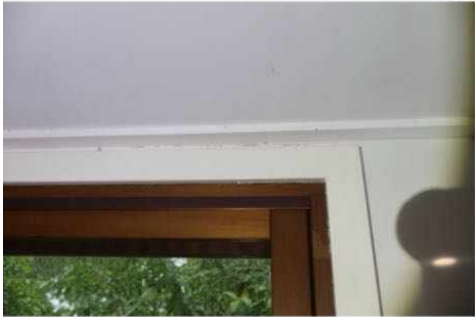
### Defects 3.02

Building:	Main Building
Location:	Kitchen > Rear
Finding:	Beading - gap
Information:	Beading acts (like cornice or skirtings) to cover the intersection or joins of building materials. It was noted at the time of inspection that beading in this area has minor gaps. This deterioration is suspected to have been caused by general ageing, which is expected in a building of this age and condition.

Beading is important in weatherproofing the surrounding building elements and preventing termite or pest ingress. Furthermore, beading works to protect the joins of building materials, which are more susceptible to deterioration and decay.

Repair or replacement of the beading is advised to ensure the protection and longevity of any associated building elements. Such works may be performed by a general handyperson or qualified carpenter.

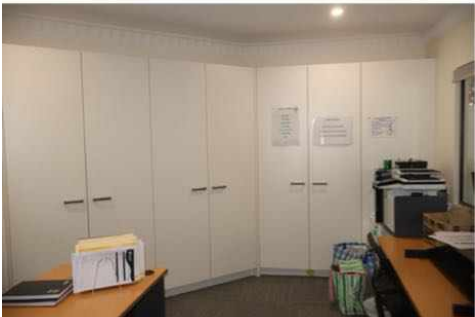
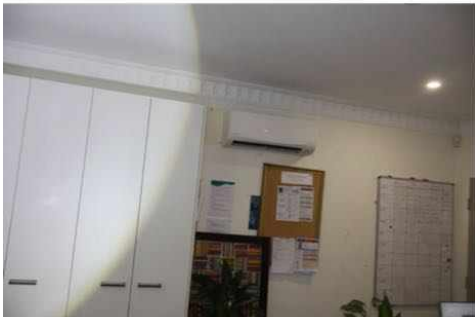
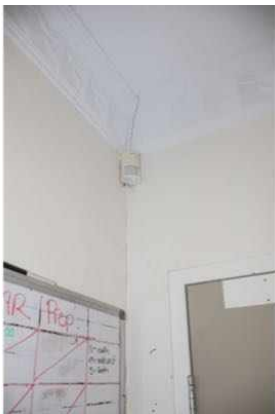
**Defects 3.03**

Building: Main Building  
Location: Office1 > Rear  
Finding: Cracks to external render - Category 1  
Information: It has been observed that cracking to rendered surfaces has occurred. The degree of damage falls within Category 1, described as fine cracks that do not need repair and which are less than 1.0mm in width limit.

Damage of this category is not considered a defect for rectification. Always contact your building inspector should cracks widen, lengthen, or become more numerous.

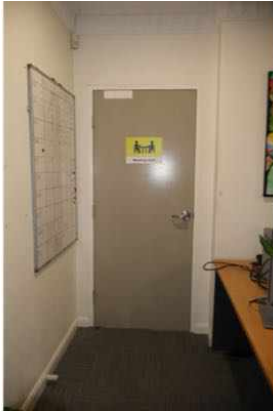
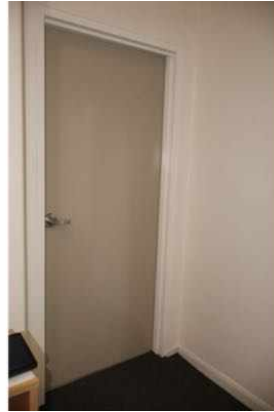
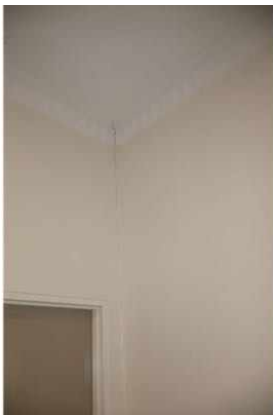
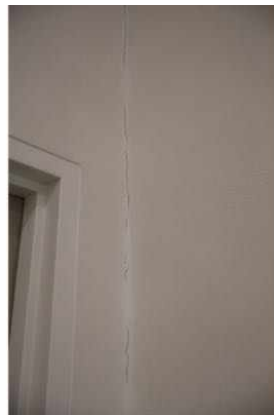
## Defects 3.04

Building: Main Building  
Location: Meeting Room > Rear  
Finding: Cracks to external render - Category 2  
Information: It has been observed that cracking to external rendered surfaces has occurred. The degree of damage falls within Category 2, described as noticeable cracks which are easily filled. Cracking of this size are generally less than 5mm in width.

Category 2 damage is required to be monitored for a period of 12 months. After the monitoring period, a crack rated at Category 2 or above is considered a defect requiring rectification.

Always contact your building inspector should cracks widen, lengthen, or become more numerous.

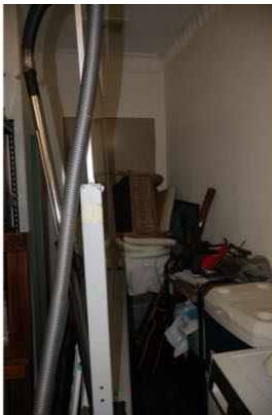
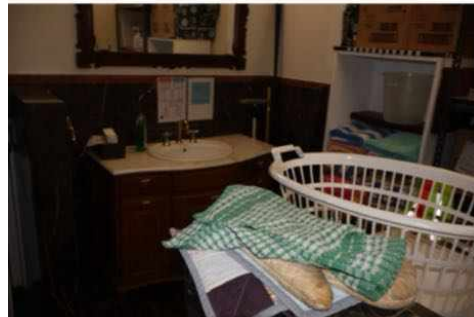
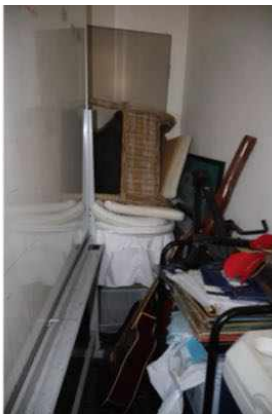
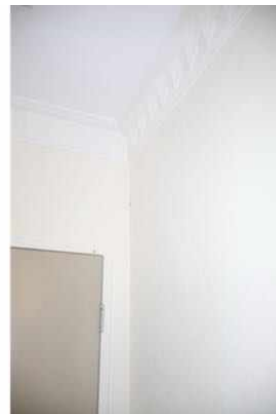
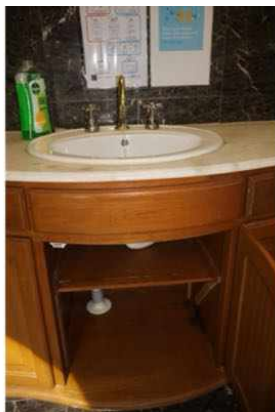
### Defects 3.05

Building: Main Building  
 Location: Laundry > Front  
 Finding: Cracks to external render - Category 1  
 Information: It has been observed that cracking to rendered surfaces has occurred. The degree of damage falls within Category 1, described as fine cracks that do not need repair and which are less than 1.0mm in width limit.

Damage of this category is not considered a defect for rectification. Always contact your building inspector should cracks widen, lengthen, or become more numerous.

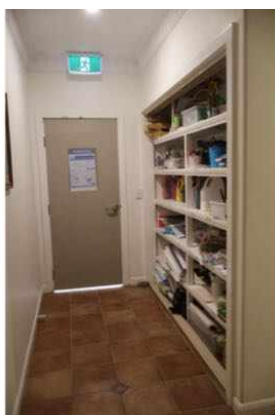
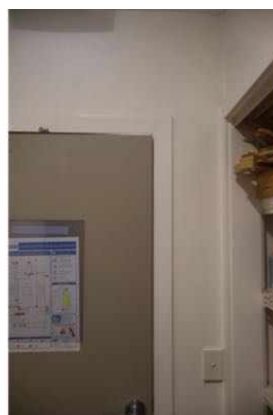
### Defects 3.06

Building:	Main Building
Location:	Storage Cupboard > Front
Finding:	Door - Binding
Information:	Binding of this door is evident during standard operation. This defect inhibits the functionality of the affected door as well as creating potential for secondary defects to associated building elements, such as damage to the door jamb.

For minor causes, a qualified carpenter or general handyperson should be appointed to perform minor rectification works at client discretion.

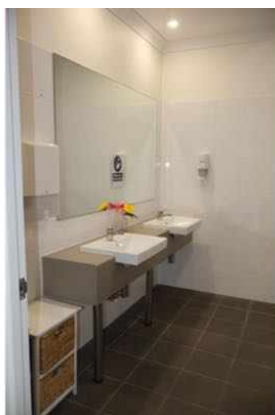
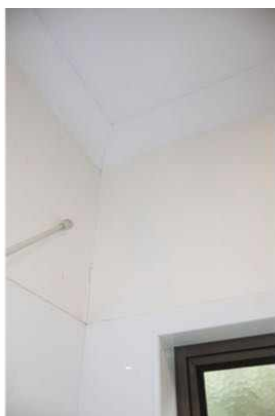
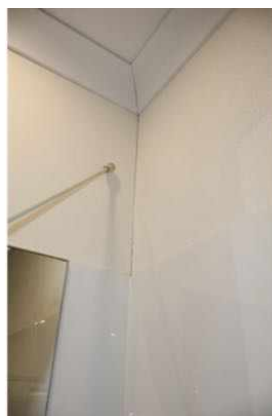
### Defects 3.07

Building:	Main Building
Location:	Ladies toilets > Rear
Finding:	Cracks to internal plaster- Category 2
Information:	It has been observed that cracking to internal plaster surfaces has occurred. The degree of damage falls within Category 2, described as noticeable cracks which are easily filled. Cracking of this size are generally less than 5mm in width.

Category 2 damage is required to be monitored for a period of 12 months. After the monitoring period, a crack rated at Category 2 or above is considered a defect

requiring rectification.

Always contact your building inspector should cracks widen, lengthen, or become more numerous.

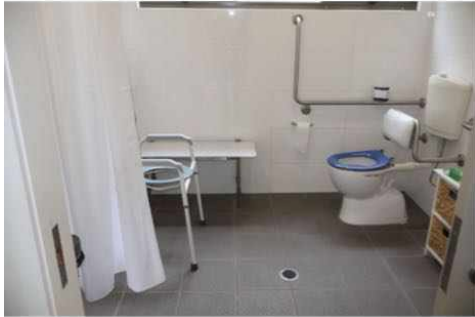
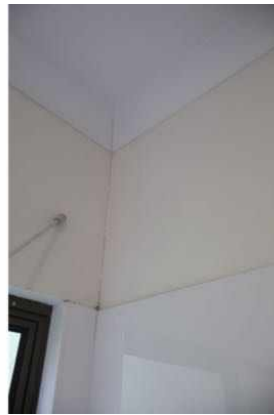
### Defects 3.08

Building:	Main Building
Location:	Bathroom > Rear
Finding:	Cracks to internal plaster- Category 2
Information:	It has been observed that cracking to internal plaster surfaces has occurred. The degree of damage falls within Category 2, described as noticeable cracks which are easily filled. Cracking of this size are generally less than 5mm in width.

Category 2 damage is required to be monitored for a period of 12 months. After the monitoring period, a crack rated at Category 2 or above is considered a defect requiring rectification.

Always contact your building inspector should cracks widen, lengthen, or become more numerous.

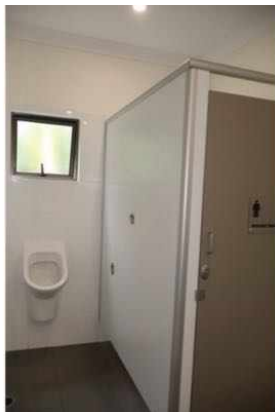
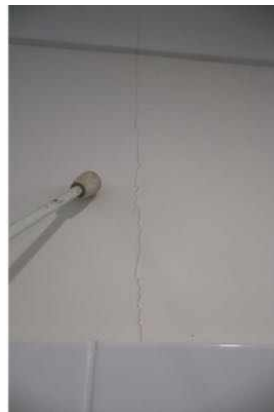
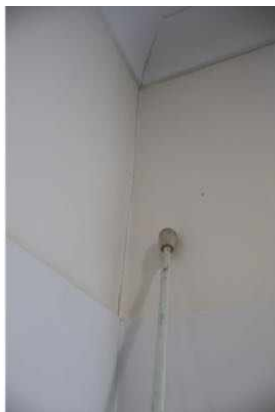
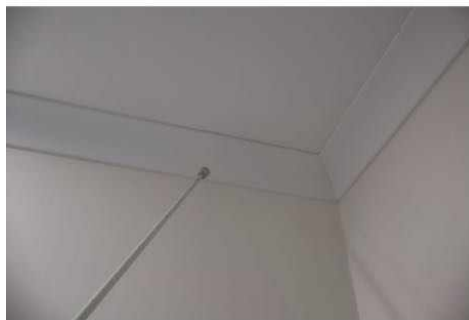
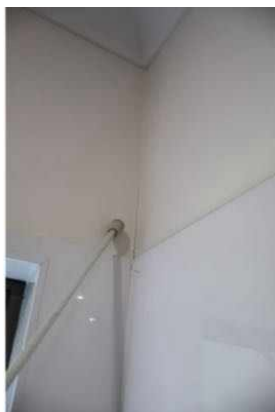
### Defects 3.09

Building: Main Building  
 Location: Men's toilets > Rear  
 Finding: Cracks to internal plaster- Category 2  
 Information: It has been observed that cracking to internal plaster surfaces has occurred. The degree of damage falls within Category 2, described as noticeable cracks which are easily filled. Cracking of this size are generally less than 5mm in width.

Category 2 damage is required to be monitored for a period of 12 months. After the monitoring period, a crack rated at Category 2 or above is considered a defect requiring rectification.

Always contact your building inspector should cracks widen, lengthen, or become more numerous.

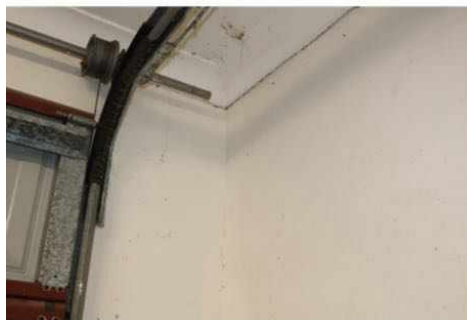
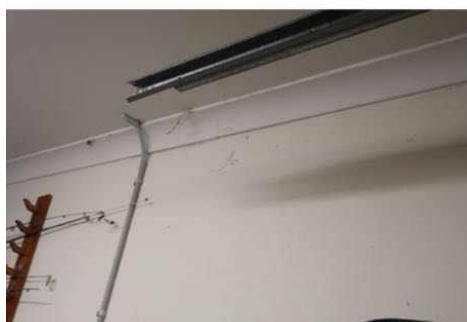
Building:	Main Building
Location:	Workshop/garage > Rear Left
Finding:	Beading - gap
Information:	Beading acts (like cornice or skirtings) to cover the intersection or joins of building materials. It was noted at the time of inspection that beading in this area has minor gaps. This deterioration is suspected to have been caused by general ageing, which is expected in a building of this age and condition.

Beading is important in weatherproofing the surrounding building elements and preventing termite or pest ingress. Furthermore, beading works to protect the joins of building materials, which are more susceptible to deterioration and decay.

Repair or replacement of the beading is advised to ensure the protection and longevity of any associated building elements. Such works may be performed by a general handyperson or qualified carpenter.

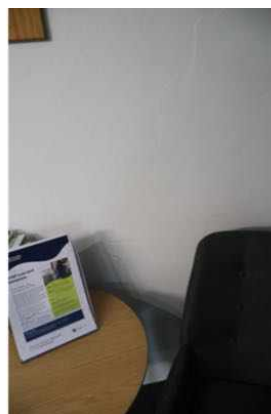
### Defects 3.11

Building:	Main Building
Location:	Reception > Rear Right
Finding:	Brickwork - Step cracking
Information:	Step cracking was identified to the brickwork in this area at the time of inspection. Step cracking, which is similar to other forms of cracking, has a variety of possible causes. However, the most common is the subsidence of adjacent footings.

Step cracking is a relatively common defect, and is most likely to occur adjacent to windows, doors and other openings. Mortar failure in the gaps between affected bricks indicates the stresses and tensions affecting the wall.

Where step cracking is extensive or severe, the client is advised to consult a structural engineer. Minor step cracking can be used as a warning sign to address factors causing stress to the wall, which can include the effect of surrounding trees, water leaks, soil erosion, or even the presence of reactive soils in the surrounding area.

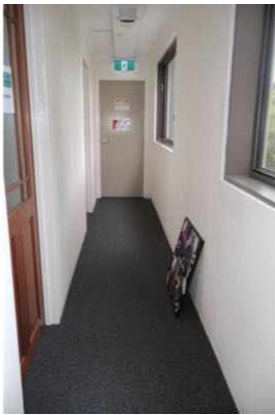
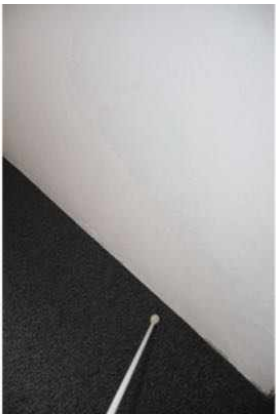
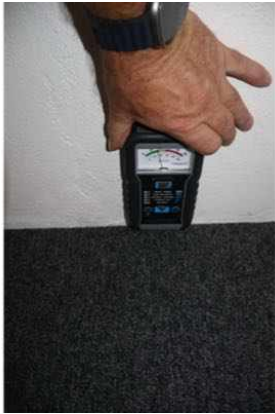
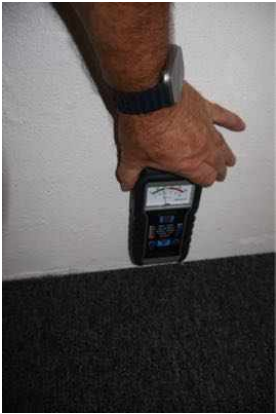
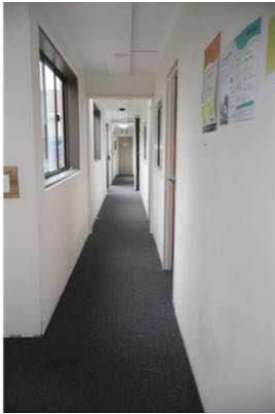
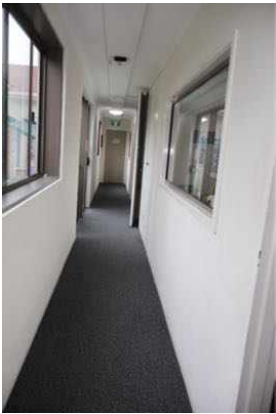
### Defects 3.12

Building:	Main Building
Location:	Hallway > Centre Left
Finding:	Render - Drummy
Information:	<p>Drummy rendered areas were identified at the time of inspection. The term 'drummy' refers to render that has become detached from its fixing, despite it still being solid. Such defects are generally caused by physical or moisture damage to the area. Drummy render may also be a direct result of poor workmanship during the construction process.</p>

Render may swell and shrink with changes in air humidity if the area has sustained moisture damage. Any exposure to moisture is capable of causing rendered areas to become drummy and/or cracked over a prolonged period of time. Drummy render generally requires chipping off and re-rendering or painting.

Specialist trades are available for these types of services. A registered builder may be required to undertake works if damage is extensive, or if secondary building defects have resulted. Immediate action is recommended to ensure that no further damage is sustained in the affected area.

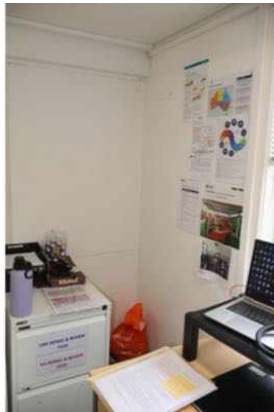
### Defects 3.13

Building: Main Building  
 Location: Office 4 > Rear  
 Finding: Cracks to internal render - Category 2  
 Information: It has been observed that cracking to internal rendered surfaces has occurred. The degree of damage falls within Category 2, described as noticeable cracks which are easily filled. Cracking of this size are generally less than 5mm in width.

Category 2 damage is required to be monitored for a period of 12 months. After the monitoring period, a crack rated at Category 2 or above is considered a defect requiring rectification.

Always contact your building inspector should cracks widen, lengthen, or become more numerous.

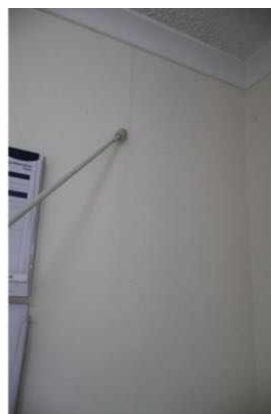
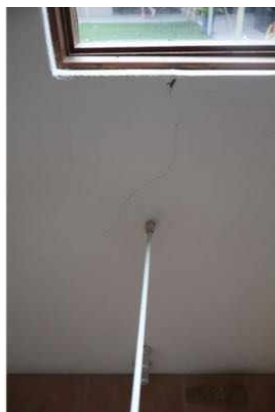
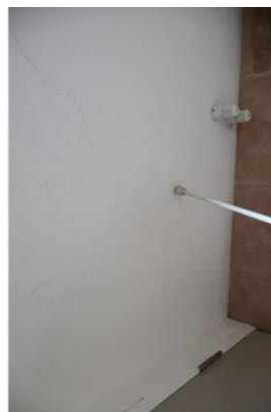
### Defects 3.14

Building:	Main Building
Location:	Stationary > Rear
Finding:	Brickwork - Step cracking
Information:	Step cracking was identified to the brickwork in this area at the time of inspection. Step cracking, which is similar to other forms of cracking, has a variety of possible causes. However, the most common is the subsidence of adjacent footings.

Step cracking is a relatively common defect, and is most likely to occur adjacent to windows, doors and other openings. Mortar failure in the gaps between affected bricks indicates the stresses and tensions affecting the wall.

Where step cracking is extensive or severe, the client is advised to consult a structural engineer. Minor step cracking can be used as a warning sign to address factors causing stress to the wall, which can include the effect of surrounding trees, water leaks, soil erosion, or even the presence of reactive soils in the surrounding area.

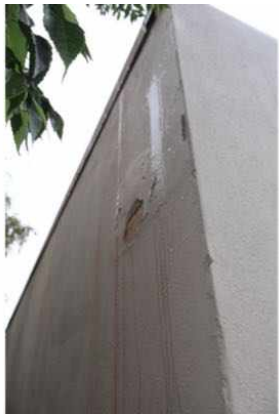
### Defects 3.15

Building:	Main Building
Location:	Walls > Rear Left
Finding:	Render - Drummy
Information:	<p>Drummy rendered areas were identified at the time of inspection. The term 'drummy' refers to render that has become detached from its fixing, despite it still being solid. Such defects are generally caused by physical or moisture damage to the area. Drummy render may also be a direct result of poor workmanship during the construction process.</p>

Render may swell and shrink with changes in air humidity if the area has sustained moisture damage. Any exposure to moisture is capable of causing rendered areas to become drummy and/or cracked over a prolonged period of time. Drummy render generally requires chipping off and re-rendering or painting.

Specialist trades are available for these types of services. A registered builder may be required to undertake works if damage is extensive, or if secondary building defects have resulted. Immediate action is recommended to ensure that no further damage is sustained in the affected area.

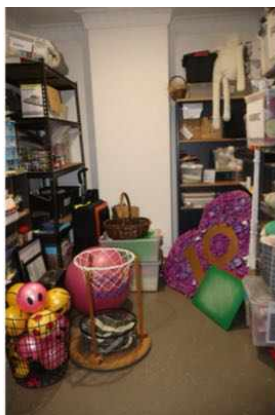
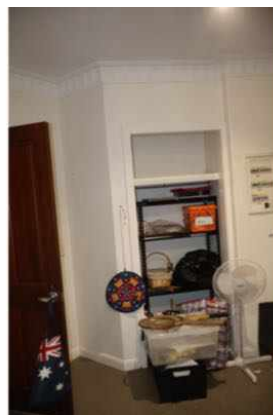
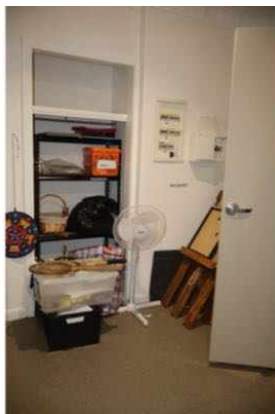
Building: Main Building  
 Location: Store Room > Existing  
 Finding: Additional Photos - Obstructions and Limitations  
 Information: These photographs are an indication of the obstructions and limitations which impeded full inspection of the property at the time of inspection. These obstructions can hide an array of defects and should be removed to allow full inspection to be carried out. A re-inspection is recommended once the areas are made accessible.

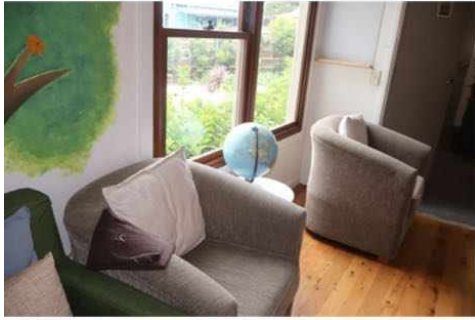
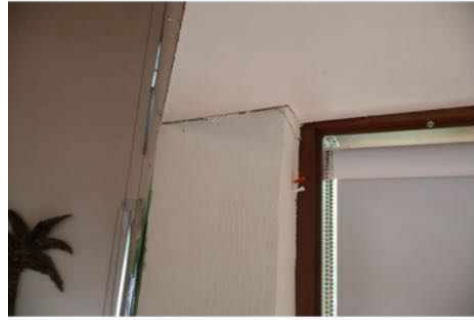
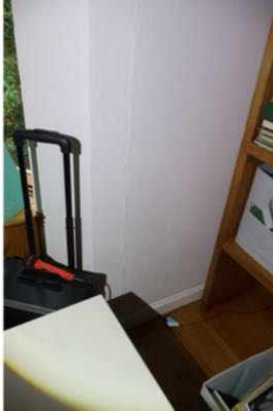
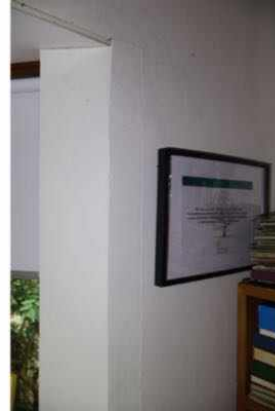
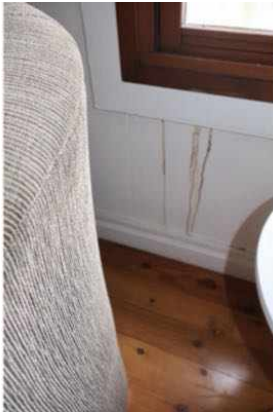
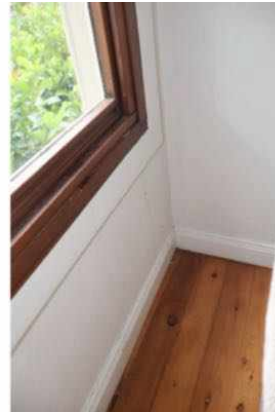
Building:	Main Building
Location:	Day centre > Rear
Finding:	Cracks to external render - Category 1
Information:	It has been observed that cracking to rendered surfaces has occurred. The degree of damage falls within Category 1, described as fine cracks that do not need repair and which are less than 1.0mm in width limit.

Damage of this category is not considered a defect for rectification. Always contact your building inspector should cracks widen, lengthen, or become more numerous.

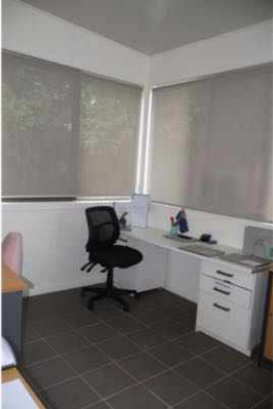
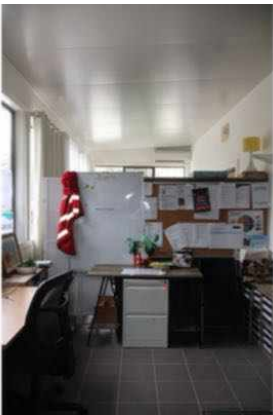
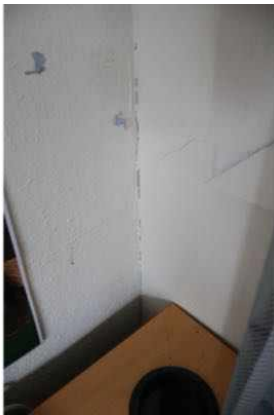
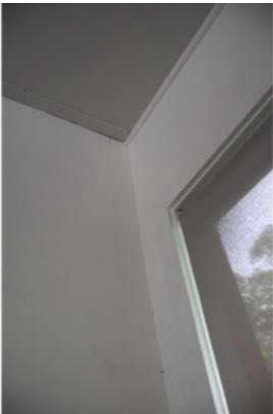
Building: Main Building  
 Location: Staff office > Rear Left  
 Finding: Water staining  
 Information: Water staining was evident in this area at the time of inspection. Water staining indicates that surfaces have been exposed to excessive moisture over time. The minerals and other elements in the water lead to staining, which may graduate to corrosion and deterioration if left unmanaged.

While mostly an appearance defect, water staining can be indicative of more serious defects, which may be currently concealed by other building elements.

Where water staining is active, a licensed plumber must be consulted to identify the cause of the staining and to provide advice on any reparation works that may be required. Replacement of any broken or damaged structures is advised.

Conversely, where water staining is old and inactive, affected building materials may be repaired or replaced at client discretion. A qualified carpenter or registered builder may be appointed to perform these works.

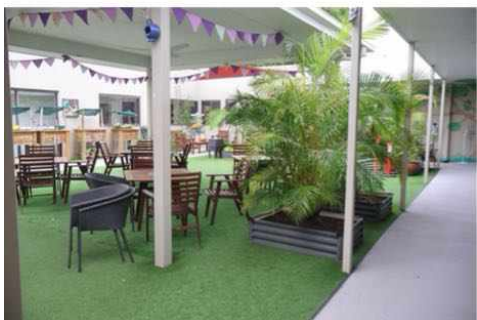
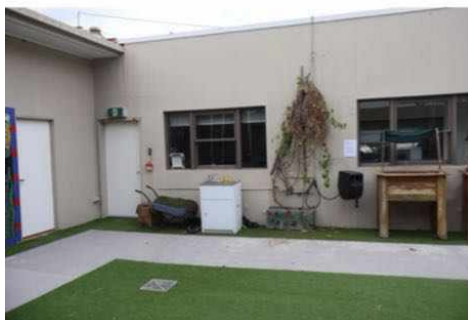
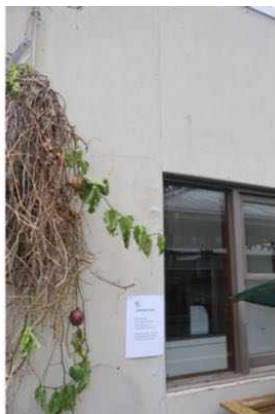
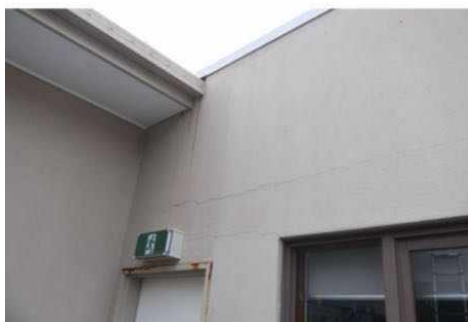
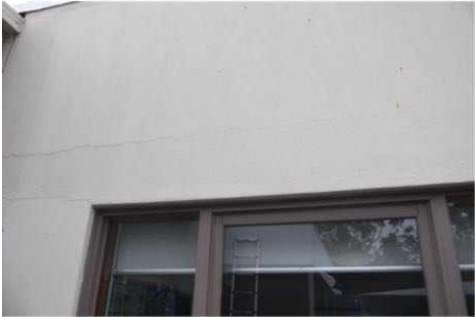
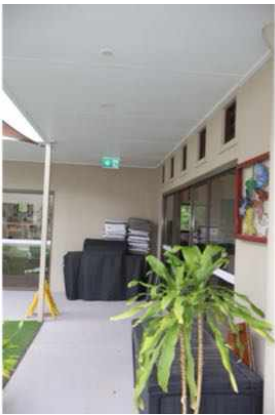
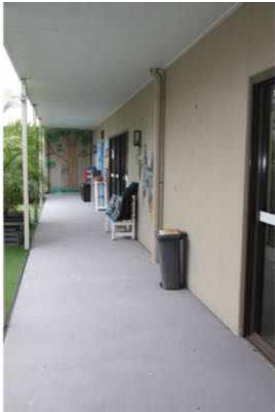
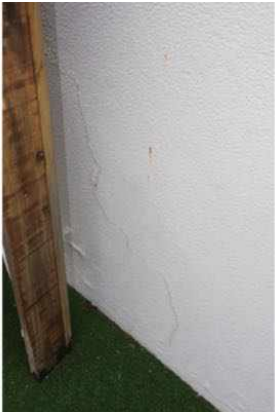
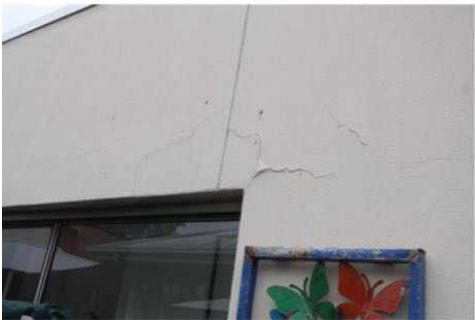
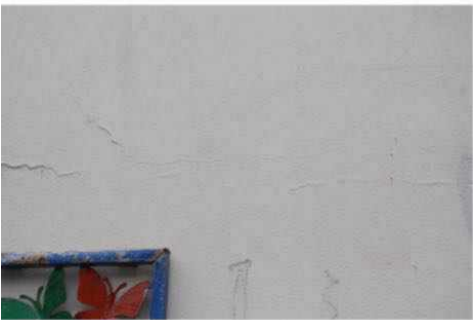
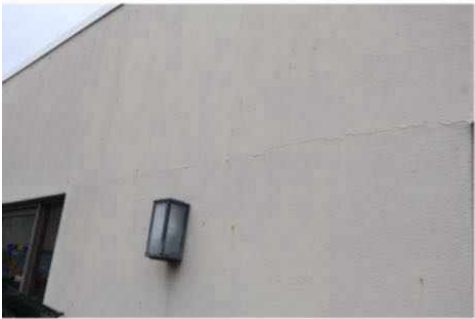
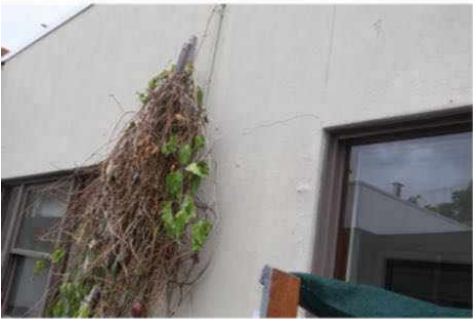
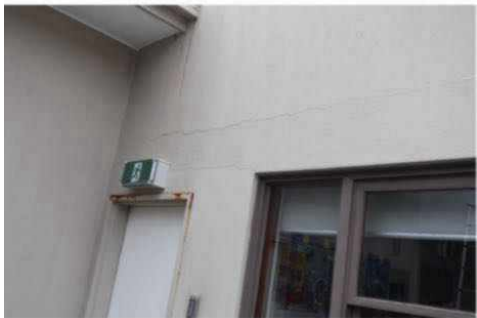
Building: Main Building  
Location: Courtyard > Existing

Finding: Water - seepage external walls  
Information: Evidence of water seepage and moisture ingress was observed through the render wall.

Indicators include staining,dampness bubbling/blistering of the render,cracking and or efflorescence.

These conditions suggest that the wall system is not weather tight,allowing water penetration behind the render finish.

Probable causes in render finish allowing moisture entry,inadequate or missing waterproofing/weatherproofing coating.

Poor flashing installation at openings,render applied directly to masonry without appropriate moisture management detailing or missing sealant at wall penetration,junctions or control.

A renderer is recommended to inspect and make recommendations on repairs.

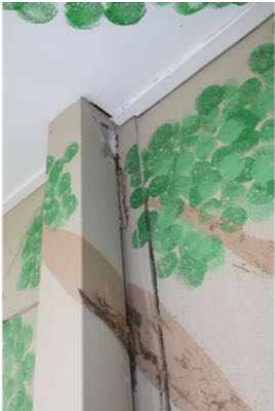
Building: Main Building  
Location: Courtyard > Front,Rear  
Finding: Exterior roof plumbing - Leaking  
Information: Active gutter leaks were evident at the time of inspection. Roof leaks can have a number of causes, including damage to gutter joints, deterioration of roof fixtures and fittings, or loosely associated materials (fascias etc.)

A roof plumber should be appointed as soon as possible to primarily identify the cause of the leak, and to provide subsequent repair works as necessary. Depending on the extent of the damage, replacement of sections of the roof gutter may be required, and may be performed by a roof plumber.

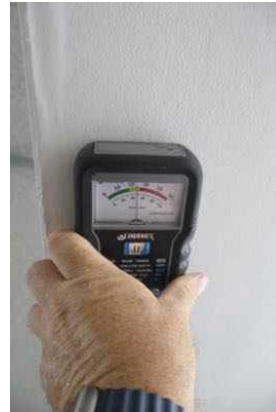
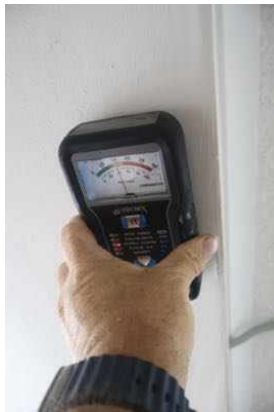
Building: Main Building  
 Location: Office 5 > Rear  
 Finding: Painted surface - Bubbling  
 Information: Sections of paint in this area was found to have bubbled and deteriorated. Paint bubbling is generally an indication of excessive moisture in the area, that is currently hidden by the painted surface.

The presence of excessive moisture can have major implications on associated building elements if left unattended. While only seemingly minor at this stage, the damage cannot be determined due to the paint obstructing any further inspection of the damage.

It is highly advised that the affected paint be cleaned to allow a further, more invasive inspection by a licensed plumber. Failure to act on this defect may necessitate major works in the future.

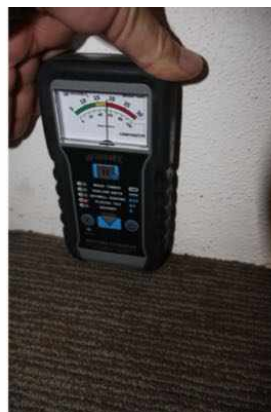
Building:	Main Building
Location:	Office 6 > Rear
Finding:	Evidence of excessive moisture was present at the time of inspection
Information:	Excessive moisture can attract termites and produce conditions that promote termite attack, fungal growth and wood decay. Excessive moisture is generally caused by deteriorated, inadequate or missing roof drainage, leaking plumbing pipes or fixtures, poorly plumbed HWS overflows or condenser units and poor site drainage. It is highly recommended that all plumbing and drainage fixtures and fittings be maintained regularly in order to prevent excessive moisture being present in the external / internal property.

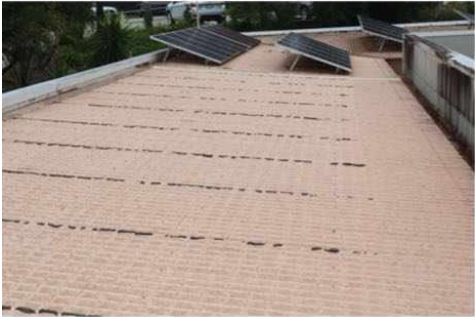
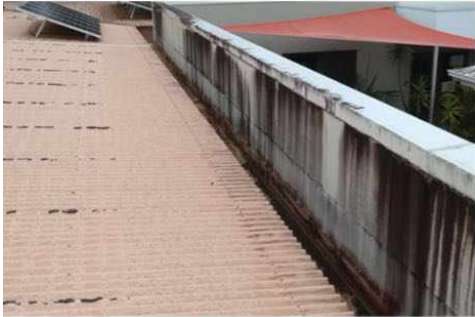
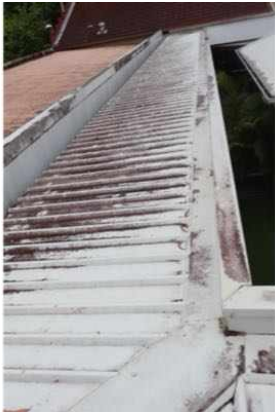
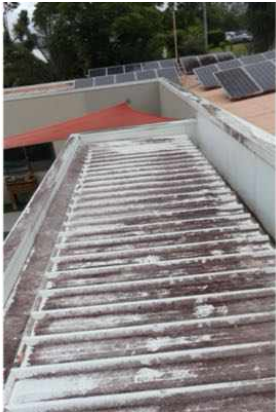
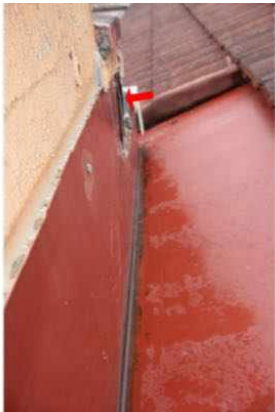
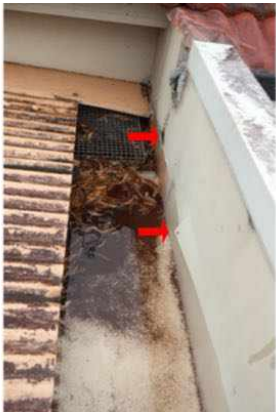
Building: Main Building  
 Location: Roof Exterior > Rear  
 Finding: Flashing holes - flashing  
 Information: Visible holes were observed on the roof flashing.

These penetrations compromise the flashings ability to provide a continuous waterproofing barrier and increase the risk of moisture ingress into the roof structure and internal building elements which was observed.

Premature deterioration of roof framing insulation, and ceiling linings.

Possible mould growth and internal damage.

Repairs to the flashing is recommended to prevent further deterioration of internal wall linings.

Engage a qualified roofing contractor to repair or replace the affected flashing sections.

All holes and penetrations should be sealed or replaced to restore a continuous waterproofing barrier in accordance with AS. 3500, AS 1562.1 and the NCC requirements for weatherproofing.

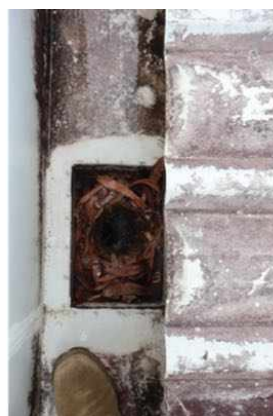
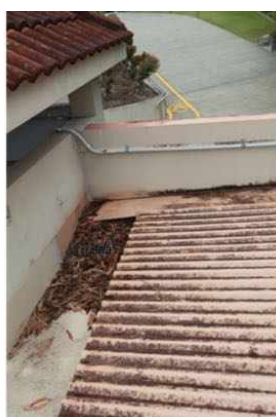
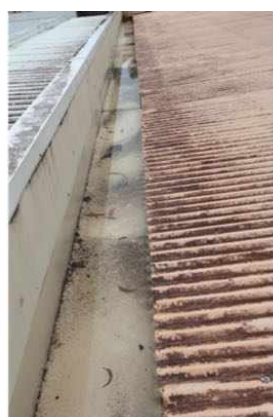
Building: Main Building  
Location: Roof Exterior > Rear Left  
Finding: Gutters - Blocked  
Information: Roof plumbing structures, such as guttering and downpipes, should be free of all debris to prevent blockages. Blockages of the guttering and downpipes will lead to pooling and accumulated water overflows, which is likely to subsequently flood eaves and exterior walls.

Blocked gutters are likely to lead to high levels of moisture in the affected areas. Such moisture will not only cause rust and decay of the associated building materials, but can also provide conditions that are conducive to termite and timber pest activity. Blockages in gutters should therefore be removed immediately to ensure dry conditions are maintained.

Consult a Licensed Plumber for further specific advice on remedial works that may be required. In the interim, it is highly advised that blocked gutters be removed by the homeowner or a general handyperson as a matter of urgency.

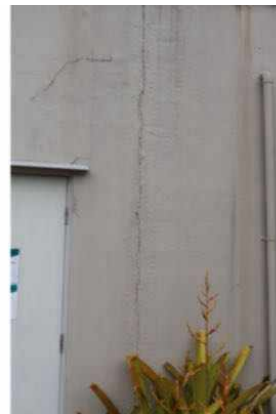
Building: Main Building  
 Location: Walls > Rear Right  
 Finding: Water - seepage  
 Information: Evidence of water seepage and moisture ingress was observed through the render wall.

Indicators include staining, dampness, bubbling/blistering of the render, cracking and or efflorescence.

These conditions suggest that the wall system is not weather tight, allowing water penetration behind the render finish.

Probable causes in render finish allowing moisture entry, inadequate or missing waterproofing/weatherproofing coating.

Poor flashing installation at openings, render applied directly to masonry without appropriate moisture management detailing or missing sealant at wall penetration, junctions or control.

A renderer is recommended to inspect and make recommendations on repairs.

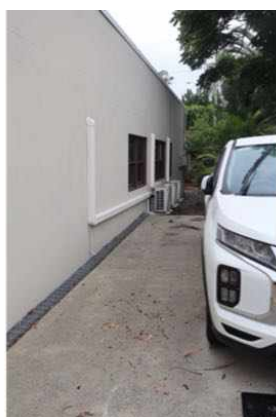
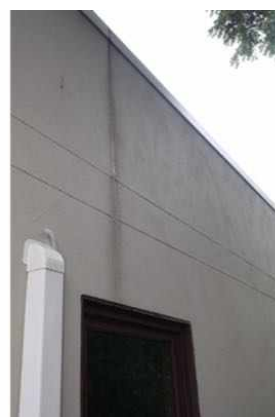
Location: Flashing > Front  
 Finding: Water leak - External  
 Information: Water leaks were found to be present to exterior plumbing work. Leaks are generally caused by deterioration of the plumbing elements over time, due to exposure to weather conditions, but may have also been caused by minor impact damage.

Such leaking creates damp conditions in the affected area, causing potential for water pooling and subsequent water damage if left unattended. These conditions may also attract termite attack, particularly if the area is subject to minimal levels of sun throughout daylight hours.

It is highly advised that a licensed plumber be appointed to rectify any water leaks that may be present. Areas of repair and replacement of plumbing fittings and fixtures may be required and, as such, a quotation should be sought.

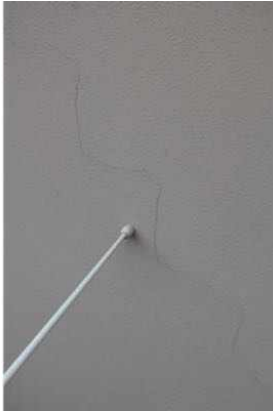
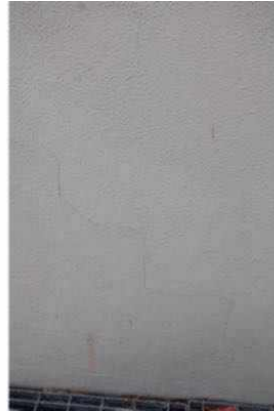
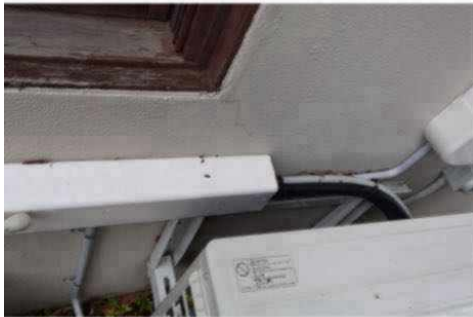
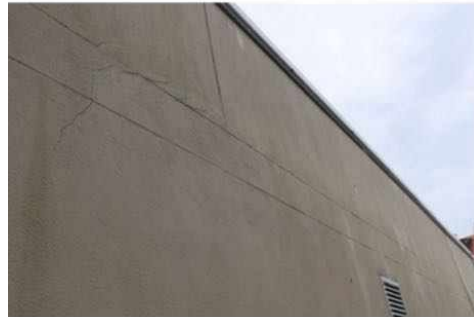
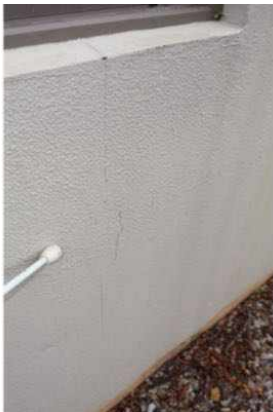
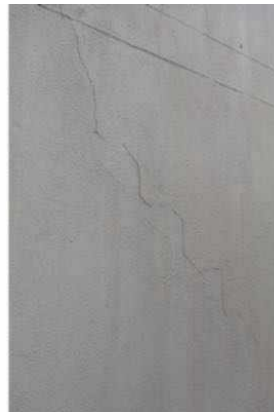
Building: Main Building  
 Location: Walls > Front  
 Finding: Brickwork - Step cracking  
 Information: Step cracking was identified to the brickwork in this area at the time of inspection. Step cracking, which is similar to other forms of cracking, has a variety of possible causes. However, the most common is the subsidence of adjacent footings.

Step cracking is a relatively common defect, and is most likely to occur adjacent to windows, doors and other openings. Mortar failure in the gaps between affected bricks indicates the stresses and tensions affecting the wall.

Where step cracking is extensive or severe, the client is advised to consult a structural engineer. Minor step cracking can be used as a warning sign to address factors causing stress to the wall, which can include the effect of surrounding trees, water leaks, soil erosion, or even the presence of reactive soils in the surrounding area.

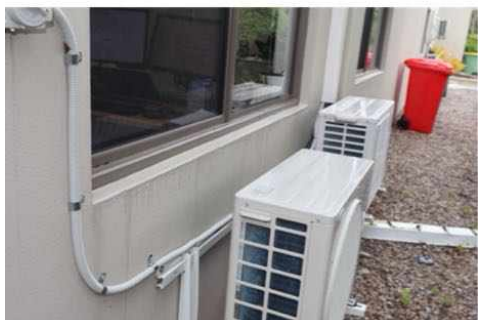
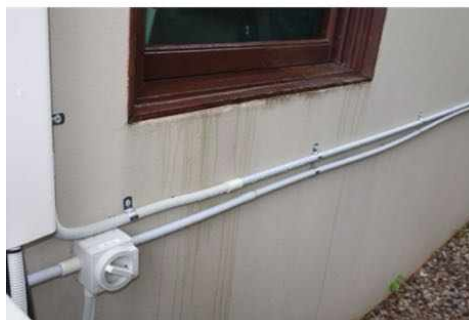
Building:	Main Building
Location:	Window > Front
Finding:	Water staining
Information:	Water staining was evident in this area at the time of inspection. Water staining indicates that surfaces have been exposed to excessive moisture over time. The minerals and other elements in the water lead to staining, which may graduate to corrosion and deterioration if left unmanaged.

While mostly an appearance defect, water staining can be indicative of more serious defects, which may be currently concealed by other building elements.

Where water staining is active, a licensed plumber must be consulted to identify the cause of the staining and to provide advice on any reparation works that may be required. Replacement of any broken or damaged structures is advised.

Conversely, where water staining is old and inactive, affected building materials may be repaired or replaced at client discretion. A qualified carpenter or registered builder may be appointed to perform these works.

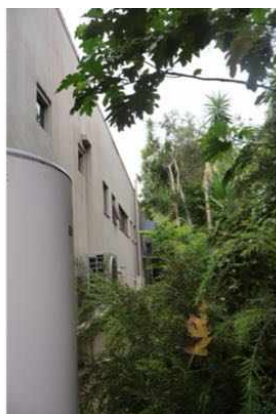
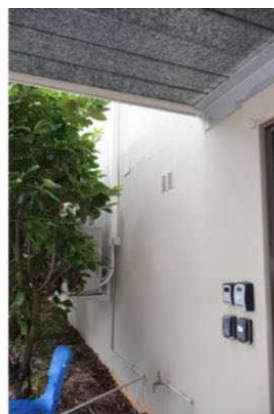
Building: Main Building  
 Location: Walls > Front Left  
 Finding: Cracks to external render - Category 2  
 Information: It has been observed that cracking to external rendered surfaces has occurred. The degree of damage falls within Category 2, described as noticeable cracks which are easily filled. Cracking of this size are generally less than 5mm in width.

Category 2 damage is required to be monitored for a period of 12 months. After the monitoring period, a crack rated at Category 2 or above is considered a defect requiring rectification.

Always contact your building inspector should cracks widen, lengthen, or become more numerous.

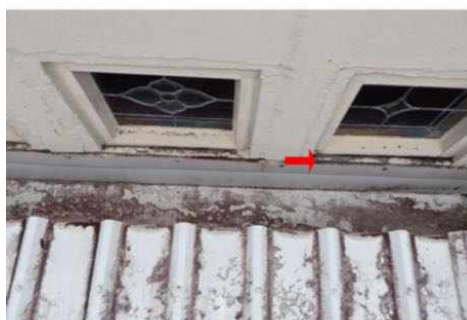
Building: Main Building  
Location: Windows > Existing  
Finding: Window seals - deteriorated  
Information: The window seals have deteriorated and are in a generally poor condition. Due to frequent exposure to weather conditions and subsequent moisture, deterioration of window seals is expected in a property of this condition and age.

Where window seals have deteriorated, the window is no longer weather-tight; rain penetration and subsequent water damage is therefore likely to ensue. Insulation of the area against external weather conditions will also be compromised.

It is recommended that all deteriorated window seals be replaced by a general handyman or sealant expert to prevent any further damage and to restore the window to a fully functional level.

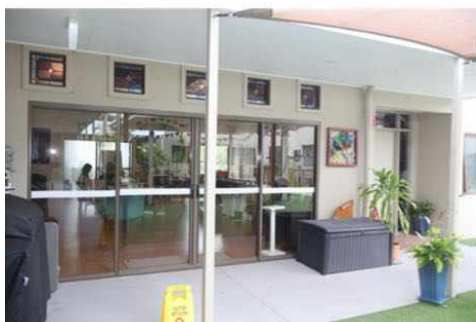
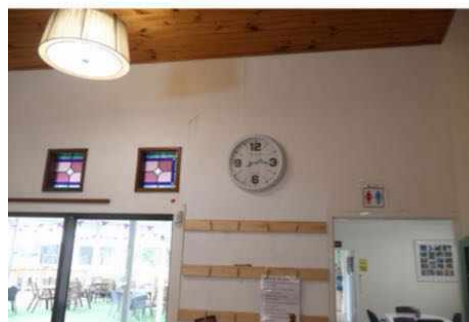
Building: Main Building  
 Location: Day centre > Existing  
 Finding: Walls - Water stained  
 Information: Water staining to sections of the walls in this area was evident at the time of inspection. Water staining indicates that surfaces have been exposed to excessive moisture over time. The minerals and other elements in the water lead to staining, which may graduate to corrosion and deterioration if left unmanaged.

While mostly an appearance defect, water staining can be indicative of more serious defects, which may be currently concealed by wall linings.

Where water staining is active, a licensed plumber must be consulted to identify the cause of the staining and to provide advice on any reparation works that may be required. Replacement of any broken or damaged structures is advised.

Conversely, where water staining is old and inactive, affected building materials may be repaired or replaced at client discretion.

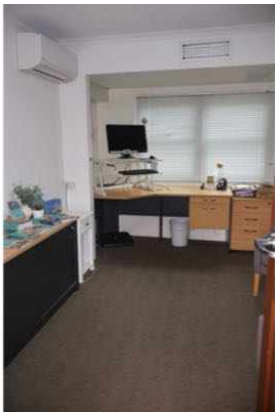
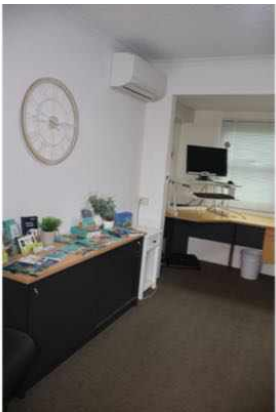
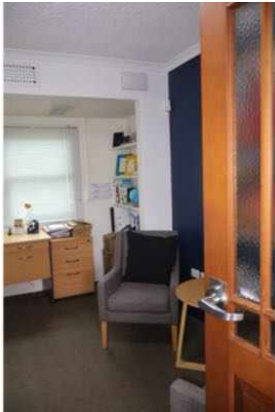
Building: Main Building  
Location: Office 8 > Existing  
Finding: Additional Photos  
Information: Additional photos are provided for your general reference

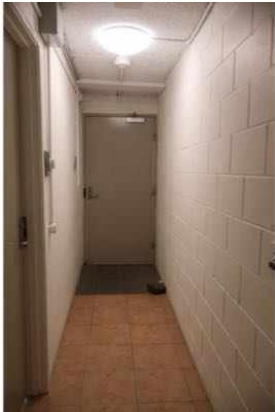
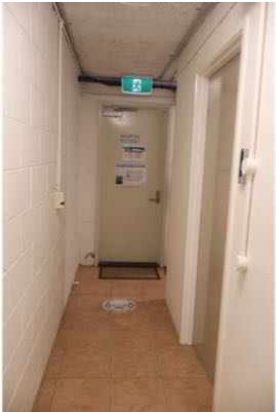
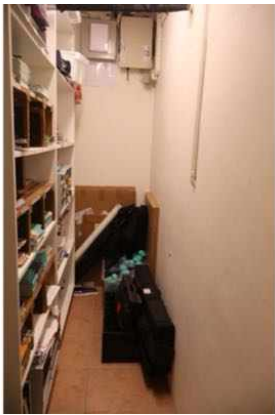
Building: Main Building  
Location: Corridors > Rear Right  
Finding: Additional Photos  
Information: Additional photos are provided for your general reference

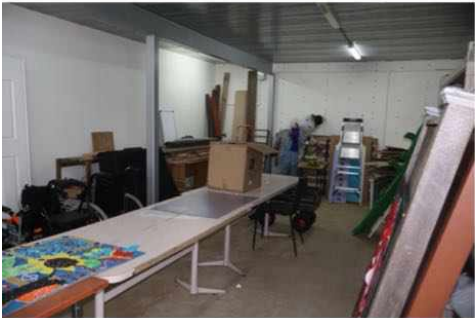
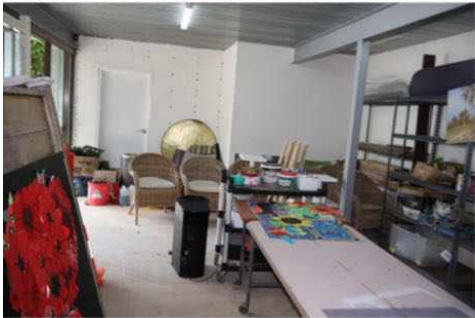
Building: Main Building  
Location: Storage room > Existing  
Finding: Additional Photos  
Information: Additional photos are provided for your general reference
