Building and Timber Pest Inspection Report

Inspection Date: Thu, 19 Feb 2026

Property Address: 13 Birdwood Rd, Georges Hall NSW 2198,
Australia

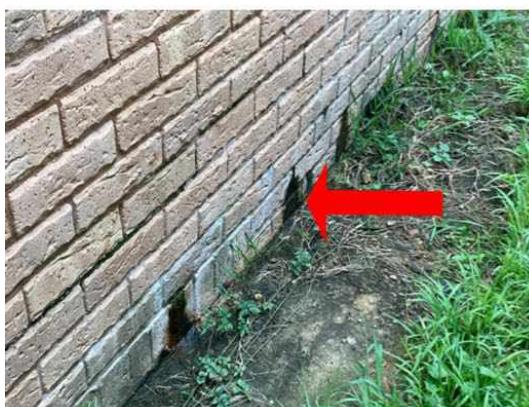
Building: Main Building
Location: All External Areas
Finding: Pipework - Leaking into subfloor
Information: Dampness to localised sections of the subfloor area was identified. It is suspected that this dampness has occurred due to leaking pipes in this area, which may be exacerbated by poor site drainage and inadequate subfloor ventilation.

Dampness in this area is likely to lead to wood rot and general deterioration of structures within the subfloor space. Excessive moisture also creates an environment which is conducive to termite and pest infestation.

A licensed plumber should be appointed immediately to repair any pipes that may be leaking. This will ensure a dry subfloor space as well as improving the water efficiency of the property. Invasive inspection in this area is highly recommended.

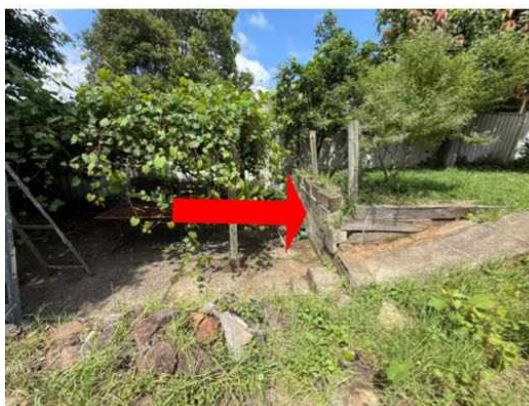
Finding 2.02

Building:	Main Building
Location:	All External Areas
Finding:	Rear Retaining Wall - Deteriorated
Information:	The retaining wall at the rear yard was observed to be in deteriorated condition, including:

- Cracked and displaced masonry units.
- Movement and misalignment of blocks.
- Localised structural instability.
- Weathered and deteriorated timber retaining elements.
- Possible inadequate drainage behind the wall.

The extent of cracking and displacement suggests structural movement, potentially caused by soil pressure buildup, poor drainage, or footing failure.

This condition may worsen over time and could result in further structural instability or partial collapse.

Engage a structural engineer or qualified retaining wall specialist to assess the structural integrity of the wall. Repairs or reconstruction may be required. Drainage behind the wall should also be investigated and upgraded where necessary.

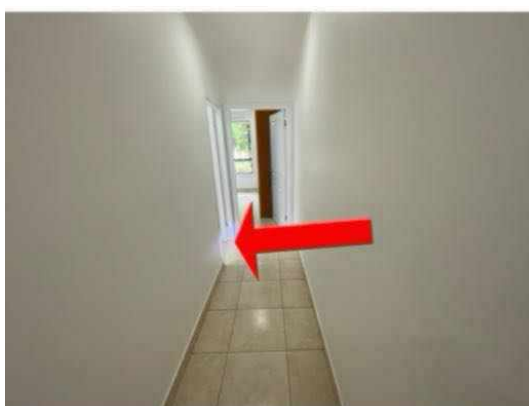
Finding 3.01

Building:	Main Building
Location:	All Internal Areas
Finding:	Tiles - Cracked or damaged
Information:	Cracking was evident to the tiling in this area at the time of inspection. While the cracking appears to be minor, this area is frequently exposed to water, allowing potential for water penetration into adjoining sections of walls or flooring.

If left unmanaged, water penetration to these areas may lead to subsequent water damage, which is likely necessitate repair work to affected building elements.

A tiling contractor should be appointed to ensure that no further water damage occurs. The re-application of silicone and grouting throughout remaining tile work is also advised, to further protect the area against water penetration.

Where water penetration has led to water damage, appointment of a relevant tradesperson may be required to repair damaged building elements.

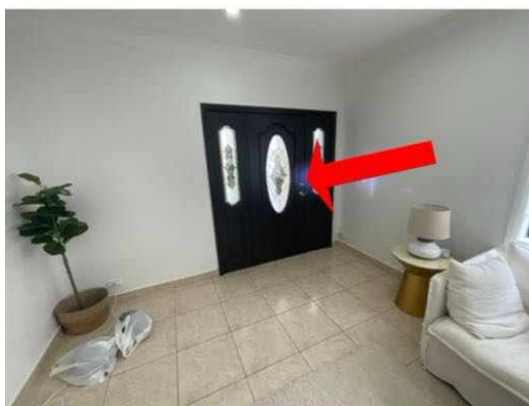
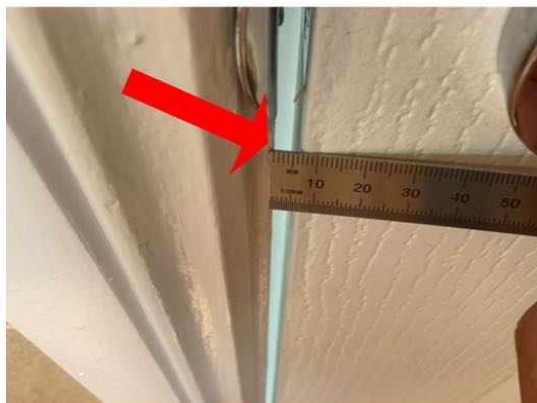
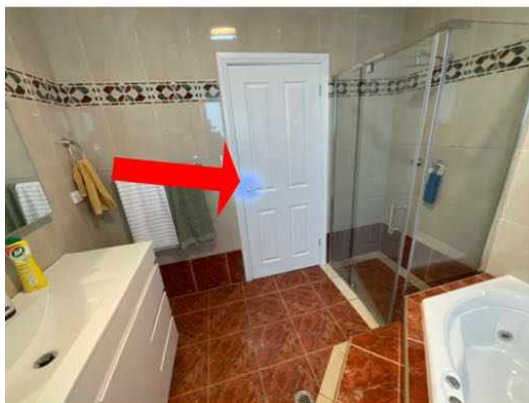
Finding 3.02

Information: A significant gap was identified between the door and door frame in this area. Where large gaps to the head or foot of door frames appear, it may indicate a variety of defects, ranging from uneven framework, sagging hinges or uneven flooring.

A gap to the head of the door may also indicate movement of the foundation of the property, which is a common occurrence and does not indicate structural damage.

A qualified carpenter should be appointed to perform remedial works to restore the door to a fully operational level.

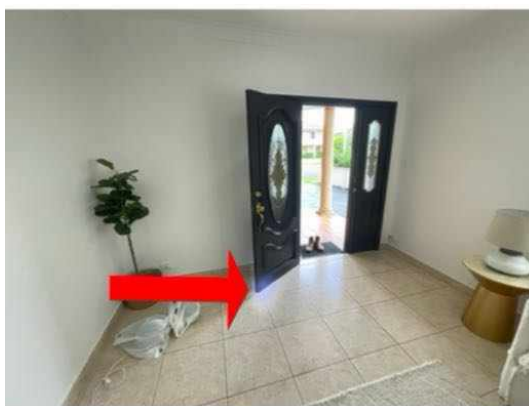
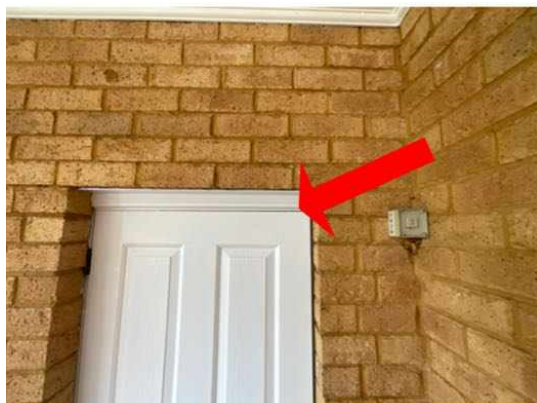
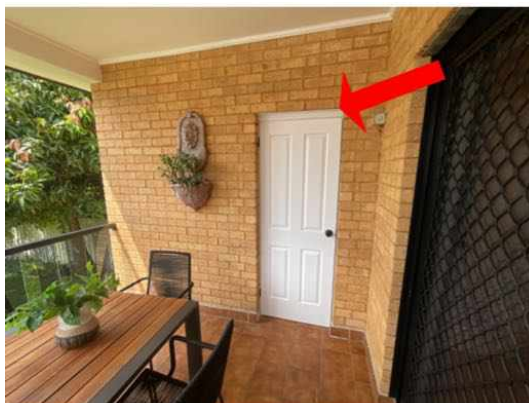
Finding 3.03

Building:	Main Building
Location:	All Internal Areas
Finding:	Door - Binding/jamming
Information:	Binding and/or jamming of this door is evident during standard operation. This defect inhibits the functionality of the affected door as well as creating potential for secondary defects to associated building elements, such as damage to the floor covering.

A door that binds to flooring or to the associated door frame may have several causes, ranging from minor defects, such as poor installation of the door or deteriorated hinges, through to major structural issues, such as damage to subfloor structures.

Where door binding/jamming appears to indicate major structural issues, a registered builder specialising in re-stumping should be appointed to provide an estimate on the cost of rectification.

For minor causes, a qualified carpenter or general handyperson should be appointed to perform minor rectification works at client discretion.

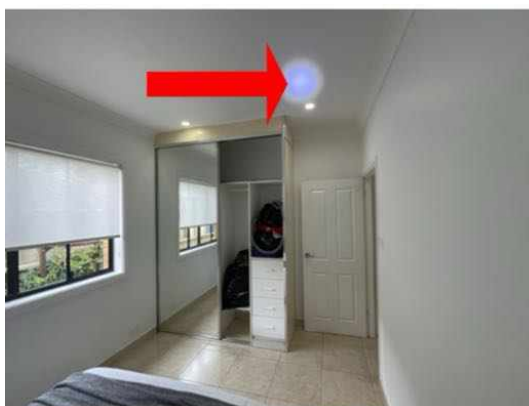
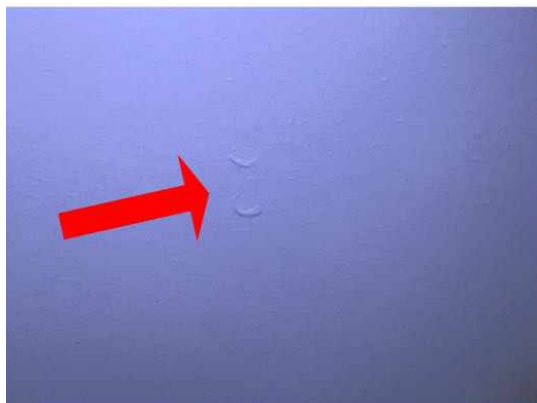
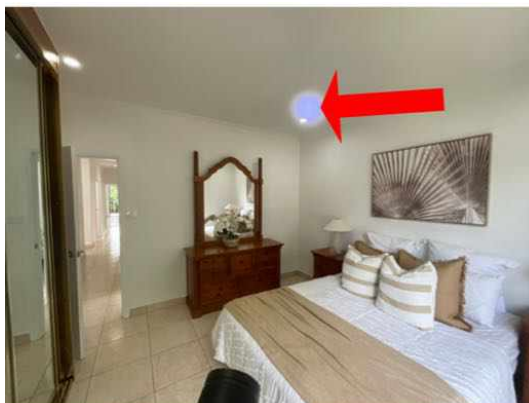
Finding 3.04

Building:	Main Building
Location:	All Internal Areas
Finding:	Ceiling nails - Popping
Information:	Numerous popped nails were identified in the internal ceiling at the time of inspection. Nails and screws hold simply by the friction between them and the surface they are applied to. Over time, the nails and screws can back out, which is often a result of general ageing and deterioration of the building structure.

If left unmanaged, the ceiling sheets may become loose and unstable, increasing the rate of deterioration of the internal ceiling and creating potential for the development of secondary defects.

Re-fastening of popped nails will help to maintain the stability of the internal ceiling and associated building elements. Such minor works will also help to improve the appearance of the affected area and secure the ceiling sheets, so as to prevent the onset of ceiling sagging. These works should be performed by a qualified carpenter or plasterer at client discretion.

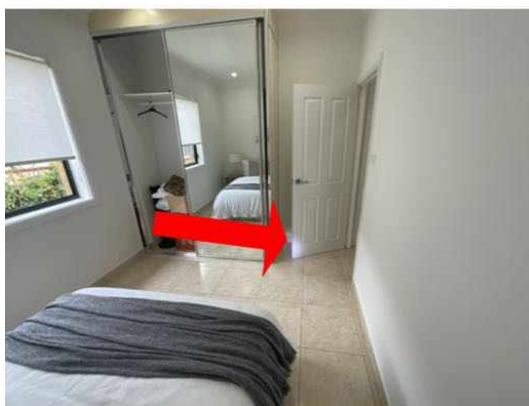
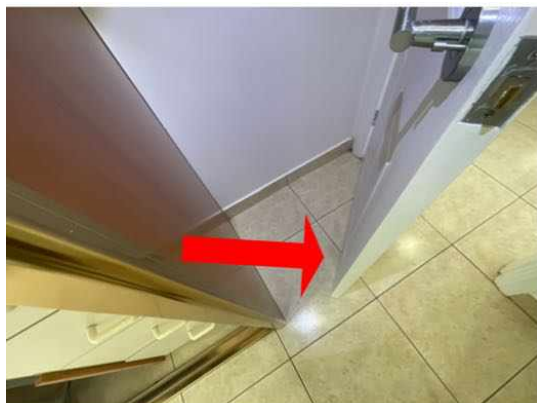
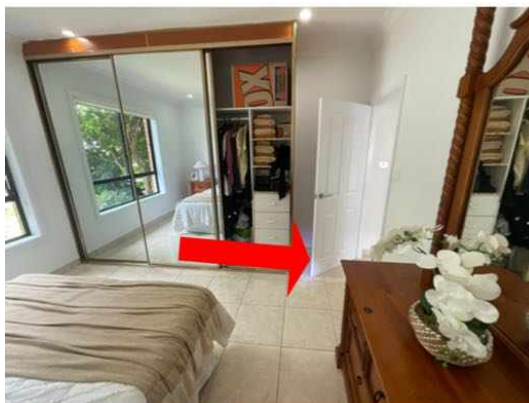
Finding 3.05

Building:	Main Building
Location:	All Internal Areas
Finding:	Door stop - Missing
Information:	The door stop is missing or is inadequate to stop the door handle from damaging the wall. Although some building elements may seem irrelevant or unnecessary, all building elements play a key role in the operation and function of the overall structure and its performance.

Re-installation or replacement of the door stop is advised as soon as possible to prevent any subsequent damage to the door or associated structures. A general handyman may be appointed to perform these works at client discretion.

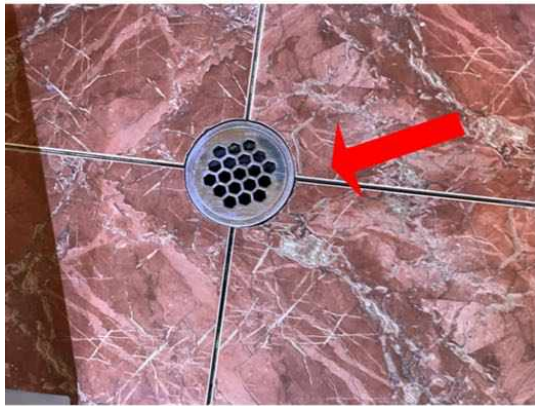
Finding 3.06

Building:	Main Building
Location:	Bathroom
Finding:	Sealant and grouting - Missing or damaged
Information:	It was noted on inspection that sealant or grout is degraded to the tiled shower alcove and or other areas of the bathroom.

Different materials and floor areas move at different rates, generally causing cracking to grout or sealant at this point. A flexible sealant is required to allow for expected expansion and contraction, while keeping the joint water tight and protective of all associated building materials.

There appears to be excessive mould to the sealant and grout which will likely require scraping out and replacement.

Flexible and mould resistant materials should be applied to affected areas to prevent any subsequent water damage that is likely to occur. Regular maintenance and replacement of damage or missing or damaged sealant and grout is highly recommended to the wet areas, as this is a regular wear and tear defect. Sealant and grouting in areas that come into regular contact with water should be maintained for the long term care of your property.

A sealant specialist or tiling contractor should be appointed to complete these works

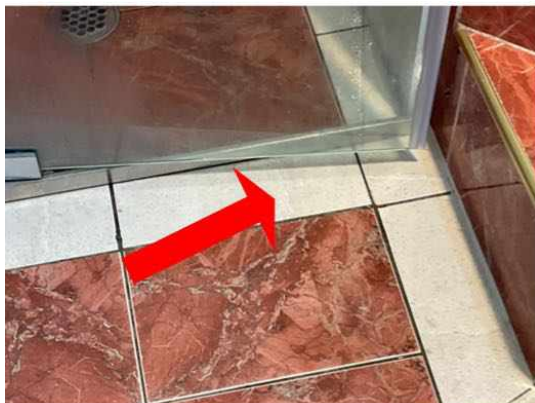
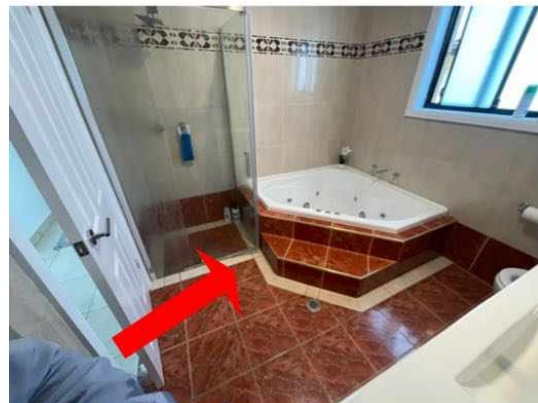
Finding 3.07

Building:	Main Building
Location:	Bathroom
Finding:	Shower base - Leaking
Information:	Leaking was evident to the shower base at the time of inspection. It is suspected that the leaking has occurred as a result of minor impact damage to the shower base or general ageing of the building elements.

Leaking from the shower base, where left unattended, is likely to lead to water damage to adjoining flooring and walls. Such damage can lead to water damage and necessitate extensive remedial works being required. Active water leaks may also create an environment that is susceptible to the formation and development of mould.

Appointment of a tiling contractor is required to repair or replace the shower base. Such works should be performed as soon as possible to ensure that no further damage occurs.

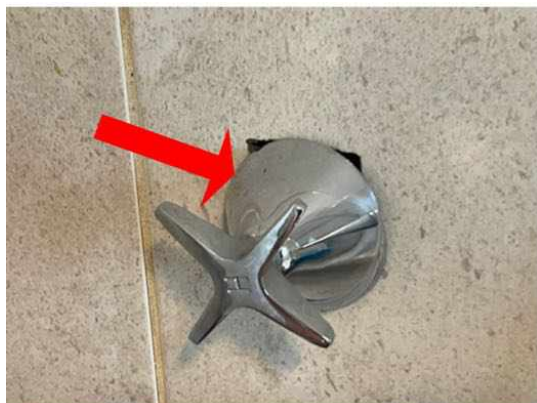
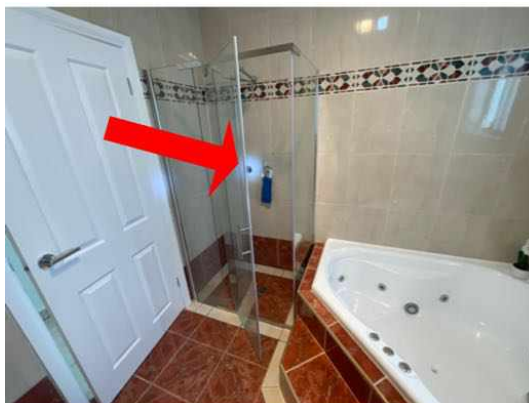
Finding 3.08

Location: Bathroom
 Finding: Fitting or fixture - Loose
 Information: The fitting in this area is loose and requires adjustment to tighten.

If left unmanaged, the fitting may further deteriorate, causing potential for the development of other minor secondary defects.

A relevant tradesperson should be appointed to perform these rectification works at discretion of the client.

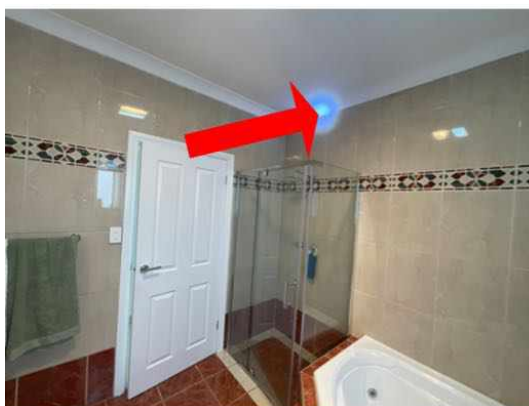
Finding 3.09

Building: Main Building
 Location: Bathroom
 Finding: Cornices - Sagging
 Information: Sagging and uneven cornices generally indicate that the building materials have swollen, due to contact with water, or the movement of the ceiling joints or that fixings (e.g. nails or glue) have become loose and require reattachment. In some cases, sagging and uneven surfaces may also indicate that there are structural issues causing surfaces to warp, twist, or sag.

Where sagging appears to be major, appointment of a structural engineer is advised to further inspect the property. Otherwise, minor works such as re-gluing of wall/ceiling sheets may be required and should be performed by an aptly qualified plasterer or carpenter.

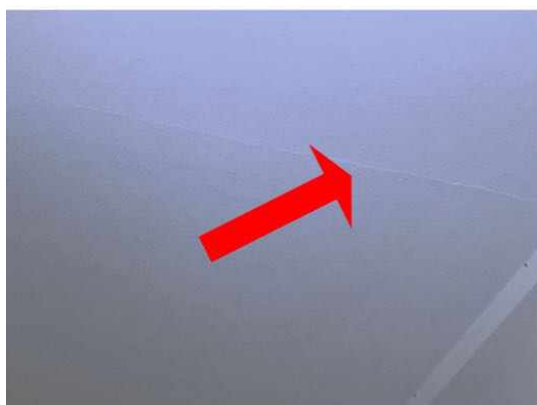
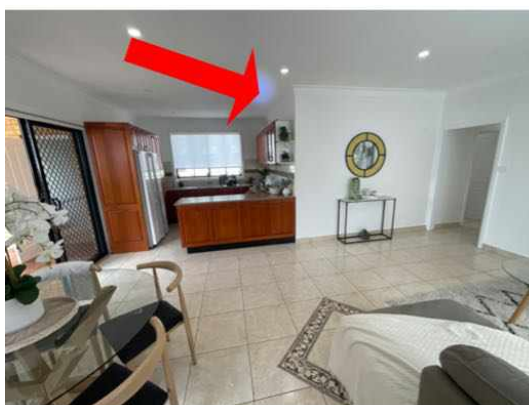
Finding 3.10

Building:	Main Building
Location:	Kitchen
Finding:	Cracking - Damage Category 1 - Fine (up to 1mm)
Information:	Although fine cracks are quite noticeable, they are often only considered to be an appearance defect, and usually do not indicate any structural damage. Generally, the cause of a fine crack is indicative of a separation between building materials and finishes (e.g. paint, plaster, etc.) along joins.

Cracking of this nature can generally be repaired with minor sanding, filling and/or repainting. Such works should be performed by a qualified painter or a general handyman.

Monitoring of all cracking should be conducted frequently. Always contact a building inspector should cracks widen, lengthen, or become more numerous.

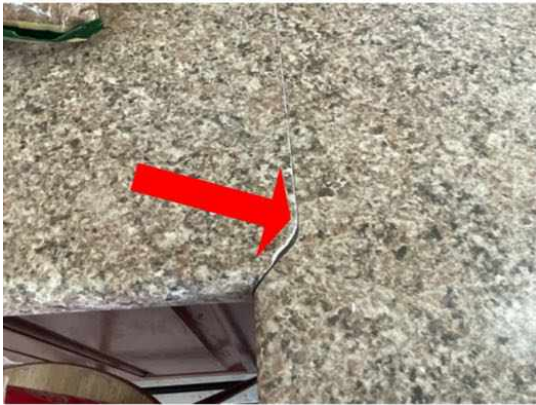
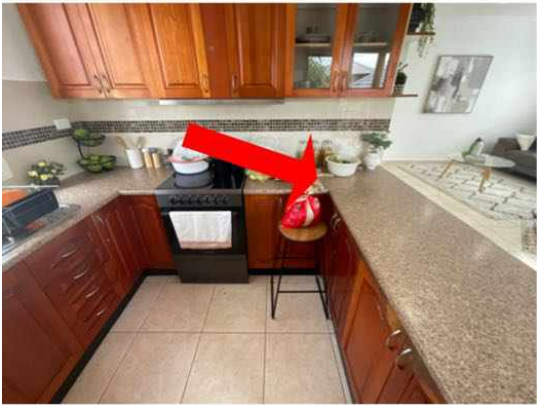
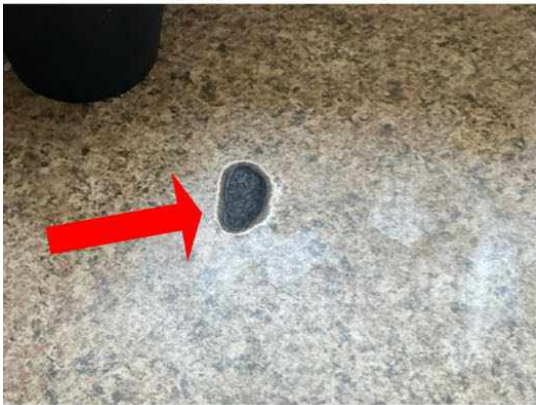
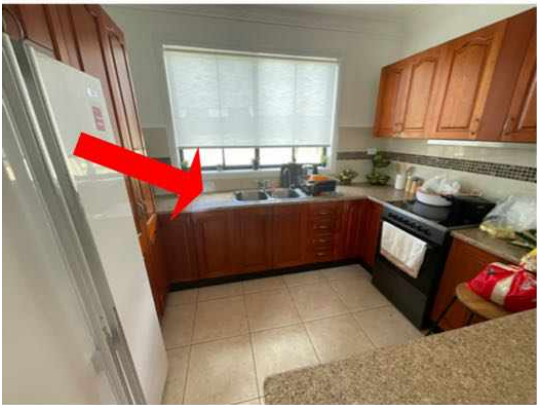
Building:	Main Building
Location:	Kitchen
Finding:	Kitchen Cabinetry - Scratches, Surface Damage & Laminate Delamination
Information:	Scratches, scuff marks, chipped edges and visible delamination of the laminate surface were observed on several sections of the kitchen cabinetry. Laminate is lifting at the edges and joints, and multiple panels show surface wear and damage.

Delamination and surface damage can:

- Permit moisture ingress, leading to swelling and further failure of the substrate.
- Reduce the durability and service life of the cabinetry.
- Be considered below acceptable workmanship under NCC and AS installation requirements.

Engage a qualified cabinet maker/joiner to:

- Repair or replace damaged panels,
- Re-adhere or re-laminate lifted sections, and
- Seal exposed edges to prevent moisture penetration.

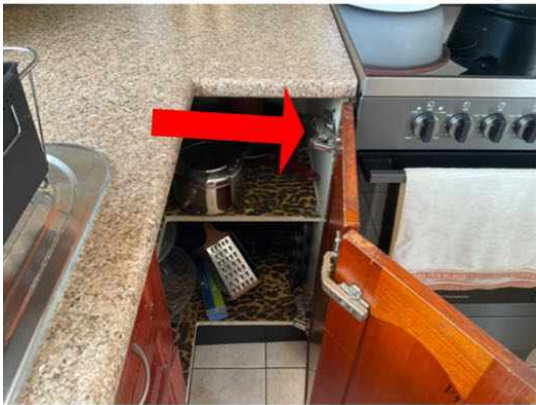
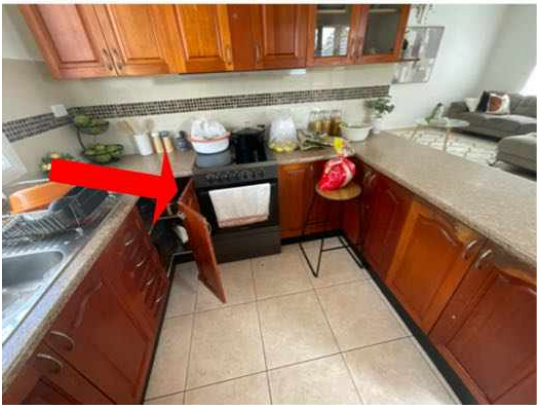
Finding 3.13

Building: Main Building
Location: Kitchen
Finding: Cabinetry - Loose hinges
Information: Several cupboard doors are not level and detract from the operational state of the cabinetry. Upon further inspection, it was noted that the hinges to the cupboard doors have deteriorated over time and, as a result, have come loose from their original fixing. To improve operation of the affected cupboard doors, a general handyman may be appointed to replace the faulty hinges. Such works should be completed at discretion of the client.

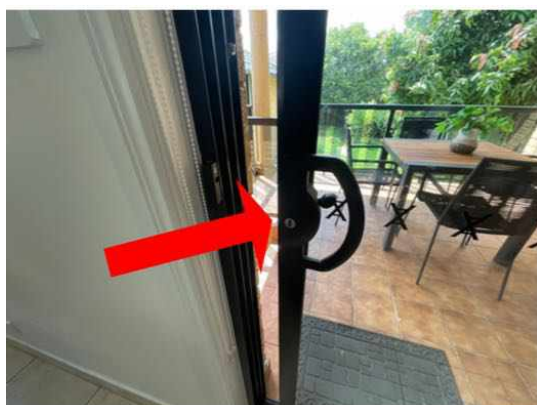
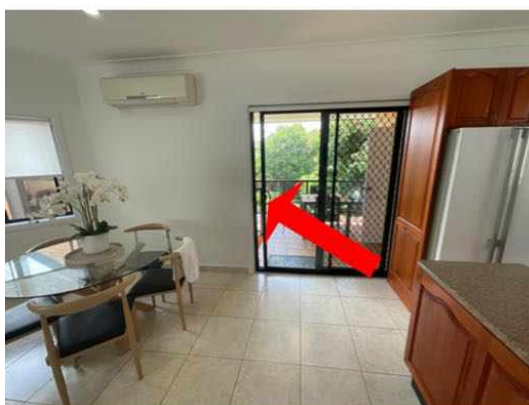
Finding 3.14

Building:	Main Building
Location:	Dining Room
Finding:	Door handle - Not latching
Information:	It was noted that the door in this area was not latching during operation at the time of inspection. Whilst detracting from the functionality of this building element, this minor defect may also be a security risk, and may therefore have serious implications if left unattended.

It is suspected that this defect has occurred due to minor issues with the associated hinges. Such damage is identified as general wear and tear, which is expected for building elements of this age.

A qualified carpenter or general handyperson may be appointed to perform rectification works as necessary, at client discretion. If left unattended, further functional impairment is likely to occur.

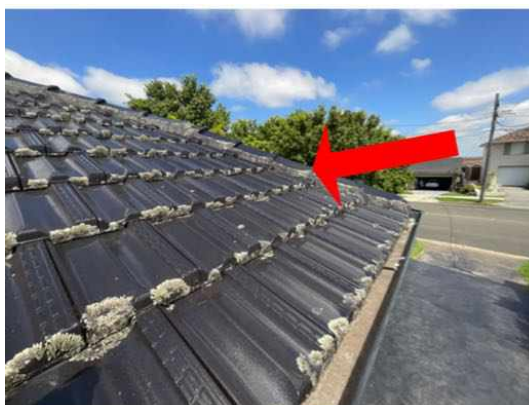
Finding 3.15

Building:	Main Building
Location:	Roof Exterior
Finding:	Mortar - Deterioration
Information:	Mortar, or 'bedding', is the material which fills joins and intersections between tiles and other building elements on the exterior roof covering, such as gable ends, hip capping and valleys. Upon inspection of the exterior roof, it was noted that sections of the mortar show varying levels of deterioration.

Mortar generally deteriorates as a result of frequent exposure to weather conditions over a prolonged period of time. Mortar that is deteriorating may allow water ingress into the roof void, putting associated building elements and roofing structures at risk of water damage. Deteriorated mortar also detracts from the functionality of roof tiles and other roofing elements, potentially decreasing weather tightness and roof drainage.

Mortar deterioration can be attended to by a handyperson where areas of deterioration are localised and easily accessible. Otherwise, consultation with a roofing contractor is advised where greater works are required.

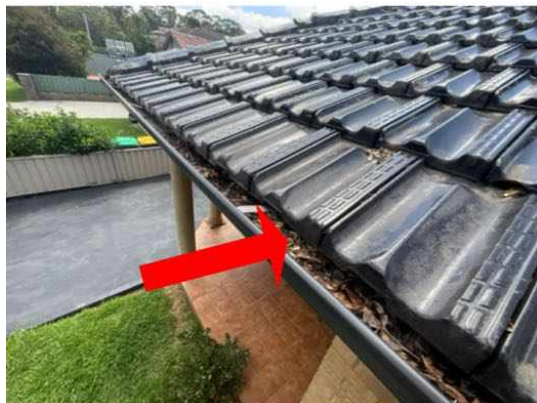
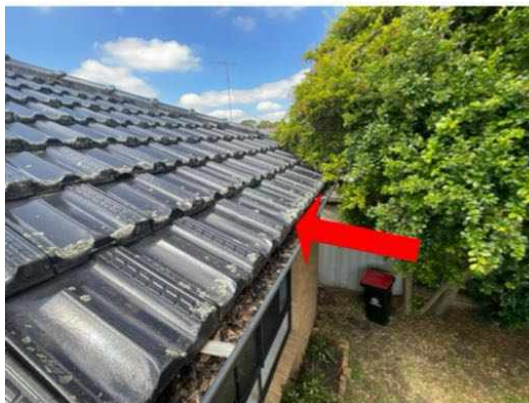
Blocked gutters are likely to lead to high levels of moisture in the affected areas. Such moisture will not only cause rust and decay of the associated building materials, but can also provide conditions that are conducive to termite and timber pest activity. Blockages in gutters should therefore be removed immediately to ensure dry conditions are maintained.

Consult a Licensed Plumber for further specific advice on remedial works that may be required. In the interim, it is highly advised that blocked gutters be removed by the homeowner or a general handyperson as a matter of urgency.

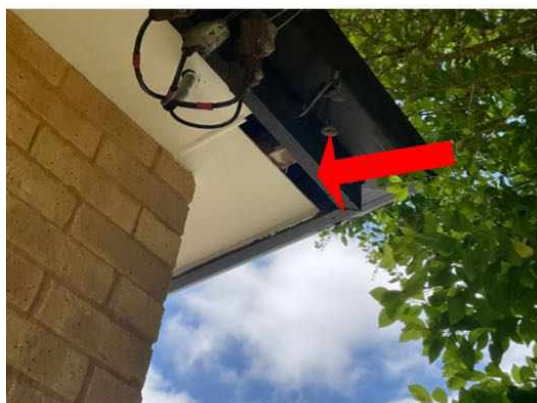
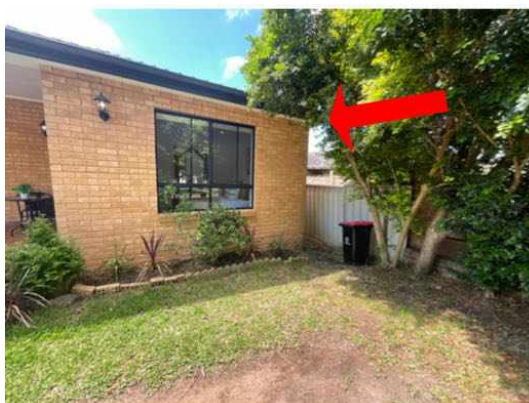
Finding 3.17

Finding: Eaves - Damaged

Information: The eaves around the external property were found to be in a visibly poor condition. The damage may have been sustained as a result of a number of possible causes, including poor roof drainage, leaking roof plumbing or minor impact damage.

The damage to the eave sheeting in this area detracts from the appearance of the structure, as well as potentially compromising the structural integrity of the roofing area.

Where eaves show moderate to severe damage, remedial works may be required. Where water damage is suspected as being the underlying cause, appointment of a licensed plumber is advised as a matter of urgency to identify the source of the water leak.

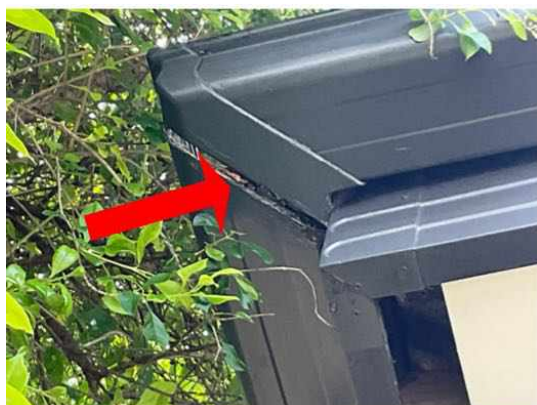
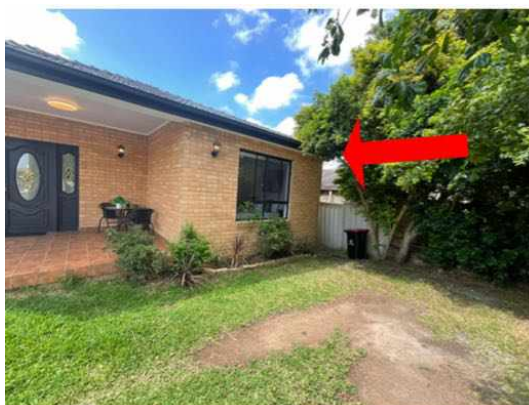
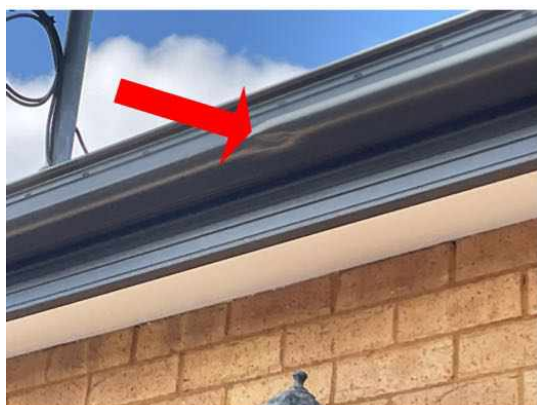
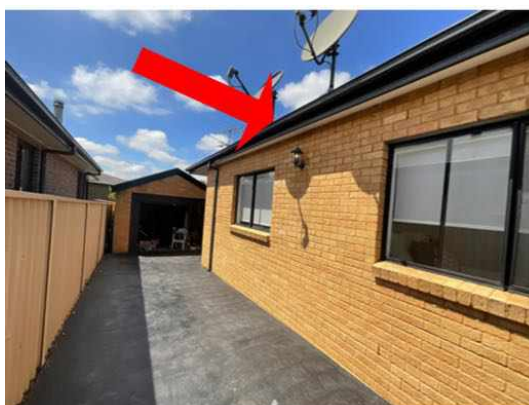
Finding 3.18

Finding: Building Element (Gutter) - Damaged

Information: Damaged gutter were found to be present to roof plumbing work. The damage of gutter creates damp conditions in the affected area , causing potential for water pooling and subsequent water damage if left unattended. These conditions may also attract termite attack, particularly if the area is subject to minimal levels of sun throughout daylight hours.

It is highly advised that a licensed roof plumber or proper tradesperson be appointed to rectify any water leaks that may be present. Areas of repair and replacement of plumbing fittings and fixtures may be required and, as such, a quotation should be sought.

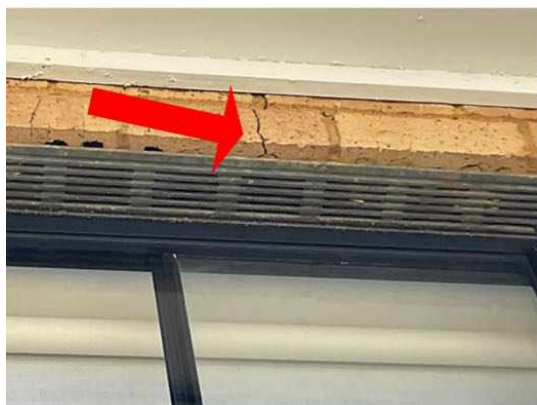
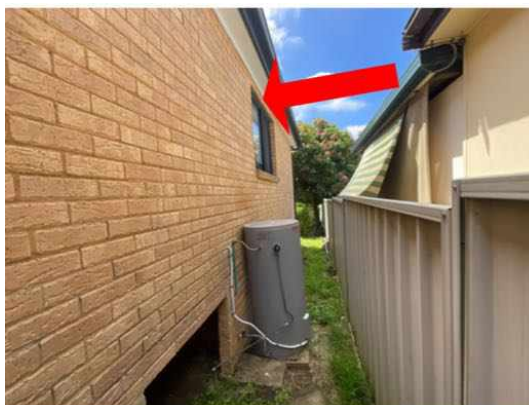
Finding 3.19

Building: Main Building
 Location: Exterior walls
 Finding: Brickwork - Cracking [Fine]
 Information: Although fine cracks are quite noticeable, they are often only considered to be an appearance defect and usually do not indicate any structural damage. Generally, the cause of a fine crack is indicative of a separation between brickwork and mortar throughout the structure, but single bricks may also show cracks of this nature.

Cracking of this nature can generally be repaired with minor filling and should be conducted by a qualified bricklayer.

Always contact a building inspector should cracks widen lengthen or become more numerous.

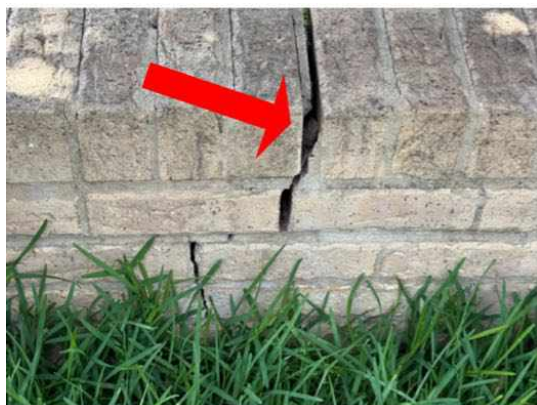
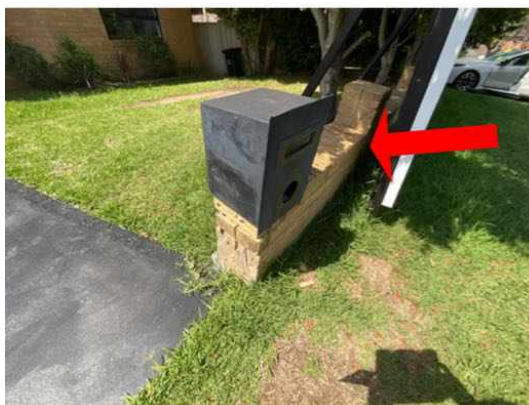
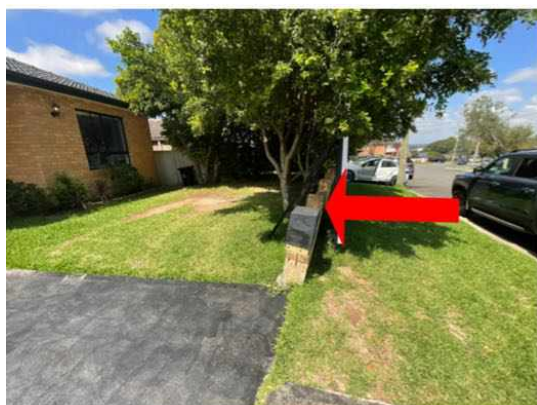
Building: Main Building
Location: All External Areas
Finding: Front Brick Boundary Fence - poor condition
Information: The brick boundary fence at the front of the property was observed to be in poor condition. The following issues were noted:

- Significant vertical cracking through brickwork.
- Separation and displacement of bricks.
- Deteriorated mortar joints.
- Evidence of structural movement.

The cracking and brick displacement indicate ongoing movement, likely associated with footing settlement and/or ground movement. The condition may compromise the structural stability of the fence and presents a potential safety risk if movement continues.

An experienced brick contractor should be engaged to assess the fence and determine whether repair or full reconstruction is required.

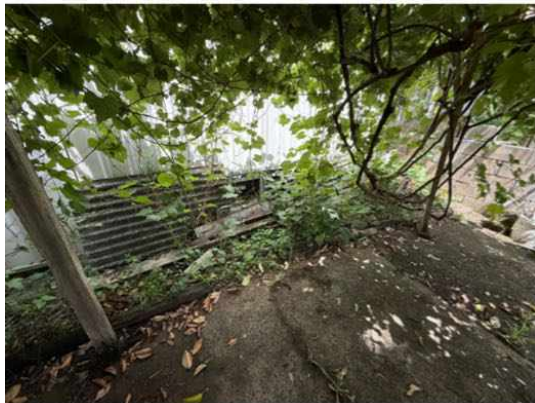
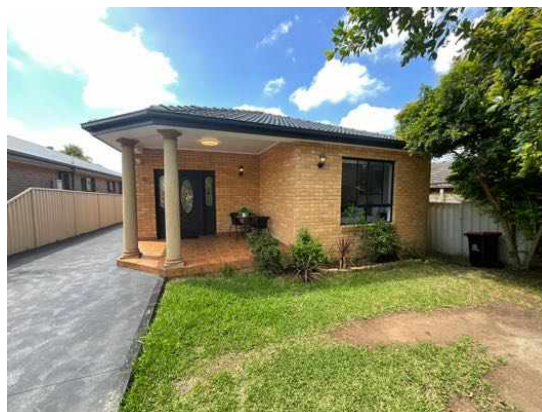
Finding 6.01

Building: Main Building
Location: All Areas
Finding: Garden Beds - Conditions Conducive to Termites
Information: Garden beds were found to be evident in the garden area. These garden beds can include untreated timber, and with a combination of moisture from watering hosing can make conditions conducive to termite activity and termite ingress.

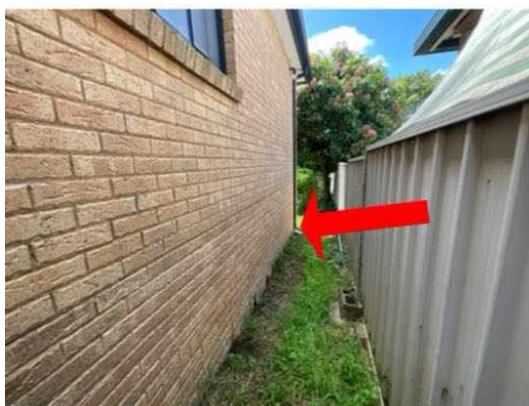
Finding 6.02

Building:	Main Building
Location:	All Areas
Finding:	Overflow (Downpipe) - Not plumbed for drainage
Information:	The overflow is not plumbed or connected to suitable drainage, which has resulted in the surrounding area becoming excessively damp. These damp conditions can lead to secondary defects such as rot, rust or corrosion of associated building elements, the formation of fungal decay, or even the creation of potential slip hazards. When coupled with poor site drainage, pooling of water may also attract termite activity to this area. It is highly recommended that a qualified plumber be appointed to install adequate drainage to the overflow. These works will ensure that the area remains dry and free of any secondary defects.

not connecting downpipes to the stormwater system can lead to various problems, including structural damage, safety hazards, and regulatory issues. It's essential to address this issue promptly by ensuring that downpipes are properly connected and directing water away from the building to mitigate these risks.

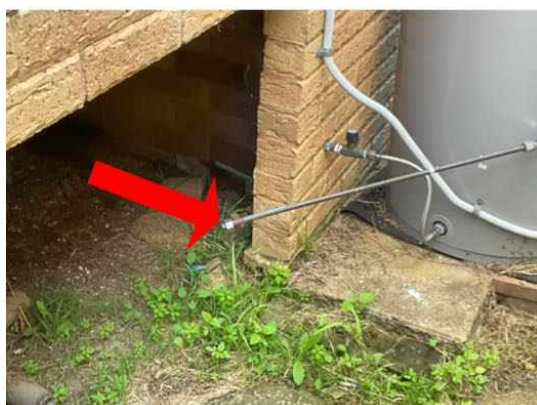
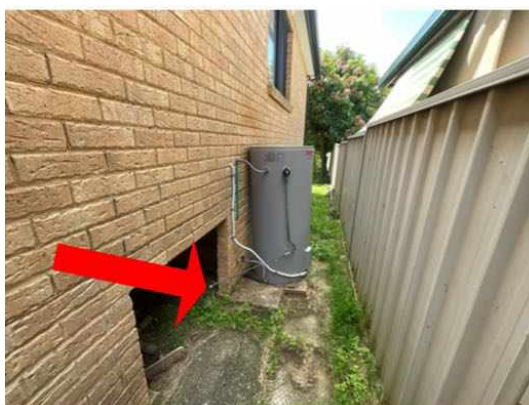
Finding 6.03

Building:	Main Building
Location:	All Areas
Finding:	HWS Overflow - Not Connected
Information:	The Hot Water System (HWS) overflow was found to be disconnected from storm water drainage and is creating excessive moisture in the surrounding area.

These damp conditions can lead to secondary defects such as rot, rust or corrosion of associated building elements, the formation of fungal decay, or even the creation of potential slip hazards. When coupled with poor site drainage, pooling of water may also attract termite activity to this area.

It is highly recommended that a licensed plumber be appointed to connect the HWS overflow in order to prevent such an environment from being created. These minor works should be carried out as soon as possible.

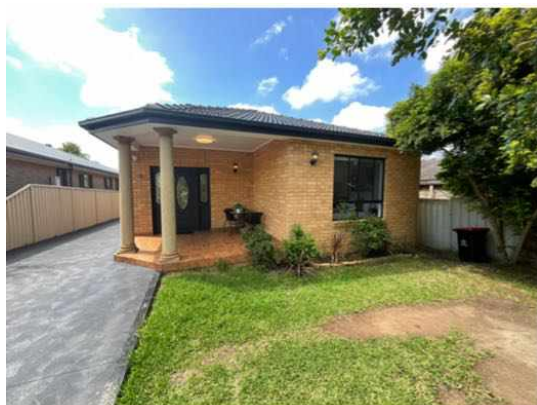
Finding 6.04

Building:	Main Building
Location:	All Areas
Finding:	Bridging of termite barrier/inspection zones
Information:	Bridging is the spanning of a termite barrier or inspection zone so that subterranean

Where bridging has occurred, full inspection is prevented and termites may enter a property in a concealed or undetectable manner.

It is recommended that minimum 75mm clearance below the bottom of weep or ventilation holes be maintained where possible, otherwise annual inspections should be conducted by a licensed pest control company. Vegetation should also be kept clear of walls to allow regular inspection of all areas.

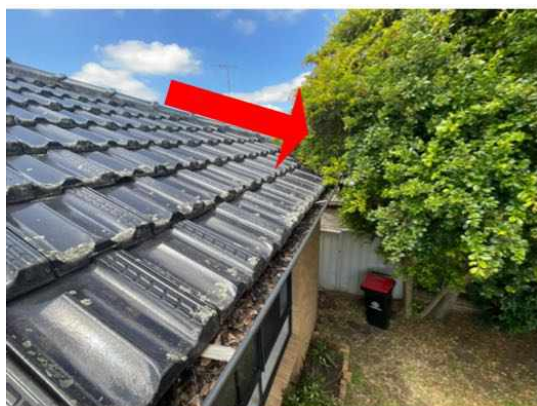
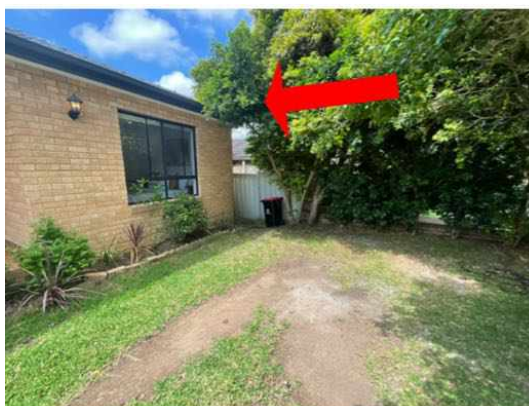
Finding 6.05

Gutters are a critical part of the building's management of storm water and rain. It is therefore important that they be kept clear to prevent secondary damage to associated building elements, including exterior and interior walls, ceiling linings and any adjoining building elements. Where gutters are blocked, pooling of rainwater is likely to occur, fast-tracking rust and corrosion of the roof plumbing elements.

It is highly advised that all overhanging tree branches be removed as soon as possible to prevent any further damage. Repair and/or replacement of sections of damaged guttering may also be required where the extent of the damage necessitates.

Such works should be performed by the homeowner; however, appointment of a landscape contractor or an arborist may be required. Consultation with a licensed roof plumber is required where guttering has been damaged.

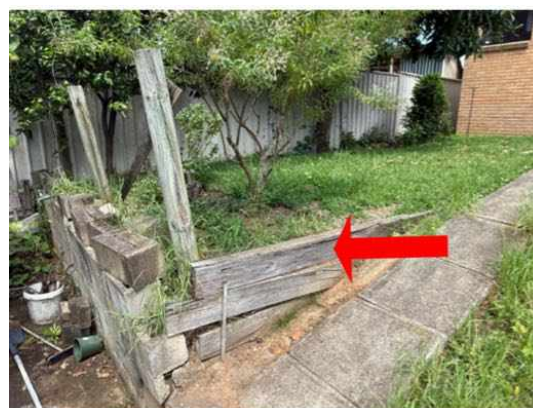
Finding 7.01

Building:	Main Building
Location:	All Areas
Finding:	Wood rot
Information:	This building element shows evidence of wood rot. Wood rot, also known as Fungal Decay, occurs when timbers and other cellulose building materials are exposed to damp conditions on an ongoing basis. This could be the result of exposure to weathering over a prolonged period of time, or the attraction of excessive moisture from other abutting building materials. Contributing factors also include poor air ventilation in the area.

Wood rot is often associated with general damp problems and is evidenced by a 'musty' smell or mould and mildew occurring on surfaces. If left unmanaged, damp conditions can lead to further health problems and the decay of timbers will continue.

Early intervention and regular maintenance, particularly of exterior timbers, will prolong the useful life of these building elements. Prior to any works being performed, the cause of the moisture that has created the visible wood rot should be identified and addressed in a suitable manner. Replacement of affected timbers may then be a necessary step in protecting surrounding building elements from such deterioration.

A qualified plumber may be appointed to assess the cause of excessive moisture and to provide advice on any remedial works as required. A qualified carpenter or registered builder may also be required to replace affected building materials.

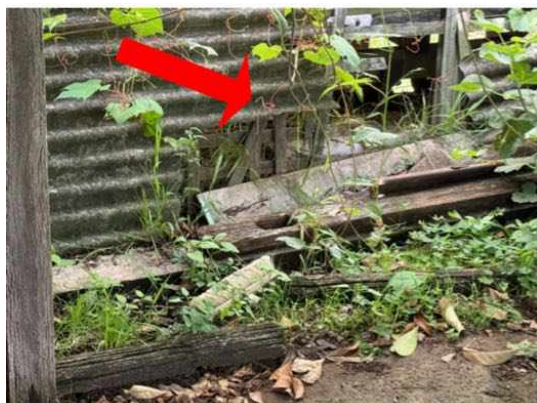
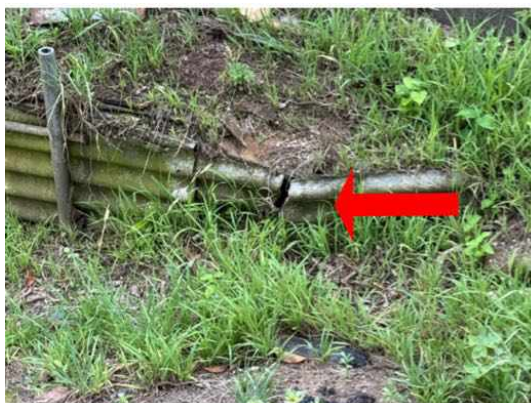
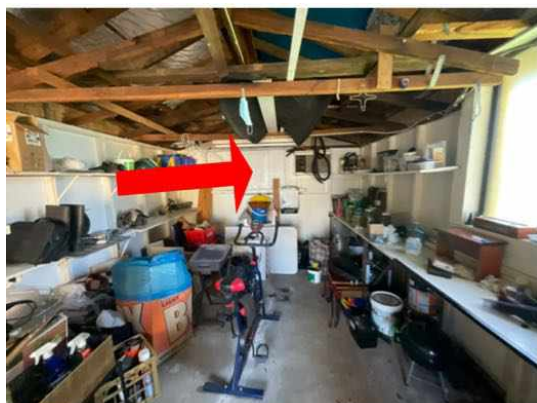
Building: Garage
Location: All Areas
Finding: Asbestos - Suspected ACM Identified on Site
Information: Reporting on Asbestos is outside the Scope of this Report. This suspected defect is highlighted as a caution only. We suspect, based on our experience in the building industry, that there is a higher risk of the identified building element containing asbestos.

As Asbestos Reporting is outside the scope of this report, we advise that you consider a separate Asbestos Inspection and Condition Audit, which can include the taking of samples for definitive confirmation of the presence of Asbestos.

In the interim, the client is advised to act with caution, especially when considering any damage to building materials general wear and tear renovations extensions demolition and general maintenance activities due to the suspected presence of Asbestos.

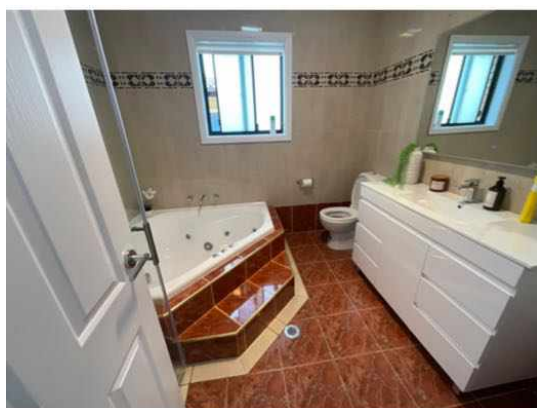
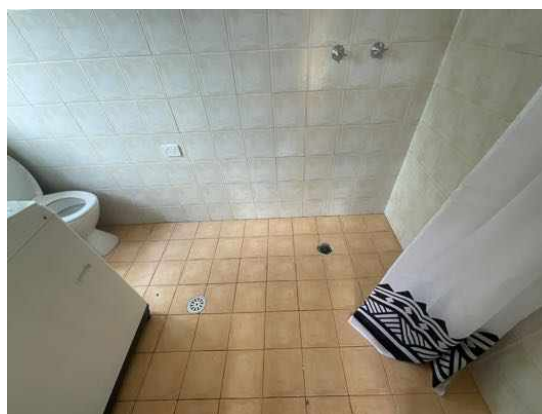
Building:	Main Building
Location:	All Areas
Finding:	Water Proofing Membranes - Information Only
Information:	Internal Water Proofing Membranes, are crucial in preventing water ingress into the property is important to know that the Membrane System used is to Australian Standards and has been installed correctly. Please refer to the original Building Documents or Maintenance Schedule for the relevant information including; - Membrane used and Manufacturers Specifications. - The Installer and Installation Certification. Especially with older property's where this information is unavailable, all wet areas should be monitored. Generally new waterproofing with a certificate may only have a guarantee of 8yrs. If any leaks, water staining, peeling or bubbling of the paint become evident to any adjacent walls or ceilings below a licensed builder or waterproofing specialist is recommended to investigate further.

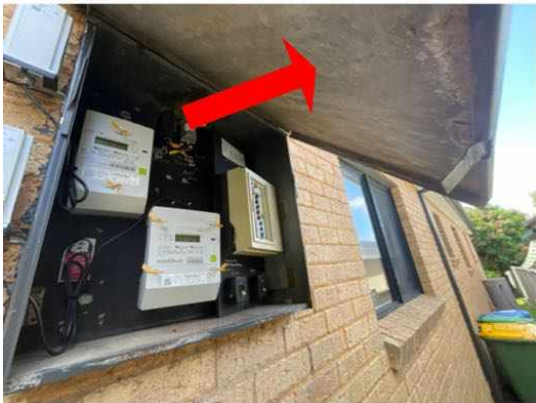
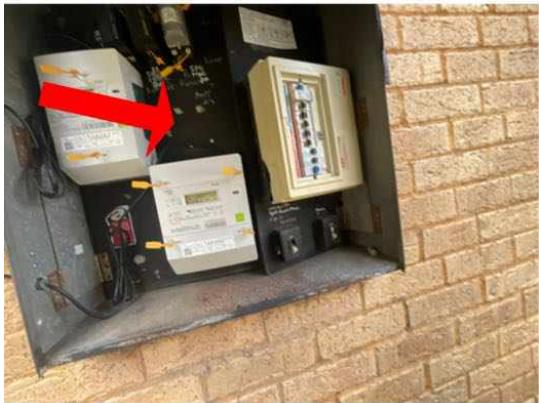
Building:	Main Building
Location:	All Areas
Finding:	Termite Management System - no evidence of a chemical installation
Information:	The application of a post-construction chemical termite barrier is highly recommended for all properties, particularly if live termite activity has been found on the site previously. Such barriers are highly effective in preventing termite attack on any timber building elements throughout the property.

A durable notice should be placed in the switchboard unit to indicate current termite barriers. At the time of inspection, it appeared as though no termite management system has been installed, with no evidence to suggest preventative works taking place.

The client may consider gaining further advice from a pest controller as to the costs and procedures involved with this application. It is recommended that obtaining such advice be a short-term priority.
