Building and Timber Pest Inspection Report

Inspection Date: Thu, 19 Feb 2026

Property Address: 13 Birdwood Rd, Georges Hall NSW 2198,
Australia

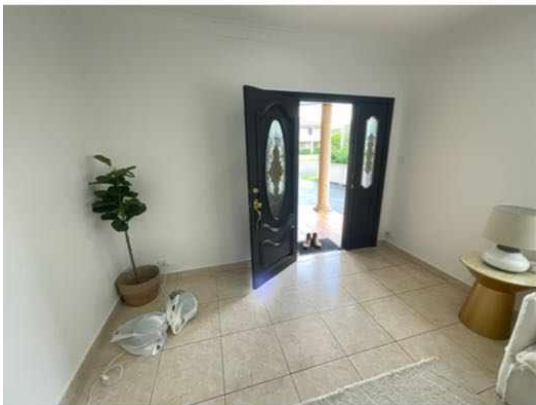
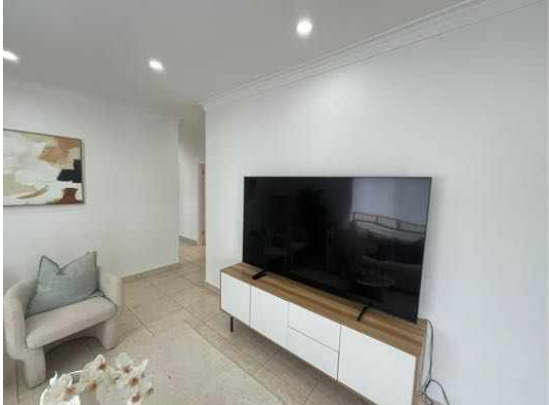
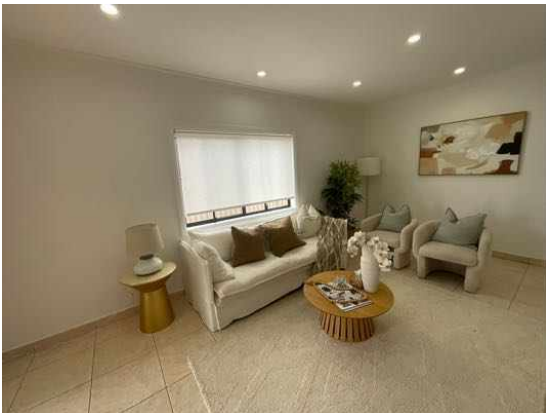
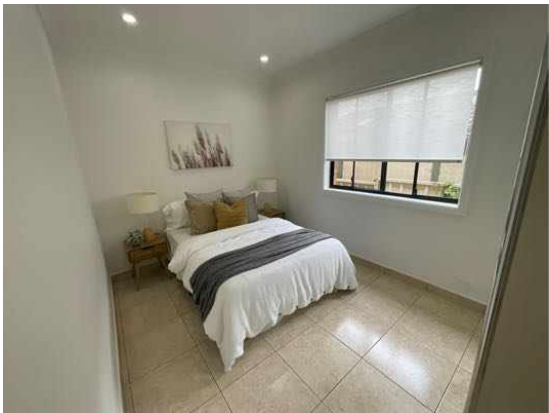
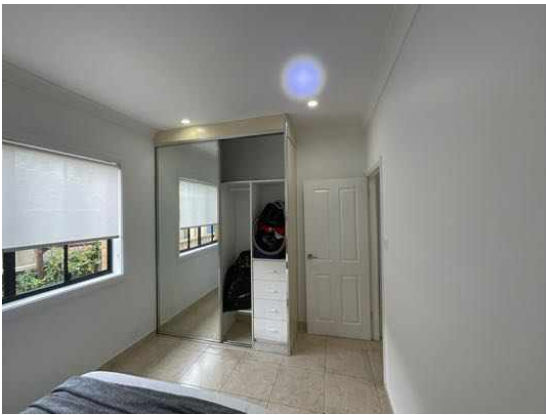
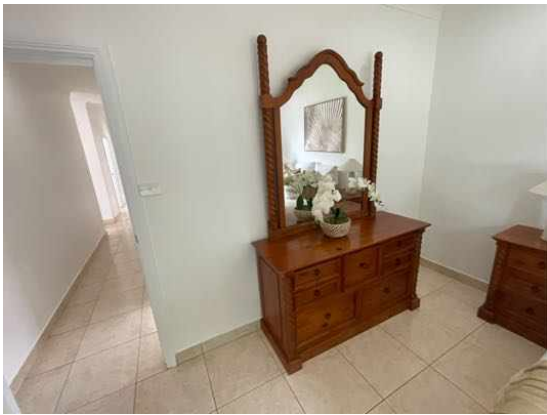
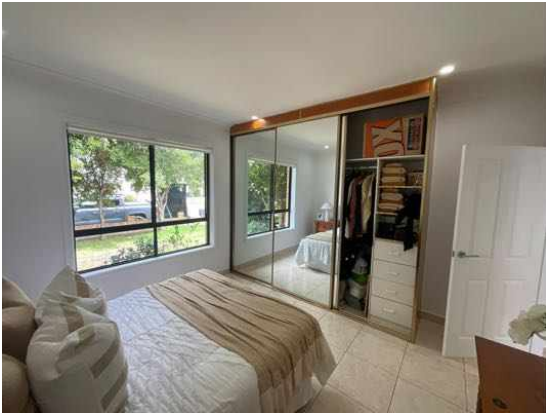
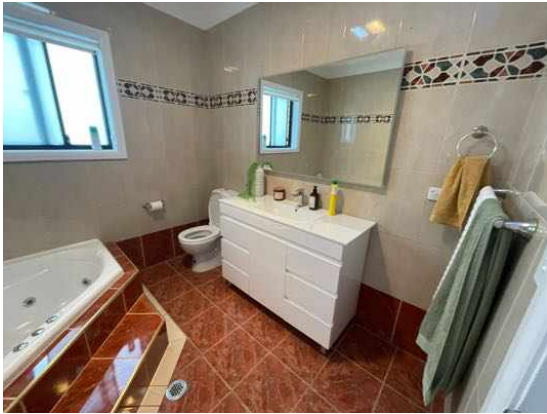
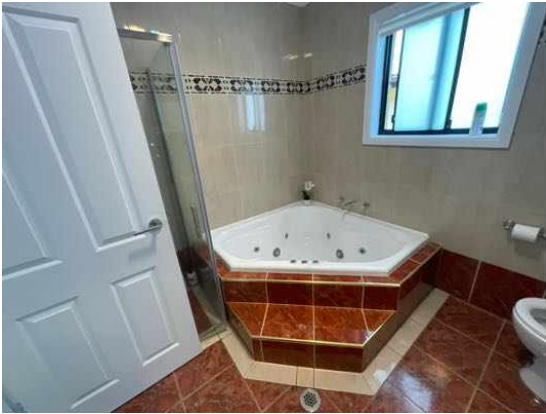
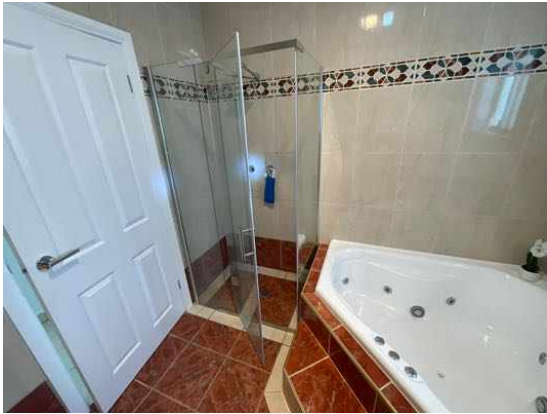
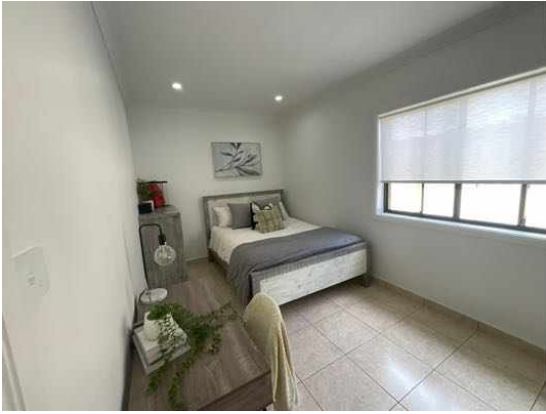
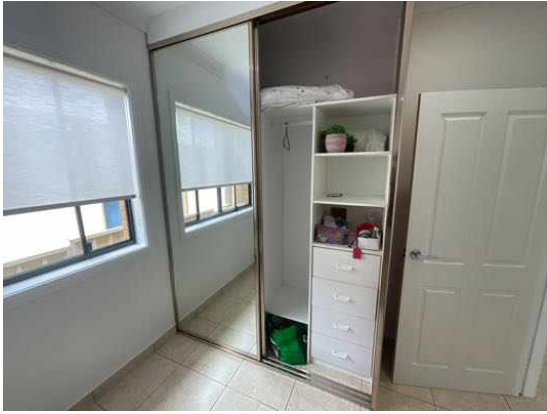
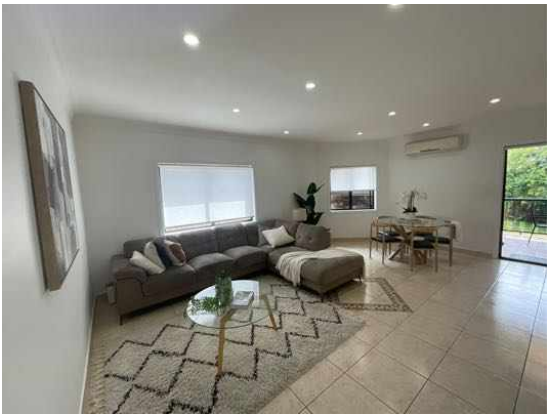
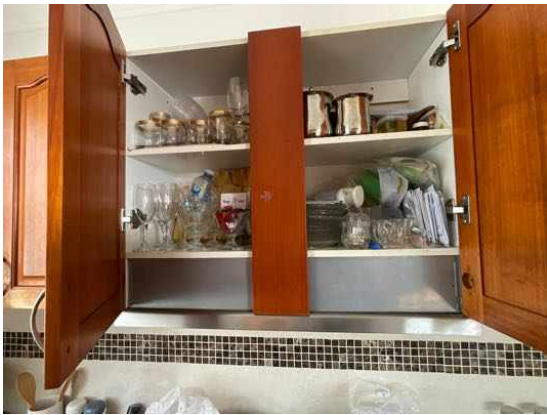
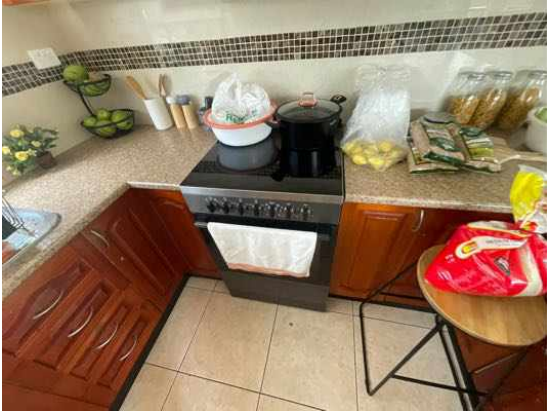
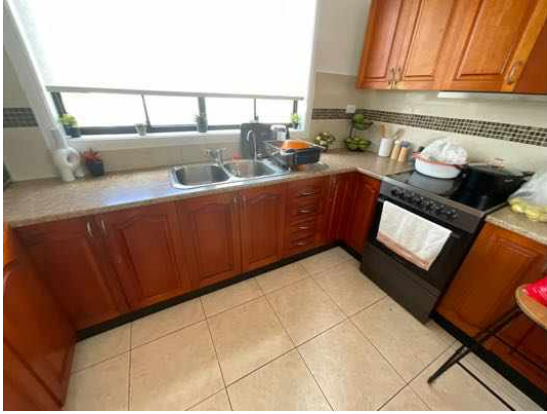
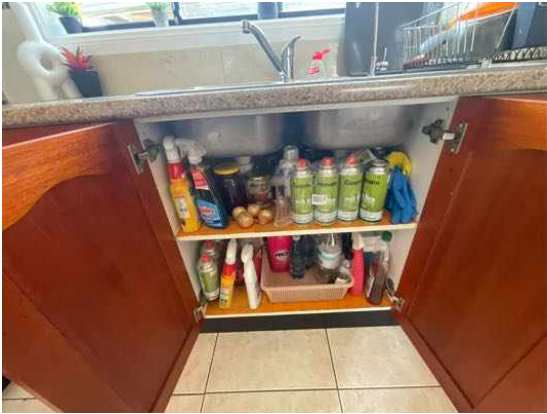
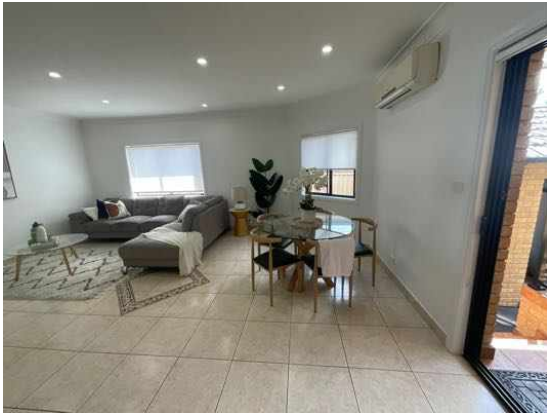
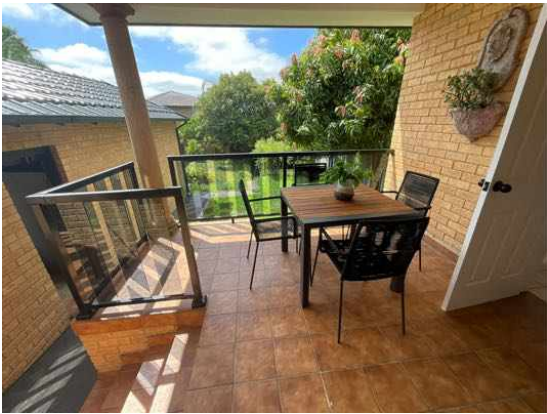
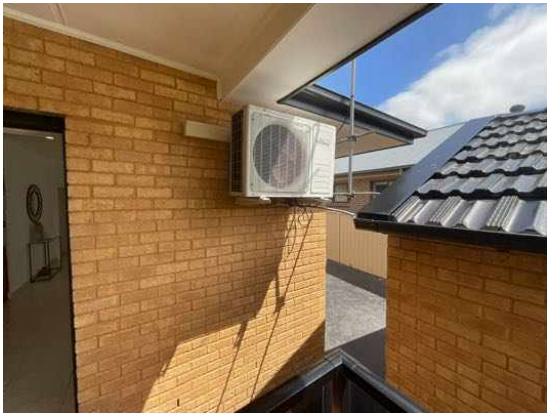
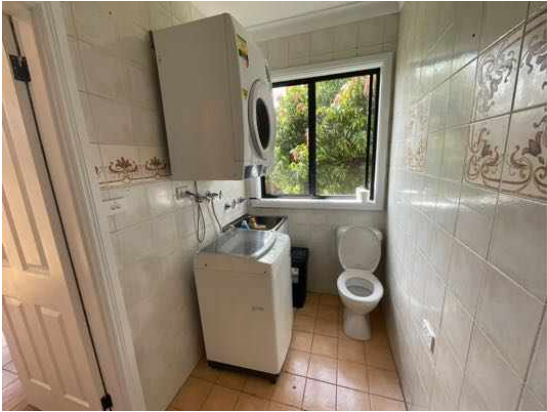
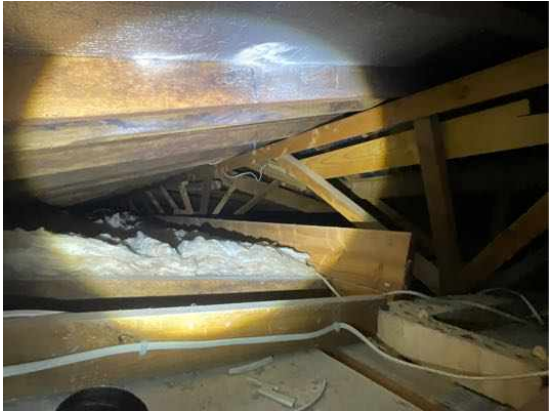
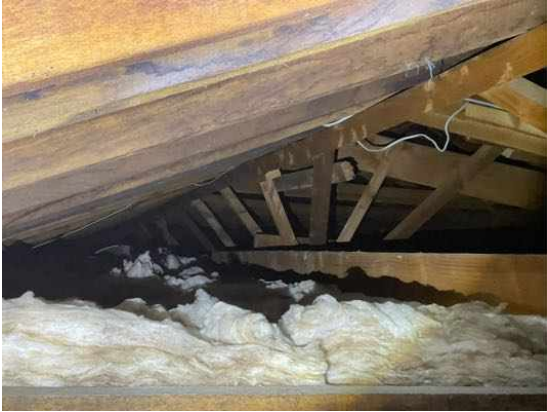
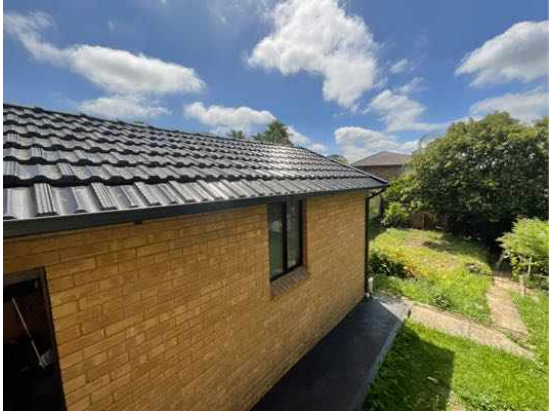
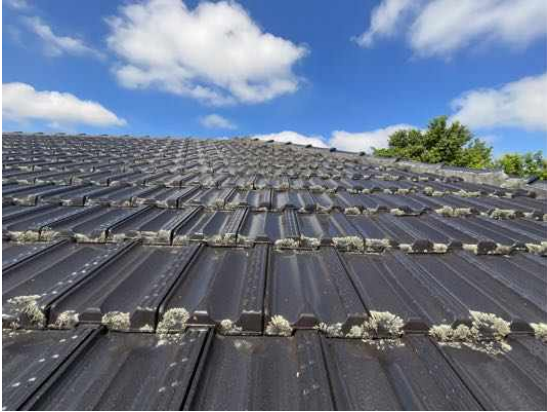
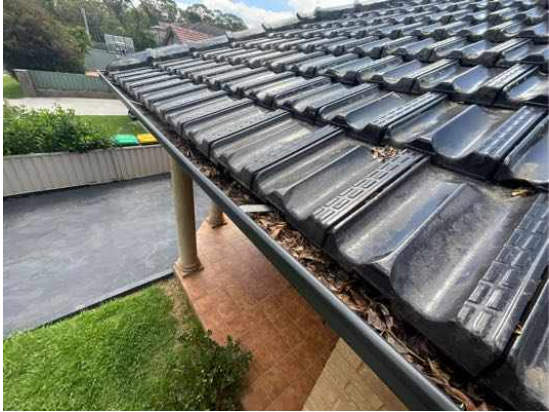
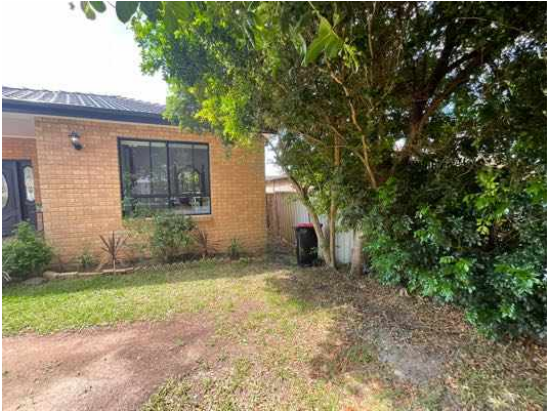
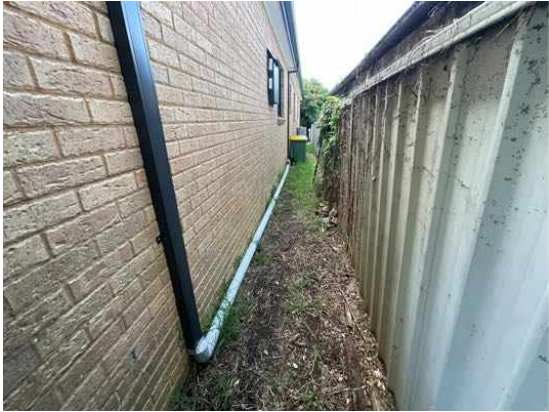
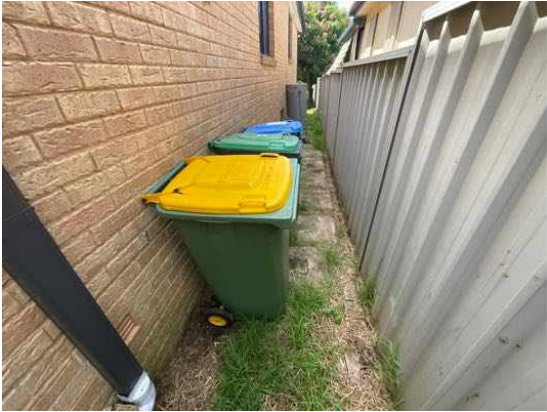
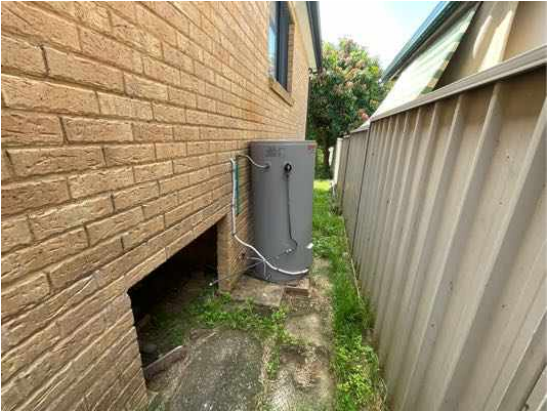
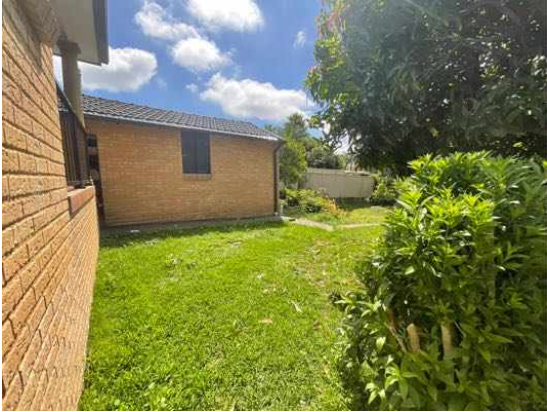
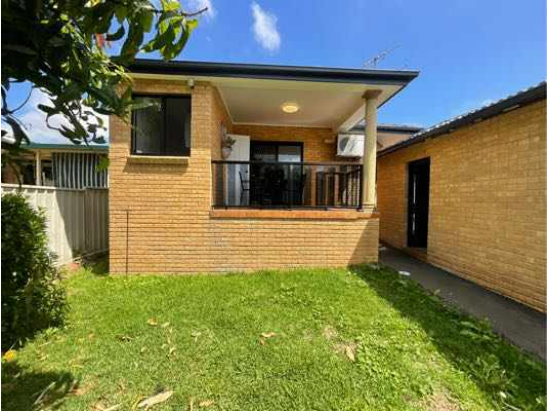
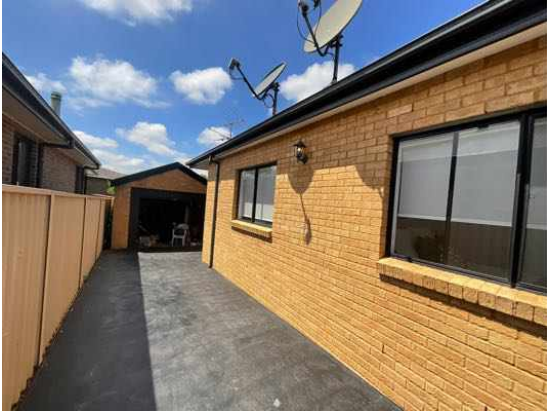
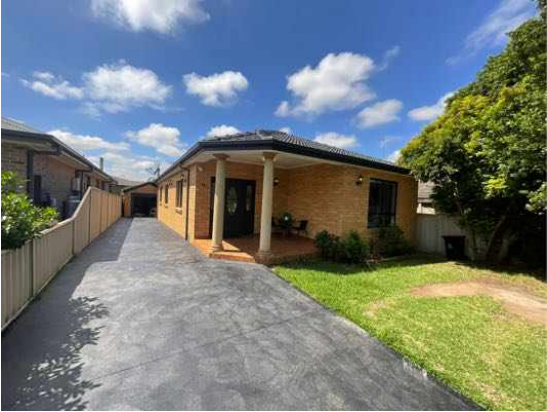
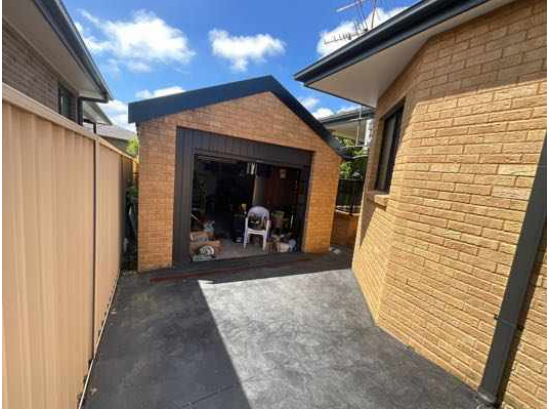
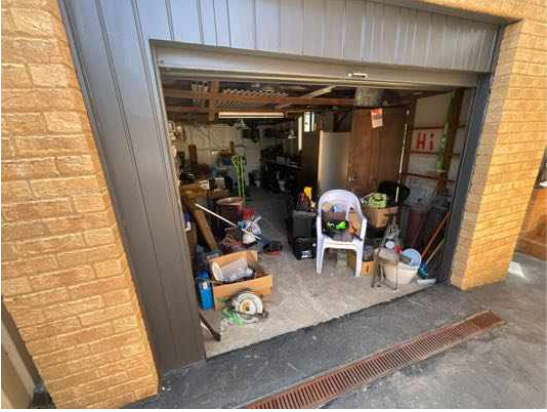
Building: Main Building
Location: All Areas
Finding: Additional Photos - Obstructions and Limitations
Information: These photographs are an indication of the obstructions and limitations which impeded full inspection of the property at the time of inspection. These obstructions can hide an array of defects and should be removed to allow full inspection to be carried out. A re-inspection is recommended once the areas are made accessible.

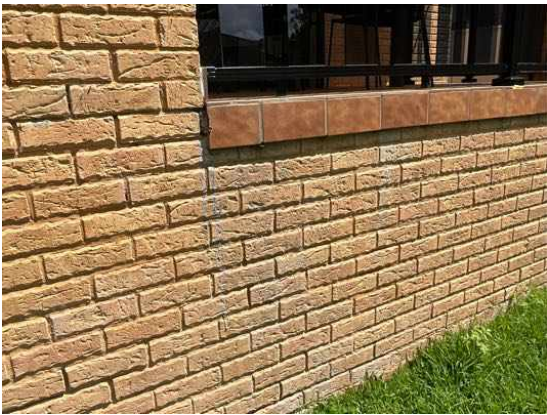
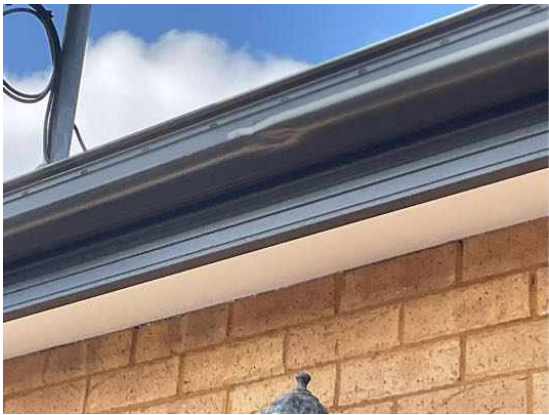
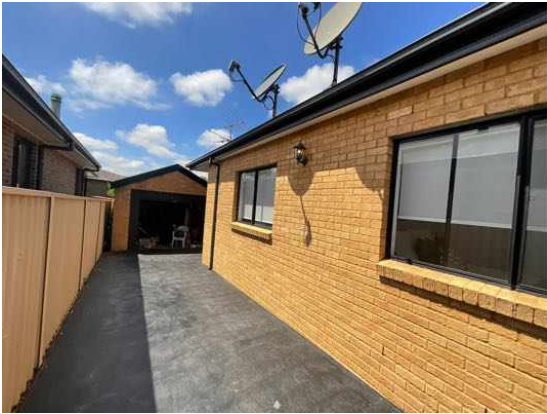
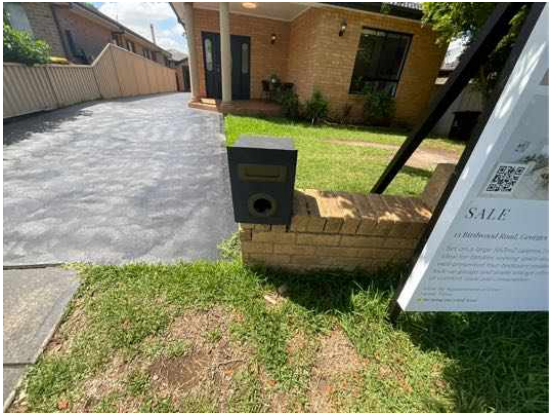
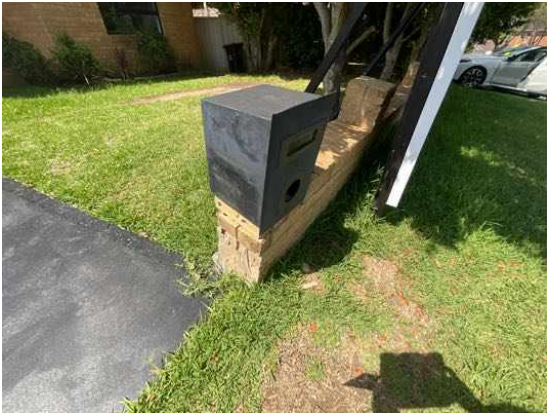
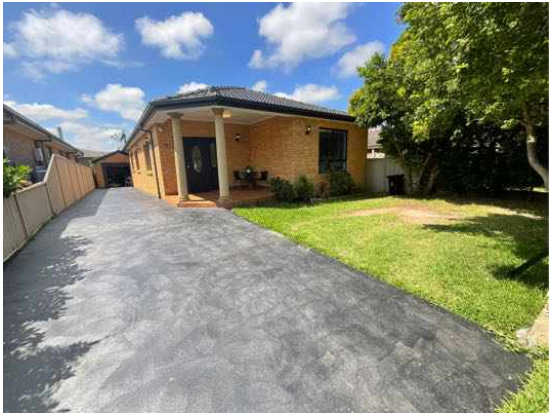
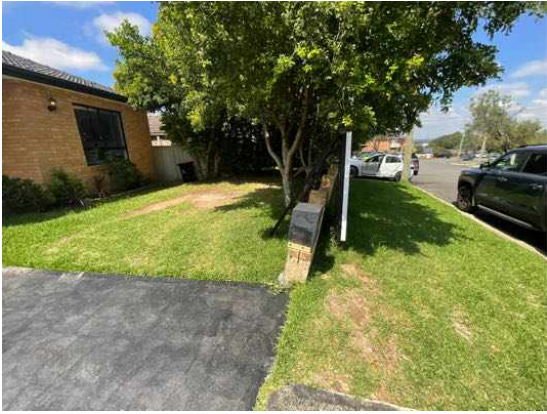
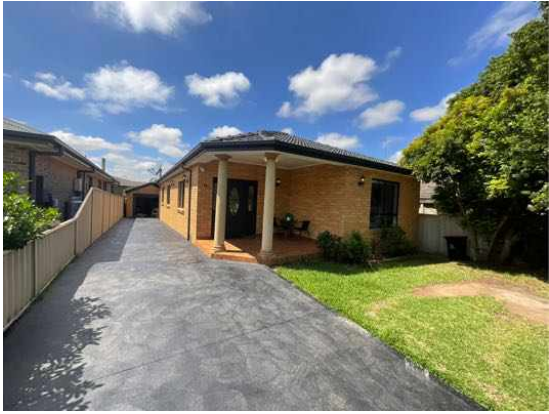
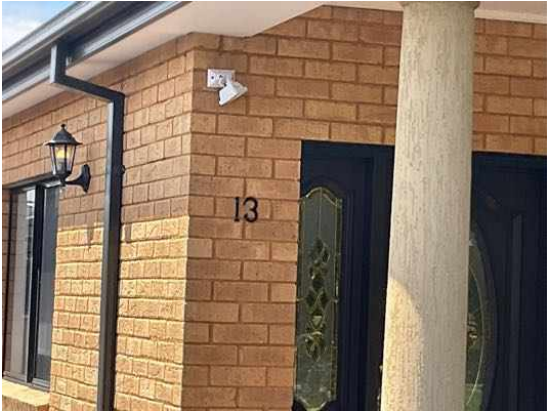
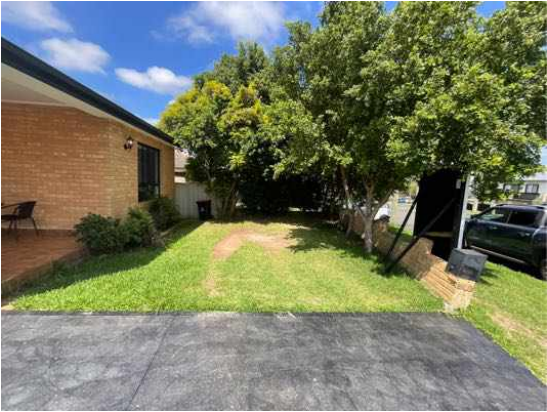
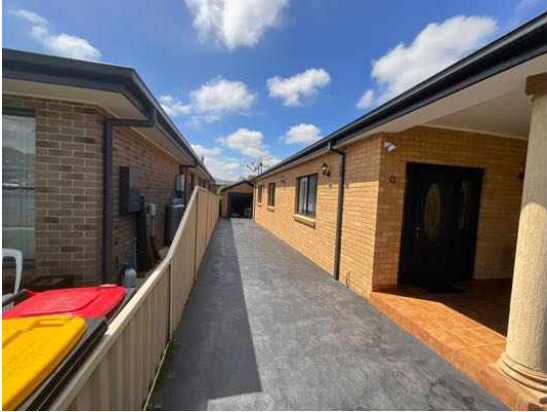
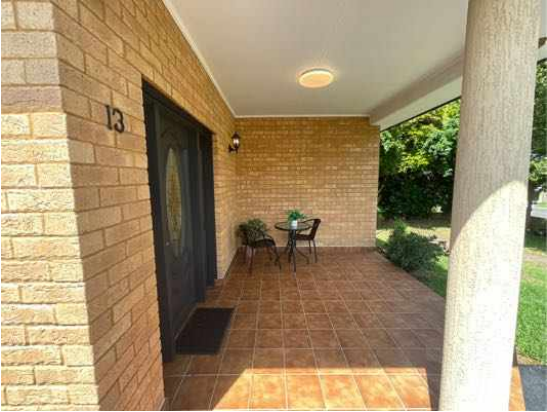
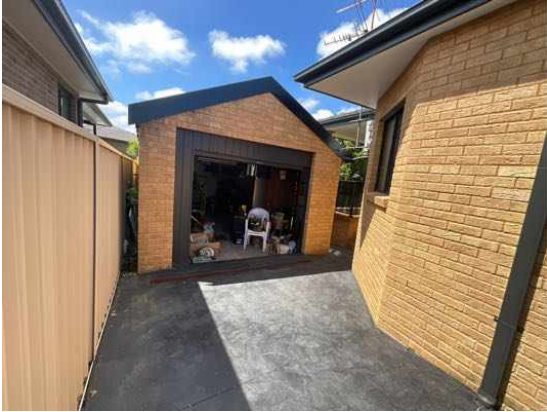
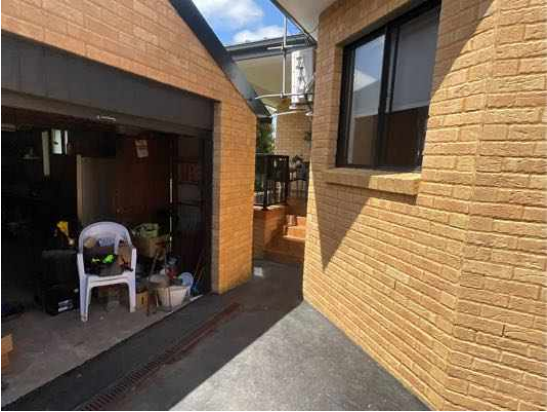
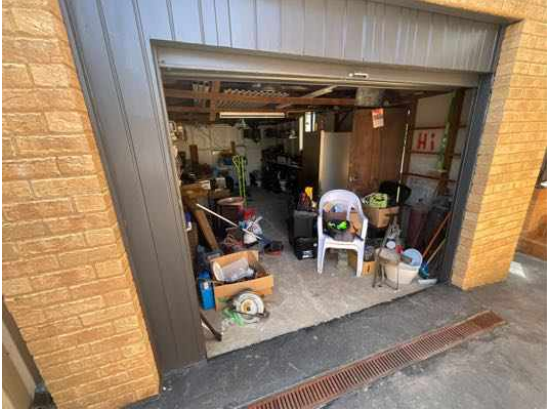
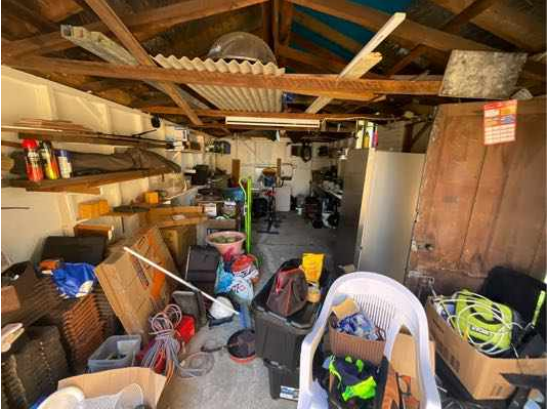
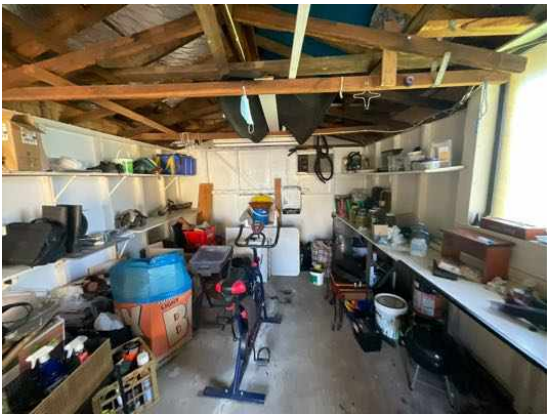
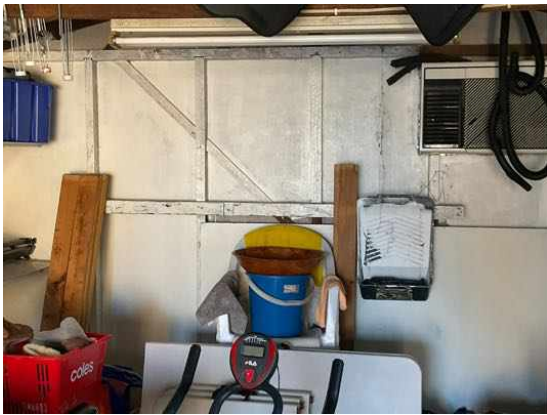
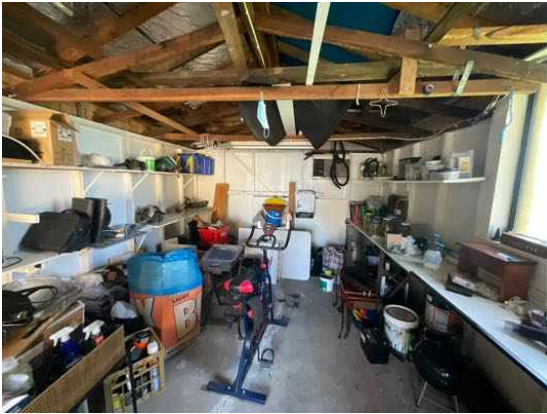
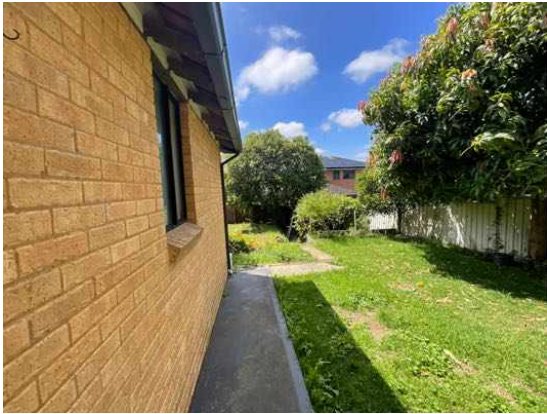
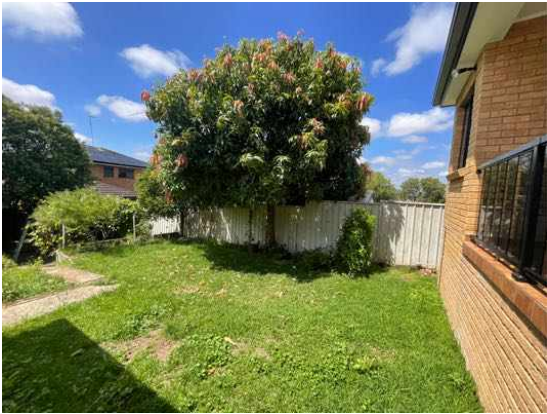
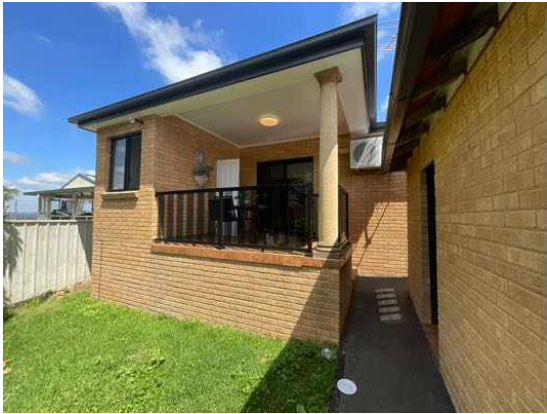
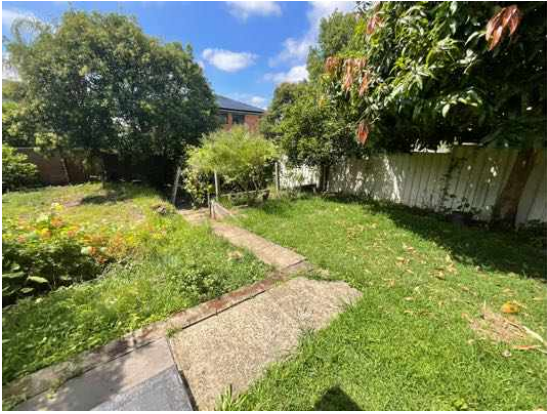
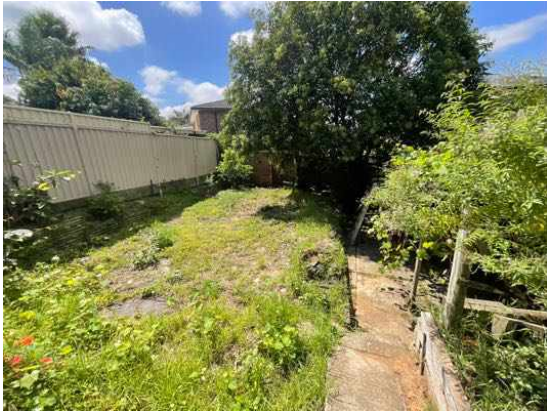
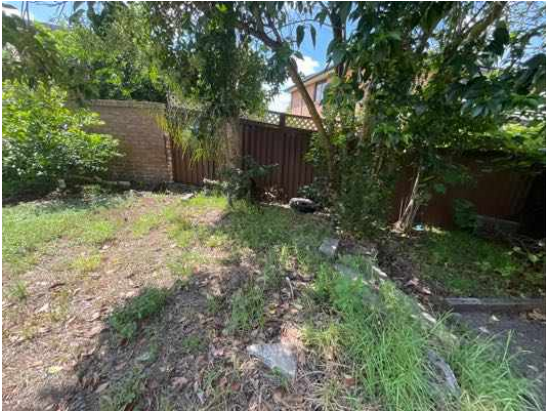
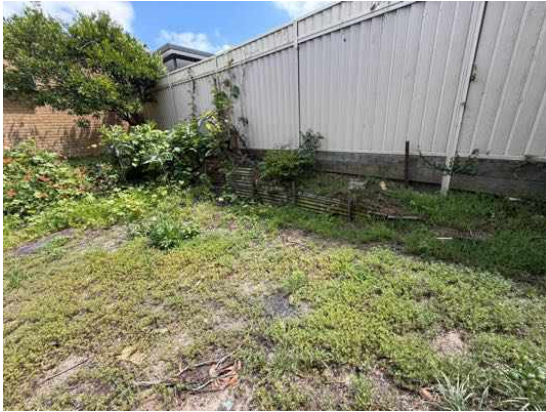
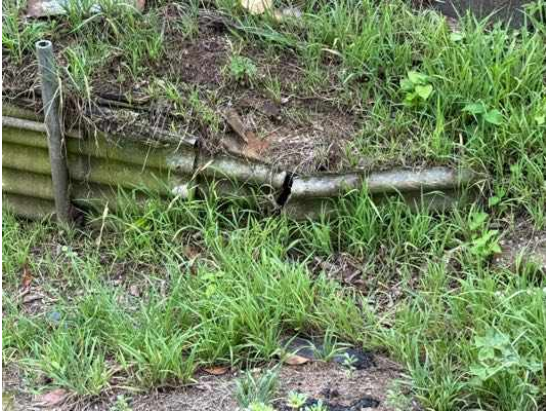
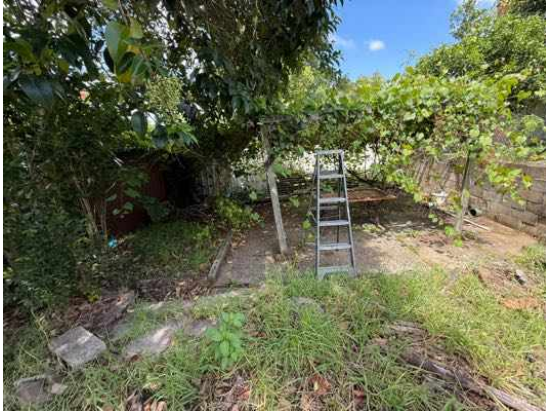
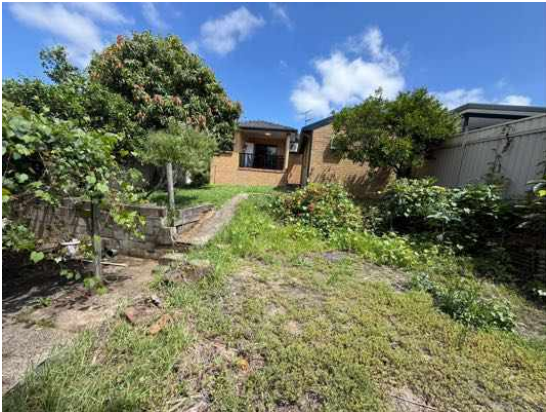
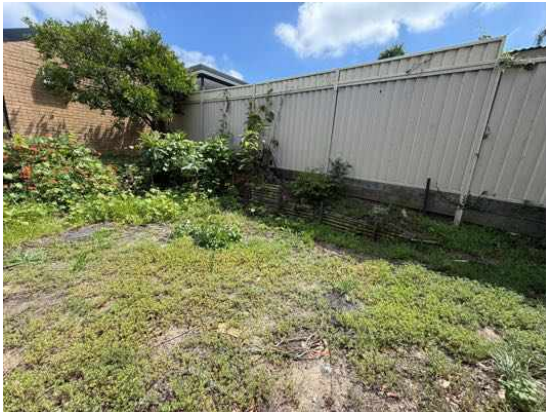
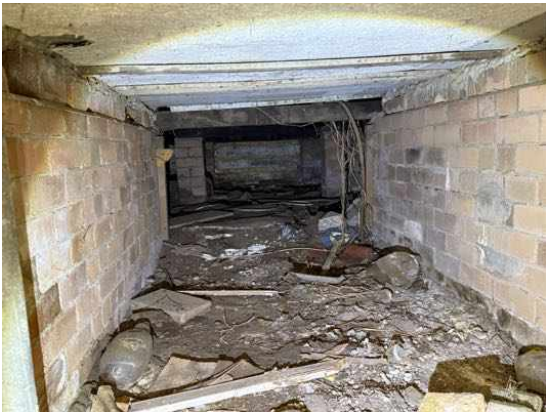
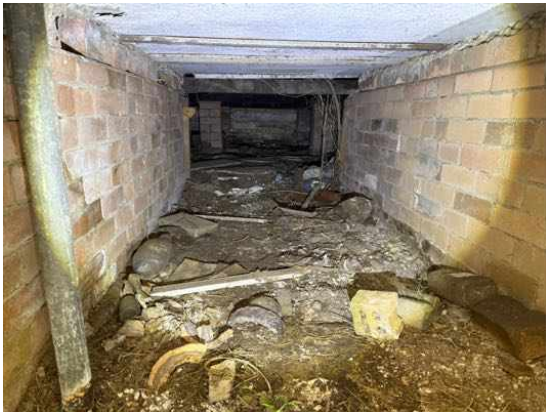
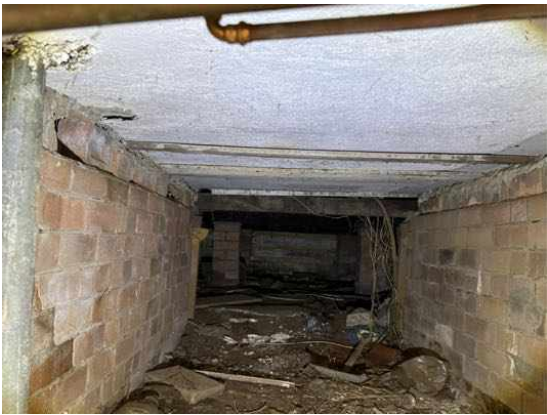
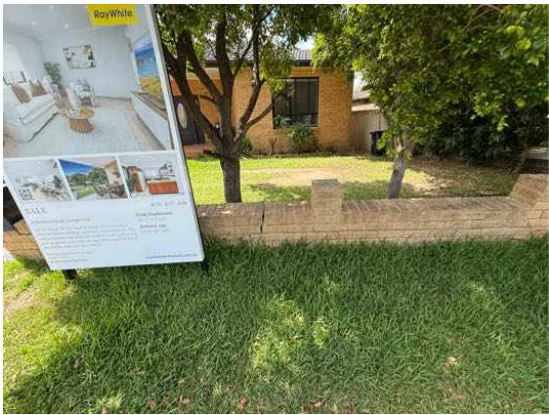
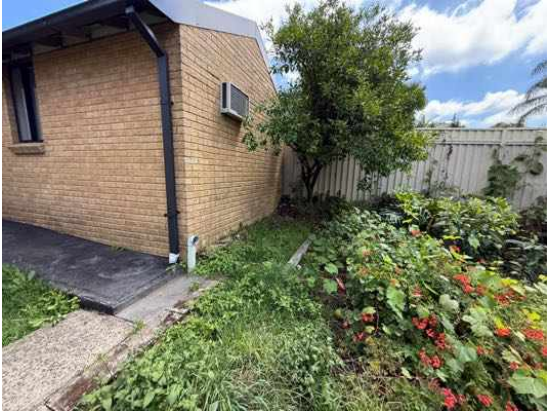
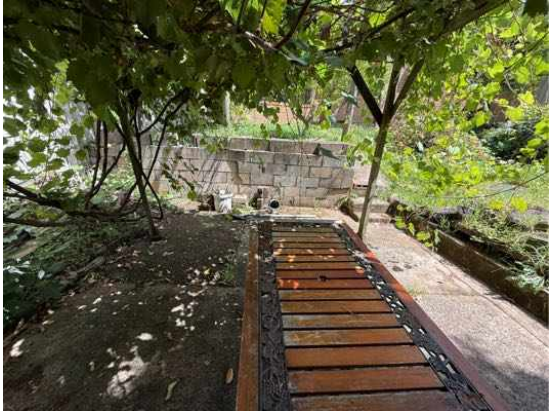
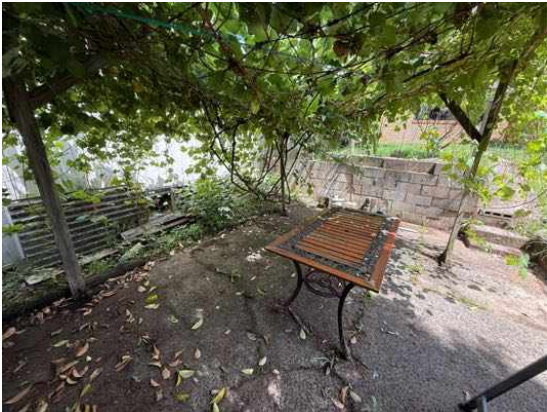
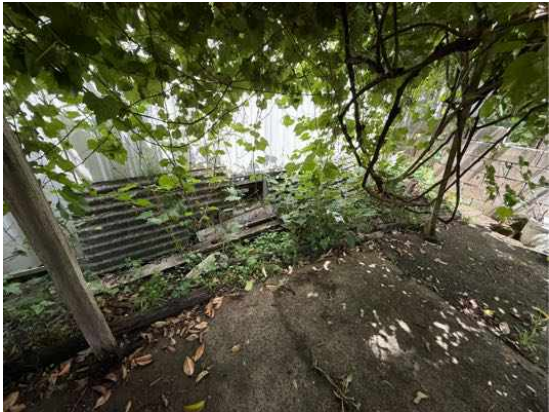
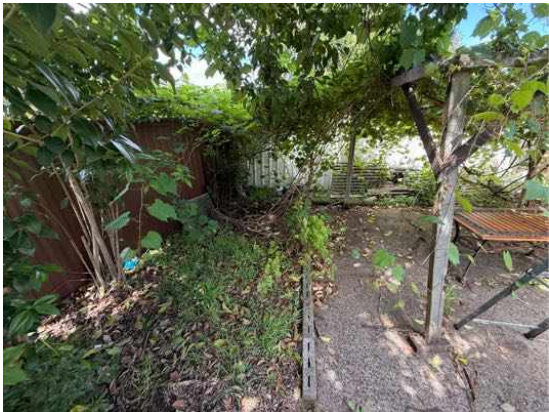
Building:	Garage
Location:	All Areas
Finding:	Evidence of termite damage
Information:	Despite no live termite or timber pest activity being indicated, previous termite damage was found to have affected this area. This damage is considered to be inactive.

It is advised that the area be visually inspected frequently to ensure that the condition of affected building materials does not worsen. At the time of inspection, damage is not structural and is only considered to be superficial.

A building contractor may be appointed to provide a further invasive inspection if further damage is evident.
