Building and Timber Pest Inspection Report

Inspection Date: Tue, 27 Jan 2026

Property Address: 126 Dartford Rd, Thornleigh NSW 2120,
Australia

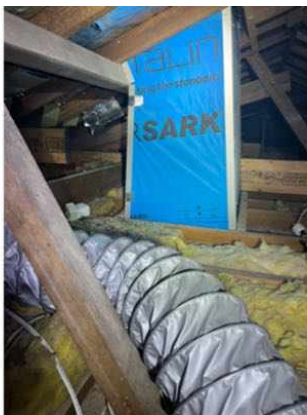
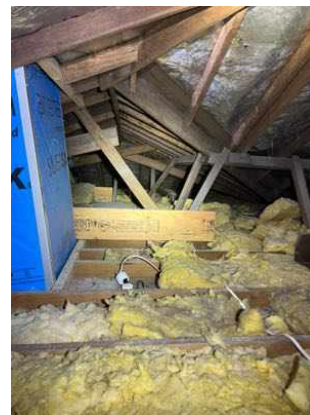
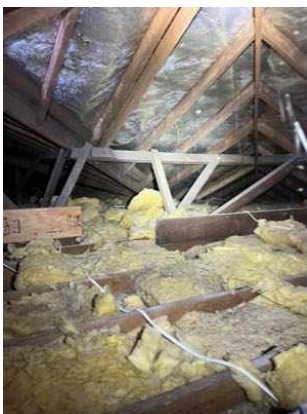
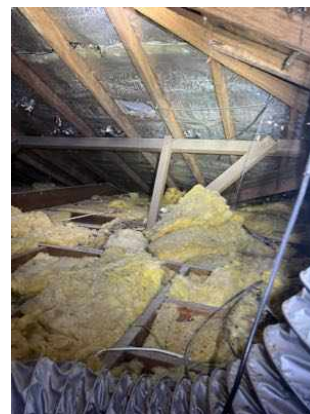
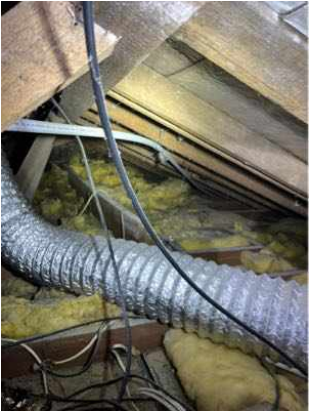
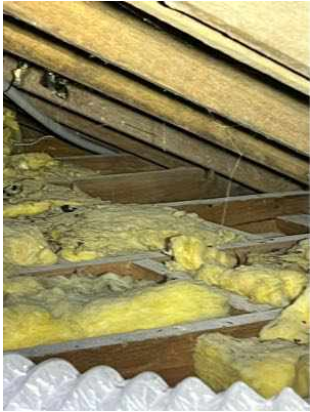
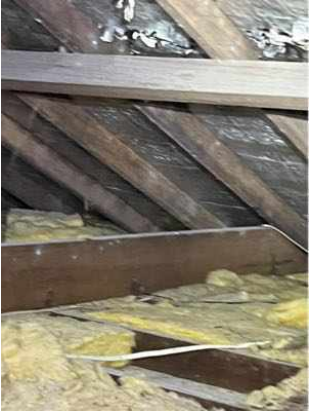
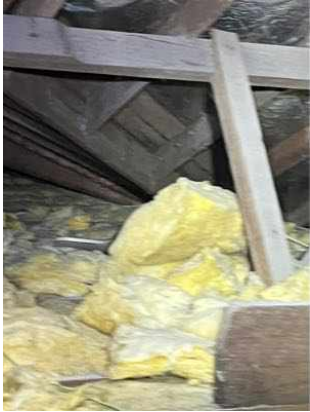
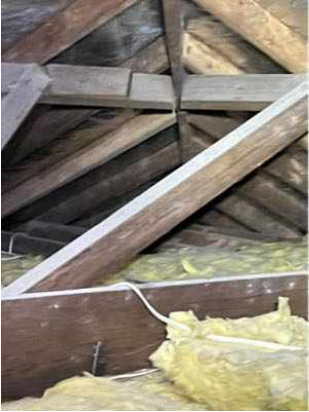
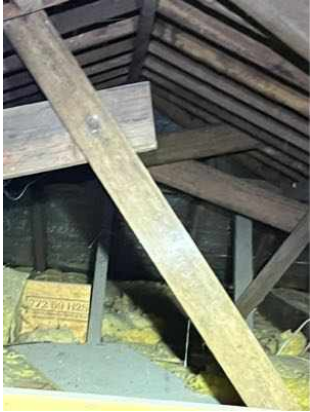
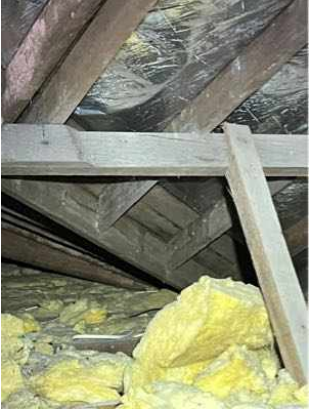
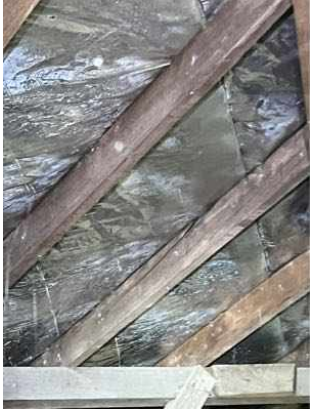
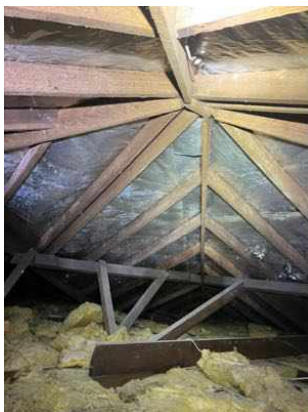
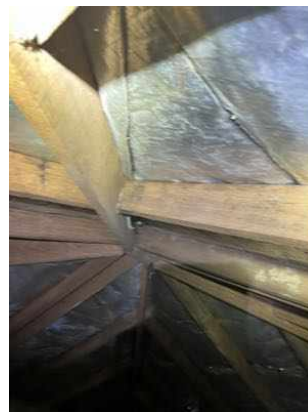
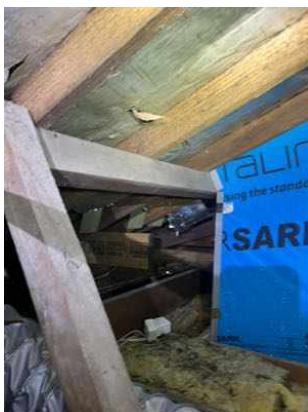
It should be noted that minor dust accumulation and small debris in sections of the ceiling void are typical for properties of this nature and age and do not indicate any immediate concern.

Overall, the condition of the roof void elements inspected is consistent with well-maintained properties, with no significant defects detected at the time of inspection. This assessment reflects the condition of accessible areas only, and limitations apply where inspection access was restricted.

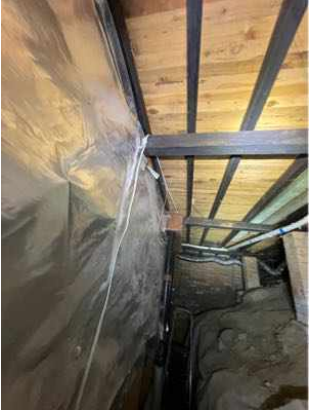
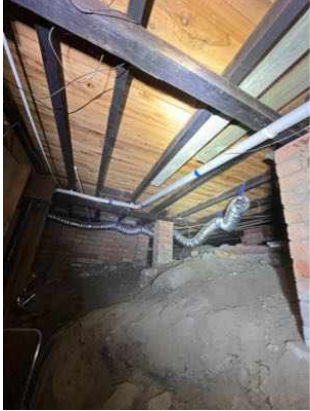
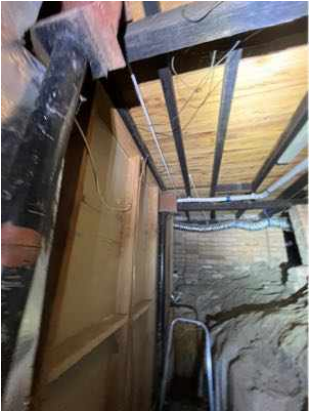
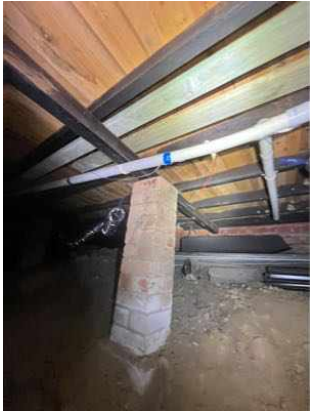
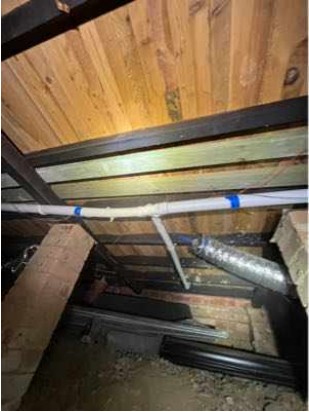
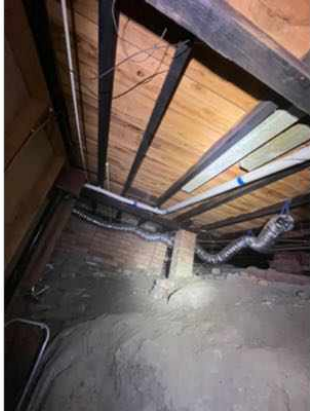
Building: Main Building
 Location: Subfloor
 Finding: Condition of Building Elements in the Subfloor
 Information: Upon completion of the subfloor inspection, the timber floor framing was observed to be in serviceable condition with no visible evidence of significant structural deterioration, fungal decay, or termite activity in the accessible areas.

Plumbing and ductwork installations are adequately positioned and appear functional, with no visible active leaks or damage at the time of inspection.

Overall, the subfloor structure is consistent with a property that has been reasonably maintained, and no significant concerns were evident during the inspection of the accessible areas.

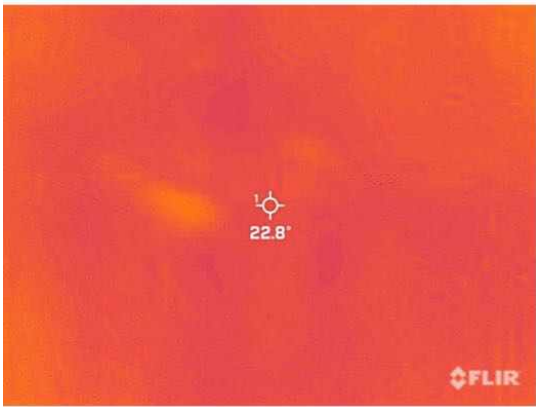
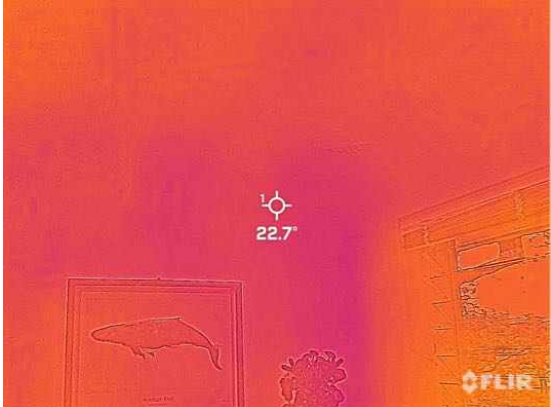
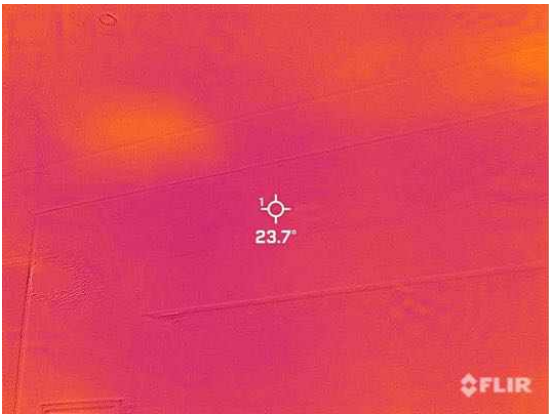
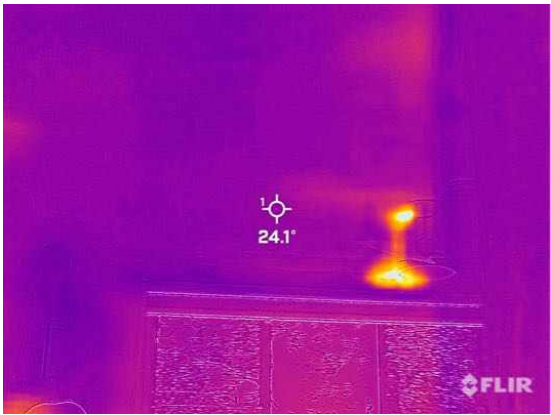
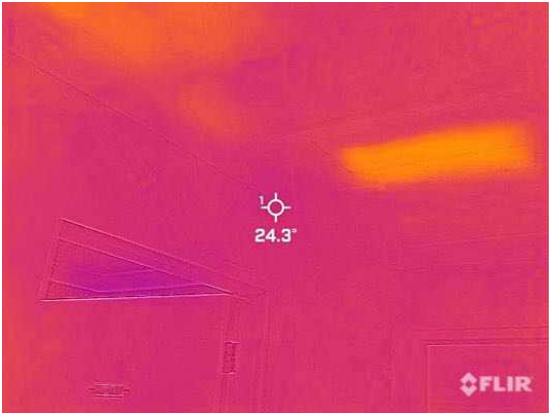
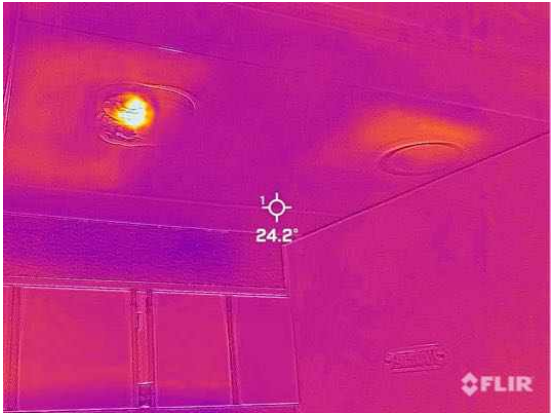
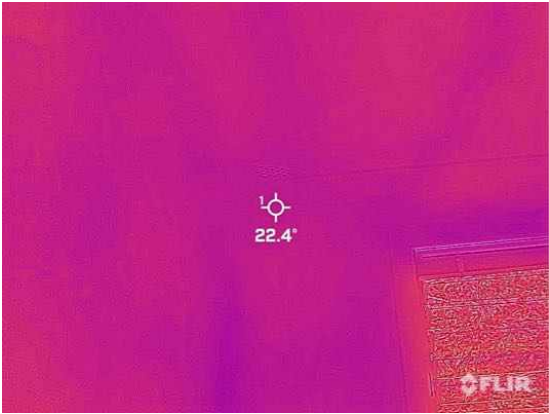
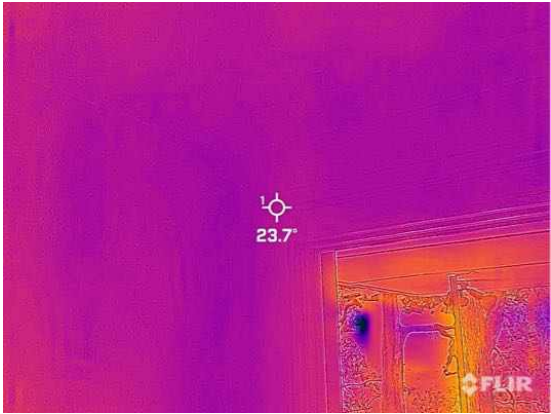
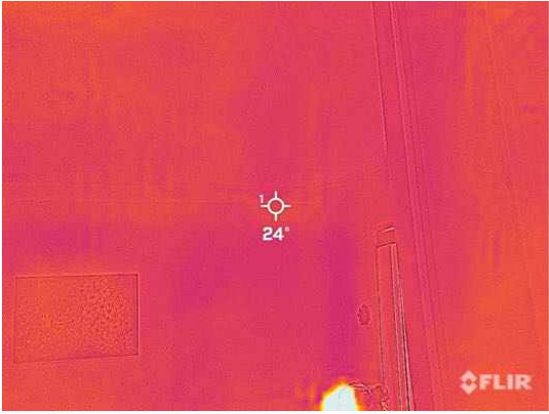
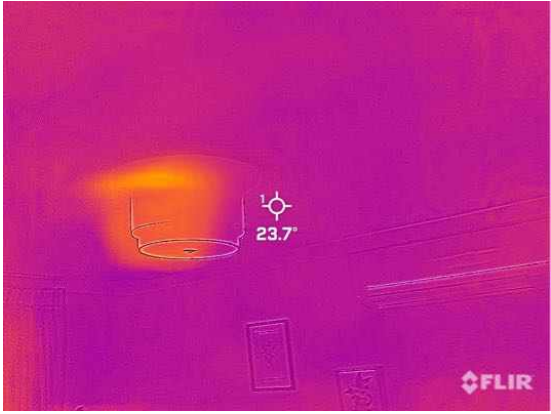
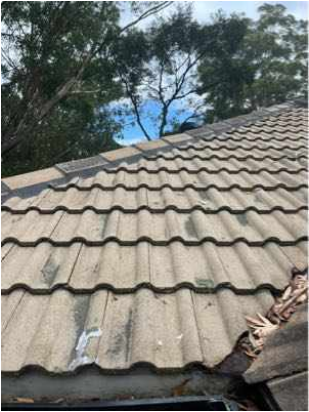
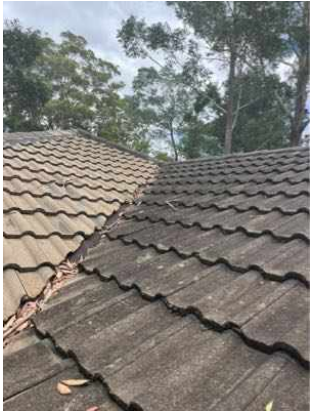
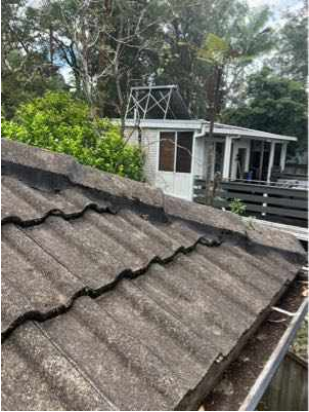
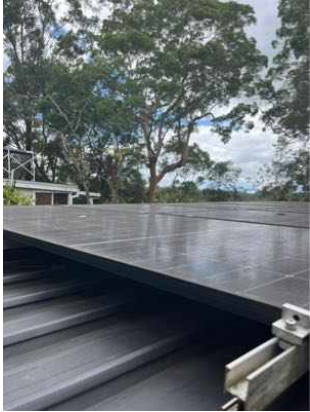
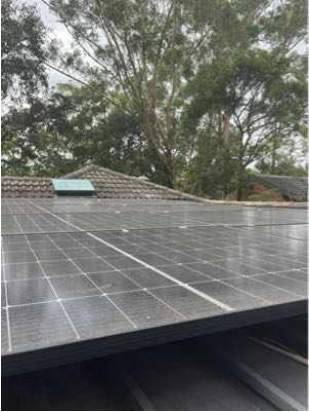
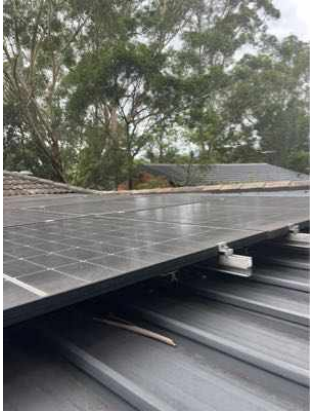
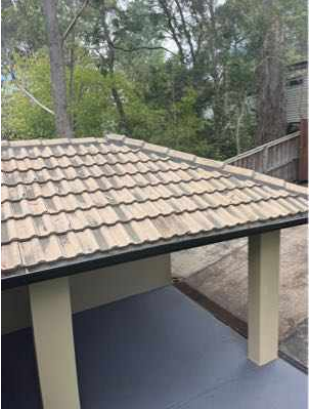
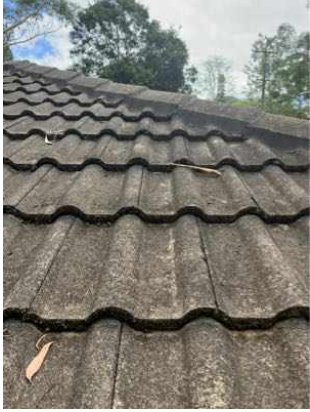
Building: Main Building
Location: All Areas
Finding: Additional Photos
Information: Thermal imaging camera was used to detect any active water leaks or/ and termite activities in the property. No water leaks or termite activities were found from inspection by thermal imaging camera. Additional photos are attached for general reference.
