Building and Timber Pest Inspection Report

Inspection Date: Tue, 13 Jan 2026

Property Address: 2A Frogmore St, Mascot NSW 2020,
Australia

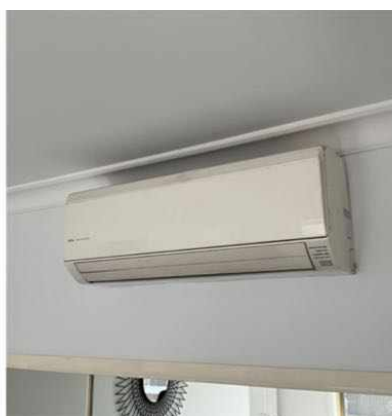
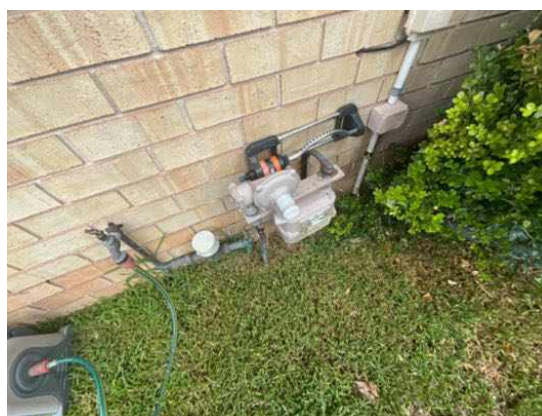
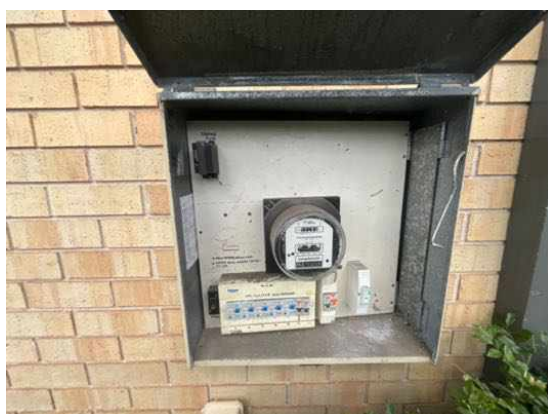
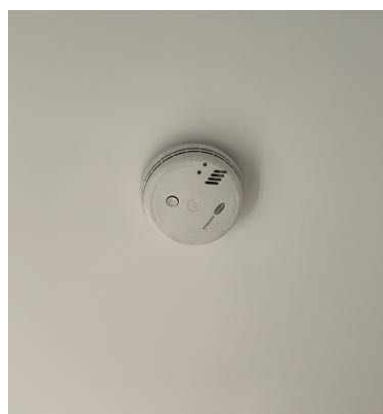
Building: Main Building
 Location: All Areas
 Finding: Photos Added
 Information: Additional photos are provided for your general reference.
