Building and Timber Pest Inspection Report

Inspection Date: Wed, 8 Apr 2026

Property Address: 4 Penola Dr, South Morang VIC 3752, Australia

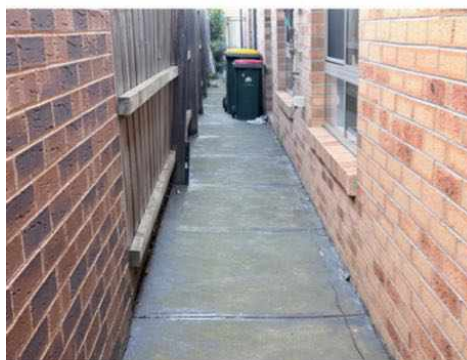
Building: Main Building
Location: Some External Areas
Finding: Step Cracking (Indicative of Localised Movement/Subsidence)- Moderate to Major
Information: Two significant step cracks were observed to the external brickwork, one located along the left-hand side wall and the other to the rear garage wall. The cracks follow a typical stepped pattern through mortar joints and brick units, with measured widths of approximately 4 mm in sections, which is indicative of moderate to major movement in accordance with common masonry assessment criteria.

The cracking pattern suggests differential or localised foundation movement. While internal observations indicate only minor signs of subsidence at this stage, the external manifestation is more pronounced, implying that movement may be concentrated along specific zones rather than uniform across the structure.

Contributing factors may include general ground movement and ageing of the structure. Additionally, site conditions appear to be influencing the issue. The paving along the left-hand side is noted to fall towards the dwelling, which can promote surface water migration toward the footing system. Although drainage points are present, they may be insufficient during heavy rainfall events. Minor gaps adjacent to the slab/edge beam further allow water ingress, which can soften supporting soils and accelerate localised subsidence over time.

If left unaddressed, continued movement may lead to further widening of cracks, potential distortion of openings, and secondary defects internally.

It is recommended that a structural engineer be engaged to assess the extent and cause of movement. Remedial works may include addressing site drainage (regrading paving, improving stormwater management), sealing gaps to limit water ingress, and undertaking masonry repairs once movement is stabilised. Continued monitoring of crack progression is also advised.

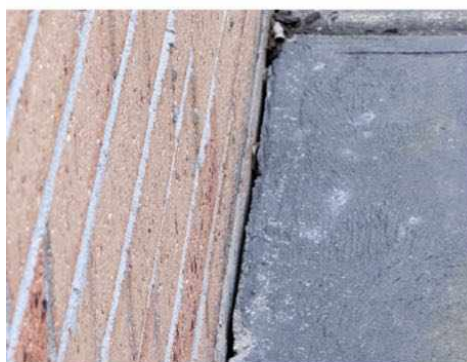
Finding 3.01

| Information: | Gaps were observed in the external concrete paving during the inspection. While not currently presenting as a major defect, these gaps may lead to minor secondary issues over time, such as potential water ingress if not addressed. |

This movement could be attributed to several factors including natural soil reactivity, general wear over time, or possible stormwater drainage issues.

In areas with reactive clay soils, it is advisable to ensure that stormwater from both roof and ground surfaces is effectively directed and regularly maintained, as consistent moisture can contribute to soil movement and may attract termites.

Engaging a licensed plumber to check the condition and adequacy of stormwater drainage is recommended. Additionally, sealing any visible gaps in the paving with the help of a licensed builder or handyman can assist in reducing moisture entry. If certain sections are significantly compromised, a licensed concreter may be consulted for potential repair or replacement.

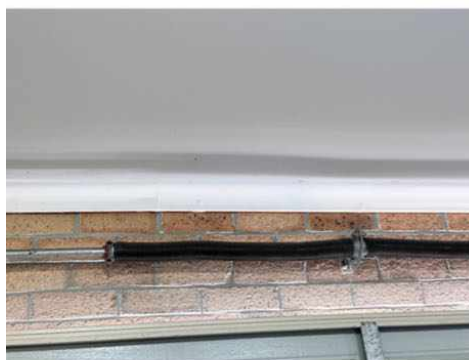
Finding 3.02

| Information: | A few popped nails were identified in the internal ceiling at the time of inspection. Nails and screws hold simply by the friction between them and the surface they are applied to. Over time, the nails and screws can back out, which is often a result of general ageing and deterioration of the building structure. |

If left unmanaged, the ceiling sheets may become loose and unstable, increasing the rate of deterioration of the internal ceiling and creating potential for the development of secondary defects.

Re-fastening of popped nails will help to maintain the stability of the internal ceiling and associated building elements. Such minor works will also help to improve the appearance of the affected area and secure the ceiling sheets, so as to prevent the onset of ceiling sagging. These works should be performed by a qualified carpenter or plasterer at client discretion.

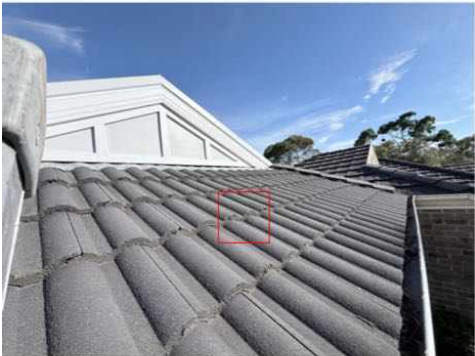
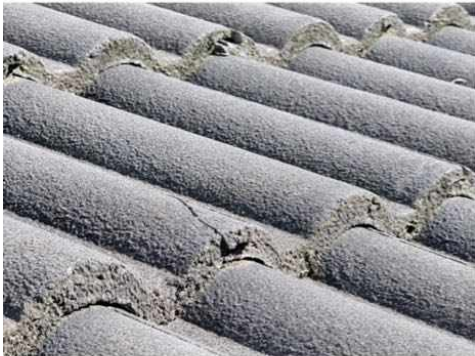
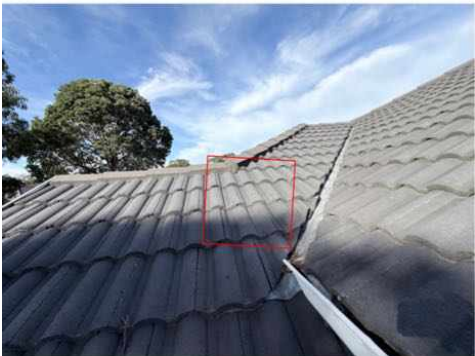
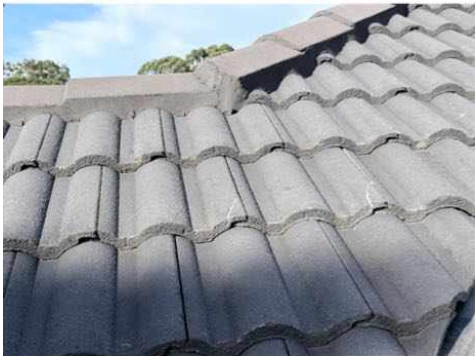
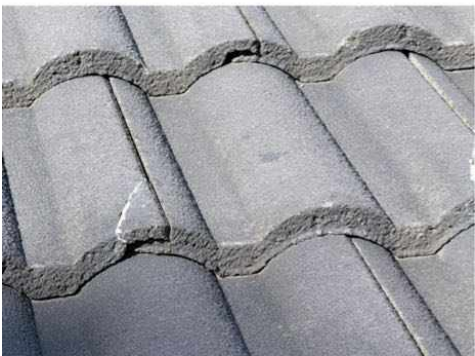
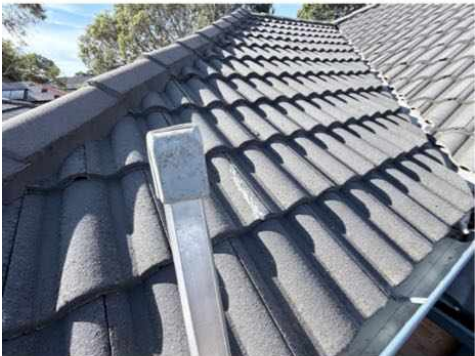
Finding 3.03

| Information: | Minor chipping and edge deterioration were observed to some roof tiles. This is typically consistent with general ageing, weathering, or minor impact damage. At the time of inspection, no evidence of active water ingress was noted; however, continued deterioration of tile edges can reduce weatherproofing effectiveness over time and may allow moisture ingress if left unaddressed. |

It is recommended that periodic roof maintenance be undertaken, including replacement of significantly chipped tiles and general inspection by a qualified roof plumber as required, to maintain the integrity and serviceability of the roof covering.

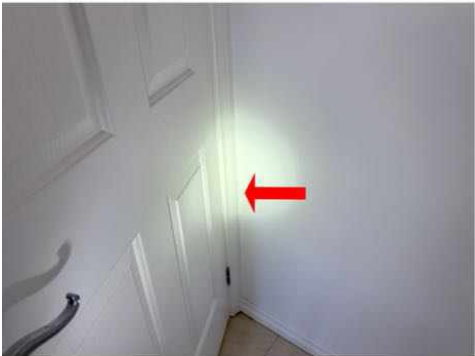
Finding 3.04

Building: Main Building
Location: Some Internal Areas
Finding: Cracking - Damage Category 1 - Fine (up to 1mm)
Information: Although fine cracks are quite noticeable, they are often only considered to be an appearance defect, and usually do not indicate any structural damage. Generally, the cause of a fine crack is indicative of a separation between building materials and finishes (e.g. paint, plaster, etc.) along joins.

Cracking of this nature can generally be repaired with minor sanding, filling and/or repainting. Such works should be performed by a qualified painter or a general handyman.

Monitoring of all cracking should be conducted frequently. Always contact a building inspector should cracks widen, lengthen, or become more numerous.

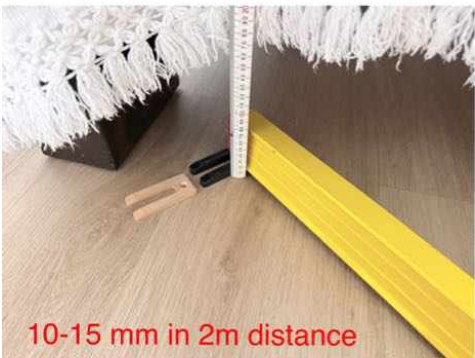
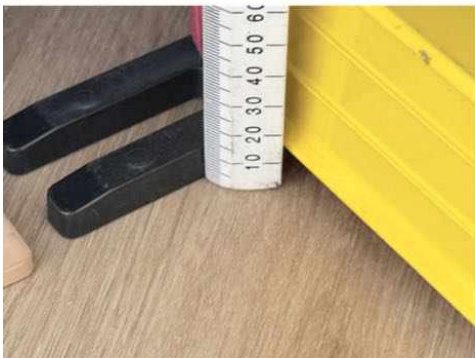
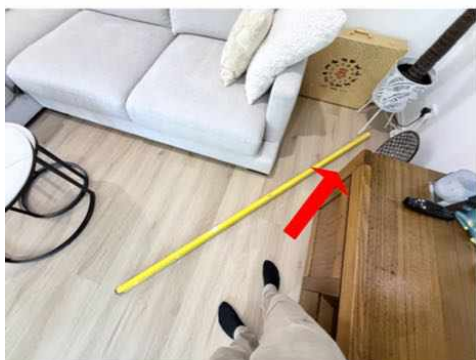
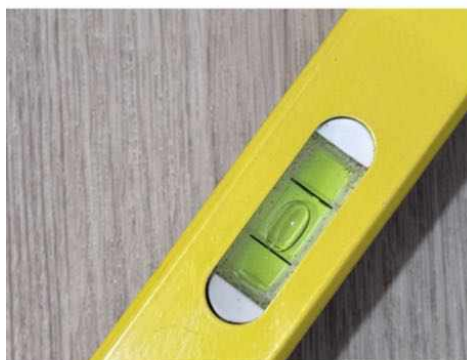
Finding 3.07

| Information: | It is suspected that the subfloor structure might have been affected by movement of the foundations, often referred to as sinking or subsidence. |

General subsidence is usually initiated by changes in soil moisture content. The most critical factor is identifying the specific causes, and identifying if this is a recurring or ongoing problem, or one that has been resolved by previous works in the past.

Subsidence can have complex and varying causes, which will influence the required remedial works. If secondary defects like door binding, cracks around the cornices, or gaps between walls & flooring are evident. It will be advised to begin by consulting a structural engineer to determine the required scope of works. This generally includes some form of underpinning, as well as addressing the underlying cause.

A Registered Builder specialising in underpinning would then generally carry out works as advised by an Engineer.

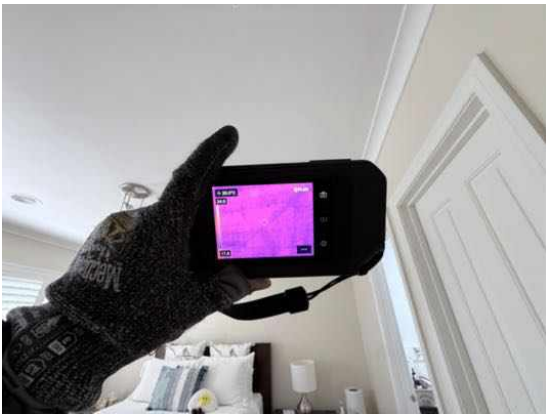
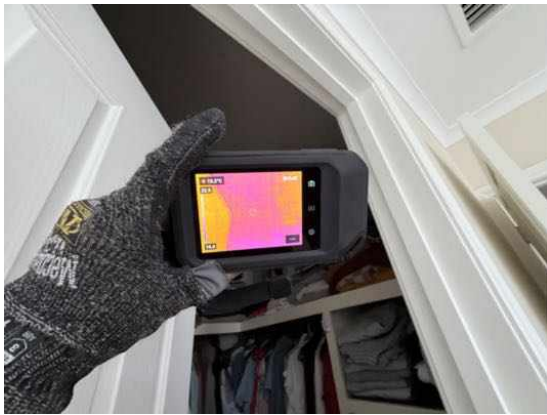
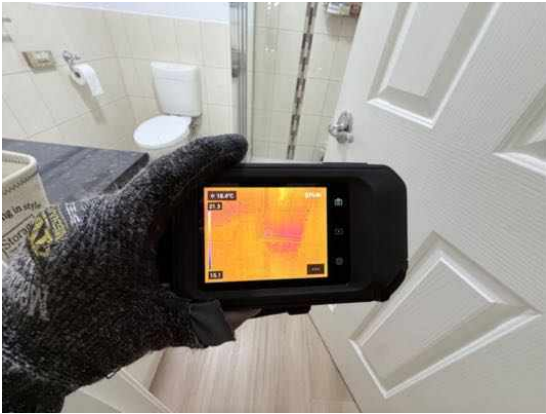
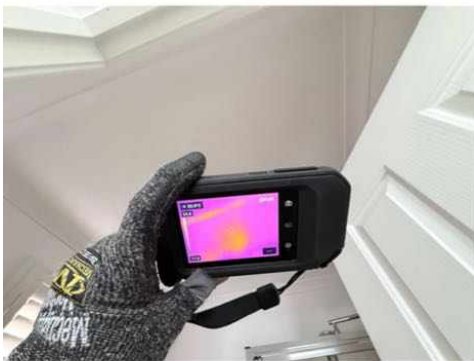
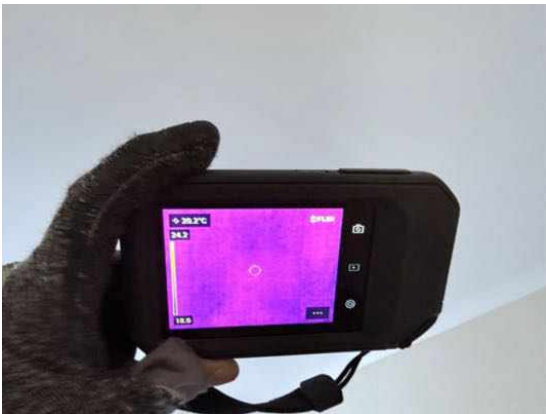
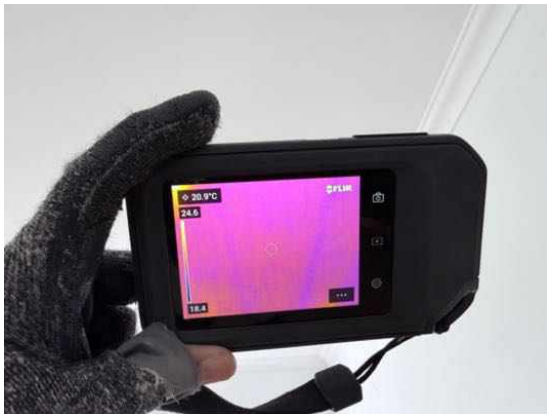
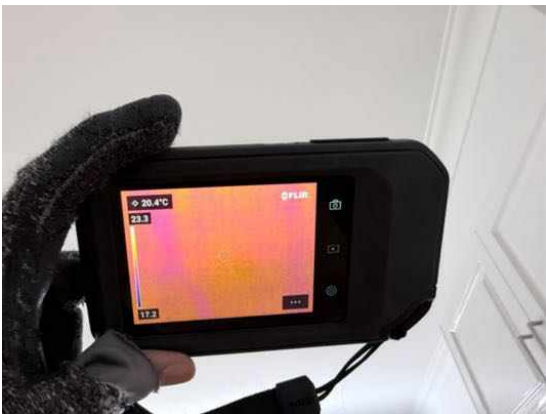
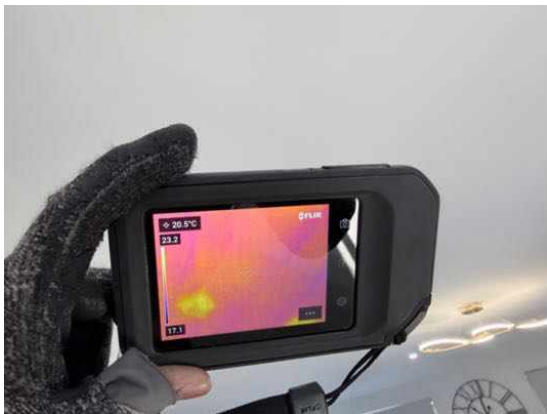
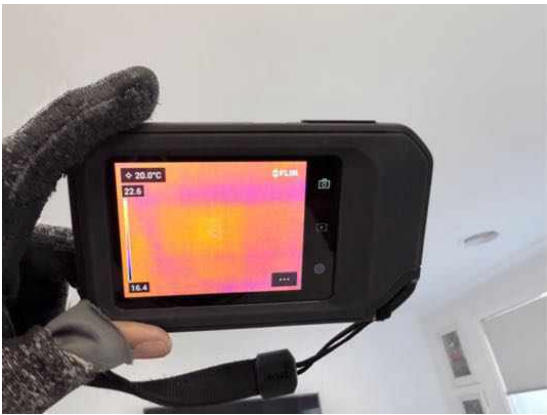
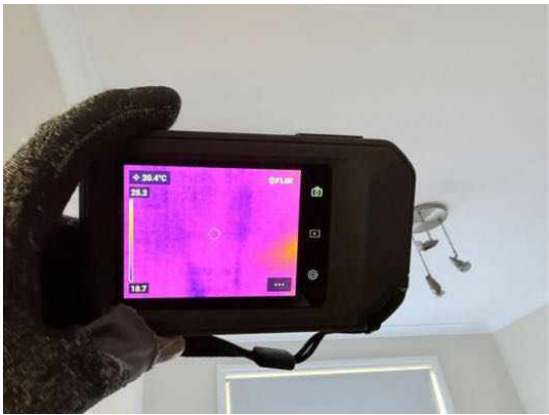
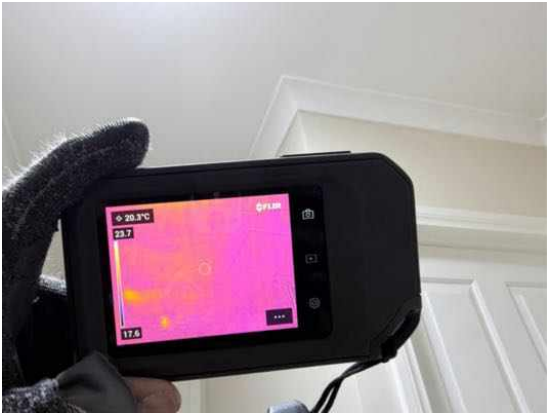
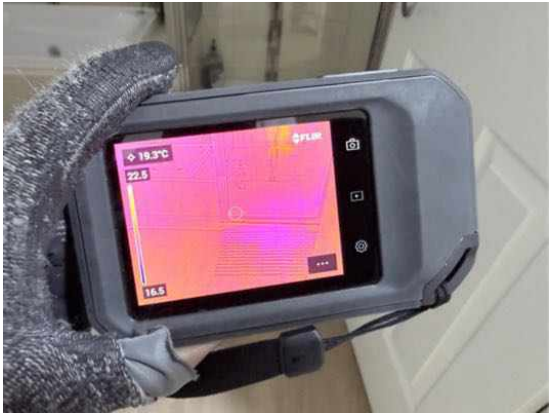
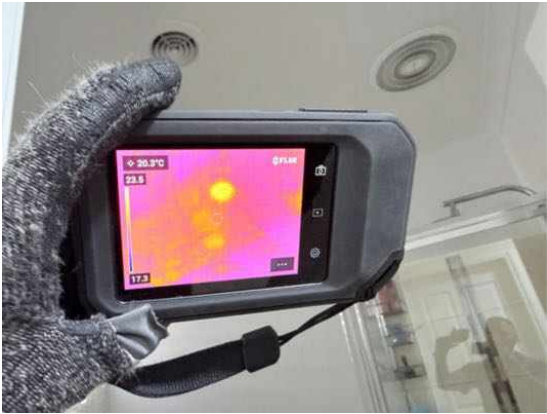
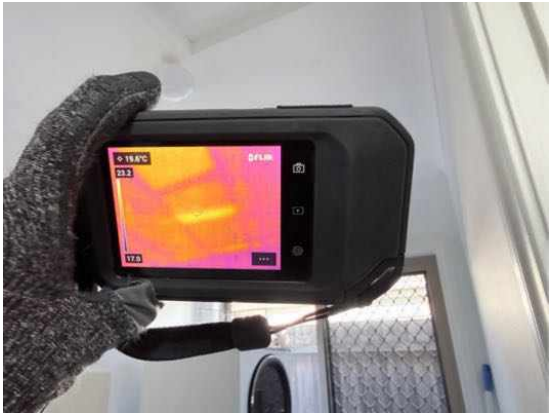
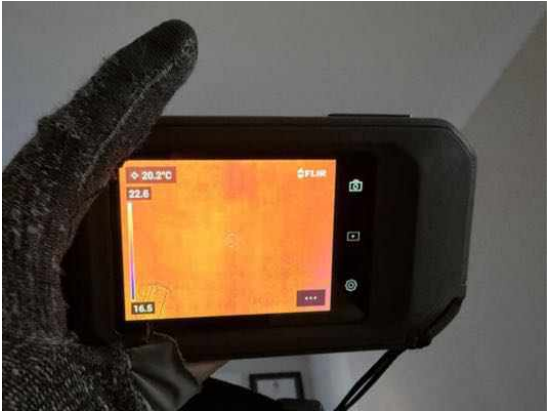
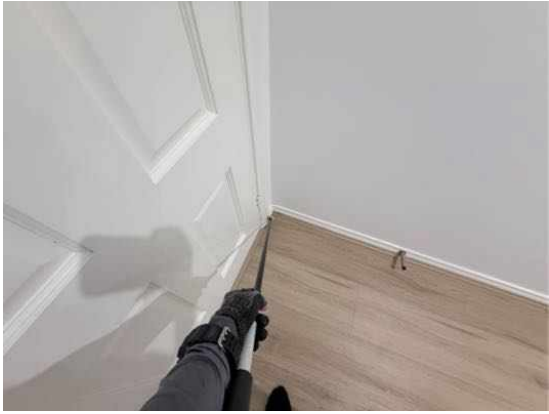
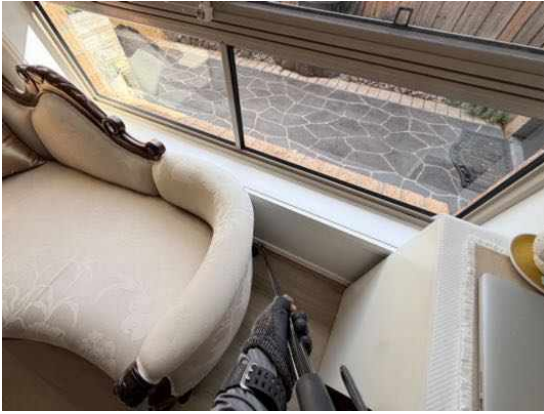
Building: Main Building
Location: All Areas
Finding: Termite Techniques
Information: All areas of the dwelling are checked with particular attention paid to wet areas which were closely assessed to check for excessive levels of moisture and temperature anomalies.

No evidence of termite activity was found inside the house at the time of the inspection.

In an attempt to identify the presence of hidden timber pest activity, a variety of techniques are adopted to identify irregularities including, a moisture meter reading of susceptible areas, sounding of timber elements using a device called a "donga" visual assessment of materials affected by moisture or signs of deformity, trails and bridging constructed by termites, irregular and regular shaped holes in timber elements indicating pest destruction.

Termite activity generates high temperatures and moisture and if this irregularity is found it can be grounds for further investigation.

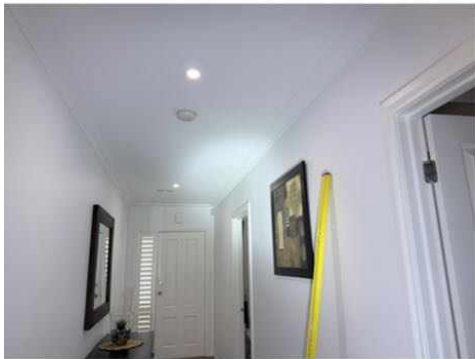
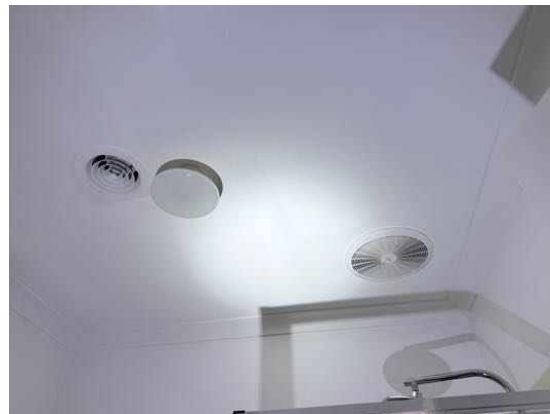
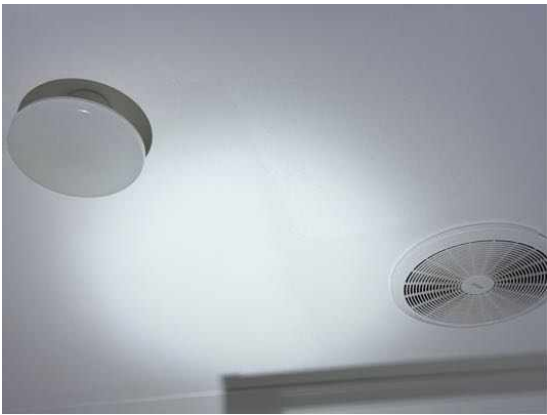
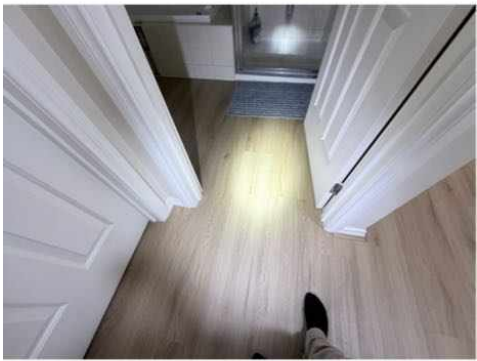
Information: Whenever a property is refurbished, majority of the defects if present could get obscured beneath the revamped work. The same can be said for this property as well. Some fine cracks are filled over, walls have been painted etc. It is difficult to pinpoint on any particular defects present below such layers.

Once the property is occupied, all areas should be monitored for a period of 12-24 months to lookout for any arising defects. If staining or cracking is noticed extensively in that period, always consult your building inspector.

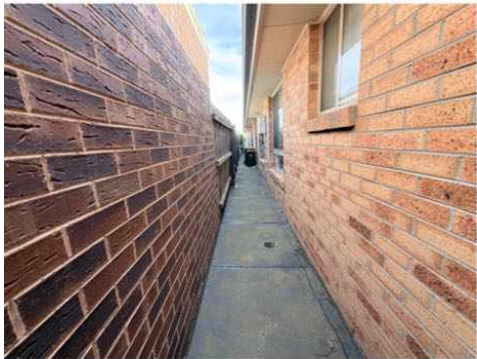
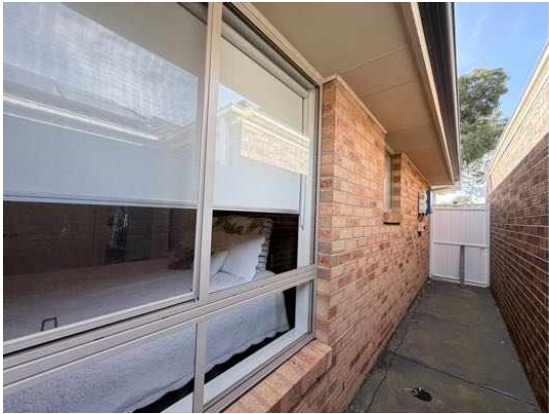
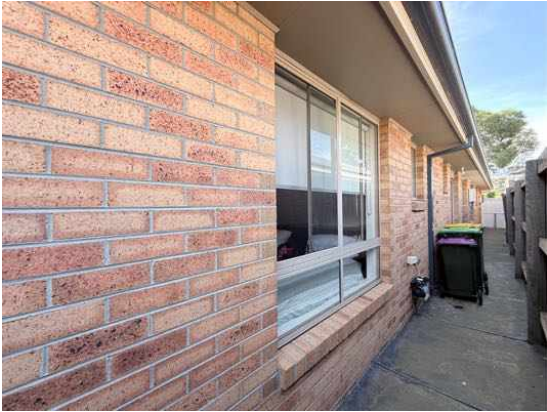
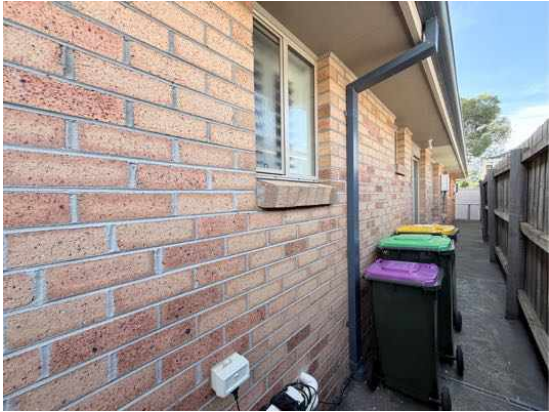
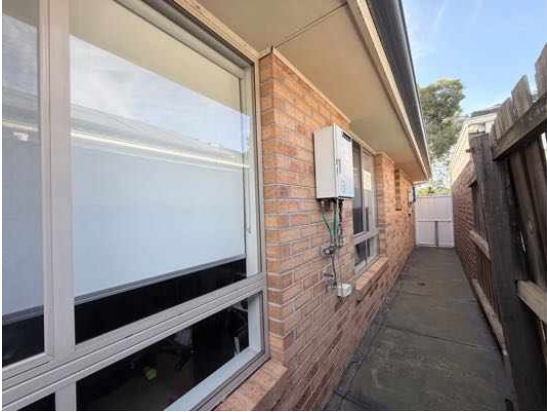
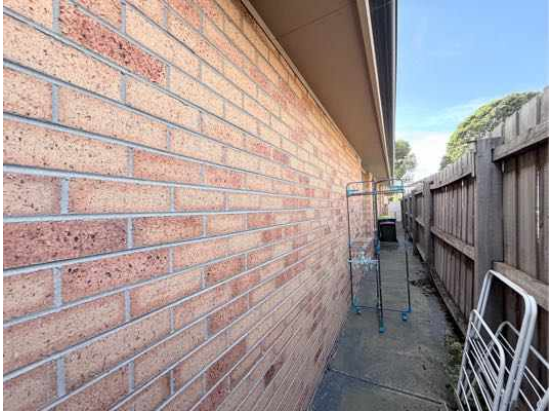
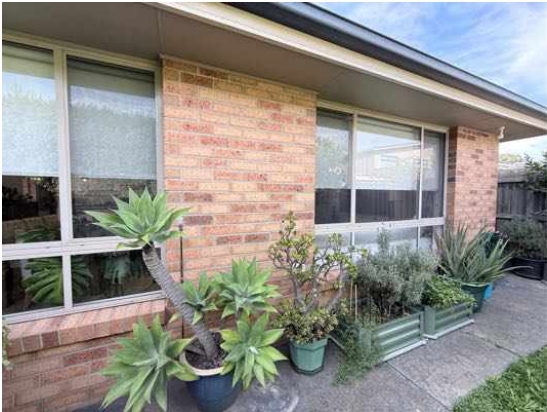
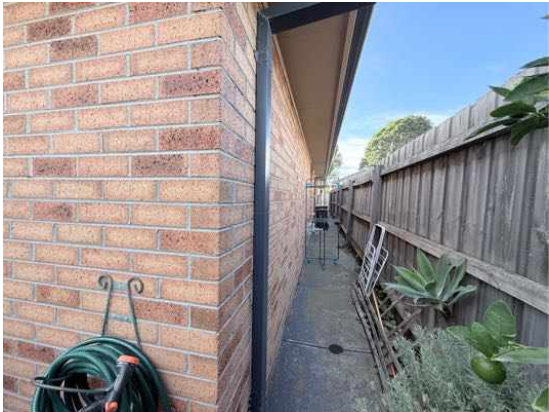
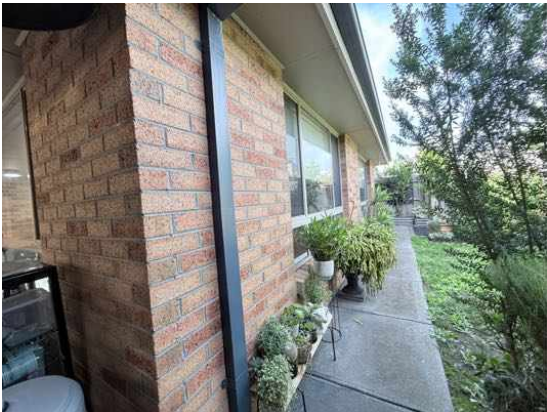
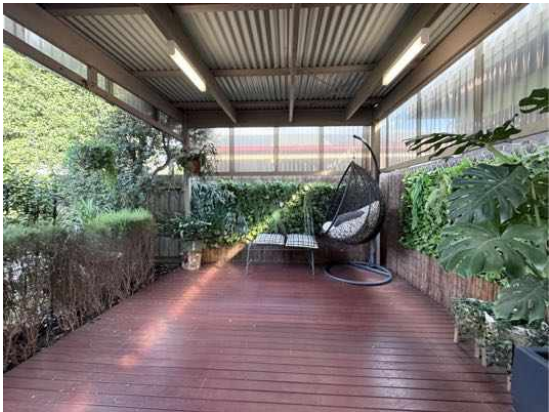
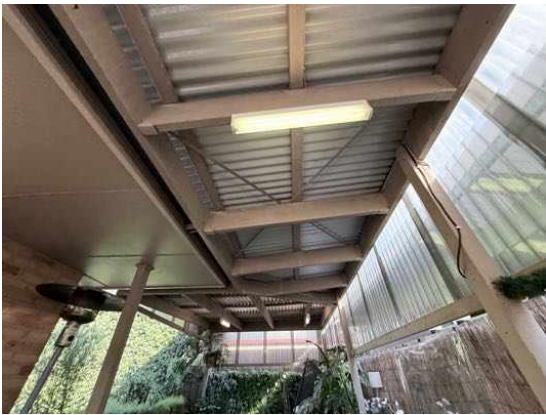
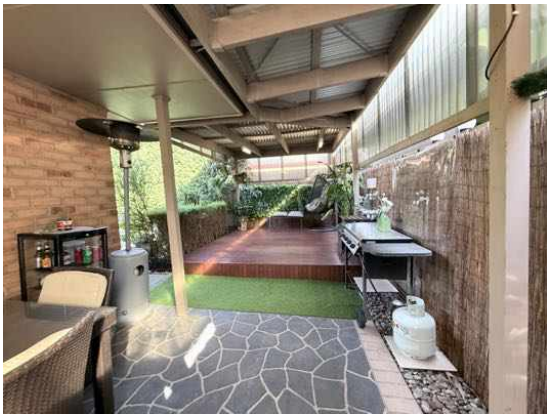
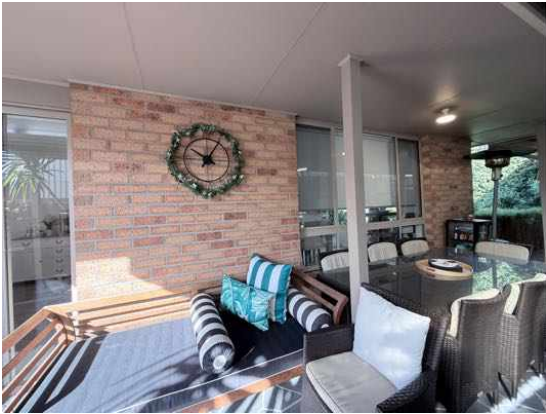
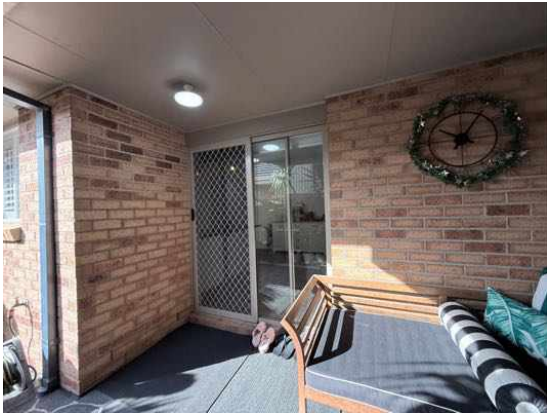
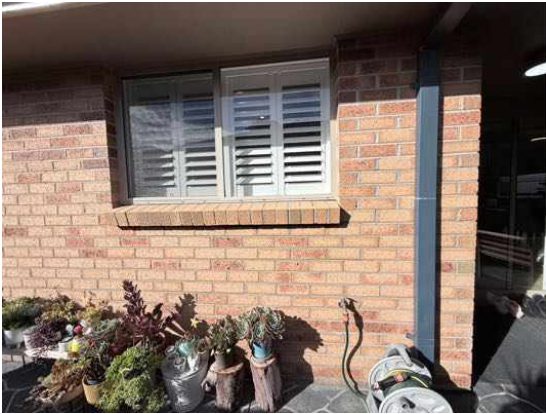
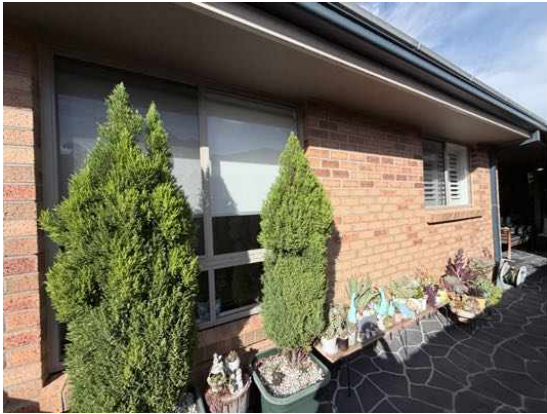
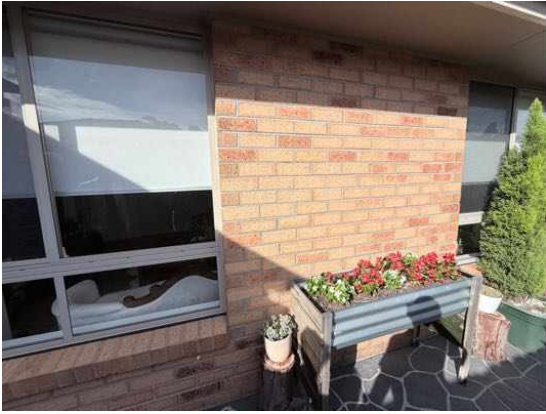
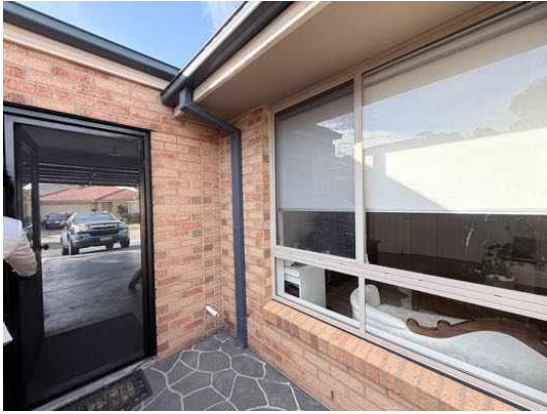
Building: Main Building
Location: All Areas
Finding: Additional photos & Obstruction/Limitations.
Information: Additional photos for general documentation. May have some minor maintenance items not listed in the defects section.

Furthermore, some photographs are an indication of the obstructions and limitations which impeded full inspection of the property at the time of inspection. These obstructions can hide an array of defects and should be removed to allow full inspection to be carried out. A re-inspection is recommended once the areas are made accessible.
