Building and Timber Pest Inspection Report

Inspection Date: Thu, 05 Mar 2026

Property Address: 1/11 Erskine Ave, Reservoir VIC 3073,
Australia

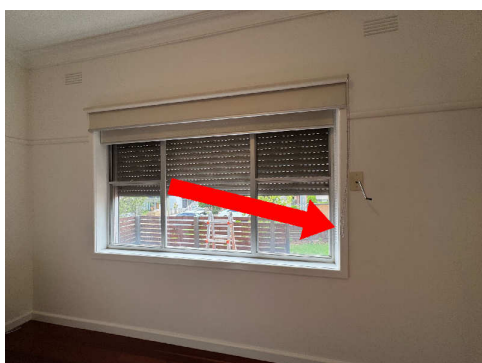
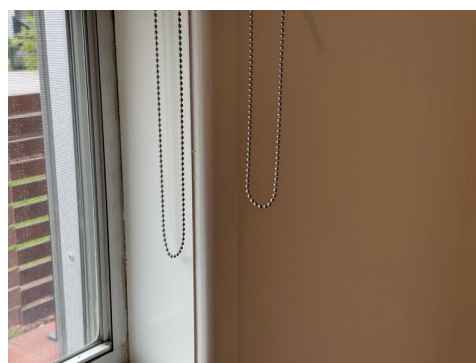
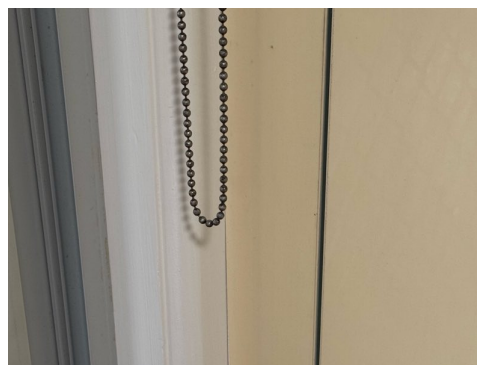
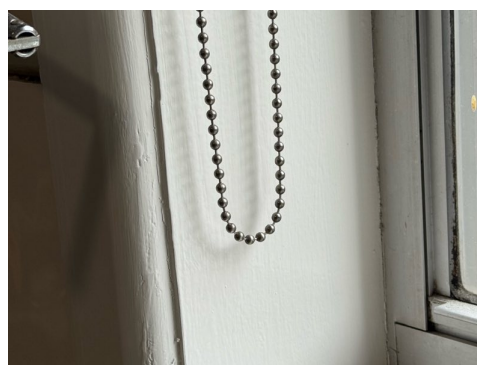
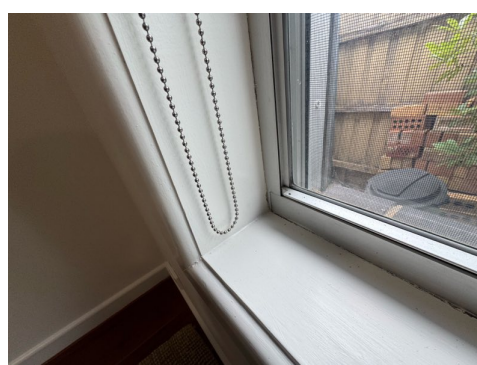
Finding: Curtain & Blind - Safety Cord

Information: Looped curtains and blind cords pose a significant strangulation hazard for children as they can place the loop over their heads and/or get tangled in the loose cords. The mandatory standard for blinds, curtains and window fittings (in place from 30th December 2010) requires all new window furnishings to come with warning labels and to be installed with tensioning devices. However, as this standard is not retrospective, curtains and blinds installed before 2010 still need to be made safe. Check all the rooms in your house for any blinds or curtains with long, loose or looped cords. This includes any cords within children's reach at floor level or near furniture they can climb on. Secure any loose or looped cords with cleats or tension devices - these can be purchased from your local curtain and blind retailer or hardware store. Do not put furniture such as cots, beds, highchairs, playpens, couches, chairs, tables or bookshelves near a window where children can reach the blind or curtain cord. When installing new blinds and curtains, ensure you or the installer secures loose or looped cords immediately. Depending on the types of curtains/blinds in your home, various kits and devices can help you make them safe. These can be purchased from your local hardware store, curtain, or blind retailer. It is recommended that this defect be resolved immediately to avoid harm to occupants.

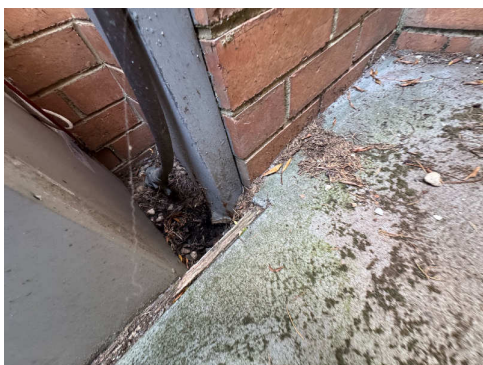
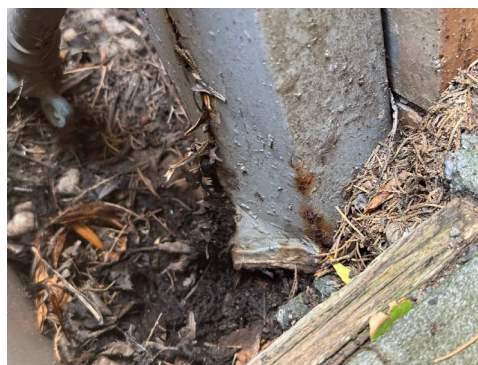
Blocked gutters and drains are likely to lead to high levels of moisture in the affected areas. Such moisture will not only cause rust and decay of the associated building materials, but can also provide conditions that are conducive to termite and timber pest activity. Blockages in gutters and drains should therefore be removed immediately to ensure dry conditions are maintained.

A qualified plumber should be appointed to further inspect the property and perform any necessary remedial works. It is also recommended that a CCTV inspection of the stormwater drainage system be carried out to identify any blockages, damage, or defects that may be contributing to poor site drainage. Water damage and secondary defects are likely to occur if the issue remains unmanaged.

It is highly advised that gutters and drains be checked and cleaned regularly for the long-term care of your property.

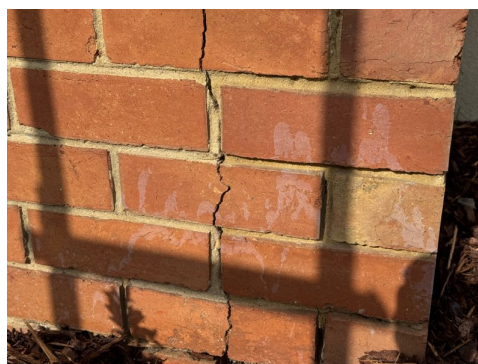
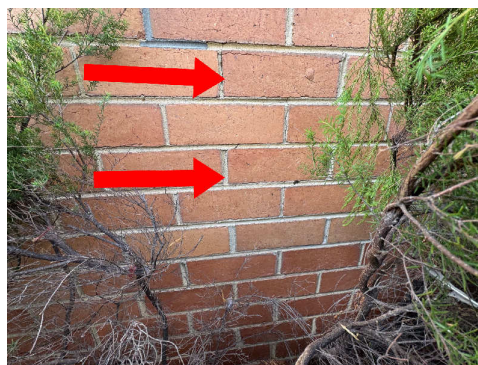
Finding 3.02

Finding: Brickwork - Cracking [Fine]

Information: Although fine cracks are quite noticeable, they are often only considered to be an appearance defect and usually do not indicate any structural damage. Generally, the cause of a fine crack is indicative of a separation between brickwork and mortar throughout the structure, but single bricks may also show cracks of this nature.

Cracking of this nature can generally be repaired with minor filling and should be conducted by a qualified bricklayer.

Always contact a building inspector should cracks widen lengthen or become more numerous.

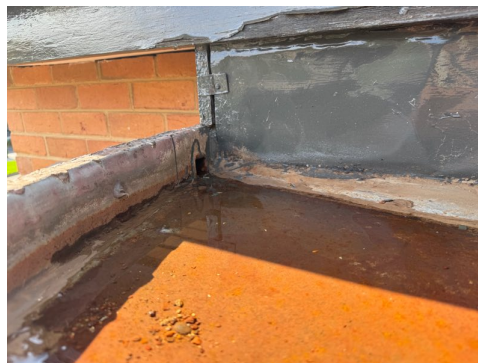
Finding 3.03

Finding: Building element - Rusted or corroded

Information: This building element shows evidence of rusting and corrosion. As surface rust provides no protection to the underlying iron, the deteriorating condition is likely to worsen if not addressed in the short-term. Rust formation can be controlled with coatings, such as paint, that isolate the iron from the environment. as does regular general maintenance. A painting contractor or general handy person should be appointed as soon as possible to perform necessary works to ensure the area is protected against further deterioration.

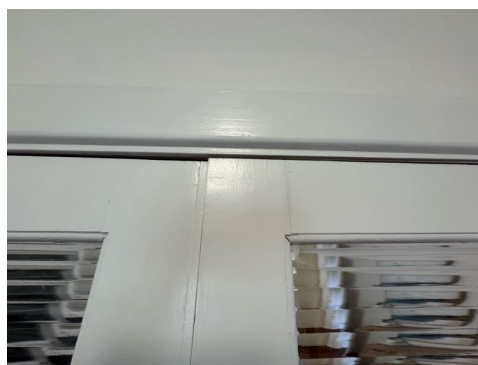
Finding 3.04

Finding: Door - Rubbing

Information: The door was found to be rubbing during standard operation. This defect inhibits the functionality of the affected door as well as creating potential for secondary defects to associated building elements. A qualified carpenter or general handyperson should be appointed to perform minor rectification works to improve the operational state of the associated door at the clients discretion.

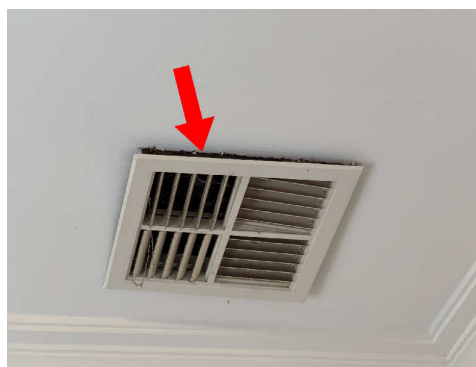
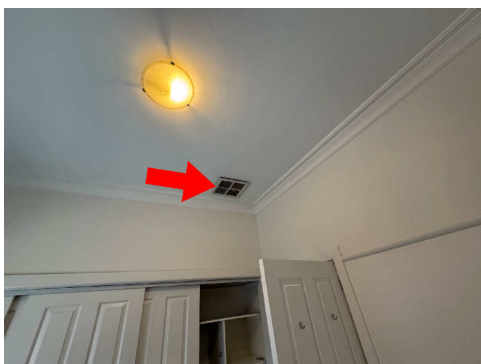
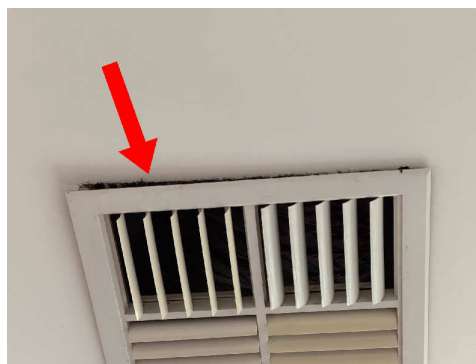
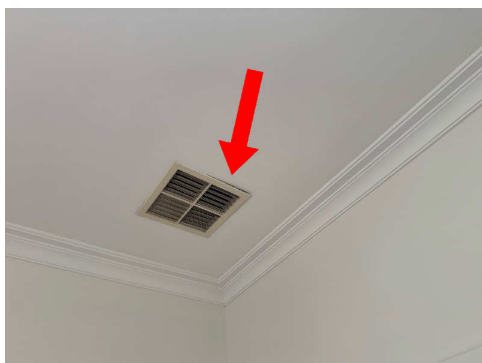
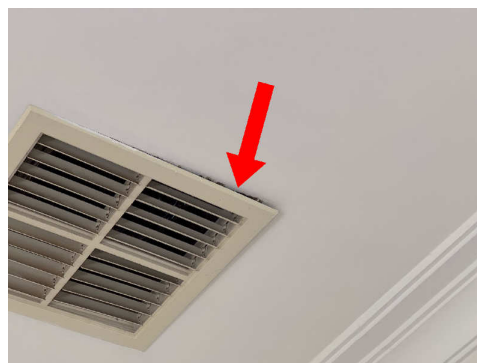
Finding 3.05

Finding: Air vent or grille loose.

Information: At the time of inspection, the air vent was observed to be loose and not securely fixed in position.
Breakage occurs generally when the building materials have either aged and decayed, or as a result of damage (accidental or deliberate).

Repair and/or replacement of broken elements is advised to ensure that additional secondary defects do not arise as a consequence. Such works are necessary, as all building elements play a key role in the operation and function of the overall structure and its performance.

A relevant tradesperson should be appointed to repair or replace the affected building element prior to any subsequent damage being caused.

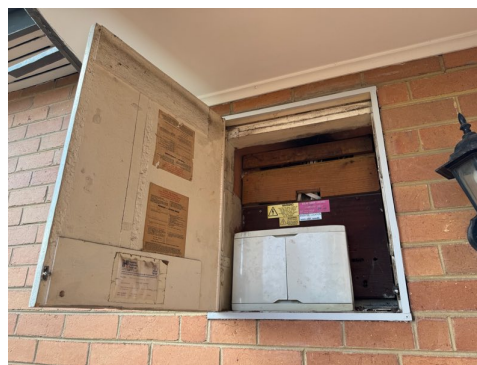
Finding 6.01

Building:	Main Building
Location:	Meter Box
Finding:	Termite Management System - no evidence of a chemical installation
Information:	<p>The application of a post-construction chemical termite barrier is highly recommended for all properties, particularly if live termite activity has been found on the site previously. Such barriers are highly effective in preventing termite attack on any timber building elements throughout the property.</p> <p>A durable notice should be placed in the switchboard unit to indicate current termite barriers. At the time of inspection, it appeared as though no termite management system has been installed, with no evidence to suggest preventative works taking place.</p> <p>The client may consider gaining further advice from a pest controller as to the costs and procedures involved with this application. It is recommended that obtaining such advice be a short-term priority.</p>

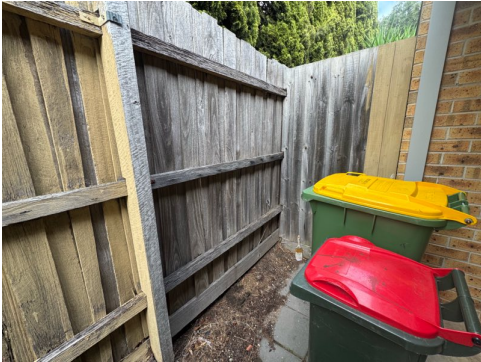
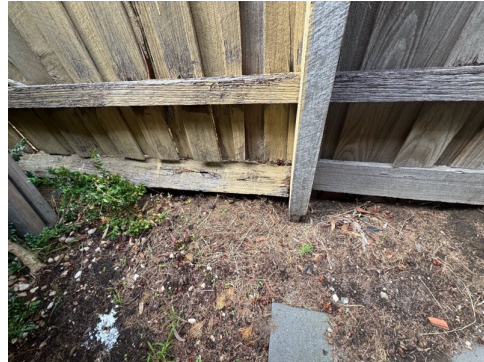
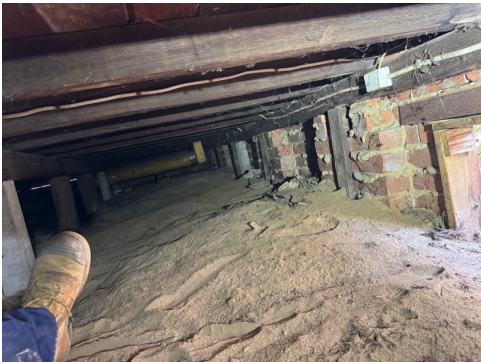
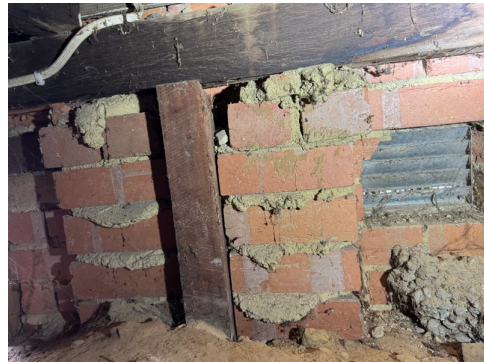
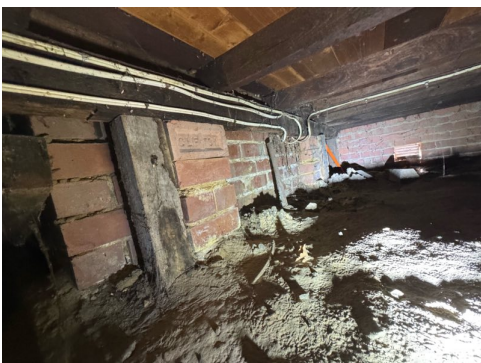
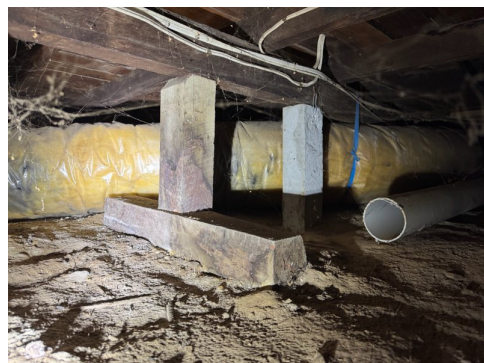
Finding 6.02

Information: Where timber elements are in direct contact with the ground and consequently moisture or dampness they become conducive to termite activity. Whether timber is used as a building element part of a fencing structure or stored as an unused item they can provide an environment that is attractive to termite infestation.

When met with excessive moisture timber begins to decay and develop wood rot. Any timbers that are in direct contact with external grounds especially if left untreated or non-durable also provide ingress for subterranean termites into that particular element. Consider replacement with more durable materials i.e. treated timber or non timber elements.

It is highly recommended that termite or timber pest inspections be carried out every 6-12 months to aid protection of the property against infestation.

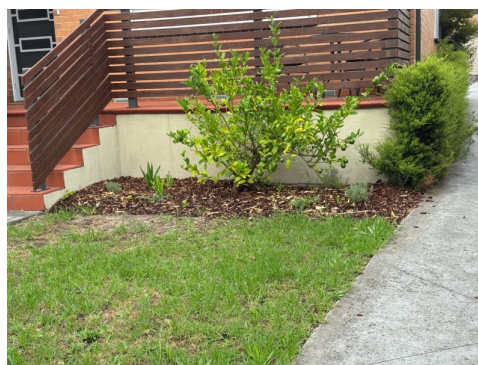
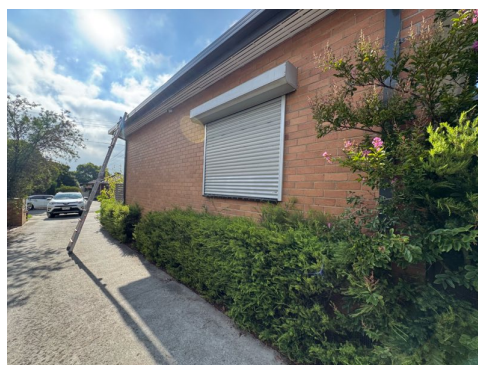
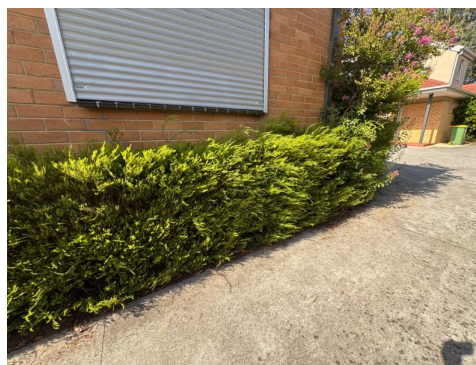
Finding 6.03

Finding: Garden Beds - Conditions Conducive to Termites

Information: Garden beds were found at the time of inspection. These garden beds can include untreated timber, and with a combination of moisture from watering hosing can make conditions conducive to termite activity and termite ingress.

The building of gardens or planting of shrubs close to the perimeter of the building may promote termite activity. It is highly recommended that termite or timber pest inspections be carried out every 6-12 months to aid protection of the property against infestation.

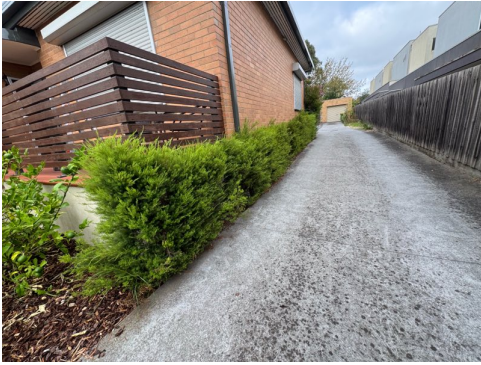
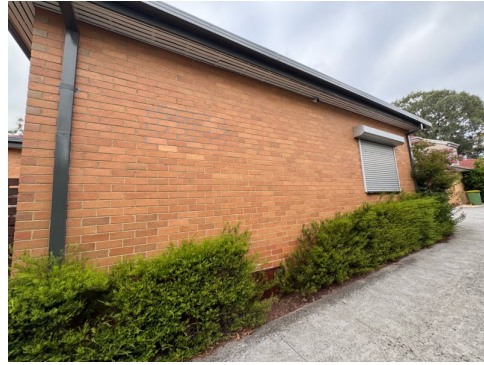
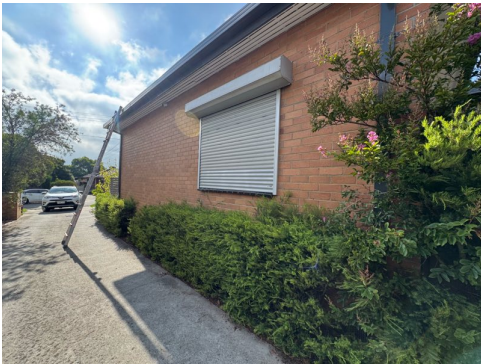
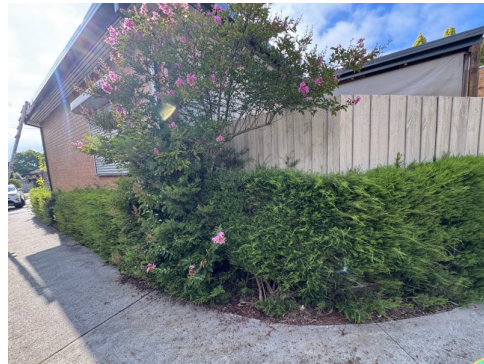
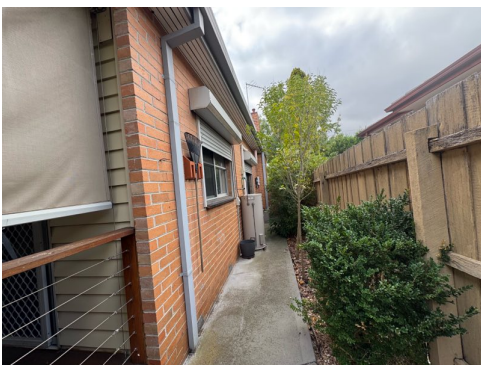
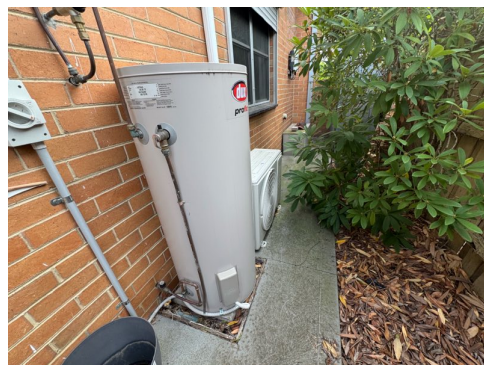
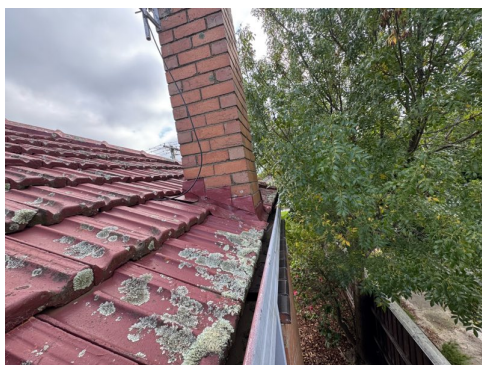
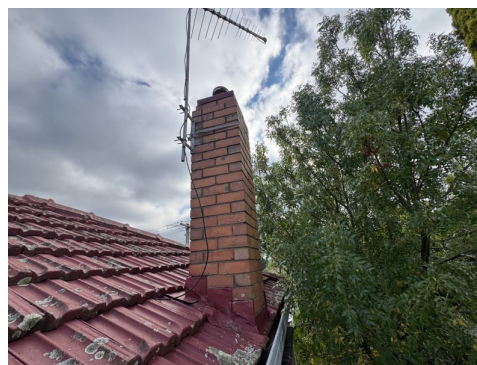
Finding 6.04

Information: A complete inspection cannot be achieved when vegetation obstructs the inspection of building elements, also known as bridging, as it provides a bridging point for termite access. Consequently, moisture or dampness may be present, and the area becomes conducive to termite activity. Plants against or very close to buildings provide cover and shade and can provide an environment that is attractive to termite infestation.

The removal and replanting of species that do not provide "cover" or cutting back of existing vegetation will greatly assist in preventing bridging.

To minimise the risk of termite attack, materials conducive to termite activity should be removed as soon as possible, and re-inspection should be arranged.

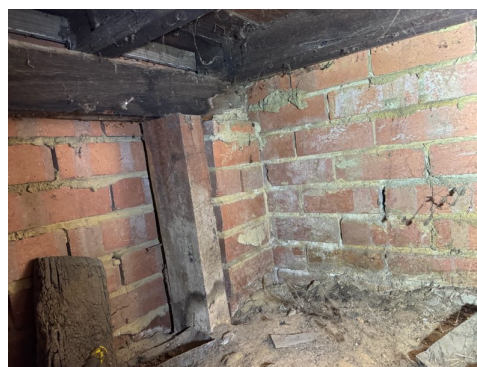
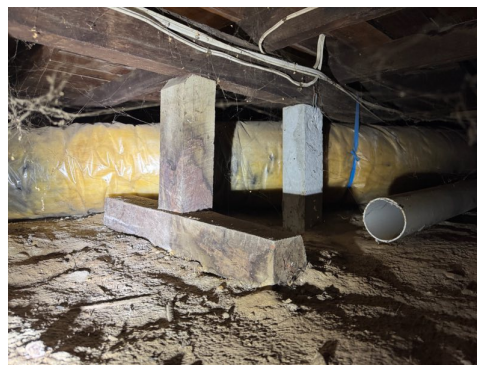
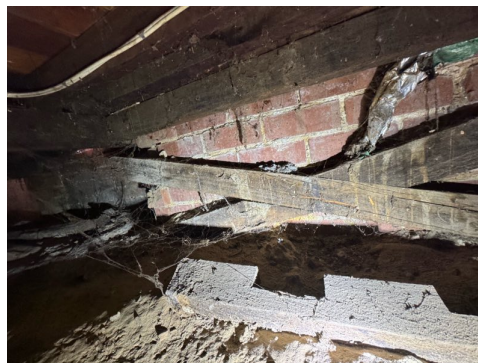
Information: The storing of timbers in the subfloor space or around the external property increases the risk of termite activity being present. As they are likely to come into contact with weather conditions or excessive moisture wood rot is likely to develop on timbers that are not treated.

It is highly recommended that any stored timbers be immediately removed from areas in which they may attract any termite / timber pest attack. Minimisation of risk / prevention of termite attack is far more adequate than dealing with the presence of termite activity.

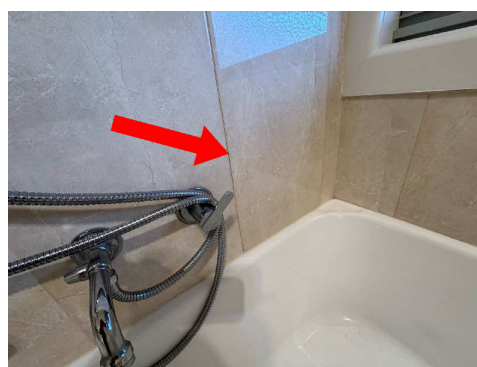
Flexible and mould resistant materials should be applied to affected areas to prevent any subsequent water damage that is likely to occur. Regular maintenance and replacement of damage or missing or damaged sealant and grout is highly recommended to the wet areas, as this is a regular wear and tear defect. Sealant and grouting in areas that come into regular contact with water should be maintained for the long term care of your property.

A sealant specialist or tiling contractor should be appointed to complete these works in the short to medium term.

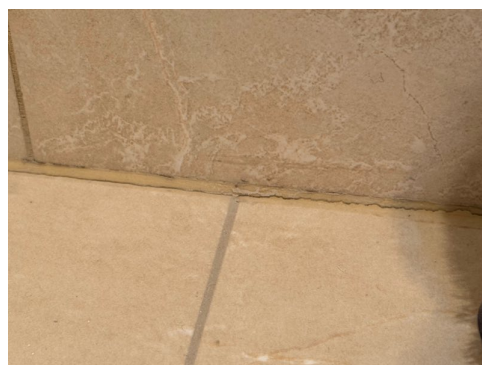
Finding: Sealant and grouting - Missing or damaged

Information: It was noted on inspection that sealant or grout is degraded to the tiled shower alcove and or other areas of the bathroom.

Different materials and floor areas move at different rates, generally causing cracking to grout or sealant at this point. A flexible sealant is required to allow for expected expansion and contraction, while keeping the joint water tight and protective of all associated building materials.

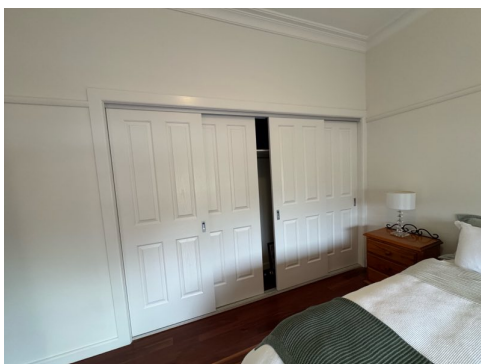
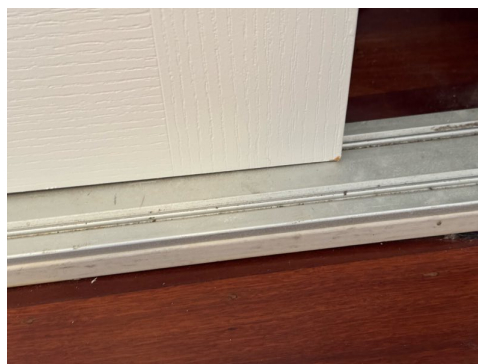
Location:	Bedroom
Finding:	Door - Stiff to slide
Information:	<p>The door to this area were difficult to slide along the associated track at the time of the inspection.</p> <p>Generally, factors such as the general age of the building element and a lack of maintenance are the usual causes for this defect.</p> <p>Repair is advised to improve the operational state of the associated doors. Replacement of door hardware may be required, or minor repairs and cleaning.</p> <p>A qualified carpenter or general handyperson should be appointed to perform rectification works as soon as possible.</p>

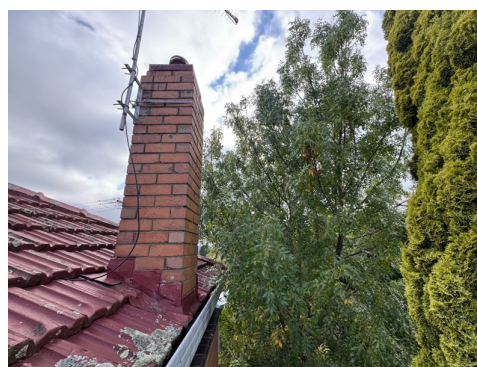
Building:	Main Building
Location:	Roof Exterior
Finding:	Trees - Overhanging and filling gutters

Gutters are a critical part of the building's management of storm water and rain. It is therefore important that they be kept clear to prevent secondary damage to associated building elements, including exterior and interior walls, ceiling linings and any adjoining building elements. Where gutters are blocked, pooling of rainwater is likely to occur, fast-tracking rust and corrosion of the roof plumbing elements.

It is highly advised that all overhanging tree branches be removed as soon as possible to prevent any further damage. Repair and/or replacement of sections of damaged guttering may also be required where the extent of the damage necessitates.

Such works should be performed by the homeowner; however, appointment of a landscape contractor or an arborist may be required. Consultation with a licensed roof plumber is required where guttering has been damaged.

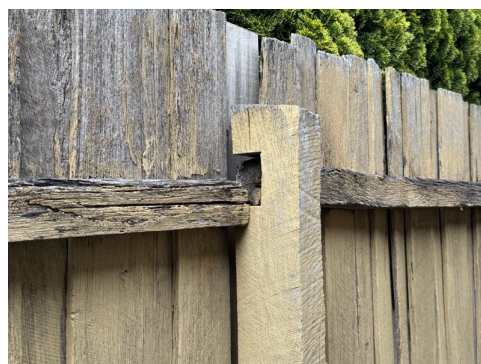
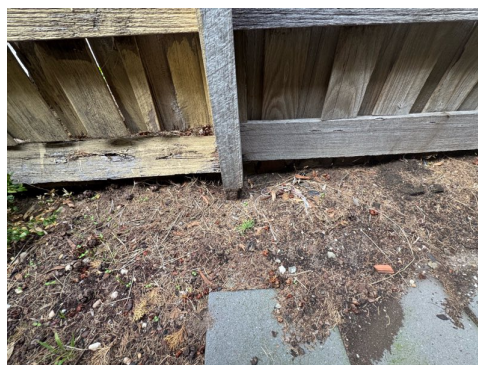
Building: Main Building
 Location: Fencing
 Finding: Fencing - Deteriorated

It was noted at the time of inspection that sections of the fencing throughout the property have deteriorated. Typically fencing deteriorates due to age and or wear, rot and or rust which is generally expected for a structure of this age, due to prolonged exposure to weather conditions. Sometimes inadequate installation or maintenance can be to blame.

If left unattended, it is likely that further damage will occur. It is suspected that repair of several elements of the fencing may be required however replacement may be a consideration of the client also.

A licensed fencing contractor should be appointed to provide further advice and perform rectification works as necessary.

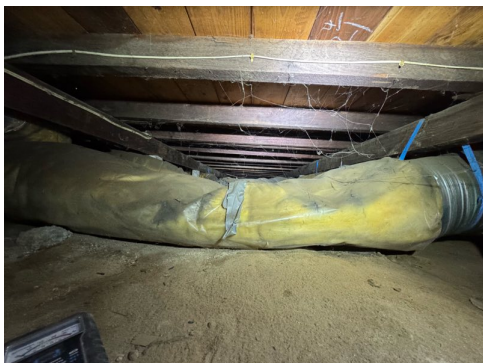
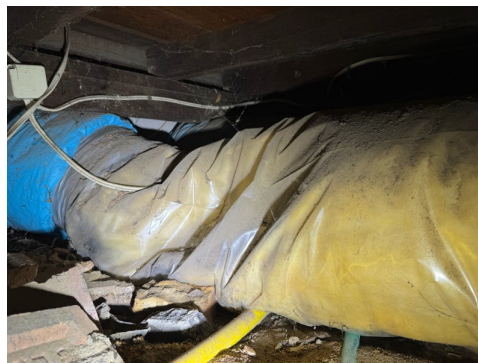
Information: At the time of inspection, the ducted heating system was suspected to be non-operational. Sections of the ductwork were also observed to be damaged in the subfloor and no gas meter was located at the time of inspection.

This item is provided for information purposes only. Further information regarding the operation of the system should be obtained from the vendor or the vendor's agent. A licensed HVAC contractor should inspect the system and carry out any necessary repairs as required.

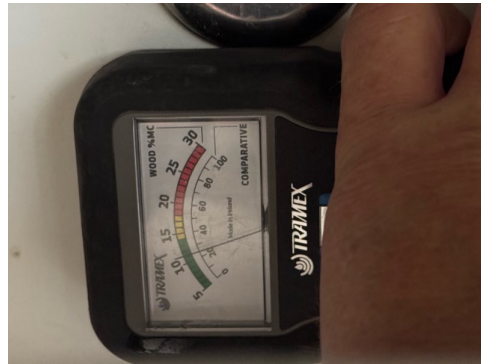
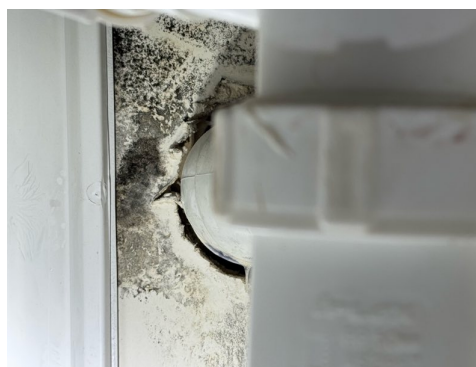
Building: Main Building
Location: Laundry
Finding: Mould - Present

Information: Where evidence of mould growth was noted, there may be environmental, biological or health issues associated with the report. A specialist inspection by a suitably qualified environmental health inspector is warranted, where mould is extensive or where any queries regarding air quality spores or other related issues apply.

Generally, the client is advised to ensure that the general environment is free of moisture and humidity to aid in the prevention of mould formation and development. Any mould found during the inspection should be cleaned immediately by a cleaning contractor or the homeowner as applicable.

Please note that severely affected building elements may require replacement by a registered builder or qualified carpenter.

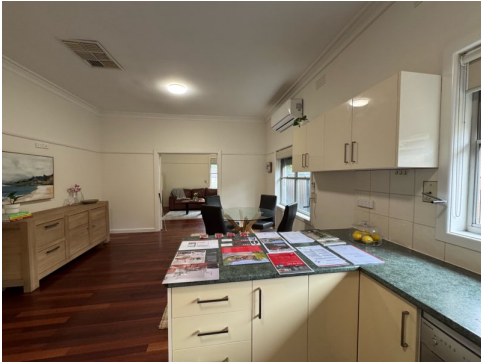
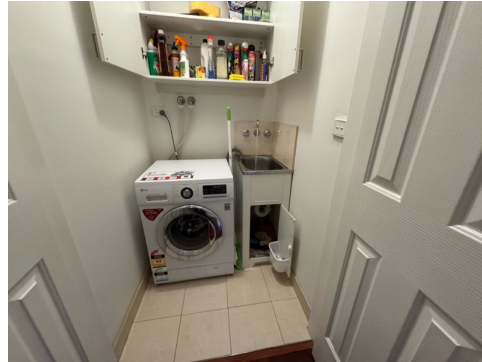
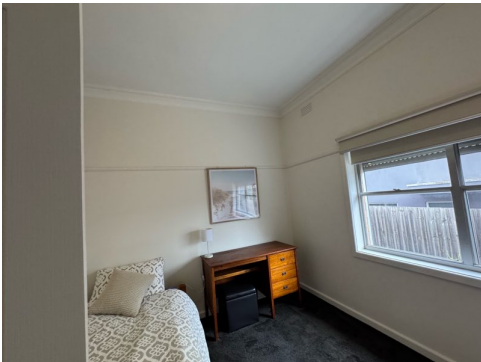
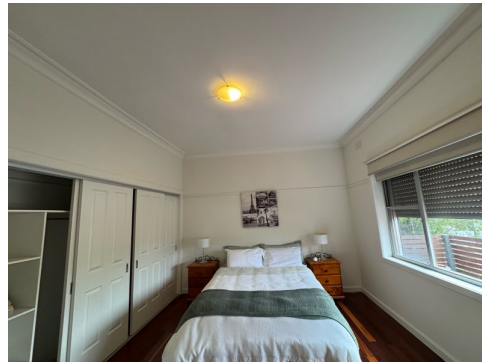
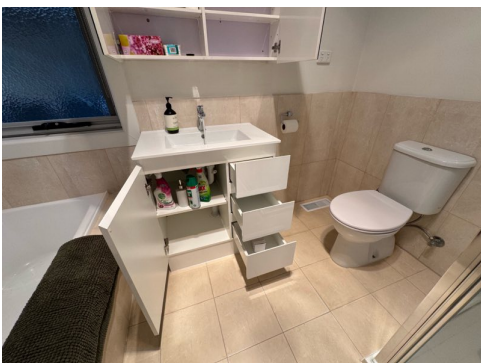
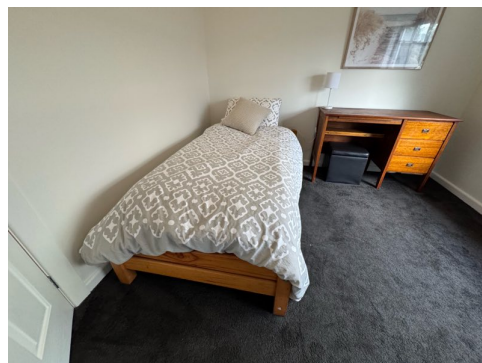
Information: These photographs are an indication of the obstructions and limitations which impeded full inspection of the property at the time of inspection. These obstructions can hide an array of defects and should be removed to allow full inspection to be carried out. A re-inspection is recommended once the areas are made accessible.

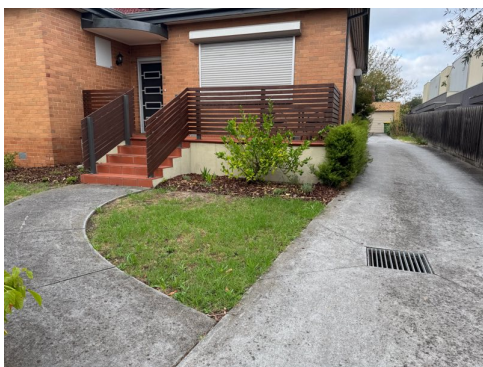
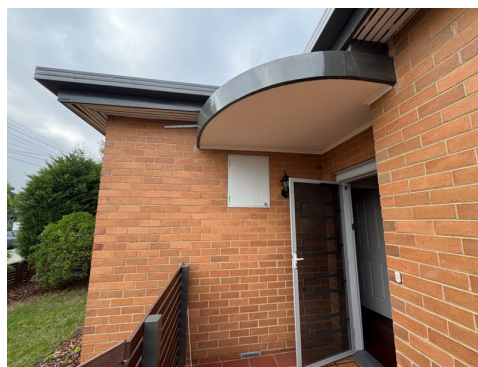
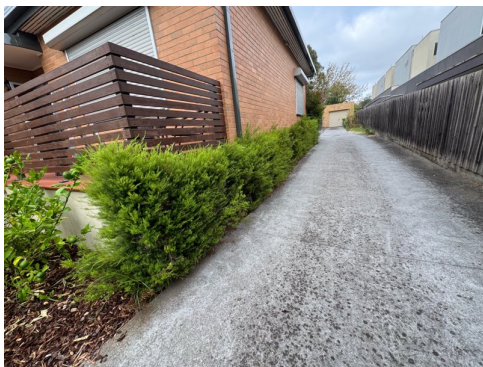
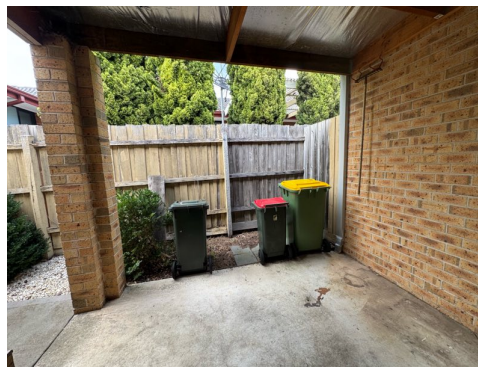
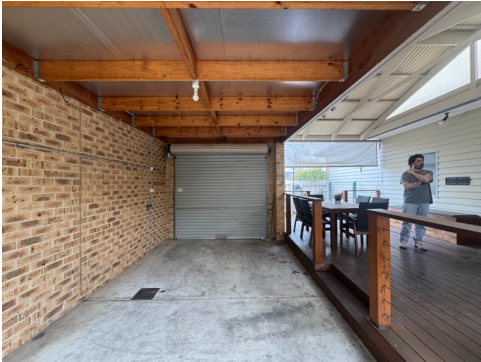
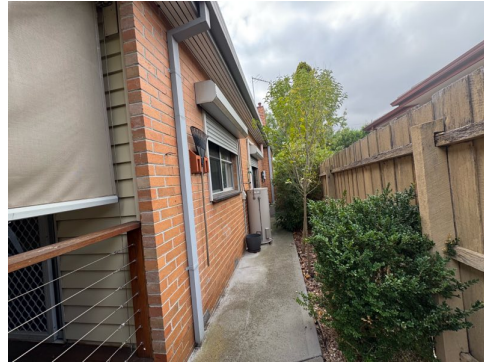
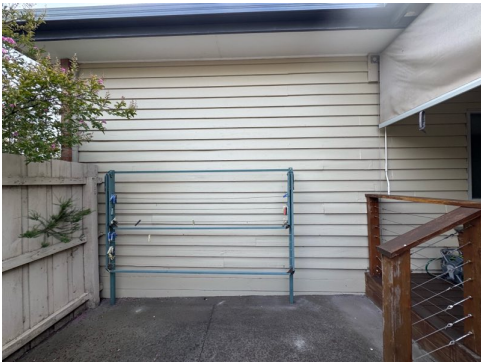
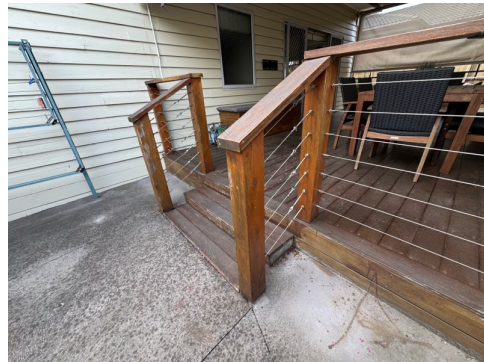
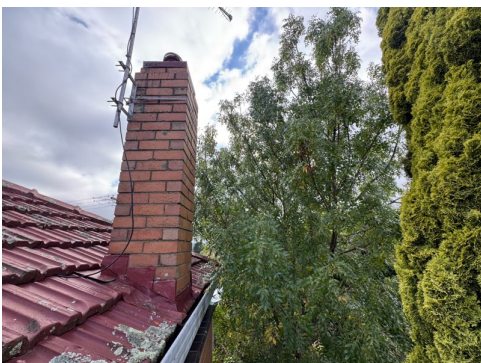
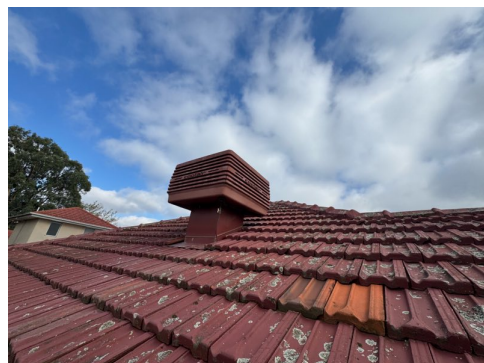
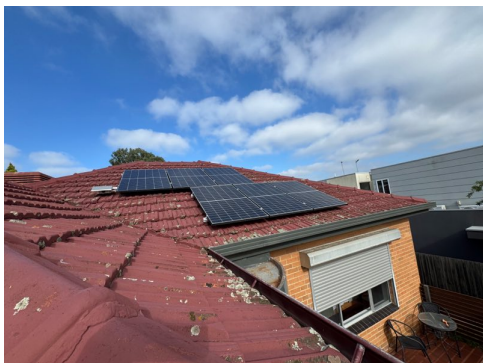
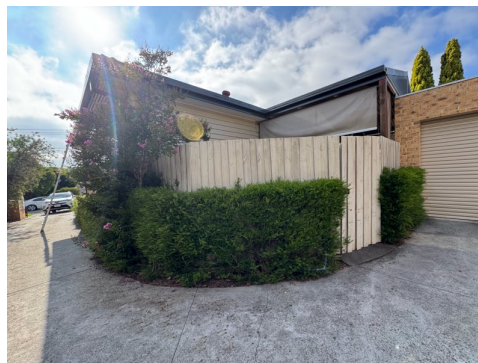
Finding: Additional Photos - Obstructions and Limitations

Information: These photographs are an indication of the obstructions and limitations which impeded full inspection of the property at the time of inspection. These obstructions can hide an array of defects and should be removed to allow full inspection to be carried out. A re-inspection is recommended once the areas are made accessible.

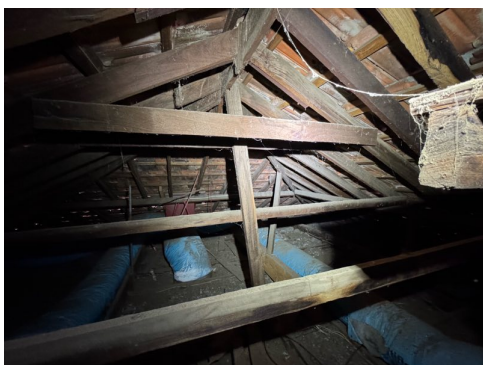
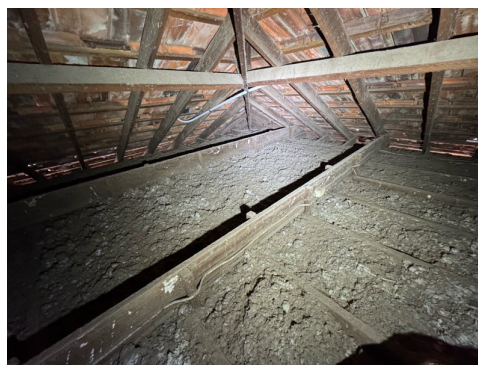
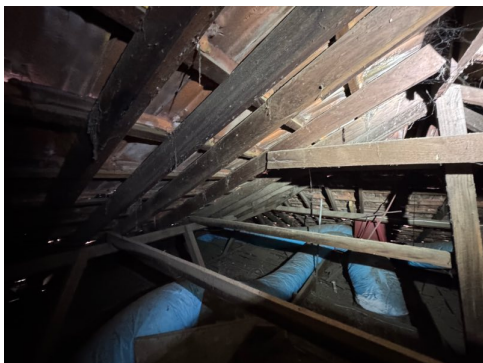
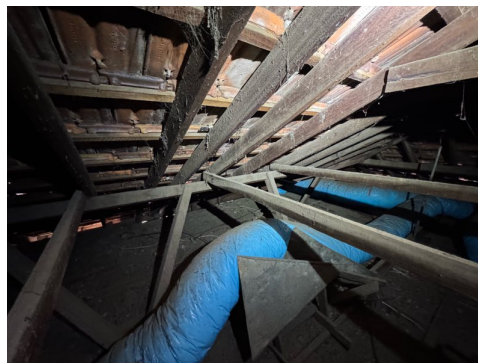
Finding: Additional Photos - Obstructions and Limitations

Information: These photographs are an indication of the obstructions and limitations which impeded full inspection of the property at the time of inspection. These obstructions can hide an array of defects and should be removed to allow full inspection to be carried out. A re-inspection is recommended once the areas are made accessible.

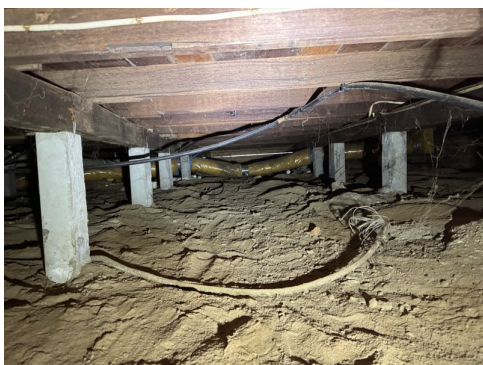
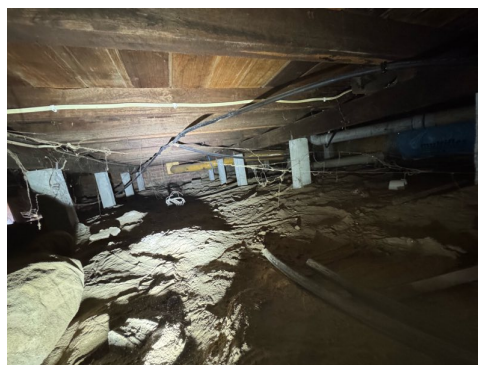
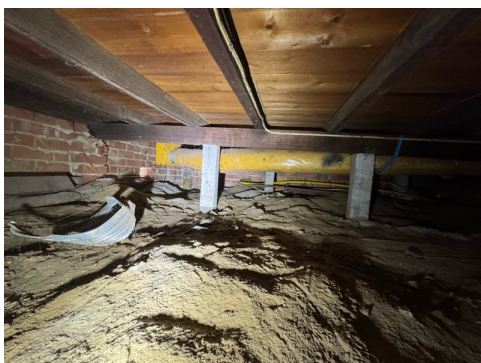
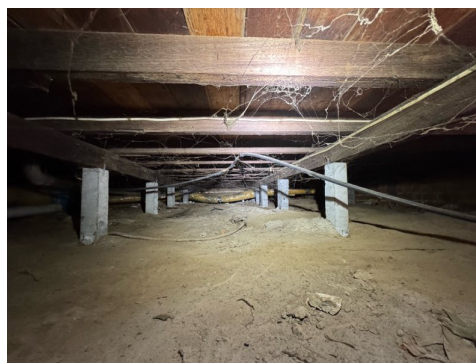
Finding: Additional Photos - Obstructions and Limitations

Information: These photographs are an indication of the obstructions and limitations which impeded full inspection of the property at the time of inspection. These obstructions can hide an array of defects and should be removed to allow full inspection to be carried out. A re-inspection is recommended once the areas are made accessible.

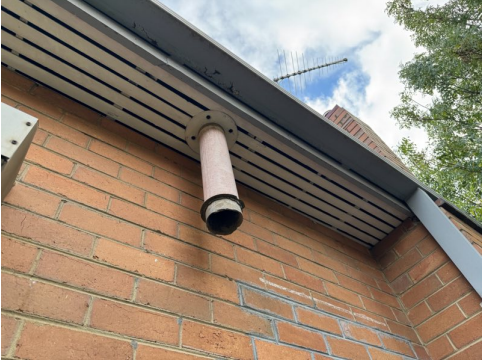
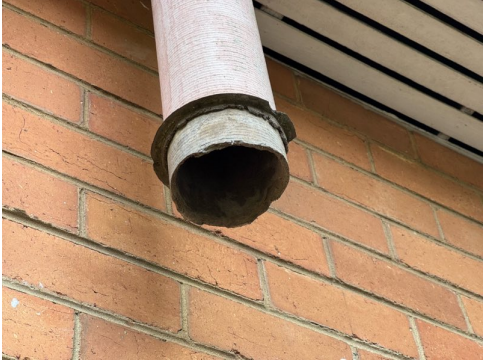
Information: Reporting on Asbestos is outside the Scope of this Report. This suspected defect is highlighted as a caution only. We suspect, based on our experience in the building industry, that there is a higher risk of the identified building element containing asbestos.

As Asbestos Reporting is outside the scope of this report, we advise that you consider a separate Asbestos Inspection and Condition Audit, which can include the taking of samples for definitive confirmation of the presence of Asbestos.

In the interim, the client is advised to act with caution, especially when considering any damage to building materials general wear and tear renovations extensions demolition and general maintenance activities due to the suspected presence of Asbestos.
