Building and Timber Pest Inspection Report

Inspection Date: Wed, 14 Jan 2026

Property Address: 6 Goddard St, Turrella NSW 2205, Australia

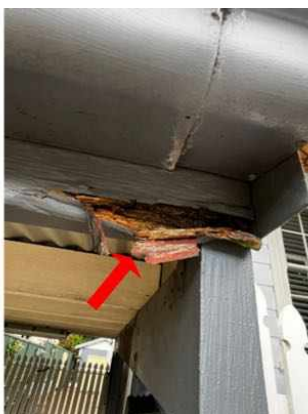
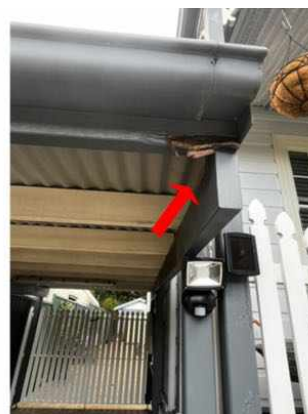
Building: Main Building
 Location: Carport
 Finding: Timber - exposed to weather
 Information: External timbers that are frequently exposed to harsh weather conditions require adequate protection in order to maintain their condition. Where timbers have not been painted or treated adequately, general deterioration is likely to occur at an accelerated rate.

If left unattended, replacement of these timbers is likely to be necessary in the short-term future. Adequate treatment of these timbers is required as soon as possible by a painting contractor or general handyman.

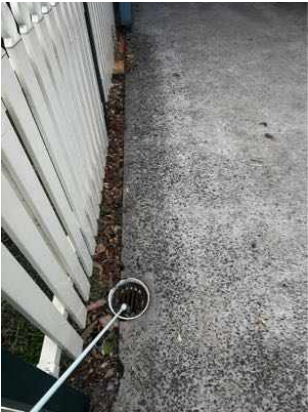
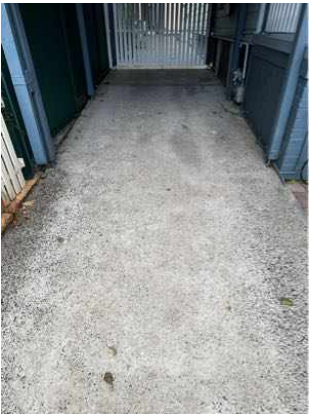
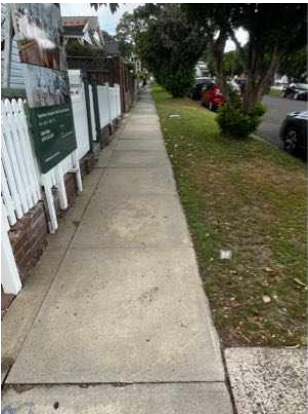
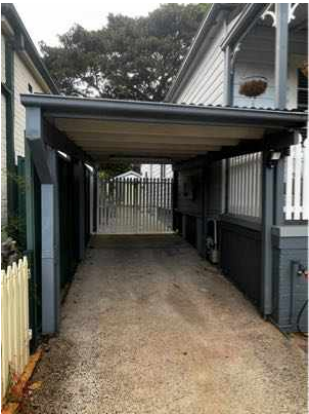
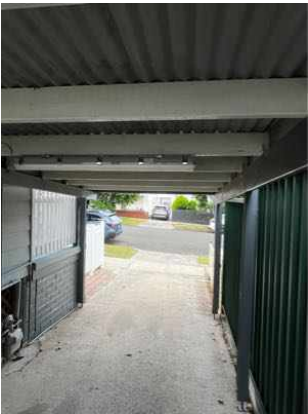
Finding 3.02

Building: Main Building
 Location: Driveway
 Finding: Crack in concrete slab - Category 2
 Information: A crack coded as Category 2 was identified in the slab. A Category 2 crack is described as a distinct crack, with the slab being noticeably curved or changed in level.

To be considered Category 2, the approximate width of the crack is less than 2.0mm, or a change in offset of less than 15mm when a 3m straight edge is placed over the defect.

Category 2 cracks to slabs should be monitored for a period of 12 months. At the end of the monitoring period, cracks rated greater than Category 2 are considered defects that require rectification.

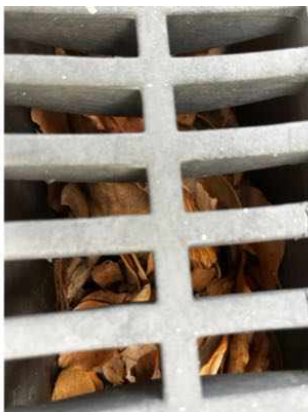
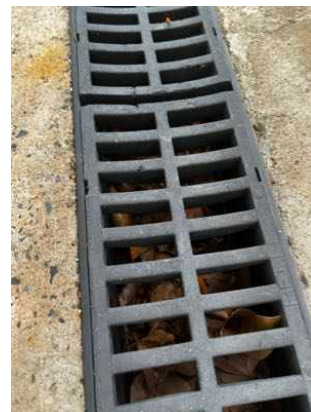
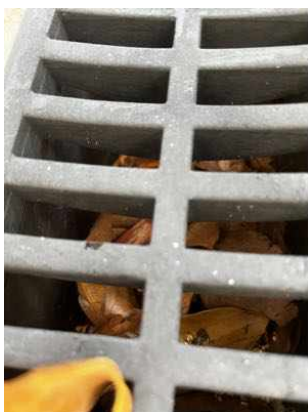
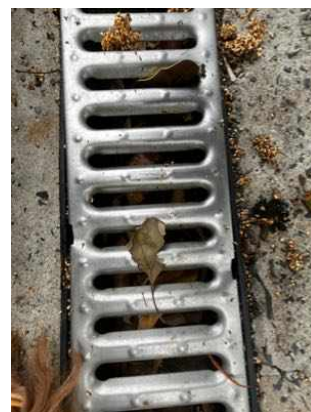
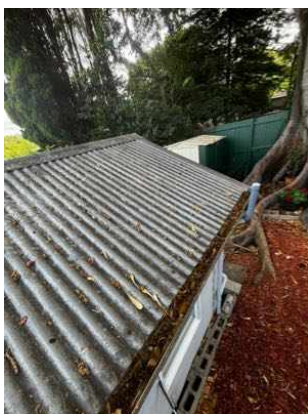
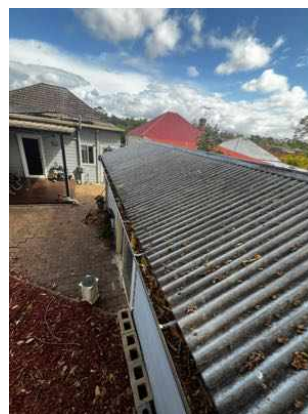
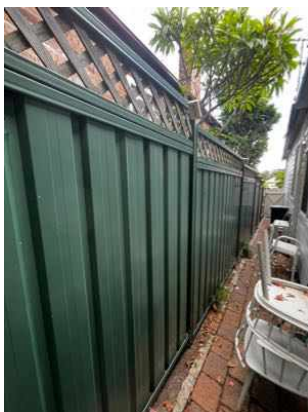
Finding 3.03

Building: Main Building
Location: All External Areas

Information: Water pooling happens in sections of the roof guttering and floor guttering too.. This is generally a secondary defect caused by blocked or partially blocked gutters. Such blockages and subsequent water pooling are likely to lead to rust and water damage to associated structures if left unattended.

The Gutter running at the back of the house roofline was not connected to a downpipe or a continues gutter from the colourbond roof. Hence water pouring from the gutter - show evidence.

Any areas of guttering that shows evidence of water pooling should be checked for partial or full blockages and any secondary damage that may have occurred as a result. Depending on the extent of the damage, building elements may require repair and/or replacement to ensure adequate roof drainage and function of exterior plumbing system.

A roofing plumber should be appointed as soon as possible to rectify this issue. It is highly advised that all gutters be maintained on a frequent basis to ensure the condition of roof plumbing.

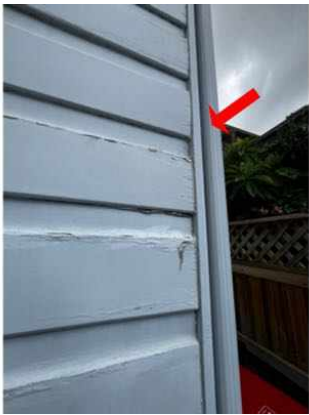
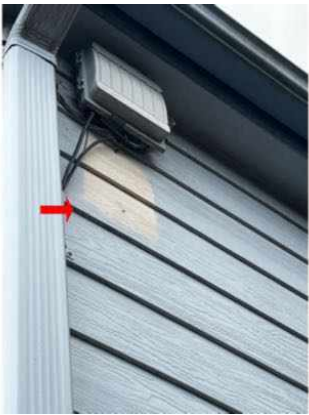
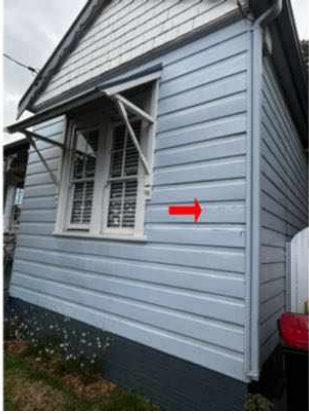
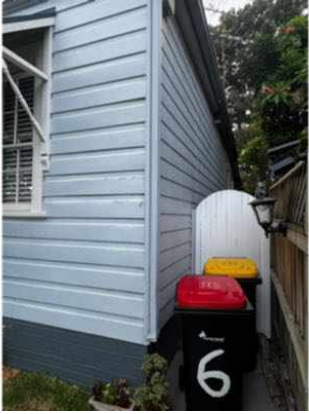
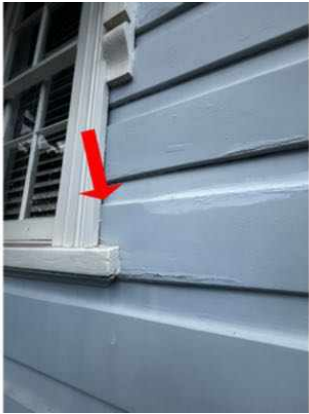
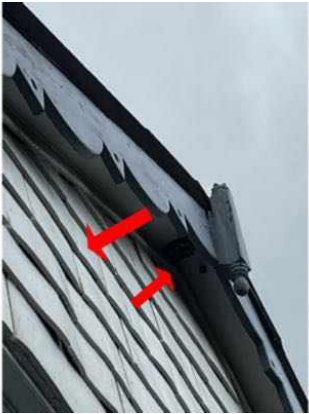
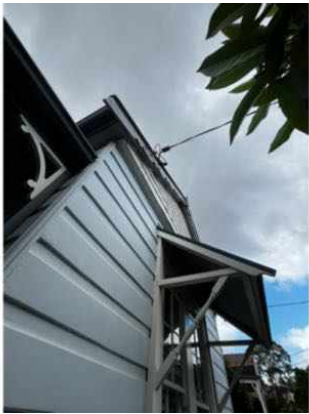
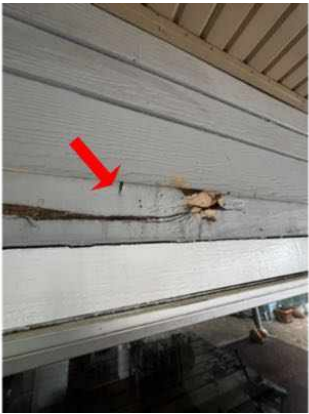
Finding 3.04

Building:	Main Building
Location:	All External Areas
Finding:	Weatherboards - Rotting
Information:	The external weatherboards show signs of (wood rot) in several sections. This wood rot is suspected to have developed over a prolonged period of time due to frequent weather exposure, which is expected in a property of this age and condition

Weatherboards are sealed and protected by paint and other sealants. When these sealants deteriorate over time, they allow water penetration to the weatherboards, causing wood rot. If left unmanaged, the wood rot is likely to develop further, possibly necessitating major repair or replacement works in the long-term future.

To maintain the condition of the external wall cladding, any severely affected weatherboards should be substituted as soon as possible with pre-treated replacements. Where weatherboards have rotted due to excessive moisture other than rain penetration, the cause of the moisture should be identified immediately by a licensed plumber. A qualified carpenter should be appointed to repair and replace rotting weatherboards.

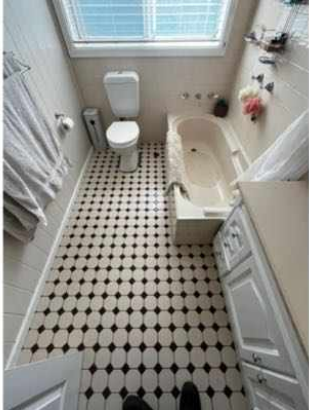
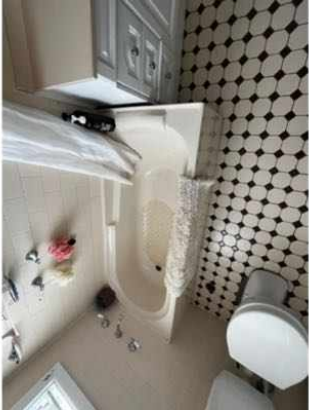
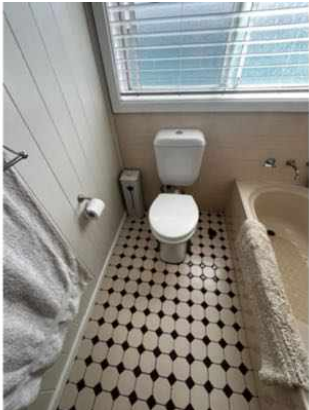
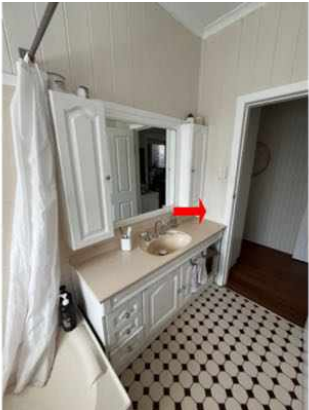
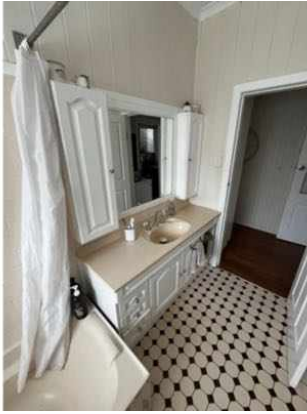
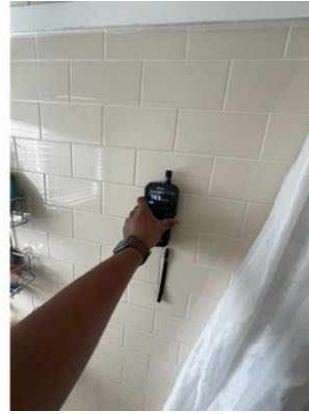
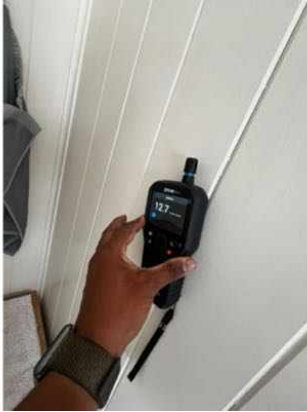
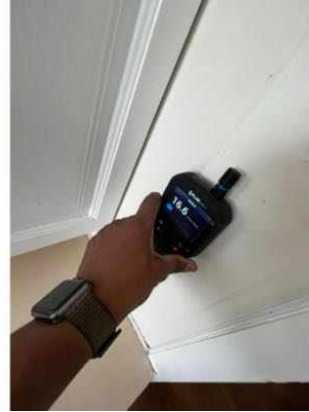
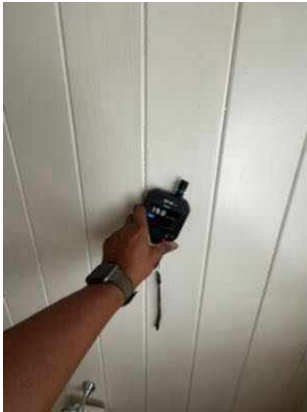
Finding 3.05

Building: Main Building
Location: Bathroom
Finding: Sealant application Required - Missing or damaged
Information: It was noted on inspection that sealant is missing in certain areas of the bathroom which are shown on the photos.

Different materials and floor areas move at different rates, generally causing cracking to grout or sealant at this point. A flexible sealant is required to allow for expected expansion and contraction, while keeping the joint water tight and protective of all associated building materials.

A sealant specialist or tiling contractor should be appointed to complete these works as soon as possible.

Kindly also check all plumbing fittings and connections by a licensed Plumber before handover.

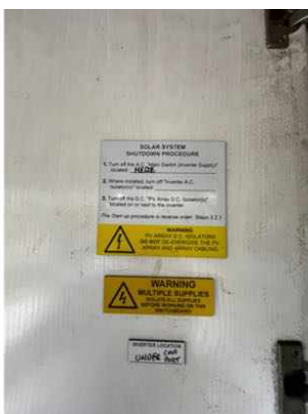
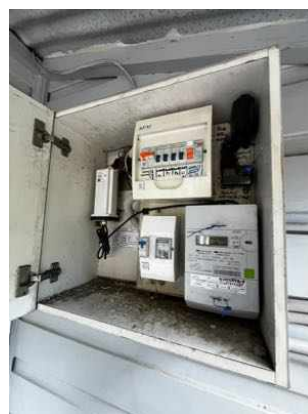
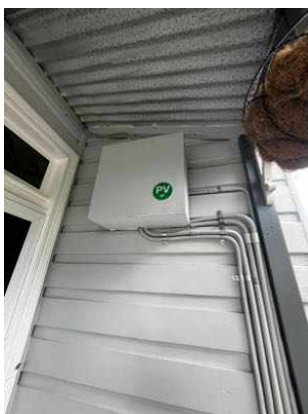
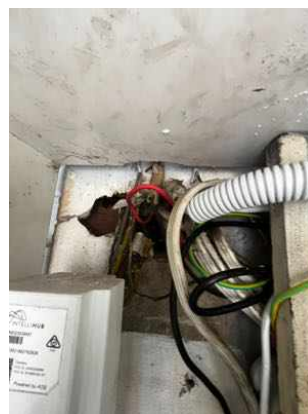
Building:	Main Building
Location:	Electrical Switchboard
Finding:	Termite Management System - no evidence of a chemical installation no Durable Notice
Information:	The application of a post-construction chemical termite barrier is highly recommended for all properties, particularly if live termite activity has been found on the site previously. Such barriers are highly effective in preventing termite attack on any timber building elements throughout the property.

A durable notice should be placed in the switchboard unit to indicate current termite barriers. At the time of inspection, it appeared as though no termite management system has been installed, with no evidence to suggest preventative works taking place.

The client may consider gaining further advice from a pest controller as to the costs and procedures involved with this application. It is recommended that obtaining such advice be a short-term priority.

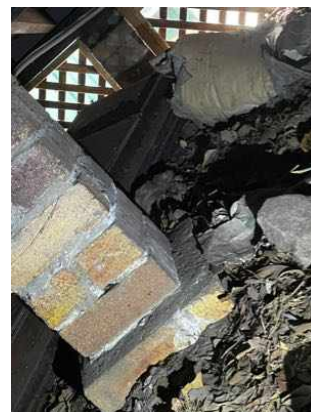
Finding 6.02

Building:	Main Building
Location:	Subfloor
Finding:	Subfloor - / Obstructions and limitations - No Access

Antcaps missing on top of Brick stumps.

The storing of timbers/ Other items/ Ducting/ Pipes/ Services/ Electrical Wiring in the subfloor space or around the external property increases the risk of termite activity being present. As they are likely to come into contact with weather conditions or excessive moisture wood rot is likely to develop on timbers that are not treated.

It is highly recommended that any stored timbers be immediately removed from areas in which they may attract any termite / timber pest attack. Minimisation of risk / prevention of termite attack is far more adequate than dealing with the presence of termite activity.

These obstructions can hide an array of defects and should be removed to allow full inspection to be carried out. A re-inspection is recommended once the areas are made accessible.

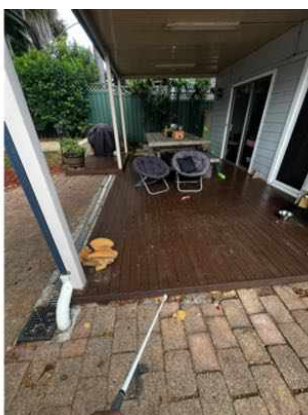
Finding 6.05

Building:	Main Building
Location:	Studio- Back
Finding:	Water pooling - against property
Information:	Water appears to be pooling against the house. It is suspected that this is a result of poor site drainage but may also be due to excessive moisture from an unidentified source.

Where water is pooling against the house water damage to the external wall cladding is imminent.

Such water pooling also increases the risk of termite activity and the development of fungal decay in the area.

Consult a Licensed Plumber regarding the cost of potential site drainage rectification works.

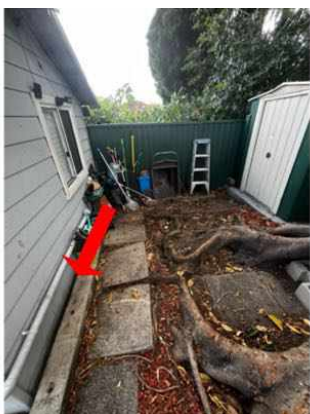
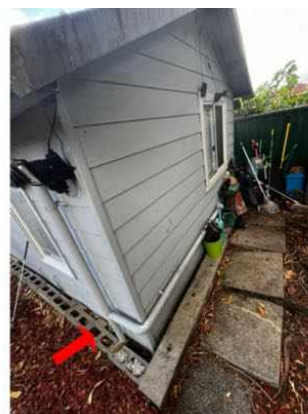
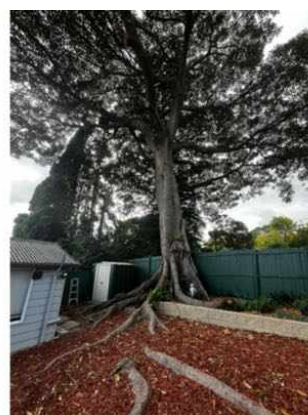
Finding 6.06

Building:	Main Building
Location:	All Areas
Finding:	Building materials in direct ground contact - conducive to termites
Information:	Where timber elements are in direct contact with the ground and consequently moisture or dampness they become conducive to termite activity. Whether timber is used as a building element part of a fencing structure or stored as an unused item they can provide an environment that is attractive to termite infestation.

When met with excessive moisture timber begins to decay and develop wood rot. Any timbers that are in direct contact with external grounds especially if left untreated or non-durable also provide ingress for subterranean termites into that particular element.

The removal of any such materials and timbers stored that may be conducive to termite activity should be removed as soon as possible to minimise the risk of termite attack.

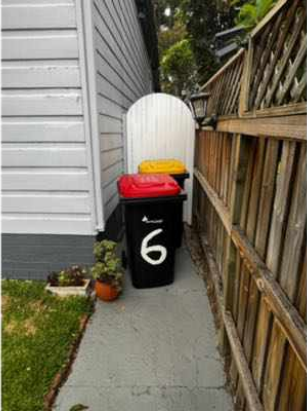
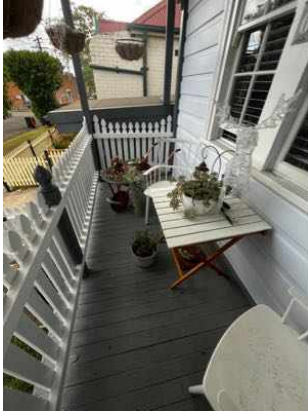
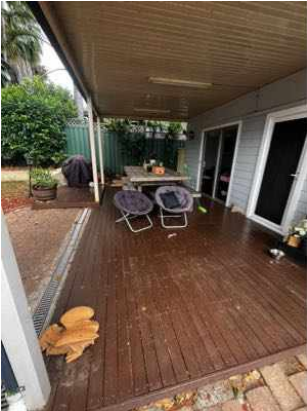
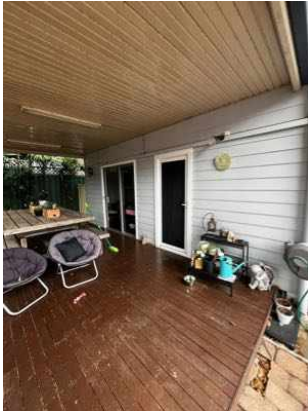
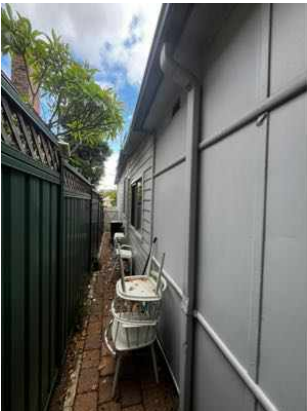
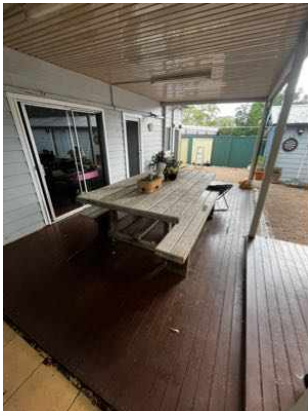
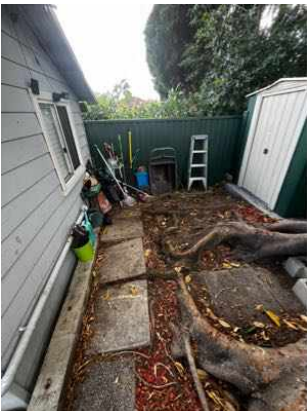
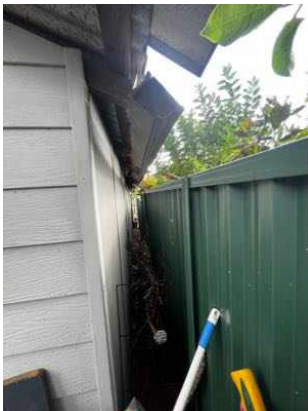
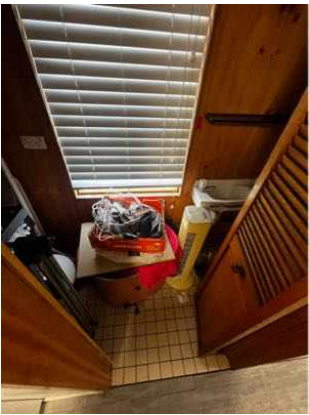
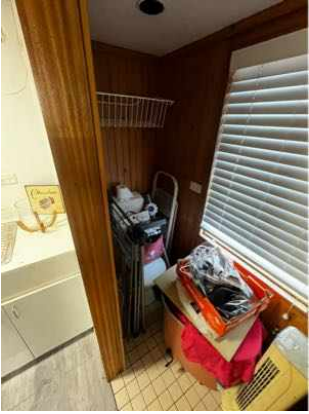
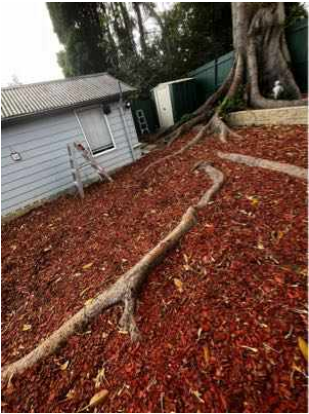
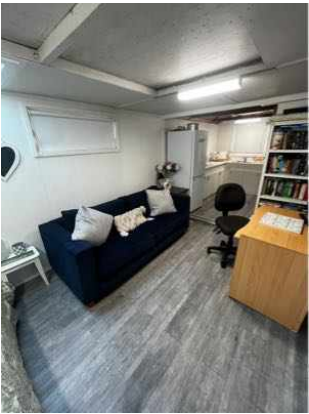
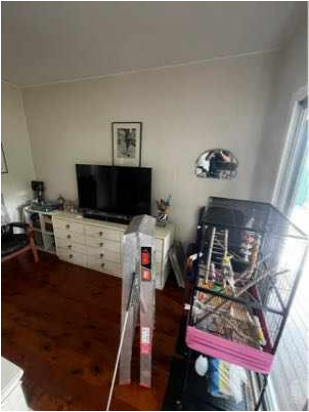
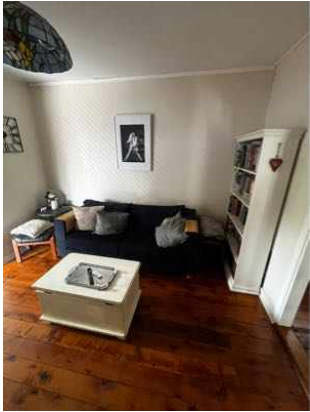
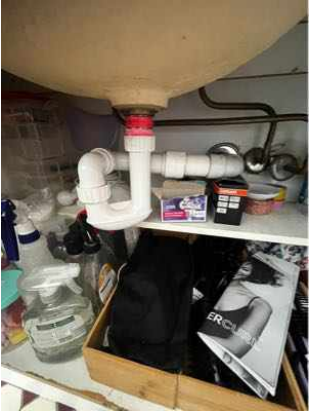
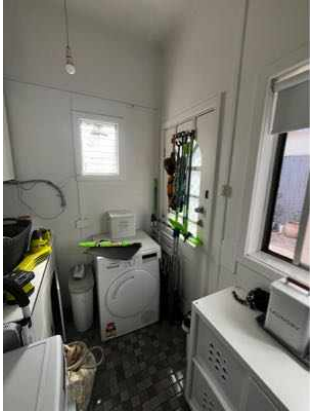
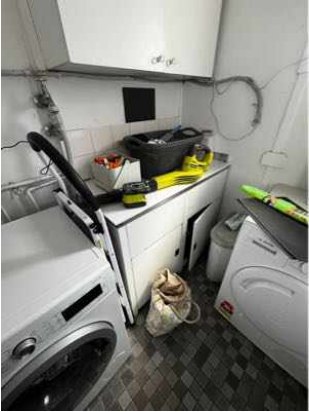
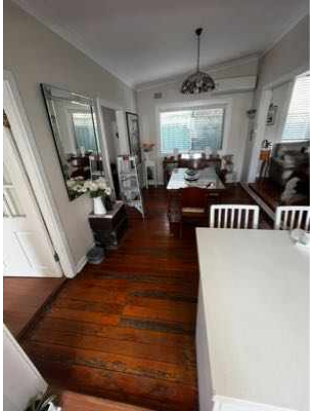
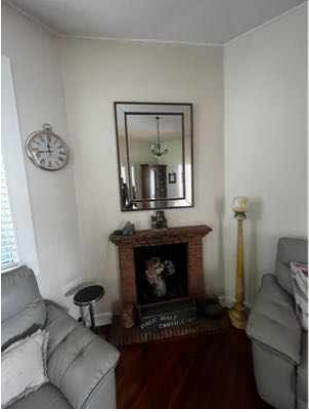
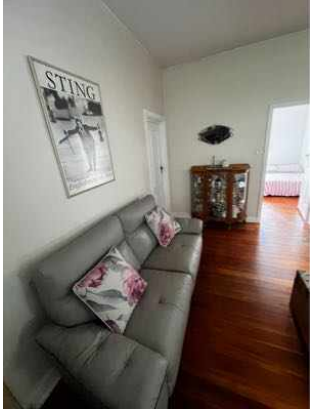
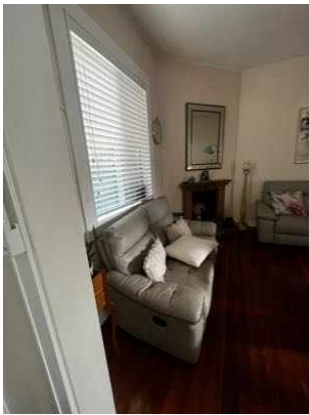
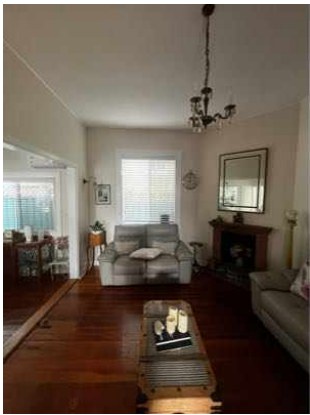
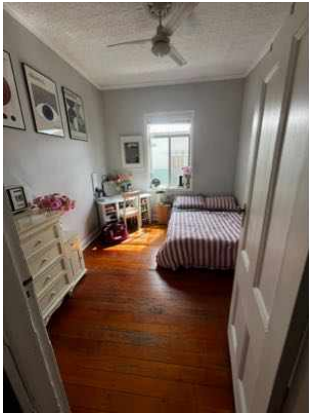
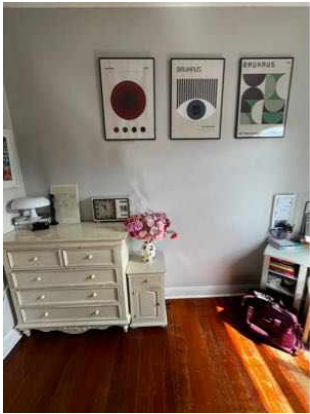
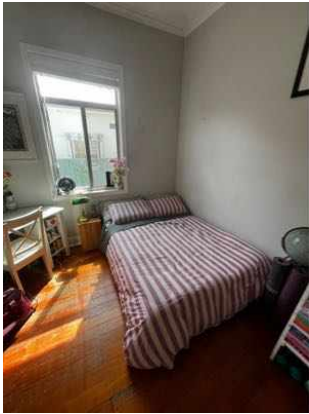
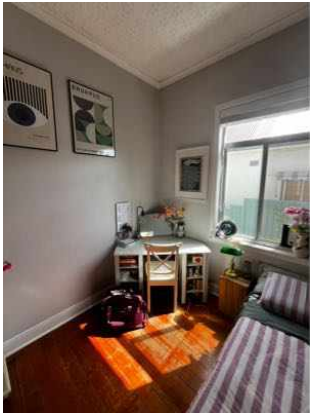
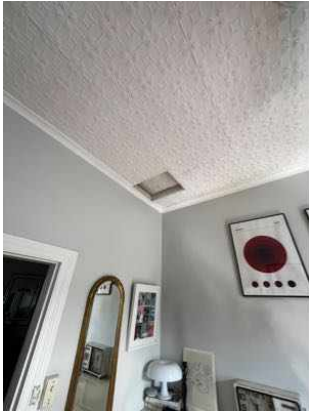
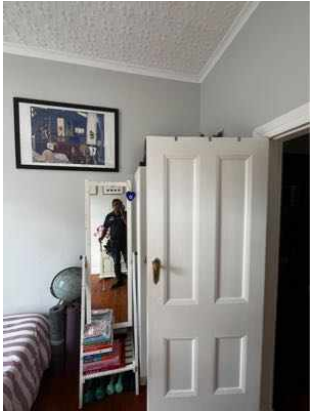
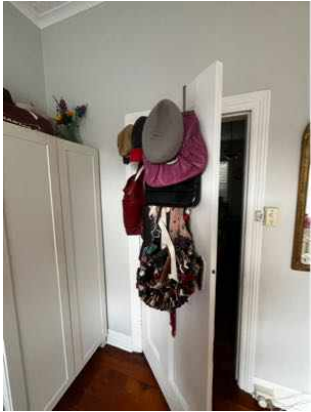
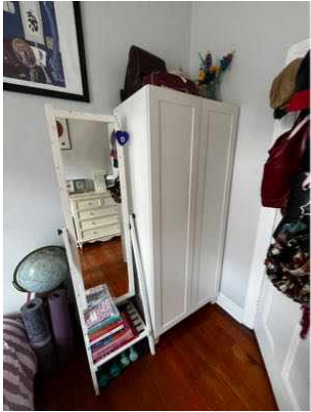
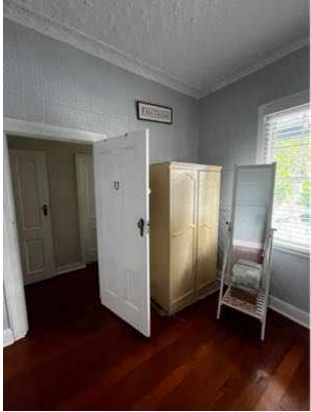
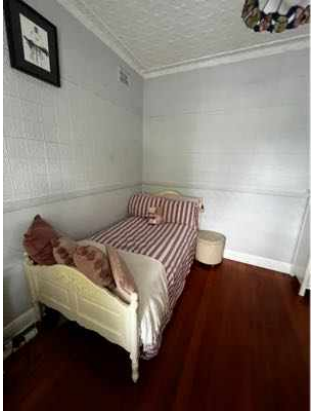
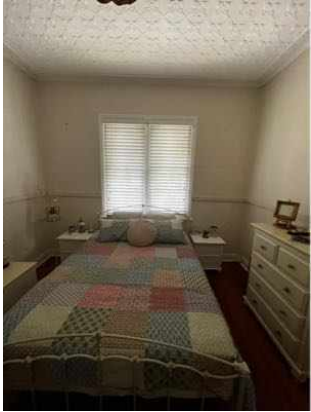
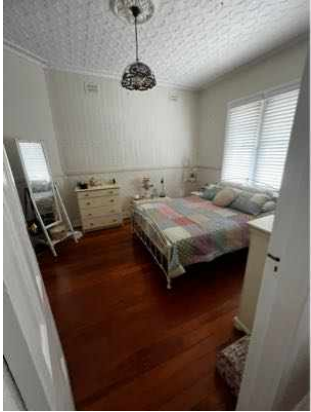
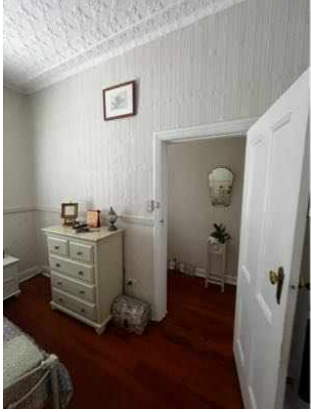
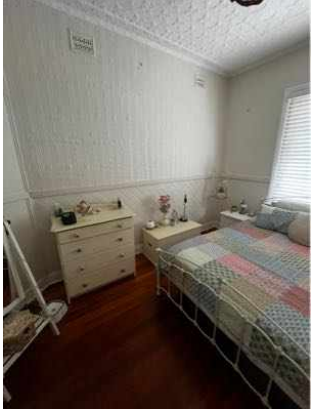
Finding 6.08

Building: Main Building
 Location: All Areas
 Finding: Additional Photos - Obstructions and Limitations
 Information: These photographs are an indication of the obstructions and limitations which impeded full inspection of the property at the time of inspection. These obstructions can hide an array of defects and should be removed to allow full inspection to be carried out. A re-inspection is recommended once the areas are made accessible.

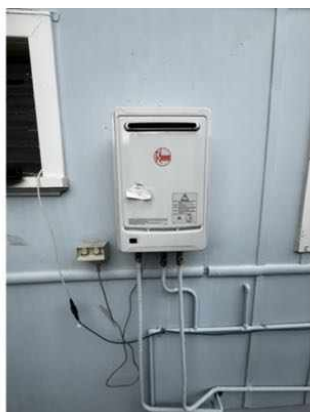
Building: Main Building
 Location: Laundry
 Finding: Hot Water Unit
 Information: The HWS appeared to be working in good condition during the inspection.

Water pressure appears to be normal, however, this is not an opinion of a licensed plumber.

Water hammer was not noted when taps are turned off fast in the Kitchen and Vanity area.

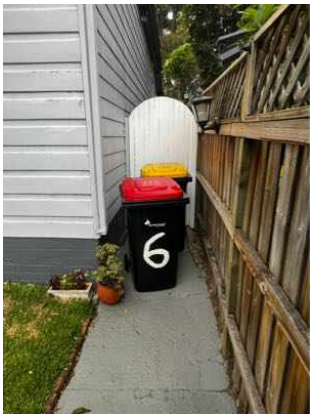
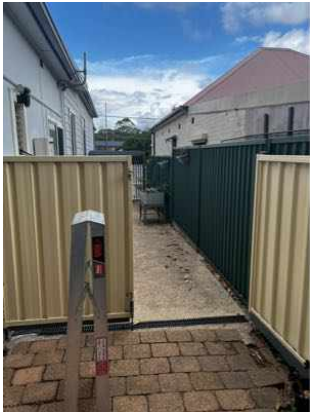
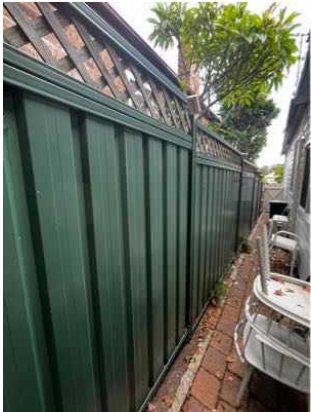
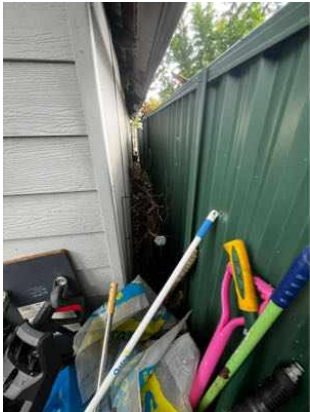
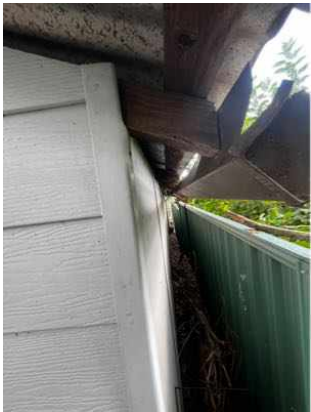
Building: Main Building
 Location: Yard
 Finding: Perimeter Fencing - Timber fence/ Colourbond Fence
 Information: For your information photos taken at the time of inspection - During the inspection the Colourbond fence was inspected and found minor defects/ dents, deterioration but the fence at the back of the property Timber fence inspected.

Please appoint a fence installer to inspect and rectify the same at buyers convenience.

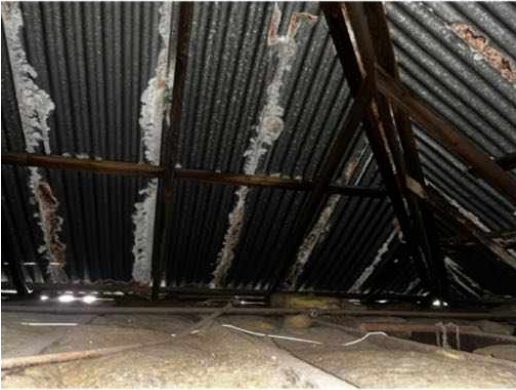
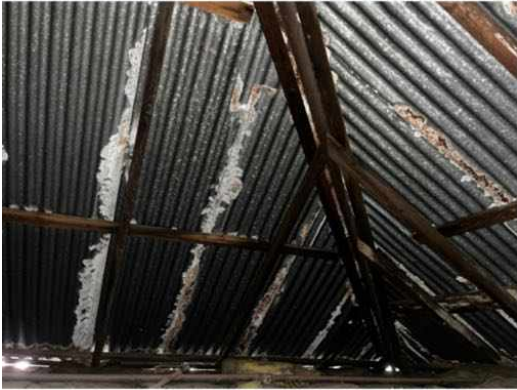
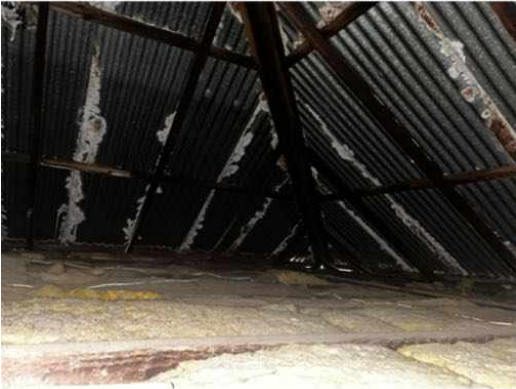
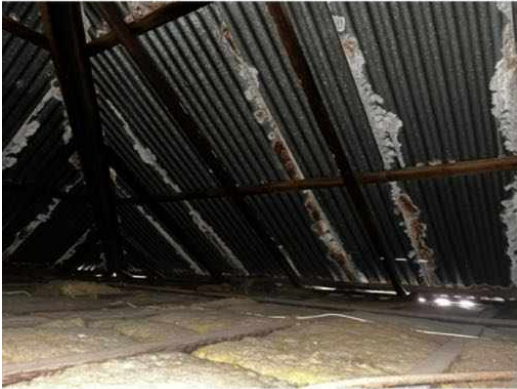
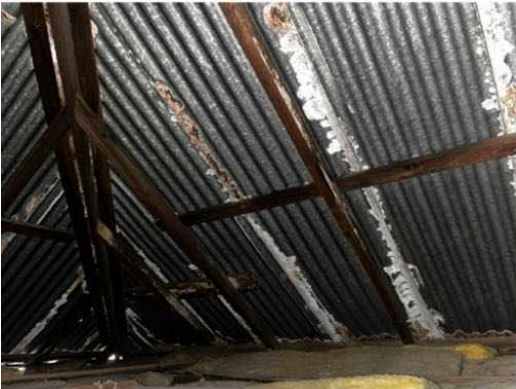
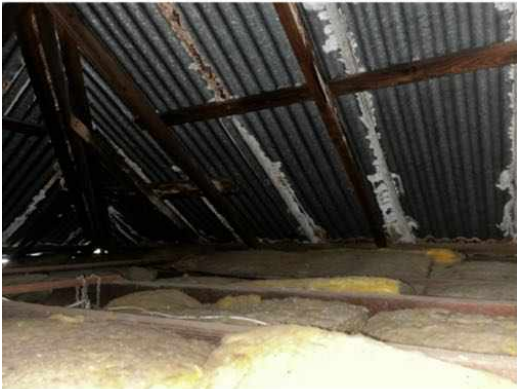
Building: Main Building
 Location: Roof Void
 Finding: Obstructions and Limitations - Roof space
 Information: These photographs are an indication of the obstructions and limitations which impeded full inspection of the Roof Space/Void at the time of inspection such as Stored items, Skylight tubes, Electrical wires , insulation and cross beams, rafters, low clearance as of the pitch in the roof.

A re-inspection is recommended once the areas are made accessible.

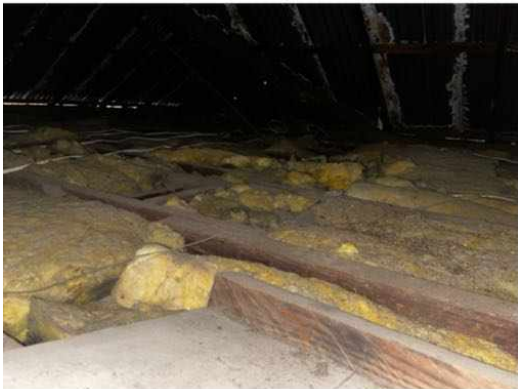
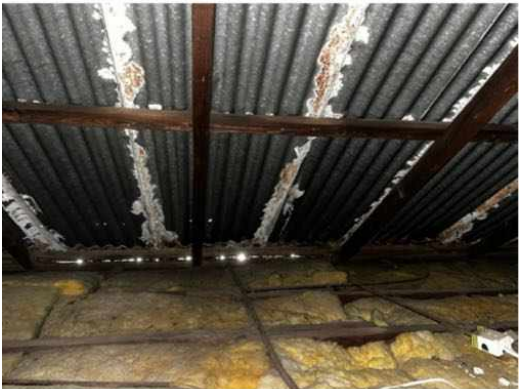
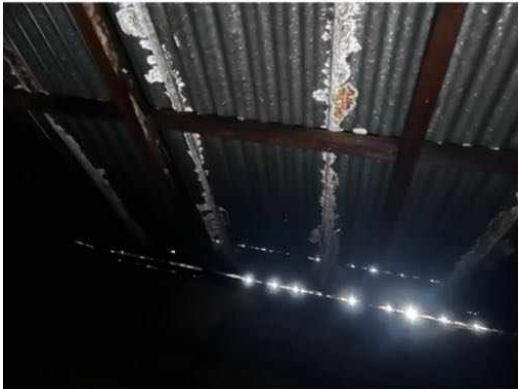
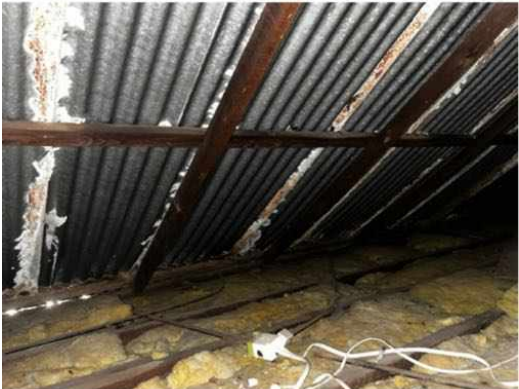
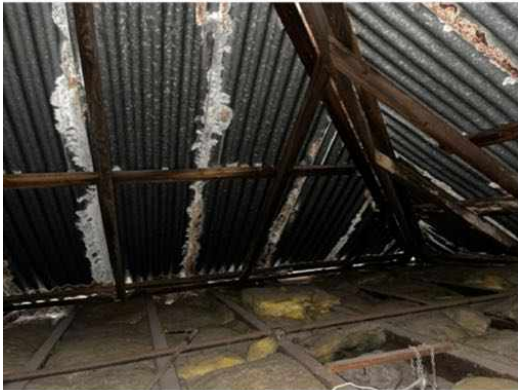
Signs or Rust in the roofing sheets are visible during inspection. For a longevity of the structure and the property the buyer can consider replacing the rusted sheets if preferred.

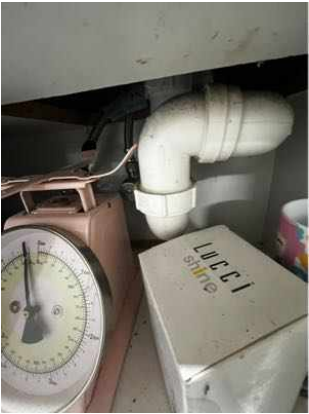
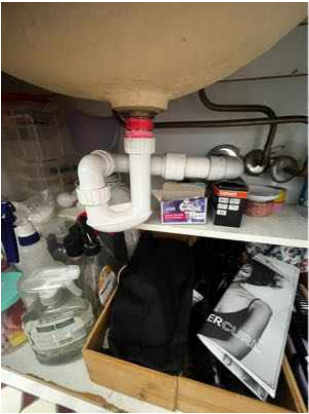
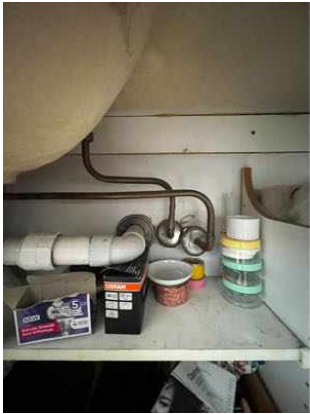
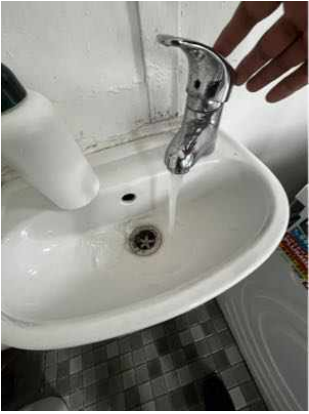
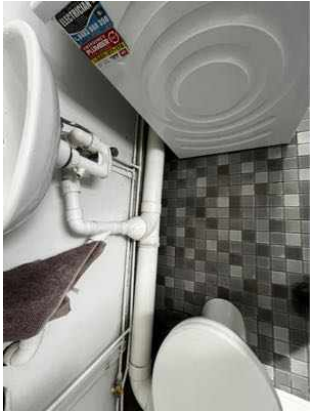
Building: Main Building
Location: Kitchen/ Laundry Bathroom
Finding: Cabinetry Plumbing - Kitchen/ Laundry/Bathroom
Information: All cupboards where sinks and basins with drainage plumbing were inspected and no evidence of leaks were present at the time of inspection.

For your information only no remedial works are required at the time of inspection.

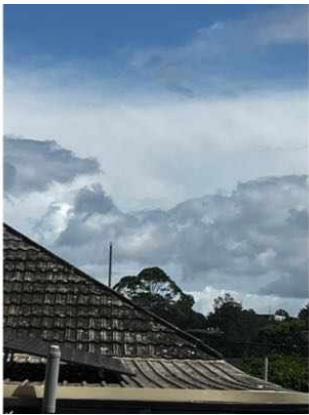
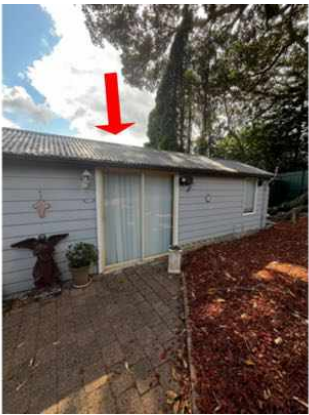
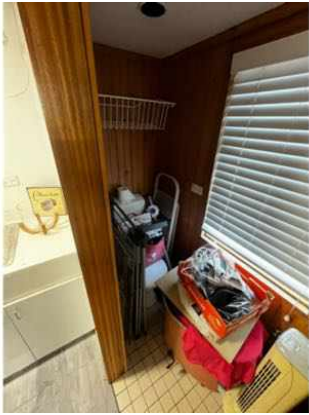
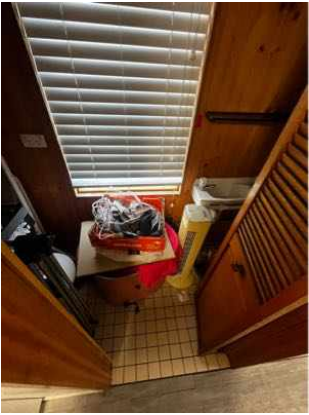
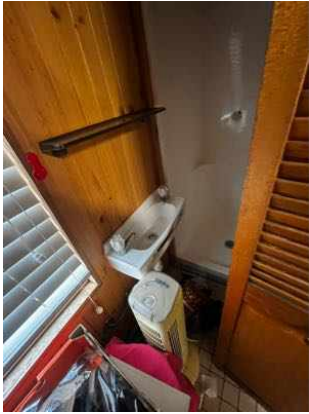
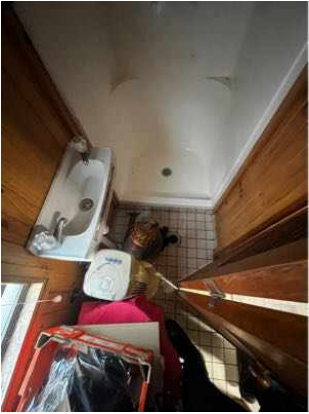
Building: Studio
 Location: All Areas
 Finding: Additional Photos - Obstructions and Limitations
 Information: These photographs are an indication of the obstructions and limitations which impeded full inspection of the property at the time of inspection inside the studio.

These obstructions can hide an array of defects and should be removed to allow full inspection to be carried out. A re-inspection is recommended once the areas are made accessible.

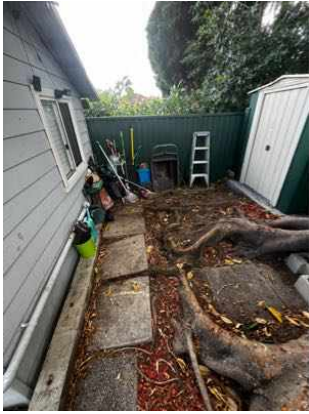
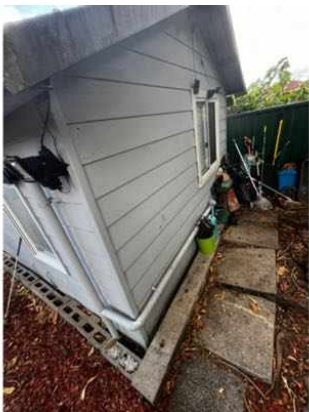
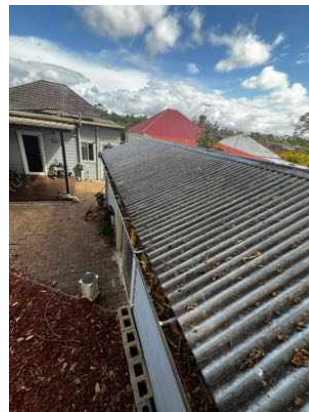
Building: Studio
 Location: Studio
 Finding: Garage converted to Studio Additional structure - Non-compliant - Check
 Information: The additional structure that has been affixed to this area of the dwelling does not appear to comply with contemporary building practices and current Australian Standards. While the structure does not currently appear to be unsafe, compliance with such standards ensures the structural integrity of the main dwelling and abutting addition.

As building standards have not been followed, this area provides a heightened risk of the development of building defects. The structural integrity of the area may have been compromised, which creates potential for the development or presence of major safety issues.

It is highly recommended that any planned repair, remodeling or demolition works be carried out by registered builders. Such works may be necessary in the short-term future to ensure the safety and functionality of the area.
