Building and Timber Pest Inspection Report

Inspection Date: Fri, 30 Jan 2026

Property Address: 7A Malpas St Rostrevor

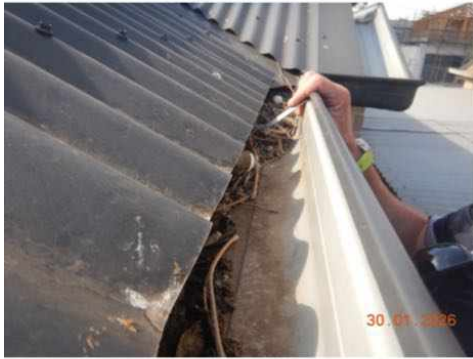
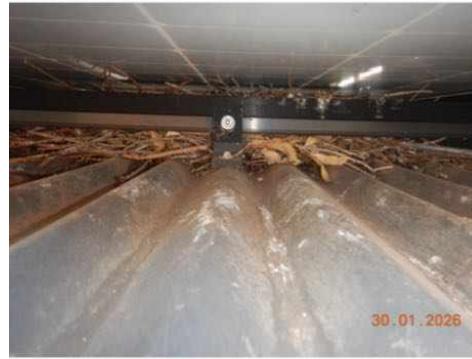
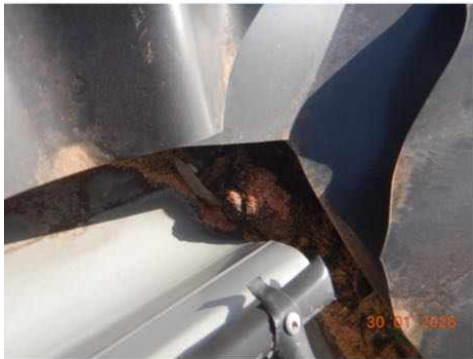
Blocked gutters are likely to lead to high levels of moisture in the affected areas. Such moisture will not only cause rust and decay of the associated building materials, but can also provide conditions that are conducive to termite and timber pest activity. Blockages in gutters should therefore be removed immediately to ensure dry conditions are maintained.

Removal of debris may expose currently concealed defects.

Consult a Licensed Plumber for further specific advice on remedial works that may be required. In the interim, it is highly advised that blocked gutters be removed by the homeowner or a general handyperson as a matter of urgency. Bird proofing the solar panels should be considered also.

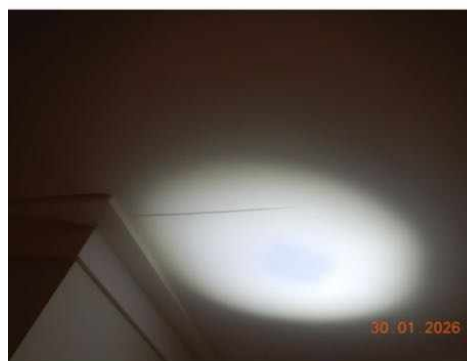
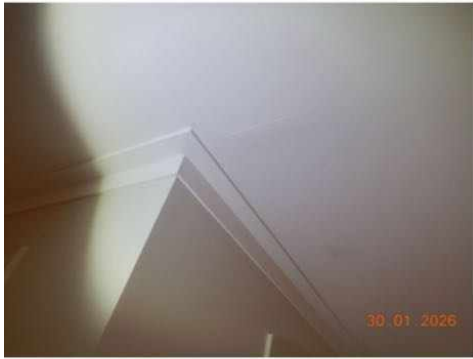
Building: Building 1
Location: Kitchen
Finding: Cracking - Damage Category 1 - Fine (up to 1mm)
Information: There were fine cracks evident to the ceiling adjacent to the kitchen at the time of inspection.

Although fine cracks are quite noticeable, they are often only considered to be an appearance defect, and usually do not indicate any structural damage. Generally, the cause of a fine crack is indicative of a separation between building materials and finishes (e.g. paint, plaster, etc.) along joints.

It is likely that the ceiling is cracking in this area due to inadequate control joints installed to the kitchen which should be installed for any Plasterboard lining over 12 m in length

Cracking of this nature can generally be repaired with minor sanding, filling and/or repainting. Such works should be performed by a qualified painter or a general handyman.

A licensed Plasterboard contractor should be appointed to install articulation joints to the ceiling to prevent further movement.

Monitoring of all cracking should be conducted frequently. Always contact a building inspector should cracks widen, lengthen, or become more numerous.

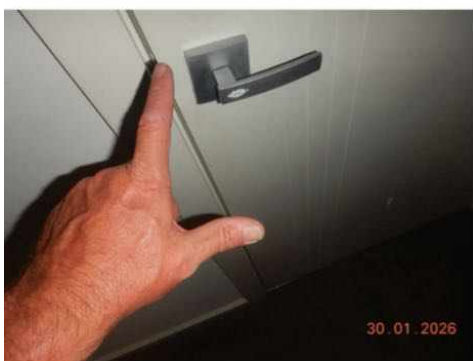
Finding 3.03

Building: Building 1
Location: All Areas
Finding: Minor defects present
Information: There were several age and maintenance related defects evident to the dwelling at the time of inspection. These defects include but are not limited to

- Many Door handles are loose.
- Front window requires paint
- PVC to rain water tank requires paint as it is not UV rated.
- Solar panels require clean

Appropriate licensed trades people could be appointed to make repairs at the discretion of the client.

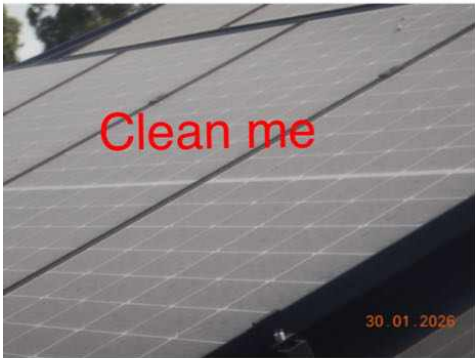
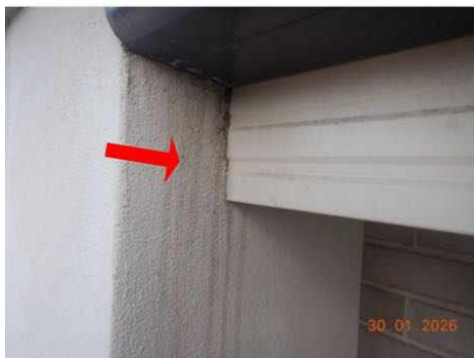
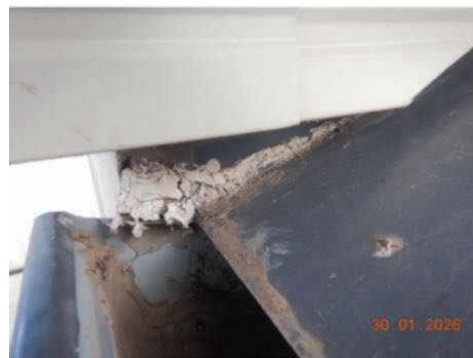
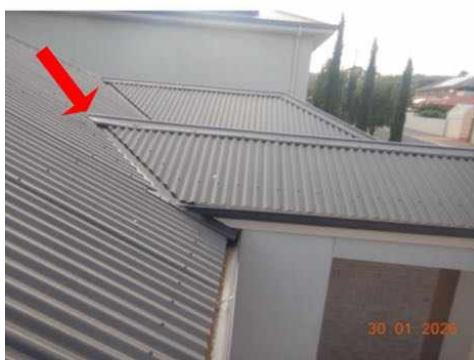
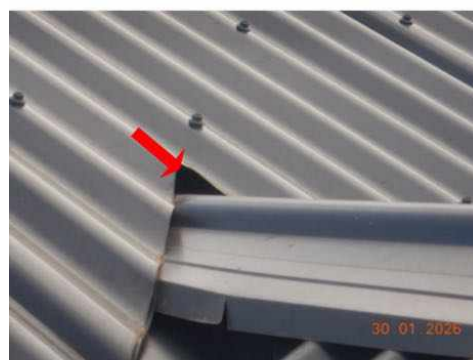
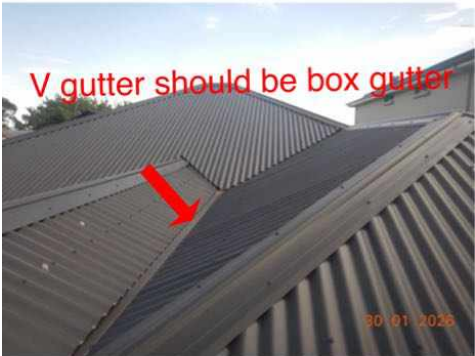
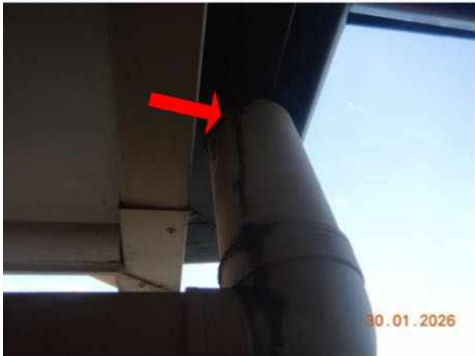
Finding 3.04

Building: Building 1
Location: Roof Exterior
Finding: Plumbing issues.
Information: All roof plumbing should to be maintained in good order.

Several roof plumbing Issues noted by the inspector include but are not limited to

- Leak to downpipe
- Gap to front section of roof potentials leak or vermin entry point.
- There is a v gutter placed at the front section of roof which are not acceptable practice and should be a box gutter. Should be closely monitored and cleaned regularly.

It is highly recommended that the client makes contact with a licensed plumber to make required investigations and adjustments prior to any further secondary defects being created.

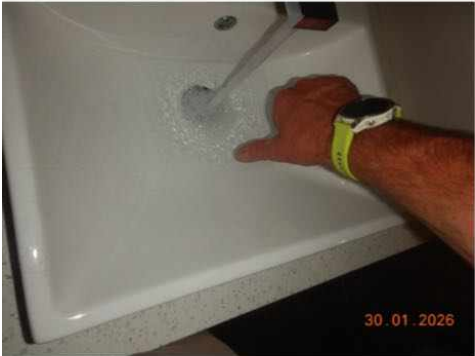
Finding 3.05

Building: Building 1
Location: All Internal Areas
Finding: Plumbing - Drain plug defective
Information: The drain plugs to the bathroom hand basins appeared to be inoperable at the time of inspection requiring maintenance or repair.

Degraded drain plugs can create issues with regard to functionality and should be addressed to bring the basin back to an operational stage.

A licensed plumber should be appointed to repair or replace the drain plugs at the discretion of the client.

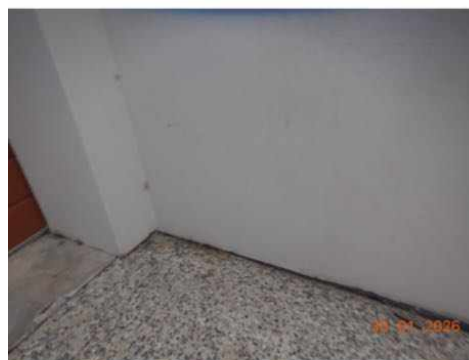
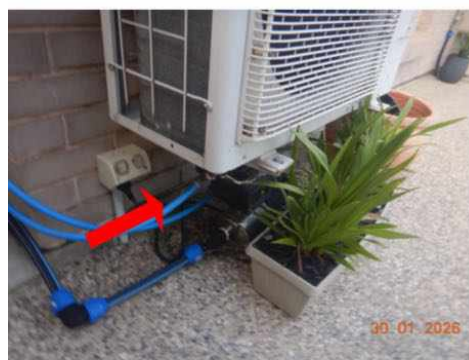
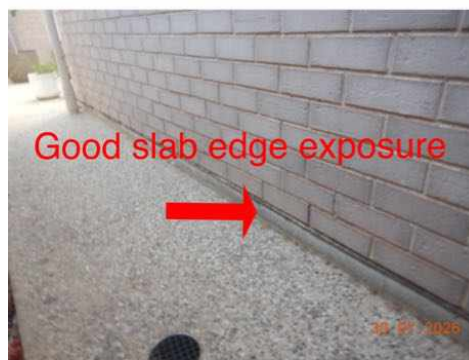
If the slab edge is not properly exposed there is a high risk of concealed termite attack which your inspector will likely not be able to see. Sometimes, in order to determine the type of slab, a suitably qualified person such as an architect or builder may be required to consult construction plans.

Where the slab edge cannot be properly inspected, it is highly recommended that termite or timber pest inspections be carried out every 6-12 months to aid protection of the property against infestation and termite treatment advice is followed closely.

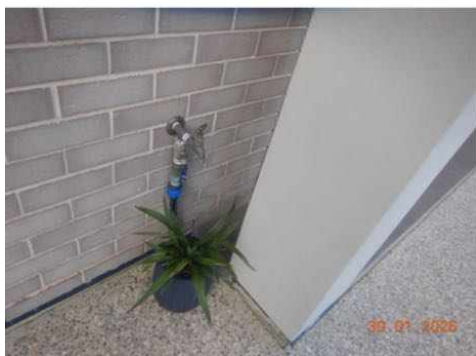
Finding 6.02

Building: Building 1
 Location: Yard - Side
 Finding: Air conditioner and or external tap - No drainage
 Information: Moisture around the perimeter of the building should be minimised to ensure that the area is kept dry and stable which in turn reduces the risk of water damage and termite infestation.

There appears to be no drainage points set up to the air conditioning unit, and or the external tap. While this is not a legal requirement it is recommended to reduce the risk of moisture related issues and the creation of an environment conducive to termite activity.

It is recommended that a licensed plumber be appointed to set up drainage in order to prevent such an environment from being created.

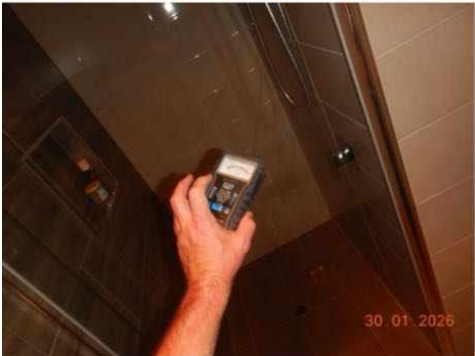
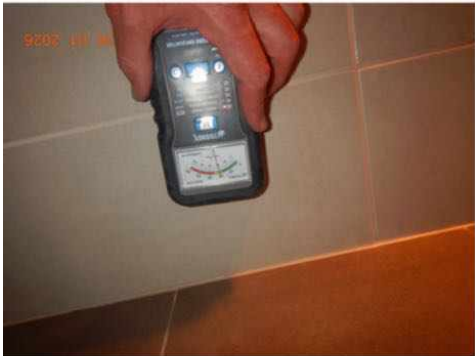
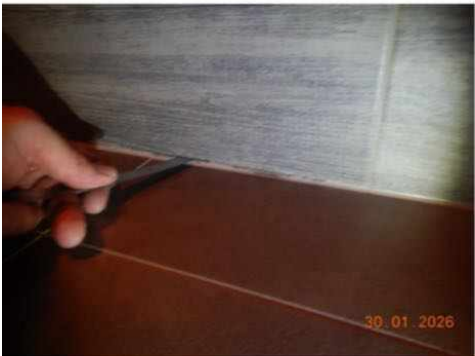
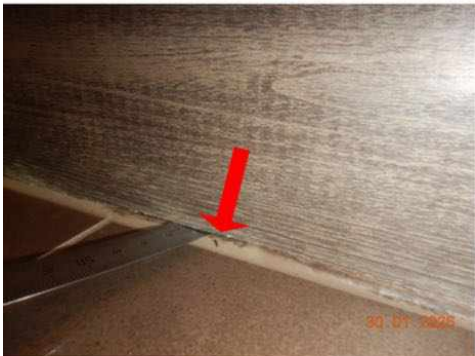
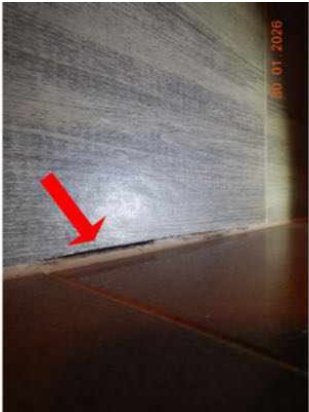
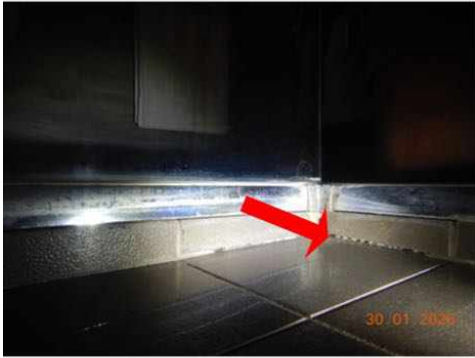
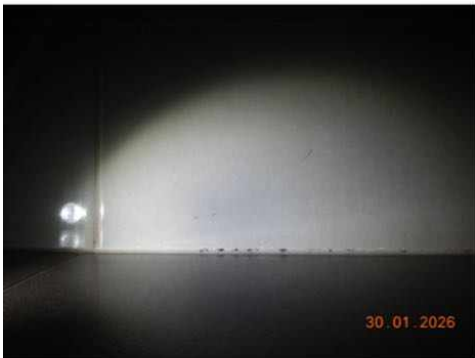
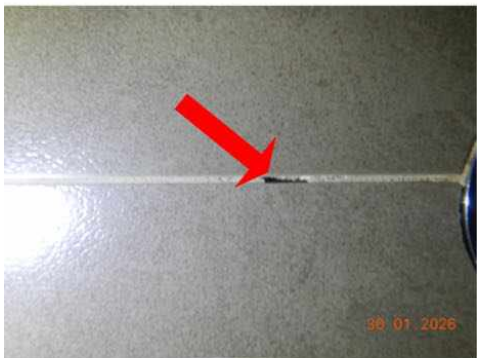
Finding 6.03

| Information: | It was noted on inspection that sealant and grout is showing signs of deterioration to both bathrooms. There were no abnormally high readings for moisture in the area. |

Secondary defects can occur if maintenance is not carried out ranging from moisture in walls to deterioration of adjacent building elements

Flexible and materials should be applied to affected areas to prevent any subsequent water damage that can occur. Regular maintenance and replacement of damaged/deteriorated sealant and grout is highly recommended as this is a regular wear and tear defect.

Repairs are required and should be carried out by a licensed bathroom sealant specialist immediately.

Silicone and grout generally need repair at least every 5 years and as such close monitoring should be carried out in the future after repairs are carried out.

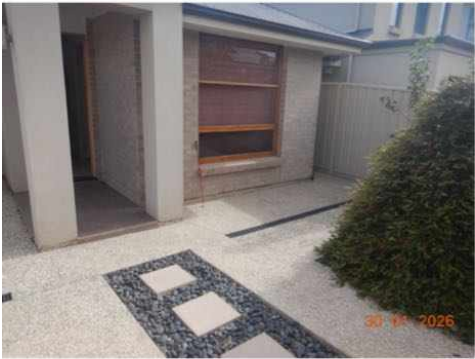
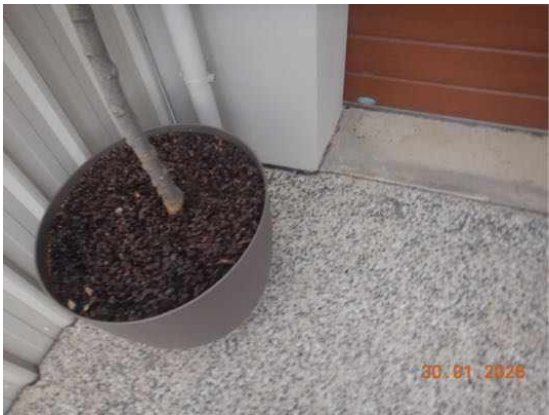
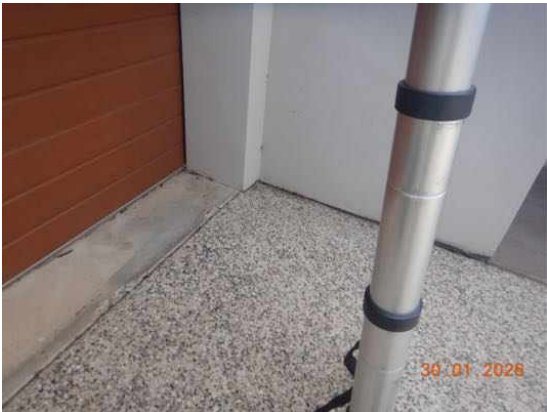
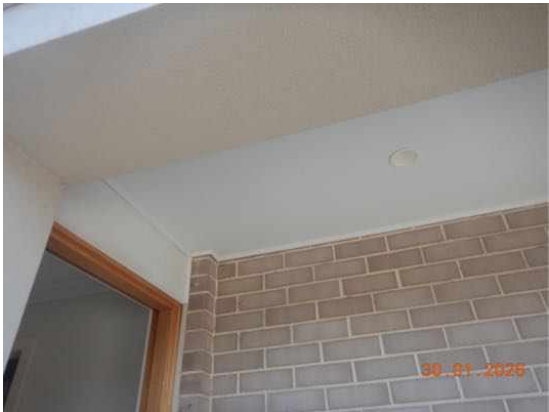
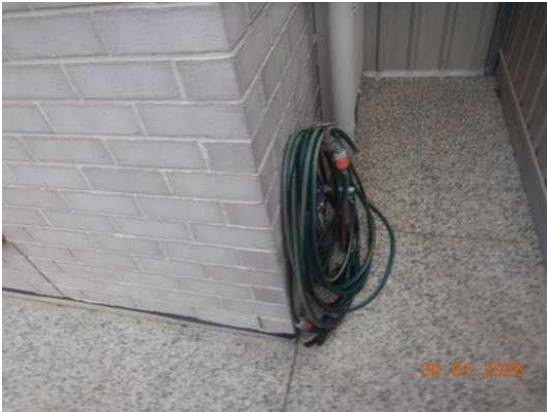
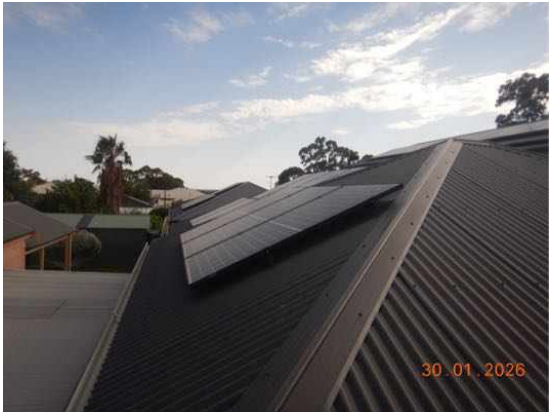
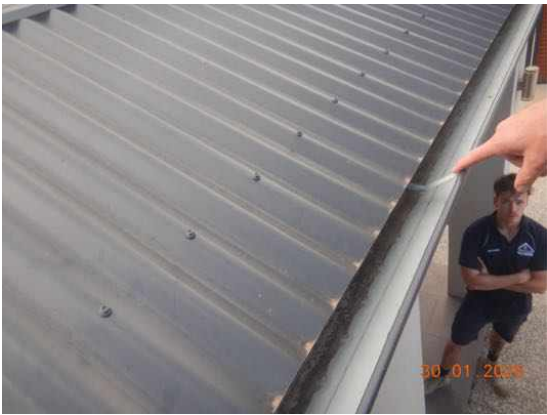
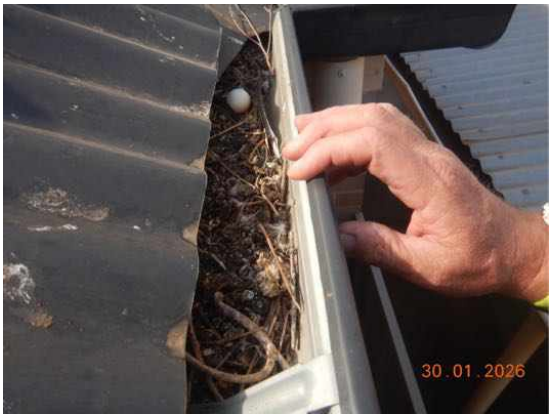
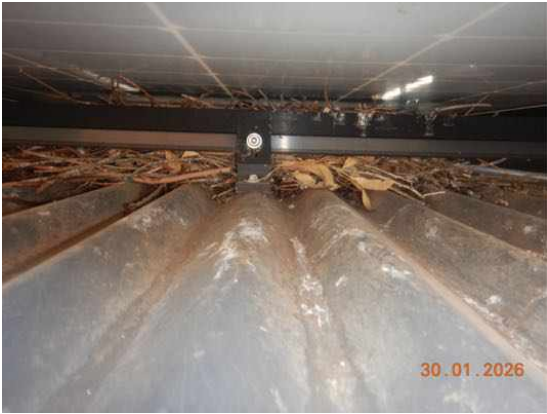
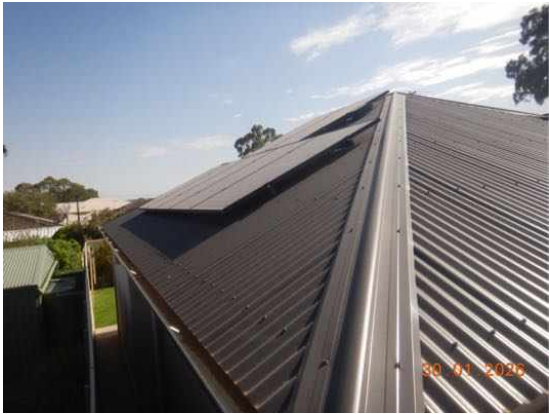
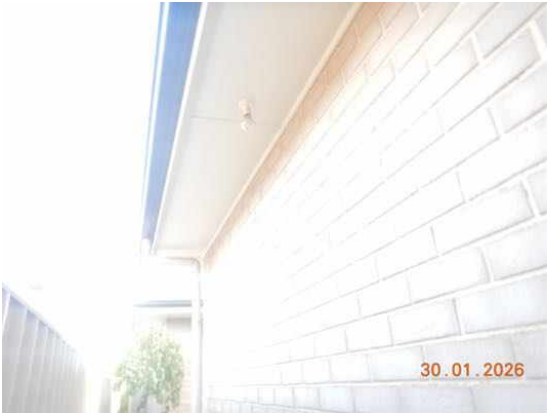
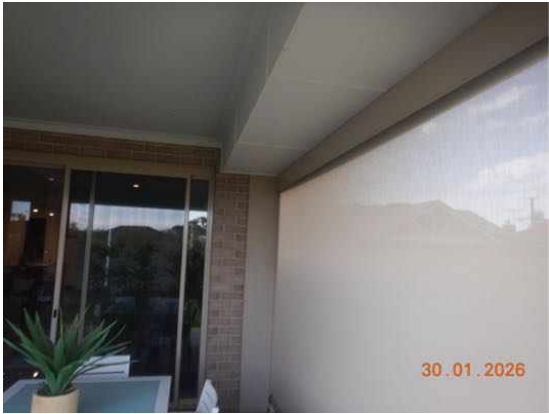
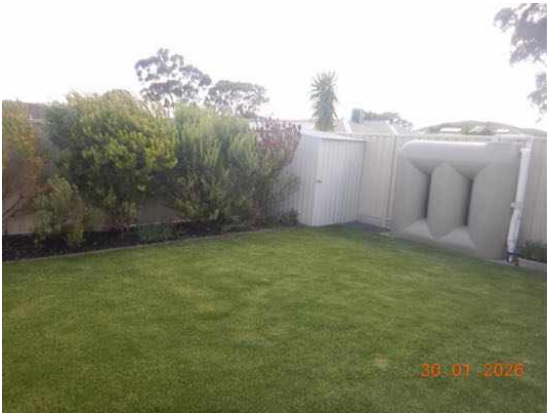
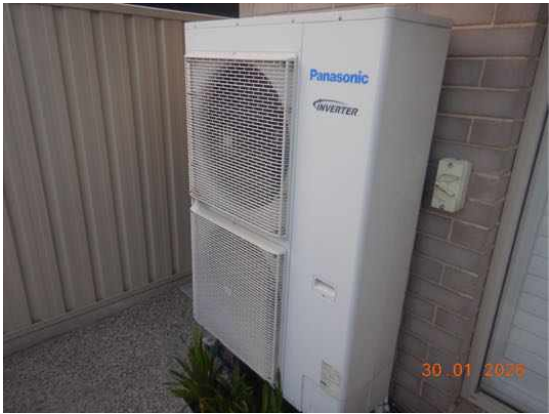
Building: Building 1
Location: All Areas
Finding: Additional Photos - Obstructions and Limitations
Information:

These photographs are an indication of the obstructions and limitations which impeded full inspection of the property at the time of inspection. These obstructions can hide an array of defects and should be removed to allow full inspection to be carried out.

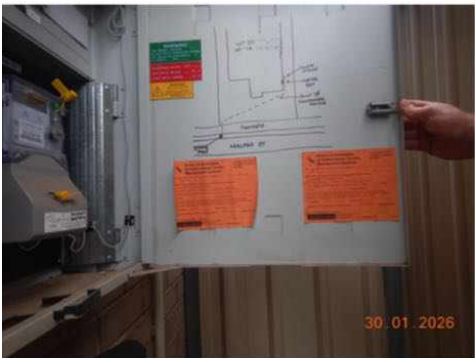
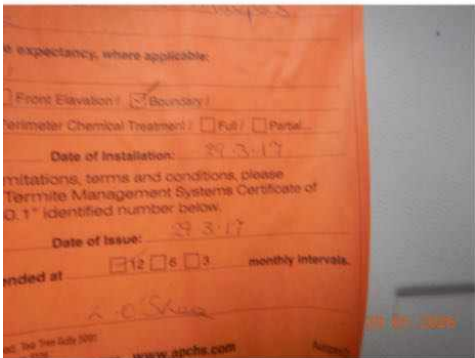
The following items were noted as - Evidence of a previous termite management program

Where a Termite Management System has been identified you should refer to the type of barrier date of installation warranty conditions and any documentation provided by a builder or past owner.

Consult the company who installed the barrier to confirm whether the system is still under warranty and the extent of the system.
