Building and Timber Pest Inspection Report

Inspection Date: Wed, 18 Feb 2026

Property Address: 5 Riverview Parade, Leonay NSW 2750, Australia

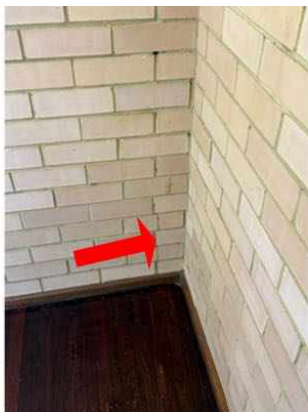
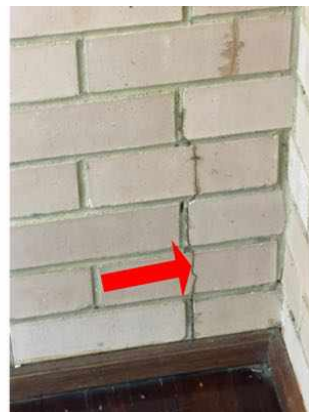
Building: Main Building
Location: Shed
Finding: Brickwork - Cracking [Extensive repairs required]
Information: Major cracking is evident to the brickwork in this area. When managing this degree of cracking, major extensive repair work is generally required. Such work is likely to involve replacement of sections of affected brickwork.

Structural issues are generally the underlying cause of such cracking. It is suspected that this damage has been created due to movement of key structural elements or general subsidence of associated footings.

A structural engineer and bricklayer should be appointed immediately to inspect the structural integrity of the affected brickwork and to assess the safety of the associated structures. The engineer can also nominate a scope of works required for rectification.

Always contact a building inspector or engineer should cracks widen lengthen or become more numerous, even after repair works have been completed.

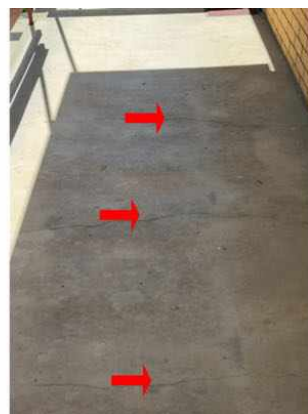
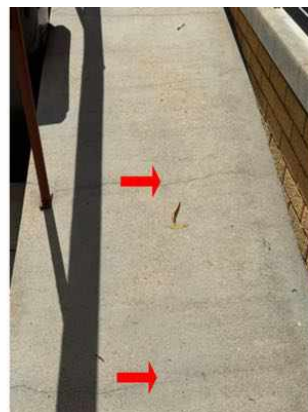
Finding 3.01

Building:	Main Building
Location:	Rear porch and ramp
Finding:	Cracking - External Concrete Paving Damage Category 0 - Hairline (less than 1mm)
Information:	Hairline cracks were identified in external concrete paving. Hairline cracks are very minor in nature and generally are only ever an appearance defect. To be classified as a Category 0 or hairline crack, the crack width would be less than 0.3mm. While such cracking may be noticeable in some cases, it is common and does not indicate any structural damage.

Generally the cause of a hairline crack in existing concrete paving such as driveways and pathways is indicative of the expansion and contraction of the concrete. Such causes are generally due to environmental factors, such as moisture levels, weather conditions, root systems of nearby trees or the soil types on which they are laid.

Hairline cracks may also be due to poor original installation of the concrete. Factors such as poor compaction of the sub surface and/or inadequate reinforcing of the slab may create cracking and other secondary defects.

Monitoring of all cracking should be conducted frequently. Always contact a building inspector should cracks widen, lengthen, or become more numerous.

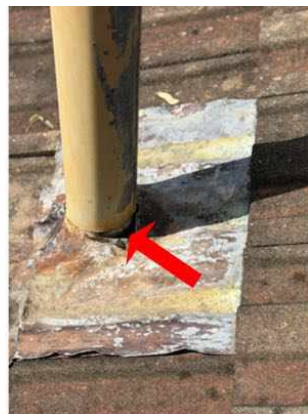
Finding 3.02

Building:	Main Building
Location:	Roof Exterior
Finding:	Flashing-Weathered/repair required
Information:	The lead flashing installed around the roof vent penetration was observed to be deteriorated at the time of inspection. Signs of wear and breakdown were noted, and a visible gap is present between the flashing and the penetration.

This gap may allow water ingress during rainfall, increasing the risk of moisture penetration into the roof space and potential damage to surrounding building elements.

It is recommended that a suitably qualified roofing contractor assess the affected area. The deteriorated lead flashing should be repaired or replaced as required, and all gaps properly sealed to ensure the penetration is watertight and performing as intended.

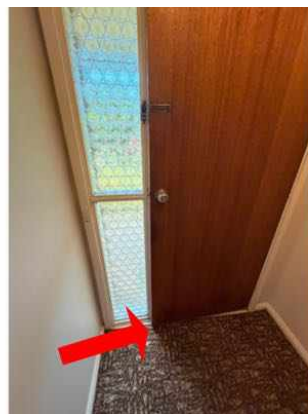
Finding 3.03

Information: Binding and/or jamming of this door is evident during standard operation. This defect inhibits the functionality of the affected door as well as creating potential for secondary defects to associated building elements, such as damage to the door and jamb.

A door that binds to flooring or to the associated door frame may have several causes, ranging from minor defects, such as poor installation of the door or deteriorated hinges, through to minor building movement.

For minor causes, a qualified carpenter or general handyperson should be appointed to perform minor rectification works at client discretion.

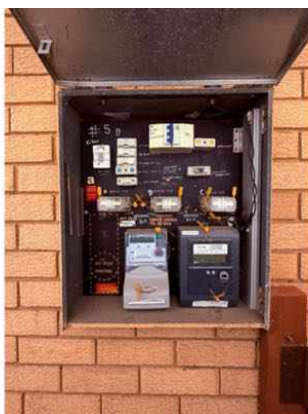
Building:	Main Building
Location:	Electrical Meter-box
Finding:	Termite Management System - no evidence of installation
Information:	The application of a post-construction chemical termite barrier is highly recommended for all properties, particularly if live termite activity has been found on the site previously. Such barriers are highly effective in preventing termite attack on any timber building elements throughout the property.

A durable notice should be placed in the switchboard unit to indicate current termite barriers. At the time of inspection, it appeared as though no termite management system has been installed, with no evidence to suggest preventative works taking place.

The client may consider gaining further advice from a pest controller as to the costs and procedures involved with this application. It is recommended that obtaining such advice be a short-term priority.

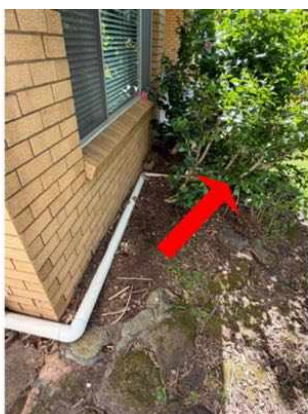
Where roof plumbing doesn't drain adequately, the area at the base perimeter can become excessively damp, potentially creating an environment that is susceptible to rust and corrosion of surrounding building elements, as well as attracting termites and other pests.

It is highly recommended that a plumber be appointed to further inspect the area and to connect all downpipes adequately as soon as possible.

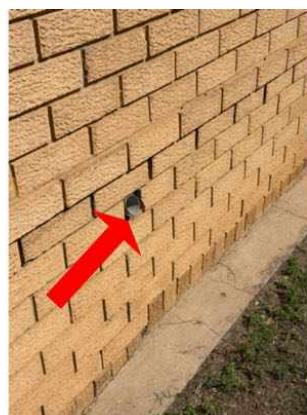
Finding 6.04

Building:	Main Building
Location:	Hot Water/AC units
Finding:	Overflows not plumbed to drainage

These damp conditions can lead to secondary defects such as rot, rust or corrosion of associated building elements, the formation of fungal decay, or even the creation of potential slip hazards. When coupled with poor site drainage, pooling of water may also attract termite activity to this area.

It is highly recommended that a qualified plumber be appointed to install adequate drainage to the overflow. These works will ensure that the area remains dry and free of any secondary defects.

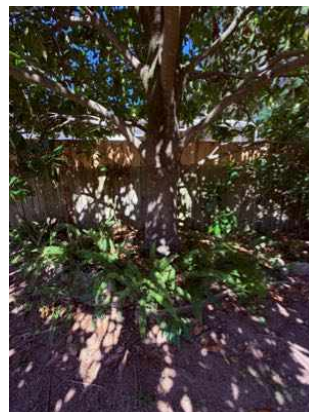
Finding 6.05

Building: Main Building
 Location: Yard
 Finding: Large trees/stumps within 30m of house
 Information: There are a number of large trees/stumps within 30m of the house which may contain natural termite activity. It is important to monitor these areas to ensure no natural activity is allowed to progress into the main house.

Regular inspections are recommended. Consider test drilling any large trees.

A pest controller can be contacted to carry out such testing at the owners discretion.

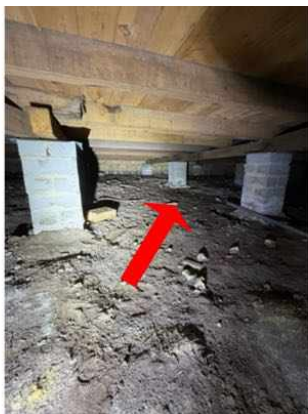
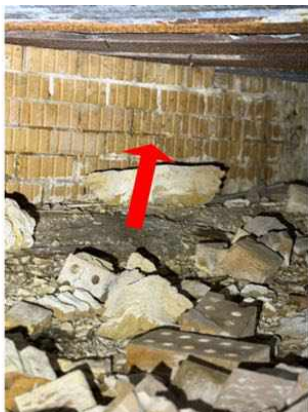
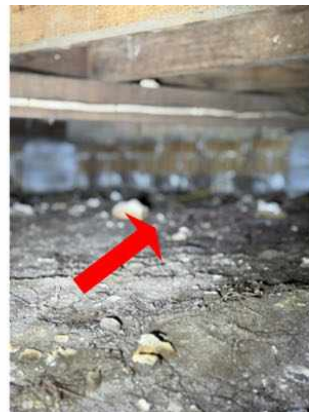
Finding 6.06

Building:	Main Building
Location:	Subfloor
Finding:	Excessive subfloor moisture
Information:	Excessive moisture can attract termites and produce conditions that promote termite attack fungal growth and wood decay.

Excessive moisture is generally caused by inadequate subfloor ventilation and poor site drainage.

There appear to be inadequate vents installed to the perimeter of the building and I would suggest that further solar powered fans or the like be installed to improve cross flow ventilation and aid in keeping the subfloor area relatively dry.

The installation of additional surface drainage to the rear of the property would also be beneficial to keeping the subfloor dry.

It is highly recommended that both subfloor ventilation and site drainage be improved and maintained regularly in order to prevent excessive moisture being present in the external / internal property.

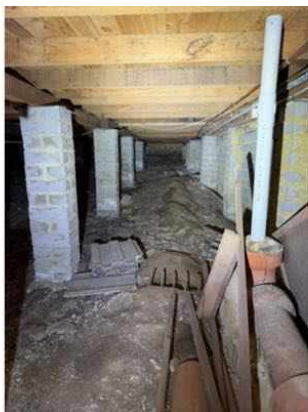
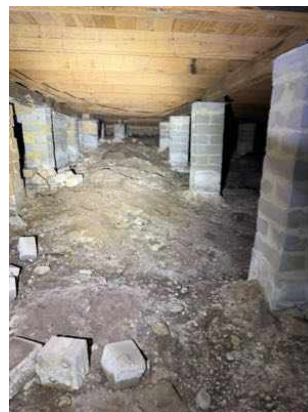
Finding 6.07

Building:	Main Building
Location:	Subfloor
Finding:	Subfloor - Lack of ventilation
Information:	It was noted at the time of inspection that the subfloor area lacks adequate ventilation. Ventilation can be restricted by a variety of minor defects, including obstructions in the subfloor space, a lack of vents or a low clearance.

A well ventilated subfloor aids in maintaining dry conditions, preventing secondary damage such as wood rot and pest activity, as well as preventing the development of mould and mildew (which can lead to respiratory safety hazards for occupants).

The initial step in improving ventilation is to ensure that the subfloor area is free of any debris or stored items. Where ventilation is still inadequate, it is advised to ensure that all vents are clear of blockages, and additional vents may be installed.

The client may also consider mechanical ventilation (powered fans) to improve subfloor airflow. Remedial works should be conducted as a matter of urgency to protect against the development of potentially harmful subfloor conditions.

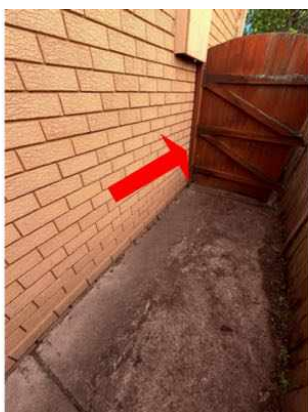
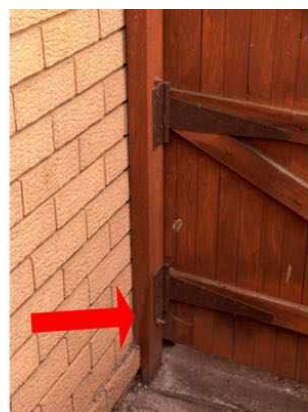
Finding 6.08

Building:	Main Building
Location:	All Areas
Finding:	Bridging of termite barriers - Fences abutting building
Information:	Bridging is the spanning of a termite barrier or inspection zone so that subterranean termites are provided with passage over or around that barrier.

At the time of inspection it was noted that fences abutting the building on both left and right hand sides created a point for concealed access of termites into the building.

Where any part of an attachment to a building is not isolated and is not provided with a clear gap of at least 25mm from the building, bridging occurs.

The client should consider obtaining further advice from a timber pest technician regarding treatments required in this area. It is recommended that obtaining such advice be a short-term priority.

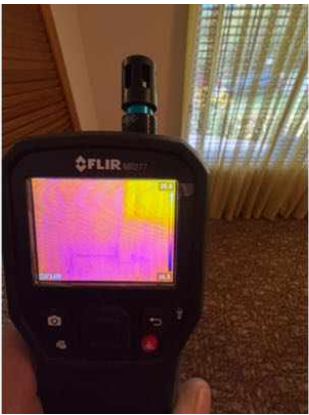
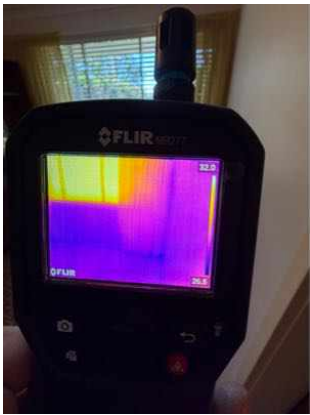
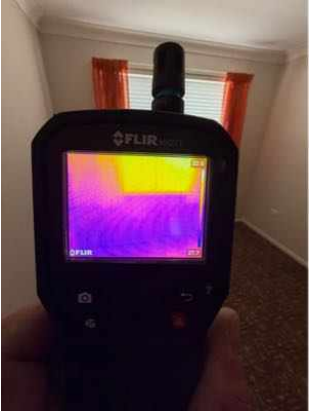
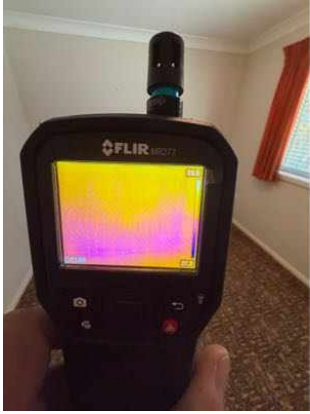
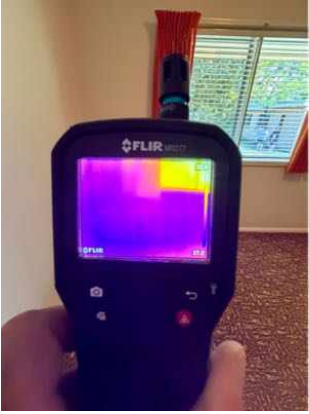
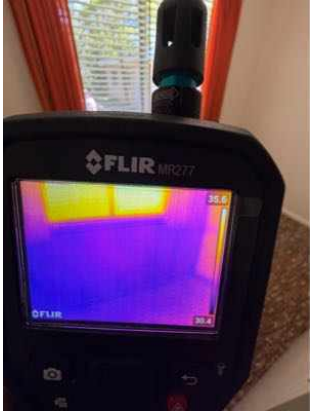
Building: Main Building
 Location: All Internal Areas
 Finding: For your information-Thermal camera
 Information: AS 3660.2:2017 is the recommendation for the carrying out of 'Additional Tests' using specialist non-destructive tools:

A thermal imaging inspection was carried out throughout the interior of the house using a Flir MR277 thermal camera. No thermal anomalies were noted that would be consistent with any current termite activity, however various factors must be taken into effect which may hamper or impede the reading obtainable by the imager. These factors include obstructions, ambient temperature, wall material and thickness etc. If any surface is restricted visually or otherwise, a proper thermal reading is not possible and is not within the scope of this inspection. Any findings or otherwise is reported on at the time of the inspection only.

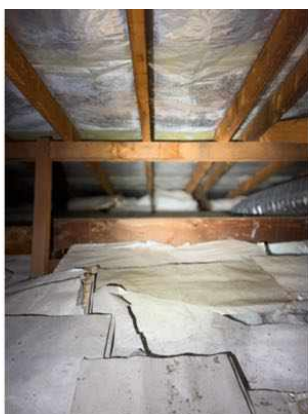
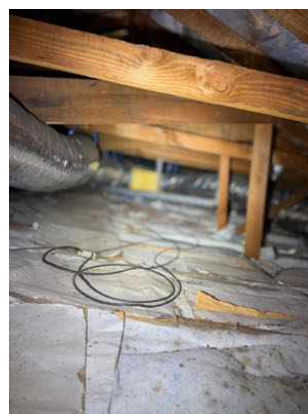
Building:	Main Building
Location:	Roof Void
Finding:	Obstructions and Limitations-Roof Void
Information:	These photographs are an indication of the obstructions and limitations that impeded the full inspection of the roof cavity at the time of inspection. Note that the insulation covered nearly all the ceiling joists, which are a major structural element of the ceiling; the inspection was also limited to areas with an allowable crawl space of 600mm x 600mm, in particular towards the external walls where the roof line diminishes, it was not accessible. These obstructions and limitations can hide an array of defects and should be removed to allow a full inspection to be carried out. A re-inspection is recommended once areas are made accessible.

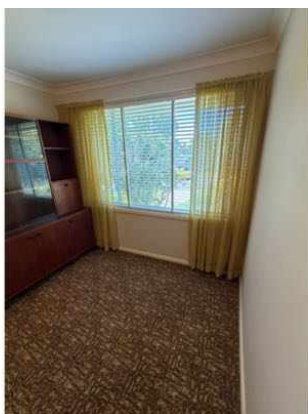
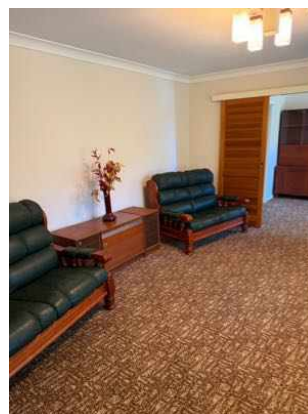
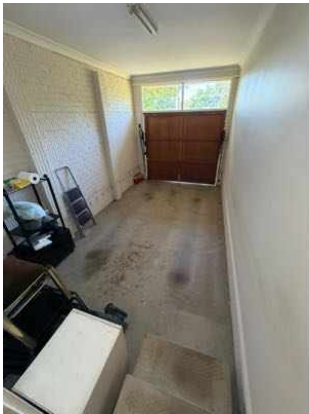
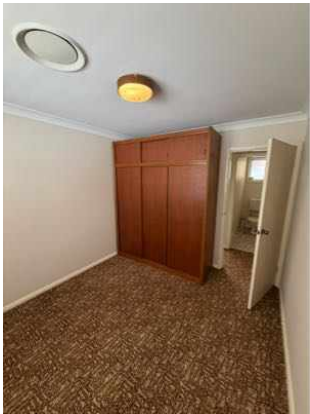
Building:	Main Building
Location:	Internal Areas
Finding:	Obstructions and Limitations-Internal areas
Information:	These photographs are an indication of the obstructions and limitations which impeded full inspection of the internal areas at the time of inspection. These obstructions can hide an array of defects and should be removed to allow a full inspection to be carried out. A re-inspection is recommended once the areas are made accessible.

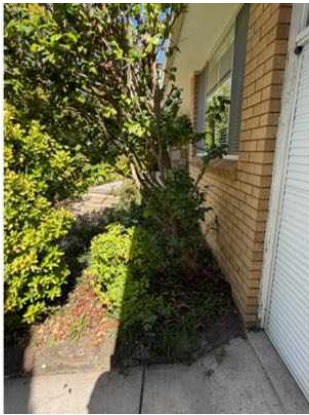
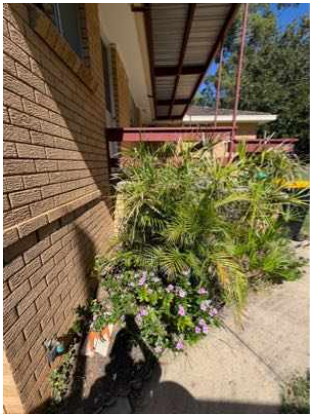
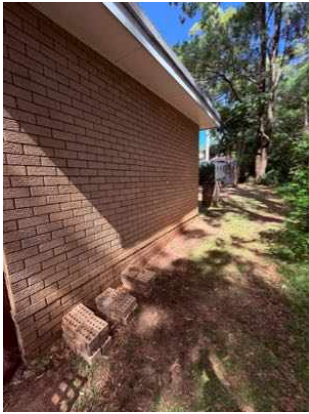
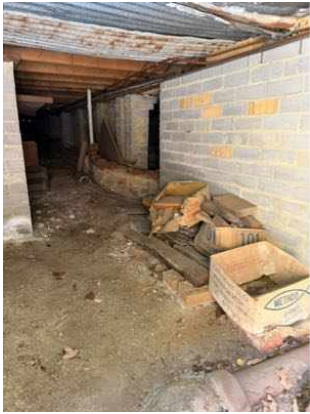
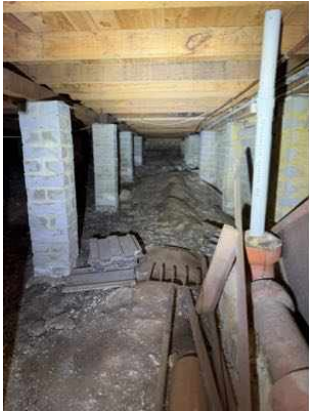
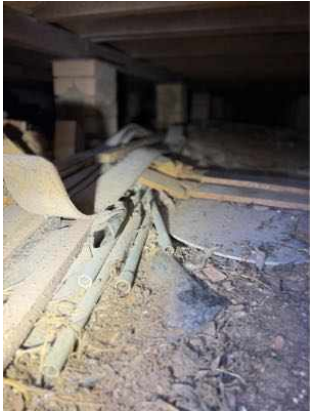
Building: Main Building
Location: External Areas/Sub-Floor
Finding: Obstructions and Limitations-External Areas/Sub-Floor
Information: These photographs are an indication of the obstructions and limitations which impeded full inspection of the external areas at the time of inspection. These obstructions can hide an array of defects and should be removed to allow full inspection to be carried out. A re-inspection is recommended once the areas are made accessible.

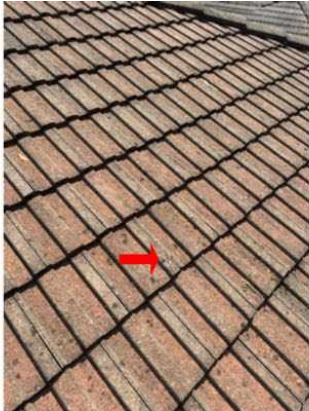
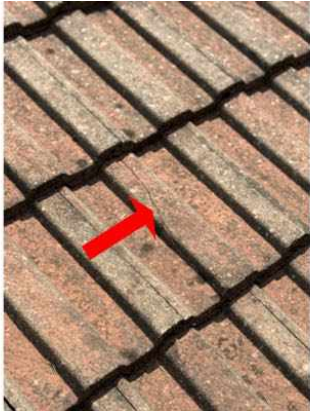
Building: Main Building
Location: Roof Exterior
Finding: Roof tiles - Weathered
Information: Upon inspection of the exterior roofing, the majority of roof tiles were considered to be in a fair condition. While weathering of the tiles is consistent with the age of the property, maintenance works are required.

Isolated areas of mortar have come loose in the valleys and minor cracking is also present. Re-pointing and re-sealing the may be considered as an interim solution by the client to help preserve and extend the life span of the tiles.

Where left unmanaged, deteriorating roof tiles are likely to lead to a number of secondary defects, including minor water leaks and weather exposure to internal roofing structures.

Consultation with a roofing contractor is highly advised to gain advice on cost of remedial works that may be required in the short to medium term. Remedial works are likely to increase the longevity of the exterior roofing structure.

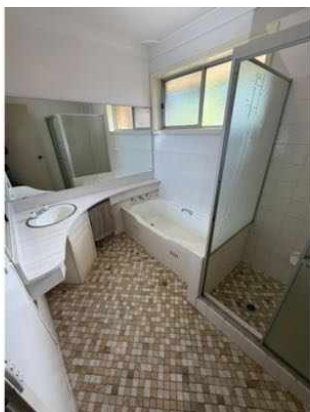
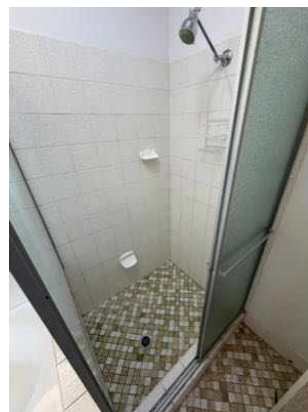
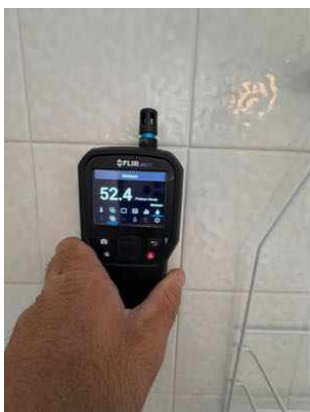
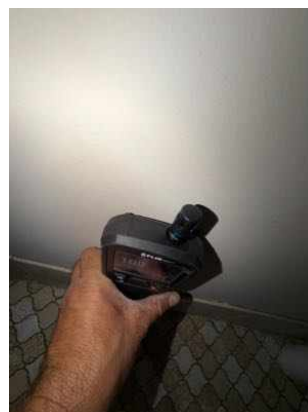
Building: Main Building
 Location: Showers
 Finding: Shower seals recommended
 Information: The waterproofing to the shower recess was assessed by checking the walls in and around the shower recess for varying moisture content. Although a higher than normal reading was observed, there were no significant variations across the tested areas.

No sign of recent water damage was evident upon a visual inspection of the surrounding walls, where the visual nature of the inspection was possible. Consequently, there is no conclusive evidence of any current shower recess leakage and it is reasonable to assume the shower waterproofing is sound.

Note that if the shower is not used, or has not been used for some time, moisture readings would not vary significantly and this can lead to erroneous results. It is not possible under the visual inspection criteria (under which a prepurchase inspection is carried out) to categorically determine if there are leaks. If a more accurate assessment is required, a special purpose inspection should be requested.

Further plumbing inspections are always recommended.

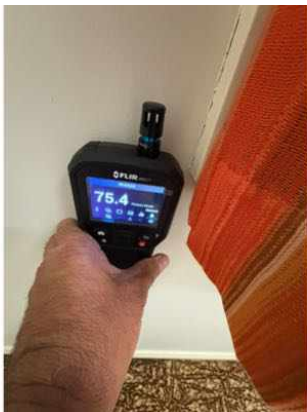
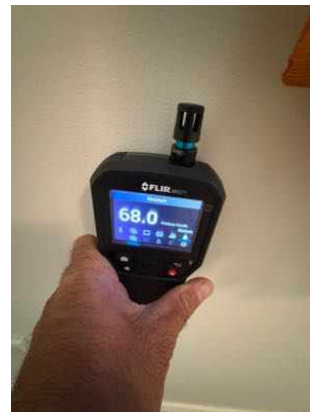
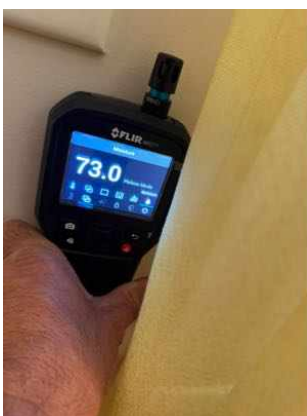
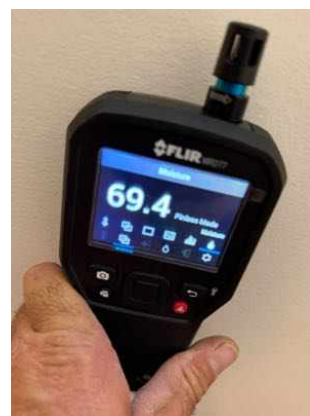
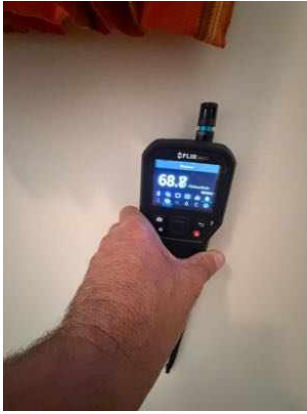
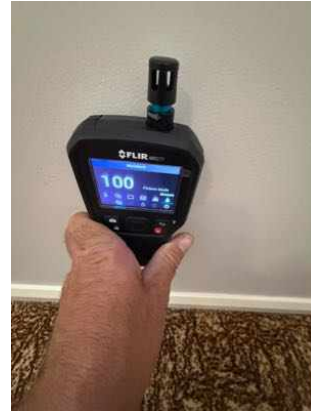
Building:	Main Building
Location:	All Areas
Finding:	FYI-Moisture Readings
Information:	Moisture readings taken during the inspection were recorded using a FLIR MR277 moisture meter, which provides numerical values rather than direct percentage readings. These values are not expressed as a percentage of moisture content but

In short, while percentages are familiar, the meters numeric scale offers a more nuanced and material - sensitive method of identifying moisture issues. Elevated readings – especially those exceeding baseline values by around 20 points or more – are flagged for further investigation, even if no visible damage is present.

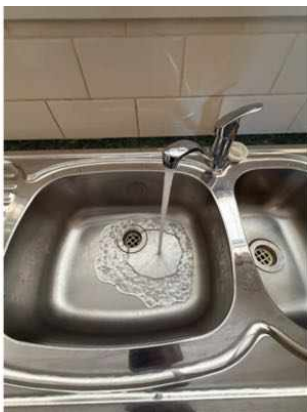
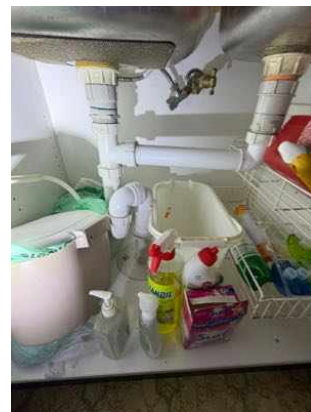
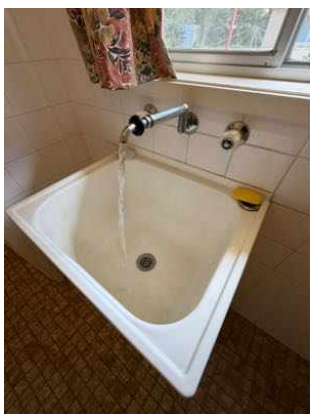
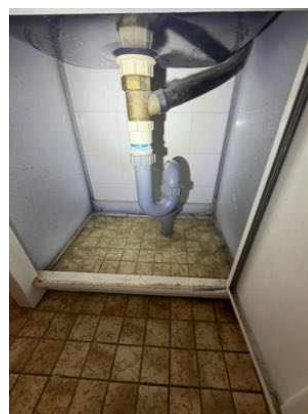
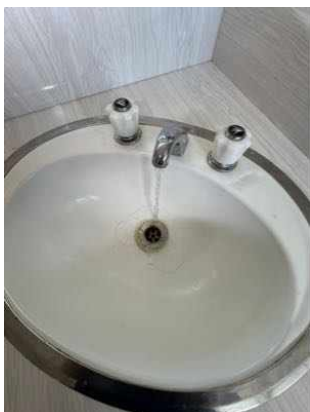
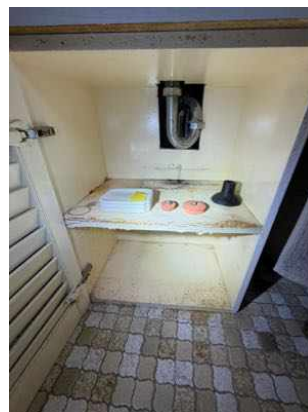
Building: Main Building
 Location: Cabinetry Plumbing
 Finding: FYI-Cabinetry Plumbing
 Information: All cupboards where sinks and basins with drainage plumbing were inspected no evidence of leaks were present at the time of inspection.

For your information only no remedial works are required at the time of inspection.

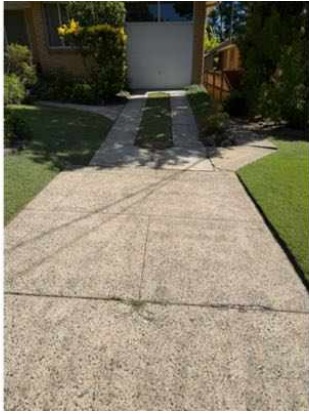
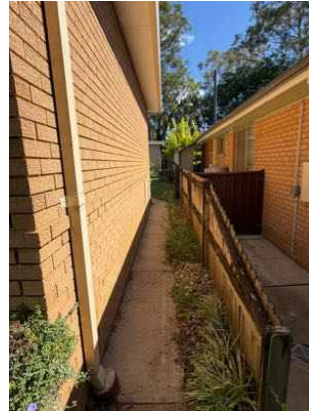
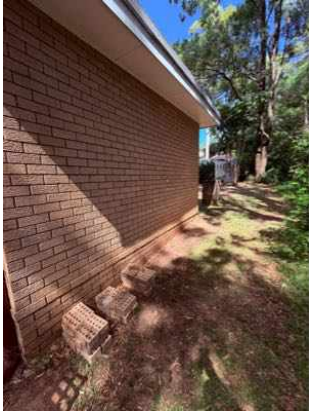
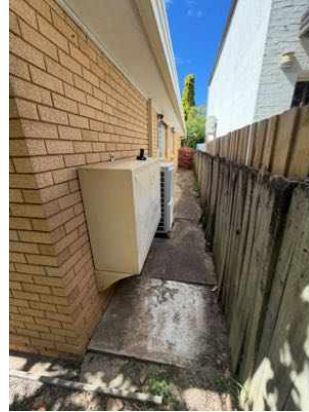
The general adequacy of site drainage is not included in the standard property inspection report. Comments on surface water drainage are limited as where there may have been either little or no rainfall for a period of time, surface water drainage may appear to be adequate during the inspection but then during periods of heavy rain may be found to be inadequate.

Any comments made in this section are relevant only in light of the conditions present at the time of inspection. It is recommended that a smoke test be obtained to determine any illegal connections, blocked or broken drains.

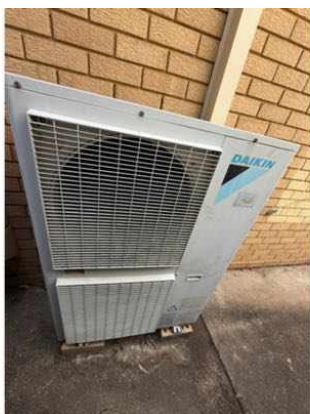
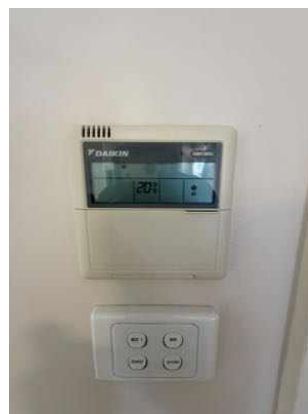
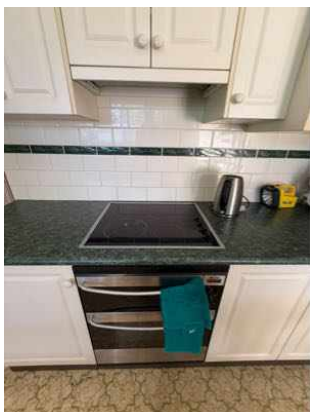
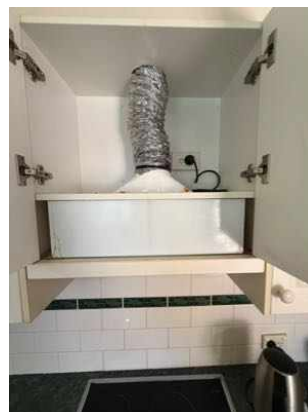
Building:	Main Building
Location:	Plumbing/electrical/gas/aircon/pool equipment etc
Finding:	FYI-Plumbing and Electrical
Information:	Plumbing and Electrical inspections are outside the scope of the building inspection and must be conducted by a licensed and registered trades person.

It is highly recommended that the client makes immediate arrangements to have the gas appliances checked by a licensed gas plumber to ensure that the appliances are working safely and efficiently.

We recommend all other installations be checked also.

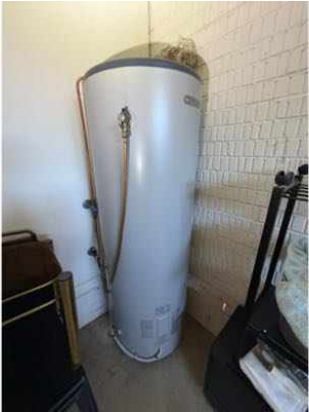
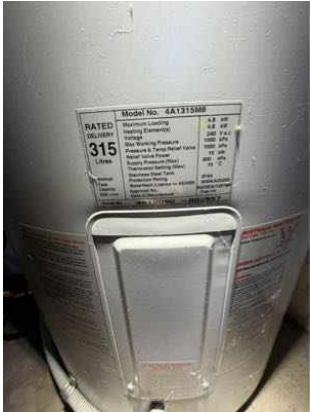
Building: Main Building
 Location: Hot Water System
 Finding: FYI-Hot Water Unit
 Information: The HWS appeared to be in good condition at the time of inspection. For the date of manufacture - (see attached photo)

Water pressure appears to be normal, however, this is not an opinion of a licensed plumber. No water hammer was noted when taps are turned off fast.

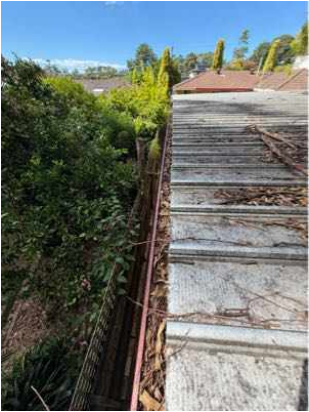
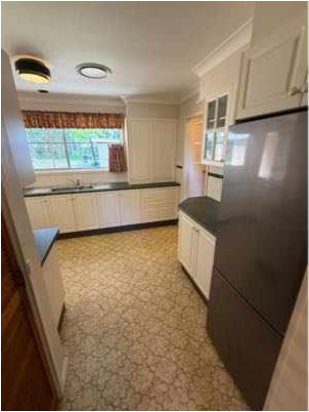
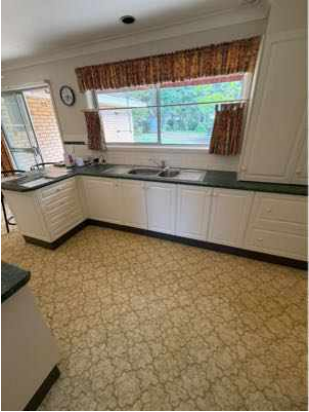
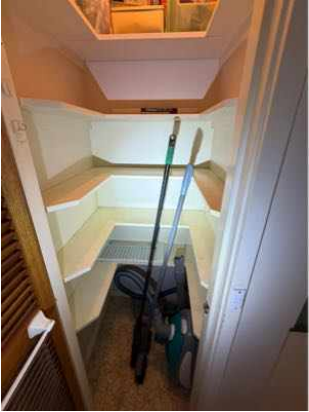
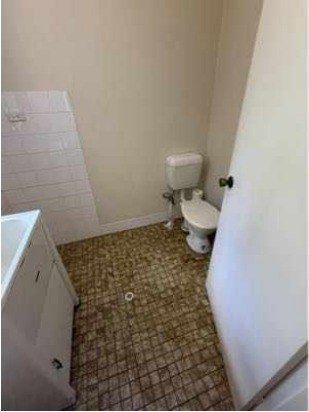
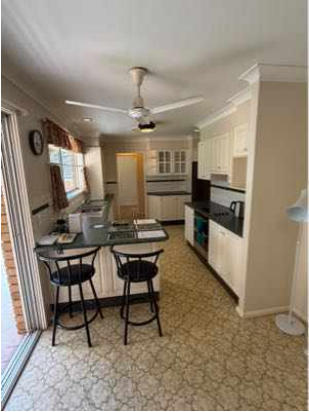
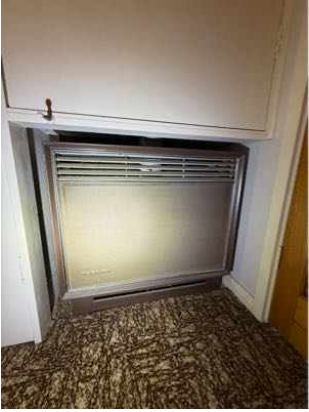
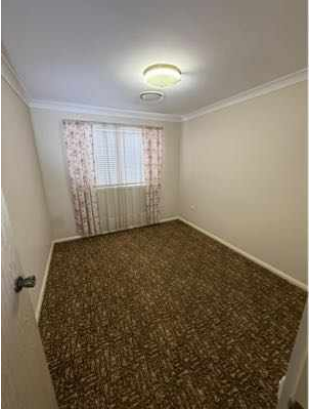
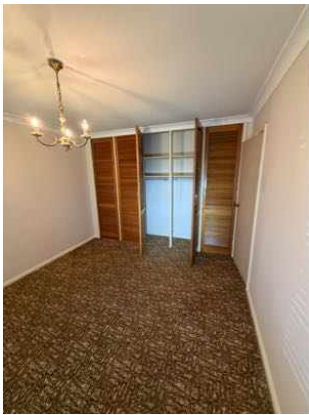
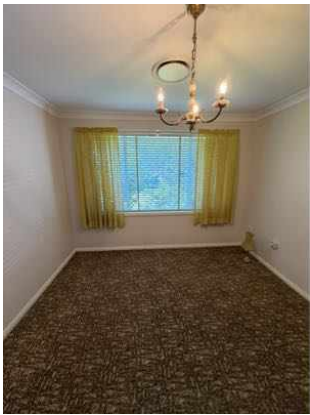
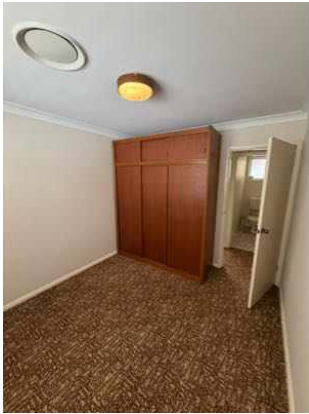
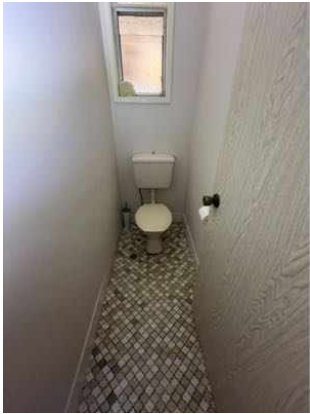
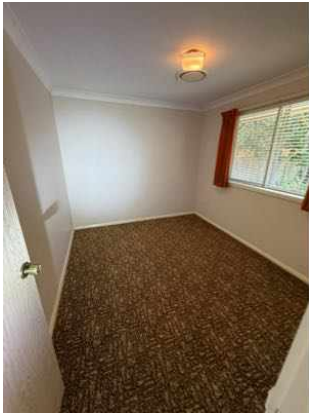
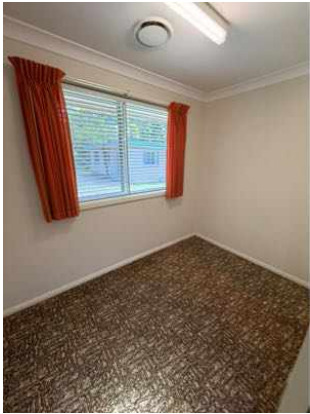
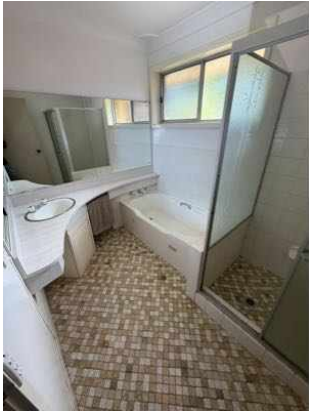
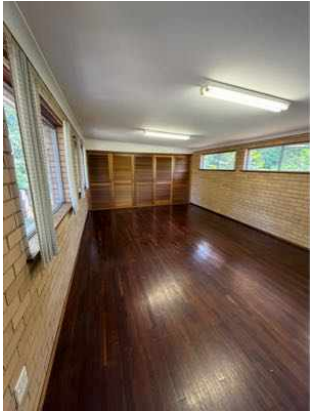
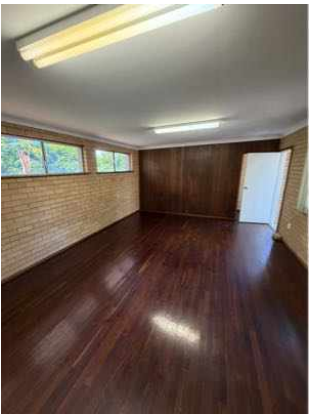
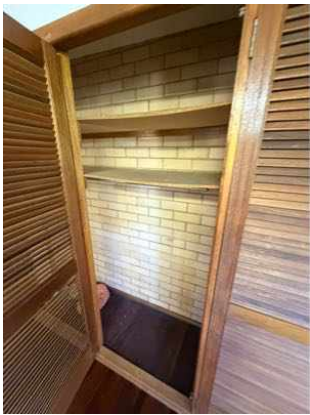
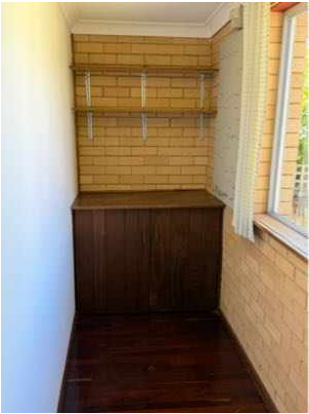
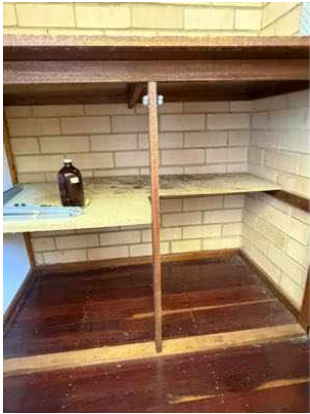
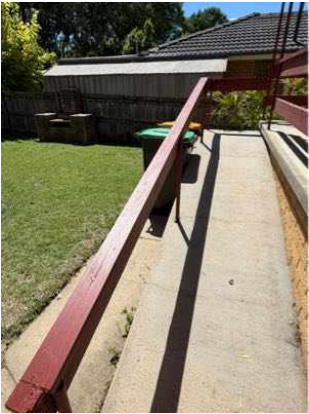
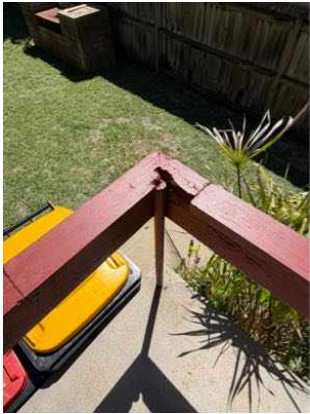
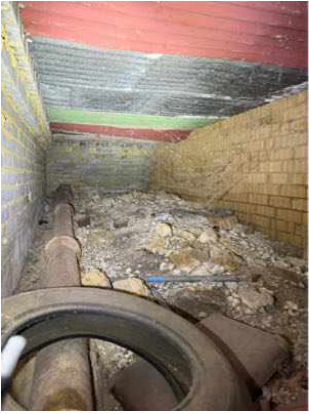
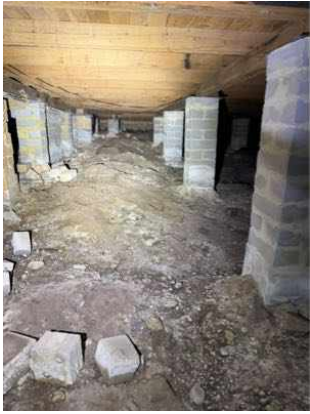
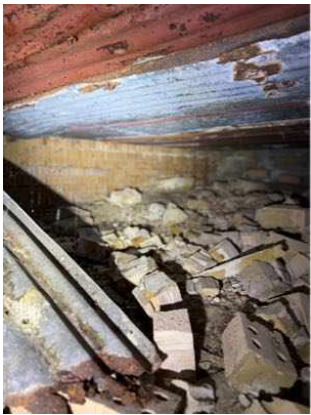
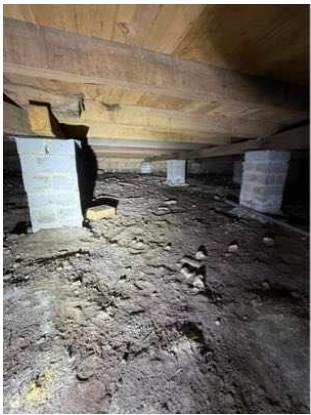
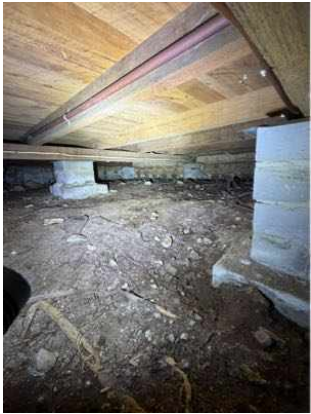
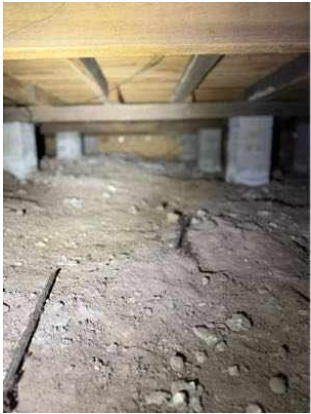
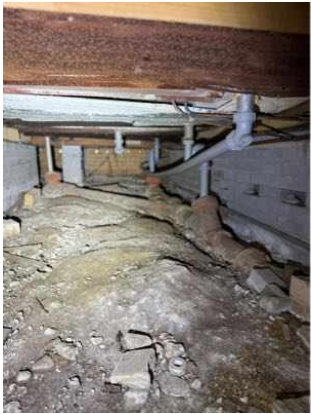
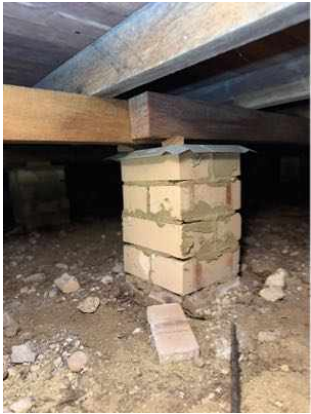
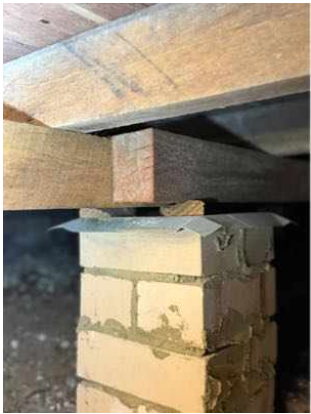
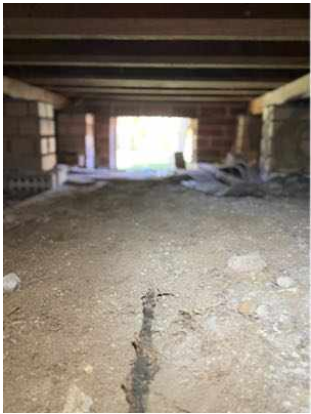
Noted Item

Building: Main Building
 Location: All Areas
 Finding: FYI-Additional Photos
 Information: Additional photos are provided for your general reference and may include obstructions, testing of water and windows, moisture readings or minor maintenance items.
