# Building and Timber Pest Inspection Report

Inspection Date: Thu, 29 Jan 2026

Property Address: 23 North St, Casino NSW 2470, Australia

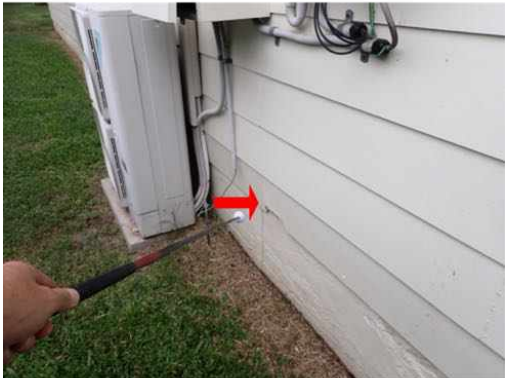
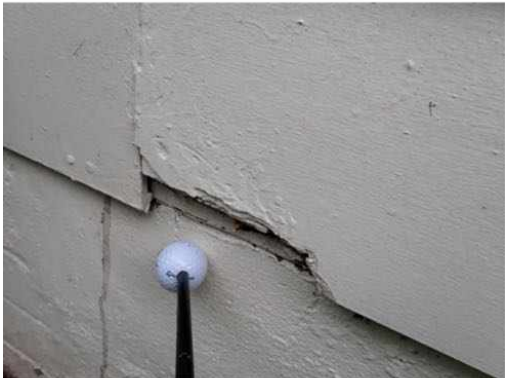
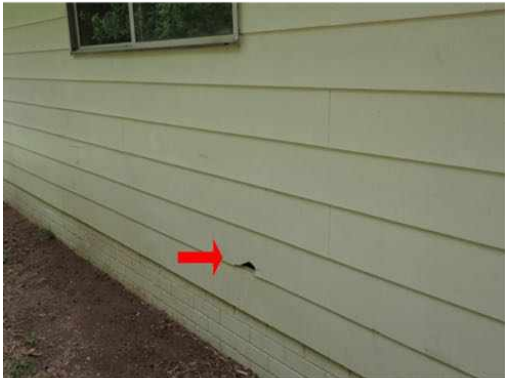
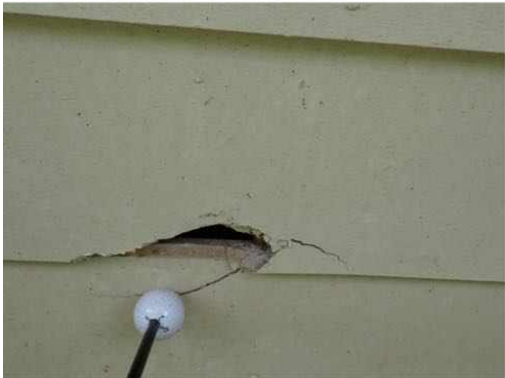
#### Finding 1.01

Building: Main Building  
Location: External cladding  
Finding: External Cladding – Damage (Possible Asbestos-Containing Material)  
Information: Damage was identified to sections of the external cladding, which may contain asbestos-containing material due to the age of the building. No testing or confirmation of asbestos content was carried out, as this is outside the scope of this inspection. Disturbance of the affected areas may pose a health risk. Further assessment is recommended prior to any repair or removal works. Any required works should be carried out by a licensed asbestos contractor, with repairs completed by a suitably qualified builder as required.

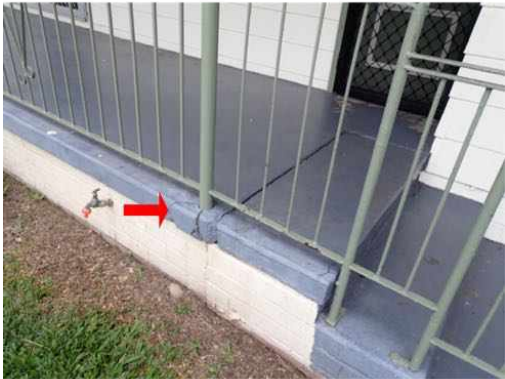
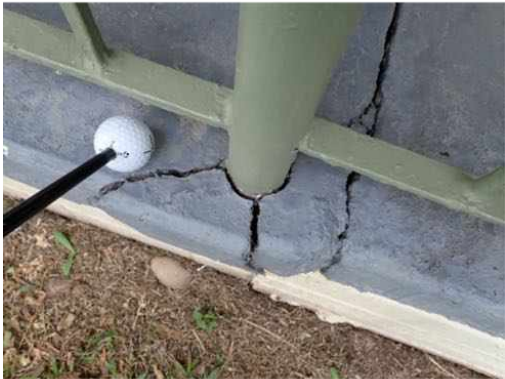
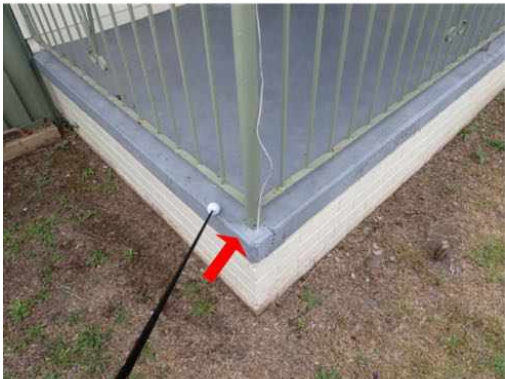
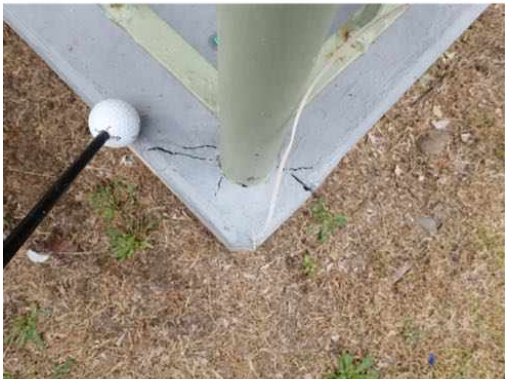
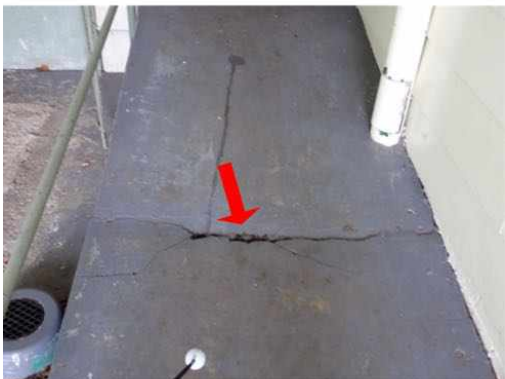
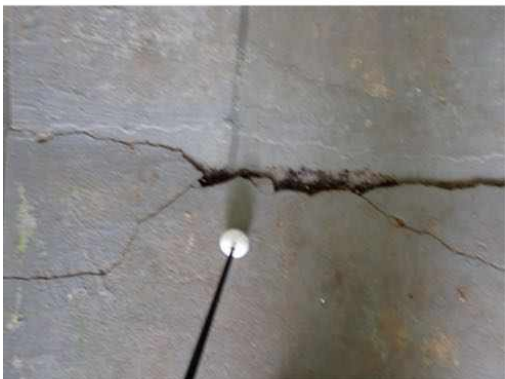
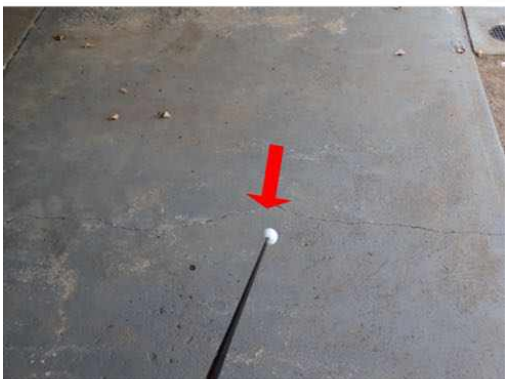
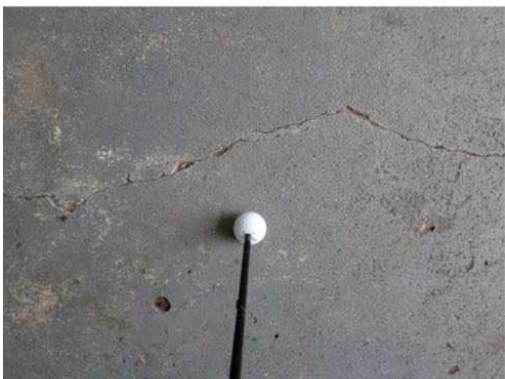
#### Finding 2.01

Location: Concreted areas  
Finding: Concrete Areas – Major and Minor Cracking  
Information: Major and minor cracks were identified to the concrete ramps, front patio, and rear concreted areas. This condition may be associated with ground movement, shrinkage, or age-related deterioration. Cracking may worsen over time and allow moisture ingress if left unaddressed. Ongoing monitoring and repair or replacement as required is recommended. Works should be carried out by a licensed concreter or suitably qualified contractor.

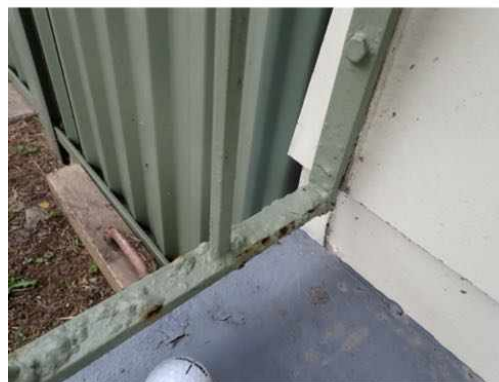
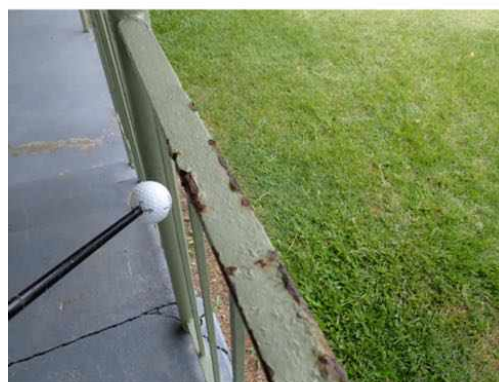
Finding 2.02

Building:	Main Building
Location:	Front patio area
Finding:	Front Patio Balustrade – Rusting
Information:	Rust was identified to the steel balustrade at the front patio. This condition is typically associated with age and weather exposure and may worsen over time if left untreated. Cleaning, rust treatment, and protective coating are recommended to help prevent further corrosion. Works should be carried out by a suitably qualified metal tradesperson or experienced handyman.

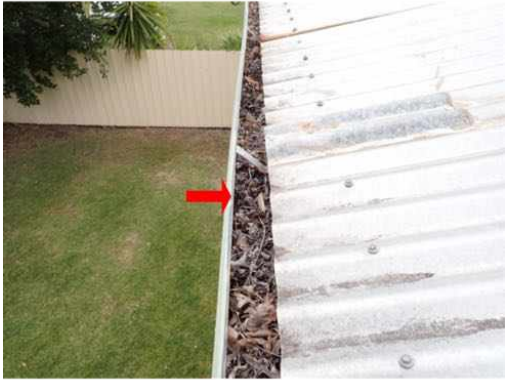
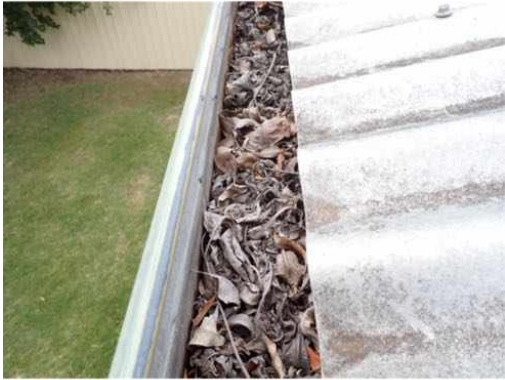
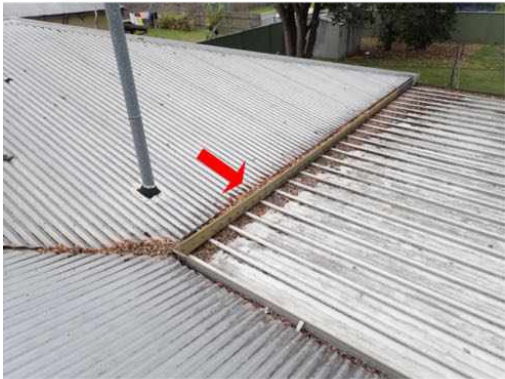
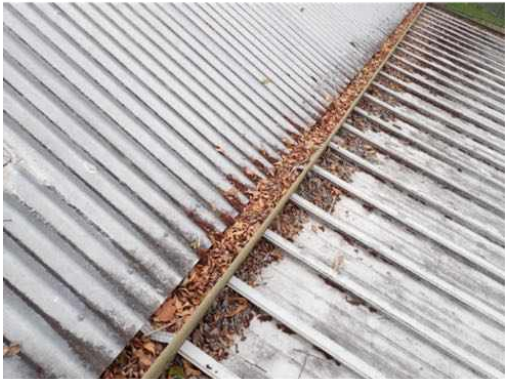
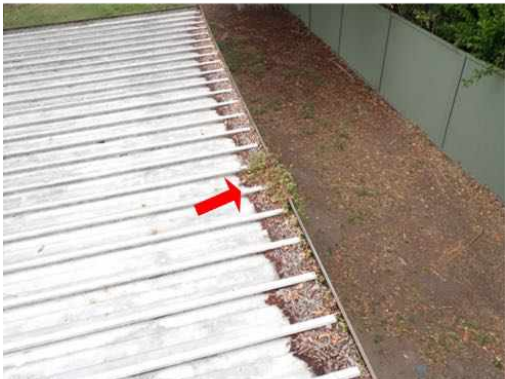
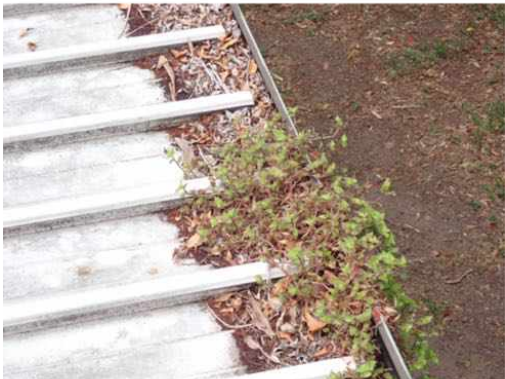
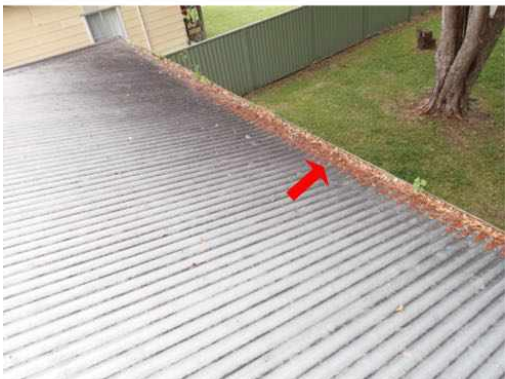
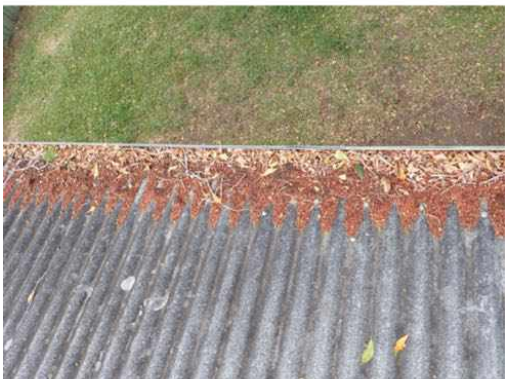
### Finding 2.03

Building:	Main Building
Location:	Roof
Finding:	Roof – Poor Condition
Information:	The roof was observed to be in poor condition, with rust identified to isolated sections of corrugated iron, as well as to downpipes and gutters. Gutters were also found to be blocked. These conditions may lead to reduced roof service life, water overflow, and an increased risk of water ingress if left unaddressed. Cleaning of gutters and repair or replacement of affected roofing and drainage components is recommended. Works should be carried out by a licensed roofing contractor or suitably qualified roof plumber.

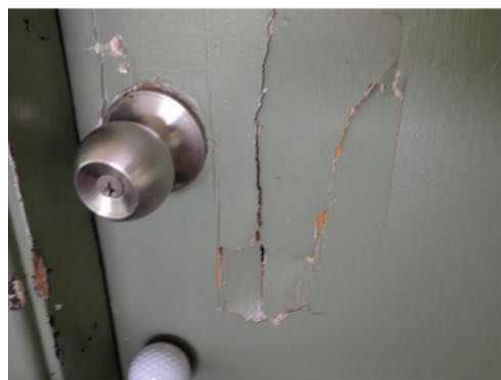
**Finding 2.04**

Building: Main Building  
Location: Garage rear door  
Finding: Rear Garage Door – Impact Damage  
Information: Impact-related damage was identified to the rear garage door. This condition may affect the appearance and operation of the door and could worsen over time if left unaddressed. Repair or replacement of the damaged door is recommended as required. Works should be carried out by a carpenter or suitably qualified tradesperson.

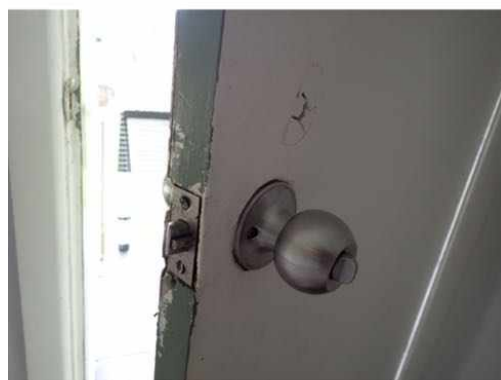
### Finding 2.05

Building:	Main Building
Location:	Entry door
Finding:	Entry Door – Poor Condition
Information:	The entry door was observed to be in poor condition. This may affect its appearance and operation and may worsen over time if left unaddressed. Repair or replacement of the door and associated hardware is recommended as required. Works should be carried out by a carpenter or suitably qualified tradesperson.

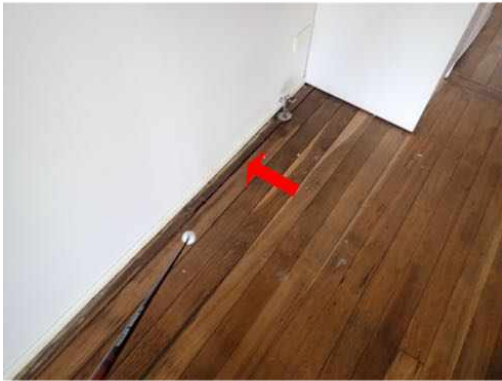
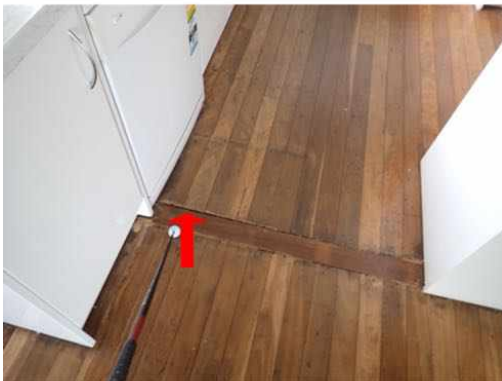
### Finding 2.06

Building:	Main Building
Location:	Timber flooring
Finding:	Timber Flooring – Poor Condition and Termite Damage
Information:	Sections of the timber flooring were found to be in poor condition, with evidence of termite damage identified. This condition may be associated with timber pest activity, age, wear, or moisture exposure and may worsen over time if left unaddressed. Further assessment is recommended to determine the extent of damage. Repair or replacement of affected flooring sections should be carried out as required by a licensed timber pest technician and a suitably qualified carpenter or flooring contractor.

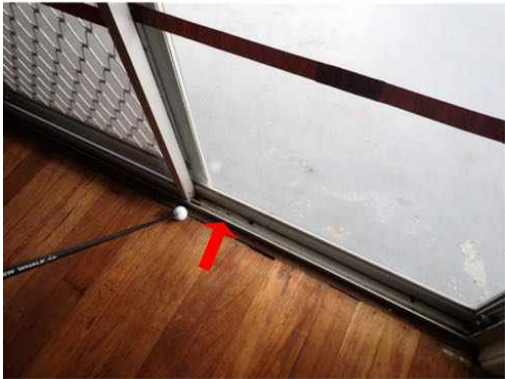
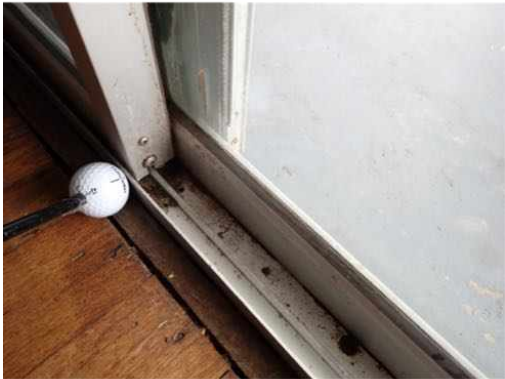
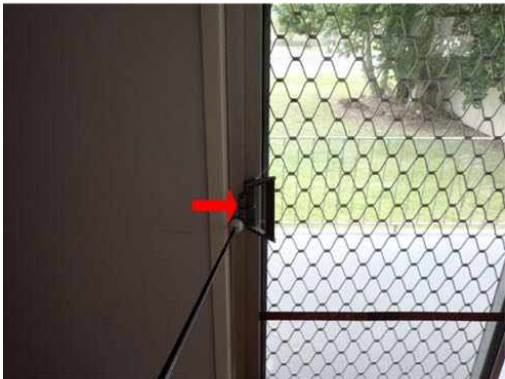
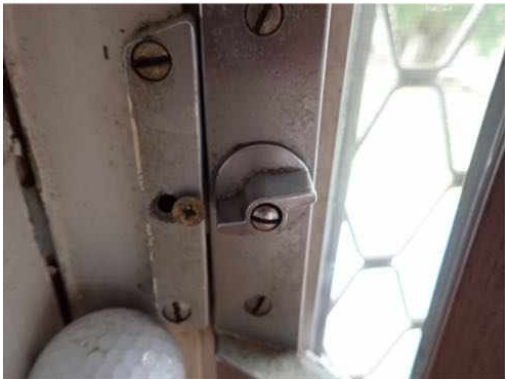
### Finding 2.07

Building:	Main Building
Location:	Dining room
Finding:	Sliding Door – Poor Condition
Information:	The sliding door was observed to be in poor condition and difficult to operate. The door latch was found to be broken and poorly fixed. These issues may affect security and ongoing usability of the door. Repair or replacement of the door hardware, and adjustment of the door as required, is recommended. Works should be carried out by a carpenter, glazier, or suitably qualified tradesperson.

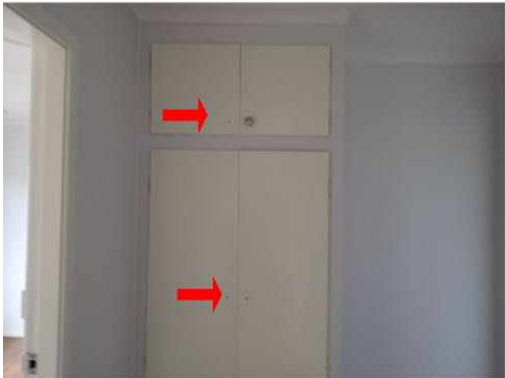
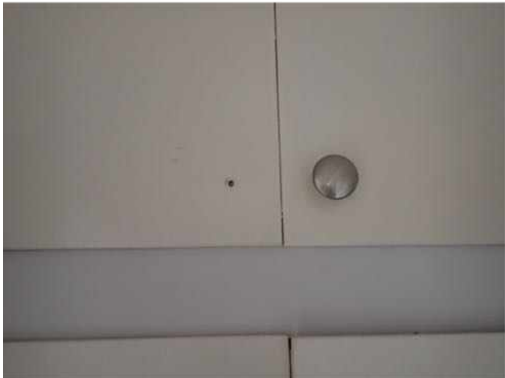
**Finding 2.08**

Building: Main Building  
 Location: Robes and linen cupboards  
 Finding: Robes and Linen Cupboards – Poor Condition  
 Information: The robes and linen cupboards were observed to be in poor condition. Defects identified included missing and loose handles, swollen and damaged doors, and deteriorated shelving. These issues may affect usability and appearance and may worsen over time if left unaddressed. Repair or replacement of affected components is recommended as required. Works should be carried out by a carpenter or cabinet maker.

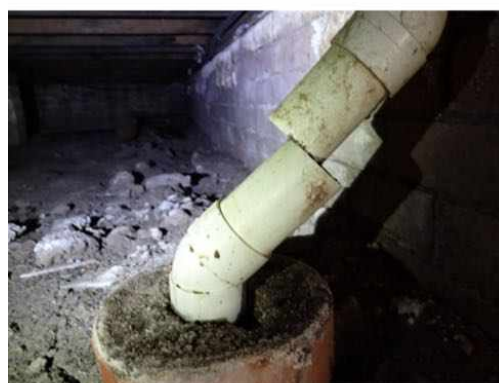
### Finding 2.10

Building:	Main Building
Location:	Subfloor
Finding:	Subfloor – Kitchen Waste Pipe Cut
Information:	The kitchen waste pipe was observed to be cut within the subfloor area. This condition may affect proper waste discharge and could lead to leaks, blockages, or moisture-related damage if left unaddressed. Further investigation and rectification of the pipework is recommended. Works should be carried out by a licensed plumber.

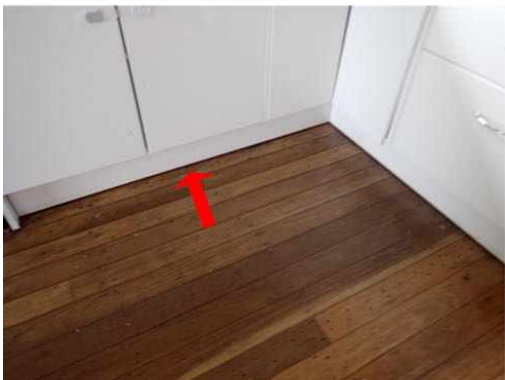
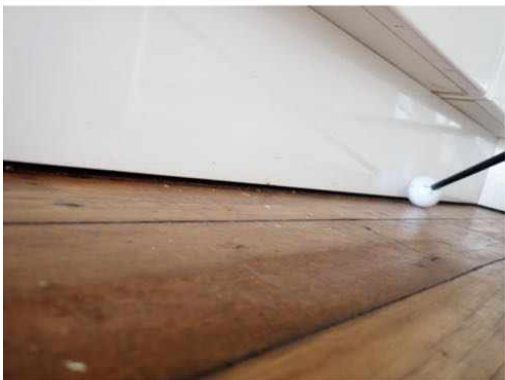
### Finding 3.01

Building:	Main Building
Location:	Kitchen
Finding:	Kitchen – Fair Condition with Defects
Information:	The kitchen was observed to be in fair condition overall; however, several defects were identified, including missing silicone, poor application of grout, broken bin drawer fittings, and a small crack in the laminate benchtop. While these issues are generally minor, they may affect functionality and durability if left unaddressed. Rectification of the identified defects is recommended as required. Works can be carried out by a suitably qualified carpenter, cabinet maker, or handyman.

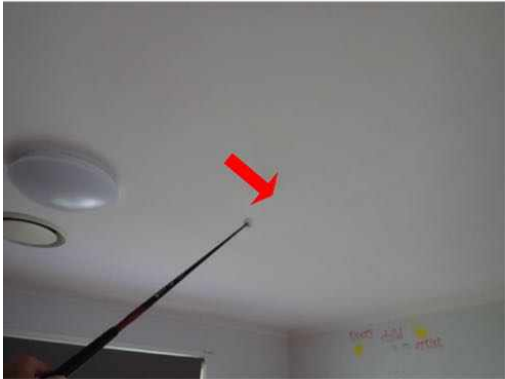
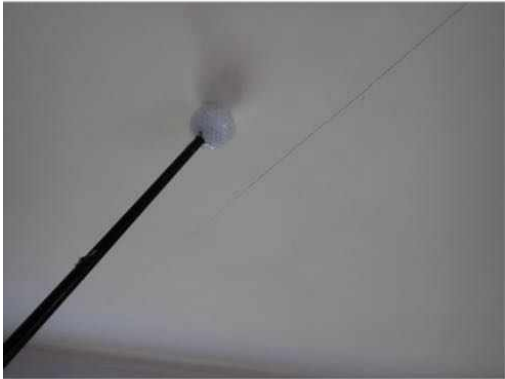
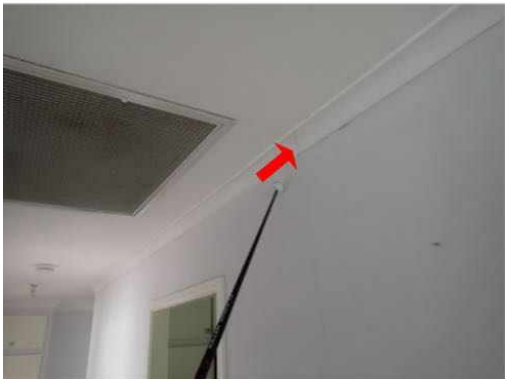
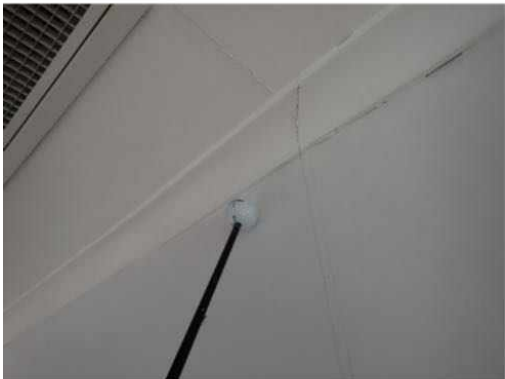
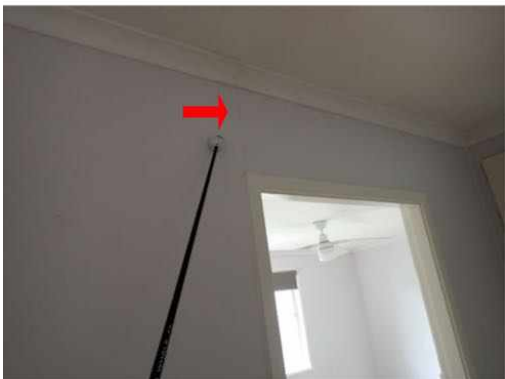
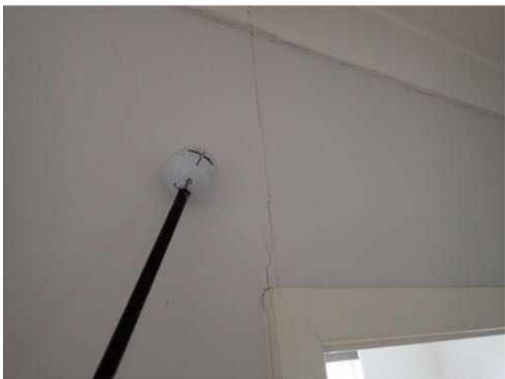
Finding 3.02

Building: Main Building  
Location: All areas  
Finding: Internal Cladding – Cracking  
Information: Minor cracks were identified to internal wall cladding, with a larger crack noted to the bathroom ceiling. This is a common defect for a home of this age and is typically associated with movement, shrinkage, or age-related wear. Cracks may worsen over time if left unaddressed. Monitoring and repair as required is recommended. Works should be carried out by a plasterer or suitably qualified tradesperson.

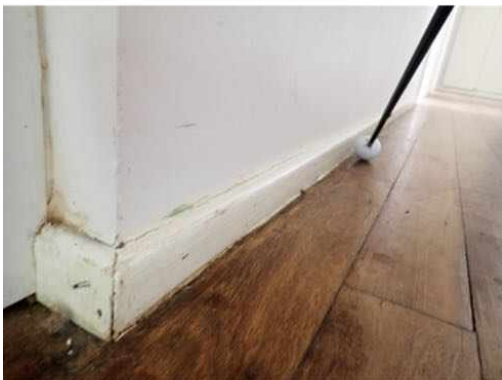
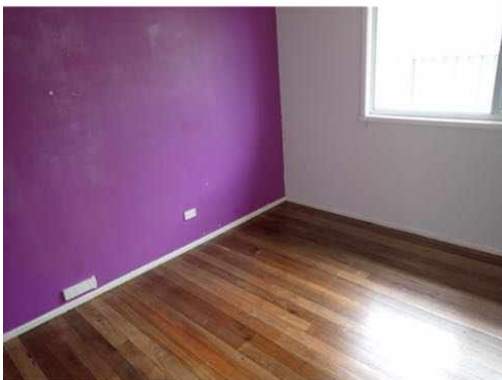
### Finding 3.03

Building:	Main Building
Location:	Internal painted areas
Finding:	Internal Painted Surfaces – Poor Condition
Information:	General internal painted surfaces were observed to be in poor condition. This appears to be consistent with age, wear, and deferred maintenance. Repainting and associated surface preparation is recommended to improve finish and protect underlying materials. Works should be carried out by a painter or suitably qualified tradesperson.

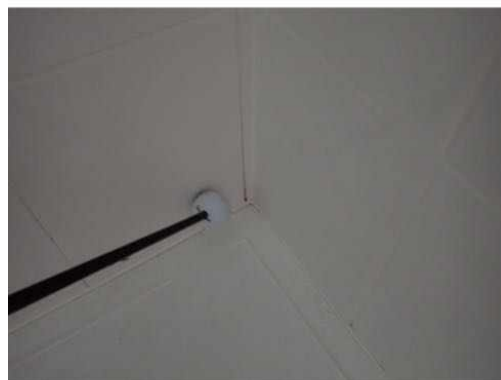
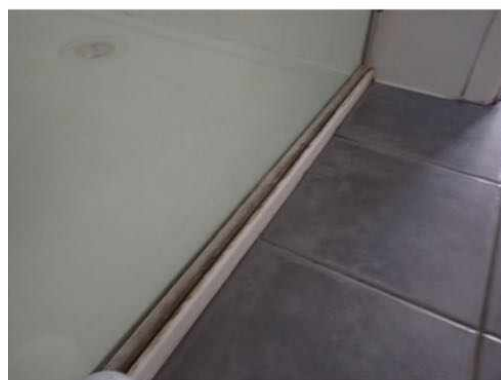
### Finding 3.04

Building:	Main Building
Location:	Bathroom
Finding:	Bathroom – Deteriorated Silicone
Information:	Deteriorated silicone sealant was identified within the bathroom. This condition may allow moisture penetration behind tiled surfaces and contribute to ongoing deterioration if left unaddressed. Removal and replacement of the failed silicone is recommended to maintain adequate water resistance. Works should be carried out by a licensed tiler or suitably qualified tradesperson.

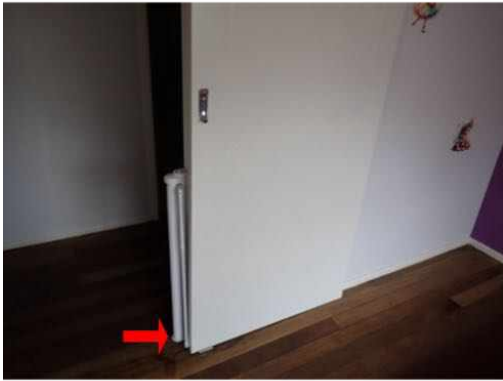
### Finding 3.05

Building:	Main Building
Location:	Bedroom
Finding:	Bedroom Sliding Door – Not Operating
Information:	The sliding door to the bedroom was not operating correctly at the time of inspection. This condition may be due to worn rollers, misalignment, or damaged tracks and may affect usability and security if left unaddressed. Repair or adjustment of the door is recommended as required. Works should be carried out by a carpenter, or suitably qualified tradesperson.

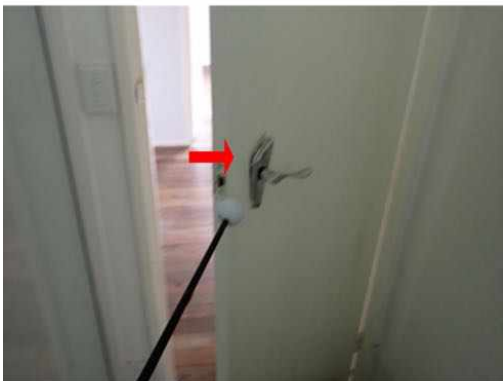
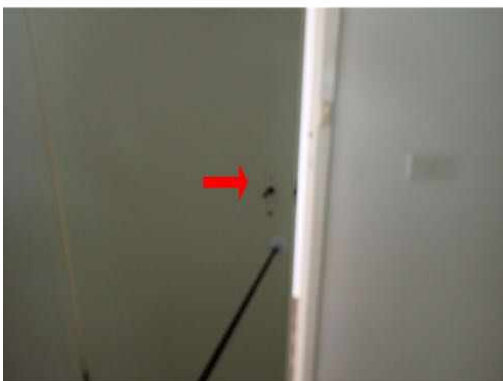
### Finding 3.06

Building: Main Building  
Location: Bathroom and the laundry  
Finding: Bathroom and laundry Door Handles – Damage  
Information: Damage was identified to the bathroom and laundry door handles. This condition may affect the operation and security of the door and could worsen over time if left unaddressed. Repair or replacement of the damaged handle is recommended as required. Works should be carried out by a carpenter or suitably qualified handyman.

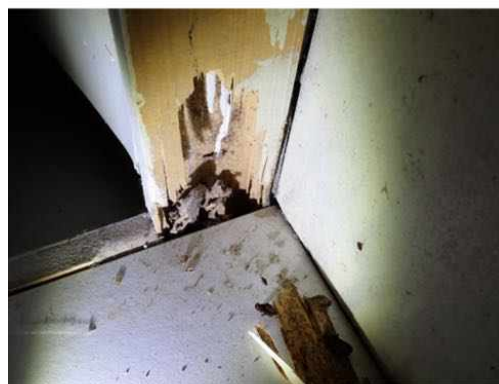
### Finding 5.02

Building:	Main Building
Location:	Laundry
Finding:	Linen Cupboard Door Frame – Termite Damage
Information:	Termite damage was identified to the linen cupboard door frame. This indicates timber pest activity, which may lead to further deterioration if left unaddressed. Further assessment is recommended to determine the extent of damage and whether active infestation is present. Repair or replacement of the affected timber should be carried out as required. Works should be undertaken by a licensed timber pest technician and a suitably qualified carpenter.

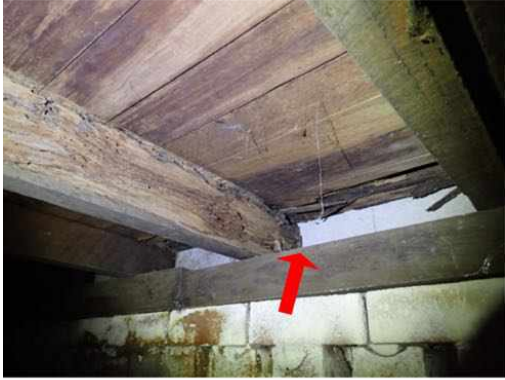
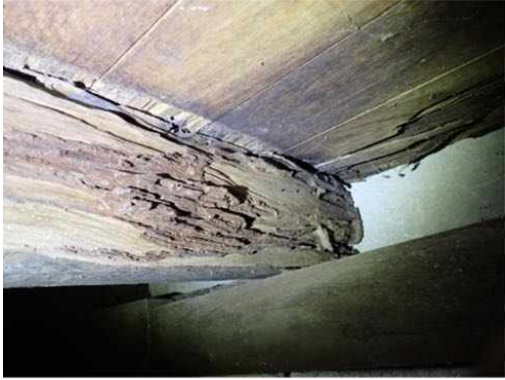
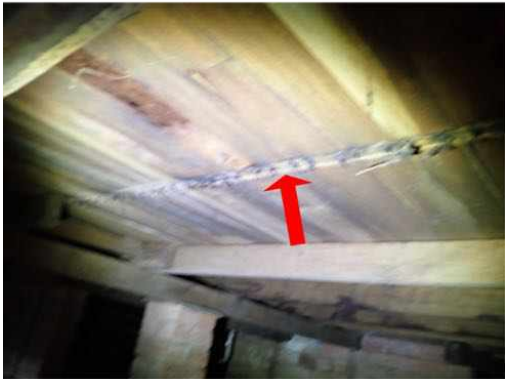
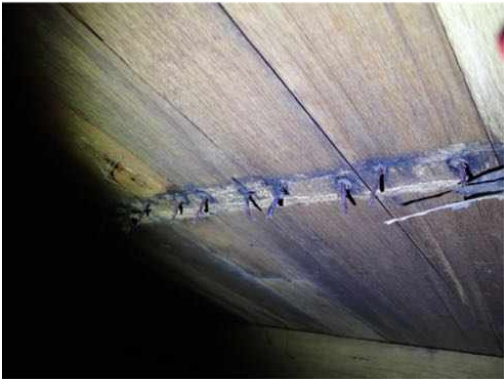
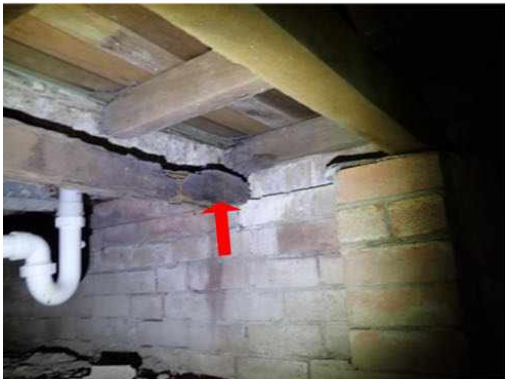
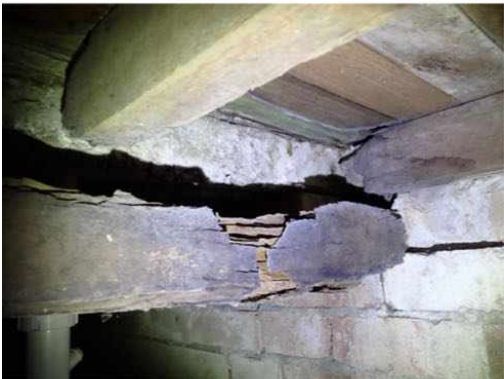
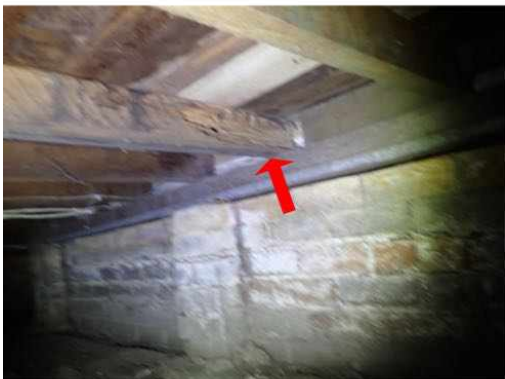
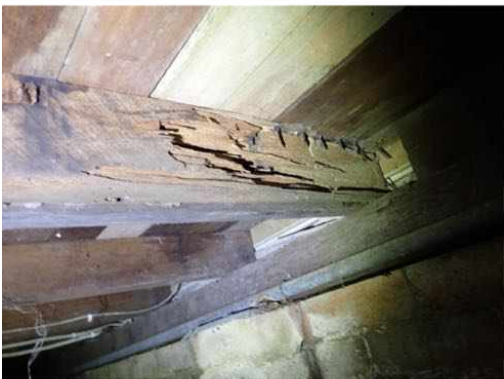
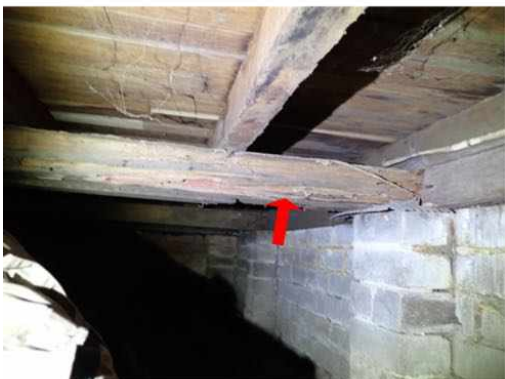
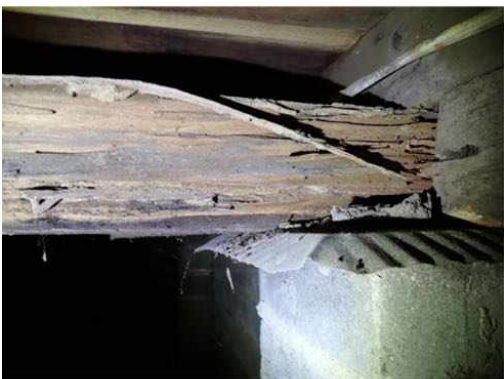
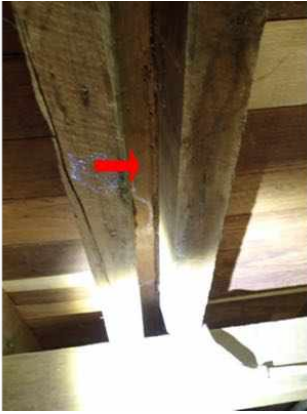
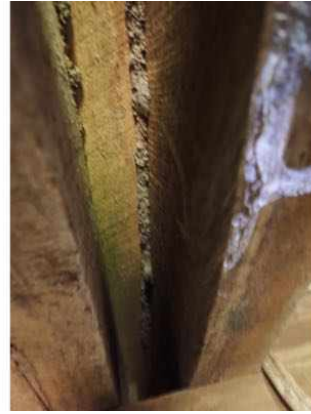
### Finding 5.03

Building:	Main Building
Location:	Subfloor
Finding:	Subfloor – Structural Termite Damage
Information:	Multiple areas of termite damage were identified throughout the subfloor. The extent and nature of the damage are considered structural, indicating a reduction in the load-bearing capacity of affected timbers. Further invasive investigation is required to determine the full extent of damage and whether active infestation is present. Rectification works, including repair or replacement of affected structural timbers, will be required as necessary. Assessment and treatment should be carried out by a

licensed timber pest technician, with rectification works completed by a licensed builder in consultation with a structural engineer if required.

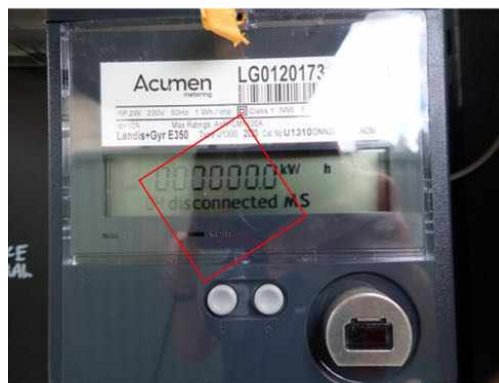
Building:	Main Building
Location:	Electrical Meter box
Finding:	Electrical Supply – Power Disconnected at Time of Inspection
Information:	The electrical power to the property was disconnected at the time of inspection. As a result, the operation of electrical fixtures, fittings, appliances, and systems could not be fully assessed. Any defects relating to the electrical installation may exist but were not observable under these conditions. It is recommended that the electrical system be tested once power is restored. Assessment and any required rectification should be carried out by a licensed electrician.

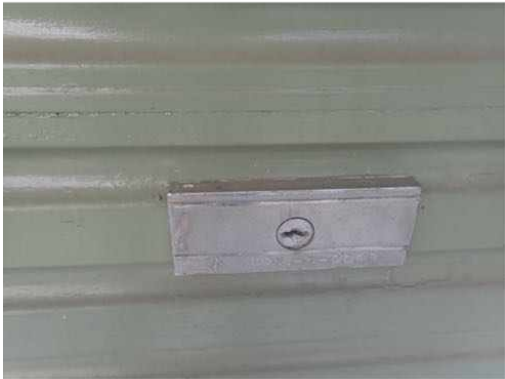
Building:	Main Building
Location:	Garage roller door
Finding:	Garage Roller Door and Ceiling Space – Not Tested / Not Inspected
Information:	The garage roller door was locked at the time of inspection, and there was no electrical power available to operate the door. As a result, the operation and condition of the door and motor (if fitted) could not be fully assessed. In addition, the ceiling manhole was located within the garage, and due to the lack of access, the ceiling space could not be inspected. Defects may exist but were not observable under these conditions. Any required assessment or repairs should be carried out by a garage door specialist or suitably qualified tradesperson once access and power are available.
