Building and Timber Pest Inspection Report

Inspection Date: Thu, 29 Jan 2026

Property Address: 7 Newton St, Shepparton VIC 3630,
Australia, units 1 and 2

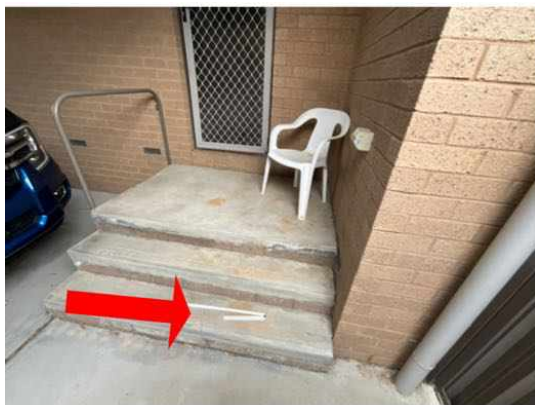
Building: Building 1
 Location: Entry
 Finding: Cracking - External Concrete Paving Damage Category 1 - Fine (less than 2mm)
 Information: Fine cracks were identified in external concrete paving. Although fine cracks are quite noticeable, they are often only considered to be an appearance defect, and usually do not indicate any structural damage. To be considered a Category 1 or fine crack, the crack is found to be less than 2mm in width.

Generally the cause of a hairline crack in existing concrete paving such as driveways and pathways is indicative of the expansion and contraction of the concrete. Such causes are generally due to environmental factors, such as moisture levels, weather conditions, root systems of nearby trees or the soil types on which they are laid.

Fine cracks may also be due to poor original installation of the concrete. Factors such as poor compaction of the sub surface and/or inadequate reinforcing of the slab may create cracking and other secondary defects.

Monitoring of all cracking should be conducted frequently. Always contact a building inspector should cracks widen, lengthen, or become more numerous.

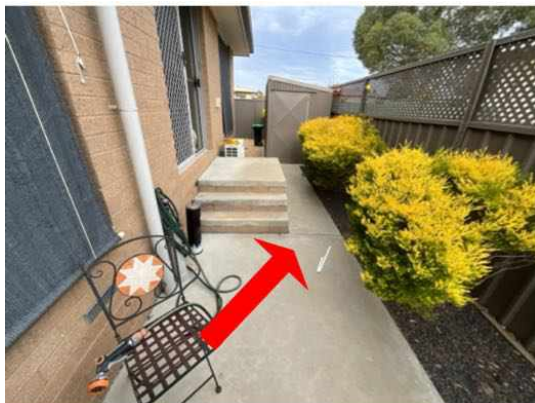
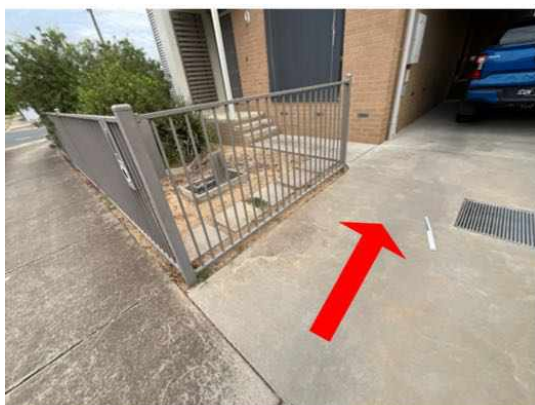
Finding 3.02

Building: Building 1
 Location: Yard - Back, driveway
 Finding: Cracking - External Concrete Paving Damage Category 1 - Fine (less than 2mm)
 Information: Fine cracks were identified in external concrete paving. Although fine cracks are quite noticeable, they are often only considered to be an appearance defect, and usually do not indicate any structural damage. To be considered a Category 1 or fine crack, the crack is found to be less than 2mm in width.

Generally the cause of a hairline crack in existing concrete paving such as driveways and pathways is indicative of the expansion and contraction of the concrete. Such causes are generally due to environmental factors, such as moisture levels, weather conditions, root systems of nearby trees or the soil types on which they are laid.

Fine cracks may also be due to poor original installation of the concrete. Factors such as poor compaction of the sub surface and/or inadequate reinforcing of the slab may create cracking and other secondary defects.

Monitoring of all cracking should be conducted frequently. Always contact a building inspector should cracks widen, lengthen, or become more numerous.

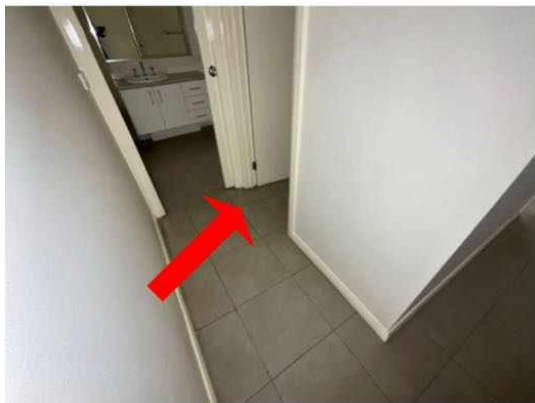
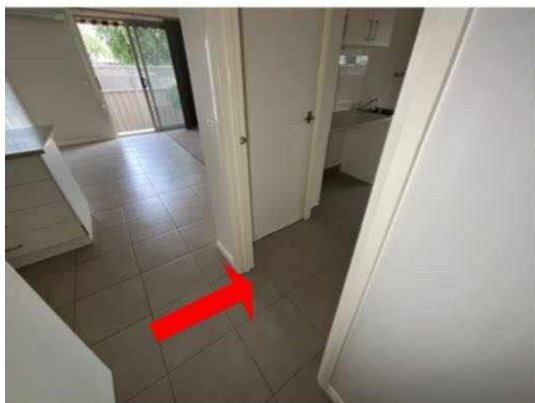
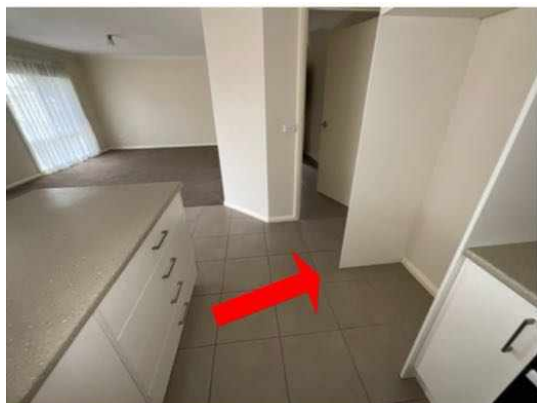
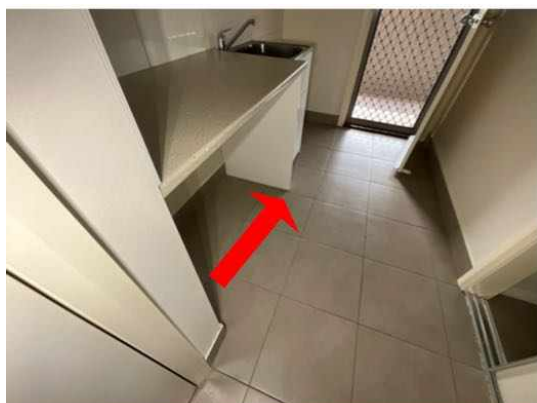
Finding 3.03

Building: Building 2
Location: Hall, laundry, kitchen
Finding: Cracked floor tiles
Information: Cracking in the floor tiles was evident in this area at the time of inspection. It is suspected that this cracking has occurred as a result of minor settlement or impact damage.

Cracked tiles throughout the household detract from the overall appearance of the affected areas however it is unlikely to create or lead to any secondary defects.

While not considered a matter of urgency, replacement of cracked floor tiles is recommended at the clients discretion. A tiling contractor may be appointed to perform these works. Where cracks become more numerous, contact a licensed building inspector for further investigation.

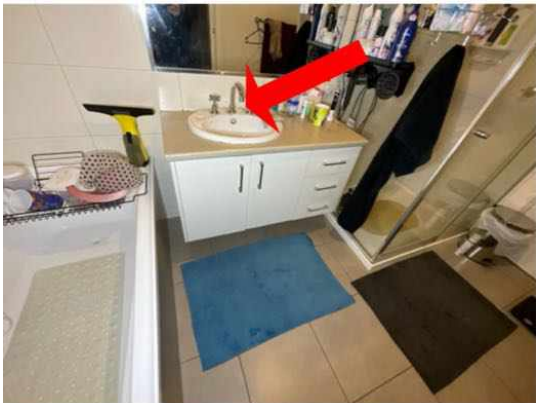
Location: Bathroom
Finding: Inadequate sealant or Grout
Information: This area has a lack of effective Sealant or Grout. This is allowing the ingress of water to the structure inside the wall.

The presence of water encourages Termite attack, Mould and Fungal Decay.

A Tiler or General Handy person must be contacted as soon as possible to effect repairs and prevent further deterioration.

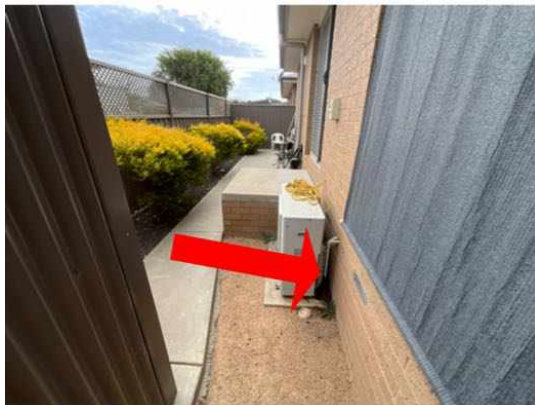
Finding 6.02

Building:	Building 1
Location:	Yard - Back
Finding:	Air conditioner - Disconnected overflow
Information:	The Air Conditioner (A/C) overflow was found to be disconnected from storm water drainage and is creating excessive moisture in the surrounding area.

Such leaking creates an environment which is conducive to an array of defects, including water damage to associated building elements and the attraction of termite or timber pest infestation.

It is highly recommended that a licensed plumber be appointed to connect the A/C overflow in order to prevent such an environment from being created. These minor works should be carried out as soon as possible.

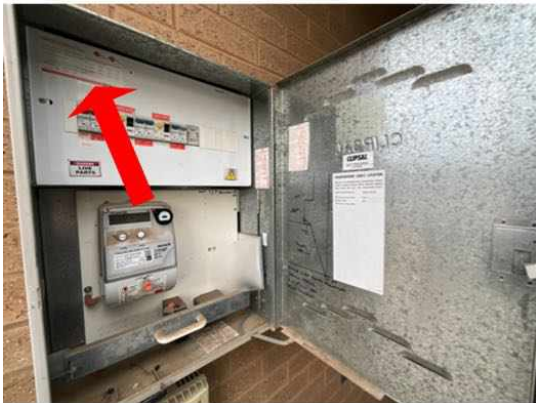
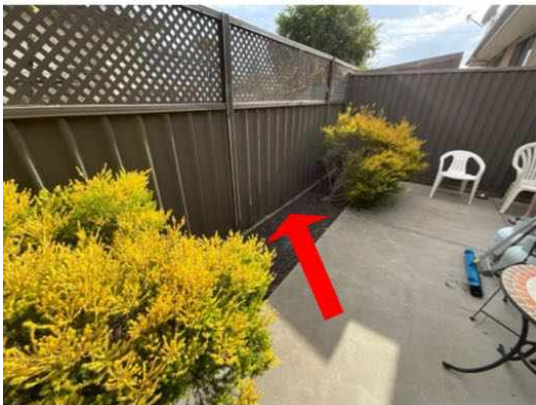
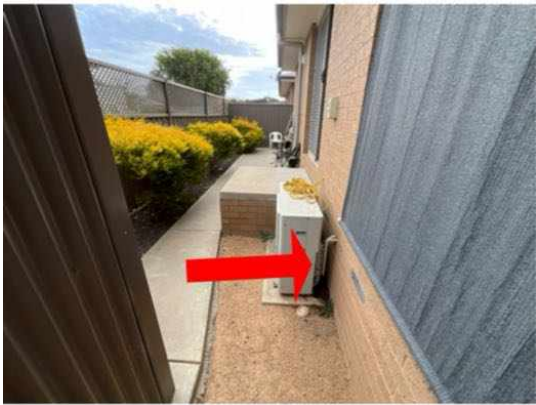
Location: All Areas
Finding: Termite Management System - no evidence of a chemical installation
Information: The application of a post-construction chemical termite barrier is highly recommended for all properties, particularly if live termite activity has been found on the site previously. Such barriers are highly effective in preventing termite attack on any timber building elements throughout the property.

A durable notice should be placed in the switchboard unit to indicate current termite barriers. At the time of inspection, it appeared as though no termite management system has been installed, with no evidence to suggest preventative works taking place.

The client may consider gaining further advice from a pest controller as to the costs and procedures involved with this application. It is recommended that obtaining such advice be a short-term priority.

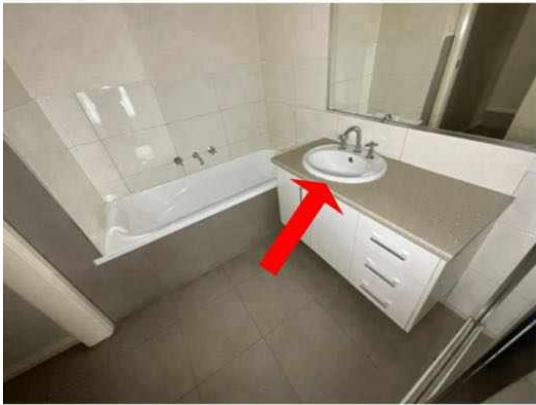
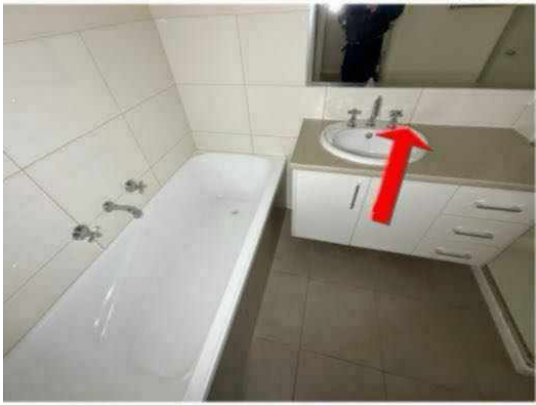
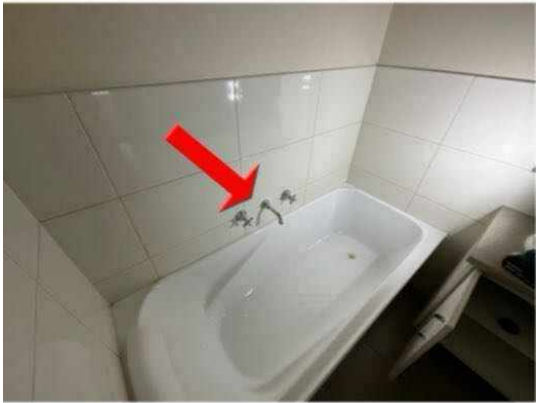
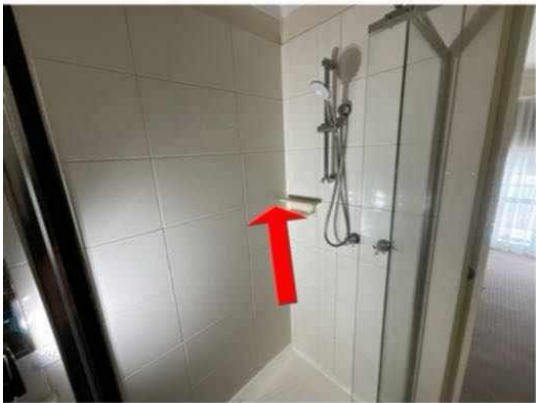
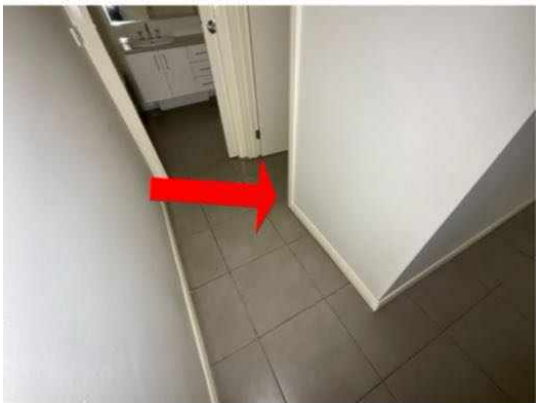
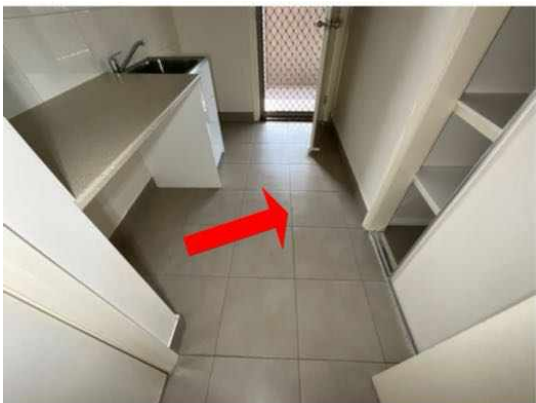
Finding 6.05

Building: Building 2
 Location: Bathroom, Wc, laundry
 Finding: Inadequate sealant or Grout
 Information: This area has a lack of effective Sealant or Grout. This is allowing the ingress of water to the structure inside the wall.

The presence of water encourages Termite attack, Mould and Fungal Decay.

A Tiler or General Handy person must be contacted as soon as possible to effect repairs and prevent further deterioration.

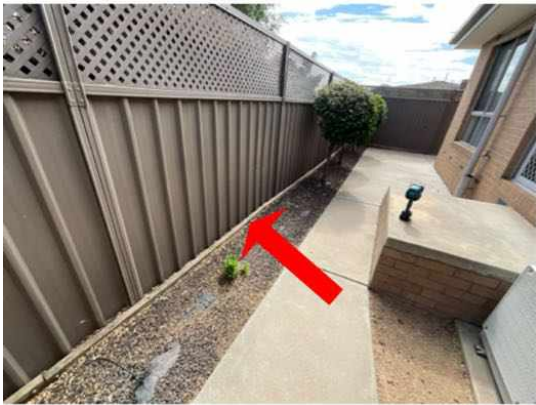
Finding 6.06

Building: Building 2
Location: Yard - Back, front
Finding: Untreated or non-durable timbers in a hazardous environment
Information: To reduce the risk of timber pest attack it is essential that timber used in a hazardous environment (e.g. in direct contact with the ground or frequently exposed to damp conditions) is of sufficient durability and/or is adequately preservative treated.

Untreated timbers in direct contact with the ground are likely to develop severe wood rot and/or fungal decay if left unattended creating attraction for subterranean termites to infest the timbers from surrounding areas.

If untreated or non-durable timbers are found to be in a hazardous environment it is highly advised that replacement of these building elements be performed as soon as possible to aid the protection of the property against termite / timber pest attack.

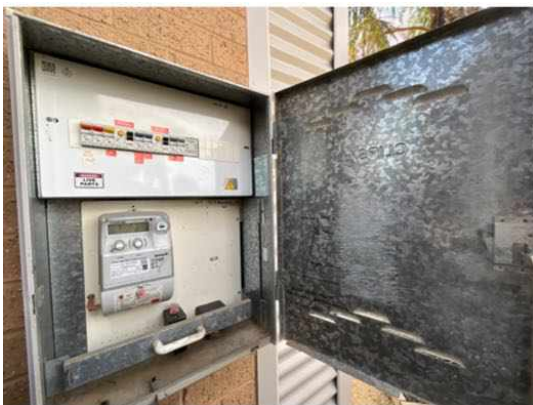
Finding 6.07

Building:	Building 2
Location:	All Areas
Finding:	Termite Management System - no evidence of a chemical installation
Information:	The application of a post-construction chemical termite barrier is highly recommended for all properties, particularly if live termite activity has been found on the site previously. Such barriers are highly effective in preventing termite attack on any timber building elements throughout the property.

A durable notice should be placed in the switchboard unit to indicate current termite barriers. At the time of inspection, it appeared as though no termite management system has been installed, with no evidence to suggest preventative works taking place.

The client may consider gaining further advice from a pest controller as to the costs and procedures involved with this application. It is recommended that obtaining such advice be a short-term priority.

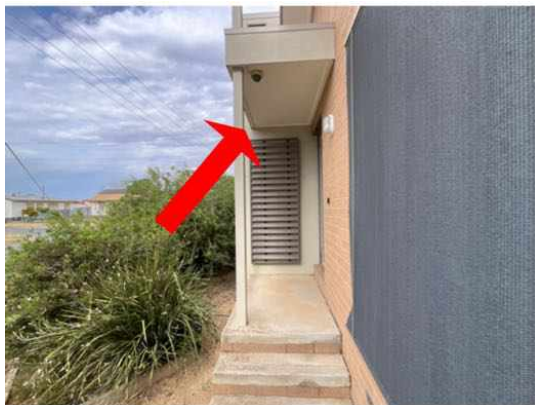
Building: Building 1
 Location: Entry
 Finding: Timber - exposed to weather
 Information: External timbers that are frequently exposed to harsh weather conditions require adequate protection in order to maintain their condition. Where timbers have not been painted or treated adequately, general deterioration is likely to occur at an accelerated rate.

If left unattended, replacement of these timbers is likely to be necessary in the short-term future. Adequate treatment of these timbers is required as soon as possible by a painting contractor or general handyman.

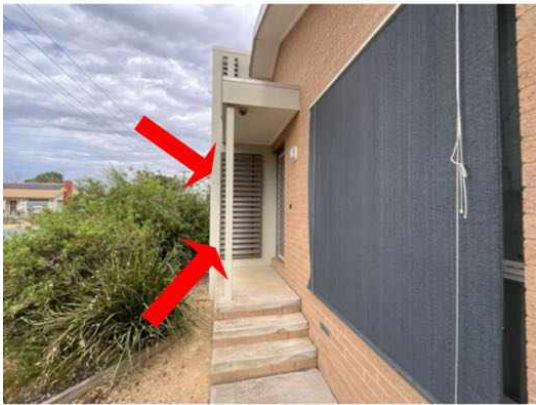
Building: Building 1
 Location: Entry
 Finding: Render- Cracking
 Information: Cracking to the render in this area was identified at the time of inspection.

This type of cracking is often consistent with general dilapidation of the property, and may continue to develop if left unmaintained.

Frequent monitoring should be carried out to identify any further damage.

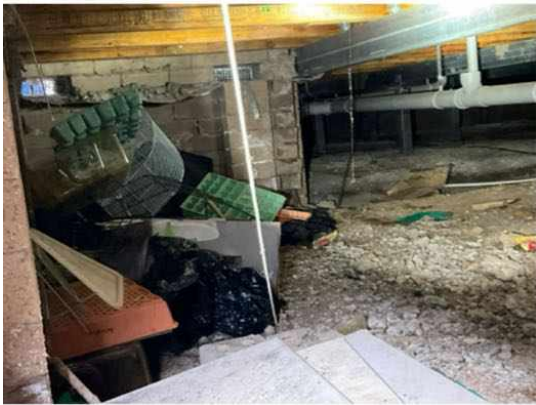
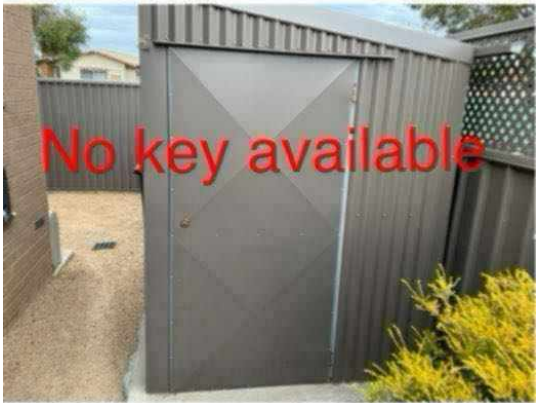
Building: Building 1
 Location: All Areas
 Finding: Additional Photos - Obstructions and Limitations
 Information: These photographs are an indication of the obstructions and limitations which impeded full inspection of the property at the time of inspection. These obstructions can hide an array of defects and should be removed to allow full inspection to be carried out. A re-inspection is recommended once the areas are made accessible.

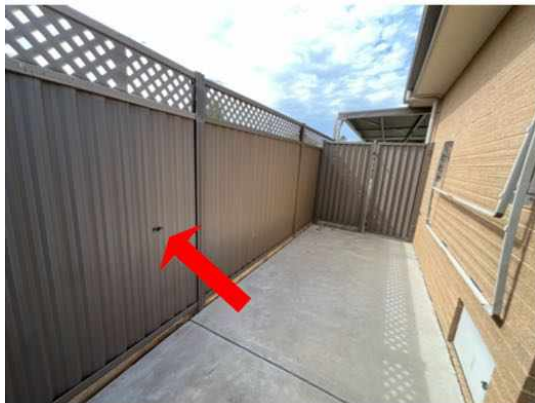
Building: Building 2
 Location: Fence
 Finding: Paint residue
 Information: The fence shows a kind of overspray of paint. This is a cosmetic defect in this case.

No action is required except at the discretion of the client.

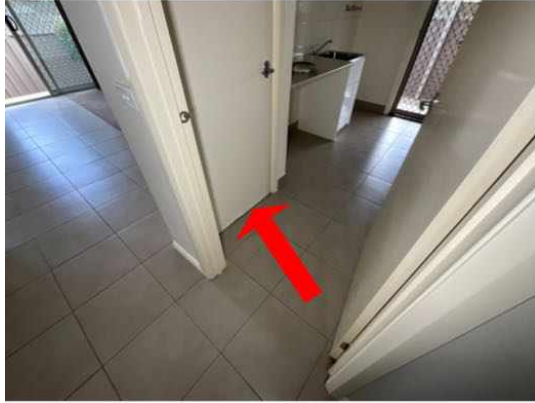
Building: Building 2
 Location: Laundry
 Finding: MDF- Moisture affected
 Information: The Particle board (MDF) in this area has been affected by excess moisture. This moisture has caused swelling of the material. A lack of effective paint or other coating has probably allowed the moisture to penetrate and deteriorate the material over time.

In cases of minor swelling a painter or Handy person could re-paint and restore the area.

In cases where the material is structurally compromised a carpenter or General handy person could be contacted to replace the damaged elements and complete all needed restoration.

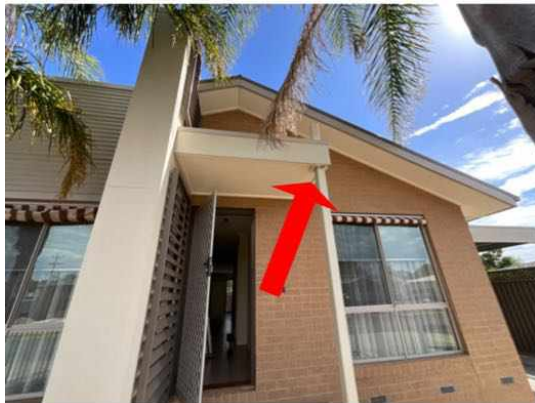
Building: Building 2
 Location: Entry
 Finding: Timber - exposed to weather
 Information: External timbers that are frequently exposed to harsh weather conditions require adequate protection in order to maintain their condition. Where timbers have not been painted or treated adequately, general deterioration is likely to occur at an accelerated rate.

If left unattended, replacement of these timbers is likely to be necessary in the short-term future. Adequate treatment of these timbers is required as soon as possible by a painting contractor or general handyman.

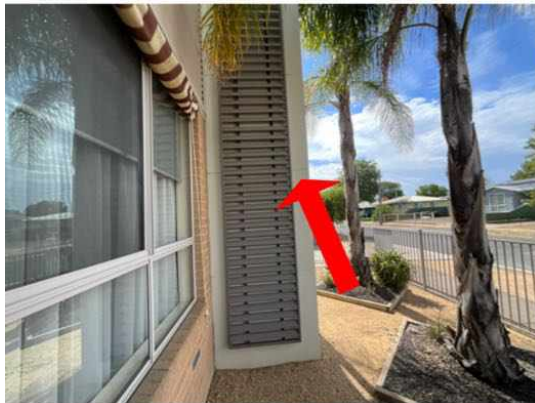
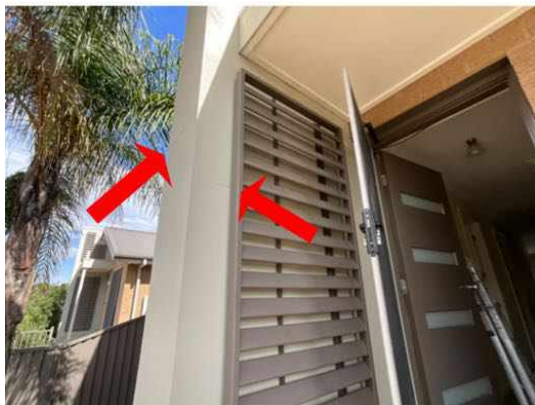
Building: Building 2
 Location: Entry
 Finding: Render- Cracking
 Information: Cracking to the render in this area was identified at the time of inspection.

This type of cracking is often consistent with general dilapidation of the property, and

may continue to develop if left unmaintained.

Frequent monitoring should be carried out to identify any further damage.

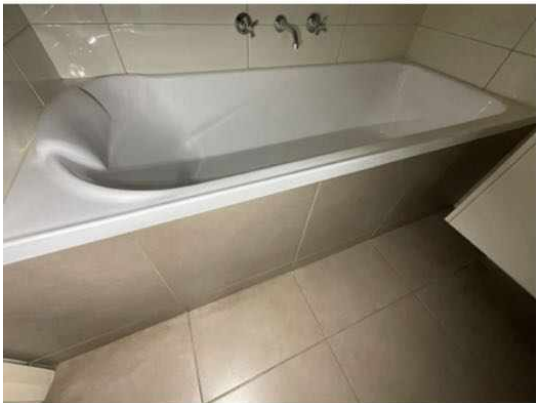
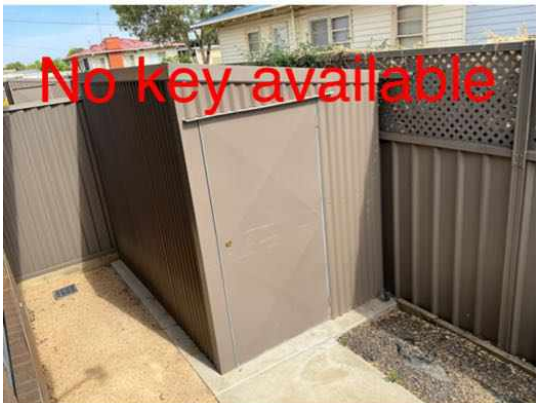
Building:	Building 2
Location:	All Areas
Finding:	Additional Photos - Obstructions and Limitations
Information:	These photographs are an indication of the obstructions and limitations which impeded full inspection of the property at the time of inspection. These obstructions can hide an array of defects and should be removed to allow full inspection to be carried out. A re-inspection is recommended once the areas are made accessible.
