Building and Timber Pest Inspection Report

Inspection Date: Wed, 25 Mar 2026

Property Address: 5 Kuraji Close, Glenmore Park NSW 2745

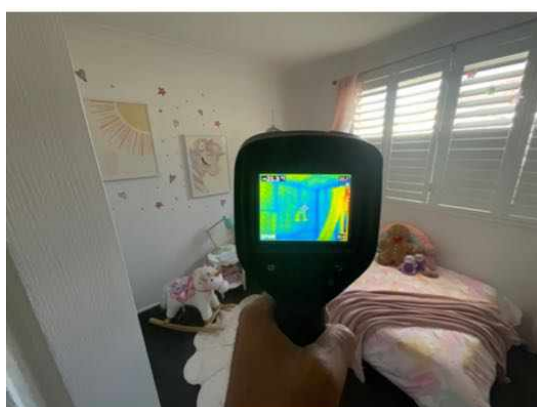
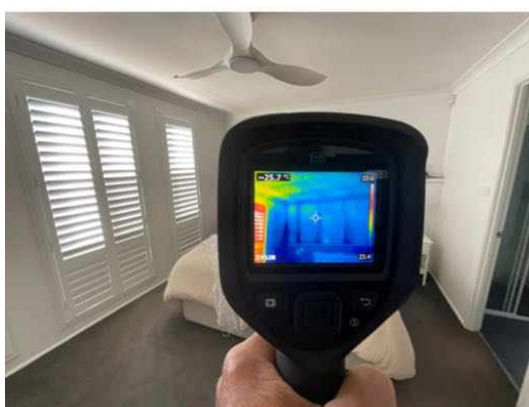
Termites release heat in the form of carbon dioxide and build mud tubes with high moisture content, which can create irregular heat patterns on surfaces such as walls, ceilings, and floors.

At the time of the inspection, no abnormalities indicating live termite activity were observed. However, it's important to note that various factors—such as obstructions, ambient temperature, and wall material/thickness—can impact the accuracy of thermal readings. In cases where surfaces are visually restricted or obstructed, a comprehensive thermal scan may not always be feasible.

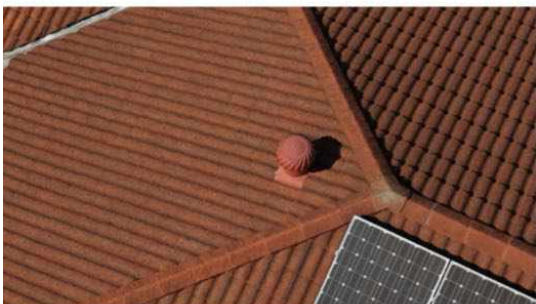
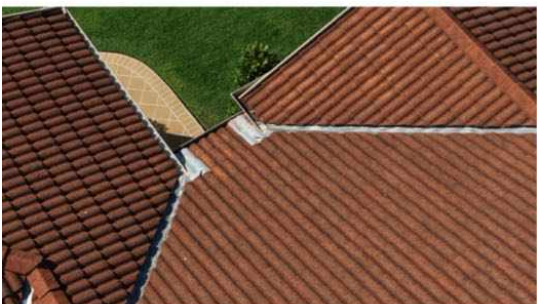
Building: Main Building
Location: Roof Void
Finding: Roof Void – Limited Accessibility..
Information: Observation:

Installation of an additional manhole is recommended to facilitate a re-inspection and enable a more thorough assessment of the roof void in the future. This will help ensure that all structural elements and concealed areas are properly evaluated.

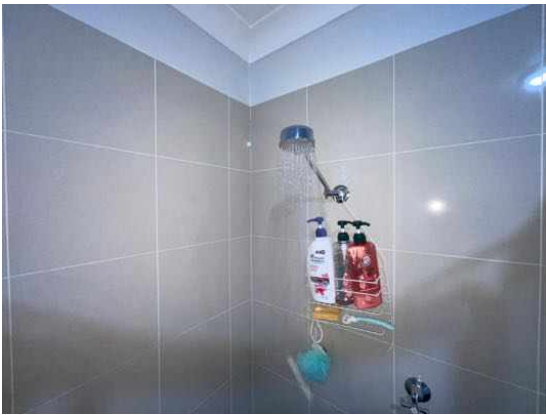
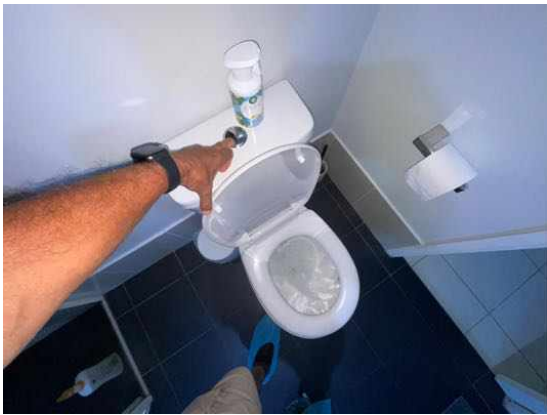
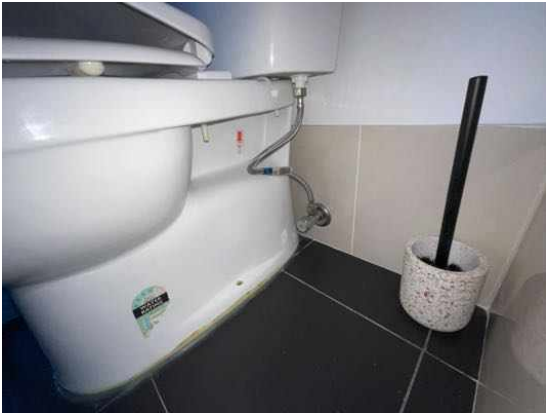
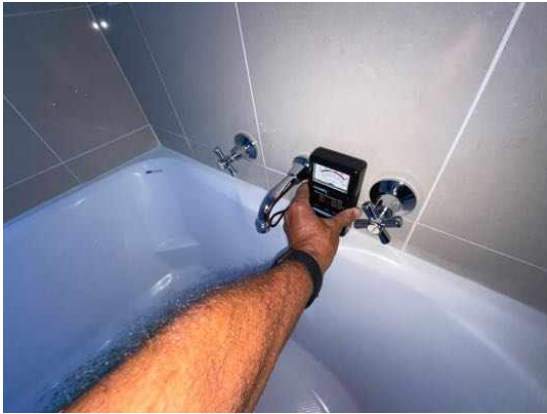
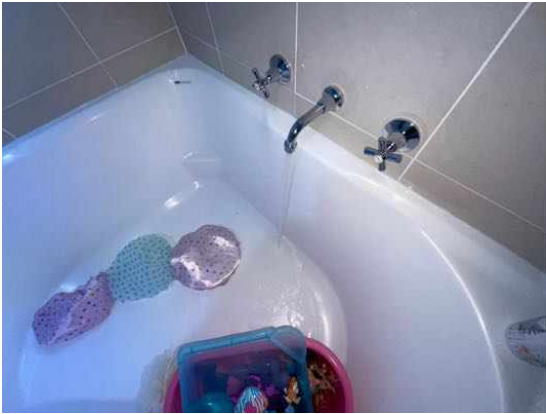
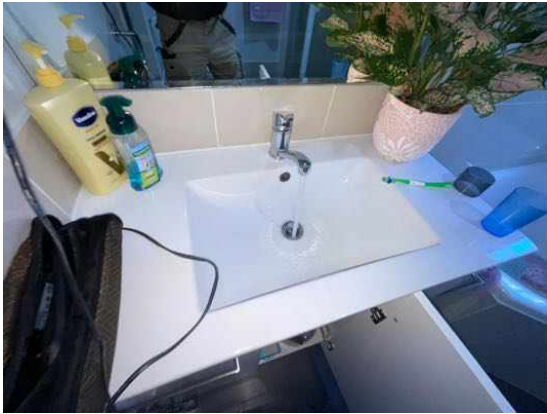
Building: Main Building
Location: Ensuite
Finding: Wet Areas - Bathroom(s) - Overall Condition & Recommendations.
Information: Overall Condition & Recommendations

It is not possible under the visual inspection criteria of a standard pre-purchase report to categorically determine if leaks are present. If a more detailed or accurate assessment is required, a special-purpose inspection should be undertaken.

Alternatively, the assumption should be made that leakage may occur, particularly where historical or environmental conditions are conducive. The visual nature of this inspection cannot detect issues concealed behind wall/floor linings or cabinetry, and invasive investigation may be necessary to confirm the true condition of adjacent or hidden structures.

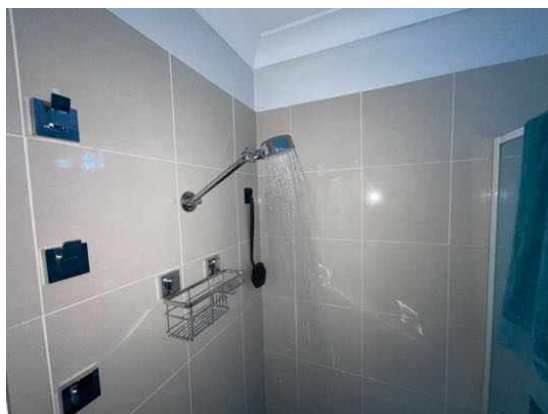
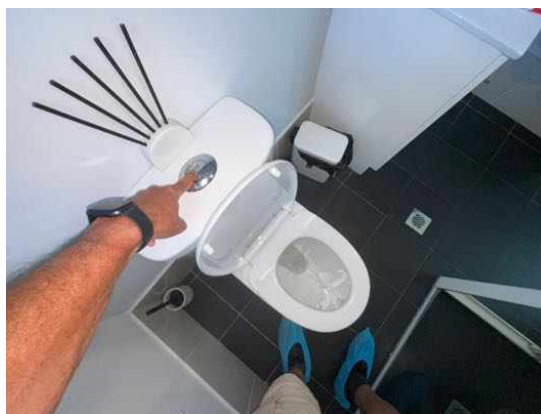
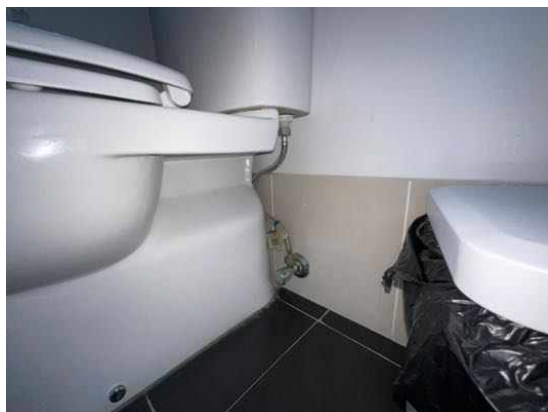
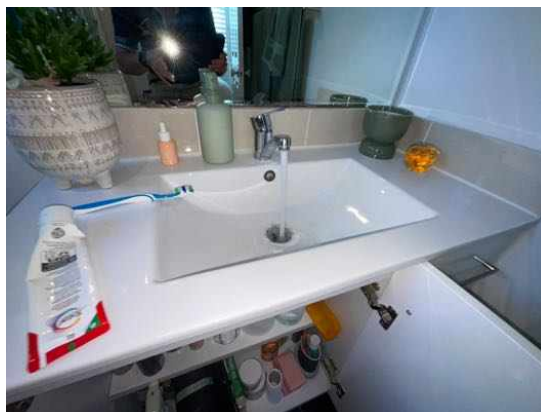
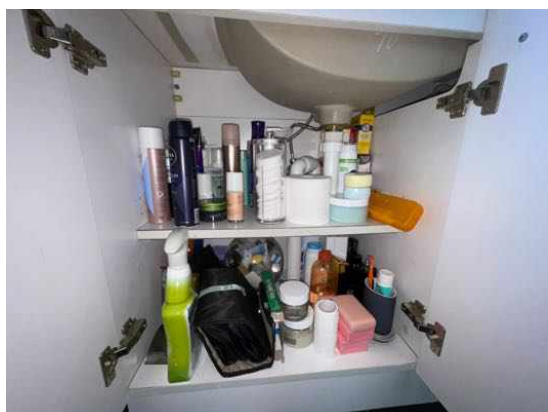
Building: Main Building
 Location: All Areas
 Finding: Water Pressure – Observation Only.
 Information: During the inspection, water pressure appeared to be within a normal operating range based on a basic functional check. However, this observation was made without the use of pressure testing equipment and does not constitute an assessment by a licensed plumber.

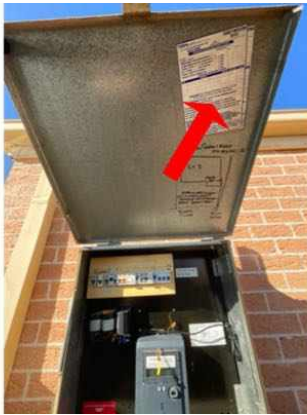
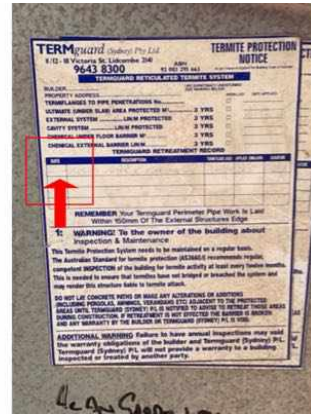
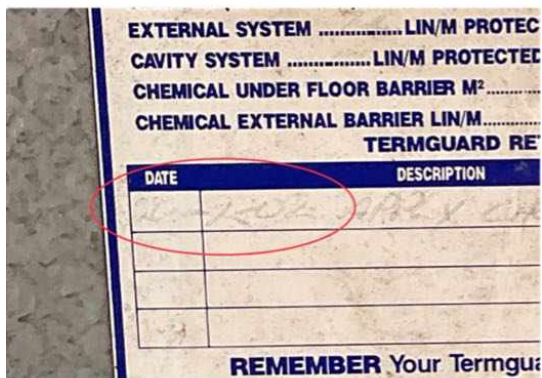
Building:	Main Building
Location:	All Areas
Finding:	Termite Management System – Chemical Barrier (Previous Treatment Noted)
Information:	Observation:

Chemical termite barriers are designed to provide a protective treated zone around and/or beneath the structure to deter or eliminate subterranean termite activity. While such systems can be effective, their performance is time-limited and dependent on factors including product type, soil conditions, environmental exposure, and whether regular re-treatment or top-ups have been undertaken.

Where a system is out of date or not maintained in accordance with manufacturer specifications, the level of protection is significantly reduced or may no longer be effective. This may leave the property vulnerable to concealed termite entry and potential timber damage without obvious external signs.

This assessment is based on visible evidence only and the presence of the durable notice. No invasive inspection, soil testing, or verification of the extent, continuity, or effectiveness of the chemical barrier was undertaken. The actual condition, coverage, and residual efficacy of the system cannot be confirmed. Hidden termite activity may

exist in concealed areas not accessible at the time of inspection.

It is recommended that the client obtain further clarification from a licensed pest management professional regarding the original installation, including treatment date, chemical type, design life, and any maintenance or replenishment history.

A current termite management plan should be established, which may include re-treatment, installation of a new chemical barrier, or implementation of an alternative management system in accordance with relevant Australian Standards. Ongoing routine inspections at intervals not exceeding 12 months (or more frequently where conditions warrant) are strongly advised to ensure continued protection.
