Building and Timber Pest Inspection Report

Inspection Date: Mon, 16 Mar 2026

Property Address: 48/120-124 Cabramatta Rd E, Cabramatta
NSW 2166, Australia

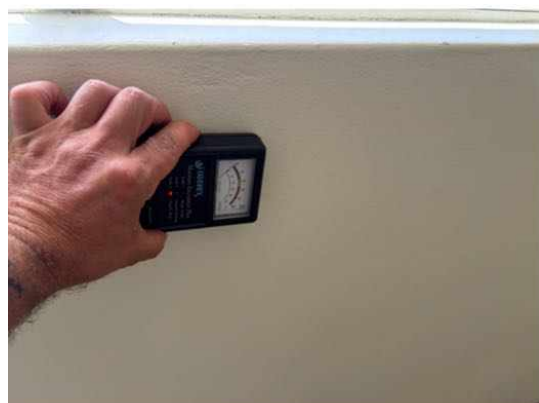
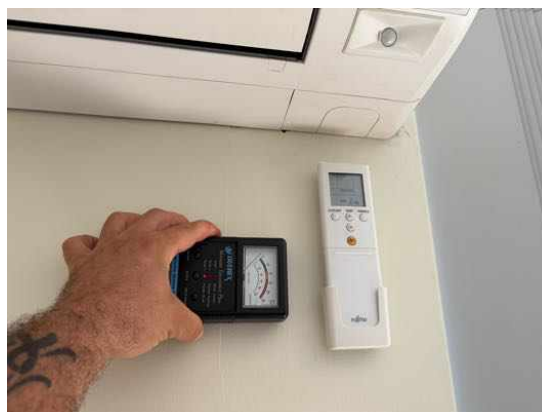
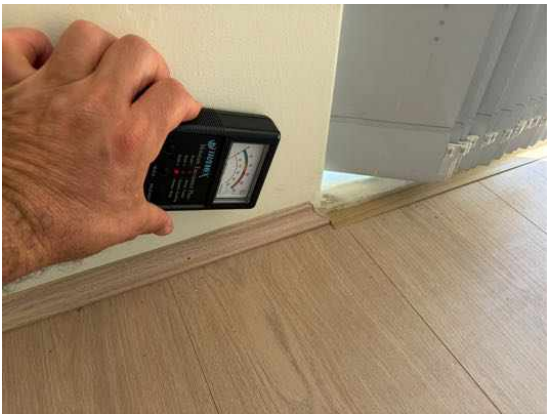
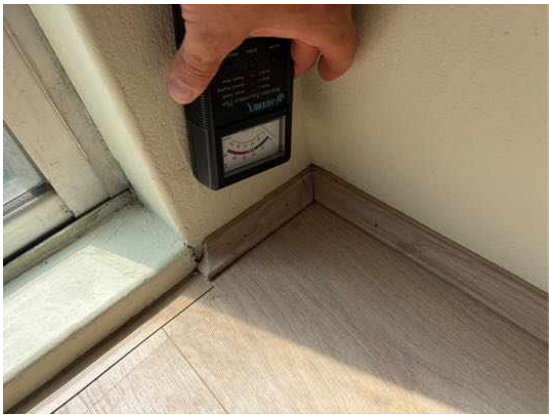
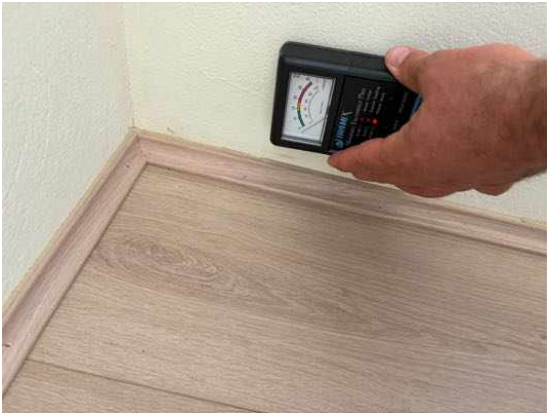
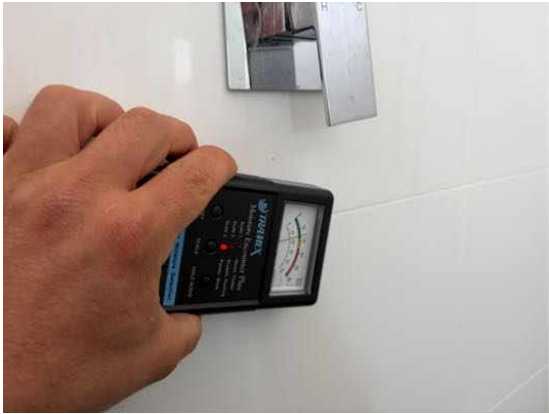
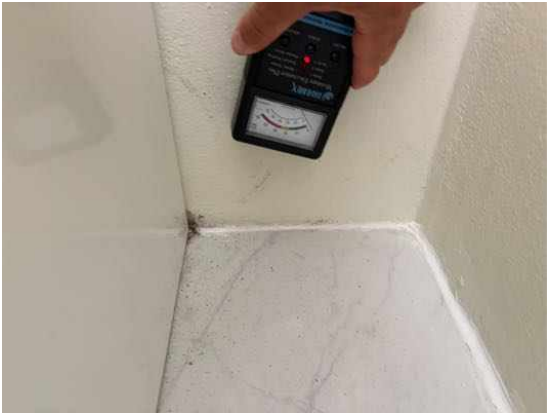
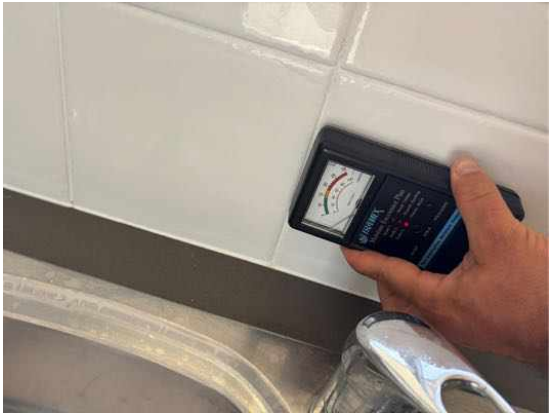
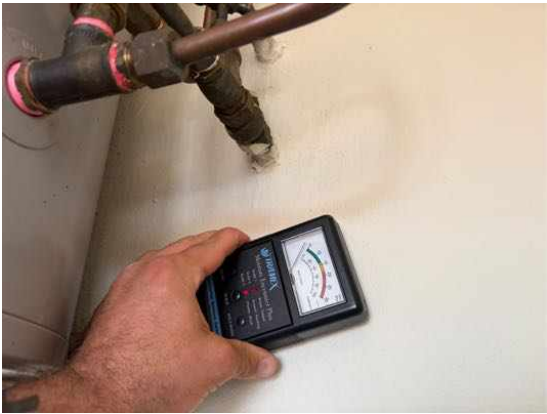
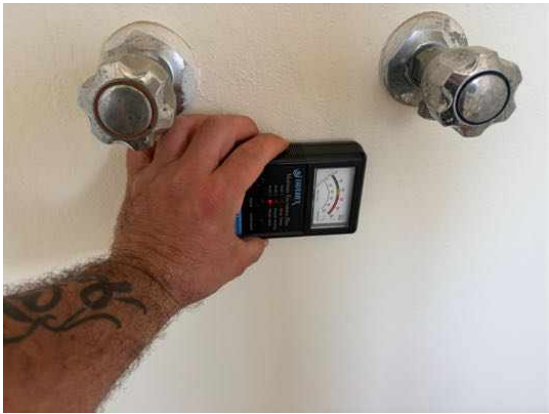
Building: Main Building
 Location: All Areas
 Finding: Moisture metre
 Information: During the inspection the property was checked for moisture using a moisture metre.

This is for information only.

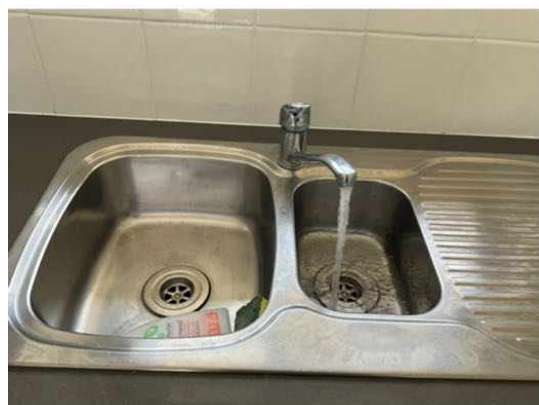
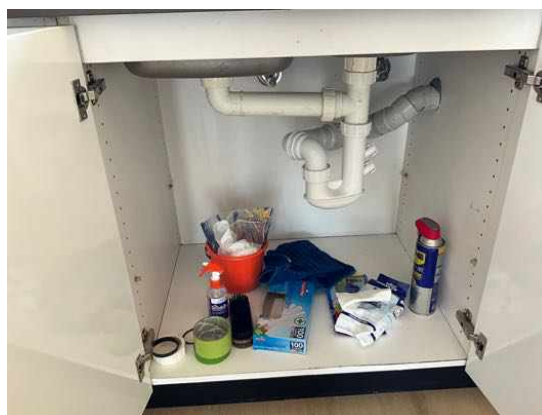
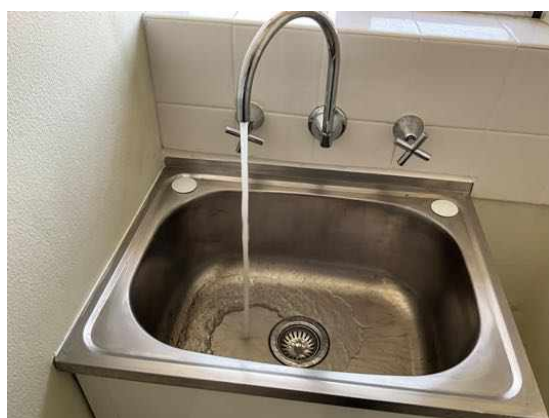
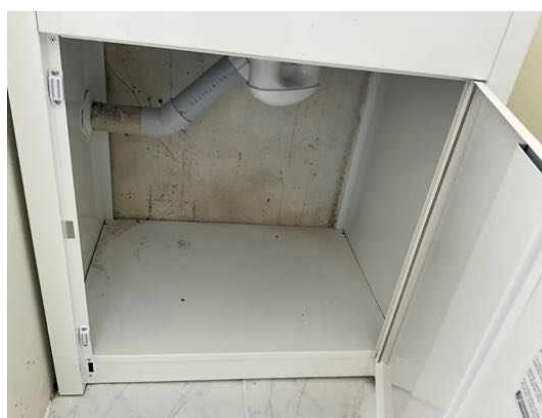
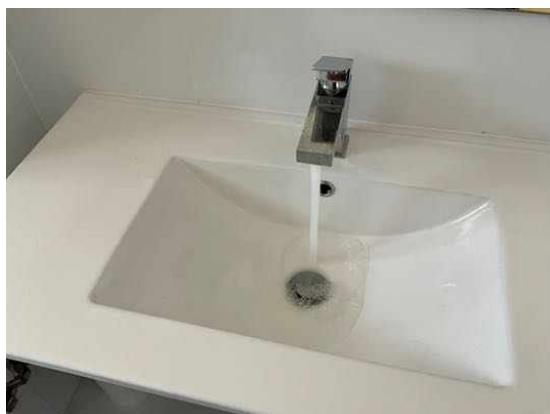
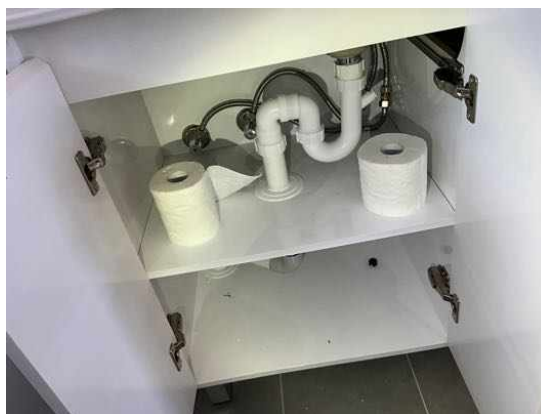
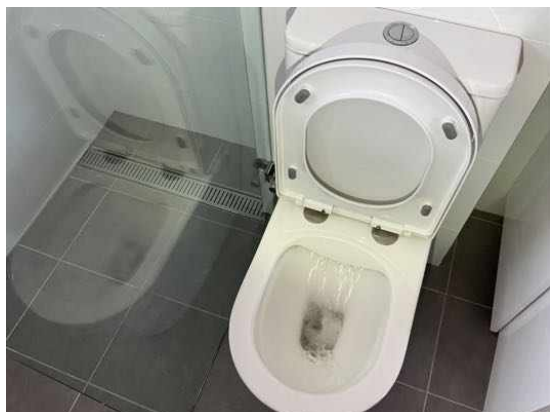
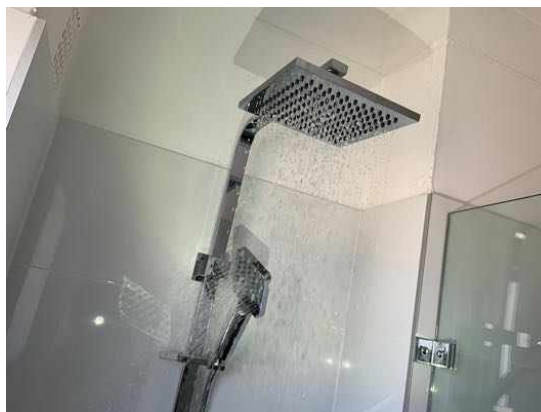
Building: Main Building
Location: All Wet Areas
Finding: Waterproofing
Information:

All taps, mixers and toilets were tested for operation, except for those obstructed. The waterproofing to the shower recess was assessed by checking the walls in and around the shower recess for varying moisture content. There were no significant variations across the tested areas. No sign of recent water damage was evident upon a visual inspection of the surrounding walls, where the visual nature of the inspection was possible.

Consequently, there is no conclusive evidence of any current shower recess leakage other than those which may have already been mentioned earlier in this report. It is reasonable to assume the shower waterproofing is sound. Note that if the shower is not used, or has not been used for some time, moisture readings would not vary significantly and this can lead to erroneous results. It is not possible under the visual inspection criteria (under which a prepurchase inspection is carried out) to categorically determine if there are leaks. If a more accurate assessment is required, a special purpose inspection should be requested. Alternatively, the assumption should be made that the shower may leak.

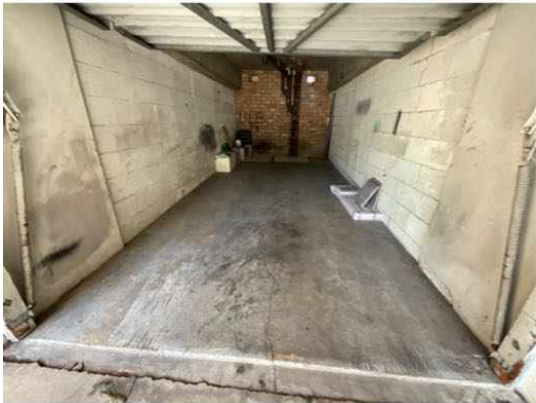
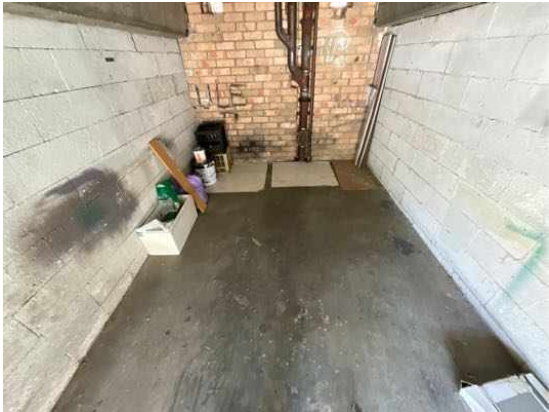
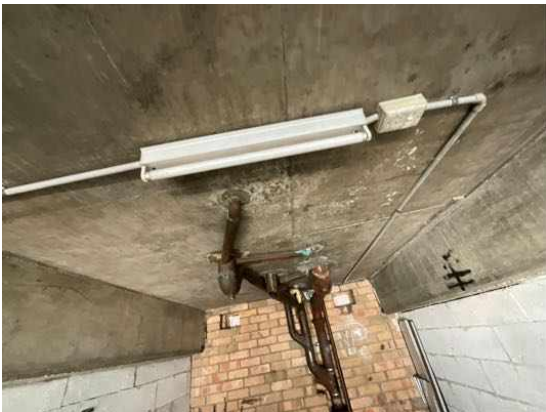
Building:	Main Building
Location:	Garage
Finding:	Additional Photos- Garage
Information:	Additional photos are provided for your general reference. Arrows may have been included to highlight areas of importance. Please discuss these photos with your building consultant for clarification.

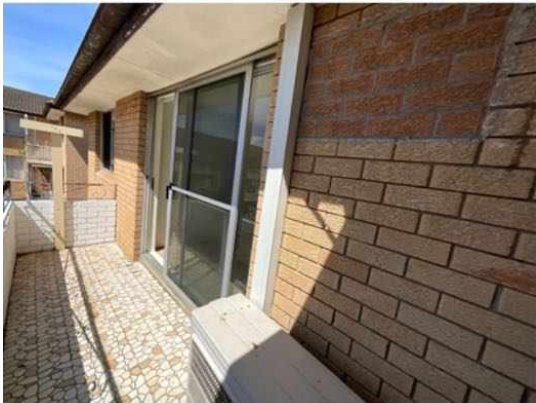
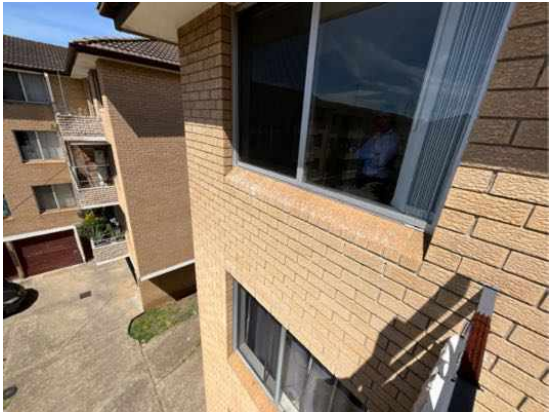
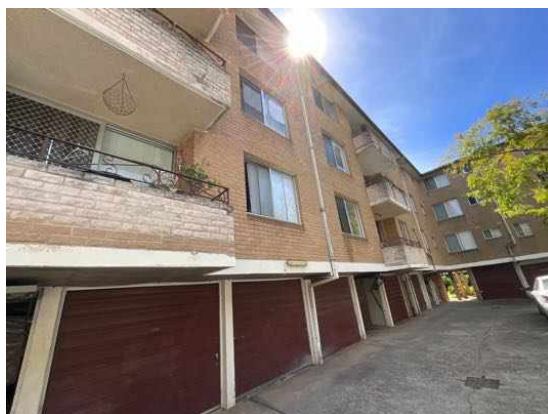
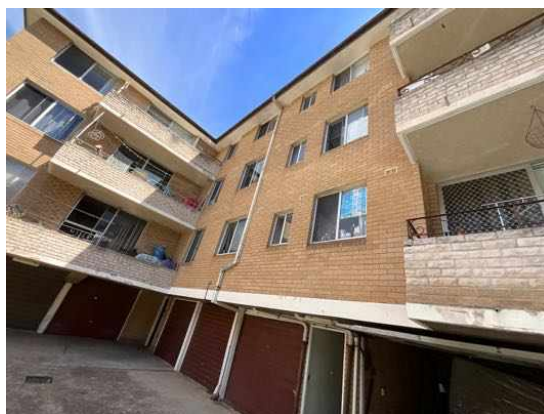
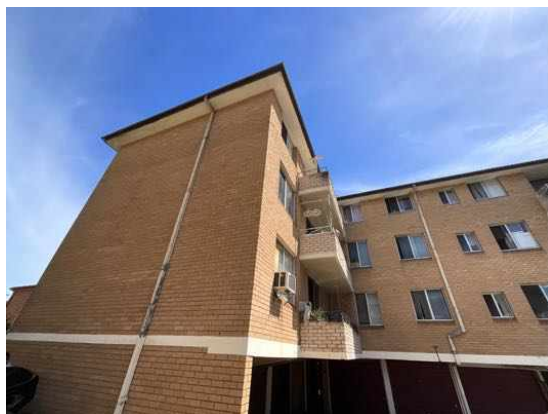
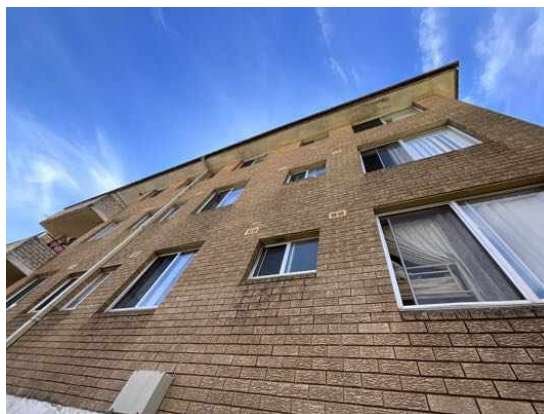
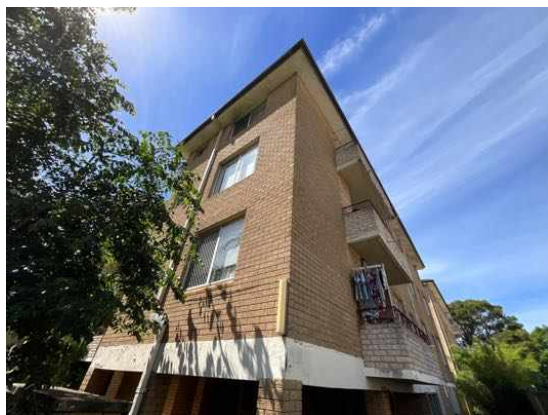
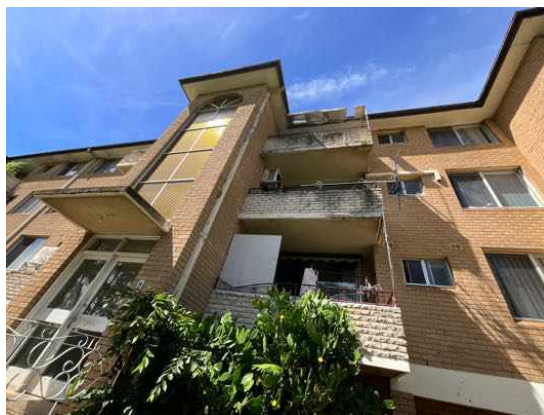
Building: Main Building
Location: Exterior
Finding: Additional Photos
Information:

Additional photos are provided for your general reference.

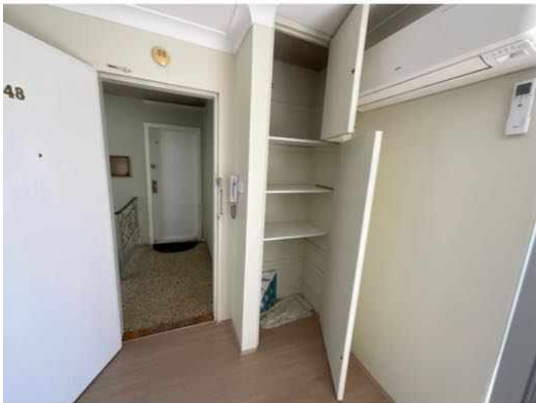
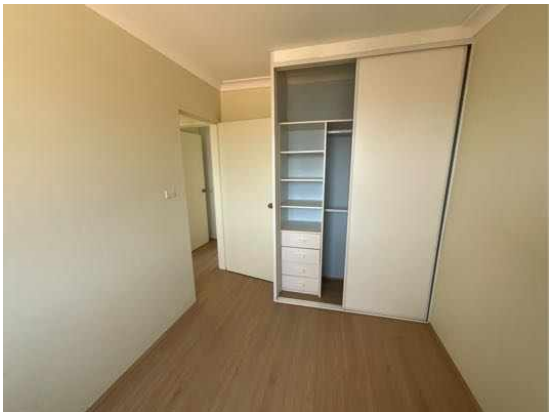
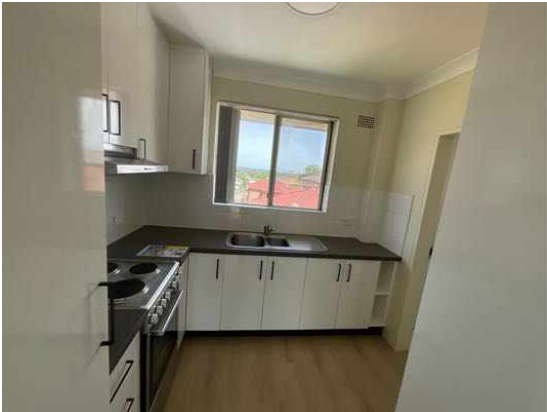
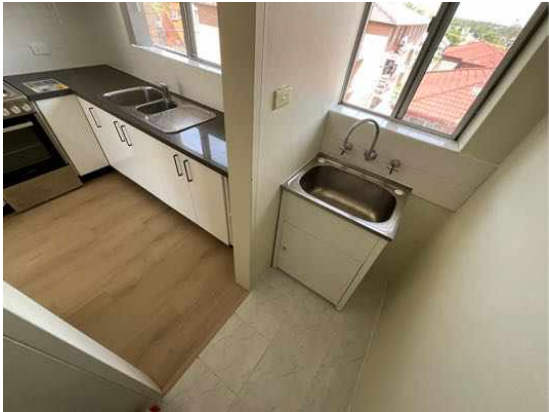
Building: Main Building
Location: All Areas
Finding: Additional Photos - Obstructions and Limitations
Information:

These photographs are an indication of the obstructions and limitations which impeded full inspection of the property at the time of inspection. These obstructions can hide an array of defects and should be removed to allow full inspection to be carried out. A re-inspection is recommended once the areas are made accessible.
