# Building and Timber Pest Inspection Report

Inspection Date: Tue, 20 Jan 2026

Property Address: 7 Brookside St, Upwey VIC 3158, Australia

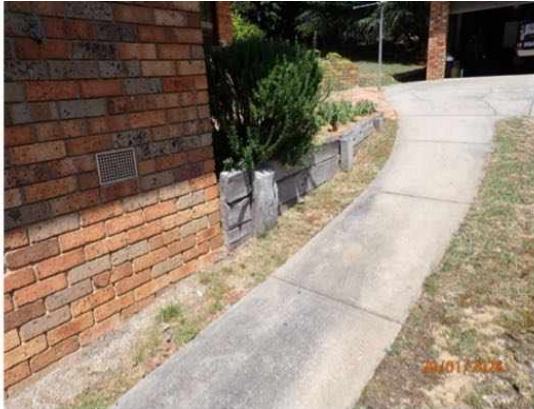
#### Finding 3.02

Building: Main Building  
 Location: All External Areas  
 Finding: Retaining wall - Defective  
 Information: The retaining wall in this area was found to be defective at the time of inspection.

Generally, defective retaining walls are caused by poor original design or material use. However, deteriorated retaining walls may also be a result of substandard construction, poor site drainage or unmanaged stormwater flows.

If left unmanaged, the retaining wall may become a safety hazard if it continues to destabilise. Where retaining walls further rot and decay, an environment is created that is conducive to termite and pest infestation.

Significant repair and replacement should be expected. Where retaining walls are considered structural walls, a structural engineer / surveyor should be consulted regarding required remedial works. Otherwise, a landscaper or retaining wall installer may be appointed to repair or replace the wall, at the discretion of the client.

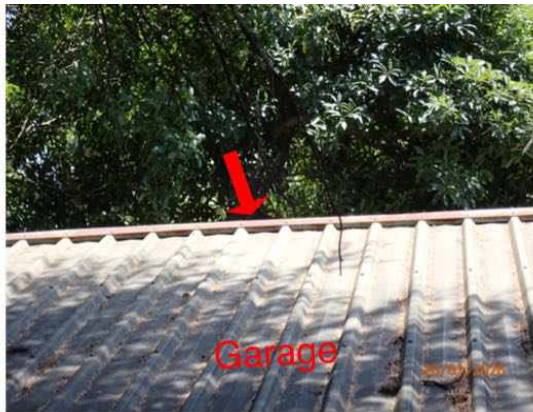
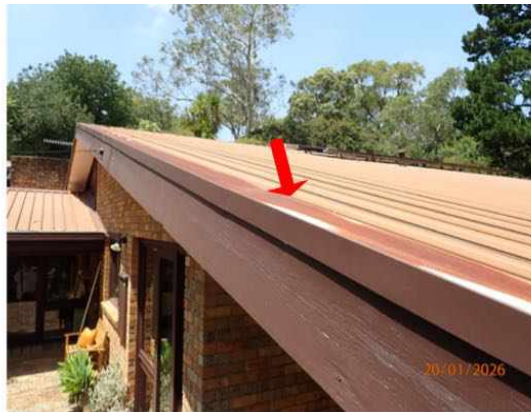
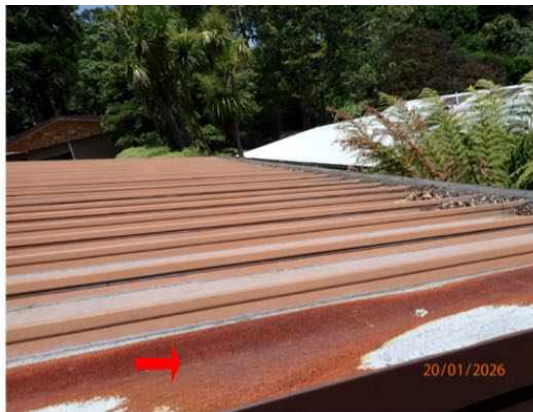
Building:	Main Building
Location:	Roof Exterior
Finding:	Roof Flashing - Rusted or corroded
Information:	The roof flashing has areas of rust and corrosion. Rusted roof plumbing will generally develop holes and leaks that can affect other building elements with poor drainage of storm water. Poorly drained roof areas will also lead to damp conditions surrounding the base perimeter of the building which, if left unmanaged, can lead to a range of secondary building defects.

Repair and/or replacement of rusted roof plumbing is highly required in order to reinstate the roof drainage system to a fully operational level. To further maintain these areas, gutters should be cleaned frequently, allowing the avoidance of any partial blockages.

A licensed plumber or specialist roof restoration company should be appointed to undertake these works. It is advised that such works be completed as soon as possible to prevent any further damage and deterioration.

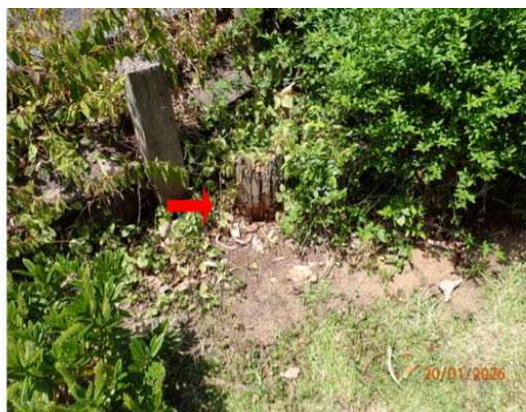
Building:	Main Building
Location:	Exterior walls - front
Finding:	Evidence of termite damage - minor
Information:	Despite no live termite or timber pest activity being indicated, previous termite damage was found to have affected this area. This damage is considered to be inactive and is minor in nature.

It is advised that the area be visually inspected frequently to ensure that the condition of affected building materials does not worsen. At the time of inspection, damage is not structural and is only considered to be superficial.

A building contractor may be appointed to provide a further invasive inspection if further damage is evident.

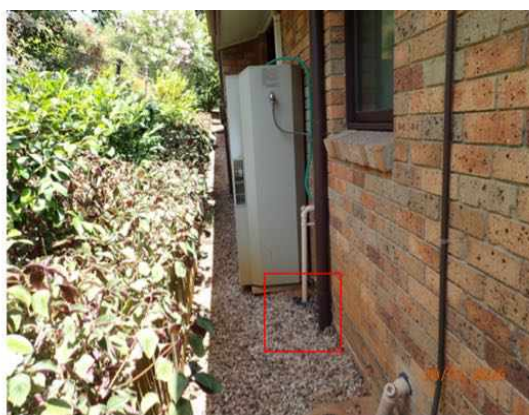
Building:	Main Building
Location:	All External Areas
Finding:	HWS Overflow - Not Connected
Information:	The Hot Water System (HWS) overflow was found to be disconnected from storm water drainage and is creating excessive moisture in the surrounding area.

These damp conditions can lead to secondary defects such as rot, rust or corrosion of associated building elements, the formation of fungal decay, or even the creation of potential slip hazards. When coupled with poor site drainage, pooling of water may also attract termite activity to this area.

It is highly recommended that a licensed plumber be appointed to connect the HWS overflow in order to prevent such an environment from being created. These minor works should be carried out as soon as possible.

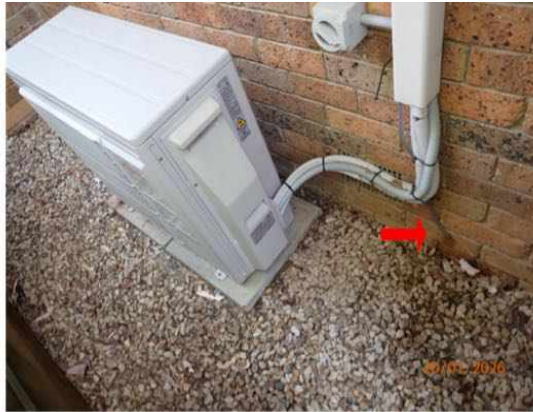
**Finding 6.04**

Building: Main Building  
 Location: All External Areas  
 Finding: Air condition discharge - Not plumbed for drainage  
 Information: The Air condition discharge is not plumbed or connected to suitable drainage, which has resulted in the surrounding area becoming excessively damp. These damp conditions can lead to secondary defects such as rot, rust or corrosion of associated building elements, the formation of fungal decay, or even the creation of potential slip hazards. When coupled with poor site drainage, pooling of water may also attract termite activity to this area. It is highly recommended that a qualified plumber be appointed to install adequate drainage to the overflow. These works will ensure that the area remains dry and free of any secondary defects.

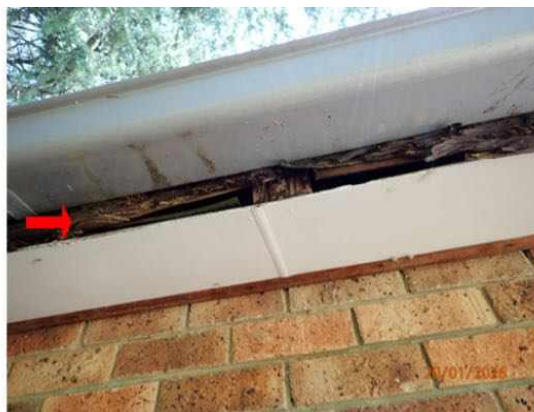
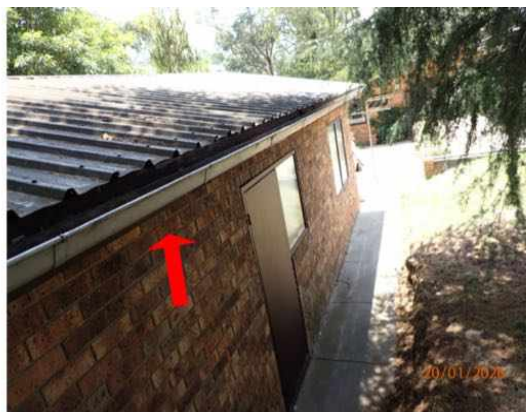
Wood rot, also known as Fungal Decay, poses a significant threat to the structural integrity of fascias and barges. This decay occurs due to prolonged exposure to damp conditions, which may be exacerbated by faults in the roof plumbing, leading to excessive moisture in the affected areas. Additionally, frequent exposure to rain and weather conditions accelerates the deterioration of these building elements.

Immediate action is necessary to address the wood rot and prevent further deterioration. Engaging a roof plumber to inspect all roof plumbing and identify the cause of excessive moisture is essential. Following identification of the root cause, replacement of affected fascias and barges may be required to protect surrounding building elements from further decay. A qualified plumber should be appointed to carry out any necessary remedial works to address the source of moisture. Additionally, a qualified carpenter or registered builder may be needed to replace the affected building materials. Implementing a regular maintenance schedule to inspect and maintain fascias and barges can help prevent future occurrences of wood rot.

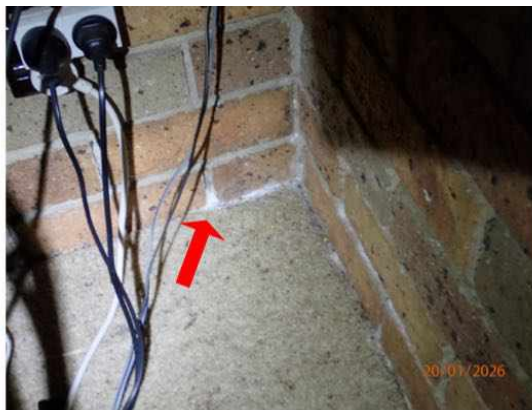
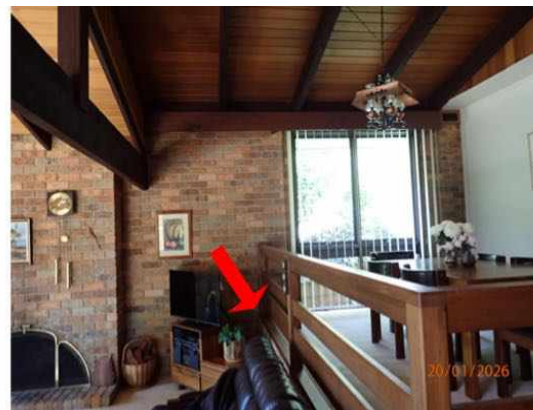
Building: Main Building  
 Location: Lounge Room  
 Finding: Brickwork - Efflorescence  
 Information: Efflorescence was observed on the brickwork during the inspection. This condition is typically caused by moisture drawing soluble salts to the surface, leaving behind a white, powdery residue. While efflorescence itself is not structurally damaging, it may indicate excessive moisture within the brickwork, which can lead to secondary issues such as deterioration of mortar joints or internal dampness. No moisture detected during inspection.

It is recommended to monitor the affected areas and address any potential moisture sources, such as poor drainage or water ingress. If the condition worsens, consultation with a licensed plumber may be necessary to implement remedial measures.

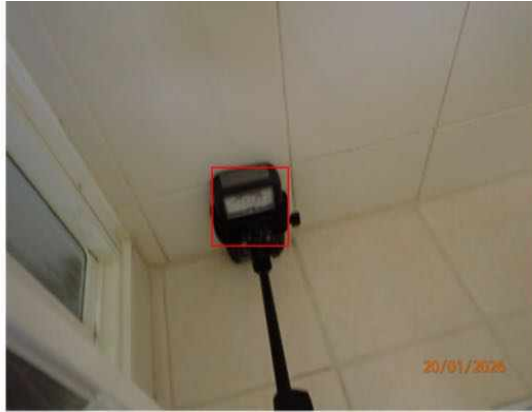
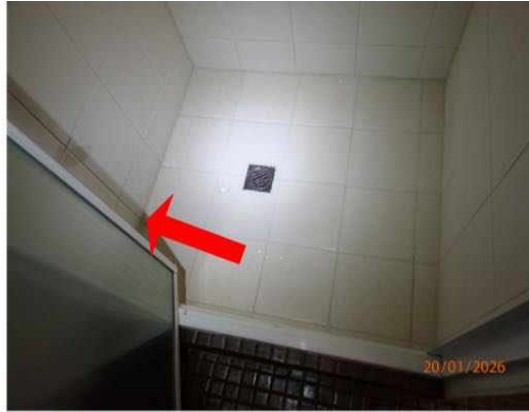
Unmanaged damp in the shower recess is likely to facilitate the formation and development of mould and fungi growth, decaying associated building materials and compromising their structural integrity of associated elements.

Consultation with a bathroom sealant specialist or a tiller is advised immediately to identify the cause of damp and to perform remedial works as required. Always ensure that sealant and grout is in good condition to prevent any moisture issues occurring in the future.

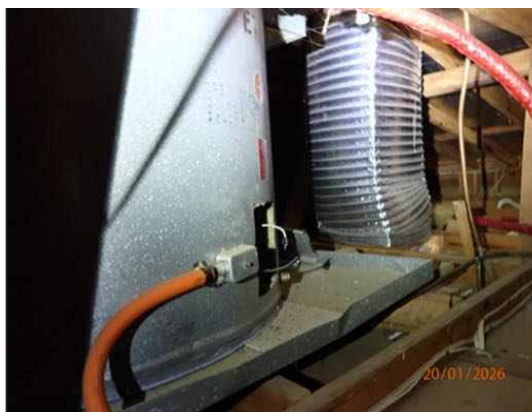
Building: Main Building  
 Location: Roof Void  
 Finding: Old water heater tank - Decommissioned  
 Information: An old decommissioned water heater tank was found in the roof space. Although it is no longer in use, its presence poses a potential risk if not properly managed.

Even though the unit is decommissioned, it could still contain residual water, which may cause the tank to rust over time. This rust can eventually lead to water leakage, potentially damaging internal areas and compromising the integrity of the surrounding building elements.

To prevent any potential issues, it is recommended to engage a plumber to inspect the water heater tank and ensure it is completely drained and secured. This will help prevent any water leakage and related damage, ensuring the safety and integrity of the property.

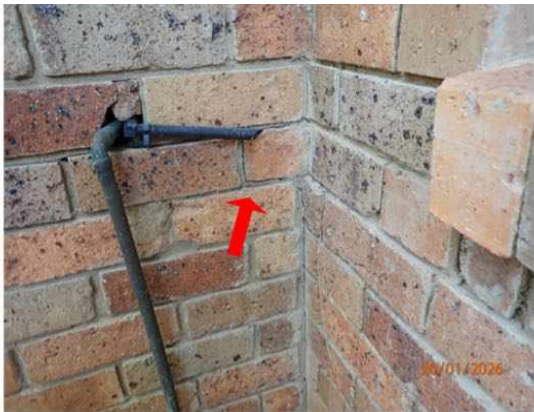
Building:	Main Building
Location:	Exterior walls - left side
Finding:	Brickwork - cracking hairline
Information:	Minor cracking was observed on the brickwork during the inspection. This is consistent with the age of the house and expected foundation movements over the years.

While the cracks are not currently a structural concern, it is recommended to monitor them for any changes, such as widening or lengthening. If significant changes are noted, it may be necessary to engage a structural engineer to assess and recommend appropriate remedial actions.

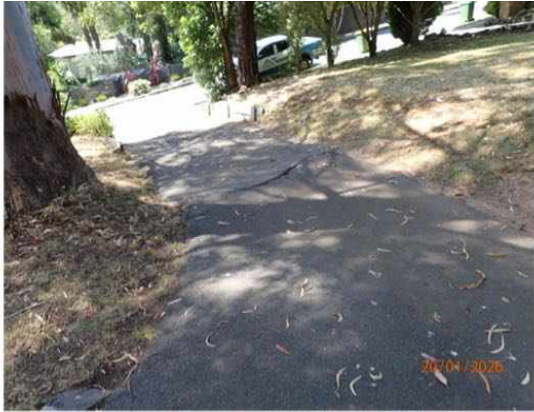
Building: Main Building  
Location: Exterior walls - front  
Finding: Drive way damaged  
Information: The exterior driveway was noted damaged during inspection, with cracking and surface deterioration observed. It is suspected that the damage is due to inadequate construction and ongoing ground movement, compounded by the influence of roots from mature trees located on the property. It is recommended to monitor the condition of the driveway and engage a qualified concreter or registered builder to assess the extent of damage and advise on appropriate remedial works if the deterioration progresses.

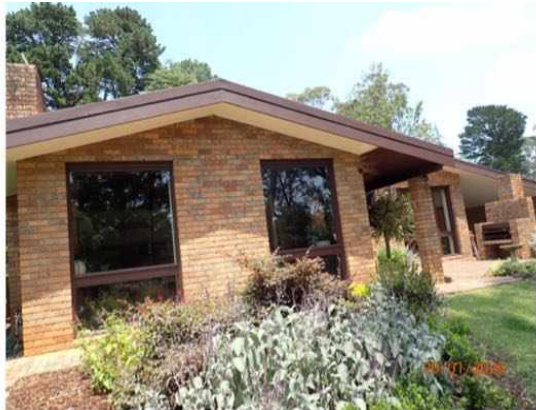
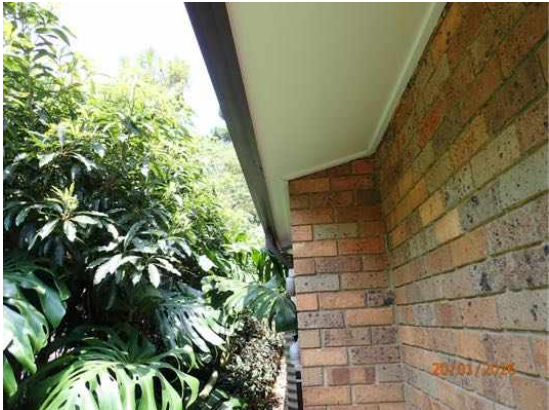
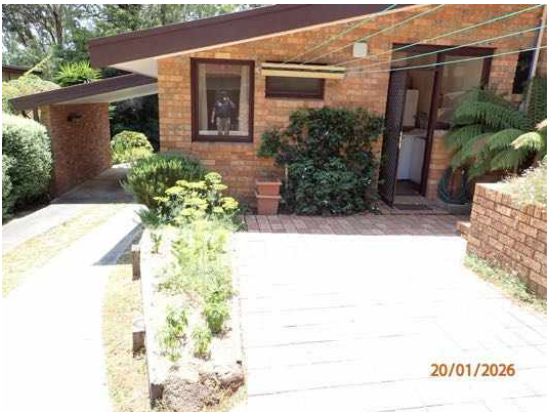
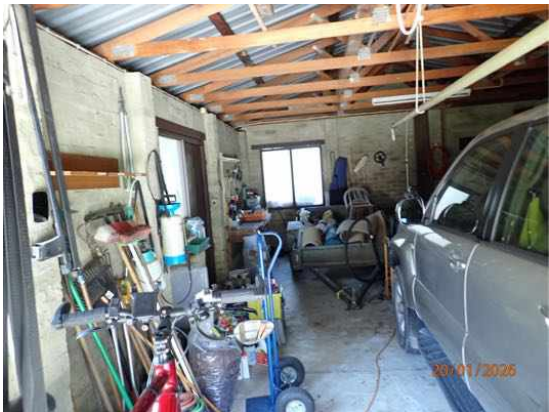
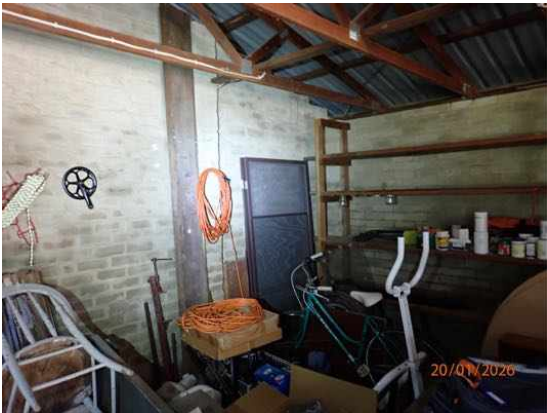
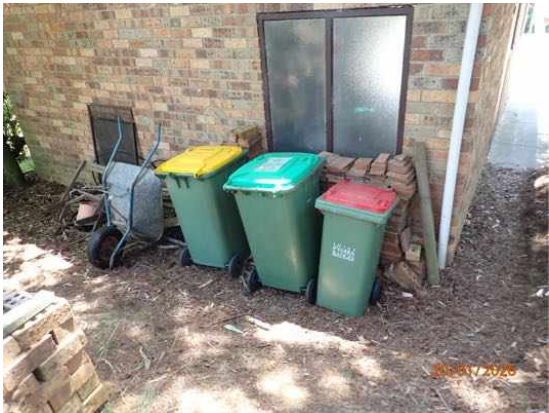
Building: Main Building  
 Location: All External Areas  
 Finding: Additional Photos - Obstructions and Limitations External Areas  
 Information: These photographs are an indication of the obstructions and limitations which impeded full inspection of the External areas of the property at the time of inspection. These obstructions can hide an array of defects and should be removed to allow full inspection to be carried out. A re-inspection is recommended once the areas are made accessible.

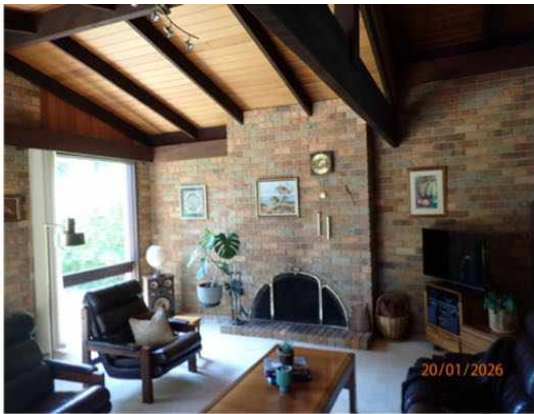
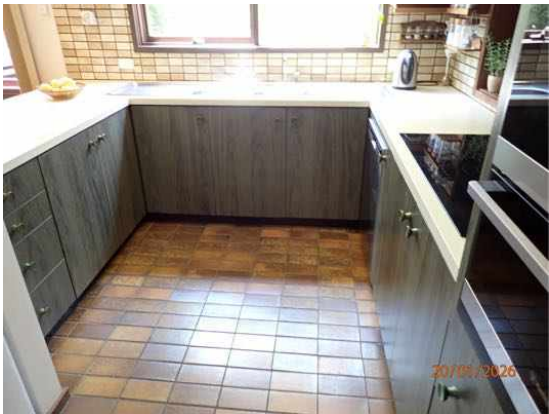
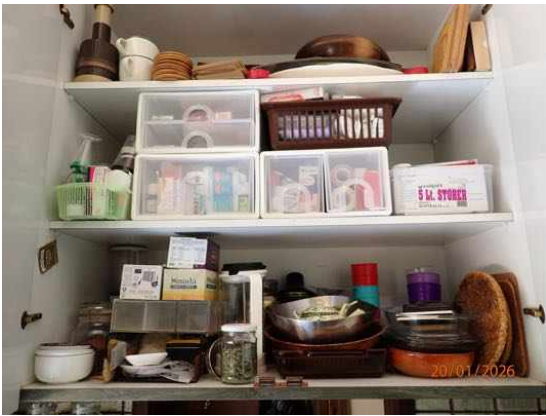
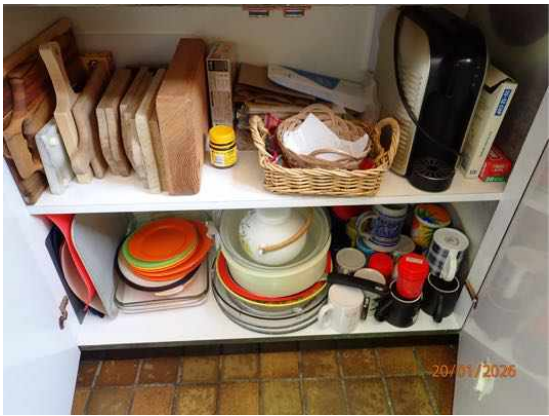
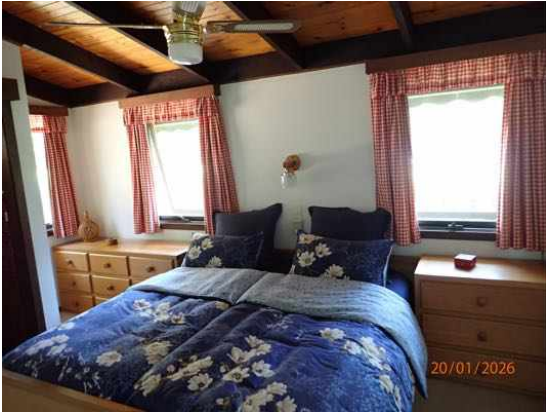
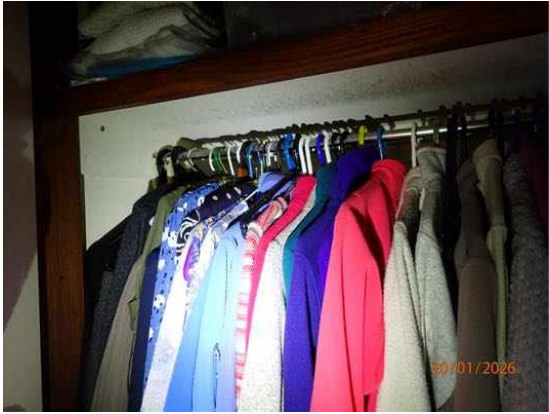
Building: Main Building  
Location: All Internal Areas  
Finding: Additional Photos - Obstructions and Limitations internal Areas  
Information: These photographs are an indication of the obstructions and limitations which impeded full inspection of the internal areas of the property at the time of inspection. These obstructions can hide an array of defects and should be removed to allow full inspection to be carried out. A re-inspection is recommended once the areas are made accessible.

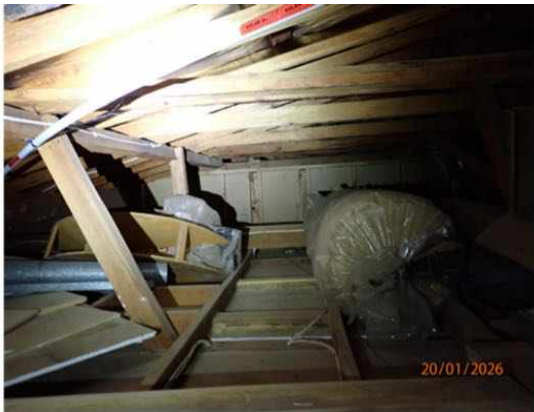
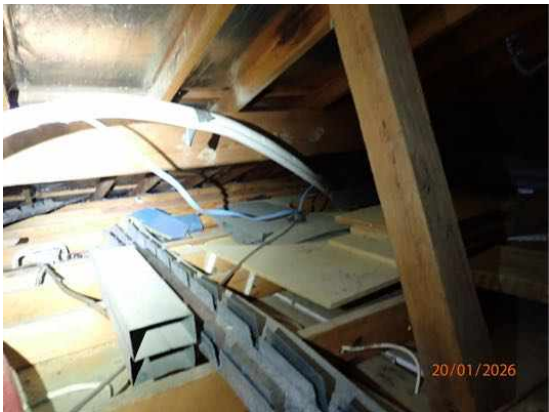
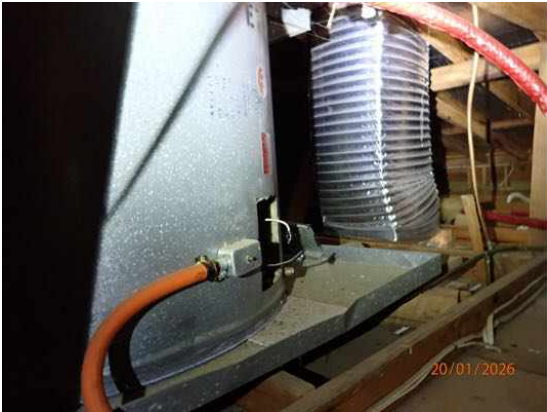
Building: Main Building  
 Location: Roof Void  
 Finding: Additional Photos - Obstructions and Limitations Roof Void  
 Information: These photographs are an indication of the obstructions and limitations which impeded full inspection of the Roof Void of the property at the time of inspection. These obstructions can hide an array of defects and should be removed to allow full inspection to be carried out. A re-inspection is recommended once the areas are made accessible.

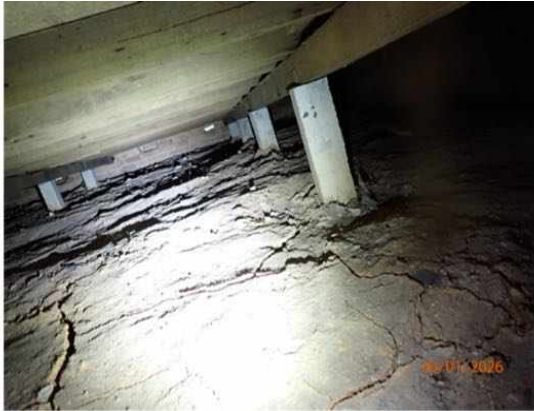
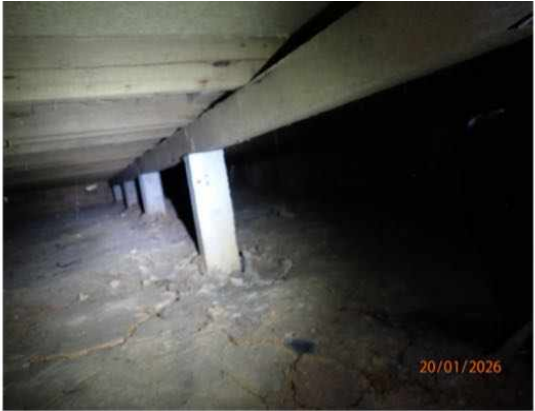
Building: Main Building  
Location: Subfloor  
Finding: Additional Photos - Obstructions and Limitations Subfloor Areas  
Information: These photographs are an indication of the obstructions and limitations which impeded full inspection of the subfloor areas of the property at the time of inspection. These obstructions can hide an array of defects and should be removed to allow full inspection to be carried out. A re-inspection is recommended once the areas are made accessible.
