Building and Timber Pest Inspection Report

Inspection Date: Thu, 12 Mar 2026

Property Address: 6 Bugden St, Wodonga VIC 3690, Australia

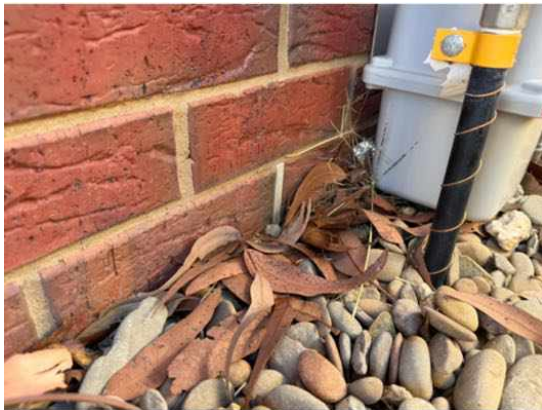
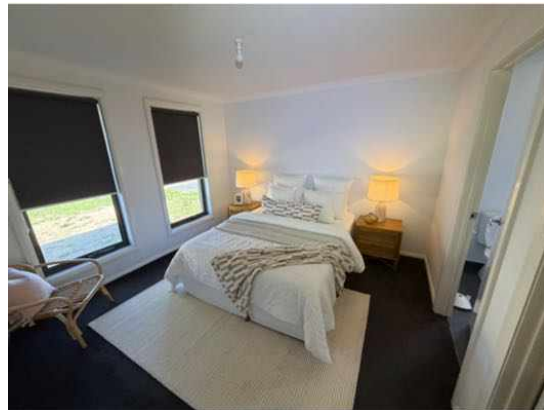
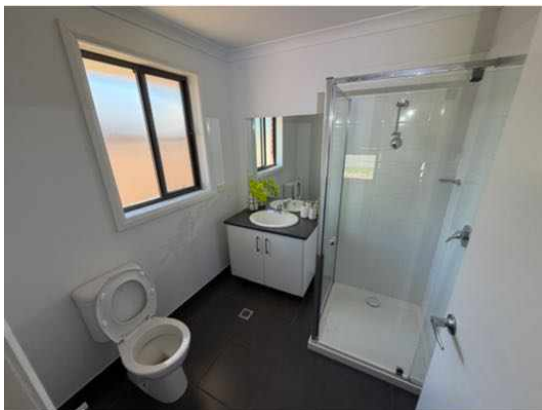
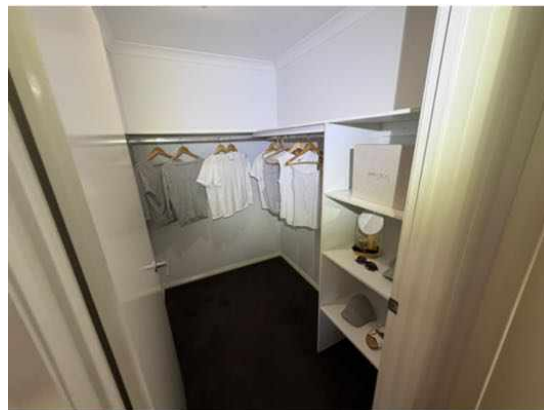
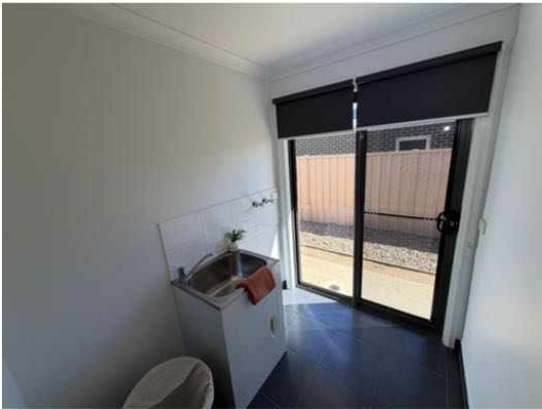
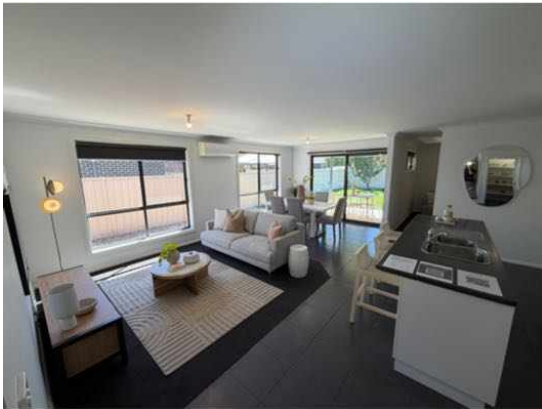
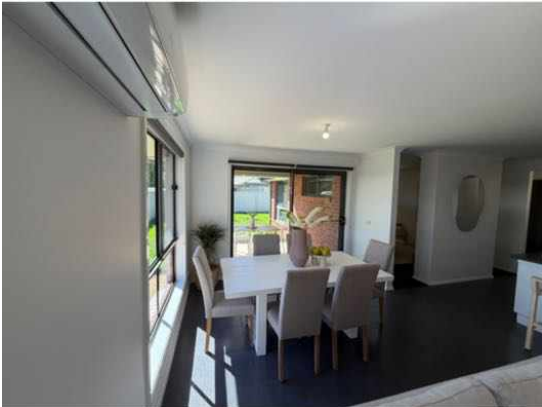
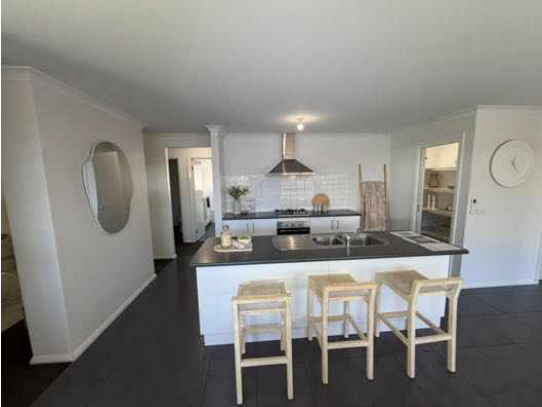
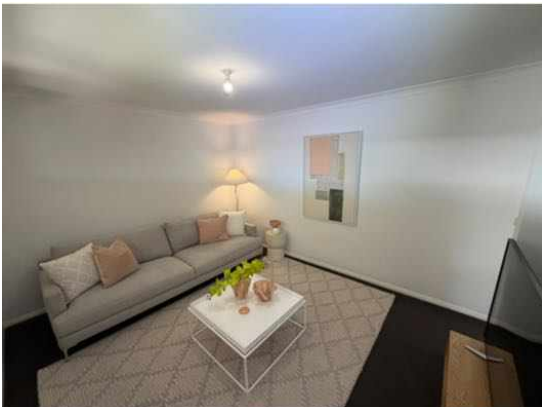
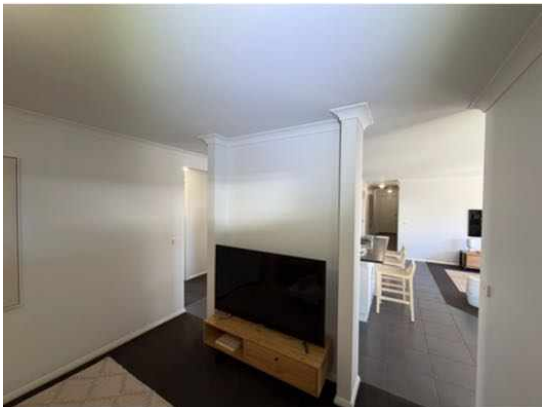
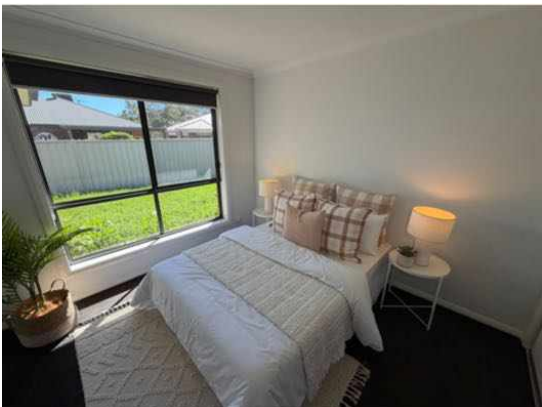
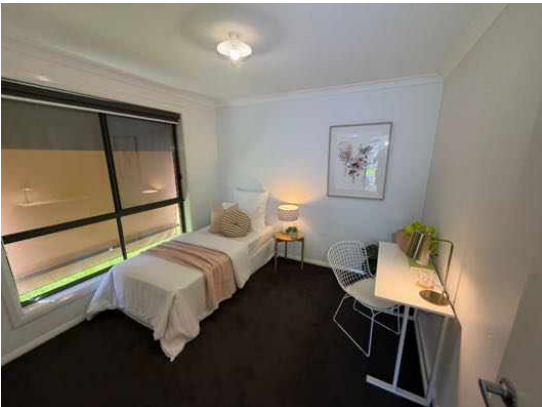
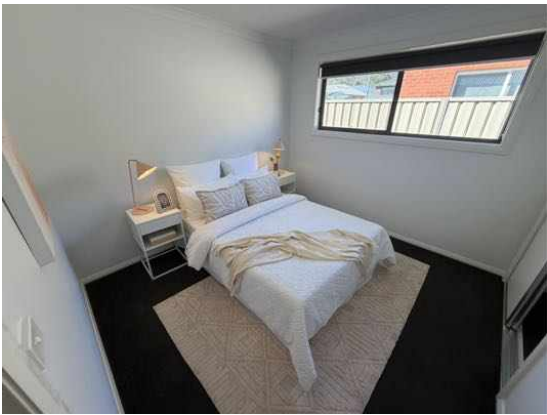
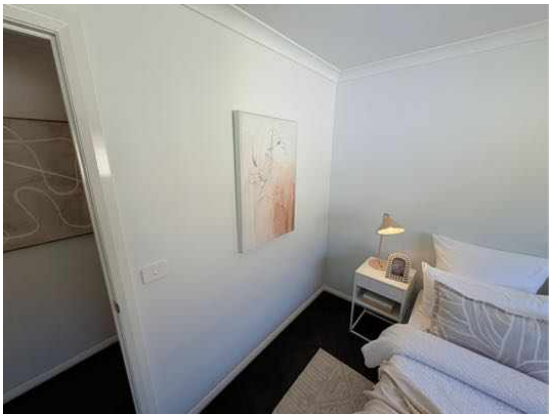
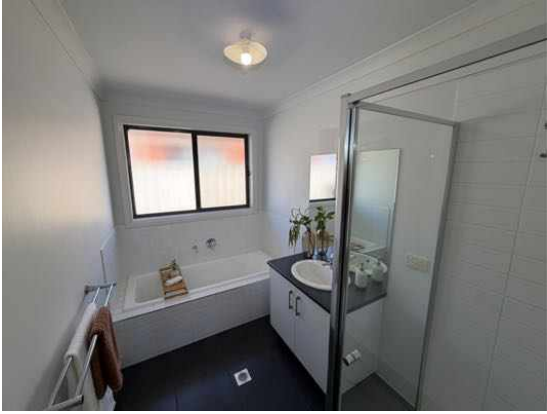
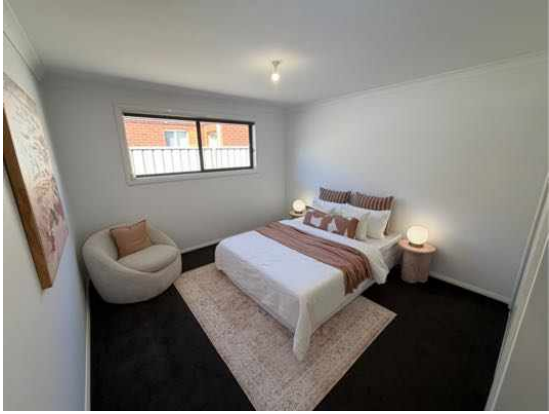
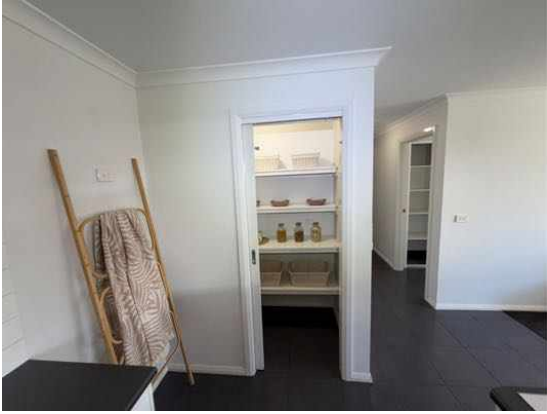
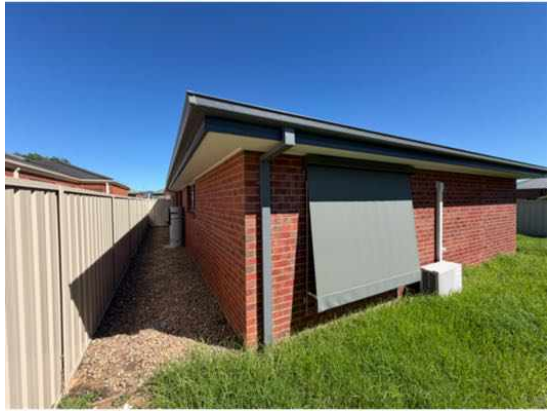
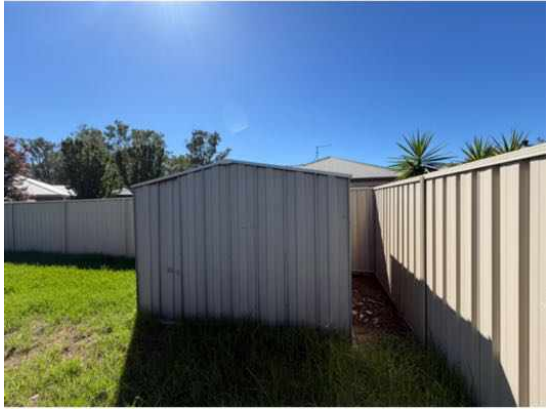
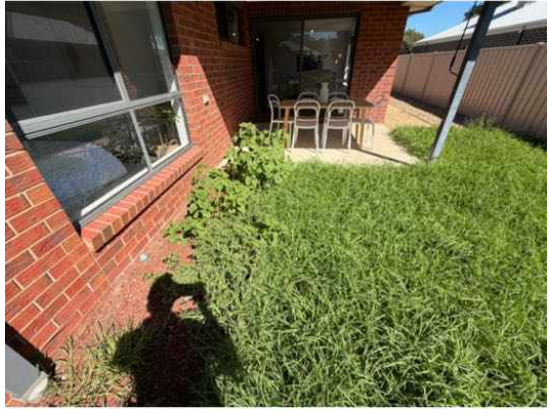
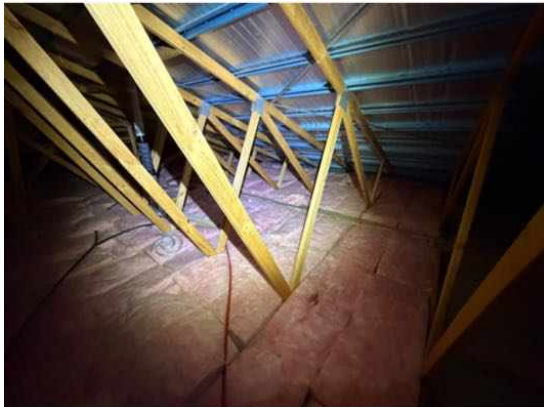
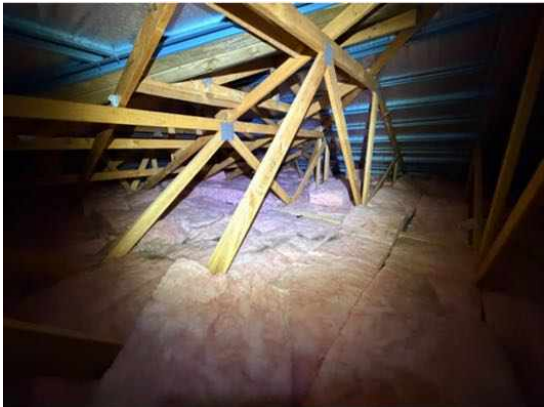
Building: Main Building
Location: All Areas
Finding: Additional Photos - Obstructions and Limitations
Information: These photographs are an indication of the obstructions and limitations which impeded full inspection of the property at the time of inspection. These obstructions can hide an array of defects and should be removed to allow full inspection to be carried out. A re-inspection is recommended once the areas are made accessible.
