Building Inspection Report

Inspection Date: Fri, 23 Jan 2026

Property Address: 4/3-5 Atkinson St, Liverpool NSW 2170,
Australia

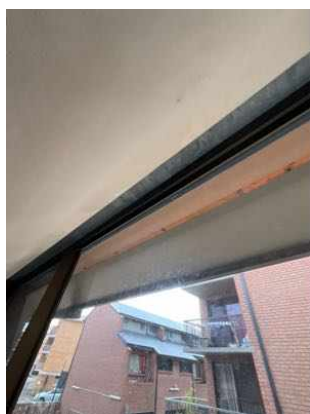
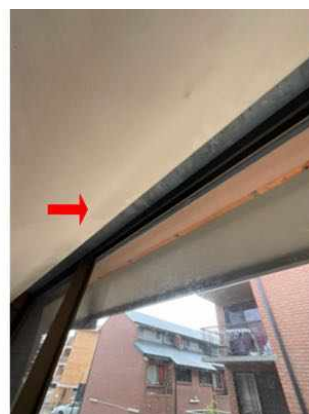
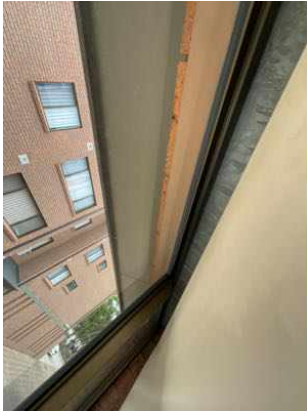
Defects 1.01

| Finding: | Window child lock missing |
| Information: | The window in question lacks a child lock mechanism, which poses a potential safety risk to young occupants in the premises. As per Australian Standards windows accessible to children should be equipped with appropriate child safety locks to prevent accidental opening, reducing the risk of falls and ensuring compliance with safety regulations. |

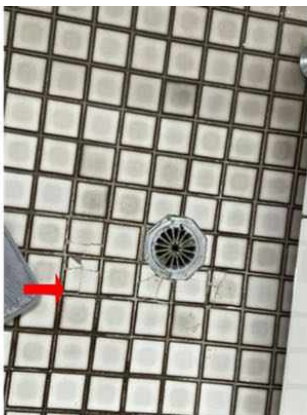
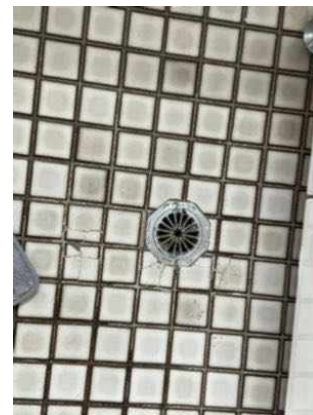
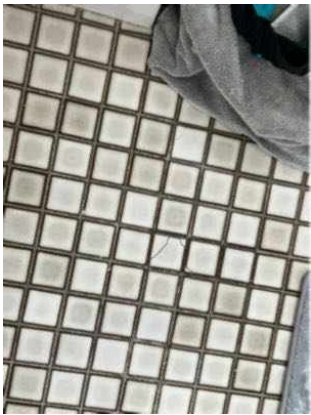
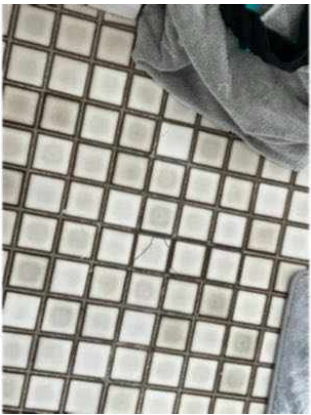
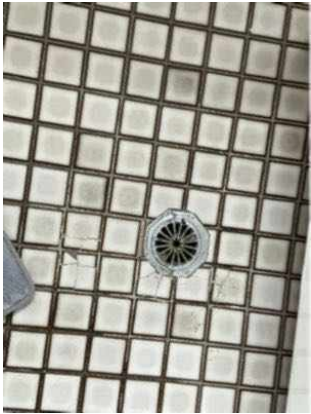
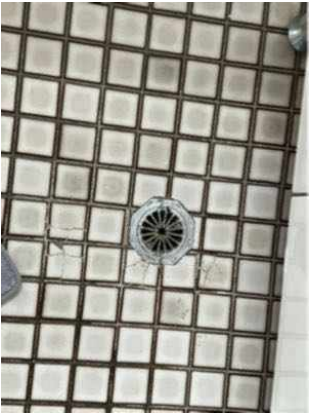
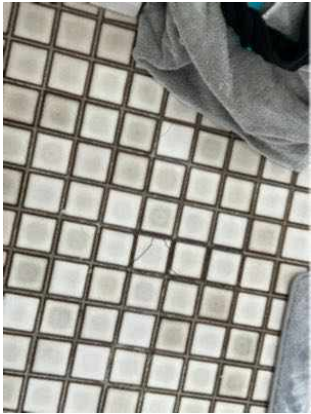
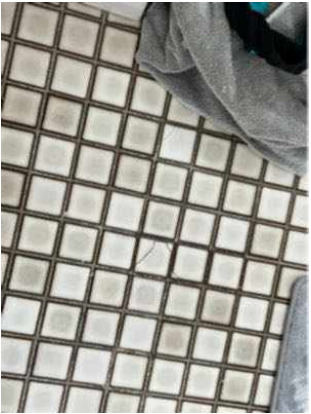
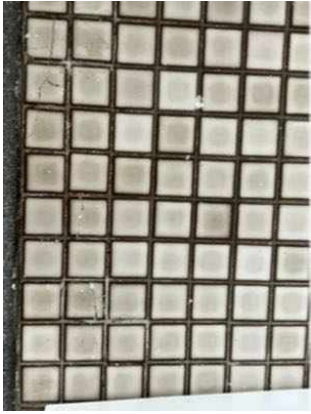
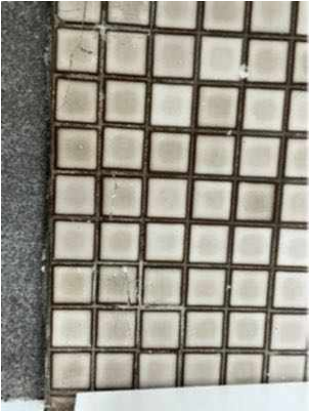
Defects 2.01

| Finding: | Tiles - Cracked or damaged |
| Information: | Cracking was evident to the tiling in this area at the time of inspection. While the cracking appears to be minor, this area is frequently exposed to water, allowing potential for water penetration into adjoining sections of walls or flooring. |

If left unmanaged, water penetration to these areas may lead to subsequent water damage, which is likely necessitate repair work to affected building elements.

A tiling contractor should be appointed to ensure that no further water damage occurs. The re-application of silicone and grouting throughout remaining tile work is also advised, to further protect the area against water penetration.

Where water penetration has led to water damage, appointment of a relevant tradesperson may be required to repair damaged building elements.

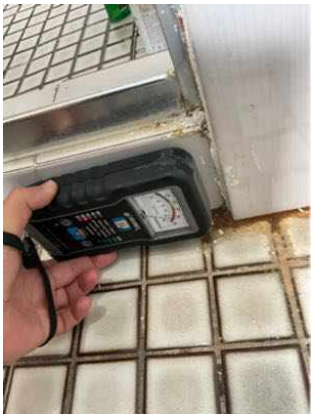
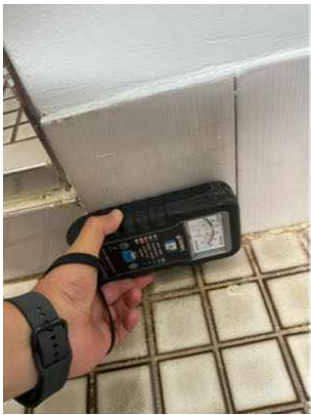
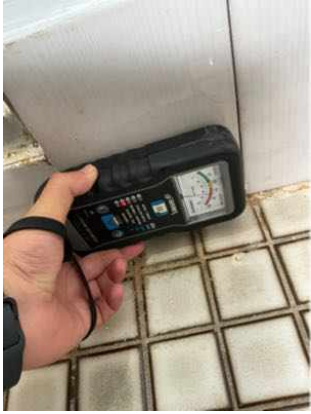
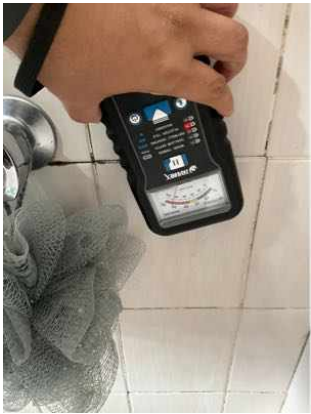
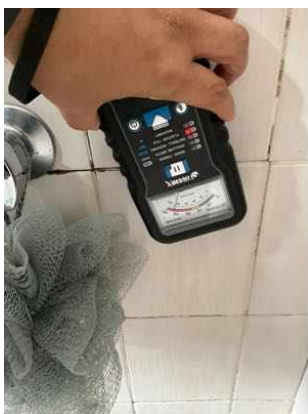
Defects 2.02

Building: Main Building
Location: Bathroom
Finding: Evidence of excessive moisture was present at the time of inspection
Information: Excessive moisture is present behind the bathroom tiles, indicating a potential water leakage issue within the wall.

The prolonged presence of moisture can lead to mold growth, deteriorate the structure, and create an environment conducive to health hazards. Additionally, it may compromise the adhesive holding the tiles, leading to their detachment.

A licensed plumber or a qualified contractor specializing in water damage remediation should investigate the source of the moisture, fix any leaks, and address the damage. Additionally, replacing affected tiles and ensuring proper waterproofing are crucial to preventing future issues.

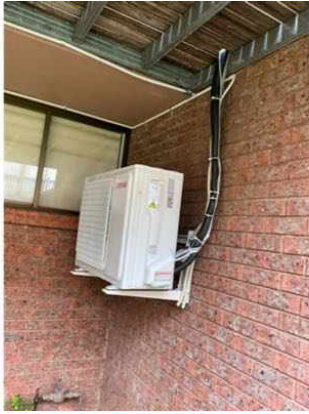
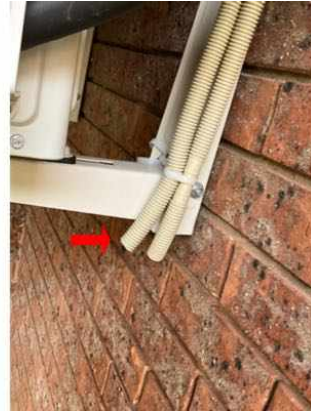
Defects 3.01

| Finding: | Air conditioner - Disconnected overflow |
| Information: | The Air Conditioner (A/C) overflow was found to be disconnected from storm water drainage and is creating excessive moisture in the surrounding area. |

Such leaking creates an environment which is conducive to an array of defects, including water damage to associated building elements and the attraction of termite or timber pest infestation.

It is highly recommended that a licensed plumber be appointed to connect the A/C overflow in order to prevent such an environment from being created. These minor works should be carried out as soon as possible.

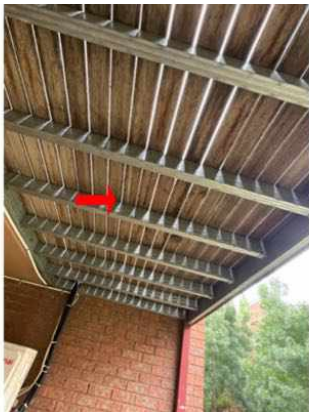
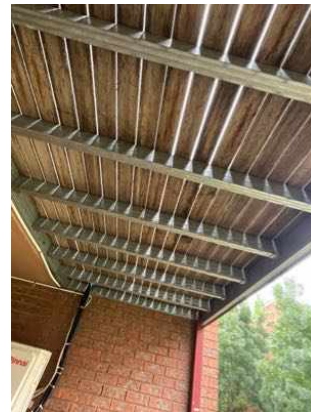
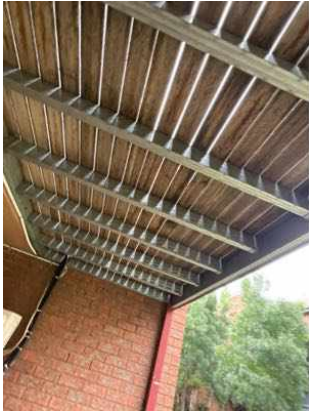
Defects 3.04

External timber structures are also constantly exposed to weather deteriorates in an exhilarate manner, ongoing assessments are required.

It is highly recommended that a structural engineer further, assess the external timber balcony or a deck to inform the client of its load capacity.

Regular maintenance inspections by competent practitioners is needed.

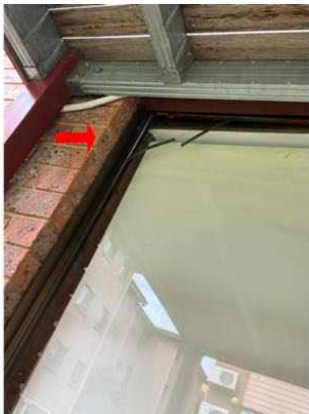
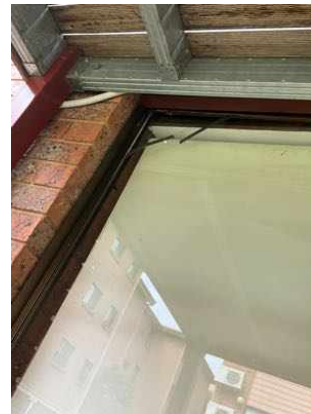
Defects 3.05

| Finding: | Beadings - damaged or deteriorated. |
| Information: | Damaged or deteriorated beadings pose several risks. They compromise the integrity, allowing drafts, moisture, and even pests to enter the building. This can lead to energy loss, water damage, and decreased indoor air quality. |

A qualified repair technician should be contacted to assess and repair the damaged or deteriorated beadings. They can replace worn-out beadings, and ensure it is properly installed and function to maintain energy efficiency and structural integrity.

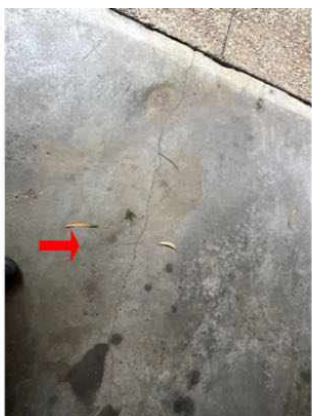
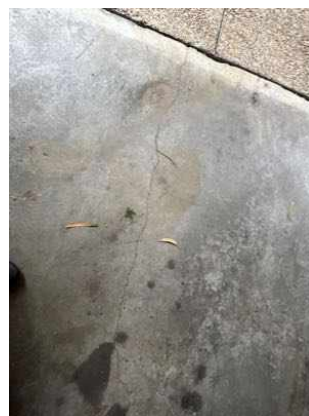
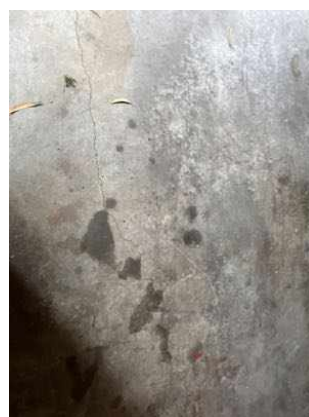
Defects 3.06

| Finding: | Crack in concrete slab - Category 0 |
| Information: | A crack coded as Category 0 was identified in the slab. A Category 0 crack is described as a hairline crack, representing insignificant movement of slab from level. |

The approximate width of the crack to be considered Category 0 is 0.3mm, or change

in offset of less than 8mm when a 3m straight edge is placed over the defect.

No rectification is required at this time. However, all cracking should be monitored over a 12 month period to identify any further damage in the area.

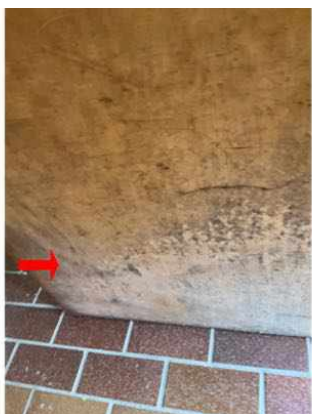
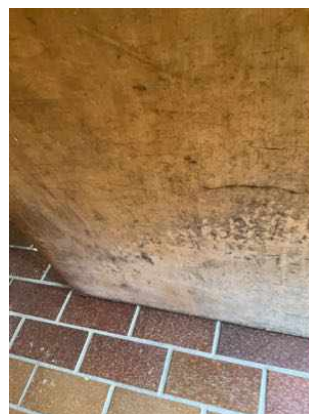
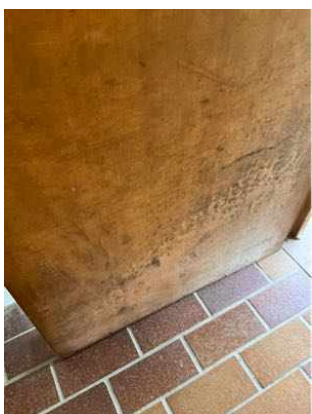
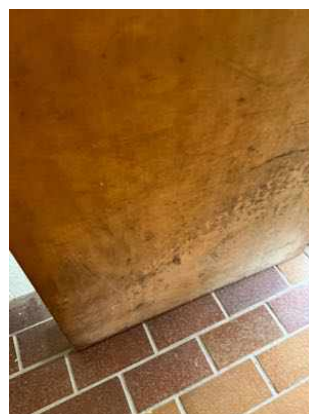
Defects 3.07

| Information: | External timbers that are frequently exposed to harsh weather conditions require adequate protection in order to maintain their condition. Where timbers have not been painted or treated adequately, general deterioration is likely to occur at an accelerated rate. |

If left unattended, replacement of these timbers is likely to be necessary in the short-term future. Adequate treatment of these timbers is required as soon as possible by a painting contractor or general handyman.

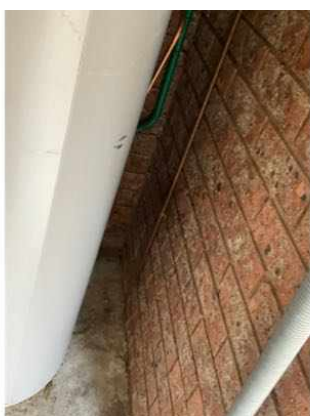
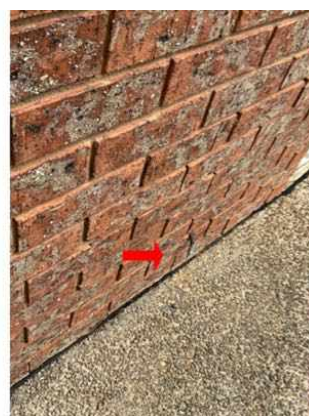
These damp conditions can lead to secondary defects such as rot, rust or corrosion of associated building elements, the formation of fungal decay, or even the creation of potential slip hazards. When coupled with poor site drainage, pooling of water may also attract termite activity to this area.

It is highly recommended that a licensed plumber be appointed to connect the HWS overflow in order to prevent such an environment from being created. These minor works should be carried out as soon as possible.

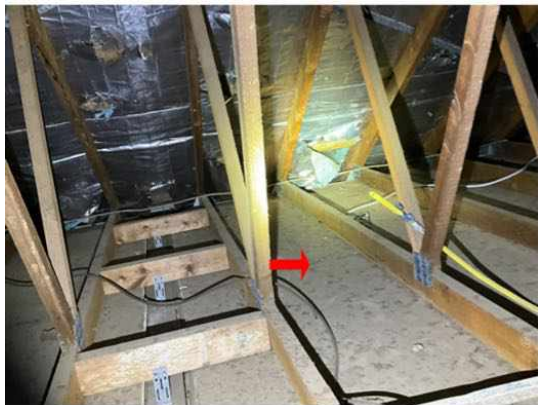
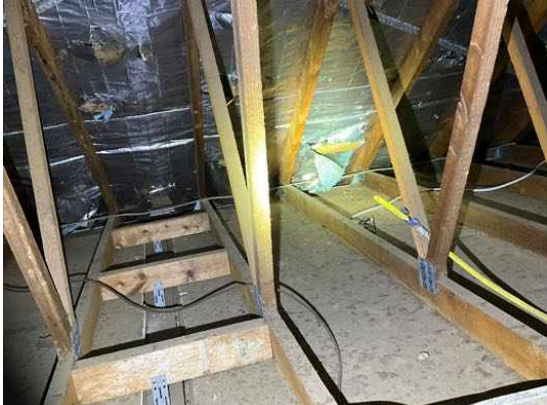
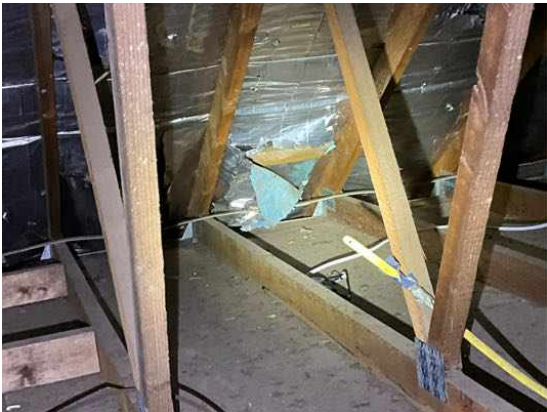
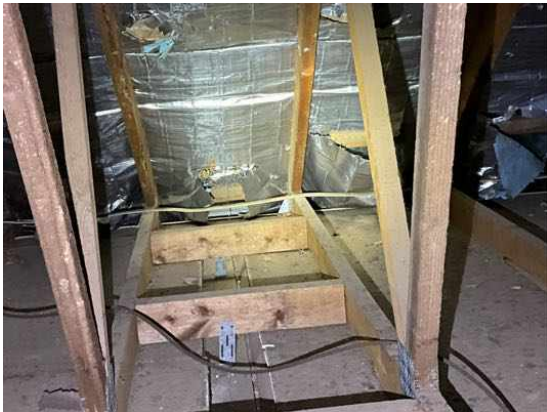
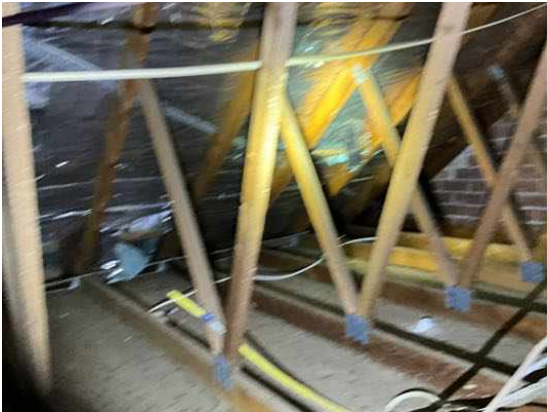
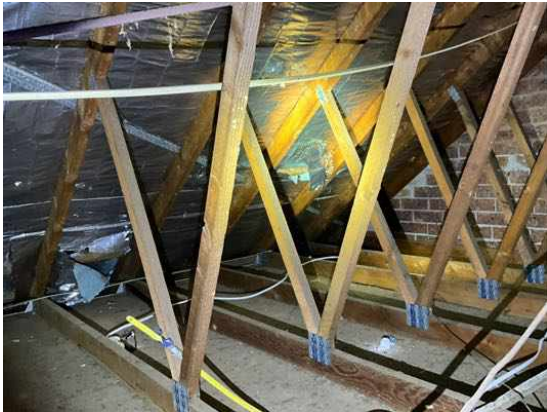
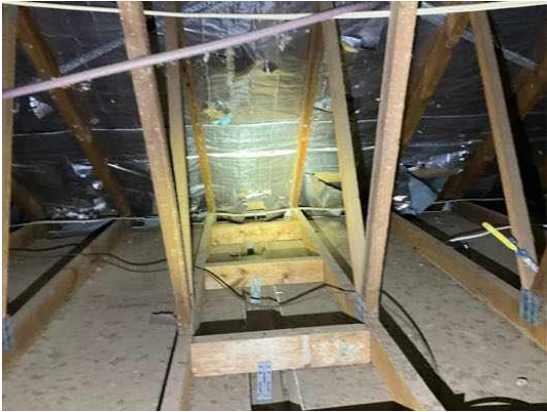
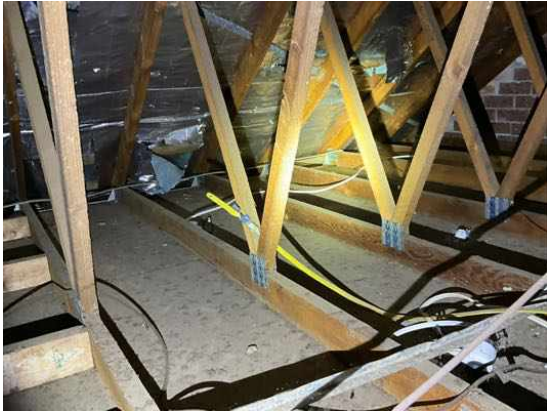
Defects 3.15

| Finding: | Insulation - Missing |
| Information: | Upon inspection of the roof void it was noted that insulation is not present. |

Insufficient insulation will result in a comparatively higher cost to heat and cool a property as there is a lack of Insulation (or uneven coverage of insulation) which works as a barrier to heat transfer. This helps to keep out unwanted heat in summer and preserves warmth inside your home in winter. It can also help soundproof your home from unwanted airborne noise transfer.

Where insulation is absent, the area does not meet current Australian Standards. Installation of adequate insulation is required and should be conducted as soon as possible.

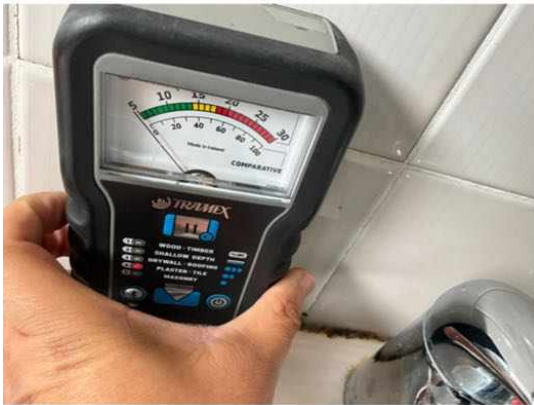
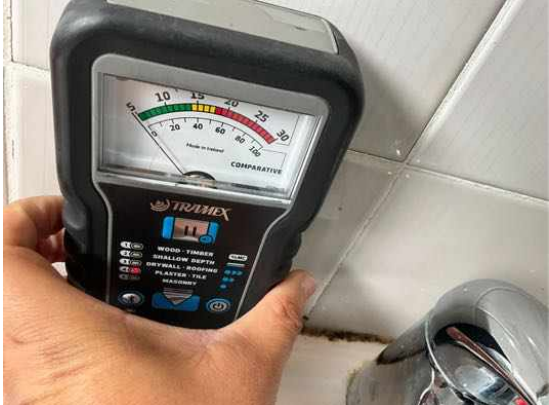
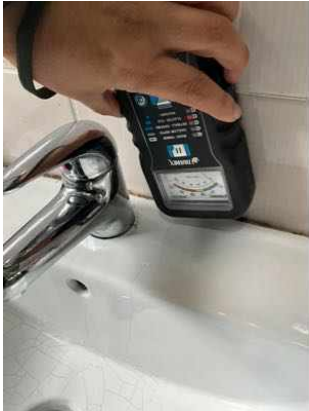
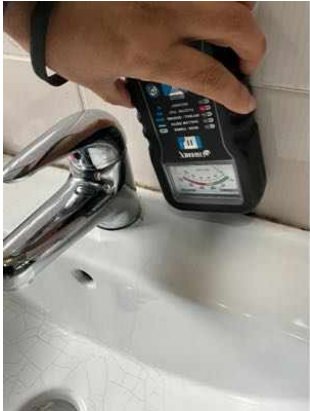
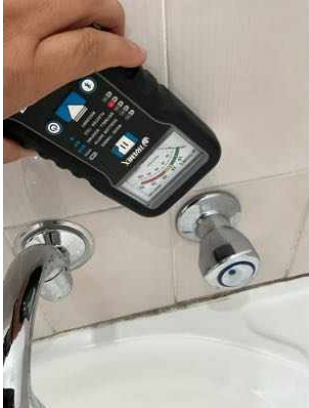
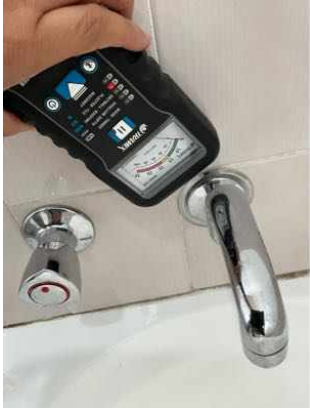
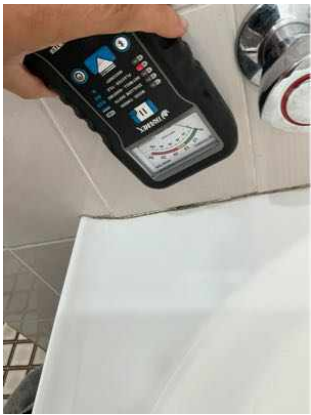
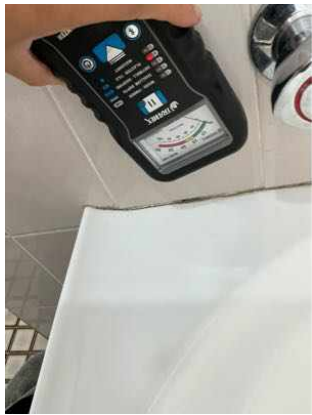
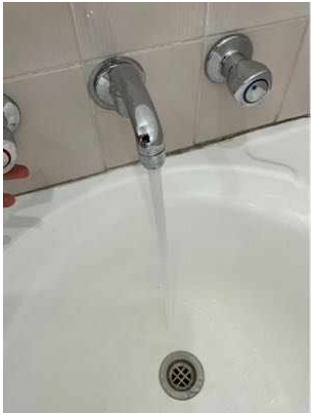
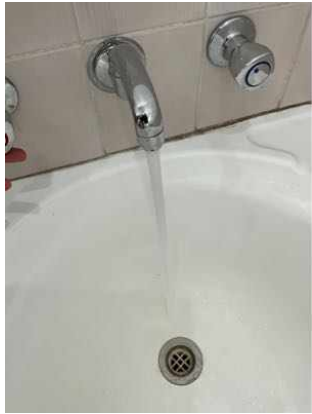
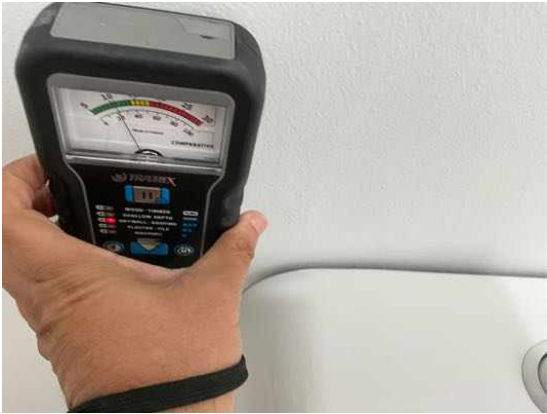
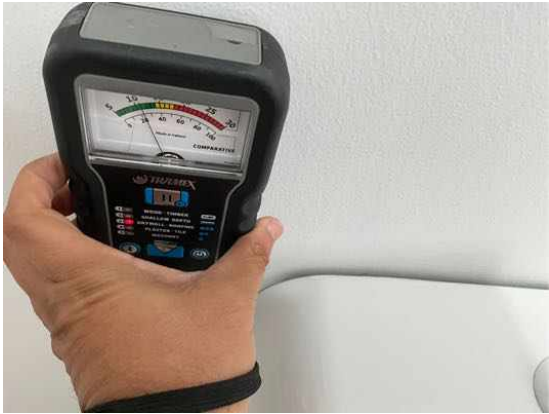
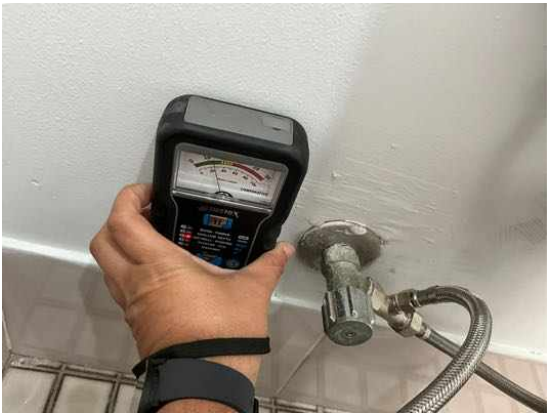
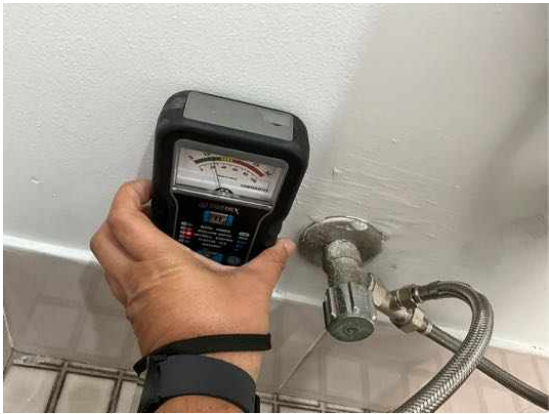
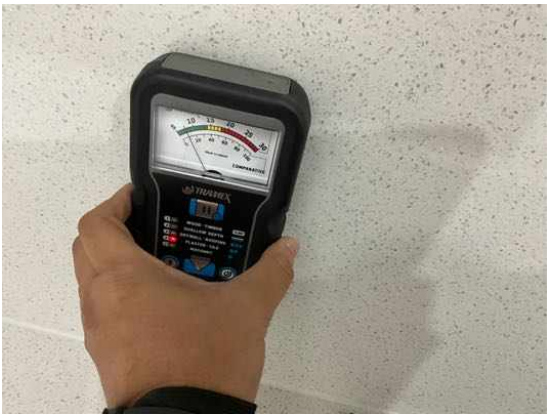
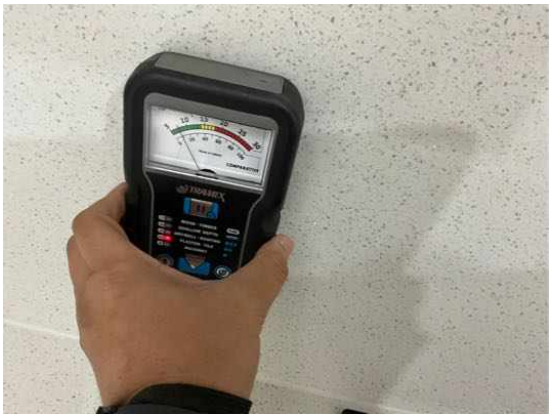
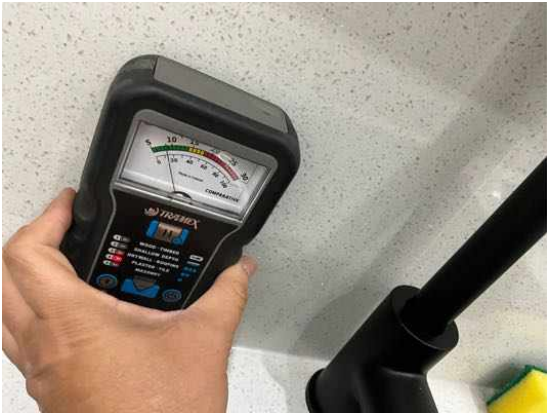
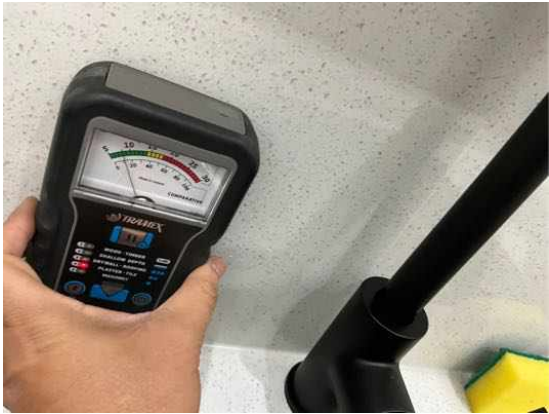
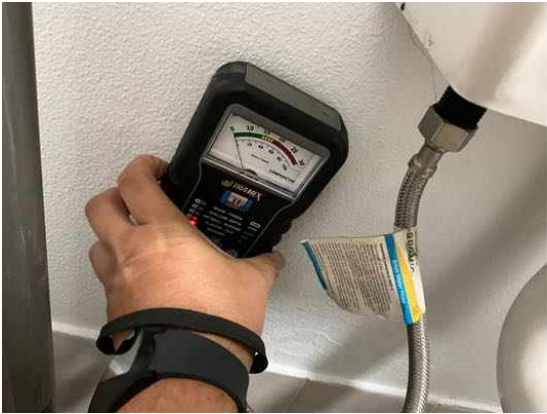
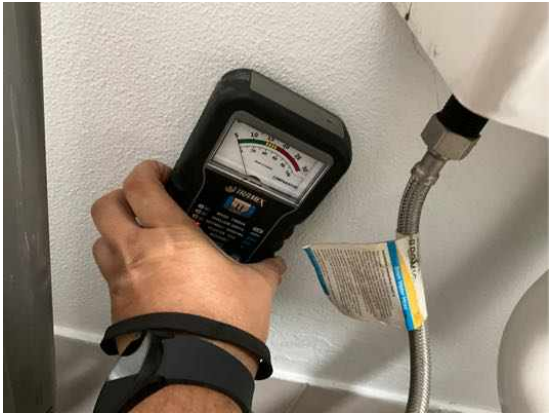
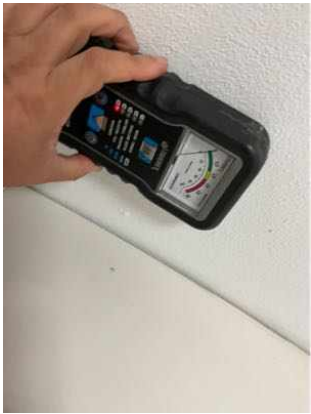
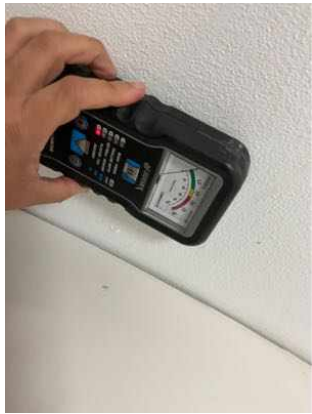
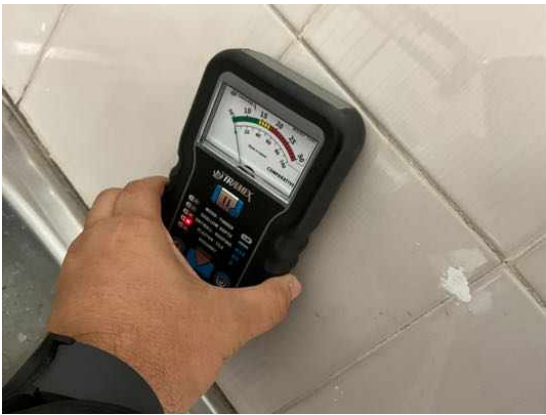
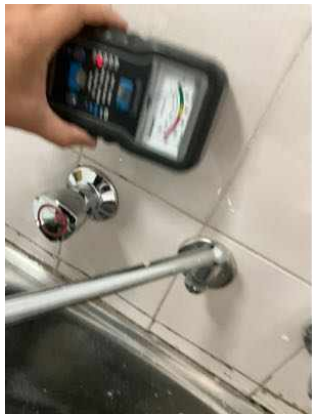
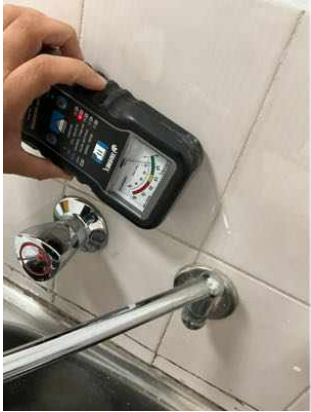
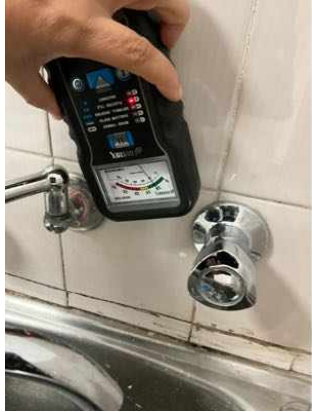
- Building: Main Building
- Location: All Areas
- Finding: Additional Photos
- Information: Additional photos are provided for your general reference

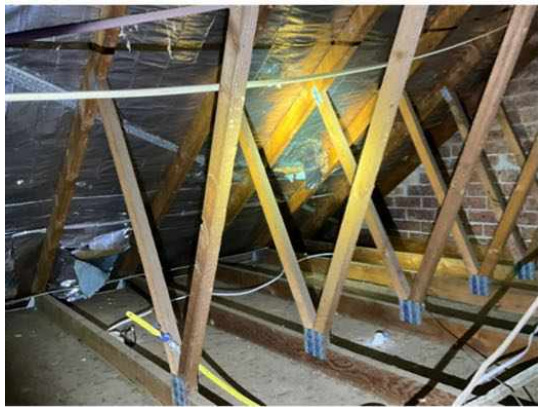
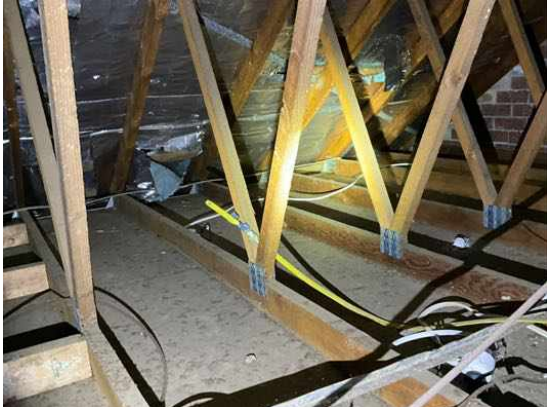
Building: Main Building
Location: All Areas
Finding: Additional Photos - Obstructions and Limitations
Information: These photographs are an indication of the obstructions and limitations which impeded full inspection of the property at the time of inspection. These obstructions can hide an array of defects and should be removed to allow full inspection to be carried out. A re-inspection is recommended once the areas are made accessible.
