Building Inspection Report

Inspection Date: Wed, 1 Apr 2026

Property Address: 210/32 Alice St, Newtown NSW 2042,
Australia

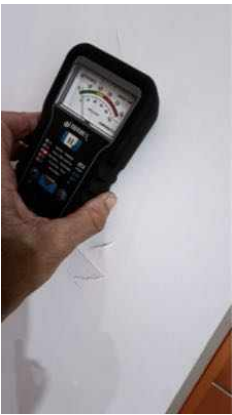
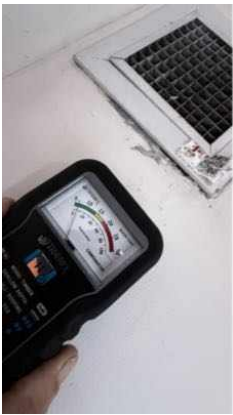
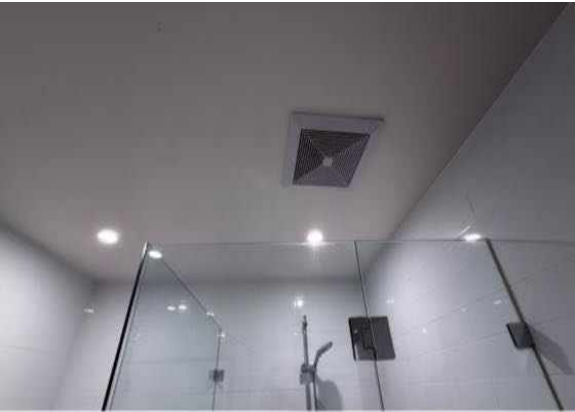
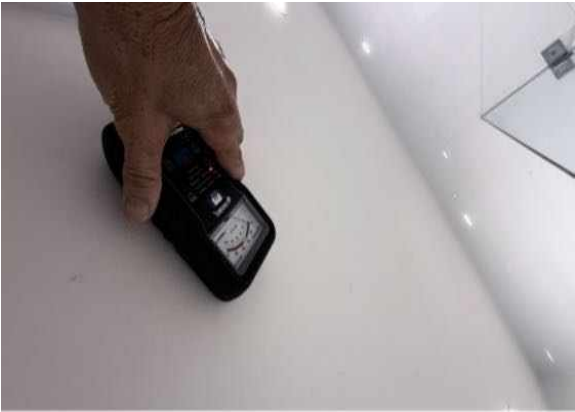
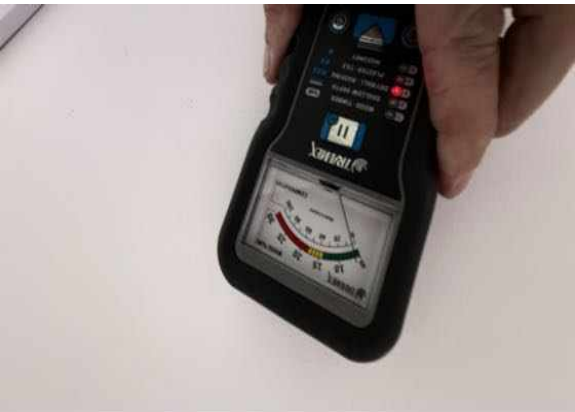
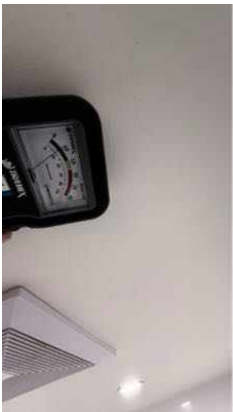
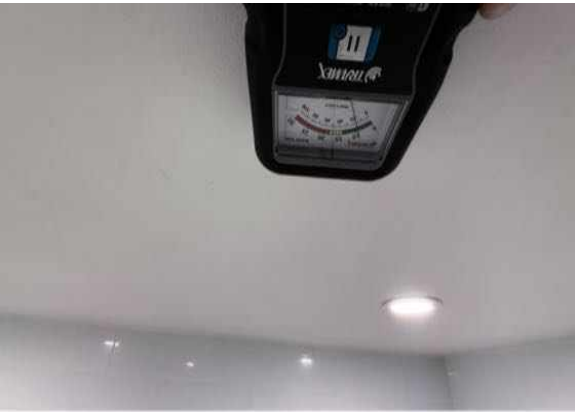
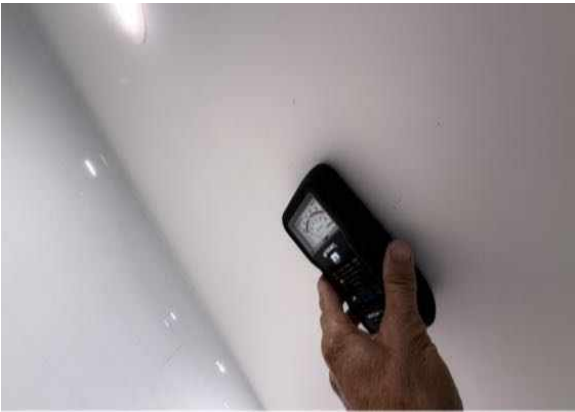
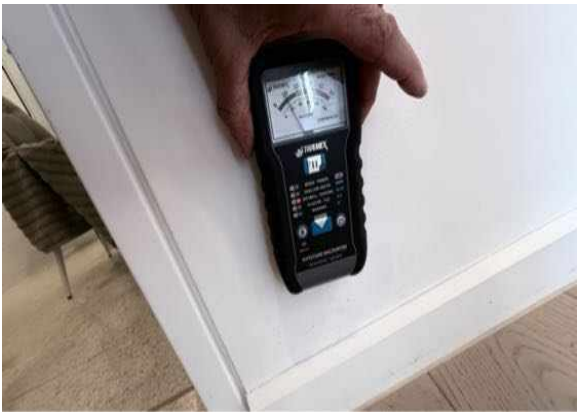
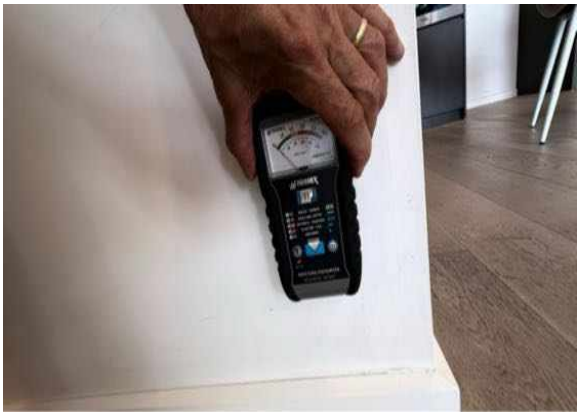
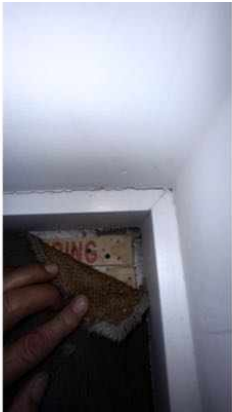
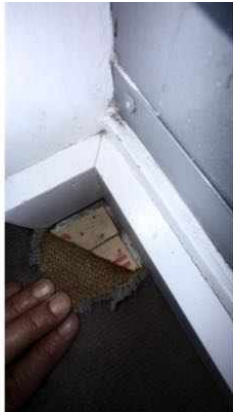
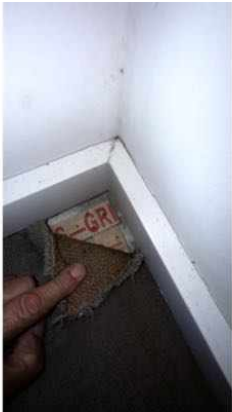
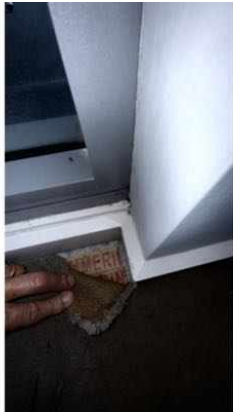
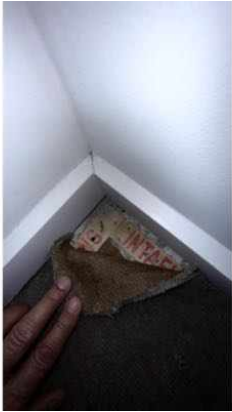
Finding: Moisture readings

Information: At the time of inspection, low moisture readings were noted in several accessible areas of the property, including, but not limited to, those shown in the accompanying photographs.

These areas were evaluated for elevated moisture levels and temperature irregularities, which can indicate potential issues such as hidden leaks, failing waterproofing, or poor ventilation.
