Building and Timber Pest Inspection Report

Inspection Date: Mon, 23 Mar 2026

Property Address: 16/12-14 Darcy Road, Westmead, NSW
2145

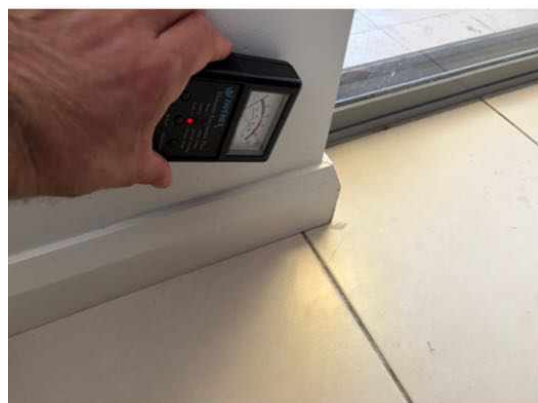
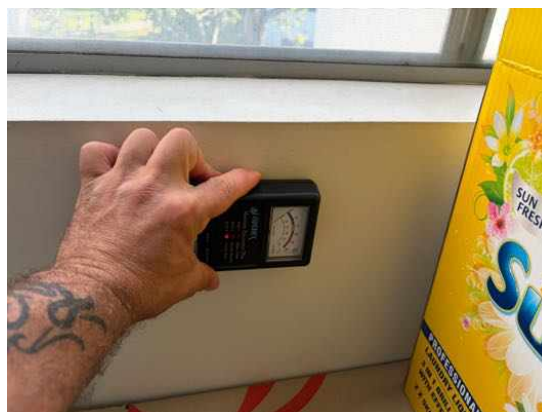
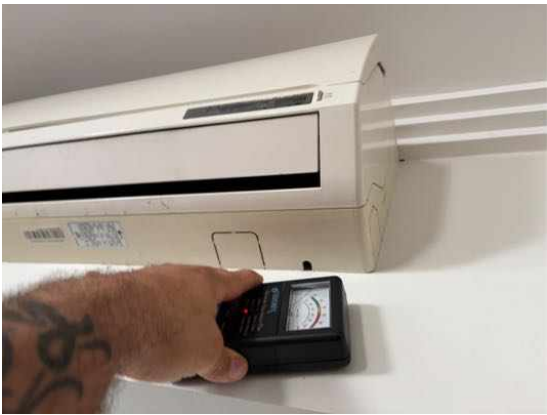
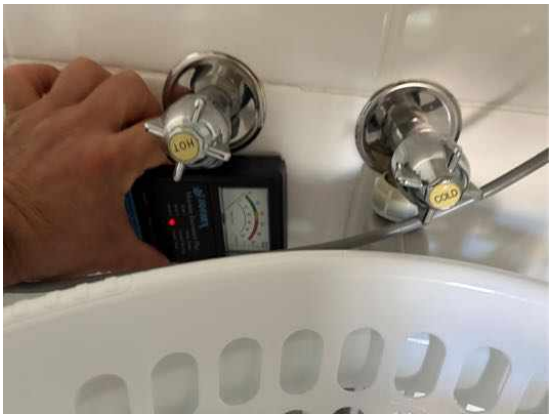
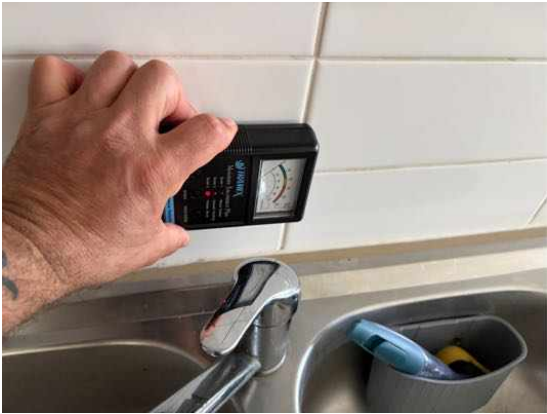
Building: Main Building
 Location: All Areas
 Finding: Moisture metre
 Information: During the inspection the property was checked for moisture using a moisture metre.

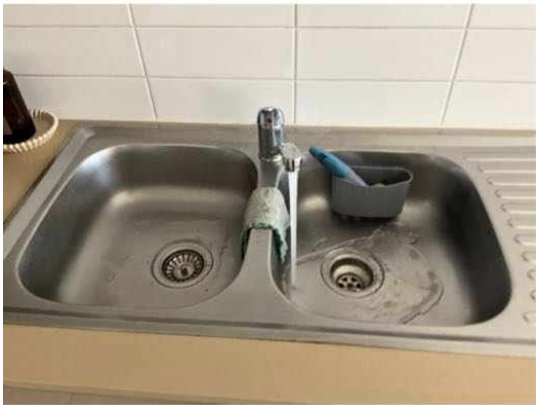
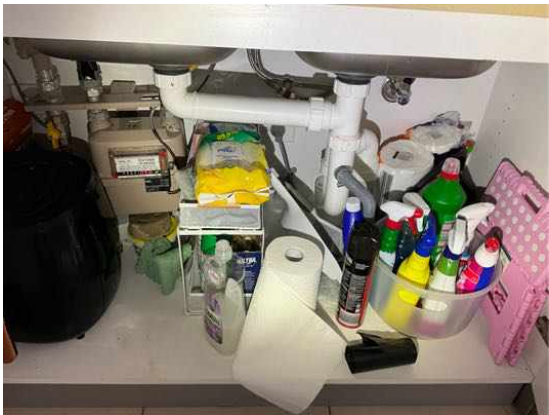
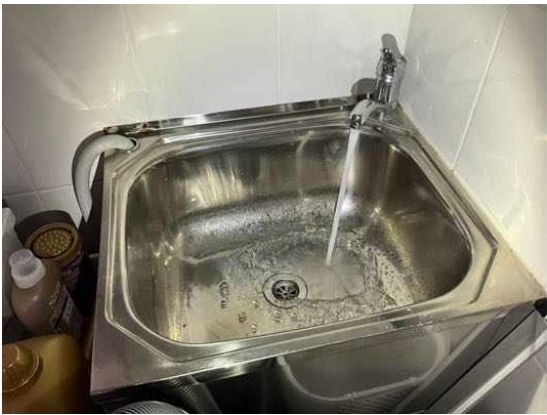
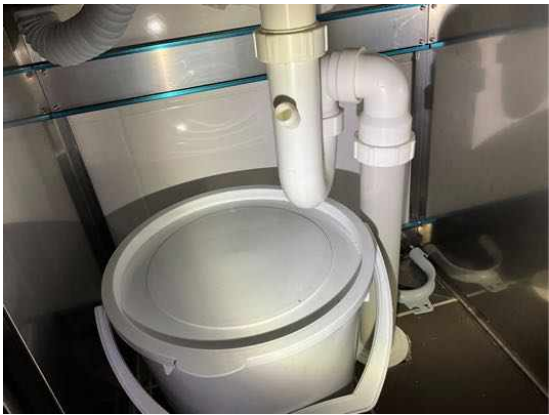
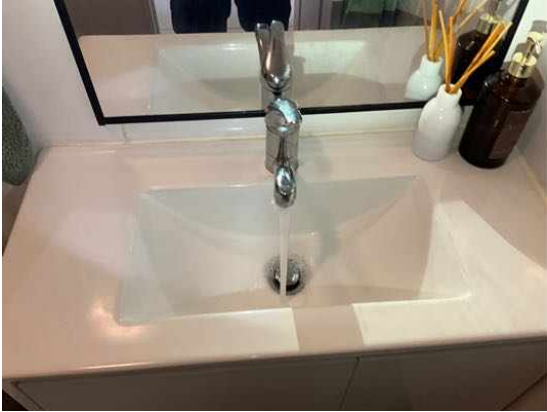
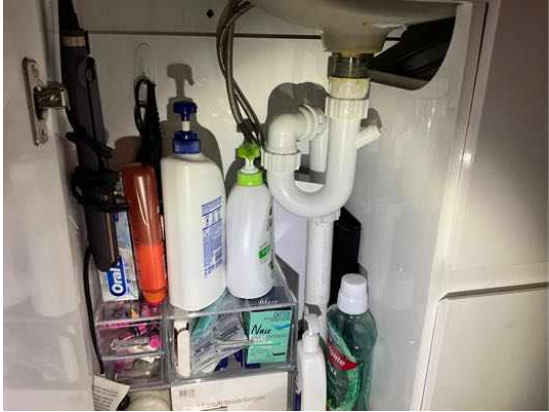
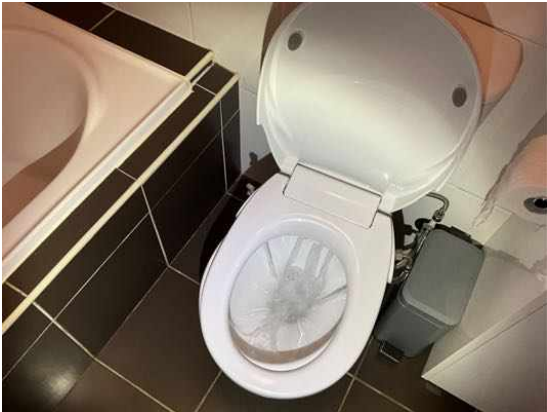
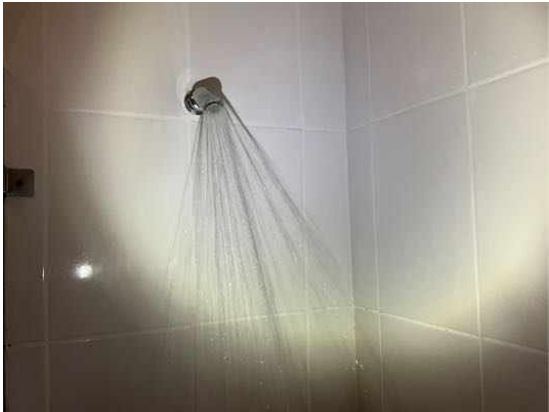
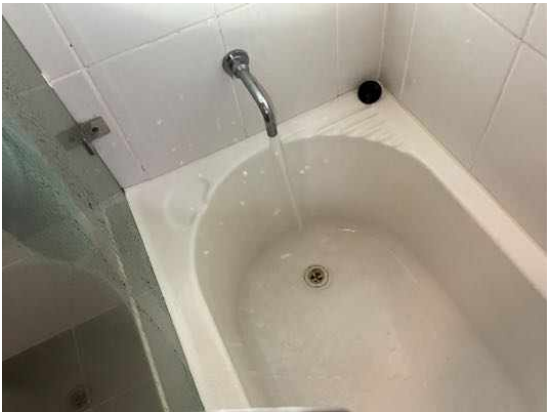
Building: Main Building
Location: All Wet Areas
Finding: Additional Photos
Information:

Additional photos are provided for your general reference.

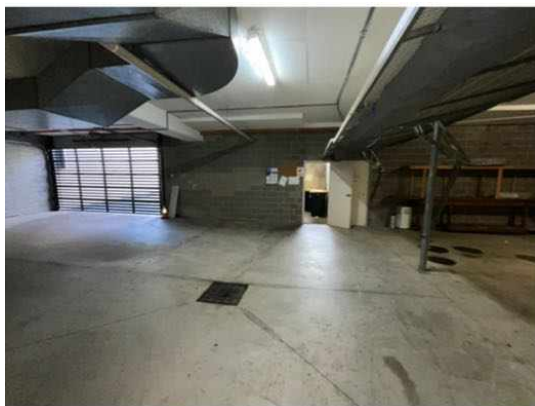
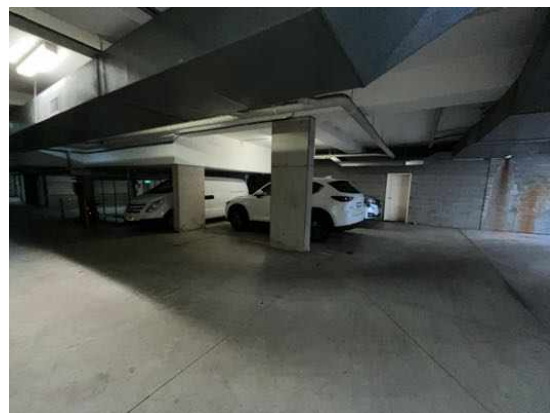
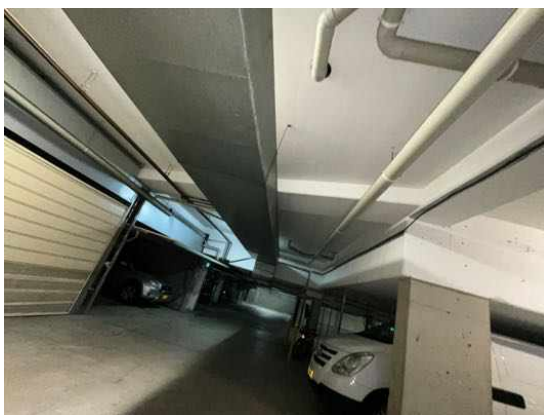
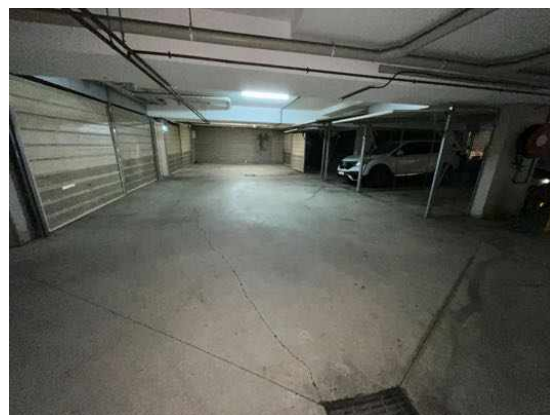
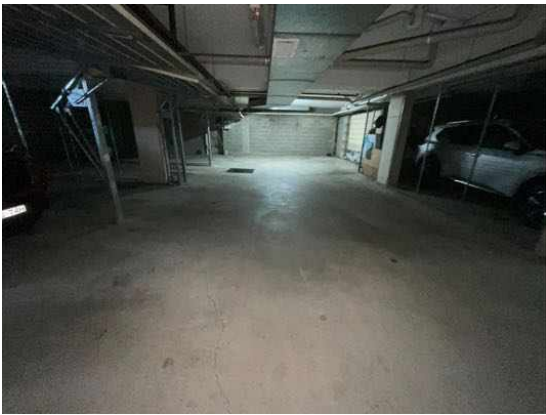
Building: Main Building
 Location: Garage
 Finding: Additional Photos- Garage
 Information: Additional photos are provided for your general reference. Arrows may have been included to highlight areas of importance. Please discuss these photos with your building consultant for clarification.

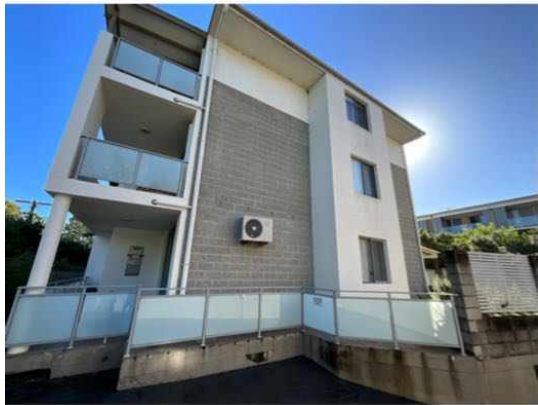
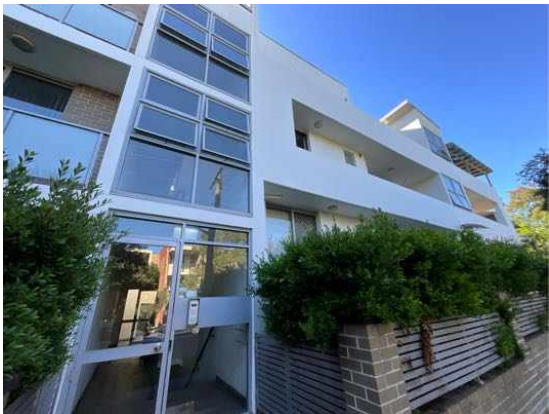
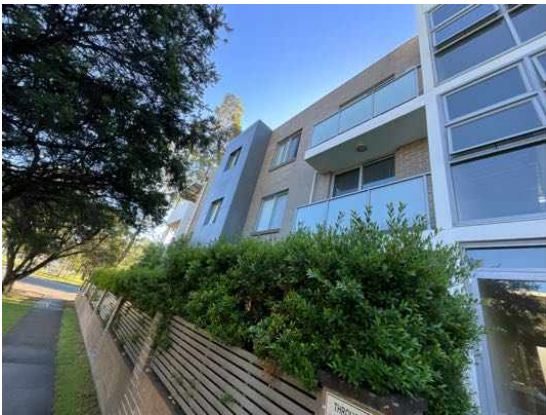
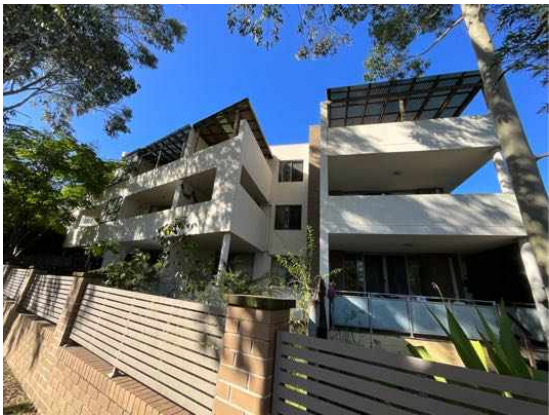
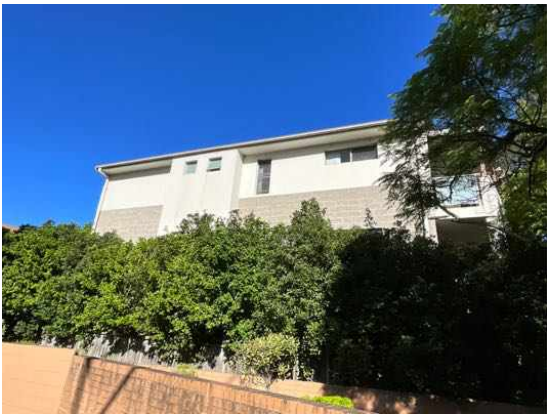
Finding: Additional Photos

Information: Additional photos are provided for your general reference.

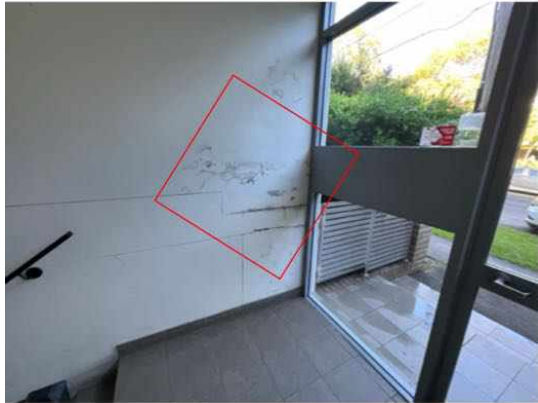
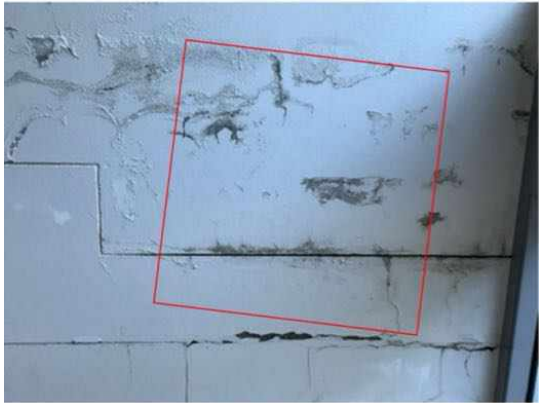
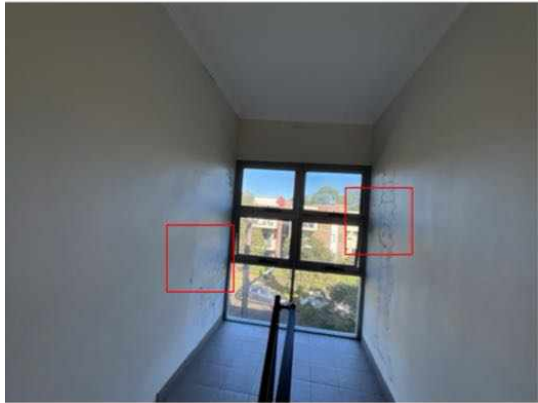
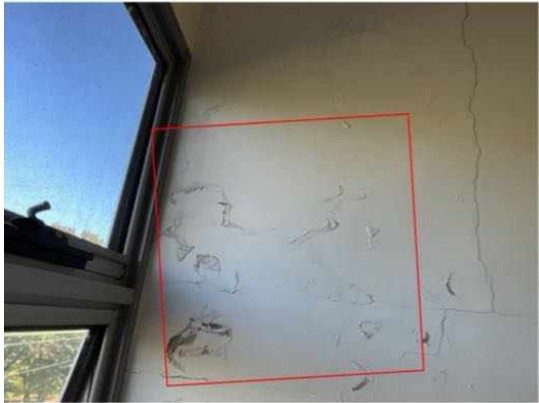
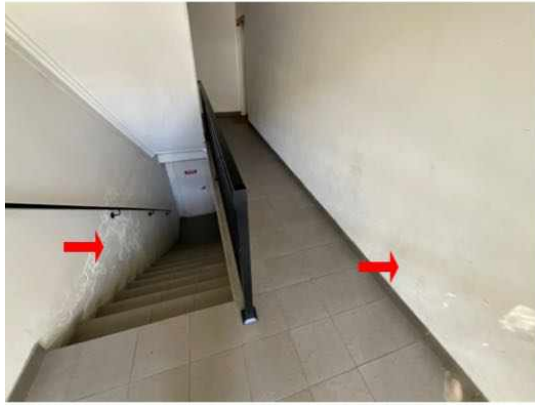
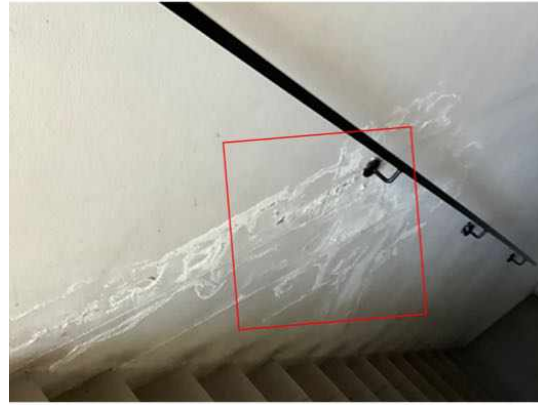
Building: Main Building
Location: Other common areas
Finding: Additional Photos
Information:

Additional photos are provided for your general reference.

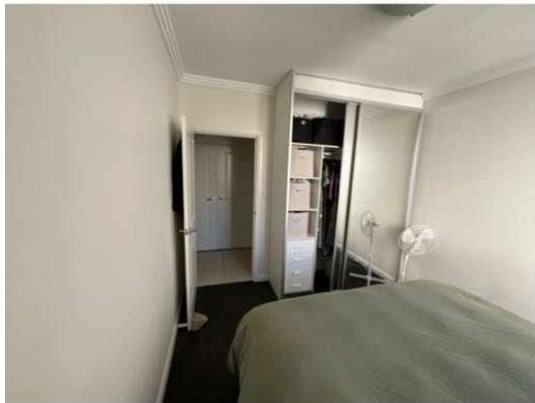
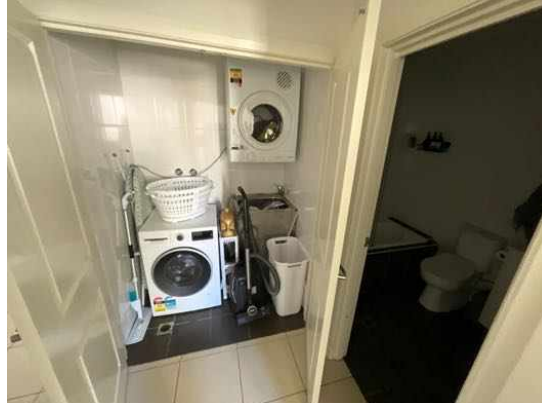
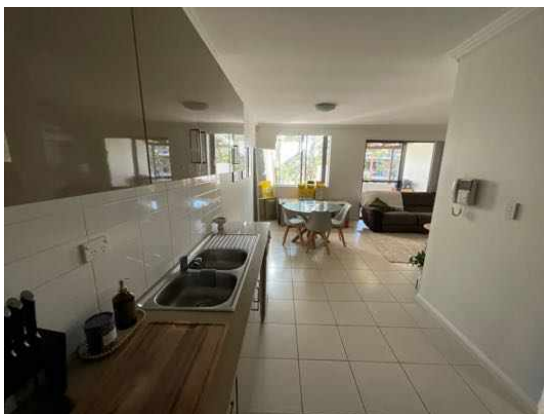
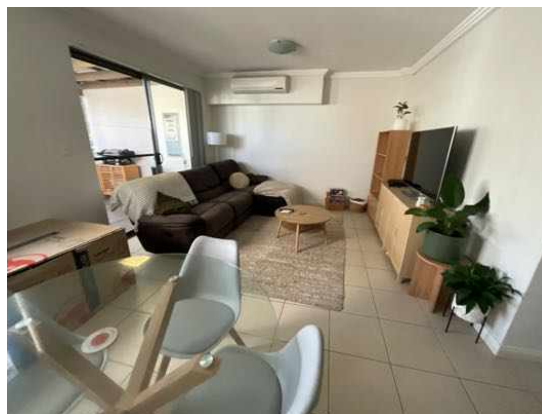
Building: Main Building
 Location: All Areas
 Finding: Additional Photos - Obstructions and Limitations
 Information:

These photographs are an indication of the obstructions and limitations which impeded full inspection of the property at the time of inspection. These obstructions can hide an array of defects and should be removed to allow full inspection to be carried out. A re-inspection is recommended once the areas are made accessible.
