Building Inspection Report

Inspection Date: Thu, 2 Apr 2026

Property Address: 43 Willow Dr, Hampton Park VIC 3976,
Australia

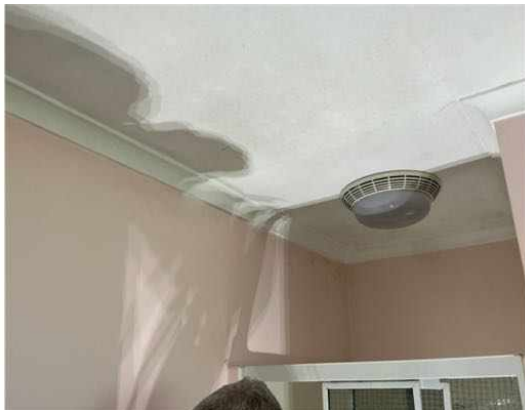
Defects 1.04

Information: Where evidence of mould growth was noted, there may be environmental, biological or health issues associated with the report. A specialist inspection by a suitably qualified environmental health inspector is warranted, where mould is extensive or where any queries regarding air quality spores or other related issues apply.

Generally, the client is advised to ensure that the general environment is free of moisture and humidity to aid in the prevention of mould formation and development. Any mould found during the inspection should be cleaned immediately by a cleaning contractor or the homeowner as applicable.

Please note that severely affected building elements may require replacement by a registered builder or qualified carpenter.

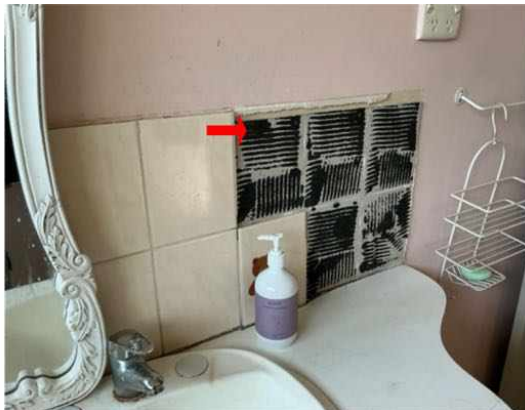
Defects 1.06

Information: Reporting on Asbestos is outside the Scope of this Report. This suspected defect is highlighted as a caution only. We suspect, based on our experience in the building industry, that there is a higher risk of the identified building element containing asbestos.

As Asbestos Reporting is outside the scope of this report, we advise that you consider a separate Asbestos Inspection and Condition Audit, which can include the taking of samples for definitive confirmation of the presence of Asbestos.

In the interim, the client is advised to act with caution, especially when considering any damage to building materials general wear and tear renovations extensions demolition and general maintenance activities due to the suspected presence of Asbestos.

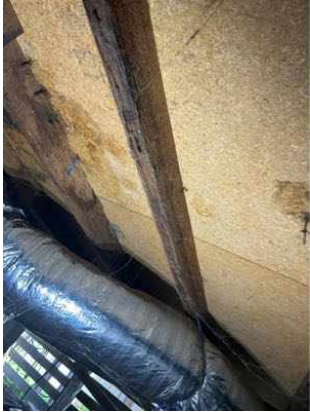
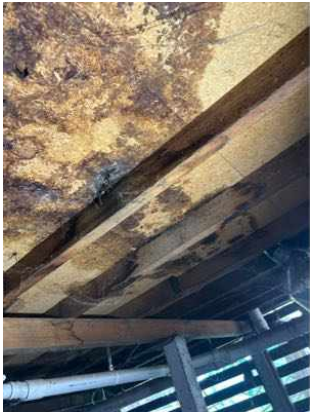
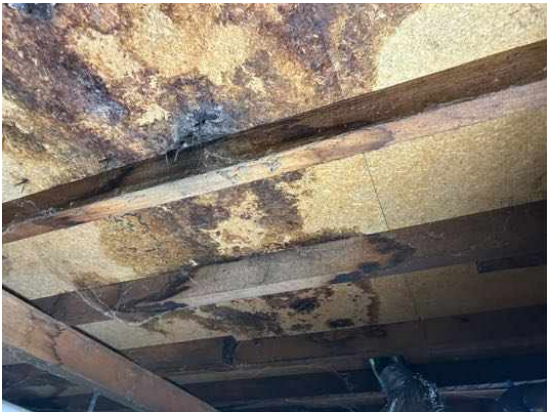
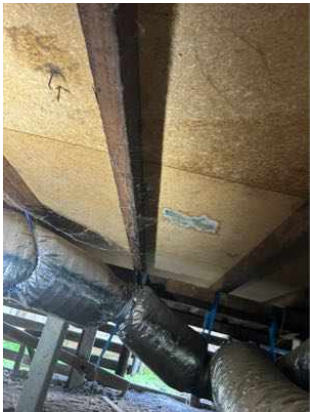
Defects 2.03

Finding: Shower - Leaking

Information: Leaking was evident to the shower area at the time of inspection as shown in photos with the moisture meter. It is suspected that the leaking has occurred as a result of general ageing of the building elements.

Leaking from the shower base, where left unattended, is likely to lead to water damage to adjoining flooring and walls. Leaking can lead to water damage and necessitate extensive remedial works being required. Active water leaks may also create an environment that is susceptible to the formation and development of mould.

Appointment of a tiling contractor is required to replace the shower the bathroom waterproofing and tiling. Such works should be performed as soon as possible to ensure that no further damage occurs.

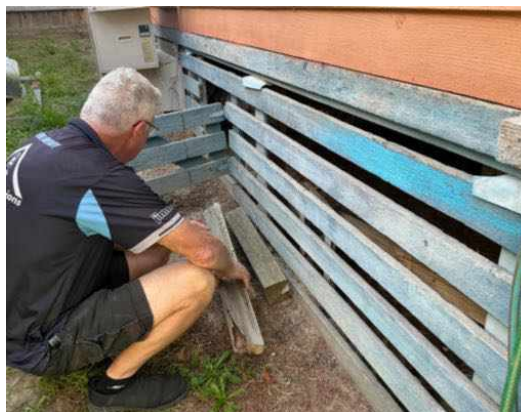
Defects 3.01

Building:	Main Building
Location:	Subfloor
Finding:	Stored timbers - subfloor space or external area
Information:	The storing of timbers in the subfloor space or around the external property increases the risk of termite activity being present. As they are likely to come into contact with weather conditions or excessive moisture wood rot is likely to develop on timbers that are not treated.

It is highly recommended that any stored timbers be immediately removed from areas in which they may attract any termite / timber pest attack. Minimisation of risk / prevention of termite attack is far more adequate than dealing with the presence of termite activity.

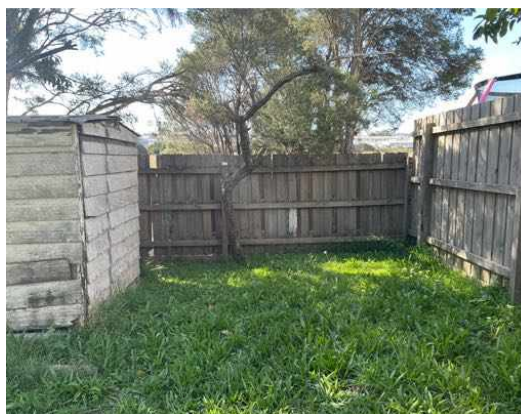
Defects 3.02

Building:	Main Building
Location:	Rear Elevation
Finding:	Fencing - Deteriorated
Information:	It was noted at the time of inspection that sections of the fencing throughout the property have deteriorated. Typically fencing deteriorates due to age and or wear, rot and or rust which is generally expected for a structure of this age, due to prolonged exposure to weather conditions. Sometimes inadequate installation or maintenance can be to blame.

If left unattended, it is likely that further damage will occur. It is suspected that repair of several elements of the fencing may be required however replacement may be a consideration of the client also.

A licensed fencing contractor should be appointed to provide further advice and perform rectification works as necessary.

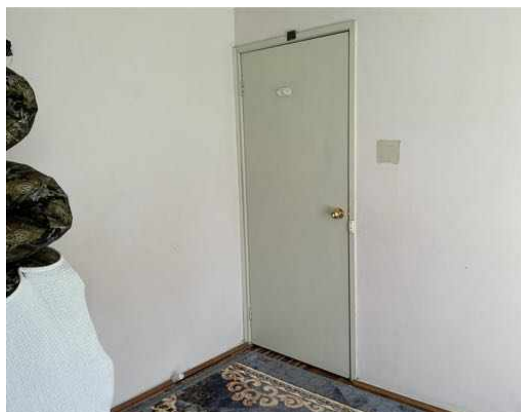
Defects 3.04

Building:	Main Building
Location:	Bedroom
Finding:	Door handle - Not latching
Information:	It was noted that the door in this area was not latching during operation at the time of inspection. Whilst detracting from the functionality of this building element, this minor

It is suspected that this defect has occurred due to minor issues with the associated hinges. Such damage is identified as general wear and tear, which is expected for building elements of this age.

A qualified carpenter or general handyperson may be appointed to perform rectification works as necessary, at client discretion. If left unattended, further functional impairment is likely to occur.

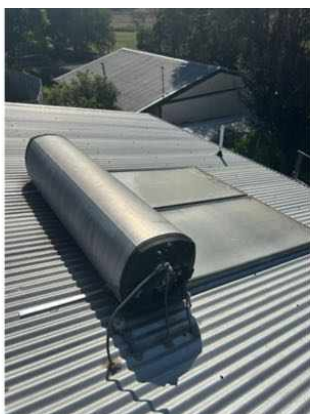
Defects 3.09

Building:	Main Building
Location:	Solar Hot water
Finding:	Appliances Disconnected
Information:	On inspection of this roof the old disconnected solar hot water service was found to be disconnected.

This would indicate that the unit is not functioning and would ideally need to be removed from the Roof rather than it continue to deteriorate and possibly affect the surrounding roofing materials.

Recommend a plumber or a suitable experienced handyman to remove and make good the roof where any penetrations exist.

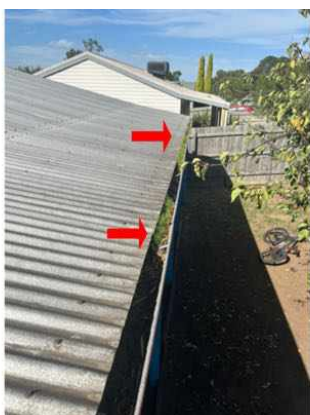
Defects 3.10

Building:	Main Building
Location:	Gutters
Finding:	Gutters - Blocked
Information:	Roof plumbing structures, such as guttering and downpipes, should be free of all debris to prevent blockages. Blockages of the guttering and downpipes will lead to pooling and accumulated water overflows, which is likely to subsequently flood eaves and exterior walls.

Blocked gutters are likely to lead to high levels of moisture in the affected areas. Such moisture will not only cause rust and decay of the associated building materials, but can also provide conditions that are conducive to termite and timber pest activity. Blockages in gutters should therefore be removed immediately to ensure dry conditions are maintained.

Consult a Licensed Plumber for further specific advice on remedial works that may be required. In the interim, it is highly advised that blocked gutters be removed by the homeowner or a general handyperson as a matter of urgency.

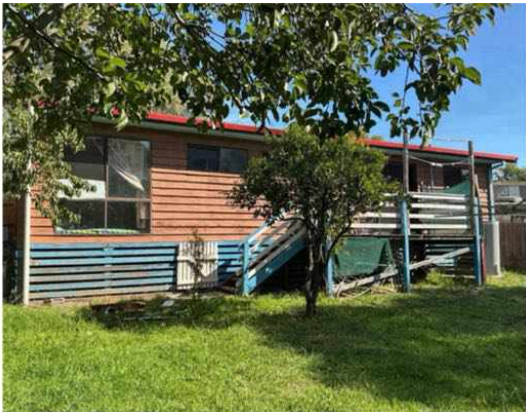
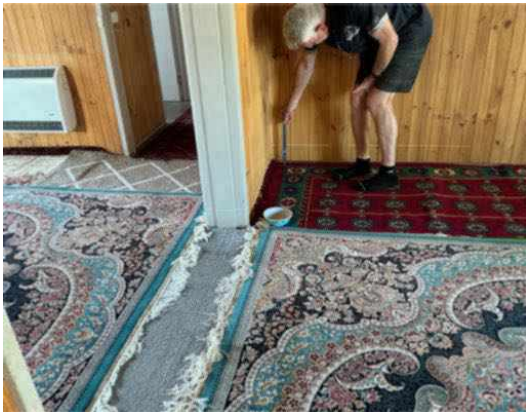
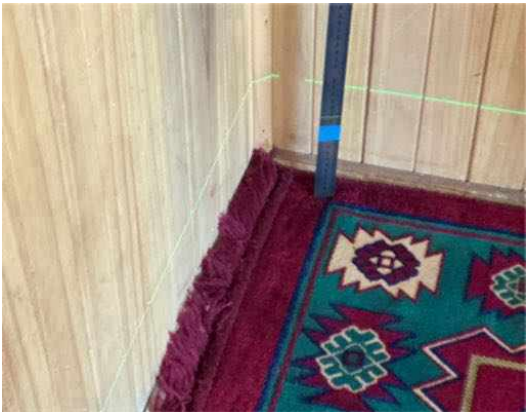
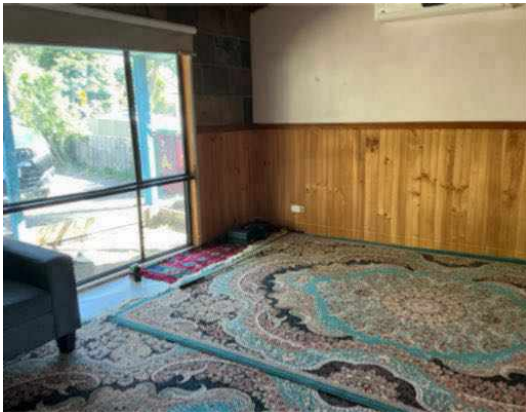
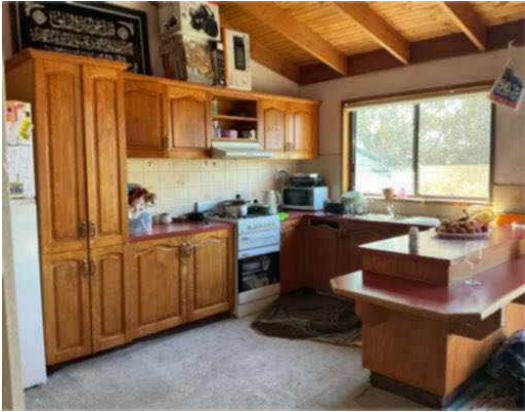
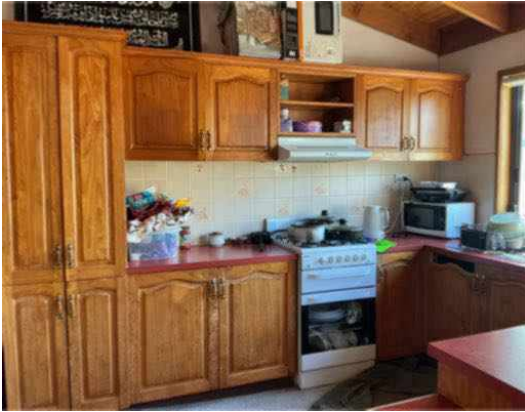
Noted Item

Building: Main Building
Location: All Areas
Finding: Additional Photos and Obstructions and Limitations
Information: These are additional photographs and photographs of the obstructions and limitations inside and outside (furniture, landscaping etc) which may impede full inspection of the property at the time of inspection. These obstructions can hide an array of defects and may be removed to allow full inspection to be carried out. A re-inspection may be made if clients require once the areas are made accessible.

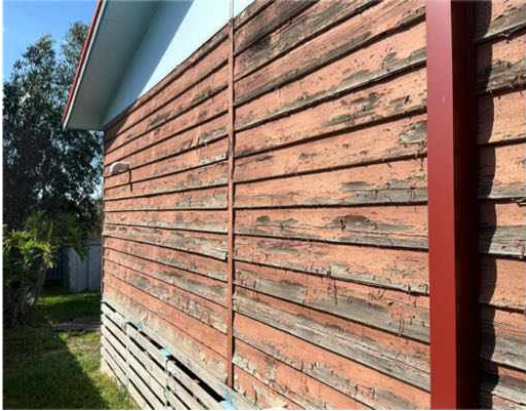
Noted Item

Building:	Main Building
Location:	All Areas
Finding:	External painting deteriorated
Information:	Much of the external paintwork including but not limited to windows, fascias, guttering, veranda and other external fitments have been neglected and require attention to prepare and re-paint.

Degraded paint finishes should be sanded back, filled, leveled and painted, as applicable. Where inadequate or missing paint protection has led to the deterioration of the associated building element, repair and/or replacement of this building element may be required.

A painting contractor should be appointed as soon as possible to perform necessary works to aid the appearance of the affected area and to ensure the area is protected against further deterioration. Alternatively, the homeowner following manufacturer instructions may perform these works.

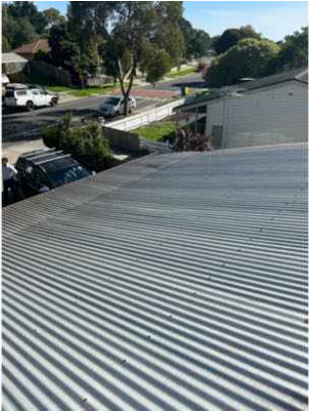
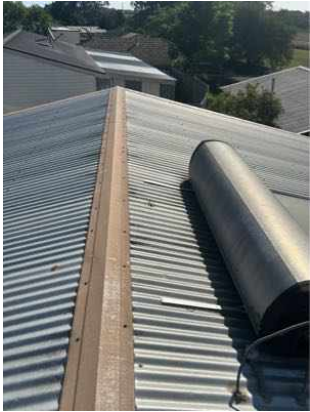
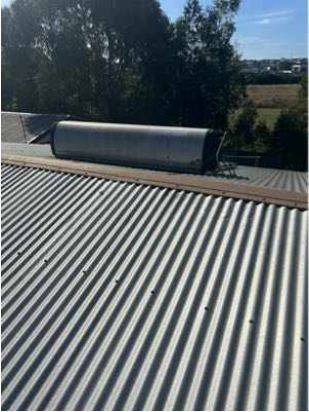
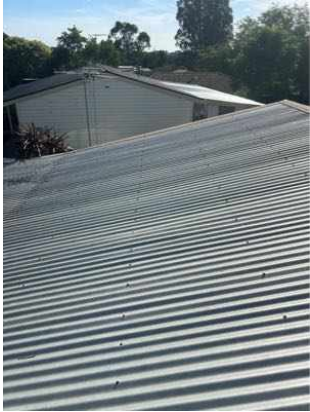
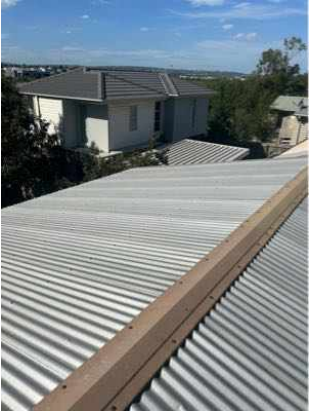
Building: Main Building
Location: All Areas
Finding: Additional Photos
Information: Additional photos are provided for your general reference
