Building and Timber Pest Inspection Report

Inspection Date: Tue, 24 Feb 2026

Property Address: 4/40 Royal Ave, Glen Huntly VIC 3163,
Australia

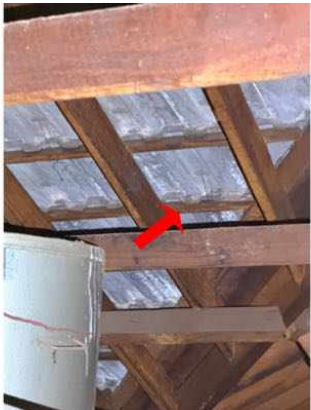
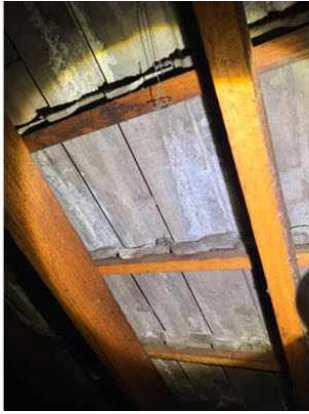
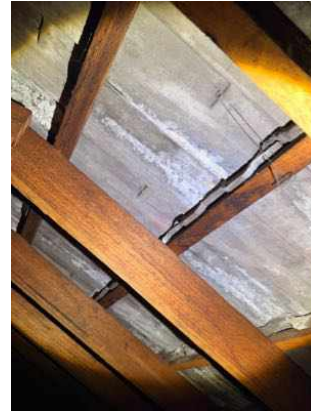
Building:	Main Building
Location:	Roof Exterior
Finding:	Roof tiles - Weathered
Information:	Upon inspection of the exterior roofing, the majority of roof tiles were considered to be in a fair condition. While weathering of the tiles is consistent with the age of the property, maintenance works are required.

Isolated areas of mortar have come loose in the valleys and minor cracking is also present. Re-pointing and re-sealing the may be considered as an interim solution by the client to help preserve and extend the life span of the tiles.

Where left unmanaged, deteriorating roof tiles are likely to lead to a number of secondary defects, including minor water leaks and weather exposure to internal roofing structures.

Efflorescence was observed on the underside of the roofing material. This is identified by the white, powdery staining that forms when moisture within the material dissolves salts, which are then carried to the surface and deposited as the water evaporates.

While efflorescence itself is not structurally damaging, it indicates that moisture is penetrating or accumulating in the roof covering. If left unaddressed, ongoing moisture exposure may contribute to deterioration of roofing materials and encourage timber

decay or corrosion of fixings.

It is recommended to monitor the area for signs of active leaks and ensure roof drainage and ventilation are adequate. If moisture ingress persists, a licensed roofing contractor should be engaged to investigate and carry out necessary rectification works.

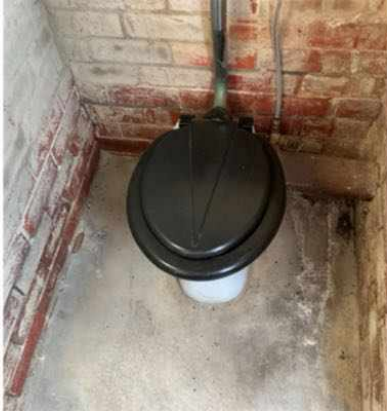
Building: Main Building
Location: Garage
Finding: Toilet plumbing – leakage observed
Information: Water leakage was observed at the toilet connection area when the toilet was operated, with associated moisture staining noted to the adjacent floor.

Ongoing leakage may lead to moisture damage, mould growth, and deterioration of surrounding building elements if not rectified.

Engage a licensed plumber to inspect the toilet connections, rectify the leak, and test the installation to ensure it is fully watertight.

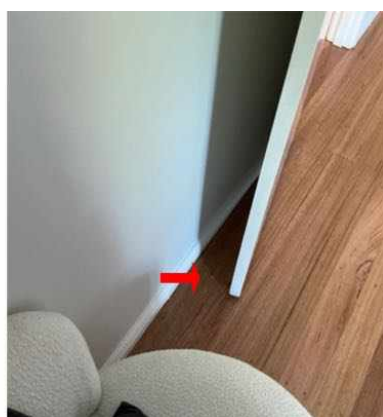
Building:	Main Building
Location:	Bedroom
Finding:	Door stop - Missing
Information:	The door stop is missing or is inadequate to stop the door handle from damaging the wall. Although some building elements may seem irrelevant or unnecessary, all building elements play a key role in the operation and function of the overall structure and its performance.

Re-installation or replacement of the door stop is advised as soon as possible to prevent any subsequent damage to the door or associated structures. A general handyman may be appointed to perform these works at client discretion.

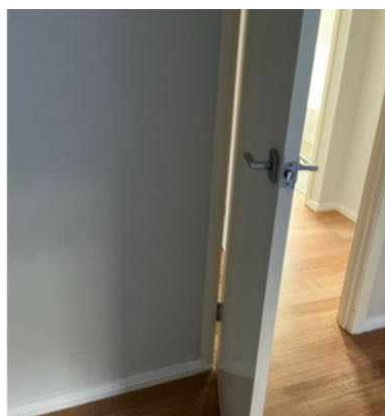
Building:	Main Building
Location:	Bedroom 2
Finding:	Door stop - Missing
Information:	The door stop is missing or is inadequate to stop the door handle from damaging the wall. Although some building elements may seem irrelevant or unnecessary, all building elements play a key role in the operation and function of the overall structure and its performance.

Re-installation or replacement of the door stop is advised as soon as possible to prevent any subsequent damage to the door or associated structures. A general handyman may be appointed to perform these works at client discretion.

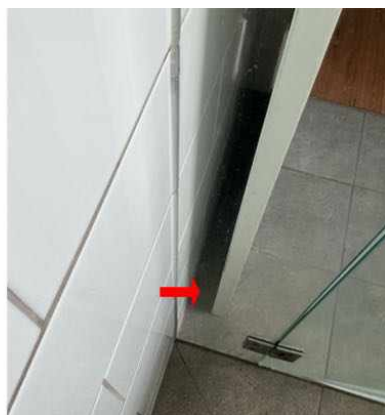
Building:	Main Building
Location:	Bathroom
Finding:	Door stop missing — damaged
Information:	The door stop is missing behind the door. This has resulted in visible impact damage to the wall.

Continued use without a door stop may lead to further damage to the wall, fittings, or

door hardware.

It is recommended to install an appropriate door stop or bumper to prevent further impact damage and to repair the affected wall area as required.

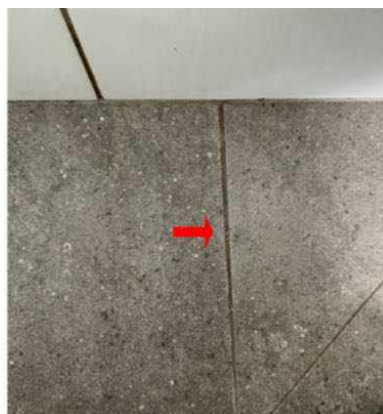
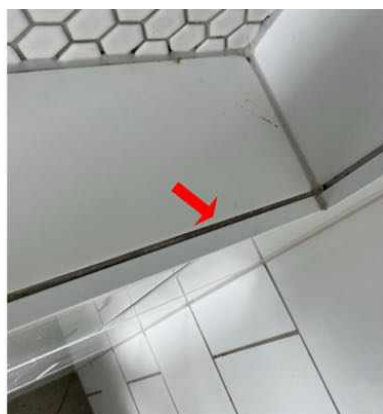
Building:	Main Building
Location:	Bathroom
Finding:	Sealant and grout deteriorate
Information:	The compromised sealant and deterioration of grout may allow water to penetrate into the substrate beneath the tiles. Over time, this can lead to deterioration of the underlying waterproofing membrane, increasing the risk of moisture ingress and potential structural damage.

It is recommended that a licensed waterproofing contractor be engaged to remove the degraded sealant, repair or replace the deteriorated grout, and reapply suitable waterproof-grade sealant. These works should be carried out as soon as possible to prevent further water penetration and damage to the balcony structure.

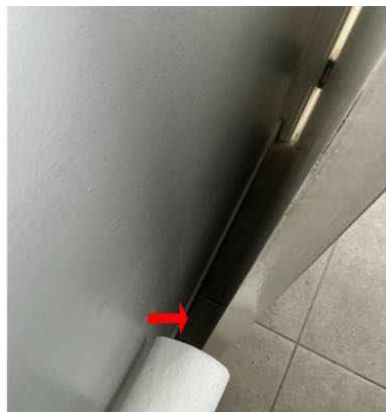
Building:	Main Building
Location:	Toilet (WC)
Finding:	Door stop missing – damaged
Information:	The door stop is missing behind the bedroom door. This has resulted in visible impact damage to the wall.

Continued use without a door stop may lead to further damage to the wall, fittings, or door hardware.

It is recommended to install an appropriate door stop or bumper to prevent further impact damage and to repair the affected wall area as required.

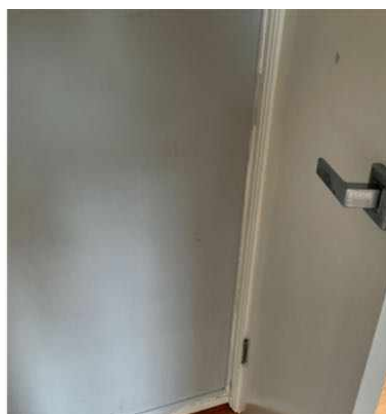
Building:	Main Building
Location:	Laundry
Finding:	Door stop - Missing
Information:	The door stop is missing or is inadequate to stop the door handle from damaging the wall. Although some building elements may seem irrelevant or unnecessary, all building elements play a key role in the operation and function of the overall structure and its performance.

Re-installation or replacement of the door stop is advised as soon as possible to prevent any subsequent damage to the door or associated structures. A general handyman may be appointed to perform these works at client discretion.

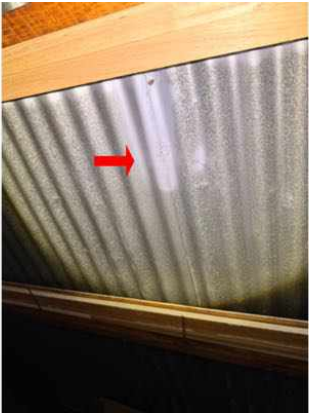
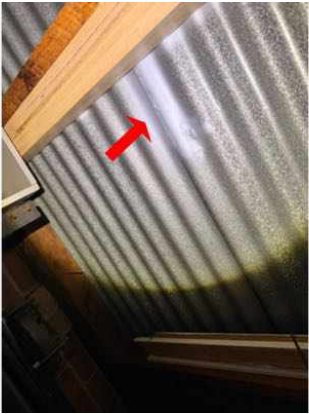
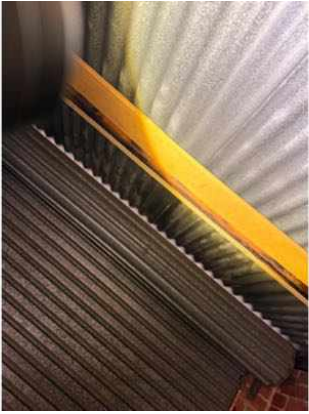
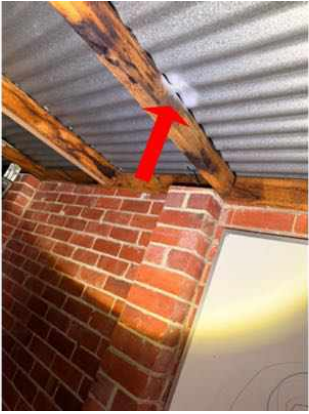
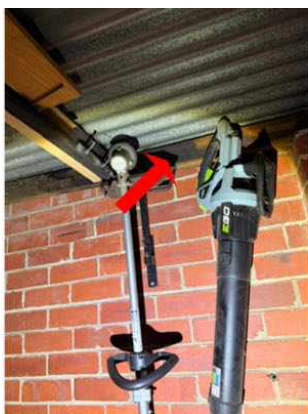
Building:	Main Building
Location:	Roof Exterior
Finding:	Garage roof/ceiling – Corrosion & possible moisture-related damage
Information:	At the time of inspection, the corrugated garage roof sheets/flashings showed significant corrosion. The garage ceiling lining appeared to be recently painted, and dark staining was noted to garage ceiling timbers.

Corrosion can lead to perforation and water ingress. The repainting may conceal previous moisture staining, and the darkened timbers may indicate past or ongoing moisture exposure, which can result in timber deterioration and recurring internal damage.

Engage a licensed roofing plumber/roofing contractor to investigate for leaks and assess the roof condition, then repair/replace affected sheets/flashings as required; once watertight, have a builder/carpenter assess the stained timbers and complete any necessary repairs/replacement before further cosmetic painting.

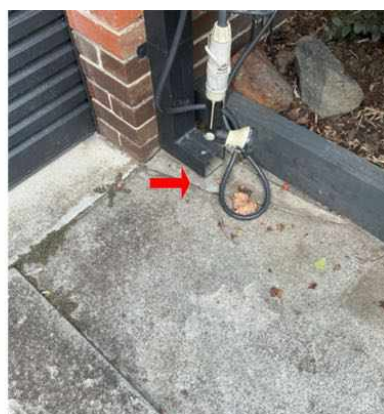
Where roof plumbing does not drain adequately, water can discharge directly to the soil around the building perimeter, leading to excessive damp conditions. Over time, this may contribute to rust and corrosion of nearby building elements and create conditions that can attract termites and other pests. Prolonged water discharge to soil can also potentially contribute to structural movement.

It is recommended that a licensed plumber further inspect the area and install appropriate drainage connections where required.

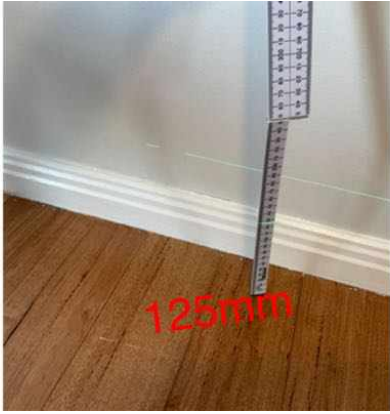
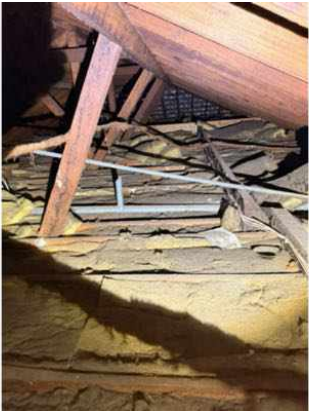
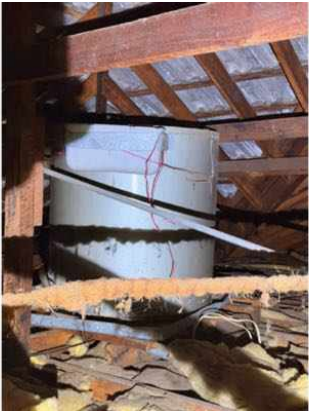
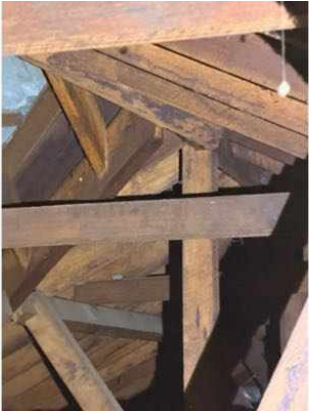
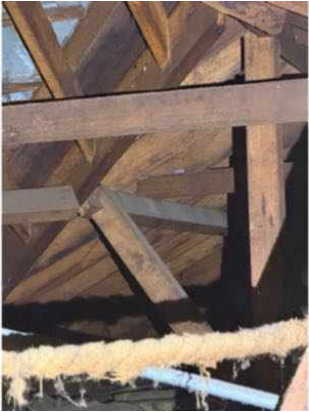
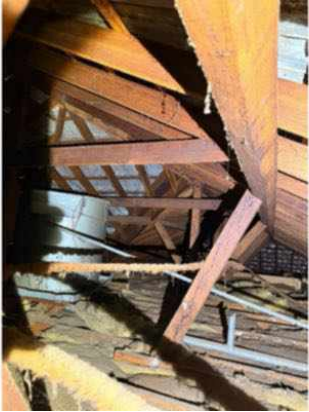
Building: Main Building
Location: Roof Void
Finding: Roof void timber condition.
Information: At the time of inspection, the majority of roof void timbers were observed to be in generally acceptable condition when considered against the age of the property. Isolated timbers exhibited darker staining/discolouration, which may indicate past or active moisture ingress. No significant timber decay, softening, or wood rot was identified within the accessible roof void areas at the time of inspection. It is recommended that the client monitor the stained timbers during and after periods of heavy rainfall to confirm there is no ongoing moisture ingress and to help maintain the roof structure in a sound condition.

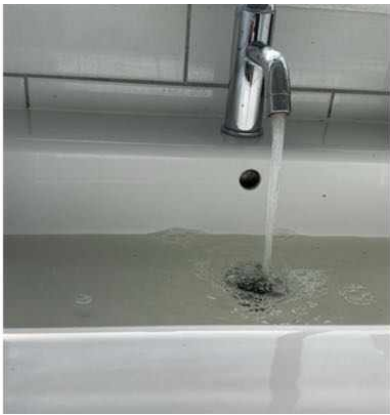
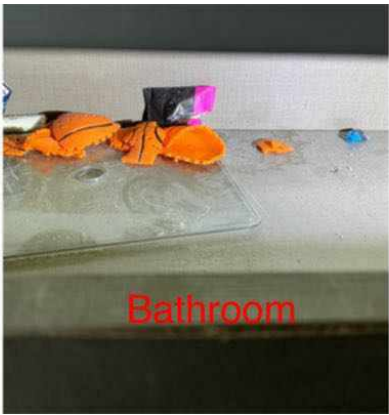
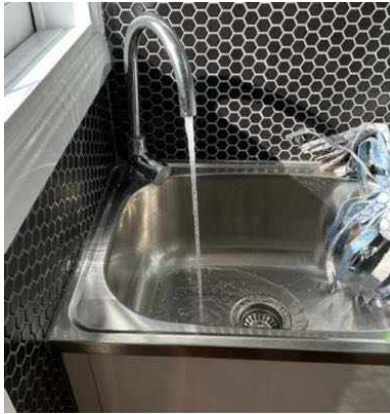
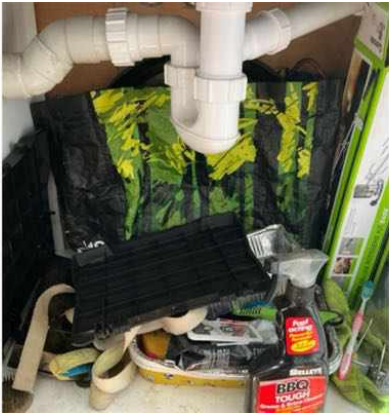
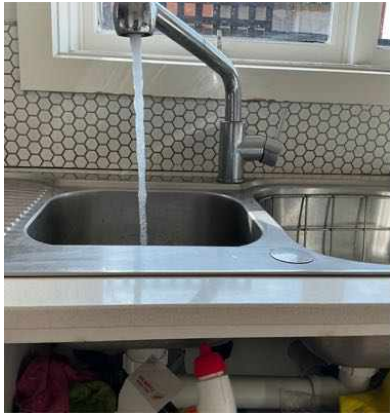
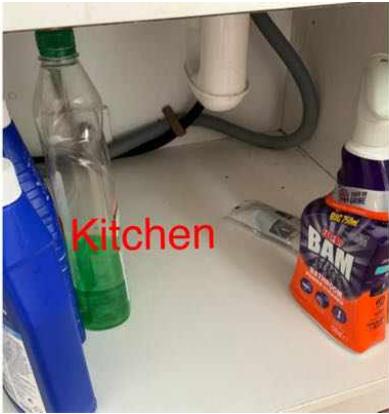
Building:	Main Building
Location:	Cabinetry plumbing
Finding:	For your information
Information:	Cabinetry plumbing - No leaks evident

All cupboards where sinks and basins with drainage plumbing were inspected and no evidence of leaks were present at the time of inspection.

For your information only no remedial works are required at the time of inspection.

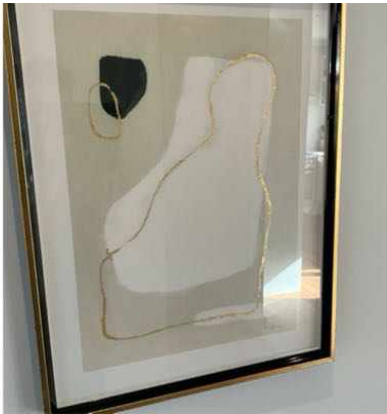
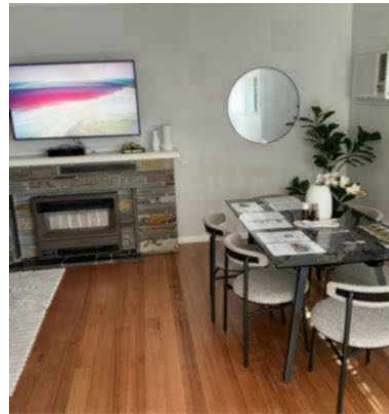
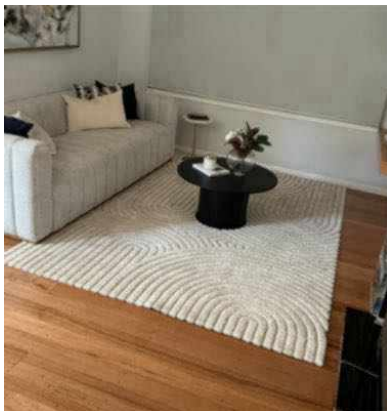
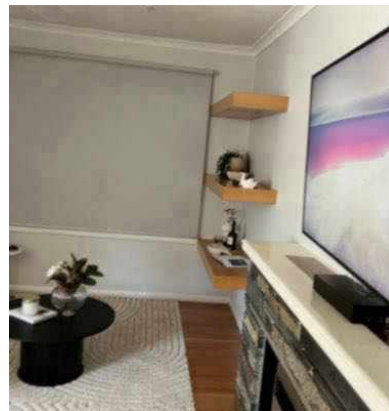
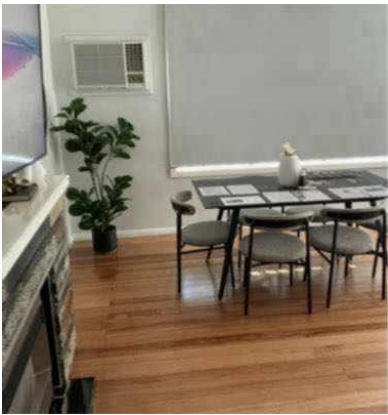
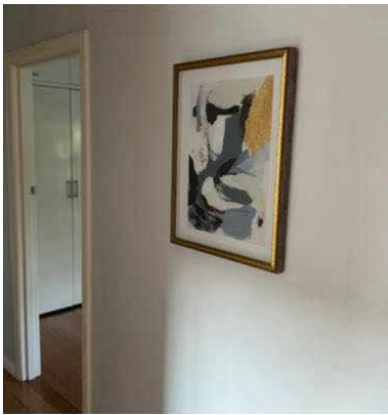
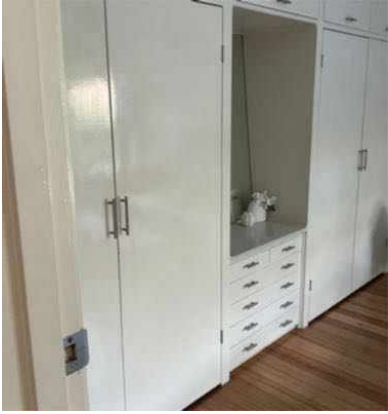
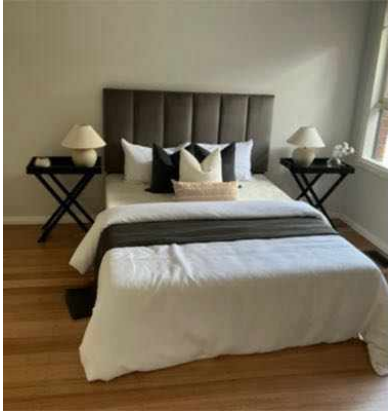
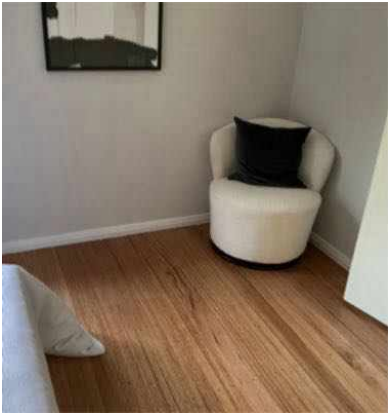
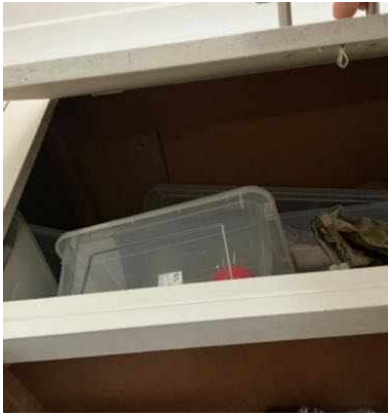
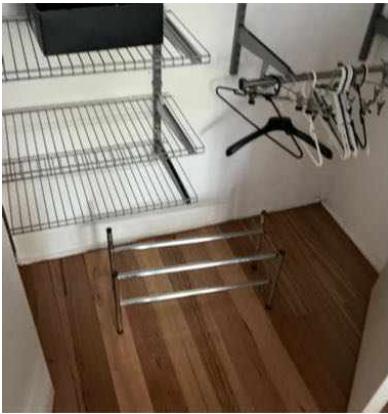
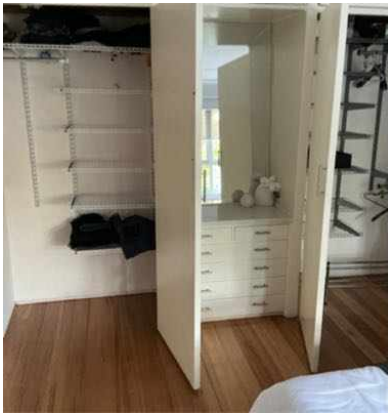
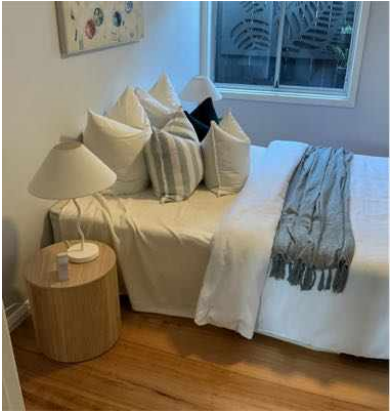
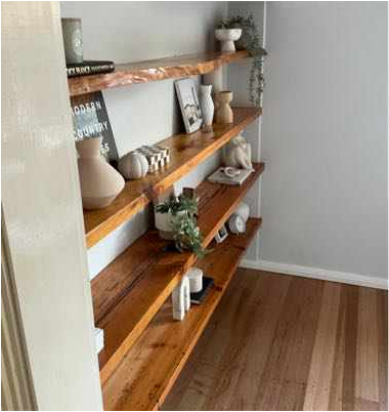
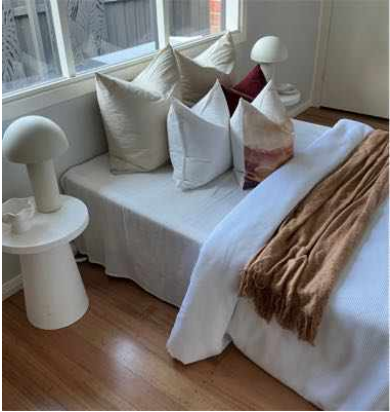
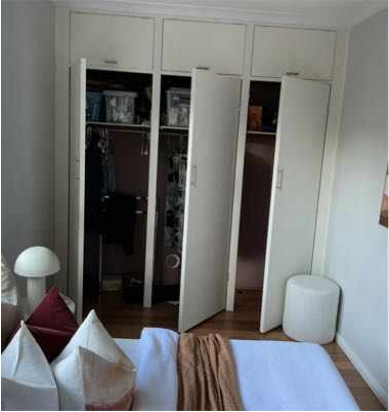
Building: Main Building
Location: All Areas
Finding: Additional Photos - Obstructions and Limitations
Information: These photographs are an indication of the obstructions and limitations which impeded full inspection of the property at the time of inspection. These obstructions can hide an array of defects and should be removed to allow full inspection to be carried out. A re-inspection is recommended once the areas are made accessible. Arrows and highlights have been included to identify minor defects. The purchaser can discuss further with the building inspector.
