Building Inspection Report

Inspection Date: Thu, 12 Mar 2026

Property Address: 1118/243 Pyrmont St, Pyrmont NSW 2009,
Australia

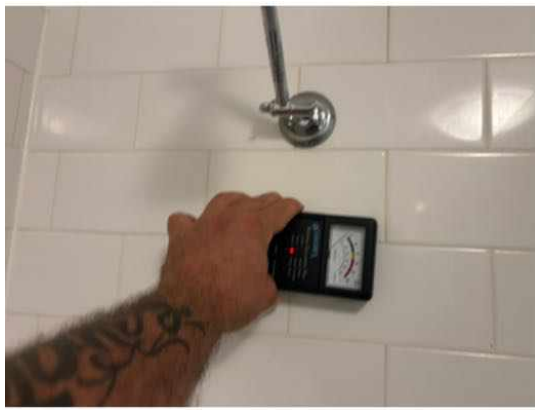
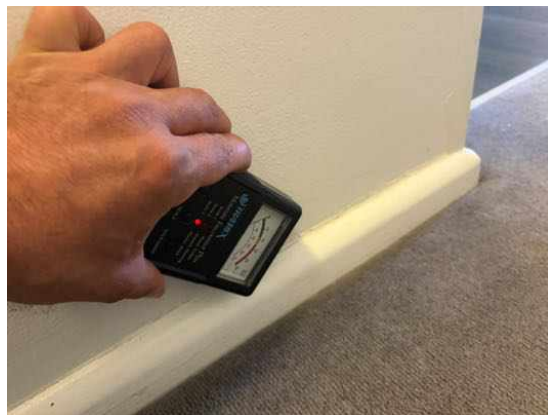
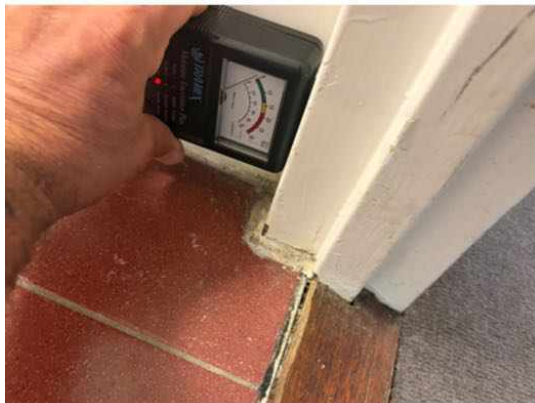
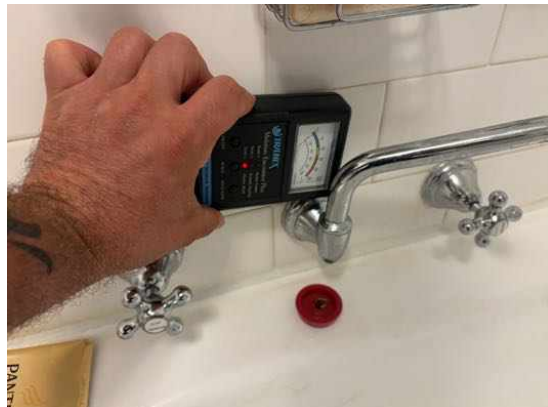
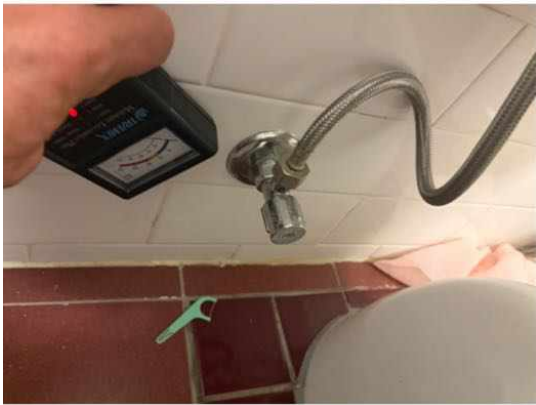
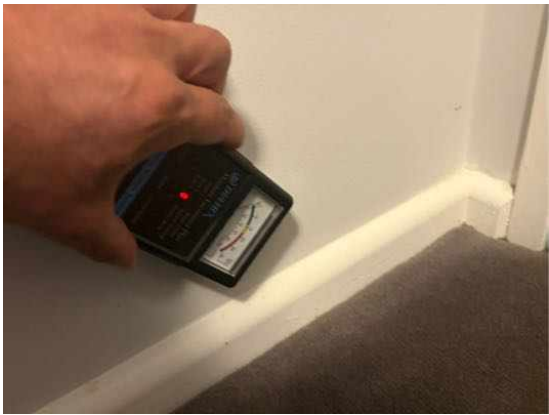
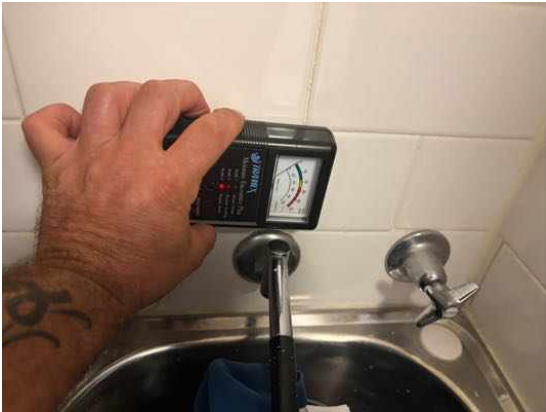
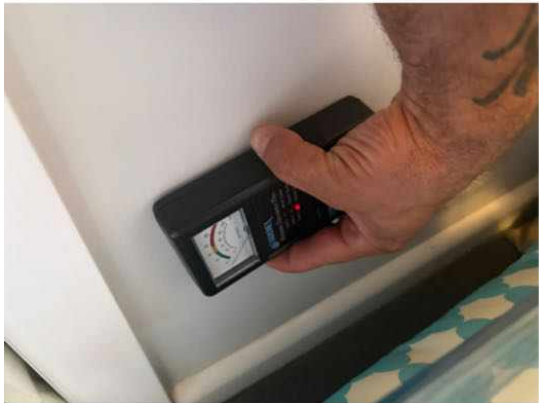
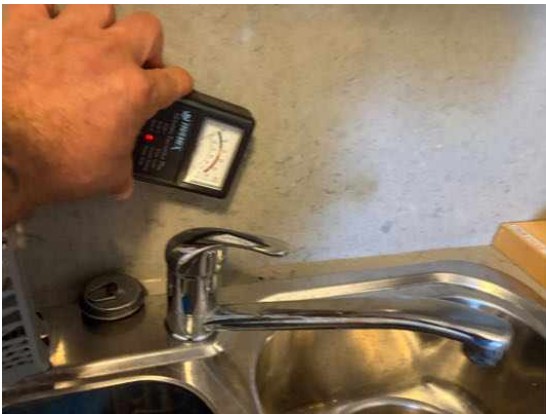
Building: Main Building
Location: All Areas
Finding: Moisture metre
Information: During the inspection the property was checked for moisture using a moisture metre.

This is for information only.

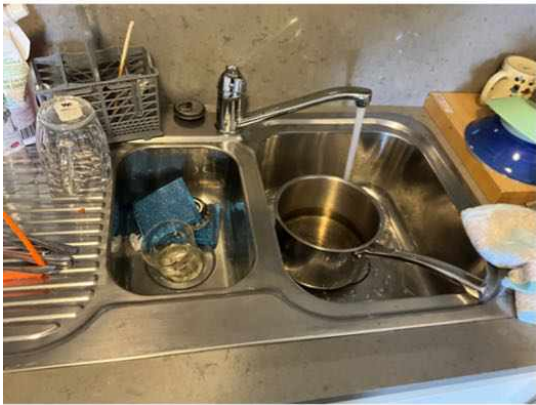
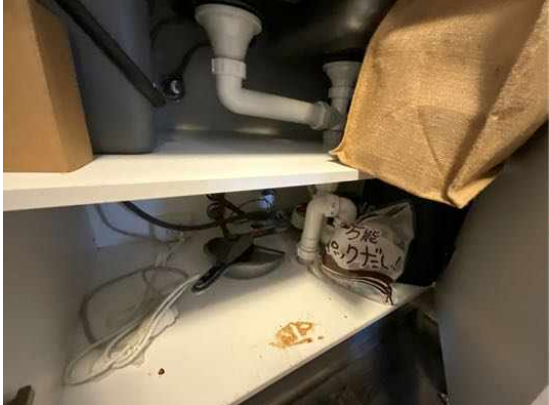
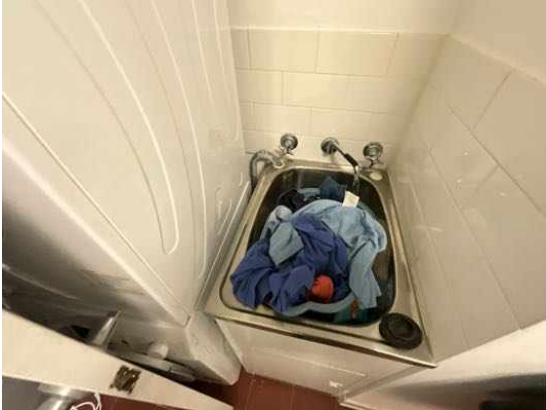
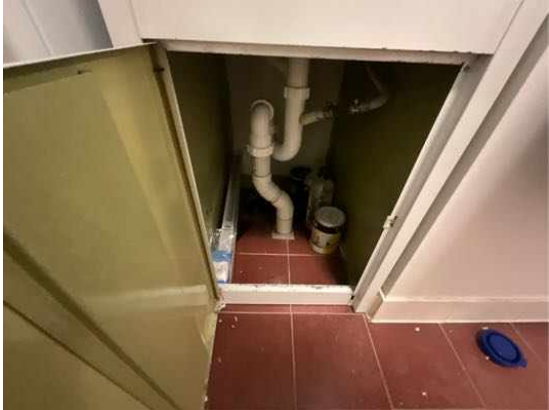
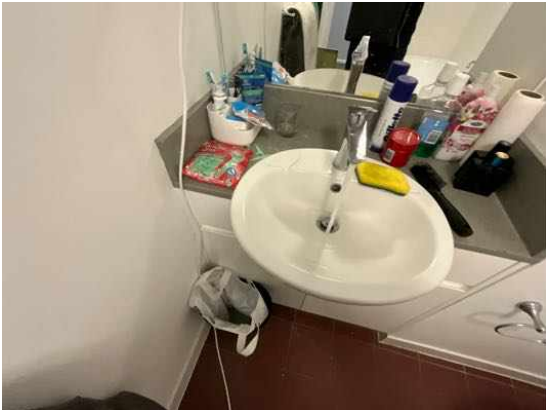
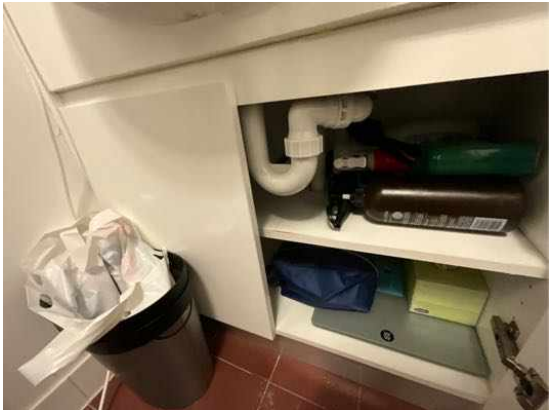
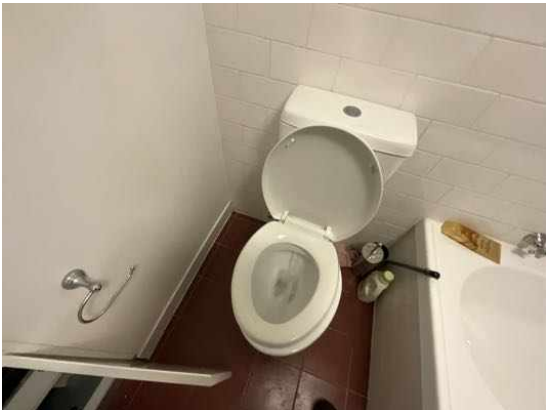
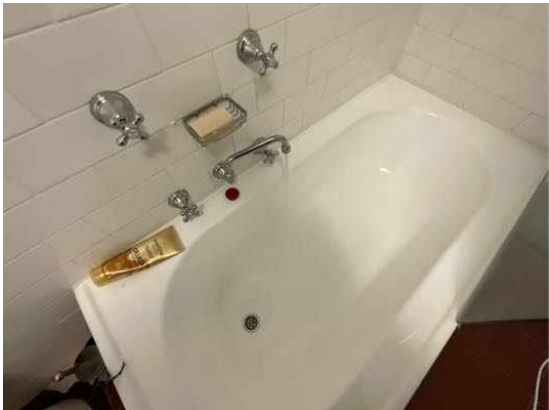
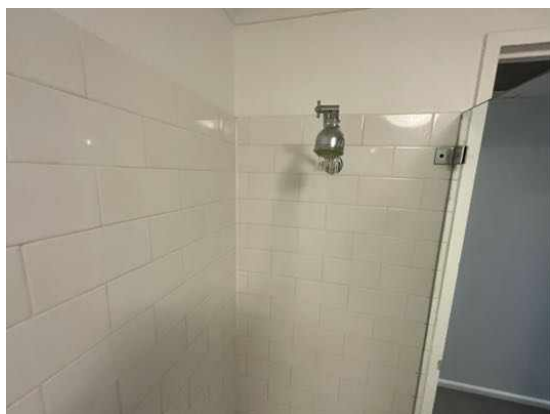
Noted Item

Building: Main Building
Location: All Wet Areas
Finding: Additional Photos
Information:

Additional photos are provided for your general reference.

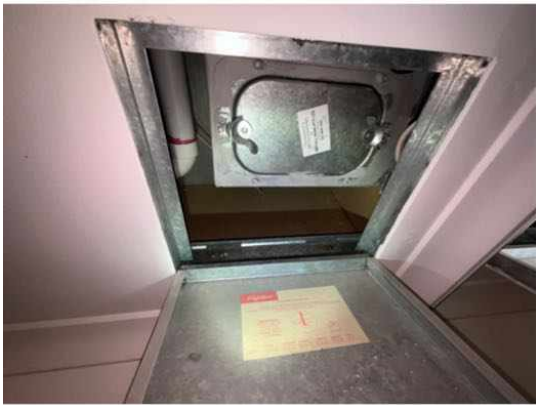
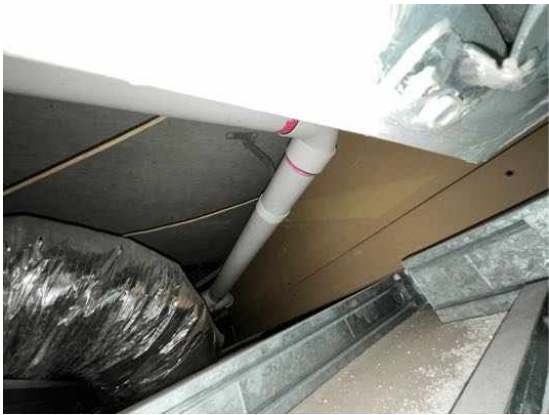
Noted Item

Building:	Main Building
Location:	Ceiling cavity
Finding:	Additional Photos- ceiling cavity
Information:	Additional photos are provided for your general reference. Arrows may have been included to highlight areas of importance. Please discuss these photos with your building consultant for clarification.

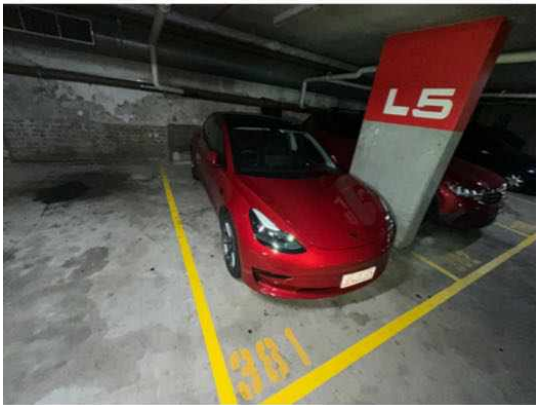
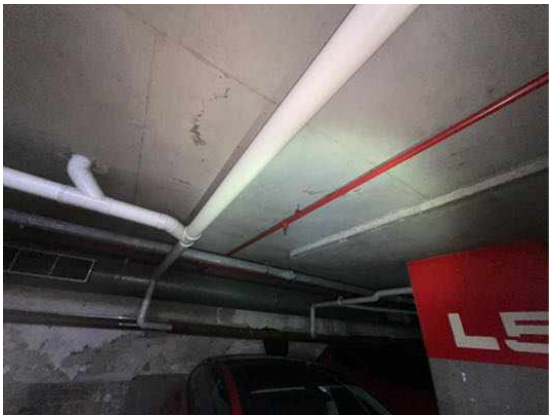
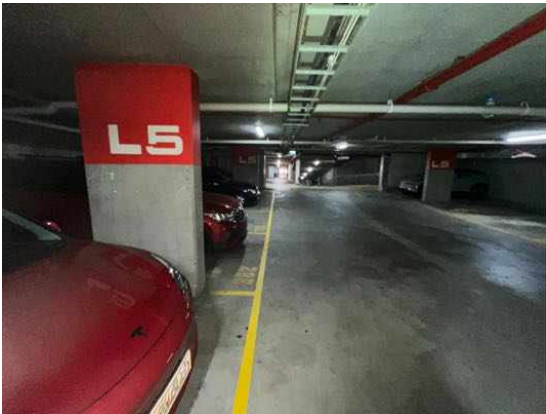
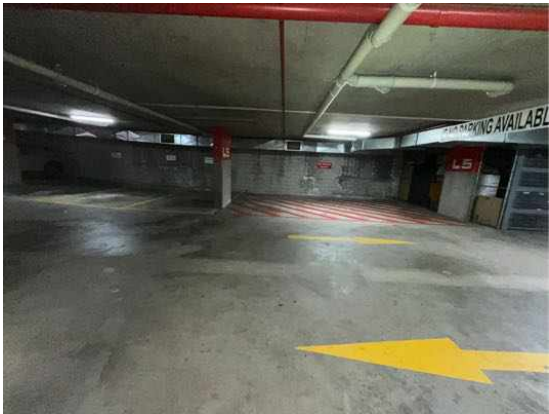
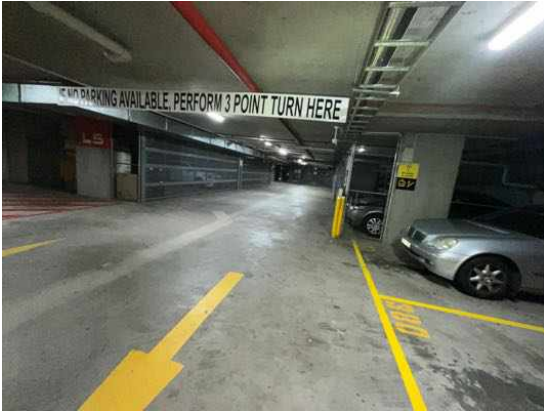
Noted Item

Building: Main Building
 Location: Garage
 Finding: Additional Photos- Garage
 Information: Additional photos are provided for your general reference. Arrows may have been included to highlight areas of importance. Please discuss these photos with your building consultant for clarification.
