# Building and Timber Pest Inspection Report

Inspection Date: Fri, 13 Feb 2026

Property Address: 8 Somerset Rd, Yallourn North VIC 3825,  
Australia

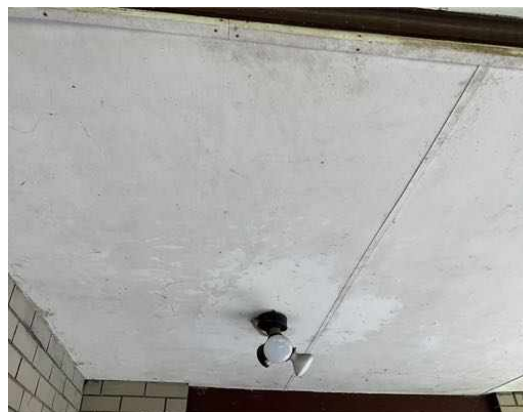
Building:	Main Building
Location:	All Areas
Finding:	Asbestos - Suspected ACM Identified on Site
Information:	Eaves were suspected to contain asbestos at the time of inspection. Reporting on Asbestos is outside the Scope of this Report. This suspected defect is highlighted as a caution only. We suspect, based on our experience in the building industry, that there is a higher risk of the identified building element containing asbestos.

As Asbestos Reporting is outside the scope of this report, we advise that you consider a separate Asbestos Inspection and Condition Audit, which can include the taking of samples for definitive confirmation of the presence of Asbestos.

In the interim, the client is advised to act with caution, especially when considering any damage to building materials general wear and tear renovations extensions demolition and general maintenance activities due to the suspected presence of Asbestos.

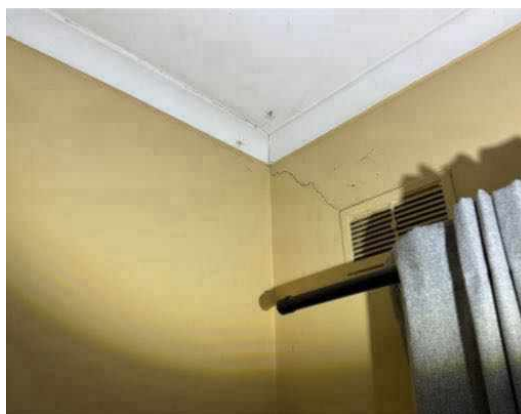
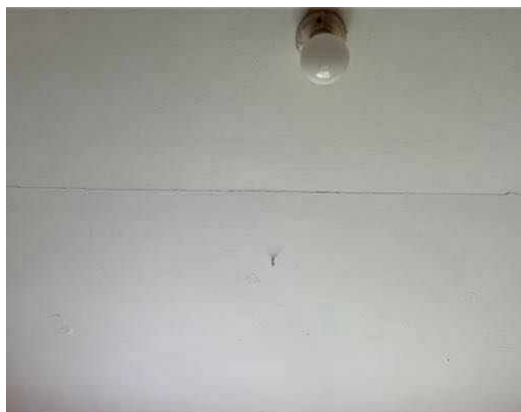
#### Finding 2.01

Building:	Main Building
Location:	All Areas
Finding:	Major Internal Cracking Indicative of Structural Movement
Information:	Several significant cracks were observed to internal walls during the inspection. The extent and pattern of cracking are suggestive of structural movement rather than minor cosmetic settlement. Cracks of this nature may be associated with foundation movement, footing settlement, slab heave, or structural stress within load-bearing

Structural movement can compromise the integrity of the building over time and may lead to further cracking, distortion of door and window frames, and potential instability if not properly assessed and addressed. Ongoing movement may result in progressive damage to both structural and non-structural components.

It is strongly recommended that a qualified structural engineer be engaged to conduct a detailed assessment to determine the cause, extent, and required remedial measures. Depending on the findings, solutions may include structural rectification works and/or installation of appropriate expansion/control joints where applicable. Remedial works should be carried out in accordance with engineering recommendations.

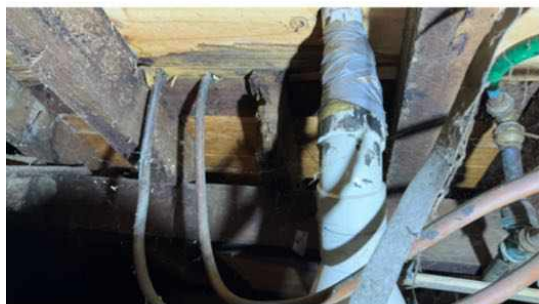
## Finding 2.02

Building:	Main Building
Location:	Subfloor
Finding:	Active Water Leakage Observed in Subfloor Area
Information:	Active water leakage was observed within the subfloor area during the inspection, located in proximity to plumbing pipework. Visible moisture and wet conditions were noted around the affected section. The source of the leak could not be fully determined due to the non-invasive nature of the inspection; however, the presence of active water indicates a plumbing defect requiring urgent attention.

Ongoing water leakage within a subfloor environment can lead to timber decay, fungal growth, corrosion of metal components, and conditions conducive to termite infestation. Prolonged dampness may also compromise structural integrity of floor framing members and create unhealthy environmental conditions.

This is considered a major defect. Immediate assessment and rectification by a licensed plumber is strongly recommended to identify and repair the source of leakage. Following repairs, the affected area should be allowed to dry thoroughly and any damaged structural elements should be assessed and repaired as necessary by a suitably qualified tradesperson.

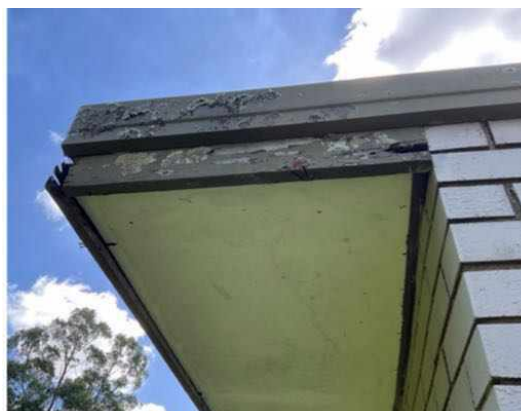
### Finding 3.01

Building:	Main Building
Location:	Roof Exterior
Finding:	Wood rot - Fascias
Information:	Fascias and barges in this area shows evidence of wood rot. Wood rot, also known as Fungal Decay, occurs when timbers and other cellulose building materials are exposed to damp conditions on an ongoing basis. This could be the result of exposure to weathering over a prolonged period of time, or the attraction of excessive moisture from other abutting building materials.

It is likely that this wood rot has developed as a result of faults in the roof plumbing, creating excessive moisture in this area. Frequent exposure to rain and other weather conditions also make fascia's and barges susceptible to accelerated deterioration.

Early intervention and regular maintenance, particularly of exterior timbers, will prolong the useful life of these building elements. Prior to any works being performed, the cause of the moisture that has created the visible wood rot should be identified and addressed in a suitable manner. Replacement of affected timbers may then be a necessary step in protecting surrounding building elements from such deterioration.

A qualified plumber may be appointed to assess the cause of excessive moisture and to provide advice on any remedial works as required. A qualified carpenter or registered builder may also be required to replace affected building materials.

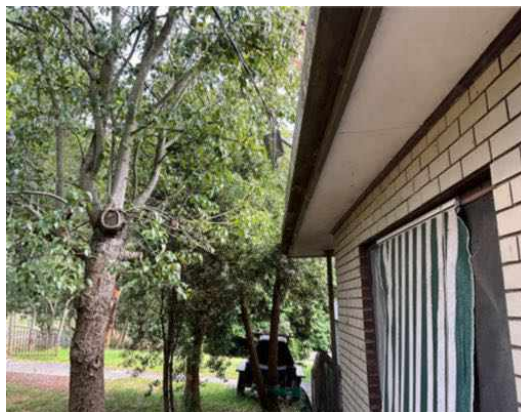
### Finding 3.02

Building:	Main Building
Location:	All Areas
Finding:	Trees - Overhanging and filling gutters
Information:	Overhanging trees often result in excessive amounts of leaf debris accumulating in gutters.

Gutters are a critical part of the building's management of storm water and rain. It is therefore important that they be kept clear to prevent secondary damage to associated building elements, including exterior and interior walls, ceiling linings and any adjoining building elements. Where gutters are blocked, pooling of rainwater is likely to occur, fast-tracking rust and corrosion of the roof plumbing elements.

It is highly advised that all overhanging tree branches be removed as soon as possible to prevent any further damage. Repair and/or replacement of sections of damaged guttering may also be required where the extent of the damage necessitates.

Such works should be performed by the homeowner; however, appointment of a landscape contractor or an arborist may be required. Consultation with a licensed roof plumber is required where guttering has been damaged.

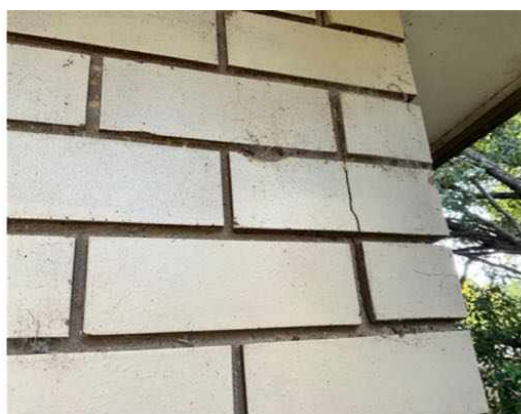
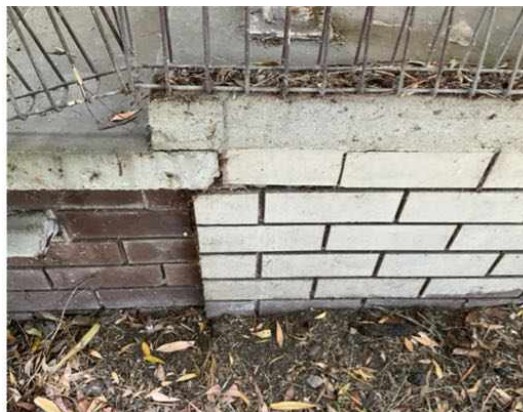
### Finding 3.03

Finding: Minor Cracking and Mortar Deterioration to Brickwork

Information: Several minor cracks were observed in the brickwork during the inspection. In addition, sections of mortar joints were noted to be deteriorated. The cracking appears consistent with minor movement and general age-related wear, while the mortar deterioration is likely due to weather exposure and normal building settlement over time.

If left unaddressed, deteriorated mortar joints may allow moisture ingress into the brickwork, which can contribute to further deterioration, potential damp-related issues, and accelerated wear of masonry components. Although the cracks observed are minor in nature, ongoing movement could lead to further separation if not monitored.

It is recommended that a qualified bricklayer or registered builder assess the affected areas and undertake repointing of deteriorated mortar joints as required. The cracks should be monitored for any signs of progression, and further investigation should be arranged if significant movement is noted.

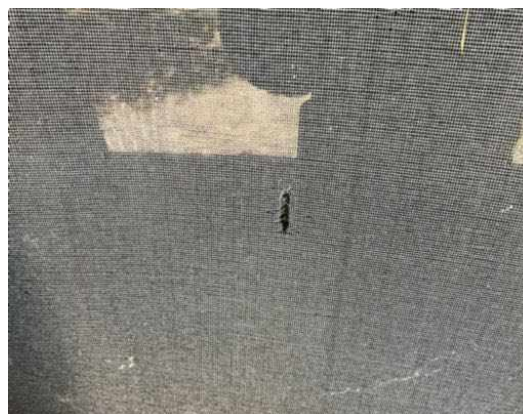
Building:	Main Building
Location:	All Internal Areas
Finding:	Flyscreens - Damanged
Information:	Flyscreens were found to be damaged to the windows at the time of inspection. Whether the flyscreens have not been installed properly of damaged post-installation, it detracts from the complete operational state of the window.

Where not repaired, damaged flyscreens allow pest and insect ingress into the adjoining rooms. It is advised that all damaged building elements be replaced in order to ensure the full function of all building structures.

A general handyerson or a repairer may be appointed to repair flyscreens at the discretion of the client.

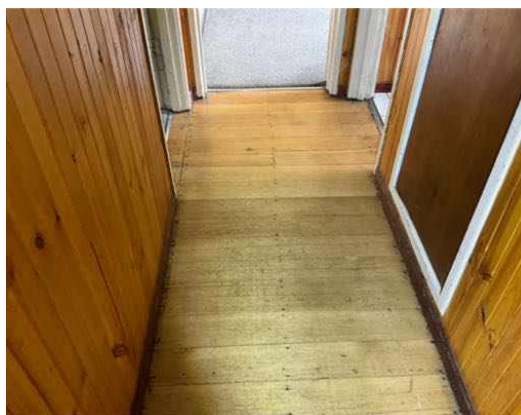
### Finding 3.06

Building:	Main Building
Location:	All Areas
Finding:	Flooring - Uneven
Information:	The internal flooring in this area is out of level and uneven. Uneven flooring is likely to indicate minor defects such as expected movement of the foundations of the

It is advised that the flooring be closely monitored to identify any further movement. Where flooring remains relatively unchanged for an extended period of time (i.e. several months), it is likely that this defect has been caused by expected movement of the foundations of the property.

However, where flooring is uneven further, potentially invasive inspection of the subfloor structures and stumps in this area is required. In this case, works to repair are likely to be required, and would be carried out by a registered builder specialising in re-stumping.

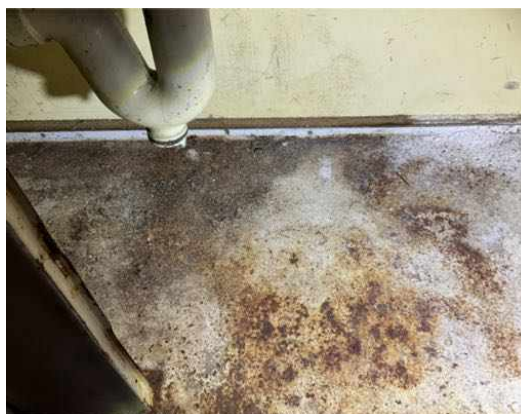
Building: Main Building  
 Location: Laundry  
 Finding: Rusting to Laundry Sink  
 Information: Rusting was observed to the laundry sink at the time of inspection. The corrosion appears consistent with age-related wear and prolonged exposure to moisture, which is common in wet areas such as laundries. Surface deterioration was noted to the metal components.

If left unaddressed, ongoing corrosion may result in further material degradation, potential perforation of the sink basin, and water leakage into surrounding cabinetry or flooring. Continued moisture exposure may also accelerate deterioration of adjacent fixtures.

It is recommended that the affected sink be assessed by a licensed plumber and repaired or replaced as necessary. Prompt attention will help prevent potential leakage and maintain the serviceability of the fixture.

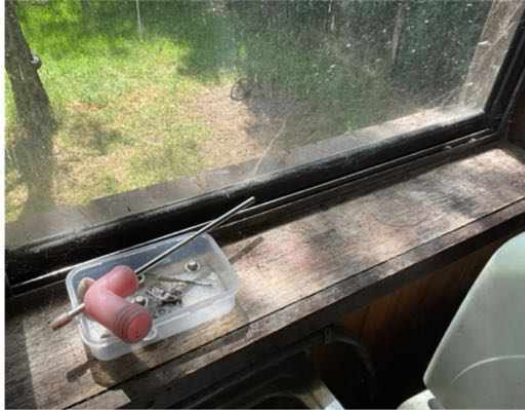
### Finding 3.11

Building: Main Building  
 Location: All Areas  
 Finding: Weathered Window Reveal  
 Information: A weathered reveal was observed in this area at the time of inspection. This deterioration is minor in nature and may be due to age, sun exposure, or intermittent moisture contact.

If left unmanaged, continued weathering may allow moisture to penetrate the surrounding materials, potentially leading to staining, decay, or further deterioration of the window frame and adjoining wall surfaces.

It is recommended that this area be regularly monitored for any signs of water ingress. If deterioration progresses or moisture is detected, a qualified carpenter or painter should be engaged to repair and reseal the affected section to prevent further damage.

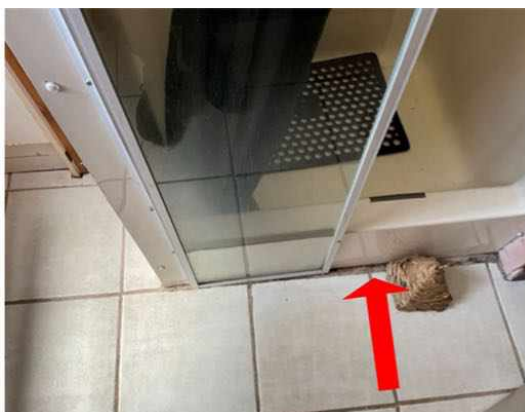
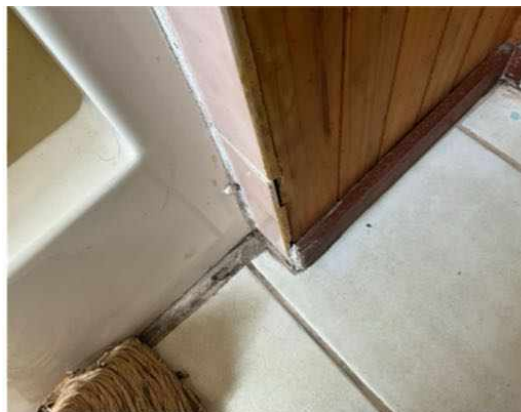
### Finding 3.12

Finding: Deteriorated Grout to External Shower Area

Information: Deterioration of grout was observed to tiled surfaces within the external shower area during the inspection. Sections of grout were noted to be cracked, recessed, or missing between tiles. This condition is commonly associated with weather exposure, movement, and general wear over time, particularly in external wet areas.

Deteriorated grout may allow water penetration beneath the tiled surface, potentially leading to moisture ingress into the substrate. Prolonged exposure to moisture can result in loosening of tiles, deterioration of underlying materials, and potential structural or waterproofing issues if left unaddressed.

It is recommended that the affected areas be regouted by a suitably qualified tiler or registered builder. The underlying waterproofing membrane (if applicable) should also be assessed to ensure continued water resistance and prevent further damage.

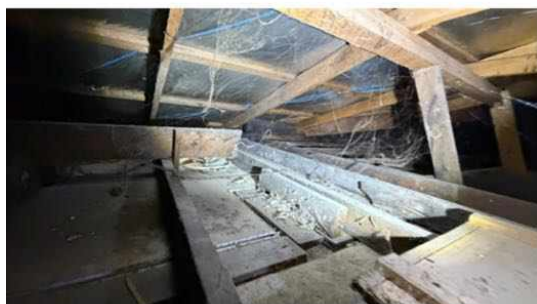
### Finding 3.13

Building:	Main Building
Location:	Roof Void
Finding:	Absence of Insulation in Roof Cavity
Information:	No thermal insulation was observed within the roof cavity at the time of inspection. The roof space appeared to be uninsulated, which may be inconsistent with current energy efficiency expectations under modern building standards. The assessment was limited to a visual inspection of accessible areas only.

The absence of insulation can significantly reduce the energy efficiency of the dwelling, leading to increased heat loss in winter and heat gain in summer. This may result in higher heating and cooling costs and reduced internal comfort levels.

It is recommended that a qualified insulation installer assess the roof cavity and install appropriate ceiling insulation in accordance with current NCC requirements and manufacturer specifications. Care should be taken to maintain clearances around electrical fittings and ensure compliance with safety standards.

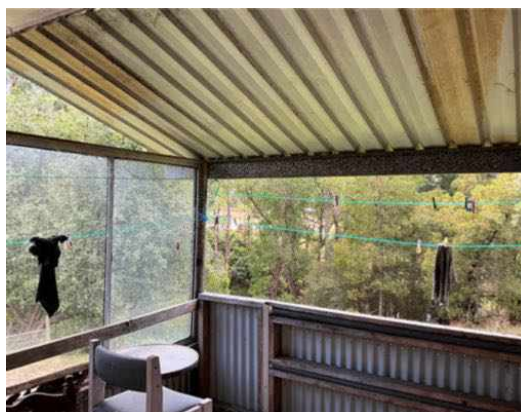
### Finding 3.14

Finding: Deteriorated structures  
 Information: Gutters missing rusting observed

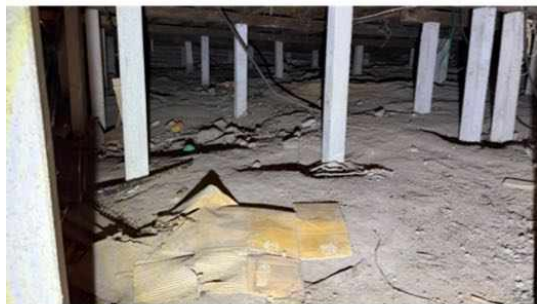
### Finding 3.15

Building: Main Building  
 Location: Subfloor  
 Finding: Backfill substandard for stumps  
 Information: Backfill was not completed around several stumps, leaving gaps and depressions in the surrounding soil. This issue is present in areas where the stumps were installed but not properly backfilled after excavation. The likely cause of this condition is inadequate soil replacement during or after the stump installation process, potentially due to time constraints, oversight, or soil compaction issues.

The lack of proper backfill creates low points around the stumps where water can accumulate, leading to persistent moisture retention. This condition increases the risk of timber decay and creates an environment conducive to termite activity, which can compromise the structural integrity of the stumps over time. Additionally, prolonged water ponding may contribute to soil movement and instability around the stumps, potentially affecting the overall foundation support.

To address this issue, it is recommended to properly backfill the affected areas with well-compacted soil to eliminate depressions and improve drainage. Ensuring

adequate grading around the stumps will help direct water away from the structure, reducing the risk of moisture-related damage. If necessary, additional drainage solutions should be considered to prevent future water accumulation. Regular monitoring of moisture levels and termite activity is also advised to protect the structural components.

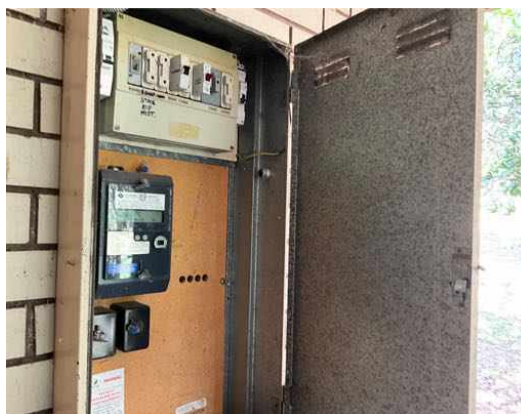
A durable notice should be placed in the switchboard unit to indicate current termite barriers. At the time of inspection, it appeared as though no termite management system has been installed, with no evidence to suggest preventative works taking place.

The client may consider gaining further advice from a pest controller as to the costs and procedures involved with this application. It is recommended that obtaining such advice be a short-term priority.

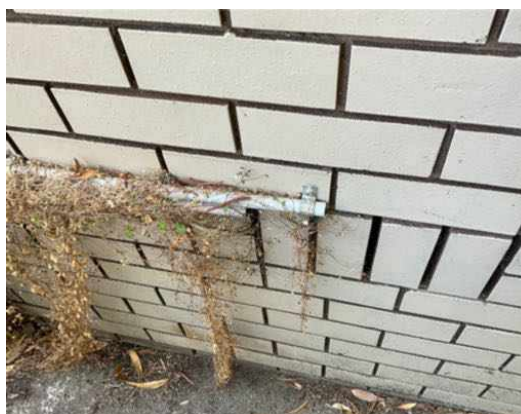
### Finding 6.02

Building:	Main Building
Location:	All External Areas
Finding:	Air conditioner - Disconnected overflow
Information:	The Air Conditioner (A/C) overflow was found to be disconnected from storm water drainage and is creating excessive moisture in the surrounding area.

Such leaking creates an environment which is conducive to an array of defects, including water damage to associated building elements and the attraction of termite or timber pest infestation.

It is highly recommended that a licensed plumber be appointed to connect the A/C overflow in order to prevent such an environment from being created. These minor works should be carried out as soon as possible.

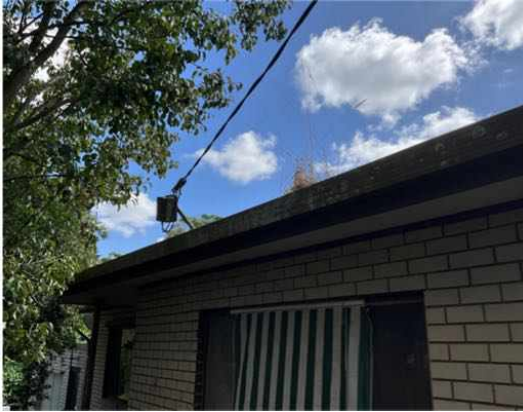
Excess moisture resulting from blocked gutters can accelerate timber deterioration, increasing the risk of fungal decay and attracting timber pests such as termites. Moisture-damaged timber is highly susceptible to infestation, as pests are drawn to damp and softened wood. If left unaddressed, this issue can lead to structural weakening and costly remediation work.

It is strongly recommended that all blockages in the gutters and downpipes be cleared immediately to maintain dry conditions and reduce the risk of timber pest activity. Homeowners or a general handyperson can perform routine cleaning; however, a licensed plumber should be consulted for further assessment and any necessary remedial work. Ongoing gutter maintenance is crucial in preventing future moisture-related timber issues.

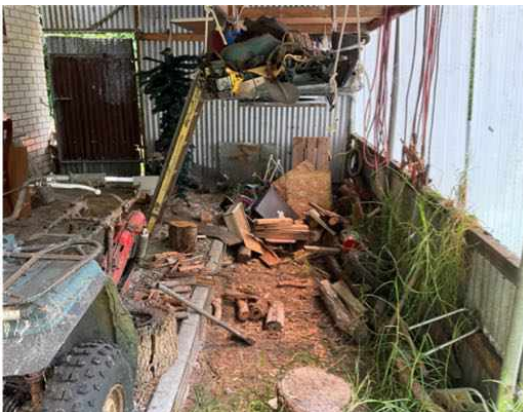
Building:	Main Building
Location:	All External Areas
Finding:	Timber debris - exterior areas & subfloor space
Information:	Timber debris were found in the exterior areas & subfloor space at the time of inspection. The storing of timbers in the subfloor space or around the external property increases the risk of termite activity being present. As they are likely to come into contact with weather conditions or excessive moisture wood rot is likely to develop on timbers that are not treated.

It is highly recommended that any stored timbers be immediately removed from areas in which they may attract any termite / timber pest attack. Minimisation of risk / prevention of termite attack is far more adequate than dealing with the presence of termite activity.

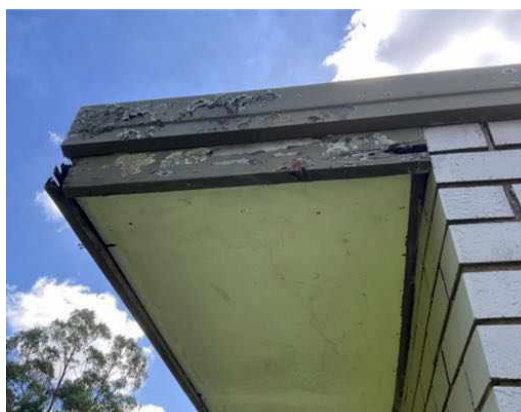
### Finding 7.01

Location: Roof Exterior  
 Finding: Wood rot - Fascias  
 Information: Fascias and bargees in this area shows evidence of wood rot. Wood rot, also known as Fungal Decay, occurs when timbers and other cellulose building materials are exposed to damp conditions on an ongoing basis. This could be the result of exposure to weathering over a prolonged period of time, or the attraction of excessive moisture from other abutting building materials.

It is likely that this wood rot has developed as a result of faults in the roof plumbing, creating excessive moisture in this area. Frequent exposure to rain and other weather conditions also make fascia's and bargees susceptible to accelerated deterioration.

Early intervention and regular maintenance, particularly of exterior timbers, will prolong the useful life of these building elements. Prior to any works being performed, the cause of the moisture that has created the visible wood rot should be identified and addressed in a suitable manner. Replacement of affected timbers may then be a necessary step in protecting surrounding building elements from such deterioration.

A qualified plumber may be appointed to assess the cause of excessive moisture and to provide advice on any remedial works as required. A qualified carpenter or registered builder may also be required to replace affected building materials.

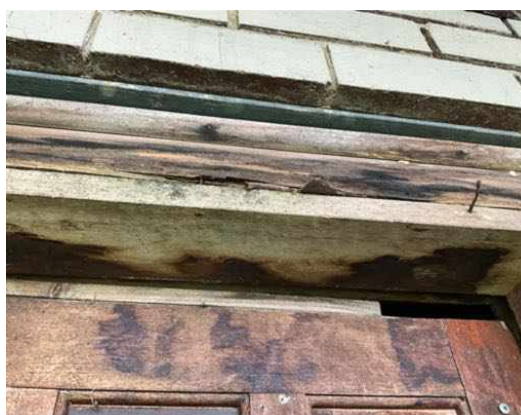
### Finding 7.02

Building: Main Building  
 Location: All Areas  
 Finding: Wood rot  
 Information: This building element shows evidence of wood rot. Wood rot, also known as Fungal Decay, occurs when timbers and other cellulose building materials are exposed to damp conditions on an ongoing basis. This could be the result of exposure to weathering over a prolonged period of time, or the attraction of excessive moisture from other abutting building materials. Contributing factors also include poor air ventilation in the area.

Wood rot is often associated with general damp problems and is evidenced by a

'musty' smell or mould and mildew occurring on surfaces. If left unmanaged, damp conditions can lead to further health problems and the decay of timbers will continue.

Early intervention and regular maintenance, particularly of exterior timbers, will prolong the useful life of these building elements. Prior to any works being performed, the cause of the moisture that has created the visible wood rot should be identified and addressed in a suitable manner. Replacement of affected timbers may then be a necessary step in protecting surrounding building elements from such deterioration.

A qualified plumber may be appointed to assess the cause of excessive moisture and to provide advice on any remedial works as required. A qualified carpenter or registered builder may also be required to replace affected building materials.

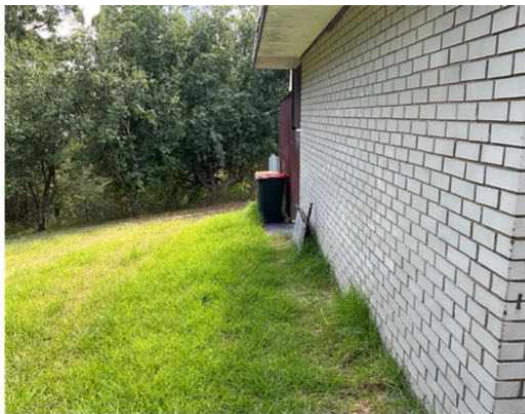
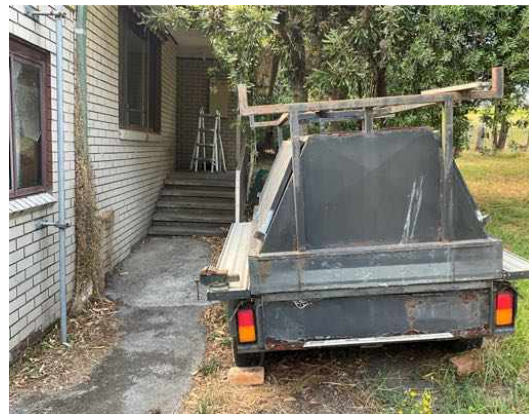
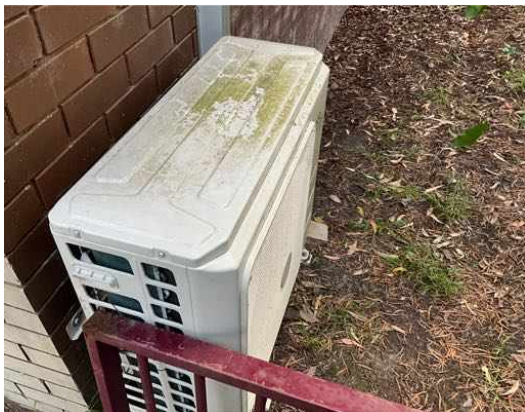
Building:	Main Building
Location:	All External Areas
Finding:	Obstructions and Limitations - External areas
Information:	These photographs are an indication of the obstructions and limitations which impeded full inspection of the external areas of the property at the time of inspection. These obstructions can hide an array of defects and should be removed to allow full inspection to be carried out. A re-inspection is recommended once the areas are made accessible.

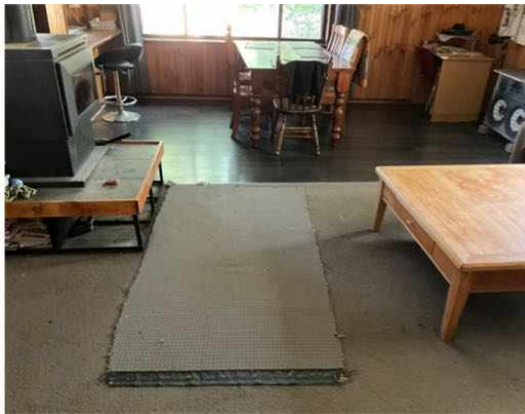
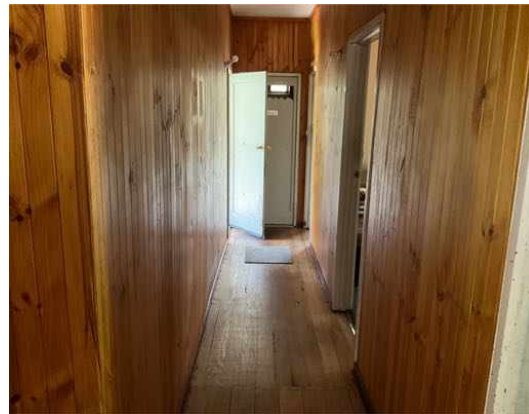
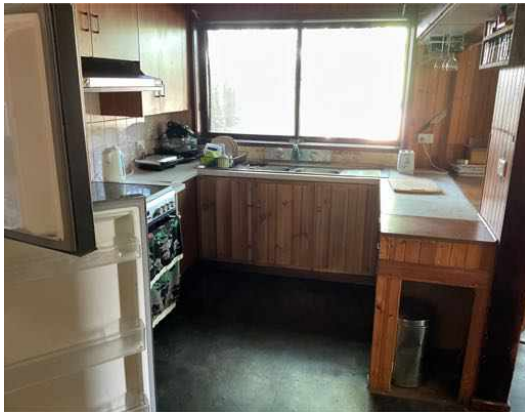
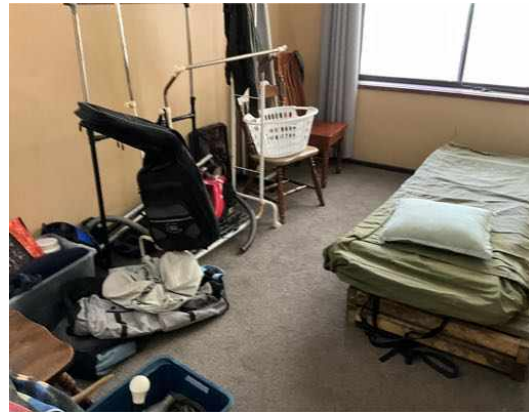
Building:	Main Building
Location:	All Internal Areas
Finding:	Obstructions and Limitations - Internal areas
Information:	These photographs are an indication of the obstructions and limitations which impeded full inspection of the internal areas of the property at the time of inspection.

These obstructions can hide an array of defects and should be removed to allow full inspection to be carried out. A re-inspection is recommended once the areas are made accessible.

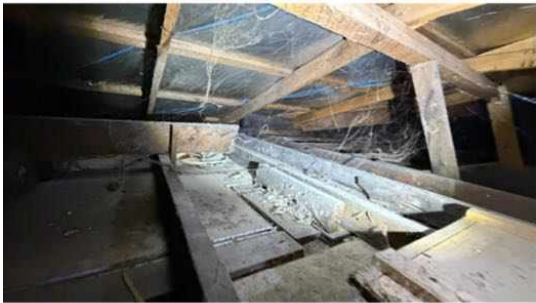
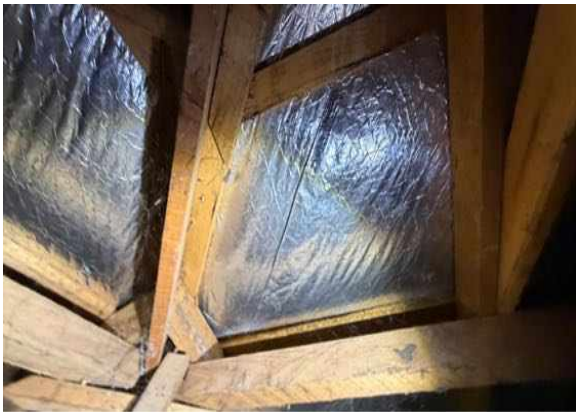
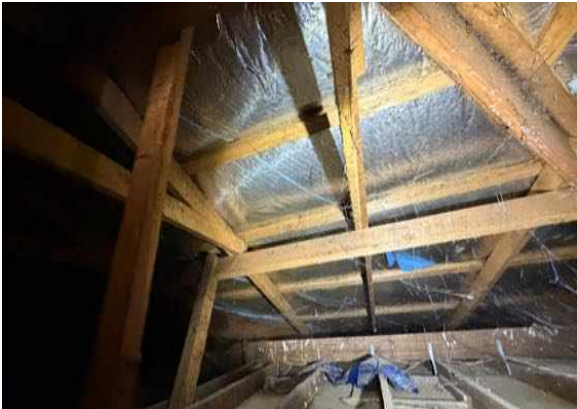
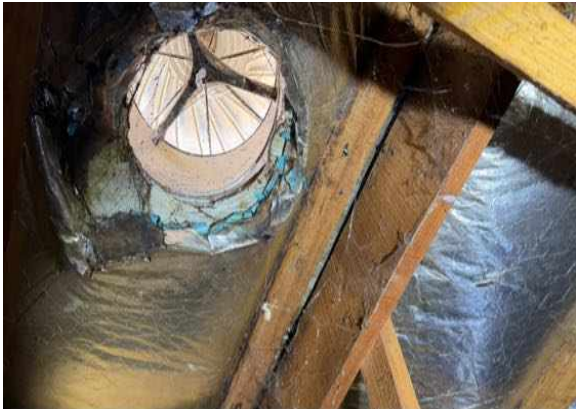
Building: Main Building  
 Location: Roof Void  
 Finding: Obstructions and Limitations - Roof Cavity  
 Information: These photographs are an indication of the obstructions and limitations which impeded full inspection of the roof cavity of the main building at the time of inspection. These obstructions can hide an array of defects and should be removed to allow full inspection to be carried out. A re-inspection is recommended once the areas are made accessible.

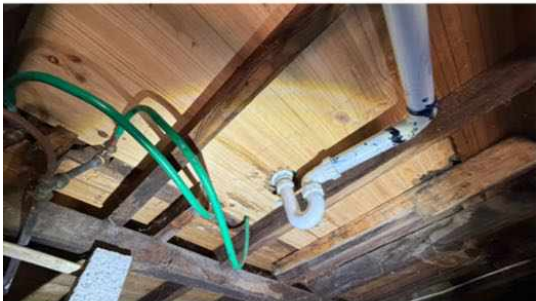
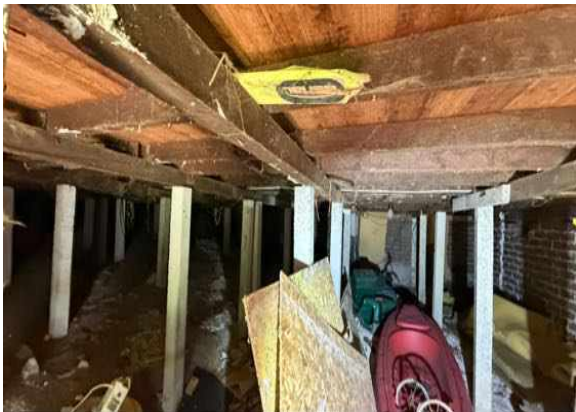
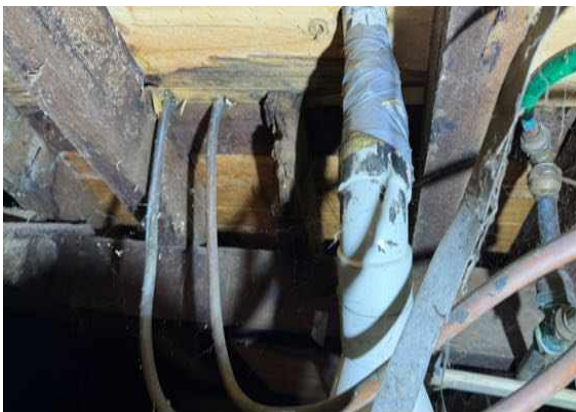
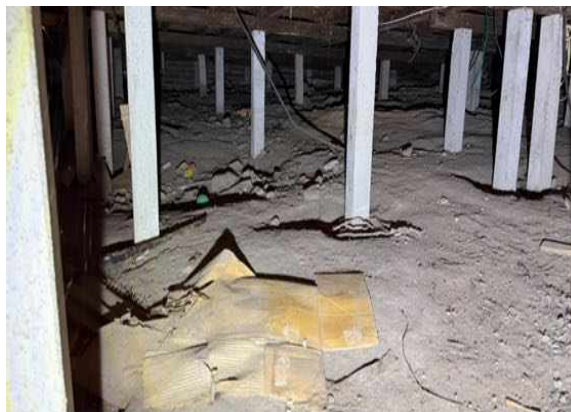
Building: Main Building  
Location: Subfloor  
Finding: Obstructions and Limitations - Subfloor  
Information: These photographs are an indication of the obstructions and limitations which impeded full inspection of the subfloor of the main building at the time of inspection. These obstructions can hide an array of defects and should be removed to allow full inspection to be carried out. A re-inspection is recommended once the areas are made accessible.

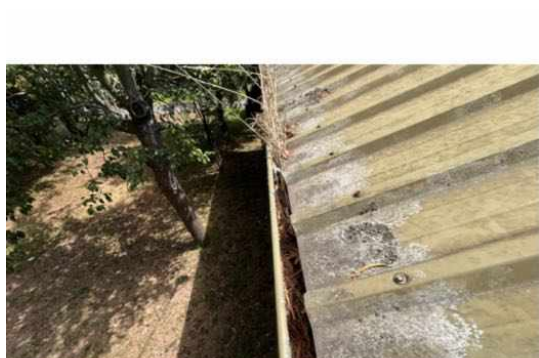
Building:	Main Building
Location:	Roof Exterior
Finding:	Deterioration and Rusted Fasteners to Corrugated Iron Roof
Information:	Upon external visual inspection, the corrugated iron roof was found to be in fair overall condition for its apparent age; however, signs of deterioration were observed. Surface wear consistent with weather exposure was noted, and several roof screws/fasteners were found to be rusted. Corroded fasteners may compromise the effectiveness of the roof sheeting connections and sealing washers over time.

If left unaddressed, ongoing corrosion of fasteners can lead to loosening of roof sheets, reduced weather tightness, and potential water ingress during heavy rainfall or wind events. Progressive deterioration may also accelerate corrosion of adjacent metal components.

It is recommended that a licensed roofing contractor undertake a detailed inspection to assess the extent of deterioration and replace rusted fasteners as required. Ongoing periodic maintenance is advised to ensure the roof remains secure and weatherproof. Please note that this assessment is based on an external visual inspection only and does not include invasive or internal roof space evaluation.

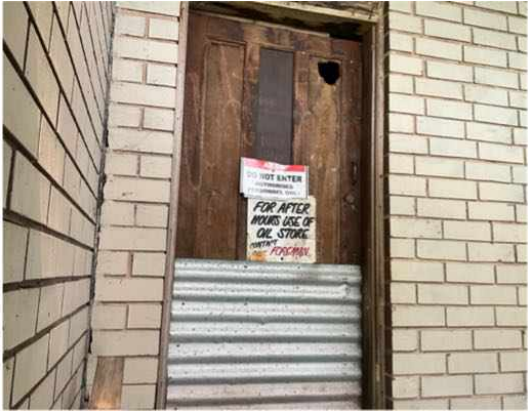
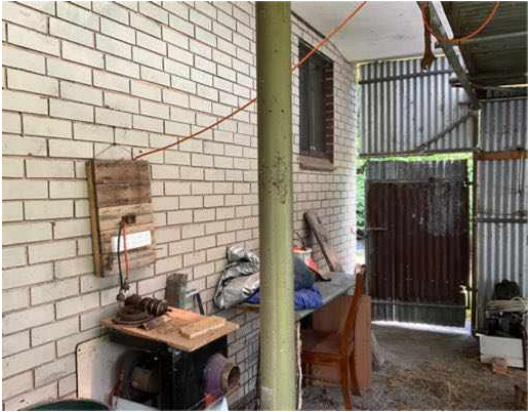
Building: Main Building  
 Location: Garage  
 Finding: Garage Area Not Accessible – For Your Information  
 Information: Please note that the garage area was not accessible at the time of inspection and therefore was not assessed. Access was restricted due to conditions present on site, and the inspection was limited to areas that were safely and reasonably accessible in accordance with the scope of a standard visual, non-invasive inspection.

As this area could not be inspected, the condition of the structure, finishes, and any installed services within the garage remains unknown.

If required, a follow-up inspection can be arranged once access is made available
