Building Inspection Report

Inspection Date: Wed, 25 Feb 2026

Property Address: 15 Merlot Rd, Pakenham VIC 3810,
Australia

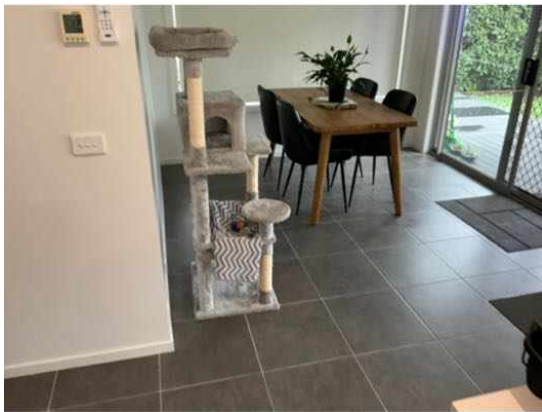
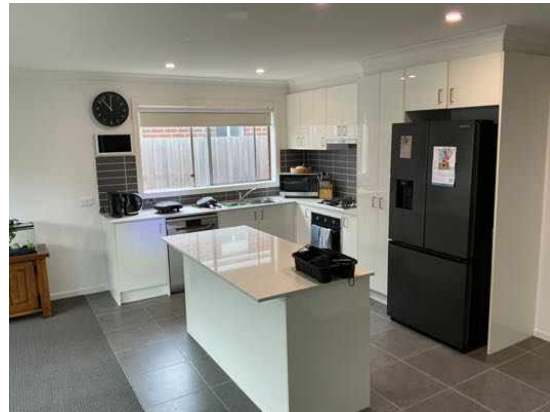
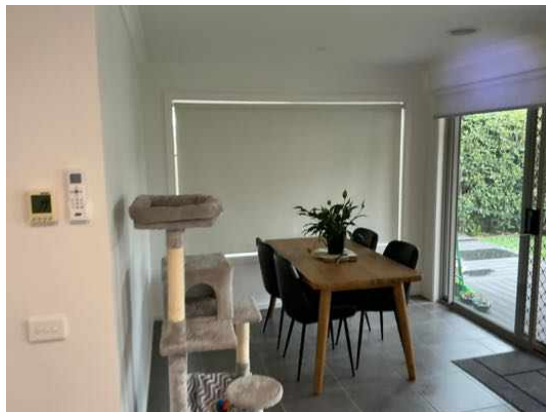
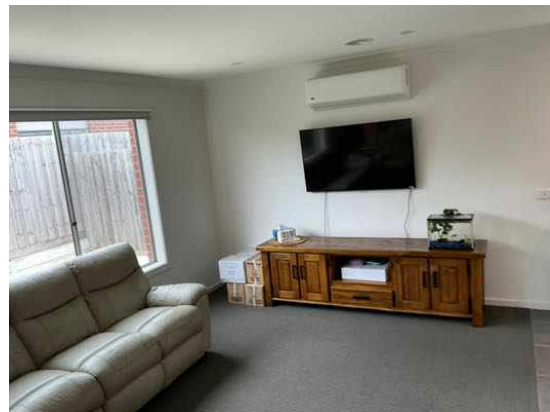
Building: Main Building
 Location: All Areas
 Finding: Obstructions and Limitations - Interior
 Information: These photographs are an indication of the obstructions and limitations which impeded the inspection of the internal areas of the property at the time of inspection. These obstructions can hide an array of defects and should be removed to allow full inspection to be carried out. A re-inspection is recommended once the areas are made accessible.

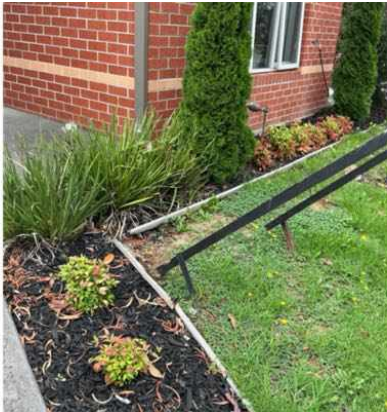
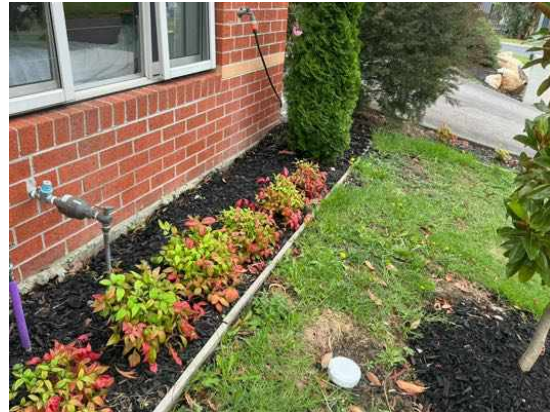
Building: Main Building
 Location: All External Areas
 Finding: Obstructions and Limitations - Exterior
 Information: These photographs are an indication of the obstructions and limitations which impeded the inspection of the external areas of the property at the time of inspection.

These obstructions can hide an array of defects and should be removed to allow full inspection to be carried out. A re-inspection is recommended once the areas are made accessible.

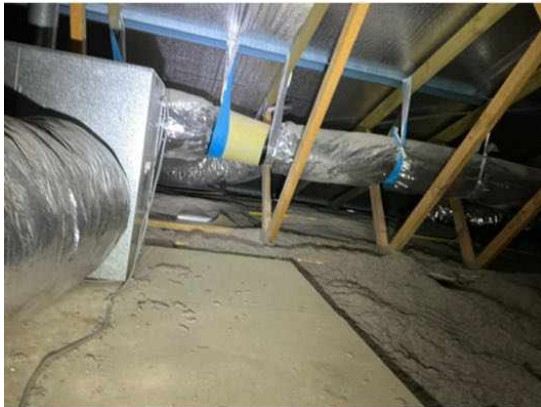
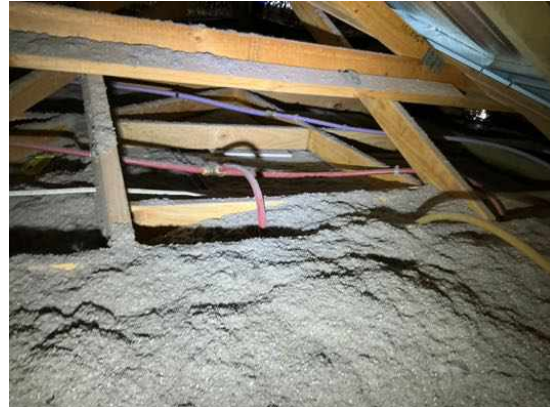
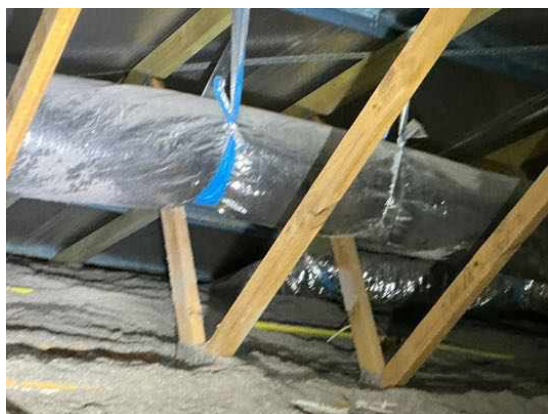
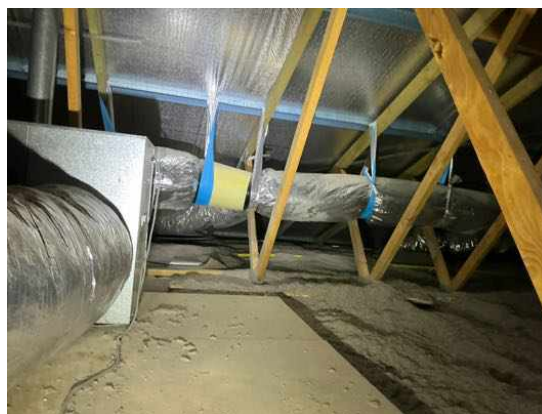
Finding: Obstructions and Limitations - roof cavity

Information: These photographs are an indication of the obstructions and limitations which impeded the inspection of the roof cavity area of the property at the time of inspection. These obstructions can hide an array of defects and should be removed to allow full inspection to be carried out. A re-inspection is recommended once the areas are made accessible.
