# Building and Timber Pest Inspection Report

Inspection Date: Thu, 9 Apr 2026

Property Address: 95 Bellevue Ave, Rosanna VIC 3084,  
Australia

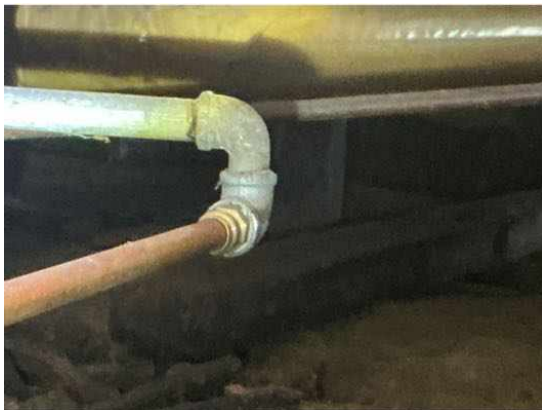
Building: Main Building  
Location: Subfloor  
Finding: Gas leak/dangerous/subfloor inspection terminated  
Information: It was noted at the time of the inspection that the gas pipe to the left-hand side of the subfloor door was not crimped, was loose and came apart. This caused a serious gas leak which filled the subfloor with gas.

The inspection of the subfloor had to be terminated due to safety reasons and it is recommended that the inspection of the sub for be completed once the area is made safe.

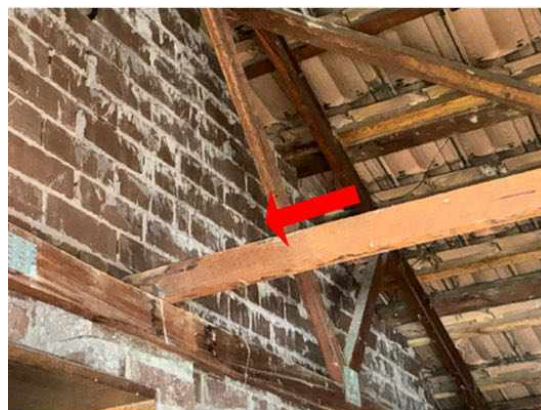
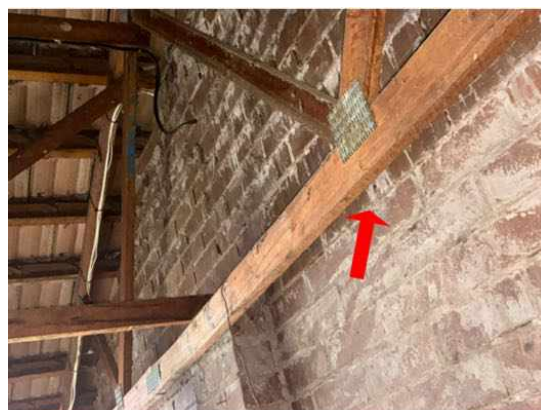
### Finding 2.01

Building:	Main Building
Location:	Garage
Finding:	No brick ties to masonry Gable end
Information:	It was noted at the time of the inspection that the brick Gable ends to the garage were constructed of single skin brickwork and were not tied with brick ties to the timber structure. It appears that the building has been constructed in this manner, however the brickwork could become unstable and create a safety hazard.

Building regulations have always stated Brickwork should be tied to the timber structure at 400 mm or 600 mm centres depending on timber supports spacing..

A registered builder or bricklayer should be engaged to review immediately

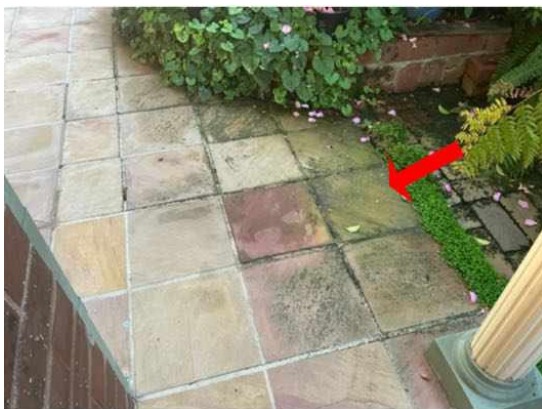
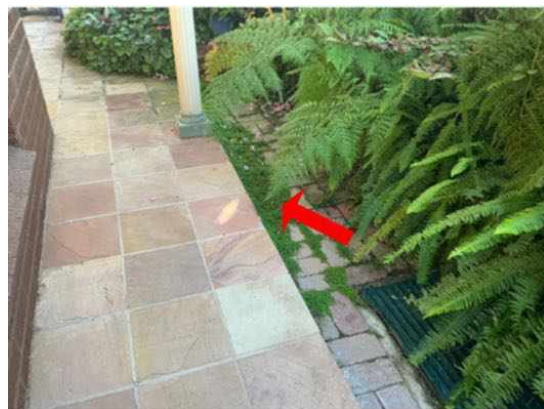
Building:	Main Building
Location:	All External Areas
Finding:	Site drainage - Inadequate
Information:	The site drainage around the entire building area was found to be inadequate at the time of inspection, creating potential for subsequent water damage to associated building elements.

It is important that water does not lie against the base of walls; surrounding paths and ground levels should be sloped to drain water away from walls. Downpipes should not discharge stormwater onto lower walls or plinths. Stormwater should be carried away by large, regularly cleaned drains. Ground levels may need to be lowered to expose a buried DPC.

Where site drainage is inadequate, installation of an Agricultural (Aggie) Drain may be required. A qualified plumber should be appointed to further inspect the property and perform any remedial works as necessary. Water damage and secondary defects are likely to occur if left unmanaged.

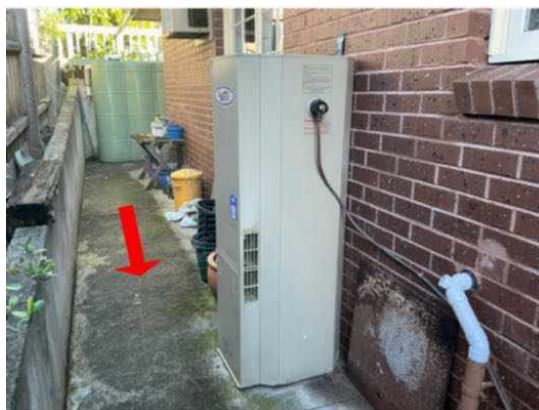
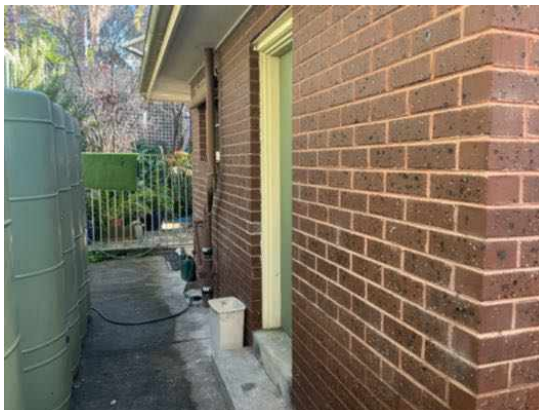
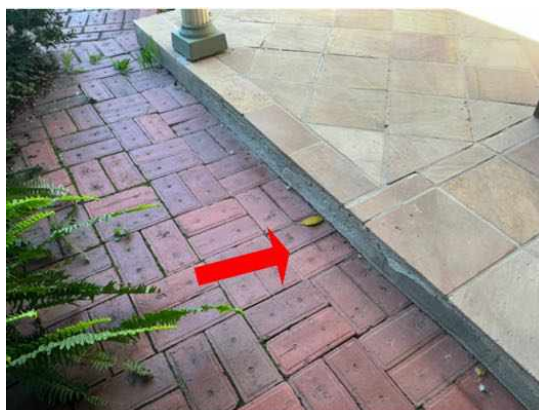
### Finding 3.04

Building: Main Building  
 Location: Exterior walls - left side  
 Finding: Incomplete or substandard works  
 Information: The brickwork to the left-hand side elevation to the building appears to be incomplete or have been completed to a substandard level.

Works that have not been completed to a satisfactory level create potential for the development of building defects and may impede on the safety and integrity of the overall structure.

It is highly recommended that a qualified bricklayer be appointed to complete these

works and ensure the safety of the area and the longevity of all associated building elements.

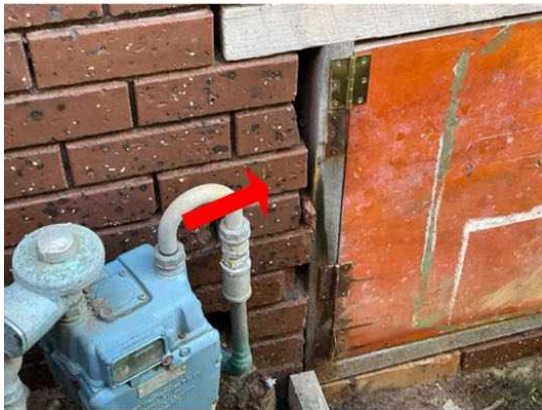
### Finding 3.05

Building:	Main Building
Location:	Subfloor
Finding:	Incomplete or substandard works/subfloor door and frame
Information:	The works to the subfloor door appear to be incomplete or have been completed to a substandard level.

Works that have not been completed to a satisfactory level create potential for the development of building defects and may impede on the safety and integrity of the overall structure.

It is highly recommended that the relevant trades be appointed to complete these works and ensure the safety of the area and the longevity of all associated building elements.

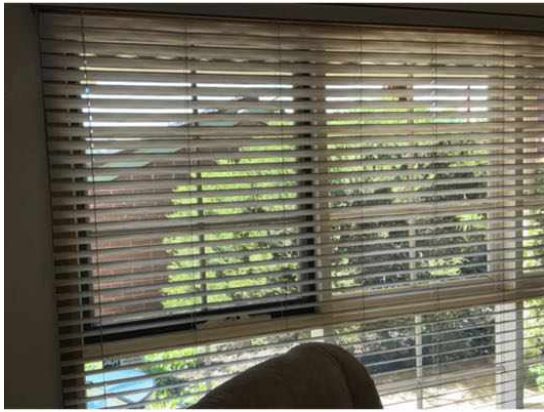
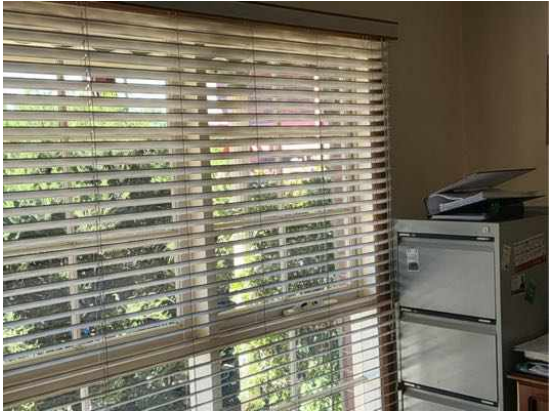
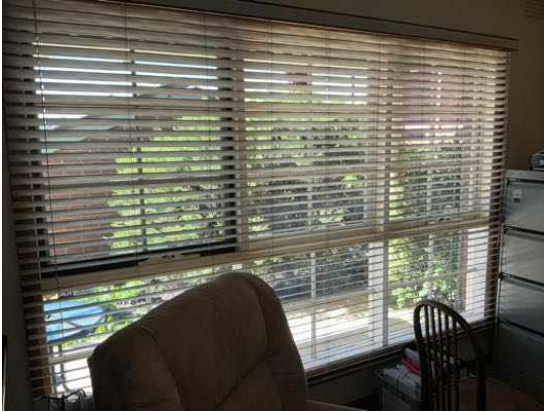
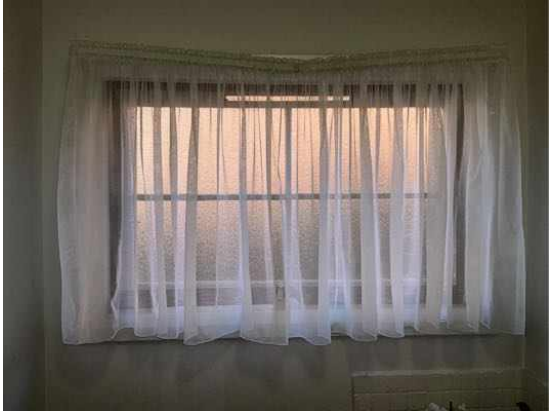
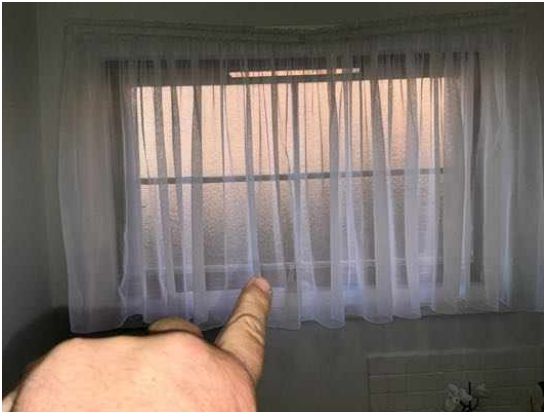
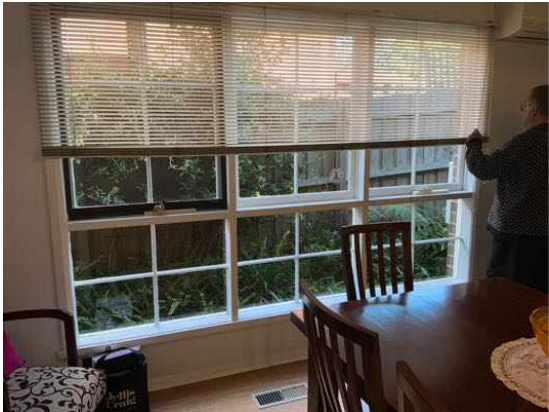
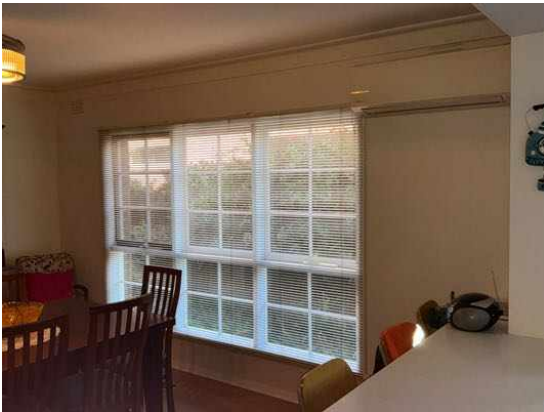
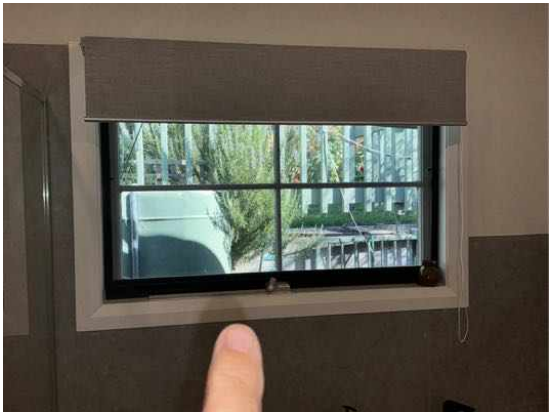
Fresh air and ventilation cannot be provided to the room

The sashes require adjustment to allow the window to function as intended. Such works may be completed by a qualified carpenter or registered builder.At the owners discretion.

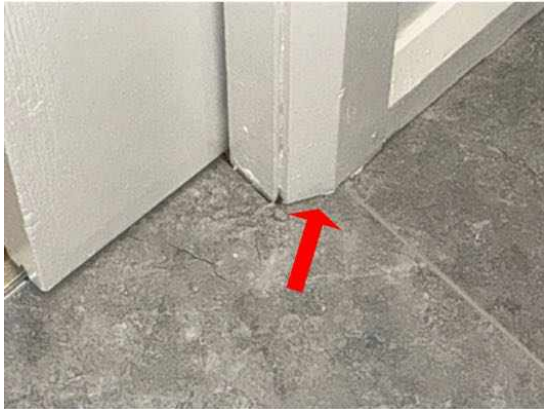
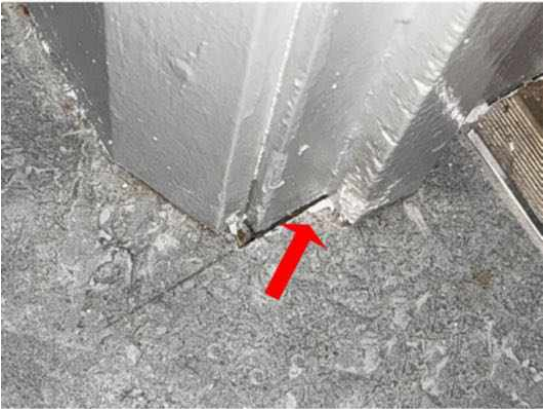
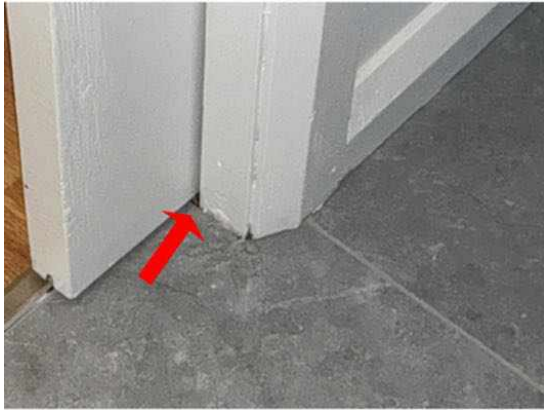
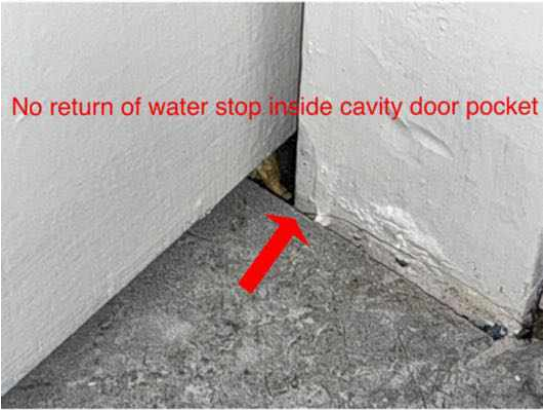
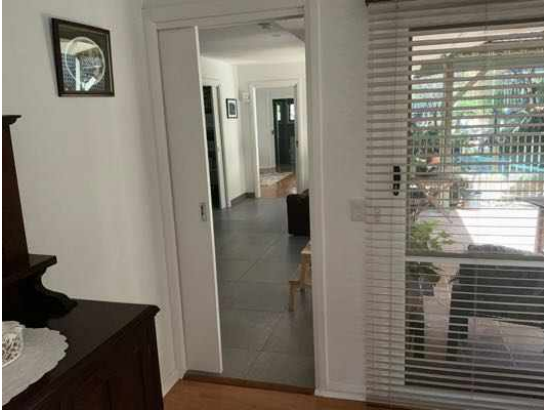
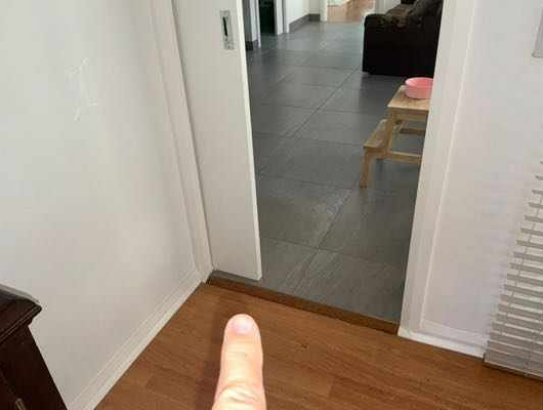
### Finding 3.07

Building:	Main Building
Location:	GF Bathroom
Finding:	Waterproofing not installed correctly
Information:	It was noted at the time of the inspection that the waterproofing to the cavity sliding door has been installed incorrectly and does not comply to Australian standard.

Water bars should return underneath the cavity door and seal the pocket from the ingress of moisture. The architraves and door frames should not be fitted below the tiling. A gap should be left and caulked to prevent wicking of moisture into the timber work.

It is assumed that the bathroom is a recent renovation and is subject to current Australian standards AS 3740

A qualified waterproof proof and tiler should be engaged to review as soon as possible

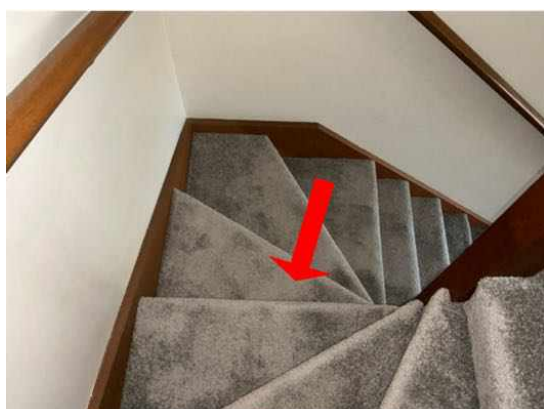
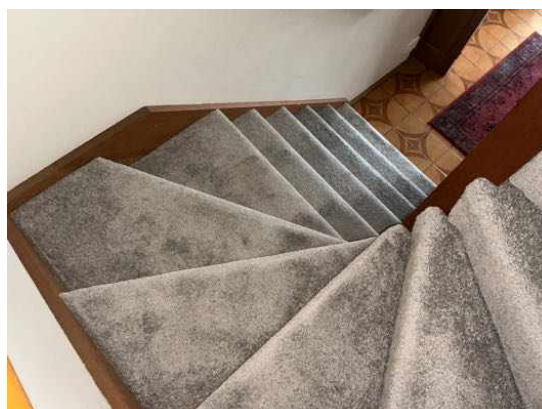
Building: Main Building  
 Location: Stairs - Internal  
 Finding: Stairs noisy  
 Information: It was observed that the internal stairs made a creaking noise when walked upon

The creaking is due a loosening over time of the tread and riser fixings inside the stair case construction.

A qualified carpenter should be engaged d to review at the owners discretion.

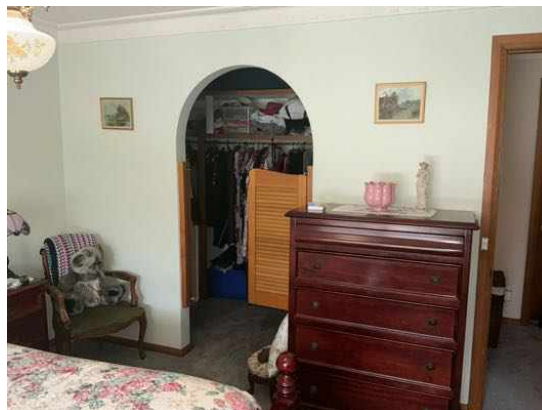
### Finding 3.10

Location: Walk In Robe  
 Finding: Saloon door walking robe  
 Information: It was noted at the time of the inspection that a saloon door to the double doors in the walk-in robe was missing. Although this is an aesthetic defect it detracts from the overall appeal of the building

A qualified carpenter should be engaged to review at the owners discretion

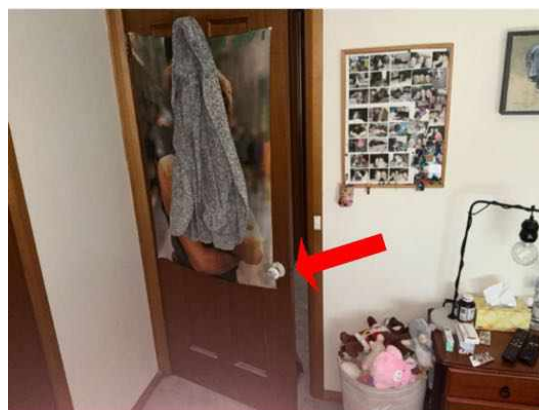
Building: Main Building  
 Location: Bedroom 2  
 Finding: Door handle loose  
 Information: The door handle was found to be loose.

Unattended to the handle could fall off and make the door inoperative.

A carpenter/handy man should be appointed immediately to review and adjust at the owners discretion.

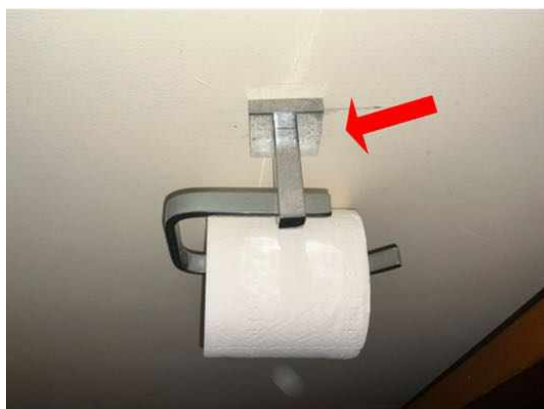
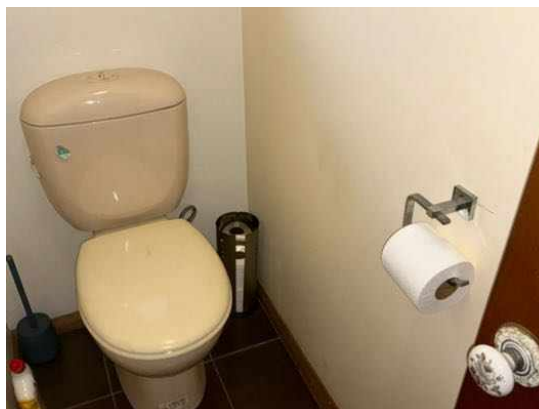
### Finding 3.14

Building:	Main Building
Location:	Toilet (WC)
Finding:	Toilet roll holder - Loose
Information:	The toilet roll holder was found to be loose at the time of inspection. While not a major operational defect, function can deteriorate if the problem is left unmanaged.

It is advised that the homeowner performs remedial works to re-attach the toilet roll holder to its original fixing. A general handyperson may be required to perform these works.

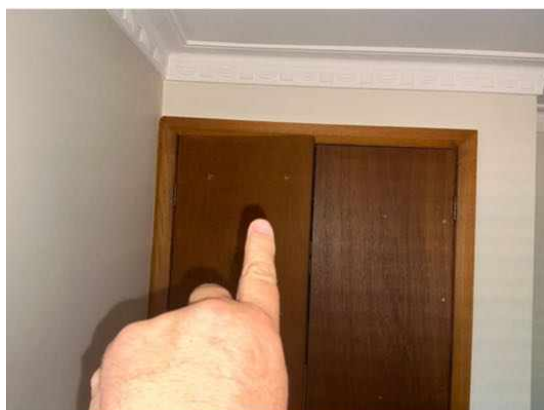
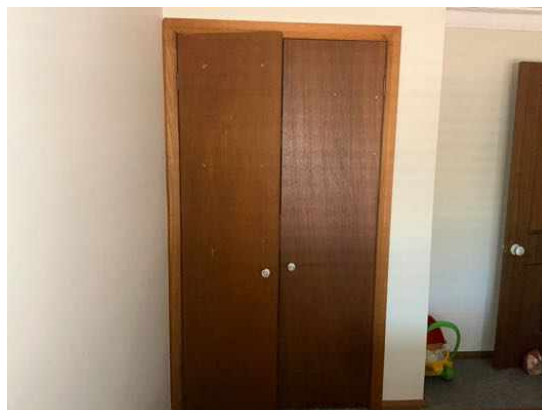
### Finding 3.15

Building:	Main Building
Location:	Bedroom 4
Finding:	Door - Binding/jamming
Information:	Binding and/or jamming of this door is evident during standard operation. This defect inhibits the functionality of the affected door as well as creating potential for secondary defects to associated building elements, such as damage to the floor covering.

Where door binding/jamming appears to indicate major structural issues, a registered builder specialising in re-stumping should be appointed to provide an estimate on the cost of rectification.

For minor causes, a qualified carpenter or general handyperson should be appointed to perform minor rectification works at client discretion.

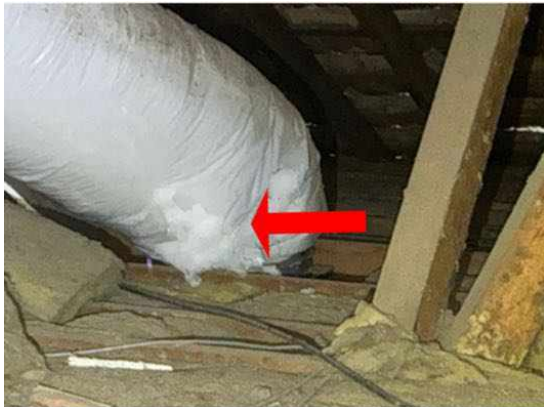
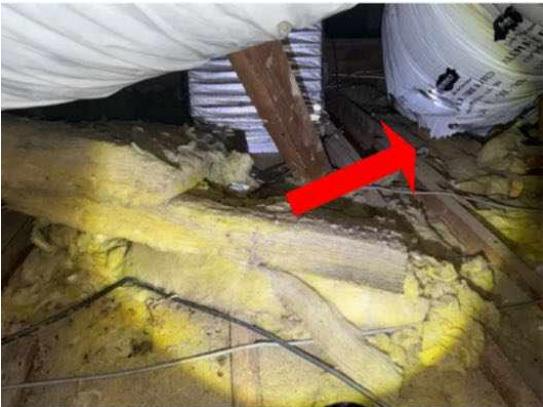
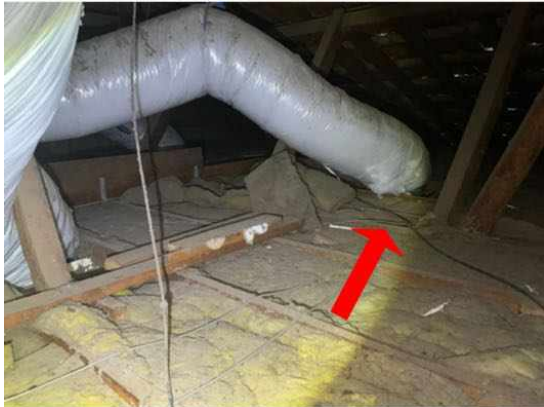
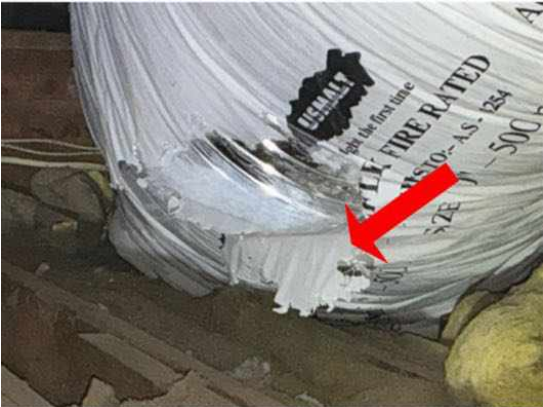
Building:	Main Building
Location:	Roof Void
Finding:	Heating / Cooling Ducts - damaged
Information:	The heating/cooling ducts were found to be damaged and not at a fully operational level. Generally, damage to ducts occurs as a result of aging and material deterioration, but impact damage or pest damage may also be the underlying cause.

The damage sustained by the ducts detracts from the energy efficiency of the property. The airflow within the property is likely to be restricted, particularly in areas where ducting shows signs of major damage.

A heating/cooling specialist should be appointed to provide further advice on remedial work options and to perform any works deemed necessary.

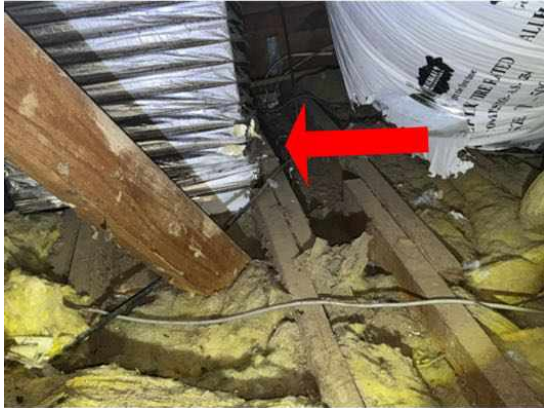
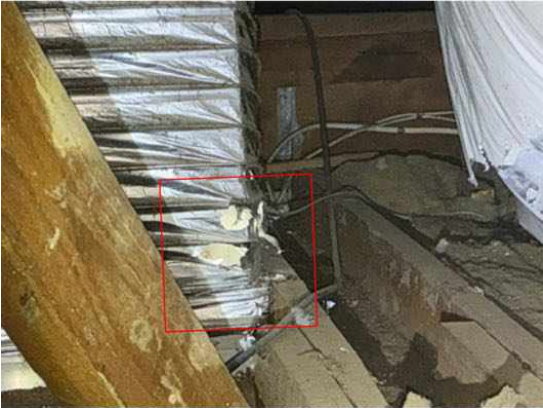
**Finding 3.17**

Building: Main Building  
 Location: Roof Void  
 Finding: Flexible skylight shaft damaged  
 Information: It was noted at the time of the inspection that the flexible skylight shaft in the roof space has been damaged. It appears that this has been damaged by unwanted pests. Unattended to the reflective coating to the shaft will not operate efficiently and allow dust into the skylight shaft. further deterioration could occur to the flexible shaft.

A skylight specialist should be engaged to review at the owners discretion

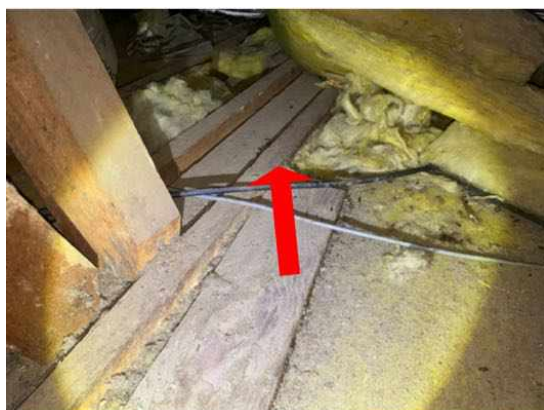
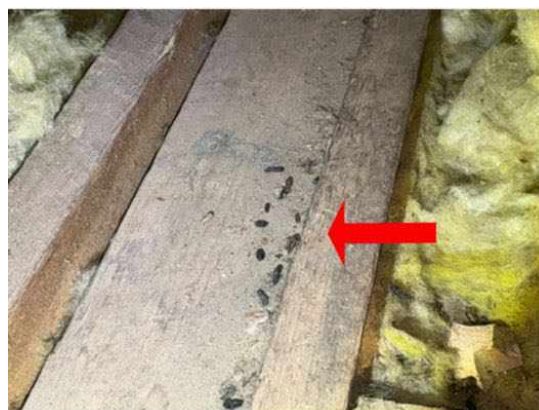
### Finding 3.18

Building:	Main Building
Location:	Roof Void
Finding:	Evidence of Vermin
Information:	Evidence of pests or rodents were present in the roof space at time of inspection including animal pings and odor. Rodents can cause issues ranging from smells and stains through to physical damage to wiring and other elements in the roof void. A licensed pest controller should be appointed to free the roof void of any pests and to install deterrents or seal access points to ensure that rodents can not enter the roof space as easily.

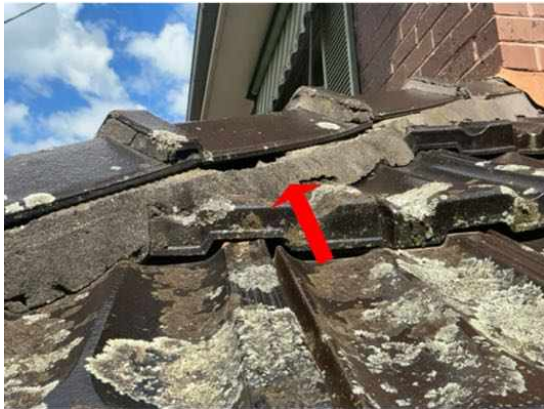
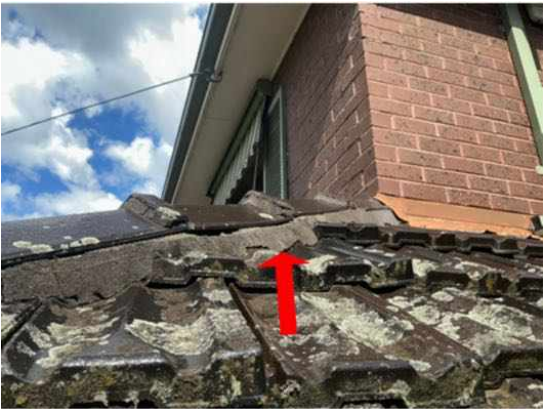
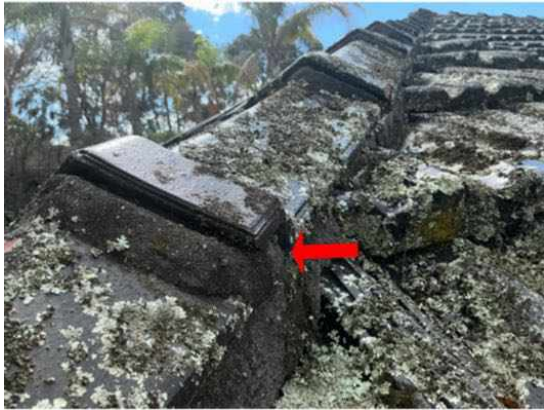
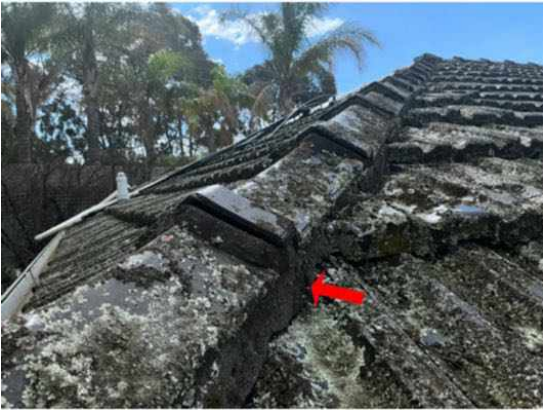
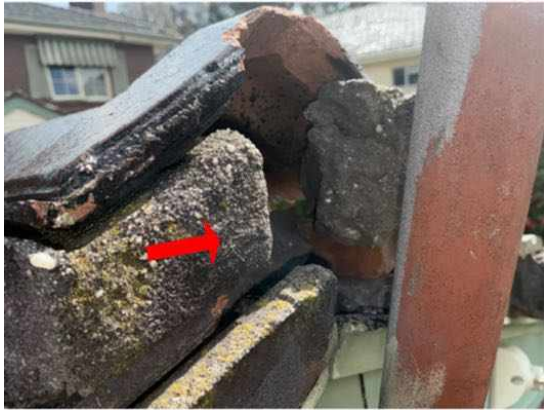
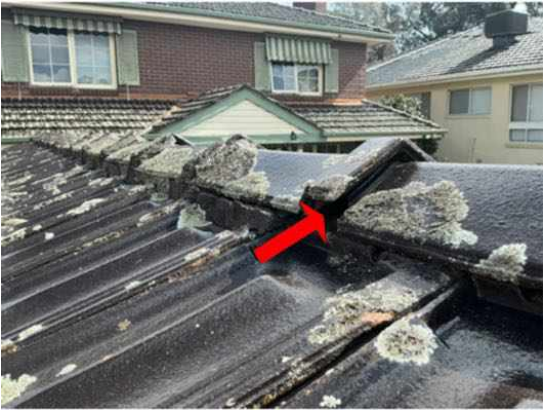
### Finding 3.19

Building:	Main Building
Location:	Roof Exterior
Finding:	Roof tiles - Hip tiles broken
Information:	Hip tiles, in a manner similar to ridge tiles, cap the apex of roof hips or intersections, and are vital in promoting adequate roof drainage. Due to their location, they are susceptible to accelerated weathering, and may breakdown over time.

If left unmanaged, broken hip tiles is likely to allow water ingress into internal areas, which creates potential for secondary damage to roof spaces and ceiling linings.

The maintenance of roofing tiles is particularly important in creating a weather resistant roofing structure. Replacement of broken hip tiles is required by a roofing contractor as soon as possible to assist in the prevention of any further damage that may ensue.

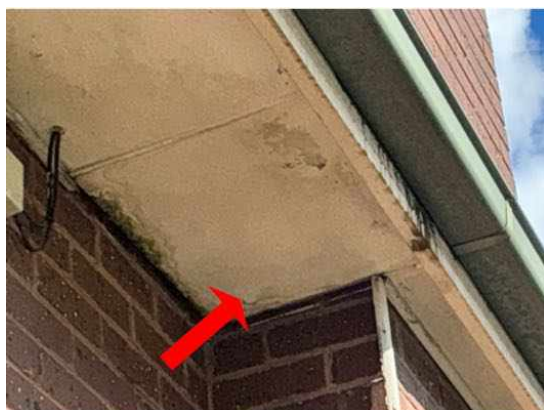
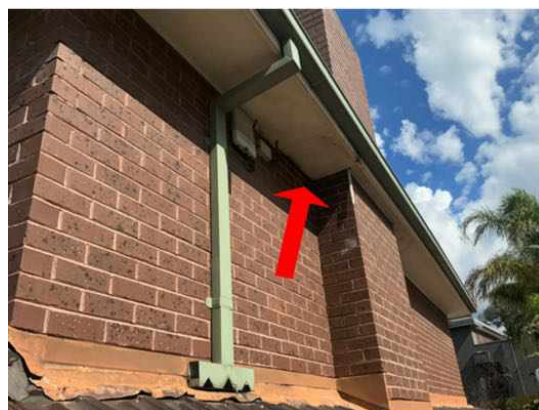
Finding 3.20

Building:	Main Building
Location:	Eaves
Finding:	Water leak - Active- gutter.
Information:	Generally, water leaks occur when a particular area of the property is not weather or water tight. As the surrounding area was found to be damp at the time of inspection, the leak is considered ongoing and hence requires urgent action.

Regardless of the location, even minor leaks that are left unmanaged can lead to serious damage of associated building elements and result in the need for replacement of building materials. Mould and other hazards such as electrical hazards may also arise if the leak is left to develop.

It is highly advised that the cause of the leak be identified and resolved immediately by a licensed plumber to prevent any further damage. Depending on the extent of the damage previously sustained, repair and/or replacement of any affected building materials may be required.

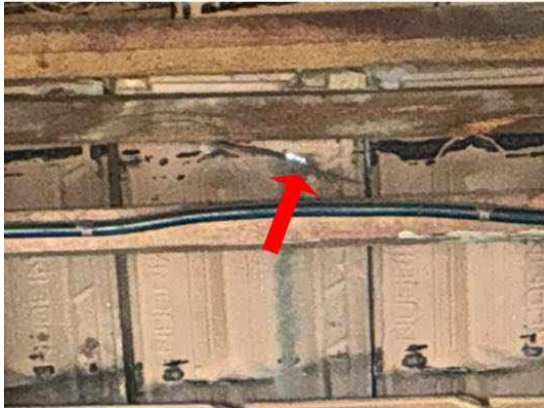
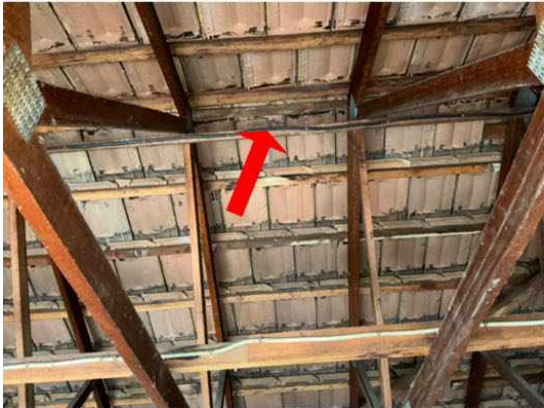
### Finding 3.21

Building:	Main Building
Location:	Garage
Finding:	Roof tile - Broken
Information:	Upon inspection of the exterior roof covering, a broken roofing tile was identified. Broken and friable roof tiles are generally the result of ageing and weathering of what is essentially a porous material.

If left to further deteriorate, broken and brittle roof tiles are likely to lead to water penetration via the roof into the ceiling space, causing secondary damage to ceiling linings, insulation and roof structures. Broken roof tiles are also likely to detract from the effectiveness of the roof drainage system, creating potential for secondary damage to the exterior roof covering and roof plumbing.

Replacement of broken tiles is required and should be performed by a roofing contractor as soon as possible.

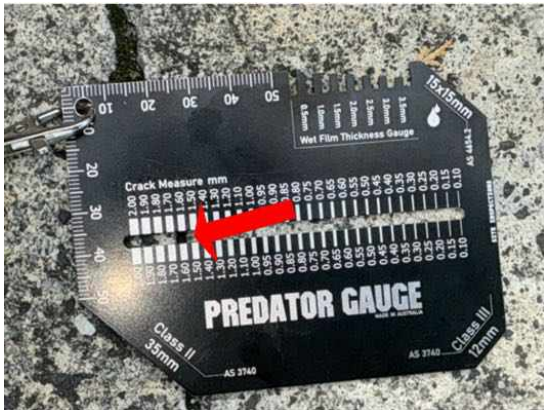
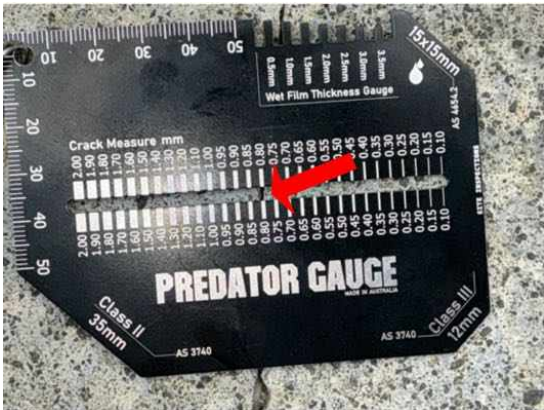
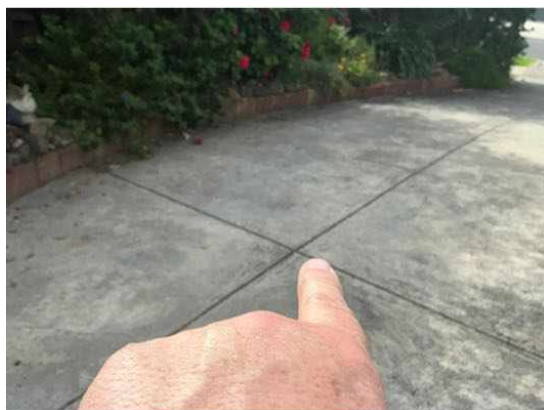
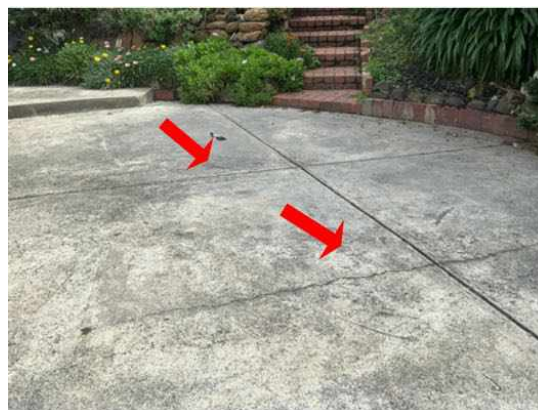
**Finding 3.22**

Building: Main Building  
 Location: Driveway  
 Finding: Crack in concrete slab - Category 2  
 Information: A crack coded as Category 2 was identified in the slab. A Category 2 crack is described as a distinct crack, with the slab being noticeably curved or changed in level.

To be considered Category 2, the approximate width of the crack is less than 2.0mm, or a change in offset of less than 15mm when a 3m straight edge is placed over the defect.

Category 2 cracks to slabs should be monitored for a period of 12 months. At the end of the monitoring period, cracks rated greater than Category 2 are considered defects that require rectification.

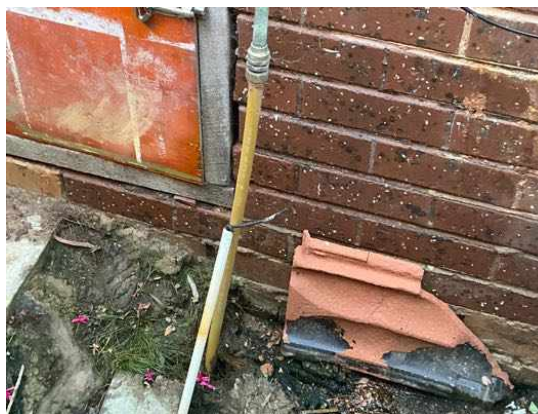
### Finding 3.23

Building:	Main Building
Location:	Exterior walls - left side
Finding:	PVC gas pipe not UV protected
Information:	It was observed at the time of the inspection that the PVC gas pipe to the RHS of the subfloor door was not adequately protected from UV radiation.

UV radiation can prematurely deteriorate plastic plumbing fittings and should be protected with a suitable material.

A licensed gas permit should be engaged to review as soon as possible

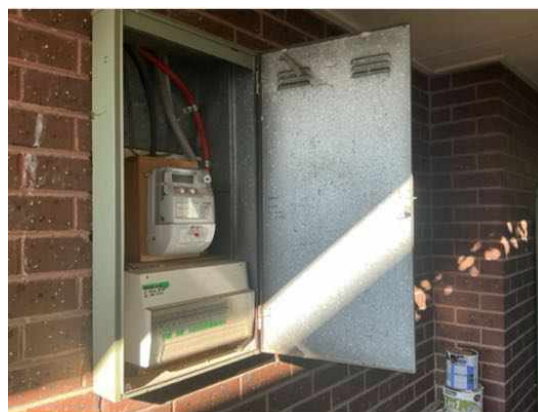
Building:	Main Building
Location:	Meter Box
Finding:	Termite Management System - no evidence of a chemical installation
Information:	The application of a post-construction chemical termite barrier is highly recommended for all properties, particularly if live termite activity has been found on the site previously. Such barriers are highly effective in preventing termite attack on any timber building elements throughout the property.

A durable notice should be placed in the switchboard unit to indicate current termite barriers. At the time of inspection, it appeared as though no termite management system has been installed, with no evidence to suggest preventative works taking place.

The client may consider gaining further advice from a pest controller as to the costs and procedures involved with this application. It is recommended that obtaining such advice be a short-term priority.

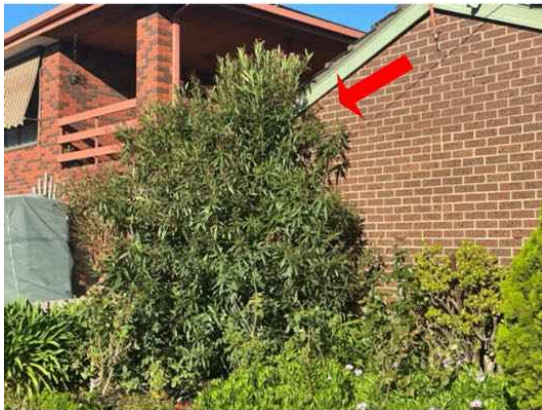
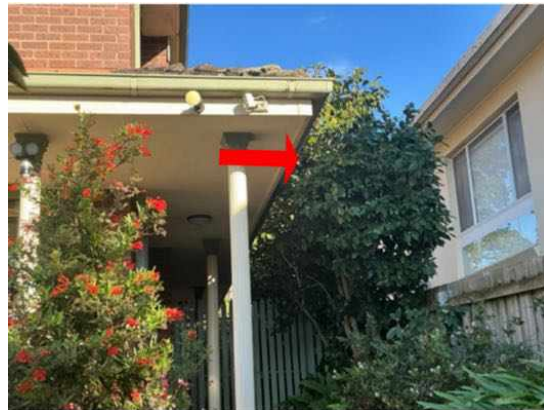
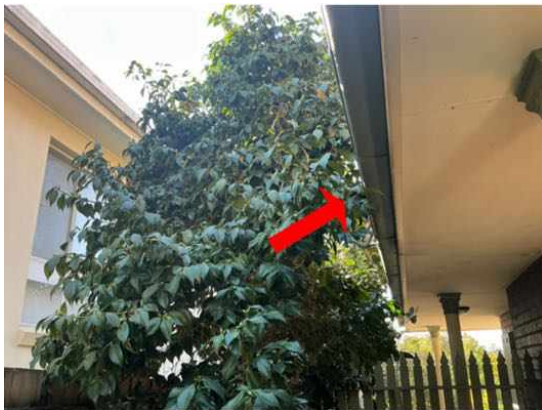
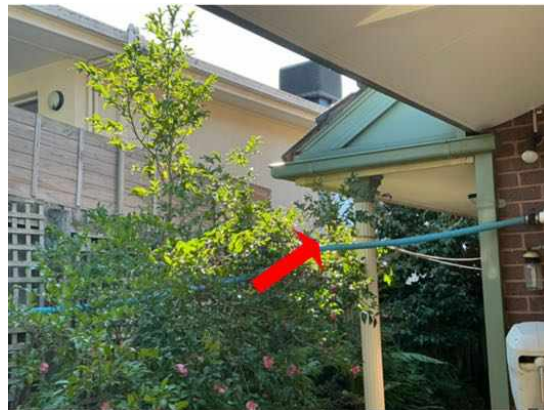
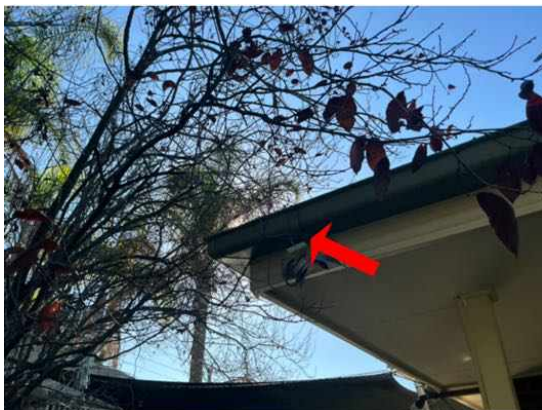
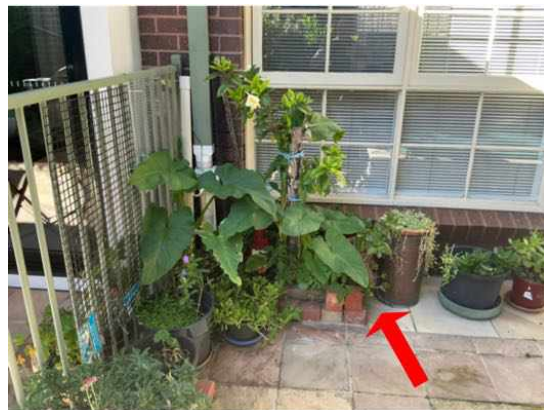
## Finding 6.02

Building:	Main Building
Location:	All External Areas
Finding:	Bridging - Vegetation
Information:	Where vegetation obstructs inspection of building elements, also known as bridging as it provides a bridging point for the access of termites, full inspection can not be achieved. Consequently moisture or dampness may be present and the areas becomes conducive to termite activity. Plants against or very close to buildings provide cover, shade and can provide an environment that is attractive to termite infestation.

The removal and replanting of species that do not provide "cover" or cutting back of existing vegetation will assist greatly in preventing Bridging from occurring.

The removal of any such materials that may be conducive to termite activity should be carried out as soon as possible and arrange re inspection to minimize the risk of termite attack.

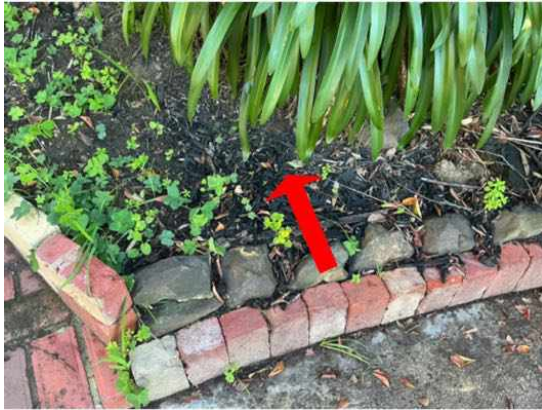
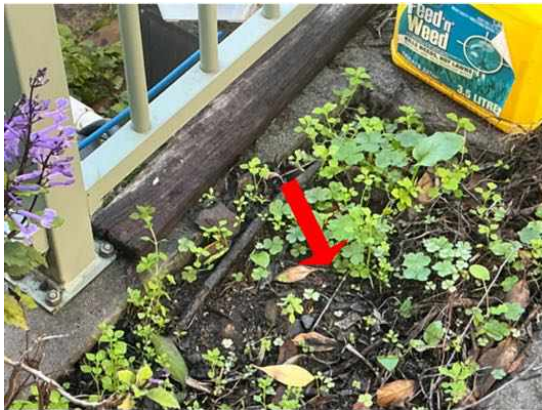
### Finding 6.03

Building:	Main Building
Location:	All External Areas
Finding:	Garden Beds - Conditions Conducive to Termites
Information:	Garden beds were found to be evident in the garden area. These garden beds can include untreated timber, and with a combination of moisture from watering hosing can make conditions conducive to termite activity and termite ingress.

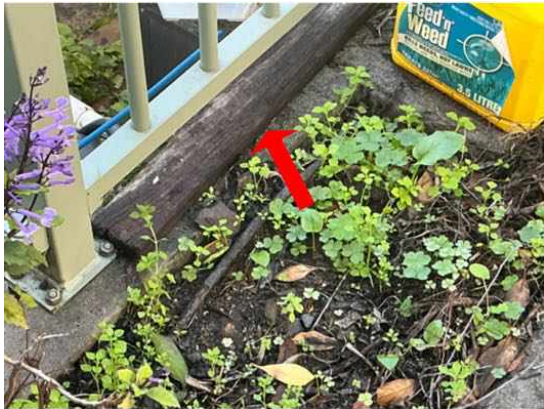
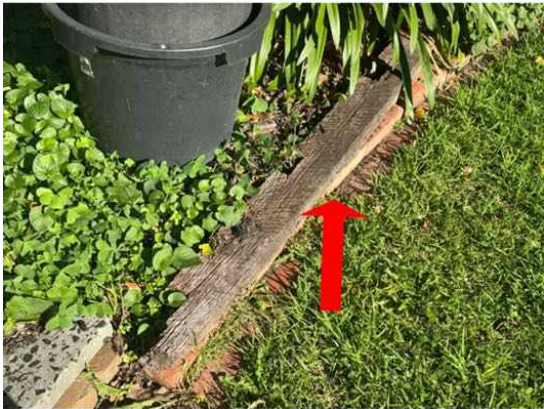
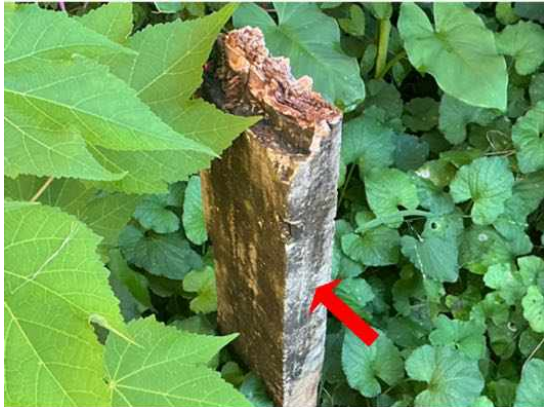
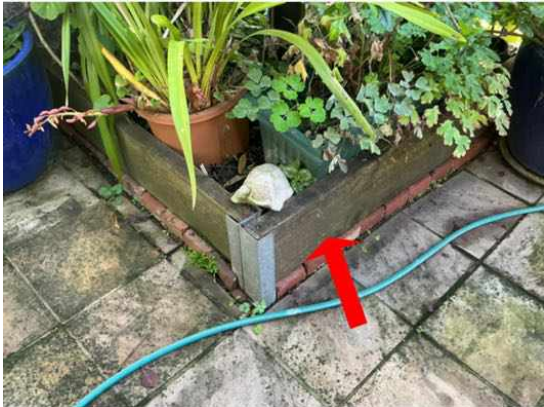
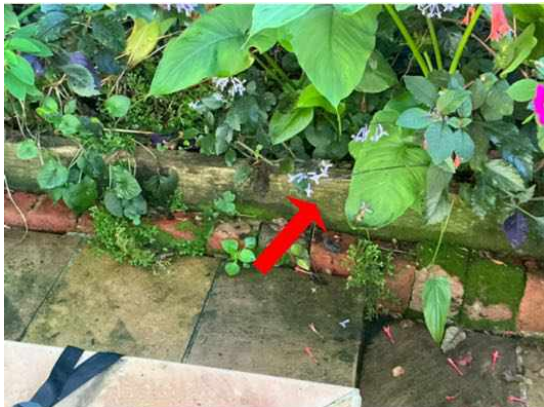
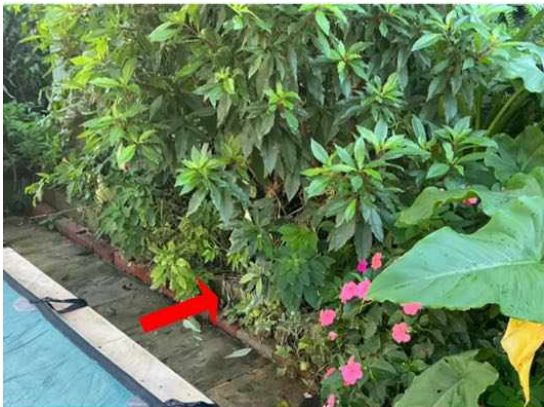
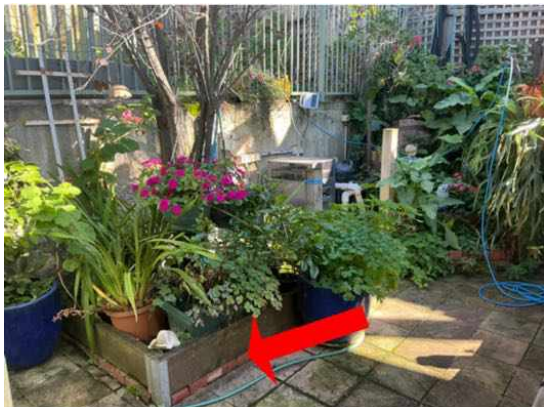
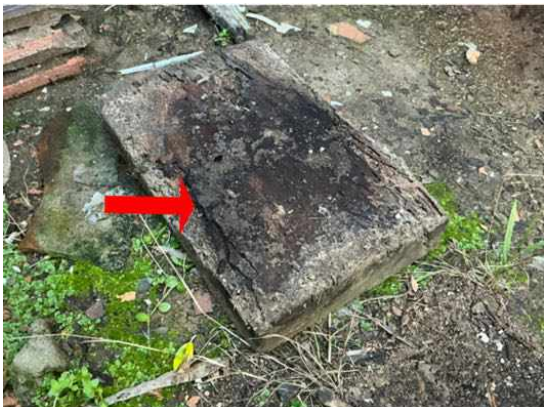
Building:	Main Building
Location:	All External Areas
Finding:	Untreated or non-durable timbers in a hazardous environment
Information:	To reduce the risk of timber pest attack it is essential that timber used in a hazardous environment (e.g. in direct contact with the ground or frequently exposed to damp conditions) is of sufficient durability and/or is adequately preservative treated.

Untreated timbers in direct contact with the ground are likely to develop severe wood rot and/or fungal decay if left unattended creating attraction for subterranean termites to infest the timbers from surrounding areas.

If untreated or non-durable timbers are found to be in a hazardous environment it is highly advised that replacement of these building elements be performed as soon as possible to aid the protection of the property against termite / timber pest attack.

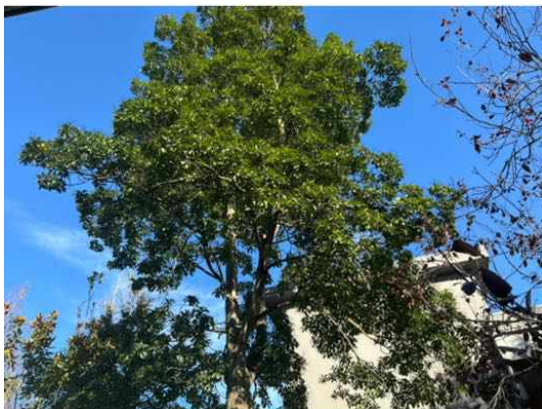
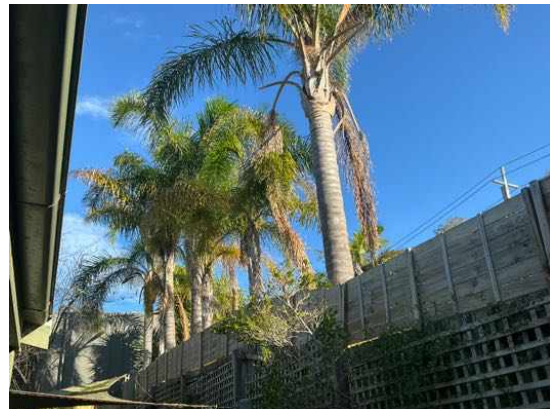
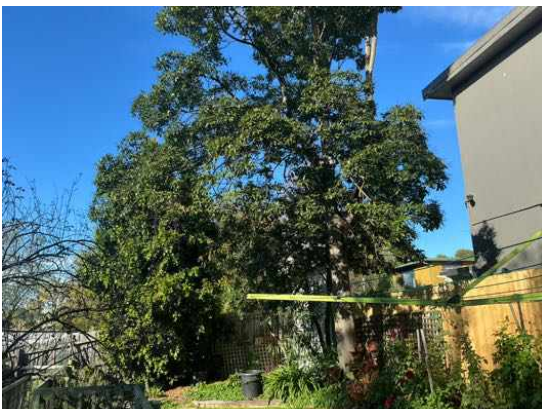
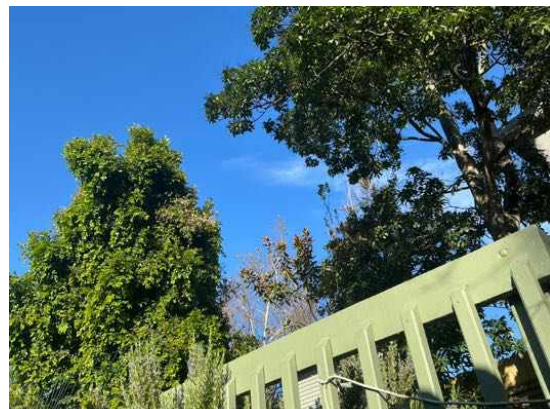
Finding 6.05

Building: Main Building  
 Location: All External Areas  
 Finding: Trees on the property TP  
 Information: During the inspection, it was observed that significant trees are located within the property perimeter which poses a potential risk for termites infestation. The proximity of the trees to the structure increases the likelihood of subterranean termites using the root system as pathways to access the building compromising its integrity.

Given the propensity for such trees to harbour and facilitate the spread of termites, it is strongly recommended that a comprehensive termite protection plan be implemented to mitigate this risk.

As an initial remedial action consultation with a qualified arborist and pest control specialist is advised to assess the health and species of the trees in question, as well as explore options for creating a barrier or modifying the landscape to deter termite access.

Regular monitoring and maintenance should be prioritised to ensure the ongoing protection of the property from potential termite activity.

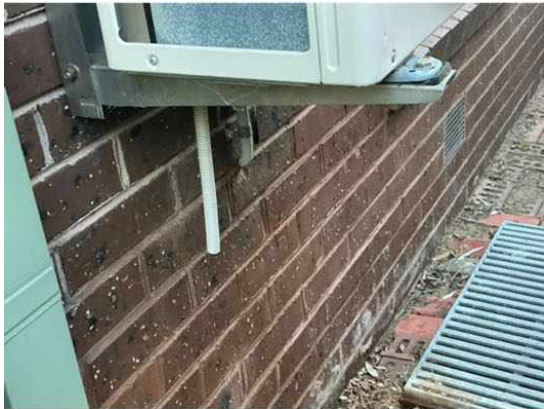
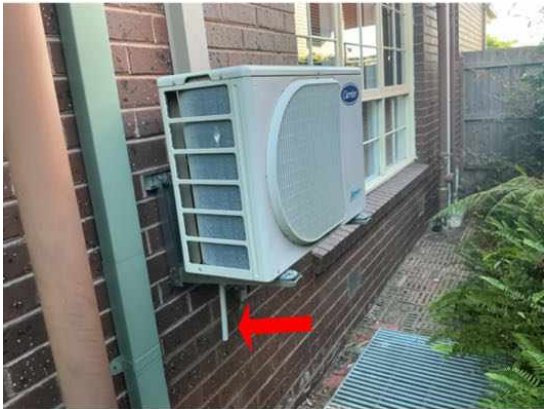
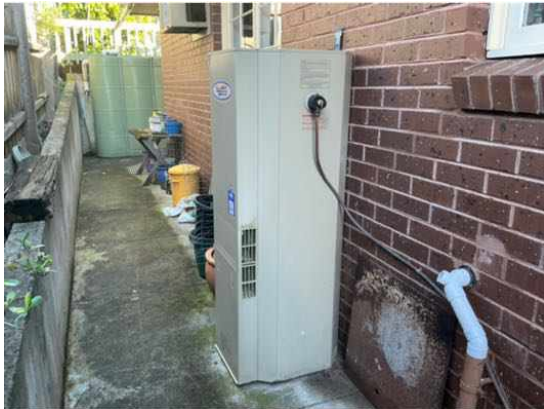
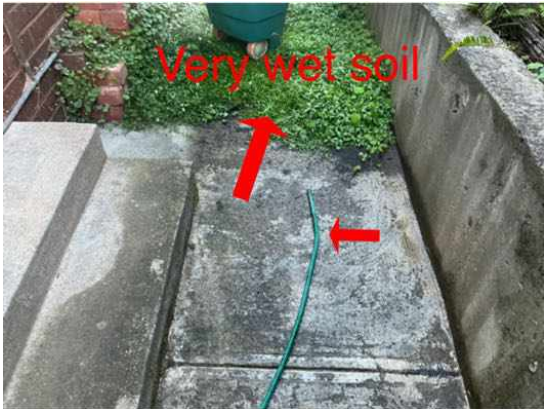
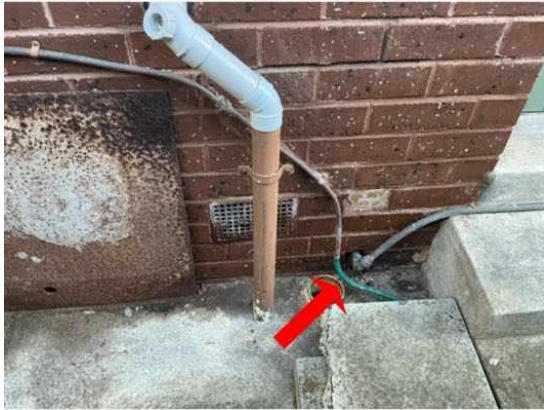
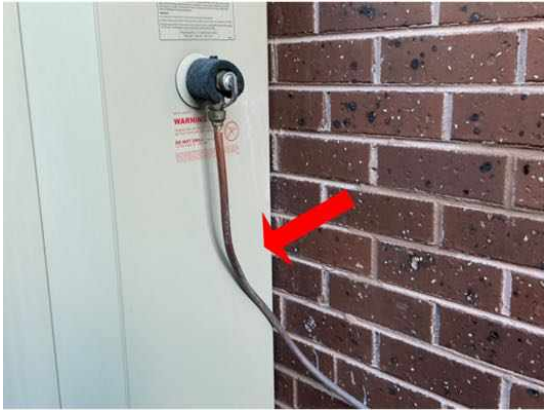
### Finding 6.06

Building: Main Building

Location: All External Areas  
Finding: Air conditioner and hot water heater condenser pipe not connected  
Information: The A/C and water heater condenser overflow where found to be disconnected from the stormwater system and is creating excessive moisture to the surrounding area.

Such leaking creates an environment which is conducive to an array of defects including water damage to associated building materials and the attraction of termites or timber pest infestation.

A Licensed plumber should be engaged to review as soon as possible
