# Building and Timber Pest Inspection Report

Inspection Date: Thu, 9 Apr 2026

Property Address: 95 Bellevue Ave, Rosanna VIC 3084,  
Australia

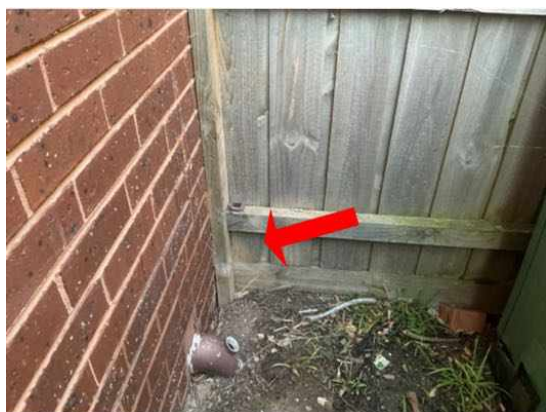
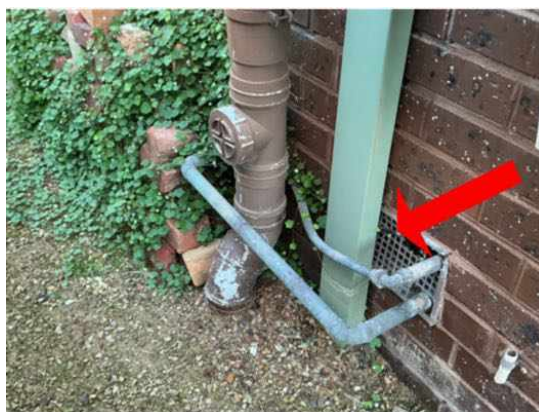
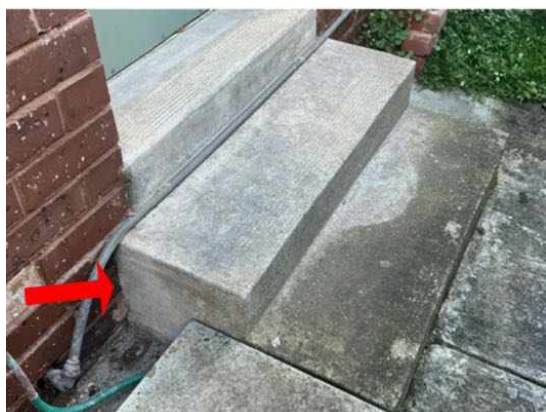
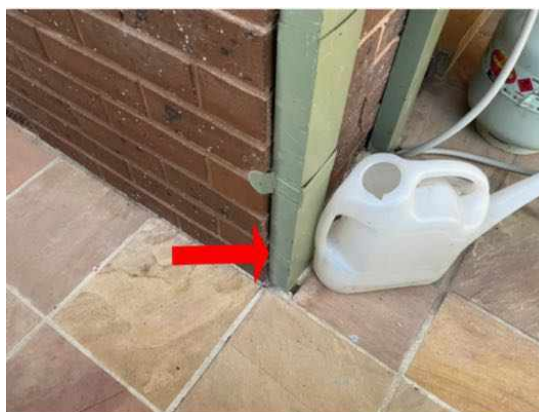
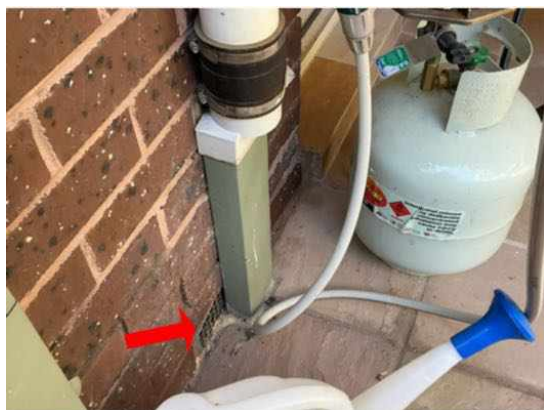
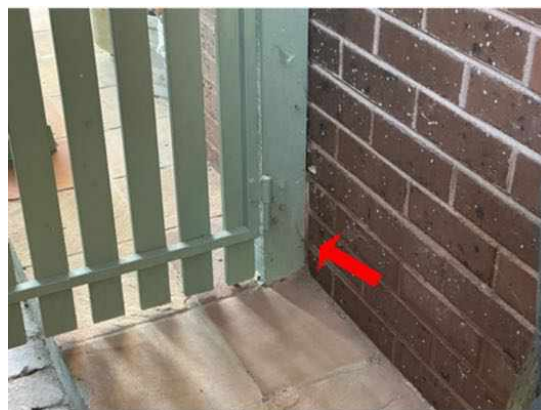
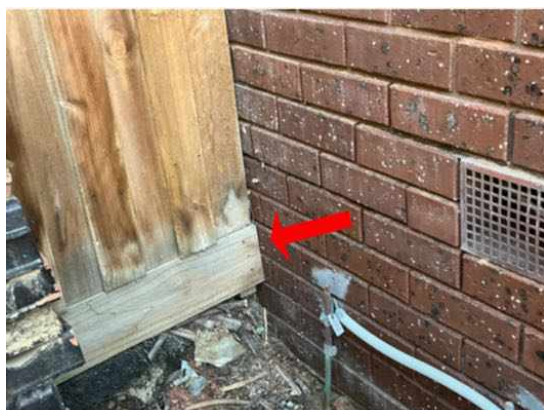
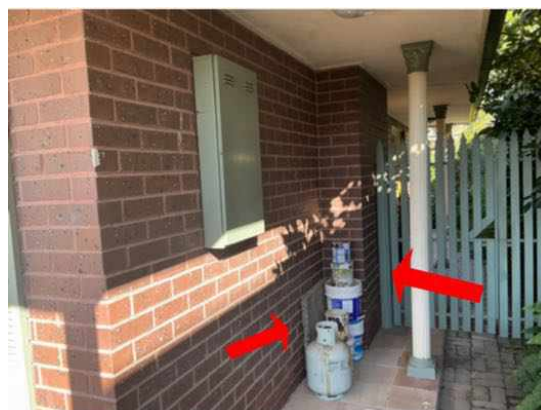
**Finding 6.07**

Building: Main Building  
Location: All External Areas  
Finding: Bridging or breaching of termite barriers - adjacent internal flooring  
Information: Bridging is the spanning of a termite barrier or inspection zone so that subterranean termites are provided with passage over or around that barrier.

It is important for internal flooring to be raised above adjacent external ground levels. Where external ground levels are above internal flooring water pooling and subsequent internal flooding is likely to occur which may attract termite activity to the internal area.

It is highly advised that a landscaper or paver be appointed to lower external grounds that are raised above adjacent internal flooring. Alternatively if external grounds and internal flooring is level installation of a raised door sill may be appropriate in preventing any water pooling in the area.

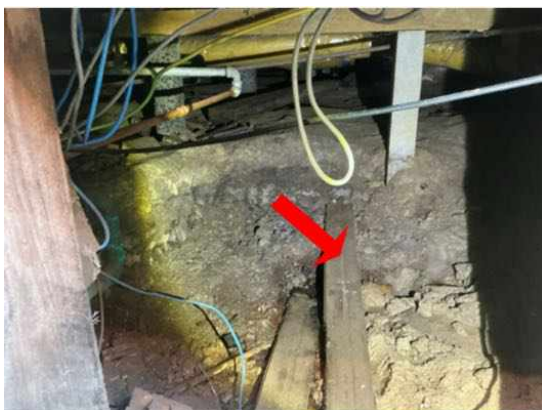
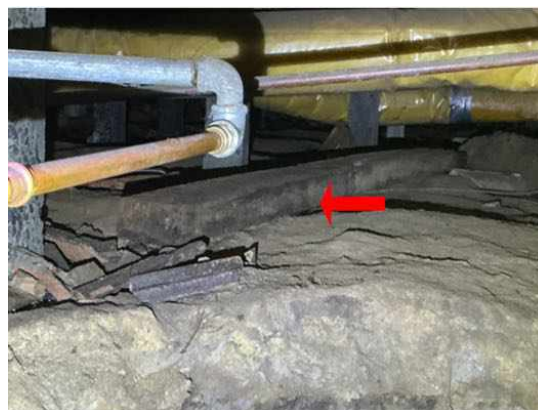
### Finding 6.08

Building:	Main Building
Location:	Subfloor
Finding:	Stored timbers - subfloor space or external area
Information:	The storing of timbers in the subfloor space or around the external property increases the risk of termite activity being present. As they are likely to come into contact with weather conditions or excessive moisture wood rot is likely to develop on timbers that are not treated.

It is highly recommended that any stored timbers be immediately removed from areas in which they may attract any termite / timber pest attack. Minimisation of risk / prevention of termite attack is far more adequate than dealing with the presence of termite activity.

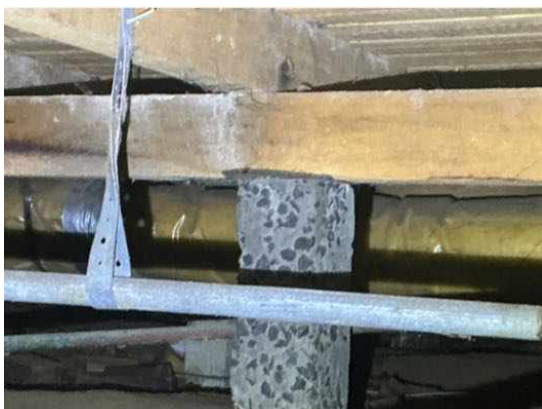
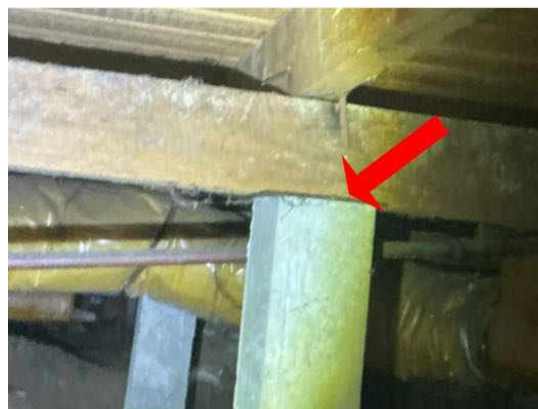
### Finding 6.09

Building:	Main Building
Location:	Subfloor
Finding:	Ant caps - Not installed
Information:	Ant caps have not been installed to the subfloor structure at the time of inspection. Generally, ant caps are installed to the intersection between the top of the stumps (or piers) and the subfloor structures.

Installed during the construction process, ant caps are designed to easily identify termite or pest ingress from stumps to the adjoining bearers.

Where ant caps have not been installed, frequent monitoring of these areas should be carried out in order to identify any signs of termite or timber pest workings.

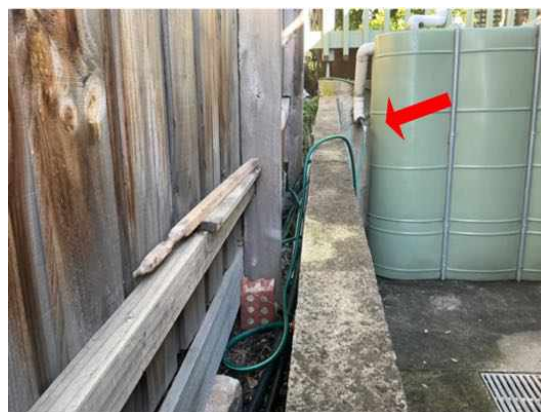
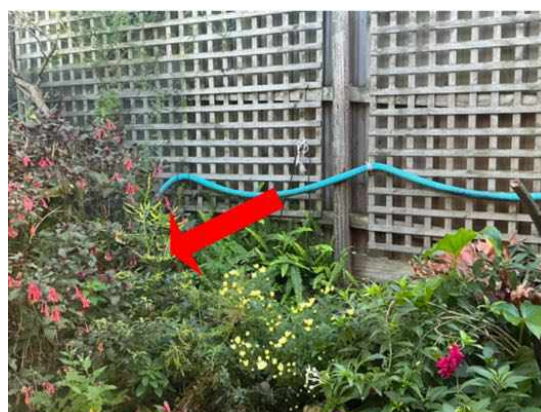
### Finding 6.10

Building:	Main Building
Location:	All External Areas
Finding:	Stormwater irrigation diversion
Information:	It was observed at the time of the inspection that the overflow to the rainwater tank was not connected to the stormwater and was being used for irrigation purposes. There was also rainwater diversion from downpipes which was also being used for

garden irrigation. These should be connected to the stormwater as it is providing excess moisture to the surrounding area which is conducive to termite activity.

Unattended to the foundation material to the building could become saturated and unstable. This could lead to movement and cracking of rigid building elements.

A licensed plumber should be engaged to review as soon as possible.

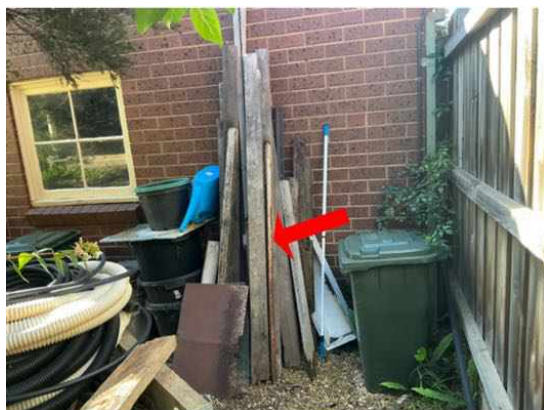
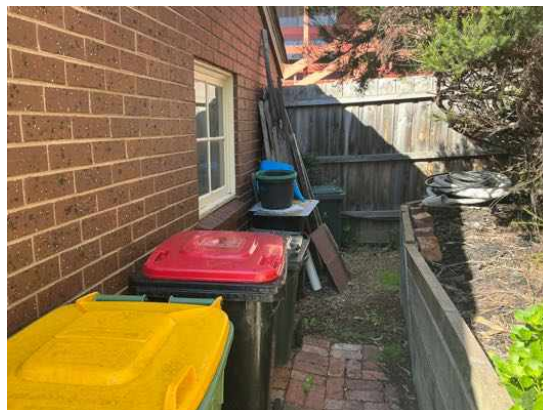
### Finding 6.11

Building:	Main Building
Location:	All External Areas
Finding:	Stored timbers - external area
Information:	The storing of timbers around the external property increases the risk of termite activity being present. As they are likely to come into contact with weather conditions or excessive moisture wood rot is likely to develop on timbers that are not treated.

It is highly recommended that any stored timbers be immediately removed from areas in which they may attract any termite / timber pest attack. Minimisation of risk / prevention of termite attack is far more adequate than dealing with the presence of termite activity.

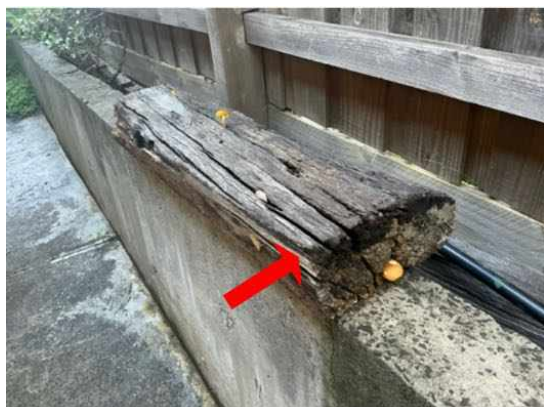
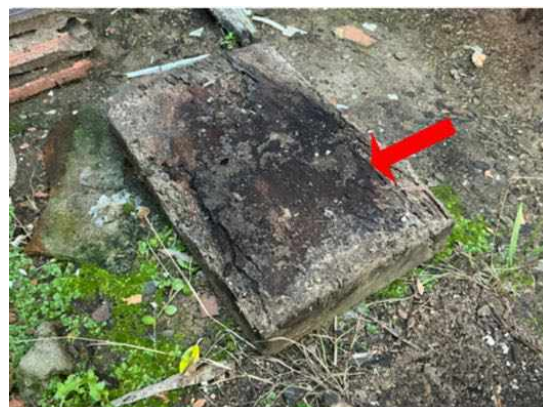
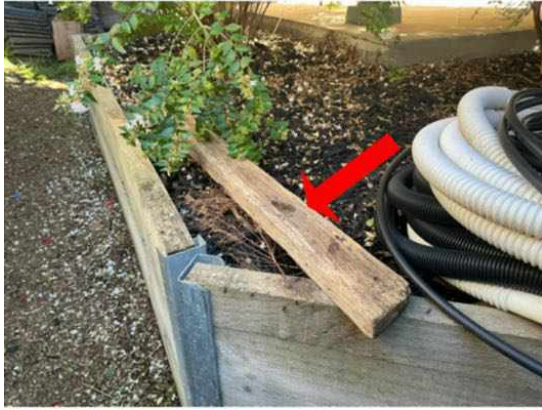
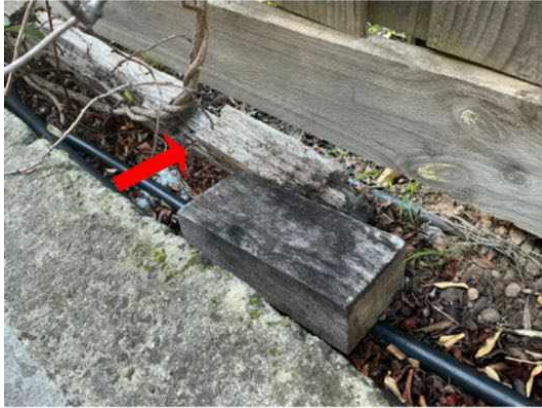
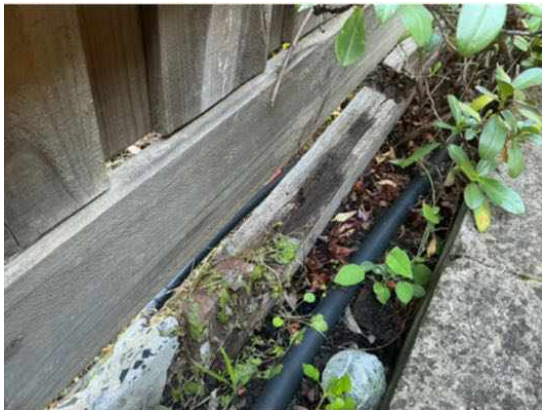
### Finding 7.01

Building:	Main Building
Location:	All External Areas
Finding:	Fungal decay - present (localised)
Information:	Fungal decay also known as wood decay or wood rot generally refers to the deterioration of timber elements when in contact with excessive levels of moisture for a prolonged period of time.

The development of fungal decay is accelerated by temperatures in the range of 5degreeC to 40degreeC as well as the presence of oxygen. Generally fungal decay develops on timber elements that are in use in an external environment which are exposed to rain penetration.

In this case although the affected timber element is in a decaying state the extent of any visible damage appears to be localised to a specific area and is yet to spread to other parts of the building element or affect adjoining structures. The fungal decay is therefore likely to be of a relatively superficial nature with minimal impact on the structural integrity or tensile strength of the timber element.

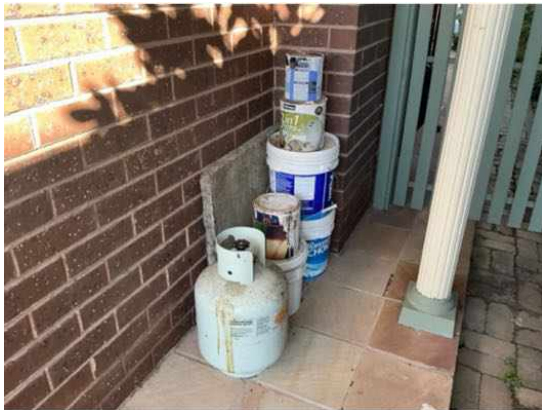
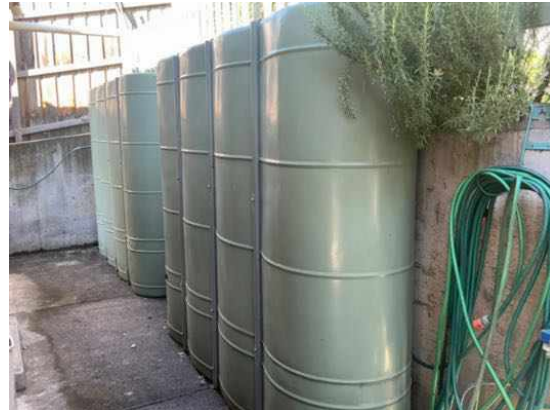
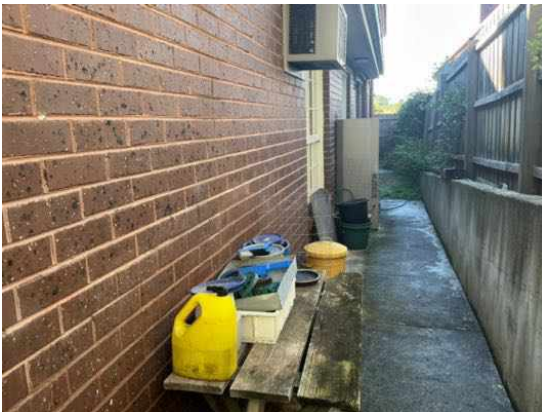
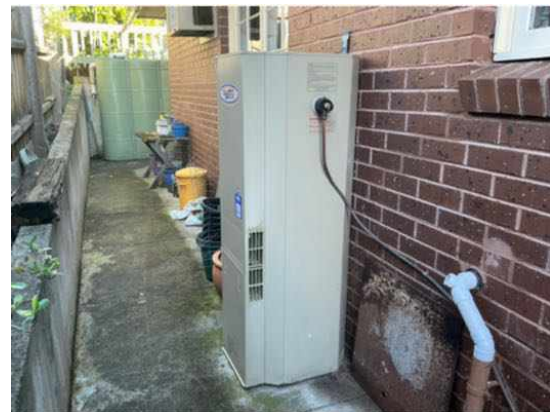
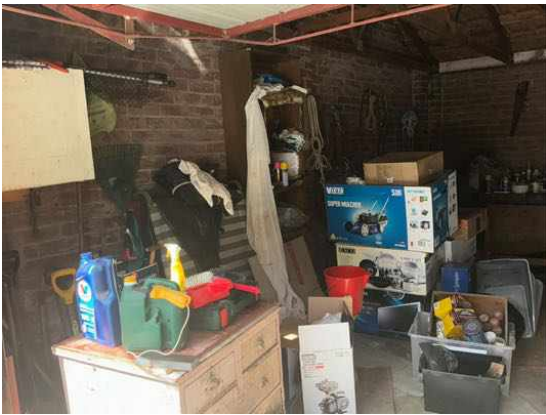
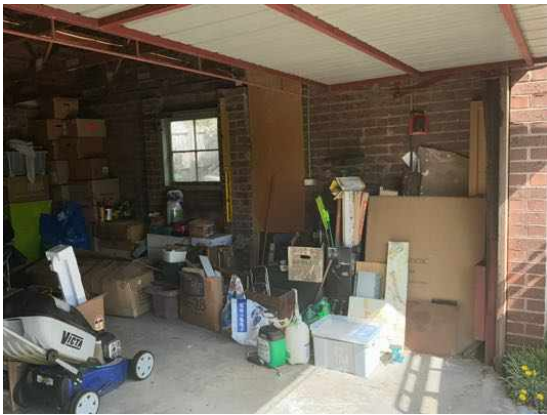
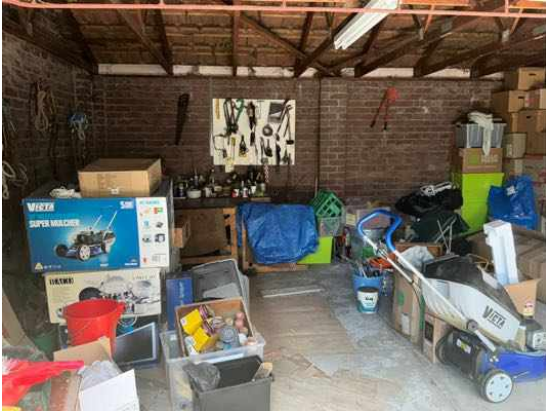
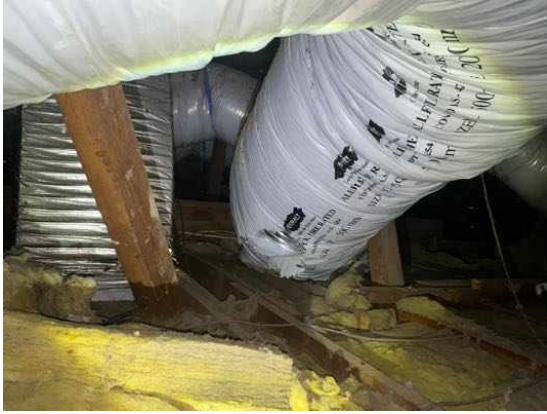
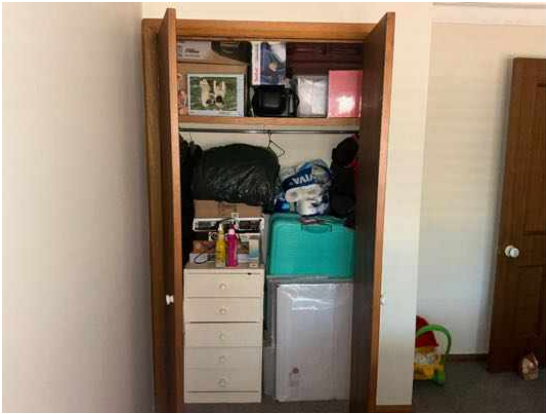
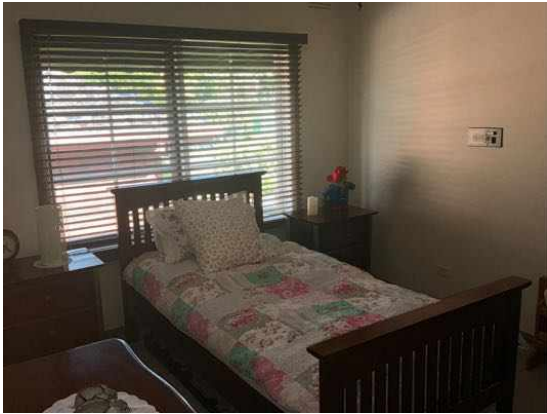
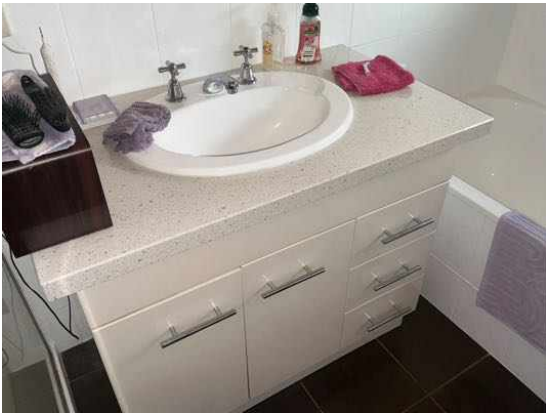
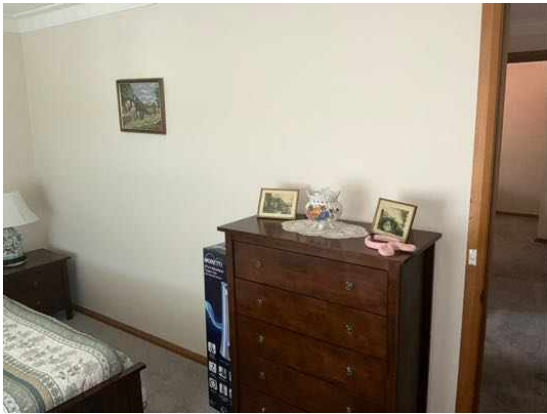
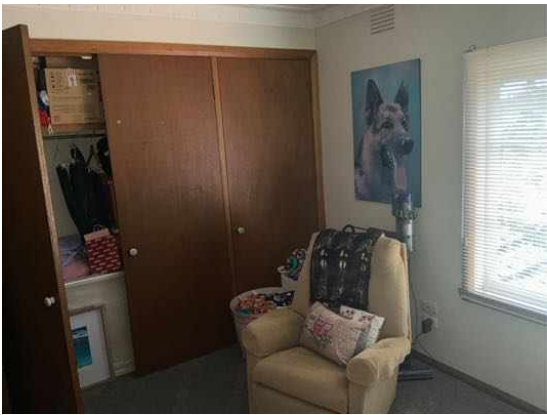
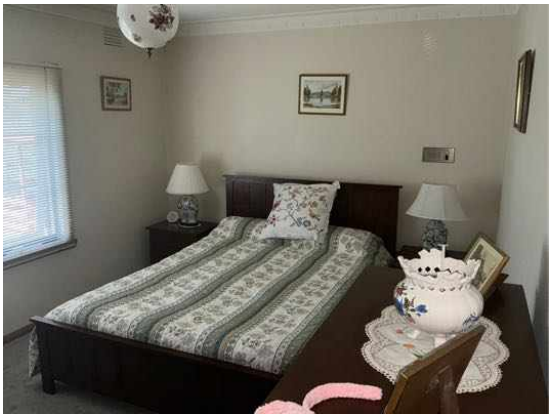
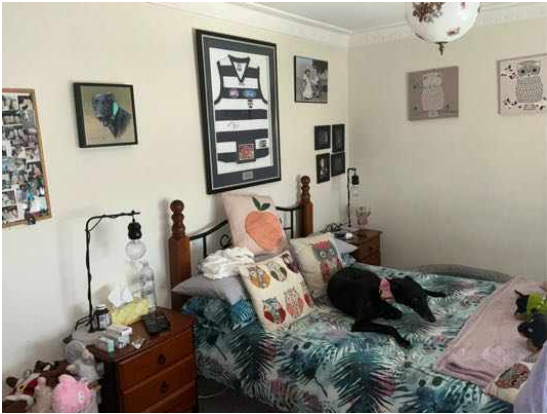
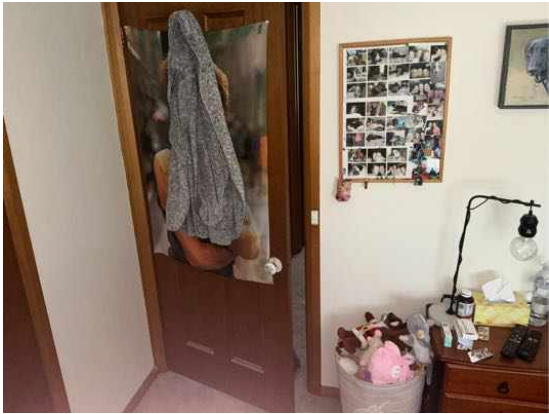
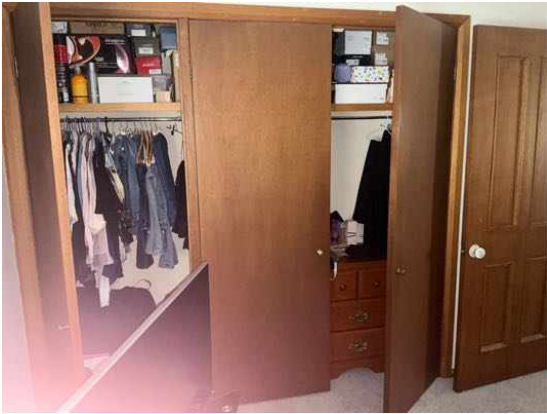
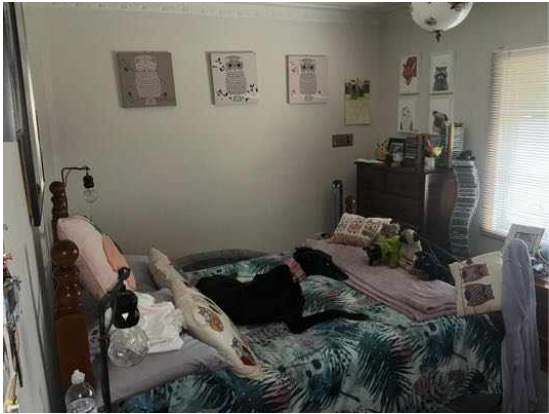
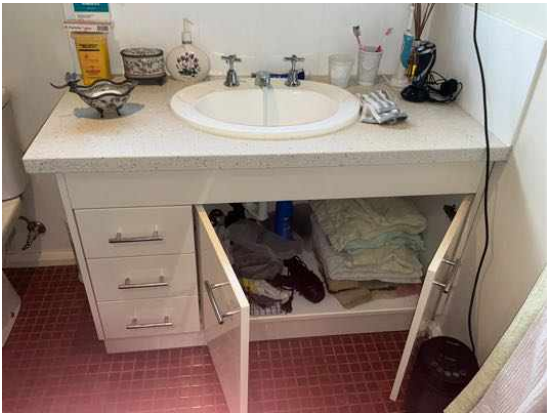
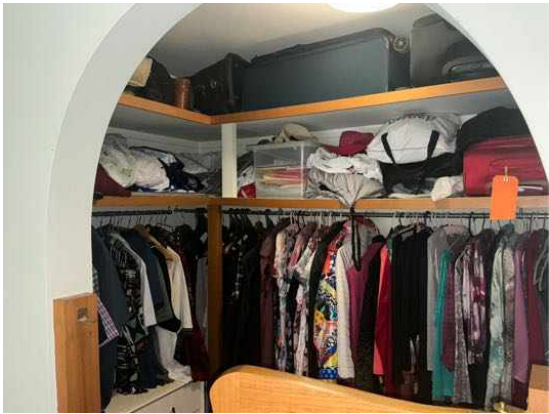
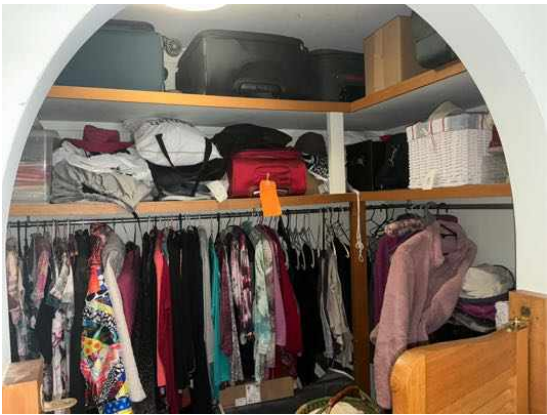
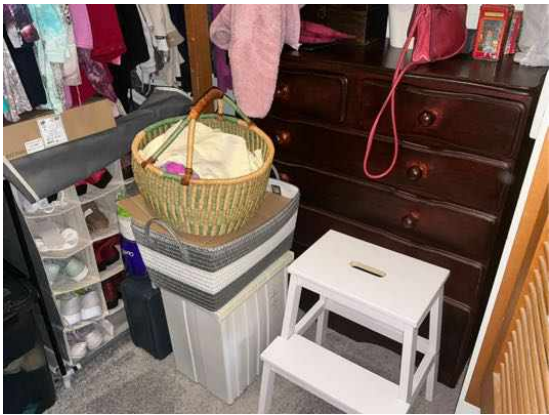
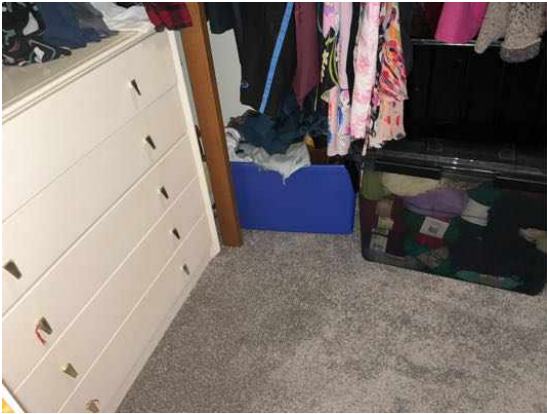
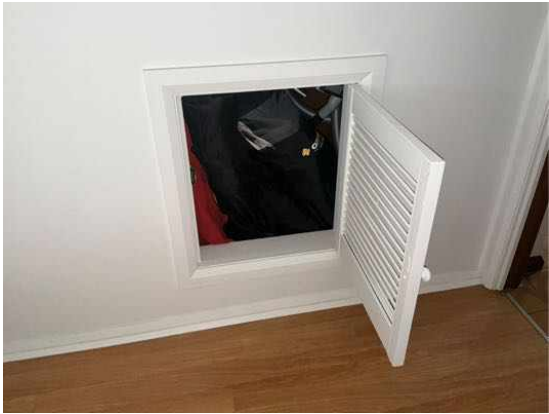
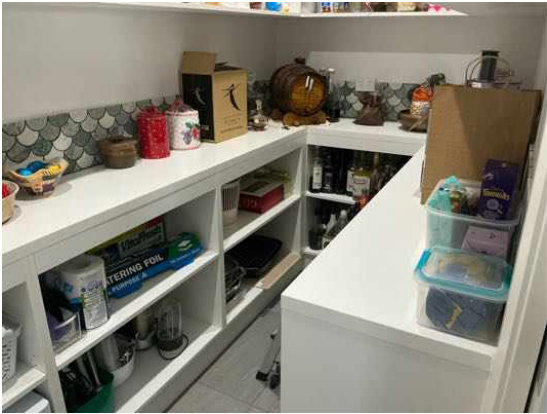
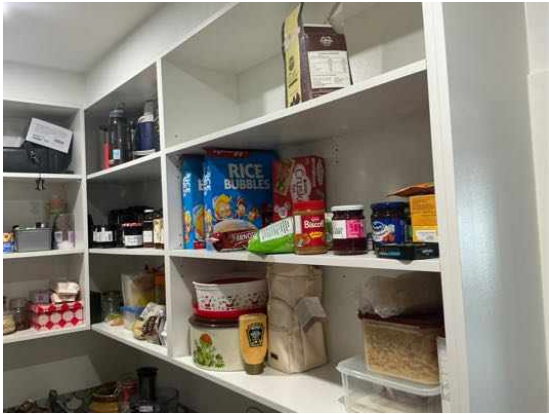
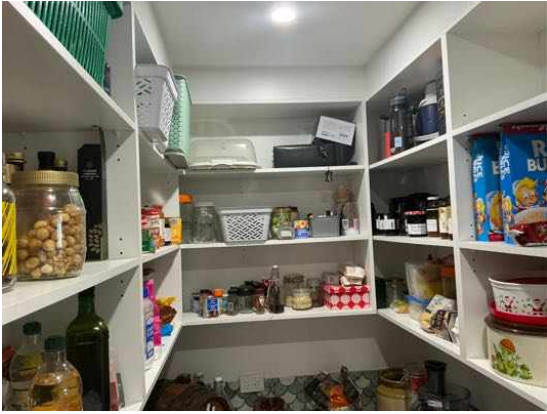
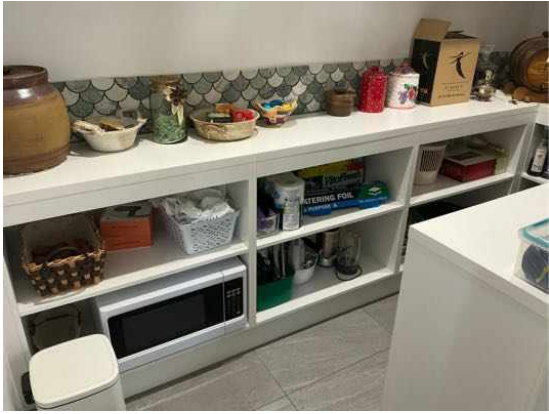
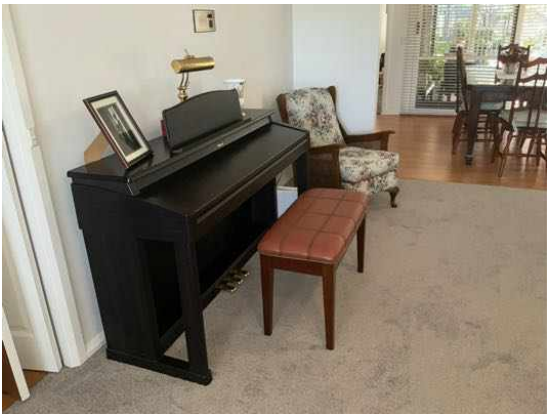
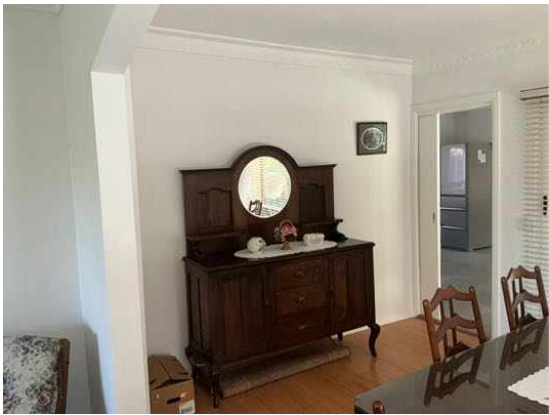
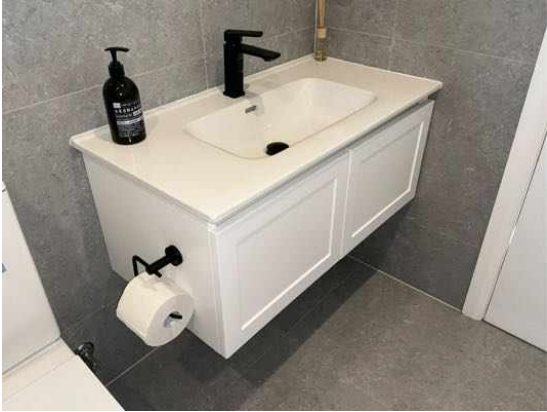
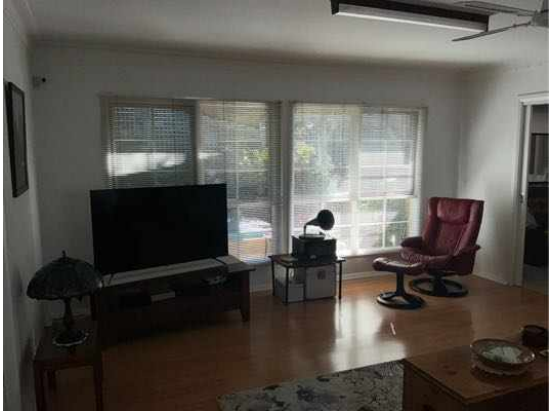
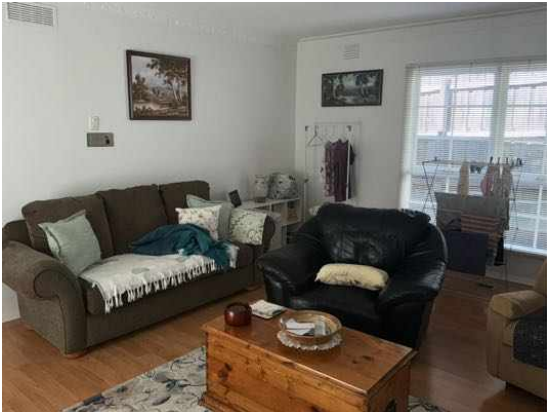
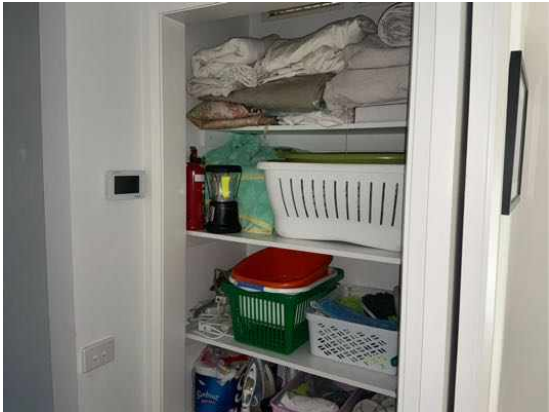
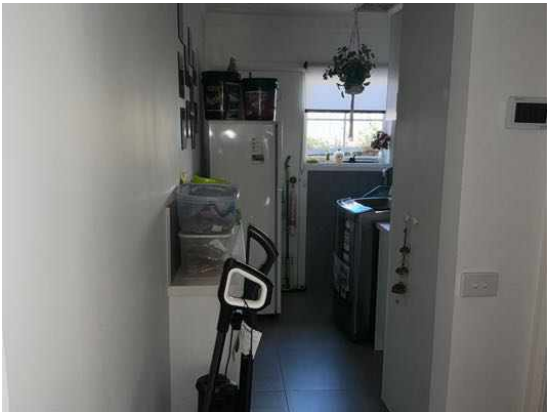
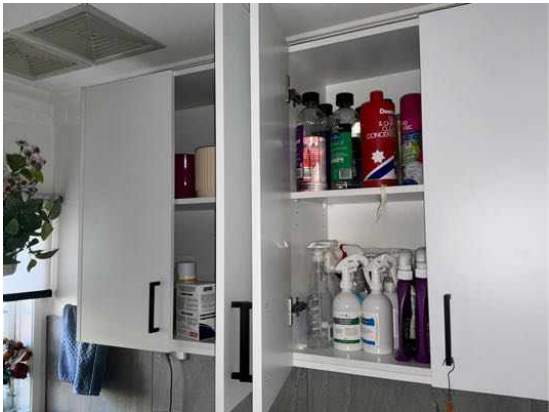
Building: Main Building  
Location: All Areas  
Finding: Additional Photos - Obstructions and Limitations  
Information: These photographs are an indication of the obstructions and limitations which impeded full inspection of the property at the time of inspection. These obstructions can hide an array of defects and should be removed to allow full inspection to be carried out. A re-inspection is recommended once the areas are made accessible.

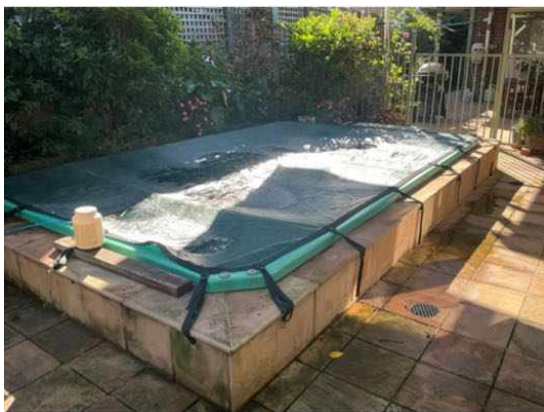
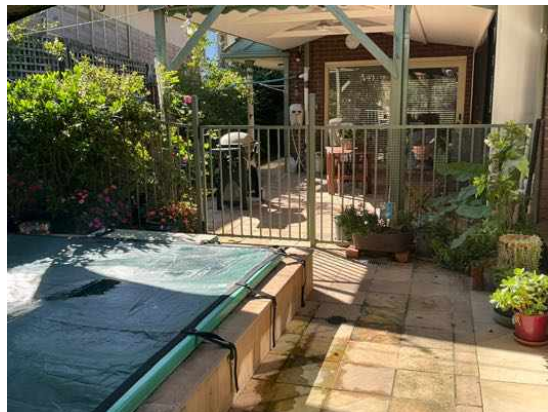
Building: Main Building  
 Location: Yard - Side  
 Finding: Pool fencing - Inspection required  
 Information: It is suspected that areas of the pool fencing may not comply with Australian Standards. Assessment of the pool area is required.

Please note that this inspection does not cover pool fencing and other pool fittings and fixtures. It is highly advised that a specialist be appointed to inspect the pool and surrounding area and provide advice on rectification works that may be required.
